**Flood Control Project Maintenance  
Levee Inspections**

**Fall 2015 Levee Maintenance Deficiency Summary Report**

**Sutter Maintenance Yard Maintenance Area 0005**

**Fall 2015 Levee Inspection Results**

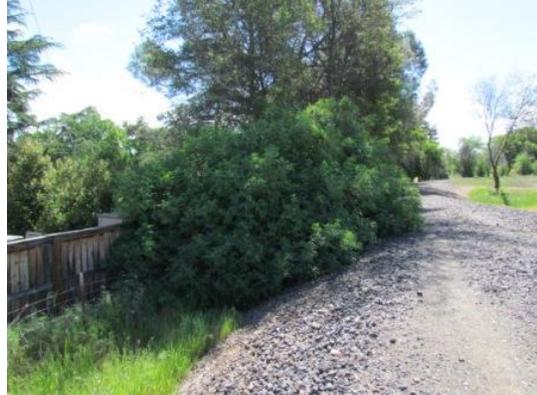
Photo 1 of 1 : FA\_2015\_MA0005\_196\_903\_20150910\_00017.jpg

LM Start	<b>0.56</b>	Rating **	M	Issue No.	<b>903</b>
LM End	<b>0.56</b>	Issue Type +	Ma	Location *	LS
Category	Earthen Levee		GPS Latitude/Longitude		
			Start	End	
Item	Vegetation		39.690745 °	39.690745 °	
			-121.777342 °	-121.777342 °	
DWR ID	DWR_MA0005_01_s_2012_903				
Action/Comments					
Elderberries are blocking visibility and flood fight capability.

View of the large elderberries along the L/S toe.

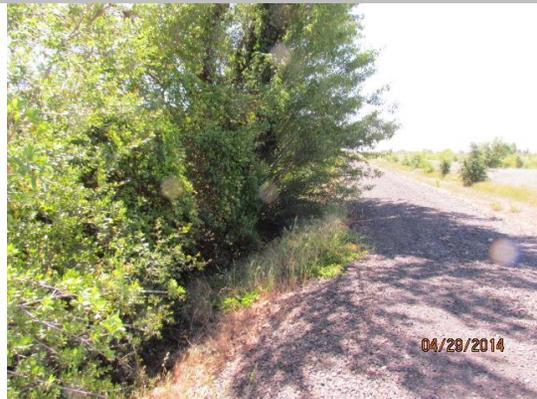
Photo 1 of 1 : FA\_2015\_MA0005\_196\_32\_20150910\_00012.jpg

LM Start	<b>0.77</b>	Rating **	M	Issue No.	<b>32</b>
LM End	<b>0.77</b>	Issue Type +	Ma	Location *	LS
Category	Earthen Levee		GPS Latitude/Longitude		
			Start	End	
Item	Trim / Thin Trees		39.687917 °	39.687917 °	
			-121.777393 °	-121.777393 °	
DWR ID	DWR_MA0005_01_s_2014_32				
Action/Comments					
Thin trees to allow visibility of the ground and room to flood fight.

Trim the trees along the landside slope.

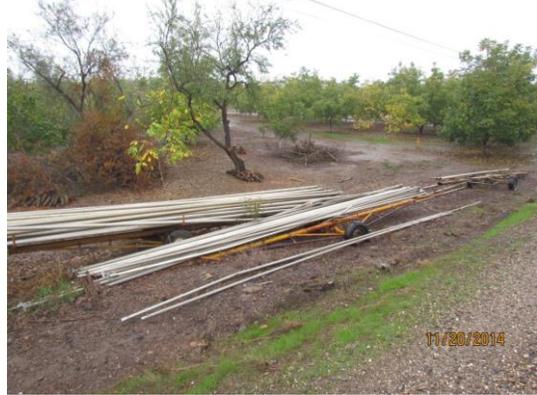
Photo 1 of 1 : FA\_2015\_MA0005\_196\_30\_20150910\_00010.jpg

LM Start	<b>1.53</b>	Rating **	M	Issue No.	<b>30</b>
LM End	<b>1.53</b>	Issue Type +	En	Location *	LS
Category	Earthen Levee		GPS Latitude/Longitude		
			Start	End	
Item	Encroachments		39.677130 °	39.677130 °	
			-121.777583 °	-121.777583 °	
DWR ID	DWR_MA0005_01_f_2014_30				
Action/Comments					
Equipment

View of the sprinkler pipe and equipment along the landside toe.

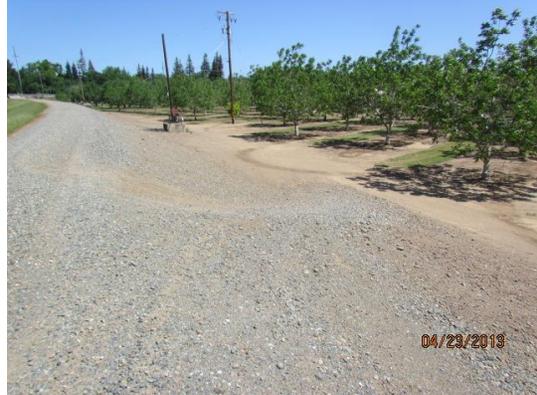
Photo 1 of 1 : FA\_2015\_MA0005\_196\_16\_20150910\_00007.jpg

View of the unauthorized vehicle ramp on the landside slope.

LM Start	<b>1.61</b>	Rating **	M	Issue No.	<b>16</b>
LM End	<b>1.61</b>	Issue Type +	Ma	Location *	LS
Category	Earthen Levee		GPS Latitude/Longitude		
			Start	End	
Item	Slope Stability		39.676129 °	39.676129 °	
			-121.778171 °	-121.778171 °	
DWR ID	DWR_MA0005_01_s_2013_16				
Action/Comments					
Repair the levee slope damaged by vehicle traffic and prevent access where possible.

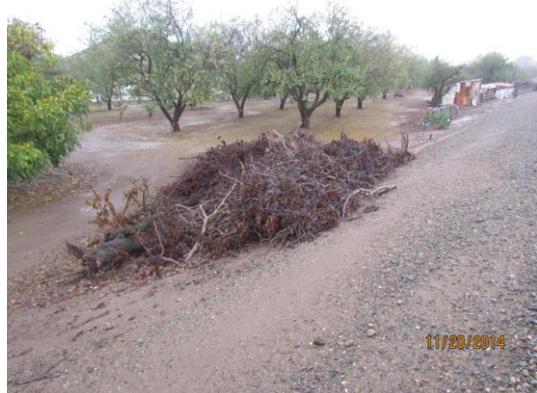
Photo 1 of 1 : FA\_2015\_MA0005\_196\_34\_20150910\_00014.jpg

LM Start	<b>1.64</b>	Rating **	M	Issue No.	<b>34</b>
LM End	<b>1.64</b>	Issue Type +	En	Location *	LS
Category	Earthen Levee		GPS Latitude/Longitude		
			Start	End	
Item	Encroachments		39.675763 °	39.675763 °	
			-121.778485 °	-121.778485 °	
DWR ID	DWR_MA0005_01_f_2014_34				
Action/Comments					
Prunings

View of the prunings along the landside toe.

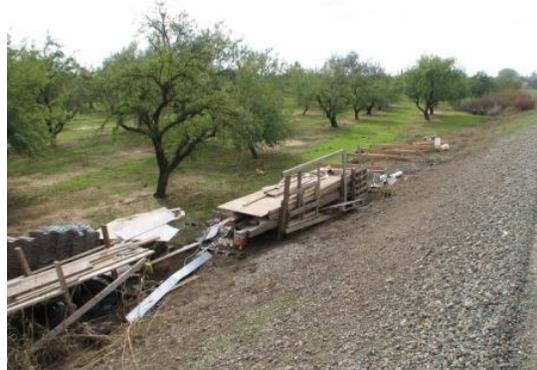
Photo 1 of 1 : FA\_2015\_MA0005\_196\_1\_20150910\_00001.jpg

LM Start	<b>1.66</b>	Rating **	M	Issue No.	<b>1</b>
LM End	<b>1.66</b>	Issue Type +	Ma	Location *	LS
Category	Earthen Levee		GPS Latitude/Longitude		
			Start	End	
Item	Encroachments		39.675528 °	39.675528 °	
			-121.778642 °	-121.778642 °	
DWR ID	DWR_MA0005_01_s_2012_1				
Action/Comments					
Debris

View of the removed garbage but construction supply on pallets.

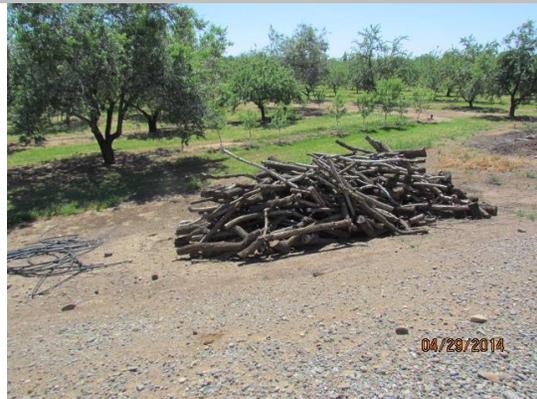
Photo 1 of 1 : FA\_2015\_MA0005\_196\_33\_20150910\_00013.jpg

LM Start	<b>1.69</b>	Rating **	M	Issue No.	<b>33</b>
LM End	<b>1.69</b>	Issue Type +	En	Location *	LS
Category	Earthen Levee		GPS Latitude/Longitude		
			Start	End	
Item	Encroachments		39.675158 °	39.675158 °	
			-121.779025 °	-121.779025 °	
DWR ID	DWR_MA0005_01_s_2014_33				
Action/Comments					
Firewood

View of the firewood along the landside toe.

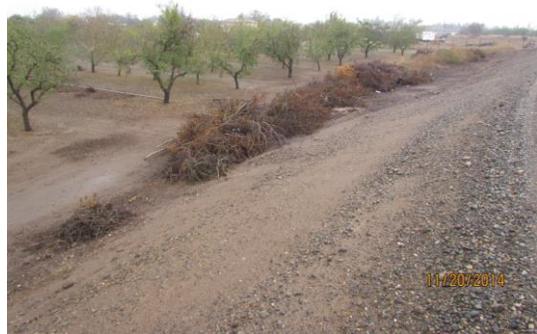
Photo 1 of 1 : FA\_2015\_MA0005\_196\_35\_20150910\_00015.jpg

LM Start	<b>1.88</b>	Rating **	M	Issue No.	<b>35</b>
LM End	<b>1.88</b>	Issue Type +	En	Location *	LS
Category	Earthen Levee		GPS Latitude/Longitude		
			Start	End	
Item	Encroachments		39.672627 °	39.672627 °	
			-121.779778 °	-121.779778 °	
DWR ID	DWR_MA0005_01_f_2014_35				
Action/Comments					
Prunings

View of the prunings along the landside toe.

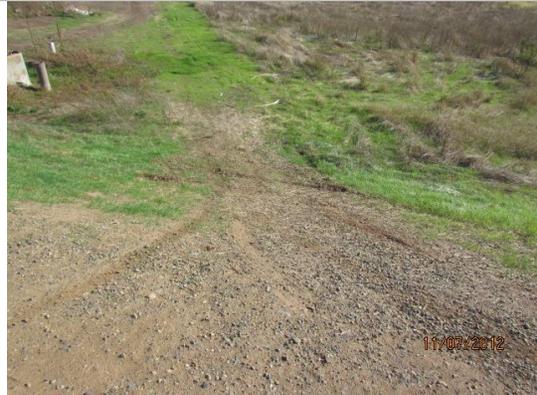
Photo 1 of 1 : FA\_2015\_MA0005\_196\_9\_20150910\_00005.jpg

View of the vehicle erosion along the landside slope.

LM Start	<b>2.54</b>	Rating **	M	Issue No.	<b>9</b>
LM End	<b>2.54</b>	Issue Type +	Ma	Location *	LS
Category	Earthen Levee		GPS Latitude/Longitude		
			Start	End	
Item	Slope Stability		39.663876 °	39.663876 °	
			-121.784014 °	-121.784014 °	
DWR ID	DWR_MA0005_01_f_2012_9				
Action/Comments					
Repair the levee slope damaged by vehicle traffic and prevent access where possible.

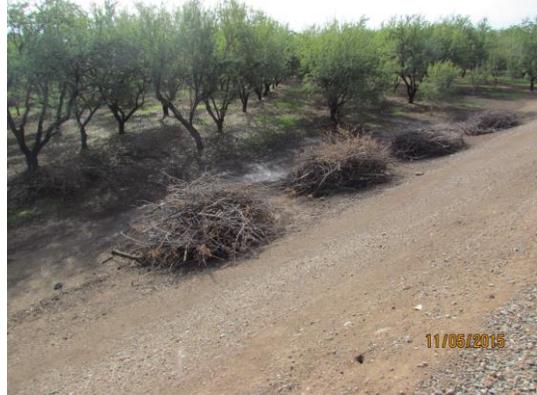
Photo 1 of 1 : FA\_2015\_MA0005\_196\_36\_20151109\_00018.jpg

LM Start	<b>2.81</b>	Rating **	M	Issue No.	<b>36</b>
LM End	<b>2.81</b>	Issue Type +	En	Location *	LS
Category	Earthen Levee		GPS Latitude/Longitude		
			Start	End	
Item	Encroachments		39.660203 °	39.660203 °	
			-121.785107 °	-121.785107 °	
DWR ID	DWR_MA0005_01_f_2015_36				
Action/Comments					
Prunings Inspector Comments: Remove the prunings from the landside toe.

View of the prunings along the landside toe.

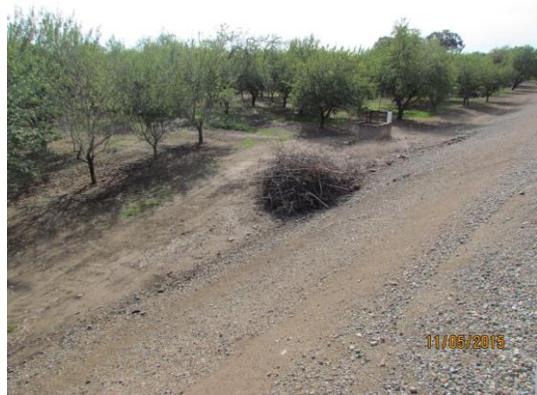
Photo 1 of 1 : FA\_2015\_MA0005\_196\_37\_20151109\_00019.jpg

LM Start	<b>3.00</b>	Rating **	M	Issue No.	<b>37</b>
LM End	<b>3.00</b>	Issue Type +	En	Location *	LS
Category	Earthen Levee		GPS Latitude/Longitude		
			Start	End	
Item	Encroachments		39.657815 °	39.657815 °	
			-121.786693 °	-121.786693 °	
DWR ID	DWR_MA0005_01_f_2015_37				
Action/Comments					
Prunings Inspector Comments: Remove the prunings from the landside toe.

View of the prunings along the landside toe.

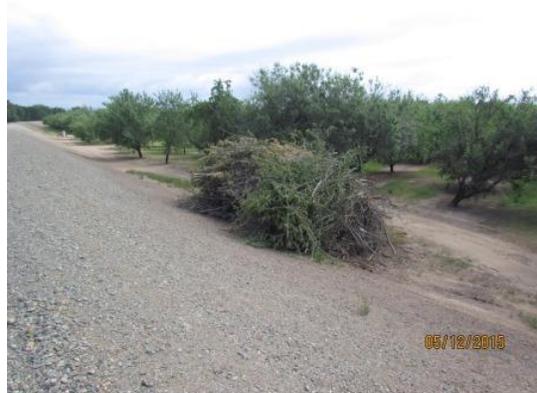
Photo 1 of 1 : FA\_2015\_MA0005\_196\_2\_20150910\_00002.jpg

LM Start	<b>3.08</b>	Rating **	M	Issue No.	<b>2</b>
LM End	<b>3.08</b>	Issue Type +	En	Location *	LS
Category	Earthen Levee		GPS Latitude/Longitude		
			Start	End	
Item	Encroachments		39.656735 °	39.656735 °	
			-121.787163 °	-121.787163 °	
DWR ID	DWR_MA0005_01_f_2014_2				
Action/Comments					
Prunings Inspector Comments: Remove the prunings from the landside toe.

View of the prunings along the landside toe.

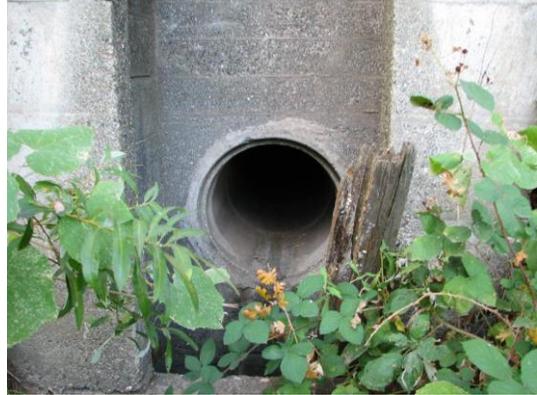
Photo 1 of 3 : UCIP\_FA\_2015\_4852.jpg

Item	DWR UCIP Field Study			39.649522 °	39.649522 °
				-121.787965 °	-121.787965 °
DWR ID					
<b>Action/Comments</b>					
Inspector Comments: FS_ID:46476 DS_ID:1615 EP_NO: N/A FS_HLM: 3.666 Repair Type: Non-Urgent Crossing Status: Found UCIP Comments: 8/5/2015 Abandoned crossing. Slide gate stem is bent and gate is inoperable. Needs to be properly abandoned. Pipe appears to be abandoned. Slide gate open and inoperable. Pipe should be properly abandoned. 5/29/2013 Same as last inspection. 11/20/2013 Same as last inspection. 6/11/2014 Same as last inspection. 12/8/2014 Same as last inspection. FIELD_STRUCT_DESC: 30-inch corrugated metal siphon through levee, 10.5 feet below crown. Slide gate in corrugated metal riser on waterward slope. Concrete distribution box on LS toe and concrete overflow and siphon box at edge of berm. (USCE 1958) FS Date: 08/06/2015

Outlet in Concrete overflow box at WS berm.

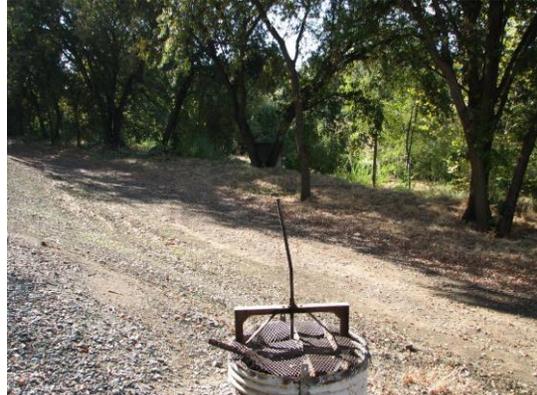
Photo 2 of 3 : UCIP\_FA\_2015\_4853.jpg

CMP riser with slide gate on WS shoulder. Notice bent screw in open position.

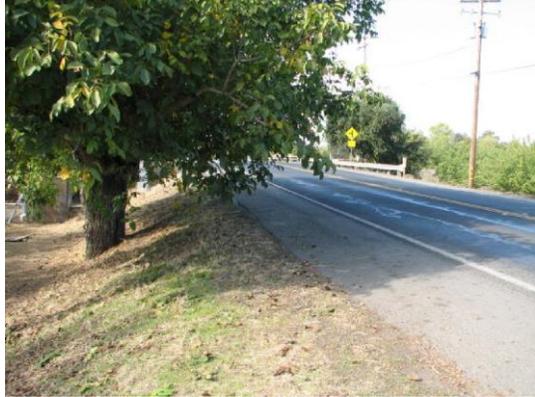
Photo 1 of 2 : UCIP\_FA\_2015\_4858.jpg

LM Start	<b>3.90</b>	Rating **	M	Issue No.	<b>906</b>
LM End	<b>3.90</b>	Issue Type +	En	Location *	LS
Category	Supplemental			GPS Latitude/Longitude	
				Start	End
Item	DWR UCIP Field Study			39.645846 °	39.645846 °
				-121.785155 °	-121.785155 °
DWR ID					
Action/Comments					
Inspector Comments: FS_ID:46479 DS_ID:1619 EP_NO: 6544-A FS_HLM: 3.966 Repair Type: Non-Urgent Crossing Status: Indicator Found

Location of PG&E access lid 250-feet east of levee crown on south side of roadway.

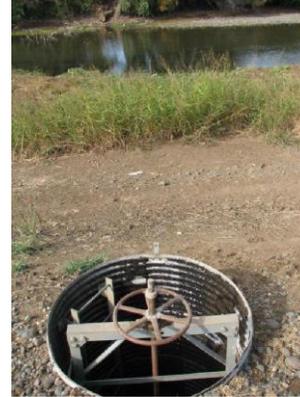
Photo 1 of 2 : UCIP\_FA\_2015\_6545.jpg

LM Start	<b>5.56</b>	Rating **	M	Issue No.	<b>907</b>
LM End	<b>5.56</b>	Issue Type +	En	Location *	LS
Category	Supplemental			GPS Latitude/Longitude	
				Start	End
Item	DWR UCIP Field Study			39.624559 °	39.624559 °
				-121.772141 °	-121.772141 °
DWR ID					
Action/Comments					
Inspector Comments: FS_ID:46482 DS_ID:1620 EP_NO: N/A FS_HLM: 5.65 Repair Type: Non-Urgent Crossing Status: Found

54-inch CMP riser and slide gate on WS shoulder.

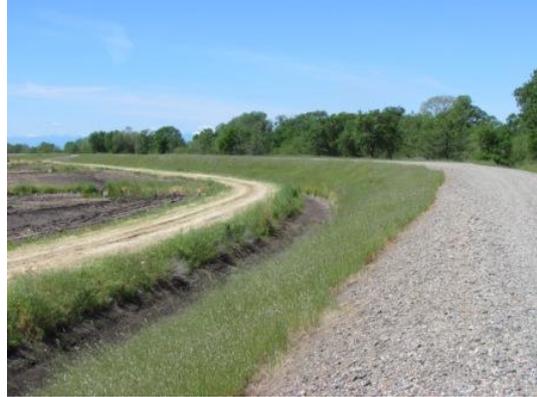
Photo 1 of 1 : FA\_2015\_MA0005\_196\_5\_20150910\_00003.jpg

LM Start	<b>9.54</b>	Rating **	M	Issue No.	<b>5</b>
LM End	<b>10.33</b>	Issue Type +	En	Location *	LS
Category	Earthen Levee		GPS Latitude/Longitude		
			Start	End	
Item	Encroachments		39.574837 °	39.567892 °	
			-121.807913 °	-121.819283 °	
DWR ID	DWR_MA0005_01_s_2012_5				
Action/Comments					
Ditch

View of the agricultural ditch along the L/S toe.

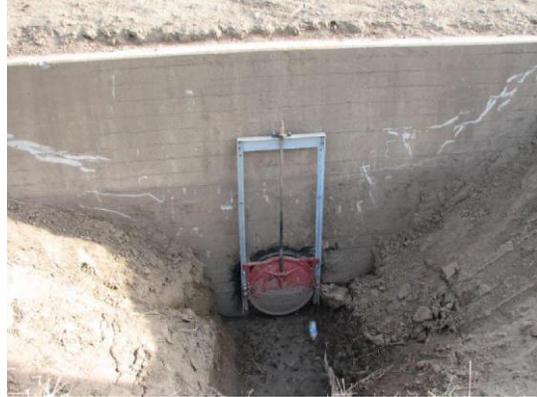
Photo 1 of 3 : UCIP\_FA\_2015\_6695.jpg

Inspector Comments: FS\_ID:46513  
 DS\_ID:1634  
 EP\_NO: N/A  
 FS\_HLM: 10.405  
 Repair Type: Non-Urgent  
 Crossing Status: Found  
 UCIP Comments: 8/4/2015 Abandoned pipe. Casey Wilder has started the steps to have the pipe properly abandoned and removed from the levee.5/29/2013 Same as last inspection.11/19/2013 Same as last inspection.6/11/2014 Same as last inspection.12/8/2014 Same as last inspection.  
 FIELD\_STRUCT\_DESC: 24-inch corrugated metal pipe through the levee, 14.5 feet below the crown. Slide gate on the waterward end on concrete headwall. Flap gate on the landward side. (USCE 1952)  
 FS Date: 08/25/2015

Headwall and slide gate on WS toe.

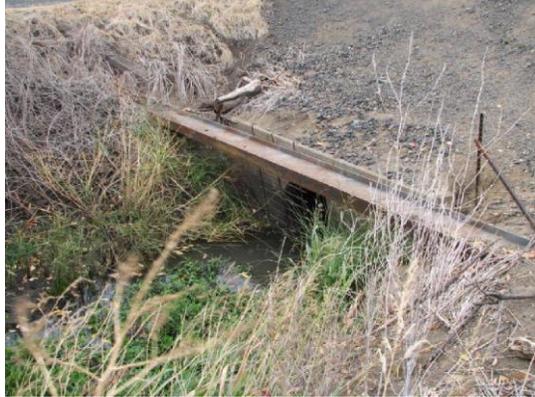
Photo 3 of 3 : UCIP\_FA\_2015\_6192.jpg

LM Start	<b>14.46</b>	Rating **	M	Issue No.	<b>916 (cont)</b>	
LM End	<b>14.46</b>	Issue Type +	En	Location *	LS	
Category	Supplemental			GPS Latitude/Longitude		
				Start	End	
Item	DWR UCIP Field Study			39.522200 °	39.522200 °	
				-121.865592 °	-121.865592 °	
DWR ID						
Action/Comments						
Inspector Comments: FS_ID:46530 DS_ID:1639 EP_NO: N/A FS_HLM: 14.66 Repair Type: Non-Urgent Crossing Status: Found

Headwall at inlet on LS toe.

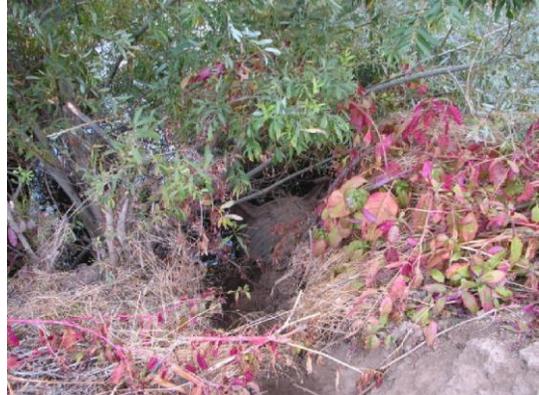
Photo 2 of 3 : UCIP\_FA\_2015\_6482.jpg

Flap gate on WS slope.

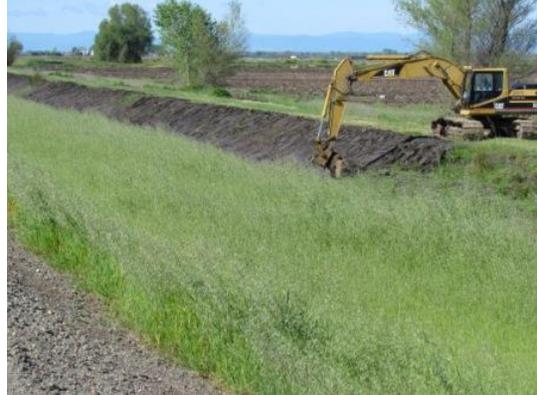
Photo 1 of 1 : FA\_2015\_MA0005\_197\_7\_20150910\_00004.jpg

LM Start	<b>3.10</b>	Rating **	M	Issue No.	<b>7</b>
LM End	<b>4.53</b>	Issue Type +	En	Location *	LS
Category	Earthen Levee		GPS Latitude/Longitude		
			Start	End	
Item	Encroachments		39.551780 °	39.567430 °	
			-121.840507 °	-121.823065 °	
DWR ID	DWR_MA0005_02_s_2012_7				
Action/Comments					
Ditch

View of the agricultural ditch along the landside toe.

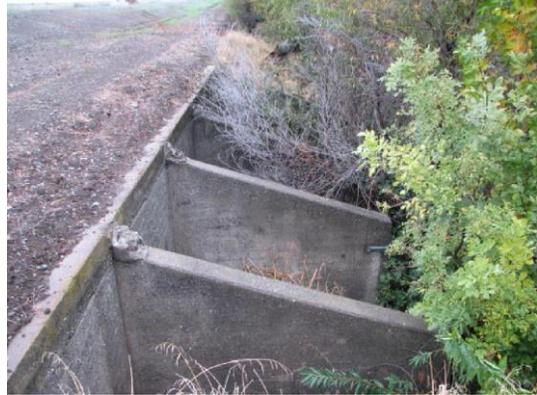
Photo 2 of 3 : UCIP\_FA\_2015\_6405.jpg

Item	DWR UCIP Field Study			39.562875 °	39.562875 °
				-121.828782 °	-121.828782 °
DWR ID					
Action/Comments					
Inspector Comments: FS_ID:46400 DS_ID:16300 EP_NO: N/A FS_HLM: 4.155 Repair Type: Non-Urgent Crossing Status: Found UCIP Comments: 7/28/2015 Crossing is listed as abandoned but it is not filled with concrete like crossings 1-4 here. Pipe open on WS and is not filled with concrete. 6/6/2013 Sutter Maintenance Yard supervisor Jason Cooper said there is a flap gate on the LS end of the pipe in the western most ditch to prevent high water flooding. Not sure if this is adequate, will talk to levee inspector to find out. 11/13/2013 Same as last inspection. 6/04/2014 Same as last inspection. 11/25/2014 Same as last inspection. FIELD_STRUCT_DESC: 5 of 5: 60-inch drain pipe through the levee, 16.6 feet below the crown. Pipe partially plugged on LS with concrete wall. Flap gate installed on concrete plug to allow floodwater from LS to flow to WS. (USACE 1955) FS Date: 07/29/2015

Concrete headwall on WS shoulder.

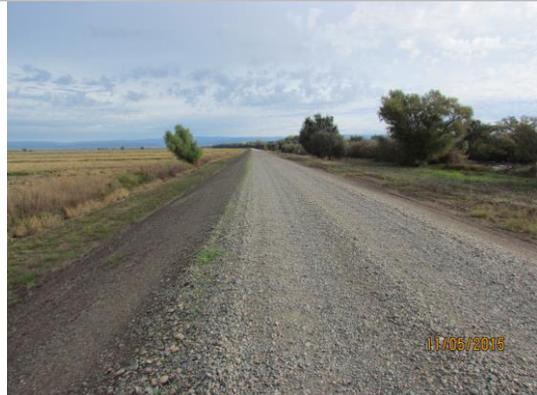
Photo 1 of 1 : FA\_2015\_MA0005\_197\_37\_20151109\_00019.jpg

LM Start	<b>4.86</b>	Rating **	A	Issue No.	<b>37</b>
LM End	<b>4.86</b>	Issue Type +	Ma	Location *	LS
Category	Earthen Levee			GPS Latitude/Longitude	
				Start	End
Item	Vegetation			39.570702 °	39.570702 °
				-121.818677 °	-121.818677 °
DWR ID	DWR_MA0005_02_f_2015_37				
Action/Comments					
Control annual grass and weeds on the levee slopes and easements. Inspector Comments: Sutter Yard burned and dragged both slopes.

View of no vegetation on both slopes.

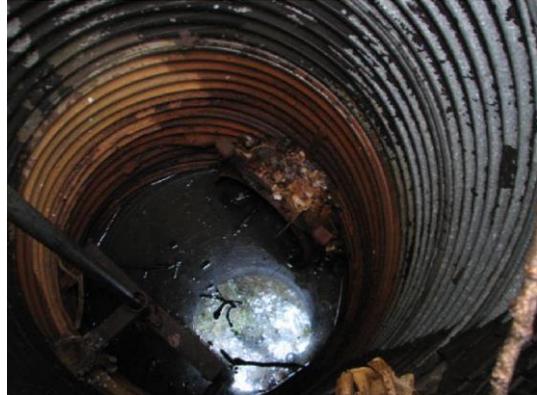
Photo 2 of 2 : UCIP\_FA\_2015\_6444.jpg

Item	DWR UCIP Field Study			39.576008 °	39.576008 °
				-121.812599 °	-121.812599 °
DWR ID					
Action/Comments					
Inspector Comments: FS_ID:46408 DS_ID:1650 EP_NO: N/A FS_HLM: 5.427 Repair Type: Non-Urgent Crossing Status: Found UCIP Comments: 7/28/2015 Abandoned- still cannot locate a LS ans WS pipe end. Appears abandoned. Unable to locate outfall on WS. Unable to locate inlet on LS. 6/6/2013 Same as last inspection. 11/12/2013 Same as last inspection. 6/04/2014 Same as last inspection. 11/25/2014 Same as last inspection. FIELD_STRUCT_DESC: 24-inch corrugated metal pipe through the levee, 12.5 feet below the crown. Slide gate and flap gate in 56-inch cmp riser on WS berm. Flap gate on the waterward end. (USACE 1955) FS Date: 07/29/2015

Slide gate and flap gate inside CMP riser on WS berm.

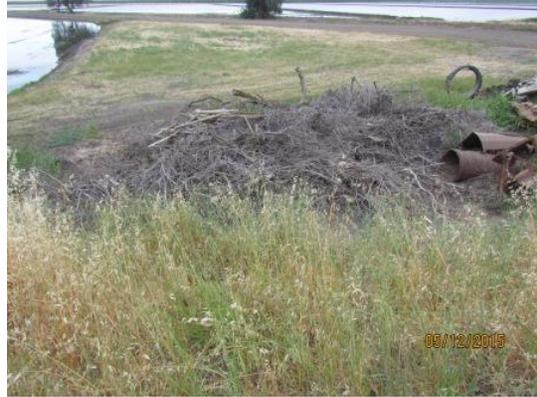
Photo 1 of 1 : FA\_2015\_MA0005\_197\_34\_20150910\_00013.jpg

LM Start	<b>5.91</b>	Rating **	M	Issue No.	<b>34</b>
LM End	<b>5.91</b>	Issue Type +	En	Location *	LS
Category	Earthen Levee		GPS Latitude/Longitude		
			Start	End	
Item	Encroachments		39.583052 °	39.583052 °	
			-121.807423 °	-121.807423 °	
DWR ID	DWR_MA0005_02_s_2015_34				
Action/Comments					
Prunings Inspector Comments: Remove the prunings from the landside toe.

View of the prunings along the landside toe.

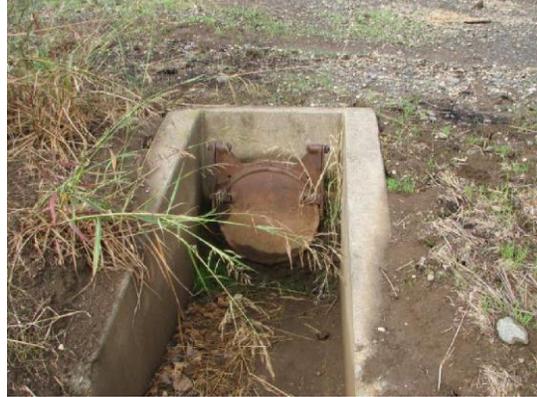
Photo 1 of 3 : UCIP\_FA\_2015\_4792.jpg

**Action/Comments**  
 Inspector Comments: FS\_ID:46545  
 DS\_ID:1664  
 EP\_NO: N/A  
 FS\_HLM: 8.938  
 Repair Type: Non-Urgent  
 Crossing Status: Found  
 UCIP Comments: 7/30/2015 LS inlet is still buried. LS inlet is buried under soil and covered with brambles. Slide gate missing from LS. 6/6/2013 Same as last inspection. 11/13/2013 Same as last inspection. 6/4/2014 Same as last inspection. 11/24/2014 Same as last inspection.  
 FIELD\_STRUCT\_DESC: 24-inch pipe through the levee, 12.0 feet below the crown. Flap gate on waterward end. Concrete headwall on the waterward end. (USACE 1957)  
 FS Date: 08/26/2015

Concrete U shaped headwall and flap gate at WS toe.

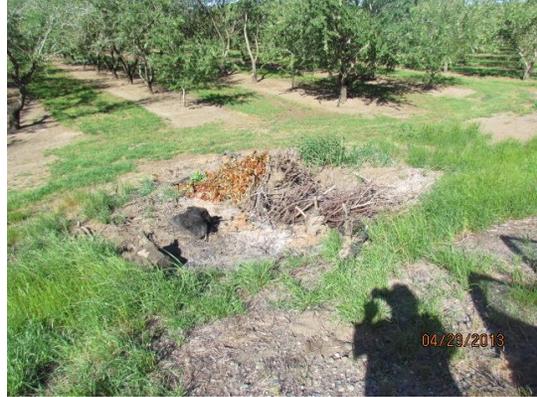
Photo 1 of 1 : FA\_2015\_MA0005\_197\_3\_20150910\_00002.jpg

LM Start	<b>10.38</b>	Rating **	M	Issue No.	<b>3</b>
LM End	<b>10.38</b>	Issue Type +	Ma	Location *	LS
Category	Earthen Levee		GPS Latitude/Longitude		
			Start	End	
Item	Encroachments		39.639018 °	39.639018 °	
			-121.781458 °	-121.781458 °	
DWR ID	DWR_MA0005_02_s_2012_3				
Action/Comments					
Prunings

View of the prunings along the landside toe.

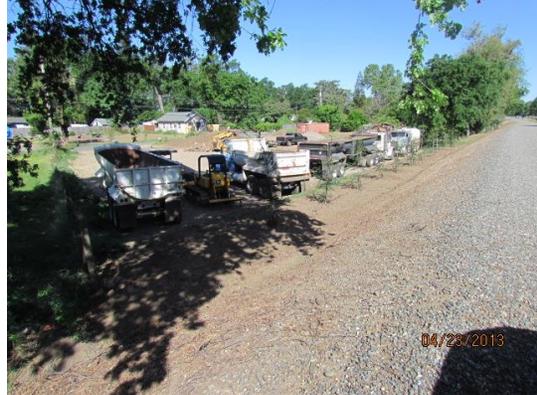
Photo 1 of 1 : FA\_2015\_MA0005\_197\_21\_20150910\_00010.jpg

LM Start	<b>10.79</b>	Rating **	M	Issue No.	<b>21</b>
LM End	<b>10.82</b>	Issue Type +	En	Location *	LS
Category	Earthen Levee		GPS Latitude/Longitude		
			Start	End	
Item	Encroachments		39.644076 °	39.644480 °	
			-121.785471 °	-121.785762 °	
DWR ID	DWR_MA0005_02_s_2013_21				
Action/Comments					
Tree or limb

View of the redwood trees planted along the landside toe.

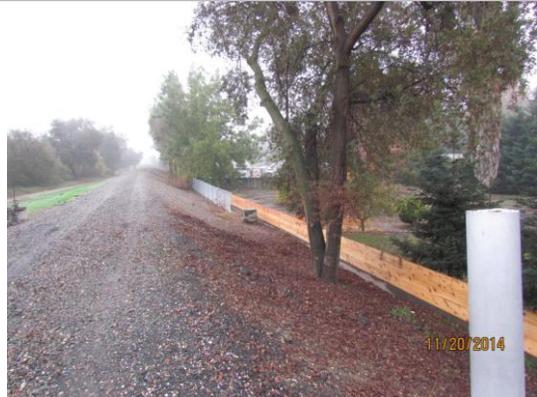
Photo 1 of 1 : FA\_2015\_MA0005\_197\_41\_20150910\_00017.jpg

LM Start	<b>10.89</b>	Rating **	U	Issue No.	<b>41</b>
LM End	<b>10.93</b>	Issue Type +	En	Location *	LS
Category	Earthen Levee		GPS Latitude/Longitude		
			Start	End	
Item	Encroachments		39.645318 °	39.645858 °	
			-121.786345 °	-121.786742 °	
DWR ID	DWR_MA0005_02_f_2014_41				
Action/Comments					
Fence Inspector Comments: Remove or apply for permit for the fence along landside toe

View of the new fence along the landside toe.

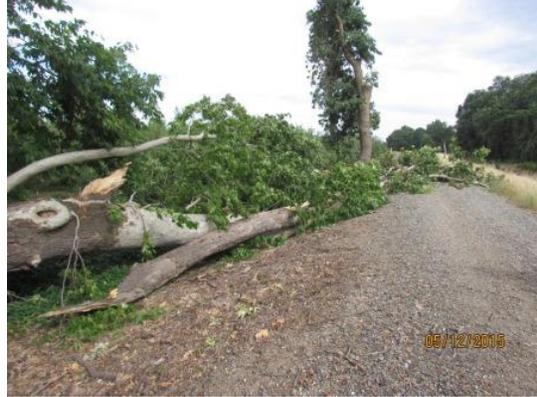
Photo 1 of 1 : FA\_2015\_MA0005\_197\_36\_20150910\_00015.jpg

LM Start	<b>11.10</b>	Rating **	M	Issue No.	<b>36</b>
LM End	<b>11.10</b>	Issue Type +	Ma	Location *	LS
Category	Earthen Levee			GPS Latitude/Longitude	
				Start	End
Item	Encroachments			39.647913 °	39.647913 °
				-121.788330 °	-121.788330 °
DWR ID	DWR_MA0005_02_s_2015_36				
Action/Comments					
Tree or limb Inspector Comments: Remove the tree from the landside slope.

Remove the tree from the landside slope.

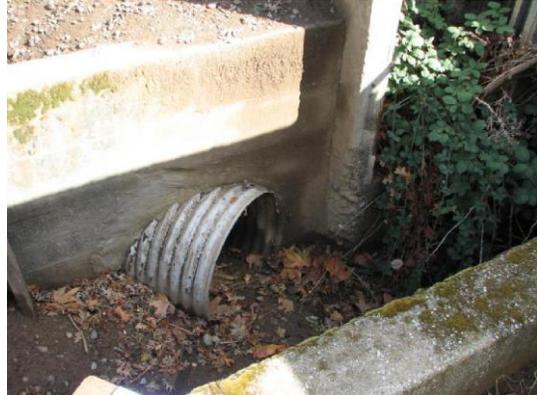
Photo 3 of 3 : UCIP\_FA\_2015\_4895.jpg

Item	DWR UCIP Field Study			39.648185 °	39.648185 °
				-121.788563 °	-121.788563 °
DWR ID					
Action/Comments					
Inspector Comments: FS_ID:46553 DS_ID:1671 EP_NO: N/A FS_HLM: 11.287 Repair Type: Non-Urgent Crossing Status: Found UCIP Comments: 7/30/2015 Abandoned crossing. Unable to locate the WS end of pipe. Pipe appears abandoned. It needs to be abandoned properly. 6/6/2013 Same as last inspection. 11/13/2013 Same as last inspection. 6/4/2014 Same as last inspection. 11/24/2014 Same as last inspection. FIELD_STRUCT_DESC: 30-inch corrugated metal siphon through the levee, 9.4 feet below the crown. Slide gate in 42-inch corrugated metal riser on the waterward slope. Concrete distribution box on the landward side. (USCE 1958) FS Date: 08/26/2015

Pipe at concrete distribution box on LS toe.

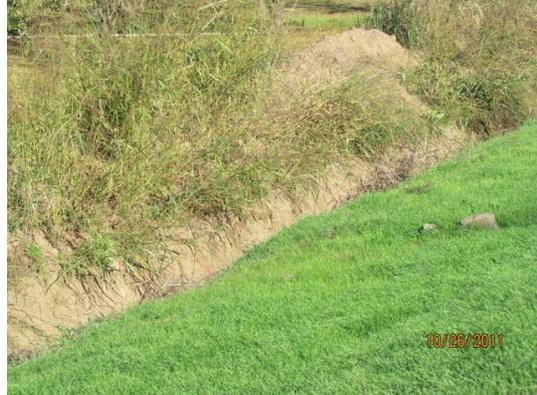
Photo 1 of 1 : FA\_2015\_MA0005\_197\_6\_20150910\_00003.jpg

LM Start	<b>11.57</b>	Rating **	M	Issue No.	<b>6</b>
LM End	<b>11.77</b>	Issue Type +	En	Location *	LS
Category	Earthen Levee		GPS Latitude/Longitude		
			Start	End	
Item	Encroachments		39.654268 °	39.657142 °	
			-121.789525 °	-121.788690 °	
DWR ID	DWR_MA0005_02_s_2012_6				
Action/Comments					
Ditch

View of the ditch along the Landside toe.

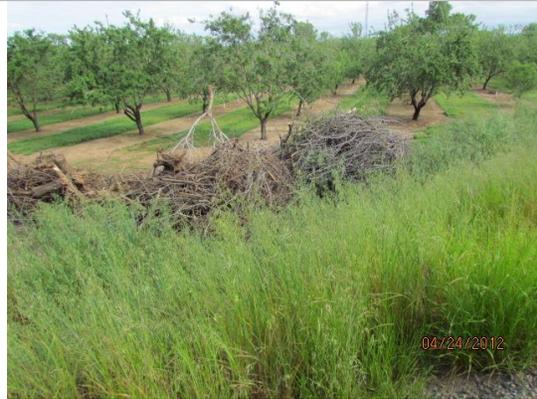
Photo 1 of 1 : FA\_2015\_MA0005\_197\_19\_20150910\_00009.jpg

LM Start	<b>12.83</b>	Rating **	M	Issue No.	<b>19</b>
LM End	<b>12.83</b>	Issue Type +	En	Location *	LS
Category	Earthen Levee			GPS Latitude/Longitude	
				Start	End
Item	Encroachments			39.671239 °	39.671239 °
				-121.782486 °	-121.782486 °
DWR ID	DWR_MA0005_02_s_2012_19				
Action/Comments					
Prunings

View of the brush pile at the toe of the levee.

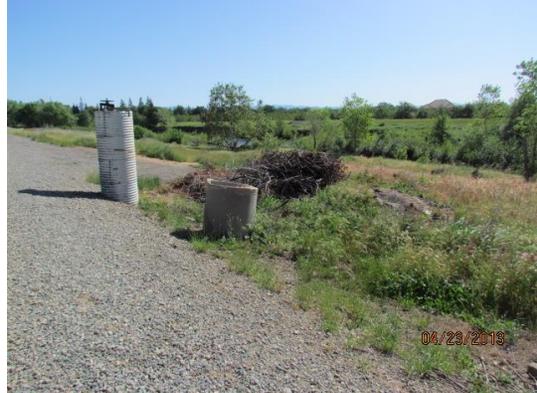
Photo 1 of 1 : FA\_2015\_MA0005\_197\_22\_20150910\_00011.jpg

LM Start	<b>13.15</b>	Rating **	M	Issue No.	<b>22</b>
LM End	<b>13.15</b>	Issue Type +	En	Location *	WS
Category	Earthen Levee		GPS Latitude/Longitude		
			Start	End	
Item	Encroachments		39.675311 °	39.675311 °	
			-121.780371 °	-121.780371 °	
DWR ID	DWR_MA0005_02_s_2013_22				
Action/Comments					
Prunings

View of the prunings along the waterside toe.

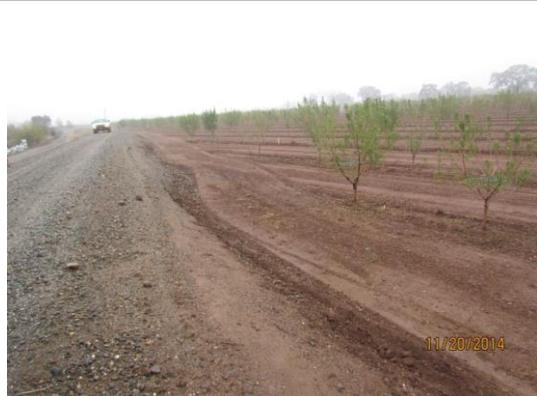
Photo 1 of 1 : FA\_2015\_MA0005\_197\_43\_20150910\_00018.jpg

LM Start	<b>14.13</b>	Rating **	U	Issue No.	<b>43</b>
LM End	<b>14.13</b>	Issue Type +	Ma	Location *	LS
Category	Earthen Levee			GPS Latitude/Longitude	
				Start	End
Item	Slope Stability			39.688715 °	39.688715 °
				-121.778345 °	-121.778345 °
DWR ID	DWR_MA0005_02_f_2014_43				
Action/Comments					
Repair slope instability.

View of the tilling into the landside slope.

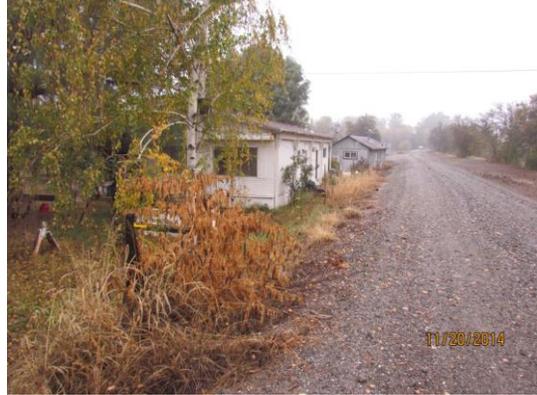
Photo 1 of 1 : FA\_2015\_MA0005\_197\_25\_20150910\_00012.jpg

LM Start	<b>14.33</b>	Rating **	U	Issue No.	<b>25</b>
LM End	<b>14.33</b>	Issue Type +	En	Location *	LS
Category	Earthen Levee		GPS Latitude/Longitude		
			Start	End	
Item	Encroachments		39.691580 °	39.691580 °	
			-121.779254 °	-121.779254 °	
DWR ID	DWR_MA0005_02_s_2012_25				
Action/Comments					
Building Inspector Comments: Unpermitted structure.

View of the buildings at the landside toe.

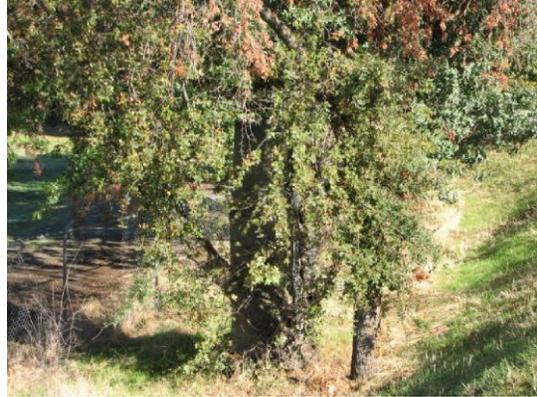
Photo 1 of 2 : UCIP\_FA\_2015\_3780.jpg

LM Start	<b>15.26</b>	Rating **	M	Issue No.	<b>60</b>
LM End	<b>15.26</b>	Issue Type +	En	Location *	LS
Category	Supplemental			GPS Latitude/Longitude	
				Start	End
Item	DWR UCIP Field Study			39.704409 °	39.704409 °
				-121.777803 °	-121.777803 °
DWR ID					
Action/Comments					
Inspector Comments: FS_ID:46577 DS_ID:1686 EP_NO: N/A FS_HLM: 15.489 Repair Type: Non-Urgent Crossing Status: Found

Concrete riser on LS toe.

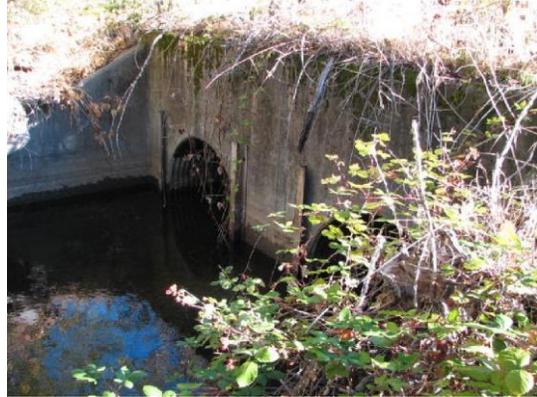
Photo 1 of 3 : UCIP\_FA\_2015\_3782.jpg

LM Start	<b>15.47</b>	Rating **	M	Issue No.	<b>61</b>
LM End	<b>15.47</b>	Issue Type +	En	Location *	LS
Category	Supplemental			GPS Latitude/Longitude	
				Start	End
Item	DWR UCIP Field Study			39.707544 °	39.707544 °
				-121.777701 °	-121.777701 °
DWR ID					
Action/Comments					
Inspector Comments: FS_ID:46576 DS_ID:1687 EP_NO: N/A FS_HLM: 15.71 Repair Type: Non-Urgent Crossing Status: Found

Concrete headwall on LS toe.

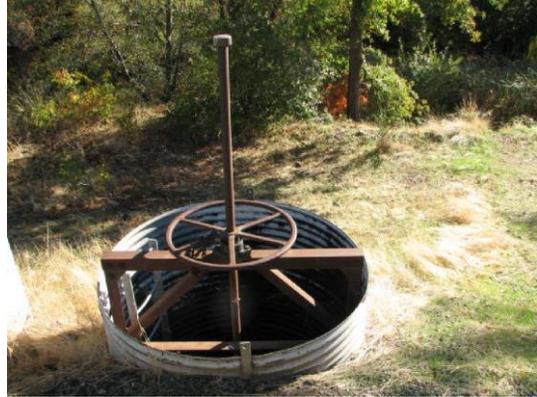
Photo 3 of 3 : UCIP\_FA\_2015\_3784.jpg

LM Start	<b>15.47</b>	Rating **	M	Issue No.	<b>61 (cont)</b>
LM End	<b>15.47</b>	Issue Type +	En	Location *	LS
Category	Supplemental			GPS Latitude/Longitude	
				Start	End
Item	DWR UCIP Field Study			39.707544 °	39.707544 °
				-121.777701 °	-121.777701 °
DWR ID					
Action/Comments					
Inspector Comments: FS_ID:46576 DS_ID:1687 EP_NO: N/A FS_HLM: 15.71 Repair Type: Non-Urgent Crossing Status: Found

66-inch CMP riser on WS shoulder with slide gate.

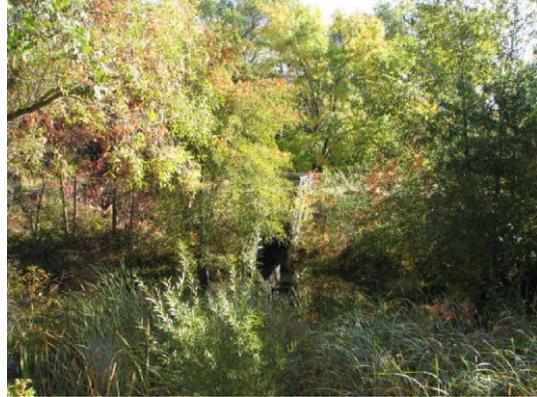
Photo 2 of 3 : UCIP\_FA\_2015\_3786.jpg

Item	DWR UCIP Field Study			39.707569 °	39.707569 °
				-121.777705 °	-121.777705 °
DWR ID					
Action/Comments					
Inspector Comments: FS_ID:46578 DS_ID:16316 EP_NO: N/A FS_HLM: 15.711 Repair Type: Non-Urgent Crossing Status: Found UCIP Comments: 8/3/2015 Crossing appears in good condition but needs a cover made for the riser.Good candidate for video inspection.6/6/2013 Same as last inspection. Need to construct cover for top of standpipe.11/13/2013 Same as last inspection.6/4/2014 Same as last inspection.11/25/2014 Same as last inspection. FIELD_STRUCT_DESC: 2 of 2: 54-inch siphon pipe through the levee, 17.8 feet below crown. Slide gate in 66-inch CMP riser on waterward side shoulder. Concrete headwall and irrigation ditch at the landward toe. Large structure in floodway likely related. (USCE 1958) FS Date: 08/26/2015

Related structure out in floodway.

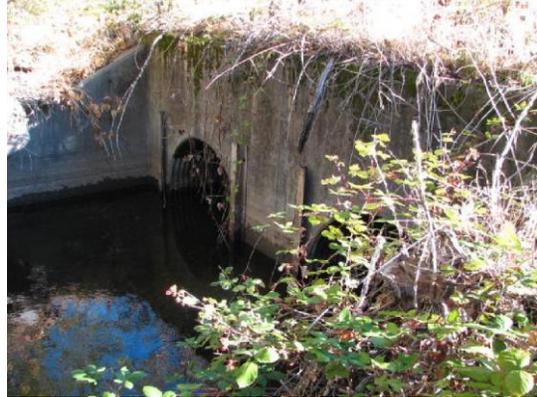
Photo 3 of 3 : UCIP\_FA\_2015\_3787.jpg

Concrete headwall at LS toe.
