**Flood Control Project Maintenance  
Levee Inspections****LMA District Cover Sheet****Spring 2014 Levee Inspection Results****Sutter Maintenance Yard Maintenance Area 0005**

**Spring 2014 Levee Inspection Results**

**Sutter Maintenance Yard Maintenance Area 0005**

Waterway			Bank	Unit Miles
Unit No. 01 Butte Creek 1			Left	15.29
	Spring (March - May)	Summer (June - August)	(September - November) Fall	Winter (December - February)
Unit Maintenance Rating (Fall Only)				
Date of Inspection	04/29/2014 - 04/29/2014			
DWR Inspector	Bob Duffey			
Accompanied By	Jason Cooper Sutter Maintenance Yard

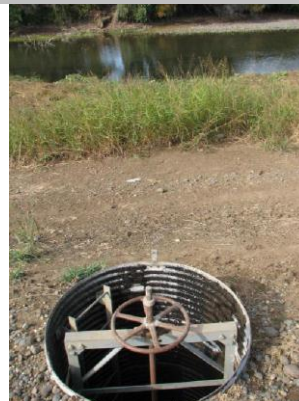
Photo 1 of 1 : UCIP\_4141.jpg

FIELD\_STRUCT\_DESC: 1 of 2. 36-inch pipe through levee 11.0 feet below crown. Slide gate in 54-inch corrugated metal riser on waterward slope and concrete "U" headwall on the landward side. (USACE 1957)  
FS Date: 11/21/2013 12:38:13 PM

54-inch CMP riser and slide gate on WS shoulder.

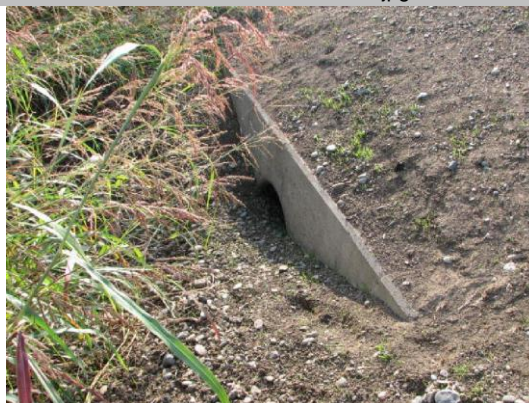
Photo 1 of 1 : UCIP\_4146.jpg

LM Start	7.70	Rating **	M	Issue No.	20
LM End	7.70	Issue Type +	En	Location *	LS
Category	Supplemental			GPS Latitude/Longitude	
				Start	End
Item	DWR UCIP Field Study			39.597725 °	39.597725 °
				-121.787257 °	-121.787257 °
DWR ID	DWR_MA0005_01_s _ 2014_20				
Action/Comments					
Inspector Comments: FS_ID:24553					
EP_NO: N/A					
Repair Type:					
Crossing Status:					
UCIP Comments: Pipe filled with soil and outlet/appurtances are buried 5/29/2013 Same as last inspection11/19/2013 Same as last inspection.					
FIELD_STRUCT_DESC: 24-inch pipe through levee, 8.5 feet below crown. Flap gate on the waterward end. Concrete "U" shaped headwall on LS toe. (USCE 1952)					
FS Date: 11/21/2013 12:51:20 PM

Headwall at LS toe.

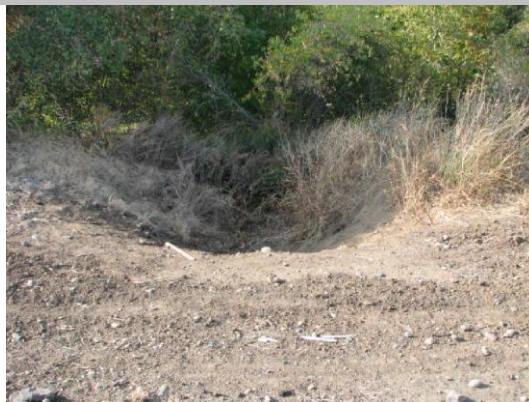
Photo 1 of 1 : UCIP\_4150.jpg

LM Start	8.33	Rating **	M	Issue No.	21
LM End	8.33	Issue Type +	En	Location *	LS
Category	Supplemental			GPS Latitude/Longitude	
				Start	End
Item	DWR UCIP Field Study			39.589751 °	39.589751 °
				-121.792818 °	-121.792818 °
DWR ID	DWR_MA0005_01_s _ 2014_21				
Action/Comments					
Inspector Comments: FS_ID:24555					
EP_NO: N/A					
Repair Type:					
Crossing Status:					
UCIP Comments: Pipe filled with soil 5/29/2013 Same as last inspection 11/19/2013 Same as last inspection.					
FIELD_STRUCT_DESC: 24-inch corrugated metal pipe through the levee, 9.3 feet below the crown. Flap gate on the waterward end.					
Concrete headwall at both toes. (USACE 1952)					
FS Date: 11/21/2013 12:53:16 PM

Outlet at WS toe.

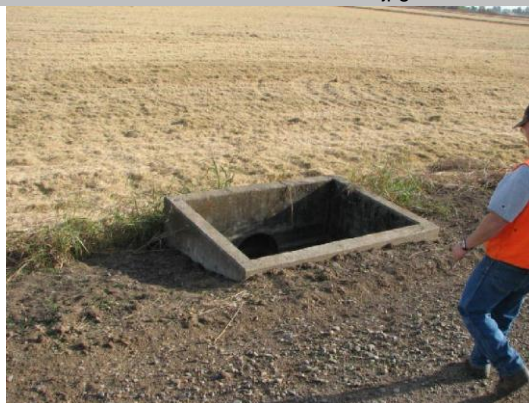
Photo 1 of 1 : UCIP\_4153.jpg

LM Start	9.21	Rating **	M	Issue No.	22
LM End	9.21	Issue Type +	En	Location *	LS
Category	Supplemental			GPS Latitude/Longitude	
				Start	End
Item	DWR UCIP Field Study			39.579908 °	39.579908 °
				-121.802790 °	-121.802790 °
DWR ID	DWR_MA0005_01_s_2014_22				
Action/Comments					
Inspector Comments: FS_ID:24558					
EP_NO: N/A					
Repair Type:					
Crossing Status:					
UCIP Comments: Need to confirm proper abandonment of pipe. Pipe should be plugged on LS/29/2013 Same as last inspection11/19/2013 Same as last inspection.					
FIELD_STRUCT_DESC: 16-inch steel pipe through the levee, 11.5 feet below the crown. Distribution box at the landward toe. (USACE 1955)					
FS Date: 11/21/2013 1:01:31 PM

Concrete distribution box at LS toe.

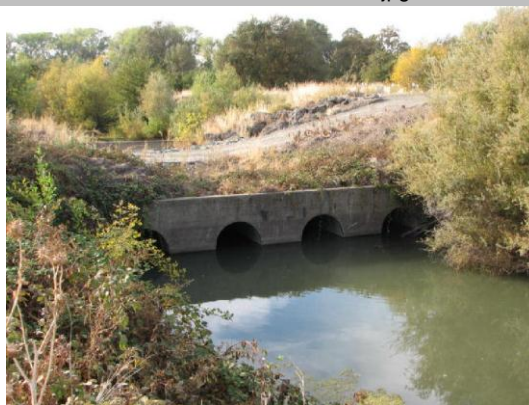
Photo 1 of 1 : UCIP\_4155.jpg

LM Start	9.65	Rating **	M	Issue No.	23
LM End	9.65	Issue Type +	En	Location *	LS
Category	Supplemental			GPS Latitude/Longitude	
				Start	End
Item	DWR UCIP Field Study			39.575072 °	39.575072 °
				-121.807805 °	-121.807805 °
DWR ID	DWR_MA0005_01_s_2014_23				
Action/Comments					
Inspector Comments: FS_ID:24559					
EP_NO: N/A					
Repair Type:					
Crossing Status:					
UCIP Comments: Seems there should be flap gates on this structure5/29/2013 Flap gates were removed by DWR Sutter Maintenance Yard to allow water to flow freely through crossing and not back up in ditch11/19/2013 Same as last inspection.					
FIELD_STRUCT_DESC: 1 of 4: 66 Inch Corrugated Metal Pipe through levee, 17.9 feet below the crown. Concrete headwalls on both ends. (USCE 1952).					
FS Date: 11/21/2013 1:02:12 PM

LS of pipe crossing.

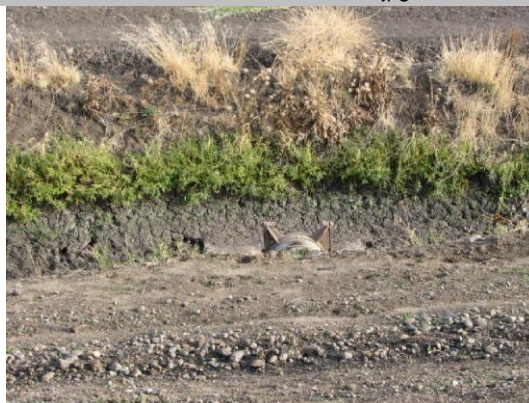
Photo 1 of 1 : UCIP\_4161.jpg

LM Start	10.19	Rating **	M	Issue No.	27
LM End	10.19	Issue Type +	En	Location *	LS
Category	Supplemental			GPS Latitude/Longitude	
				Start	End
Item	DWR UCIP Field Study			39.570596 °	39.570596 °
				-121.815215 °	-121.815215 °
DWR ID	DWR_MA0005_01_s_2014_27				
Action/Comments					
Inspector Comments: FS_ID:24563					
EP_NO: N/A					
Repair Type:					
Crossing Status:					
UCIP Comments: Pipe and headwall buried on WS, no access to slide gate 5/29/2013 Same as last inspection 11/19/2013 Same as last inspection.					
FIELD_STRUCT_DESC: 24-inch corrugated metal pipe through the levee, 12.5 feet below the crown. Slide gate on the waterward end. Flap gate and headwall on the landward end. Concrete headwall at the waterward toe. (USCE 1952)					
FS Date: 11/21/2013 1:05:26 PM

Flap gate and headwall at LS toe in irrigation or drainage ditch.

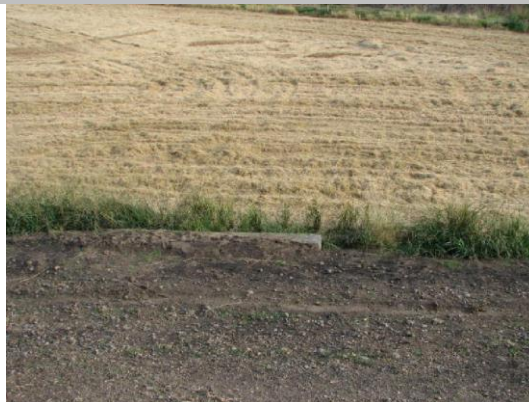
Photo 1 of 1 : UCIP\_4163.jpg

LM Start	10.99	Rating **	M	Issue No.	28
LM End	10.99	Issue Type +	En	Location *	LS
Category	Supplemental			GPS Latitude/Longitude	
				Start	End
Item	DWR UCIP Field Study			39.562559 °	39.562559 °
				-121.825808 °	-121.825808 °
DWR ID	DWR_MA0005_01_s_2014_28				
Action/Comments					
Inspector Comments: FS_ID:24565					
EP_NO: N/A					
Repair Type:					
Crossing Status:					
UCIP Comments: Pipe buried on both sides of levee5/29/2013 Same as last inspection11/19/2013 Same as last inspection.					
FIELD_STRUCT_DESC: 30-inch corrugated metal drainpipe through the levee, 12.2 feet below the crown. Flap gate on the waterward end. (USCE 1952)					
FS Date: 11/21/2013 1:06:52 PM

Concrete headwall at LS toe.

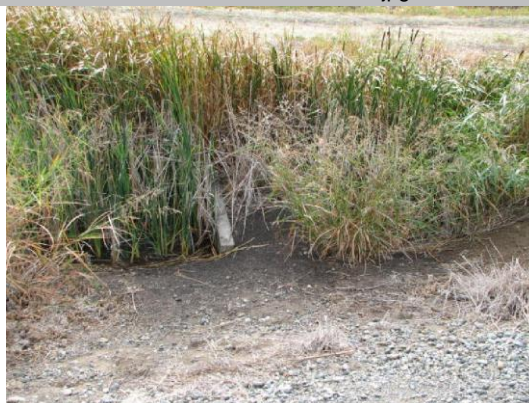
Photo 1 of 1 : UCIP\_4164.jpg

LM Start	12.00	Rating **	M	Issue No.	29
LM End	12.00	Issue Type +	En	Location *	LS
Category	Supplemental			GPS Latitude/Longitude	
				Start	End
Item	DWR UCIP Field Study			39.551212 °	39.551212 °
				-121.837724 °	-121.837724 °
DWR ID	DWR_MA0005_01_s_2014_29				
Action/Comments					
Inspector Comments: FS_ID:24577					
EP_NO: N/A					
Repair Type:					
Crossing Status:					
UCIP Comments: Pipe burried on both LS and WS/29/2013 Same as last inspection11/19/2013 Same as last inspection.					
FIELD_STRUCT_DESC: 48" Corrugated Metal Pipe riser and sparling water meter/irrigation structure. 4-foot by 6-foot concrete outlet box on LS toe.(USACE 1952)					
FS Date: 11/21/2013 1:31:58 PM

Buried pipe at concrete box, LS toe.

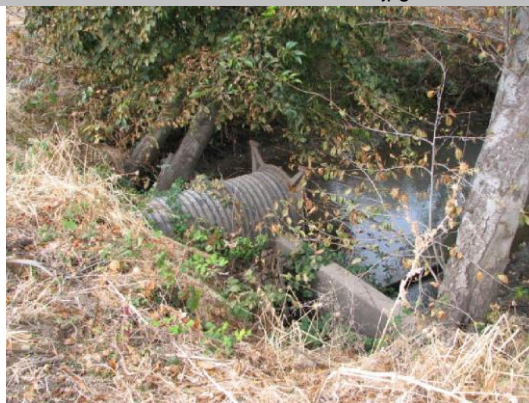
Photo 1 of 1 : UCIP\_4166.jpg

LM Start	14.66	Rating **	M	Issue No.	30
LM End	14.66	Issue Type +	En	Location *	LS
Category	Supplemental			GPS Latitude/Longitude	
				Start	End
Item	DWR UCIP Field Study			39.522200 °	39.522200 °
				-121.865592 °	-121.865592 °
DWR ID	DWR_MA0005_01_s_2014_30				
Action/Comments					
Inspector Comments: FS_ID:24581					
EP_NO: N/A					
Repair Type:					
Crossing Status:					
UCIP Comments: Soil under Concrete wing walls on WS toe has been eroded. No soil supporting wing walls 5/29/2013 Same as last inspection 11/19/2013 Same as last inspection.					
FIELD_STRUCT_DESC: 36-inch corrugated metal pipe through the levee, 13.0 feet below the crown. Flap gate on the waterward end. Concrete headwall on both ends. (USCE 1952)					
FS Date: 11/21/2013 1:35:23 PM

CMP pipe, flap gate, and headwall on WS toe.

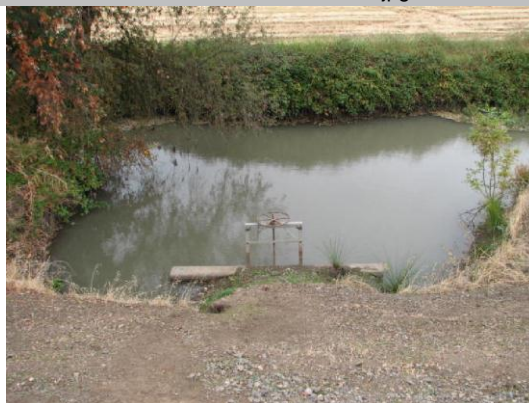
Photo 1 of 1 : UCIP\_3927.jpg

LM Start	1.94	Rating **	M	Issue No.	24
LM End	1.94	Issue Type +	En	Location *	LS
Category	Supplemental			GPS Latitude/Longitude	
				Start	End
Item	DWR UCIP Field Study			39.537455 °	39.537455 °
				-121.853061 °	-121.853061 °
DWR ID	DWR_MA0005_02_s _ 2014_24				
Action/Comments					
Inspector Comments: FS_ID:24055					
EP_NO: N/A					
Repair Type:					
Crossing Status:					
UCIP Comments: Vegetation needs to be cleared from outlet 6/6/2013 Same as last inspection 11/12/2013 Same as last inspection.					
FIELD_STRUCT_DESC: 36-inch corrugated metal pipe through the levee, 17.0 feet below the crown. Flap gate on the waterward end. Slide gate on LS toe. Concrete headwall at both toes.					
FS Date: 11/14/2013 9:05:28 AM

Concrete headwall and slide gate on LS toe.

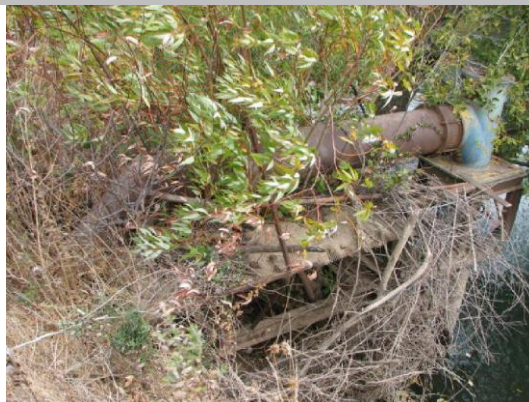
Photo 1 of 1 : UCIP\_3928.jpg

LM Start	2.92	Rating **	M	Issue No.	27
LM End	2.92	Issue Type +	En	Location *	LS
Category	Supplemental			GPS Latitude/Longitude	
				Start	End
Item	DWR UCIP Field Study			39.549014 °	39.549014 °
				-121.842866 °	-121.842866 °
DWR ID	DWR_MA0005_02_s _ 2014_27				
Action/Comments					
Inspector Comments: FS_ID:24056					
EP_NO: 3927					
Repair Type:					
Crossing Status:					
UCIP Comments: Pump does not appear to be in use or is abandoned 6/6/2013 Same as last inspection 11/12/2013 Same as last inspection.					
FIELD_STRUCT_DESC: 20-inch steel pipe through the levee, 2.4 feet below the crown. Siphon breaker in 24-inch corrugated metal riser on the landward shoulder. Portable pump on the waterward side. (Permit No. 3927)					
FS Date: 11/14/2013 9:06:21 AM

Pump on metal pier at WS toe.

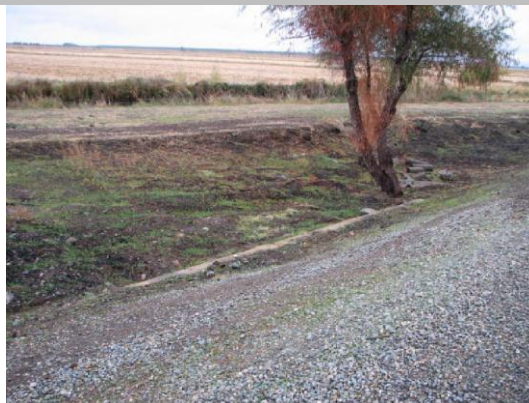
Photo 1 of 2 : UCIP\_5250.jpg

LM Start	4.16	Rating **	M	Issue No.	28
LM End	4.16	Issue Type +	En	Location *	LS
Category	Supplemental			GPS Latitude/Longitude	
				Start	End
Item	DWR UCIP Field Study			39.562875 °	39.562875 °
				-121.828782 °	-121.828782 °
DWR ID	DWR_MA0005_02_s _ 2014_28				
Action/Comments					
Inspector Comments: FS_ID:26386					
EP_NO: N/A					
Repair Type:					
Crossing Status:					
UCIP Comments: Pipe open on WS and is not filled with					
concrete6/6/2013 Sutter Maintenance Yard supervisor Jason Cooper					
said there is a flap gate on the LS end of the pipe in the western most					
ditch to prevent high water flooding. Not sure if this is adequate, will					
talk to levee inspector to find out1/13/2013 Same as last inspection.					
FIELD_STRUCT_DESC: 5 of 5: 60-inch drain pipe through the levee,

16.6 feet below the crown. Pipe partially plugged on LS with concrete					
wall. Flap gate installed on concrete plug to allow floodwater from LS to					
flow to WS. (USACE 1955)					
FS Date: 1/6/2014 8:34:56 AM

Concrete headwall on LS shoulder

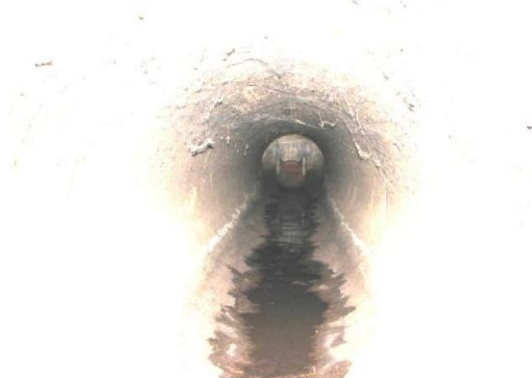
Photo 2 of 2 : UCIP\_5252.jpg

LM Start	4.16	Rating **	M	Issue No.	28 (cont)
LM End	4.16	Issue Type +	En	Location *	LS
Category	Supplemental			GPS Latitude/Longitude	
				Start	End
Item	DWR UCIP Field Study			39.562875 °	39.562875 °
				-121.828782 °	-121.828782 °
DWR ID	DWR_MA0005_02_s _ 2014_28				
Action/Comments					
Inspector Comments: FS_ID:26386					
EP_NO: N/A					
Repair Type:					
Crossing Status:					
UCIP Comments: Pipe open on WS and is not filled with concrete 6/6/2013 Sutter Maintenance Yard supervisor Jason Cooper said there is a flap gate on the LS end of the pipe in the western most ditch to prevent high water flooding. Not sure if this is adequate, will talk to levee inspector to find out 1/13/2013 Same as last inspection.					
FIELD_STRUCT_DESC: 5 of 5: 60-inch drain pipe through the levee, 16.6 feet below the crown. Pipe partially plugged on LS with concrete wall. Flap gate installed on concrete plug to allow floodwater from LS to flow to WS. (USACE 1955)

Flap gate installed inside pipe at LS toe, visible from WS toe.

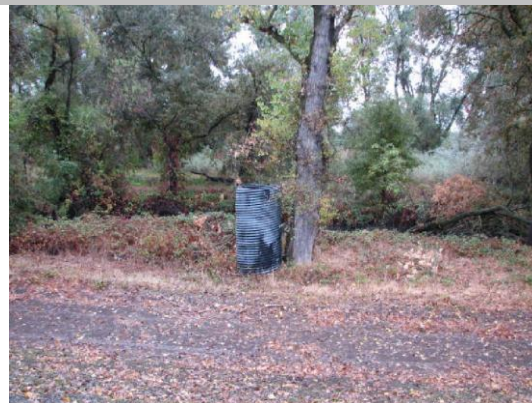
Photo 1 of 1 : UCIP\_3930.jpg

LM Start	5.43	Rating **	M	Issue No.	29
LM End	5.43	Issue Type +	En	Location *	LS
Category	Supplemental			GPS Latitude/Longitude	
				Start	End
Item	DWR UCIP Field Study			39.576008 °	39.576008 °
				-121.812599 °	-121.812599 °
DWR ID	DWR_MA0005_02_s _ 2014_29				
Action/Comments					
Inspector Comments: FS_ID:24075					
EP_NO: N/A					
Repair Type:					
Crossing Status:					
UCIP Comments: Appears abandoned. Unable to locate outfall on WS. Unable to locate inlet on LS 6/6/2013 Same as last inspection 11/12/2013 Same as last inspection.					
FIELD_STRUCT_DESC: 24-inch corrugated metal pipe through the levee, 12.5 feet below the crown. Slide gate and flap gate in 56-inch cmp riser on WS berm. Flap gate on the waterward end. (USACE 1955)					
FS Date: 11/14/2013 10:01:52 AM

56-inch CMP riser on WS berm.

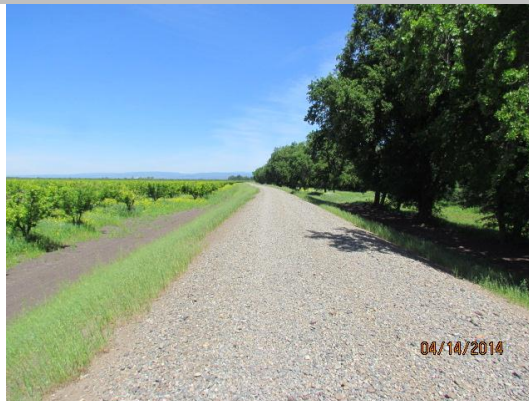
Photo 1 of 1 : rduffey\_s\_20140421\_167.jpg

LM Start	6.66	Rating **	A	Issue No.	43
LM End	6.66	Issue Type +	Ma	Location *	LS
Category	Earthen Levee			GPS Latitude/Longitude	
				Start	End
Item	Vegetation			39.590320 °	39.590320 °
				-121.799698 °	-121.799698 °
DWR ID	DWR_MA0005_02_s _ 2014_43				
Action/Comments					
Control annual grass and weeds on the levee slopes and easements.

View of the native grasses growing on both slopes.

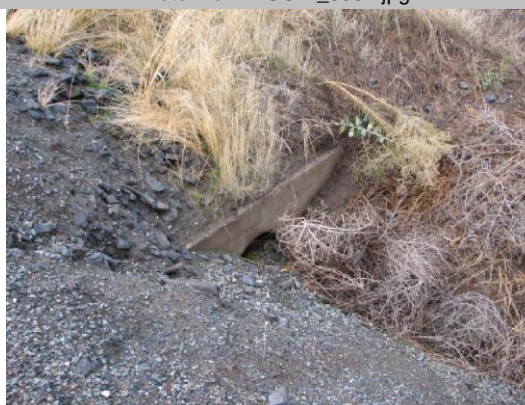
Photo 1 of 1 : UCIP\_3932.jpg

LM Start	8.12	Rating **	M	Issue No.	30
LM End	8.12	Issue Type +	En	Location *	LS
Category	Supplemental			GPS Latitude/Longitude	
				Start	End
Item	DWR UCIP Field Study			39.607802 °	39.607802 °
				-121.785597 °	-121.785597 °
DWR ID	DWR_MA0005_02_s _ 2014_30				
Action/Comments					
Inspector Comments: FS_ID:24085					
EP_NO: N/A					
Repair Type:					
Crossing Status:					
UCIP Comments: Pipe 3/4 full with soil on LS 6/6/2013 Same as last inspection 11/12/2013 Same as last inspection.					
FIELD_STRUCT_DESC: 24-inch corrugated metal pipe through the levee, 6.7 feet below the crown. Concrete headwall at the landward toe.					
Flap gate on the waterward end. (USACE 1955)					
FS Date: 11/14/2013 10:22:35 AM

Concrete headwall on LS toe.

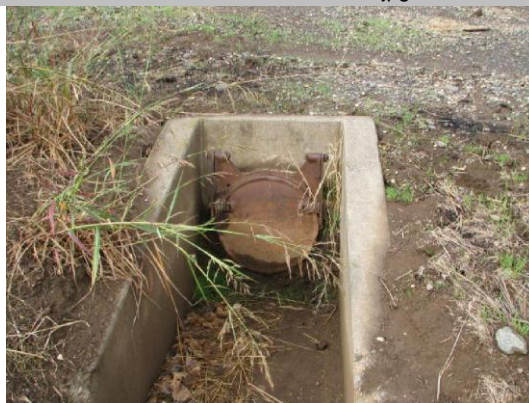
Photo 1 of 1 : UCIP\_3958.jpg

LM Start	8.94	Rating **	M	Issue No.	31
LM End	8.94	Issue Type +	En	Location *	LS
Category	Supplemental			GPS Latitude/Longitude	
				Start	End
Item	DWR UCIP Field Study			39.618163 °	39.618163 °
				-121.778745 °	-121.778745 °
DWR ID	DWR_MA0005_02_s _ 2014_31				
Action/Comments					
Inspector Comments: FS_ID:24111					
EP_NO: N/A					
Repair Type:					
Crossing Status:					
UCIP Comments: LS inlet is buried under soil and covered with brambles. Slide gate missing from LS 6/2013 Same as last inspection 11/13/2013 Same as last inspection.					
FIELD_STRUCT_DESC: 24-inch pipe through the levee, 12.0 feet below the crown. Flap gate on waterward end. Concrete headwall on the waterward end. (USACE 1957)					
FS Date: 11/14/2013 12:08:28 PM

Concrete U shaped headwall and flap gate at WS toe.

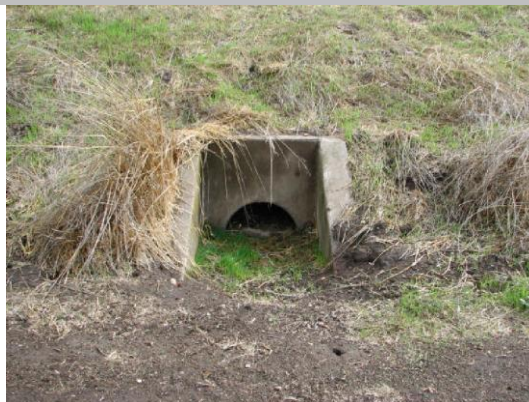
Photo 1 of 1 : UCIP\_3964.jpg

LM Start	9.59	Rating **	M	Issue No.	32
LM End	9.59	Issue Type +	En	Location *	LS
Category	Supplemental			GPS Latitude/Longitude	
				Start	End
Item	DWR UCIP Field Study			39.626894 °	39.626894 °
				-121.775180 °	-121.775180 °
DWR ID	DWR_MA0005_02_s _ 2014_32				
Action/Comments					
Inspector Comments: FS_ID:24116					
EP_NO: N/A					
Repair Type:					
Crossing Status:					
UCIP Comments: Pipe 1/2 filled with soil 6/6/2013 Same as last inspection 11/13/2013 Same as last inspection.					
FIELD_STRUCT_DESC: 24-inch corrugated metal storm drain pipe through the levee, 11.2 feet below the crown. Flap gate on waterward end. Concrete "U" shaped headwalls on both ends. (USCE 1957)					
FS Date: 11/14/2013 12:17:23 PM

Concrete U-shaped headwall on LS toe.

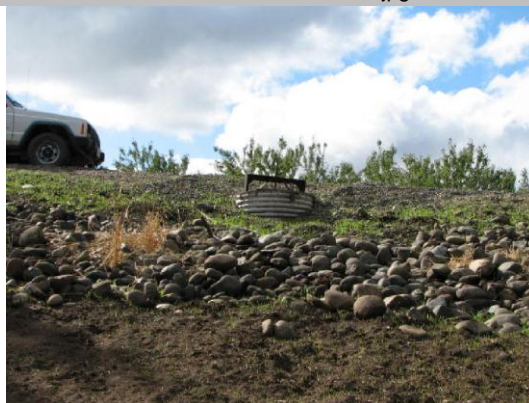
Photo 1 of 1 : UCIP\_3972.jpg

LM Start	11.29	Rating **	M	Issue No.	33
LM End	11.29	Issue Type +	En	Location *	LS
Category	Supplemental			GPS Latitude/Longitude	
				Start	End
Item	DWR UCIP Field Study			39.648185 °	39.648185 °
				-121.788563 °	-121.788563 °
DWR ID	DWR_MA0005_02_s_2014_33				
Action/Comments					
Inspector Comments: FS_ID:24125					
EP_NO: N/A					
Repair Type:					
Crossing Status:					
UCIP Comments: Pipe appears abandoned. It needs to be abandoned properly. 9/6/2013 Same as last inspection. 11/13/2013 Same as last inspection.					
FIELD_STRUCT_DESC: 30-inch corrugated metal siphon through the levee, 9.4 feet below the crown. Slide gate in 42-inch corrugated metal riser on the waterward slope. Concrete distribution box on the landward side. (USCE 1958)					
FS Date: 11/14/2013 12:35:49 PM

CM riser with slide gate on WS shoulder.

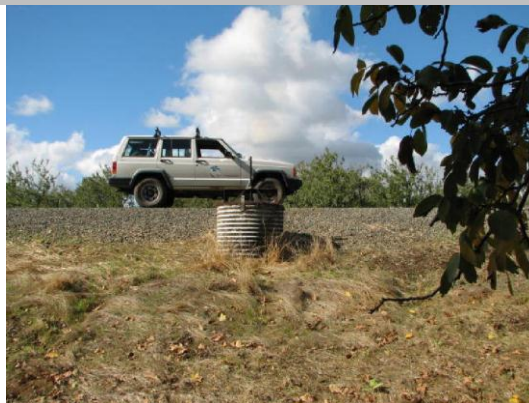
Photo 1 of 1 : UCIP\_3977.jpg

LM Start	12.25	Rating **	M	Issue No.	34
LM End	12.25	Issue Type +	En	Location *	LS
Category	Supplemental			GPS Latitude/Longitude	
				Start	End
Item	DWR UCIP Field Study			39.660980 °	39.660980 °
				-121.786341 °	-121.786341 °
DWR ID	DWR_MA0005_02_s_2014_34				
Action/Comments					
Inspector Comments: FS_ID:24126					
EP_NO: N/A					
Repair Type:					
Crossing Status:					
UCIP Comments: This pipe appears to be abandoned6/6/2013					
Same as last inspection11/13/2013 Same as last inspection.					
FIELD_STRUCT_DESC: 30-inch siphon pipe through the levee, 12.3 feet below the crown. Slide gate in 42-inch corrugated metal riser on the waterward slope. 5-foot X 5-foot Concrete distribution box at LS toe. (USCAE 1958)					
FS Date: 11/14/2013 12:43:55 PM

42-inch CMP riser on WS shoulder with slide gate.

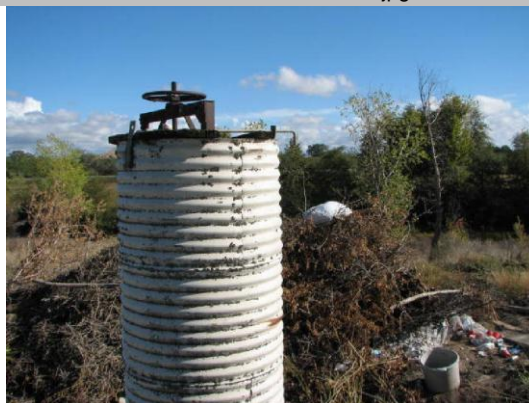
Photo 1 of 1 : UCIP\_3978.jpg

LM Start	13.35	Rating **	M	Issue No.	35
LM End	13.35	Issue Type +	En	Location *	WS
Category	Supplemental			GPS Latitude/Longitude	
				Start	End
Item	DWR UCIP Field Study			39.675379 °	39.675379 °
				-121.780319 °	-121.780319 °
DWR ID	DWR_MA0005_02_s_2014_35				
Action/Comments					
Inspector Comments: FS_ID:24128					
EP_NO: N/A					
Repair Type:					
Crossing Status:					
UCIP Comments: Pipe appears to be abandoned. No pump found.					
Pipe should be abandoned properly 6/6/2013 Same as last inspection 11/13/2013 Same as last inspection.					
FIELD_STRUCT_DESC: 24-inch pipe through the levee, 9.0 feet below the crown. Slide gate in 36-inch corrugated metal riser on the waterward slope. Pump and 36-inch concrete standpipe on the waterward berm. (USCE 1958)					
FS Date: 11/14/2013 12:47:15 PM

Slide gate in CM riser on WS toe.

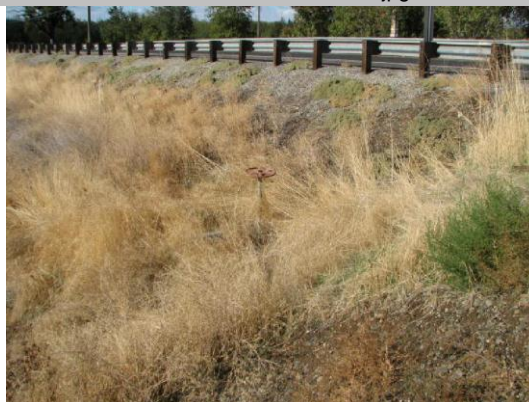
Photo 1 of 1 : UCIP\_3980.jpg

LM Start	13.59	Rating **	M	Issue No.	36
LM End	13.59	Issue Type +	En	Location *	WS
Category	Supplemental			GPS Latitude/Longitude	
				Start	End
Item	DWR UCIP Field Study			39.678267 °	39.678267 °
				-121.778322 °	-121.778322 °
DWR ID	DWR_MA0005_02_s_2014_36				
Action/Comments					
Inspector Comments: FS_ID:24130					
EP_NO: 17127					
Repair Type:					
Crossing Status:					
UCIP Comments: Debris, soil, and vegetation creating minor blockage at flap gate outlet 6/6/2013 Same as last inspection 11/13/2013					
Flap gate is completely blocked from being able to open.					
FIELD_STRUCT_DESC: 36-Inch Corrugated Metal pipe drain pipe through the levee approximately 12-feet below the crown. 4-foot X 4-foot concrete box and slide gate on land side. Concrete headwall and flap gate at waterside outlet. (Permit No. 17127)					
FS Date: 11/14/2013 12:51:11 PM

Slide gate at 4X4 concrete box on LS slope.

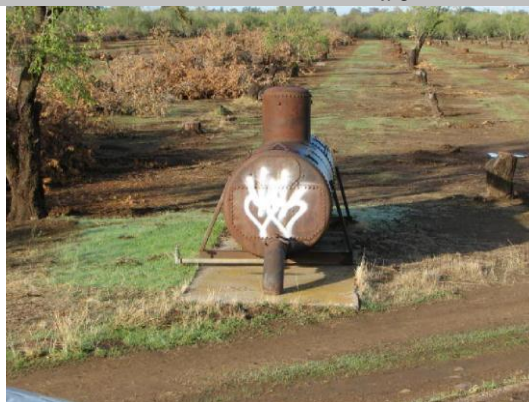
Photo 1 of 1 : UCIP\_3981.jpg

LM Start	13.99	Rating **	M	Issue No.	37
LM End	13.99	Issue Type +	En	Location *	WS
Category	Supplemental			GPS Latitude/Longitude	
				Start	End
Item	DWR UCIP Field Study			39.683896 °	39.683896 °
				-121.778183 °	-121.778183 °
DWR ID	DWR_MA0005_02_s _ 2014_37				
Action/Comments					
Inspector Comments: FS_ID:24138					
EP_NO: N/A					
Repair Type:					
Crossing Status:					
UCIP Comments: Pipe appears to be abandoned 6/6/2013 Boiler has been removed and pipe buried on LS. Unable to locate 1/13/2013 Unable to locate.					
FIELD_STRUCT_DESC: 8-inch steel pipe through levee, 6.5 feet below crown. Boiler attached to LS end of pipe. (USACE 1958)					
FS Date: 11/14/2013 1:12:54 PM

Pipe attached at boiler on LS toe.

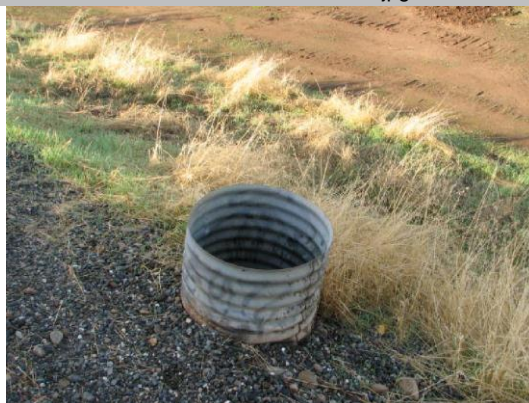
Photo 1 of 1 : UCIP\_3982.jpg

LM Start	14.15	Rating **	M	Issue No.	38
LM End	14.15	Issue Type +	En	Location *	WS
Category	Supplemental			GPS Latitude/Longitude	
				Start	End
Item	DWR UCIP Field Study			39.685961 °	39.685961 °
				-121.779041 °	-121.779041 °
DWR ID	DWR_MA0005_02_s_2014_38				
Action/Comments					
Inspector Comments: FS_ID:24139					
EP_NO: N/A					
Repair Type:					
Crossing Status:					
UCIP Comments: Pipe appears to be abandoned6/6/2013 Same as last inspection1/13/2013 Same as last inspection.					
FIELD_STRUCT_DESC: 6-inch steel pipe through levee, 7.1 feet below crown. Siphon breaker in corrugated metal riser on landward slope. One corrugated metal cutoff wall. Pipe is open on both ends. (USCE 1958)					
FS Date: 11/14/2013 1:13:38 PM

CM riser with siphon breaker on LS shoulder.

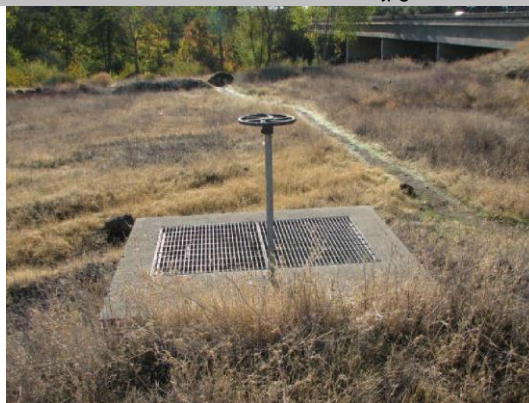
Photo 1 of 2 : UCIP\_3985.jpg

Concrete box and gate on WS shoulder.

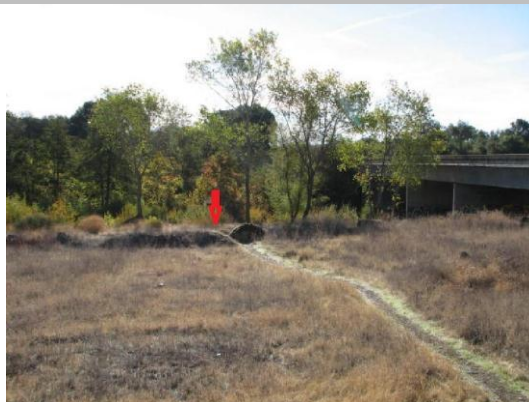
Photo 2 of 2 : UCIP\_3986.jpg

LM Start	14.82	Rating **	M	Issue No.	39 (cont)
LM End	14.82	Issue Type +	En	Location *	LS

Location of pipe at outlet.

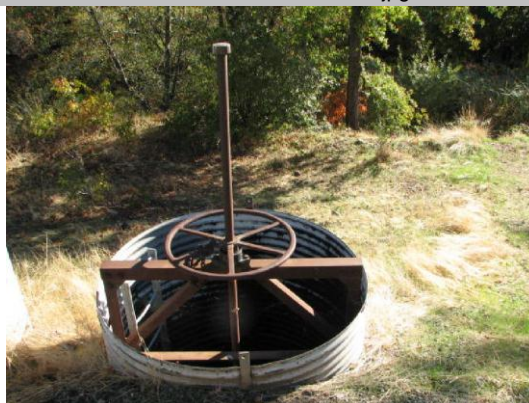
Photo 1 of 1 : UCIP\_3990.jpg

LM Start	15.71	Rating **	M	Issue No.	40
LM End	15.71	Issue Type +	En	Location *	LS
Category	Supplemental			GPS Latitude/Longitude	
				Start	End
Item	DWR UCIP Field Study			39.707544 °	39.707544 °
				-121.777701 °	-121.777701 °
DWR ID	DWR_MA0005_02_s _ 2014_40				
Action/Comments					
Inspector Comments: FS_ID:24145

66-inch CMP riser on WS shoulder with slide gate.

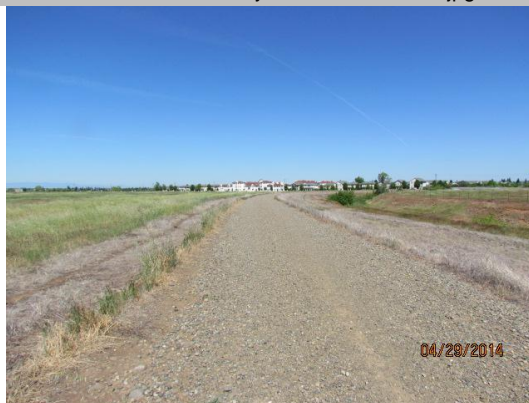
Photo 1 of 1 : rduffey\_s\_20140505\_239.jpg

LM Start	0.49	Rating **	A	Issue No.	1
LM End	0.49	Issue Type +	Ma	Location *	LS
Category	Earthen Levee			GPS Latitude/Longitude	
				Start	End
Item	Vegetation			39.723848 °	39.723848 °
				-121.780529 °	-121.780529 °
DWR ID	DWR_MA0005_03_s _ 2014_1				
Action/Comments					
Control annual grass and weeds on the levee slopes and easements.

View of the native grasses on the landside slopes.
