**Flood Control Project Maintenance  
Levee Inspections**  
**LMA District Cover Sheet**  
**Spring 2016 Levee Inspection Results**

**Sutter Maintenance Yard Maintenance Area 0005**

**Spring 2016 Levee Inspection Results**

Waterway	Bank	Unit Miles
Unit No. 01 Butte Creek	Left	15.08

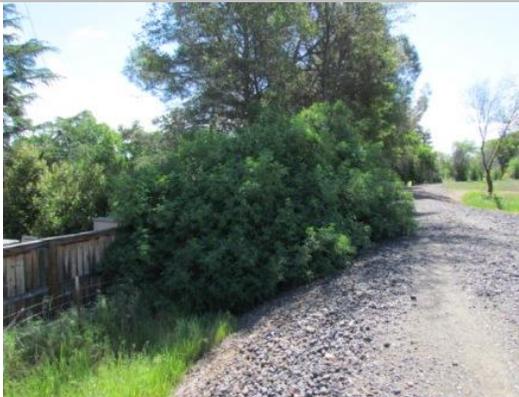
Photo 1 of 1 : SP\_2016\_MA0005\_196\_903\_20160321\_00020.jpg

LM Start	<b>0.56</b>	Rating **	M	Issue No.	<b>903</b>
LM End	<b>0.56</b>	Issue Type +	Ma	Location *	LS
Category	Earthen Levee		GPS Latitude/Longitude		
			Start	End	
Item	Vegetation		39.690745 °	39.690745 °	
			-121.777342 °	-121.777342 °	
DWR ID	DWR_MA0005_01_s_2012_903				
Comment Code					
V4 : Elderberries are blocking visibility and flood fight capability.					
Inspector Comment

View of the large elderberries along the L/S toe.

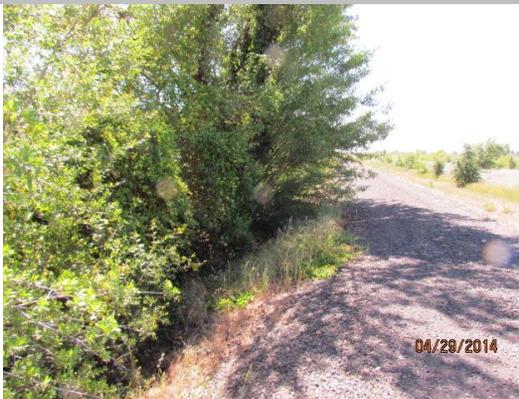
Photo 1 of 1 : SP\_2016\_MA0005\_196\_32\_20160321\_00012.jpg

LM Start	<b>0.77</b>	Rating **	M	Issue No.	<b>32</b>
LM End	<b>0.77</b>	Issue Type +	Ma	Location *	LS
Category	Earthen Levee		GPS Latitude/Longitude		
			Start	End	
Item	Trim / Thin Trees		39.687917 °	39.687917 °	
			-121.777393 °	-121.777393 °	
DWR ID	DWR_MA0005_01_s_2014_32				
Comment Code					
T2 : Thin trees to allow visibility of the ground and room to flood fight.					
Inspector Comment

Trim the trees along the landside slope.

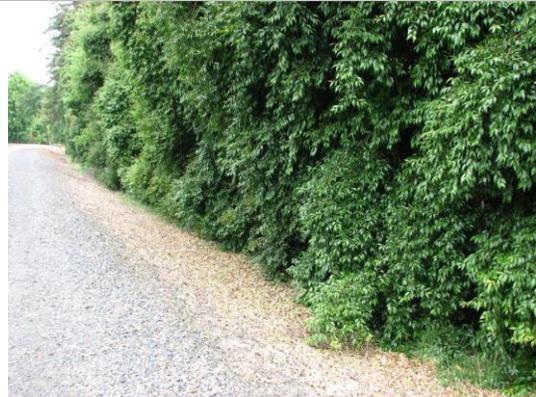
Photo 1 of 1 : SP\_2016\_MA0005\_196\_43\_20160509\_00056.jpg

LM Start	<b>1.16</b>	Rating **	M	Issue No.	<b>43</b>
LM End	<b>1.22</b>	Issue Type +	En	Location *	LS
Category	Earthen Levee			GPS Latitude/Longitude	
				Start	End
Item	Vegetation			39.682402 °	39.681563 °
				-121.776405 °	-121.776508 °
DWR ID	DWR_MA0005_01_s_2016_43				
Comment Code					
V6 : Landscaping					
Inspector Comment

5/5/2016: Trim vegetation to allow visibility and access to L/S toe and slope.

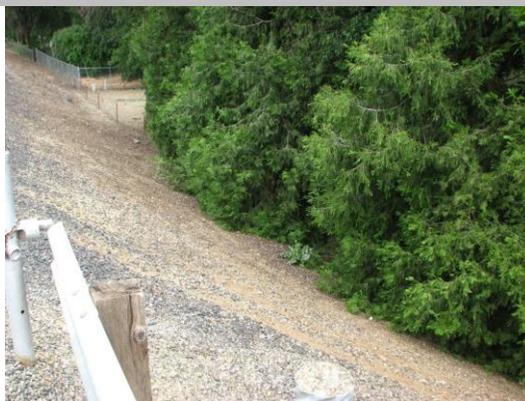
Photo 1 of 1 : SP\_2016\_MA0005\_196\_40\_20160509\_00054.jpg

LM Start	<b>1.45</b>	Rating **	M	Issue No.	<b>40</b>
LM End	<b>1.45</b>	Issue Type +	En	Location *	LS
Category	Earthen Levee		GPS Latitude/Longitude		
			Start	End	
Item	Vegetation		39.678318 °	39.678318 °	
			-121.777231 °	-121.777231 °	
DWR ID	DWR_MA0005_01_s_2016_40				
Comment Code					
V6 : Landscaping					
Inspector Comment					
cedar trees need to be trimmed up.

5/5/2016: Trim trees to allow visibility and access to L/S slope and toe.

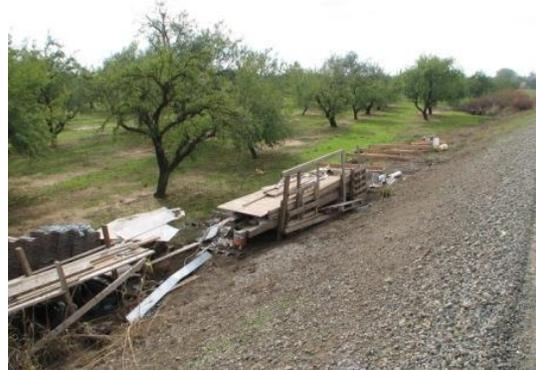
Photo 1 of 1 : SP\_2016\_MA0005\_196\_1\_20160321\_00001.jpg

LM Start	<b>1.66</b>	Rating **	M	Issue No.	<b>1</b>
LM End	<b>1.66</b>	Issue Type +	En	Location *	LS
Category	Earthen Levee		GPS Latitude/Longitude		
			Start	End	
Item	Encroachments		39.675528 °	39.675528 °	
			-121.778642 °	-121.778642 °	
DWR ID	DWR_MA0005_01_s_2012_1				
Comment Code					
DE : Debris					
Inspector Comment

View of the removed garbage but construction supply on pallets.

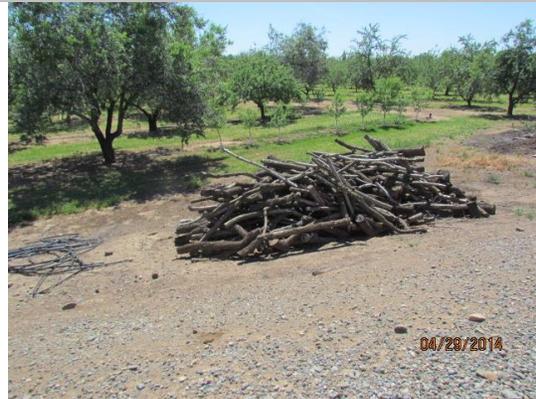
Photo 1 of 1 : SP\_2016\_MA0005\_196\_33\_20160321\_00013.jpg

LM Start	<b>1.69</b>	Rating **	M	Issue No.	<b>33</b>
LM End	<b>1.69</b>	Issue Type +	En	Location *	LS
Category	Earthen Levee		GPS Latitude/Longitude		
			Start	End	
Item	Encroachments		39.675158 °	39.675158 °	
			-121.779025 °	-121.779025 °	
DWR ID	DWR_MA0005_01_s_2014_33				
Comment Code					
FW : Firewood					
Inspector Comment

View of the firewood along the landside toe.

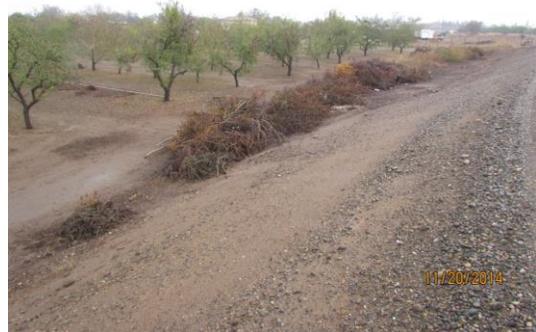
Photo 1 of 1 : SP\_2016\_MA0005\_196\_35\_20160321\_00015.jpg

LM Start	<b>1.88</b>	Rating **	M	Issue No.	<b>35</b>
LM End	<b>1.88</b>	Issue Type +	En	Location *	LS
Category	Earthen Levee		GPS Latitude/Longitude		
			Start	End	
Item	Encroachments		39.672627 °	39.672627 °	
			-121.779778 °	-121.779778 °	
DWR ID	DWR_MA0005_01_f_2014_35				
Comment Code					
PR : Prunings					
Inspector Comment

View of the prunings along the landside toe.

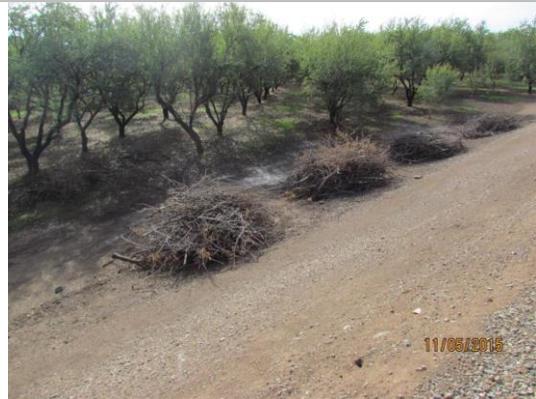
Photo 1 of 1 : SP\_2016\_MA0005\_196\_36\_20160321\_00016.jpg

LM Start	<b>2.81</b>	Rating **	A/W	Issue No.	<b>36</b>
LM End	<b>2.81</b>	Issue Type +	En	Location *	LS
Category	Earthen Levee		GPS Latitude/Longitude		
			Start	End	
Item	Encroachments		39.660203 °	39.660203 °	
			-121.785107 °	-121.785107 °	
DWR ID	DWR_MA0005_01_f_2015_36				
Comment Code					
PR : Prunings					
Inspector Comment					
Remove the prunings from the landside toe.

View of the prunings along the landside toe.

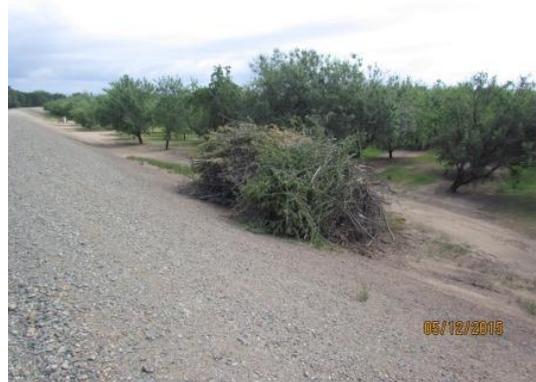
Photo 1 of 1 : SP\_2016\_MA0005\_196\_2\_20160321\_00002.jpg

LM Start	<b>3.08</b>	Rating **	M	Issue No.	<b>2</b>
LM End	<b>3.08</b>	Issue Type +	En	Location *	LS
Category	Earthen Levee		GPS Latitude/Longitude		
			Start	End	
Item	Encroachments		39.656735 °	39.656735 °	
			-121.787163 °	-121.787163 °	
DWR ID	DWR_MA0005_01_f_2014_2				
Comment Code					
PR : Prunings					
Inspector Comment					
Remove the prunings from the landside toe.

View of the prunings along the landside toe.

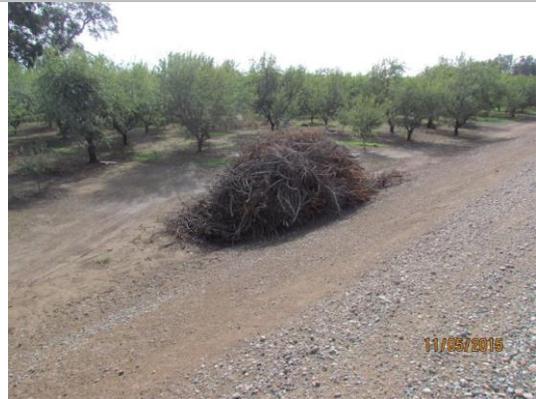
Photo 1 of 1 : SP\_2016\_MA0005\_196\_38\_20160321\_00018.jpg

LM Start	<b>3.21</b>	Rating **	M	Issue No.	<b>38</b>
LM End	<b>3.21</b>	Issue Type +	En	Location *	LS
Category	Earthen Levee		GPS Latitude/Longitude		
			Start	End	
Item	Encroachments		39.654938 °	39.654938 °	
			-121.787892 °	-121.787892 °	
DWR ID	DWR_MA0005_01_f_2015_38				
Comment Code					
PR : Prunings					
Inspector Comment					
Remove the prunings from the landside toe.

View of the prunings along the landside toe.

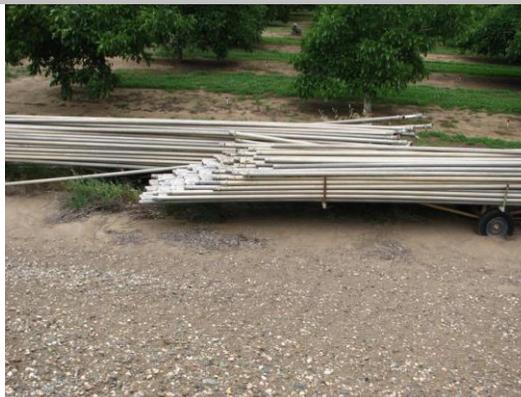
Photo 1 of 1 : SP\_2016\_MA0005\_196\_27\_20160509\_00053.jpg

LM Start	<b>4.13</b>	Rating **	M	Issue No.	<b>27</b>
LM End	<b>4.13</b>	Issue Type +	En	Location *	LS
Category	Earthen Levee			GPS Latitude/Longitude	
				Start	End
Item	Encroachments			39.643100 °	39.643100 °
				-121.782827 °	-121.782827 °
DWR ID	DWR_MA0005_01_s_2016_27				
Comment Code					
EQ : Equipment					
Inspector Comment					
Agricultural piping on trailer.

5/5/2016: Remove equipment from L/S toe.

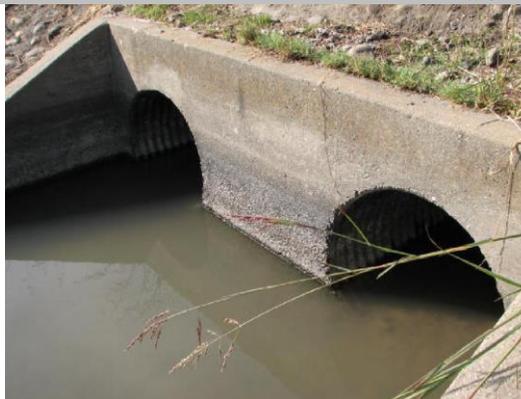
Photo 1 of 2 : UCIP\_SP\_2016\_48272\_67941.jpg

FS\_ID:48272  
 DS\_ID:1620  
 EP\_NO: N/A  
 Repair Type: Non-Urgent  
 Crossing Status: Found  
 UCIP Comments: 5/9/2016 Abandoned pipe. Needs a cover for the standpipe.8/5/2015 Abandoned crossing. Covers need to be made for tops of standpipes to prevent falls.12/8/2014 Same as last inspection.6/11/2014 Same as last inspection.11/19/2013 Same as last inspection.5/29/2013 Same as last inspection. Land owner said pipes are abandoned and no longer used. Covers should be made for top of standpipe to prevent falls. Pipes should be properly abandoned.10/30/2012 Pipe 1/2 filled with soil at slide gate end.  
 FIELD\_STRUCT\_DESC: 1 of 2: 36-inch drainage pipe through the levee, 11.0 feet below the crown. Slide gate in 54-inch corrugated metal riser on waterside (WS) slope. Concrete "U" headwall on the landside (LS). [Additional Reference(s): DWR Levee Log, 1990. Sacramento O&M Manual 516, April 1960 (Station 470+00)].

Headwall at LS toe.

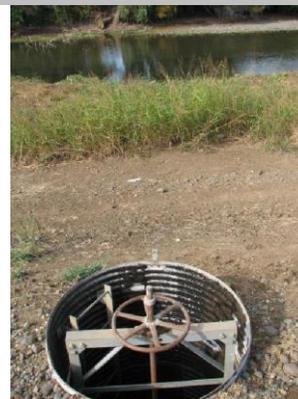
Photo 2 of 2 : UCIP\_SP\_2016\_48272\_67940.jpg

54-inch CMP riser and slide gate on WS shoulder.

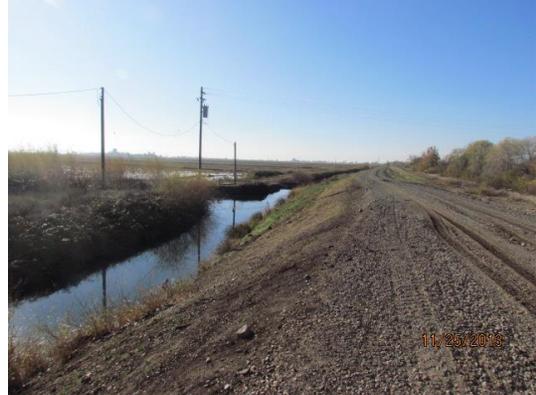
Photo 1 of 1 : SP\_2016\_MA0005\_196\_55\_20160321\_00019.jpg

LM Start	<b>5.69</b>	Rating **	M	Issue No.	<b>55</b>
LM End	<b>6.23</b>	Issue Type +	En	Location *	LS
Category	Earthen Levee		GPS Latitude/Longitude		
			Start	End	
Item	Encroachments		39.622766 °	39.615666 °	
			-121.773159 °	-121.777353 °	
DWR ID	DWR_MA0005_01_s_2015_55				
Comment Code					
DT : Ditch					
Inspector Comment

View of the irrigation ditch along the landside toe.

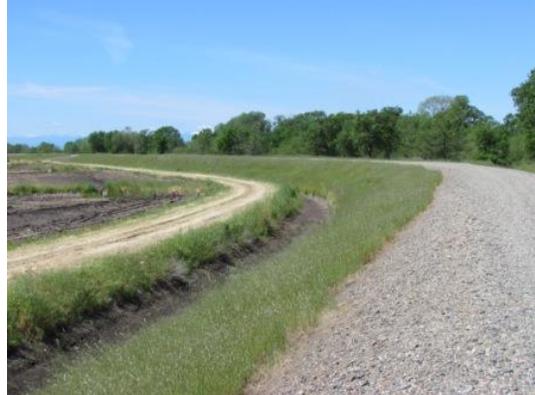
Photo 1 of 1 : SP\_2016\_MA0005\_196\_5\_20160321\_00003.jpg

LM Start	<b>9.54</b>	Rating **	M	Issue No.	<b>5</b>
LM End	<b>10.33</b>	Issue Type +	En	Location *	LS
Category	Earthen Levee		GPS Latitude/Longitude		
			Start	End	
Item	Encroachments		39.574837 °	39.567892 °	
			-121.807913 °	-121.819283 °	
DWR ID	DWR_MA0005_01_s_2012_5				
Comment Code					
DT : Ditch					
Inspector Comment

View of the agricultural ditch along the L/S toe.

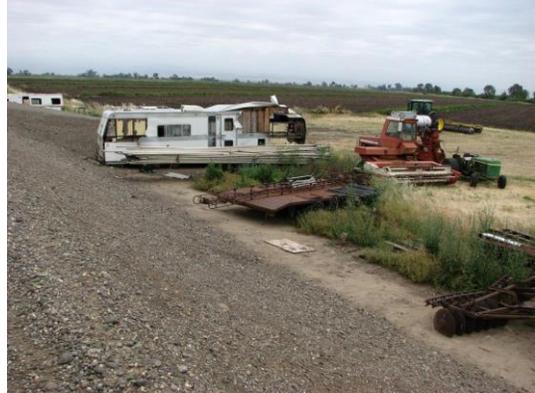
Photo 1 of 1 : SP\_2016\_MA0005\_196\_26\_20160509\_00052.jpg

LM Start	<b>10.37</b>	Rating **	M	Issue No.	<b>26</b>
LM End	<b>10.37</b>	Issue Type +	En	Location *	LS
Category	Earthen Levee		GPS Latitude/Longitude		
			Start	End	
Item	Encroachments		39.567541 °	39.567541 °	
			-121.819786 °	-121.819786 °	
DWR ID	DWR_MA0005_01_s_2016_26				
Comment Code					
EQ : Equipment					
Inspector Comment					
Abandoned motorhomes and farm equipment.

5/5/2016: Remove abandoned motorhome and equipment from L/S toe.

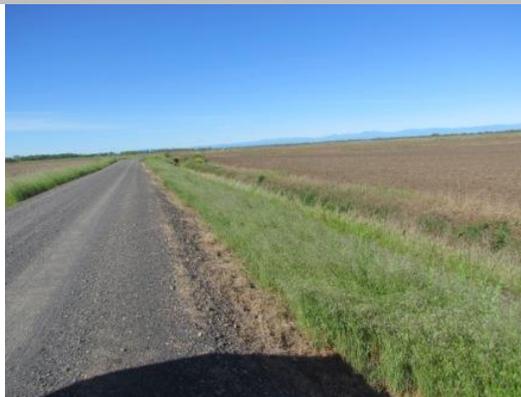
Photo 1 of 1 : SP\_2016\_MA0005\_197\_1\_20160321\_00001.jpg

LM Start	<b>1.21</b>	Rating **	M	Issue No.	<b>1</b>
LM End	<b>1.59</b>	Issue Type +	En	Location *	LS
Category	Earthen Levee		GPS Latitude/Longitude		
			Start	End	
Item	Encroachments		39.529933 °	39.534102 °	
			-121.861563 °	-121.856947 °	
DWR ID	DWR_MA0005_02_s_2012_1				
Comment Code					
DT : Ditch					
Inspector Comment

View of the agricultural ditch along the landside toe.

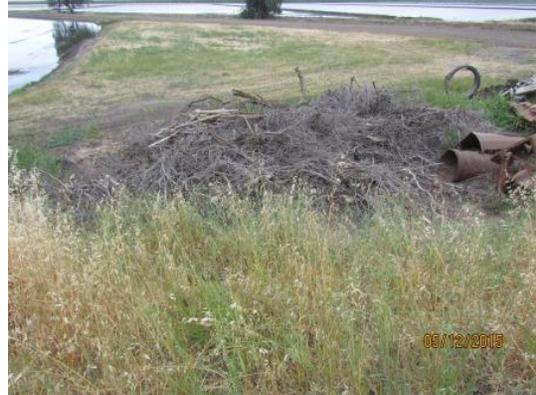
Photo 1 of 1 : SP\_2016\_MA0005\_197\_34\_20160321\_00013.jpg

LM Start	<b>5.91</b>	Rating **	M	Issue No.	<b>34</b>
LM End	<b>5.91</b>	Issue Type +	En	Location *	LS
Category	Earthen Levee		GPS Latitude/Longitude		
			Start	End	
Item	Encroachments		39.583052°	39.583052°	
			-121.807423°	-121.807423°	
DWR ID	DWR_MA0005_02_s_2015_34				
Comment Code					
PR : Prunings					
Inspector Comment					
Remove the prunings from the landside toe.

View of the prunings along the landside toe.

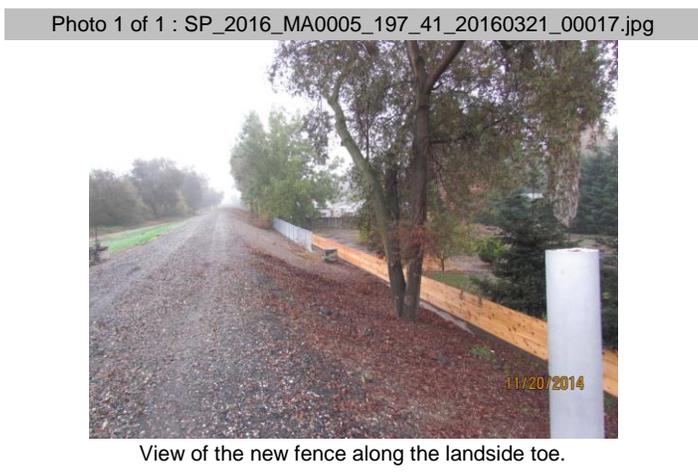
LM Start	<b>10.89</b>	Rating **	U	Issue No.	<b>41</b>
LM End	<b>10.93</b>	Issue Type +	En	Location *	LS
Category	Earthen Levee		GPS Latitude/Longitude		
			Start	End	
Item	Encroachments		39.645318 °	39.645858 °	
			-121.786345 °	-121.786742 °	
DWR ID	DWR_MA0005_02_f_2014_41				
Comment Code					
FE : Fence					
Inspector Comment					
Remove or apply for permit for the fence along landside toe

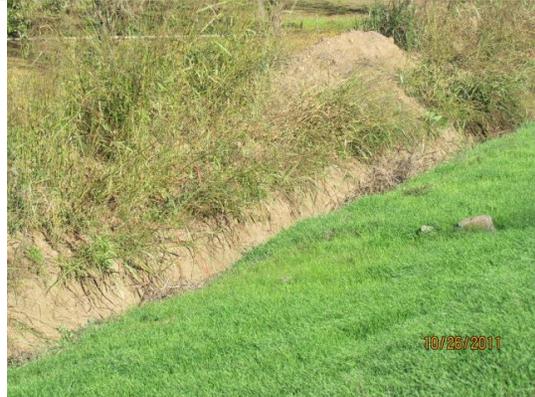
Photo 1 of 1 : SP\_2016\_MA0005\_197\_6\_20160321\_00003.jpg

LM Start	<b>11.57</b>	Rating **	M	Issue No.	<b>6</b>
LM End	<b>11.77</b>	Issue Type +	En	Location *	LS
Category	Earthen Levee		GPS Latitude/Longitude		
			Start	End	
Item	Encroachments		39.654268 °	39.657142 °	
			-121.789525 °	-121.788690 °	
DWR ID	DWR_MA0005_02_s_2012_6				
Comment Code					
DT : Ditch					
Inspector Comment

View of the ditch along the Landside toe.

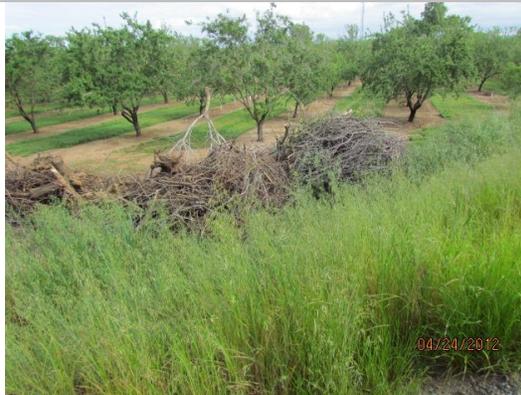
Photo 1 of 1 : SP\_2016\_MA0005\_197\_19\_20160321\_00009.jpg

LM Start	<b>12.83</b>	Rating **	M	Issue No.	<b>19</b>
LM End	<b>12.83</b>	Issue Type +	En	Location *	LS
Category	Earthen Levee		GPS Latitude/Longitude		
			Start	End	
Item	Encroachments		39.671239 °	39.671239 °	
			-121.782486 °	-121.782486 °	
DWR ID	DWR_MA0005_02_s_2012_19				
Comment Code					
PR : Prunings					
Inspector Comment

View of the brush pile at the toe of the levee.

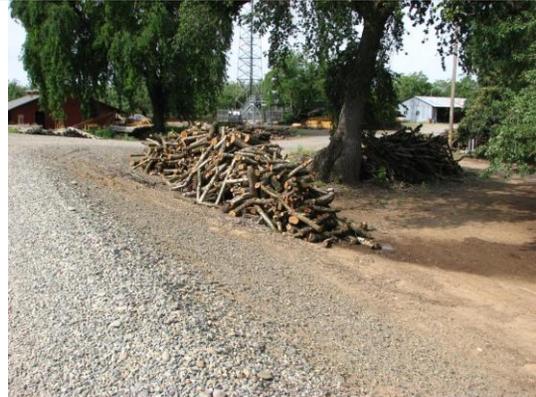
Photo 1 of 1 : SP\_2016\_MA0005\_197\_42\_20160509\_00064.jpg

LM Start	<b>13.06</b>	Rating **	M	Issue No.	<b>42</b>
LM End	<b>13.06</b>	Issue Type +	En	Location *	LS
Category	Earthen Levee		GPS Latitude/Longitude		
			Start	End	
Item	Encroachments		39.674219 °	39.674219 °	
			-121.781188 °	-121.781188 °	
DWR ID	DWR_MA0005_02_s_2016_42				
Comment Code					
FW : Firewood					
Inspector Comment

5/5/2016: Remove firewood pile from L/S slope.

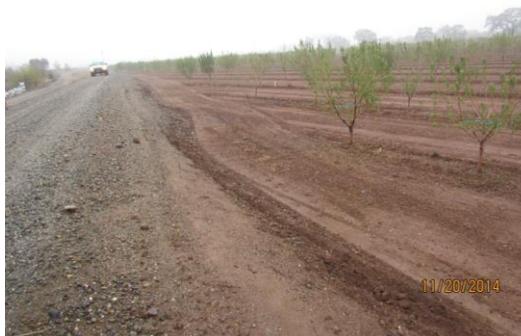
Photo 1 of 1 : SP\_2016\_MA0005\_197\_43\_20160321\_00018.jpg

LM Start	<b>14.13</b>	Rating **	U	Issue No.	<b>43</b>
LM End	<b>14.13</b>	Issue Type +	Ma	Location *	LS
Category	Earthen Levee		GPS Latitude/Longitude		
			Start	End	
Item	Slope Stability		39.688715 °	39.688715 °	
			-121.778345 °	-121.778345 °	
DWR ID	DWR_MA0005_02_f_2014_43				
Comment Code					
S1 : Repair slope instability.					
Inspector Comment

View of the tilling into the landside slope.

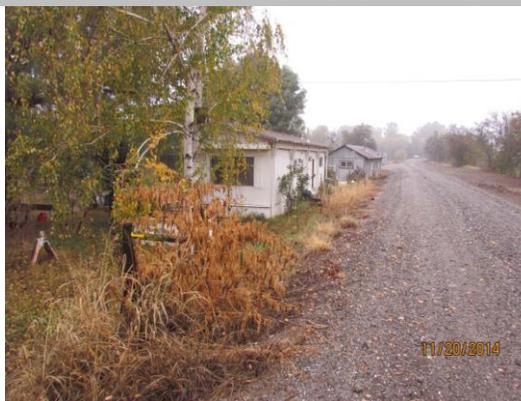
Photo 1 of 1 : SP\_2016\_MA0005\_197\_25\_20160321\_00012.jpg

LM Start	<b>14.33</b>	Rating **	U	Issue No.	<b>25</b>
LM End	<b>14.33</b>	Issue Type +	En	Location *	LS
Category	Earthen Levee		GPS Latitude/Longitude		
			Start	End	
Item	Encroachments		39.691580 °	39.691580 °	
			-121.779254 °	-121.779254 °	
DWR ID	DWR_MA0005_02_s_2012_25				
Comment Code					
BU : Building					
Inspector Comment					
Unpermitted structure.

View of the buildings at the landside toe.
