**Flood Control Project Maintenance
Levee Inspections**
LMA District Cover Sheet
Spring 2017 Levee Inspection Results

Sutter Maintenance Yard Maintenance Area 0005

Spring 2017 Levee Inspection Results

Waterway			Bank	Unit Miles
Unit No. 01 Butte Creek			Left	15.08
	Spring (March - May)	Summer (June - August)	(September - November) Fall	Winter (December - February)
Unit Maintenance Rating (Fall Only)				
Date of Inspection	5/2/2017 - 5/2/2017			
DWR Inspector	Bob Duffey			
Accompanied By	Shawn Freitag Sutter Maintenance Yard

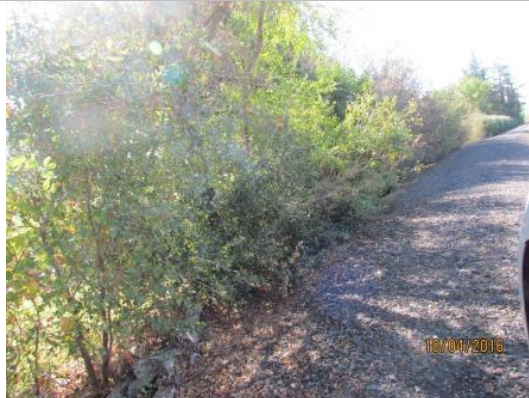
Photo 1 of 1 : SP_2017_MA0005_196_32_20170315_00012.jpg

LM Start	0.58	Rating **	M	Issue No.	32
LM End	0.68	Issue Type +	Ma	Location *	LS
Category	Earthen Levee			GPS Latitude/Longitude	
				Start	End
Item	Trim / Thin Trees			39.690496 °	39.689137 °
				-121.777109 °	-121.776938 °
DWR ID	DWR_MA0005_01_s _ 2014_32				
Comment Code					
T2 : Thin trees to allow visibility of the ground and room to flood fight.					
Inspector Comment

View of the trees along the landside toe blocking visibility.

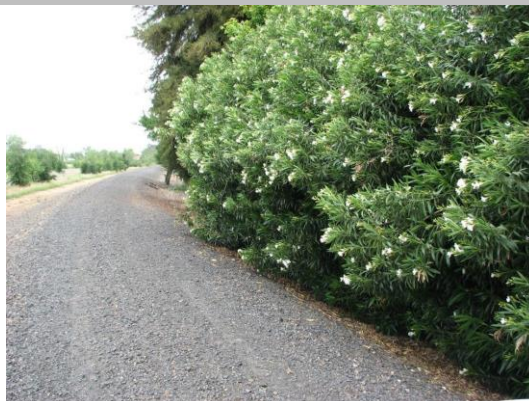
Photo 1 of 1 : SP_2017_MA0005_196_44_20170315_00021.jpg

LM Start	0.68	Rating **	U	Issue No.	44
LM End	0.77	Issue Type +	En	Location *	LS
Category	Earthen Levee			GPS Latitude/Longitude	
				Start	End
Item	Vegetation			39.689135 °	39.687968 °
				-121.776929 °	-121.777387 °
DWR ID	DWR_MA0005_01_s _ 2016_44				
Comment Code					
V6 : Landscaping					
Inspector Comment

View of oleanders along the landside toe.

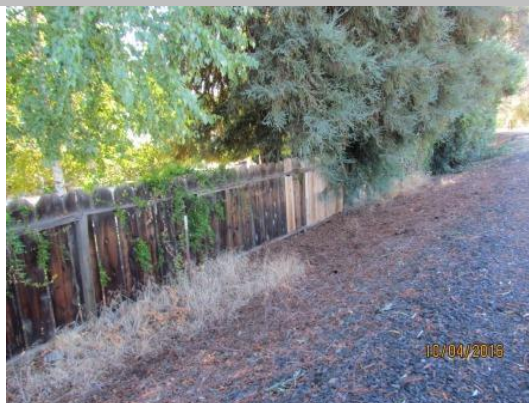
Photo 1 of 1 : SP_2017_MA0005_196_49_20170315_00024.jpg

LM Start	0.90	Rating **	U	Issue No.	49
LM End	0.92	Issue Type +	En	Location *	LS
Category	Earthen Levee			GPS Latitude/Longitude	
				Start	End
Item	Encroachments			39.686087 °	39.685756 °
				-121.777555 °	-121.777540 °
DWR ID	DWR_MA0005_01_f_2016_49				
Comment Code					
FE : Fence					
Inspector Comment

View of the wood plank fence at the landside toe.

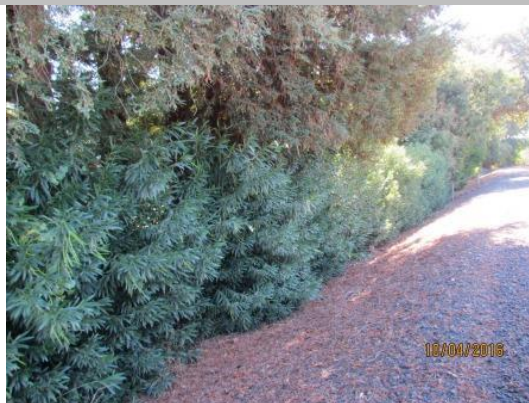
Photo 1 of 1 : SP_2017_MA0005_196_50_20170315_00025.jpg

LM Start	0.98	Rating **	U	Issue No.	50
LM End	1.00	Issue Type +	En	Location *	LS
Category	Earthen Levee			GPS Latitude/Longitude	
				Start	End
Item	Vegetation			39.684843 °	39.684606 °
				-121.777132 °	-121.776975 °
DWR ID	DWR_MA0005_01_f_2016_50				
Comment Code					
V6 : Landscaping					
Inspector Comment					
Oleanders blocking visibility.

View of the oleanders along the landside toe.

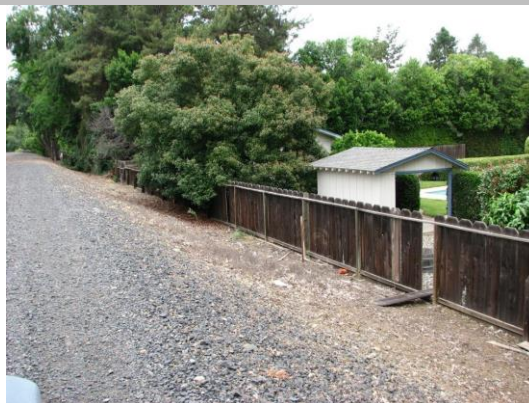
Photo 1 of 1 : SP_2017_MA0005_196_42_20170315_00019.jpg

LM Start	1.24	Rating **	U	Issue No.	42
LM End	1.26	Issue Type +	En	Location *	LS
Category	Earthen Levee			GPS Latitude/Longitude	
				Start	End
Item	Encroachments			39.681305 °	39.681044 °
				-121.776533 °	-121.776547 °
DWR ID	DWR_MA0005_01_s_2016_42				
Comment Code					
FE : Fence					
Inspector Comment

View of the wood plank fence at the landside toe.

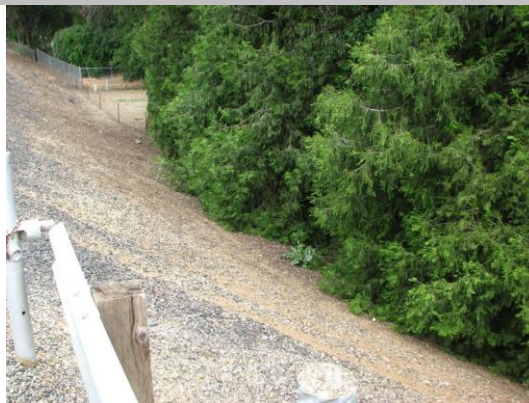
Photo 1 of 1 : SP_2017_MA0005_196_40_20170315_00018.jpg

LM Start	1.45	Rating **	M	Issue No.	40
LM End	1.45	Issue Type +	En	Location *	LS
Category	Earthen Levee			GPS Latitude/Longitude	
				Start	End
Item	Vegetation			39.678318 °	39.678318 °
				-121.777231 °	-121.777231 °
DWR ID	DWR_MA0005_01_s_2016_40				
Comment Code					
V6 : Landscaping					
Inspector Comment					
Cedar trees need to be trimmed up.

View of the overgrown cedar trees on the landside toe.

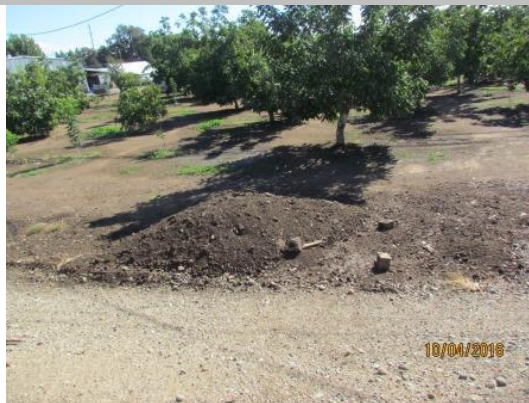
Photo 1 of 1 : SP_2017_MA0005_196_53_20170315_00026.jpg

LM Start	1.52	Rating **	M	Issue No.	53
LM End	1.52	Issue Type +	En	Location *	LS
Category	Earthen Levee			GPS Latitude/Longitude	
				Start	End
Item	Encroachments			39.677240 °	39.677240 °
				-121.777521 °	-121.777521 °
DWR ID	DWR_MA0005_01_f_2016_53				
Comment Code					
DE : Debris					
Inspector Comment					
Remove the pile of soil and rocks on the landside toe.

View of the soil and rock pile on the landside toe.

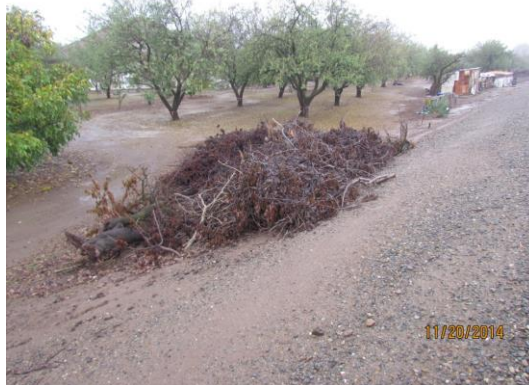
Photo 1 of 1 : SP_2017_MA0005_196_34_20170315_00013.jpg

LM Start	1.64	Rating **	U	Issue No.	34
LM End	1.64	Issue Type +	En	Location *	LS
Category	Earthen Levee			GPS Latitude/Longitude	
				Start	End
Item	Encroachments			39.675763 °	39.675763 °
				-121.778485 °	-121.778485 °
DWR ID	DWR_MA0005_01_f_2014_34				
Comment Code					
PR : Prunings					
Inspector Comment

View of the prunings along the landside toe.

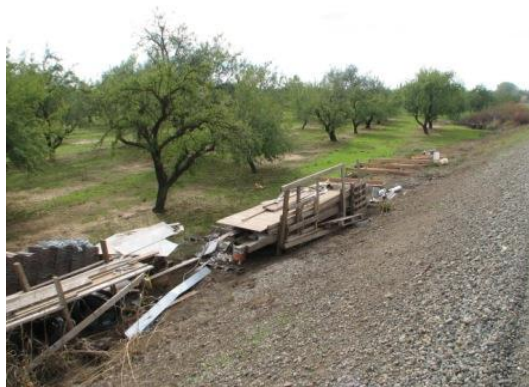
Photo 1 of 1 : SP_2017_MA0005_196_1_20170315_00001.jpg

LM Start	1.66	Rating **	M	Issue No.	1
LM End	1.66	Issue Type +	En	Location *	LS
Category	Earthen Levee			GPS Latitude/Longitude	
				Start	End
Item	Encroachments			39.675528 °	39.675528 °
				-121.778642 °	-121.778642 °
DWR ID	DWR_MA0005_01_s_2012_1				
Comment Code					
DE : Debris					
Inspector Comment

View of the construction supply on pallets.

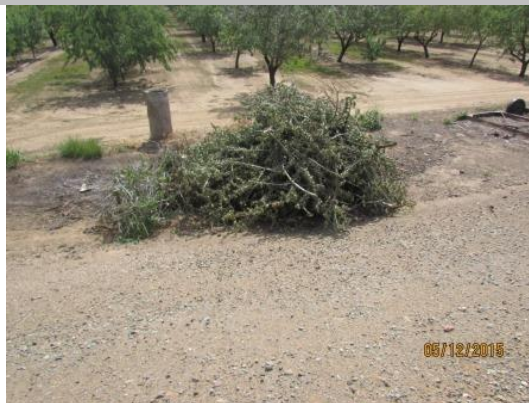
Photo 1 of 1 : SP_2017_MA0005_196_28_20170315_00009.jpg

LM Start	1.82	Rating **	M	Issue No.	28
LM End	1.82	Issue Type +	En	Location *	LS
Category	Earthen Levee			GPS Latitude/Longitude	
				Start	End
Item	Encroachments			39.673390 °	39.673390 °
				-121.779830 °	-121.779830 °
DWR ID	DWR_MA0005_01_s_2015_28				
Comment Code					
PR : Prunings					
Inspector Comment					
Remove the prunings from the landside toe.

View of the prunings along the landside toe.

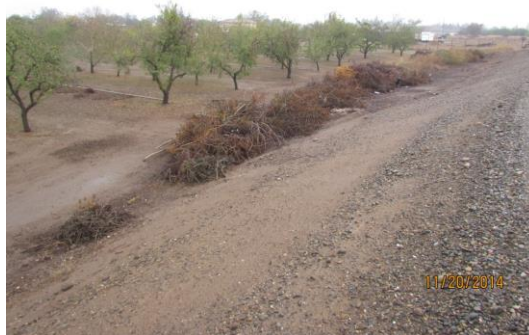
Photo 1 of 1 : SP_2017_MA0005_196_35_20170315_00014.jpg

LM Start	1.88	Rating **	M	Issue No.	35
LM End	1.88	Issue Type +	En	Location *	LS
Category	Earthen Levee			GPS Latitude/Longitude	
				Start	End
Item	Encroachments			39.672627 °	39.672627 °
				-121.779778 °	-121.779778 °
DWR ID	DWR_MA0005_01_f_2014_35				
Comment Code					
PR : Prunings					
Inspector Comment					
Remove the prunings from the landside toe.

View of the prunings along the landside toe.

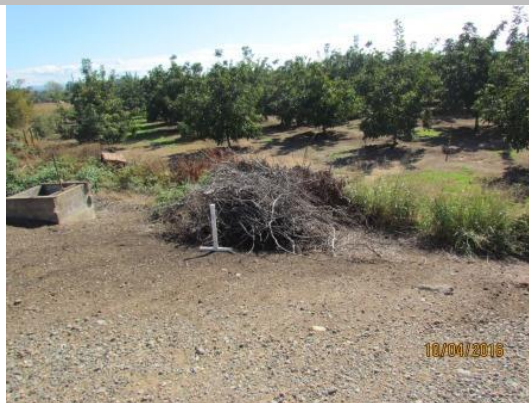
Photo 1 of 1 : SP_2017_MA0005_196_54_20170315_00027.jpg

LM Start	2.10	Rating **	M	Issue No.	54
LM End	2.10	Issue Type +	En	Location *	LS
Category	Earthen Levee			GPS Latitude/Longitude	
				Start	End
Item	Encroachments			39.670018 °	39.670018 °
				-121.781997 °	-121.781997 °
DWR ID	DWR_MA0005_01_f_2016_54				
Comment Code					
PR : Prunings					
Inspector Comment					
Remove the prunings from the landside toe.

View of the prunings along the landside toe.

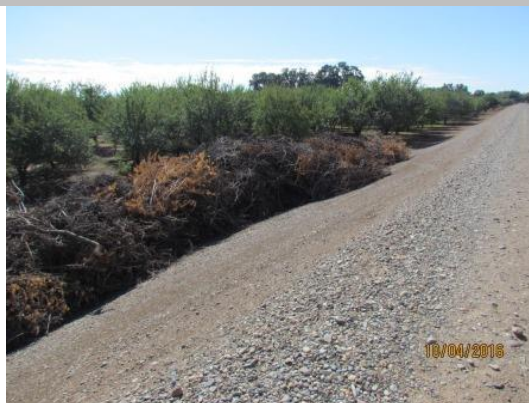
Photo 1 of 1 : SP_2017_MA0005_196_37_20170315_00015.jpg

LM Start	3.06	Rating **	U	Issue No.	37
LM End	3.06	Issue Type +	En	Location *	LS
Category	Earthen Levee			GPS Latitude/Longitude	
				Start	End
Item	Encroachments			39.656911 °	39.656911 °
				-121.787097 °	-121.787097 °
DWR ID	DWR_MA0005_01_f_2015_37				
Comment Code					
PR : Prunings					
Inspector Comment					
Remove the prunings from the landside toe.

View of the prunings along the landside toe.

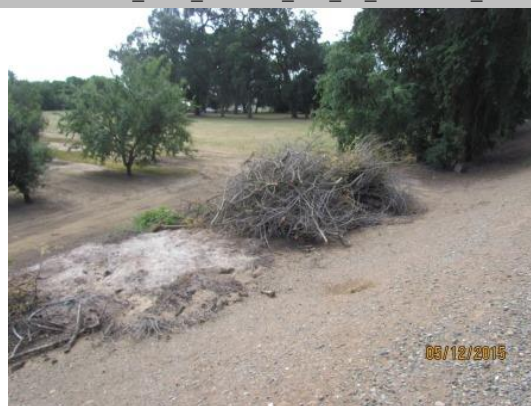
Photo 1 of 1 : SP_2017_MA0005_196_31_20170315_00011.jpg

LM Start	3.42	Rating **	M	Issue No.	31
LM End	3.42	Issue Type +	En	Location *	LS
Category	Earthen Levee			GPS Latitude/Longitude	
				Start	End
Item	Encroachments			39.652028 °	39.652028 °
				-121.789090 °	-121.789090 °
DWR ID	DWR_MA0005_01_s_2015_31				
Comment Code					
PR : Prunings					
Inspector Comment					
Remove the prunings from the landside toe.

View of the prunings along the landside toe.

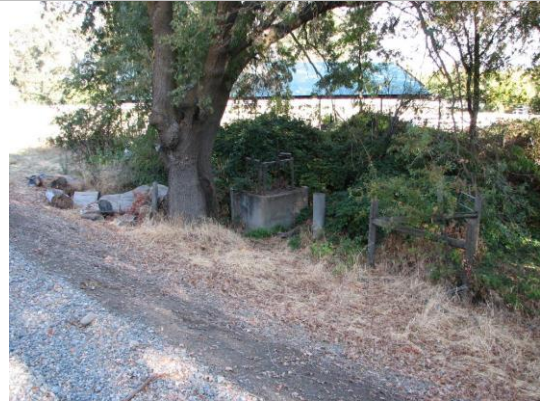
Photo 1 of 3 : UCIP_SP_2017_50841_67928.jpg

FS_ID:50841
DS_ID:1615
EP_NO: N/A
Repair Type: Non-Urgent
Crossing Status: Found
UCIP Comments: 11/15/2016 Abandoned- slide gate is opened and inoperable. Needs to be properly abandoned. (DWR Sutter Yard-AFreitag)5/9/2016 Abandoned crossing. Slide gate stem bent and wheel is missing.8/5/2015 Abandoned crossing. Slide gate stem is bent and gate is inoperable. Needs to be properly abandoned.12/8/2014 Same as last inspection.6/11/2014 Same as last inspection.11/20/2013 Same as last inspection.5/29/2013 Same as last inspection.10/30/2012 Pipe appears to be abandoned. Slide gate open and inoperable. Pipe should be properly abandoned. FIELD_STRUCT_DESC: 30-inch corrugated metal irrigation pipe (siphon) through the levee, 10.5 feet below the crown. Slide gate in a corrugated metal riser on the waterside (WS) slope. Concrete distribution box on the landside (LS) toe and concrete overflow and siphon box at the edge of berm. [Additional Reference(s): DWR Levee Log, 1990. USACE Sacramento O&M Manual 516, April 1960 (Station 368+17)].

Concrete distribution box on LS toe.

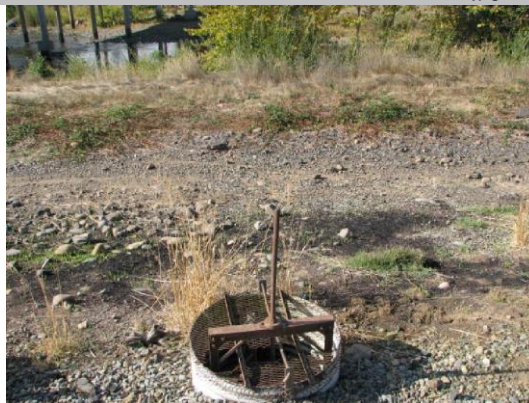
Photo 1 of 3 : UCIP_SP_2017_50843_67931.jpg

FS_ID:50843
DS_ID:1616
EP_NO: N/A
Repair Type: No Action Needed
Crossing Status: Found
UCIP Comments: 11/15/2016 Crossing appears to be in good condition. (DWR Sutter Yard- A Freitag) 5/9/2016 Crossing appears to be in good condition. 8/5/2015 WS pipe end is being overgrown by trees and other vegetation. Needs to be cleared back. 12/8/2014 Same as last inspection. 6/11/2014 Same as last inspection. 11/20/2013 Same as last inspection. 5/29/2013 Same as last inspection.
FIELD_STRUCT_DESC: 24-inch corrugated metal drainage pipe through the levee, 16.5 feet below the crown. Slide gate in a corrugated metal riser on the waterside (WS) slope. Flap gate on the waterside toe. Inlet on the landside (LS) toe, not found. [Additional Reference(s): DWR Levee Log, 1990. USACE Sacramento O&M Manual 516, April 1960 (Station 381+36)].
FS Date: 11/21/2016 1:34:00 PM

CMP riser and slide gate on WS shoulder.

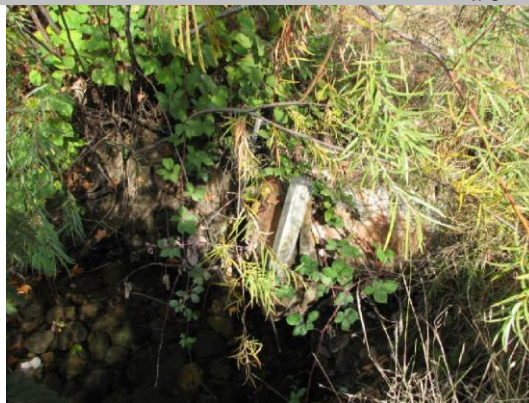
Photo 3 of 3 : UCIP_SP_2017_50843_67929.jpg

Item	DWR UCIP LMA Responsibility			39.646217 °	39.646217 °	
				-121.785431 °	-121.785431 °	
DWR ID						
Comment Code						
Inspector Comment						
FS_ID:50843 DS_ID:1616 EP_NO: N/A Repair Type: No Action Needed Crossing Status: Found UCIP Comments: 11/15/2016 Crossing appears to be in good condition. (DWR Sutter Yard- A Freitag)5/9/2016 Crossing appears to be in good condition.8/5/2015 WS pipe end is being overgrown by trees and other vegetation. Needs to be cleared back.12/8/2014 Same as last inspection.6/11/2014 Same as last inspection.11/20/2013 Same as last inspection.5/29/2013 Same as last inspection. FIELD_STRUCT_DESC: 24-inch corrugated metal drainage pipe through the levee, 16.5 feet below the crown. Slide gate in a corrugated metal riser on the waterside (WS) slope. Flap gate on the waterside toe. Inlet on the landside (LS) toe, not found. [Additional Reference(s): DWR Levee Log, 1990. USACE Sacramento O&M Manual 516, April 1960 (Station 381+36)]. FS Date: 11/21/2016 1:34:00 PM

Flap gate in channel at WS toe.

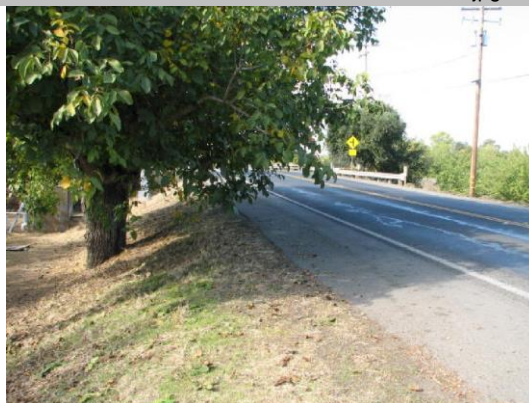
Photo 2 of 2 : UCIP_SP_2017_50846_67935.jpg

FS_ID:50846
 DS_ID:1619
 EP_NO: 6544-A
 Repair Type: Non-Urgent
 Crossing Status: Indicator Found
 UCIP Comments: 11/15/2016 Crossing appears to be in good condition. (DWR Sutter Yard- AFreitag)5/9/2016 Crossing appears to be in good condition.8/5/2015 Pipe is suspected to cross inside of bridge.12/8/2014 Same as last inspection.6/11/2014 Same as last inspection.11/20/2013 Same as last inspection.5/29/2013 Same as last inspection.10/30/2012 Pipeline should be marked where pipe crosses levee as it is 4-feet below the surface.
 FIELD_STRUCT_DESC: 6-inch concrete encased steel high pressure gas pipeline through the levee, 4 feet below the crown. 8-inch diameter Pacific Gas & Electric gas access manhole located on the south side of the road 250-feet east of the levee crown. (Permit No. 6544A, 1969 - Pacific Gas & Electric) [Additional Reference(s): DWR Levee Log, 1990].
 FS Date: 11/21/2016 1:36:44 PM

Location of PG&E access lid 250-feet east of levee crown on south side of roadway.

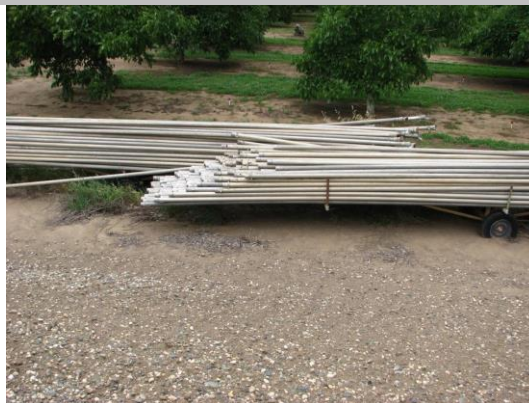
Photo 1 of 1 : SP_2017_MA0005_196_27_20170315_00008.jpg

LM Start	4.13	Rating **	M	Issue No.	27
LM End	4.13	Issue Type +	En	Location *	LS
Category	Earthen Levee			GPS Latitude/Longitude	
				Start	End
Item	Encroachments			39.643100 °	39.643100 °
				-121.782827 °	-121.782827 °
DWR ID	DWR_MA0005_01_s_2017_27				
Comment Code					
EQ : Equipment					
Inspector Comment					
Agricultural piping on trailer.

5/5/2016: Remove equipment from L/S toe.

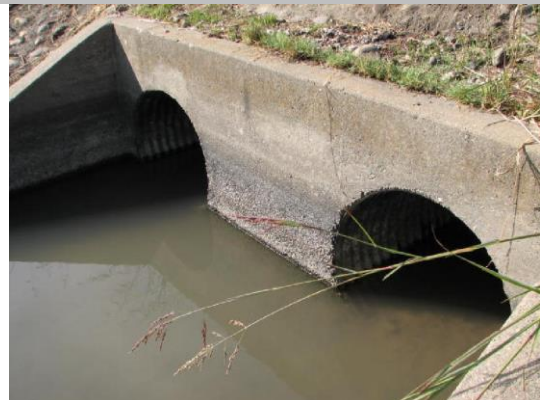
Photo 2 of 3 : UCIP_SP_2017_50847_67938.jpg

FS_ID:50847
DS_ID:1768
EP_NO: N/A
Repair Type: Non-Urgent
Crossing Status: Found
UCIP Comments: 11/15/2016 Abandoned. Needs standpipe cover.
(DWR Sutter Yard- A Freitag) 5/9/2016 Abandoned pipe. Needs a cover for standpipe. 8/5/2015 Abandoned pipes. Need covers made for tops of standpipes to prevent falls. 12/8/2014 Same as last inspection. 6/11/2014 Same as last inspection. 11/19/2013 Same as last inspection. 5/29/2013 Same as last inspection. Land owner said pipes are abandoned and no longer used. Covers should be made for top of standpipe to prevent falls. Pipes should be properly abandoned. 10/30/2012 Pipe 1/2 filled with soil at slide gate on WS. FIELD_STRUCT_DESC: *ABANDONED* 2 of 2: 36-inch corrugated metal drainage pipe through the levee, 11 feet below the crown. Slide gate in a 54-inch corrugated metal riser on the waterside (WS) slope. Concrete "U" shaped headwall on the landside (LS). [Additional Reference(s): DWR Levee Log, 1990. Sacramento O&M Manual 516, April 1960 (Station 470+00)].

Headwall at LS toe.

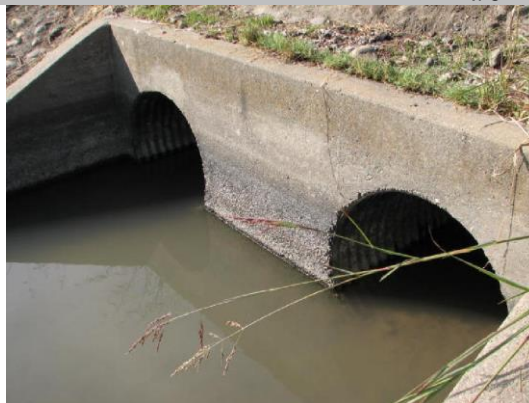
Photo 1 of 2 : UCIP_SP_2017_50848_67941.jpg

FS_ID:50848
DS_ID:1620
EP_NO: N/A
Repair Type: Non-Urgent
Crossing Status: Found
UCIP Comments: 11/15/2016 Abandoned. Needs cover for the standpipe. (DWR Sutter Yard- A Freitag) 5/9/2016 Abandoned pipe. Needs a cover for the standpipe. 8/5/2015 Abandoned crossing. Covers need to be made for tops of standpipes to prevent falls. 12/8/2014 Same as last inspection. 6/11/2014 Same as last inspection. 11/19/2013 Same as last inspection. 5/29/2013 Same as last inspection. Land owner said pipes are abandoned and no longer used. Covers should be made for top of standpipe to prevent falls. Pipes should be properly abandoned. 10/30/2012 Pipe 1/2 filled with soil at slide gate end.
FIELD_STRUCT_DESC: *ABANDONED* 1 of 2: 36-inch drainage pipe through the levee, 11 feet below the crown. Slide gate in a 54-inch corrugated metal riser on the waterside (WS) slope. Concrete "U" headwall on the landside (LS). [Additional Reference(s): DWR Levee Log, 1990. Sacramento O&M Manual 516, April 1960 (Station 470+00)].

Headwall at LS toe.

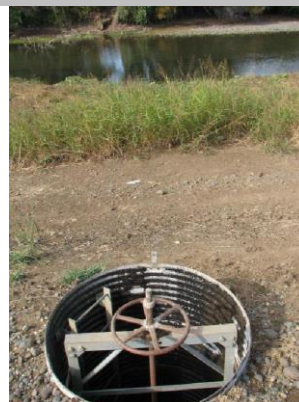
Photo 2 of 2 : UCIP_SP_2017_50848_67940.jpg

54-inch CMP riser and slide gate on WS shoulder.

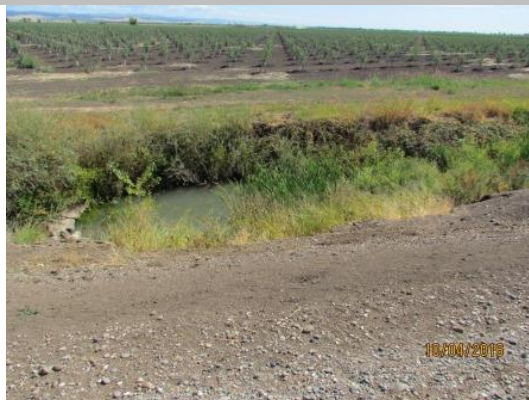
Photo 2 of 2 : SP_2017_MA0005_196_56_20170315_00030.jpg

LM Start	5.81	Rating **	U	Issue No.	56
LM End	5.81	Issue Type +	Ma	Location *	LS
Category	Earthen Levee			GPS Latitude/Longitude	
				Start	End
Item	Erosion / Bank Caving			39.621261 °	39.621261 °
				-121.773973 °	-121.773973 °
DWR ID	DWR_MA0005_01_f_2016_56				
Comment Code					
E2 : Schedule repair of erosion site prior to the next inspection.					
Inspector Comment

Another view of the landside toe erosion.

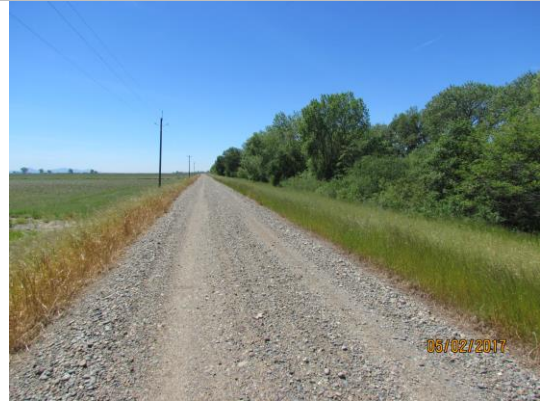
Photo 1 of 1 : SP_2017_MA0005_196_66_20170508_00085.jpg

LM Start	7.38	Rating **	A	Issue No.	66
LM End	7.38	Issue Type +	Ma	Location *	LS
Category	Earthen Levee			GPS Latitude/Longitude	
				Start	End
Item	Vegetation			39.600403 °	39.600403 °
				-121.785862 °	-121.785862 °
DWR ID	DWR_MA0005_01_s_2017_66				
Comment Code					
V1 : Control annual grass and weeds on the levee slopes and easements.					
Inspector Comment

View of native grasses on both slopes.

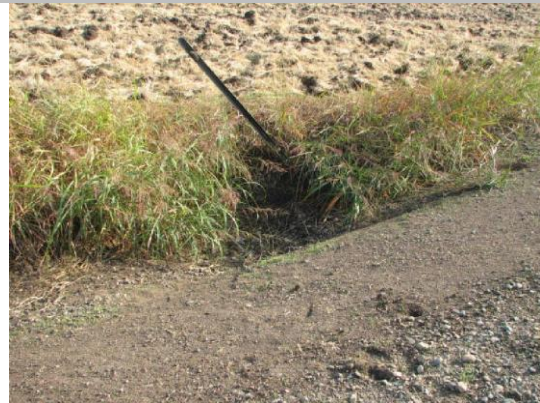
Photo 1 of 2 : UCIP_SP_2017_50864_67970.jpg

Comment Code					
Inspector Comment					
FS_ID:50864 DS_ID:1628 EP_NO: N/A Repair Type: Non-Urgent Crossing Status: Found UCIP Comments: 11/15/2016 Appears abandoned and should be done so properly. (DWR Sutter Yard- AFreitag)5/11/2016 Possibly an abandoned crossing. LS inlet was over 50% buried and nothing was found on the WS.8/4/2015 LS pipe end filled about 50% with soil and WS pipe end is buried.12/8/2014 Same as last inspection.6/11/2014 Same as last inspection.11/19/2013 Same as last inspection.5/29/2013 Same as last inspection.10/30/2012 Pipe filled with soil and outlet/appurtances are burried. FIELD_STRUCT_DESC: *ABANDONED* 24-inch corrugated metal drainage pipe through the levee, 8.5 feet below the crown. Flap gate on the waterside (WS). Concrete "U" shaped headwall on the landside (LS) toe. [Additional Reference(s): DWR Levee Log, 1990. Sacramento O&M Manual 515, April 1955 (Station 576+72), USACE As-built Drawings 50-4-2637, Exhibit B, Sheet 2, April 1950 (station 576+72.4)]. FS Date: 11/21/2016 1:51:54 PM

Headwall at LS toe.

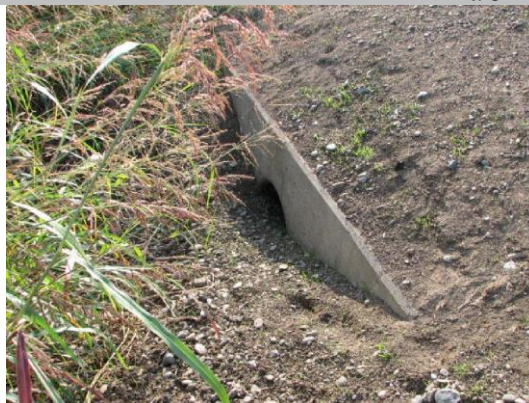
Photo 2 of 2 : UCIP_SP_2017_50864_67969.jpg

Item	DWR UCIP LMA Responsibility			39.597725 °	39.597725 °	
				-121.787257 °	-121.787257 °	
DWR ID						
Comment Code						
Inspector Comment						
FS_ID:50864 DS_ID:1628 EP_NO: N/A Repair Type: Non-Urgent Crossing Status: Found UCIP Comments: 11/15/2016 Appears abandoned and should be done so properly. (DWR Sutter Yard- AFreitag)5/11/2016 Possibly an abandoned crossing. LS inlet was over 50% buried and nothing was found on the WS.8/4/2015 LS pipe end filled about 50% with soil and WS pipe end is buried.12/8/2014 Same as last inspection.6/11/2014 Same as last inspection.11/19/2013 Same as last inspection.5/29/2013 Same as last inspection.10/30/2012 Pipe filled with soil and outlet/appurtances are burried. FIELD_STRUCT_DESC: *ABANDONED* 24-inch corrugated metal drainage pipe through the levee, 8.5 feet below the crown. Flap gate on the waterside (WS). Concrete "U" shaped headwall on the landside (LS) toe. [Additional Reference(s): DWR Levee Log, 1990. Sacramento O&M Manual 515, April 1955 (Station 576+72), USACE As-built Drawings 50-4-2637, Exhibit B, Sheet 2, April 1950 (station 576+72.4)]. FS Date: 11/21/2016 1:51:54 PM

Headwall at LS toe.

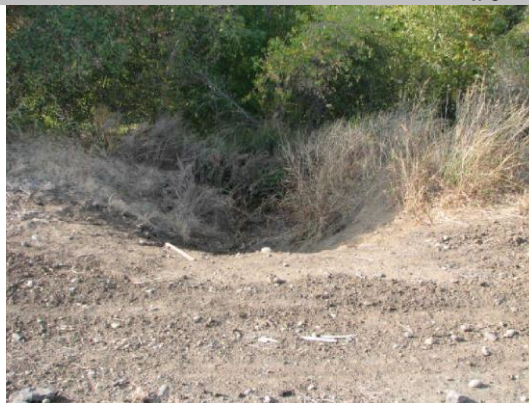
Photo 1 of 3 : UCIP_SP_2017_50865_67973.jpg

Comment Code					
Inspector Comment					
FS_ID:50865 DS_ID:1629 EP_NO: N/A Repair Type: Non-Urgent Crossing Status: Found UCIP Comments: 11/15/2016 LS inlet was unburied and entire pipe is about 25% full of soil. WS flapgate was shut and partially buried. (DWR Sutter Yard- A Freitag)5/11/2016 WS flap gate was about 50% buried and LS was 100% buried. Appears to be an abandoned crossing.8/4/2015 WS flap gate is partially buried by soil and being overgrown with vegetation. LS pipe end was underwater and suspected to still be completely buried with soil.12/8/2014 Same as last inspection.6/11/2014 Same as last inspection.11/19/2013 Same as last inspection.5/29/2013 Same as last inspection.10/30/2012 Pipe filled with soil. FIELD_STRUCT_DESC: 24-inch corrugated metal drainage pipe through the levee, 9.3 feet below the crown. Flap gate on the waterside (WS). Concrete headwall at the landside (LS) and the WS toes. [Additional Reference(s): DWR Levee Log, 1990. Sacramento O&M 515, April 1955 (Station 609+79). USACE As-Built Drawing 50-4-2637, Exhibit B, Sheet 3, April 1950 (Station 609+78.5)]. FS Date: 11/21/2016 1:53:01 PM

Outlet at WS toe.

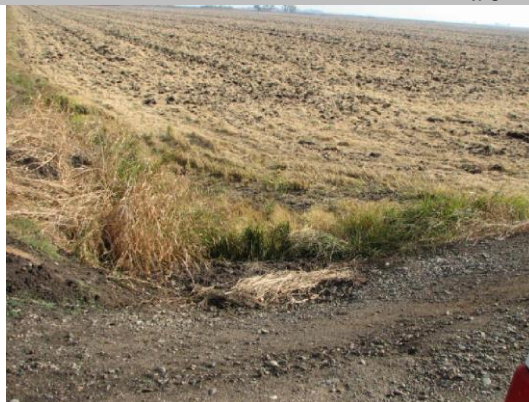
Photo 2 of 3 : UCIP_SP_2017_50865_67972.jpg

Buried inlet at LS toe.

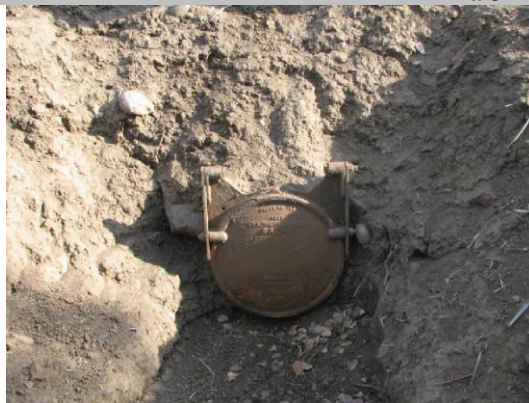
Photo 3 of 3 : UCIP_SP_2017_50865_67971.jpg

Flap gate at WS toe.

Comment Code					
Inspector Comment					
FS_ID:50865 DS_ID:1629 EP_NO: N/A Repair Type: Non-Urgent Crossing Status: Found UCIP Comments: 11/15/2016 LS inlet was unburied and entire pipe is about 25% full of soil. WS flapgate was shut and partially buried. (DWR Sutter Yard- A Freitag) 5/11/2016 WS flap gate was about 50% buried and LS was 100% buried. Appears to be an abandoned crossing. 8/4/2015 WS flap gate is partially buried by soil and being overgrown with vegetation. LS pipe end was underwater and suspected to still be completely buried with soil. 12/8/2014 Same as last inspection. 6/11/2014 Same as last inspection. 11/19/2013 Same as last inspection. 5/29/2013 Same as last inspection. 10/30/2012 Pipe filled with soil. FIELD_STRUCT_DESC: 24-inch corrugated metal drainage pipe through the levee, 9.3 feet below the crown. Flap gate on the waterside (WS). Concrete headwall at the landside (LS) and the WS toes. [Additional Reference(s): DWR Levee Log, 1990. Sacramento O&M 515, April 1955 (Station 609+79). USACE As-Built Drawing 50-4-2637, Exhibit B, Sheet 3, April 1950 (Station 609+78.5)]. FS Date: 11/21/2016 1:53:01 PM

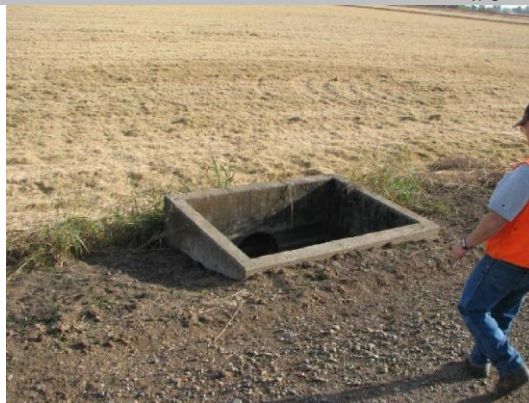
Photo 1 of 3 : UCIP_SP_2017_50868_67976.jpg

FS_ID:50868
DS_ID:1631
EP_NO: N/A
Repair Type: Non-Urgent
Crossing Status: Found
UCIP Comments: 11/15/2016 Abandoned. (DWR Sutter Yard-AFreitag)5/11/2016 Abandoned pipe.8/4/2015 Abandoned pipe. Casey Wilder has started the steps to have the pipe properly abandoned and removed from the levee.12/8/2014 Same as last inspection.6/11/2014 Same as last inspection.11/19/2013 Same as last inspection.5/29/2013 Same as last inspection.10/30/2012 Need to confirm proper abandonment of pipe. Pipe should be plugged on LS.
FIELD_STRUCT_DESC: 16-inch steel irrigation pipe through the levee, 11.5 feet below the crown. Distribution box at the landside (LS) toe.
[Additional Reference(s): DWR Levee Log, 1990. Sacramento O&M Manual 515, April 1955 (Station 655+68). USACE As-built Drawing 50-4-2637, Exhibit B, Sheet 3, April 1950 (Station 655+68.2)].
FS Date: 11/21/2016 2:10:15 PM

Concrete distribution box at LS toe.

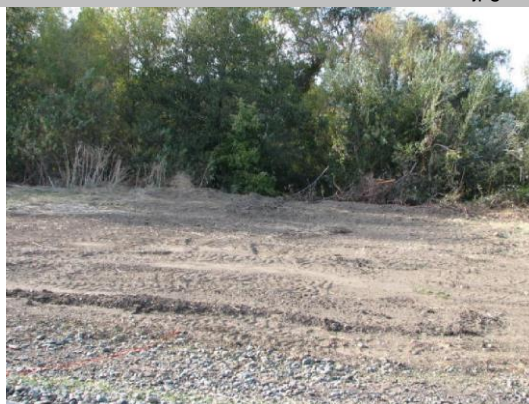
Photo 2 of 3 : UCIP_SP_2017_50868_67975.jpg

WS shoulder.

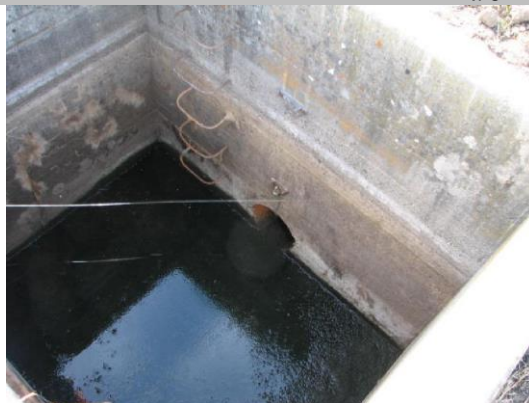
Photo 3 of 3 : UCIP_SP_2017_50868_67974.jpg

Item	DWR UCIP Field Study			39.579908 °	39.579908 °	
				-121.802790 °	-121.802790 °	
DWR ID						
Comment Code						
Inspector Comment						
FS_ID:50868 DS_ID:1631 EP_NO: N/A Repair Type: Non-Urgent Crossing Status: Found UCIP Comments: 11/15/2016 Abandoned. (DWR Sutter Yard-AFreitag)5/11/2016 Abandoned pipe.8/4/2015 Abandoned pipe. Casey Wilder has started the steps to have the pipe properly abandoned and removed from the levee.12/8/2014 Same as last inspection.6/11/2014 Same as last inspection.11/19/2013 Same as last inspection.5/29/2013 Same as last inspection.10/30/2012 Need to confirm proper abandonment of pipe. Pipe should be plugged on LS. FIELD_STRUCT_DESC: 16-inch steel irrigation pipe through the levee, 11.5 feet below the crown. Distribution box at the landside (LS) toe. [Additional Reference(s): DWR Levee Log, 1990. Sacramento O&M Manual 515, April 1955 (Station 655+68). USACE As-built Drawing 50-4-2637, Exhibit B, Sheet 3, April 1950 (Station 655+68.2)]. FS Date: 11/21/2016 2:10:15 PM

Pipe at bottom of concrete distribution box.

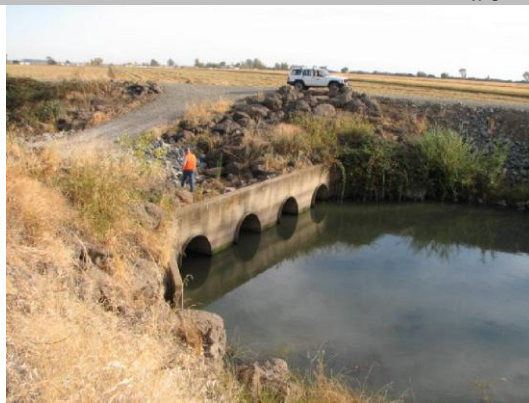
Photo 1 of 2 : UCIP_SP_2017_50869_67979.jpg

FS_ID:50869
DS_ID:1775
EP_NO: N/A
Repair Type: No Action Needed
Crossing Status: Found
UCIP Comments: 11/15/2016 Crossing appears to be in good condition. (DWR Sutter Yard- A Freitag) 5/11/2016 Crossing appears to be in good condition. 8/4/2015 Crossing is in good condition. No noticeable issues to report. 12/8/2014 Same as last inspection. 6/11/2014 Same as last inspection. 11/19/2013 Same as last inspection. 5/29/2013 Flap gates were removed by DWR Sutter Maintenance Yard to allow water to flow freely through crossing and not back up in ditch. 10/30/2012 Seems there should be flap gates on this structure.
FIELD_STRUCT_DESC: [Robert's Creek Outlet Structure] 1 of 4: 66-inch corrugated metal drainage pipe through the levee, 17.9 feet below the crown. Concrete headwalls on the landside (LS) and the waterside (WS). [Additional Reference(s): DWR Levee Log, 1990. Sacramento O&M Manual 515, April 1955 (Station 678+00). USACE As-built Drawing 50-4-2637, Exhibit B, Sheet 3, April 1950 (Station 678+00)].

WS of pipe crossing

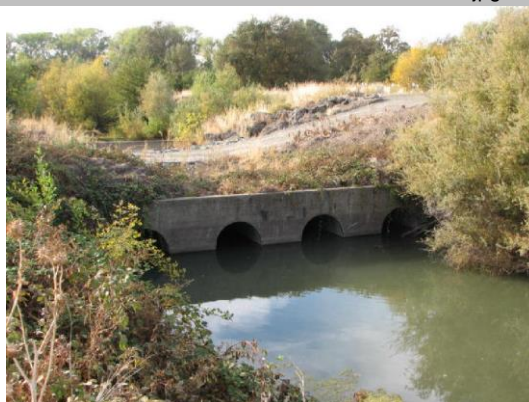
Photo 2 of 2 : UCIP_SP_2017_50869_67978.jpg

LS of pipe crossing.

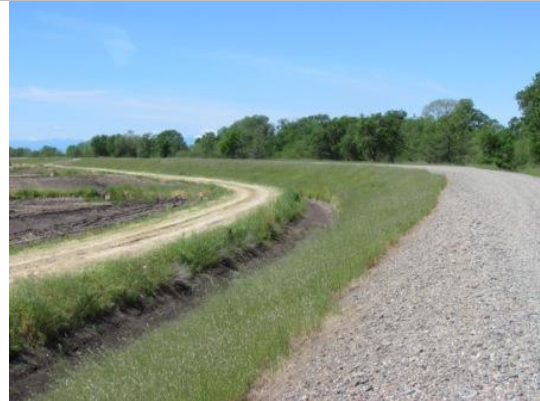
Photo 1 of 1 : SP_2017_MA0005_196_5_20170315_00002.jpg

LM Start	9.54	Rating **	M	Issue No.	5
LM End	10.33	Issue Type +	En	Location *	LS
Category	Earthen Levee			GPS Latitude/Longitude	
				Start	End
Item	Encroachments			39.574837 °	39.567892 °
				-121.807913 °	-121.819283 °
DWR ID	DWR_MA0005_01_s_2012_5				
Comment Code					
DT : Ditch					
Inspector Comment

View of the agricultural ditch along the landside toe.

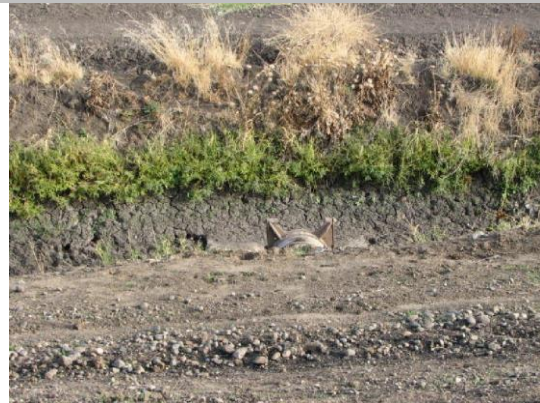
Photo 1 of 1 : UCIP_SP_2017_50873_67986.jpg

Comment Code					
Inspector Comment					
FS_ID:50873 DS_ID:1633 EP_NO: N/A Repair Type: Non-Urgent Crossing Status: Found UCIP Comments: 11/15/2016 Abandoned. (DWR Sutter Yard-AFreitag)5/11/2016 Abandoned crossing.8/4/2015 Abandoned pipe. Casey Wilder has started the steps to have the pipe properly abandoned and removed from the levee.12/8/2014 Same as last inspection.6/11/2014 Same as last inspection.11/19/2013 Same as last inspection.5/29/2013 Same as last inspection.10/30/2012 Pipe and headwall buried on WS, no access to slide gate. FIELD_STRUCT_DESC: 24-inch corrugated metal irrigation pipe through the levee, 12.5 feet below the crown. Slide gate on the waterside (WS). Flap gate and headwall on the landside (LS). Concrete headwall at the WS toe. [Additional Reference(s): DWR Levee Log, 1990. Sacramento O&M Manual 515, April 1955 (Station 706+00)]. FS Date: 11/21/2016 2:20:10 PM

Flap gate and headwall at LS toe in irrigation or drainage ditch.

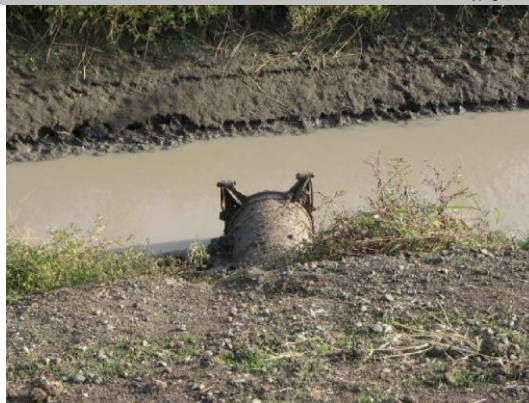
Photo 1 of 3 : UCIP_SP_2017_50874_67989.jpg

Comment Code					
Inspector Comment					
FS_ID:50874					
DS_ID:1634					
EP_NO: N/A					
Repair Type: Non-Urgent					
Crossing Status: Found					
UCIP Comments: 11/15/2016 Abandoned. (DWR Sutter Yard-AFreitag)5/11/2016 Abandoned crossing.8/4/2015 Abandoned pipe. Casey Wilder has started the steps to have the pipe properly abandoned and removed from the levee.12/8/2014 Same as last inspection.6/11/2014 Same as last inspection.11/19/2013 Same as last inspection.5/29/2013 Same as last inspection.					
FIELD_STRUCT_DESC: 24-inch corrugated metal irrigation pipe through the levee, 14.5 feet below the crown. Slide gate on the waterside (WS) on concrete headwall. Flap gate on the landside (LS).					
[Additional Reference(s): DWR Levee Log, 1990. Sacramento O&M Manual 515, April 1955 (Station 717+50)].					
FS Date: 11/21/2016 2:25:16 PM

Pipe and flap gate on LS toe.

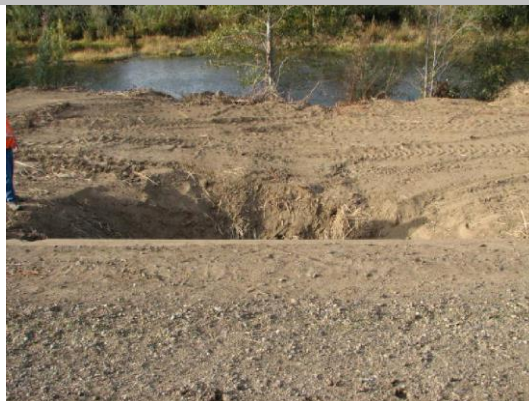
Photo 2 of 3 : UCIP_SP_2017_50874_67988.jpg

headwall at WS toe.

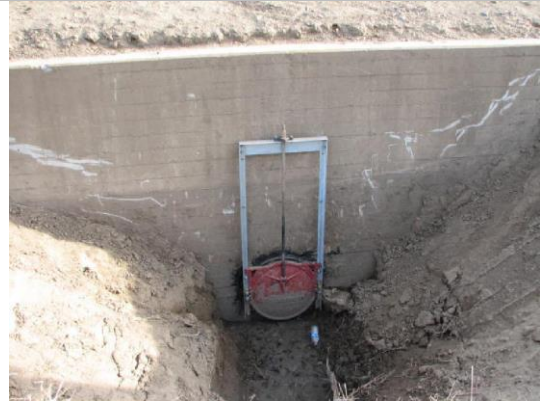
Photo 3 of 3 : UCIP_SP_2017_50874_67987.jpg

Item	DWR UCIP Field Study			39.568523 °	39.568523 °	
				-121.818232 °	-121.818232 °	
DWR ID						
Comment Code						
Inspector Comment						
FS_ID:50874						
DS_ID:1634						
EP_NO: N/A						
Repair Type: Non-Urgent						
Crossing Status: Found						
UCIP Comments: 11/15/2016 Abandoned. (DWR Sutter Yard-AFreitag)5/11/2016 Abandoned crossing.8/4/2015 Abandoned pipe. Casey Wilder has started the steps to have the pipe properly abandoned and removed from the levee.12/8/2014 Same as last inspection.6/11/2014 Same as last inspection.11/19/2013 Same as last inspection.5/29/2013 Same as last inspection.						
FIELD_STRUCT_DESC: 24-inch corrugated metal irrigation pipe through the levee, 14.5 feet below the crown. Slide gate on the waterside (WS) on concrete headwall. Flap gate on the landside (LS). [Additional Reference(s): DWR Levee Log, 1990. Sacramento O&M Manual 515, April 1955 (Station 717+50)].

Headwall and slide gate on WS toe.

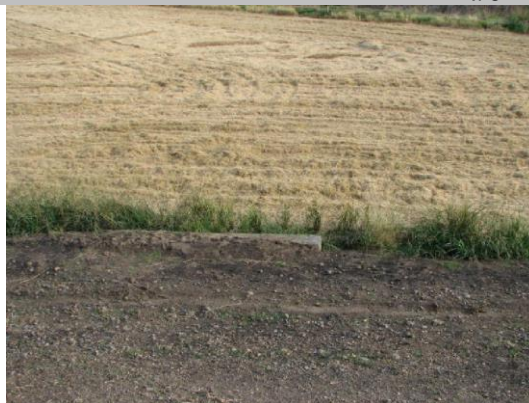
Photo 1 of 2 : UCIP_SP_2017_50875_67991.jpg

FS_ID:50875
DS_ID:1635
EP_NO: N/A
Repair Type: Non-Urgent
Crossing Status: Found
UCIP Comments: 11/15/2016 Abandoned. (DWR Sutter Yard-AFreitag)5/11/2016 Abandoned crossing.8/4/2015 Abandoned pipe. Casey Wilder has started the steps to have the pipe properly abandoned and removed from the levee.12/8/2014 Same as last inspection.6/11/2014 Same as last inspection.11/19/2013 Same as last inspection.5/29/2013 Same as last inspection.10/30/2012 Pipe buried on both sides of levee.
FIELD_STRUCT_DESC: *ABANDONED* 30-inch corrugated metal drainage pipe through the levee, 12.2 feet below the crown. Flap gate on the waterside (WS) end. [Additional Reference(s): DWR Levee Log, 1990. USACE Sacramento O&M Manual 515, April 1955 (Station 748+53). USACE As-built Drawing 50-4-2637, Exhibit B, Sheet 4, April 1950 (Station 748+53)].
FS Date: 11/21/2016 2:26:09 PM

Concrete headwall at LS toe.

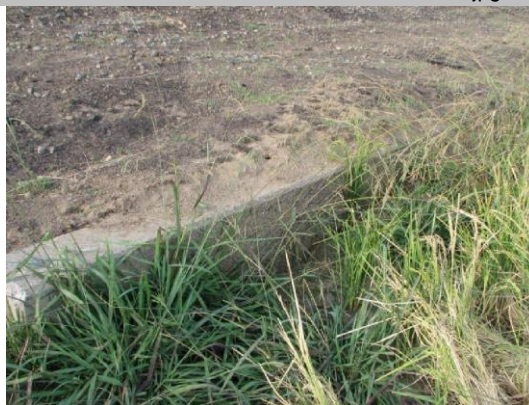
Photo 2 of 2 : UCIP_SP_2017_50875_67990.jpg

Concrete headwall at LS toe.

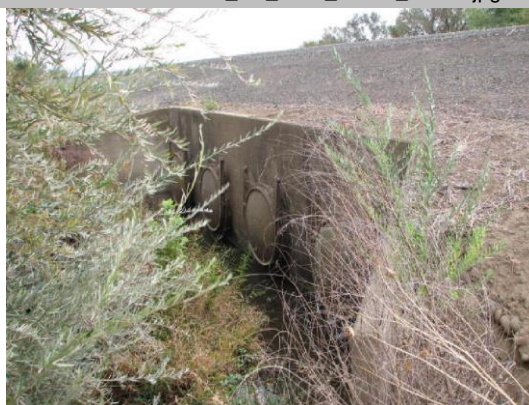
Photo 1 of 2 : UCIP_SP_2017_50882_68007.jpg

Comment Code					
Inspector Comment					
FS_ID:50882 DS_ID:1636 EP_NO: N/A Repair Type: No Action Needed Crossing Status: Found UCIP Comments: 11/15/2016 Crossing appears to be in good condition. (DWR Sutter Yard- A/Freitag)5/11/2016 Crossing appears to be in good condition.8/4/2015 Crossing appears in good condition. No noticeable issues to report.6/11/2014 Same as last inspection.11/19/2013 Same as last inspection.5/29/2013 Same as last inspection. FIELD_STRUCT_DESC: 1 of 4: 54-inch corrugated metal drainage pipe through the levee, 13.5 feet below the crown. Flap gate on the waterside (WS). Concrete headwall on landside (LS) and WS toes. [Additional Reference(s): DWR Levee Logs, 1990. USACE Sacramento O&M Manual 515, April 1955 (Station 25+18"A"). USACE As-built Drawing 50-4-2637, Exhibit B, Sheet 4, April 1950 (Station 25+18"A")]. FS Date: 11/21/2016 2:29:11 PM

WS headwall and flap gates at WS toe.

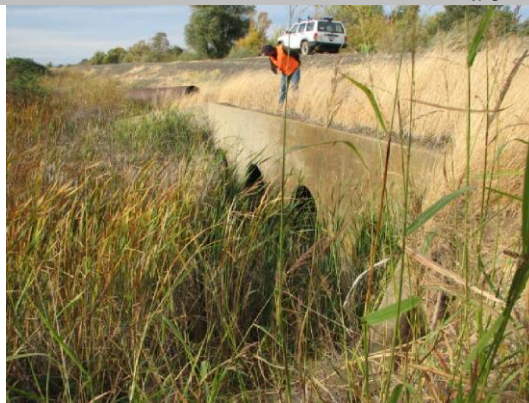
Photo 2 of 2 : UCIP_SP_2017_50882_68006.jpg

Item	DWR UCIP LMA Responsibility			39.556741 °	39.556741 °	
				-121.832071 °	-121.832071 °	
DWR ID						
Comment Code						
Inspector Comment						
FS_ID:50882 DS_ID:1636 EP_NO: N/A Repair Type: No Action Needed Crossing Status: Found UCIP Comments: 11/15/2016 Crossing appears to be in good condition. (DWR Sutter Yard- A Freitag)5/11/2016 Crossing appears to be in good condition.8/4/2015 Crossing appears in good condition. No noticeable issues to report.6/11/2014 Same as last inspection.11/19/2013 Same as last inspection.5/29/2013 Same as last inspection. FIELD_STRUCT_DESC: 1 of 4: 54-inch corrugated metal drainage pipe through the levee, 13.5 feet below the crown. Flap gate on the waterside (WS). Concrete headwall on landside (LS) and WS toes. [Additional Reference(s): DWR Levee Logs, 1990. USACE Sacramento O&M Manual 515, April 1955 (Station 25+18"A"). USACE As-built Drawing 50-4-2637, Exhibit B, Sheet 4, April 1950 (Station 25+18"A")]. FS Date: 11/21/2016 2:29:11 PM

LS intake headwall.

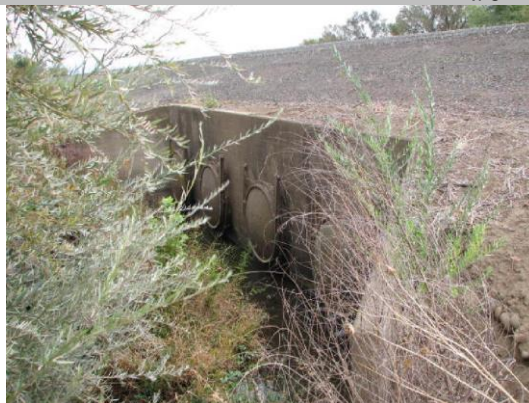
Photo 1 of 2 : UCIP_SP_2017_50883_68009.jpg

FS_ID:50883
DS_ID:1782
EP_NO: N/A
Repair Type: No Action Needed
Crossing Status: Found
UCIP Comments: 11/15/2016 Crossing appears to be in good condition. (DWR Sutter Yard- A Freitag) 5/11/2016 Crossing appears to be in good condition. 8/4/2015 Crossing appears in good condition. No noticeable issues to report. 6/11/2014 Same as last inspection. 11/19/2013 Same as last inspection. 5/29/2013 Same as last inspection.
FIELD_STRUCT_DESC: 2 of 4: 54-inch corrugated metal drainage pipe through the levee, 13.5 feet below the crown. Flap gate on the waterside (WS). Concrete headwall on the landside (LS) and the WS toes. [Additional Reference(s): DWR Levee Logs, 1990. USACE Sacramento O&M Manual 515, April 1955 (Station 28+18"A"). USACE As-built Drawing 50-4-2637, Exhibit B, Sheet 4, April 1950 (Station 25+18"A")].
FS Date: 11/21/2016 2:29:33 PM

Headwall and flap gates at WS toe.

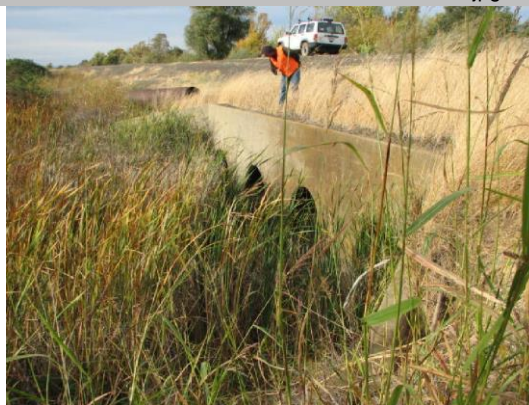
Photo 2 of 2 : UCIP_SP_2017_50883_68008.jpg

Headwall at LS toe.

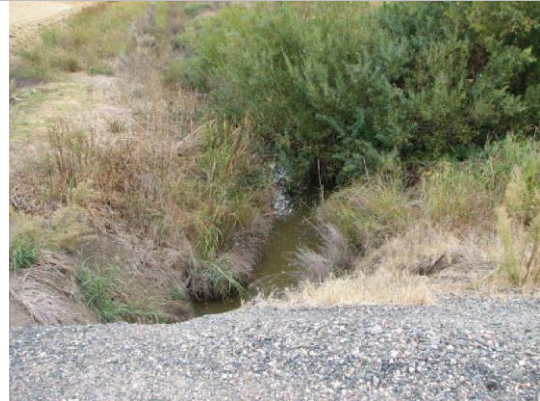
Photo 1 of 3 : UCIP_SP_2017_50886_68017.jpg

Comment Code					
Inspector Comment					
FS_ID:50886 DS_ID:1637 EP_NO: N/A Repair Type: No Action Needed Crossing Status: Found UCIP Comments: 11/15/2016 Old pipe at Nelson Road- Replaced by DS_ID 25461. (DWR Sutter Yard- AFreitag)6/22/2016 Pipe removed in 2013 and replaced with new 30-inch pipe (SEE DS_ID 25461). New pipe is inspected under DS_ID 25461. This DS_ID 1637 is no longer in use, pipe has been removed. (DWR UCIP - Olivia M.)7/30/2013 Repaired June 20135/29/2013 Pipe was video inspected and it was determined it needs full replacement. Replacement construction is scheduled to begin in the week of 6/3/2013.10/31/2012 Pipe is totally corroded through on WS toe and flap gate is missing. Pipe likely requires total replacement. FIELD_STRUCT_DESC: *REMOVED* 30-inch corrugated metal drainage pipe through the levee, 15.0 feet below the crown. Flap gate on the waterside (WS). Concrete headwall on the landside (LS) and the WS toe. [Additional Reference(s): DWR Levee Logs, 1990. USACE Sacramento O&M Manual 515, April 1955 (Station 835+21). USACE As-built Drawing 50-4-2637, Exhibit B, Sheet 4, April 1950 (Station 835+20.96)]. FS Date: 11/21/2016 2:31:25 PM

Drainage canal on LS toe.

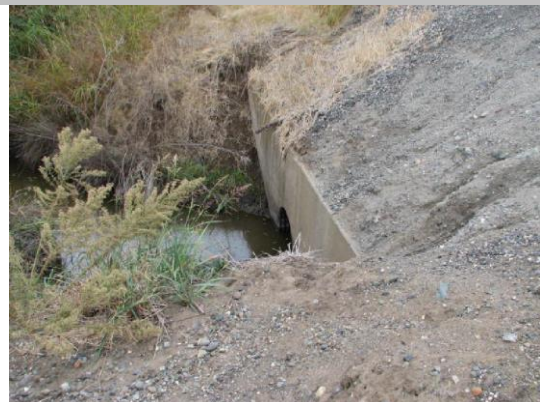
Photo 2 of 3 : UCIP_SP_2017_50886_68016.jpg

Concrete headwall on LS toe.

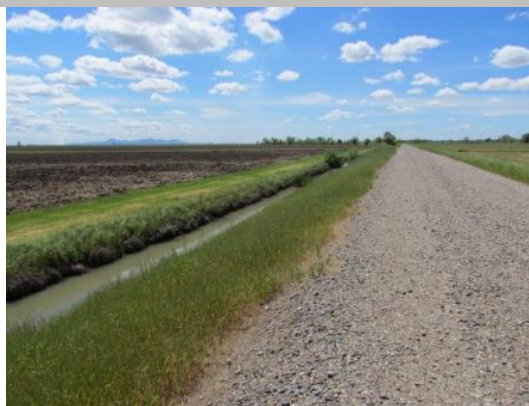
Photo 1 of 1 : SP_2017_MA0005_196_6_20170315_00003.jpg

LM Start	11.85	Rating **	M	Issue No.	6
LM End	13.64	Issue Type +	En	Location *	LS
Category	Earthen Levee			GPS Latitude/Longitude	
				Start	End
Item	Encroachments			39.551235 °	39.531462 °
				-121.837697 °	-121.856165 °
DWR ID	DWR_MA0005_01_s_2012_6				
Comment Code					
DT : Ditch					
Inspector Comment

View of the agricultural ditch along the landside toe.

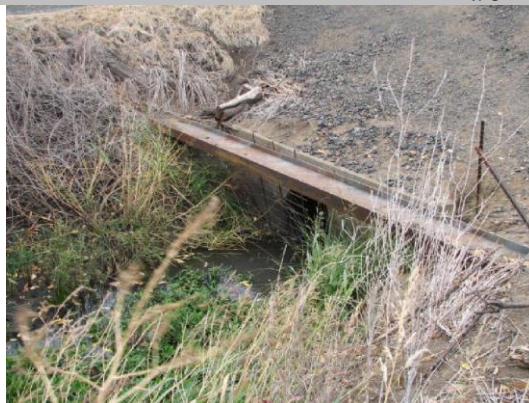
Photo 1 of 3 : UCIP_SP_2017_50891_68033.jpg

FS_ID:50891
DS_ID:1639
EP_NO: N/A
Repair Type: Non-Urgent
Crossing Status: Found
UCIP Comments: 11/15/2016 NO soil supporting the WS wing walls. (DWR Sutter Yard- AFreitag)5/11/2016 Still no soil supporting the WS wing walls and apron. WS vegetation was thinner and not a problem this time.8/4/2015 No soil supporting the WS wing walls at the WS pipe end. WS pipe end is also being overgrown with vegetation and should be cleared back.6/11/2014 Same as last inspection.11/19/2013 Same as last inspection.5/29/2013 Same as last inspection.10/31/2012 Soil under Concrete wing walls on WS toe has been eroded. No soil supporting wing walls.
FIELD_STRUCT_DESC: 36-inch corrugated metal drainage pipe through the levee, 13 feet below the crown. Flap gate on the waterside (WS). Concrete headwall on the landside (LS) and the WS ends.
[Additional Reference(s): DWR Levee Logs, 1990. USACE Sacramento O&M Manual 515, April 1955 (Station 978+25). USACE As-built Drawing 50-4-2637, Exhibit B, Sheet 5, April 1950 (Station 978+24.95)].

Headwall at inlet on LS toe.

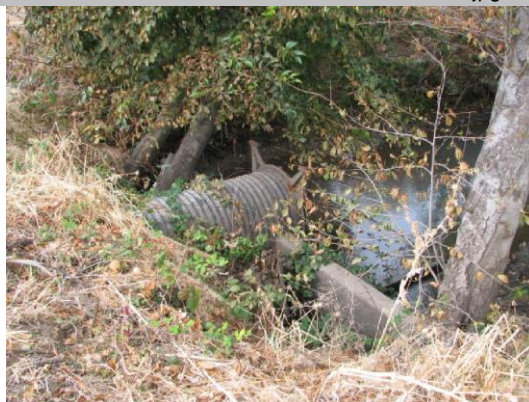
Photo 2 of 3 : UCIP_SP_2017_50891_68032.jpg

CMP pipe, flap gate, and headwall on WS toe.

Item	DWR UCIP LMA Responsibility			39.522200 °		39.522200 °
				-121.865592 °		-121.865592 °
DWR ID						
Comment Code						
Inspector Comment						
FS_ID:50891 DS_ID:1639 EP_NO: N/A Repair Type: Non-Urgent Crossing Status: Found UCIP Comments: 11/15/2016 NO soil supporting the WS wing walls. (DWR Sutter Yard- AFreitag)5/11/2016 Still no soil supporting the WS wing walls and apron. WS vegetation was thinner and not a problem this time.8/4/2015 No soil supporting the WS wing walls at the WS pipe end. WS pipe end is also being overgrown with vegetation and should be cleared back.6/11/2014 Same as last inspection.11/19/2013 Same as last inspection.5/29/2013 Same as last inspection.10/31/2012 Soil under Concrete wing walls on WS toe has been eroded. No soil supporting wing walls. FIELD_STRUCT_DESC: 36-inch corrugated metal drainage pipe through the levee, 13 feet below the crown. Flap gate on the waterside (WS). Concrete headwall on the landside (LS) and the WS ends. [Additional Reference(s): DWR Levee Logs, 1990. USACE Sacramento O&M Manual 515, April 1955 (Station 978+25). USACE As-built Drawing 50-4-2637, Exhibit B, Sheet 5, April 1950 (Station 978+24.95)]. FS Date: 11/21/2016 2:36:31 PM

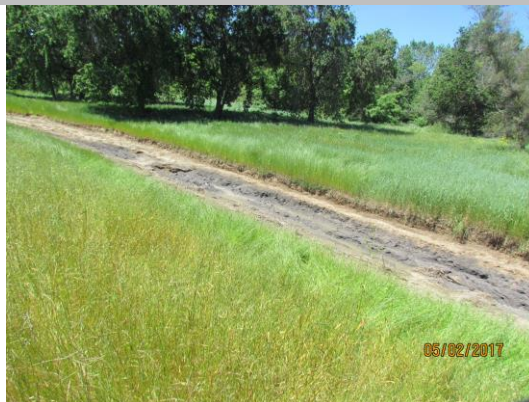
Photo 1 of 1 : SP_2017_MA0005_196_68_20170508_00088.jpg

LM Start	14.50	Rating **	U	Issue No.	68
LM End	15.07	Issue Type +	Ma	Location *	WS
Category	Earthen Levee			GPS Latitude/Longitude	
				Start	End
Item	Erosion / Bank Caving			39.521852 °	39.515597 °
				-121.866183 °	-121.873198 °
DWR ID	DWR_MA0005_01_s_2017_68				
Comment Code					
E2 : Schedule repair of erosion site prior to the next inspection.					
Inspector Comment					
Repair the erosion along the waterside toe.

View of the erosion along the waterside toe.

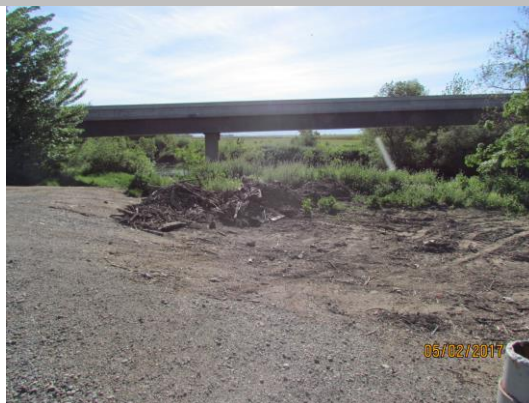
Photo 1 of 1 : SP_2017_MA0005_197_69_20170508_00106.jpg

LM Start	1.60	Rating **	M	Issue No.	69
LM End	1.60	Issue Type +	En	Location *	WS
Category	Earthen Levee			GPS Latitude/Longitude	
				Start	End
Item	Encroachments			39.534170 °	39.534170 °
				-121.856853 °	-121.856853 °
DWR ID	DWR_MA0005_02_s_2017_69				
Comment Code					
DE : Debris					
Inspector Comment					
Remove the debris from the waterside toe.

View of the debris along the waterside toe.

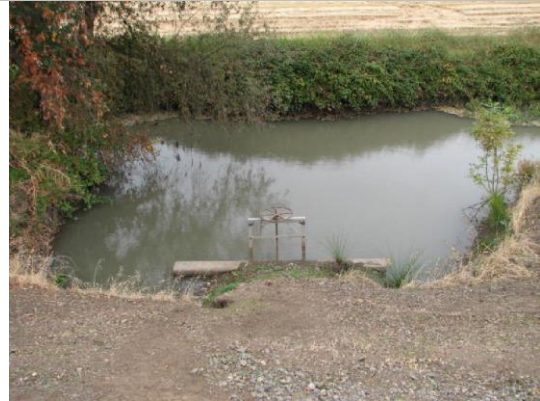
Photo 1 of 3 : UCIP_SP_2017_50904_68498.jpg

FS_ID:50904
DS_ID:1645
EP_NO: N/A
Repair Type: Urgent
Crossing Status: Found
UCIP Comments: 11/14/2016 LS erosion still present and is into the prism of the levee. WS flap gate was still mostly buried and non-operational. 5/23/2016 The tree that was overgrowing the WS flapgate has been removed. Flap gate was half buried and unable to open. Erosion on the LS is still present. (DWR Sutter Yard - afreitag)7/28/2015 LS inlet is underwater but there appears to be erosion behind the LS headwall. WS pipe end and flap gate are completely overgrown and inaccessible for inspection. (DWR Sutter Yard - afreitag)11/25/2014 Tree is overgrowing the WS pipe outlet.. Needs to be trimmed back. (DWR Sutter Yard - afreitag)6/4/2014 Same as last inspection. (DWR Sutter Yard - afreitag)11/12/2013 Same as last inspection. (DWR Sutter Yard - afreitag)6/6/2013 Same as last inspection. (DWR Sutter Yard - afreitag)10/31/2012 Vegetation needs to be cleared from outlet. (DWR UCIP - wwylie)

Concrete headwall and slide gate on LS toe.

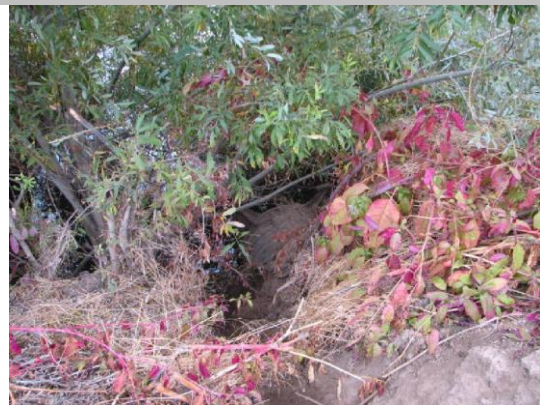
Photo 2 of 3 : UCIP_SP_2017_50904_68497.jpg

Flap gate on WS slope.

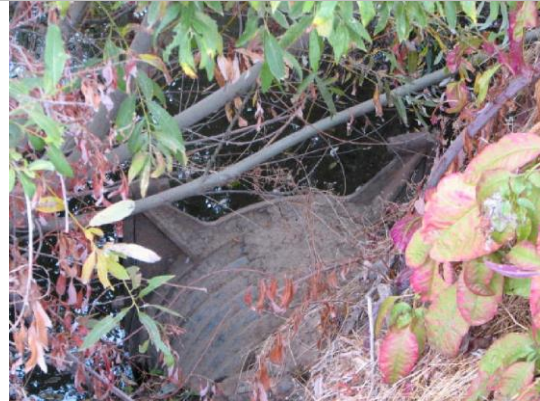
Photo 3 of 3 : UCIP_SP_2017_50904_68496.jpg

FS_ID:50904
 DS_ID:1645
 EP_NO: N/A
 Repair Type: Urgent
 Crossing Status: Found
 UCIP Comments: 11/14/2016 LS erosion still present and is into the prism of the levee. WS flap gate was still mostly buried and non-operational. 5/23/2016 The tree that was overgrowing the WS flapgate has been removed. Flap gate was half buried and unable to open. Erosion on the LS is still present. (DWR Sutter Yard - afreitag)7/28/2015 LS inlet is underwater but there appears to be erosion behind the LS headwall. WS pipe end and flap gate are completely overgrown and inaccessible for inspection. (DWR Sutter Yard - afreitag)11/25/2014 Tree is overgrowing the WS pipe outlet.. Needs to be trimmed back. (DWR Sutter Yard - afreitag)6/4/2014 Same as last inspection. (DWR Sutter Yard - afreitag)11/12/2013 Same as last inspection. (DWR Sutter Yard - afreitag)6/6/2013 Same as last inspection. (DWR Sutter Yard - afreitag)10/31/2012 Vegetation needs to be cleared from outlet. (DWR UCIP - wwylie)

Flap gate on WS slope.
