**Flood Control Project Maintenance
Levee Inspections**
LMA District Cover Sheet
Spring 2017 Levee Inspection Results

Sutter Maintenance Yard Maintenance Area 0005

Spring 2017 Levee Inspection Results

Waterway			Bank	Unit Miles
Unit No. 01 Butte Creek			Left	15.08
	Spring (March - May)	Summer (June - August)	(September - November) Fall	Winter (December - February)
Unit Maintenance Rating (Fall Only)				
Date of Inspection	5/2/2017 - 5/2/2017			
DWR Inspector	Bob Duffey			
Accompanied By	Shawn Freitag Sutter Maintenance Yard

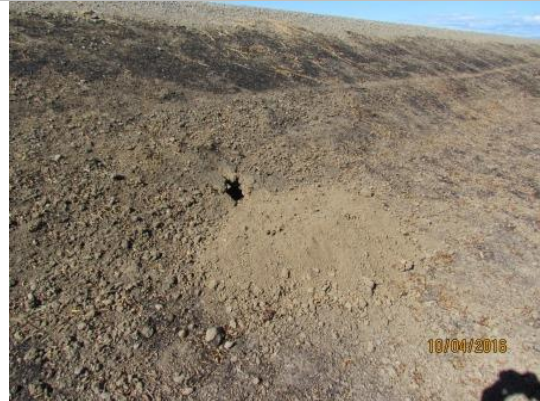
Photo 1 of 1 : SP_2017_MA0005_197_50_20170315_00025.jpg

LM Start	2.17	Rating **	M	Issue No.	50
LM End	2.17	Issue Type +	Ma	Location *	WS
Category	Earthen Levee			GPS Latitude/Longitude	
				Start	End
Item	Animal Control			39.540526 °	39.540526 °
				-121.850023 °	-121.850023 °
DWR ID	DWR_MA0005_02_f _ 2016_50				
Comment Code					
A3 : No rodents visible, but rodent burrows visible; need to backfill and compact or grout burrows.					
Inspector Comment

View of the rodent holes along the landside slope.

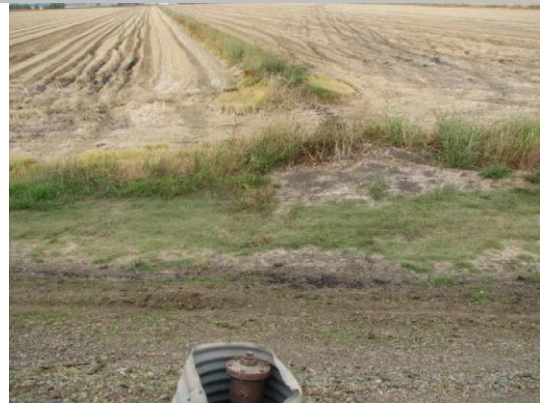
Photo 1 of 3 : UCIP_SP_2017_50905_68057.jpg

Comment Code					
Inspector Comment					
FS_ID:50905 DS_ID:1646 EP_NO: 3927 Repair Type: Non-Urgent Crossing Status: Found UCIP Comments: 11/14/2016 Appears abandoned- pump removed from pier in Butte Creek also riser and siphon breaker are no longer seen on LS shoulder. (DWR Sutter Yard- A Freitag)5/23/2016 Crossing appears to have been abandoned and removed. Could not locate the LS riser and siphon breaker.7/28/2015 No pump present during any of my inspections. Crossing appears abandoned. CMP riser has been knocked out of levee. 11/25/2014 Same as last inspection.6/04/2014 Same as last inspection.11/12/2013 Same as last inspection.6/6/2013 Same as last inspection.10/31/2012 Pump does not appear to be in use or is abandoned. FIELD_STRUCT_DESC: 20-inch (not 18-inch as referenced in the levee log) exterior coated steel irrigation pipe through the levee, 2.4 feet below the crown. Siphon breaker in a 24-inch corrugated metal riser on the landside (LS) shoulder. Portable pump on the waterside (WS). (Permit No. 3927, 1962 - Arrowhead Ranch). [Additional Reference(s): DWR Levee Log, 1990]. FS Date: 11/22/2016 9:26:11 AM

Air vent in 24-inch CMP riser on LS shoulder.

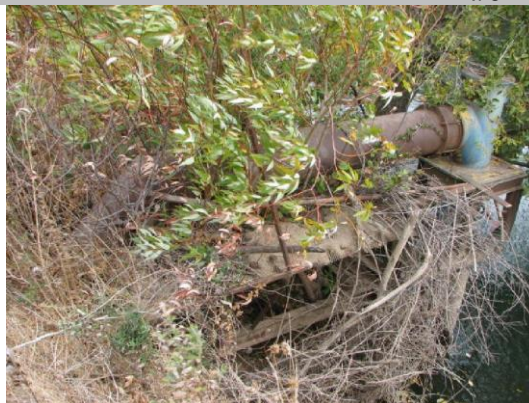
Photo 2 of 3 : UCIP_SP_2017_50905_68056.jpg

Comment Code					
Inspector Comment					
FS_ID:50905 DS_ID:1646 EP_NO: 3927 Repair Type: Non-Urgent Crossing Status: Found UCIP Comments: 11/14/2016 Appears abandoned- pump removed from pier in Butte Creek also riser and siphon breaker are no longer seen on LS shoulder. (DWR Sutter Yard- A Freitag)5/23/2016 Crossing appears to have been abandoned and removed. Could not locate the LS riser and siphon breaker.7/28/2015 No pump present during any of my inspections. Crossing appears abandoned. CMP riser has been knocked out of levee. 11/25/2014 Same as last inspection.6/04/2014 Same as last inspection.11/12/2013 Same as last inspection.6/6/2013 Same as last inspection.10/31/2012 Pump does not appear to be in use or is abandoned. FIELD_STRUCT_DESC: 20-inch (not 18-inch as referenced in the levee log) exterior coated steel irrigation pipe through the levee, 2.4 feet below the crown. Siphon breaker in a 24-inch corrugated metal riser on the landside (LS) shoulder. Portable pump on the waterside (WS). (Permit No. 3927, 1962 - Arrowhead Ranch). [Additional Reference(s): DWR Levee Log, 1990]. FS Date: 11/22/2016 9:26:11 AM

Pump on metal pier at WS toe.

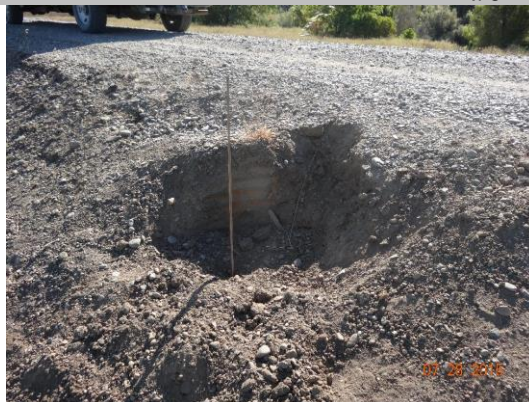
Photo 3 of 3 : UCIP_SP_2017_50905_74602.jpg

Spot where CMP riser was on the LS shoulder.

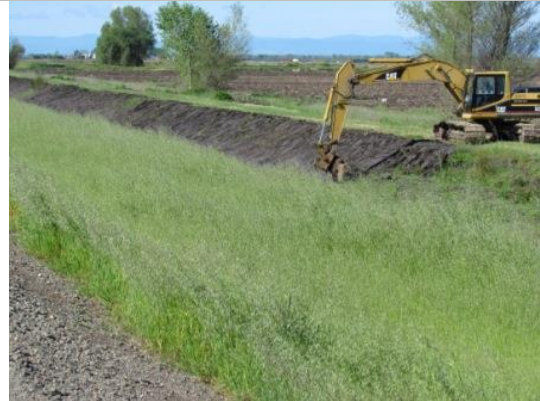
Photo 1 of 1 : SP_2017_MA0005_197_7_20170315_00004.jpg

LM Start	3.10	Rating **	M	Issue No.	7
LM End	4.04	Issue Type +	En	Location *	LS
Category	Earthen Levee			GPS Latitude/Longitude	
				Start	End
Item	Encroachments			39.551780 °	39.562341 °
				-121.840507 °	-121.829507 °
DWR ID	DWR_MA0005_02_s_2012_7				
Comment Code					
DT : Ditch					
Inspector Comment

View of the agricultural ditch along the landside toe.

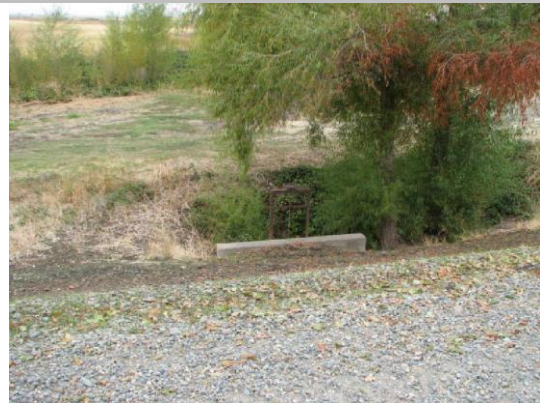
Photo 1 of 3 : UCIP_SP_2017_50906_68064.jpg

Comment Code					
Inspector Comment					
FS_ID:50906 DS_ID:1647 EP_NO: N/A Repair Type: No Action Needed Crossing Status: Found UCIP Comments: 11/14/2016 Crossing appears to be in good condition. (DWR Sutter Yard- A/Freitag)5/23/2016 Crossing appears to be in good condition.7/28/2015 Pipe appears in good condition. No noticeable issues to report.6/6/2013 Same as last inspection.11/12/2013 Same as last inspection.6/04/2014 Same as last inspection.11/25/2014 Same as last inspection. FIELD_STRUCT_DESC: 30-inch corrugated metal drainage pipe through the levee, 14.3 feet below the crown. Slide gate on the landside (LS), flap gate on the waterside (WS). Concrete headwall at the LS toe. Concrete splash apron on the WS. [Additional Reference(s): DWR Levee Logs, 1990. USACE Sacramento O&M Manual 515, April 1955 (Station 5+20"A"). USACE As-built Drawing 50-4-2637, Exhibit B, Sheet 4, April 1950 (Station 5+20"A")]. FS Date: 11/22/2016 9:27:49 AM

Concrete headwall and slide gate at LS toe.

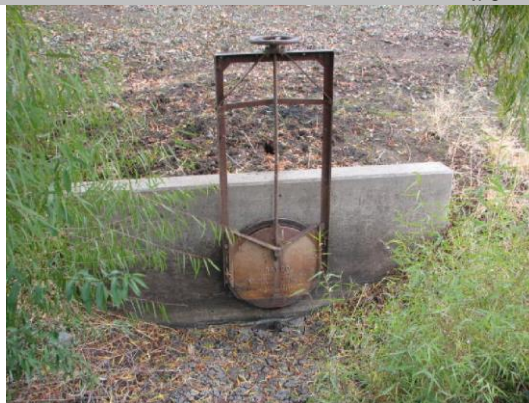
Photo 2 of 3 : UCIP_SP_2017_50906_68063.jpg

Concrete headwall and slide gate at LS toe.

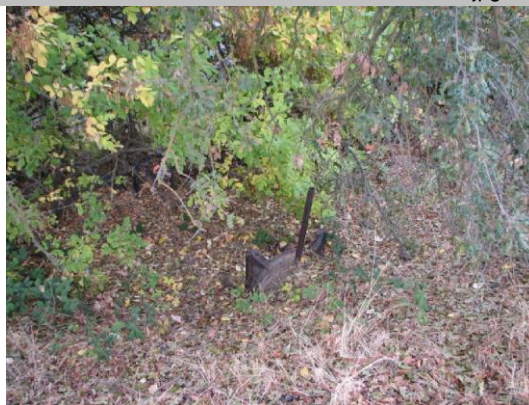
Photo 3 of 3 : UCIP_SP_2017_50906_68062.jpg

Flap gate at outlet on WS berm.

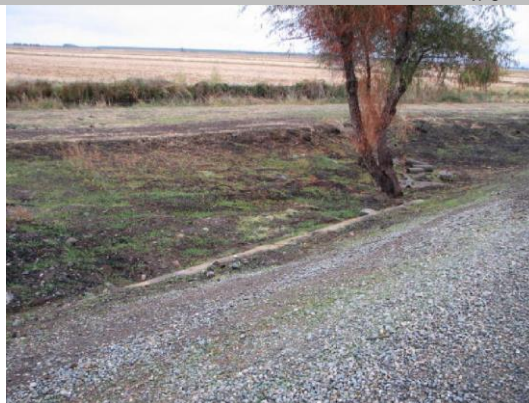
Photo 1 of 3 : UCIP_SP_2017_48780_68084.jpg

FS_ID:48780
DS_ID:16300
EP_NO: N/A
Repair Type: Non-Urgent
Crossing Status: Found
UCIP Comments: 5/23/2016 Crossing is not abandoned. Water was flowing through from the LS to WS. LS pipe inlet is about 100 yds from LS levee toe across the LS canal. 7/28/2015 Crossing is listed as abandoned but it is not filled with concrete like crossings 1-4 here. 11/25/2014 Same as last inspection. 6/04/2014 Same as last inspection. 11/13/2013 Same as last inspection. 6/6/2013 Sutter Maintenance Yard supervisor Jason Cooper said there is a flap gate on the LS end of the pipe in the western most ditch to prevent high water flooding. Not sure if this is adequate, will talk to levee inspector to find out. 11/01/2012 Pipe open on WS and is not filled with concrete.
FIELD_STRUCT_DESC: 5 of 5: 60-inch corrugated metal drainage (originally irrigation) pipe through the levee, 16.6 feet below the crown. Concrete headwall on the landside (LS) and the waterside (WS) shoulders. Pipe partially plugged on the LS with a concrete wall. Flap gate installed on the concrete plug to allow floodwater from the LS to flow to the WS (Use changed after western canal realignment under Permit No. 16667, 1997 - Western Canal WD). [Additional Reference(s): DWR Levee Logs, 1990. USACE Sacramento O&M Manual 515, April 1955 (Station 2+00"A")].

Concrete headwall on LS shoulder

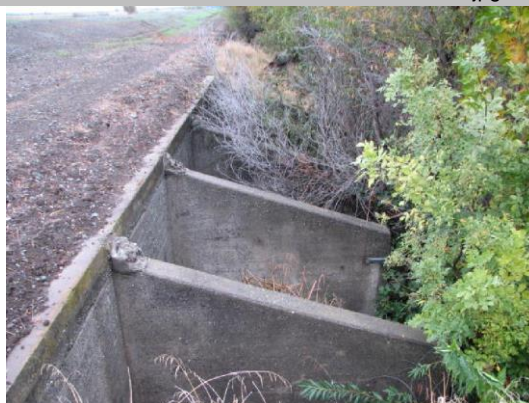
Photo 2 of 3 : UCIP_SP_2017_48780_68083.jpg

Concrete headwall on WS shoulder.

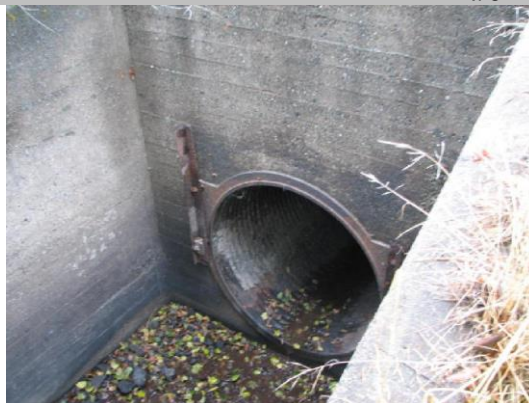
Photo 3 of 3 : UCIP_SP_2017_48780_68082.jpg

Comment Code						
Inspector Comment						
FS_ID:48780 DS_ID:16300 EP_NO: N/A Repair Type: Non-Urgent Crossing Status: Found UCIP Comments: 5/23/2016 Crossing is not abandoned. Water was flowing through from the LS to WS. LS pipe inlet is about 100 yds from LS levee toe across the LS canal.7/28/2015 Crossing is listed as abandoned but it is not filled with concrete like crossings 1-4 here.11/25/2014 Same as last inspection.6/04/2014 Same as last inspection.11/13/2013 Same as last inspection.6/6/2013 Sutter Maintenance Yard supervisor Jason Cooper said there is a flap gate on the LS end of the pipe in the western most ditch to prevent high water flooding. Not sure if this is adequate, will talk to levee inspector to find out.11/01/2012 Pipe open on WS and is not filled with concrete. FIELD_STRUCT_DESC: 5 of 5: 60-inch corrugated metal drainage (originally irrigation) pipe through the levee, 16.6 feet below the crown. Concrete headwall on the landside (LS) and the waterside (WS) shoulders. Pipe partially plugged on the LS with a concrete wall. Flap gate installed on the concrete plug to allow floodwater from the LS to flow to the WS (Use changed after western canal realignment under Permit No. 16667, 1997 - Western Canal WD). [Additional Reference(s): DWR Levee Logs, 1990. USACE Sacramento O&M Manual 515, April 1955 (Station 2+00"A")]. FS Date: 5/25/2016 12:55:00 PM

60-inch cmp open on WS.

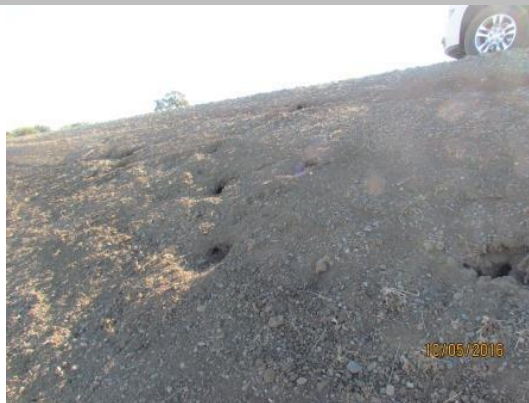
Photo 1 of 1 : SP_2017_MA0005_197_51_20170315_00026.jpg

LM Start	4.91	Rating **	M	Issue No.	51
LM End	4.91	Issue Type +	Ma	Location *	LS
Category	Earthen Levee			GPS Latitude/Longitude	
				Start	End
Item	Animal Control			39.571258 °	39.571258 °
				-121.818045 °	-121.818045 °
DWR ID	DWR_MA0005_02_f_2016_51				
Comment Code					
A3 : No rodents visible, but rodent burrows visible; need to backfill and compact or grout burrows.					
Inspector Comment

View of the rodent holes along the landside slope.

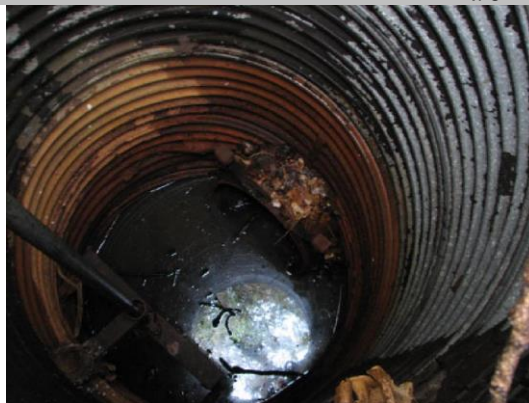
Photo 1 of 2 : UCIP_SP_2017_50920_68105.jpg

Comment Code					
Inspector Comment					
FS_ID:50920 DS_ID:1650 EP_NO: N/A Repair Type: Non-Urgent Crossing Status: Found UCIP Comments: 11/14/2016 Abandoned. (DWR Sutter Yard-AFreitag)5/23/2016 Abandoned7/28/2015 Abandoned- still cannot locate a LS ans WS pipe end.11/25/2014 Same as last inspection.6/04/2014 Same as last inspection.11/12/2013 Same as last inspection.6/6/2013 Same as last inspection.10/31/2012 Appears abandoned. Unable to locate outfall on WS. Unable to locate inlet on LS. FIELD_STRUCT_DESC: *ABANDONED* 24-inch corrugated metal drainage pipe through the levee, 12.5 feet below the crown. Slide gate and flap gate in a 56-inch corrugated metal riser on the waterside (WS) berm. Flap gate on the WS. [Additional Reference(s): DWR Levee Logs, 1990. USACE Sacramento O&M Manual 515, April 1955 (Station 688+40). USACE As-built Drawing 50-4-2637, Exhibit B, Sheet 3, April 1950 (Station 688+40)]. FS Date: 11/22/2016 10:09:44 AM

Slide gate and flap gate inside CMP riser on WS berm.

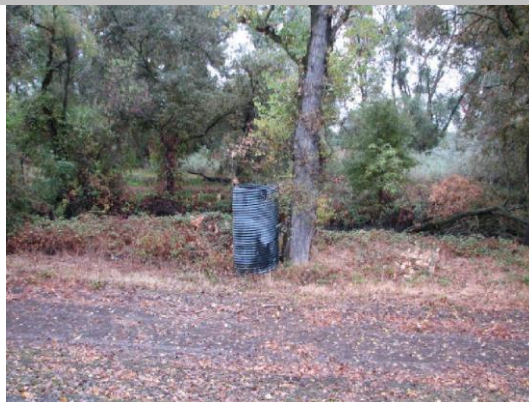
Photo 2 of 2 : UCIP_SP_2017_50920_68104.jpg

56-inch CMP riser on WS berm.

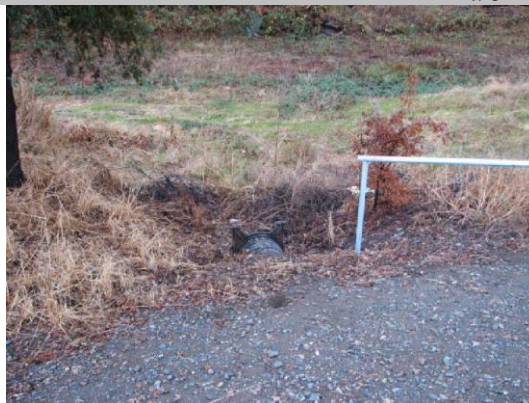
Photo 1 of 3 : UCIP_SP_2017_50927_68122.jpg

FS_ID:50927
DS_ID:1654
EP_NO: N/A
Repair Type: No Action Needed
Crossing Status: Found
UCIP Comments: 11/14/2016 Crossing appears to be in good condition. (DWR Sutter Yard- A Freitag) 5/23/2016 Crossing appears to be in good condition. 7/28/2015 Crossing appears in good condition. No noticeable issues to report. 11/24/2014 Same as last inspection. 6/04/2014 Same as last inspection. 11/12/2013 Same as last inspection. 6/6/2013 Same as last inspection.
FIELD_STRUCT_DESC: 24-inch corrugated metal drainage pipe through the levee, 9.4 feet below the crown. Flap gate on the waterside (WS). Concrete headwall at both landside (LS) and WS toes.
[Additional Reference(s): DWR Levee Logs, 1990. USACE Sacramento O&M Manual 515, April 1955 (Station 627+00). USACE As-built Drawing 50-4-2637, Exhibit B, Sheet 3, April 1950 (Station 627+00)].
FS Date: 11/22/2016 10:17:04 AM

Flap gate on WS toe.

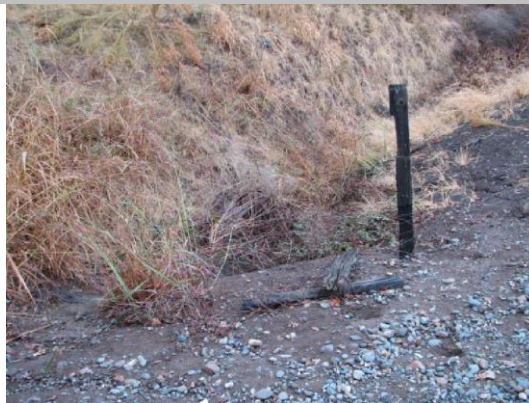
Photo 2 of 3 : UCIP_SP_2017_50927_68121.jpg

Headwall on LS toe.

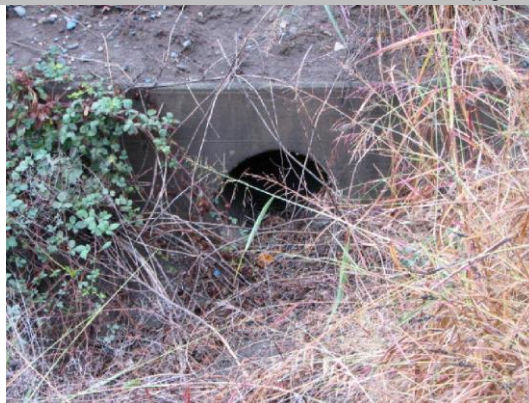
Photo 3 of 3 : UCIP_SP_2017_50927_68120.jpg

Item	DWR UCIP LMA Responsibility			39.589146 °	39.589146 °	
				-121.800463 °	-121.800463 °	
DWR ID						
Comment Code						
Inspector Comment						
FS_ID:50927 DS_ID:1654 EP_NO: N/A Repair Type: No Action Needed Crossing Status: Found UCIP Comments: 11/14/2016 Crossing appears to be in good condition. (DWR Sutter Yard- A Freitag)5/23/2016 Crossing appears to be in good condition.7/28/2015 Crossing appears in good condition. No noticeable issues to report.11/24/2014 Same as last inspection.6/04/2014 Same as last inspection.11/12/2013 Same as last inspection.6/6/2013 Same as last inspection. FIELD_STRUCT_DESC: 24-inch corrugated metal drainage pipe through the levee, 9.4 feet below the crown. Flap gate on the waterside (WS). Concrete headwall at both landside (LS) and WS toes. [Additional Reference(s): DWR Levee Logs, 1990. USACE Sacramento O&M Manual 515, April 1955 (Station 627+00). USACE As-built Drawing 50-4-2637, Exhibit B, Sheet 3, April 1950 (Station 627+00)]. FS Date: 11/22/2016 10:17:04 AM

Headwall on LS toe.

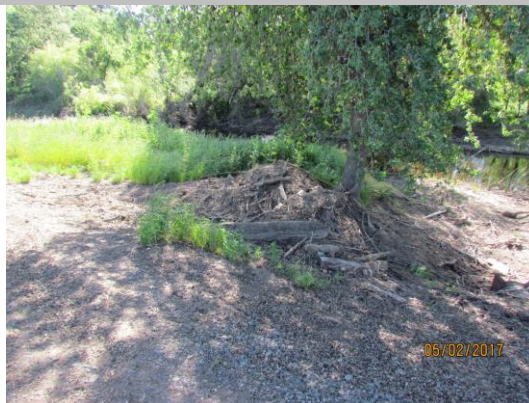
Photo 1 of 1 : SP_2017_MA0005_197_71_20170508_00108.jpg

LM Start	6.47	Rating **	M	Issue No.	71
LM End	6.47	Issue Type +	En	Location *	WS
Category	Earthen Levee			GPS Latitude/Longitude	
				Start	End
Item	Encroachments			39.589202 °	39.589202 °
				-121.800418 °	-121.800418 °
DWR ID	DWR_MA0005_02_s_2017_71				
Comment Code					
DE : Debris					
Inspector Comment					
Remove the debris from the waterside toe.

View of the debris along the waterside toe.

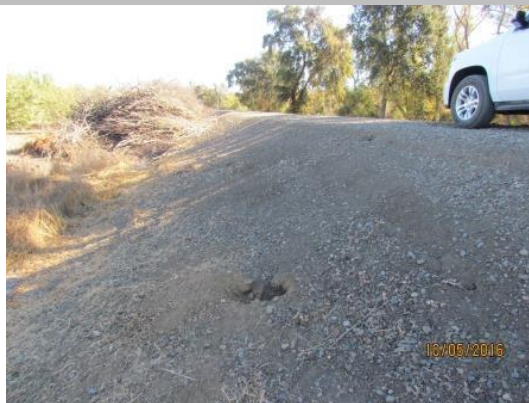
Photo 1 of 2 : SP_2017_MA0005_197_53_20170315_00028.jpg

LM Start	7.74	Rating **	U	Issue No.	53
LM End	7.74	Issue Type +	Ma	Location *	LS
Category	Earthen Levee			GPS Latitude/Longitude	
				Start	End
Item	Animal Control			39.605088 °	39.605088 °
				-121.788569 °	-121.788569 °
DWR ID	DWR_MA0005_02_f_2016_53				
Comment Code					
A1 : Exterminate rodents and backfill and compact or grout burrows.					
Inspector Comment

View of the rodent holes along the landside slope.

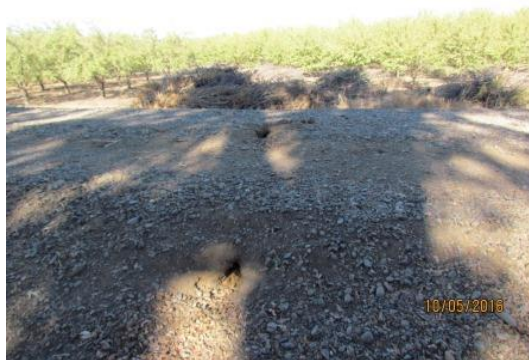
Photo 2 of 2 : SP_2017_MA0005_197_53_20170315_00029.jpg

View of the rodent holes along the crown and waterside slope.

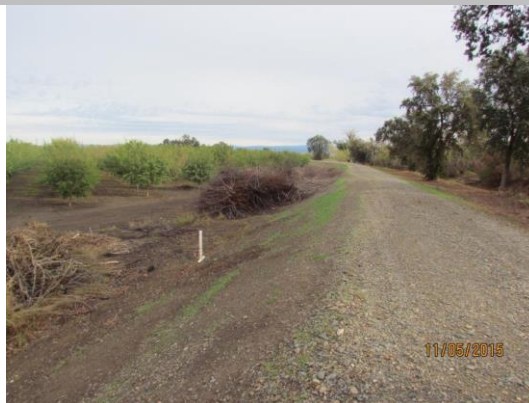
Photo 1 of 1 : SP_2017_MA0005_197_35_20170315_00012.jpg

LM Start	7.75	Rating **	M	Issue No.	35
LM End	7.75	Issue Type +	Ma	Location *	LS
Category	Earthen Levee			GPS Latitude/Longitude	
				Start	End
Item	Encroachments			39.605205 °	39.605205 °
				-121.788453 °	-121.788453 °
DWR ID	DWR_MA0005_02_s_2015_35				
Comment Code					
PR : Prunings					
Inspector Comment					
Remove the prunings from the landside slope.

View of the prunings along the landside slope.

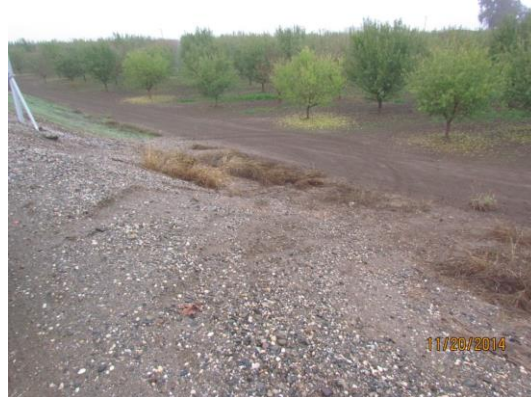
Photo 1 of 2 : SP_2017_MA0005_197_13_20170315_00005.jpg

LM Start	7.98	Rating **	M	Issue No.	13
LM End	7.98	Issue Type +	Ma	Location *	LS
Category	Earthen Levee			GPS Latitude/Longitude	
				Start	End
Item	Slope Stability			39.607710 °	39.607710 °
				-121.785868 °	-121.785868 °
DWR ID	DWR_MA0005_02_s_2012_13				
Comment Code					
S3 : Repair the levee slope damaged by vehicle traffic and prevent access where possible.					
Inspector Comment

View of the vehicle erosion along the landside slope.

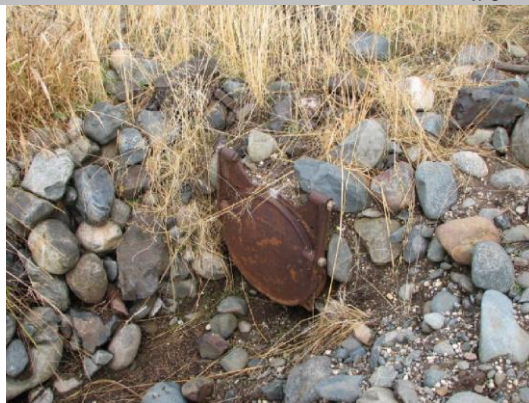
Photo 1 of 2 : UCIP_SP_2017_50930_68129.jpg

FS_ID:50930
DS_ID:1656
EP_NO: N/A
Repair Type: Non-Urgent
Crossing Status: Found
UCIP Comments: 11/14/2016 LS inlet almost completely full of soil. (DWR Sutter Yard- A Freitag) 5/23/2016 LS end is almost completely full of soil. 7/28/2015 Pipe is still over 3/4 full of soil. 11/24/2014 Same as last inspection. 6/04/2014 Same as last inspection. 11/12/2013 Same as last inspection. 6/6/2013 Same as last inspection. 10/31/2012 Pipe 3/4 full with soil on LS.
FIELD_STRUCT_DESC: 24-inch (not 18-inch as shown in as-built drawings) corrugated metal drainage pipe through the levee, 6.7 feet below the crown. Concrete headwall at the landside (LS) toe. Flap gate on the waterside (WS). [Additional Reference(s): DWR Levee Logs, 1990. USACE As-Built Drawings 50-4-2637, Exhibit B, Sheet 2, April 1950 (Station 550+60)].
FS Date: 11/22/2016 10:19:47 AM

Flap gate at WS toe.

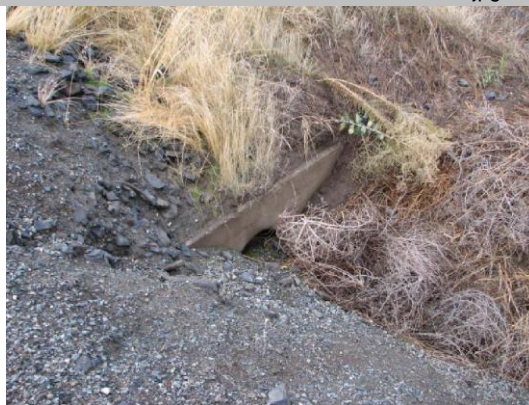
Photo 2 of 2 : UCIP_SP_2017_50930_68128.jpg

Concrete headwall on LS toe.

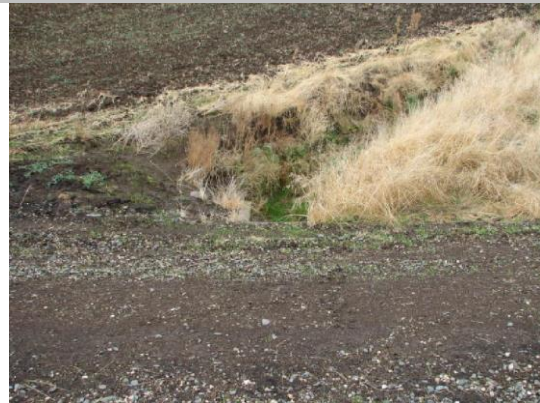
Photo 1 of 3 : UCIP_SP_2017_50937_68394.jpg

Comment Code					
Inspector Comment					
FS_ID:50937 DS_ID:1662 EP_NO: N/A Repair Type: No Action Needed Crossing Status: Found UCIP Comments: 11/14/2016 Crossing appears to be in good condition. (DWR Sutter Yard- A/Freitag)5/12/2016 Crossing appears to be in good condition.7/30/2015 Crossing is in good condition. No noticeable issues to report.11/24/2014 Same as last inspection.6/4/2014 Same as last inspection.11/13/2013 Same as last inspection..6/6/2013 Same as last inspection. FIELD_STRUCT_DESC: 30-inch corrugated metal drainage pipe through the levee, 16.3 feet below the crown. Flap gate on the waterside (WS). Concrete "U" shaped headwalls on both the landside (LS) and the WS. [Additional Reference(s): DWR Levee Logs, 1990. USACE Sacramento O&M Manual 516, April 1960 (Station 374+90). USACE As-built Drawings 50-4-3367, Exhibit B, Sheet 13, April 1957 (Station 374+90)]. FS Date: 11/22/2016 10:35:19 AM

Concrete inlet on LS toe.

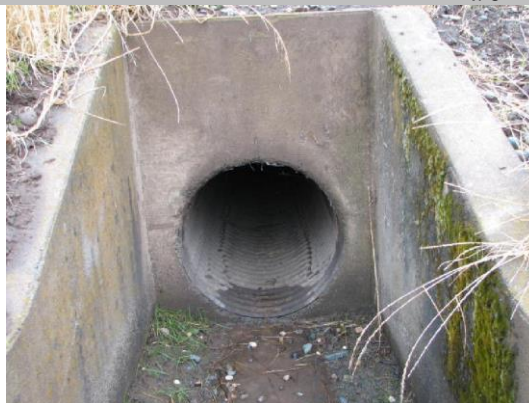
Photo 2 of 3 : UCIP_SP_2017_50937_68393.jpg

FS_ID:50937
DS_ID:1662
EP_NO: N/A
Repair Type: No Action Needed
Crossing Status: Found
UCIP Comments: 11/14/2016 Crossing appears to be in good condition. (DWR Sutter Yard- AFreitag)5/12/2016 Crossing appears to be in good condition.7/30/2015 Crossing is in good condition. No noticeable issues to report.11/24/2014 Same as last inspection.6/4/2014 Same as last inspection.11/13/2013 Same as last inspection..6/6/2013 Same as last inspection.
FIELD_STRUCT_DESC: 30-inch corrugated metal drainage pipe through the levee, 16.3 feet below the crown. Flap gate on the waterside (WS). Concrete "U" shaped headwalls on both the landside (LS) and the WS. [Additional Reference(s): DWR Levee Logs, 1990. USACE Sacramento O&M Manual 516, April 1960 (Station 374+90). USACE As-built Drawings 50-4-3367, Exhibit B, Sheet 13, April 1957 (Station 374+90)].
FS Date: 11/22/2016 10:35:19 AM

Concrete inlet on LS toe.

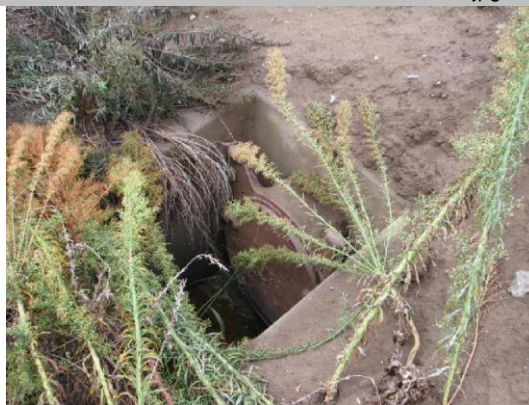
Photo 3 of 3 : UCIP_SP_2017_50937_68392.jpg

Concrete outlet and flap gate on WS toe.

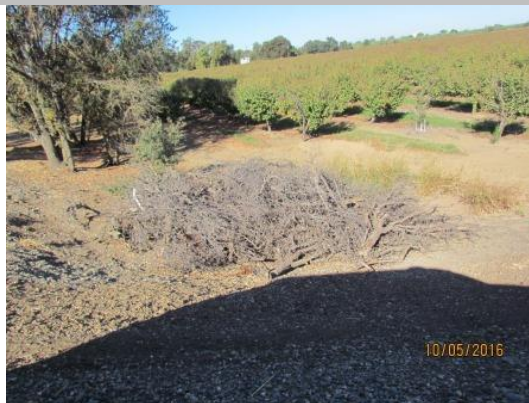
Photo 1 of 1 : SP_2017_MA0005_197_54_20170315_00030.jpg

LM Start	8.34	Rating **	M	Issue No.	54
LM End	8.34	Issue Type +	En	Location *	LS
Category	Earthen Levee			GPS Latitude/Longitude	
				Start	End
Item	Encroachments			39.612230 °	39.612230 °
				-121.782897 °	-121.782897 °
DWR ID	DWR_MA0005_02_f_2016_54				
Comment Code					
PR : Prunings					
Inspector Comment					
Remove the prunings from the landside slope.

View of the prunings along the landside toe.

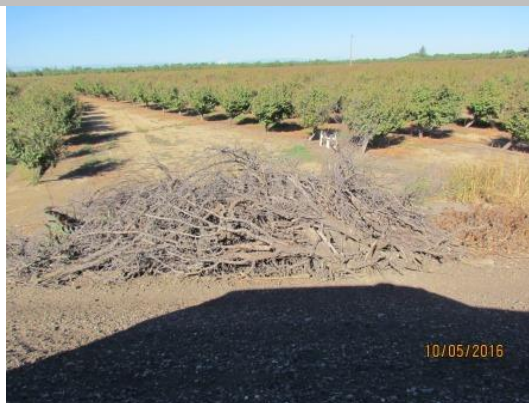
Photo 1 of 1 : SP_2017_MA0005_197_47_20170315_00022.jpg

LM Start	8.67	Rating **	M	Issue No.	47
LM End	8.67	Issue Type +	En	Location *	LS
Category	Earthen Levee			GPS Latitude/Longitude	
				Start	End
Item	Encroachments			39.616370 °	39.616370 °
				-121.779779 °	-121.779779 °
DWR ID	DWR_MA0005_02_s_2016_47				
Comment Code					
PR : Prunings					
Inspector Comment					
Remove the prunings from the landside slope.

View of the prunings along the landside toe.

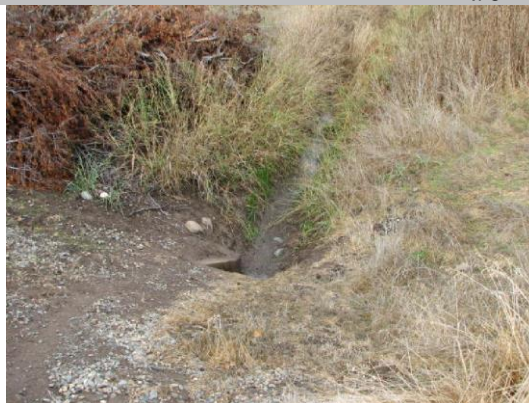
Photo 1 of 3 : UCIP_SP_2017_50939_68397.jpg

FS_ID:50939
DS_ID:1663
EP_NO: N/A
Repair Type: No Action Needed
Crossing Status: Found
UCIP Comments: 11/14/2016 Crossing appears to be in good condition. (DWR Sutter Yard- A Freitag) 5/12/2016 Crossing appears to be in good condition. 7/30/2015 Crossing appears in good condition. No noticeable issues to report. 11/24/2014 Same as last inspection. 6/4/2014 Same as last inspection. 11/13/2013 Damaged pipe section was dug up and replaced. New WS flapgate with u-shaped wingwall installed on end of pipe. 6/6/2013 Same as last inspection. Plans have been made to repair during summer of 2013 before high water season. 11/01/2012 Pipe rusted through along bottom at WS outlet. Sink hole over pipe on WS berm. WS headwall eroded eternally around backside of headwall.
FIELD_STRUCT_DESC: 24-inch corrugated metal drainage pipe through the levee, 15 feet below the crown. Flap gate on the waterside (WS). Concrete headwalls on both the landside (LS) and the WS.

Concrete U-shaped headwall on LS toe.

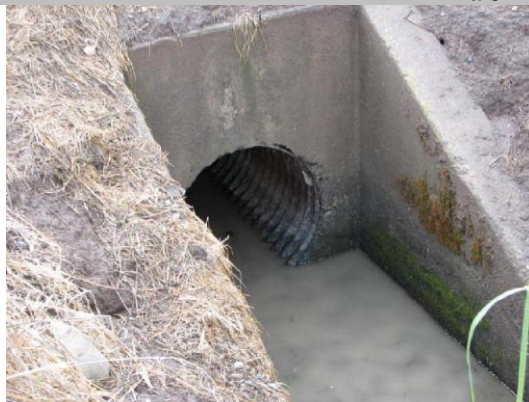
Photo 2 of 3 : UCIP_SP_2017_50939_68396.jpg

Concrete U-shaped headwall on LS toe.

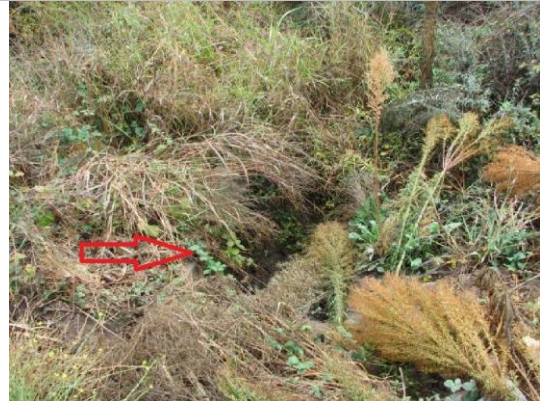
Photo 3 of 3 : UCIP_SP_2017_50939_68395.jpg

Comment Code					
Inspector Comment					
FS_ID:50939 DS_ID:1663 EP_NO: N/A Repair Type: No Action Needed Crossing Status: Found UCIP Comments: 11/14/2016 Crossing appears to be in good condition. (DWR Sutter Yard- A Freitag)5/12/2016 Crossing appears to be in good condition. 7/30/2015 Crossing appears in good condition. No noticeable issues to report.11/24/2014 Same as last inspection.6/4/2014 Same as last inspection.11/13/2013 Damaged pipe section was dug up and replaced. New WS flapgate with u-shaped wingwall installed on end of pipe.6/6/2013 Same as last inspection. Plans have been made to repair during summer of 2013 before high water season.11/01/2012 Pipe rusted through along bottom at WS outlet. Sink hole over pipe on WS berm. WS headwall eroded eternally around backside of headwall. FIELD_STRUCT_DESC: 24-inch corrugated metal drainage pipe through the levee, 15 feet below the crown. Flap gate on the waterside (WS). Concrete headwalls on both the landside (LS) and the WS. [Additional Reference(s): DWR Levee Logs, 1990. USACE As-built Drawings 50-4-3367, Exhibit B, Sheet 11 (Station 340+04)]. FS Date: 11/22/2016 10:36:37 AM

Concrete U shaped outlet and flap gate at WS of Berm.

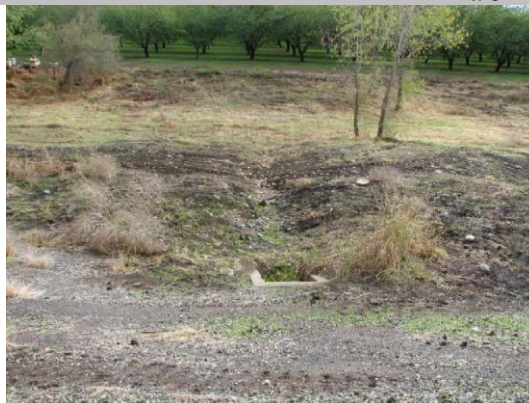
Photo 1 of 3 : UCIP_SP_2017_50940_68406.jpg

Comment Code					
Inspector Comment					
FS_ID:50940 DS_ID:1664 EP_NO: N/A Repair Type: Non-Urgent Crossing Status: Found UCIP Comments: 11/14/2016 LS slide gate still missing. Rest of crossing appears in good condition. (DWR Sutter Yard-AFreitag)5/12/2016 LS inlet was unburied. Slide gate still missing7/30/2015 LS inlet is still buried.11/24/2014 Same as last inspection.6/4/2014 Same as last inspection.11/13/2013 Same as last inspection.6/6/2013 Same as last inspection.11/01/2012 LS inlet is buried under soil and covered with brambles. Slide gate missing from LS. FIELD_STRUCT_DESC: 24-inch corrugated metal drainage pipe through the levee, 12 feet below the crown. Flap gate on the waterside (WS). Concrete headwall on the WS. Concrete headwall on the landside (LS), not found. [Additional Reference(s): DWR Levee Logs, 1990. USACE Sacramento O&M Manual 516, April 1960 (Station 338+04). USACE As-built Drawings 50-4-3367, April 1957, Exhibit B, Sheet 11 (Station 338+04)]. FS Date: 11/22/2016 10:37:46 AM

WS outlet and concrete U shaped headwall.

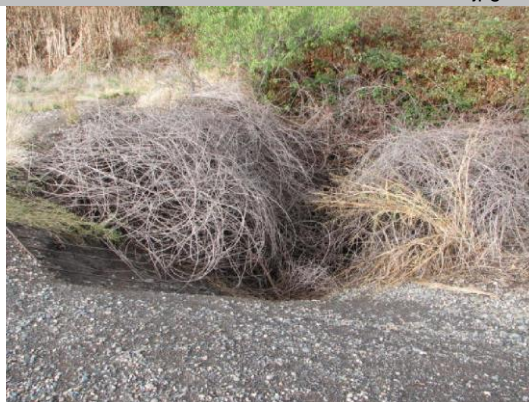
Photo 2 of 3 : UCIP_SP_2017_50940_68404.jpg

Brambles and soil over pipe at inlet.

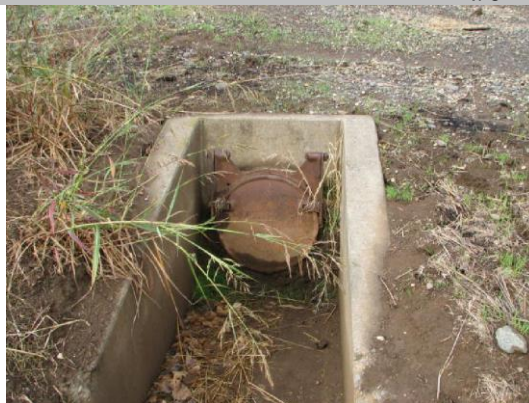
Photo 3 of 3 : UCIP_SP_2017_50940_68403.jpg

Comment Code						
Inspector Comment						
FS_ID:50940 DS_ID:1664 EP_NO: N/A Repair Type: Non-Urgent Crossing Status: Found UCIP Comments: 11/14/2016 LS slide gate still missing. Rest of crossing appears in good condition. (DWR Sutter Yard-AFreitag)5/12/2016 LS inlet was unburied. Slide gate still missing7/30/2015 LS inlet is still buried.11/24/2014 Same as last inspection.6/4/2014 Same as last inspection.11/13/2013 Same as last inspection.6/6/2013 Same as last inspection.11/01/2012 LS inlet is buried under soil and covered with brambles. Slide gate missing from LS. FIELD_STRUCT_DESC: 24-inch corrugated metal drainage pipe through the levee, 12 feet below the crown. Flap gate on the waterside (WS). Concrete headwall on the WS. Concrete headwall on the landside (LS), not found. [Additional Reference(s): DWR Levee Logs, 1990. USACE Sacramento O&M Manual 516, April 1960 (Station 338+04). USACE As-built Drawings 50-4-3367, April 1957, Exhibit B, Sheet 11 (Station 338+04)]. FS Date: 11/22/2016 10:37:46 AM

Concrete U shaped headwall and flap gate at WS toe.

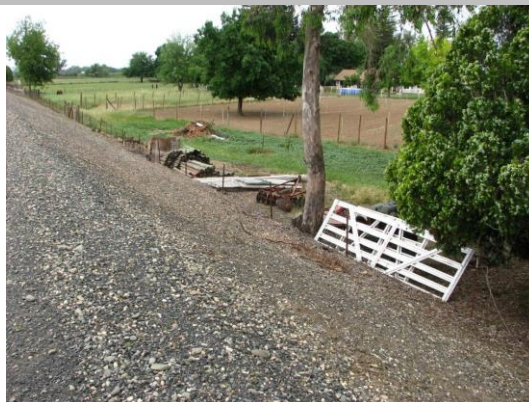
Photo 1 of 1 : SP_2017_MA0005_197_45_20170315_00020.jpg

LM Start	9.09	Rating **	M	Issue No.	45
LM End	9.09	Issue Type +	En	Location *	LS
Category	Earthen Levee			GPS Latitude/Longitude	
				Start	End
Item	Encroachments			39.622017 °	39.622017 °
				-121.776552 °	-121.776552 °
DWR ID	DWR_MA0005_02_s_2016_45				
Comment Code					
EQ : Equipment					
Inspector Comment

Remove equipment and materials from the landside toe.

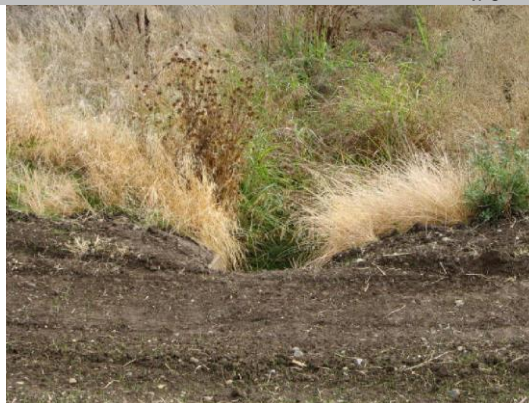
Photo 1 of 3 : UCIP_SP_2017_50941_68413.jpg

FS_ID:50941
DS_ID:1665
EP_NO: N/A
Repair Type: No Action Needed
Crossing Status: Found
UCIP Comments: 11/14/2016 Crossing appears to be in good condition. (DWR Sutter Yard- AFreitag)5/12/2016 Crossing appears to be in good condition.7/30/2015 Crossing appears in good condition. No noticeable issues to report.11/24/2014 Same as last inspection.6/4/2014 Same as last inspection.11/13/2013 Same as last inspection.6/6/2013 Same as last inspection.
FIELD_STRUCT_DESC: 24-inch corrugated metal drainage pipe through the levee, 11.3 feet below the crown. Flap gate on the waterside (WS). Concrete headwalls on both the landside (LS) and the WS. [Additional Reference(s): DWR Levee Logs, 1990. USACE Sacramento O&M Manual 516, April 1960 (Station 321+20)].
FS Date: 11/22/2016 11:46:50 AM

Concrete U shaped headwall and flap gate on WS toe.

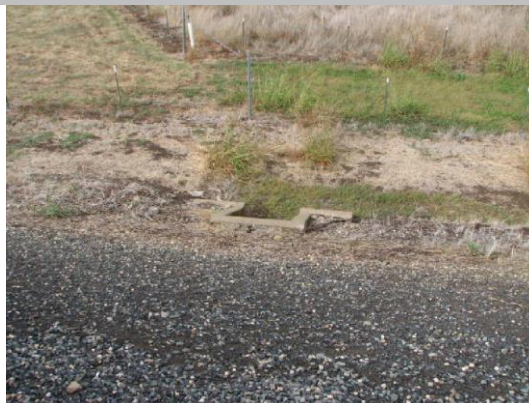
Photo 2 of 3 : UCIP_SP_2017_50941_68412.jpg

Concrete U shaped headwall on LS toe.

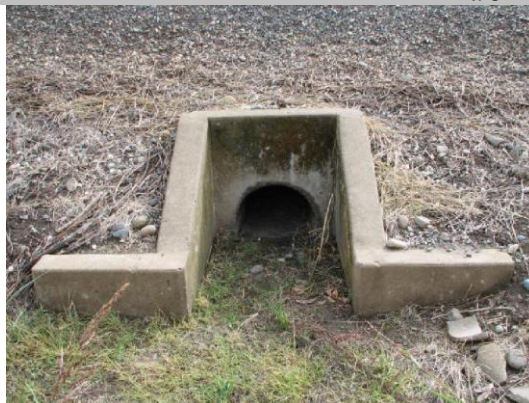
Photo 3 of 3 : UCIP_SP_2017_50941_68411.jpg

Item	DWR UCIP LMA Responsibility			39.622377 °	39.622377 °	
				-121.776327 °	-121.776327 °	
DWR ID						
Comment Code						
Inspector Comment						
FS_ID:50941						
DS_ID:1665						
EP_NO: N/A						
Repair Type: No Action Needed						
Crossing Status: Found						
UCIP Comments: 11/14/2016 Crossing appears to be in good condition. (DWR Sutter Yard- A Freitag)5/12/2016 Crossing appears to be in good condition. 7/30/2015 Crossing appears in good condition. No noticeable issues to report.11/24/2014 Same as last inspection.6/4/2014 Same as last inspection.11/13/2013 Same as last inspection.6/6/2013 Same as last inspection.						
FIELD_STRUCT_DESC: 24-inch corrugated metal drainage pipe through the levee, 11.3 feet below the crown. Flap gate on the waterside (WS). Concrete headwalls on both the landside (LS) and the WS. [Additional Reference(s): DWR Levee Logs, 1990. USACE Sacramento O&M Manual 516, April 1960 (Station 321+20)].

Concrete U shaped headwall on LS toe.

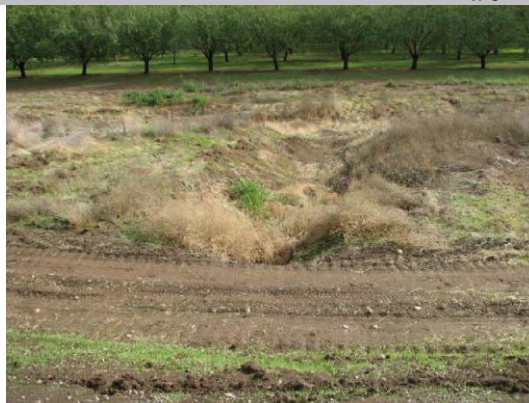
Photo 1 of 3 : UCIP_SP_2017_50942_68417.jpg

Comment Code					
Inspector Comment					
FS_ID:50942 DS_ID:1666 EP_NO: N/A Repair Type: Non-Urgent Crossing Status: Found UCIP Comments: 11/14/2016 LS pipe inlet is half full of soil. WS flap gate shut but half buried by sediment. (DWR Sutter Yard-AFreitag)5/12/2016 Pipe is half full of soil.7/30/2015 Pipe is 1/4 to 1/2 full of soil still.11/24/2014 Same as last inspection.6/4/2014 Same as last inspection.11/13/2013 Same as last inspection.6/6/2013 Same as last inspection.11/01/2012 Pipe 1/2 filled with soil. FIELD_STRUCT_DESC: 24-inch corrugated metal drainage pipe through the levee, 11.2 feet below the crown. Flap gate on the waterside (WS). Concrete "U" shaped headwalls on both the landside (LS) and the WS. [Additional Reference(s): DWR Levee Logs, 1990. USACE Sacramento O&M Manual 516, April 1960 (Station 304+10). USACE As-built Drawings 50-4-3367, April 1957, Exhibit B, Sheet 3 (Station 304+10)]. FS Date: 11/22/2016 12:04:57 PM

View of outlet looking toward WS toe.

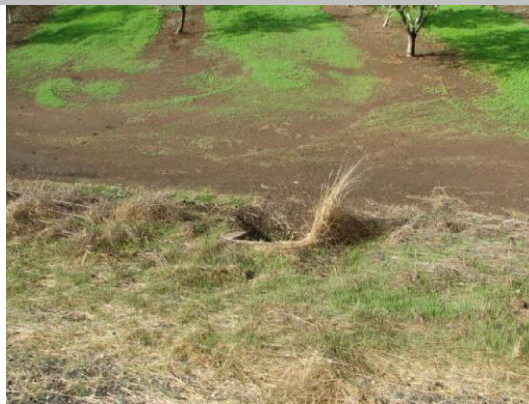
Photo 2 of 3 : UCIP_SP_2017_50942_68416.jpg

View of inlet on LS toe.

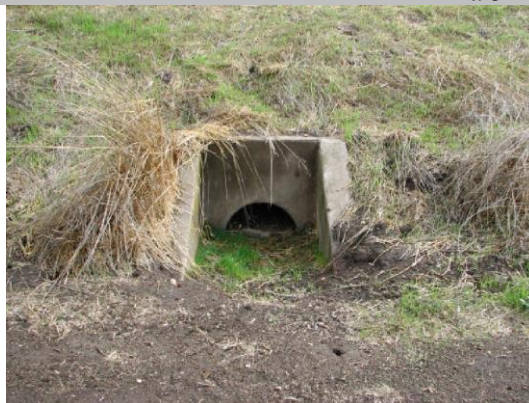
Photo 3 of 3 : UCIP_SP_2017_50942_68415.jpg

Comment Code					
Inspector Comment					
FS_ID:50942 DS_ID:1666 EP_NO: N/A Repair Type: Non-Urgent Crossing Status: Found UCIP Comments: 11/14/2016 LS pipe inlet is half full of soil. WS flap gate shut but half buried by sediment. (DWR Sutter Yard-AFreitag)5/12/2016 Pipe is half full of soil.7/30/2015 Pipe is 1/4 to 1/2 full of soil still.11/24/2014 Same as last inspection.6/4/2014 Same as last inspection.11/13/2013 Same as last inspection.6/6/2013 Same as last inspection.11/01/2012 Pipe 1/2 filled with soil. FIELD_STRUCT_DESC: 24-inch corrugated metal drainage pipe through the levee, 11.2 feet below the crown. Flap gate on the waterside (WS). Concrete "U" shaped headwalls on both the landside (LS) and the WS. [Additional Reference(s): DWR Levee Logs, 1990. USACE Sacramento O&M Manual 516, April 1960 (Station 304+10). USACE As-built Drawings 50-4-3367, April 1957, Exhibit B, Sheet 3 (Station 304+10)]. FS Date: 11/22/2016 12:04:57 PM

Concrete U-shaped headwall on LS toe.

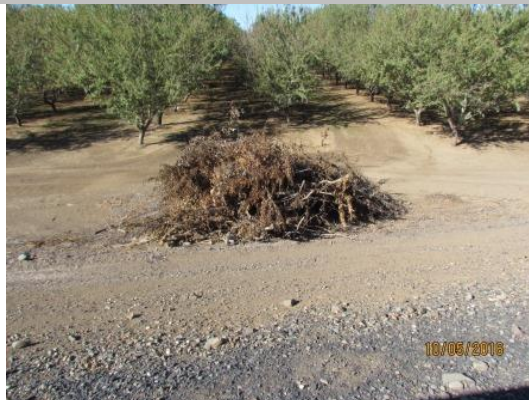
Photo 1 of 1 : SP_2017_MA0005_197_56_20170315_00032.jpg

LM Start	9.72	Rating **	M	Issue No.	56
LM End	9.72	Issue Type +	En	Location *	LS
Category	Earthen Levee			GPS Latitude/Longitude	
				Start	End
Item	Encroachments			39.630937 °	39.630937 °
				-121.774960 °	-121.774960 °
DWR ID	DWR_MA0005_02_f_2016_56				
Comment Code					
PR : Prunings					
Inspector Comment

View of the prunings along the landside toe.

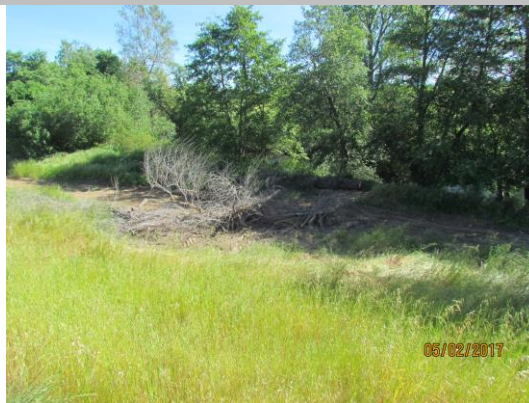
Photo 1 of 1 : SP_2017_MA0005_197_72_20170508_00110.jpg

LM Start	9.92	Rating **	M	Issue No.	72
LM End	9.92	Issue Type +	En	Location *	WS
Category	Earthen Levee			GPS Latitude/Longitude	
				Start	End
Item	Encroachments			39.633392 °	39.633392 °
				-121.776963 °	-121.776963 °
DWR ID	DWR_MA0005_02_s _ 2017_72				
Comment Code					
TR : Tree or limb					
Inspector Comment					
Remove the tree from the waterside toe.

View of the tree along the waterside toe.

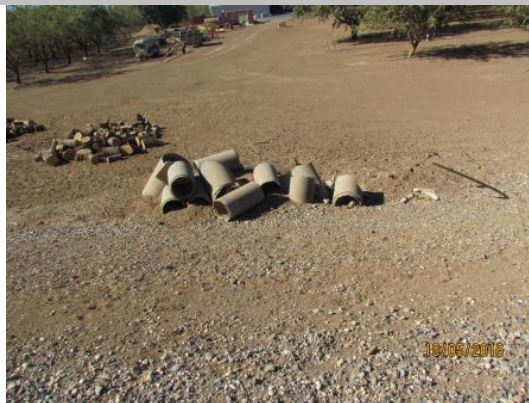
Photo 1 of 1 : SP_2017_MA0005_197_57_20170315_00033.jpg

LM Start	10.47	Rating **	M	Issue No.	57
LM End	10.47	Issue Type +	En	Location *	LS
Category	Earthen Levee			GPS Latitude/Longitude	
				Start	End
Item	Encroachments			39.640156 °	39.640156 °
				-121.782397 °	-121.782397 °
DWR ID	DWR_MA0005_02_f_2016_57				
Comment Code					
MA : Material					
Inspector Comment					
Remove broken concrete pipes from the landside toe.

View of the broken concrete pipes along the landside toe.

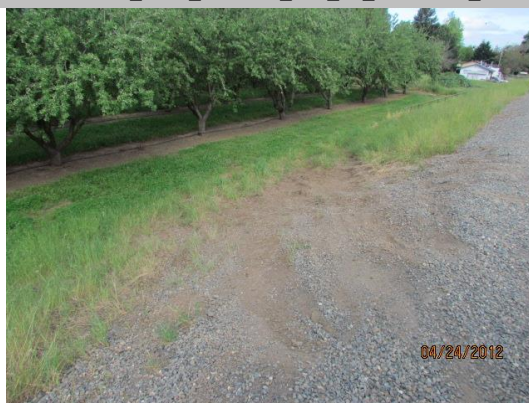
Photo 1 of 1 : SP_2017_MA0005_197_18_20170315_00007.jpg

LM Start	10.63	Rating **	M	Issue No.	18
LM End	10.63	Issue Type +	Ma	Location *	LS
Category	Earthen Levee			GPS Latitude/Longitude	
				Start	End
Item	Slope Stability			39.642061 °	39.642061 °
				-121.783861 °	-121.783861 °
DWR ID	DWR_MA0005_02_s_2012_18				
Comment Code					
S3 : Repair the levee slope damaged by vehicle traffic and prevent access where possible.					
Inspector Comment

View of the vehicle erosion along the slope of the levee.

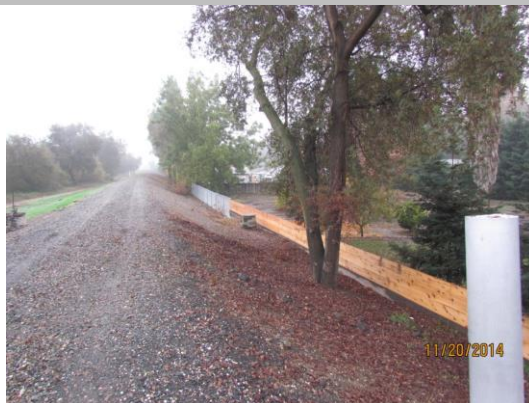
Photo 1 of 1 : SP_2017_MA0005_197_41_20170315_00017.jpg

LM Start	10.90	Rating **	U	Issue No.	41
LM End	10.93	Issue Type +	En	Location *	LS
Category	Earthen Levee			GPS Latitude/Longitude	
				Start	End
Item	Encroachments			39.645508 °	39.645858 °
				-121.786515 °	-121.786742 °
DWR ID	DWR_MA0005_02_f_2014_41				
Comment Code					
FE : Fence					
Inspector Comment					
Remove or apply for permit for the fence along landside toe

View of the new fence along the landside toe.

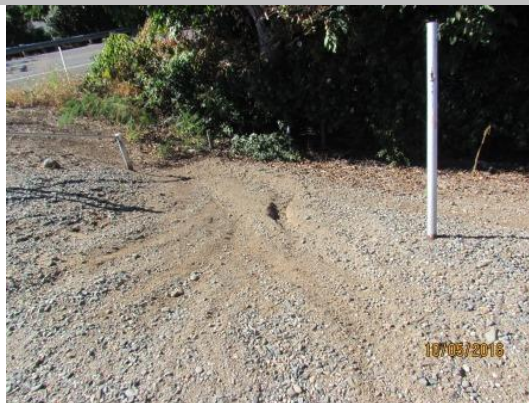
Photo 1 of 1 : SP_2017_MA0005_197_58_20170315_00034.jpg

LM Start	10.95	Rating **	M	Issue No.	58
LM End	10.95	Issue Type +	Ma	Location *	LS
Category	Earthen Levee			GPS Latitude/Longitude	
				Start	End
Item	Slope Stability			39.646045 °	39.646045 °
				-121.786927 °	-121.786927 °
DWR ID	DWR_MA0005_02_f_2016_58				
Comment Code					
S2 : Repair the levee slope damaged by foot traffic and prevent access where possible.					
Inspector Comment

View of the damaged landside slope.

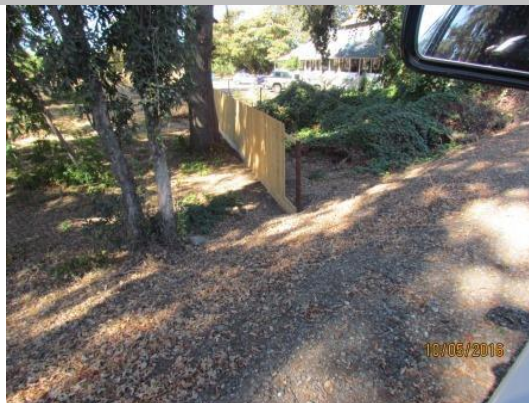
Photo 1 of 1 : SP_2017_MA0005_197_60_20170315_00035.jpg

LM Start	11.04	Rating **	U	Issue No.	60
LM End	11.04	Issue Type +	En	Location *	LS
Category	Earthen Levee			GPS Latitude/Longitude	
				Start	End
Item	Encroachments			39.647238 °	39.647238 °
				-121.787866 °	-121.787866 °
DWR ID	DWR_MA0005_02_f_2016_60				
Comment Code					
FE : Fence					
Inspector Comment					
Apply for permit or remove the fence post.

View of a newly constructed fence.

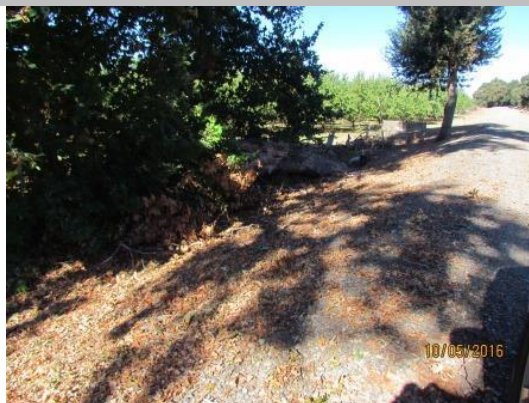
Photo 1 of 1 : SP_2017_MA0005_197_36_20170315_00013.jpg

LM Start	11.10	Rating **	M	Issue No.	36
LM End	11.10	Issue Type +	Ma	Location *	LS
Category	Earthen Levee			GPS Latitude/Longitude	
				Start	End
Item	Encroachments			39.647913 °	39.647913 °
				-121.788330 °	-121.788330 °
DWR ID	DWR_MA0005_02_s _ 2015_36				
Comment Code					
TR : Tree or limb					
Inspector Comment

Remove the tree log from the landside toe.

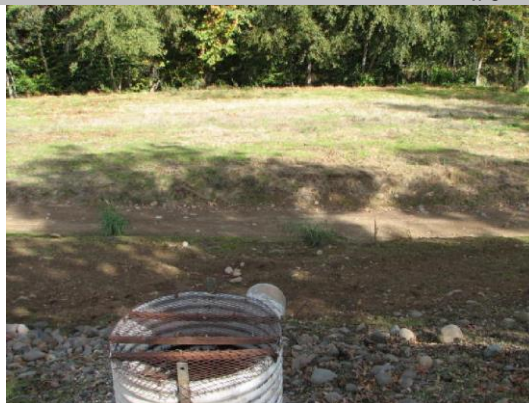
Photo 1 of 3 : UCIP_SP_2017_50947_68429.jpg

FS_ID:50947
DS_ID:1670
EP_NO: N/A
Repair Type: Non-Urgent
Crossing Status: Found
UCIP Comments: 11/14/2016 Appears abandoned- Slide gates in WS riser and LS distribution box missing. (DWR Sutter Yard-AFreitag)5/11/2016 Crossing appears to be in good condition.7/30/2015 Crossing appears in good condition. No noticeable issues to report.11/24/2014 Same as last inspection.6/4/2014 Same as last inspection.11/13/2013 Same as last inspection.6/6/2013 New flap gate installed on WS end of pipe.
FIELD_STRUCT_DESC: 24-inch (not 18-inch concrete as shown in as-built drawings) corrugated metal irrigation pipe through the levee, 9.7 feet below the crown. Slide gate in corrugated metal riser on the waterside (WS) slope. Flap gate on the WS toe. Slide gate in concrete distribution box on the landside (LS). [Additional Reference(s): DWR Levee Logs, 1990. USACE Sacramento O&M Manual 516, April 1960 (Station 215+65). USACE As-built Drawings 50-4-3367, April 1957, Exhibit B, Sheet 2 (Station 215+65)].

CM riser on WS shoulder-missing slide gate.

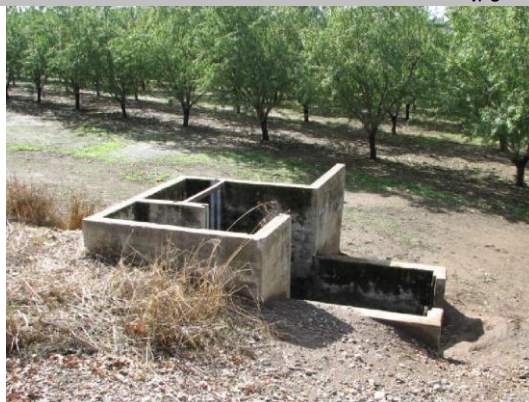
Photo 2 of 3 : UCIP_SP_2017_50947_68433.jpg

Distribution box on LS toe. Missing slide gate at pipe entrance.

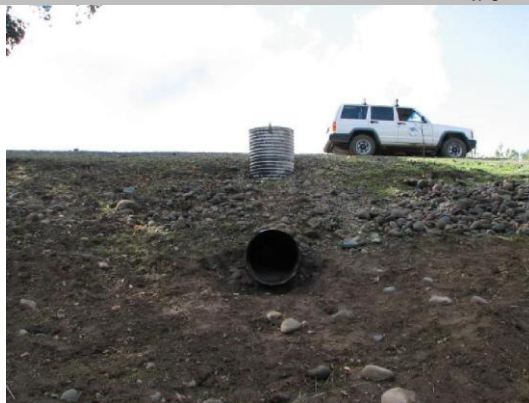
Photo 3 of 3 : UCIP_SP_2017_50947_68432.jpg

Item	DWR UCIP Field Study			39.648169 °		39.648169 °
				-121.788541 °		-121.788541 °
DWR ID						
Comment Code						
Inspector Comment						
FS_ID:50947 DS_ID:1670 EP_NO: N/A Repair Type: Non-Urgent Crossing Status: Found UCIP Comments: 11/14/2016 Appears abandoned- Slide gates in WS riser and LS distribution box missing. (DWR Sutter Yard-AFreitag)5/11/2016 Crossing appears to be in good condition.7/30/2015 Crossing appears in good condition. No noticeable issues to report.11/24/2014 Same as last inspection.6/4/2014 Same as last inspection.11/13/2013 Same as last inspection.6/6/2013 New flap gate installed on WS end of pipe. FIELD_STRUCT_DESC: 24-inch (not 18-inch concrete as shown in as-built drawings) corrugated metal irrigation pipe through the levee, 9.7 feet below the crown. Slide gate in corrugated metal riser on the waterside (WS) slope. Flap gate on the WS toe. Slide gate in concrete distribution box on the landside (LS). [Additional Reference(s): DWR Levee Logs, 1990. USACE Sacramento O&M Manual 516, April 1960 (Station 215+65). USACE As-built Drawings 50-4-3367, April 1957, Exhibit B, Sheet 2 (Station 215+65)]. FS Date: 11/22/2016 12:31:54 PM

View of pipe from WS looking toward LS.

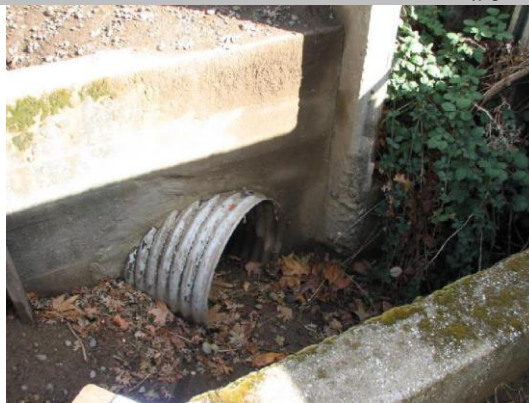
Photo 1 of 3 : UCIP_SP_2017_50948_68436.jpg

Comment Code					
Inspector Comment					
FS_ID:50948 DS_ID:1671 EP_NO: N/A Repair Type: Non-Urgent Crossing Status: Found UCIP Comments: 11/14/2016 Appears abandoned. (DWR Sutter Yard-AFreitag)5/11/2016 Abandoned crossing7/30/2015 Abandoned crossing. Unable to locate the WS end of pipe.11/24/2014 Same as last inspection.6/4/2014 Same as last inspection.11/13/2013 Same as last inspection.6/6/2013 Same as last inspection.11/01/2012 Pipe appears abandoned. It needs to be abandoned properly. FIELD_STRUCT_DESC: 30-inch corrugated metal irrigation pipe through the levee, 9.4 feet below the crown. Slide gate in a 42-inch corrugated metal riser on the waterside (WS) slope. Concrete distribution box on the landside (LS). [Additional Reference(s): DWR Levee Logs, 1990. USACE Sacramento O&M Manual 516, April 1960 (Station 215+46)]. FS Date: 11/22/2016 12:47:44 PM

Pipe at concrete distribution box on LS toe.

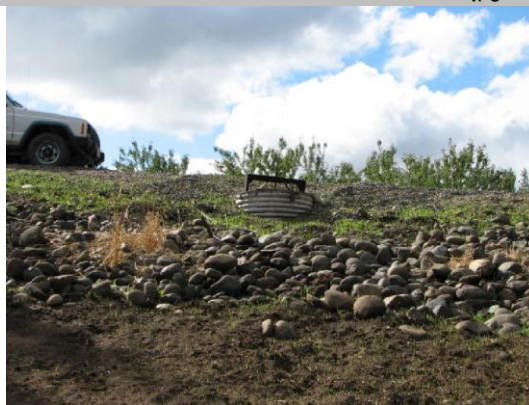
Photo 2 of 3 : UCIP_SP_2017_50948_68435.jpg

CM riser with slide gate on WS shoulder.

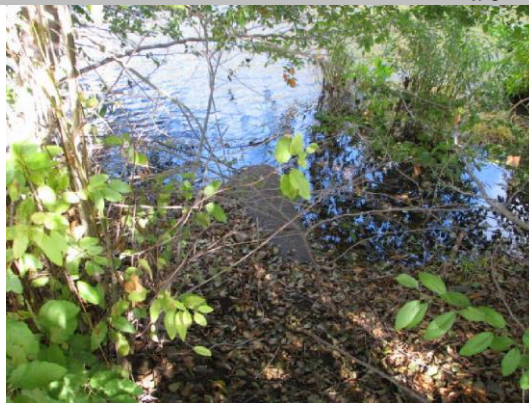
Photo 3 of 3 : UCIP_SP_2017_50948_68434.jpg

Item	DWR UCIP Field Study			39.648185 °	39.648185 °	
				-121.788563 °	-121.788563 °	
DWR ID						
Comment Code						
Inspector Comment						
FS_ID:50948 DS_ID:1671 EP_NO: N/A Repair Type: Non-Urgent Crossing Status: Found UCIP Comments: 11/14/2016 Appears abandoned. (DWR Sutter Yard-AFreitag)5/11/2016 Abandoned crossing7/30/2015 Abandoned crossing. Unable to locate the WS end of pipe.11/24/2014 Same as last inspection.6/4/2014 Same as last inspection.11/13/2013 Same as last inspection.6/6/2013 Same as last inspection.11/01/2012 Pipe appears abandoned. It needs to be abandoned properly. FIELD_STRUCT_DESC: 30-inch corrugated metal irrigation pipe through the levee, 9.4 feet below the crown. Slide gate in a 42-inch corrugated metal riser on the waterside (WS) slope. Concrete distribution box on the landside (LS). [Additional Reference(s): DWR Levee Logs, 1990. USACE Sacramento O&M Manual 516, April 1960 (Station 215+46)]. FS Date: 11/22/2016 12:47:44 PM

Concrete pipe at edge of creek on WS.

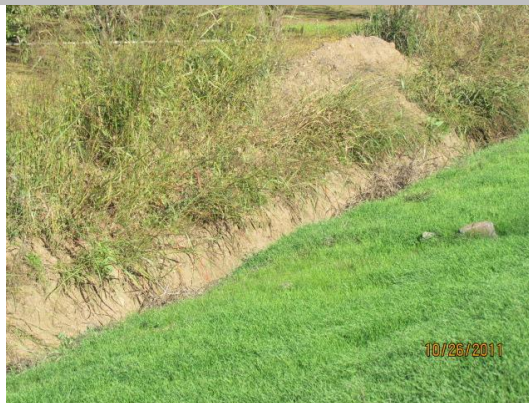
Photo 1 of 1 : SP_2017_MA0005_197_6_20170315_00003.jpg

LM Start	11.57	Rating **	M	Issue No.	6
LM End	11.77	Issue Type +	En	Location *	LS
Category	Earthen Levee			GPS Latitude/Longitude	
				Start	End
Item	Encroachments			39.654349 °	39.657142 °
				-121.789531 °	-121.788690 °
DWR ID	DWR_MA0005_02_s_2012_6				
Comment Code					
DT : Ditch					
Inspector Comment

View of the ditch along the Landside toe.
