**Flood Control Project Maintenance
Levee Inspections**
LMA District Cover Sheet
Spring 2017 Levee Inspection Results

Sutter Maintenance Yard Maintenance Area 0005

Spring 2017 Levee Inspection Results

Waterway			Bank	Unit Miles
Unit No. 01 Butte Creek			Left	15.08
	Spring (March - May)	Summer (June - August)	(September - November) Fall	Winter (December - February)
Unit Maintenance Rating (Fall Only)				
Date of Inspection	5/2/2017 - 5/2/2017			
DWR Inspector	Bob Duffey			
Accompanied By	Shawn Freitag Sutter Maintenance Yard

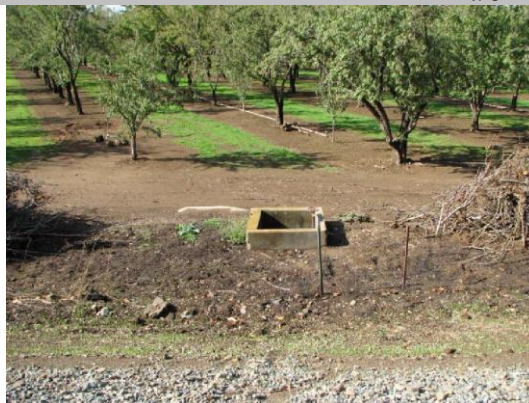
Photo 1 of 3 : UCIP_SP_2017_50949_68439.jpg

FS_ID:50949
DS_ID:1672
EP_NO: N/A
Repair Type: Non-Urgent
Crossing Status: Found
UCIP Comments: 11/14/2016 Crossing appears to be in good condition. (DWR Sutter Yard- AFreitag)5/11/2016 Crossing appears to be in good condition.7/30/2015 Crossing is not abandoned. Water was flowing through the standpipe on the WS shoulder. Unable to locate the source of the water or where it was flowing to.11/24/2014 Same as last inspection.6/4/2014 Same as last inspection.11/13/2013 Same as last inspection.6/6/2013 Same as last inspection.11/01/2012 This pipe appears to be abandoned.
FIELD_STRUCT_DESC: 30-inch corrugated metal irrigation pipe through the levee, 12.3 feet below the crown. Slide gate in a 42-inch corrugated metal riser on the waterside (WS) slope. 5-foot by 5-foot Concrete distribution box at landside (LS) toe. [Additional Reference(s): DWR Levee Logs, 1990. USACE Sacramento O&M Manual 516, April 1960 (Station 165+60)].

5X5 concrete distribution box at LS toe.

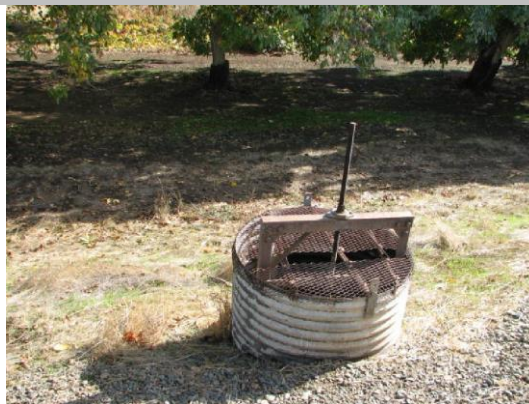
Photo 2 of 3 : UCIP_SP_2017_50949_68438.jpg

42-inch CMP riser on WS shoulder with slide gate.

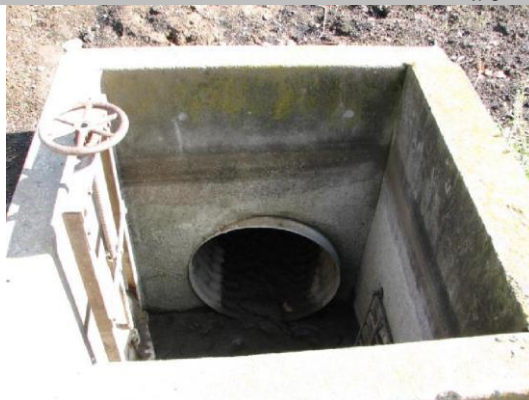
Photo 3 of 3 : UCIP_SP_2017_50949_68437.jpg

Item	DWR UCIP Field Study			39.660980 °	39.660980 °	
				-121.786341 °	-121.786341 °	
DWR ID						
Comment Code						
Inspector Comment						
FS_ID:50949 DS_ID:1672 EP_NO: N/A Repair Type: Non-Urgent Crossing Status: Found UCIP Comments: 11/14/2016 Crossing appears to be in good condition. (DWR Sutter Yard- AFreitag)5/11/2016 Crossing appears to be in good condition.7/30/2015 Crossing is not abandoned. Water was flowing through the standpipe on the WS shoulder. Unable to locate the source of the water or where it was flowing to.11/24/2014 Same as last inspection.6/4/2014 Same as last inspection.11/13/2013 Same as last inspection.6/6/2013 Same as last inspection.11/01/2012 This pipe appears to be abandoned. FIELD_STRUCT_DESC: 30-inch corrugated metal irrigation pipe through the levee, 12.3 feet below the crown. Slide gate in a 42-inch corrugated metal riser on the waterside (WS) slope. 5-foot by 5-foot Concrete distribution box at landside (LS) toe. [Additional Reference(s): DWR Levee Logs, 1990. USACE Sacramento O&M Manual 516, April 1960 (Station 165+60)]. FS Date: 11/22/2016 12:56:17 PM

Pipe at inlet to 5X5 concrete distribution box at LS toe.

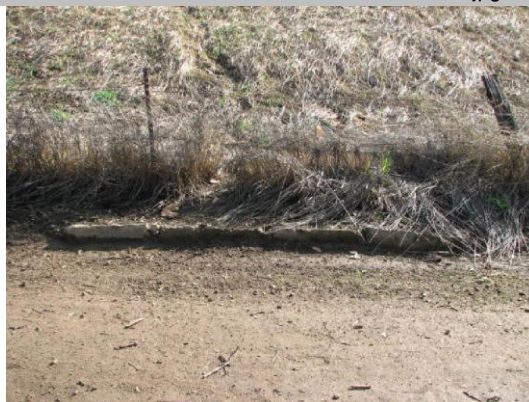
Photo 2 of 3 : UCIP_SP_2017_50950_68464.jpg

FS_ID:50950
DS_ID:1673
EP_NO: N/A
Repair Type: Non-Urgent
Crossing Status: Found
UCIP Comments: 11/14/2016 Abandoned- needs a cover for standpipe. (DWR Sutter Yard- A Freitag) 5/11/2016 Abandoned crossing. Needs a cover for the WS riser. 8/3/2015 Crossing appears abandoned. Only the slide gate inside riser on the WS shoulder could be found. Riser needs a cover made for it. 11/24/2014 Same as last inspection. 6/4/2014 Same as last inspection. 11/13/2013 Slide gate top and stem were repaired to make gate operational. 6/6/2013 New slidegate is planned to be installed during summer of 2013. 11/01/2012 Slide gate on WS shoulder bent and damaged (inoperable) Pipe appears abandoned.
FIELD_STRUCT_DESC: *ABANDONED* 24-inch corrugated metal drainage pipe through the levee, 14 feet below the crown. Slide gate in a corrugated metal riser on the waterside (WS) slope. [Additional Reference(s): DWR Levee Log, 1990. USACE Sacramento O&M Manual 516, April 1960 (Station 126+91)].

Abandoned headwall on LS toe.

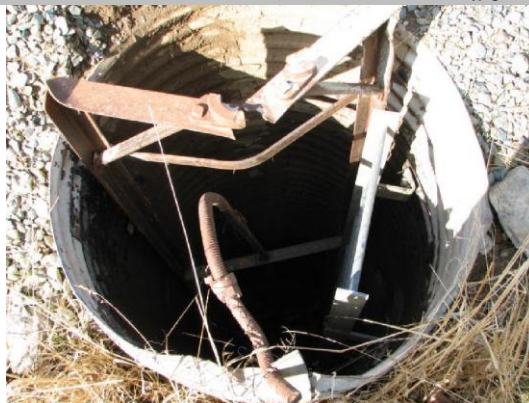
Photo 3 of 3 : UCIP_SP_2017_50950_68463.jpg

Item	DWR UCIP LMA Responsibility			39.670982 °		39.670982 °
				-121.783103 °		-121.783103 °
DWR ID						
Comment Code						
Inspector Comment						
FS_ID:50950 DS_ID:1673 EP_NO: N/A Repair Type: Non-Urgent Crossing Status: Found UCIP Comments: 11/14/2016 Abandoned- needs a cover for standpipe. (DWR Sutter Yard- A/Freitag)5/11/2016 Abandoned crossing. Needs a cover for the WS riser.8/3/2015 Crossing appears abandoned. Only the slide gate inside riser on the WS shoulder could be found. Riser needs a cover made for it.11/24/2014 Same as last inspection.6/4/2014 Same as last inspection.11/13/2013 Slide gate top and stem were repaired to make gate operational.6/6/2013 New slidegate is planned to be installed during summer of 2013.11/01/2012 Slide gate on WS shoulder bent and damaged (inoperable) Pipe appears abandoned. FIELD_STRUCT_DESC: *ABANDONED* 24-inch corrugated metal drainage pipe through the levee, 14 feet below the crown. Slide gate in a corrugated metal riser on the waterside (WS) slope. [Additional Reference(s): DWR Levee Log, 1990. USACE Sacramento O&M Manual 516, April 1960 (Station 126+91)]. FS Date: 11/22/2016 12:57:09 PM

Broken slide gate in CM riser on WS slope.

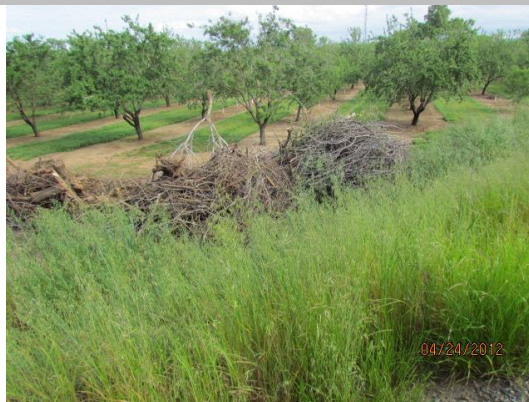
Photo 1 of 1 : SP_2017_MA0005_197_19_20170315_00008.jpg

LM Start	12.83	Rating **	M	Issue No.	19
LM End	12.83	Issue Type +	En	Location *	LS
Category	Earthen Levee			GPS Latitude/Longitude	
				Start	End
Item	Encroachments			39.671239 °	39.671239 °
				-121.782486 °	-121.782486 °
DWR ID	DWR_MA0005_02_s_2012_19				
Comment Code					
PR : Prunings					
Inspector Comment

View of the brush pile at the toe of the levee.

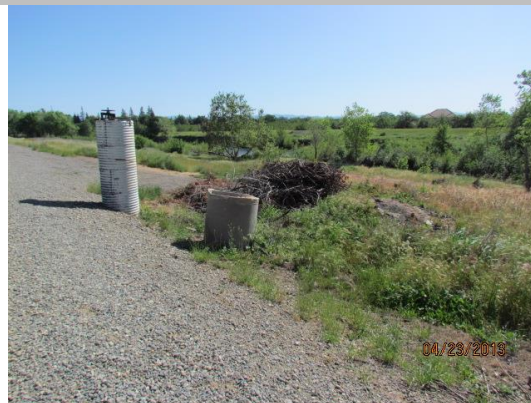
Photo 1 of 1 : SP_2017_MA0005_197_22_20170315_00009.jpg

LM Start	13.15	Rating **	M	Issue No.	22
LM End	13.15	Issue Type +	En	Location *	WS
Category	Earthen Levee			GPS Latitude/Longitude	
				Start	End
Item	Encroachments			39.675311 °	39.675311 °
				-121.780371 °	-121.780371 °
DWR ID	DWR_MA0005_02_s_2013_22				
Comment Code					
PR : Prunings					
Inspector Comment

View of the prunings along the waterside toe.

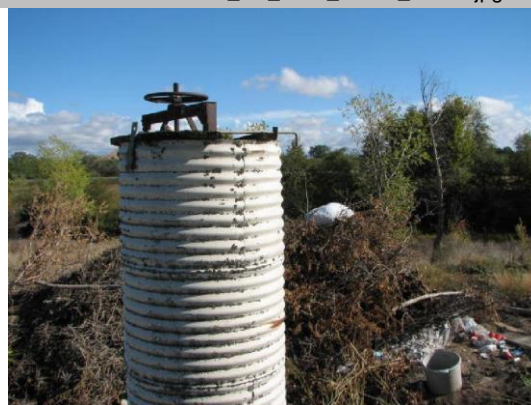
Photo 1 of 1 : UCIP_SP_2017_50951_68488.jpg

Comment Code					
Inspector Comment					
FS_ID:50951 DS_ID:1674 EP_NO: 1291 Repair Type: Non-Urgent Crossing Status: Found UCIP Comments: 11/14/2016 Appears abandoned- needs to be done so properly (DWR Sutter Yard- AFreitag)5/11/2016 Appears to be an abandoned crossing.8/3/2015 Pipe appears to be abandoned. Pump on WS berm is still missing.11/24/2014 Same as last inspection.6/4/2014 Same as last inspection.11/13/2013 Same as last inspection.6/6/2013 Same as last inspection.11/01/2012 Pipe appears to be abandoned. No pump found. Pipe should be abandoned properly. FIELD_STRUCT_DESC: 24-inch corrugated metal irrigation pipe through the levee, 9.0 feet below the crown. Slide gate in a 36-inch corrugated metal riser on the waterside (WS) slope. Pump and a 36-inch concrete standpipe on the WS. Originally installed under (Permit No. 1291, 1948 - Hansen) Permit described as a 14-inch concrete pipe. [Additional Reference(s): DWR Levee Logs, 1990. USACE Sacramento O&M Manual 516, April 1960 (Station 106+93)]. FS Date: 11/22/2016 12:58:04 PM

Slide gate in CM riser on WS toe.

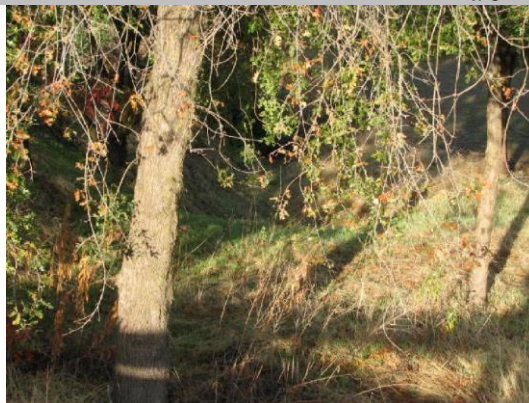
Photo 1 of 3 : UCIP_SP_2017_50960_68531.jpg

FS_ID:50960
DS_ID:1679
EP_NO: N/A
Repair Type: No Action Needed
Crossing Status: Found
UCIP Comments: 11/14/2016 Crossing appears to be in good condition. (DWR Sutter Yard- A Freitag) 5/11/2016 Crossing appears to be in good condition. 8/3/2015 Crossing appears in good condition. No noticeable issues to report. 11/25/2014 Same as last inspection. 6/4/2014 Same as last inspection. 11/13/2013 Same as last inspection. 6/6/2013 Same as last inspection.
FIELD_STRUCT_DESC: 24-inch corrugated metal drainage pipe through the levee, 14.5 feet below the crown. Concrete "U" shaped headwall on the waterside (WS). Flap gate on the WS. [Additional Reference(s): DWR Levee Logs, 1990. USACE Sacramento O&M Manual 516, April 1960 (Station 93+78)].
FS Date: 11/22/2016 1:05:24 PM

Inlet relocated after bridge replacement away from LS toe.

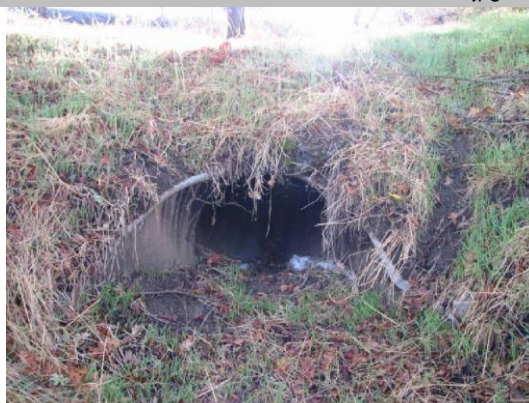
Photo 2 of 3 : UCIP_SP_2017_50960_68530.jpg

Inlet 50-feet NW of levee crown.

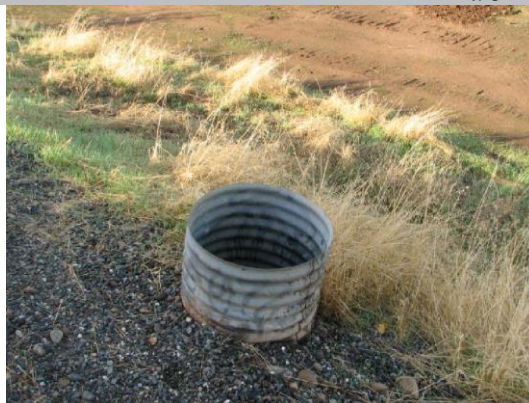
Photo 1 of 1 : UCIP_SP_2017_50962_68535.jpg

Comment Code					
Inspector Comment					
FS_ID:50962 DS_ID:1681 EP_NO: N/A Repair Type: Non-Urgent Crossing Status: Found UCIP Comments: 11/14/2016 Appears abandoned (DWR Sutter Yard-AFreitag)5/11/216 Abandoned crossing8/3/2015 Pipe still appears abandoned.11/25/2014 Same as last inspection.6/4/2014 Same as last inspection.11/13/2013 Same as last inspection.6/6/2013 Same as last inspection.11/01/2012 Pipe appears to be abandoned. FIELD_STRUCT_DESC: *ABANDONED* 6-inch steel irrigation pipe through the levee, 7.1 feet below the crown. Siphon breaker in a corrugated metal riser on the landside (LS) slope. One corrugated metal cutoff wall. Pipe is open on both ends. [Additional Reference(s): DWR Levee Logs, 1990. USACE Sacramento O&M Manual 516, April 1960 (Station 65+52)]. FS Date: 11/22/2016 1:06:32 PM

CM riser with siphon breaker on LS shoulder.

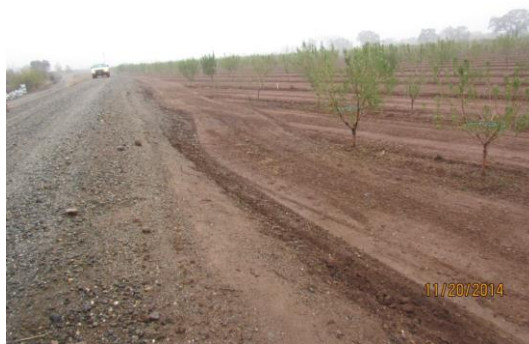
Photo 1 of 1 : SP_2017_MA0005_197_43_20170315_00019.jpg

LM Start	14.13	Rating **	U	Issue No.	43
LM End	14.13	Issue Type +	Ma	Location *	LS
Category	Earthen Levee			GPS Latitude/Longitude	
				Start	End
Item	Slope Stability			39.688715 °	39.688715 °
				-121.778345 °	-121.778345 °
DWR ID	DWR_MA0005_02_f_2014_43				
Comment Code					
S1 : Repair slope instability.					
Inspector Comment

View of the tilling into the landside slope.

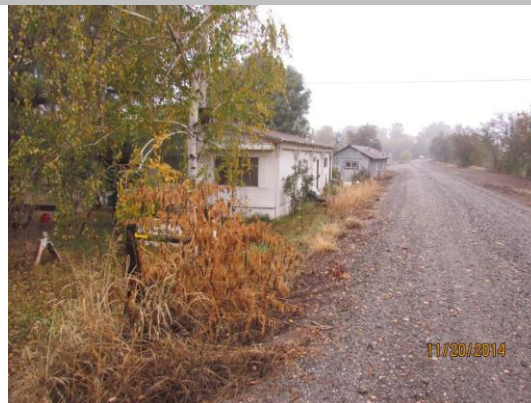
Photo 1 of 1 : SP_2017_MA0005_197_25_20170315_00010.jpg

LM Start	14.33	Rating **	U	Issue No.	25
LM End	14.33	Issue Type +	En	Location *	LS
Category	Earthen Levee			GPS Latitude/Longitude	
				Start	End
Item	Encroachments			39.691580 °	39.691580 °
				-121.779254 °	-121.779254 °
DWR ID	DWR_MA0005_02_s_2012_25				
Comment Code					
BU : Building					
Inspector Comment					
Unpermitted structure.

View of the buildings at the landside toe.

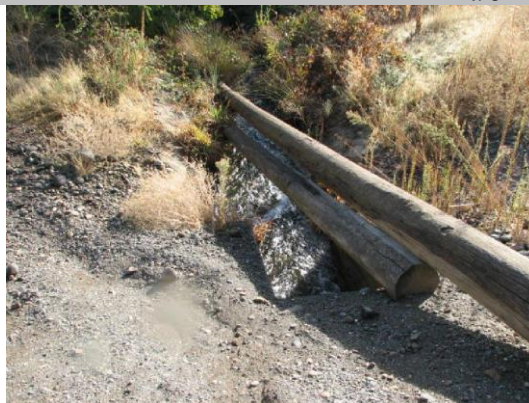
Photo 1 of 3 : UCIP_SP_2017_50963_68544.jpg

FS_ID:50963
DS_ID:1682
EP_NO: N/A
Repair Type: No Action Needed
Crossing Status: Found
UCIP Comments: 11/14/2016 Crossing appears to be in good condition. (DWR Sutter Yard- A Freitag) 5/11/2016 Crossing appears to be in good condition. 8/3/2015 Crossing appears in good condition. No noticeable issues to report. 11/25/2014 Same as last inspection. 6/4/2014 Same as last inspection. 11/13/2013 Same as last inspection. 6/6/2013 Same as last inspection.
FIELD_STRUCT_DESC: 24-inch corrugated metal drainage pipe through the levee, 7.2 feet below the crown. Concrete "U" shaped headwall and grouted spillway on the waterside (WS). Slide gate in a 48-inch concrete standpipe on the landside (LS). Flap gate on the WS.
[Additional Reference(s): DWR Levee Logs, 1990. USACE Sacramento O&M Manual 516, April 1960 (Station 37+10)].
FS Date: 11/22/2016 1:07:21 PM

Outlet at U-shaped headwall on WS toe.

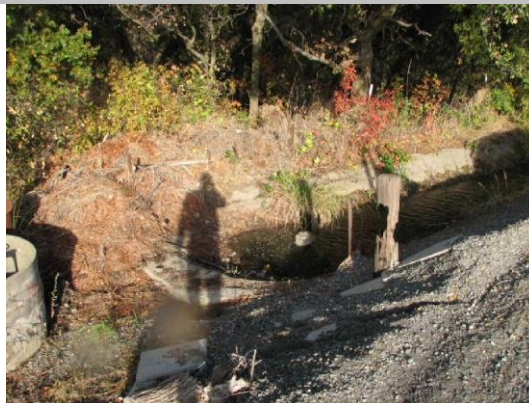
Photo 2 of 3 : UCIP_SP_2017_50963_68543.jpg

Concrete lined channel on LS toe.

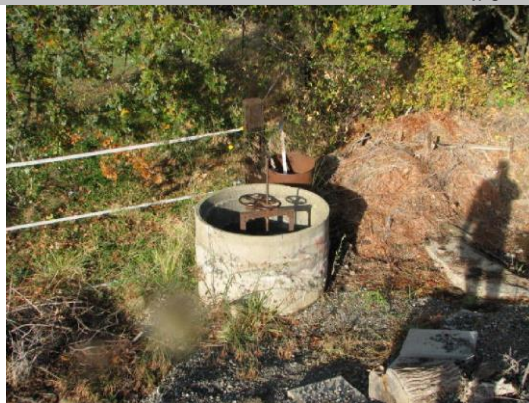
Photo 3 of 3 : UCIP_SP_2017_50963_68542.jpg

Item	DWR UCIP LMA Responsibility			39.693331 °	39.693331 °	
				-121.779556 °	-121.779556 °	
DWR ID						
Comment Code						
Inspector Comment						
FS_ID:50963 DS_ID:1682 EP_NO: N/A Repair Type: No Action Needed Crossing Status: Found UCIP Comments: 11/14/2016 Crossing appears to be in good condition. (DWR Sutter Yard- A Freitag)5/11/2016 Crossing appears to be in good condition.8/3/2015 Crossing appears in good condition. No noticeable issues to report.11/25/2014 Same as last inspection.6/4/2014 Same as last inspection.11/13/2013 Same as last inspection.6/6/2013 Same as last inspection. FIELD_STRUCT_DESC: 24-inch corrugated metal drainage pipe through the levee, 7.2 feet below the crown. Concrete "U" shaped headwall and grouted spillway on the waterside (WS). Slide gate in a 48-inch concrete standpipe on the landside (LS). Flap gate on the WS. [Additional Reference(s): DWR Levee Logs, 1990. USACE Sacramento O&M Manual 516, April 1960 (Station 37+10)]. FS Date: 11/22/2016 1:07:21 PM

Concrete standpipe and slide gate on LS toe.

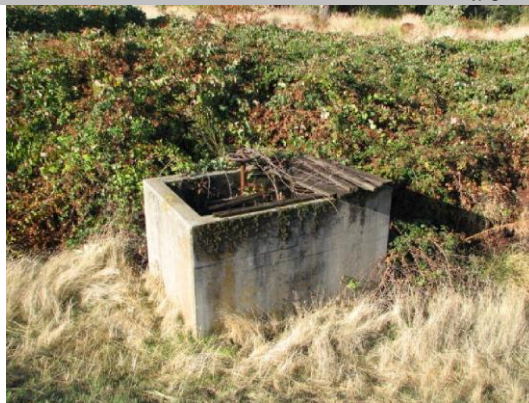
Photo 1 of 2 : UCIP_SP_2017_50967_68570.jpg

FS_ID:50967
DS_ID:1685
EP_NO: N/A
Repair Type: Non-Urgent
Crossing Status: Found
UCIP Comments: 11/14/2016 Good condition- needs a cover for the riser. (DWR Sutter Yard- A Freitag) 5/11/2016 Needs a cover for riser. The rest of the crossing appears to be in good condition. 8/3/2015 Crossing appears in good condition but needs a cover made for the riser. 11/25/2014 Same as last inspection. 6/4/2014 Same as last inspection. 11/13/2013 Same as last inspection. 6/6/2013 Same as last inspection.
FIELD_STRUCT_DESC: 42-inch steel irrigation pipe (siphon) through the levee, 10 feet below the crown. Slide gate in a 54-inch corrugated metal riser on the waterside (WS) slope. 5 foot by 8 foot Concrete distribution box on the landside (LS). Two corrugated metal cutoff walls installed within the levee. [Additional Reference(s): DWR Levee Logs, 1990. USACE Sacramento O&M Manual 516, April 1960 (Station 8+30)].

Concrete distribution box with slide gate on LS toe.

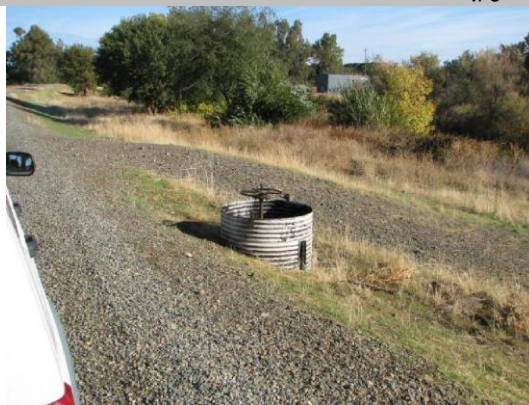
Photo 2 of 2 : UCIP_SP_2017_50967_68569.jpg

CMP riser on WS shoulder with slide gate.

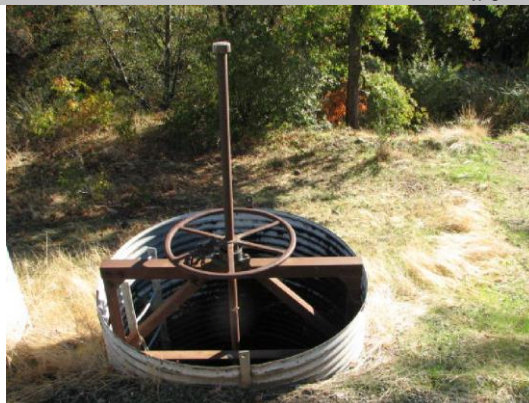
Photo 1 of 3 : UCIP_SP_2017_50969_68575.jpg

Comment Code					
Inspector Comment					
FS_ID:50969 DS_ID:1687 EP_NO: N/A Repair Type: Non-Urgent Crossing Status: Found UCIP Comments: 11/14/2016 Good condition- needs a cover for standpipe. (DWR Sutter Yard- AFreitag)5/11/2016 Needs a lcover for riser. The rest of the crossing appears in good condition.8/3/2015 Crossing is in good condition but needs a cover made for the riser.11/25/2014 Same as last inspection.6/4/2014 Same as last inspection.11/13/2013 Same as last inspection.6/6/2013 Same as last inspection. Need to construct covers for top of standpipe.11/02/2012 Good candidate for video inspection. FIELD_STRUCT_DESC: 1 of 2: 54-inch corrugated metal irrigation pipe (siphon) through the levee, 17.8 feet below the crown. Slide gate in a 66-inch corrugated metal riser on the waterside (WS). Concrete headwall and irrigation ditch at the landside (LS) toe. Edgar Slough riser units in the floodway. [Additional Reference(s): DWR Levee Logs, 1990. USACE Sacramento O&M Manual 516, April 1960 (Station 132+00)]. FS Date: 11/22/2016 1:12:18 PM

66-inch CMP riser on WS shoulder with slide gate.

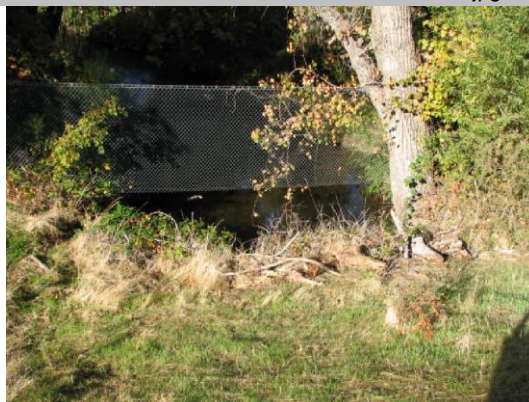
Photo 2 of 3 : UCIP_SP_2017_50969_68574.jpg

Irrigation ditch at LS toe.

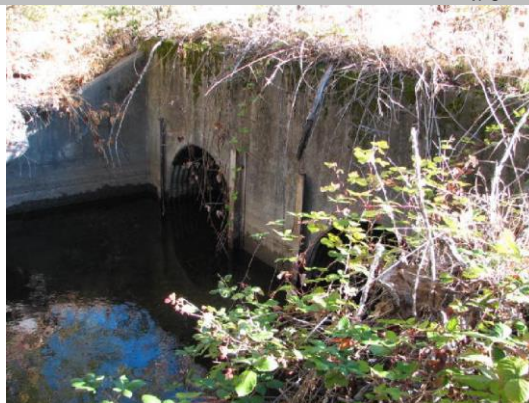
Photo 3 of 3 : UCIP_SP_2017_50969_68573.jpg

Item	DWR UCIP Field Study			39.707544 °	39.707544 °	
				-121.777701 °	-121.777701 °	
DWR ID						
Comment Code						
Inspector Comment						
FS_ID:50969 DS_ID:1687 EP_NO: N/A Repair Type: Non-Urgent Crossing Status: Found UCIP Comments: 11/14/2016 Good condition- needs a cover for standpipe. (DWR Sutter Yard- AFreitag)5/11/2016 Needs a lcover for riser. The rest of the crossing appears in good condition.8/3/2015 Crossing is in good condition but needs a cover made for the riser.11/25/2014 Same as last inspection.6/4/2014 Same as last inspection.11/13/2013 Same as last inspection.6/6/2013 Same as last inspection. Need to construct covers for top of standpipe.11/02/2012 Good candidate for video inspection. FIELD_STRUCT_DESC: 1 of 2: 54-inch corrugated metal irrigation pipe (siphon) through the levee, 17.8 feet below the crown. Slide gate in a 66-inch corrugated metal riser on the waterside (WS). Concrete headwall and irrigation ditch at the landside (LS) toe. Edgar Slough riser units in the floodway. [Additional Reference(s): DWR Levee Logs, 1990. USACE Sacramento O&M Manual 516, April 1960 (Station 132+00)]. FS Date: 11/22/2016 1:12:18 PM

Concrete headwall on LS toe.

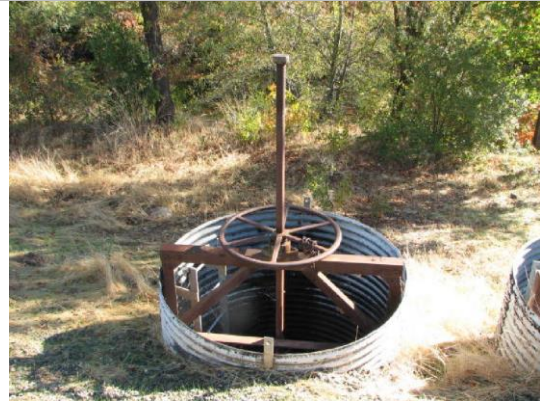
Photo 3 of 3 : UCIP_SP_2017_50970_68577.jpg

Comment Code					
Inspector Comment					
FS_ID:50970 DS_ID:16316 EP_NO: N/A Repair Type: Non-Urgent Crossing Status: Found UCIP Comments: 11/14/2016 Good condition- needs a cover for standpipe. (DWR Sutter Yard- AFreitag)5/11/2016 Needs a lcover for riser. The rest of the crossing appears in good condition.8/3/2015 Crossing appears in good condition but needs a cover made for the riser.11/25/2014 Same as last inspection.6/4/2014 Same as last inspection.11/13/2013 Same as last inspection.6/6/2013 Same as last inspection. Need to construct cover for top of standpipe.11/01/2012 Good candidate for video inspection. FIELD_STRUCT_DESC: 2 of 2: 54-inch corrugated metal irrigation pipe through the levee, 17.8 feet below the crown. Slide gate in a 66-inch corrugated metal riser on the waterside (WS). A concrete headwall and an irrigation ditch are located at the landside (LS) toe. Edgar Slough riser units located in the floodway. [Additional Reference(s): DWR Levee Logs, 1990. USACE Sacramento O&M Manual 516, April 1960 (Station 132+00)]. FS Date: 11/22/2016 1:13:26 PM

66-inch CMP riser on WS shoulder.

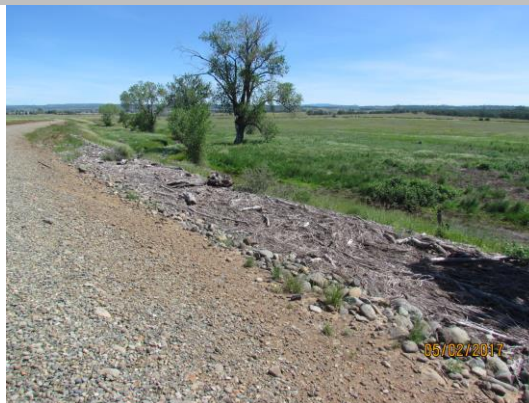
Photo 1 of 1 : SP_2017_MA0005_197_74_20170508_00111.jpg

LM Start	16.17	Rating **	M	Issue No.	74
LM End	16.17	Issue Type +	En	Location *	WS
Category	Earthen Levee			GPS Latitude/Longitude	
				Start	End
Item	Encroachments			39.715680 °	39.715680 °
				-121.783037 °	-121.783037 °
DWR ID	DWR_MA0005_02_s_2017_74				
Comment Code					
DE : Debris					
Inspector Comment					
Remove the debris from the water side slope and toe.

View of the debris along the waterside slope and toe.

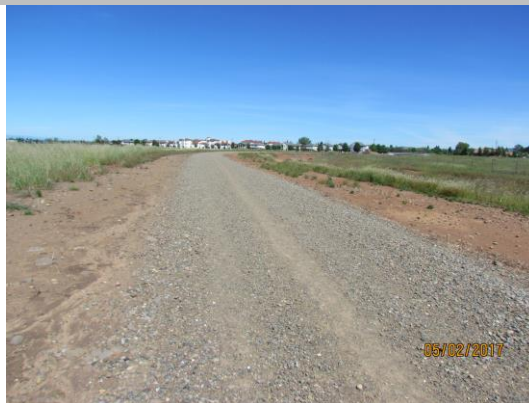
Photo 1 of 1 : SP_2017_MA0005_198_2_20170508_00001.jpg

LM Start	0.51	Rating **	A	Issue No.	2
LM End	0.51	Issue Type +	Ma	Location *	LS
Category	Earthen Levee			GPS Latitude/Longitude	
				Start	End
Item	Vegetation			39.723773 °	39.723773 °
				-121.780468 °	-121.780468 °
DWR ID	DWR_MA0005_03_s_2017_2				
Comment Code					
V1 : Control annual grass and weeds on the levee slopes and easements.					
Inspector Comment					
The vegetation was removed from both slopes.

View of no vegetation on both slopes.
