**Flood Control Project Maintenance  
Levee Inspections**  
**LMA District Cover Sheet**  
**Spring 2018 Levee Inspection Results**

**Sutter Maintenance Yard Maintenance Area 0005**

**Spring 2018 Levee Inspection Results**

Waterway			Bank	Unit Miles
Unit No. 01 Butte Creek			Left	15.08
	Spring (March - May)	Summer (June - August)	(September - November) Fall	Winter (December - February)
Unit Maintenance Rating (Fall Only)				
Date of Inspection	3/14/2018 - 3/14/2018			
DWR Inspector	Bob Duffey			
Accompanied By	Shawn Freitag Sutter Maintenance Yard

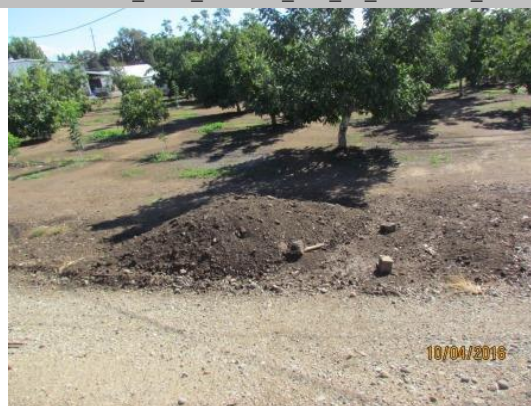
Photo 1 of 1 : SP\_2018\_MA0005\_196\_53\_20180305\_00026.jpg

LM Start	1.52	Rating **	M	Issue No.	53
LM End	1.52	Issue Type +	En	Location *	LS
Category	Earthen Levee			GPS Latitude/Longitude	
				Start	End
Item	Encroachments			39.677240 °	39.677240 °
				-121.777521 °	-121.777521 °
DWR ID	DWR_MA0005_01_f_2016_53				
Comment Code					
DE : Debris					
Inspector Comment					
Remove the pile of soil and rocks on the landside toe.

View of the soil and rock pile on the landside toe.

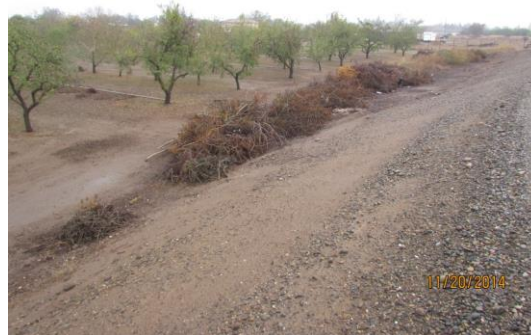
Photo 1 of 1 : SP\_2018\_MA0005\_196\_35\_20180305\_00014.jpg

LM Start	1.88	Rating **	M	Issue No.	35
LM End	1.88	Issue Type +	En	Location *	LS
Category	Earthen Levee			GPS Latitude/Longitude	
				Start	End
Item	Encroachments			39.672627 °	39.672627 °
				-121.779778 °	-121.779778 °
DWR ID	DWR_MA0005_01_f_2014_35				
Comment Code					
PR : Prunings					
Inspector Comment					
Remove the prunings from the landside toe.

View of the prunings along the landside toe.

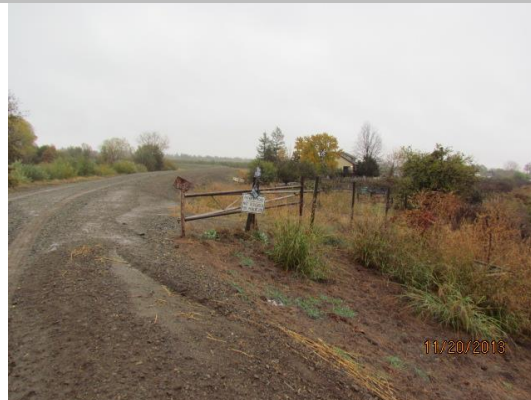
Photo 1 of 1 : SP\_2018\_MA0005\_196\_10\_20180305\_00005.jpg

LM Start	2.09	Rating **	M	Issue No.	10
LM End	2.09	Issue Type +	En	Location *	LS
Category	Earthen Levee			GPS Latitude/Longitude	
				Start	End
Item	Encroachments			39.670112 °	39.670112 °
				-121.782012 °	-121.782012 °
DWR ID	DWR_MA0005_01_s_2016_10				
Comment Code					
FE : Fence					
Inspector Comment					
No permit was found for the gate.

View of the unpermitted gate.

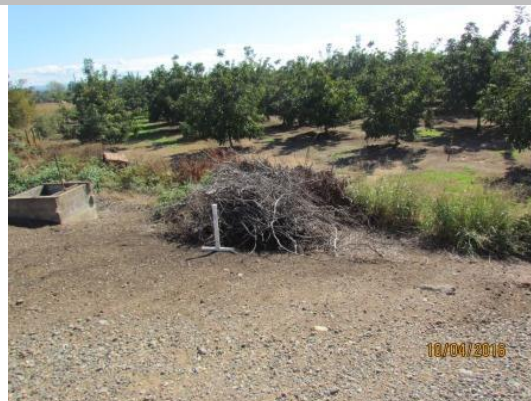
Photo 1 of 1 : SP\_2018\_MA0005\_196\_54\_20180305\_00027.jpg

LM Start	2.10	Rating **	M	Issue No.	54
LM End	2.10	Issue Type +	En	Location *	LS
Category	Earthen Levee			GPS Latitude/Longitude	
				Start	End
Item	Encroachments			39.670018 °	39.670018 °
				-121.781997 °	-121.781997 °
DWR ID	DWR_MA0005_01_f_2016_54				
Comment Code					
PR : Prunings					
Inspector Comment					
Remove the prunings from the landside toe.

View of the prunings along the landside toe.

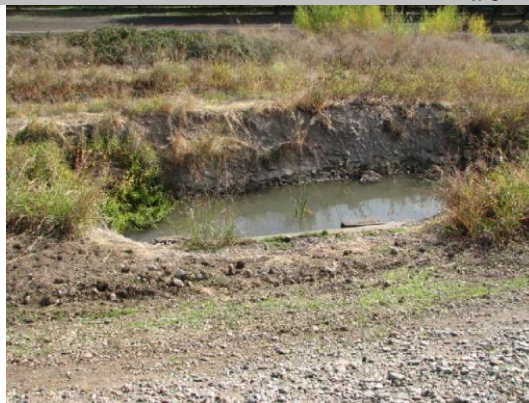
Photo 1 of 3 : UCIP\_SP\_2018\_51954\_67939.jpg

FS\_ID:51954  
DS\_ID:1768  
EP\_NO: N/A  
Repair Type: Non-Urgent  
Crossing Status: Found  
UCIP Comments: 5/15/2017 Abandoned and needs to be done properly. A sink hole formed in the WS toe road and revealed the location of the WS pipe end. Sink hole will need to be repaired before the next high water season but the pipe has been selected to be internally cleaned and camera inspected as part of the DMP project so it will have needed to be excavated along the WS end anyways. (DWR Sutter Yard- A Freitag)11/15/2016 Abandoned. Needs standpipe cover. (DWR Sutter Yard- A Freitag)5/9/2016 Abandoned pipe. Needs a cover for standpipe.8/5/2015 Abandoned pipes. Need covers made for tops of standpipes to prevent falls. 12/8/2014 Same as last inspection.6/11/2014 Same as last inspection.11/19/2013 Same as last inspection.5/29/2013 Same as last inspection. Land owner said pipes are abandoned and no longer used. Covers should be made for top of standpipe to prevent falls. Pipes should be properly abandoned.10/30/2012 Pipe 1/2 filled with soil at slide gate on WS. FIELD\_STRUCT\_DESC: "ABANDONED" 2 of 2: 36-inch corrugated metal drainage pipe through the levee, 11 feet below the crown. Slide gate in a 54-inch corrugated metal riser on the waterside (WS) slope. Concrete "U" shaped headwall on the landside (LS). [Additional Reference(s): DWR Levee Log, 1990. Sacramento O&M Manual 516, April 1960, (Station 470+00)].

Headwall at LS toe.

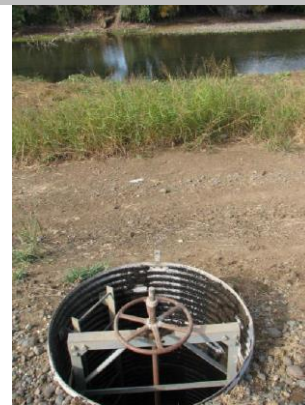
Photo 2 of 2 : UCIP\_SP\_2018\_51955\_67940.jpg

FS\_ID:51955  
DS\_ID:1620  
EP\_NO: N/A  
Repair Type: Non-Urgent  
Crossing Status: Found  
UCIP Comments: 5/15/2017 Abandoned and needs to be done properly. A sink hole formed in the WS toe road and revealed the location of the WS pipe end. Sink hole will need to be repaired before the next high water season but the pipe has been selected to be internally cleaned and camera inspected as part of the DMP project so it will have needed to be excavated along the WS end anyways. (DWR Sutter Yard- A Freitag) 11/15/2016 Abandoned. Needs cover for the standpipe. (DWR Sutter Yard- A Freitag) 5/9/2016 Abandoned pipe. Needs a cover for the standpipe. 8/5/2015 Abandoned crossing. Covers need to be made for tops of standpipes to prevent falls. 12/8/2014 Same as last inspection. 6/11/2014 Same as last inspection. 11/19/2013 Same as last inspection. 5/29/2013 Same as last inspection. Land owner said pipes are abandoned and no longer used. Covers should be made for top of standpipe to prevent falls. Pipes should be properly abandoned. 10/30/2012 Pipe 1/2 filled with soil at slide gate end.

54-inch CMP riser and slide gate on WS shoulder.

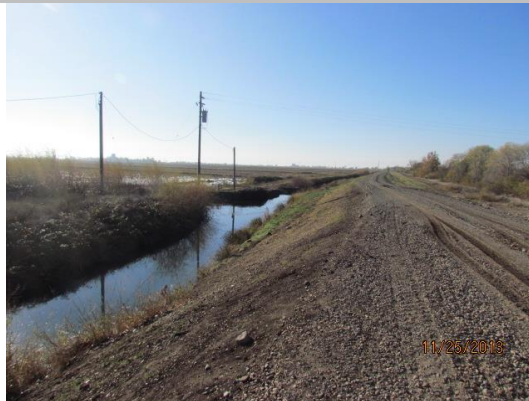
Photo 1 of 1 : SP\_2018\_MA0005\_196\_55\_20180305\_00028.jpg

LM Start	5.69	Rating **	M	Issue No.	55
LM End	6.23	Issue Type +	En	Location *	LS
Category	Earthen Levee			GPS Latitude/Longitude	
				Start	End
Item	Encroachments			39.622766 °	39.615666 °
				-121.773159 °	-121.777353 °
DWR ID	DWR_MA0005_01_s_2015_55				
Comment Code					
DT : Ditch					
Inspector Comment

View of the irrigation ditch along the landside toe.

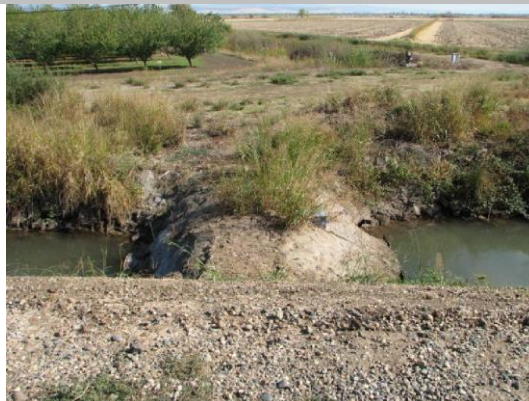
Photo 1 of 1 : UCIP\_SP\_2018\_51958\_11616.jpg

Comment Code					
Inspector Comment					
FS_ID:51958 DS_ID:1622 EP_NO: N/A Repair Type: Non-Urgent Crossing Status: Indicator Found UCIP Comments: 5/15/2017 Unable to locate. (DWR Sutter Yard-AFreitag)11/15/2016 Unable to locate. The concrete fill in the LS toe channel appears to just be erosion protection. (DWR Sutter Yard-AFreitag)8/5/2015 Unable to locate.12/8/2014 Same as last inspection.6/11/2014 Same as last inspection.11/19/2013 Same as last inspection.5/29/2013 Same as last inspection. FIELD_STRUCT_DESC: 18-inch corrugated metal drainage pipe through the levee, 15 feet below the crown, indicator found. Concrete headwall and flap gate on the waterside (WS). Concrete fill in channel on the landside (LS) toe is a good indicator of the pipe location. [Additional Reference(s): DWR Levee Log, 1990. USACE As-Built Drawing No. 50-4-3367, Exhibit B, Sheet 8, April 1957, (Station 480+25)]. FS Date: 5/31/2017 1:06:21 PM

Concrete fill on LS toe a good indicator for location of pipe.

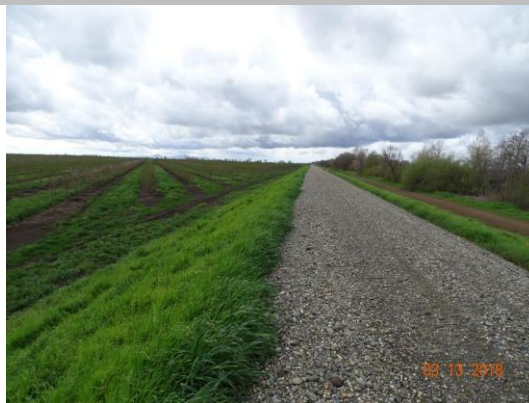
Photo 1 of 1 : SP\_2018\_MA0005\_196\_65\_20180402\_00089.jpg

LM Start	6.33	Rating **	A	Issue No.	65
LM End	6.33	Issue Type +	Ma	Location *	LS
Category	Earthen Levee			GPS Latitude/Longitude	
				Start	End
Item	Vegetation			39.614287 °	39.614287 °
				-121.777978 °	-121.777978 °
DWR ID	DWR_MA0005_01_s_2018_65				
Comment Code					
V1 : Control annual grass and weeds on the levee slopes and easements.					
Inspector Comment					
There is native grasses on both slopes.

View of the native grasses on both slopes.

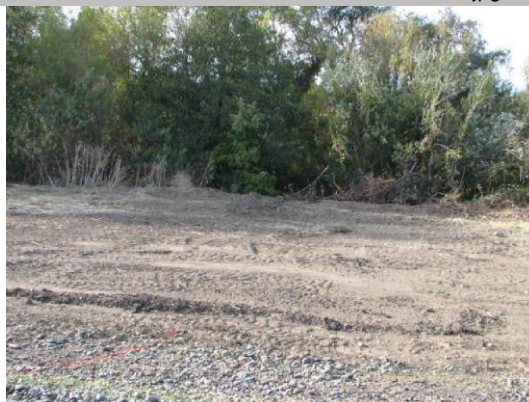
Photo 2 of 3 : UCIP\_SP\_2018\_51975\_67975.jpg

WS shoulder.

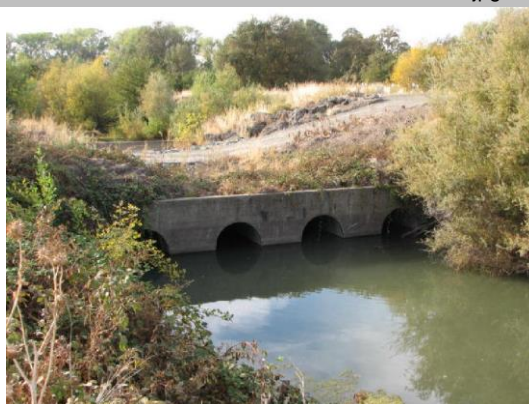
Photo 2 of 2 : UCIP\_SP\_2018\_51976\_67978.jpg

LS of pipe crossing.

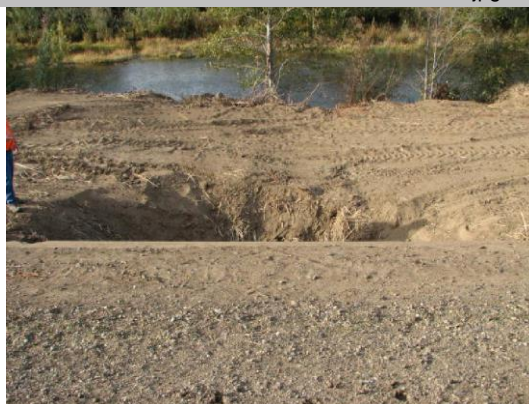
Photo 2 of 3 : UCIP\_SP\_2018\_51981\_67988.jpg

headwall at WS toe.

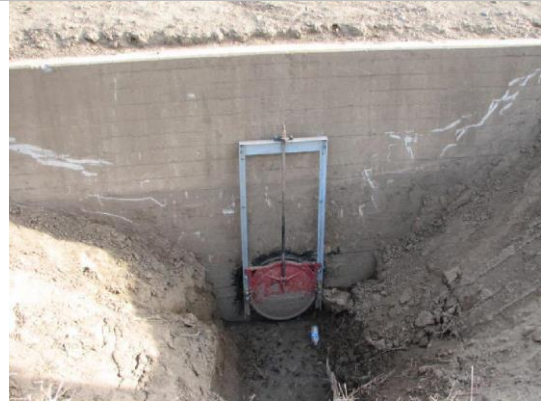
Photo 3 of 3 : UCIP\_SP\_2018\_51981\_67987.jpg

Item	DWR UCIP Field Study			39.568523 °	39.568523 °	
				-121.818232 °	-121.818232 °	
DWR ID						
Comment Code						
Inspector Comment						
FS_ID:51981 DS_ID:1634 EP_NO: N/A Repair Type: Non-Urgent Crossing Status: Found UCIP Comments: 5/16/2017 Abandoned- needs to be done so properly. Pipe has been selected to be internally cleaned and inspected as part of the DMP project. (DWR Sutter Yard- AFreitag)11/15/2016 Abandoned. (DWR Sutter Yard- AFreitag)5/11/2016 Abandoned crossing.8/4/2015 Abandoned pipe. Casey Wilder has started the steps to have the pipe properly abandoned and removed from the levee.12/8/2014 Same as last inspection.6/11/2014 Same as last inspection.11/19/2013 Same as last inspection.5/29/2013 Same as last inspection. FIELD_STRUCT_DESC: 24-inch corrugated metal irrigation pipe through the levee, 14.5 feet below the crown. Slide gate on the waterside (WS) on concrete headwall. Flap gate on the landside (LS). [Additional Reference(s): DWR Levee Log, 1990. USACE Sacramento O&M Manual 515, April 1955, (Station 717+50)]. FS Date: 5/31/2017 2:16:48 PM

Headwall and slide gate on WS toe.

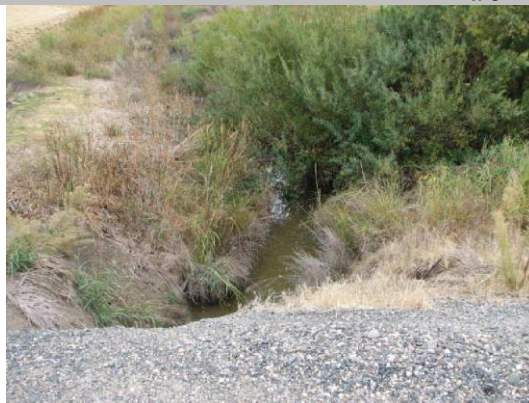
Photo 1 of 3 : UCIP\_SP\_2018\_51994\_68017.jpg

Comment Code					
Inspector Comment					
FS_ID:51994					
DS_ID:1637					
EP_NO: N/A					
Repair Type: No Action Needed					
Crossing Status: Found					
UCIP Comments: 11/15/2016 Old pipe at Nelson Road- Replaced by DS_ID 25461. (DWR Sutter Yard- A Freitag)6/22/2016 Pipe removed in 2013 and replaced with new 30-inch pipe (SEE DS_ID 25461). New pipe is inspected under DS_ID 25461. This DS_ID 1637 is no longer in use, pipe has been removed. (DWR UCIP - Olivia M.)7/30/2013 Repaired June 20135/29/2013 Pipe was video inspected and it was determined it needs full replacement. Replacement construction is scheduled to begin in the week of 6/3/2013.10/31/2012 Pipe is totally corroded through on WS toe and flap gate is missing. Pipe likely requires total replacement.					
FIELD_STRUCT_DESC: *REMOVED* 30-inch corrugated metal drainage pipe through the levee, 15 feet below the crown. Flap gate on the waterside (WS). Concrete headwalls on the landside (LS) and the WS toes. [Additional Reference(s): DWR Levee Log, 1990. USACE Sacramento O&M Manual 515, April 1955, (Station 835+21). USACE As-Built Drawing No. 50-4-2637, Exhibit B, Sheet 4, April 1950, (Station 835+20.96)].

Drainage canal on LS toe.

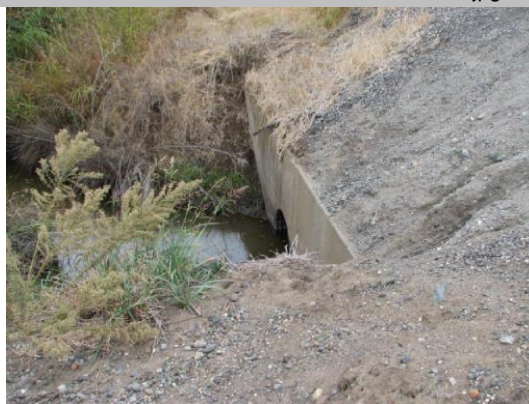
Photo 2 of 3 : UCIP\_SP\_2018\_51994\_68016.jpg

Concrete headwall on LS toe.

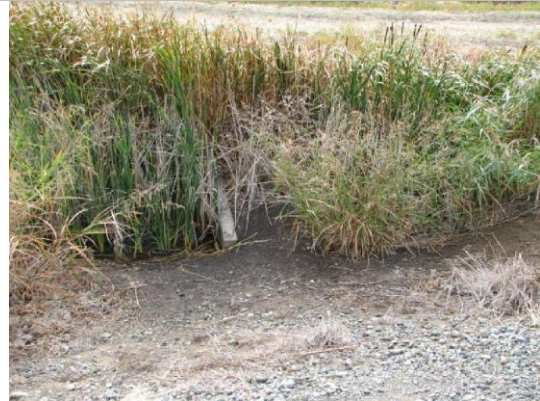
Photo 1 of 1 : UCIP\_SP\_2018\_51996\_68025.jpg

Buried pipe at concrete box, LS toe.

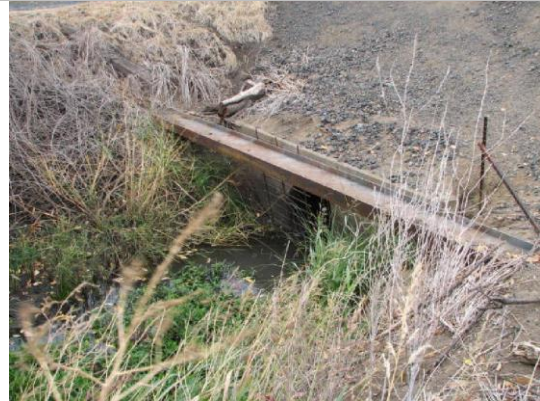
Photo 1 of 3 : UCIP\_SP\_2018\_51999\_68033.jpg

Headwall at inlet on LS toe.

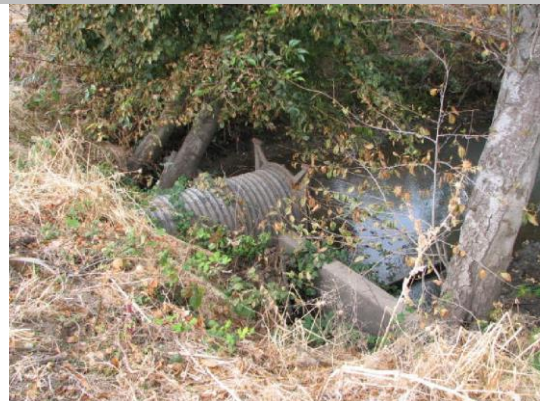
Photo 2 of 3 : UCIP\_SP\_2018\_51999\_68032.jpg

CMP pipe, flap gate, and headwall on WS toe.

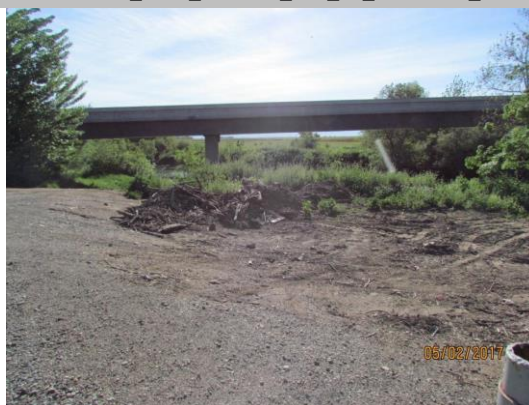
Photo 1 of 1 : SP\_2018\_MA0005\_197\_69\_20180305\_00034.jpg

LM Start	1.60	Rating **	M	Issue No.	69
LM End	1.60	Issue Type +	Ma	Location *	WS
Category	Earthen Levee			GPS Latitude/Longitude	
				Start	End
Item	Encroachments			39.534170 °	39.534170 °
				-121.856853 °	-121.856853 °
DWR ID	DWR_MA0005_02_s_2017_69				
Comment Code					
DE : Debris					
Inspector Comment					
Remove the debris from the waterside toe.

View of the debris along the waterside toe.

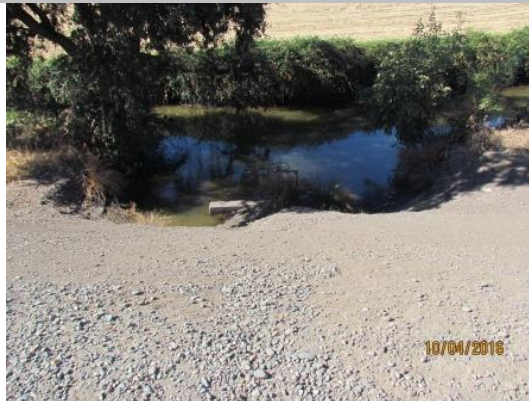
Photo 1 of 1 : SP\_2018\_MA0005\_197\_49\_20180305\_00024.jpg

LM Start	1.90	Rating **	M	Issue No.	49
LM End	1.90	Issue Type +	Ma	Location *	LS
Category	Earthen Levee			GPS Latitude/Longitude	
				Start	End
Item	Erosion / Bank Caving			39.537445 °	39.537445 °
				-121.853112 °	-121.853112 °
DWR ID	DWR_MA0005_02_f_2016_49				
Comment Code					
E2 : Schedule repair of erosion site prior to the next inspection.					
Inspector Comment					
Repair the erosion on the landside toe of the levee.

View of the landside toe erosion.

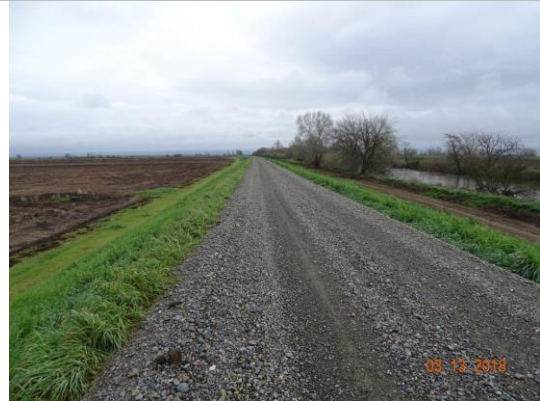
Photo 1 of 1 : SP\_2018\_MA0005\_197\_63\_20180402\_00098.jpg

LM Start	2.49	Rating **	A	Issue No.	63
LM End	2.49	Issue Type +	Ma	Location *	LS
Category	Earthen Levee			GPS Latitude/Longitude	
				Start	End
Item	Vegetation			39.544242 °	39.544242 °
				-121.846607 °	-121.846607 °
DWR ID	DWR_MA0005_02_s_2018_63				
Comment Code					
V1 : Control annual grass and weeds on the levee slopes and easements.					
Inspector Comment

View of native vegetation on both slopes.

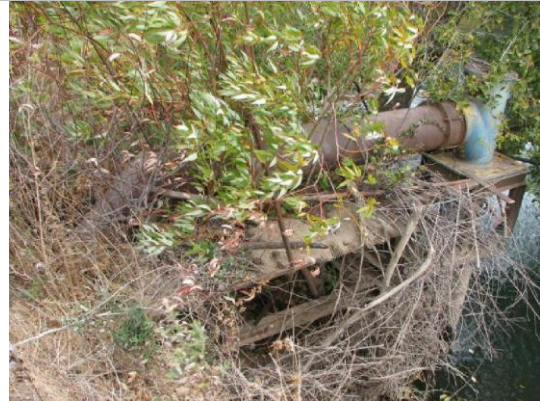
Photo 2 of 3 : UCIP\_SP\_2018\_52013\_68056.jpg

Comment Code						
Inspector Comment						
FS_ID:52013 DS_ID:1646 EP_NO: 3927 Repair Type: Non-Urgent Crossing Status: Found UCIP Comments: 5/18/2017 Appears to have been abandoned. Pump is missing from the pier and there is no sign of the riser and siphon breaker on the LS shoulder. (DWR Sutter Yard- A Freitag)11/14/2016 Appears abandoned- pump removed from pier in Butte Creek also riser and siphon breaker are no longer seen on LS shoulder. (DWR Sutter Yard- A Freitag)5/23/2016 Crossing appears to have been abandoned and removed. Could not locate the LS riser and siphon breaker.7/28/2015 No pump present during any of my inspections. Crossing appears abandoned. CMP riser has been knocked out of levee. 11/25/2014 Same as last inspection.6/04/2014 Same as last inspection.11/12/2013 Same as last inspection.6/6/2013 Same as last inspection.10/31/2012 Pump does not appear to be in use or is abandoned. FIELD_STRUCT_DESC: 20-inch (not 18-inch as referenced in the levee log) exterior coated steel irrigation pipe through the levee, 2.4 feet below the crown. Siphon breaker in a 24-inch corrugated metal riser on the landside (LS) shoulder. Portable pump on the waterside (WS). (Permit No. 3927, 1962 - Arrowhead Ranch). [Additional Reference(s): DWR Levee Log, 1990]. FS Date: 6/1/2017 9:46:03 AM

Pump on metal pier at WS toe.

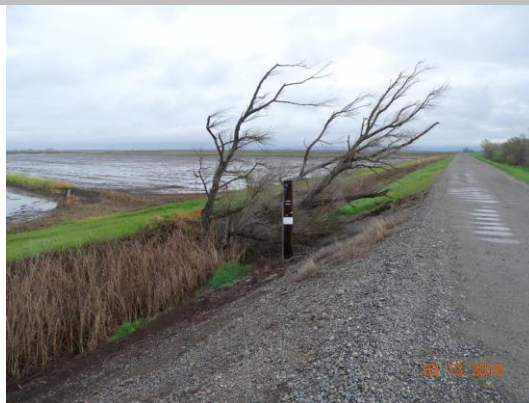
Photo 1 of 1 : SP\_2018\_MA0005\_197\_64\_20180402\_00099.jpg

LM Start	3.10	Rating **	M	Issue No.	64
LM End	3.10	Issue Type +	Ma	Location *	LS
Category	Earthen Levee			GPS Latitude/Longitude	
				Start	End
Item	Encroachments			39.551747 °	39.551747 °
				-121.840568 °	-121.840568 °
DWR ID	DWR_MA0005_02_s_2018_64				
Comment Code					
TR : Tree or limb					
Inspector Comment					
Remove the tree from the landside slope and toe.

View of the tree on the landside slope and toe.

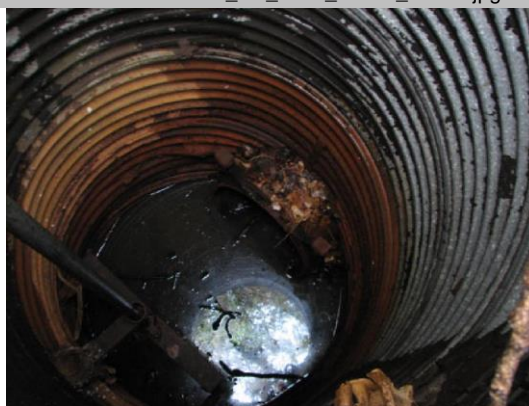
Photo 1 of 2 : UCIP\_SP\_2018\_52042\_68105.jpg

Comment Code					
Inspector Comment					
FS_ID:52042 DS_ID:1650 EP_NO: N/A Repair Type: Non-Urgent Crossing Status: Found UCIP Comments: 5/18/2017 Abandoned- only WS riser found. (DWR Sutter Yard- A Freitag) 11/14/2016 Abandoned. (DWR Sutter Yard- A Freitag) 5/23/2016 Abandoned 7/28/2015 Abandoned- still cannot locate a LS ans WS pipe end.11/25/2014 Same as last inspection.6/04/2014 Same as last inspection.11/12/2013 Same as last inspection.6/6/2013 Same as last inspection.10/31/2012 Appears abandoned. Unable to locate outfall on WS. Unable to locate inlet on LS. FIELD_STRUCT_DESC: *ABANDONED* 24-inch corrugated metal drainage pipe through the levee, 12.5 feet below the crown. Slide gate and flap gate in a 56-inch corrugated metal riser on the waterside (WS) berm. Flap gate on the WS. [Additional Reference(s): DWR Levee Log, 1990. USACE Sacramento O&M Manual 515, April 1955, (Station 688+40). USACE As-Built Drawing No. 50-4-2637, Exhibit B, Sheet 3, April 1950, (Station 688+40)]. FS Date: 6/1/2017 1:00:06 PM

Slide gate and flap gate inside CMP riser on WS berm.

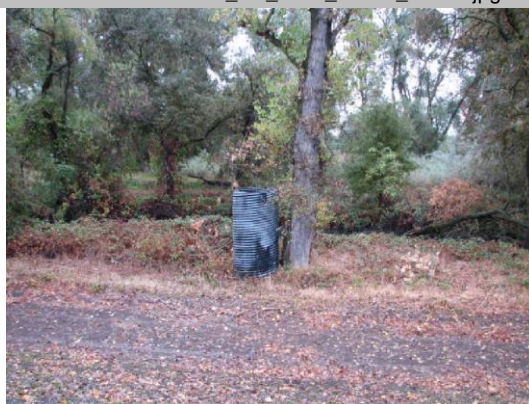
Photo 2 of 2 : UCIP\_SP\_2018\_52042\_68104.jpg

56-inch CMP riser on WS berm.

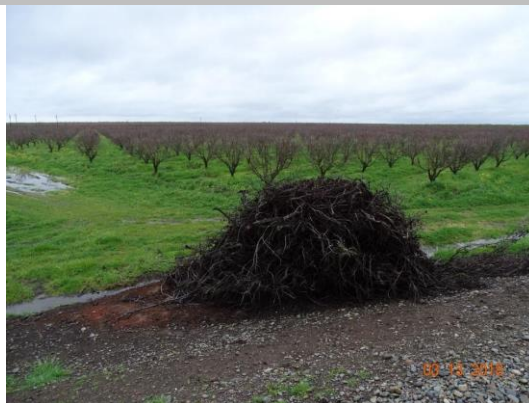
Photo 1 of 1 : SP\_2018\_MA0005\_197\_65\_20180402\_00100.jpg

LM Start	6.90	Rating **	M	Issue No.	65
LM End	6.90	Issue Type +	En	Location *	LS
Category	Earthen Levee			GPS Latitude/Longitude	
				Start	End
Item	Encroachments			39.594827 °	39.594827 °
				-121.797080 °	-121.797080 °
DWR ID	DWR_MA0005_02_s_2018_65				
Comment Code					
PR : Prunings					
Inspector Comment					
Remove the prunings from the landside toe.

View of the prunings along the landside toe.

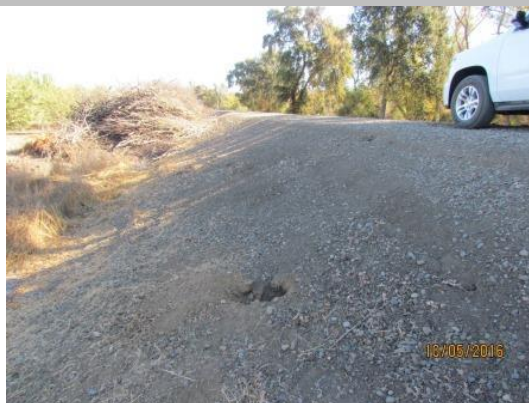
Photo 1 of 2 : SP\_2018\_MA0005\_197\_53\_20180305\_00025.jpg

LM Start	7.74	Rating **	U	Issue No.	53
LM End	7.74	Issue Type +	Ma	Location *	LS
Category	Earthen Levee			GPS Latitude/Longitude	
				Start	End
Item	Animal Control			39.605088 °	39.605088 °
				-121.788569 °	-121.788569 °
DWR ID	DWR_MA0005_02_f_2016_53				
Comment Code					
A1 : Exterminate rodents and backfill and compact or grout burrows.					
Inspector Comment

View of the rodent holes along the landside slope.

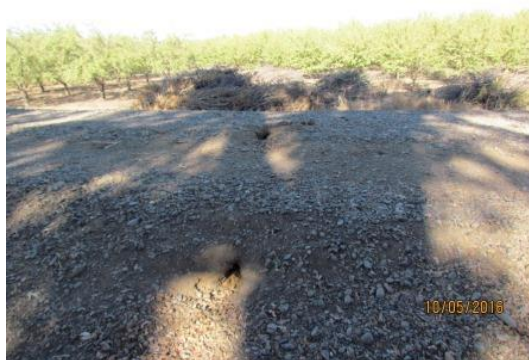
Photo 2 of 2 : SP\_2018\_MA0005\_197\_53\_20180305\_00026.jpg

View of the rodent holes along the crown and waterside slope.

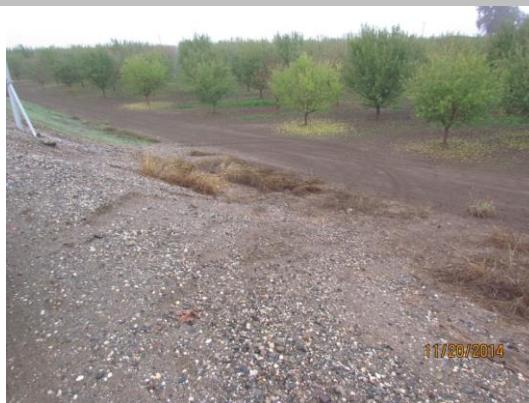
Photo 1 of 2 : SP\_2018\_MA0005\_197\_13\_20180305\_00005.jpg

LM Start	7.98	Rating **	M	Issue No.	13
LM End	7.98	Issue Type +	Ma	Location *	LS
Category	Earthen Levee			GPS Latitude/Longitude	
				Start	End
Item	Slope Stability			39.607710 °	39.607710 °
				-121.785868 °	-121.785868 °
DWR ID	DWR_MA0005_02_s_2012_13				
Comment Code					
S3 : Repair the levee slope damaged by vehicle traffic and prevent access where possible.					
Inspector Comment

View of the vehicle erosion along the landside slope.

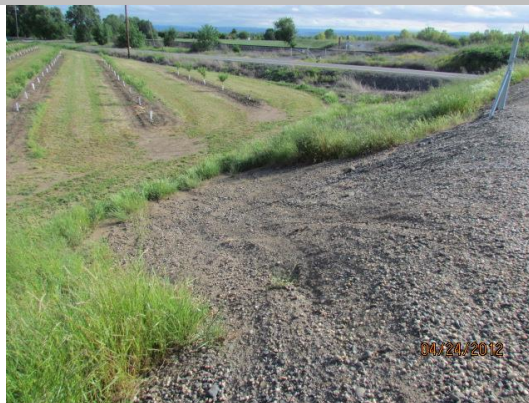
Photo 2 of 2 : SP\_2018\_MA0005\_197\_13\_20180305\_00006.jpg

View of the vehicle erosion along the slope.

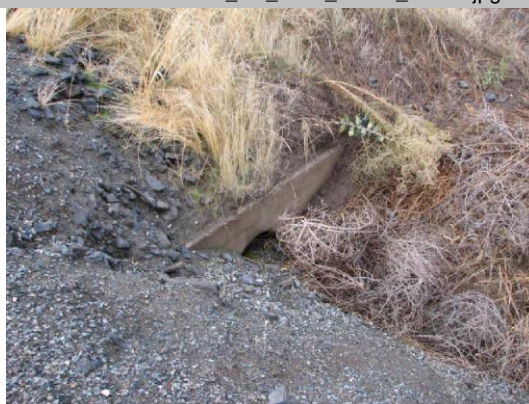
Photo 2 of 2 : UCIP\_SP\_2018\_52052\_68128.jpg

Comment Code					
Inspector Comment					
FS_ID:52052 DS_ID:1656 EP_NO: N/A Repair Type: Non-Urgent Crossing Status: Found UCIP Comments: 5/18/2017 LS inlet is almost completely full of soil. Pipe has been selected to be internally cleaned and inspected as part of the DMP project. (DWR Sutter Yard- AFreitag)11/14/2016 LS inlet almost completely full of soil. (DWR Sutter Yard- AFreitag)5/23/2016 LS end is almost completel full of soil.7/28/2015 Pipe is still over 3/4 full of soil. 11/24/2014 Same as last inspection.6/04/2014 Same as last inspection.11/12/2013 Same as last inspection.6/6/2013 Same as last inspection.10/31/2012 Pipe 3/4 full with soil on LS. FIELD_STRUCT_DESC: 24-inch (not 18-inch as shown in as-built drawing) corrugated metal drainage pipe through the levee, 6.7 feet below the crown. Concrete headwall at the landside (LS) toe. Flap gate on the waterside (WS). [Additional Reference(s): DWR Levee Log, 1990. USACE Sacramento O&M Manual 516, April 1960, (Station 379+98). USACE As-Built Drawing No. 50-4-2637, Exhibit B, Sheet 2, April 1950, (Station 550+60)]. FS Date: 6/1/2017 1:15:55 PM

Concrete headwall on LS toe.

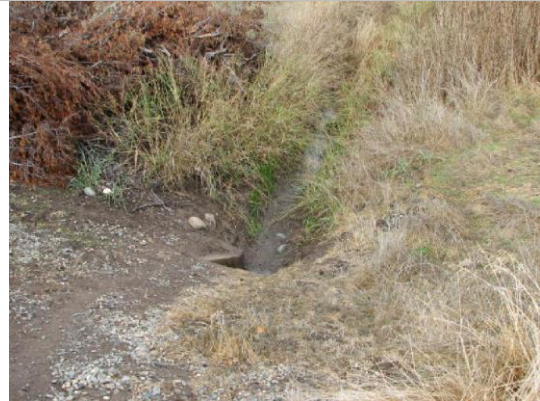
Photo 1 of 3 : UCIP\_SP\_2018\_52061\_68397.jpg

FS\_ID:52061  
DS\_ID:1663  
EP\_NO: N/A  
Repair Type: No Action Needed  
Crossing Status: Found  
UCIP Comments: 5/18/2017 Crossing appears to be in good condition. Pipe has been selected to be internally cleaned and inspected as part of the DMP project. (DWR Sutter Yard- A Freitag) 11/14/2016 Crossing appears to be in good condition. (DWR Sutter Yard- A Freitag) 5/12/2016 Crossing appears to be in good condition. 7/30/2015 Crossing appears in good condition. No noticeable issues to report. 11/24/2014 Same as last inspection. 6/4/2014 Same as last inspection. 11/13/2013 Damaged pipe section was dug up and replaced. New WS flapgate with u-shaped wingwall installed on end of pipe. 6/6/2013 Same as last inspection. Plans have been made to repair during summer of 2013 before high water season. 11/01/2012 Pipe rusted through along bottom at WS outlet. Sink hole over pipe on WS berm. WS headwall eroded eternally around backside of headwall.

Concrete U-shaped headwall on LS toe.

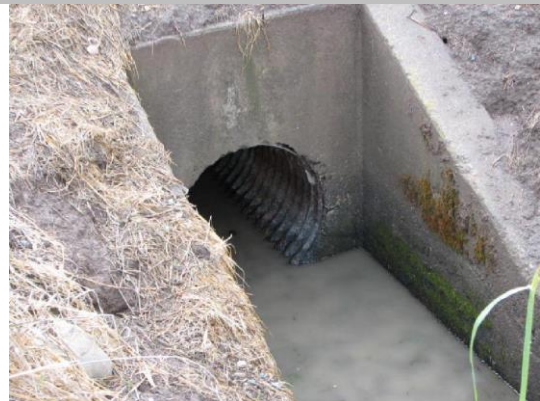
Photo 2 of 3 : UCIP\_SP\_2018\_52061\_68396.jpg

Concrete U-shaped headwall on LS toe.

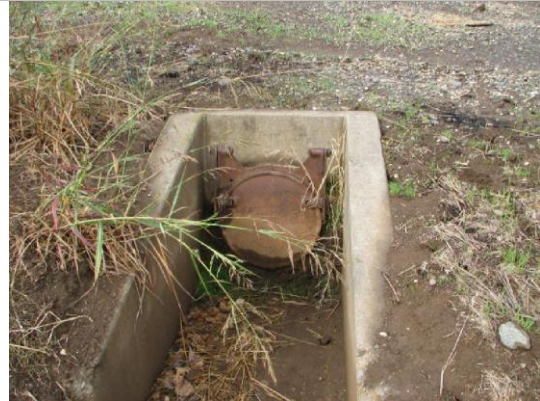
Photo 3 of 3 : UCIP\_SP\_2018\_52062\_68403.jpg

Comment Code						
Inspector Comment						
FS_ID:52062 DS_ID:1664 EP_NO: N/A Repair Type: Non-Urgent Crossing Status: Found UCIP Comments: 5/18/2017 No LS slide gate but not sure its even needed. Pipe has been selected to be internally cleaned and inspected as part of the DMP project. (DWR Sutter Yard- A/Freitag)11/14/2016 LS slide gate still missing. Rest of crossing appears in good condition. (DWR Sutter Yard- A/Freitag)5/12/2016 LS inlet was unburied. Slide gate still missing7/30/2015 LS inlet is still buried.11/24/2014 Same as last inspection.6/4/2014 Same as last inspection.11/13/2013 Same as last inspection.6/6/2013 Same as last inspection.11/01/2012 LS inlet is buried under soil and covered with brambles. Slide gate missing from LS. FIELD_STRUCT_DESC: 24-inch corrugated metal drainage pipe through the levee, 12 feet below the crown. Flap gate on the waterside (WS). Concrete headwall on the WS. Concrete headwall on the landside (LS), not found. [Additional Reference(s): DWR Levee Log, 1990. USACE Sacramento O&M Manual 516, April 1960, (Station 338+04). USACE As-Built Drawing No. 50-4-3367, Exhibit B, Sheet 11, April 1957, (Station 338+04)]. FS Date: 6/1/2017 1:29:34 PM

Concrete U shaped headwall and flap gate at WS toe.

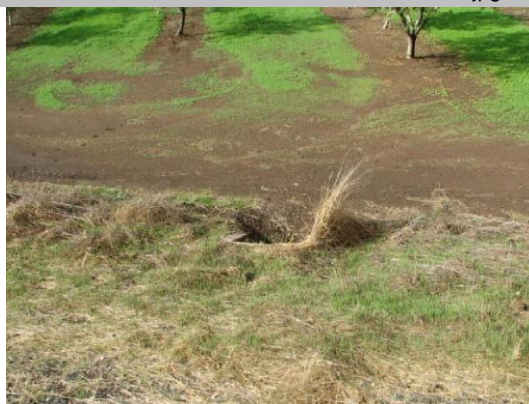
Photo 2 of 3 : UCIP\_SP\_2018\_52064\_68416.jpg

View of inlet on LS toe.

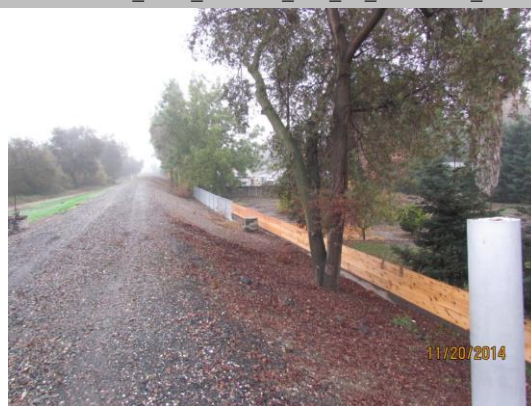
Photo 1 of 1 : SP\_2018\_MA0005\_197\_41\_20180305\_00017.jpg

LM Start	10.90	Rating **	U	Issue No.	41
LM End	10.93	Issue Type +	En	Location *	LS
Category	Earthen Levee			GPS Latitude/Longitude	
				Start	End
Item	Encroachments			39.645508 °	39.645858 °
				-121.786515 °	-121.786742 °
DWR ID	DWR_MA0005_02_f_2014_41				
Comment Code					
FE : Fence					
Inspector Comment					
Remove or apply for permit for the fence along landside toe

View of the new fence along the landside toe.

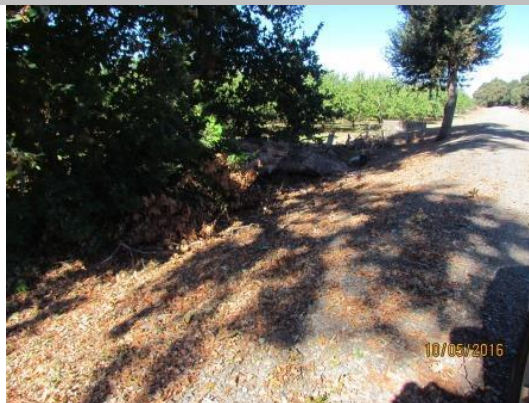
Photo 1 of 1 : SP\_2018\_MA0005\_197\_36\_20180305\_00013.jpg

LM Start	11.10	Rating **	M	Issue No.	36
LM End	11.10	Issue Type +	Ma	Location *	LS
Category	Earthen Levee			GPS Latitude/Longitude	
				Start	End
Item	Encroachments			39.647913 °	39.647913 °
				-121.788330 °	-121.788330 °
DWR ID	DWR_MA0005_02_s_2015_36				
Comment Code					
TR : Tree or limb					
Inspector Comment

Remove the tree log from the landside toe.

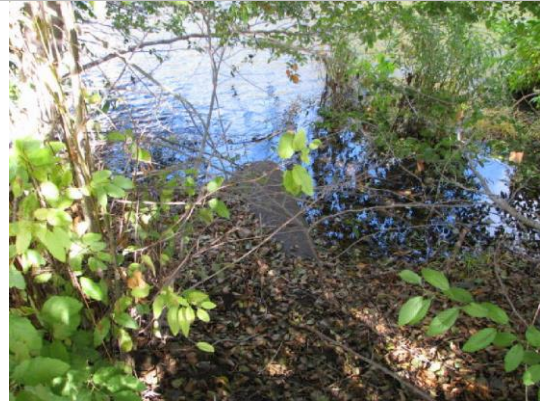
Photo 3 of 3 : UCIP\_SP\_2018\_52070\_68434.jpg

Comment Code						
Inspector Comment						
FS_ID:52070 DS_ID:1671 EP_NO: N/A Repair Type: Non-Urgent Crossing Status: Found UCIP Comments: 5/18/2017 Abandoned- WS end still buried. (DWR Sutter Yard- A Freitag)11/14/2016 Appears abandoned. (DWR Sutter Yard- A Freitag)5/11/2016 Abandoned crossing7/30/2015 Abandoned crossing. Unable to locate the WS end of pipe.11/24/2014 Same as last inspection.6/4/2014 Same as last inspection.11/13/2013 Same as last inspection.6/6/2013 Same as last inspection.11/01/2012 Pipe appears abandoned. It needs to be abandoned properly. FIELD_STRUCT_DESC: 30-inch corrugated metal irrigation pipe through the levee, 9.4 feet below the crown. Slide gate in a 42-inch corrugated metal riser on the waterside (WS) slope. Concrete distribution box on the landside (LS). [Additional Reference(s): DWR Levee Log, 1990. USACE Sacramento O&M Manual 516, April 1960, (Station 215+46)]. FS Date: 6/1/2017 1:45:09 PM

Concrete pipe at edge of creek on WS.

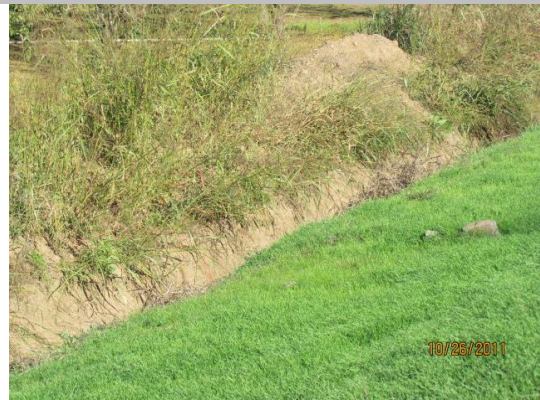
Photo 1 of 1 : SP\_2018\_MA0005\_197\_6\_20180305\_00003.jpg

LM Start	11.57	Rating **	M	Issue No.	6
LM End	11.77	Issue Type +	En	Location *	LS
Category	Earthen Levee			GPS Latitude/Longitude	
				Start	End
Item	Encroachments			39.654349 °	39.657142 °
				-121.789531 °	-121.788690 °
DWR ID	DWR_MA0005_02_s_2012_6				
Comment Code					
DT : Ditch					
Inspector Comment

View of the ditch along the Landside toe.

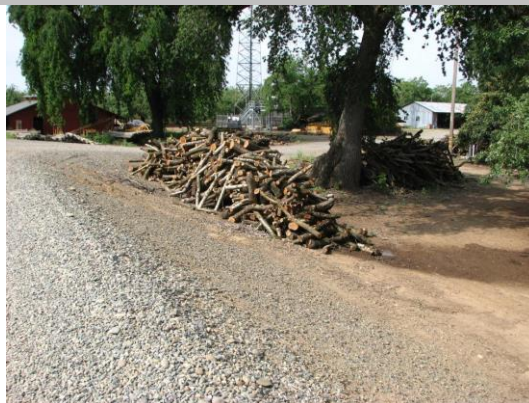
Photo 1 of 1 : SP\_2018\_MA0005\_197\_42\_20180305\_00018.jpg

LM Start	13.06	Rating **	M	Issue No.	42
LM End	13.06	Issue Type +	En	Location *	LS
Category	Earthen Levee			GPS Latitude/Longitude	
				Start	End
Item	Encroachments			39.674219 °	39.674219 °
				-121.781188 °	-121.781188 °
DWR ID	DWR_MA0005_02_s_2016_42				
Comment Code					
FW : Firewood					
Inspector Comment

View of the firewood pile at the landside toe.

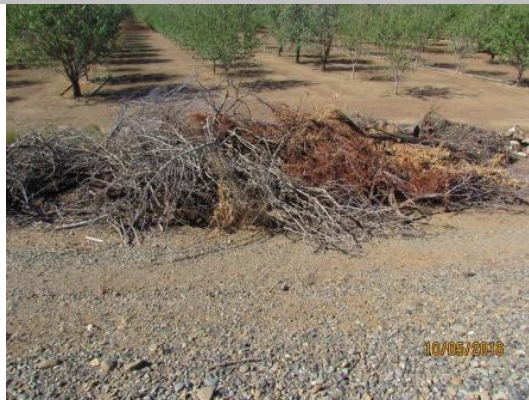
Photo 1 of 1 : SP\_2018\_MA0005\_197\_61\_20180305\_00032.jpg

LM Start	13.54	Rating **	M	Issue No.	61
LM End	13.54	Issue Type +	En	Location *	LS
Category	Earthen Levee			GPS Latitude/Longitude	
				Start	End
Item	Encroachments			39.680579 °	39.680579 °
				-121.778267 °	-121.778267 °
DWR ID	DWR_MA0005_02_f_2016_61				
Comment Code					
PR : Prunings					
Inspector Comment

View of the prunings along the landside toe.

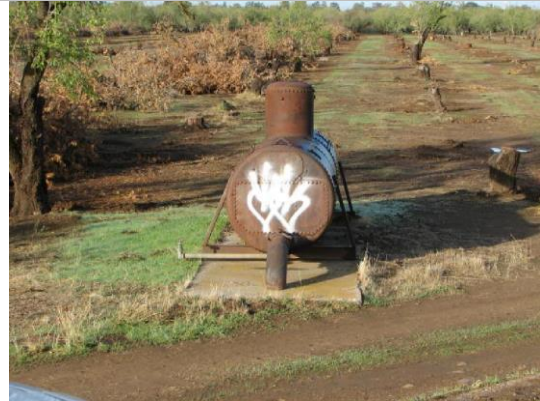
Photo 1 of 1 : UCIP\_SP\_2018\_52084\_68534.jpg

Comment Code						
Inspector Comment						
FS_ID:52084						
DS_ID:1680						
EP_NO: N/A						
Repair Type: Non-Urgent						
Crossing Status: Found						
UCIP Comments: 5/18/2017 Unable to locate. (DWR Sutter Yard-AFreitag)11/14/2016 Unable to locate. (DWR Sutter Yard-AFreitag)5/11/2016 Unable to locate.8/3/2015 Unable to locate.11/25/2014 Unable to locate.6/4/2014 Same as last inspection. Unable to locate.11/13/2013 Unable to locate.6/6/2013 Boiler has been removed and pipe buried on LS. Unable to locate.11/01/2012 Pipe appears to be abandoned.						
FIELD_STRUCT_DESC: 8-inch steel irrigation pipe through the levee, 6.5 feet below the crown. Boiler attached to the landside (LS).						
[Additional Reference(s): DWR Levee Log, 1990. USACE Sacramento O&M Manual 516, April 1960, (Station 73+27)].						
FS Date: 6/1/2017 2:11:21 PM

Pipe attached at boiler on LS toe.

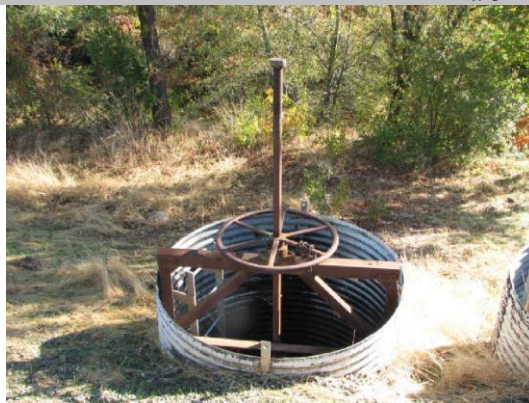
Photo 3 of 3 : UCIP\_SP\_2018\_52093\_68577.jpg

Comment Code						
Inspector Comment						
FS_ID:52093 DS_ID:16316 EP_NO: N/A Repair Type: Non-Urgent Crossing Status: Found UCIP Comments: 5/18/2017 Crossing appears to be in good condition. WS riser needs a cover. (DWR Sutter Yard- AFreitag)11/14/2016 Good condition- needs a cover for standpipe. (DWR Sutter Yard- AFreitag)5/11/2016 Needs a lcover for riser. The rest of the crossing appears in good condition.8/3/2015 Crossing appears in good condition but needs a cover made for the riser.11/25/2014 Same as last inspection.6/4/2014 Same as last inspection.11/13/2013 Same as last inspection.6/6/2013 Same as last inspection. Need to construct cover for top of standpipe.11/01/2012 Good candidate for video inspection. FIELD_STRUCT_DESC: 2 of 2: 54-inch corrugated metal irrigation pipe (siphon) through the levee, 17.8 feet below the crown. Slide gate in a 66-inch corrugated metal riser on the waterside (WS). Concrete headwall and irrigation ditch at the landside (LS) toe. Edgar Slough riser units in the floodway. [Additional Reference(s): DWR Levee Log, 1990. USACE Sacramento O&M Manual 516, April 1960, (Station 132+00)]. FS Date: 6/1/2017 2:24:17 PM

66-inch CMP riser on WS shoulder.

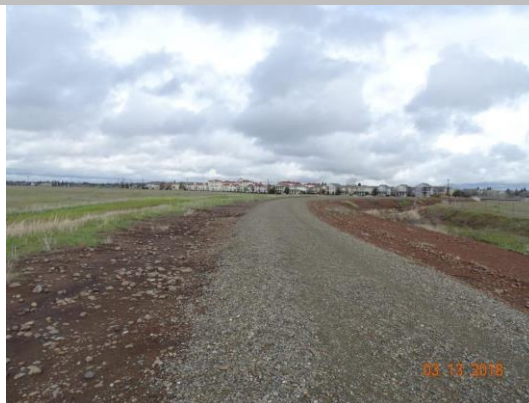
Photo 1 of 1 : SP\_2018\_MA0005\_198\_2\_20180402\_00001.jpg

LM Start	0.55	Rating **	A	Issue No.	2
LM End	0.55	Issue Type +	Ma	Location *	LS
Category	Earthen Levee			GPS Latitude/Longitude	
				Start	End
Item	Vegetation			39.724182 °	39.724182 °
				-121.780940 °	-121.780940 °
DWR ID	DWR_MA0005_03_s_2018_2				
Comment Code					
V1 : Control annual grass and weeds on the levee slopes and easements.					
Inspector Comment					
The grasses was removed from both slopes.

View of the no grasses on both slopes.
