**Flood Control Project Maintenance
Levee Inspections**
LMA District Cover Sheet
Spring 2019 Levee Inspection Results

Sutter Maintenance Yard Maintenance Area 0005

Spring 2019 Levee Inspection Results

Waterway			Bank	Unit Miles
Unit No. 01 Butte Creek			Left	15.08
	Spring (March - May)	Summer (June - August)	(September - November) Fall	Winter (December - February)
Unit Maintenance Rating (Fall Only)				
Date of Inspection	5/14/2019 - 5/14/2019			
DWR Inspector	Makar Sokol			
Accompanied By	Shawn Freitag Sutter Maintenance Yard

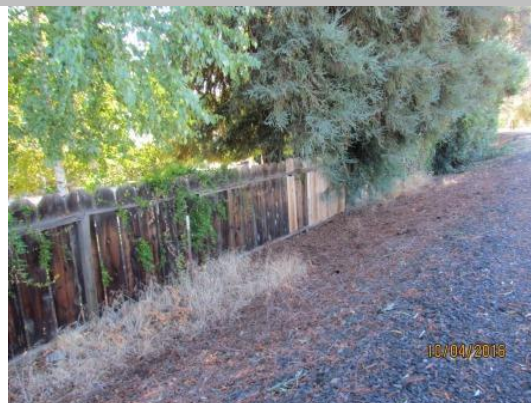
Photo 1 of 1 : SP_2019_MA0005_196_49_20190327_00024.jpg

LM Start	0.90	Rating **	U	Issue No.	49
LM End	0.92	Issue Type +	En	Location *	LS
Category	Earthen Levee			GPS Latitude/Longitude	
				Start	End
Item	Encroachments			39.686087 °	39.685756 °
				-121.777555 °	-121.777540 °
DWR ID	DWR_MA0005_01_f_2016_49				
Comment Code					
FE : Fence					
Inspector Comment

View of the wood plank fence at the landside toe.

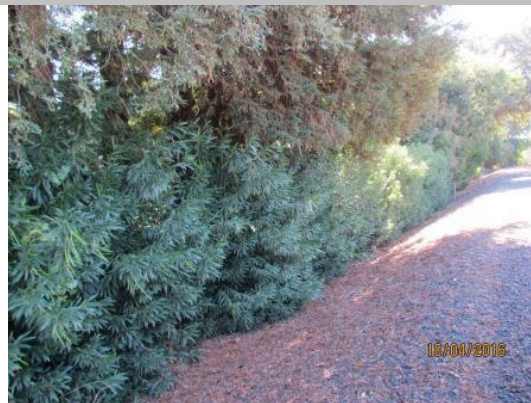
Photo 1 of 1 : SP_2019_MA0005_196_50_20190327_00025.jpg

LM Start	0.98	Rating **	U	Issue No.	50
LM End	1.00	Issue Type +	En	Location *	LS
Category	Earthen Levee			GPS Latitude/Longitude	
				Start	End
Item	Vegetation			39.684843 °	39.684606 °
				-121.777132 °	-121.776975 °
DWR ID	DWR_MA0005_01_f_2016_50				
Comment Code					
V6 : Landscaping					
Inspector Comment					
Oleanders blocking visibility.

View of the oleanders along the landside toe.

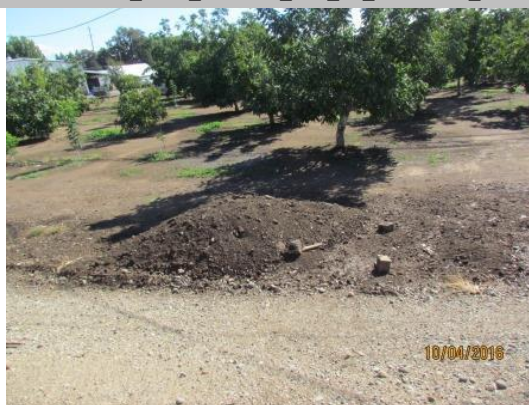
Photo 1 of 1 : SP_2019_MA0005_196_53_20190327_00026.jpg

LM Start	1.52	Rating **	M	Issue No.	53
LM End	1.52	Issue Type +	En	Location *	LS
Category	Earthen Levee			GPS Latitude/Longitude	
				Start	End
Item	Encroachments			39.677240 °	39.677240 °
				-121.777521 °	-121.777521 °
DWR ID	DWR_MA0005_01_f_2016_53				
Comment Code					
DE : Debris					
Inspector Comment					
Remove the pile of soil and rocks on the landside toe.

View of the soil and rock pile on the landside toe.

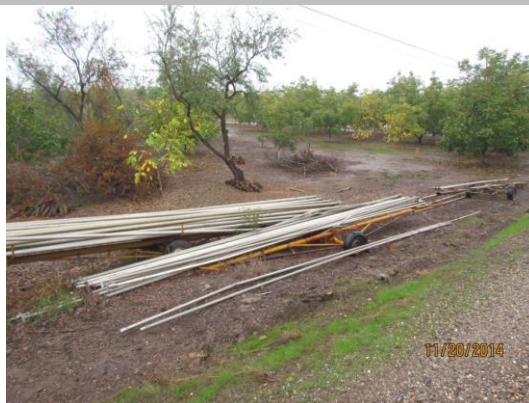
Photo 1 of 1 : SP_2019_MA0005_196_30_20190327_00010.jpg

LM Start	1.53	Rating **	M	Issue No.	30
LM End	1.53	Issue Type +	En	Location *	LS
Category	Earthen Levee			GPS Latitude/Longitude	
				Start	End
Item	Encroachments			39.677130 °	39.677130 °
				-121.777583 °	-121.777583 °
DWR ID	DWR_MA0005_01_f_2014_30				
Comment Code					
EQ : Equipment					
Inspector Comment

View of the sprinkler pipe and equipment along the landside toe.

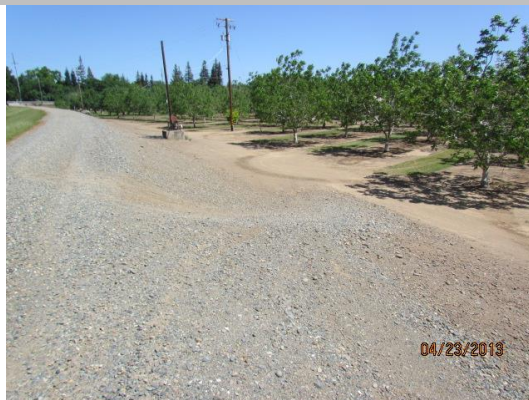
Photo 1 of 1 : SP_2019_MA0005_196_16_20190327_00006.jpg

LM Start	1.61	Rating **	M	Issue No.	16
LM End	1.61	Issue Type +	Ma	Location *	LS
Category	Earthen Levee			GPS Latitude/Longitude	
				Start	End
Item	Slope Stability			39.676129 °	39.676129 °
				-121.778171 °	-121.778171 °
DWR ID	DWR_MA0005_01_s_2013_16				
Comment Code					
S3 : Repair the levee slope damaged by vehicle traffic and prevent access where possible.					
Inspector Comment

View of the unauthorized vehicle ramp on the landside slope.

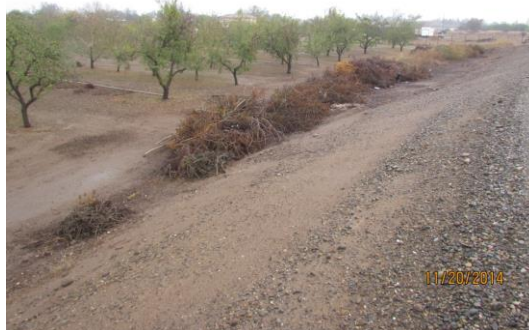
Photo 1 of 1 : SP_2019_MA0005_196_35_20190327_00014.jpg

LM Start	1.88	Rating **	M	Issue No.	35
LM End	1.88	Issue Type +	En	Location *	LS
Category	Earthen Levee			GPS Latitude/Longitude	
				Start	End
Item	Encroachments			39.672627 °	39.672627 °
				-121.779778 °	-121.779778 °
DWR ID	DWR_MA0005_01_f_2014_35				
Comment Code					
PR : Prunings					
Inspector Comment					
Remove the prunings from the landside toe.

View of the prunings along the landside toe.

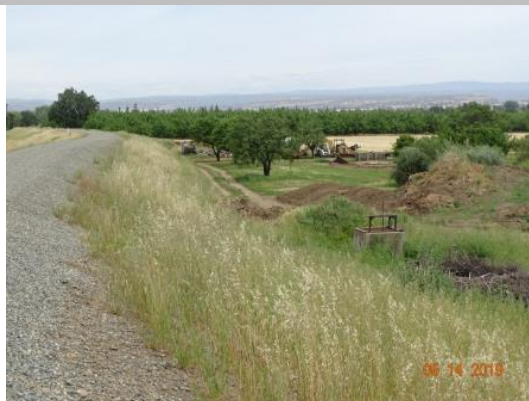
Photo 1 of 1 : SP_2019_MA0005_196_74_20190520_00089.jpg

LM Start	1.97	Rating **	U	Issue No.	74
LM End	2.59	Issue Type +	Ma	Location *	LS
Category	Earthen Levee			GPS Latitude/Longitude	
				Start	End
Item	Vegetation			39.671360 °	39.663128 °
				-121.780229 °	-121.784164 °
DWR ID	DWR_MA0005_01_s_2019_74				
Comment Code					
V1 : Control annual grass and weeds on the levee slopes and easements.					
Inspector Comment

View of the vegetation on the landside slope. Spring 2019.

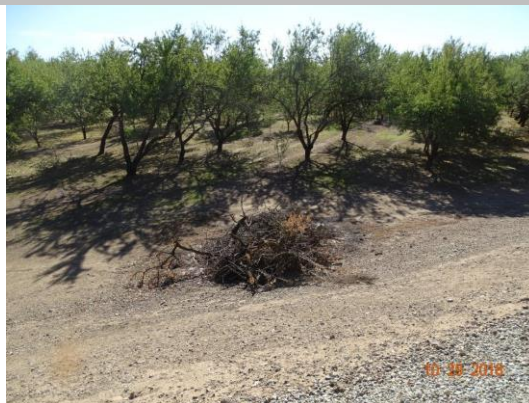
Photo 1 of 1 : SP_2019_MA0005_196_65_20190327_00031.jpg

LM Start	2.82	Rating **	M	Issue No.	65
LM End	2.82	Issue Type +	En	Location *	LS
Category	Earthen Levee			GPS Latitude/Longitude	
				Start	End
Item	Encroachments			39.660153 °	39.660153 °
				-121.785137 °	-121.785137 °
DWR ID	DWR_MA0005_01_f_2018_65				
Comment Code					
PR : Prunings					
Inspector Comment					
Remove the pruning from the landside toe.

View of the prunes along the landside toe.

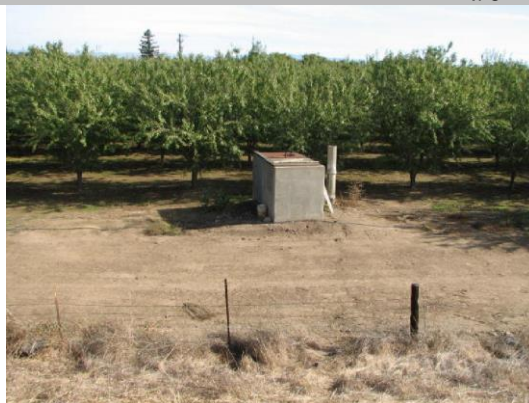
Photo 2 of 3 : UCIP_SP_2019_51949_67930.jpg

Unable to locate inlet on LS.

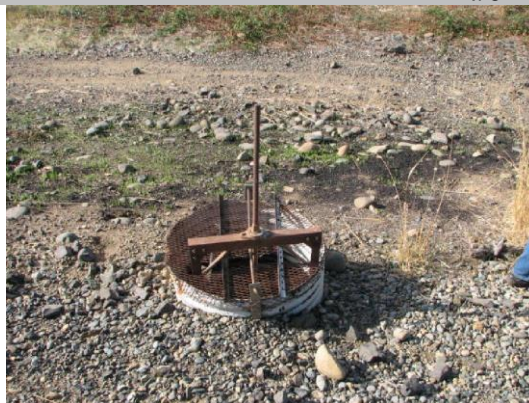
Photo 1 of 3 : UCIP_SP_2019_51950_67934.jpg

CMP riser and slide gate on WS shoulder.

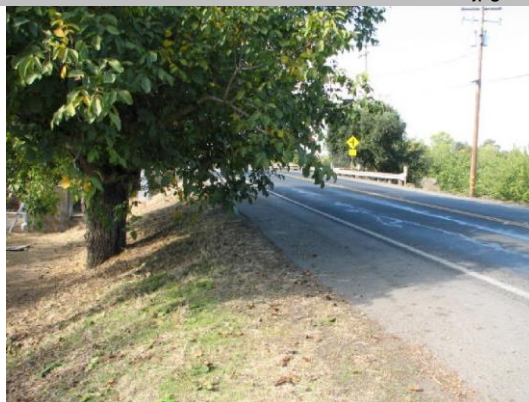
Photo 2 of 2 : UCIP_SP_2019_51952_67935.jpg

Location of PG&E access lid 250-feet east of levee crown on south side of roadway.

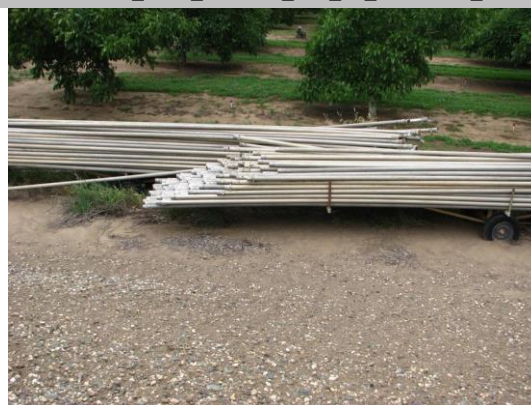
Photo 1 of 1 : SP_2019_MA0005_196_27_20190327_00008.jpg

LM Start	4.13	Rating **	M	Issue No.	27
LM End	4.13	Issue Type +	En	Location *	LS
Category	Earthen Levee		GPS Latitude/Longitude		
			Start	End	
Item	Encroachments		39.643100 °	39.643100 °	
			-121.782827 °	-121.782827 °	
DWR ID	DWR_MA0005_01_s_2017_27				
Comment Code					
EQ : Equipment					
Inspector Comment					
Agricultural piping on trailer.

5/5/2016: Remove equipment from LS toe.

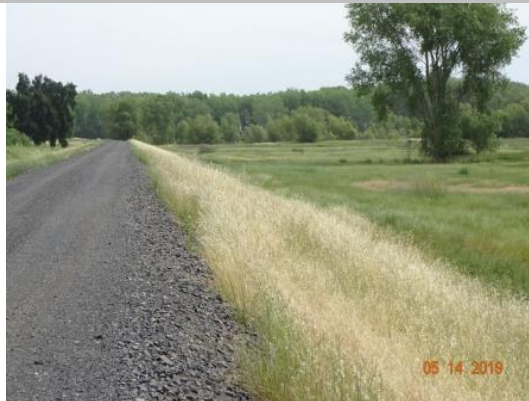
Photo 1 of 1 : SP_2019_MA0005_196_7_20190520_00090.jpg

LM Start	5.12	Rating **	U	Issue No.	7
LM End	15.06	Issue Type +	Ma	Location *	LS
Category	Earthen Levee			GPS Latitude/Longitude	
				Start	End
Item	Vegetation			39.630802 °	39.515766 °
				-121.773382 °	-121.873093 °
DWR ID	DWR_MA0005_01_s_2012_7				
Comment Code					
V1 : Control annual grass and weeds on the levee slopes and easements.					
Inspector Comment

View of the vegetation on the landside slope. Spring 2019.

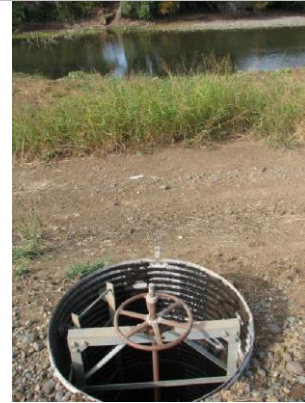
Photo 2 of 2 : UCIP_SP_2019_54040_67940.jpg

Comment Code						
Inspector Comment						
FS_ID:54040 DS_ID:1620 EP_NO: N/A Repair Type: Non-Urgent Crossing Status: Found UCIP Comments: 05/23/2019 (O. Magana - DWR UCIP)05/15/2017 Abandoned and needs to be done properly. A sink hole formed in the WS toe road and revealed the location of the WS pipe end. Sink hole will ned to be repaired before the next high water season but the pipe has been selected to be internally cleaned and camera inspected as part of the DMP project so it will have needed to be excavated along the WS end anyways. (DWR Sutter Yard- AFreitag)11/15/2016 Abandoned. Needs cover for the standpipe. (DWR Sutter Yard- AFreitag)05/09/2016 Abandoned pipe. Needs a cover for the standpipe.08/05/2015 Abandoned crossing. Covers need to be made for tops of standpipes to prevent falls.12/08/2014 Same as last inspection.06/11/2014 Same as last inspection.11/19/2013 Same as last inspection.05/29/2013 Same as last inspection. Land owner said pipes are abandoned and no longer used. Covers should be made for top of standpipe to prevent falls. Pipes should be properly abandoned.10/30/2012 Pipe 1/2 filled with soil at slide gate end. FIELD_STRUCT_DESC: *ABANDONED* 1 of 2: 36-inch drainage pipe through the levee, 11 feet below the crown. Slide gate in a 54-inch corrugated metal riser on the waterside (WS) slope. Concrete "U" headwall on the landside (LS). [Additional Reference(s): DWR Levee Log, 1990 (HLM 5.66). Sacramento O&M Manual, Unit 516 - Upper Butte Creek - Part No. 2, April 1960 (Station 470+00)]. FS Date: 5/23/2019 5:10:38 PM

54-inch CMP riser and slide gate on WS shoulder.

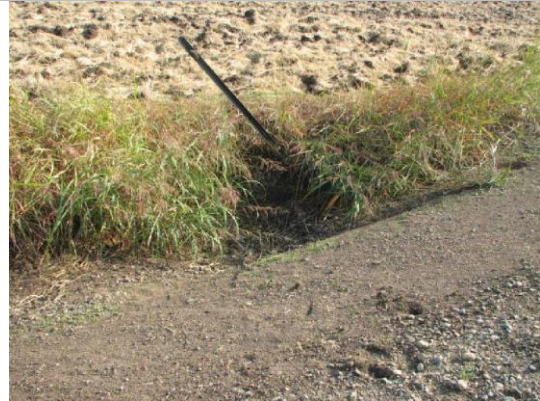
Photo 1 of 2 : UCIP_SP_2019_51970_67970.jpg

Headwall at LS toe.

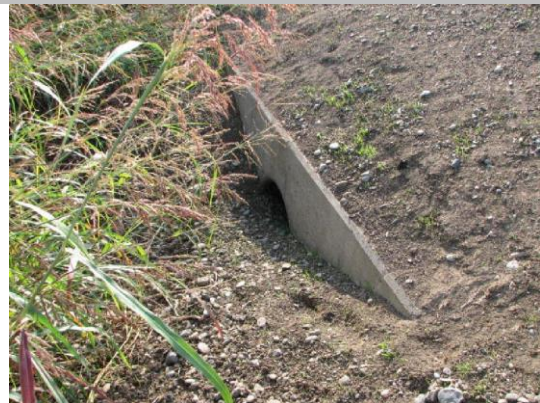
Photo 2 of 2 : UCIP_SP_2019_51970_67969.jpg

Headwall at LS toe.

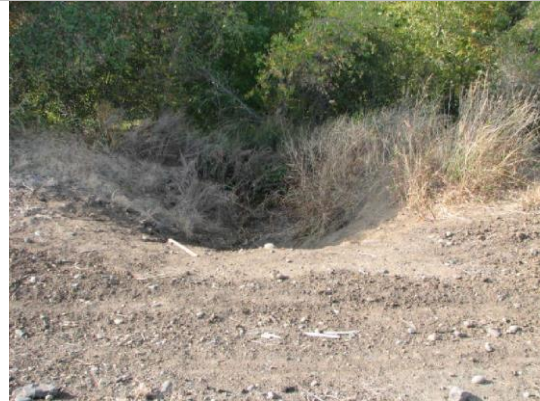
Photo 1 of 3 : UCIP_SP_2019_51972_67973.jpg

Outlet at WS toe.

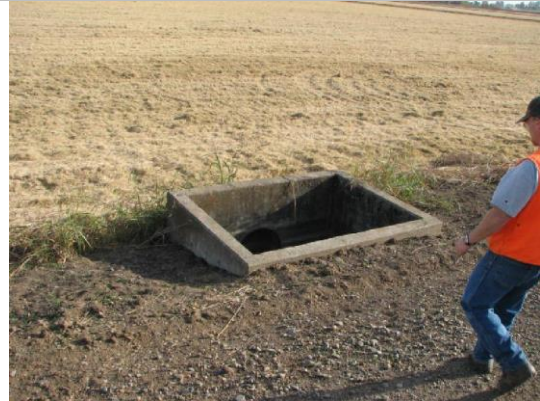
Photo 1 of 3 : UCIP_SP_2019_51975_67976.jpg

Concrete distribution box at LS toe.

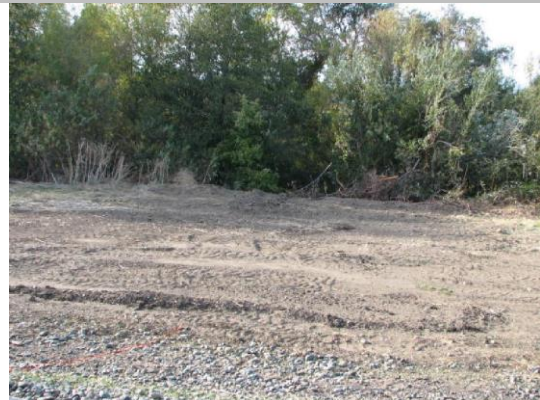
Photo 2 of 3 : UCIP_SP_2019_51975_67975.jpg

Comment Code					
Inspector Comment					
FS_ID:51975 DS_ID:1631 EP_NO: N/A Repair Type: Non-Urgent Crossing Status: Found UCIP Comments: 5/16/2017 Abandoned and needs to be done so properly. (DWR Sutter Yard- AFreitag)11/15/2016 Abandoned. (DWR Sutter Yard- AFreitag)5/11/2016 Abandoned pipe.8/4/2015 Abandoned pipe. Casey Wilder has started the steps to have the pipe properly abandoned and removed from the levee.12/8/2014 Same as last inspection.6/11/2014 Same as last inspection.11/19/2013 Same as last inspection.5/29/2013 Same as last inspection.10/30/2012 Need to confirm proper abandonment of pipe. Pipe should be plugged on LS. FIELD_STRUCT_DESC: 16-inch steel irrigation pipe through the levee, 11.5 feet below the crown. Pump located on the waterside (WS). Distribution box at the landside (LS) toe. [Additional Reference(s): DWR Levee Log, 1990 (HLM 9.21). USACE Sacramento O&M Manual, Unit 515 - Upper Butte Creek - Part No. 1, April 1955, (Station 655+68), As-Built Drawing No. 50-4-2637, Exhibit B, Sheet 3, April 1950, (Station 655+68.2)]. FS Date: 5/31/2017 2:09:46 PM

WS shoulder.

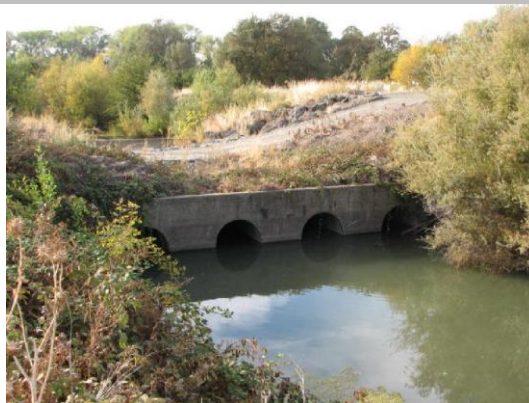
Photo 2 of 2 : UCIP_SP_2019_51976_67978.jpg

FS_ID:51976
DS_ID:1775
EP_NO: N/A
Repair Type: No Action Needed
Crossing Status: Found
UCIP Comments: 5/16/2017 Crossing appears to be in good condition. (DWR Sutter Yard- AFreitag)11/15/2016 Crossing appears to be in good condition. (DWR Sutter Yard- AFreitag)5/11/2016 Crossing appears to be in good condition.8/4/2015 Crossing is in good condition. No noticeable issues to report.12/8/2014 Same as last inspection.6/11/2014 Same as last inspection.11/19/2013 Same as last inspection.5/29/2013 Flap gates were removed by DWR Sutter Maintenance Yard to allow water to flow freely through crossing and not back up in ditch.10/30/2012 Seems there should be flap gates on this structure.
FIELD_STRUCT_DESC: [Robert's Creek Outlet Structure] 1 of 4: 66-inch corrugated metal drainage pipe through the levee, 17.9 feet below the crown. Concrete headwalls on the landside (LS) and the waterside (WS). Flap gate located on the WS. [Additional Reference(s): DWR Levee Log, 1990 (HLM 9.66). USACE Sacramento O&M Manual, Unit 515 - Upper Butte Creek - Part No. 1, April 1955, (Station 678+00), As-Built Drawing No. 50-4-2637, Exhibit B, Sheet 3, April 1950, (Station 678+00)].

LS of pipe crossing.

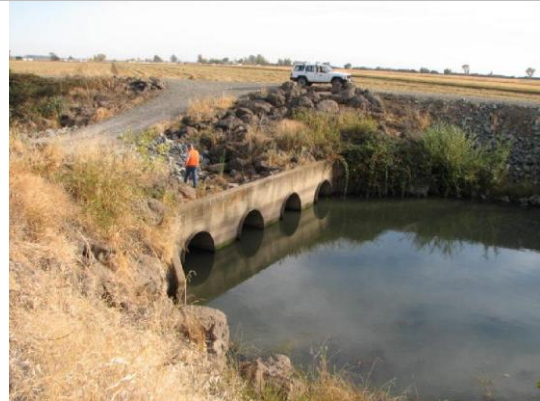
Photo 1 of 2 : UCIP_SP_2019_51978_67982.jpg

Comment Code						
Inspector Comment						
FS_ID:51978						
DS_ID:1632						
EP_NO: N/A						
Repair Type: No Action Needed						
Crossing Status: Found						
UCIP Comments: 5/16/2017 Crossing appears to be in good condition. (DWR Sutter Yard- AFreitag)11/15/2016 Crossing appears to be in good condition. (DWR Sutter Yard- AFreitag)5/11/2016 Crossing appears to be in good condition.8/4/2015 Crossing appears in good condition. No noticeable issues to report.12/8/2014 Same as last inspection.6/11/2014 Same as last inspection.11/19/2013 Same as last inspection.5/29/2013 Flap gates were removed by DWR Sutter Maintenance Yard to allow water to flow freely through crossing and not back up in ditch.10/30/2012 Seems there should be flap gates on this structure.						
FIELD_STRUCT_DESC: [Robert's Creek Outlet Structure] 3 of 4: 66-inch corrugated metal drainage pipe through the levee, 17.9 feet below the crown. Concrete headwalls on the landside (LS) and the waterside (WS). Flap gate located on the WS. [Additional Reference(s): DWR Levee Log, 1990 (HLM 9.66). USACE Sacramento O&M Manual, Unit 515 - Upper Butte Creek - Part No. 1, April 1955, (Station 678+00), As-Built Drawing No. 50-4-2637, Exhibit B, Sheet 3, April 1950, (Station 678+00)].

WS of crossing.

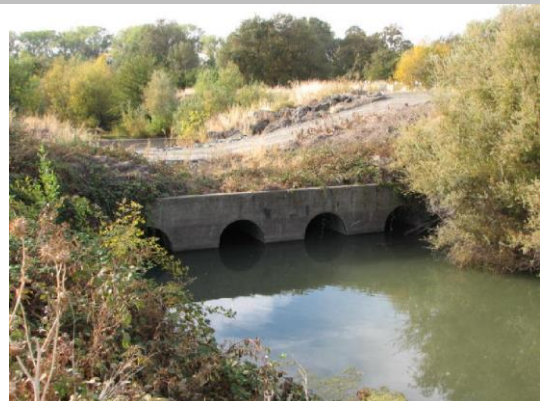
Photo 2 of 2 : UCIP_SP_2019_51978_67983.jpg

LS of crossing.

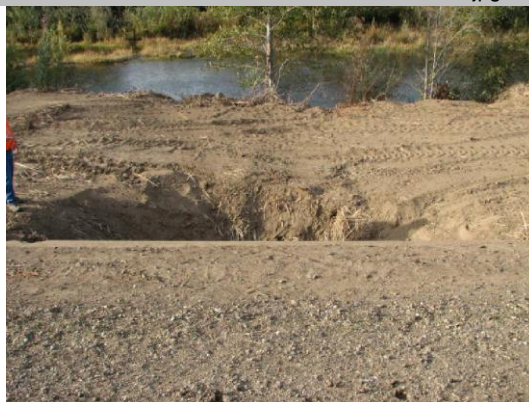
Photo 2 of 3 : UCIP_SP_2019_51981_67988.jpg

headwall at WS toe.

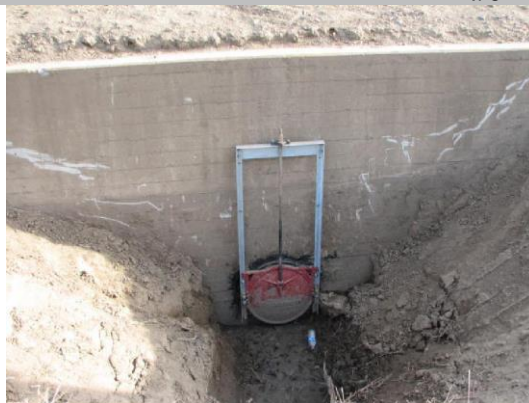
Photo 3 of 3 : UCIP_SP_2019_51981_67987.jpg

Item	DWR UCIP Field Study			39.568523 °	39.568523 °	
				-121.818232 °	-121.818232 °	
DWR ID	1634					
Comment Code						
Inspector Comment						
FS_ID:51981 DS_ID:1634 EP_NO: N/A Repair Type: Non-Urgent Crossing Status: Found UCIP Comments: 5/16/2017 Abandoned- needs to be done so properly. Pipe has been selected to be internally cleaned and inspected as part of the DMP project. (DWR Sutter Yard- AFreitag)11/15/2016 Abandoned. (DWR Sutter Yard- AFreitag)5/11/2016 Abandoned crossing.8/4/2015 Abandoned pipe. Casey Wilder has started the steps to have the pipe properly abandoned and removed from the levee.12/8/2014 Same as last inspection.6/11/2014 Same as last inspection.11/19/2013 Same as last inspection.5/29/2013 Same as last inspection. FIELD_STRUCT_DESC: 24-inch corrugated metal irrigation pipe through the levee, 14.5 feet below the crown. Slide gate on the waterside (WS) on concrete headwall. Flap gate on the landside (LS). [Additional Reference(s): DWR Levee Log, 1990 (HLM 10.41). USACE Sacramento O&M Manual, Unit 515 - Upper Butte Creek - Part No. 1, April 1955, (Station 717+50)]. FS Date: 5/31/2017 2:16:48 PM

Headwall and slide gate on WS toe.

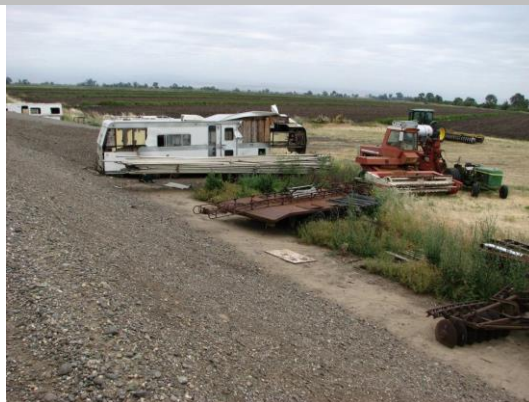
Photo 1 of 1 : SP_2019_MA0005_196_26_20190327_00007.jpg

LM Start	10.37	Rating **	M	Issue No.	26	
LM End	10.37	Issue Type +	En	Location *	LS	
Category	Earthen Levee			GPS Latitude/Longitude		
				Start		End
Item	Encroachments			39.567541 °		39.567541 °
				-121.819786 °		-121.819786 °
DWR ID	DWR_MA0005_01_s_ 2016_26					
Comment Code						
EQ : Equipment						
Inspector Comment						
Abandoned motorhomes and farm equipment should be removed from the landside toe.

5/5/2016: Remove abandoned motorhome and equipment from LS toe.

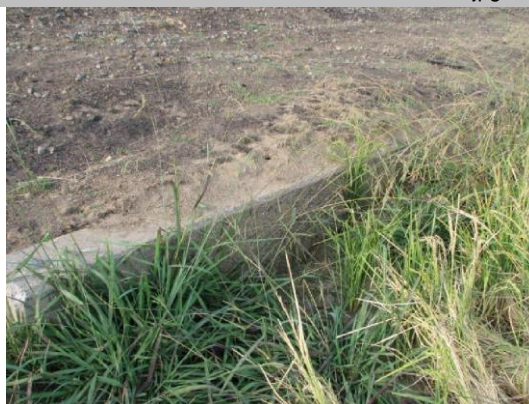
Photo 2 of 2 : UCIP_SP_2019_51982_67990.jpg

Concrete headwall at LS toe.

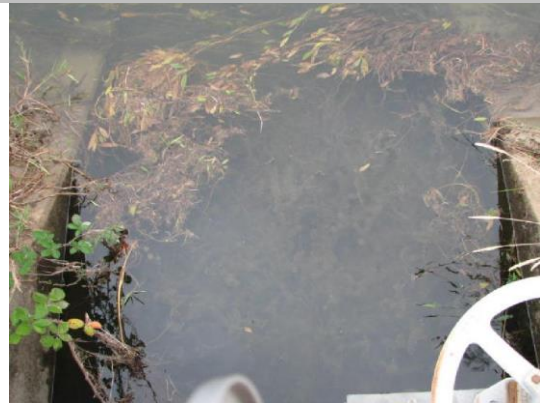
Photo 1 of 3 : UCIP_SP_2019_51988_68002.jpg

Comment Code						
Inspector Comment						
FS_ID:51988 DS_ID:1781 EP_NO: 16667 Repair Type: Non-Urgent Crossing Status: Found UCIP Comments: 5/16/2017 LS appears to be in good condition. WS outlet is too heavily vegetated to be inspected. Vegetation needs to be cleared back. Pipe has been selected to be internally cleaned and inspected as part of the DMP project. (DWR Sutter Yard-AFreitag)11/15/2016 Crossing appears to be in good condition. (DWR Sutter Yard- AFreitag)5/11/2016 Crossing appears to be in good condition.8/4/2015 Crossing appears in good condition. No noticeable issues to report.6/11/2014 Same as last inspection.11/19/2013 Same as last inspection.5/29/2013 Same as last inspection. FIELD_STRUCT_DESC: [Western Canal Siphon] 5 of 5: 18-inch reinforced concrete irrigation pipe through the levee, at an unknown depth. Pipe terminates at a concrete outlet on the waterside (WS) slope. Concrete headwalls on both the landside (LS) and the WS. Slide gate and air vent on the LS. This is a turnout that was installed for the use of the property owner. (Permit No. 16667, 1997 - Western Canal Water District). FS Date: 5/31/2017 2:23:27 PM

Concrete U shaped headwall at inlet in canal on LS.

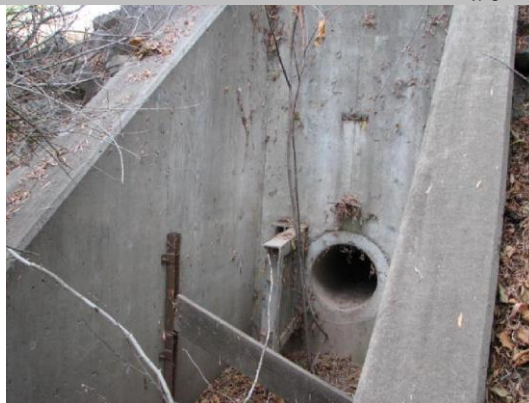
Photo 2 of 3 : UCIP_SP_2019_51988_68001.jpg

Item	DWR UCIP Field Study			39.561483 °	39.561483 °	
				-121.826939 °	-121.826939 °	
DWR ID	1781					
Comment Code						
Inspector Comment						
FS_ID:51988 DS_ID:1781 EP_NO: 16667 Repair Type: Non-Urgent Crossing Status: Found UCIP Comments: 5/16/2017 LS appears to be in good condition. WS outlet is too heavily vegetated to be inspected. Vegetation needs to be cleared back. Pipe has been selected to be internally cleaned and inspected as part of the DMP project. (DWR Sutter Yard- A/Freitag)11/15/2016 Crossing appears to be in good condition. (DWR Sutter Yard- A/Freitag)5/11/2016 Crossing appears to be in good condition.8/4/2015 Crossing appears in good condition. No noticeable issues to report.6/11/2014 Same as last inspection.11/19/2013 Same as last inspection.5/29/2013 Same as last inspection. FIELD_STRUCT_DESC: [Western Canal Siphon] 5 of 5: 18-inch reinforced concrete irrigation pipe through the levee, at an unknown depth. Pipe terminates at a concrete outlet on the waterside (WS) slope. Concrete headwalls on both the landside (LS) and the WS. Slide gate and air vent on the LS. This is a turnout that was installed for the use of the property owner. (Permit No. 16667, 1997 - Western Canal Water District). FS Date: 5/31/2017 2:23:27 PM

Concrete U shaped outlet on WS slope.

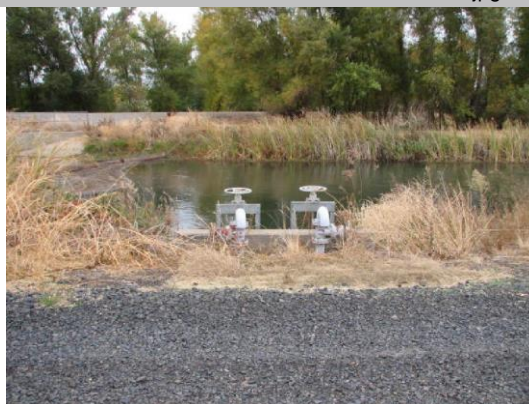
Photo 3 of 3 : UCIP_SP_2019_51988_68000.jpg

Air vents, slide gates, and concrete headwall at south side of canal on LS.

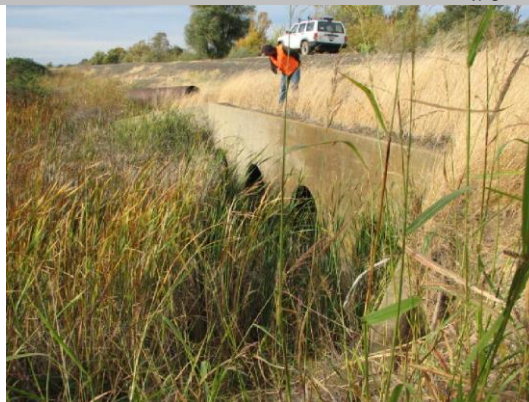
Photo 2 of 2 : UCIP_SP_2019_51991_68008.jpg

Headwall at LS toe.

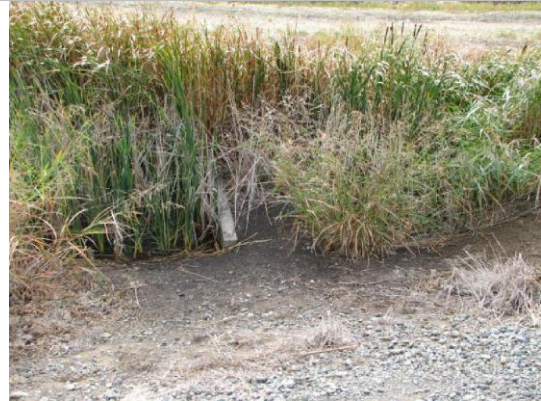
Photo 1 of 1 : UCIP_SP_2019_51996_68025.jpg

Comment Code					
Inspector Comment					
FS_ID:51996 DS_ID:1747 EP_NO: N/A Repair Type: Non-Urgent Crossing Status: Indicator Found UCIP Comments: 5/16/2017 Pipe is buried on both sides of the levee. Unable to locate. (DWR Sutter Yard- A Freitag)11/15/2016 Buried on both sides of Levee. (DWR Sutter Yard - A Freitag)5/11/2016 Buried pipe.8/4/2015 Pipe is buried on both ends.6/11/2014 Same as last inspection.11/19/2013 Same as last inspection.5/29/2013 Same as last inspection.10/31/2012 Pipe buried on both LS and WS. FIELD_STRUCT_DESC: 48-inch corrugated metal irrigation pipe through the levee, at an unknown depth, indicator found. 48-inch corrugated metal riser and a sparling water meter/irrigation structure on the landside (LS). 4-foot by 6-foot concrete distribution box at the LS toe. [Additional Reference(s): USACE Sacramento O&M Manual, Unit 515 - Upper Butte Creek - Part No. 1, April 1955, (Station 836+86), As-Built Drawing No. 50-4-2637, Exhibit B, Sheet 4, April 1950, (Station 836+86)]. FS Date: 5/31/2017 2:34:41 PM

Buried pipe at concrete box, LS toe.

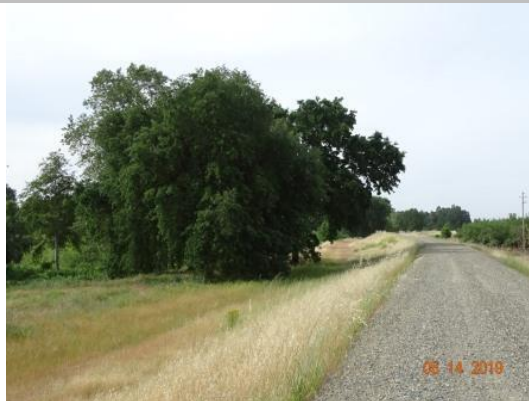
Photo 1 of 1 : SP_2019_MA0005_197_73_20190520_00102.jpg

LM Start	0.01	Rating **	U	Issue No.	73
LM End	11.74	Issue Type +	Ma	Location *	WS
Category	Earthen Levee			GPS Latitude/Longitude	
				Start	End
Item	Vegetation			39.517132 °	39.656763 °
				-121.876372 °	-121.788809 °
DWR ID	DWR_MA0005_02_s_2019_73				
Comment Code					
V1 : Control annual grass and weeds on the levee slopes and easements.					
Inspector Comment

View of the vegetation on the waterside slope. Spring 2019.

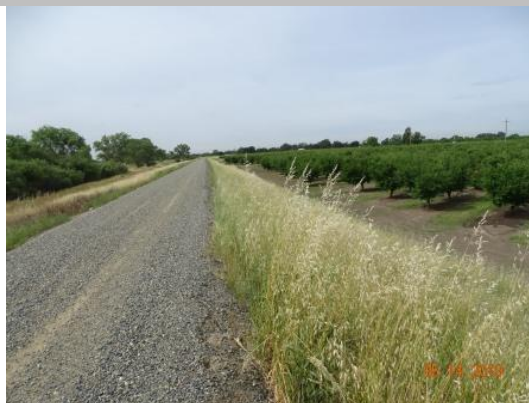
Photo 1 of 1 : SP_2019_MA0005_197_80_20190520_00103.jpg

LM Start	0.02	Rating **	U	Issue No.	80
LM End	8.76	Issue Type +	Ma	Location *	LS
Category	Earthen Levee			GPS Latitude/Longitude	
				Start	End
Item	Vegetation			39.517298 °	39.617539 °
				-121.876138 °	-121.779101 °
DWR ID	DWR_MA0005_02_s_2019_80				
Comment Code					
V1 : Control annual grass and weeds on the levee slopes and easements.					
Inspector Comment

View of the vegetation on the landside slope. Spring 2019.

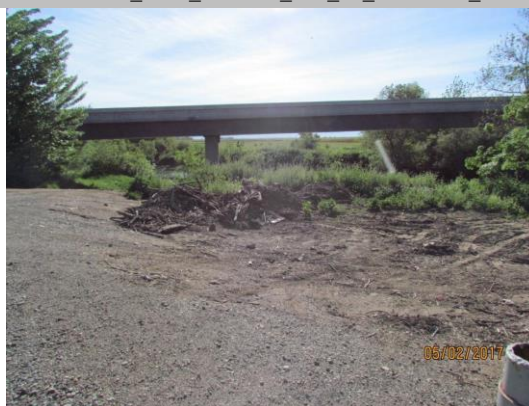
Photo 1 of 1 : SP_2019_MA0005_197_69_20190327_00037.jpg

LM Start	1.60	Rating **	M	Issue No.	69
LM End	1.60	Issue Type +	Ma	Location *	WS
Category	Earthen Levee			GPS Latitude/Longitude	
				Start	End
Item	Encroachments			39.534170 °	39.534170 °
				-121.856853 °	-121.856853 °
DWR ID	DWR_MA0005_02_s_2017_69				
Comment Code					
DE : Debris					
Inspector Comment					
Remove the debris from the waterside toe.

View of the debris along the waterside toe.

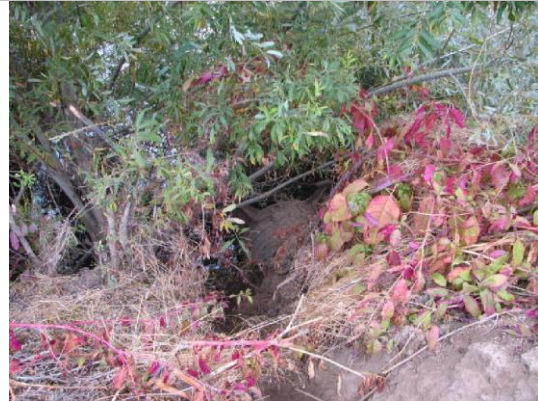
Photo 1 of 3 : UCIP_SP_2019_53009_68497.jpg

FS_ID:53009
DS_ID:1645
EP_NO: N/A
Repair Type: Urgent
Crossing Status: Found
UCIP Comments: 10/5/2018 Unable to see pipe on waterside due to high water level in the creek. Erosion is present around headwall on LS. Screw gate on LS blocked with silt approximately halfway in height. (O.Yakimov - DWR) 5/18/2017 LS erosion still present. Ws flap gate has been completely buried by sediment after the high water flows through the area. Pipe has been selected to be internally cleaned and inspected as part of the DMP project. (DWR Sutter Yard- AFreitag)11/14/2016 LS erosion still present and is into the prism of the levee. WS flap gate was still mostly buried and non-operational. (DWR Sutter Yard- AFreitag)5/23/2016 The tree that was overgrowing the WS flapgate has been removed. Flap gate was half buried and unable to open. Erosion on the LS is still present. (DWR Sutter Yard - afreitag)7/28/2015 LS inlet is underwater but there appears to be erosion behind the LS headwall. WS pipe end and flap gate are completely overgrown and inaccessible for inspection. (DWR Sutter Yard - afreitag)11/25/2014 Tree is overgrowing the WS pipe outlet.. Needs to be trimmed back. (DWR Sutter Yard - afreitag)6/4/2014 Same as last inspection. (DWR Sutter Yard - afreitag)11/12/2013 Same as last inspection. (DWR Sutter Yard - afreitag)6/6/2013 Same as last inspection. (DWR Sutter Yard - afreitag)10/31/2012 Vegetation needs to be cleared from outlet. (DWR UCIP - wwylie)

Flap gate on WS slope.

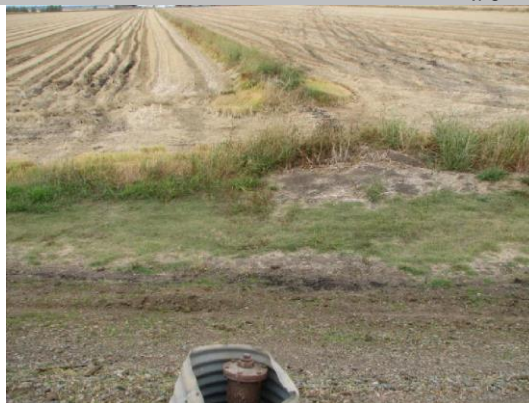
Photo 1 of 3 : UCIP_SP_2019_52013_68057.jpg

Comment Code					
Inspector Comment					
FS_ID:52013 DS_ID:1646 EP_NO: 3927 Repair Type: Non-Urgent Crossing Status: Found UCIP Comments: 5/18/2017 Appears to have been abandoned. Pump is missing from the pier and there is no sign of the riser and siphon breaker on the LS shoulder. (DWR Sutter Yard- A Freitag)11/14/2016 Appears abandoned- pump removed from pier in Butte Creek also riser and siphon breaker are no longer seen on LS shoulder. (DWR Sutter Yard- A Freitag)5/23/2016 Crossing appears to have been abandoned and removed. Could not locate the LS riser and siphon breaker.7/28/2015 No pump present during any of my inspections. Crossing appears abandoned. CMP riser has been knocked out of levee. 11/25/2014 Same as last inspection.6/04/2014 Same as last inspection.11/12/2013 Same as last inspection.6/6/2013 Same as last inspection.10/31/2012 Pump does not appear to be in use or is abandoned. FIELD_STRUCT_DESC: 20-inch (not 18-inch as referenced in the levee log) exterior coated steel irrigation pipe through the levee, 2.4 feet below the crown. Siphon breaker in a 24-inch corrugated metal riser on the landside (LS) shoulder. Portable pump on the waterside (WS). (Permit No. 3927, 1962 - Arrowhead Ranch). [Additional Reference(s): DWR Levee Log, 1990]. FS Date: 6/1/2017 9:46:03 AM

Air vent in 24-inch CMP riser on LS shoulder.

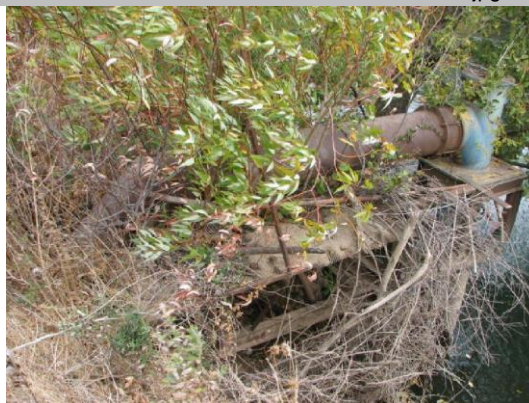
Photo 2 of 3 : UCIP_SP_2019_52013_68056.jpg

Pump on metal pier at WS toe.

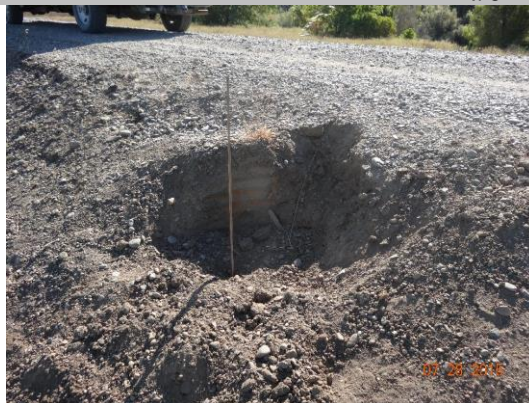
Photo 3 of 3 : UCIP_SP_2019_52013_74602.jpg

Comment Code						
Inspector Comment						
FS_ID:52013 DS_ID:1646 EP_NO: 3927 Repair Type: Non-Urgent Crossing Status: Found UCIP Comments: 5/18/2017 Appears to have been abandoned. Pump is missing from the pier and there is no sign of the riser and siphon breaker on the LS shoulder. (DWR Sutter Yard- AFreitag)11/14/2016 Appears abandoned- pump removed from pier in Butte Creek also riser and siphon breaker are no longer seen on LS shoulder. (DWR Sutter Yard- AFreitag)5/23/2016 Crossing appears to have been abandoned and removed. Could not locate the LS riser and siphon breaker.7/28/2015 No pump present during any of my inspections. Crossing appears abandoned. CMP riser has been knocked out of levee. 11/25/2014 Same as last inspection.6/04/2014 Same as last inspection.11/12/2013 Same as last inspection.6/6/2013 Same as last inspection.10/31/2012 Pump does not appear to be in use or is abandoned. FIELD_STRUCT_DESC: 20-inch (not 18-inch as referenced in the levee log) exterior coated steel irrigation pipe through the levee, 2.4 feet below the crown. Siphon breaker in a 24-inch corrugated metal riser on the landside (LS) shoulder. Portable pump on the waterside (WS). (Permit No. 3927, 1962 - Arrowhead Ranch). [Additional Reference(s): DWR Levee Log, 1990]. FS Date: 6/1/2017 9:46:03 AM

Spot where CMP riser was on the LS shoulder.

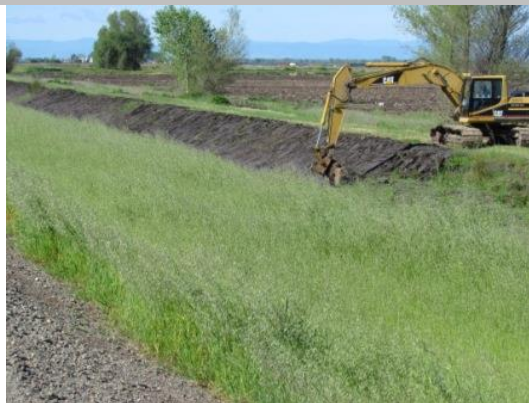
Photo 1 of 1 : SP_2019_MA0005_197_7_20190327_00004.jpg

LM Start	3.10	Rating **	M	Issue No.	7
LM End	4.04	Issue Type +	En	Location *	LS
Category	Earthen Levee			GPS Latitude/Longitude	
				Start	End
Item	Encroachments			39.551780 °	39.562341 °
				-121.840507 °	-121.829507 °
DWR ID	DWR_MA0005_02_s_2012_7				
Comment Code					
DT : Ditch					
Inspector Comment

View of the agricultural ditch along the landside toe.

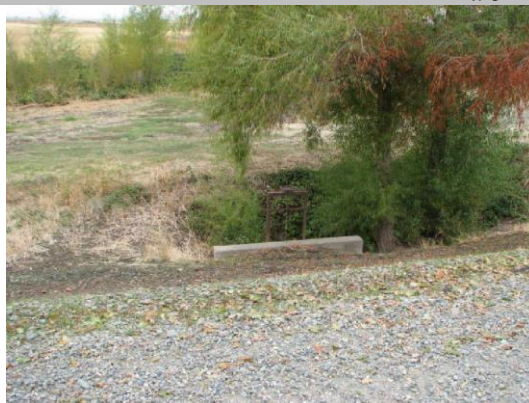
Photo 1 of 3 : UCIP_SP_2019_52014_68064.jpg

FS_ID:52014
DS_ID:1647
EP_NO: N/A
Repair Type: No Action Needed
Crossing Status: Found
UCIP Comments: 5/18/2017 Crossing appears to be in good condition. Tree near the LS screw gate could use some trimming. Pipe has been selected to be internally cleaned and inspected as part of the DMP project. (DWR Sutter Yard- A/Freitag)11/14/2016 Crossing appears to be in good condition. (DWR Sutter Yard- A/Freitag)5/23/2016 Crossing appears to be in good condition.7/28/2015 Pipe appears in good condition. No noticeable issues to report.6/6/2013 Same as last inspection.11/12/2013 Same as last inspection.6/04/2014 Same as last inspection.11/25/2014 Same as last inspection.
FIELD_STRUCT_DESC: 30-inch corrugated metal drainage pipe through the levee, 14.3 feet below the crown. Slide gate on the landside (LS). Flap gate on the waterside (WS). Concrete headwall at the LS toe. Concrete splash apron on the WS. [Additional Reference(s): DWR Levee Log, 1990. USACE Sacramento O&M Manual 515, April 1955, (Station 5+20""A""). USACE As-Built Drawing No. 50-4-2637, Exhibit B, Sheet 4, April 1950, (Station 5+20""A"").]

Concrete headwall and slide gate at LS toe.

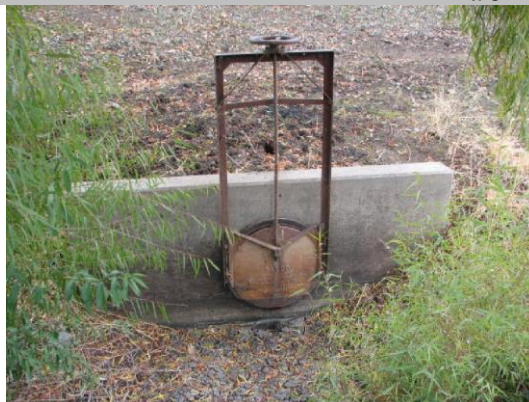
Photo 2 of 3 : UCIP_SP_2019_52014_68063.jpg

Concrete headwall and slide gate at LS toe.

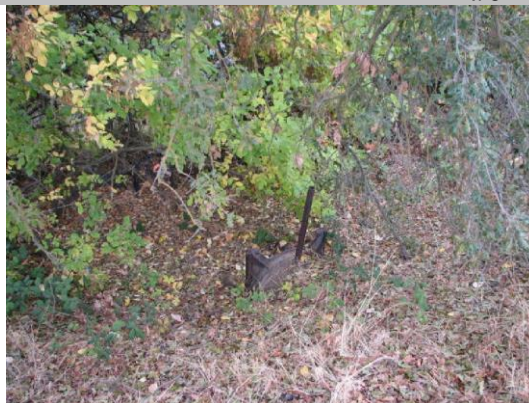
Photo 3 of 3 : UCIP_SP_2019_52014_68062.jpg

Comment Code						
Inspector Comment						
FS_ID:52014 DS_ID:1647 EP_NO: N/A Repair Type: No Action Needed Crossing Status: Found UCIP Comments: 5/18/2017 Crossing appears to be in good condition. Tree near the LS screw gate could use some trimming. Pipe has been selected to be internally cleaned and inspected as part of the DMP project. (DWR Sutter Yard- AFreitag)11/14/2016 Crossing appears to be in good condition. (DWR Sutter Yard- AFreitag)5/23/2016 Crossing appears to be in good condition.7/28/2015 Pipe appears in good condition. No noticeable issues to report.6/6/2013 Same as last inspection.11/12/2013 Same as last inspection.6/04/2014 Same as last inspection.11/25/2014 Same as last inspection. FIELD_STRUCT_DESC: 30-inch corrugated metal drainage pipe through the levee, 14.3 feet below the crown. Slide gate on the landside (LS). Flap gate on the waterside (WS). Concrete headwall at the LS toe. Concrete splash apron on the WS. [Additional Reference(s): DWR Levee Log, 1990. USACE Sacramento O&M Manual 515, April 1955, (Station 5+20""A"""). USACE As-Built Drawing No. 50-4-2637, Exhibit B, Sheet 4, April 1950, (Station 5+20""A""").] FS Date: 6/1/2017 9:47:13 AM

Flap gate at outlet on WS berm.

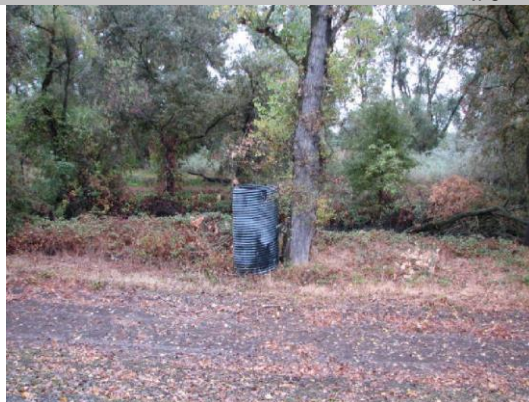
Photo 2 of 2 : UCIP_SP_2019_54041_68104.jpg

56-inch CMP riser on WS berm.

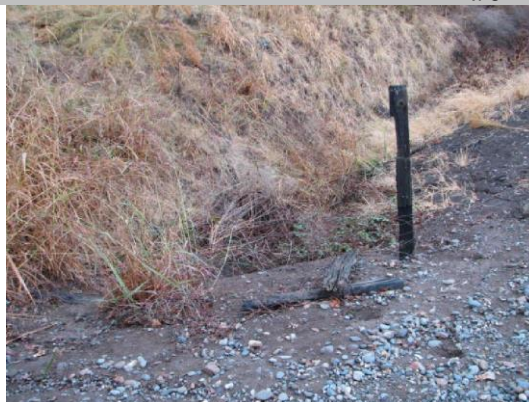
Photo 2 of 3 : UCIP_SP_2019_52049_68121.jpg

Headwall on LS toe.

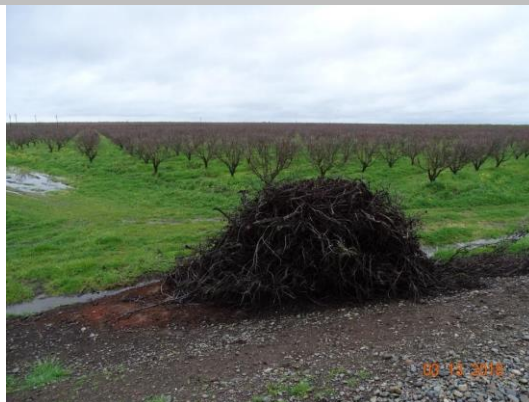
Photo 1 of 1 : SP_2019_MA0005_197_65_20190327_00034.jpg

LM Start	6.90	Rating **	M	Issue No.	65
LM End	6.90	Issue Type +	En	Location *	LS
Category	Earthen Levee			GPS Latitude/Longitude	
				Start	End
Item	Encroachments			39.594827 °	39.594827 °
				-121.797080 °	-121.797080 °
DWR ID	DWR_MA0005_02_s_2018_65				
Comment Code					
PR : Prunings					
Inspector Comment					
Remove the prunings from the landside toe.

View of the prunings along the landside toe.

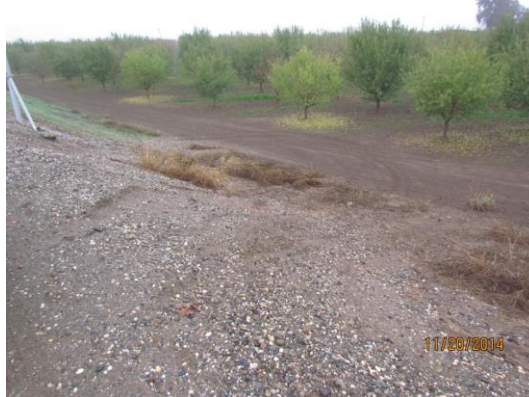
Photo 1 of 2 : SP_2019_MA0005_197_13_20190327_00005.jpg

LM Start	7.98	Rating **	M	Issue No.	13
LM End	7.98	Issue Type +	Ma	Location *	LS
Category	Earthen Levee			GPS Latitude/Longitude	
				Start	End
Item	Slope Stability			39.607710 °	39.607710 °
				-121.785868 °	-121.785868 °
DWR ID	DWR_MA0005_02_s_2012_13				
Comment Code					
S3 : Repair the levee slope damaged by vehicle traffic and prevent access where possible.					
Inspector Comment

View of the vehicle erosion along the landside slope.

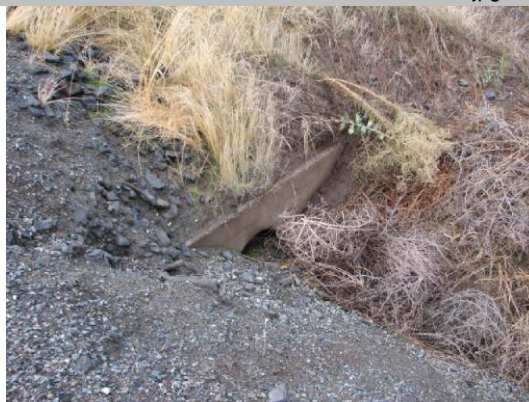
Photo 2 of 2 : UCIP_SP_2019_52052_68128.jpg

Concrete headwall on LS toe.

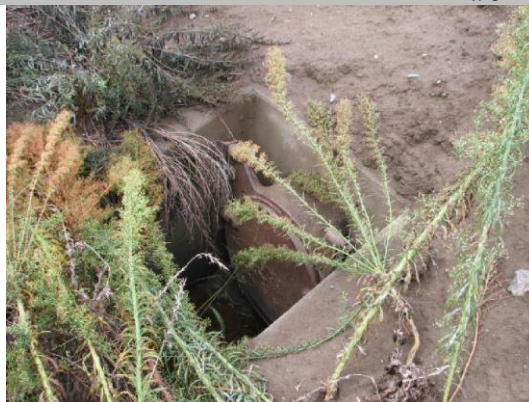
Photo 3 of 3 : UCIP_SP_2019_52059_68392.jpg

Concrete outlet and flap gate on WS toe.

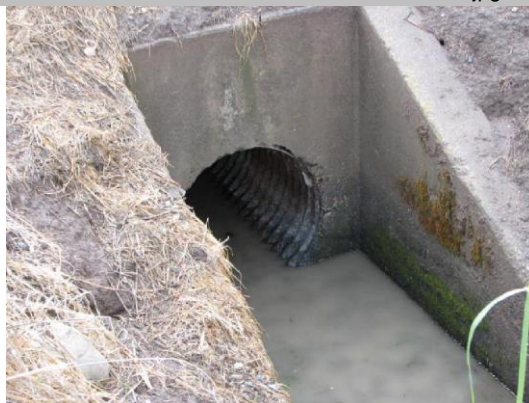
Photo 2 of 3 : UCIP_SP_2019_52061_68396.jpg

Concrete U-shaped headwall on LS toe.

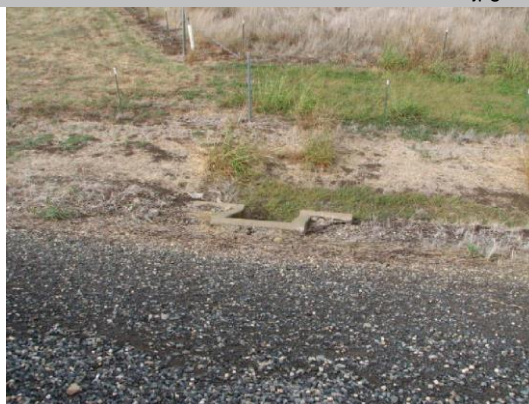
Photo 2 of 3 : UCIP_SP_2019_52063_68412.jpg

Concrete U shaped headwall on LS toe.

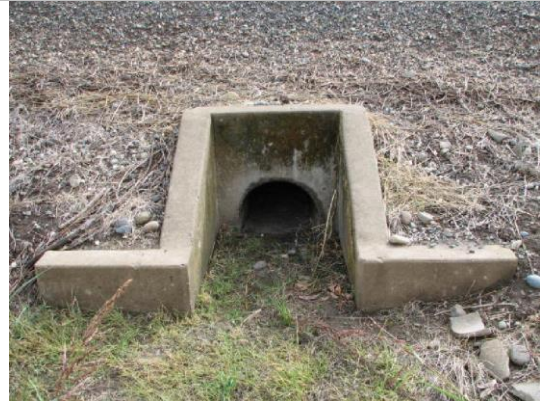
Photo 3 of 3 : UCIP_SP_2019_52063_68411.jpg

Item	DWR UCIP LMA Responsibility			39.622377 °	39.622377 °	
				-121.776327 °	-121.776327 °	
DWR ID	1665					
Comment Code						
Inspector Comment						
FS_ID:52063 DS_ID:1665 EP_NO: N/A Repair Type: No Action Needed Crossing Status: Found UCIP Comments: 5/18/2017 Crossing appears to be in good condition. Pipe has been selected to be internally cleaned and inspected as part of the DMP project. (DWR Sutter Yard- AFreitag)11/14/2016 Crossing appears to be in good condition. (DWR Sutter Yard- AFreitag)5/12/2016 Crossing appears to be in good condition. 7/30/2015 Crossing appears in good condition. No noticeable issues to report.11/24/2014 Same as last inspection.6/4/2014 Same as last inspection.11/13/2013 Same as last inspection.6/6/2013 Same as last inspection. FIELD_STRUCT_DESC: 24-inch corrugated metal drainage pipe through the levee, 11.3 feet below the crown. Flap gate on the waterside (WS). Concrete headwalls on both the landside (LS) and the WS. [Additional Reference(s): DWR Levee Log, 1990. USACE Sacramento O&M Manual 516, April 1960, (Station 321+20)]. FS Date: 6/1/2017 1:32:51 PM

Concrete U shaped headwall on LS toe.

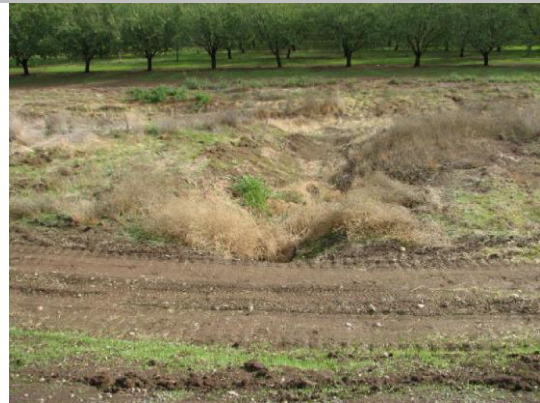
Photo 1 of 3 : UCIP_SP_2019_52064_68417.jpg

Comment Code						
Inspector Comment						
FS_ID:52064 DS_ID:1666 EP_NO: N/A Repair Type: Non-Urgent Crossing Status: Found UCIP Comments: 5/18/2017 LS inlet half full of soil and WS flap gate half buried by sediment. Pipe has been selected to be internally cleaned and inspected as part of the DMP project. (DWR Sutter Yard-AFreitag)11/14/2016 LS pipe inlet is half full of soil. WS flap gate shut but half buried by sediment. (DWR Sutter Yard-AFreitag)5/12/2016 Pipe is half full of soil.7/30/2015 Pipe is 1/4 to 1/2 full of soil still.11/24/2014 Same as last inspection.6/4/2014 Same as last inspection.11/13/2013 Same as last inspection.6/6/2013 Same as last inspection.11/01/2012 Pipe 1/2 filled with soil. FIELD_STRUCT_DESC: 24-inch corrugated metal drainage pipe through the levee, 11.2 feet below the crown. Flap gate on the waterside (WS). Concrete ""U"" shaped headwalls on both the landside (LS) and the WS. [Additional Reference(s): DWR Levee Log, 1990. USACE Sacramento O&M Manual 516, April 1960, (Station 304+10). USACE As-Built Drawing No. 50-4-3367, Exhibit B, Sheet 3, April 1957, (Station 304+10)]. FS Date: 6/1/2017 1:34:12 PM

View of outlet looking toward WS toe.

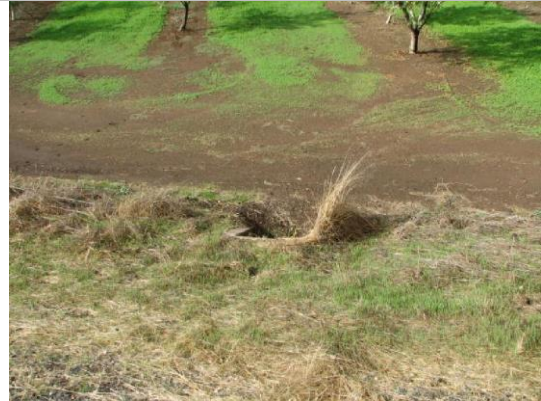
Photo 2 of 3 : UCIP_SP_2019_52064_68416.jpg

Comment Code						
Inspector Comment						
FS_ID:52064 DS_ID:1666 EP_NO: N/A Repair Type: Non-Urgent Crossing Status: Found UCIP Comments: 5/18/2017 LS inlet half full of soil and WS flap gate half buried by sediment. Pipe has been selected to be internally cleaned and inspected as part of the DMP project. (DWR Sutter Yard-AFreitag)11/14/2016 LS pipe inlet is half full of soil. WS flap gate shut but half buried by sediment. (DWR Sutter Yard-AFreitag)5/12/2016 Pipe is half full of soil.7/30/2015 Pipe is 1/4 to 1/2 full of soil still.11/24/2014 Same as last inspection.6/4/2014 Same as last inspection.11/13/2013 Same as last inspection.6/6/2013 Same as last inspection.11/01/2012 Pipe 1/2 filled with soil. FIELD_STRUCT_DESC: 24-inch corrugated metal drainage pipe through the levee, 11.2 feet below the crown. Flap gate on the waterside (WS). Concrete ""U"" shaped headwalls on both the landside (LS) and the WS. [Additional Reference(s): DWR Levee Log, 1990. USACE Sacramento O&M Manual 516, April 1960, (Station 304+10). USACE As-Built Drawing No. 50-4-3367, Exhibit B, Sheet 3, April 1957, (Station 304+10)]. FS Date: 6/1/2017 1:34:12 PM

View of inlet on LS toe.

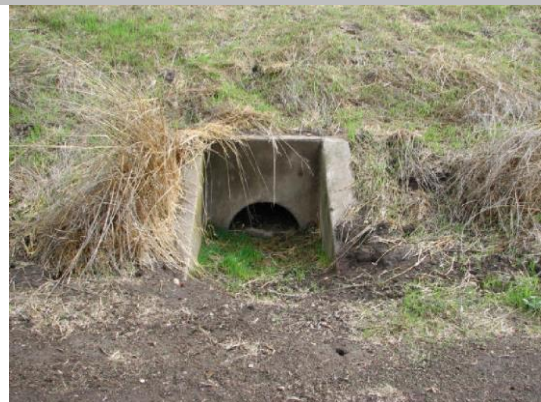
Photo 3 of 3 : UCIP_SP_2019_52064_68415.jpg

Concrete U-shaped headwall on LS toe.

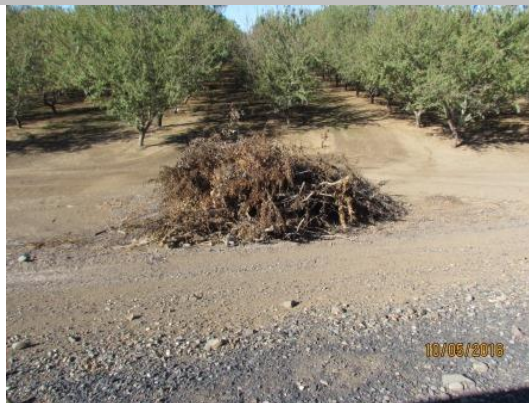
Photo 1 of 1 : SP_2019_MA0005_197_56_20190327_00028.jpg

LM Start	9.72	Rating **	M	Issue No.	56
LM End	9.72	Issue Type +	En	Location *	LS
Category	Earthen Levee			GPS Latitude/Longitude	
				Start	End
Item	Encroachments			39.630937 °	39.630937 °
				-121.774960 °	-121.774960 °
DWR ID	DWR_MA0005_02_f_2016_56				
Comment Code					
PR : Prunings					
Inspector Comment					
Remove the prunings from the landside toe.

View of the prunings along the landside toe.

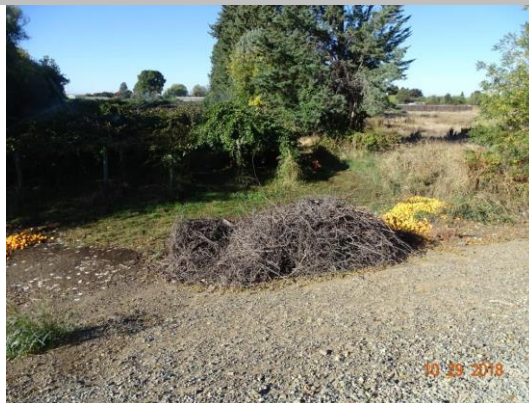
Photo 1 of 1 : SP_2019_MA0005_197_67_20190327_00035.jpg

LM Start	10.22	Rating **	M	Issue No.	67
LM End	10.22	Issue Type +	En	Location *	LS
Category	Earthen Levee			GPS Latitude/Longitude	
				Start	End
Item	Encroachments			39.637030 °	39.637030 °
				-121.779870 °	-121.779870 °
DWR ID	DWR_MA0005_02_f_2018_67				
Comment Code					
PR : Prunings					
Inspector Comment					
Remove the prunings from the landside toe.

View of the prunings along the landside toe.

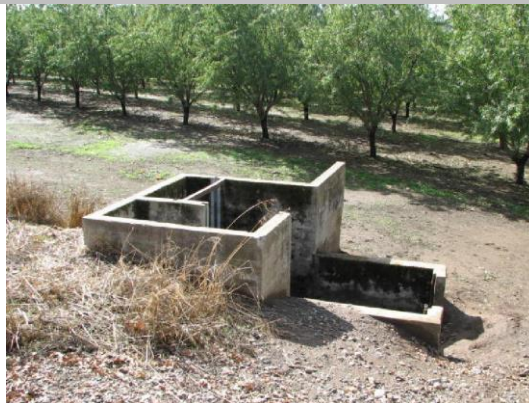
Photo 2 of 3 : UCIP_SP_2019_52069_68433.jpg

Distribution box on LS toe. Missing slide gate at pipe entrance.

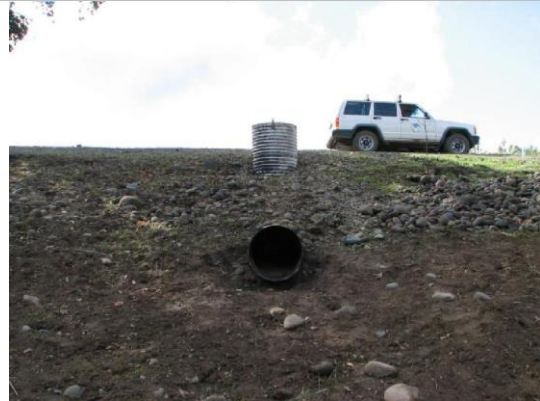
Photo 3 of 3 : UCIP_SP_2019_52069_68432.jpg

Comment Code						
Inspector Comment						
FS_ID:52069 DS_ID:1670 EP_NO: N/A Repair Type: Non-Urgent Crossing Status: Found UCIP Comments: 5/18/2017 Appears abandoned- Slide gates in WS riser and LS distribution box missing. Pipe has been selected to be internally cleaned and inspected as part of the DMP project. (DWR Sutter Yard- AFreitag)11/14/2016 Appears abandoned- Slide gates in WS riser and LS distribution box missing. (DWR Sutter Yard- AFreitag)5/11/2016 Crossing appears to be in good condition.7/30/2015 Crossing appears in good condition. No noticeable issues to report.11/24/2014 Same as last inspection.6/4/2014 Same as last inspection.11/13/2013 Same as last inspection.6/6/2013 New flap gate installed on WS end of pipe. FIELD_STRUCT_DESC: 24-inch corrugated metal (not 18-inch concrete as shown in the as-built drawing) irrigation pipe through the levee, 9.7 feet below the crown. Slide gate in corrugated metal riser on the waterside (WS) slope. Flap gate on the WS toe. Slide gate in concrete distribution box on the landside (LS). [Additional Reference(s): DWR Levee Log, 1990. USACE Sacramento O&M Manual 516, April 1960, (Station 215+65). USACE As-Built Drawing No. 50-4-3367, Exhibit B, Sheet 2, April 1957, (Station 215+65)]. FS Date: 6/1/2017 1:43:12 PM

View of pipe from WS looking toward LS.

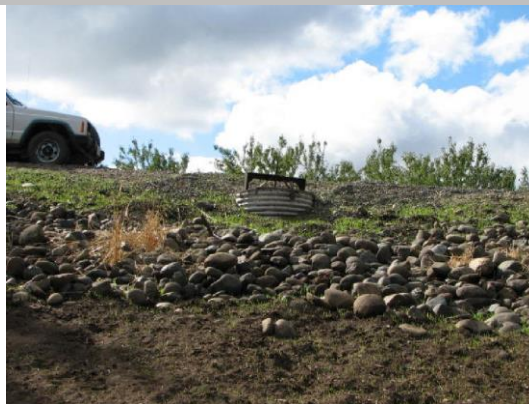
Photo 2 of 3 : UCIP_SP_2019_52070_68435.jpg

CM riser with slide gate on WS shoulder.

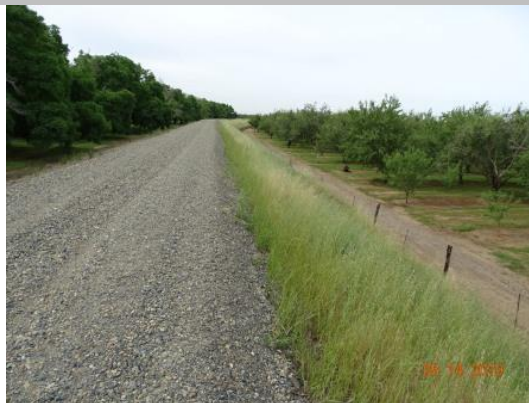
Photo 1 of 1 : SP_2019_MA0005_197_10_20190520_00104.jpg

LM Start	11.42	Rating **	U	Issue No.	10
LM End	12.82	Issue Type +	Ma	Location *	LS
Category	Earthen Levee			GPS Latitude/Longitude	
				Start	End
Item	Vegetation			39.652233 °	39.671127 °
				-121.790366 °	-121.782711 °
DWR ID	DWR_MA0005_02_s_2019_10				
Comment Code					
V1 : Control annual grass and weeds on the levee slopes and easements.					
Inspector Comment

View of the vegetation on the landside slope. Spring 2019.
