**Flood Control Project Maintenance
Levee Inspections**
LMA District Cover Sheet
Spring 2019 Levee Inspection Results

Sutter Maintenance Yard Maintenance Area 0005

Spring 2019 Levee Inspection Results

Waterway			Bank	Unit Miles
Unit No. 01 Butte Creek			Left	15.08
	Spring (March - May)	Summer (June - August)	(September - November) Fall	Winter (December - February)
Unit Maintenance Rating (Fall Only)				
Date of Inspection	5/14/2019 - 5/14/2019			
DWR Inspector	Makar Sokol			
Accompanied By	Shawn Freitag Sutter Maintenance Yard

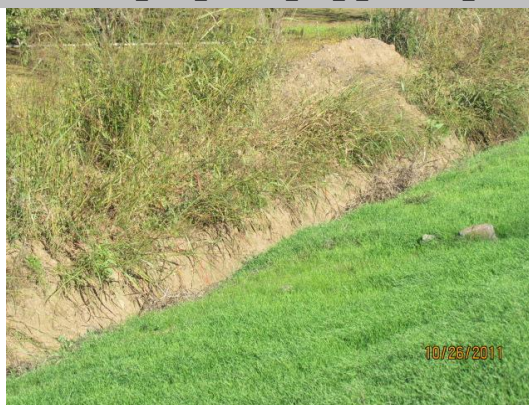
Photo 1 of 1 : SP_2019_MA0005_197_6_20190327_00003.jpg

LM Start	11.57	Rating **	M	Issue No.	6
LM End	11.77	Issue Type +	En	Location *	LS
Category	Earthen Levee			GPS Latitude/Longitude	
				Start	End
Item	Encroachments			39.654349 °	39.657142 °
				-121.789531 °	-121.788690 °
DWR ID	DWR_MA0005_02_s_2012_6				
Comment Code					
DT : Ditch					
Inspector Comment

View of the ditch along the landside toe.

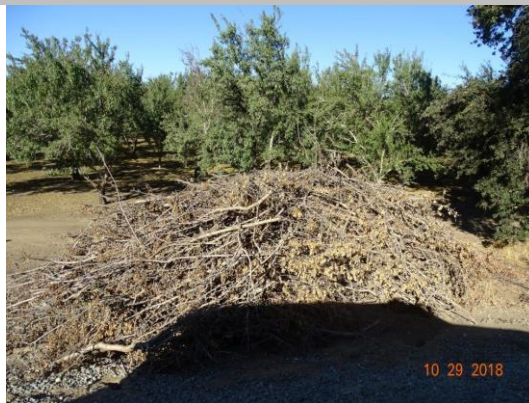
Photo 1 of 1 : SP_2019_MA0005_197_70_20190327_00038.jpg

LM Start	11.77	Rating **	M	Issue No.	70
LM End	11.77	Issue Type +	En	Location *	LS
Category	Earthen Levee			GPS Latitude/Longitude	
				Start	End
Item	Encroachments			39.657115 °	39.657115 °
				-121.788703 °	-121.788703 °
DWR ID	DWR_MA0005_02_f_2018_70				
Comment Code					
PR : Prunings					
Inspector Comment					
Remove the prunings from the landside toe.

View of the prunings along the landside toe.

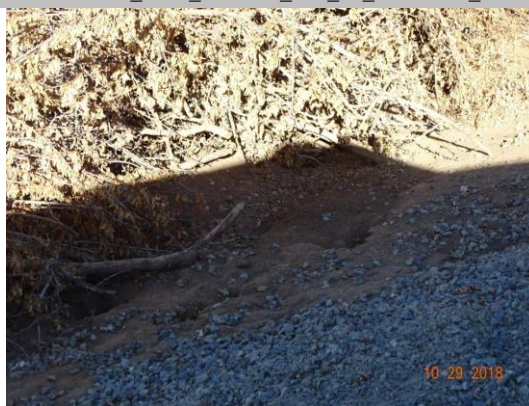
View of the rodent holes along the landside slope.

LM Start	11.77	Rating **	M	Issue No.	71
LM End	11.77	Issue Type +	Ma	Location *	LS
Category	Earthen Levee			GPS Latitude/Longitude	
				Start	End
Item	Animal Control			39.657115 °	39.657115 °
				-121.788703 °	-121.788703 °
DWR ID	DWR_MA0005_02_f_2018_71				
Comment Code					
A3 : No rodents visible, but rodent burrows visible; need to backfill and compact or grout burrows.					
Inspector Comment

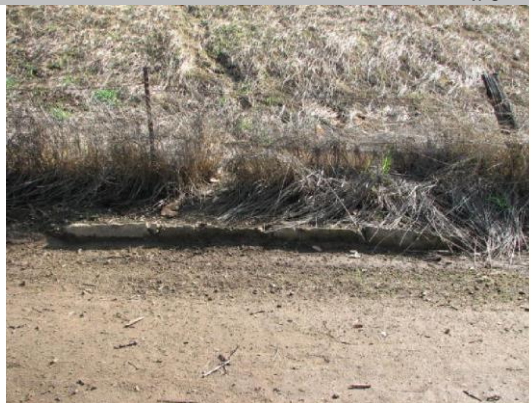
Photo 2 of 3 : UCIP_SP_2019_54048_68464.jpg

FS_ID:54048
DS_ID:1673
EP_NO: N/A
Repair Type: Non-Urgent
Crossing Status: Found
UCIP Comments: 05/23/2019 (O. Magana - DWR UCIP)05/18/2017 Abandoned- needs to be done properly. Pipe has been selected to be internally cleaned and inspected as part of the DMP project. (DWR Sutter Yard- A Freitag)11/14/2016 Abandoned- needs a cover for standpipe. (DWR Sutter Yard- A Freitag)05/11/2016 Abandoned crossing. Needs a cover to the WS riser.08/03/2015 Crossing appears abandoned. Only the slide gate inside riser on the WS shoulder could be found. Riser needs a cover made for it.11/24/2014 Same as last inspection.06/04/2014 Same as last inspection.11/13/2013 Slide gate top and stem were repaired to make gate operational.06/06/2013 New slidegate is planned to be installed during summer of 2013.11/01/2012 Slide gate on WS shoulder bent and damaged (inoperable) Pipe appears abandoned.
FIELD_STRUCT_DESC: *ABANDONED* 24-inch corrugated metal drainage pipe through the levee, 14 feet below the crown. Slide gate in a corrugated metal riser on the waterside (WS) slope. [Additional Reference(s): DWR Levee Log, 1990. USACE Sacramento O&M Manual 516, April 1960, (Station 126+91)].

Abandoned headwall on LS toe.

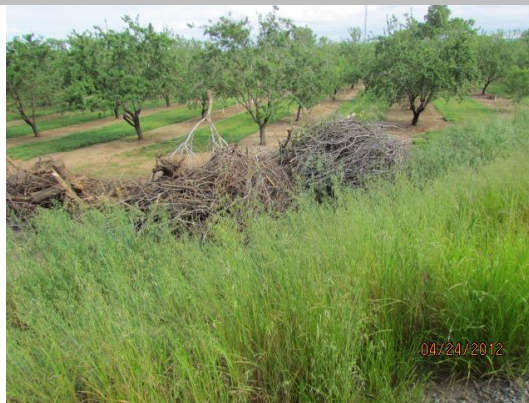
Photo 1 of 1 : SP_2019_MA0005_197_19_20190327_00008.jpg

LM Start	12.83	Rating **	M	Issue No.	19
LM End	12.83	Issue Type +	En	Location *	LS
Category	Earthen Levee			GPS Latitude/Longitude	
				Start	End
Item	Encroachments			39.671239 °	39.671239 °
				-121.782486 °	-121.782486 °
DWR ID	DWR_MA0005_02_s_2012_19				
Comment Code					
PR : Prunings					
Inspector Comment					
Remove the prunings from the landside toe.

View of the prunings at the toe of the levee.

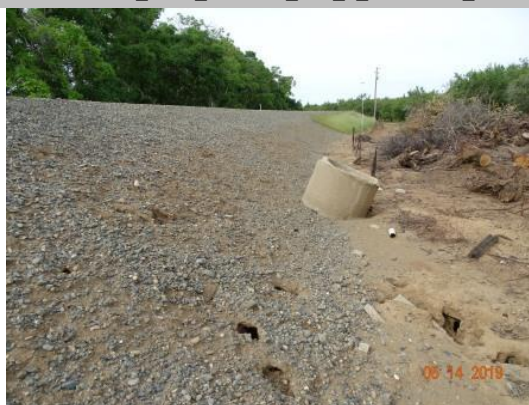
Photo 1 of 1 : SP_2019_MA0005_197_9_20190520_00105.jpg

LM Start	12.84	Rating **	M	Issue No.	9
LM End	12.84	Issue Type +	Ma	Location *	LS
Category	Earthen Levee			GPS Latitude/Longitude	
				Start	End
Item	Animal Control			39.671281 °	39.671281 °
				-121.782390 °	-121.782389 °
DWR ID	DWR_MA0005_02_s_2019_9				
Comment Code					
A3 : No rodents visible, but rodent burrows visible; need to backfill and compact or grout burrows.					
Inspector Comment

View of the animal burrows on the landside slope. Spring 2019.

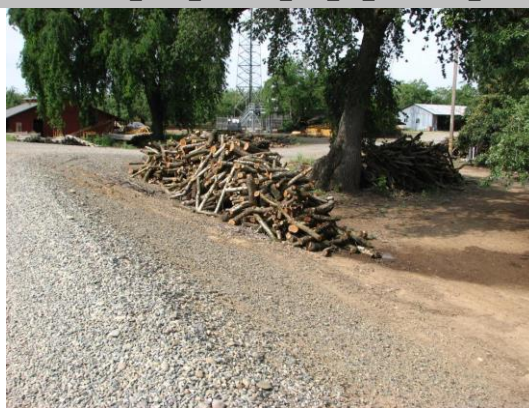
Photo 1 of 1 : SP_2019_MA0005_197_42_20190327_00018.jpg

LM Start	13.06	Rating **	M	Issue No.	42
LM End	13.06	Issue Type +	En	Location *	LS
Category	Earthen Levee			GPS Latitude/Longitude	
				Start	End
Item	Encroachments			39.674219 °	39.674219 °
				-121.781188 °	-121.781188 °
DWR ID	DWR_MA0005_02_s_2016_42				
Comment Code					
FW : Firewood					
Inspector Comment					
Remove the firewood from the landside toe.

View of the firewood pile at the landside toe.

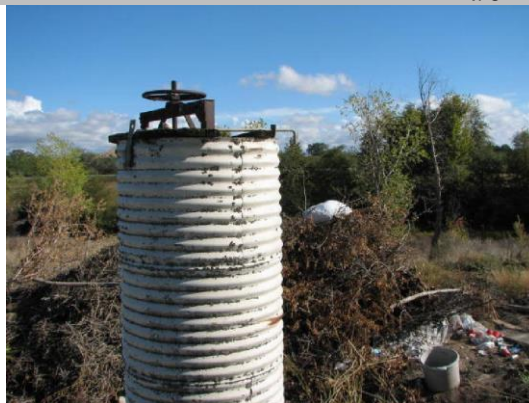
Photo 1 of 1 : UCIP_SP_2019_52073_68488.jpg

Comment Code					
Inspector Comment					
FS_ID:52073 DS_ID:1674 EP_NO: 1291 Repair Type: Non-Urgent Crossing Status: Found UCIP Comments: 5/18/2017 Appears abandoned- needs to be done properly. (DWR Sutter Yard- AFreitag)11/14/2016 Appears abandoned- needs to be done so properly (DWR Sutter Yard- AFreitag)5/11/2016 Appears to be an abandoned crossing.8/3/2015 Pipe appears to be abandoned. Pump on WS berm is still missing.11/24/2014 Same as last inspection.6/4/2014 Same as last inspection.11/13/2013 Same as last inspection.6/6/2013 Same as last inspection.11/01/2012 Pipe appears to be abandoned. No pump found. Pipe should be abandoned properly. FIELD_STRUCT_DESC: 24-inch corrugated metal (not 14-inch concrete as described in the permit) irrigation pipe through the levee, 9 feet below the crown. Slide gate in a 36-inch corrugated metal riser on the waterside (WS) slope. Pump and a 36-inch concrete standpipe on the WS. (Originally installed under Permit No. 1291, 1948 - J. P. Hansen). [Additional Reference(s): DWR Levee Log, 1990. USACE Sacramento O&M Manual 516, April 1960, (Station 106+93)]. FS Date: 6/1/2017 1:54:43 PM

Slide gate in CM riser on WS toe.

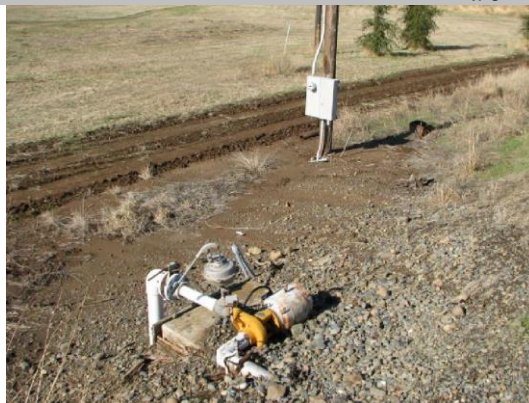
Photo 1 of 1 : UCIP_SP_2019_52074_68489.jpg

Comment Code						
Inspector Comment						
FS_ID:52074 DS_ID:1675 EP_NO: N/A Repair Type: Non-Urgent Crossing Status: Found UCIP Comments: 5/18/2017 LS visible but nothing found on WS of levee. (DWR Sutter Yard- A Freitag)11/14/2016 Still unable to locate and WS appurtances. (DWR Sutter Yard- A Freitag)5/11/2106 LS seems fine but nothing was found on the WS8/3/2015 Still unable to locate anything on the WS.11/24/2014 Same as last inspection.6/4/2014 Same as last inspection.11/13/2013 Same as last inspection.6/6/2013 Same as last inspection.11/01/2012 Unable to locate pipe on WS. FIELD_STRUCT_DESC: 8-inch steel irrigation pipe, 4 feet below the crown. Pipe is sleeved with a 5-inch aluminum irrigation pipe. Pump on a concrete pad on the landside (LS) slope. Butterfly valve on the LS slope. [Additional Reference(s): DWR Levee Log, 1990]. FS Date: 6/1/2017 1:56:04 PM

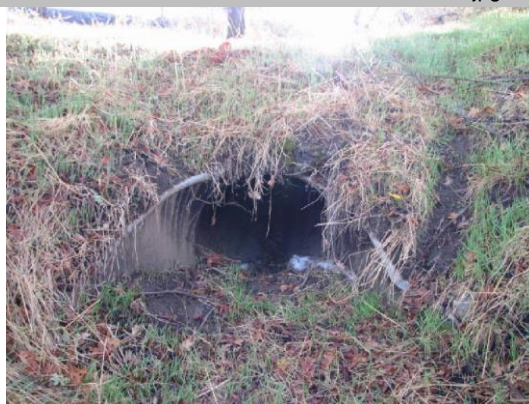
Photo 2 of 3 : UCIP_SP_2019_52083_68530.jpg

Inlet 50-feet NW of levee crown.

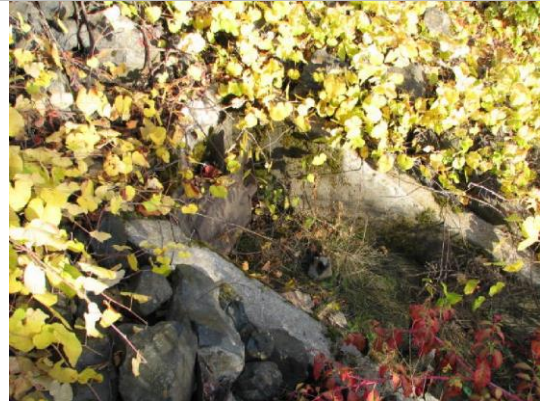
Photo 3 of 3 : UCIP_SP_2019_52083_68533.jpg

Item	DWR UCIP LMA Responsibility			39.678550 °	39.678550 °	
				-121.778339 °	-121.778339 °	
DWR ID	1679					
Comment Code						
Inspector Comment						
FS_ID:52083 DS_ID:1679 EP_NO: N/A Repair Type: No Action Needed Crossing Status: Found UCIP Comments: 5/18/2017 Crossing appears to be in good condition. Pipe has been selected to be internally cleaned and inspected as part of the DMP project. (DWR Sutter Yard- A Freitag)11/14/2016 Crossing appears to be in good condition. (DWR Sutter Yard- A Freitag)5/11/2016 Crossing appears to be in good condition.8/3/2015 Crossing appears in good condition. No noticeable issues to report.11/25/2014 Same as last inspection.6/4/2014 Same as last inspection.11/13/2013 Same as last inspection.6/6/2013 Same as last inspection. FIELD_STRUCT_DESC: 24-inch corrugated metal drainage pipe through the levee, 14.5 feet below the crown. Concrete ""U"" shaped headwall on the waterside (WS). Flap gate on the WS. [Additional Reference(s): DWR Levee Log, 1990. USACE Sacramento O&M Manual 516, April 1960, (Station 93+78)]. FS Date: 6/1/2017 2:09:55 PM

Concrete U-shaped headwall and flap gate at WS slope.

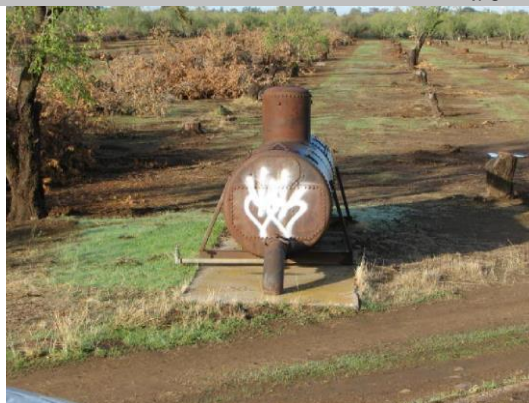
Photo 1 of 1 : UCIP_SP_2019_52084_68534.jpg

Comment Code						
Inspector Comment						
FS_ID:52084 DS_ID:1680 EP_NO: N/A Repair Type: Non-Urgent Crossing Status: Found UCIP Comments: 5/18/2017 Unable to locate. (DWR Sutter Yard-AFreitag)11/14/2016 Unable to locate. (DWR Sutter Yard-AFreitag)5/11/2016 Unable to locate.8/3/2015 Unable to locate.11/25/2014 Unable to locate.6/4/2014 Same as last inspection. Unable to locate.11/13/2013 Unable to locate.6/6/2013 Boiler has been removed and pipe buried on LS. Unable to locate.11/01/2012 Pipe appears to be abandoned. FIELD_STRUCT_DESC: 8-inch steel irrigation pipe through the levee, 6.5 feet below the crown. Boiler attached to the landside (LS). [Additional Reference(s): DWR Levee Log, 1990. USACE Sacramento O&M Manual 516, April 1960, (Station 73+27)]. FS Date: 6/1/2017 2:11:21 PM

Pipe attached at boiler on LS toe.

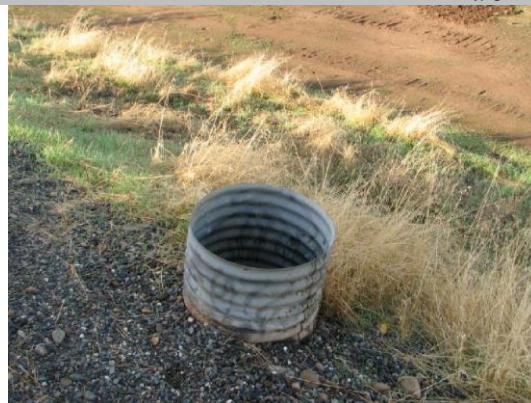
Photo 1 of 1 : UCIP_SP_2019_52085_68535.jpg

Comment Code					
Inspector Comment					
FS_ID:52085 DS_ID:1681 EP_NO: N/A Repair Type: Non-Urgent Crossing Status: Found UCIP Comments: 5/18/2017 Appears abandoned- if so needs to be done so properly. (DWR Sutter Yard- A Freitag)11/14/2016 Appears abandoned (DWR Sutter Yard- A Freitag)5/11/216 Abandoned crossing8/3/2015 Pipe still appears abandoned.11/25/2014 Same as last inspection.6/4/2014 Same as last inspection.11/13/2013 Same as last inspection.6/6/2013 Same as last inspection.11/01/2012 Pipe appears to be abandoned. FIELD_STRUCT_DESC: *ABANDONED* 6-inch steel irrigation pipe through the levee, 7.1 feet below the crown. Siphon breaker in a corrugated metal riser on the landside (LS) slope. One corrugated metal cutoff wall. Pipe is open on both ends. [Additional Reference(s): DWR Levee Log, 1990. USACE Sacramento O&M Manual 516, April 1960, (Station 65+52)]. FS Date: 6/1/2017 2:12:13 PM

CM riser with siphon breaker on LS shoulder.

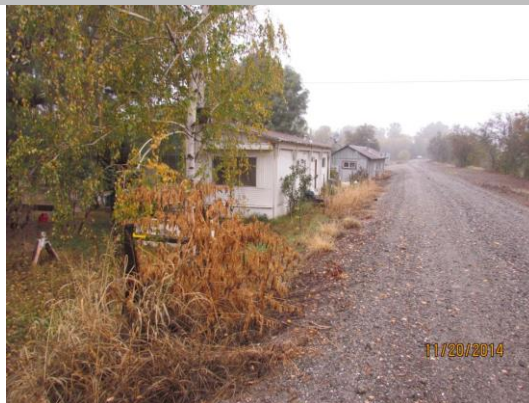
Photo 1 of 1 : SP_2019_MA0005_197_25_20190327_00010.jpg

LM Start	14.33	Rating **	U	Issue No.	25
LM End	14.33	Issue Type +	En	Location *	LS
Category	Earthen Levee			GPS Latitude/Longitude	
				Start	End
Item	Encroachments			39.691580 °	39.691580 °
				-121.779254 °	-121.779254 °
DWR ID	DWR_MA0005_02_s_2012_25				
Comment Code					
BU : Building					
Inspector Comment					
Unpermitted structure.

View of the buildings at the landside toe.

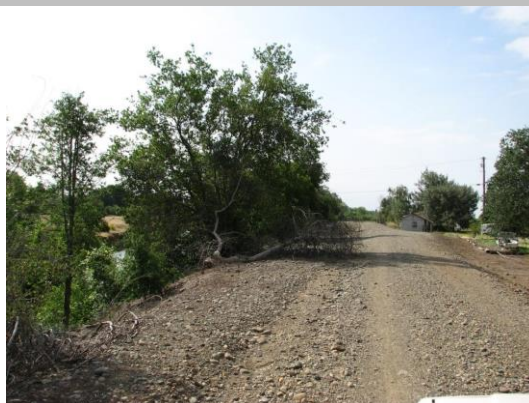
Photo 1 of 1 : SP_2019_MA0005_197_38_20190327_00014.jpg

LM Start	14.39	Rating **	M	Issue No.	38
LM End	14.39	Issue Type +	Ma	Location *	WS
Category	Earthen Levee			GPS Latitude/Longitude	
				Start	End
Item	Encroachments			39.692284 °	39.692284 °
				-121.779394 °	-121.779394 °
DWR ID	DWR_MA0005_02_s_2016_38				
Comment Code					
TR : Tree or limb					
Inspector Comment					
Remove the fallen trees from the waterside slope.

5/5/2016: Remove fallen tree from WS slope.

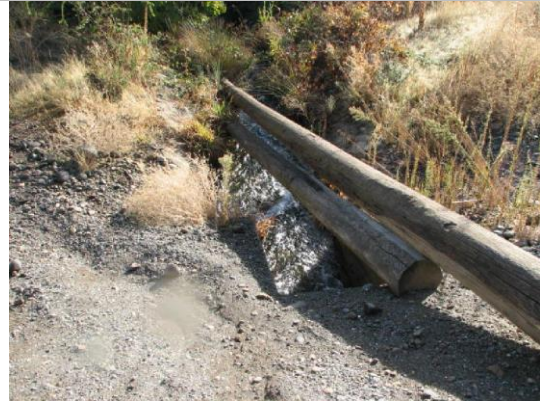
Photo 1 of 3 : UCIP_SP_2019_54049_68544.jpg

Comment Code						
Inspector Comment						
FS_ID:54049 DS_ID:1682 EP_NO: N/A Repair Type: No Action Needed Crossing Status: Found UCIP Comments: 05/23/2019 (O. Magana - DWR UCIP)05/18/2017 Crossing appears to be in good condition. Pipe has been selected to be internally cleaned and inspected as part of the DMP project. (DWR Sutter Yard- A Freitag)11/14/2016 Crossing appears to be in good condition. (DWR Sutter Yard- A Freitag)05/11/2016 Crossing appears to be in good condition.08/03/2015 Crossing appears in good condition. No noticeable issues to report.11/25/2014 Same as last inspection.06/04/2014 Same as last inspection.11/13/2013 Same as last inspection.06/06/2013 Same as last inspection. FIELD_STRUCT_DESC: 24-inch corrugated metal drainage pipe through the levee, 7.2 feet below the crown. Concrete "U" shaped headwall and grouted spillway on the waterside (WS). Slide gate in a 48-inch concrete standpipe on the landside (LS). Flap gate on the WS. [Additional Reference(s): DWR Levee Log, 1990. USACE Sacramento O&M Manual 516, April 1960, (Station 37+10)]. FS Date: 5/23/2019 5:21:51 PM

Outlet at U-shaped headwall on WS toe.

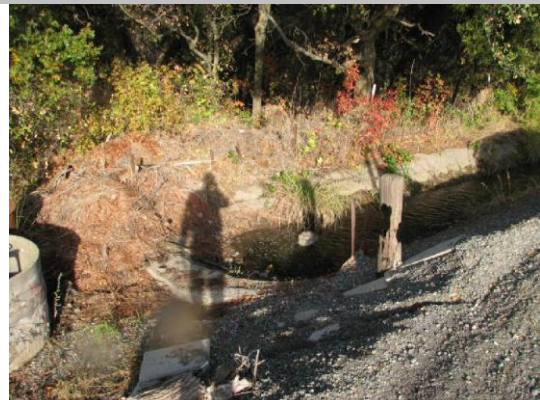
Photo 2 of 3 : UCIP_SP_2019_54049_68543.jpg

Concrete lined channel on LS toe.

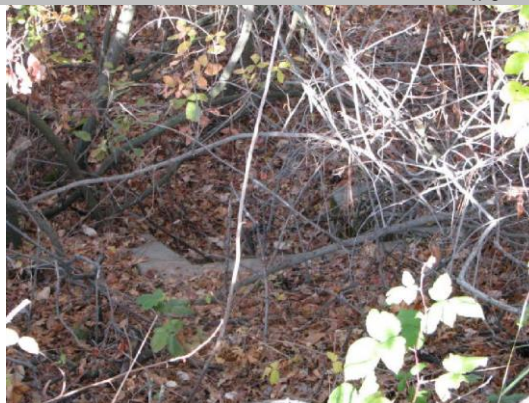
Photo 1 of 2 : UCIP_SP_2019_52087_68541.jpg

Comment Code						
Inspector Comment						
FS_ID:52087 DS_ID:1683 EP_NO: N/A Repair Type: Non-Urgent Crossing Status: Found UCIP Comments: 5/18/2017 WS appears to be in good condition. LS inlet is across a ditch and inaccessible for inspection due to dense vegetation and being down a very steep slope. Pipe has been selected to be internally cleaned and inspected as part of the DMP project. (DWR Sutter Yard- AFreitag)11/14/2016 Crossing appears to be in good condition. (DWR Sutter Yard- AFreitag)5/11/2016 Crossing appears to be in good condition.8/3/2015 Crossing appears in good condition. No noticeable issues to report.6/6/2013 Same as last inspection.11/13/2013 Same as last inspection.6/4/2014 Same as last inspection.11/25/2014 Same as last inspection. FIELD_STRUCT_DESC: 24-inch corrugated metal drainage pipe through the levee, 14.3 feet below the crown. Concrete ""U"" headwalls on both the landside (LS) and the waterside (WS). Flap gate on the WS. Inlet downhill from a concrete lined channel at the low point on the LS toe. [Additional Reference(s): DWR Levee Log, 1990. USACE Sacramento O&M Manual 516, April 1960, (Station 36+85)]. FS Date: 6/1/2017 2:14:24 PM

Inlet at LS toe.

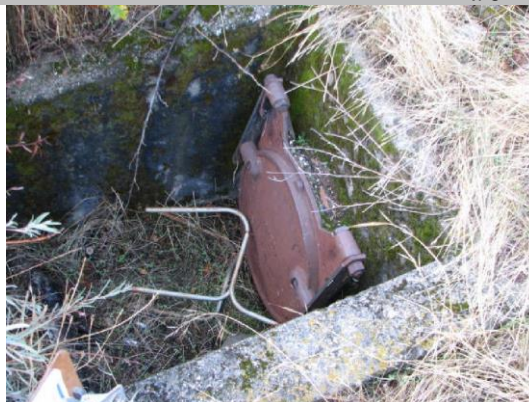
Photo 2 of 2 : UCIP_SP_2019_52087_68540.jpg

Outlet at WS toe with flap gate and concrete U-shaped headwall.

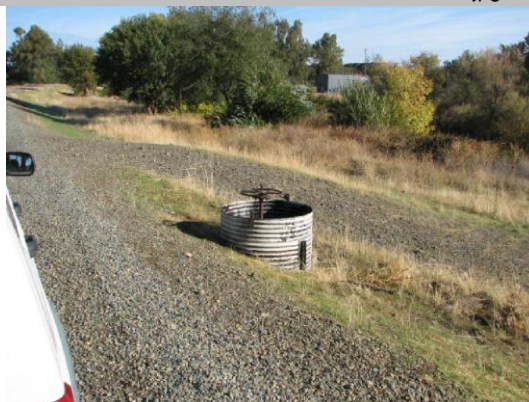
Photo 2 of 2 : UCIP_SP_2019_52090_68569.jpg

CMP riser on WS shoulder with slide gate.

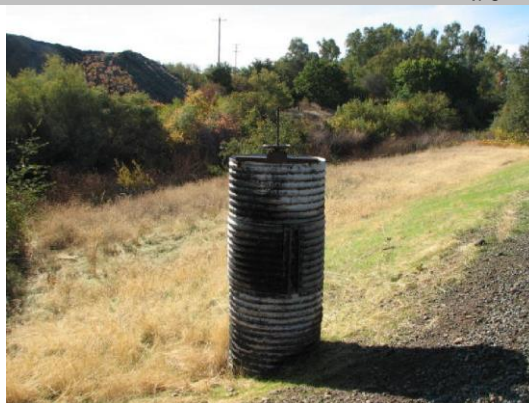
Photo 1 of 2 : UCIP_SP_2019_52091_68572.jpg

Comment Code						
Inspector Comment						
FS_ID:52091 DS_ID:1686 EP_NO: N/A Repair Type: Non-Urgent Crossing Status: Found UCIP Comments: 5/18/2017 Only WS and LS standpipes visible. (DWR Sutter Yard- AFreitag)11/14/2016 Still only WS standpipe visible. (DWR Sutter Yard- AFreitag)5/11/2016 Only WS standpipe was visible. 8/3/2015 Only able to locate the standpipe on the WS. 11/25/2014 Same as last inspection. 6/4/2014 Same as last inspection. 11/13/2013 Same as last inspection. 6/6/2013 Same as last inspection. FIELD_STRUCT_DESC: 12-inch steel irrigation pipe (siphon) through the levee, 10 feet below the crown. Slide gate in a 36-inch corrugated metal riser on the waterside (WS) slope. 30-inch concrete standpipe at the landside (LS) toe. [Additional Reference(s): DWR Levee Log, 1990. USACE Sacramento O&M Manual 516, April 1960, (Station 145+53)]. FS Date: 6/1/2017 2:22:09 PM

CMP riser on WS slope with slide gate.

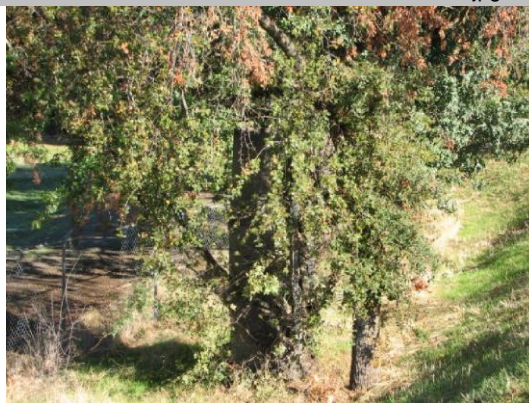
Photo 2 of 2 : UCIP_SP_2019_52091_68571.jpg

Concrete riser on LS toe.

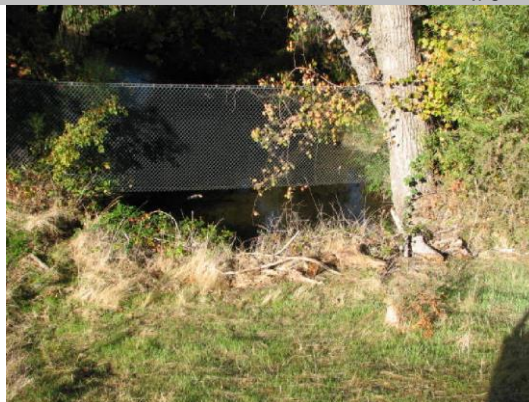
Photo 2 of 3 : UCIP_SP_2019_52092_68574.jpg

Irrigation ditch at LS toe.

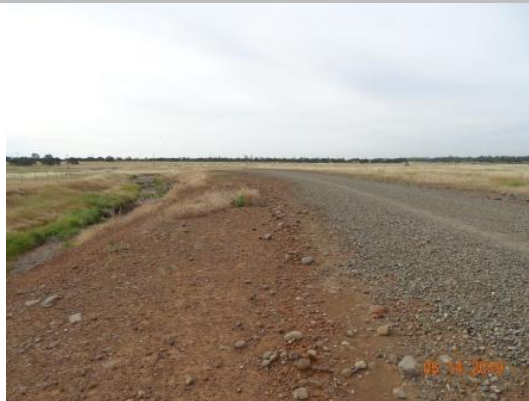
Photo 1 of 1 : SP_2019_MA0005_198_1_20190520_00001.jpg

LM Start	0.58	Rating **	A	Issue No.	1
LM End	0.58	Issue Type +	Ma	Location *	WS
Category	Earthen Levee			GPS Latitude/Longitude	
				Start	End
Item	Vegetation			39.724597 °	39.724597 °
				-121.781345 °	-121.781345 °
DWR ID	DWR_MA0005_03_s_2019_1				
Comment Code					
V1 : Control annual grass and weeds on the levee slopes and easements.					
Inspector Comment					
The vegetation is well-maintained on both landside and waterside slopes.

View of the well-maintained vegetation on the waterside slope. Spring 2019.
