**Flood Control Project Maintenance
Levee Inspections**
LMA District Cover Sheet
Spring 2020 Levee Inspection Results

Spring 2020 Levee Inspection Results

Sutter Maintenance Yard Maintenance Area 0005

Waterway			Bank	Unit Miles
Unit No. 01 Butte Creek			Left	15.08
	Spring (March - May)	Summer (June - August)	(September - November) Fall	Winter (December - February)
Unit Maintenance Rating (Fall Only)				
Date of Inspection	4/8/2020 - 4/8/2020			
DWR Inspector	Makar Sokol			
Accompanied By	Bob Duffey Sutter Maintenance Yard

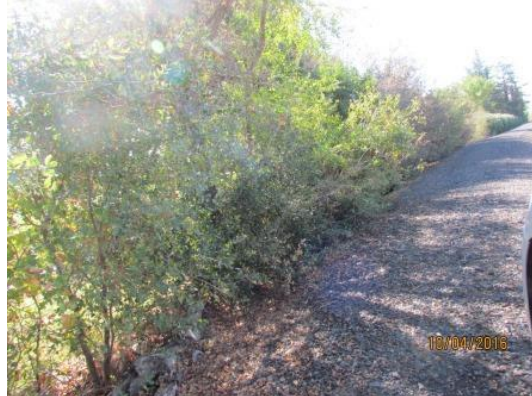
Photo 1 of 1 : SP_2020_MA0005_196_32_20200226_00011.jpg

LM Start	0.58	Rating **	M	Issue No.	32
LM End	0.68	Issue Type +	Ma	Location *	LS
Category	Earthen Levee			GPS Latitude/Longitude	
				Start	End
Item	Trim / Thin Trees			39.690496 °	39.689137 °
				-121.777109 °	-121.776938 °
DWR ID	DWR_MA0005_01_s _ 2014_32				
Comment Code					
T2 : Thin trees to allow visibility of the ground and room to flood fight.					
Inspector Comment					
Trees smaller than 4-inches in diameter at chest height shall be removed from the landside slope and within ten feet of the landside toe.

View of the trees along the landside toe blocking visibility.

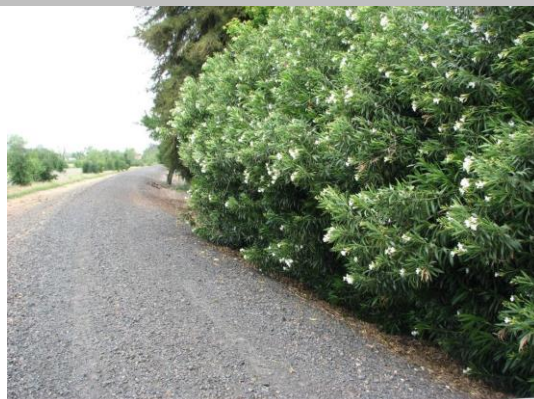
Photo 1 of 1 : SP_2020_MA0005_196_44_20200226_00016.jpg

LM Start	0.68	Rating **	U	Issue No.	44
LM End	0.77	Issue Type +	En	Location *	LS
Category	Earthen Levee			GPS Latitude/Longitude	
				Start	End
Item	Vegetation			39.689135 °	39.687968 °
				-121.776929 °	-121.777387 °
DWR ID	DWR_MA0005_01_s_2016_44				
Comment Code					
V6 : Landscaping					
Inspector Comment

View of oleanders along the landside toe.

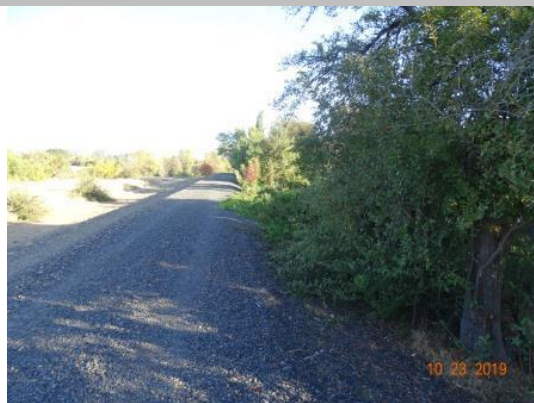
Photo 1 of 1 : SP_2020_MA0005_196_47_20200226_00018.jpg

LM Start	0.79	Rating **	M	Issue No.	47
LM End	0.82	Issue Type +	Ma	Location *	LS
Category	Earthen Levee			GPS Latitude/Longitude	
				Start	End
Item	Trim / Thin Trees			39.687676 °	39.687193 °
				-121.777419 °	-121.777461 °
DWR ID	DWR_MA0005_01_f _ 2019_47				
Comment Code					
T1 : Trim trees to at least five feet above ground level.					
Inspector Comment

View of trees that require trimming along the landside slope. Fall 2019.

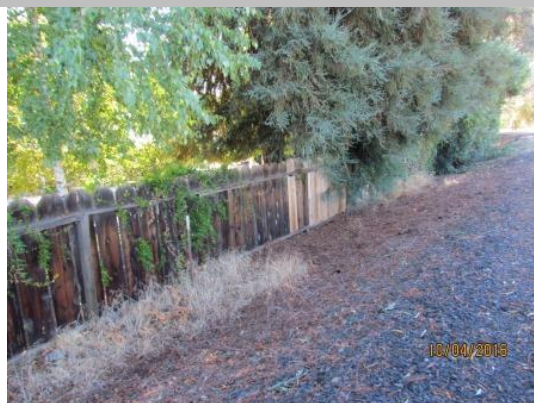
Photo 1 of 1 : SP_2020_MA0005_196_49_20200226_00019.jpg

LM Start	0.90	Rating **	U	Issue No.	49
LM End	0.92	Issue Type +	En	Location *	LS
Category	Earthen Levee			GPS Latitude/Longitude	
				Start	End
Item	Encroachments			39.686087 °	39.685756 °
				-121.777555 °	-121.777540 °
DWR ID	DWR_MA0005_01_f _ 2016_49				
Comment Code					
FE : Fence					
Inspector Comment

View of the wood plank fence at the landside toe.

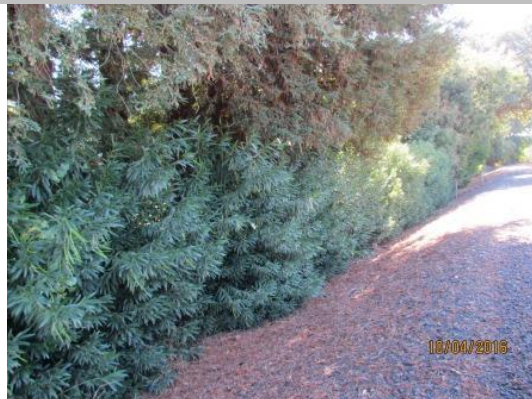
Photo 1 of 1 : SP_2020_MA0005_196_50_20200226_00020.jpg

LM Start	0.98	Rating **	U	Issue No.	50
LM End	1.00	Issue Type +	En	Location *	LS
Category	Earthen Levee			GPS Latitude/Longitude	
				Start	End
Item	Vegetation			39.684843 °	39.684606 °
				-121.777132 °	-121.776975 °
DWR ID	DWR_MA0005_01_f _ 2016_50				
Comment Code					
V6 : Landscaping					
Inspector Comment					
Oleanders are blocking visibility.

View of the oleanders along the landside toe.

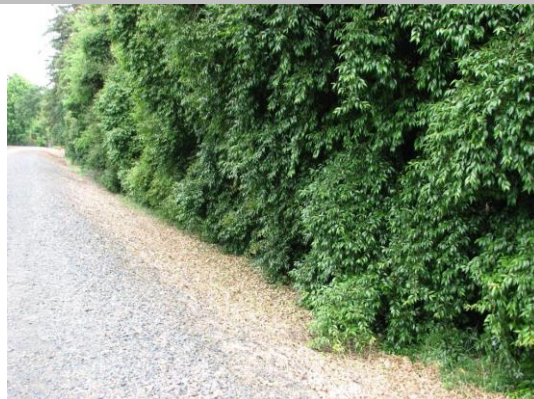
Photo 1 of 1 : SP_2020_MA0005_196_43_20200226_00015.jpg

LM Start	1.16	Rating **	M	Issue No.	43
LM End	1.24	Issue Type +	En	Location *	LS
Category	Earthen Levee			GPS Latitude/Longitude	
				Start	End
Item	Vegetation			39.682402 °	39.681322 °
				-121.776405 °	-121.776506 °
DWR ID	DWR_MA0005_01_s_2016_43				
Comment Code					
V6 : Landscaping					
Inspector Comment

View of the overgrown vegetation at the landside toe.

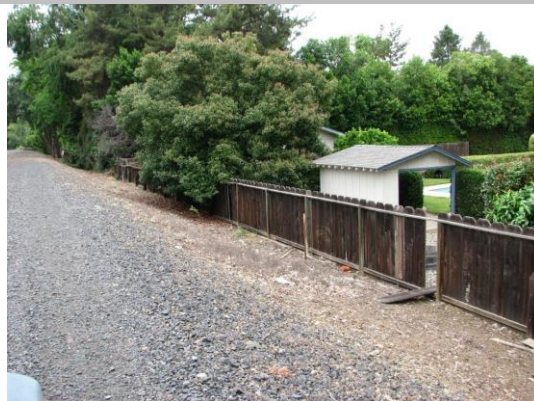
Photo 1 of 1 : SP_2020_MA0005_196_42_20200226_00014.jpg

LM Start	1.24	Rating **	U	Issue No.	42
LM End	1.26	Issue Type +	En	Location *	LS
Category	Earthen Levee			GPS Latitude/Longitude	
				Start	End
Item	Encroachments			39.681305 °	39.681044 °
				-121.776533 °	-121.776547 °
DWR ID	DWR_MA0005_01_s_2016_42				
Comment Code					
FE : Fence					
Inspector Comment

View of the wood plank fence at the landside toe.

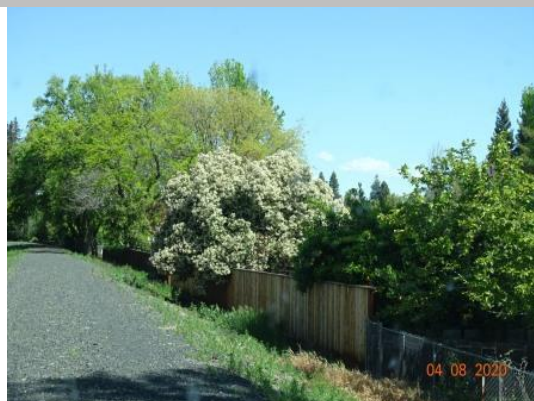
Photo 1 of 1 : SP_2020_MA0005_196_41_20200415_00082.jpg

LM Start	1.30	Rating **	U	Issue No.	41
LM End	1.36	Issue Type +	En	Location *	LS
Category	Earthen Levee			GPS Latitude/Longitude	
				Start	End
Item	Encroachments			39.680452 °	39.679551 °
				-121.776667 °	-121.776904 °
DWR ID	DWR_MA0005_01_s_2016_41				
Comment Code					
FE : Fence					
Inspector Comment					
Wood plank fencing across multiple properties.

View of the fence along the landside toe. Spring 2020.

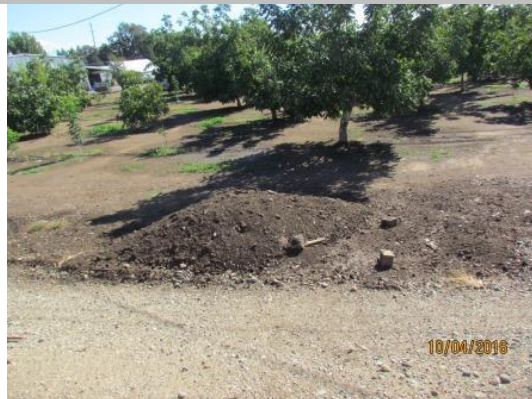
Photo 1 of 1 : SP_2020_MA0005_196_53_20200226_00021.jpg

LM Start	1.52	Rating **	M	Issue No.	53
LM End	1.52	Issue Type +	En	Location *	LS
Category	Earthen Levee			GPS Latitude/Longitude	
				Start	End
Item	Encroachments			39.677240 °	39.677240 °
				-121.777521 °	-121.777521 °
DWR ID	DWR_MA0005_01_f _ 2016_53				
Comment Code					
DE : Debris					
Inspector Comment					
Remove the pile of soil and rocks on the landside toe.

View of the soil and rock pile on the landside toe.

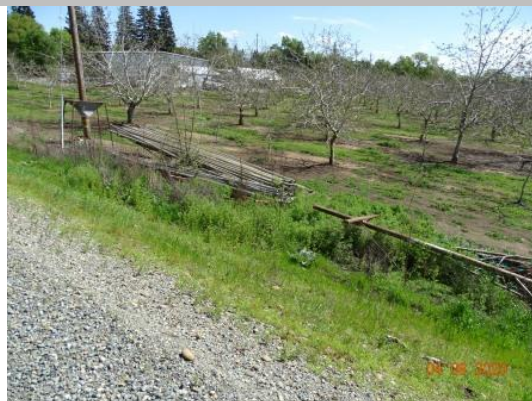
Photo 1 of 1 : SP_2020_MA0005_196_30_20200415_00083.jpg

LM Start	1.53	Rating **	M	Issue No.	30
LM End	1.53	Issue Type +	En	Location *	LS
Category	Earthen Levee			GPS Latitude/Longitude	
				Start	End
Item	Encroachments			39.677130 °	39.677130 °
				-121.777583 °	-121.777583 °
DWR ID	DWR_MA0005_01_f _ 2014_30				
Comment Code					
EQ : Equipment					
Inspector Comment

View of the sprinkler pipe and equipment along the landside toe. Spring 2020.

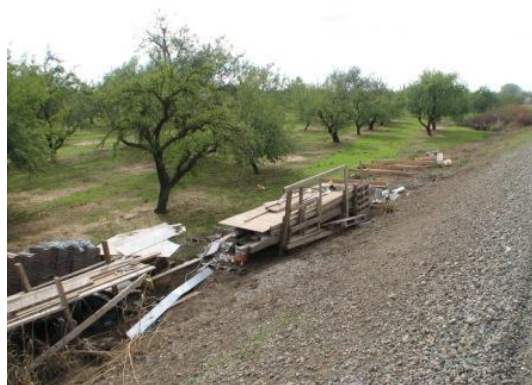
Photo 1 of 1 : SP_2020_MA0005_196_1_20200226_00001.jpg

LM Start	1.66	Rating **	M	Issue No.	1
LM End	1.66	Issue Type +	En	Location *	LS
Category	Earthen Levee			GPS Latitude/Longitude	
				Start	End
Item	Encroachments			39.675528 °	39.675528 °
				-121.778642 °	-121.778642 °
DWR ID	DWR_MA0005_01_s_2012_1				
Comment Code					
MA : Material					
Inspector Comment					
The materials and equipment should be moved ten feet away from the landside toe.

View of the construction supply on pallets.

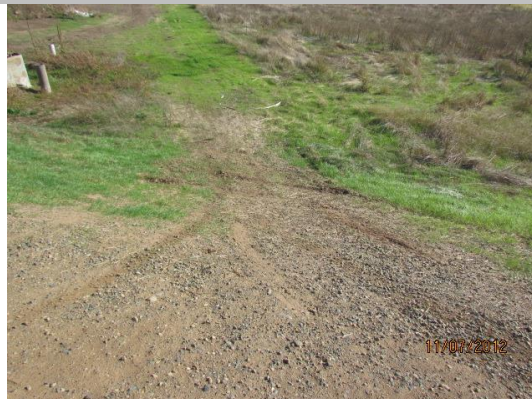
Photo 1 of 1 : SP_2020_MA0005_196_9_20200226_00004.jpg

LM Start	2.54	Rating **	M	Issue No.	9
LM End	2.54	Issue Type +	Ma	Location *	LS
Category	Earthen Levee			GPS Latitude/Longitude	
				Start	End
Item	Slope Stability			39.663876 °	39.663876 °
				-121.784014 °	-121.784014 °
DWR ID	DWR_MA0005_01_f_2012_9				
Comment Code					
S3 : Repair the levee slope damaged by vehicle traffic and prevent access where possible.					
Inspector Comment

View of the vehicle erosion along the landside slope.

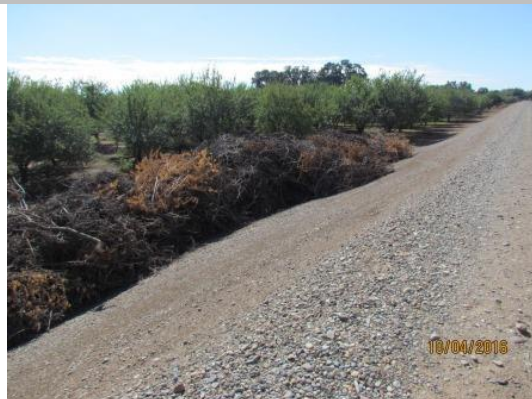
Photo 1 of 1 : SP_2020_MA0005_196_37_20200226_00012.jpg

LM Start	3.06	Rating **	M	Issue No.	37
LM End	3.06	Issue Type +	En	Location *	LS
Category	Earthen Levee			GPS Latitude/Longitude	
				Start	End
Item	Encroachments			39.656911 °	39.656911 °
				-121.787097 °	-121.787097 °
DWR ID	DWR_MA0005_01_f _ 2015_37				
Comment Code					
PR : Prunings					
Inspector Comment					
Remove the prunings from the landside toe.

View of the prunings along the landside toe.

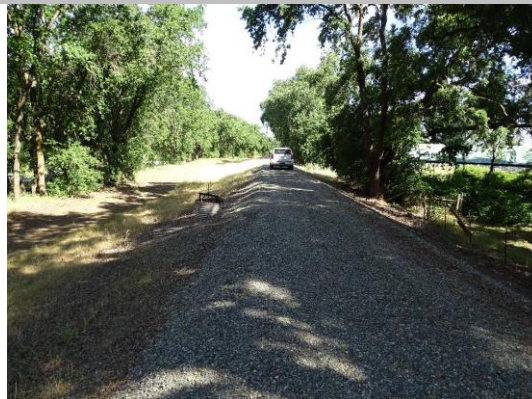
Photo 1 of 3 : UCIP_SP_2020_54140_79693.jpg

DS_ID:1615
FS_ID:54140
EP_NO: N/A
Repair Type: Non-Urgent
Crossing Status: Found
UCIP Comments: 06/05/2019 Durham Mutual Water Company fixed broken slide gate by replacing a stem. Operating wheel is missing. Crossing downgraded to non-urgent. (O.Yakimov - DWR UCIP)10/5/2018 Observed pipe running during inspection. Pipe is used to drain water from LS concrete box to WS. Field structure description was updated to show structure type as drainage pipe. Confirmed that the concrete box on LS receives water from a pipe running along the LS toe from orchards upstream and distributes water between 3 pipes, one of which crosses levee at an angle. Missing closure device on WS. Screw gate stuck in open position inside CMP riser located on WS shoulder and is not operable. (O.Yakimov - DWR)5/15/2017 WS slide gate stem bent and gate is stuck in the open position. Outlet in the the concrete box on the WS berm is opened and allowed water to free flow through the pipe during the Jan/Feb 2017 high water events. Either the screw gate needs to be repaired or a flap gate added to the outlet in the concrete box to not allow high water flows though the levee. Pipe is believed to be owned and operated by Duhram Mutual Water Company at 1807 Duhram Dayton HWY, PO Box 612, Duhram CA 95938 (530)342-9324. (DWR Sutter Yard-AFreitag) 11/15/2016 Abandoned- slide gate is opened and inoperable. Needs to be properly abandoned. (DWR Sutter Yard-AFreitag)5/9/2016 Abandoned crossing. Slide gate stem bent and wheel is missing.8/5/2015 Abandoned crossing. Slide gate stem is bent and gate is inoperable. Needs to be properly abandoned.12/8/2014 Same as last inspection.6/11/2014 Same as last inspection.11/20/2013 Same as last inspection.5/29/2013 Same as last inspection.10/30/2012 Pipe appears to be abandoned. Slide gate open and inoperable. Pipe should be properly abandoned. FIELD_STRUCT_DESC: 30-inch corrugated metal drainage pipe through the levee, 10.5 feet below the crown. Slide gate in a corrugated metal riser on the waterside (WS) slope. Concrete distribution box on the landside (LS) toe and concrete overflow and siphon box at the edge of berm. [Additional Reference(s): DWR Levee Log, 1990 (HLM 3.69). USACE Sacramento O&M Manual, Unit 516 - Upper Butte Creek - Part No. 2, April 1960 (Station 368+17)].

View of levee crown at crossing

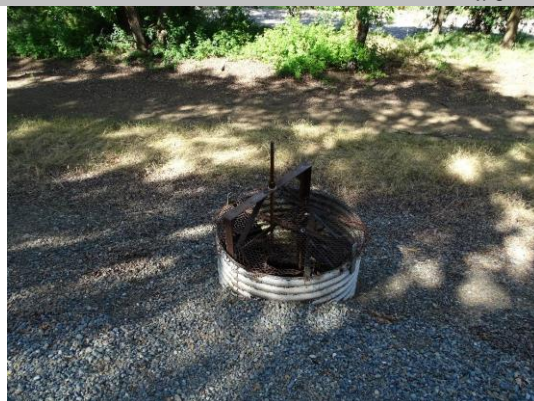
Photo 2 of 3 : UCIP_SP_2020_54140_79687.jpg

CMP riser with slide gate on WS shoulder

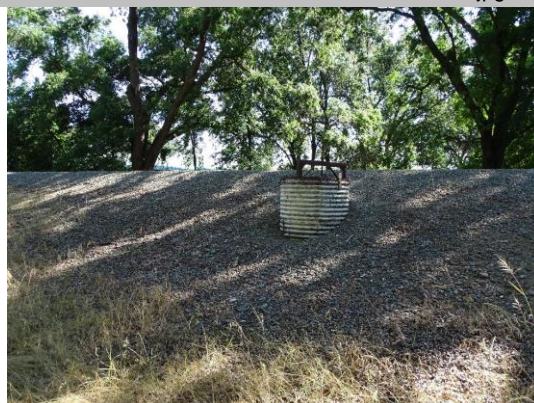
Photo 3 of 3 : UCIP_SP_2020_54140_79690.jpg

CMP riser WS shoulder

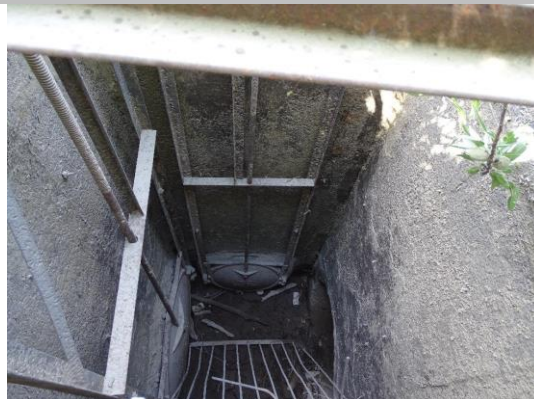
Photo 2 of 3 : UCIP_SP_2020_54141_79696.jpg

View inside of concrete distribution box on LS

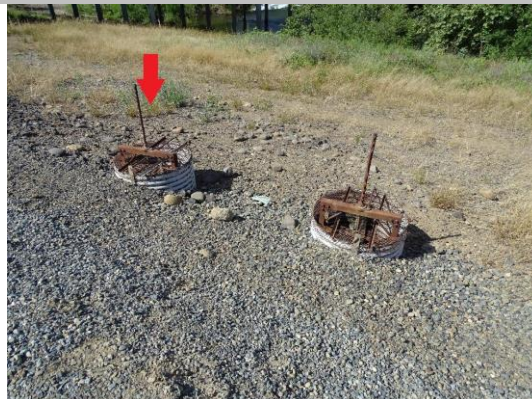
Photo 1 of 3 : UCIP_SP_2020_54142_79701.jpg

DS_ID:1617
FS_ID:54142
EP_NO: N/A
Repair Type: Non-Urgent
Crossing Status: Found
UCIP Comments: 06/05/2019 No issues recorded during inspection. (O.Yakimov - DWR UCIP)5/15/2017 Crossing appears to be in good condition. (DWR Sutter Yard- A Freitag)11/15/2016 Crossing appears to be in good condition. (DWR Sutter Yard- A Freitag)5/9/2016 Crossing appears to be in good condition.8/5/2015 Crossing appears in good condition. No noticeable issues to report.12/8/2014 Same as last inspection.6/11/2014 Same as last inspection.11/20/2013 Same as last inspection.5/29/2013 Same as last inspection.
FIELD_STRUCT_DESC: 24-inch corrugated metal irrigation siphon pipe through the levee, 16.5 feet below the crown. Slide gate in corrugated metal riser on the waterside (WS) slope. Pipe appears to be currently used for irrigation purposes. 4-foot by 8-foot concrete distribution box on the landside (LS), 40 feet from the LS toe.

CMP riser and slide gate on WS shoulder

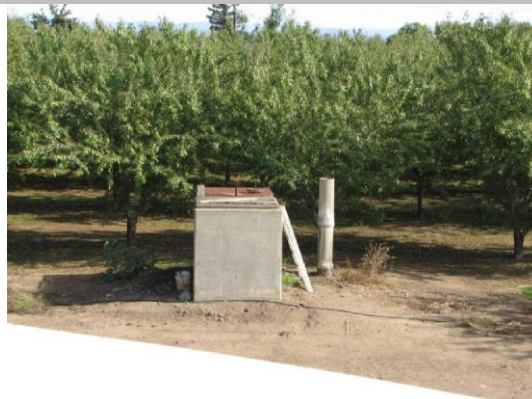
Photo 3 of 3 : UCIP_SP_2020_54142_67932.jpg

Concrete distribution box on LS, 40-feet from LS toe

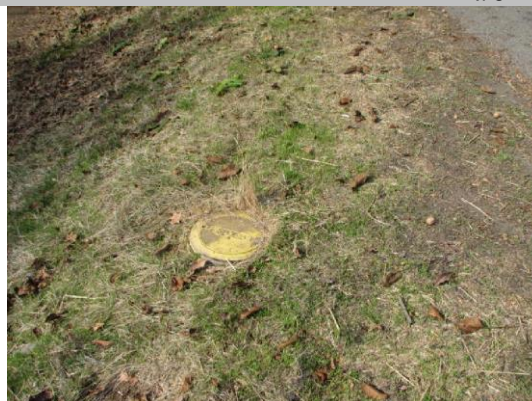
Photo 1 of 2 : UCIP_SP_2020_51952_67936.jpg

DS_ID:1619
 FS_ID:51952
 EP_NO: 6544-A
 Repair Type: Non-Urgent
 Crossing Status: Indicator Found
 UCIP Comments: 5/15/2017 Crossing appears to be in good condition.
 (DWR Sutter Yard- A Freitag)11/15/2016 Crossing appears to be in good condition. (DWR Sutter Yard- A Freitag)5/9/2016 Crossing appears to be in good condition.8/5/2015 Pipe is suspected to cross inside of bridge.12/8/2014 Same as last inspection.6/11/2014 Same as last inspection.11/20/2013 Same as last inspection.5/29/2013 Same as last inspection.10/30/2012 Pipeline should be marked where pipe crosses levee as it is 4-feet below the surface.
 FIELD_STRUCT_DESC: 6-inch concrete encased steel high pressure gas pipeline through the levee, 4 feet below the crown. 8-inch diameter Pacific Gas & Electric Company (PG&E) gas access manhole located on the south side of the road, 250 feet east of the levee crown. (6-inch gas line authorized under Permit No. 6544-A, 1969 - Pacific Gas and Electric [PG&E]) [Additional Reference(s): DWR Levee Log, 1990].

PG&E access lid on south edge of roadway.

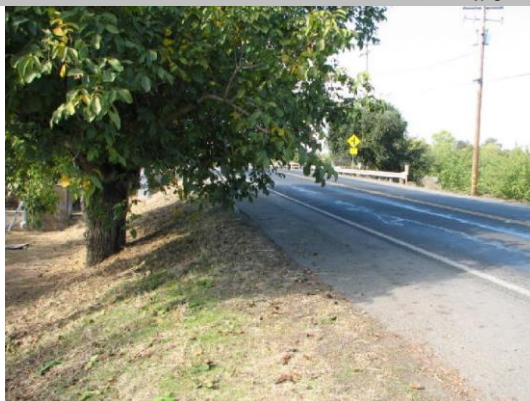
Photo 2 of 2 : UCIP_SP_2020_51952_67935.jpg

Location of PG&E access lid 250-feet east of levee crown on south side of roadway.

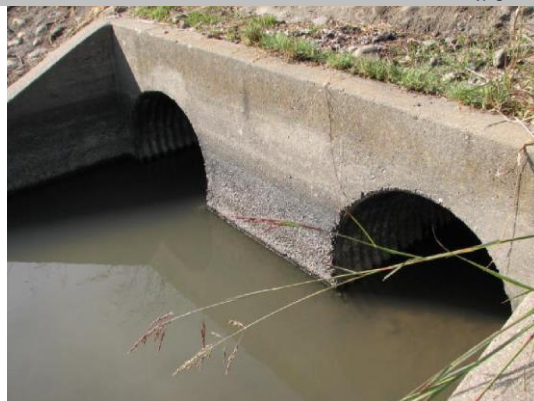
Photo 2 of 3 : UCIP_SP_2020_54039_67938.jpg

DS_ID:1768
FS_ID:54039
EP_NO: N/A
Repair Type: Non-Urgent
Crossing Status: Found
UCIP Comments: 05/23/2019 (O. Magana - DWR UCIP)05/15/2017 Abandoned and needs to be done properly. A sink hole formed in the WS toe road and revealed the location of the WS pipe end. Sink hole will need to be repaired before the next high water season but the pipe has been selected to be internally cleaned and camera inspected as part of the DMP project so it will have needed to be excavated along the WS end anyways. (DWR Sutter Yard- A Freitag)11/15/2016 Abandoned. Needs standpipe cover. (DWR Sutter Yard- A Freitag)05/09/2016 Abandoned pipe. Needs a cover for standpipe.08/05/2015 Abandoned pipes. Need covers made for tops of standpipes to prevent falls. 12/08/2014 Same as last inspection.06/11/2014 Same as last inspection.11/19/2013 Same as last inspection.05/29/2013 Same as last inspection. Land owner said pipes are abandoned and no longer used. Covers should be made for top of standpipe to prevent falls. Pipes should be properly abandoned.10/30/2012 Pipe 1/2 filled with soil at slide gate on WS. FIELD_STRUCT_DESC: *ABANDONED* 2 of 2: 36-inch corrugated metal drainage pipe through the levee, 11 feet below the crown. Slide gate in a 54-inch corrugated metal riser on the waterside (WS) slope. Concrete "U" shaped headwall on the landside (LS). [Additional Reference(s): DWR Levee Log, 1990 (HLM 5.66). Sacramento O&M Manual, Unit 516 - Upper Butte Creek - Part No. 2, April 1960 (Station 470+00)].

Headwall at LS toe.

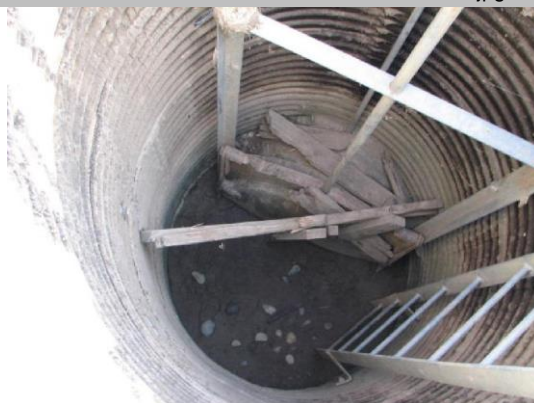
Photo 3 of 3 : UCIP_SP_2020_54039_67937.jpg

Slide gate at bottom of cmp riser.

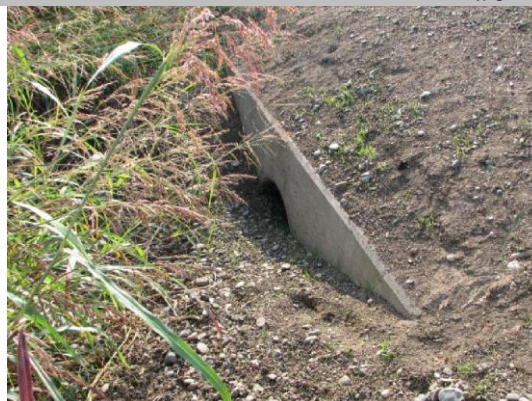
Photo 2 of 2 : UCIP_SP_2020_51970_67969.jpg

Headwall at LS toe.

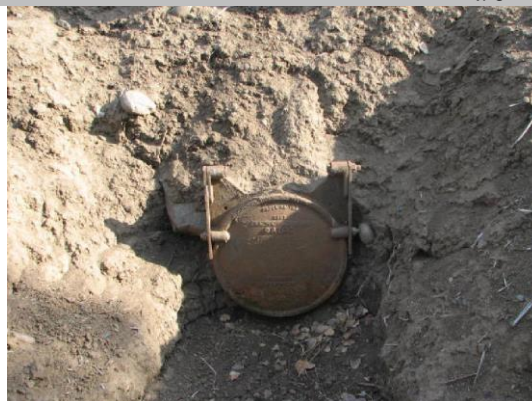
Photo 3 of 3 : UCIP_SP_2020_51972_67971.jpg

LM Start	8.21	Rating **	M	Issue No.	912 (cont)
LM End	8.21	Issue Type +	Ma	Location *	
Category	Supplemental		GPS Latitude/Longitude		
			Start	End	
Item	DWR UCIP LMA Responsibility		39.589751 °	39.589751 °	
			-121.792818 °	-121.792818 °	
DWR ID	1629

Flap gate at WS toe.

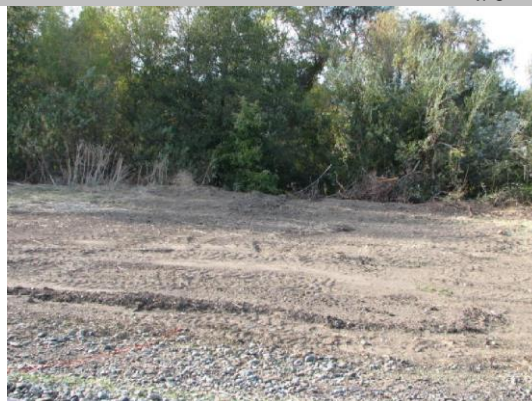
Photo 2 of 3 : UCIP_SP_2020_51975_67975.jpg

DS_ID:1631
 FS_ID:51975
 EP_NO: N/A
 Repair Type: Non-Urgent
 Crossing Status: Found
 UCIP Comments: 5/16/2017 Abandoned and needs to be done so properly. (DWR Sutter Yard- A Freitag) 11/15/2016 Abandoned. (DWR Sutter Yard- A Freitag) 5/11/2016 Abandoned pipe. 8/4/2015 Abandoned pipe. Casey Wilder has started the steps to have the pipe properly abandoned and removed from the levee. 12/8/2014 Same as last inspection. 6/11/2014 Same as last inspection. 11/19/2013 Same as last inspection. 5/29/2013 Same as last inspection. 10/30/2012 Need to confirm proper abandonment of pipe. Pipe should be plugged on LS.
 FIELD_STRUCT_DESC: 16-inch steel irrigation pipe through the levee, 11.5 feet below the crown. Pump located on the waterside (WS). Distribution box at the landside (LS) toe. [Additional Reference(s): DWR Levee Log, 1990 (HLM 9.21). USACE Sacramento O&M Manual, Unit 515 - Upper Butte Creek - Part No. 1, April 1955, (Station 655+68). USACE As-Built Drawing No. 50-4-2637, Exhibit B, Sheet 3, April 1950, (Station 655+68.2)].

LM Start	9.08	Rating **	M	Issue No.	913 (cont)
LM End	9.08	Issue Type +	En	Location *	
Category	Supplemental			GPS Latitude/Longitude	
				Start	End
Item	DWR UCIP Field Study			39.579908 °	39.579908 °
				-121.802790 °	-121.802790 °
DWR ID	1631

WS shoulder.

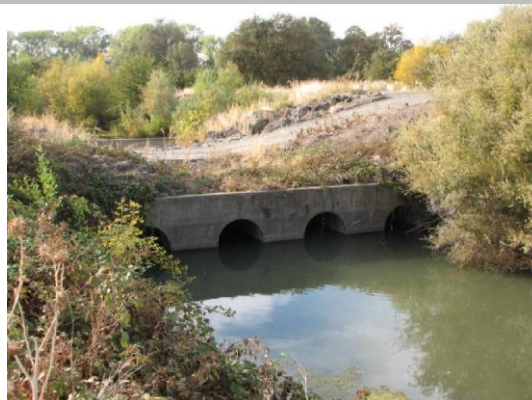
Photo 2 of 2 : UCIP_SP_2020_51976_67978.jpg

LM Start	9.52	Rating **	A/W	Issue No.	914 (cont)
LM End	9.52	Issue Type +	Ma	Location *

LS of pipe crossing.

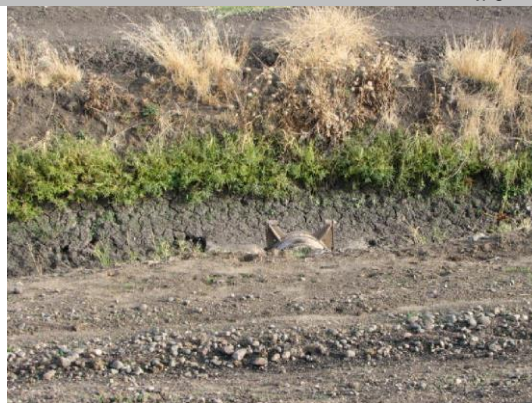
Photo 1 of 1 : UCIP_SP_2020_51980_67986.jpg

LM Start	10.04	Rating **	M	Issue No.	918	
LM End	10.04	Issue Type +	En	Location *		
Category	Supplemental			GPS Latitude/Longitude		
				Start	End	
Item	DWR UCIP Field Study			39.570596 °	39.570596 °	
				-121.815215 °	-121.815215 °	
DWR ID	1633

Comment Code						
Inspector Comment						
DS_ID:1633 FS_ID:51980 EP_NO: N/A Repair Type: Non-Urgent Crossing Status: Found UCIP Comments: 5/16/2017 Abandoned crossing and needs to be done so properly. Pipe has been selected to be internally cleaned and inspected as part of the DMP project. (DWR Sutter Yard-AFreitag)11/15/2016 Abandoned. (DWR Sutter Yard-AFreitag)5/11/2016 Abandoned crossing.8/4/2015 Abandoned pipe. Casey Wilder has started the steps to have the pipe properly abandoned and removed from the levee.12/8/2014 Same as last inspection.6/11/2014 Same as last inspection.11/19/2013 Same as last inspection.5/29/2013 Same as last inspection.10/30/2012 Pipe and headwall buried on WS, no access to slide gate. FIELD_STRUCT_DESC: 24-inch corrugated metal irrigation pipe through the levee, 12.5 feet below the crown. Slide gate on the waterside (WS). Flap gate and headwall on the landside (LS). Concrete headwall at the WS toe. [Additional Reference(s): DWR Levee Log, 1990 (HLM 10.19). USACE Sacramento O&M Manual, Unit 515 - Upper Butte Creek - Part No. 1, April 1955, (Station 706+00). USACE As-Built Drawing No. 50-4-2637, Exhibit B, Sheet 3, April 1950]. FS Date: 5/31/2017 2:15:33 PM

Flap gate and headwall at LS toe in irrigation or drainage ditch.

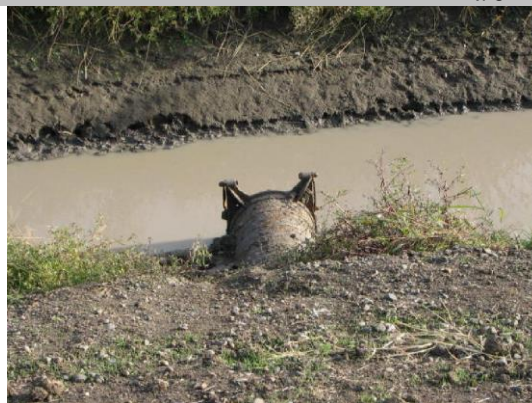
Photo 1 of 3 : UCIP_SP_2020_51981_67989.jpg

Comment Code					
Inspector Comment					
DS_ID:1634 FS_ID:51981 EP_NO: N/A Repair Type: Non-Urgent Crossing Status: Found UCIP Comments: 5/16/2017 Abandoned- needs to be done so properly. Pipe has been selected to be internally cleaned and inspected as part of the DMP project. (DWR Sutter Yard- A Freitag)11/15/2016 Abandoned. (DWR Sutter Yard- A Freitag)5/11/2016 Abandoned crossing.8/4/2015 Abandoned pipe. Casey Wilder has started the steps to have the pipe properly abandoned and removed from the levee.12/8/2014 Same as last inspection.6/11/2014 Same as last inspection.11/19/2013 Same as last inspection.5/29/2013 Same as last inspection. FIELD_STRUCT_DESC: 24-inch corrugated metal irrigation pipe through the levee, 14.5 feet below the crown. Slide gate on the waterside (WS) on concrete headwall. Flap gate on the landside (LS). [Additional Reference(s): DWR Levee Log, 1990 (HLM 10.41). USACE Sacramento O&M Manual, Unit 515 - Upper Butte Creek - Part No. 1, April 1955, (Station 717+50). USACE As-Built Drawing No. 50-4-2637, Exhibit B, Sheet 3, April 1950]. FS Date: 5/31/2017 2:16:48 PM

Pipe and flap gate on LS toe.

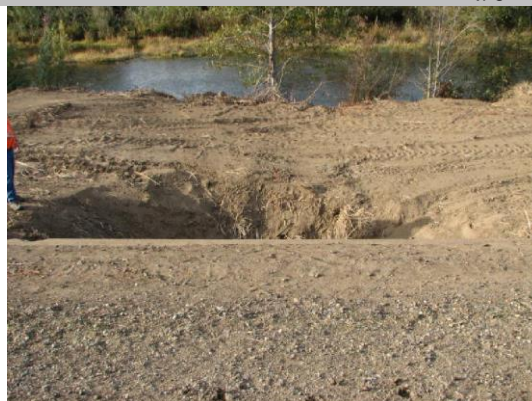
Photo 2 of 3 : UCIP_SP_2020_51981_67988.jpg

LM Start	10.26	Rating **	M	Issue No.	919 (cont)	
LM End	10.26	Issue Type +	En	Location *		
Category	Supplemental			GPS Latitude/Longitude		
				Start	End	
Item	DWR UCIP Field Study			39.568523 °	39.568523 °	
				-121.818232 °	-121.818232 °	
DWR ID	1634

headwall at WS toe.

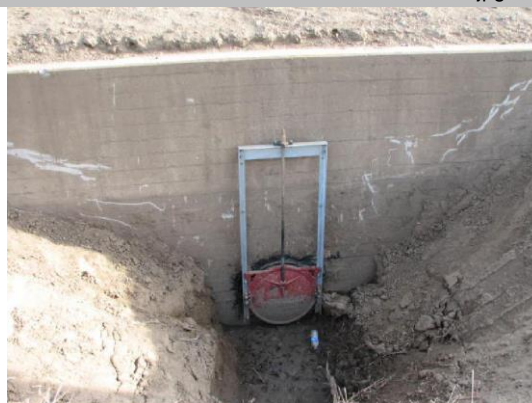
Photo 3 of 3 : UCIP_SP_2020_51981_67987.jpg

LM Start	10.26	Rating **	M	Issue No.	919 (cont)
LM End	10.26	Issue Type +	En	Location *

Headwall and slide gate on WS toe.

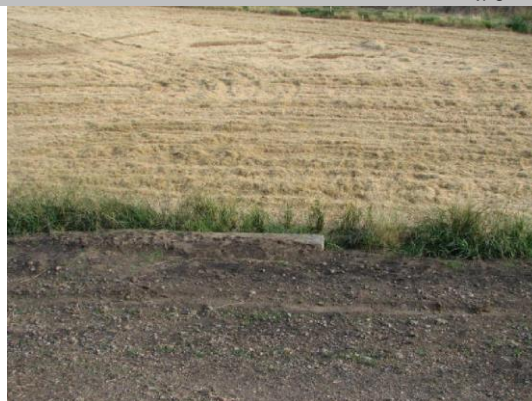
DS_ID:1635
FS_ID:51982
EP_NO: N/A
Repair Type: Non-Urgent
Crossing Status: Found
UCIP Comments: 5/16/2017 Abandoned- needs to be done so properly. (DWR Sutter Yard- A Freitag) 11/15/2016 Abandoned. (DWR Sutter Yard- A Freitag) 5/11/2016 Abandoned crossing. 8/4/2015 Abandoned pipe. Casey Wilder has started the steps to have the pipe properly abandoned and removed from the levee. 12/8/2014 Same as last inspection. 6/11/2014 Same as last inspection. 11/19/2013 Same as last inspection. 5/29/2013 Same as last inspection. 10/30/2012 Pipe buried on both sides of levee.
FIELD_STRUCT_DESC: *ABANDONED* 30-inch corrugated metal drainage pipe through the levee, 12.2 feet below the crown. Flap gate on the waterside (WS) end. [Additional Reference(s): DWR Levee Log, 1990 (HLM 10.99). USACE Sacramento O&M Manual, Unit 515 - Upper Butte Creek - Part No. 1, April 1955, (Station 748+53). USACE As-Built Drawing No. 50-4-2637, Exhibit B, Sheet 4, April 1950].

LM Start	10.84	Rating **	M	Issue No.	920 (cont)
LM End	10.84	Issue Type +	Ma	Location *

Concrete headwall at LS toe.

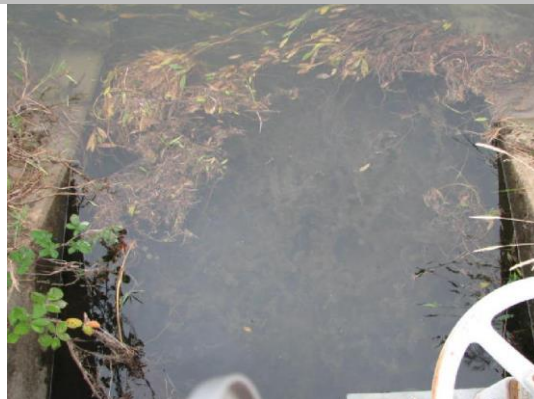
Photo 1 of 3 : UCIP_SP_2020_51988_68002.jpg

DS_ID:1781
FS_ID:51988
EP_NO: 16667
Repair Type: Non-Urgent
Crossing Status: Found
UCIP Comments: 5/16/2017 LS appears to be in good condition. WS outlet is too heavily vegetated to be inspected. Vegetation needs to be cleared back. Pipe has been selected to be internally cleaned and inspected as part of the DMP project. (DWR Sutter Yard- A Freitag) 11/15/2016 Crossing appears to be in good condition. (DWR Sutter Yard- A Freitag) 5/11/2016 Crossing appears to be in good condition. 8/4/2015 Crossing appears in good condition. No noticeable issues to report. 6/11/2014 Same as last inspection. 11/19/2013 Same as last inspection. 5/29/2013 Same as last inspection.
FIELD_STRUCT_DESC: [Western Canal Siphon] 5 of 5: 18-inch reinforced concrete irrigation pipe through the levee, at an unknown depth. Pipe terminates at a concrete outlet on the waterside (WS) slope. Concrete headwalls on both the landside (LS) and the WS. Slide gate and air vent on the LS. This is a turnout that was installed for the use of the property owner. (three 10-foot pipes under the channel and levees of Butte Creek, two 18-inch pipes under the east levee and two 42-inch pipes under the west levee of Butte Creek work authorized under Permit No. 16667, 1997 - Western Canal Water District).

LM Start	10.94	Rating **	M	Issue No.	921 (cont)
LM End	10.94	Issue Type +	En	Location *

Concrete U shaped headwall at inlet in canal on LS.

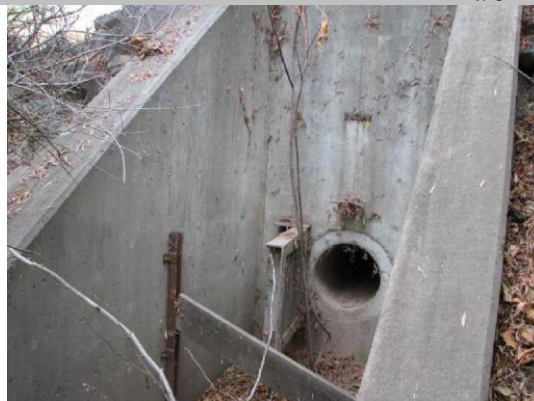
Photo 2 of 3 : UCIP_SP_2020_51988_68001.jpg

Concrete U shaped outlet on WS slope.

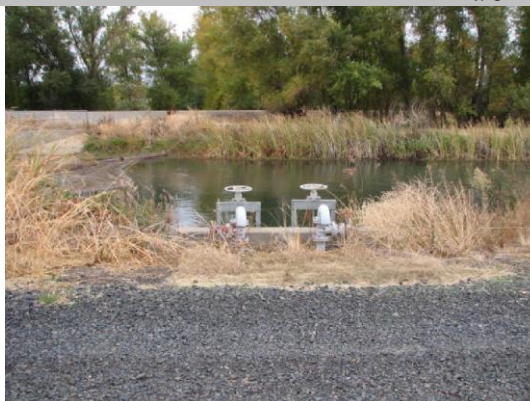
Photo 3 of 3 : UCIP_SP_2020_51988_68000.jpg

LM Start	10.94	Rating **	M	Issue No.	921 (cont)
LM End	10.94	Issue Type +	En	Location *	
Category	Supplemental		GPS Latitude/Longitude		
			Start	End	
Item	DWR UCIP Field Study		39.561483 °	39.561483 °	
			-121.826939 °	-121.826939 °	
DWR ID	1781

Air vents, slide gates, and concrete headwall at south side of canal on LS.

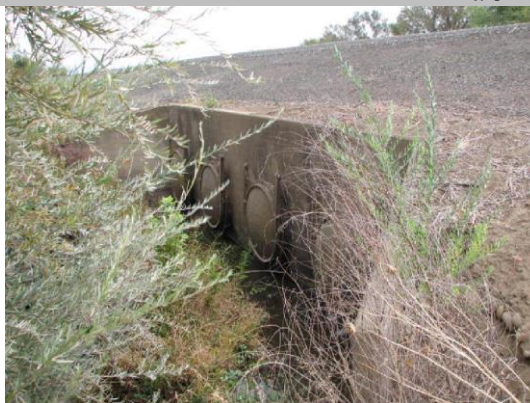
Photo 1 of 2 : UCIP_SP_2020_51990_68007.jpg

LM Start	11.36	Rating **	A/W	Issue No.	922
LM End	11.36	Issue Type +	Ma	Location *	
Category	Supplemental		GPS Latitude/Longitude		
			Start	End	
Item	DWR UCIP LMA Responsibility		39.556741 °	39.556741 °	
			-121.832071 °	-121.832071 °	
DWR ID	1636

DS_ID:1636
FS_ID:51990
EP_NO: N/A
Repair Type: No Action Needed
Crossing Status: Found
UCIP Comments: 5/16/2017 Crossing appears to be in good condition. Pipe has been selected to be internally cleaned and inspected as part of the DMP project. (DWR Sutter Yard- A/Freitag)11/15/2016 Crossing appears to be in good condition. (DWR Sutter Yard- A/Freitag)5/11/2016 Crossing appears to be in good condition.8/4/2015 Crossing appears in good condition. No noticeable issues to report.6/11/2014 Same as last inspection.11/19/2013 Same as last inspection.5/29/2013 Same as last inspection.
FIELD_STRUCT_DESC: 1 of 4: 54-inch corrugated metal drainage pipe through the levee, 13.5 feet below the crown. Flap gate on the waterside (WS). Concrete headwalls on the landside (LS) and the WS toes. [Additional Reference(s): DWR Levee Log, 1990 (HLM 11.52). USACE Sacramento O&M Manual, Unit 515 - Upper Butte Creek - Part No. 1, April 1955, (Station 25+18 "A"). USACE As-Built Drawing No. 50-4-2637, Exhibit B, Sheet 4, April 1950].

WS headwall and flap gates at WS toe.

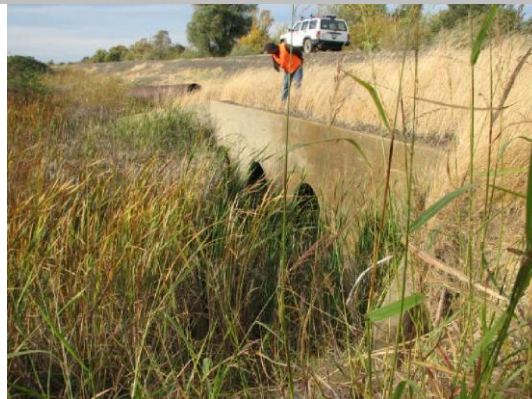
Photo 2 of 2 : UCIP_SP_2020_51992_68010.jpg

DS_ID:1783
FS_ID:51992
EP_NO: N/A
Repair Type: No Action Needed
Crossing Status: Found
UCIP Comments: 5/16/2017 Crossing appears to be in good condition. Pipe has been selected to be internally cleaned and inspected as part of the DMP project. (DWR Sutter Yard- A/Freitag)11/15/2016 Crossing appears to be in good condition. (DWR Sutter Yard- A/Freitag)5/11/2016 Crossing appears to be in good condition.8/4/2015 Crossing appears in good condition. No noticeable issues to report.6/11/2014 Same as last inspection.11/19/2013 Same as last inspection.5/29/2013 Same as last inspection.
FIELD_STRUCT_DESC: 3 of 4: 54-inch corrugated metal drainage pipe through the levee, 13.5 feet below the crown. Flap gate on the waterside (WS). Concrete headwalls on the landside (LS) and the WS toes. [Additional Reference(s): DWR Levee Log, 1990 (HLM 11.52). USACE Sacramento O&M Manual, Unit 515 - Upper Butte Creek - Part No. 1, April 1955, (Station 25+18 "A"). USACE As-Built Drawing No. 50-4-2637, Exhibit B, Sheet 4, April 1950].

Headwall on LS toe.

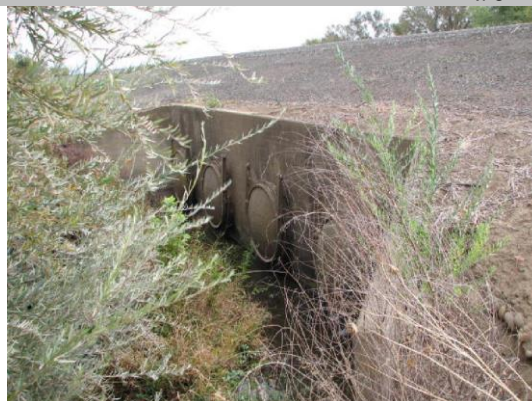
Photo 1 of 2 : UCIP_SP_2020_51993_68013.jpg

Headwall and flap gates at WS toe.

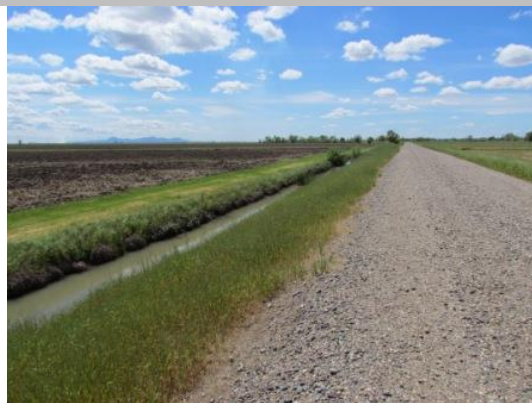
Photo 1 of 1 : SP_2020_MA0005_196_6_20200226_00003.jpg

LM Start	11.85	Rating **	M	Issue No.	6
LM End	13.64	Issue Type +	En	Location *	LS
Category	Earthen Levee			GPS Latitude/Longitude	
				Start	End
Item	Encroachments			39.551235 °	39.531462 °
				-121.837697 °	-121.856165 °
DWR ID	DWR_MA0005_01_s_2012_6				
Comment Code					
DT : Ditch					
Inspector Comment

View of the agricultural ditch along the landside toe.

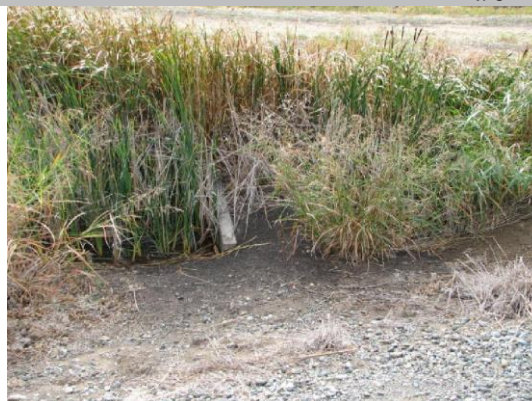
Photo 1 of 1 : UCIP_SP_2020_51996_68025.jpg

Comment Code					
Inspector Comment					
DS_ID:1747 FS_ID:51996 EP_NO: N/A Repair Type: Non-Urgent Crossing Status: Indicator Found UCIP Comments: 5/16/2017 Pipe is buried on both sides of the levee. Unable to locate. (DWR Sutter Yard- AFreitag)11/15/2016 Buried on both sides of Levee. (DWR Sutter Yard - AFreitag)5/11/2016 Buried pipe.8/4/2015 Pipe is buried on both ends.6/11/2014 Same as last inspection.11/19/2013 Same as last inspection.5/29/2013 Same as last inspection.10/31/2012 Pipe buried on both LS and WS. FIELD_STRUCT_DESC: 48-inch corrugated metal irrigation pipe through the levee, at an unknown depth, indicator found. 48-inch corrugated metal riser and a sparling water meter/irrigation structure on the landside (LS). 4-foot by 6-foot concrete distribution box at the LS toe. [Additional Reference(s): USACE Sacramento O&M Manual, Unit 515 - Upper Butte Creek - Part No. 1, April 1955, (Station 836+86). USACE As-Built Drawing No. 50-4-2637, Exhibit B, Sheet 4, April 1950, (Station 836+85.70)]. FS Date: 5/31/2017 2:34:41 PM

Buried pipe at concrete box, LS toe.

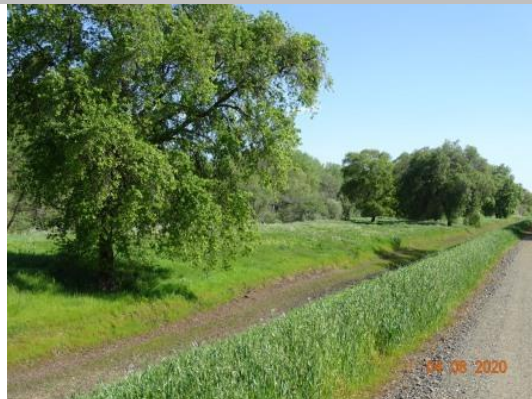
Photo 1 of 1 : SP_2020_MA0005_196_57_20200415_00087.jpg

LM Start	14.02	Rating **	M	Issue No.	57
LM End	14.86	Issue Type +	Ma	Location *	WS
Category	Earthen Levee			GPS Latitude/Longitude	
				Start	End
Item	Vegetation			39.526978 °	39.518137 °
				-121.860223 °	-121.871064 °
DWR ID	DWR_MA0005_01_s _ 2020_57				
Comment Code					
V1 : Control annual grass and weeds on the levee slopes and easements.					
Inspector Comment

View of the vegetation along the waterside slope. Spring 2020.

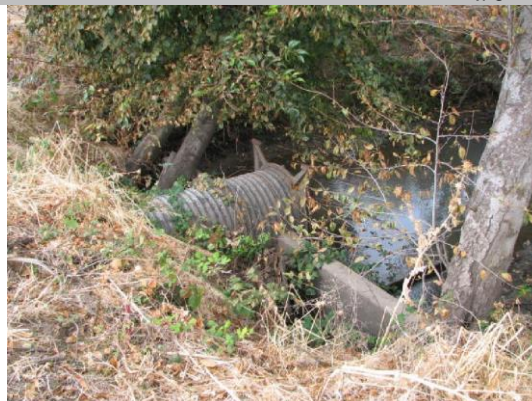
Photo 2 of 3 : UCIP_SP_2020_51999_68032.jpg

CMP pipe, flap gate, and headwall on WS toe.

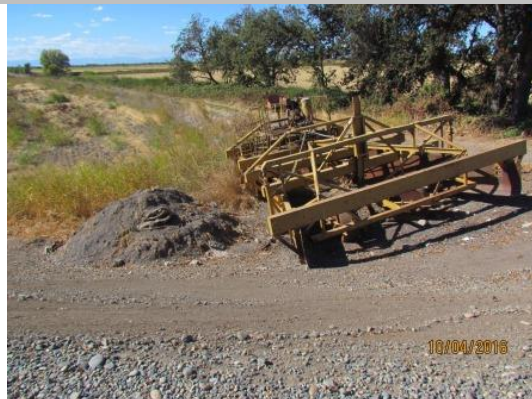
Photo 1 of 1 : SP_2020_MA0005_197_48_20200226_00018.jpg

LM Start	1.86	Rating **	M	Issue No.	48
LM End	1.86	Issue Type +	En	Location *	LS
Category	Earthen Levee			GPS Latitude/Longitude	
				Start	End
Item	Encroachments			39.536915 °	39.536915 °
				-121.853669 °	-121.853669 °
DWR ID	DWR_MA0005_02_f_2016_48				
Comment Code					
EQ : Equipment					
Inspector Comment					
Remove pile of soil and rocks and ag equipment from the landside toe of the levee.

View of soil pile, rocks, and ag equipment.

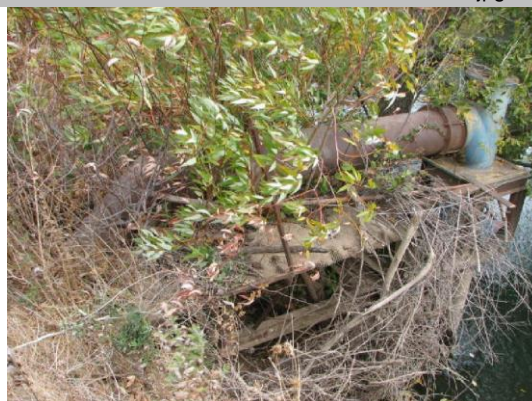
Photo 2 of 3 : UCIP_SP_2020_52013_68056.jpg

Pump on metal pier at WS toe.

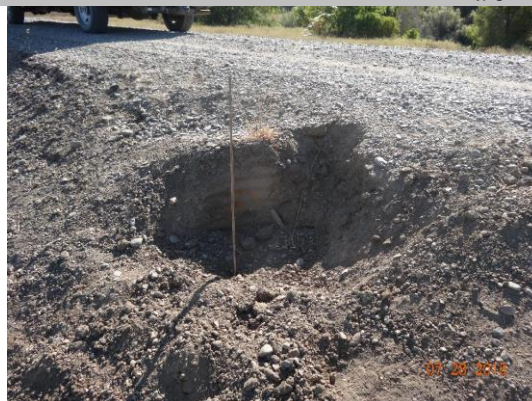
Photo 3 of 3 : UCIP_SP_2020_52013_74602.jpg

Spot where CMP riser was on the LS shoulder.

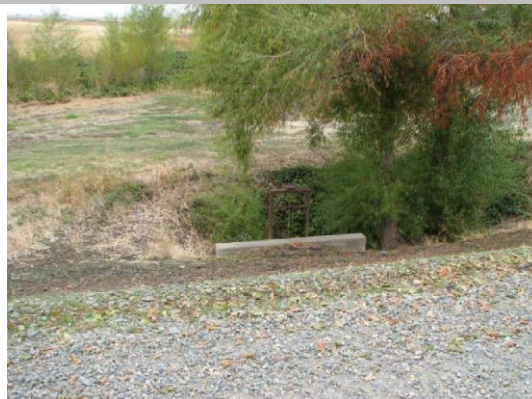
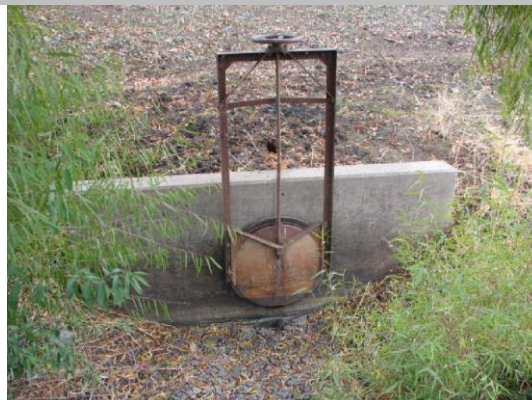
DS_ID:1647
FS_ID:52014
EP_NO: N/A
Repair Type: No Action Needed
Crossing Status: Found
UCIP Comments: 5/18/2017 Crossing appears to be in good condition. Tree near the LS screw gate could use some trimming. Pipe has been selected to be internally cleaned and inspected as part of the DMP project. (DWR Sutter Yard- AFreitag)11/14/2016 Crossing appears to be in good condition. (DWR Sutter Yard- AFreitag)5/23/2016 Crossing appears to be in good condition.7/28/2015 Pipe appears in good condition. No noticeable issues to report.6/6/2013 Same as last inspection.11/12/2013 Same as last inspection.6/04/2014 Same as last inspection.11/25/2014 Same as last inspection.
FIELD_STRUCT_DESC: 30-inch corrugated metal drainage pipe through the levee, 14.3 feet below the crown. Slide gate on the landside (LS). Flap gate on the waterside (WS). Concrete headwall at the LS toe. Concrete splash apron on the WS. [Additional Reference(s): DWR Levee Log, 1990 (HLM 4.08). USACE Sacramento O&M Manual, Unit 515 - Upper Butte Creek - Part No. 1, April 1955, (Station 5+20 "A"). USACE As-Built Drawing No. 50-4-2637, Exhibit B, Sheet 4, April 1950].

Concrete headwall and slide gate at LS toe.

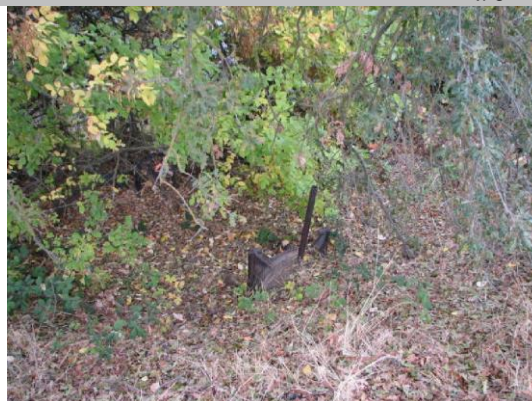
Photo 3 of 3 : UCIP_SP_2020_52014_68062.jpg

Flap gate at outlet on WS berm.

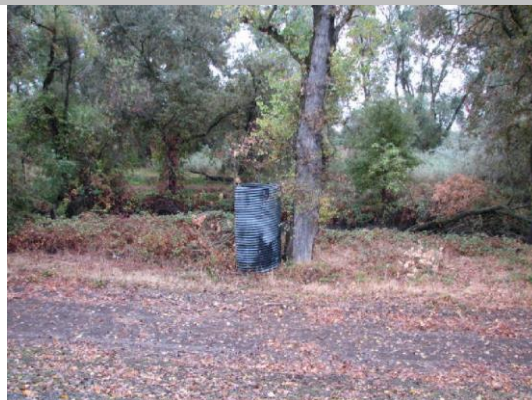
Photo 2 of 2 : UCIP_SP_2020_54041_68104.jpg

56-inch CMP riser on WS berm.

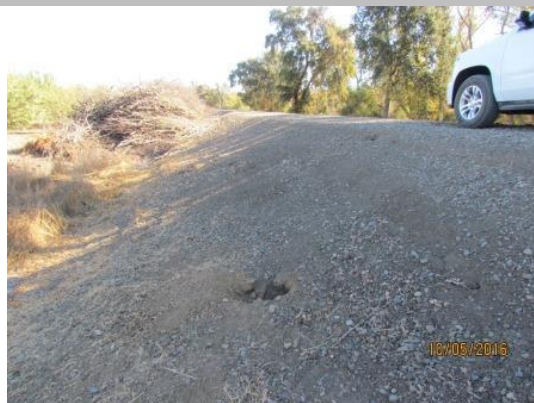
Photo 1 of 2 : SP_2020_MA0005_197_53_20200226_00020.jpg

LM Start	7.74	Rating **	U	Issue No.	53
LM End	7.74	Issue Type +	Ma	Location *	LS
Category	Earthen Levee			GPS Latitude/Longitude	
				Start	End
Item	Animal Control			39.605088 °	39.605088 °
				-121.788569 °	-121.788569 °
DWR ID	DWR_MA0005_02_f_2016_53				
Comment Code					
A3 : No rodents visible, but rodent burrows visible; need to backfill and compact or grout burrows.					
Inspector Comment

View of the rodent holes along the landside slope.

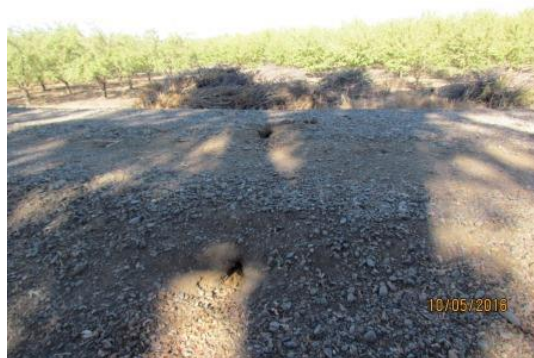
Photo 2 of 2 : SP_2020_MA0005_197_53_20200226_00021.jpg

View of the rodent holes along the crown and waterside slope.

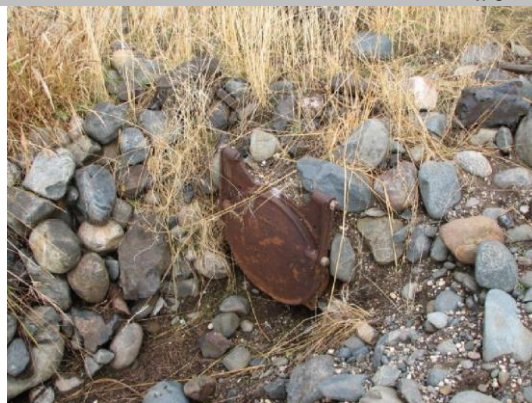
Photo 1 of 2 : UCIP_SP_2020_52052_68129.jpg

Comment Code					
Inspector Comment					
DS_ID:1656 FS_ID:52052 EP_NO: N/A Repair Type: Non-Urgent Crossing Status: Found UCIP Comments: 5/18/2017 LS inlet is almost completely full of soil. Pipe has been selected to be internally cleaned and inspected as part of the DMP project. (DWR Sutter Yard- A/Freitag)11/14/2016 LS inlet almost completely full of soil. (DWR Sutter Yard- A/Freitag)5/23/2016 LS end is almost completel full of soil.7/28/2015 Pipe is still over 3/4 full of soil. 11/24/2014 Same as last inspection.6/04/2014 Same as last inspection.11/12/2013 Same as last inspection.6/6/2013 Same as last inspection.10/31/2012 Pipe 3/4 full with soil on LS. FIELD_STRUCT_DESC: 18-inch corrugated metal drainage pipe through the levee at an unknown depth below the crown. Concrete headwall at the landside (LS) toe. Flap gate on the waterside (WS). [Additional Reference(s): USACE Sacramento O&M Manual, Unit 515 - Upper Butte Creek - Part No. 1, April 1955, pipe referenced only in USACE As-Built Drawing No. 50-4-2637, Exhibit B, Sheet 2, April 1950, (Station 550+42)]. FS Date: 6/1/2017 1:15:55 PM

Flap gate at WS toe.

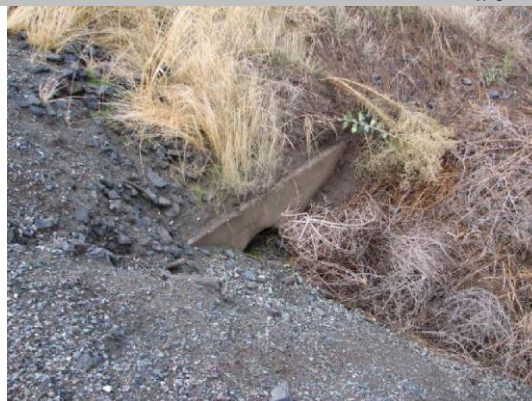
Photo 2 of 2 : UCIP_SP_2020_52052_68128.jpg

Concrete headwall on LS toe.

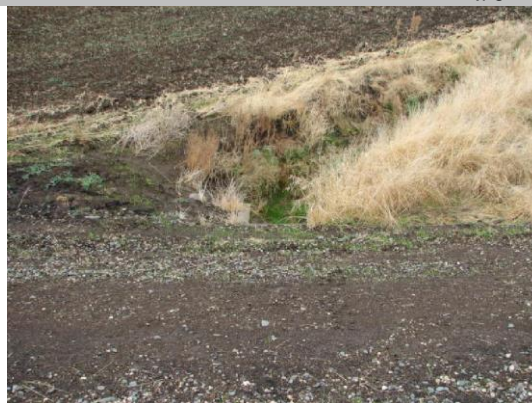
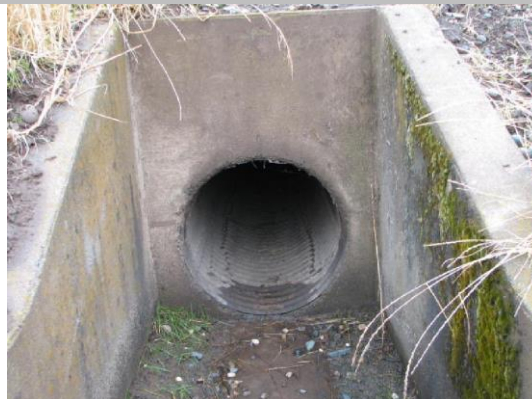
Comment Code						
Inspector Comment						
DS_ID:1662 FS_ID:52059 EP_NO: N/A Repair Type: No Action Needed Crossing Status: Found UCIP Comments: 5/18/2017 Crossing appears to be in good condition. Pipe has been selected to be internally cleaned and inspected as part of the DMP project. (DWR Sutter Yard- AFreitag)11/14/2016 Crossing appears to be in good condition. (DWR Sutter Yard- AFreitag)5/12/2016 Crossing appears to be in good condition.7/30/2015 Crossing is in good condition. No noticeable issues to report.11/24/2014 Same as last inspection.6/4/2014 Same as last inspection.11/13/2013 Same as last inspection..6/6/2013 Same as last inspection. FIELD_STRUCT_DESC: 30-inch corrugated metal drainage pipe through the levee, 16.3 feet below the crown. Flap gate on the waterside (WS). Concrete "U" shaped headwalls on both the landside (LS) and the WS. [Additional Reference(s): DWR Levee Log, 1990 (HLM 8.21). USACE Sacramento O&M Manual, Unit 516 - Upper Butte Creek - Part No. 2, April 1960, (Station 374+90). USACE As-Built Drawing No. 50-4-3367, Exhibit B, Sheet 13, April 1957]. FS Date: 6/1/2017 1:25:58 PM

Concrete inlet on LS toe.

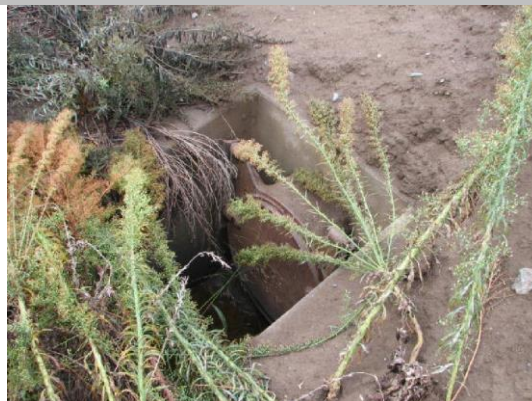
Photo 3 of 3 : UCIP_SP_2020_52059_68392.jpg

Concrete outlet and flap gate on WS toe.

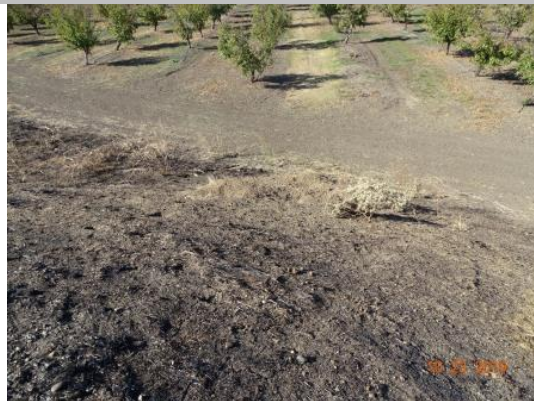
Photo 1 of 1 : SP_2020_MA0005_197_73_20200226_00030.jpg

LM Start	8.76	Rating **	U	Issue No.	73
LM End	8.76	Issue Type +	Ma	Location *	LS
Category	Earthen Levee			GPS Latitude/Longitude	
				Start	End
Item	Animal Control			39.617598 °	39.617598 °
				-121.779100 °	-121.779100 °
DWR ID	DWR_MA0005_02_f _ 2019_73				
Comment Code					
A3 : No rodents visible, but rodent burrows visible; need to backfill and compact or grout burrows.					
Inspector Comment

View of two large rodent burrows on the landside slope and toe. Fall 2019.

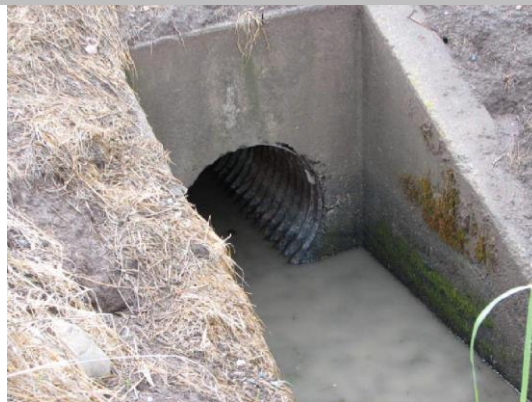
DS_ID:1663
FS_ID:52061
EP_NO: N/A
Repair Type: No Action Needed
Crossing Status: Found
UCIP Comments: 5/18/2017 Crossing appears to be in good condition. Pipe has been selected to be internally cleaned and inspected as part of the DMP project. (DWR Sutter Yard- AFreitag)11/14/2016 Crossing appears to be in good condition. (DWR Sutter Yard- AFreitag)5/12/2016 Crossing appears to be in good condition. 7/30/2015 Crossing appears in good condition. No noticeable issues to report. 11/24/2014 Same as last inspection. 6/4/2014 Same as last inspection. 11/13/2013 Damaged pipe section was dug up and replaced. New WS flapgate with u-shaped wingwall installed on end of pipe. 6/6/2013 Same as last inspection. Plans have been made to repair during summer of 2013 before high water season. 11/01/2012 Pipe rusted through along bottom at WS outlet. Sink hole over pipe on WS berm. WS headwall eroded eternally around backside of headwall.

Concrete U-shaped headwall on LS toe.

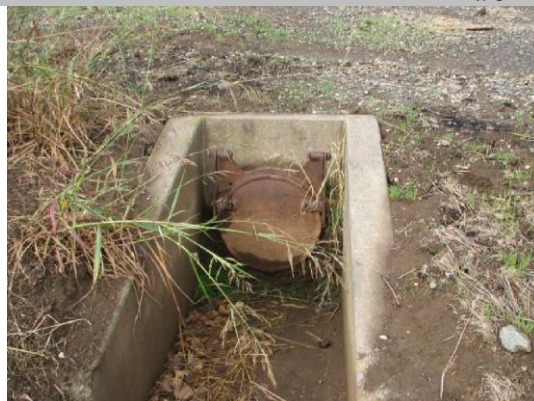
Photo 3 of 3 : UCIP_SP_2020_52062_68403.jpg

Comment Code						
Inspector Comment						
DS_ID:1664 FS_ID:52062 EP_NO: N/A Repair Type: Non-Urgent Crossing Status: Found UCIP Comments: 5/18/2017 No LS slide gate but not sure its even needed. Pipe has been selected to be internally cleaned and inspected as part of the DMP project. (DWR Sutter Yard- AFreitag)11/14/2016 LS slide gate still missing. Rest of crossing appears in good condition. (DWR Sutter Yard- AFreitag)5/12/2016 LS inlet was unburied. Slide gate still missing7/30/2015 LS inlet is still buried.11/24/2014 Same as last inspection.6/4/2014 Same as last inspection.11/13/2013 Same as last inspection.6/6/2013 Same as last inspection.11/01/2012 LS inlet is buried under soil and covered with brambles. Slide gate missing from LS. FIELD_STRUCT_DESC: 24-inch corrugated metal drainage pipe through the levee, 12 feet below the crown. Flap gate on the waterside (WS). Concrete headwall on the WS. Concrete headwall on the landside (LS), not found. [Additional Reference(s): DWR Levee Log, 1990 (HLM 8.93). USACE Sacramento O&M Manual, Unit 516 - Upper Butte Creek - Part No. 2, April 1960, (Station 338+04). USACE As-Built Drawing No. 50-4-3367, Exhibit B, Sheet 11, April 1957]. FS Date: 6/1/2017 1:29:34 PM

Concrete U shaped headwall and flap gate at WS toe.
