**Flood Control Project Maintenance
Levee Inspections**
LMA District Cover Sheet
Spring 2020 Levee Inspection Results

Spring 2020 Levee Inspection Results

Sutter Maintenance Yard Maintenance Area 0005

Waterway			Bank	Unit Miles
Unit No. 01 Butte Creek			Left	15.08
	Spring (March - May)	Summer (June - August)	(September - November) Fall	Winter (December - February)
Unit Maintenance Rating (Fall Only)				
Date of Inspection	4/8/2020 - 4/8/2020			
DWR Inspector	Makar Sokol			
Accompanied By	Bob Duffey Sutter Maintenance Yard

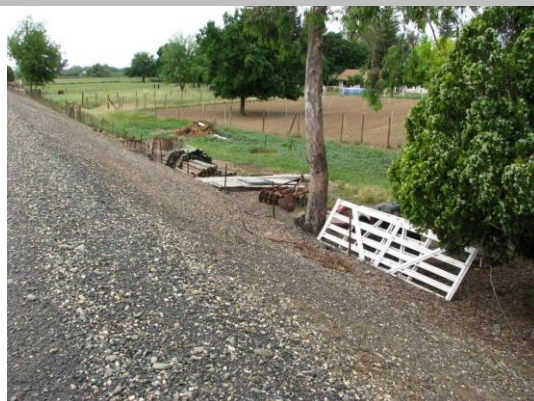
Photo 1 of 1 : SP_2020_MA0005_197_45_20200226_00015.jpg

View of equipment and materials from the landside toe.

LM Start	9.09	Rating **	M	Issue No.	45
LM End	9.09	Issue Type +	En	Location *	LS
Category	Earthen Levee			GPS Latitude/Longitude	
				Start	End
Item	Encroachments			39.622017 °	39.622017 °
				-121.776552 °	-121.776552 °
DWR ID	DWR_MA0005_02_s_2016_45				
Comment Code					
EQ : Equipment					
Inspector Comment					
Materials and equipment should be removed from the landside toe.

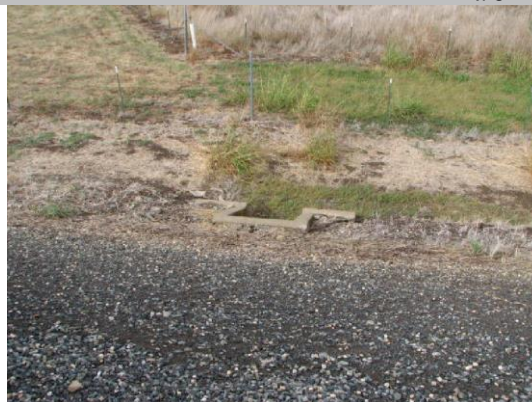
Photo 2 of 3 : UCIP_SP_2020_52063_68412.jpg

Concrete U shaped headwall on LS toe.

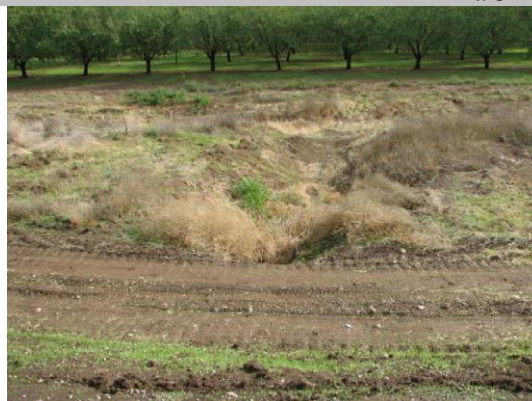
Photo 1 of 3 : UCIP_SP_2020_52064_68417.jpg

DS_ID:1666
FS_ID:52064
EP_NO: N/A
Repair Type: Non-Urgent
Crossing Status: Found
UCIP Comments: 5/18/2017 LS inlet half full of soil and WS flap gate half buried by sediment. Pipe has been selected to be internally cleaned and inspected as part of the DMP project. (DWR Sutter Yard-AFreitag)11/14/2016 LS pipe inlet is half full of soil. WS flap gate shut but half buried by sediment. (DWR Sutter Yard-AFreitag)5/12/2016 Pipe is half full of soil.7/30/2015 Pipe is 1/4 to 1/2 full of soil still.11/24/2014 Same as last inspection.6/4/2014 Same as last inspection.11/13/2013 Same as last inspection.6/6/2013 Same as last inspection.11/01/2012 Pipe 1/2 filled with soil.
FIELD_STRUCT_DESC: 24-inch corrugated metal drainage pipe through the levee, 11.2 feet below the crown. Flap gate on the waterside (WS). Concrete "U" shaped headwalls on both the landside (LS) and the WS. [Additional Reference(s): DWR Levee Log, 1990 (HLM 9.57). USACE Sacramento O&M Manual, Unit 516 - Upper Butte Creek - Part No. 2, April 1960, (Station 304+10). USACE As-Built Drawing No. 50-4-3367, Exhibit B, Sheet 3, April 1957].

View of outlet looking toward WS toe.

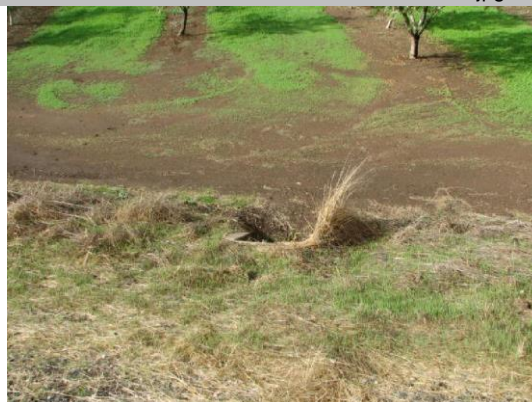
Photo 2 of 3 : UCIP_SP_2020_52064_68416.jpg

View of inlet on LS toe.

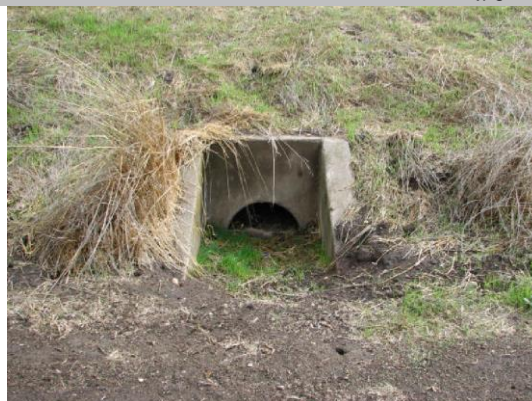
Photo 3 of 3 : UCIP_SP_2020_52064_68415.jpg

Concrete U-shaped headwall on LS toe.

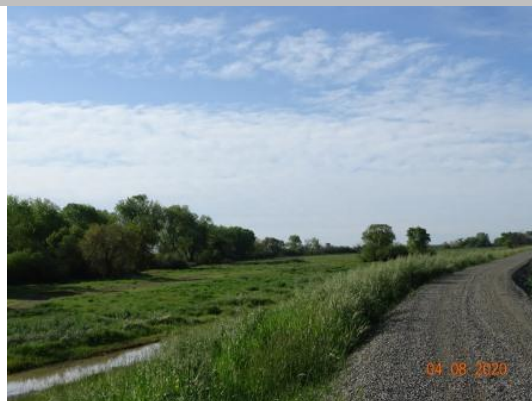
Photo 1 of 1 : SP_2020_MA0005_197_69_20200415_00093.jpg

LM Start	9.53	Rating **	U	Issue No.	69
LM End	9.70	Issue Type +	Ma	Location *	WS
Category	Earthen Levee			GPS Latitude/Longitude	
				Start	End
Item	Vegetation			39.628098 °	39.630558 °
				-121.775065 °	-121.774871 °
DWR ID	DWR_MA0005_02_s_2020_69				
Comment Code					
V1 : Control annual grass and weeds on the levee slopes and easements.					
Inspector Comment

View of the vegetation along the waterside slope. Spring 2020.

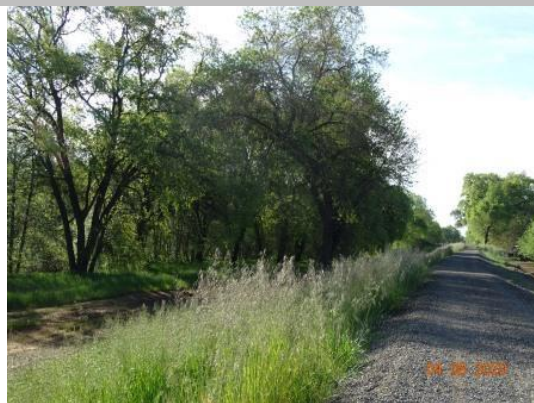
Photo 1 of 1 : SP_2020_MA0005_197_65_20200415_00097.jpg

LM Start	10.95	Rating **	U	Issue No.	65
LM End	11.21	Issue Type +	Ma	Location *	WS
Category	Earthen Levee			GPS Latitude/Longitude	
				Start	End
Item	Vegetation			39.646140 °	39.649377 °
				-121.787001 °	-121.789472 °
DWR ID	DWR_MA0005_02_s_2020_65				
Comment Code					
V1 : Control annual grass and weeds on the levee slopes and easements.					
Inspector Comment

View of the vegetation along the waterside slope. Spring 2020.

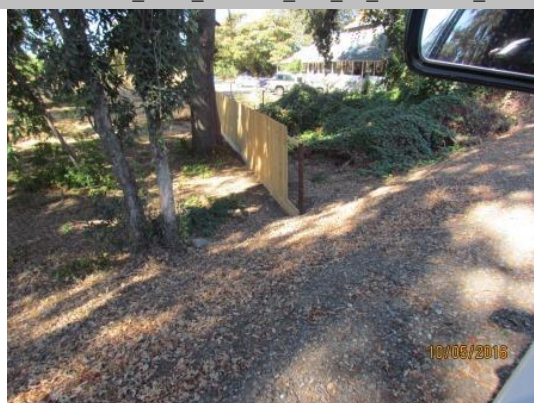
Photo 1 of 1 : SP_2020_MA0005_197_60_20200226_00025.jpg

Fence now extends along LS toe, parallel to the levee.

LM Start	10.98	Rating **	U	Issue No.	60
LM End	11.04	Issue Type +	En	Location *	LS
Category	Earthen Levee			GPS Latitude/Longitude	
				Start	End
Item	Encroachments			39.646523 °	39.647238 °
				-121.787310 °	-121.787866 °
DWR ID	DWR_MA0005_02_f _ 2016_60				
Comment Code					
FE : Fence					
Inspector Comment					
Apply for permit or remove the fence from the landside toe.

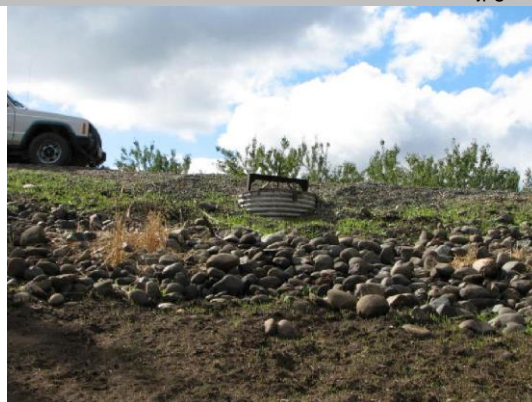
Photo 2 of 3 : UCIP_SP_2020_52070_68435.jpg

CM riser with slide gate on WS shoulder.

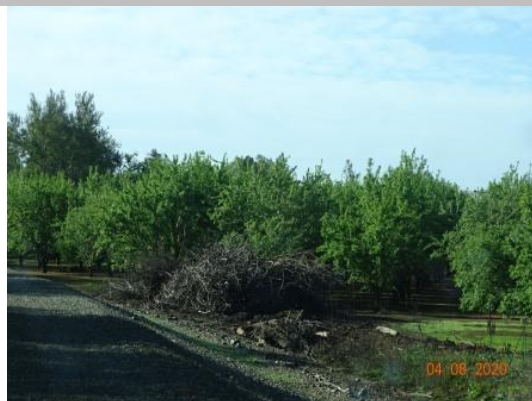
Photo 1 of 1 : SP_2020_MA0005_197_63_20200415_00098.jpg

LM Start	11.23	Rating **	M	Issue No.	63
LM End	11.23	Issue Type +	En	Location *	LS
Category	Earthen Levee			GPS Latitude/Longitude	
				Start	End
Item	Encroachments			39.649627 °	39.649627 °
				-121.789668 °	-121.789668 °
DWR ID	DWR_MA0005_02_s_2020_63				
Comment Code					
PR : Prunings					
Inspector Comment

View of the prunings at landside toe. Spring 2020.

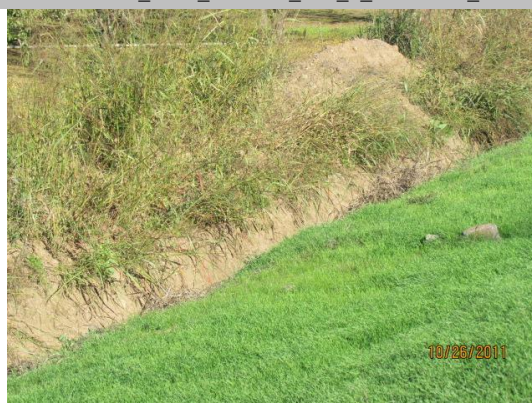
Photo 1 of 1 : SP_2020_MA0005_197_6_20200226_00003.jpg

LM Start	11.27	Rating **	M	Issue No.	6
LM End	11.77	Issue Type +	En	Location *	LS
Category	Earthen Levee			GPS Latitude/Longitude	
				Start	End
Item	Encroachments			39.650046 °	39.657142 °
				-121.789945 °	-121.788690 °
DWR ID	DWR_MA0005_02_s_2012_6				
Comment Code					
DT : Ditch					
Inspector Comment

View of the ditch along the landside toe.

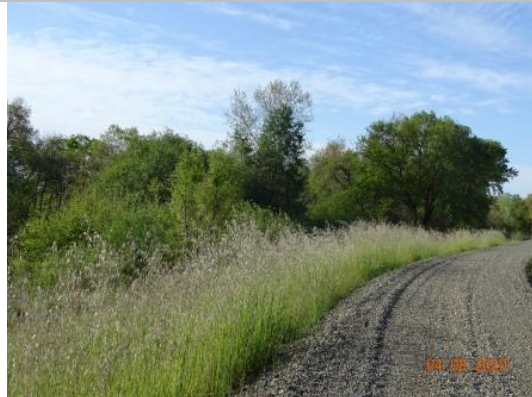
Photo 1 of 1 : SP_2020_MA0005_197_61_20200415_00099.jpg

LM Start	11.36	Rating **	U	Issue No.	61
LM End	11.74	Issue Type +	Ma	Location *	WS
Category	Earthen Levee			GPS Latitude/Longitude	
				Start	End
Item	Vegetation			39.651306 °	39.656727 °
				-121.790417 °	-121.788826 °
DWR ID	DWR_MA0005_02_s _ 2020_61				
Comment Code					
V1 : Control annual grass and weeds on the levee slopes and easements.					
Inspector Comment

View of the vegetation along the waterside slope. Spring 2020.

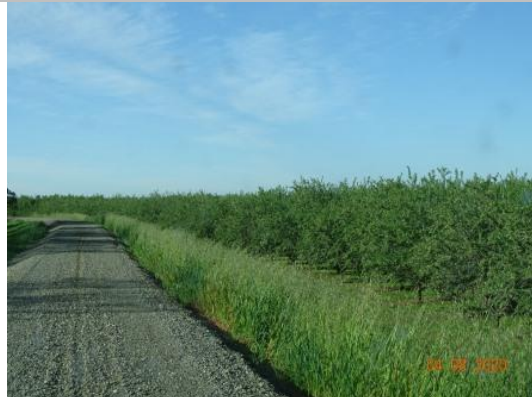
Photo 1 of 1 : SP_2020_MA0005_197_52_20200415_00100.jpg

LM Start	11.44	Rating **	U	Issue No.	52
LM End	12.81	Issue Type +	Ma	Location *	LS
Category	Earthen Levee			GPS Latitude/Longitude	
				Start	End
Item	Vegetation			39.652502 °	39.671094 °
				-121.790336 °	-121.782818 °
DWR ID	DWR_MA0005_02_s _ 2020_52				
Comment Code					
V1 : Control annual grass and weeds on the levee slopes and easements.					
Inspector Comment

View of the vegetation along the landside toe. Spring 2020.

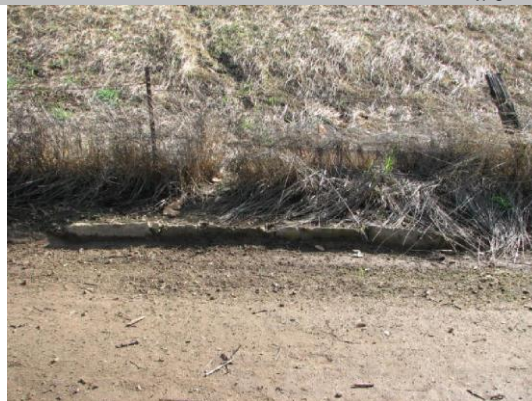
Photo 2 of 3 : UCIP_SP_2020_54048_68464.jpg

DS_ID:1673
FS_ID:54048
EP_NO: N/A
Repair Type: Non-Urgent
Crossing Status: Found
UCIP Comments: 05/23/2019 (O. Magana - DWR UCIP)05/18/2017 Abandoned- needs to be done properly. Pipe has been selected to be internally cleaned and inspected as part of the DMP project. (DWR Sutter Yard- AFreitag)11/14/2016 Abandoned- needs a cover for standpipe. (DWR Sutter Yard- AFreitag)05/11/2016 Abandoned crossing. Needs a cover to the WS riser.08/03/2015 Crossing appears abandoned. Only the slide gate inside riser on the WS shoulder could be found. Riser needs a cover made for it.11/24/2014 Same as last inspection.06/04/2014 Same as last inspection.11/13/2013 Slide gate top and stem were repaired to make gate operational.06/06/2013 New slidegate is planned to be installed during summer of 2013.11/01/2012 Slide gate on WS shoulder bent and damaged (inoperable) Pipe appears abandoned. FIELD_STRUCT_DESC: *ABANDONED* 24-inch corrugated metal drainage pipe through the levee, 14 feet below the crown. Slide gate in a corrugated metal riser on the waterside (WS) slope. [Additional Reference(s): DWR Levee Log, 1990 (HLM 12.98). USACE Sacramento O&M Manual, Unit 516 - Upper Butte Creek - Part No. 2, April 1960, (Station 126+91)].

Abandoned headwall on LS toe.

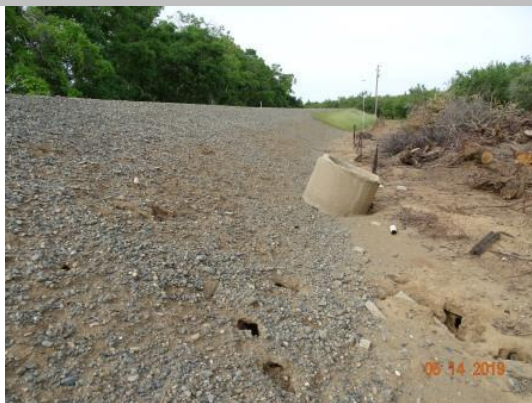
Photo 1 of 1 : SP_2020_MA0005_197_9_20200226_00005.jpg

LM Start	12.84	Rating **	M	Issue No.	9
LM End	12.84	Issue Type +	Ma	Location *	LS
Category	Earthen Levee			GPS Latitude/Longitude	
				Start	End
Item	Animal Control			39.671281 °	39.671281 °
				-121.782390 °	-121.782389 °
DWR ID	DWR_MA0005_02_s_2019_9				
Comment Code					
A3 : No rodents visible, but rodent burrows visible; need to backfill and compact or grout burrows.					
Inspector Comment

View of the animal burrows on the landside slope. Spring 2019.

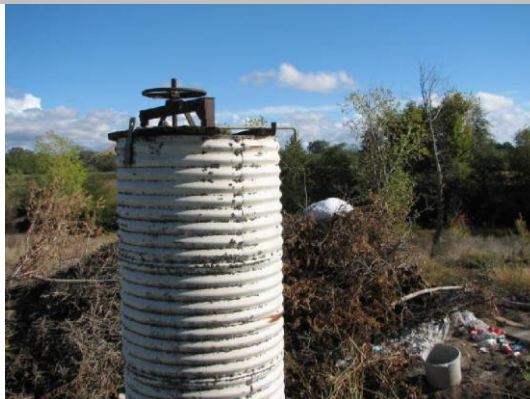
Photo 1 of 1 : UCIP_SP_2020_52073_68488.jpg

Comment Code						
Inspector Comment						
DS_ID:1674 FS_ID:52073 EP_NO: 1291 Repair Type: Non-Urgent Crossing Status: Found UCIP Comments: 5/18/2017 Appears abandoned- needs to be done properly. (DWR Sutter Yard- AFreitag)11/14/2016 Appears abandoned- needs to be done so properly (DWR Sutter Yard- AFreitag)5/11/2016 Appears to be an abandoned crossing.8/3/2015 Pipe appears to be abandoned. Pump on WS berm is still missing.11/24/2014 Same as last inspection.6/4/2014 Same as last inspection.11/13/2013 Same as last inspection.6/6/2013 Same as last inspection.11/01/2012 Pipe appears to be abandoned. No pump found. Pipe should be abandoned properly. FIELD_STRUCT_DESC: 24-inch corrugated metal (not 14-inch concrete as described in the permit) irrigation pipe through the levee, 9 feet below the crown. Slide gate in a 36-inch corrugated metal riser on the waterside (WS) slope. Pump and a 36-inch concrete standpipe on the WS. (14-inch pipe referenced under Permit No. 1291, 1948 - J. P. Hansen). [Additional Reference(s): DWR Levee Log, 1990 (HLM 13.35). USACE Sacramento O&M Manual, Unit 516 - Upper Butte Creek - Part No. 2, April 1960, (Station 106+93)]. FS Date: 6/1/2017 1:54:43 PM

Slide gate in CM riser on WS toe.

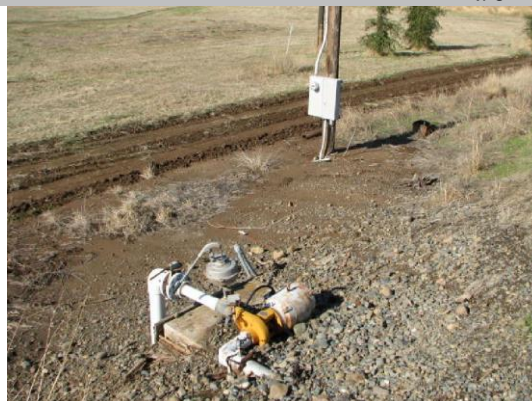
Photo 1 of 1 : UCIP_SP_2020_52074_68489.jpg

Comment Code					
Inspector Comment					
DS_ID:1675 FS_ID:52074 EP_NO: N/A Repair Type: Non-Urgent Crossing Status: Found UCIP Comments: 5/18/2017 LS visible but nothing found on WS of levee. (DWR Sutter Yard- AFreitag)11/14/2016 Still unable to locate and WS appurtances. (DWR Sutter Yard- AFreitag)5/11/2106 LS seems fine but nothing was found on the WS8/3/2015 Still unable to locate anything on the WS.11/24/2014 Same as last inspection.6/4/2014 Same as last inspection.11/13/2013 Same as last inspection.6/6/2013 Same as last inspection.11/01/2012 Unable to locate pipe on WS. FIELD_STRUCT_DESC: 8-inch steel irrigation pipe, 4 feet below the crown. Pipe is sleeved with a 5-inch aluminum irrigation pipe. Pump on a concrete pad on the landside (LS) slope. Butterfly valve on the LS slope. [Additional Reference(s): DWR Levee Log, 1990]. FS Date: 6/1/2017 1:56:04 PM

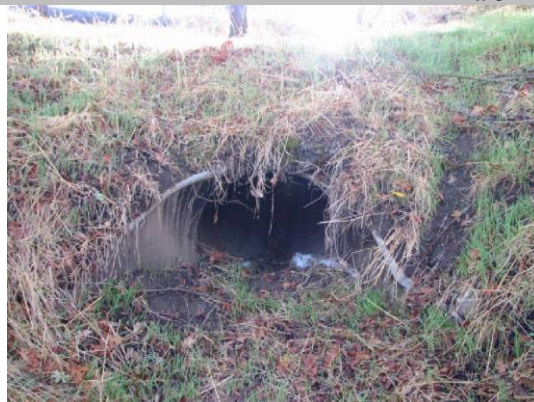
Photo 2 of 3 : UCIP_SP_2020_52083_68530.jpg

Inlet relocated after bridge replacement away from LS toe.

Inlet 50-feet NW of levee crown.

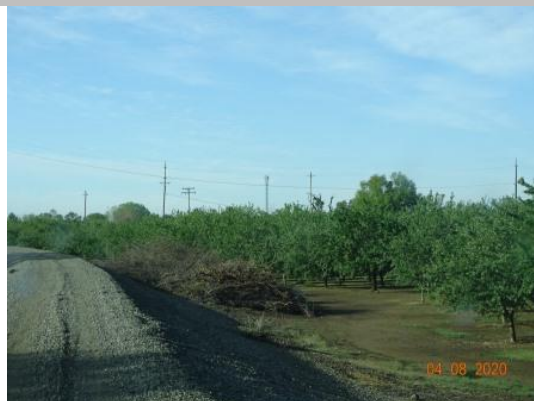
Photo 1 of 1 : SP_2020_MA0005_197_42_20200415_00101.jpg

LM Start	13.54	Rating **	M	Issue No.	42
LM End	13.54	Issue Type +	En	Location *	LS
Category	Earthen Levee			GPS Latitude/Longitude	
				Start	End
Item	Encroachments			39.680593 °	39.680593 °
				-121.778266 °	-121.778266 °
DWR ID	DWR_MA0005_02_s_2020_42				
Comment Code					
PR : Prunings					
Inspector Comment

View of the prunings at the landside toe. Spring 2020.

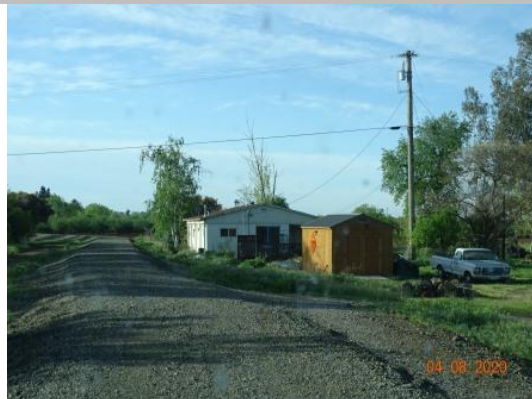
Photo 1 of 1 : SP_2020_MA0005_197_25_20200415_00102.jpg

LM Start	14.33	Rating **	U	Issue No.	25
LM End	14.33	Issue Type +	En	Location *	LS
Category	Earthen Levee			GPS Latitude/Longitude	
				Start	End
Item	Encroachments			39.691580 °	39.691580 °
				-121.779254 °	-121.779254 °
DWR ID	DWR_MA0005_02_s_2012_25				
Comment Code					
BU : Building					
Inspector Comment					
Unpermitted structure.

View of the buildings at the landside toe. Spring 2020.

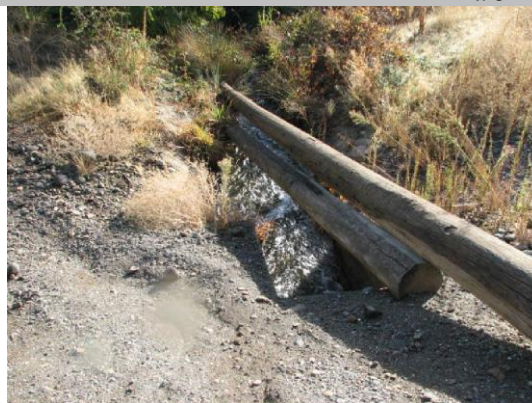
Photo 1 of 3 : UCIP_SP_2020_54049_68544.jpg

Comment Code					
Inspector Comment					
DS_ID:1682 FS_ID:54049 EP_NO: N/A Repair Type: No Action Needed Crossing Status: Found UCIP Comments: 05/23/2019 (O. Magana - DWR UCIP)05/18/2017 Crossing appears to be in good condition. Pipe has been selected to be internally cleaned and inspected as part of the DMP project. (DWR Sutter Yard- A Freitag)11/14/2016 Crossing appears to be in good condition. (DWR Sutter Yard- A Freitag)05/11/2016 Crossing appears to be in good condition.08/03/2015 Crossing appears in good condition. No noticeable issues to report.11/25/2014 Same as last inspection.06/04/2014 Same as last inspection.11/13/2013 Same as last inspection.06/06/2013 Same as last inspection. FIELD_STRUCT_DESC: 24-inch corrugated metal drainage pipe through the levee, 7.2 feet below the crown. Concrete "U" shaped headwall and grouted spillway on the waterside (WS). Slide gate in a 48-inch concrete standpipe on the landside (LS). Flap gate on the WS. [Additional Reference(s): DWR Levee Log, 1990 (HLM 14.68). USACE Sacramento O&M Manual, Unit 516 - Upper Butte Creek - Part No. 2, April 1960, (Station 37+10)]. FS Date: 5/23/2019 5:21:51 PM

Outlet at U-shaped headwall on WS toe.

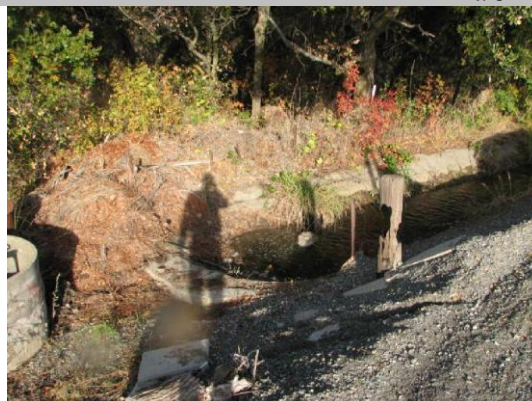
Photo 2 of 3 : UCIP_SP_2020_54049_68543.jpg

Concrete lined channel on LS toe.

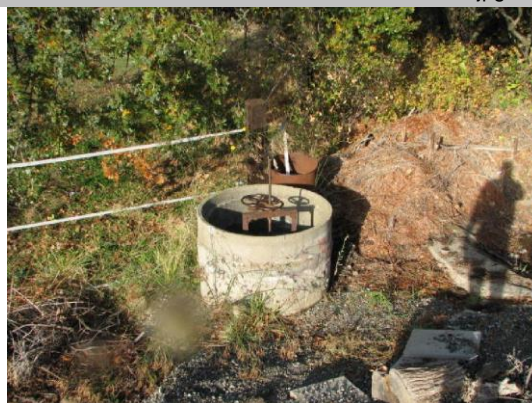
Photo 3 of 3 : UCIP_SP_2020_54049_68542.jpg

Concrete standpipe and slide gate on LS toe.

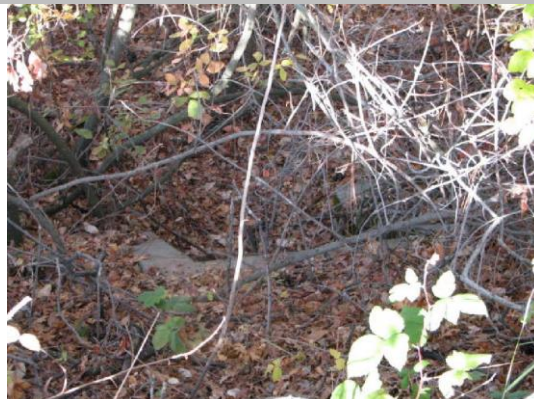
Photo 1 of 2 : UCIP_SP_2020_52087_68541.jpg

DS_ID:1683
FS_ID:52087
EP_NO: N/A
Repair Type: Non-Urgent
Crossing Status: Found
UCIP Comments: 5/18/2017 WS appears to be in good condition. LS inlet is across a ditch and inaccessible for inspection due to dense vegetation and being down a very steep slope. Pipe has been selected to be internally cleaned and inspected as part of the DMP project. (DWR Sutter Yard- A Freitag)11/14/2016 Crossing appears to be in good condition. (DWR Sutter Yard- A Freitag)5/11/2016 Crossing appears to be in good condition.8/3/2015 Crossing appears in good condition. No noticeable issues to report.6/6/2013 Same as last inspection.11/13/2013 Same as last inspection.6/4/2014 Same as last inspection.11/25/2014 Same as last inspection.
FIELD_STRUCT_DESC: 24-inch corrugated metal drainage pipe through the levee, 14.3 feet below the crown. Concrete "U" headwalls on both the landside (LS) and the waterside (WS). Flap gate on the WS. Inlet downhill from a concrete lined channel at the low point on the LS toe. [Additional Reference(s): DWR Levee Log, 1990 (HLM 14.69). USACE Sacramento O&M Manual, Unit 516 - Upper Butte Creek - Part No. 2, April 1960, (Station 36+85)].

Inlet at LS toe.

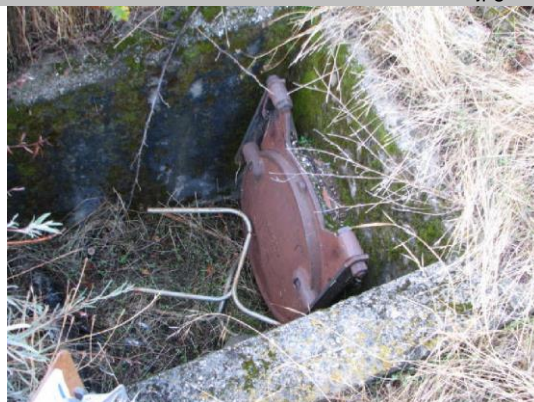
Photo 2 of 2 : UCIP_SP_2020_52087_68540.jpg

Outlet at WS toe with flap gate and concrete U-shaped headwall.

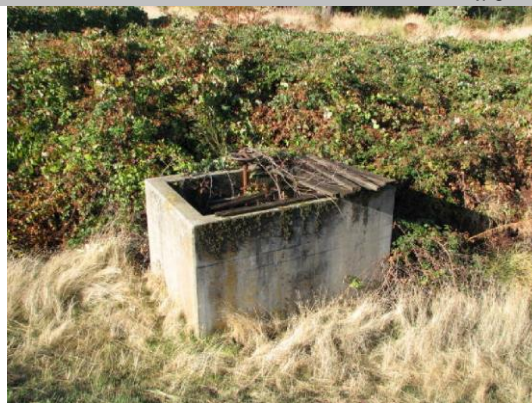
Photo 1 of 2 : UCIP_SP_2020_52090_68570.jpg

Comment Code						
Inspector Comment						
DS_ID:1685 FS_ID:52090 EP_NO: N/A Repair Type: Non-Urgent Crossing Status: Found UCIP Comments: 5/18/2017 Crossing appears to be in good condition. WS riser needs a cover. (DWR Sutter Yard-AFreitag)11/14/2016 Good condition- needs a cover for the riser. (DWR Sutter Yard- AFreitag)5/11/2016 Needs a cover for riser. The rest of the crossing appears to be in good condition.8/3/2015 Crossing appears in good condition but needs a cover made for the riser.11/25/2014 Same as last inspection.6/4/2014 Same as last inspection.11/13/2013 Same as last inspection.6/6/2013 Same as last inspection. FIELD_STRUCT_DESC: 42-inch steel irrigation pipe (siphon) through the levee, 10 feet below the crown. Slide gate in a 54-inch corrugated metal riser on the waterside (WS) slope. 5-foot by 8-foot concrete distribution box on the landside (LS). Two corrugated metal cutoff walls installed within the levee. [Additional Reference(s): DWR Levee Log, 1990 (HLM 15.22). USACE Sacramento O&M Manual, Unit 516 - Upper Butte Creek - Part No. 2, April 1960, (Station 8+30)]. FS Date: 6/1/2017 2:21:26 PM

Concrete distribution box with slide gate on LS toe.

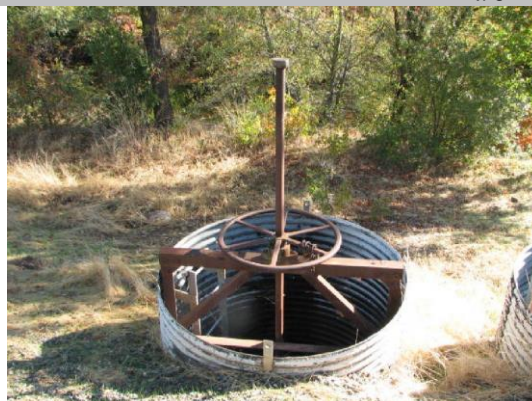
Photo 3 of 3 : UCIP_SP_2020_52093_68577.jpg

66-inch CMP riser on WS shoulder.

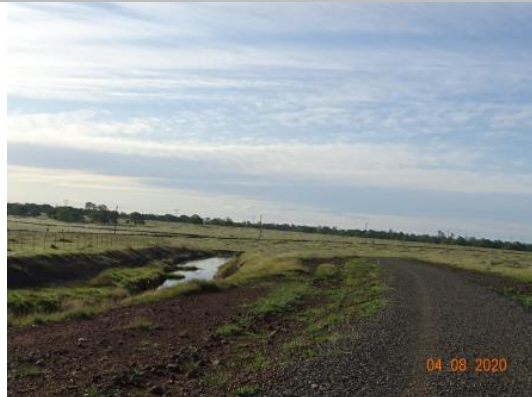
Photo 1 of 1 : SP_2020_MA0005_198_1_20200415_00001.jpg

LM Start	0.57	Rating **	A	Issue No.	1
LM End	0.57	Issue Type +	Ma	Location *	WS
Category	Earthen Levee			GPS Latitude/Longitude	
				Start	End
Item	Vegetation			39.724483 °	39.724483 °
				-121.781266 °	-121.781266 °
DWR ID	DWR_MA0005_03_s_2020_1				
Comment Code					
V1 : Control annual grass and weeds on the levee slopes and easements.					
Inspector Comment					
Good vegetation control along the waterside and landside slopes.

View of the vegetation along the waterside slope. Spring 2020.
