Flood Control Project Maintenance Levee Inspections LMA District Cover Sheet

Sutter Maintenance Yard Maintenance Area 0005

Waterway			Bank	Unit Miles
Unit No. 01 Butte Creek			Left	15.08
	Spring (March - May)	Summer (June - August)	(September - November) Fall	Winter (December - February)
Unit Maintenance Rating (Fall Only)				
Date of Inspection	3/24/2021 - 3/24/2021			
DWR Inspector	Makar Sokol			
Accompanied By	Bob Duffey Sutter Maintenance Yard

Levee Inspection Report By Mile - Spring 2021

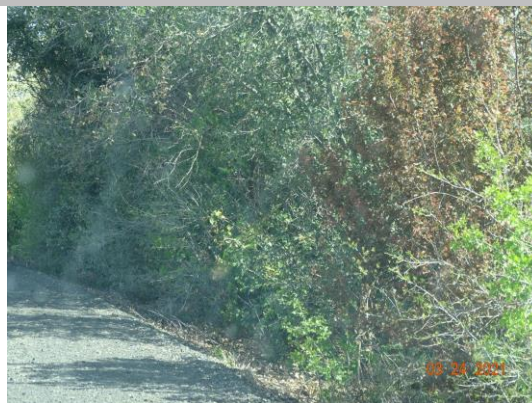
Photo 1 of 1 : SP_2021_MA0005_196_32_20210407_00079.jpg

LM Start	0.58	Rating **	M	Issue No.	32
LM End	0.68	Issue Type +	Ma	Location *	LS
Category	Earthen Levee			GPS Latitude/Longitude	
				Start	End
Item	Trim / Thin Trees			39.690496 °	39.689137 °
				-121.777109 °	-121.776938 °
DWR ID	DWR_MA0005_01_s_2014_32				
Comment Code					
T2 : Thin trees to allow visibility of the ground and room to flood fight.					
Inspector Comment					
Trees smaller than 4-inches in diameter at chest height shall be removed from the landside slope and within ten feet of the landside toe.

View of the trees along the landside toe blocking visibility. Spring 2021.

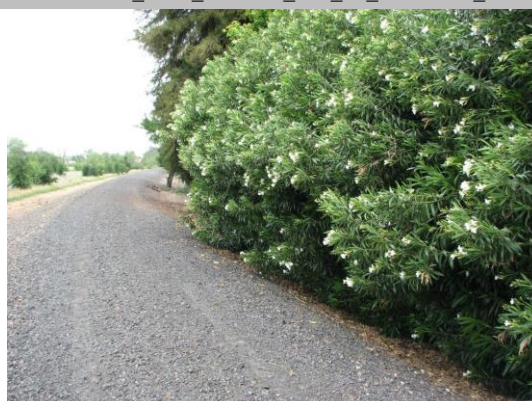
Photo 1 of 1 : SP_2021_MA0005_196_44_20210224_00015.jpg

LM Start	0.68	Rating **	M	Issue No.	44
LM End	0.77	Issue Type +	En	Location *	LS
Category	Earthen Levee			GPS Latitude/Longitude	
				Start	End
Item	Vegetation			39.689135 °	39.687968 °
				-121.776929 °	-121.777387 °
DWR ID	DWR_MA0005_01_s_2016_44				
Comment Code					
V6 : Landscaping					
Inspector Comment

View of oleanders along the landside toe.

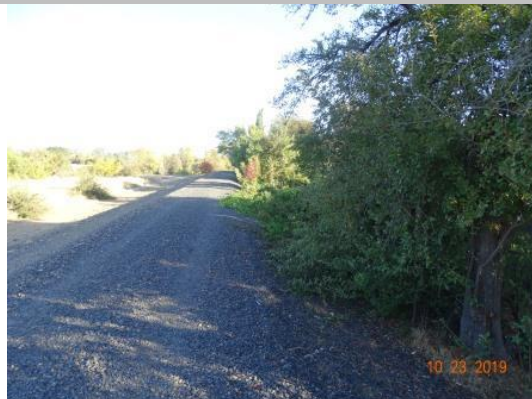
Photo 1 of 1 : SP_2021_MA0005_196_47_20210224_00017.jpg

LM Start	0.79	Rating **	M	Issue No.	47
LM End	0.82	Issue Type +	En	Location *	LS
Category	Earthen Levee			GPS Latitude/Longitude	
				Start	End
Item	Vegetation			39.687676 °	39.687193 °
				-121.777419 °	-121.777461 °
DWR ID	DWR_MA0005_01_f_2019_47				
Comment Code					
V6 : Landscaping					
Inspector Comment

View of trees that require trimming along the landside slope. Fall 2019.

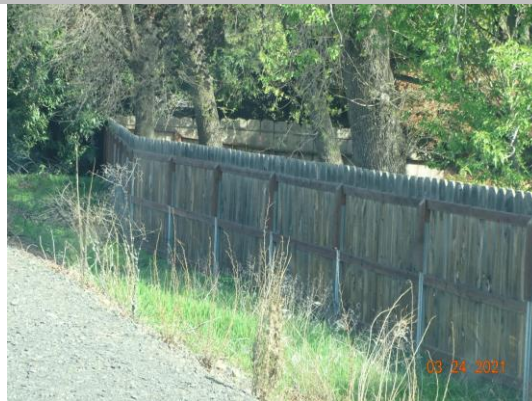
Photo 1 of 1 : SP_2021_MA0005_196_49_20210407_00080.jpg

LM Start	0.90	Rating **	U	Issue No.	49
LM End	0.92	Issue Type +	En	Location *	LS
Category	Earthen Levee			GPS Latitude/Longitude	
				Start	End
Item	Encroachments			39.686087 °	39.685756 °
				-121.777555 °	-121.777540 °
DWR ID	DWR_MA0005_01_f _ 2016_49				
Comment Code					
FE : Fence					
Inspector Comment

View of the wood plank fence at the landside toe. Spring 2021.

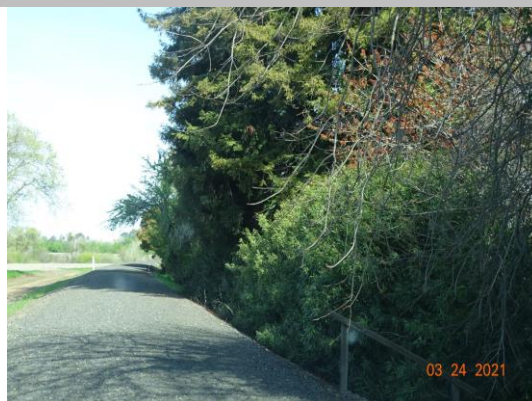
Photo 1 of 1 : SP_2021_MA0005_196_50_20210407_00081.jpg

LM Start	0.98	Rating **	U	Issue No.	50
LM End	1.00	Issue Type +	En	Location *	LS
Category	Earthen Levee			GPS Latitude/Longitude	
				Start	End
Item	Vegetation			39.684843 °	39.684606 °
				-121.777132 °	-121.776975 °
DWR ID	DWR_MA0005_01_f _ 2016_50				
Comment Code					
V6 : Landscaping					
Inspector Comment					
Oleanders are blocking visibility.

View of the landscaping along the landside toe. Spring 2021.

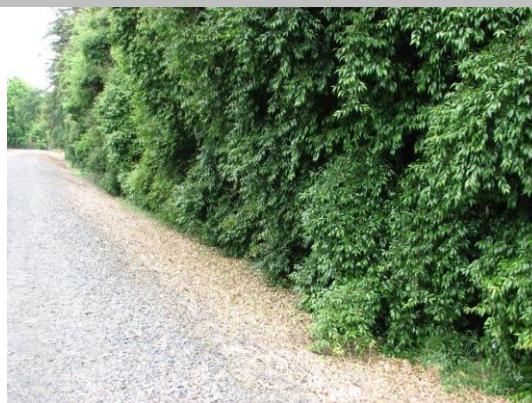
Photo 1 of 1 : SP_2021_MA0005_196_43_20210224_00014.jpg

LM Start	1.16	Rating **	M	Issue No.	43
LM End	1.24	Issue Type +	En	Location *	LS
Category	Earthen Levee			GPS Latitude/Longitude	
				Start	End
Item	Vegetation			39.682402 °	39.681322 °
				-121.776405 °	-121.776506 °
DWR ID	DWR_MA0005_01_s_2016_43				
Comment Code					
V6 : Landscaping					
Inspector Comment

View of the overgrown vegetation at the landside toe.

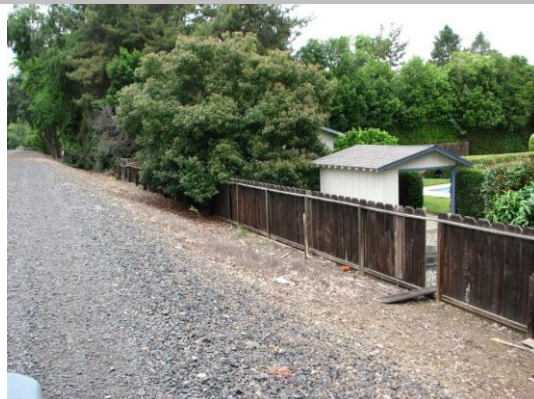
Photo 1 of 1 : SP_2021_MA0005_196_42_20210224_00013.jpg

LM Start	1.24	Rating **	U	Issue No.	42
LM End	1.26	Issue Type +	En	Location *	LS
Category	Earthen Levee			GPS Latitude/Longitude	
				Start	End
Item	Encroachments			39.681305 °	39.681044 °
				-121.776533 °	-121.776547 °
DWR ID	DWR_MA0005_01_s _ 2016_42				
Comment Code					
FE : Fence					
Inspector Comment

View of the wood plank fence at the landside toe.

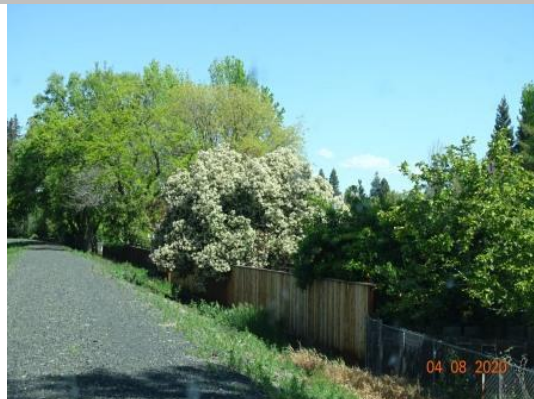
Photo 1 of 1 : SP_2021_MA0005_196_41_20210224_00012.jpg

LM Start	1.30	Rating **	U	Issue No.	41
LM End	1.36	Issue Type +	En	Location *	LS
Category	Earthen Levee			GPS Latitude/Longitude	
				Start	End
Item	Encroachments			39.680452 °	39.679551 °
				-121.776667 °	-121.776904 °
DWR ID	DWR_MA0005_01_s _ 2016_41				
Comment Code					
FE : Fence					
Inspector Comment					
Wood plank fencing across multiple properties.

View of the fence along the landside toe. Spring 2020.

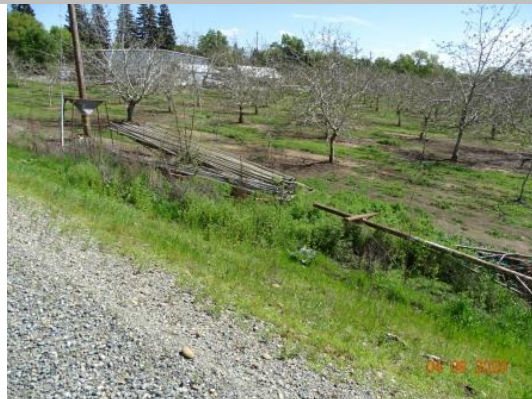
Photo 1 of 1 : SP_2021_MA0005_196_30_20210224_00008.jpg

LM Start	1.53	Rating **	M	Issue No.	30
LM End	1.53	Issue Type +	En	Location *	LS
Category	Earthen Levee			GPS Latitude/Longitude	
				Start	End
Item	Encroachments			39.677130 °	39.677130 °
				-121.777583 °	-121.777583 °
DWR ID	DWR_MA0005_01_f_2014_30				
Comment Code					
EQ : Equipment					
Inspector Comment

View of the sprinkler pipe and equipment along the landside toe. Spring 2020.

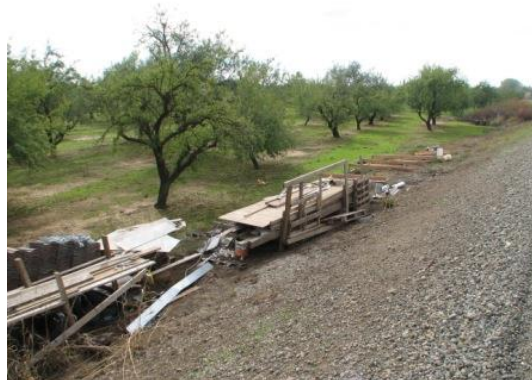
Photo 1 of 1 : SP_2021_MA0005_196_1_20210224_00001.jpg

View of the construction supply on pallets.

LM Start	1.66	Rating **	M	Issue No.	1
LM End	1.66	Issue Type +	En	Location *	LS
Category	Earthen Levee			GPS Latitude/Longitude	
				Start	End
Item	Encroachments			39.675528 °	39.675528 °
				-121.778642 °	-121.778642 °
DWR ID	DWR_MA0005_01_s_2012_1				
Comment Code					
MA : Material					
Inspector Comment					
The materials and equipment should be moved ten feet away from the landside toe.

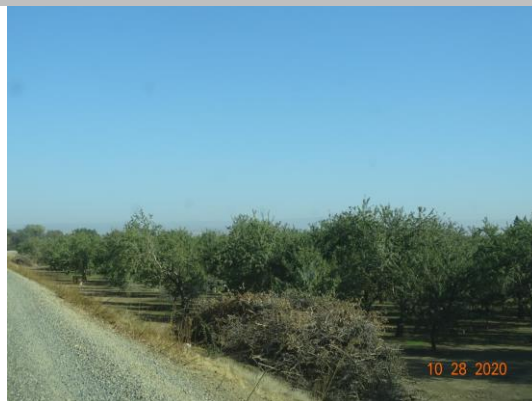
Photo 1 of 1 : SP_2021_MA0005_196_38_20210224_00011.jpg

View of the prunings along the landside toe. Fall 2020.

LM Start	3.21	Rating **	M	Issue No.	38
LM End	3.21	Issue Type +	En	Location *	LS
Category	Earthen Levee			GPS Latitude/Longitude	
				Start	End
Item	Encroachments			39.654938 °	39.654938 °
				-121.787892 °	-121.787892 °
DWR ID	DWR_MA0005_01_f_2015_38				
Comment Code					
PR : Prunings					
Inspector Comment					
Remove the prunings from the landside toe.

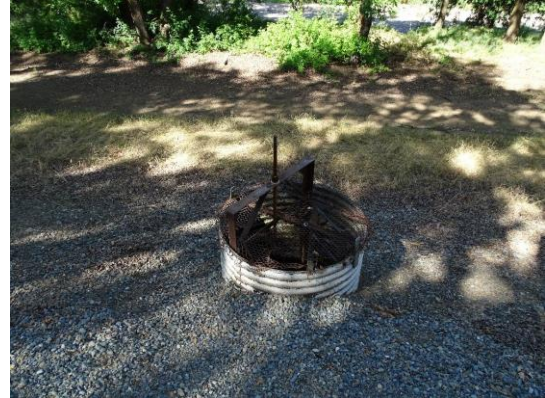
Photo 2 of 3 : UCIP_SP_2021_59679_79687.jpg

FS_ID:59679
DS_ID:1615
EP_NO: N/A
Repair Type: Non-Urgent
Crossing Status: Found
UCIP Comments: 07/30/2020 UCIP staff received CVFPB Enforcement Case No. 9708 Compliance Letter confirming repair of screw gate by Durham Mutual Water Company. CVFPB Enforcement Case No. 2019-9708 has been closed. Owner is seeking permit for 30-inch pipe. UCIP record will be update the UCIP record when the permit is issued by the CVFPB. (O. Magana - DWR UCIP)06/05/2019 Durham Mutual Water Company fixed broken slide gate by replacing a stem. Operating wheel is missing. Crossing downgraded to non-urgent. (O. Yakimov - DWR UCIP)10/5/2018 Observed pipe running during inspection. Pipe is used to drain water from LS concrete box to WS. Field structure description was updated to show structure type as drainage pipe. Confirmed that the concrete box on LS receives water from a pipe running along the LS toe from orchards upstream and distributes water between 3 pipes, one of which crosses levee at an angle. Missing closure device on WS. Screw gate stuck in open position inside CMP riser located on WS shoulder and is not operable. (O. Yakimov - DWR)5/15/2017 WS slide gate stem bent and gate is stuck in the open position. Outlet in the the concrete box on the WS berm is opened and allowed water to free flow through the pipe during the Jan/Feb 2017 high water events. Either the screw gate needs to be repaired or a flap gate added to the outlet in the concrete box to not allow high water flows though the levee. Pipe is believed to be owned and operated by Duhram Mutual Water Company at 1807 Duhram Dayton HWY, PO Box 612, Duhram CA 95938 (530)342-9324. (A. Freitag - DWR Sutter Yard) 11/15/2016 Abandoned- slide gate is opened and inoperable. Needs to be properly abandoned. (A. Freitag - DWR Sutter Yard)05/09/2016 Abandoned crossing. Slide gate stem bent and wheel is missing. (A. Freitag - DWR Sutter Yard)08/05/2015 Abandoned crossing. Slide gate stem is bent and gate is inoperable. Needs to be properly abandoned. (A. Freitag - DWR Sutter Yard)12/08/2014 Same as last inspection. (A. Freitag - DWR Sutter Yard)06/11/2014 Same as last inspection. (A. Freitag - DWR Sutter Yard)11/20/2013 Same as last inspection. (A. Freitag - DWR Sutter Yard)05/29/2013 Same as last inspection. (A. Freitag - DWR Sutter Yard)10/30/2012 Pipe appears to be abandoned. Slide gate open and inoperable. Pipe should be properly abandoned. (W. Wylie - DWR UCIP)

CMP riser with slide gate on WS shoulder

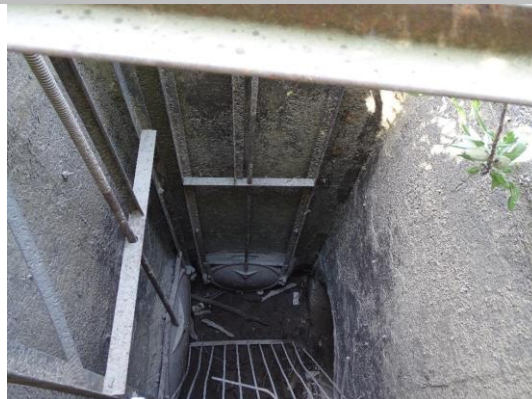
Photo 2 of 3 : UCIP_SP_2021_58165_79696.jpg

FS_ID:58165
DS_ID:1616
EP_NO: N/A
Repair Type: Non-Urgent
Crossing Status: Found
UCIP Comments: 06/05/2019 No issues recorded during inspection. (O.Yakimov - DWR UCIP)
05/15/2017 Crossing appears to be in good condition. LS inlet is located in the Distribution box on the LS toe. This is an overflow pipe used to regulate water levels in side the box. Pipe has been selected to be internally cleaned and inspected as part fo the DMP project. (A. Freitag - DWR Sutter Yard)11/15/2016 Crossing appears to be in good condition. (A. Freitag - DWR Sutter Yard)05/09/2016 Crossing appears to be in good condition. (A. Freitag - DWR Sutter Yard)08/05/2015 WS pipe end is being overgrown by trees and other vegetation. Needs to be cleared back. (A. Freitag - DWR Sutter Yard)12/08/2014 Same as last inspection. (A. Freitag - DWR Sutter Yard)06/11/2014 Same as last inspection. (A. Freitag - DWR Sutter Yard)11/20/2013 Same as last inspection. (A. Freitag - DWR Sutter Yard)05/29/2013 Same as last inspection. (A. Freitag - DWR Sutter Yard)

View inside of concrete distribution box on LS

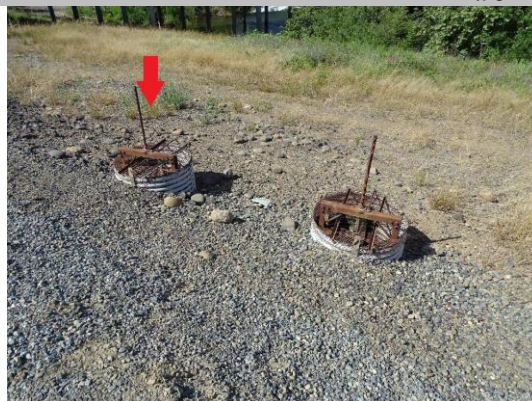
Photo 1 of 3 : UCIP_SP_2021_58166_79701.jpg

FS_ID:58166
DS_ID:1617
EP_NO: N/A
Repair Type: Non-Urgent
Crossing Status: Found
UCIP Comments: 06/05/2019 No issues recorded during inspection. (O.Yakimov - DWR UCIP)05/15/2017 Crossing appears to be in good condition. (A. Freitag - DWR Sutter Yard)11/15/2016 Crossing appears to be in good condition. (A. Freitag - DWR Sutter Yard)05/09/2016 Crossing appears to be in good condition. (A. Freitag - DWR Sutter Yard)08/05/2015 Crossing appears in good condition. No noticeable issues to report. (A. Freitag - DWR Sutter Yard)12/08/2014 Same as last inspection. (A. Freitag - DWR Sutter Yard)06/11/2014 Same as last inspection. (A. Freitag - DWR Sutter Yard)11/20/2013 Same as last inspection. (A. Freitag - DWR Sutter Yard)05/29/2013 Same as last inspection. (A. Freitag - DWR Sutter Yard)
FIELD_STRUCT_DESC: 24-inch corrugated metal irrigation siphon pipe through the levee, 16.5 feet below the crown. Slide gate in corrugated metal riser on the waterside (WS) slope. Pipe appears to be currently used for irrigation purposes. 4-foot by 8-foot concrete distribution box on the landside (LS), 40 feet from the LS toe.

CMP riser and slide gate on WS shoulder

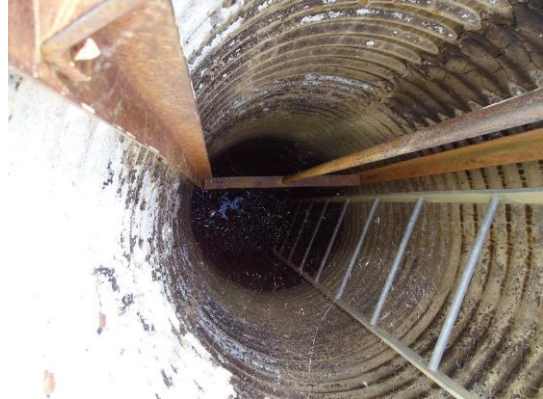
Photo 2 of 3 : UCIP_SP_2021_58166_79703.jpg

Inside view of CMP riser on WS shoulder

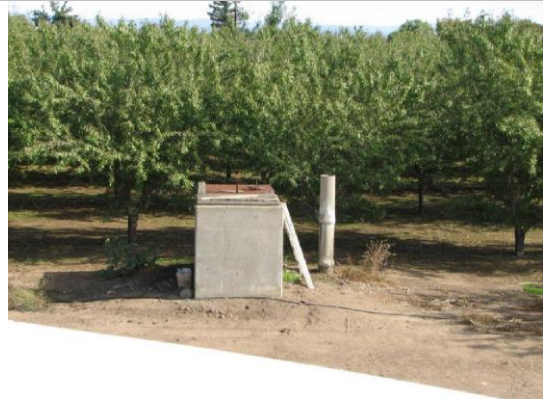
Photo 3 of 3 : UCIP_SP_2021_58166_67932.jpg

Concrete distribution box on LS, 40-feet from LS toe

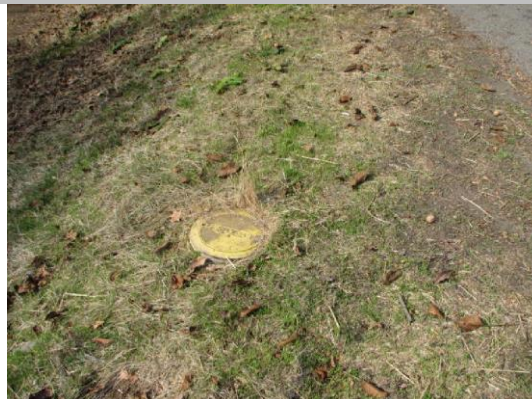
Photo 1 of 2 : UCIP_SP_2021_58206_67936.jpg

FS_ID:58206
DS_ID:1619
EP_NO: 6544-A
Repair Type: Non-Urgent
Crossing Status: Indicator Found
UCIP Comments: 05/15/2017 Crossing appears to be in good condition. (A. Freitag - DWR Sutter Yard)11/15/2016 Crossing appears to be in good condition. (A. Freitag - DWR Sutter Yard)05/09/2016 Crossing appears to be in good condition. (A. Freitag - DWR Sutter Yard)08/05/2015 Pipe is suspected to cross inside of bridge. (A. Freitag - DWR Sutter Yard)12/08/2014 Same as last inspection. (A. Freitag - DWR Sutter Yard)06/11/2014 Same as last inspection. (A. Freitag - DWR Sutter Yard)11/20/2013 Same as last inspection. (A. Freitag - DWR Sutter Yard)05/29/2013 Same as last inspection. (A. Freitag - DWR Sutter Yard)10/30/2012 Pipeline should be marked where pipe crosses levee as it is 4-feet below the surface. (W. Wylie - DWR UCIP)
FIELD_STRUCT_DESC: 6-inch concrete encased steel high pressure gas pipeline through the levee, 4 feet below the crown. 8-inch diameter Pacific Gas & Electric Company (PG&E) gas access manhole located on the south side of the road, 250 feet east of the levee crown. (6-inch gas line authorized under Permit No. 6544-A, 1969 - Pacific Gas and Electric [PG&E]) [Additional Reference(s): DWR Levee Log, 1990].

PG&E access lid on south edge of roadway.

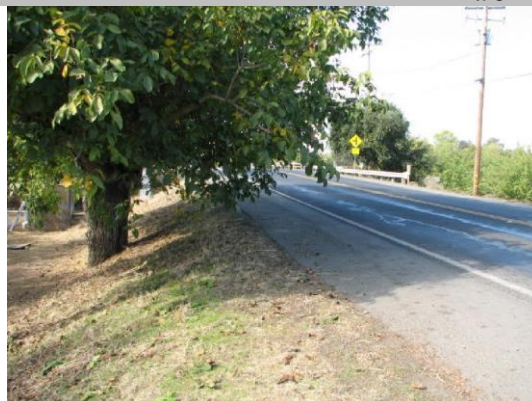
Photo 2 of 2 : UCIP_SP_2021_58206_67935.jpg

Location of PG&E access lid 250-feet east of levee crown on south side of roadway.

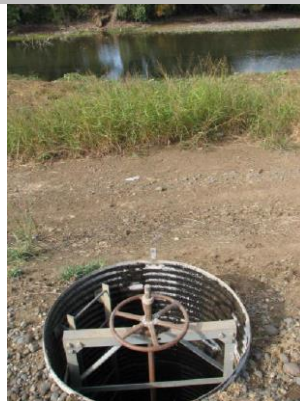
Photo 2 of 2 : UCIP_SP_2021_58207_67940.jpg

FS_ID:58207
DS_ID:1620
EP_NO: N/A
Repair Type: Non-Urgent
Crossing Status: Found
UCIP Comments: 05/23/2019 (O. Magana - DWR UCIP)05/15/2017 Abandoned and needs to be done properly. A sink hole formed in the WS toe road and revealed the location of the WS pipe end. Sink hole will need to be repaired before the next high water season but the pipe has been selected to be internally cleaned and camera inspected as part of the DMP project so it will have needed to be excavated along the WS end anyways. (A. Freitag - DWR Sutter Yard)11/15/2016 Abandoned. Needs cover for the standpipe. (A. Freitag - DWR Sutter Yard)05/09/2016 Abandoned pipe. Needs a cover for the standpipe. (A. Freitag - DWR Sutter Yard)08/05/2015 Abandoned crossing. Covers need to be made for tops of standpipes to prevent falls. (A. Freitag - DWR Sutter Yard)12/08/2014 Same as last inspection. (A. Freitag - DWR Sutter Yard)06/11/2014 Same as last inspection. (A. Freitag - DWR Sutter Yard)11/19/2013 Same as last inspection. (A. Freitag - DWR Sutter Yard)05/29/2013 Same as last inspection. Land owner said pipes are abandoned and no longer used. Covers should be made for top of standpipe to prevent falls. Pipes should be properly abandoned. (A. Freitag - DWR Sutter Yard)10/30/2012 Pipe 1/2 filled with soil at slide gate end. (W. Wylie - DWR UCIP) FIELD_STRUCT_DESC: *ABANDONED* 1 of 2: 36-inch drainage pipe through the levee, 11 feet below the crown. Slide gate in a 54-inch corrugated metal riser on the waterside (WS) slope. Concrete "U" headwall on the landside (LS). [Additional Reference(s): DWR Levee Log, 1990 (HLM 5.66). Sacramento O&M Manual, Unit 516 - Upper Butte Creek - Part No. 2, April 1960 (Station 470+00)].

54-inch CMP riser and slide gate on WS shoulder.

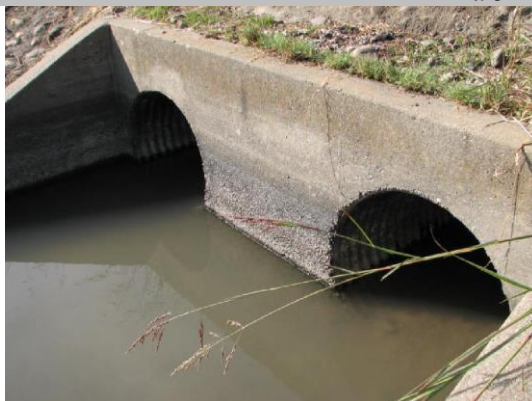
Photo 2 of 3 : UCIP_SP_2021_58212_67938.jpg

FS_ID:58212
DS_ID:1768
EP_NO: N/A
Repair Type: Non-Urgent
Crossing Status: Found
UCIP Comments: 05/23/2019 (O. Magana - DWR UCIP)05/15/2017 Abandoned and needs to be done properly. A sink hole formed in the WS toe road and revealed the location of the WS pipe end. Sink hole will need to be repaired before the next high water season but the pipe has been selected to be internally cleaned and camera inspected as part of the DMP project so it will have needed to be excavated along the WS end anyways. (A. Freitag - DWR Sutter Yard)11/15/2016 Abandoned. Needs standpipe cover. (A. Freitag - DWR Sutter Yard)05/09/2016 Abandoned pipe. Needs a cover for standpipe. (A. Freitag - DWR Sutter Yard)08/05/2015 Abandoned pipes. Need covers made for tops of standpipes to prevent falls. (A. Freitag - DWR Sutter Yard) 12/08/2014 Same as last inspection. (A. Freitag - DWR Sutter Yard)06/11/2014 Same as last inspection. (A. Freitag - DWR Sutter Yard)11/19/2013 Same as last inspection. (A. Freitag - DWR Sutter Yard)05/29/2013 Same as last inspection. Land owner said pipes are abandoned and no longer used. Covers should be made for top of standpipe to prevent falls. Pipes should be properly abandoned. (A. Freitag - DWR Sutter Yard)10/30/2012 Pipe 1/2 filled with soil at slide gate on WS. (W. Wylie - DWR UCIP)

Headwall at LS toe.

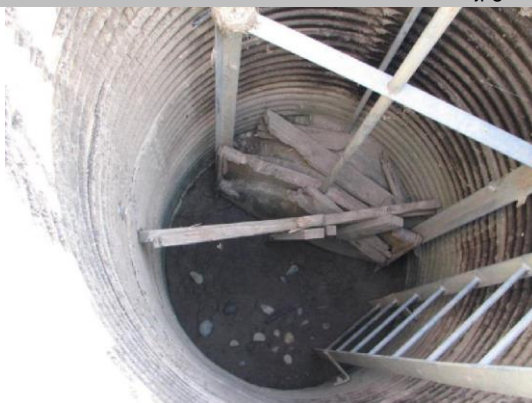
Photo 3 of 3 : UCIP_SP_2021_58212_67937.jpg

Slide gate at bottom of cmp riser.

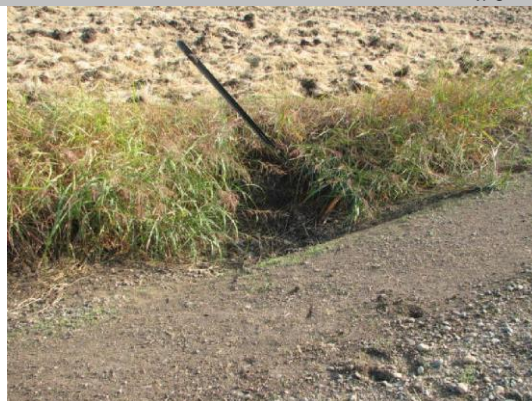
Photo 1 of 2 : UCIP_SP_2021_58208_67970.jpg

Headwall at LS toe.

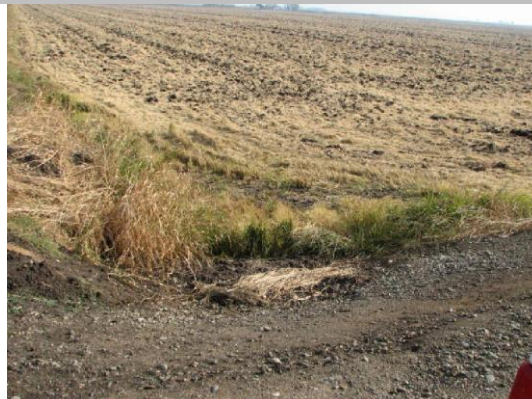
Photo 2 of 3 : UCIP_SP_2021_58209_67972.jpg

Buried inlet at LS toe.

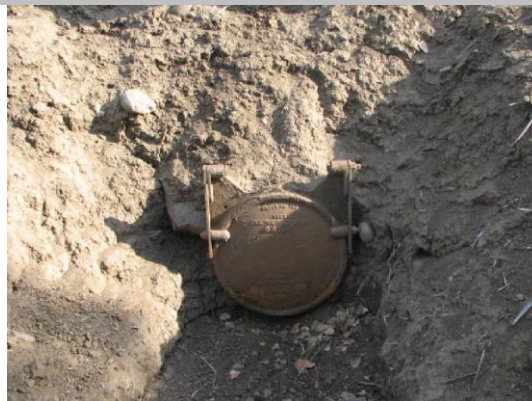
Photo 3 of 3 : UCIP_SP_2021_58209_67971.jpg

Flap gate at WS toe.

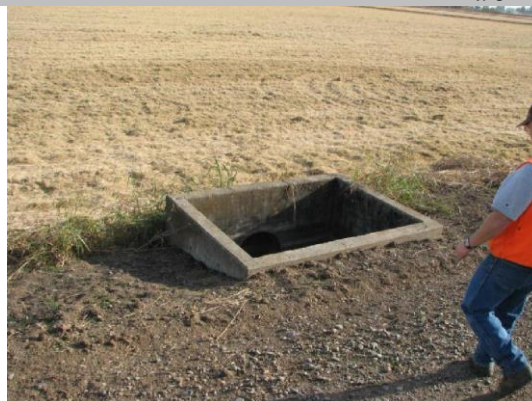
Photo 1 of 3 : UCIP_SP_2021_58210_67976.jpg

Concrete distribution box at LS toe.

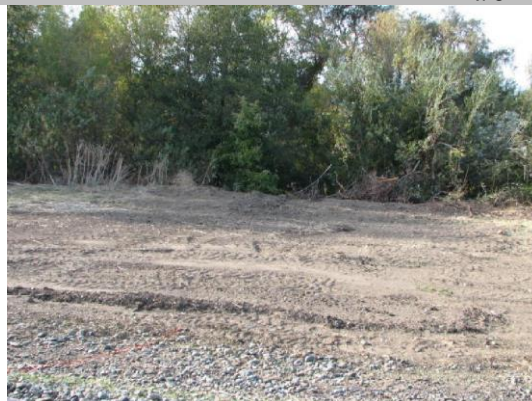
Photo 2 of 3 : UCIP_SP_2021_58210_67975.jpg

WS shoulder.

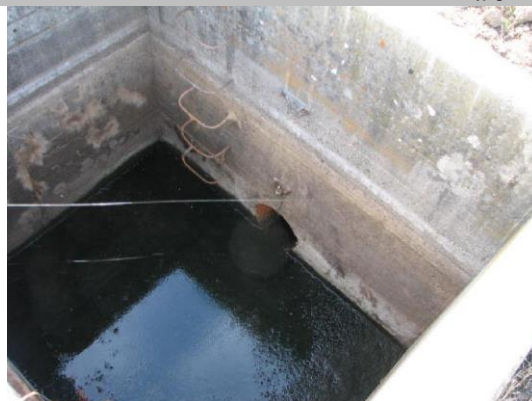
Photo 3 of 3 : UCIP_SP_2021_58210_67974.jpg

Pipe at bottom of concrete distribution box.

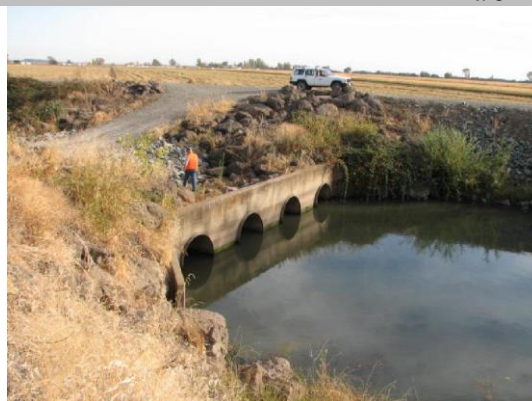
Photo 1 of 2 : UCIP_SP_2021_58213_67979.jpg

FS_ID:58213
DS_ID:1775
EP_NO: N/A
Repair Type: No Action Needed
Crossing Status: Found
UCIP Comments: 05/16/2017 Crossing appears to be in good condition. (A. Freitag - DWR Sutter Yard)11/15/2016 Crossing appears to be in good condition. (A. Freitag - DWR Sutter Yard)05/11/2016 Crossing appears to be in good condition. (A. Freitag - DWR Sutter Yard)08/04/2015 Crossing is in good condition. No noticeable issues to report. (A. Freitag - DWR Sutter Yard)12/08/2014 Same as last inspection. (A. Freitag - DWR Sutter Yard)06/11/2014 Same as last inspection. (A. Freitag - DWR Sutter Yard)11/19/2013 Same as last inspection. (A. Freitag - DWR Sutter Yard)05/29/2013 Flap gates were removed by DWR Sutter Maintenance Yard to allow water to flow freely through crossing and not back up in ditch. (A. Freitag - DWR Sutter Yard)10/30/2012 Seems there should be flap gates on this structure. (W. Wylie - DWR UCIP) FIELD_STRUCT_DESC: [Robert's Creek Outlet Structure] 1 of 4: 66-inch corrugated metal drainage pipe through the levee, 17.9 feet below the crown. Concrete headwalls on the landside (LS) and the waterside (WS). Flap gate located on the WS. [Additional Reference(s): DWR Levee Log, 1990 (HLM 9.66). USACE Sacramento O&M Manual, Unit 515 - Upper Butte Creek - Part No. 1, April 1955, (Station 678+00). USACE As-Built Drawing No. 50-4-2637, Exhibit B, Sheet 3, April 1950]. FS Date: 5/31/2017 2:10:00 PM

WS of pipe crossing

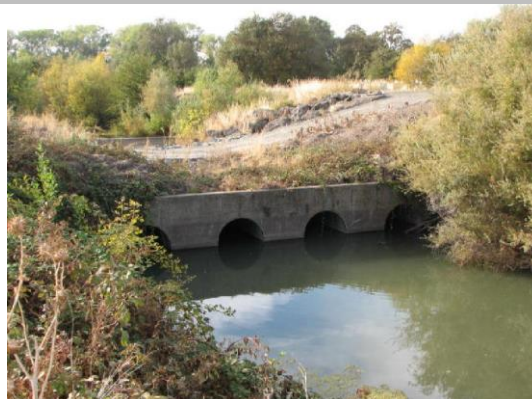
Photo 2 of 2 : UCIP_SP_2021_58213_67978.jpg

LS of pipe crossing.

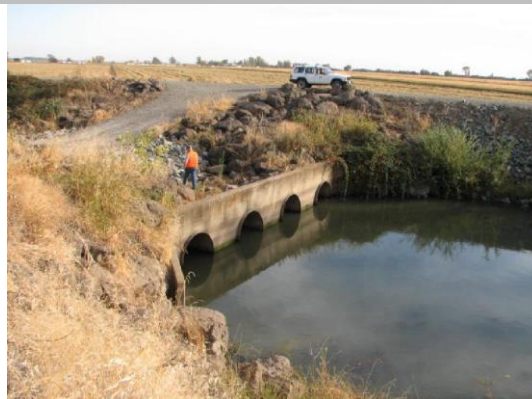
Photo 1 of 2 : UCIP_SP_2021_51977_67981.jpg

WS of crossing.

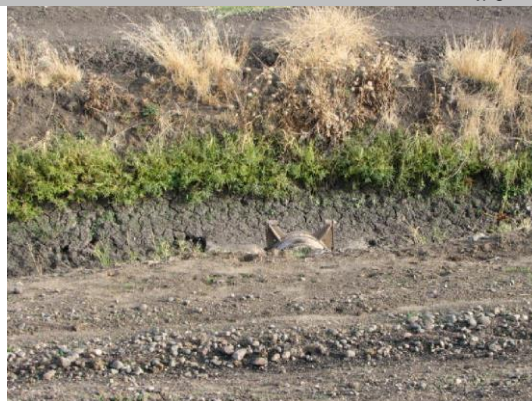
Photo 1 of 1 : UCIP_SP_2021_51980_67986.jpg

Comment Code						
Inspector Comment						
FS_ID:51980 DS_ID:1633 EP_NO: N/A Repair Type: Non-Urgent Crossing Status: Found UCIP Comments: 5/16/2017 Abandoned crossing and needs to be done so properly. Pipe has been selected to be internally cleaned and inspected as part of the DMP project. (DWR Sutter Yard-AFreitag)11/15/2016 Abandoned. (DWR Sutter Yard-AFreitag)5/11/2016 Abandoned crossing.8/4/2015 Abandoned pipe. Casey Wilder has started the steps to have the pipe properly abandoned and removed from the levee.12/8/2014 Same as last inspection.6/11/2014 Same as last inspection.11/19/2013 Same as last inspection.5/29/2013 Same as last inspection.10/30/2012 Pipe and headwall buried on WS, no access to slide gate. FIELD_STRUCT_DESC: 24-inch corrugated metal irrigation pipe through the levee, 12.5 feet below the crown. Slide gate on the waterside (WS). Flap gate and headwall on the landside (LS). Concrete headwall at the WS toe. [Additional Reference(s): DWR Levee Log, 1990 (HLM 10.19). USACE Sacramento O&M Manual, Unit 515 - Upper Butte Creek - Part No. 1, April 1955, (Station 706+00). USACE As-Built Drawing No. 50-4-2637, Exhibit B, Sheet 3, April 1950]. FS Date: 5/31/2017 2:15:33 PM

Flap gate and headwall at LS toe in irrigation or drainage ditch.

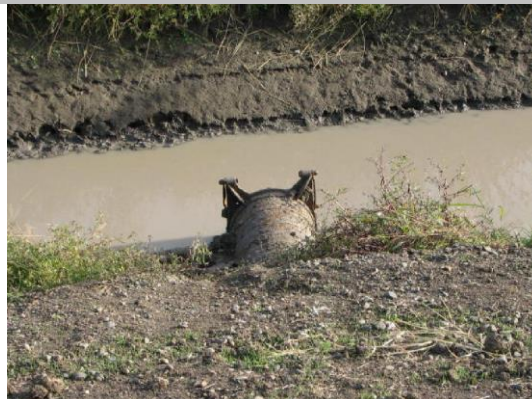
Photo 1 of 3 : UCIP_SP_2021_51981_67989.jpg

Comment Code					
Inspector Comment					
FS_ID:51981 DS_ID:1634 EP_NO: N/A Repair Type: Non-Urgent Crossing Status: Found UCIP Comments: 5/16/2017 Abandoned- needs to be done so properly. Pipe has been selected to be internally cleaned and inspected as part of the DMP project. (DWR Sutter Yard- AFreitag)11/15/2016 Abandoned. (DWR Sutter Yard- AFreitag)5/11/2016 Abandoned crossing.8/4/2015 Abandoned pipe. Casey Wilder has started the steps to have the pipe properly abandoned and removed from the levee.12/8/2014 Same as last inspection.6/11/2014 Same as last inspection.11/19/2013 Same as last inspection.5/29/2013 Same as last inspection. FIELD_STRUCT_DESC: 24-inch corrugated metal irrigation pipe through the levee, 14.5 feet below the crown. Slide gate on the waterside (WS) on concrete headwall. Flap gate on the landside (LS). [Additional Reference(s): DWR Levee Log, 1990 (HLM 10.41). USACE Sacramento O&M Manual, Unit 515 - Upper Butte Creek - Part No. 1, April 1955, (Station 717+50). USACE As-Built Drawing No. 50-4-2637, Exhibit B, Sheet 3, April 1950]. FS Date: 5/31/2017 2:16:48 PM

Pipe and flap gate on LS toe.

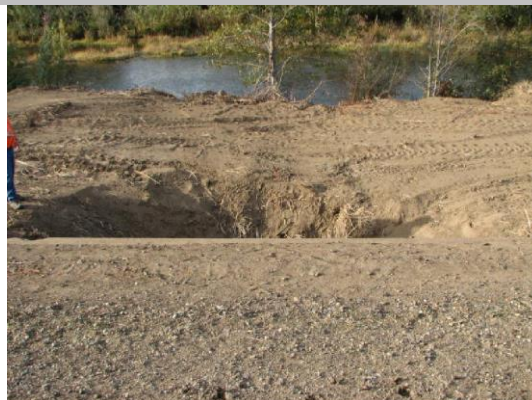
Photo 2 of 3 : UCIP_SP_2021_51981_67988.jpg

headwall at WS toe.

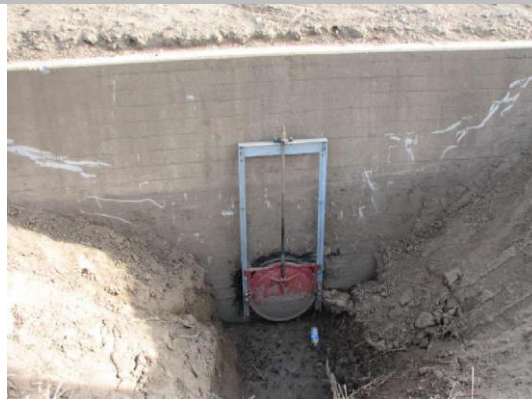
Photo 3 of 3 : UCIP_SP_2021_51981_67987.jpg

Headwall and slide gate on WS toe.

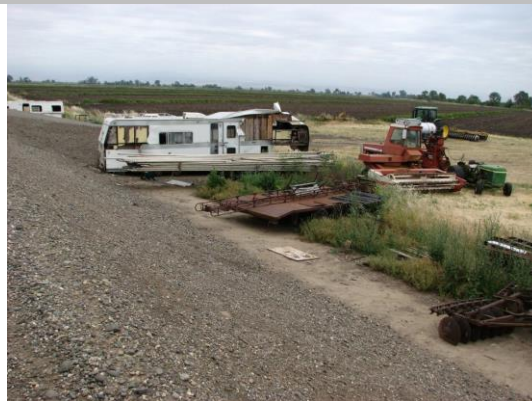
Photo 1 of 1 : SP_2021_MA0005_196_26_20210224_00006.jpg

LM Start	10.37	Rating **	M	Issue No.	26
LM End	10.37	Issue Type +	En	Location *	LS
Category	Earthen Levee			GPS Latitude/Longitude	
				Start	End
Item	Encroachments			39.567541 °	39.567541 °
				-121.819786 °	-121.819786 °
DWR ID	DWR_MA0005_01_s_2016_26				
Comment Code					
EQ : Equipment					
Inspector Comment					
Abandoned motorhomes and farm equipment should be removed from the landside toe.

5/5/2016: Remove abandoned motorhome and equipment from LS toe.

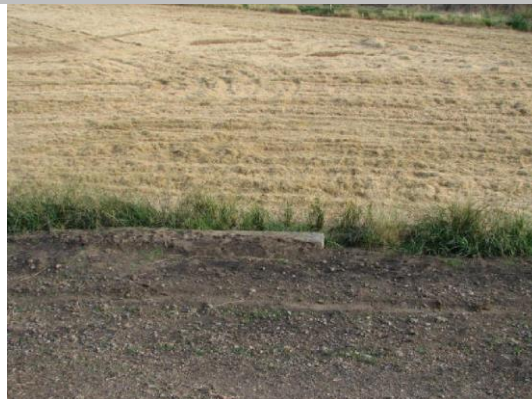
Photo 1 of 2 : UCIP_SP_2021_51982_67991.jpg

FS_ID:51982
DS_ID:1635
EP_NO: N/A
Repair Type: Non-Urgent
Crossing Status: Found
UCIP Comments: 5/16/2017 Abandoned- needs to be done so properly. (DWR Sutter Yard- A Freitag) 11/15/2016 Abandoned. (DWR Sutter Yard- A Freitag) 5/11/2016 Abandoned crossing. 8/4/2015 Abandoned pipe. Casey Wilder has started the steps to have the pipe properly abandoned and removed from the levee. 12/8/2014 Same as last inspection. 6/11/2014 Same as last inspection. 11/19/2013 Same as last inspection. 5/29/2013 Same as last inspection. 10/30/2012 Pipe buried on both sides of levee.
FIELD_STRUCT_DESC: *ABANDONED* 30-inch corrugated metal drainage pipe through the levee, 12.2 feet below the crown. Flap gate on the waterside (WS) end. [Additional Reference(s): DWR Levee Log, 1990 (HLM 10.99). USACE Sacramento O&M Manual, Unit 515 - Upper Butte Creek - Part No. 1, April 1955, (Station 748+53). USACE As-Built Drawing No. 50-4-2637, Exhibit B, Sheet 4, April 1950].

Concrete headwall at LS toe.

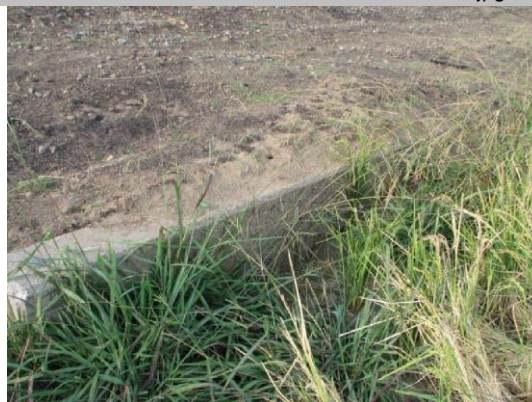
Photo 2 of 2 : UCIP_SP_2021_51982_67990.jpg

Concrete headwall at LS toe.

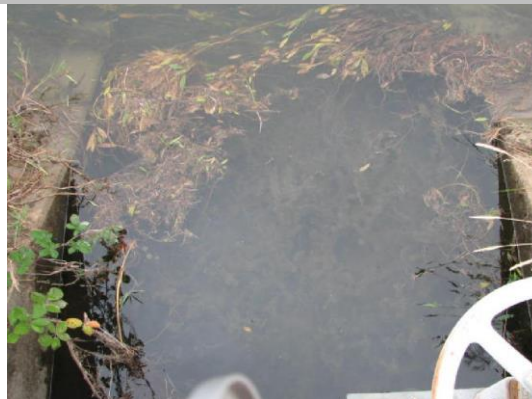
Photo 1 of 3 : UCIP_SP_2021_58217_68002.jpg

FS_ID:58217
DS_ID:1781
EP_NO: 16667
Repair Type: Non-Urgent
Crossing Status: Found
UCIP Comments: 05/16/2017 LS appears to be in good condition. WS outlet is too heavily vegetated to be inspected. Vegetation needs to be cleared back. Pipe has been selected to be internally cleaned and inspected as part of the DMP project. (A. Freitag - DWR Sutter Yard)11/15/2016 Crossing appears to be in good condition. (A. Freitag - DWR Sutter Yard)05/11/2016 Crossing appears to be in good condition. (A. Freitag - DWR Sutter Yard)08/04/2015 Crossing appears in good condition. No noticeable issues to report. (A. Freitag - DWR Sutter Yard)06/11/2014 Same as last inspection. (A. Freitag - DWR Sutter Yard)11/19/2013 Same as last inspection. (A. Freitag - DWR Sutter Yard)05/29/2013 Same as last inspection. (A. Freitag - DWR Sutter Yard)
FIELD_STRUCT_DESC: [Western Canal Siphon] 5 of 5: 18-inch reinforced concrete irrigation pipe through the levee, at an unknown depth. Pipe terminates at a concrete outlet on the waterside (WS) slope. Concrete headwalls on both the landside (LS) and the WS. Slide gate and air vent on the LS. This is a turnout that was installed for the use of the property owner. (three 10-foot pipes under the channel and levees of Butte Creek, two 18-inch pipes under the east levee and two 42-inch pipes under the west levee of Butte Creek work authorized under Permit No. 16667, 1997 - Western Canal Water District).

Concrete U shaped headwall at inlet in canal on LS.

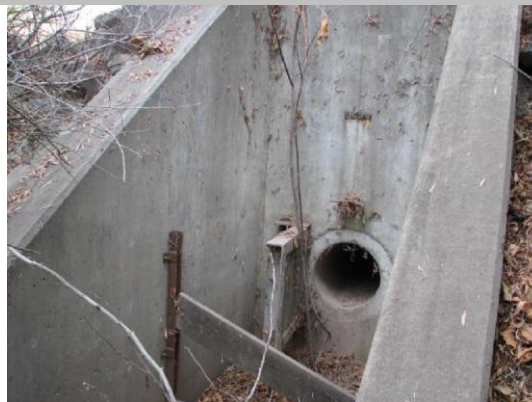
Photo 2 of 3 : UCIP_SP_2021_58217_68001.jpg

Concrete U shaped outlet on WS slope.

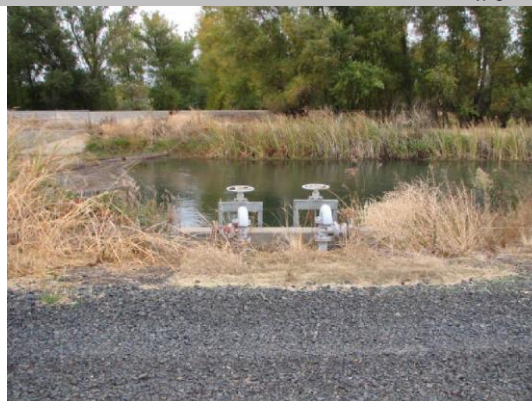
Photo 3 of 3 : UCIP_SP_2021_58217_68000.jpg

Air vents, slide gates, and concrete headwall at south side of canal on LS.

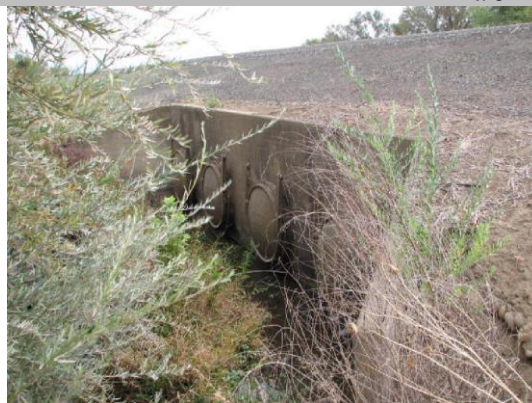
Photo 1 of 2 : UCIP_SP_2021_58218_68007.jpg

FS_ID:58218
DS_ID:1636
EP_NO: N/A
Repair Type: No Action Needed
Crossing Status: Found
UCIP Comments: 05/16/2017 Crossing appears to be in good condition. Pipe has been selected to be internally cleaned and inspected as part of the DMP project. (A. Freitag - DWR Sutter Yard)11/15/2016 Crossing appears to be in good condition. (A. Freitag - DWR Sutter Yard)05/11/2016 Crossing appears to be in good condition. (A. Freitag - DWR Sutter Yard)08/04/2015 Crossing appears in good condition. No noticeable issues to report. (A. Freitag - DWR Sutter Yard)06/11/2014 Same as last inspection. (A. Freitag - DWR Sutter Yard)11/19/2013 Same as last inspection. (A. Freitag - DWR Sutter Yard)05/29/2013 Same as last inspection. (A. Freitag - DWR Sutter Yard)
FIELD_STRUCT_DESC: 1 of 4: 54-inch corrugated metal drainage pipe through the levee, 13.5 feet below the crown. Flap gate on the waterside (WS). Concrete headwalls on the landside (LS) and the WS toes. [Additional Reference(s): DWR Levee Log, 1990 (HLM 11.52). USACE Sacramento O&M Manual, Unit 515 - Upper Butte Creek - Part No. 1, April 1955, (Station 25+18 "A"). USACE As-Built Drawing No. 50-4-2637, Exhibit B, Sheet 4, April 1950].

WS headwall and flap gates at WS toe.

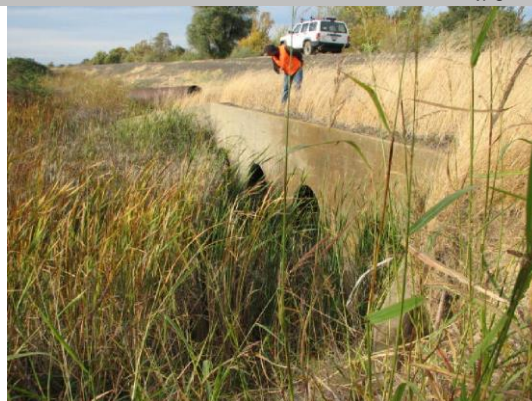
Photo 2 of 2 : UCIP_SP_2021_58218_68006.jpg

LS intake headwall.

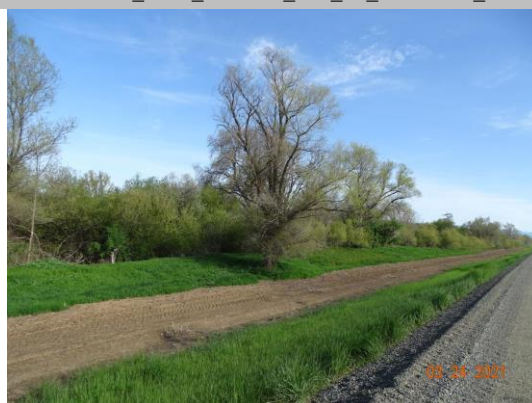
Photo 1 of 1 : SP_2021_MA0005_196_57_20210407_00082.jpg

LM Start	11.63	Rating **	M	Issue No.	57
LM End	11.66	Issue Type +	Ma	Location *	WS
Category	Earthen Levee			GPS Latitude/Longitude	
				Start	End
Item	Vegetation			39.553771 °	39.553348 °
				-121.835196 °	-121.835653 °
DWR ID	DWR_MA0005_01_s_2021_57				
Comment Code					
V1 : Control annual grass and weeds on the levee slopes and easements.					
Inspector Comment

View of the vegetation along the waterside slope. Spring 2021.

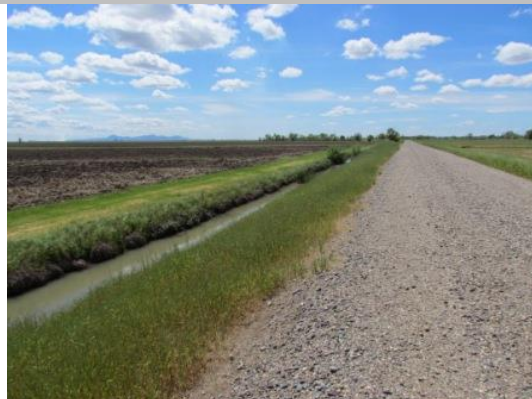
Photo 1 of 1 : SP_2021_MA0005_196_6_20210224_00003.jpg

LM Start	11.85	Rating **	M	Issue No.	6
LM End	13.64	Issue Type +	En	Location *	LS
Category	Earthen Levee			GPS Latitude/Longitude	
				Start	End
Item	Encroachments			39.551235 °	39.531462 °
				-121.837697 °	-121.856165 °
DWR ID	DWR_MA0005_01_s_2012_6				
Comment Code					
DT : Ditch					
Inspector Comment

View of the agricultural ditch along the landside toe.

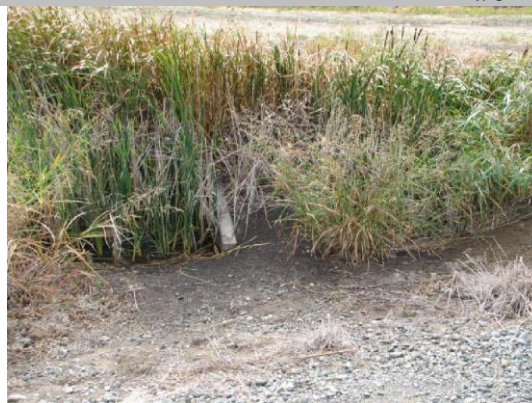
Photo 1 of 1 : UCIP_SP_2021_58224_68025.jpg

Comment Code						
Inspector Comment						
FS_ID:58224 DS_ID:1747 EP_NO: N/A Repair Type: Non-Urgent Crossing Status: Indicator Found UCIP Comments: 05/16/2017 Pipe is buried on both sides of the levee. Unable to locate. (A. Freitag - DWR Sutter Yard)11/15/2016 Buried on both sides of Levee. (A. Freitag - DWR Sutter Yard)05/11/2016 Buried pipe. (A. Freitag - DWR Sutter Yard)08/04/2015 Pipe is buried on both ends. (A. Freitag - DWR Sutter Yard)06/11/2014 Same as last inspection. (A. Freitag - DWR Sutter Yard)11/19/2013 Same as last inspection. (A. Freitag - DWR Sutter Yard)05/29/2013 Same as last inspection. (A. Freitag - DWR Sutter Yard)10/31/2012 Pipe burried on both LS and WS. (W. Wylie - DWR UCIP) FIELD_STRUCT_DESC: 48-inch corrugated metal irrigation pipe through the levee, at an unknown depth, indicator found. 48-inch corrugated metal riser and a sparling water meter/irrigation structure on the landside (LS). 4-foot by 6-foot concrete distribution box at the LS toe. [Additional Reference(s): USACE Sacramento O&M Manual, Unit 515 - Upper Butte Creek - Part No. 1, April 1955, (Station 836+86). USACE As-Built Drawing No. 50-4-2637, Exhibit B, Sheet 4, April 1950, (Station 836+85.70)]. FS Date: 5/31/2017 2:34:00 PM

Buried pipe at concrete box, LS toe.

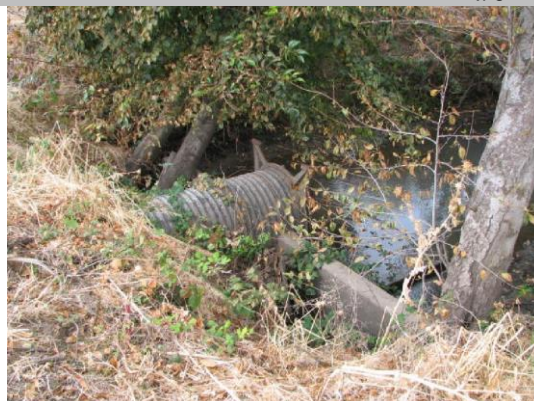
Photo 2 of 3 : UCIP_SP_2021_58227_68032.jpg

CMP pipe, flap gate, and headwall on WS toe.

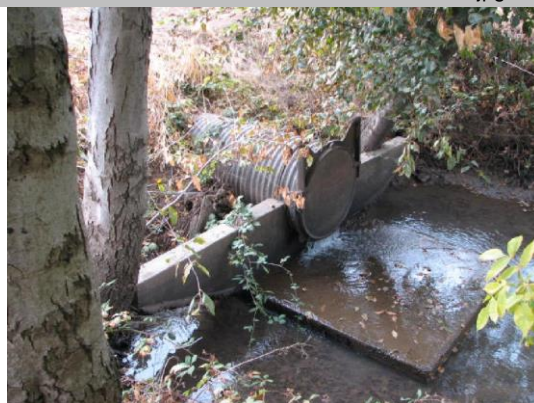
Photo 3 of 3 : UCIP_SP_2021_58227_68031.jpg

Wingwalls of headwall not supported by soil.

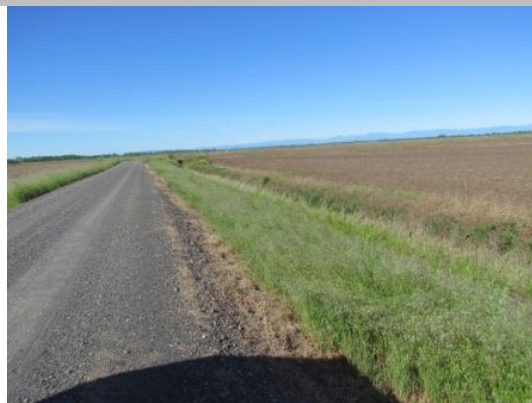
Photo 1 of 1 : SP_2021_MA0005_197_1_20210224_00001.jpg

LM Start	1.21	Rating **	M	Issue No.	1
LM End	1.59	Issue Type +	En	Location *	LS
Category	Earthen Levee			GPS Latitude/Longitude	
				Start	End
Item	Encroachments			39.529933 °	39.534102 °
				-121.861563 °	-121.856947 °
DWR ID	DWR_MA0005_02_s_2012_1				
Comment Code					
DT : Ditch					
Inspector Comment

View of the agricultural ditch along the landside toe.

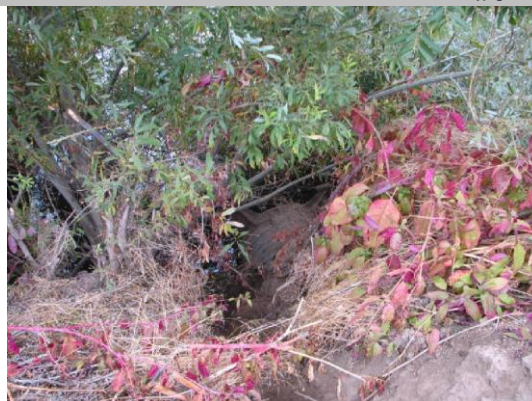
Photo 1 of 3 : UCIP_SP_2021_58240_68497.jpg

FS_ID:58240
DS_ID:1645
EP_NO: N/A
Repair Type: Urgent
Crossing Status: Found
UCIP Comments: 10/05/2018 Unable to see pipe on waterside due to high water level in the creek. Erosion is present around headwall on LS. Screw gate on LS blocked with silt approximately halfway in height. (O. Yakimov - DWR UCIP) 05/18/2017 LS erosion still present. Ws flap gate has been completely buried by sediment after the high water flows through the area. Pipe has been selected to be internally cleaned and inspected as part of the DMP project. (A. Freitag - DWR Sutter Yard)11/14/2016 LS erosion still present and is into the prism of the levee. WS flap gate was still mostly buried and non-operational. (A. Freitag - DWR Sutter Yard)05/23/2016 The tree that was overgrowing the WS flapgate has been removed. Flap gate was half buried and unable to open. Erosion on the LS is still present. (A. Freitag - DWR Sutter Yard)07/28/2015 LS inlet is underwater but there appears to be erosion behind the LS headwall. WS pipe end and flap gate are completely overgrown and inaccessible for inspection. (A. Freitag - DWR Sutter Yard)11/25/2014 Tree is overgrowing the WS pipe outlet.. Needs to be trimmed back. (A. Freitag - DWR Sutter Yard)06/04/2014 Same as last inspection. (A. Freitag - DWR Sutter Yard)11/12/2013 Same as last inspection. (A. Freitag - DWR Sutter Yard)06/06/2013 Same as last inspection. (A. Freitag - DWR Sutter Yard)10/31/2012 Vegetation needs to be cleared from outlet. (W. Wylie - DWR UCIP)

Flap gate on WS slope.

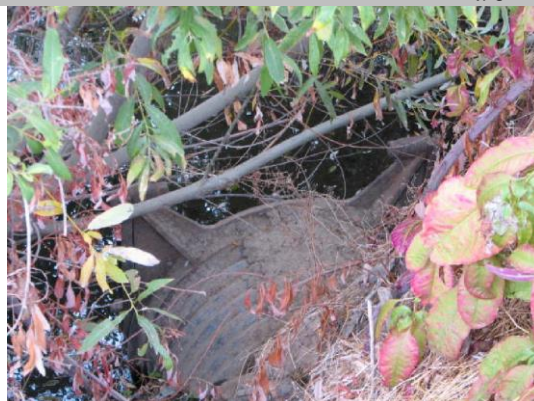
Photo 2 of 3 : UCIP_SP_2021_58240_68496.jpg

Flap gate on WS slope.

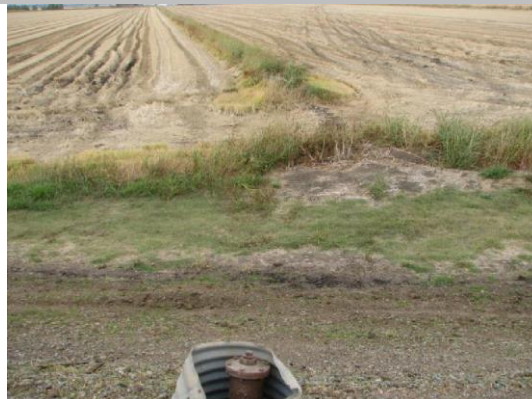
Photo 1 of 3 : UCIP_SP_2021_58241_68057.jpg

FS_ID:58241
DS_ID:1646
EP_NO: 3927
Repair Type: Non-Urgent
Crossing Status: Found
UCIP Comments: 05/18/2017 Appears to have been abandoned. Pump is missing from the pier and there is no sign of the riser and siphon breaker on the LS shoulder. (A. Freitag - DWR Sutter Yard)11/14/2016 Appears abandoned- pump removed from pier in Butte Creek also riser and siphon breaker are no longer seen on LS shoulder. (A. Freitag - DWR Sutter Yard)05/23/2016 Crossing appears to have been abandoned and removed. Could not locate the LS riser and siphon breaker. (A. Freitag - DWR Sutter Yard)07/28/2015 No pump present during any of my inspections. Crossing appears abandoned. CMP riser has been knocked out of levee. (A. Freitag - DWR Sutter Yard) 11/25/2014 Same as last inspection. (A. Freitag - DWR Sutter Yard)06/04/2014 Same as last inspection. (A. Freitag - DWR Sutter Yard)11/12/2013 Same as last inspection. (A. Freitag - DWR Sutter Yard)06/06/2013 Same as last inspection. (A. Freitag - DWR Sutter Yard)10/31/2012 Pump does not appear to be in use or is abandoned. (A. Freitag - DWR Sutter Yard)

Air vent in 24-inch CMP riser on LS shoulder.

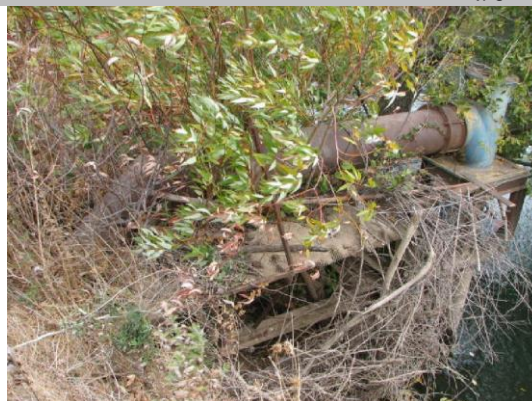
Photo 2 of 3 : UCIP_SP_2021_58241_68056.jpg

Pump on metal pier at WS toe.

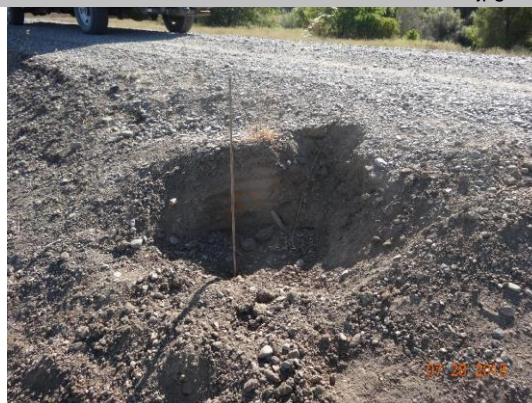
Photo 3 of 3 : UCIP_SP_2021_58241_74602.jpg

Spot where CMP riser was on the LS shoulder.

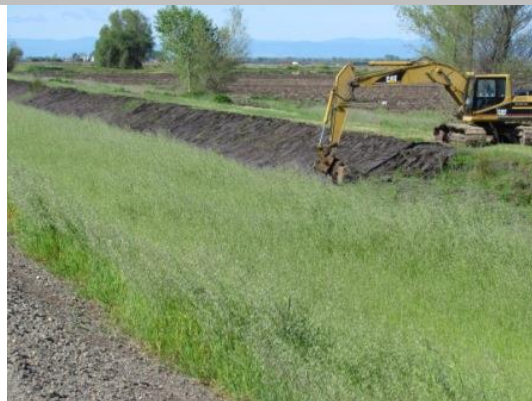
Photo 1 of 1 : SP_2021_MA0005_197_7_20210224_00003.jpg

LM Start	3.10	Rating **	M	Issue No.	7
LM End	4.04	Issue Type +	En	Location *	LS
Category	Earthen Levee			GPS Latitude/Longitude	
				Start	End
Item	Encroachments			39.551780 °	39.562341 °
				-121.840507 °	-121.829507 °
DWR ID	DWR_MA0005_02_s_2012_7				
Comment Code					
DT : Ditch					
Inspector Comment

View of the agricultural ditch along the landside toe.

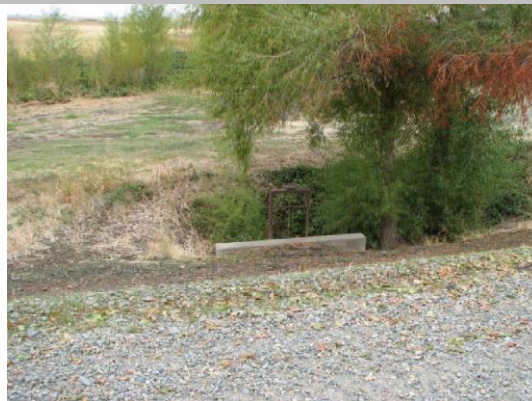
Photo 1 of 3 : UCIP_SP_2021_58242_68064.jpg

Comment Code						
Inspector Comment						
FS_ID:58242 DS_ID:1647 EP_NO: N/A Repair Type: No Action Needed Crossing Status: Found UCIP Comments: 05/18/2017 Crossing appears to be in good condition. Tree near the LS screw gate could use some trimming. Pipe has been selected to be internally cleaned and inspected as part of the DMP project. (A. Freitag - DWR Sutter Yard)11/14/2016 Crossing appears to be in good condition. (A. Freitag - DWR Sutter Yard)05/23/2016 Crossing appears to be in good condition. (A. Freitag - DWR Sutter Yard)07/28/2015 Pipe appears in good condition. No noticeable issues to report. (A. Freitag - DWR Sutter Yard)06/06/2013 Same as last inspection. (A. Freitag - DWR Sutter Yard)11/12/2013 Same as last inspection. (A. Freitag - DWR Sutter Yard)06/04/2014 Same as last inspection. (A. Freitag - DWR Sutter Yard)11/25/2014 Same as last inspection. (A. Freitag - DWR Sutter Yard) FIELD_STRUCT_DESC: 30-inch corrugated metal drainage pipe through the levee, 14.3 feet below the crown. Slide gate on the landside (LS). Flap gate on the waterside (WS). Concrete headwall at the LS toe. Concrete splash apron on the WS. [Additional Reference(s): DWR Levee Log, 1990 (HLM 4.08). USACE Sacramento O&M Manual, Unit 515 - Upper Butte Creek - Part No. 1, April 1955, (Station 5+20 "A"). USACE As-Built Drawing No. 50-4-2637, Exhibit B, Sheet 4, April 1950]. FS Date: 6/1/2017 9:47:00 AM

Concrete headwall and slide gate at LS toe.

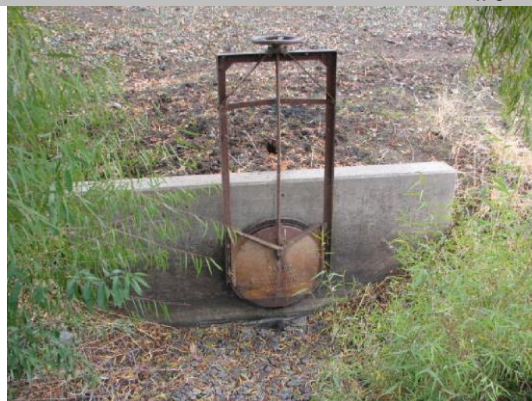
Photo 2 of 3 : UCIP_SP_2021_58242_68063.jpg

Concrete headwall and slide gate at LS toe.

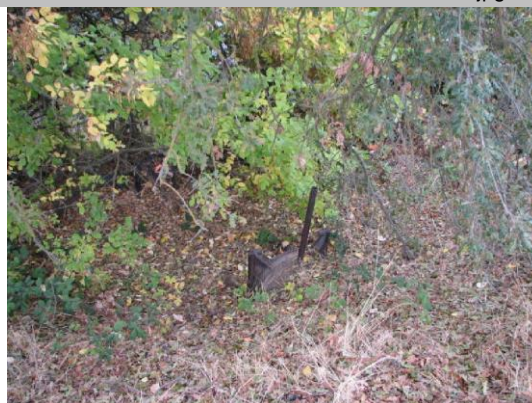
Photo 3 of 3 : UCIP_SP_2021_58242_68062.jpg

Flap gate at outlet on WS berm.

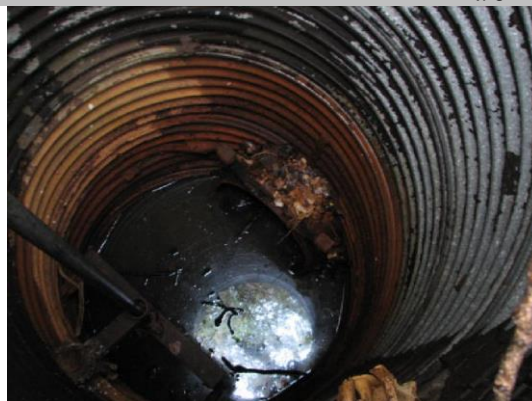
Photo 1 of 2 : UCIP_SP_2021_58258_68105.jpg

FS_ID:58258
DS_ID:1650
EP_NO: N/A
Repair Type: Non-Urgent
Crossing Status: Found
UCIP Comments: 05/23/2019 (O. Magana - DWR UCIP)05/18/2017 Abandoned- only WS riser found. (A. Freitag - DWR Sutter Yard)11/14/2016 Abandoned. (A. Freitag - DWR Sutter Yard)05/23/2016 Abandoned. (A. Freitag - DWR Sutter Yard)07/28/2015 Abandoned- still cannot locate a LS ans WS pipe end. (A. Freitag - DWR Sutter Yard)11/25/2014 Same as last inspection. (A. Freitag - DWR Sutter Yard)06/04/2014 Same as last inspection. (A. Freitag - DWR Sutter Yard)11/12/2013 Same as last inspection. (A. Freitag - DWR Sutter Yard)06/06/2013 Same as last inspection. (A. Freitag - DWR Sutter Yard)10/31/2012 Appears abandoned. Unable to locate outfall on WS. Unable to locate inlet on LS. (W. Wylie - DWR UCIP)
FIELD_STRUCT_DESC: *ABANDONED* 24-inch corrugated metal drainage pipe through the levee, 12.5 feet below the crown. Slide gate and flap gate in a 56-inch corrugated metal riser on the waterside (WS) berm. Flap gate on the WS. [Additional Reference(s): DWR Levee Log, 1990 (HLM 5.41). USACE Sacramento O&M Manual, Unit 515 - Upper Butte Creek - Part No. 1, April 1955, (Station 688+40). USACE As-Built Drawing No. 50-4-2637, Exhibit B, Sheet 3, April 1950].

Slide gate and flap gate inside CMP riser on WS berm.

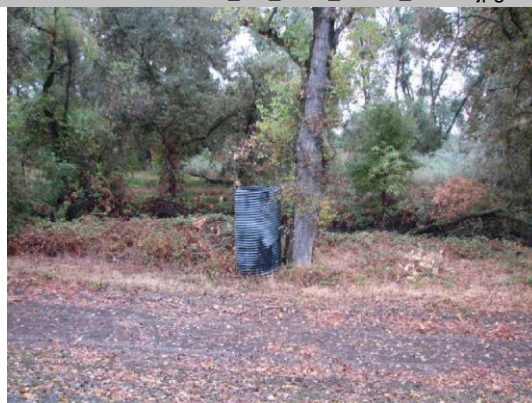
Photo 2 of 2 : UCIP_SP_2021_58258_68104.jpg

56-inch CMP riser on WS berm.
