Flood Control Project Maintenance Levee Inspections LMA District Cover Sheet

Sutter Maintenance Yard Maintenance Area 0005

Waterway			Bank	Unit Miles
Unit No. 01 Butte Creek			Left	15.08
	Spring (March - May)	Summer (June - August)	(September - November) Fall	Winter (December - February)
Unit Maintenance Rating (Fall Only)				
Date of Inspection	3/24/2021 - 3/24/2021			
DWR Inspector	Makar Sokol			
Accompanied By	Bob Duffey Sutter Maintenance Yard

Levee Inspection Report By Mile - Spring 2021

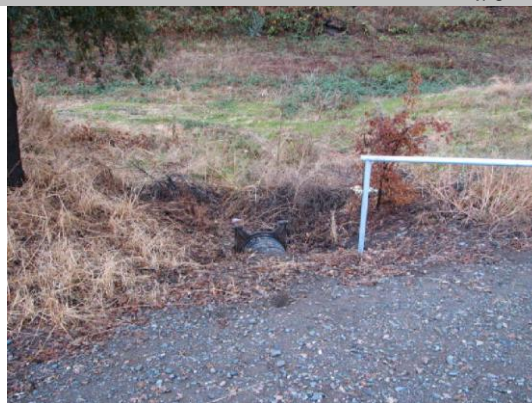
Photo 1 of 3 : UCIP_SP_2021_58265_68122.jpg

Comment Code						
Inspector Comment						
FS_ID:58265						
DS_ID:1654						
EP_NO: N/A						
Repair Type: No Action Needed						
Crossing Status: Found						
UCIP Comments: 05/18/2017 Crossing appears to be in good condition. Pipe has been selected to be internally cleaned and inspected as part of the DMP project. (A. Freitag - DWR Sutter Yard)11/14/2016 Crossing appears to be in good condition. (A. Freitag - DWR Sutter Yard)05/23/2016 Crossing appears to be in good condition. (A. Freitag - DWR Sutter Yard)07/28/2015 Crossing appears in good condition. No noticeable issues to report. (A. Freitag - DWR Sutter Yard)11/24/2014 Same as last inspection. (A. Freitag - DWR Sutter Yard)06/04/2014 Same as last inspection. (A. Freitag - DWR Sutter Yard)11/12/2013 Same as last inspection. (A. Freitag - DWR Sutter Yard)06/06/2013 Same as last inspection. (A. Freitag - DWR Sutter Yard)						
FIELD_STRUCT_DESC: 24-inch corrugated metal drainage pipe through the levee, 9.4 feet below the crown. Flap gate on the waterside (WS). Concrete headwalls at both the landside (LS) and the WS toes. [Additional Reference(s): DWR Levee Log, 1990 (HLM 6.56). USACE Sacramento O&M Manual, Unit 515 - Upper Butte Creek - Part No. 1, April 1955, (Station 627+00). USACE As-Built Drawing No. 50-4-2637, Exhibit B, Sheet 3, April 1950].

Flap gate on WS toe.

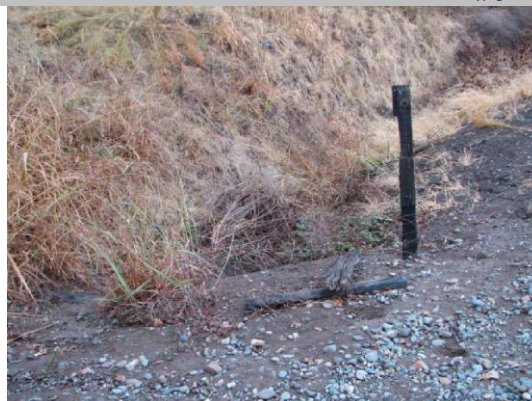
Photo 2 of 3 : UCIP_SP_2021_58265_68121.jpg

Headwall on LS toe.

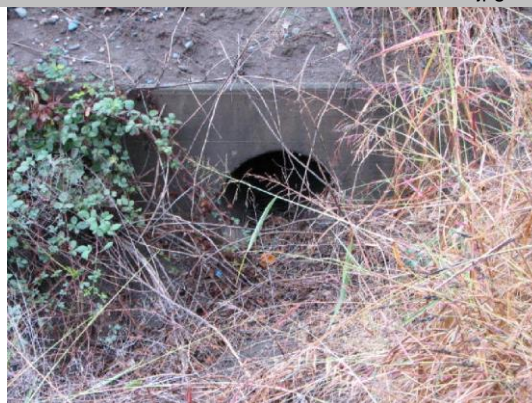
Photo 3 of 3 : UCIP_SP_2021_58265_68120.jpg

Headwall on LS toe.

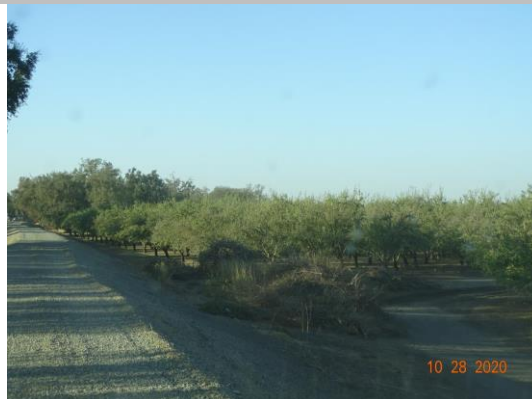
Photo 1 of 1 : SP_2021_MA0005_197_35_20210224_00007.jpg

LM Start	7.75	Rating **	M	Issue No.	35
LM End	7.75	Issue Type +	En	Location *	LS
Category	Earthen Levee			GPS Latitude/Longitude	
				Start	End
Item	Encroachments			39.605205 °	39.605205 °
				-121.788453 °	-121.788453 °
DWR ID	DWR_MA0005_02_s_2015_35				
Comment Code					
PR : Prunings					
Inspector Comment					
Remove the prunings from the landside toe.

View of the prunings along the landside toe. Fall 2020.

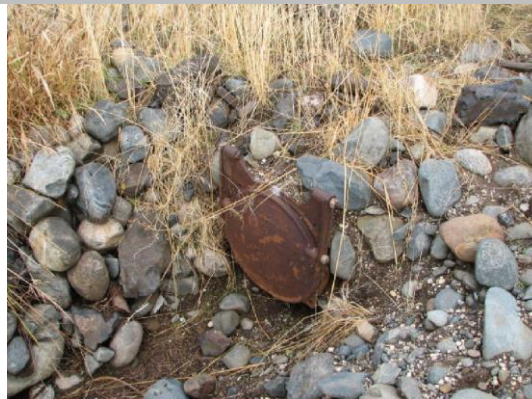
Photo 1 of 2 : UCIP_SP_2021_58269_68129.jpg

FS_ID:58269
DS_ID:1656
EP_NO: N/A
Repair Type: Non-Urgent
Crossing Status: Found
UCIP Comments: 05/18/2017 LS inlet is almost completely full of soil. Pipe has been selected to be internally cleaned and inspected as part of the DMP project. (A. Freitag - DWR Sutter Yard)11/14/2016 LS inlet almost completely full of soil. (A. Freitag - DWR Sutter Yard)05/23/2016 LS end is almost completel full of soil. (A. Freitag - DWR Sutter Yard)07/28/2015 Pipe is still over 3/4 full of soil. (A. Freitag - DWR Sutter Yard)11/24/2014 Same as last inspection. (A. Freitag - DWR Sutter Yard)06/04/2014 Same as last inspection. (A. Freitag - DWR Sutter Yard)11/12/2013 Same as last inspection. (A. Freitag - DWR Sutter Yard)06/06/2013 Same as last inspection. (A. Freitag - DWR Sutter Yard)10/31/2012 Pipe 3/4 full with soil on LS. (W. Wylie - DWR UCIP)
FIELD_STRUCT_DESC: 18-inch corrugated metal drainage pipe through the levee at an unknown depth below the crown. Concrete headwall at the landside (LS) toe. Flap gate on the waterside (WS).

Flap gate at WS toe.

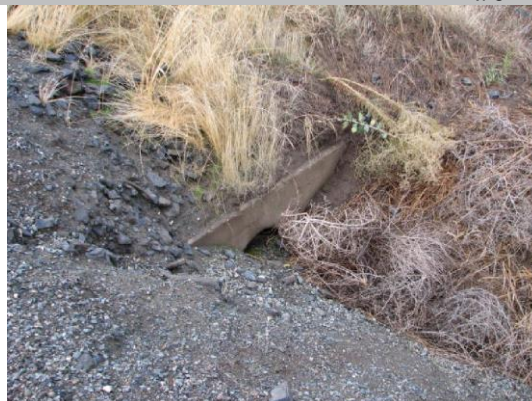
Photo 2 of 2 : UCIP_SP_2021_58269_68128.jpg

Concrete headwall on LS toe.

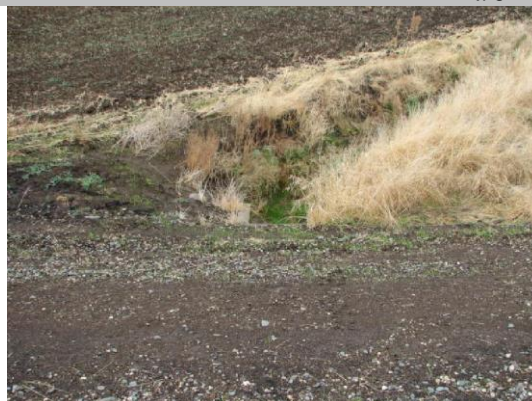
Photo 1 of 3 : UCIP_SP_2021_58277_68394.jpg

FS_ID:58277
DS_ID:1662
EP_NO: N/A
Repair Type: No Action Needed
Crossing Status: Found
UCIP Comments: 05/18/2017 Crossing appears to be in good condition. Pipe has been selected to be internally cleaned and inspected as part of the DMP project. (A. Freitag - DWR Sutter Yard)11/14/2016 Crossing appears to be in good condition. (A. Freitag - DWR Sutter Yard)05/12/2016 Crossing appears to be in good condition. (A. Freitag - DWR Sutter Yard)07/30/2015 Crossing is in good condition. No noticeable issues to report. (A. Freitag - DWR Sutter Yard)11/24/2014 Same as last inspection. (A. Freitag - DWR Sutter Yard)06/04/2014 Same as last inspection. (A. Freitag - DWR Sutter Yard)11/13/2013 Same as last inspection. (A. Freitag - DWR Sutter Yard)06/06/2013 Same as last inspection. (A. Freitag - DWR Sutter Yard)
FIELD_STRUCT_DESC: 30-inch corrugated metal drainage pipe through the levee, 16.3 feet below the crown. Flap gate on the waterside (WS). Concrete "U" shaped headwalls on both the landside (LS) and the WS. [Additional Reference(s): DWR Levee Log, 1990 (HLM 8.21). USACE Sacramento O&M Manual, Unit 516 - Upper Butte Creek - Part No. 2, April 1960, (Station 374+90). USACE As-Built Drawing No. 50-4-3367, Exhibit B, Sheet 13, April 1957].

Concrete inlet on LS toe.

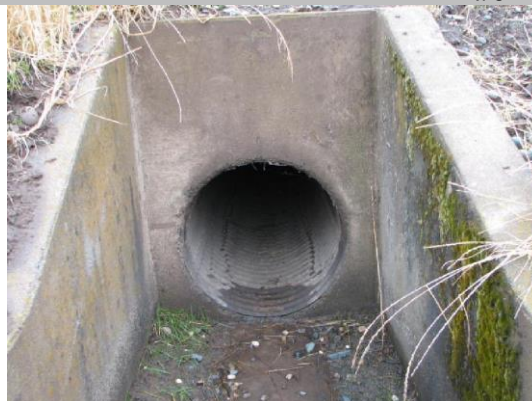
Photo 2 of 3 : UCIP_SP_2021_58277_68393.jpg

Concrete inlet on LS toe.

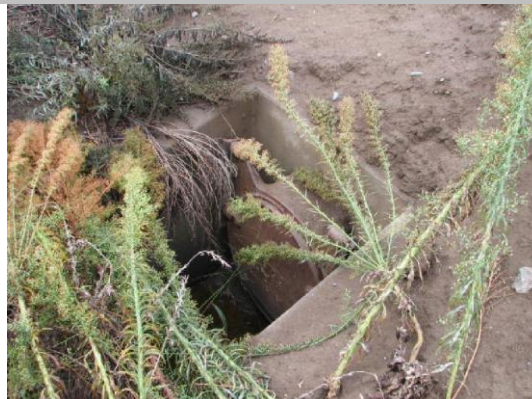
Photo 3 of 3 : UCIP_SP_2021_58277_68392.jpg

Concrete outlet and flap gate on WS toe.

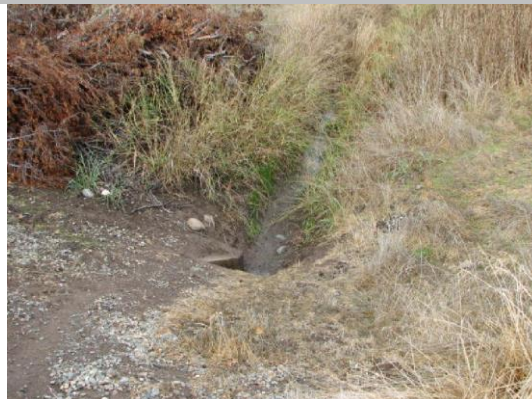
Photo 1 of 3 : UCIP_SP_2021_58279_68397.jpg

FS_ID:58279
DS_ID:1663
EP_NO: N/A
Repair Type: No Action Needed
Crossing Status: Found
UCIP Comments: 05/18/2017 Crossing appears to be in good condition. Pipe has been selected to be internally cleaned and inspected as part of the DMP project. (A. Freitag - DWR Sutter Yard)11/14/2016 Crossing appears to be in good condition. (A. Freitag - DWR Sutter Yard)05/12/2016 Crossing appears to be in good condition. (A. Freitag - DWR Sutter Yard)07/30/2015 Crossing appears in good condition. No noticeable issues to report. (A. Freitag - DWR Sutter Yard)11/24/2014 Same as last inspection. (A. Freitag - DWR Sutter Yard)06/04/2014 Same as last inspection. (A. Freitag - DWR Sutter Yard)11/13/2013 Damaged pipe section was dug up and replaced. New WS flapgate with u-shaped wingwall installed on end of pipe. (A. Freitag - DWR Sutter Yard)06/06/2013 Same as last inspection. Plans have been made to repair during summer of 2013 before high water season. (A. Freitag - DWR Sutter Yard)11/01/2012 Pipe rusted through along bottom at WS outlet. Sink hole over pipe on WS berm. WS headwall eroded eternally around backside of headwall. (W. Wylie - DWR UCIP)

Concrete U-shaped headwall on LS toe.

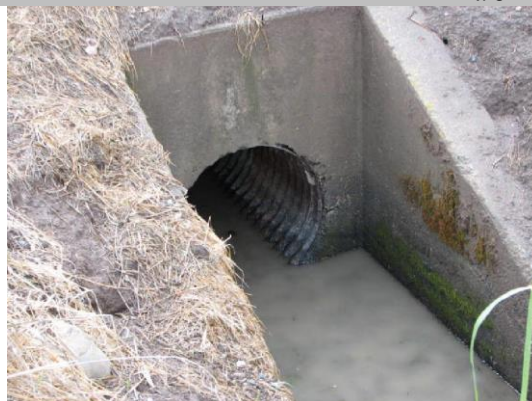
Photo 2 of 3 : UCIP_SP_2021_58279_68396.jpg

Concrete U-shaped headwall on LS toe.

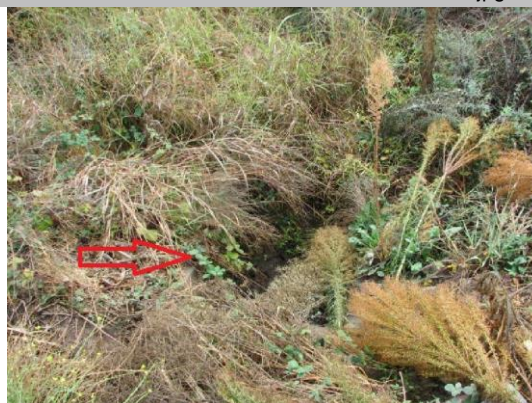
Photo 3 of 3 : UCIP_SP_2021_58279_68395.jpg

Concrete U shaped outlet and flap gate at WS of Berm.

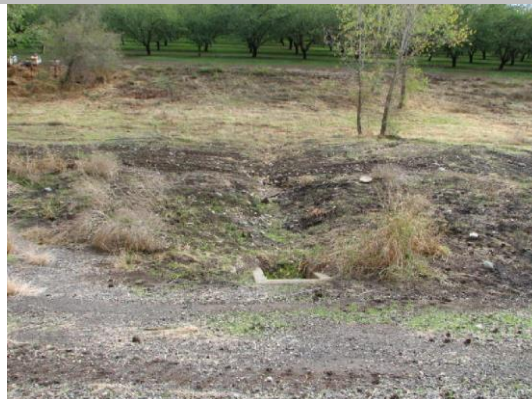
Photo 1 of 3 : UCIP_SP_2021_58280_68406.jpg

FS_ID:58280
DS_ID:1664
EP_NO: N/A
Repair Type: Non-Urgent
Crossing Status: Found
UCIP Comments: 05/18/2017 No LS slide gate but not sure its even needed. Pipe has been selected to be internally cleaned and inspected as part of the DMP project. (A. Freitag - DWR Sutter Yard)11/14/2016 LS slide gate still missing. Rest of crossing appears in good condition. (A. Freitag - DWR Sutter Yard)05/12/2016 LS inlet was unburied. Slide gate still missing. (A. Freitag - DWR Sutter Yard)07/30/2015 LS inlet is still buried. (A. Freitag - DWR Sutter Yard)11/24/2014 Same as last inspection. (A. Freitag - DWR Sutter Yard)06/04/2014 Same as last inspection. (A. Freitag - DWR Sutter Yard)11/13/2013 Same as last inspection. (A. Freitag - DWR Sutter Yard)06/06/2013 Same as last inspection. (A. Freitag - DWR Sutter Yard)11/01/2012 LS inlet is buried under soil and covered with brambles. Slide gate missing from LS. (W. Wylie - DWR UCIP)

WS outlet and concrete U shaped headwall.

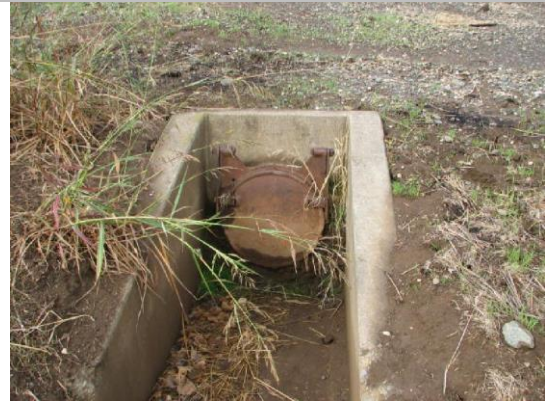
Photo 3 of 3 : UCIP_SP_2021_58280_68403.jpg

Concrete U shaped headwall and flap gate at WS toe.

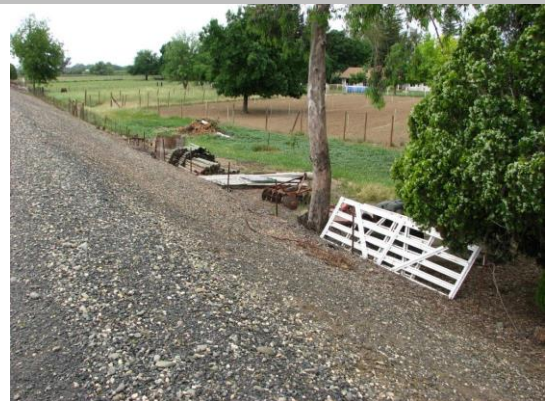
Photo 1 of 1 : SP_2021_MA0005_197_45_20210224_00010.jpg

LM Start	9.09	Rating **	M	Issue No.	45
LM End	9.09	Issue Type +	En	Location *	LS
Category	Earthen Levee			GPS Latitude/Longitude	
				Start	End
Item	Encroachments			39.622017 °	39.622017 °
				-121.776552 °	-121.776552 °
DWR ID	DWR_MA0005_02_s_2016_45				
Comment Code					
EQ : Equipment					
Inspector Comment					
Materials and equipment should be removed from the landside toe.

View of equipment and materials from the landside toe.

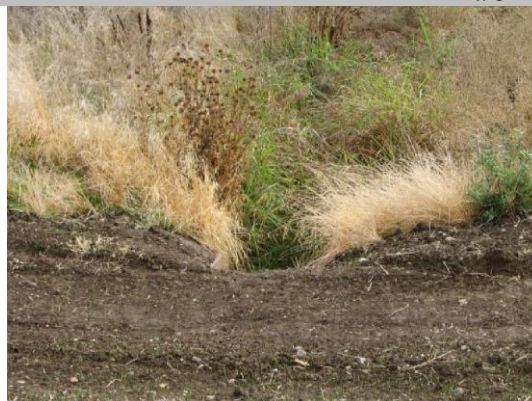
Photo 1 of 3 : UCIP_SP_2021_58281_68413.jpg

FS_ID:58281
DS_ID:1665
EP_NO: N/A
Repair Type: No Action Needed
Crossing Status: Found
UCIP Comments: 05/18/2017 Crossing appears to be in good condition. Pipe has been selected to be internally cleaned and inspected as part of the DMP project. (A. Freitag - DWR Sutter Yard)11/14/2016 Crossing appears to be in good condition. (A. Freitag - DWR Sutter Yard)05/12/2016 Crossing appears to be in good condition. (A. Freitag - DWR Sutter Yard)07/30/2015 Crossing appears in good condition. No noticeable issues to report. (A. Freitag - DWR Sutter Yard)11/24/2014 Same as last inspection. (A. Freitag - DWR Sutter Yard)06/04/2014 Same as last inspection. (A. Freitag - DWR Sutter Yard)11/13/2013 Same as last inspection. (A. Freitag - DWR Sutter Yard)06/06/2013 Same as last inspection. (A. Freitag - DWR Sutter Yard)
FIELD_STRUCT_DESC: 24-inch corrugated metal drainage pipe through the levee, 11.3 feet below the crown. Flap gate on the waterside (WS). Concrete headwalls on both the landside (LS) and the WS. [Additional Reference(s): DWR Levee Log, 1990 (HLM 9.25). USACE Sacramento O&M Manual, Unit 516 - Upper Butte Creek - Part No. 2, April 1960, (Station 321+20)].

Concrete U shaped headwall and flap gate on WS toe.

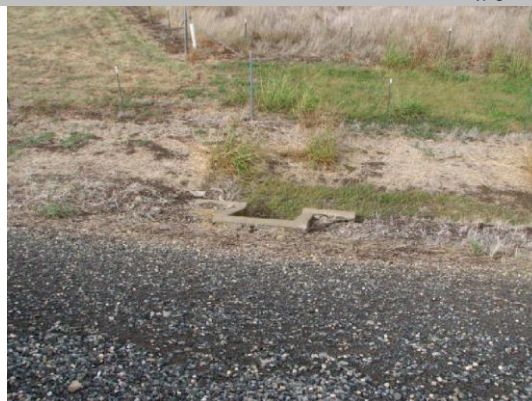
Photo 2 of 3 : UCIP_SP_2021_58281_68412.jpg

Concrete U shaped headwall on LS toe.

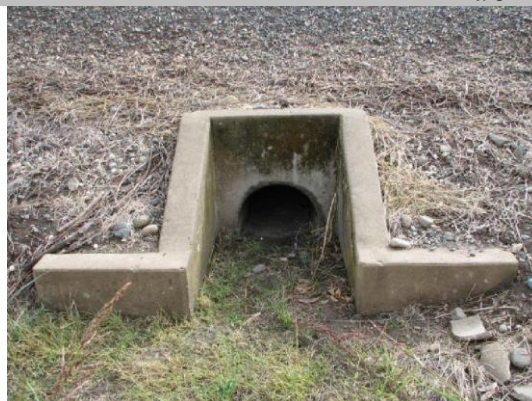
Photo 3 of 3 : UCIP_SP_2021_58281_68411.jpg

Concrete U shaped headwall on LS toe.

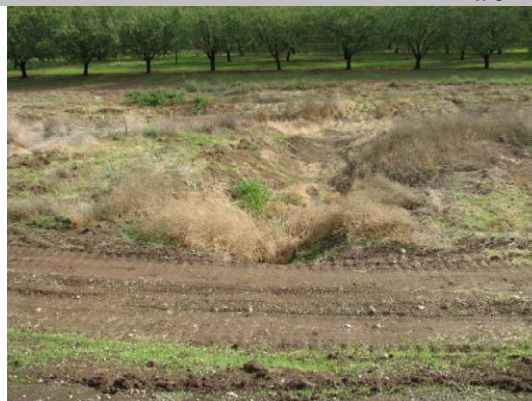
Photo 1 of 3 : UCIP_SP_2021_58282_68417.jpg

FS_ID:58282
DS_ID:1666
EP_NO: N/A
Repair Type: Non-Urgent
Crossing Status: Found
UCIP Comments: 05/18/2017 LS inlet half full of soil and WS flap gate half buried by sediment. Pipe has been selected to be internally cleaned and inspected as part of the DMP project. (A. Freitag - DWR Sutter Yard)11/14/2016 LS pipe inlet is half full of soil. WS flap gate shut but half buried by sediment. (A. Freitag - DWR Sutter Yard)05/12/2016 Pipe is half full of soil. (A. Freitag - DWR Sutter Yard)07/30/2015 Pipe is 1/4 to 1/2 full of soil still. (A. Freitag - DWR Sutter Yard)11/24/2014 Same as last inspection. (A. Freitag - DWR Sutter Yard)06/04/2014 Same as last inspection. (A. Freitag - DWR Sutter Yard)11/13/2013 Same as last inspection. (A. Freitag - DWR Sutter Yard)06/06/2013 Same as last inspection. (A. Freitag - DWR Sutter Yard)11/01/2012 Pipe 1/2 filled with soil. (W. Wylie - DWR UCIP)
FIELD_STRUCT_DESC: 24-inch corrugated metal drainage pipe through the levee, 11.2 feet below the crown. Flap gate on the waterside (WS). Concrete "U" shaped headwalls on both the landside (LS) and the WS. [Additional Reference(s): DWR Levee Log, 1990 (HLM 9.57). USACE Sacramento O&M Manual, Unit 516 - Upper Butte Creek - Part No. 2, April 1960, (Station 304+10). USACE As-Built Drawing No. 50-4-3367, Exhibit B, Sheet 3, April 1957].

View of outlet looking toward WS toe.

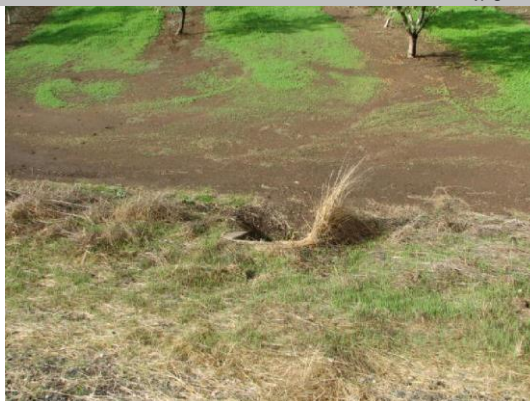
Photo 2 of 3 : UCIP_SP_2021_58282_68416.jpg

View of inlet on LS toe.

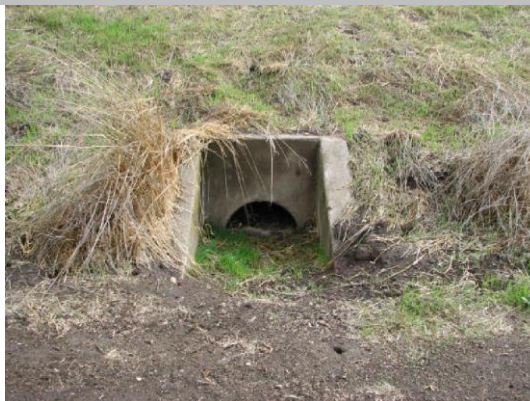
Photo 3 of 3 : UCIP_SP_2021_58282_68415.jpg

Concrete U-shaped headwall on LS toe.

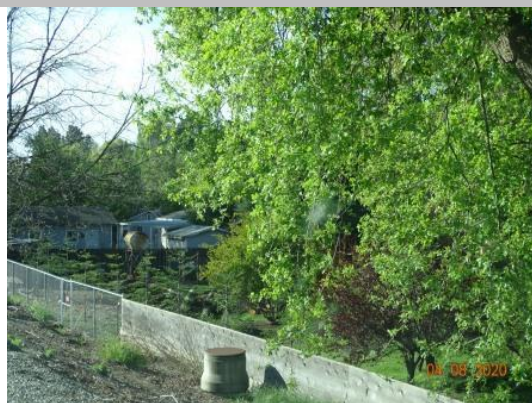
Photo 1 of 1 : SP_2021_MA0005_197_41_20210224_00009.jpg

LM Start	10.90	Rating **	U	Issue No.	41
LM End	10.93	Issue Type +	En	Location *	LS
Category	Earthen Levee			GPS Latitude/Longitude	
				Start	End
Item	Encroachments			39.645508 °	39.645858 °
				-121.786515 °	-121.786742 °
DWR ID	DWR_MA0005_02_f_2014_41				
Comment Code					
FE : Fence					
Inspector Comment					
Remove or apply for permit for the fence along landside toe

View of the fence along the landside toe. Spring 2020.

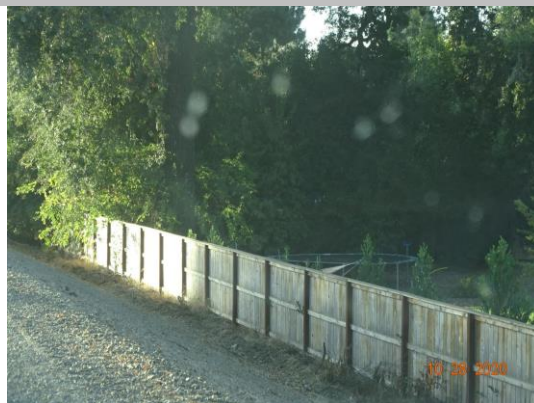
Photo 1 of 1 : SP_2021_MA0005_197_60_20210224_00015.jpg

LM Start	10.98	Rating **	U	Issue No.	60
LM End	11.04	Issue Type +	En	Location *	LS
Category	Earthen Levee			GPS Latitude/Longitude	
				Start	End
Item	Encroachments			39.646523 °	39.647238 °
				-121.787310 °	-121.787866 °
DWR ID	DWR_MA0005_02_f _ 2016_60				
Comment Code					
FE : Fence					
Inspector Comment

View of a wooden fence along the landside toe. Fall 2020.

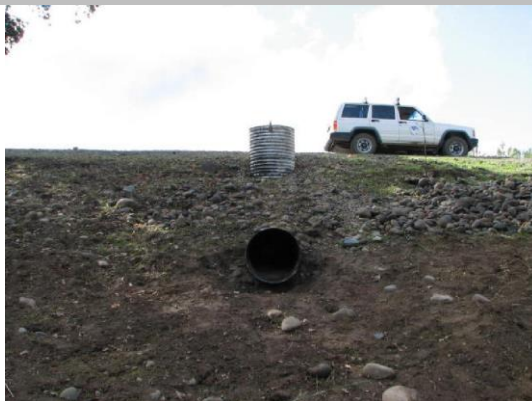
Photo 3 of 3 : UCIP_SP_2021_58287_68432.jpg

CM riser on WS shoulder-missing slide gate.

Distribution box on LS toe. Missing slide gate at pipe entrance.

View of pipe from WS looking toward LS.

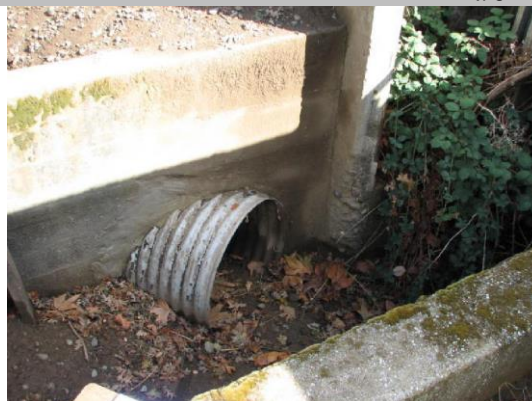
Photo 1 of 3 : UCIP_SP_2021_58288_68436.jpg

FS_ID:58288
DS_ID:1671
EP_NO: N/A
Repair Type: Non-Urgent
Crossing Status: Found
UCIP Comments: 05/18/2017 Abandoned- WS end still buried. (A. Freitag - DWR Sutter Yard)11/14/2016 Appears abandoned. (A. Freitag - DWR Sutter Yard)05/11/2016 Abandoned crossing. (A. Freitag - DWR Sutter Yard)07/30/2015 Abandoned crossing. Unable to locate the WS end of pipe. (A. Freitag - DWR Sutter Yard)11/24/2014 Same as last inspection. (A. Freitag - DWR Sutter Yard)06/04/2014 Same as last inspection. (A. Freitag - DWR Sutter Yard)11/13/2013 Same as last inspection. (A. Freitag - DWR Sutter Yard)06/06/2013 Same as last inspection. (A. Freitag - DWR Sutter Yard)11/01/2012 Pipe appears abandoned. It needs to be abandoned properly. (W. Wylie - DWR UCIP)
FIELD_STRUCT_DESC: 30-inch corrugated metal irrigation pipe through the levee, 9.4 feet below the crown. Slide gate in a 42-inch corrugated metal riser on the waterside (WS) slope. Concrete distribution box on the landside (LS). [Additional Reference(s): DWR Levee Log, 1990 (HLM 11.27). USACE Sacramento O&M Manual, Unit 516 - Upper Butte Creek - Part No. 2, April 1960, (Station 215+46)].

Pipe at concrete distribution box on LS toe.

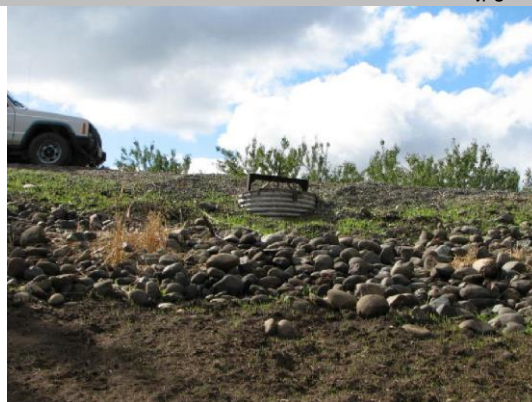
Photo 2 of 3 : UCIP_SP_2021_58288_68435.jpg

CM riser with slide gate on WS shoulder.

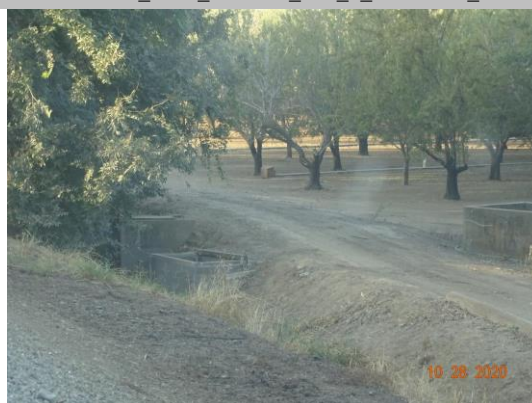
Photo 1 of 1 : SP_2021_MA0005_197_6_20210224_00002.jpg

LM Start	11.27	Rating **	M	Issue No.	6
LM End	11.77	Issue Type +	En	Location *	LS
Category	Earthen Levee			GPS Latitude/Longitude	
				Start	End
Item	Encroachments			39.650046 °	39.657142 °
				-121.789945 °	-121.788690 °
DWR ID	DWR_MA0005_02_s_2012_6				
Comment Code					
DT : Ditch					
Inspector Comment

View of the ditch along the landside toe. Fall 2020.

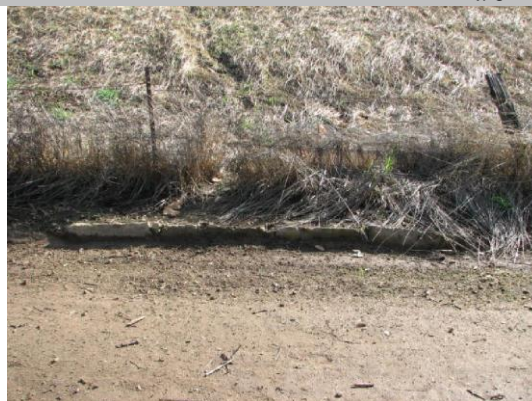
Photo 2 of 3 : UCIP_SP_2021_58290_68464.jpg

Comment Code						
Inspector Comment						
FS_ID:58290 DS_ID:1673 EP_NO: N/A Repair Type: Non-Urgent Crossing Status: Found UCIP Comments: 05/23/2019 (O. Magana - DWR UCIP)05/18/2017 Abandoned- needs to be done properly. Pipe has been selected to be internally cleaned and inspected as part of the DMP project. (A. Freitag - DWR Sutter Yard)11/14/2016 Abandoned- needs a cover for standpipe. (A. Freitag - DWR Sutter Yard)05/11/2016 Abandoned crossing. Needs a cover fo the WS riser. (A. Freitag - DWR Sutter Yard)08/03/2015 Crossing appears abandoned. Only the slide gate inside riser on the WS shoulder could be found. Riser needs a cover made for it. (A. Freitag - DWR Sutter Yard)11/24/2014 Same as last inspection. (A. Freitag - DWR Sutter Yard)06/04/2014 Same as last inspection. (A. Freitag - DWR Sutter Yard)11/13/2013 Slide gate top and stem were repaired to make gate operational. (A. Freitag - DWR Sutter Yard)06/06/2013 New slidegate is planned to be installed during summer of 2013. (A. Freitag - DWR Sutter Yard)11/01/2012 Slide gate on WS shoulder bent and damaged (inoperable) Pipe appears abandoned. (W. Wylie - DWR UCIP) FIELD_STRUCT_DESC: *ABANDONED* 24-inch corrugated metal drainage pipe through the levee, 14 feet below the crown. Slide gate in a corrugated metal riser on the waterside (WS) slope. [Additional Reference(s): DWR Levee Log, 1990 (HLM 12.98). USACE Sacramento O&M Manual, Unit 516 - Upper Butte Creek - Part No. 2, April 1960, (Station 126+91)]. FS Date: 5/23/2019 5:20:00 PM

Abandoned headwall on LS toe.

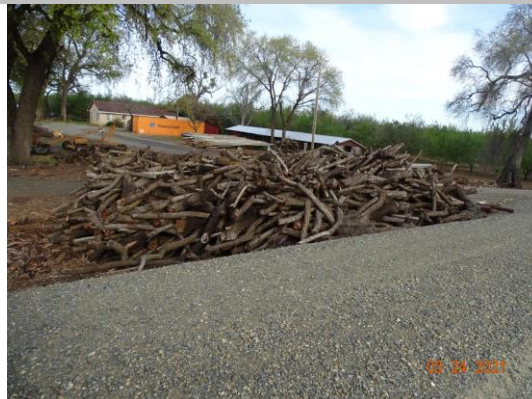
Photo 1 of 1 : SP_2021_MA0005_197_50_20210407_00082.jpg

LM Start	13.07	Rating **	U	Issue No.	50
LM End	13.07	Issue Type +	En	Location *	LS
Category	Earthen Levee			GPS Latitude/Longitude	
				Start	End
Item	Encroachments			39.674321 °	39.674321 °
				-121.781163 °	-121.781163 °
DWR ID	DWR_MA0005_02_s_2020_50				
Comment Code					
FW : Firewood					
Inspector Comment

View of the pile of firewood at the landside toe. Spring 2021.

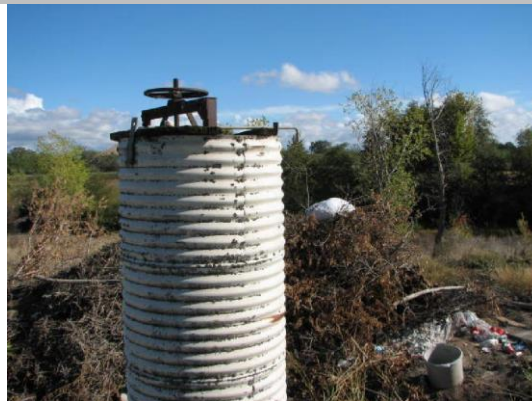
Photo 1 of 1 : UCIP_SP_2021_58291_68488.jpg

Comment Code						
Inspector Comment						
FS_ID:58291 DS_ID:1674 EP_NO: 1291 Repair Type: Non-Urgent Crossing Status: Found UCIP Comments: 05/18/2017 Appears abandoned- needs to be done properly. (A. Freitag - DWR Sutter Yard)11/14/2016 Appears abandoned- needs to be done so properly. (A. Freitag - DWR Sutter Yard)05/11/2016 Appears to be an abandoned crossing. (A. Freitag - DWR Sutter Yard)08/03/2015 Pipe appears to be abandoned. Pump on WS berm is still missing. (A. Freitag - DWR Sutter Yard)11/24/2014 Same as last inspection. (A. Freitag - DWR Sutter Yard)06/04/2014 Same as last inspection. (A. Freitag - DWR Sutter Yard)11/13/2013 Same as last inspection. (A. Freitag - DWR Sutter Yard)06/06/2013 Same as last inspection. (A. Freitag - DWR Sutter Yard)11/01/2012 Pipe appears to be abandoned. No pump found. Pipe should be abandoned properly. (W. Wylie - DWR UCIP) FIELD_STRUCT_DESC: 24-inch corrugated metal (not 14-inch concrete as described in the permit) irrigation pipe through the levee, 9 feet below the crown. Slide gate in a 36-inch corrugated metal riser on the waterside (WS) slope. Pump and a 36-inch concrete standpipe on the WS. (14-inch pipe referenced under Permit No. 1291, 1948 - J. P. Hansen). [Additional Reference(s): DWR Levee Log, 1990 (HLM 13.35). USACE Sacramento O&M Manual, Unit 516 - Upper Butte Creek - Part No. 2, April 1960, (Station 106+93)]. FS Date: 6/1/2017 1:54:00 PM

Slide gate in CM riser on WS toe.

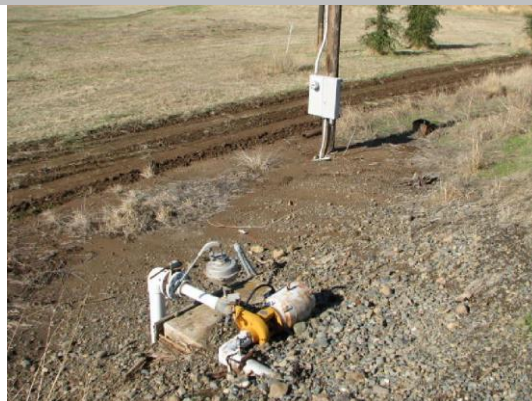
Photo 1 of 1 : UCIP_SP_2021_58292_68489.jpg

Comment Code					
Inspector Comment					
FS_ID:58292 DS_ID:1675 EP_NO: N/A Repair Type: Non-Urgent Crossing Status: Found UCIP Comments: 05/18/2017 LS visible but nothing found on WS of levee. (A. Freitag - DWR Sutter Yard)11/14/2016 Still unable to locate and WS appurtances. (A. Freitag - DWR Sutter Yard)05/11/2016 LS seems fine but nothing was found on the WS. (A. Freitag - DWR Sutter Yard)08/03/2015 Still unable to locate anything on the WS. (A. Freitag - DWR Sutter Yard)11/24/2014 Same as last inspection. (A. Freitag - DWR Sutter Yard)06/04/2014 Same as last inspection. (A. Freitag - DWR Sutter Yard)11/13/2013 Same as last inspection. (A. Freitag - DWR Sutter Yard)06/06/2013 Same as last inspection. (A. Freitag - DWR Sutter Yard)11/01/2012 Unable to locate pipe on WS. (A. Freitag - DWR Sutter Yard) FIELD_STRUCT_DESC: 8-inch steel irrigation pipe, 4 feet below the crown. Pipe is sleeved with a 5-inch aluminum irrigation pipe. Pump on a concrete pad on the landside (LS) slope. Butterfly valve on the LS slope. [Additional Reference(s): DWR Levee Log, 1990]. FS Date: 6/1/2017 1:56:00 PM

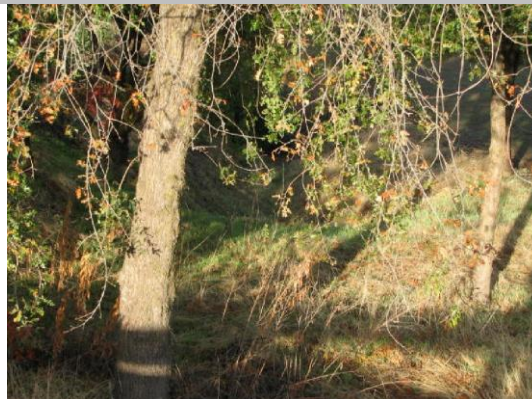
Photo 1 of 3 : UCIP_SP_2021_58301_68531.jpg

FS_ID:58301
DS_ID:1679
EP_NO: N/A
Repair Type: No Action Needed
Crossing Status: Found
UCIP Comments: 05/18/2017 Crossing appears to be in good condition. Pipe has been selected to be internally cleaned and inspected as part of the DMP project. (A. Freitag - DWR Sutter Yard)11/14/2016 Crossing appears to be in good condition. (A. Freitag - DWR Sutter Yard)05/11/2016 Crossing appears to be in good condition. (A. Freitag - DWR Sutter Yard)08/03/2015 Crossing appears in good condition. No noticeable issues to report. (A. Freitag - DWR Sutter Yard)11/25/2014 Same as last inspection. (A. Freitag - DWR Sutter Yard)06/04/2014 Same as last inspection. (A. Freitag - DWR Sutter Yard)11/13/2013 Same as last inspection. (A. Freitag - DWR Sutter Yard)06/06/2013 Same as last inspection. (A. Freitag - DWR Sutter Yard)
FIELD_STRUCT_DESC: 24-inch corrugated metal drainage pipe through the levee, 14.5 feet below the crown. Concrete "U" shaped headwall on the waterside (WS). Flap gate on the WS. [Additional Reference(s): DWR Levee Log, 1990 (HLM 13.61). USACE Sacramento O&M Manual, Unit 516 - Upper Butte Creek - Part No. 2, April 1960, (Station 93+78)].

Inlet relocated after bridge replacement away from LS toe.

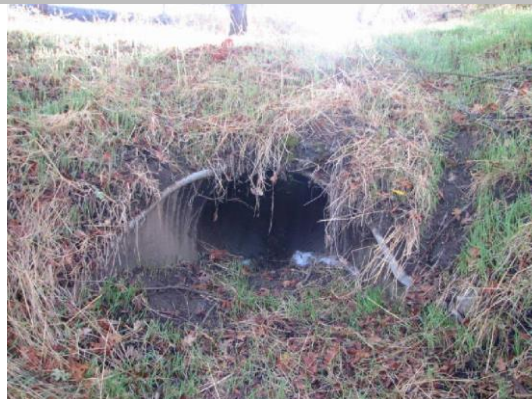
Photo 2 of 3 : UCIP_SP_2021_58301_68530.jpg

Inlet 50-feet NW of levee crown.

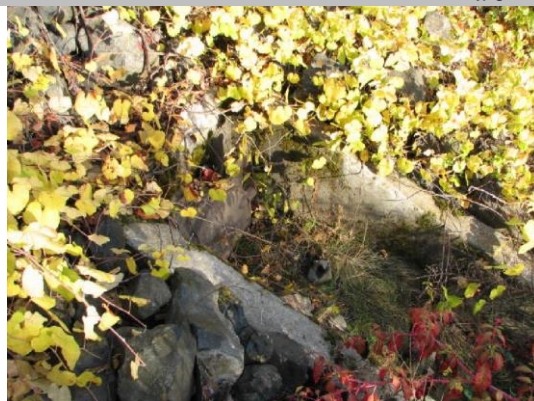
Photo 3 of 3 : UCIP_SP_2021_58301_68533.jpg

Concrete U-shaped headwall and flap gate at WS slope.

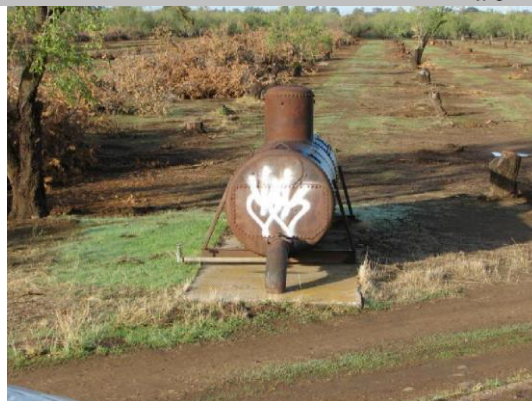
Photo 1 of 1 : UCIP_SP_2021_58302_68534.jpg

Comment Code					
Inspector Comment					
FS_ID:58302 DS_ID:1680 EP_NO: N/A Repair Type: Non-Urgent Crossing Status: Found UCIP Comments: 05/18/2017 Unable to locate. (A. Freitag - DWR Sutter Yard)11/14/2016 Unable to locate. (A. Freitag - DWR Sutter Yard)05/11/2016 Unable to locate. (A. Freitag - DWR Sutter Yard)08/03/2015 Unable to locate. (A. Freitag - DWR Sutter Yard)11/25/2014 Unable to locate. (A. Freitag - DWR Sutter Yard)06/04/2014 Same as last inspection. Unable to locate. (A. Freitag - DWR Sutter Yard)11/13/2013 Unable to locate. (A. Freitag - DWR Sutter Yard)06/06/2013 Boiler has been removed and pipe buried on LS. Unable to locate. (A. Freitag - DWR Sutter Yard)11/01/2012 Pipe appears to be abandoned. (W. Wylie - DWR UCIP) FIELD_STRUCT_DESC: 8-inch steel irrigation pipe through the levee, 6.5 feet below the crown. Boiler attached to the landside (LS). [Additional Reference(s): DWR Levee Log, 1990 (HLM 13.99). USACE Sacramento O&M Manual, Unit 516 - Upper Butte Creek - Part No. 2, April 1960, (Station 73+27)]. FS Date: 6/1/2017 2:11:00 PM

Pipe attached at boiler on LS toe.

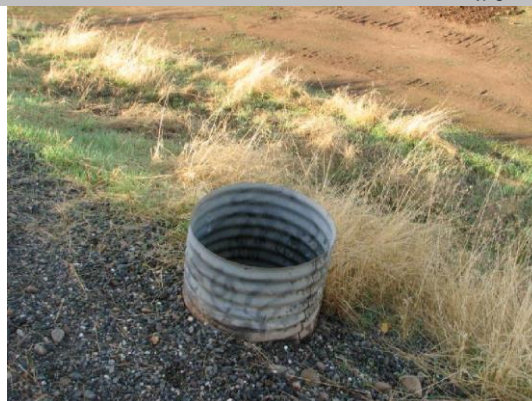
Photo 1 of 1 : UCIP_SP_2021_58303_68535.jpg

Comment Code						
Inspector Comment						
FS_ID:58303 DS_ID:1681 EP_NO: N/A Repair Type: Non-Urgent Crossing Status: Found UCIP Comments: 05/18/2017 Appears abandoned- if so needs to be done so properly. (A. Freitag - DWR Sutter Yard)11/14/2016 Appears abandoned. (A. Freitag - DWR Sutter Yard)05/11/2016 Abandoned crossing. (A. Freitag - DWR Sutter Yard)08/03/2015 Pipe still appears abandoned. (A. Freitag - DWR Sutter Yard)11/25/2014 Same as last inspection. (A. Freitag - DWR Sutter Yard)06/04/2014 Same as last inspection. (A. Freitag - DWR Sutter Yard)11/13/2013 Same as last inspection. (A. Freitag - DWR Sutter Yard)06/06/2013 Same as last inspection. (A. Freitag - DWR Sutter Yard)11/01/2012 Pipe appears to be abandoned. (W. Wylie - DWR UCIP) FIELD_STRUCT_DESC: *ABANDONED* 6-inch steel irrigation pipe through the levee, 7.1 feet below the crown. Siphon breaker in a corrugated metal riser on the landside (LS) slope. One corrugated metal cutoff wall. Pipe is open on both ends. [Additional Reference(s): DWR Levee Log, 1990 (HLM 14.15). USACE Sacramento O&M Manual, Unit 516 - Upper Butte Creek - Part No. 2, April 1960, (Station 65+52)]. FS Date: 6/1/2017 2:12:00 PM

CM riser with siphon breaker on LS shoulder.

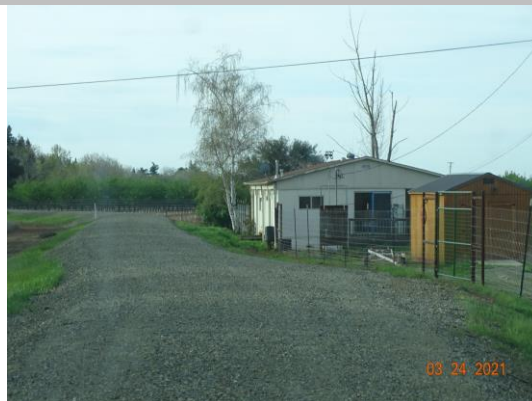
Photo 1 of 1 : SP_2021_MA0005_197_25_20210407_00084.jpg

LM Start	14.33	Rating **	U	Issue No.	25
LM End	14.33	Issue Type +	En	Location *	LS
Category	Earthen Levee			GPS Latitude/Longitude	
				Start	End
Item	Encroachments			39.691580 °	39.691580 °
				-121.779254 °	-121.779254 °
DWR ID	DWR_MA0005_02_s_2012_25				
Comment Code					
BU : Building					
Inspector Comment					
Unpermitted structure.

View of the buildings at the landside toe. Spring 2021.

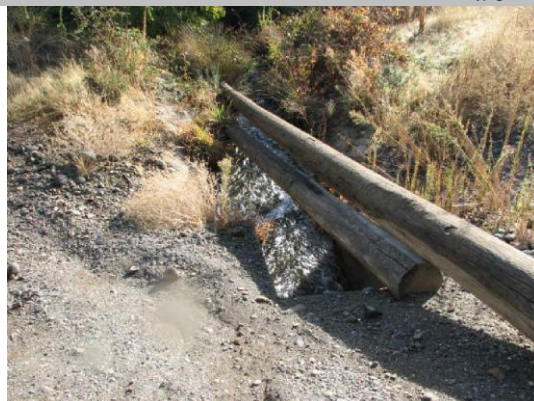
Photo 1 of 3 : UCIP_SP_2021_58304_68544.jpg

FS_ID:58304
DS_ID:1682
EP_NO: N/A
Repair Type: No Action Needed
Crossing Status: Found
UCIP Comments: 05/23/2019 (O. Magana - DWR UCIP)05/18/2017 Crossing appears to be in good condition. Pipe has been selected to be internally cleaned and inspected as part of the DMP project. (A. Freitag - DWR Sutter Yard)11/14/2016 Crossing appears to be in good condition. (A. Freitag - DWR Sutter Yard)05/11/2016 Crossing appears to be in good condition. (A. Freitag - DWR Sutter Yard)08/03/2015 Crossing appears in good condition. No noticeable issues to report. (A. Freitag - DWR Sutter Yard)11/25/2014 Same as last inspection. (A. Freitag - DWR Sutter Yard)06/04/2014 Same as last inspection. (A. Freitag - DWR Sutter Yard)11/13/2013 Same as last inspection. (A. Freitag - DWR Sutter Yard)06/06/2013 Same as last inspection. (A. Freitag - DWR Sutter Yard)
FIELD_STRUCT_DESC: 24-inch corrugated metal drainage pipe through the levee, 7.2 feet below the crown. Concrete "U" shaped headwall and grouted spillway on the waterside (WS). Slide gate in a 48-inch concrete standpipe on the landside (LS). Flap gate on the WS.

Outlet at U-shaped headwall on WS toe.

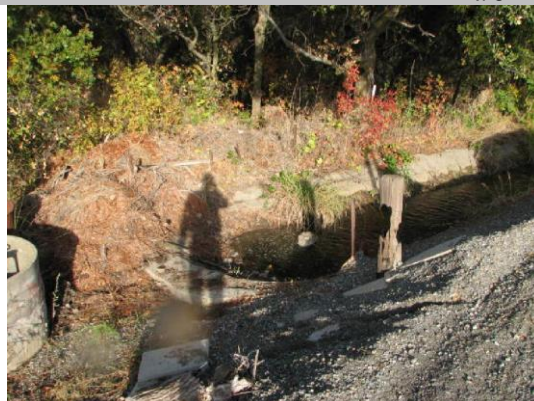
Photo 2 of 3 : UCIP_SP_2021_58304_68543.jpg

Concrete lined channel on LS toe.

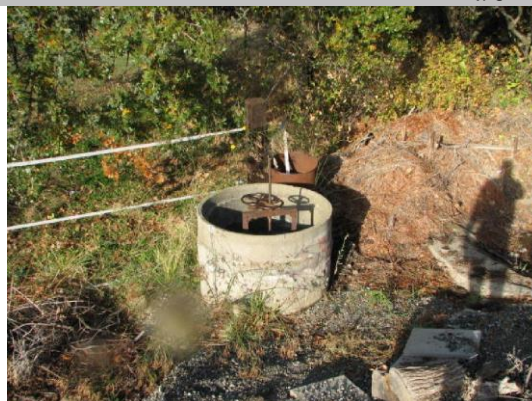
Photo 3 of 3 : UCIP_SP_2021_58304_68542.jpg

Concrete standpipe and slide gate on LS toe.

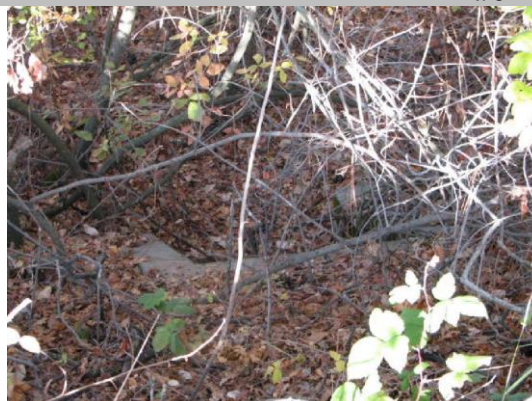
Photo 1 of 2 : UCIP_SP_2021_58312_68541.jpg

FS_ID:58312
DS_ID:1683
EP_NO: N/A
Repair Type: Non-Urgent
Crossing Status: Found
UCIP Comments: 05/18/2017 WS appears to be in good condition. LS inlet is across a ditch and inaccessible for inspection due to dense vegetation and being down a very steep slope. Pipe has been selected to be internally cleaned and inspected as part of the DMP project. (A. Freitag - DWR Sutter Yard)11/14/2016 Crossing appears to be in good condition. (A. Freitag - DWR Sutter Yard)05/11/2016 Crossing appears to be in good condition. (A. Freitag - DWR Sutter Yard)08/03/2015 Crossing appears in good condition. No noticeable issues to report. (A. Freitag - DWR Sutter Yard)11/25/2014 Same as last inspection. (A. Freitag - DWR Sutter Yard)06/04/2014 Same as last inspection. (A. Freitag - DWR Sutter Yard)11/13/2013 Same as last inspection. (A. Freitag - DWR Sutter Yard)06/06/2013 Same as last inspection. (A. Freitag - DWR Sutter Yard)

Inlet at LS toe.

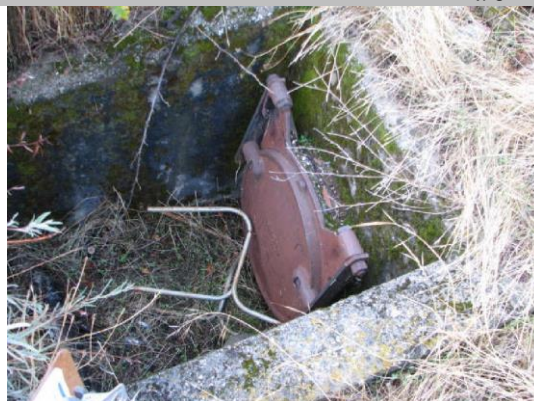
Photo 2 of 2 : UCIP_SP_2021_58312_68540.jpg

Outlet at WS toe with flap gate and concrete U-shaped headwall.

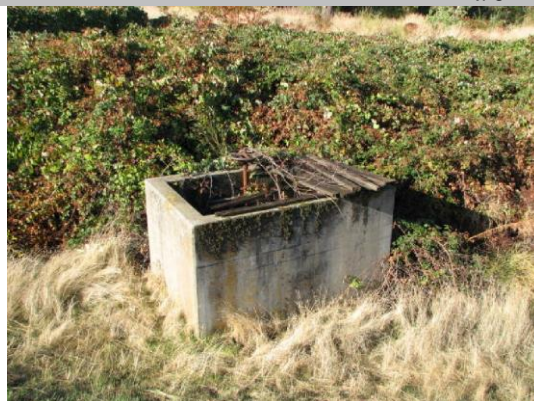
Photo 1 of 2 : UCIP_SP_2021_58308_68570.jpg

FS_ID:58308
DS_ID:1685
EP_NO: N/A
Repair Type: Non-Urgent
Crossing Status: Found
UCIP Comments: 05/18/2017 Crossing appears to be in good condition. WS riser needs a cover. (A. Freitag - DWR Sutter Yard)11/14/2016 Good condition- needs a cover for the riser. (A. Freitag - DWR Sutter Yard)05/11/2016 Needs a cover for riser. The rest of the crossing appears to be in good condition. (A. Freitag - DWR Sutter Yard)08/03/2015 Crossing appears in good condition but needs a cover made for the riser. (A. Freitag - DWR Sutter Yard)11/25/2014 Same as last inspection. (A. Freitag - DWR Sutter Yard)06/04/2014 Same as last inspection. (A. Freitag - DWR Sutter Yard)11/13/2013 Same as last inspection. (A. Freitag - DWR Sutter Yard)06/06/2013 Same as last inspection. (A. Freitag - DWR Sutter Yard)
FIELD_STRUCT_DESC: 42-inch steel irrigation pipe (siphon) through the levee, 10 feet below the crown. Slide gate in a 54-inch corrugated metal riser on the waterside (WS) slope. 5-foot by 8-foot concrete distribution box on the landside (LS). Two corrugated metal cutoff walls installed within the levee. [Additional Reference(s): DWR Levee Log, 1990 (HLM 15.22). USACE Sacramento O&M Manual, Unit 516 - Upper Butte Creek - Part No. 2, April 1960, (Station 8+30)].

Concrete distribution box with slide gate on LS toe.

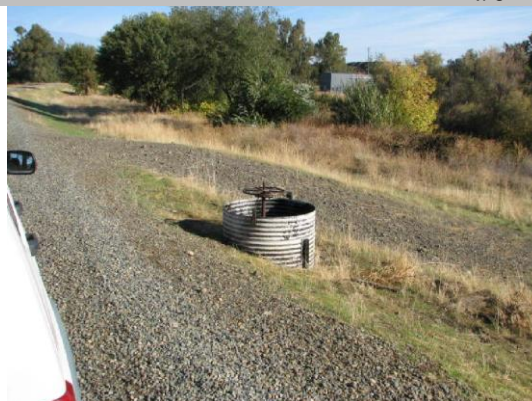
Photo 2 of 2 : UCIP_SP_2021_58308_68569.jpg

CMP riser on WS shoulder with slide gate.

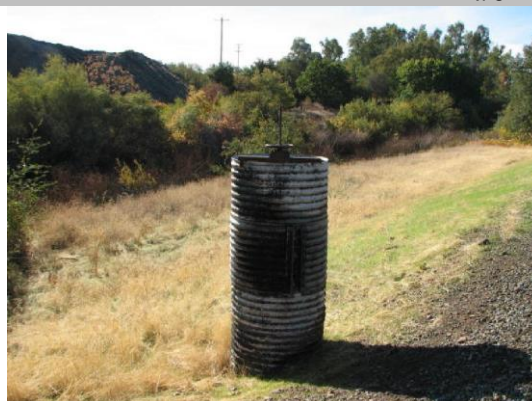
Photo 1 of 2 : UCIP_SP_2021_58309_68572.jpg

FS_ID:58309
DS_ID:1686
EP_NO: N/A
Repair Type: Non-Urgent
Crossing Status: Found
UCIP Comments: 05/18/2017 Only WS and LS standpipes visible. (A. Freitag - DWR Sutter Yard)11/14/2016 Still only WS standpipe visible. (A. Freitag - DWR Sutter Yard)05/11/2016 Only WS standpipe was visible. (A. Freitag - DWR Sutter Yard)08/03/2015 Only able to locate the standpipe on the WS. (A. Freitag - DWR Sutter Yard)11/25/2014 Same as last inspection. (A. Freitag - DWR Sutter Yard)06/04/2014 Same as last inspection. (A. Freitag - DWR Sutter Yard)11/13/2013 Same as last inspection. (A. Freitag - DWR Sutter Yard)06/06/2013 Same as last inspection. (A. Freitag - DWR Sutter Yard)
FIELD_STRUCT_DESC: 12-inch steel irrigation pipe (siphon) through the levee, 10 feet below the crown. Slide gate in a 36-inch corrugated metal riser on the waterside (WS) slope. 30-inch concrete standpipe at the landside (LS) toe. [Additional Reference(s): DWR Levee Log, 1990 (HLM 15.48). USACE Sacramento O&M Manual, Unit 516 - Upper Butte Creek - Part No. 2, April 1960, (Station 145+53)].

CMP riser on WS slope with slide gate.

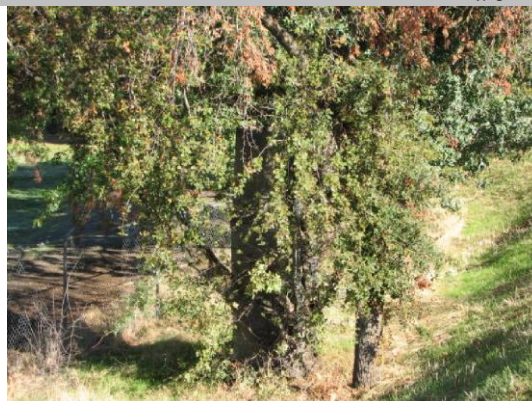
Photo 2 of 2 : UCIP_SP_2021_58309_68571.jpg

Concrete riser on LS toe.

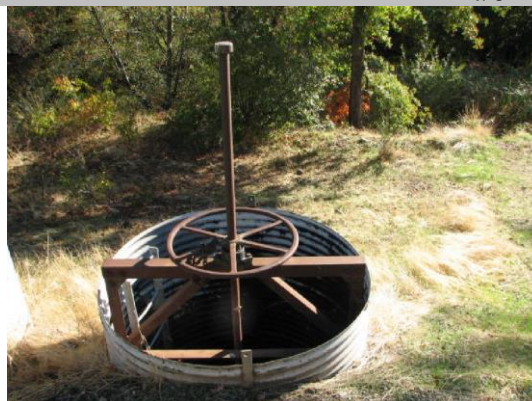
Photo 1 of 3 : UCIP_SP_2021_58310_68575.jpg

FS_ID:58310
DS_ID:1687
EP_NO: N/A
Repair Type: Non-Urgent
Crossing Status: Found
UCIP Comments: 05/18/2017 Crossing appears to be in good condition. WS riser needs a cover. (A. Freitag - DWR Sutter Yard)11/14/2016 Good condition- needs a cover for standpipe. (A. Freitag - DWR Sutter Yard)05/11/2016 Needs a lcover for riser. The rest of the crossing appears in good condition. (A. Freitag - DWR Sutter Yard)08/03/2015 Crossing is in good condition but needs a cover made for the riser. (A. Freitag - DWR Sutter Yard)11/25/2014 Same as last inspection. (A. Freitag - DWR Sutter Yard)06/04/2014 Same as last inspection. (A. Freitag - DWR Sutter Yard)11/13/2013 Same as last inspection. (A. Freitag - DWR Sutter Yard)06/06/2013 Same as last inspection. Need to construct covers for top of standpipe. (A. Freitag - DWR Sutter Yard)11/02/2012 Good candidate for video inspection. (W. Wylie - DWR UCIP)
FIELD_STRUCT_DESC: 1 of 2: 54-inch corrugated metal irrigation pipe (siphon) through the levee, 17.8 feet below the crown. Slide gate in a 66-inch corrugated metal riser on the waterside (WS). Concrete headwall and irrigation ditch at the landside (LS) toe. Edgar Slough riser units in the floodway. [Additional Reference(s): DWR Levee Log, 1990 (HLM 15.71). USACE Sacramento O&M Manual, Unit 516 - Upper Butte Creek - Part No. 2, April 1960, (Station 132+00)].

66-inch CMP riser on WS shoulder with slide gate.

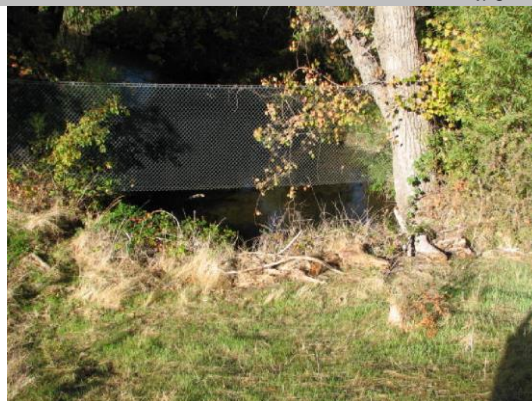
Photo 2 of 3 : UCIP_SP_2021_58310_68574.jpg

LM Start	15.47	Rating **	M	Issue No.	33 (cont)
LM End	15.47	Issue Type +	En	Location *	
Category	Supplemental		GPS Latitude/Longitude		
			Start	End	
Item	DWR UCIP Field Study		39.707544 °	39.707544 °	
			-121.777701 °	-121.777701 °	
DWR ID	1687

Irrigation ditch at LS toe.

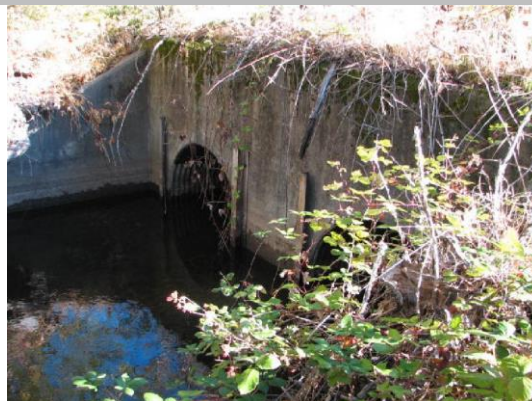
Photo 3 of 3 : UCIP_SP_2021_58310_68573.jpg

LM Start	15.47	Rating **	M	Issue No.	33 (cont)
LM End	15.47	Issue Type +	En	Location *

Concrete headwall on LS toe.

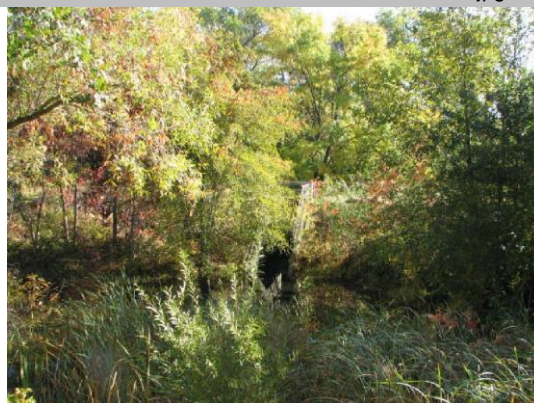
Photo 2 of 3 : UCIP_SP_2021_58311_68578.jpg

Related structure out in floodway.

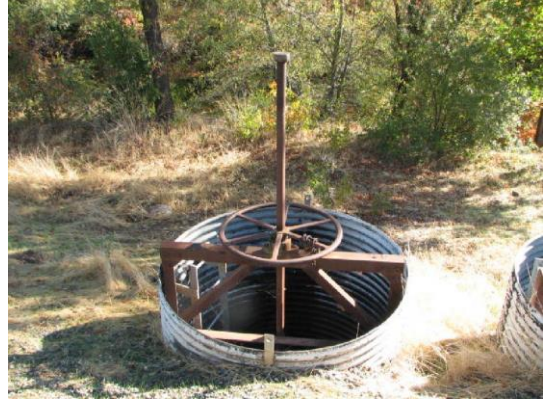
Photo 3 of 3 : UCIP_SP_2021_58311_68577.jpg

LM Start	15.48	Rating **	M	Issue No.	36 (cont)
LM End	15.48	Issue Type +	En	Location *	
Category	Supplemental			GPS Latitude/Longitude	
				Start	End
Item	DWR UCIP Field Study			39.707569 °	39.707569 °
				-121.777705 °	-121.777705 °
DWR ID	16316

66-inch CMP riser on WS shoulder.

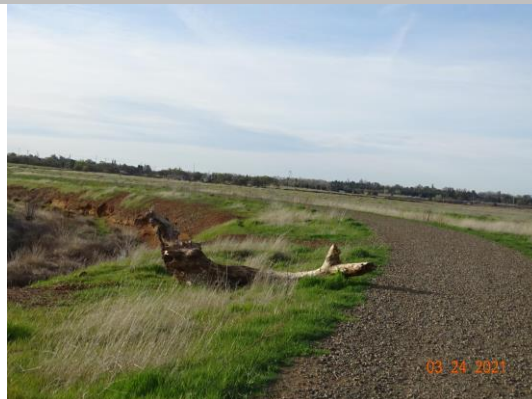
Photo 1 of 1 : SP_2021_MA0005_198_2_20210407_00002.jpg

LM Start	0.62	Rating **	M	Issue No.	2
LM End	0.62	Issue Type +	Ma	Location *	WS
Category	Earthen Levee			GPS Latitude/Longitude	
				Start	End
Item	Encroachments			39.725185 °	39.725185 °
				-121.781575 °	-121.781575 °
DWR ID	DWR_MA0005_03_s_2021_2				
Comment Code					
TR : Tree or limb					
Inspector Comment

View of the tree limb on the waterside slope. Spring 2021.
