# Flood Control Project Maintenance Levee Inspections LMA District Cover Sheet

## Sutter Maintenance Yard Maintenance Area 0005

**Flood Control Project Maintenance  
Levee Inspections  
Unit Cover Sheet**

Waterway			Bank	Unit Miles
Unit No. 01 Butte Creek			Left	15.08
	Spring (March - May)	Summer (June - August)	(September - November) Fall	Winter (December - February)
Unit Maintenance Rating (Fall Only)				
Date of Inspection	3/23/2022 - 3/23/2022			
DWR Inspector	Makar Sokol			
Accompanied By	Shawn Freitag DWR Sutter Yard

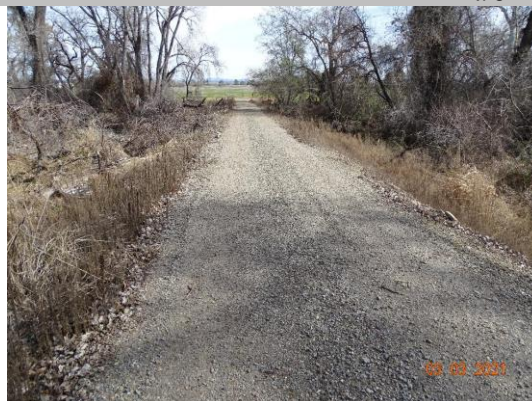
Photo 1 of 3 : UCIP\_SP\_2022\_64542\_96648.jpg

Comment Code						
Inspector Comment						
FS_ID:64542 DS_ID:1609 EP_NO: N/A Repair Type: Non-Urgent Crossing Status: Found UCIP Comments: 03/03/2021 Crossing changed from No Action Needed to Non-Urgent. Missing cover on 48-inch riser on waterside slope. No permit found authorizing this crossing. Legacy irrigation pipe. (O.Yakimov - UCIP DWR)05/15/2017 Crossing appears to be in good condition. Pipe has been selected for to be internally cleanded and inspected as part of the DMP project. (A. Freitag - DWR Sutter Yard)11/15/2016 Crossing appears to be in good condition. (A. Freitag - DWR Sutter Yard)05/09/2016 Crossing appeaers to be in good condition. (A. Freitag - DWR Sutter Yard)08/05/2015 Crossing appears in good condition. No noticeable issues to report. (A. Freitag - DWR Sutter Yard)12/08/2014 Same as last inspection. (A. Freitag - DWR Sutter Yard)06/11/2014 Same as last inspection. (A. Freitag - DWR Sutter Yard)11/20/2013 Same as last inspection. (A. Freitag - DWR Sutter Yard)05/29/2013 Same as last inspection. (A. Freitag - DWR Sutter Yard) FIELD_STRUCT_DESC: 36-inch corrugated metal irrigation pipe through the levee, 8 feet below the crown. Slide gate in a 48-inch corrugated metal riser on the waterside (WS) slope. Concrete "U" shaped headwalls at the toe of each slope. [Additional Reference(s): DWR Levee Log, 1990 (HLM 0.07). USACE Sacramento O&M Manual, Unit 516, April 1960, Revised 3 February 2011, (Station 5+92), listed as 36-inch pipe. FS Date: 3/3/2021 9:12:51 AM

Top of Levee: View of crown at the crossing.

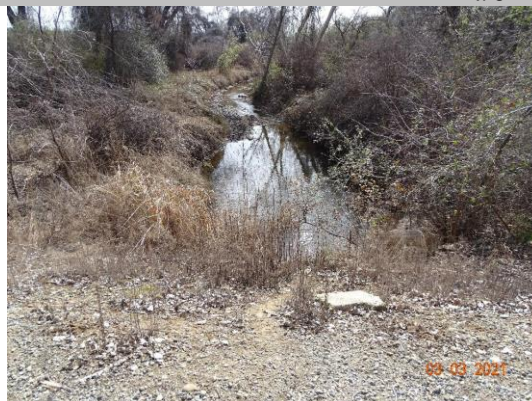
Photo 2 of 3 : UCIP\_SP\_2022\_64542\_96649.jpg

LM Start	<b>0.07</b>	Rating **	M	Issue No.	<b>2 (cont)</b>
LM End	<b>0.07</b>	Issue Type +	En	Location *	
Category	Supplemental		GPS Latitude/Longitude		
			Start	End	
Item	DWR UCIP Field Study		39.696620 °	39.696620 °	
			-121.774385 °	-121.774385 °	
DWR ID	1609

Land-Side: View landside from crown

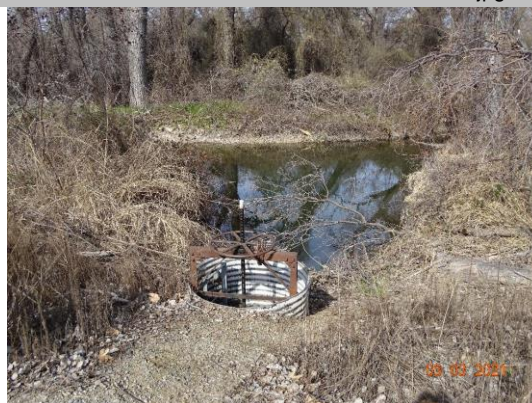
Photo 3 of 3 : UCIP\_SP\_2022\_64542\_96650.jpg

Water-Side: View of levee slope at the crossing. Slide gate in CMP riser

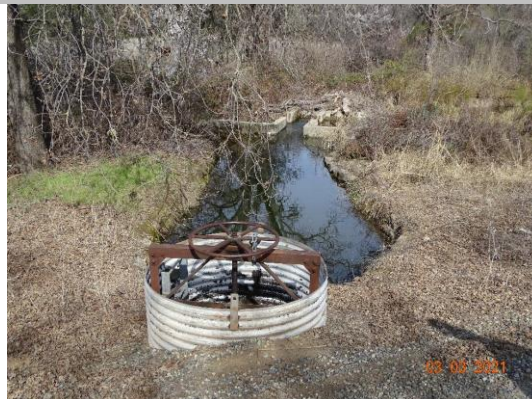
Photo 2 of 3 : UCIP\_SP\_2022\_64543\_96655.jpg

FS\_ID:64543  
DS\_ID:1610  
EP\_NO: N/A  
Repair Type: Non-Urgent  
Crossing Status: Found  
UCIP Comments: 03/03/2021 Record updated from No Action Needed to Non-Urgent. Missing cover on 36-inch CMP riser on waterside slope. No permit has been identified authorizing pipe. DMP internal video inspection has not found pipe integrity issues. LOF of crossing is less or equal to 4.0. Recommend next video inspection in 5 years.  
(O.Yakimov - DWR UCIP)  
05/15/2017 Crossing appears to be in good condition. Pipe has been selected to be internally cleaned and inspected as part of the DMP project. (A. Freitag - DWR Sutter Yard)11/15/2016 Crossing appears to be in good condition. (A. Freitag - DWR Sutter Yard)05/09/2016 Crossing appears to be in good condition. (A. Freitag - DWR Sutter Yard)08/05/2015 Crossing appears in good condition. No noticeable issues to report. (A. Freitag - DWR Sutter Yard)12/08/2014 Same as last inspection. (A. Freitag - DWR Sutter Yard)06/11/2014 Same as last inspection. (A. Freitag - DWR Sutter Yard)11/20/2013 Same as last inspection. (A. Freitag - DWR Sutter Yard)05/29/2013 Same as last inspection. (A. Freitag - DWR Sutter Yard)

LM Start	0.13	Rating **	M	Issue No.	3 (cont)	
LM End	0.13	Issue Type +	En	Location *		
Category	Supplemental			GPS Latitude/Longitude		
				Start	End	
Item	DWR UCIP Field Study			39.696005 °	39.696005 °	
				-121.775178 °	-121.775178 °	
DWR ID	1610

Water-Side: View of levee slope looking from crown. CMP riser on levee slope

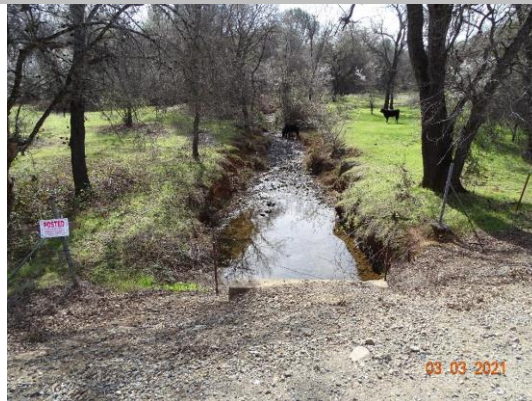
Photo 3 of 3 : UCIP\_SP\_2022\_64543\_96654.jpg

Land-Side: View of levee slope looking from crown. Irrigation ditch on landside

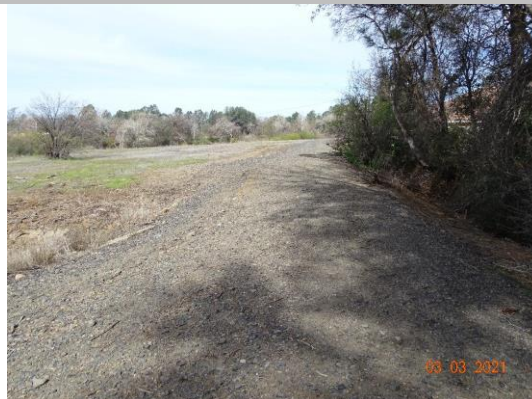
Photo 1 of 3 : UCIP\_SP\_2022\_64548\_96679.jpg

Comment Code						
Inspector Comment						
FS_ID:64548 DS_ID:1611 EP_NO: N/A Repair Type: Non-Urgent Crossing Status: Found UCIP Comments: 03/03/2021 Record updated from No Action Needed to Non-Urgent. No permit has been identified authorizing pipe. Pipe has been CIPP lined. (O.Yakimov - DWR UCIP) 05/15/2017 Crossing appears to be in good condition. Pipe has been selected to be internally cleaned and inspected as part of the DMP project. (A. Freitag - DWR Sutter Yard)11/15/2016 Crossing appears to be in good condition. (A. Freitag - DWR Sutter Yard)05/09/2016 Crossing appears to be in good condition. (A. Freitag - DWR Sutter Yard)08/05/2015 Crossing appears in good condition. No noticeable issues to report. (A. Freitag - DWR Sutter Yard)12/08/2014 Same as last inspection. (A. Freitag - DWR Sutter Yard)06/11/2014 Same as last inspection. (A. Freitag - DWR Sutter Yard)11/20/2013 Same as last inspection. (A. Freitag - DWR Sutter Yard)05/29/2013 Same as last inspection. (A. Freitag - DWR Sutter Yard) FIELD_STRUCT_DESC: 24-inch CIPP-lined corrugated metal drainage pipe through the levee, 6 feet below the crown. Flap gate on the waterside (WS). Concrete "U" shaped headwalls at the toe of the landside (LS) and the waterside (WS) slopes. [Additional Reference(s): DWR Levee Log, 1990 (HLM 0.60).USACE Sacramento O&M Manual, Unit 516, April 1960, Revised 3 February 2011, (Station 205+60), listed as 24-inch pipe]. FS Date: 3/3/2021 10:15:11 AM

Top of Levee: View of levee crown looking downstream

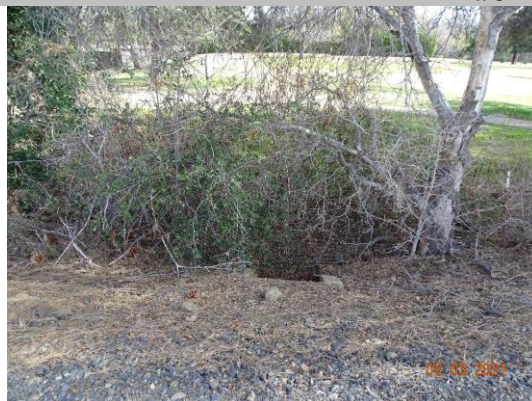
Photo 2 of 3 : UCIP\_SP\_2022\_64548\_96680.jpg

LM Start	0.57	Rating **	M	Issue No.	4 (cont)
LM End	0.57	Issue Type +	En	Location *	
Category	Supplemental			GPS Latitude/Longitude	
				Start	End
Item	DWR UCIP Field Study			39.690612 °	39.690612 °
				-121.777235 °	-121.777235 °
DWR ID	1611

Land-Side: View of levee slope looking from crown

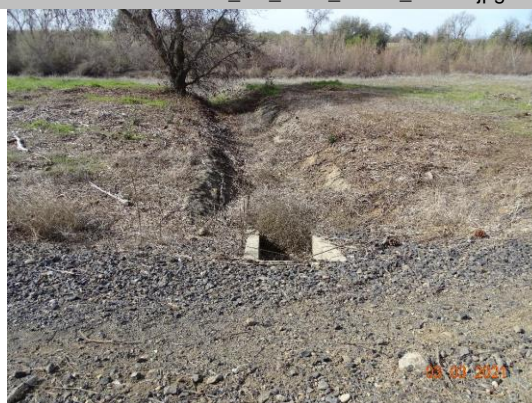
Photo 3 of 3 : UCIP\_SP\_2022\_64548\_96681.jpg

Water-Side: View of levee slope looking from crown. U-shaped headwall on levee slope

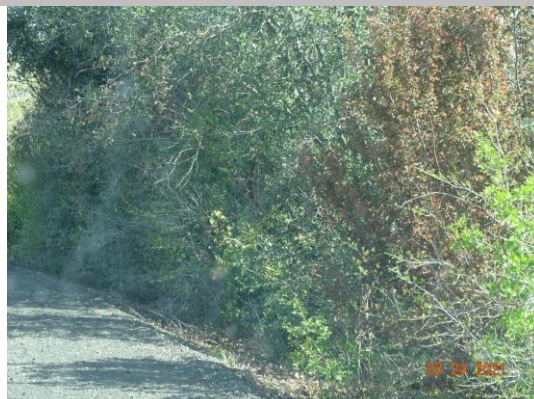
Photo 1 of 1 : SP\_2022\_MA0005\_196\_32\_20220307\_00008.jpg

LM Start	0.58	Rating **	M	Issue No.	32
LM End	0.68	Issue Type +	Ma	Location *	LS
Category	Earthen Levee			GPS Latitude/Longitude	
				Start	End
Item	Trim / Thin Trees			39.690496 °	39.689137 °
				-121.777109 °	-121.776938 °
DWR ID	DWR_MA0005_01_s_2014_32				
Comment Code					
T1 : Trim and thin trees to at least five feet above ground level to allow visibility of the ground and room to flood fight.					
Inspector Comment					
Trees smaller than 4-inches in diameter at chest height should be removed from the landside slope and within ten feet of the landside toe.

View of the trees along the landside toe blocking visibility. Spring 2021.

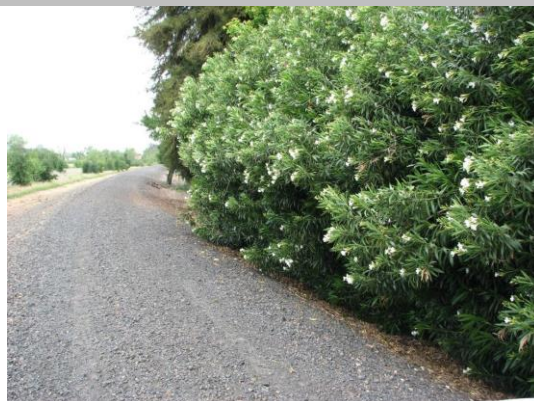
Photo 1 of 1 : SP\_2022\_MA0005\_196\_44\_20220307\_00014.jpg

LM Start	0.68	Rating **	M	Issue No.	44
LM End	0.77	Issue Type +	En	Location *	LS
Category	Earthen Levee			GPS Latitude/Longitude	
				Start	End
Item	Vegetation			39.689135 °	39.687968 °
				-121.776929 °	-121.777387 °
DWR ID	DWR_MA0005_01_s_2016_44				
Comment Code					
V6 : Landscaping					
Inspector Comment

View of oleanders along the landside toe.

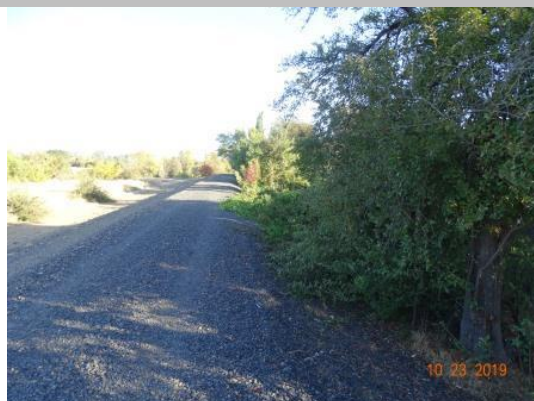
Photo 1 of 1 : SP\_2022\_MA0005\_196\_47\_20220307\_00015.jpg

LM Start	0.79	Rating **	M	Issue No.	47
LM End	0.82	Issue Type +	En	Location *	LS
Category	Earthen Levee			GPS Latitude/Longitude	
				Start	End
Item	Vegetation			39.687676 °	39.687193 °
				-121.777419 °	-121.777461 °
DWR ID	DWR_MA0005_01_f_2019_47				
Comment Code					
V6 : Landscaping					
Inspector Comment

View of trees that require trimming along the landside slope. Fall 2019.

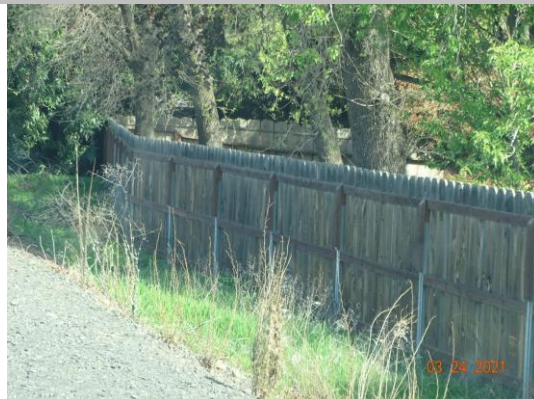
Photo 1 of 1 : SP\_2022\_MA0005\_196\_49\_20220307\_00016.jpg

LM Start	0.90	Rating **	U	Issue No.	49
LM End	0.94	Issue Type +	En	Location *	LS
Category	Earthen Levee			GPS Latitude/Longitude	
				Start	End
Item	Encroachments			39.686087 °	39.685418 °
				-121.777555 °	-121.777448 °
DWR ID	DWR_MA0005_01_f_2016_49				
Comment Code					
FE : Fence					
Inspector Comment

View of the wood plank fence at the landside toe. Spring 2021.

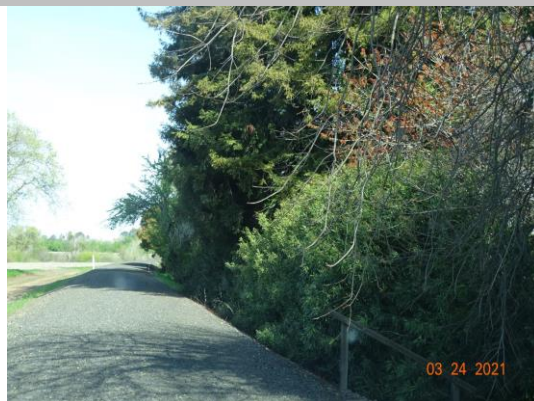
Photo 1 of 1 : SP\_2022\_MA0005\_196\_50\_20220307\_00017.jpg

LM Start	0.98	Rating **	U	Issue No.	50
LM End	1.00	Issue Type +	En	Location *	LS
Category	Earthen Levee			GPS Latitude/Longitude	
				Start	End
Item	Vegetation			39.684843 °	39.684606 °
				-121.777132 °	-121.776975 °
DWR ID	DWR_MA0005_01_f_2016_50				
Comment Code					
V6 : Landscaping					
Inspector Comment					
Oleanders are blocking visibility.

View of the landscaping along the landside toe. Spring 2021.

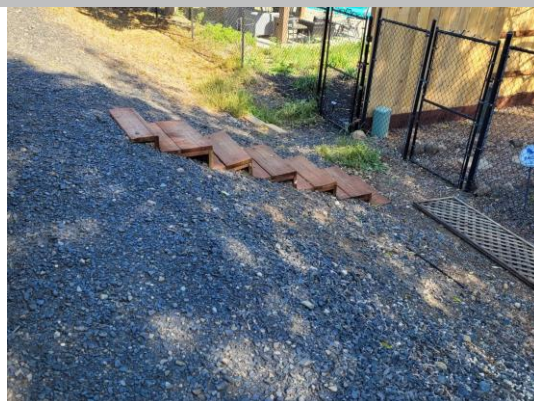
Photo 1 of 1 : SP\_2022\_MA0005\_196\_87\_20220328\_00149.jpg

LM Start	1.02	Rating **	M	Issue No.	87
LM End	1.02	Issue Type +	En	Location *	LS
Category	Earthen Levee			GPS Latitude/Longitude	
				Start	End
Item	Encroachments			39.684334 °	39.684334 °
				-121.776814 °	-121.776814 °
DWR ID	DWR_MA0005_01_s_2022_87				
Comment Code					
ST : Stairway					
Inspector Comment

View of the stairway on the landside slope. Spring 2022.

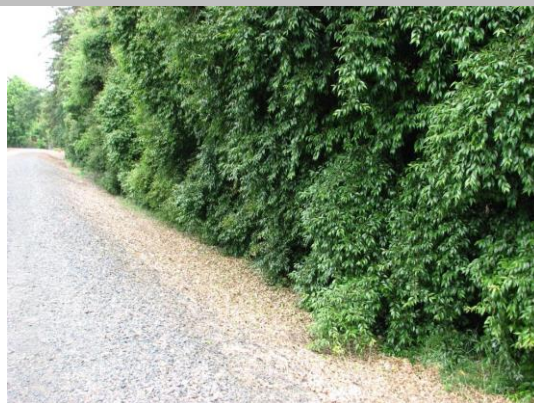
Photo 1 of 1 : SP\_2022\_MA0005\_196\_43\_20220307\_00013.jpg

LM Start	1.16	Rating **	M	Issue No.	43
LM End	1.24	Issue Type +	En	Location *	LS
Category	Earthen Levee			GPS Latitude/Longitude	
				Start	End
Item	Vegetation			39.682402 °	39.681322 °
				-121.776405 °	-121.776506 °
DWR ID	DWR_MA0005_01_s_2016_43				
Comment Code					
V6 : Landscaping					
Inspector Comment

View of the overgrown vegetation at the landside toe.

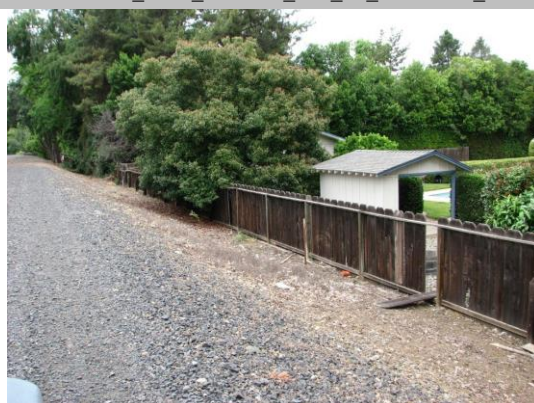
Photo 1 of 1 : SP\_2022\_MA0005\_196\_42\_20220307\_00012.jpg

LM Start	1.24	Rating **	U	Issue No.	42
LM End	1.26	Issue Type +	En	Location *	LS
Category	Earthen Levee			GPS Latitude/Longitude	
				Start	End
Item	Encroachments			39.681305 °	39.681044 °
				-121.776533 °	-121.776547 °
DWR ID	DWR_MA0005_01_s_2016_42				
Comment Code					
FE : Fence					
Inspector Comment

View of the wood plank fence at the landside toe.

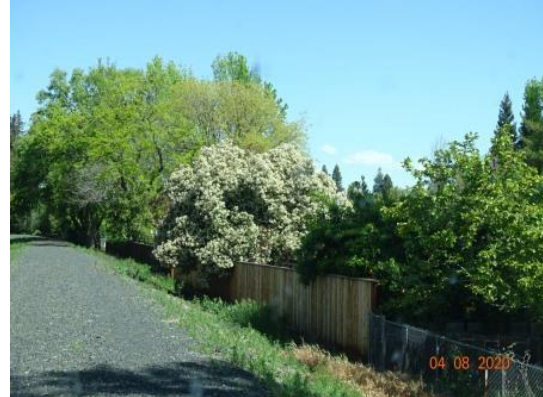
Photo 1 of 1 : SP\_2022\_MA0005\_196\_41\_20220307\_00011.jpg

LM Start	1.30	Rating **	U	Issue No.	41
LM End	1.36	Issue Type +	En	Location *	LS
Category	Earthen Levee			GPS Latitude/Longitude	
				Start	End
Item	Encroachments			39.680452 °	39.679551 °
				-121.776667 °	-121.776904 °
DWR ID	DWR_MA0005_01_s _ 2016_41				
Comment Code					
FE : Fence					
Inspector Comment					
Wood plank fencing across multiple properties.

View of the fence along the landside toe. Spring 2020.

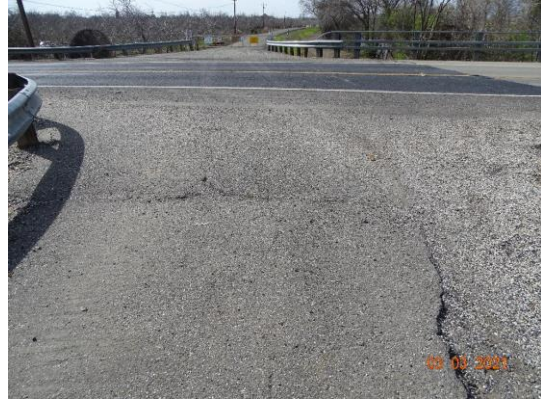
Photo 1 of 3 : UCIP\_SP\_2022\_64992\_97290.jpg

Comment Code						
Inspector Comment						
FS_ID:64992 DS_ID:1613 EP_NO: N/A Repair Type: Non-Urgent Crossing Status: Found UCIP Comments: 03/03/2021 Record updated from No Action Needed to Non-Urgent. No inspection records were available to determine status of line through the levee. No permit has been found authorizing this pipe through the levee. Gas line sign installed only on waterside shoulder. Cathodic protection testing point attached to the sign. (O.Yakimov - DWR UCIP) 05/15/2017 Crossing appears to be in good condition. (A. Freitag - DWR Sutter Yard)11/15/2016 Crossing appears to be in good condition. (A. Freitag - DWR Sutter Yard)05/09/2016 Crossing appears to be in good condition. (A. Freitag - DWR Sutter Yard)08/05/2015 Pipeline is located inside of bridge. (A. Freitag - DWR Sutter Yard) 12/08/2014 Same as last inspection. (A. Freitag - DWR Sutter Yard)06/11/2014 Same as last inspection. (A. Freitag - DWR Sutter Yard)11/20/2013 Same as last inspection. (A. Freitag - DWR Sutter Yard)05/29/2013 Same as last inspection. (A. Freitag - DWR Sutter Yard) FIELD_STRUCT_DESC: 7-inch gas line of an unknown material through the levee, 3 feet below the crown. Vent located on the waterside (WS) shoulder. Plans for bridge replacement show the utility crossing under the westbound lane inside the bridge. (Existing bridge replacement authorized under Permit No. 14301, 1986 - Butte County Department of Public Works). [Additional Reference(s): DWR Levee Log, 1990 (HLM 1.50)]. FS Date: 3/3/2021 2:36:42 PM

Top of Levee: View of levee crown looking downstream

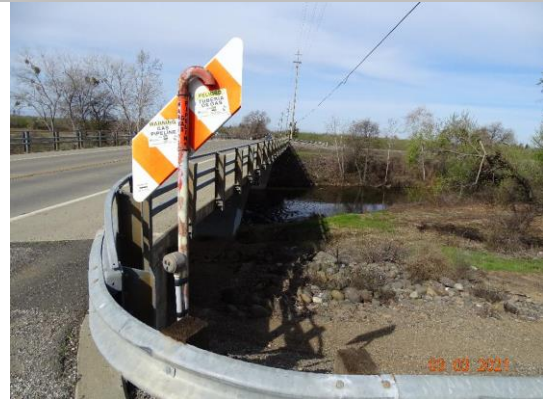
Photo 2 of 3 : UCIP\_SP\_2022\_64992\_97291.jpg

LM Start	<b>1.46</b>	Rating **	M	Issue No.	<b>7 (cont)</b>
LM End	<b>1.46</b>	Issue Type +	En	Location *	
Category	Supplemental		GPS Latitude/Longitude		
			Start	End	
Item	DWR UCIP Field Study		39.678151 °	39.678151 °	
			-121.777263 °	-121.777263 °	
DWR ID	1613

Water-Side: View of levee slope looking from crown. Gas line sign on levee shoulder

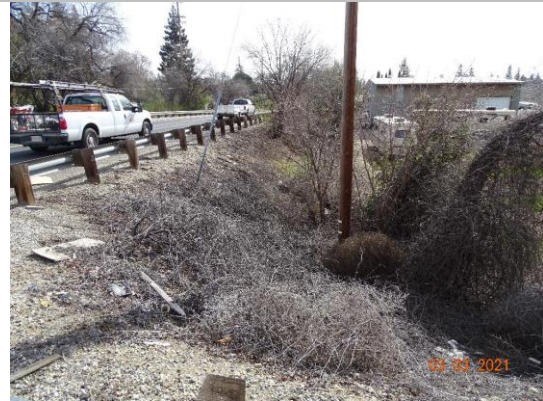
Photo 2 of 3 : UCIP\_SP\_2022\_65002\_97303.jpg

Comment Code						
Inspector Comment						
FS_ID:65002 DS_ID:1640 EP_NO: 13778 Repair Type: Non-Urgent Crossing Status: Not Found UCIP Comments: 03/03/2021 Record updated from No Action Needed to Non-Urgent. Crossing not found. According to description conduit could be located inside the bridge under the east bound lane. (O.Yakimov - DWR UCIP) 05/15/2017 Conduit ran inside of bridge. Not visible from the levee. (A. Freitag - DWR Sutter Yard)11/15/2016 Crossing description says conduit is ran inside of the bridge. (A. Freitag - DWR Sutter Yard)05/09/2016 Unable to locate. (A. Freitag - DWR Sutter Yard)  08/05/2015 Crossing is said to be located inside of the bridge. (A. Freitag - DWR Sutter Yard)12/08/2014 Unable to locate. (A. Freitag - DWR Sutter Yard)06/11/2014 Same as last inspection. (A. Freitag - DWR Sutter Yard)11/20/2013 Same as last inspection. (A. Freitag - DWR Sutter Yard)05/29/2013 Same as last inspection. (A. Freitag - DWR Sutter Yard) FIELD_STRUCT_DESC: 4-inch fiberglass communication conduit through the levee, 4 feet below the crown, not found. Conduit crosses at the downstream side of the bridge. Plans for bridge replacement indicate utilities were relocated inside the bridge under the east bound lane. (4-inch fiber glass duct through both levees authorized under Permit No. 13778, 1984 - Pacific Bell). [Additional Reference(s): DWR Levee Log, 1990 (HLM 1.50)]. FS Date: 3/3/2021 3:07:42 PM

LM Start	<b>1.47</b>	Rating **	M	Issue No.	<b>8 (cont)</b>
LM End	<b>1.47</b>	Issue Type +	En	Location *	
Category	Supplemental		GPS Latitude/Longitude		
			Start	End	
Item	DWR UCIP Field Study		39.677995 °	39.677995 °	
			-121.777263 °	-121.777263 °	
DWR ID	1640

Land-Side: View of levee slope looking from crown

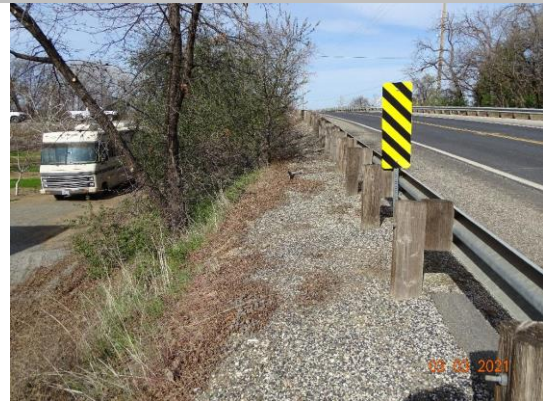
Photo 3 of 3 : UCIP\_SP\_2022\_65002\_97304.jpg

Water-Side: View of levee slope looking from crown

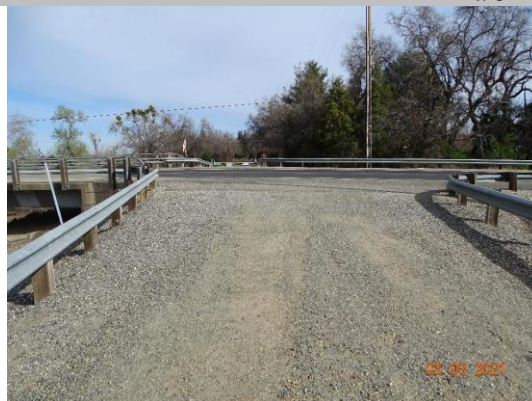
Photo 1 of 3 : UCIP\_SP\_2022\_65004\_97305.jpg

Comment Code						
Inspector Comment						
FS_ID:65004 DS_ID:1767 EP_NO: 5411 Repair Type: Non-Urgent Crossing Status: Not Found UCIP Comments: 03/03/2021 Record updated from No Action Needed to Non-Urgent. Crossing not found. According to description conduit located inside the bridge under the east bound lane. (O.Yakimov - DWR UCIP) 05/15/2017 Crossing appears to be in good condition. (A. Freitag - DWR Sutter Yard)11/15/2016 Crossing appears to be in good condition. (A. Freitag - DWR Sutter Yard)05/09/2016 Crossing appears to be in good condition. (A. Freitag - DWR Sutter Yard)08/05/2015 Crossing is said to be located inside of bridge. (A. Freitag - DWR Sutter Yard)12/08/2014 Same as last inspection. (A. Freitag - DWR Sutter Yard)06/11/2014 Same as last inspection. (A. Freitag - DWR Sutter Yard)11/20/2013 Same as last inspection. (A. Freitag - DWR Sutter Yard)05/29/2013 Same as last inspection. (A. Freitag - DWR Sutter Yard) FIELD_STRUCT_DESC: 3.5-inch steel communication conduit through the levee, 3 feet below the crown. Plans for the bridge place the communication conduits inside the bridge under the east bound lane. (three 3.5-inch pipe conduits authorized under Permit No. 5411, 1966 - Pacific Telephone and Telegraph Company [PT&T]). (New bridge construction authorized under Permit No. 14301, 1986 - Butte County Department of Public Works). [Additional Reference(s): DWR Levee Log, 1990 (HLM 1.50)]. FS Date: 3/3/2021 3:29:53 PM

Top of Levee: View of levee crown looking upstream

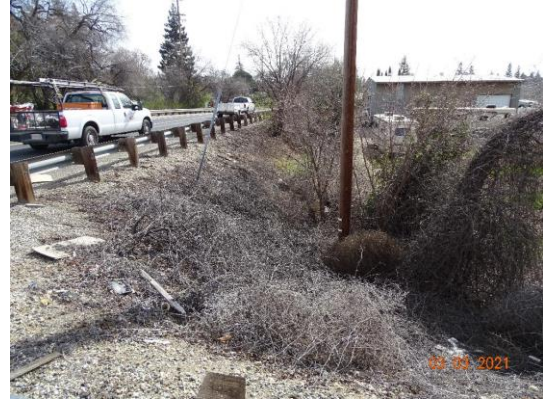
Photo 2 of 3 : UCIP\_SP\_2022\_65110\_97322.jpg

Comment Code						
Inspector Comment						
FS_ID:65110 DS_ID:1766 EP_NO: 5411 Repair Type: Non-Urgent Crossing Status: Not Found UCIP Comments: 03/03/2021 Record updated from No Action Needed to Non-Urgent. Crossing not found. According to description conduit located inside the bridge under the east bound lane. (O.Yakimov - DWR UCIP) 05/15/2017 Crossing appears to be in good condition. (A. Freitag - DWR Sutter Yard)11/15/2016 Crossing appears to be in good condition. (A. Freitag - DWR Sutter Yard)05/09/2016 Crossing appears to be in good condition. (A. Freitag - DWR Sutter Yard)08/05/2015 Crossing is said to be located inside of bridge. (A. Freitag - DWR Sutter Yard)12/08/2014 Same as last inspection. (A. Freitag - DWR Sutter Yard)06/11/2014 Same as last inspection. (A. Freitag - DWR Sutter Yard)11/20/2013 Same as last inspection. (A. Freitag - DWR Sutter Yard)05/29/2013 Same as last inspection. (A. Freitag - DWR Sutter Yard) FIELD_STRUCT_DESC: 3.5-inch steel communication conduit through the levee, 3 feet below the crown. Plans for the bridge place the communication conduits inside the bridge under the east bound lane. (three 3.5-inch pipe conduits authorized under Permit No. 5411, 1966 - Pacific Telephone and Telegraph Company [PT&T]). (New bridge construction authorized under Permit No. 14301, 1986 - Butte County Department of Public Works). [Additional Reference(s): DWR Levee Log, 1990 (HLM 1.50)]. FS Date: 3/3/2021 9:13:18 AM

LM Start	1.47	Rating **	M	Issue No.	15 (cont)
LM End	1.47	Issue Type +	En	Location *	
Category	Supplemental			GPS Latitude/Longitude	
				Start	End
Item	DWR UCIP Field Study			39.677995 °	39.677995 °
				-121.777263 °	-121.777263 °
DWR ID	1766

Land-Side: View of levee slope looking from crown

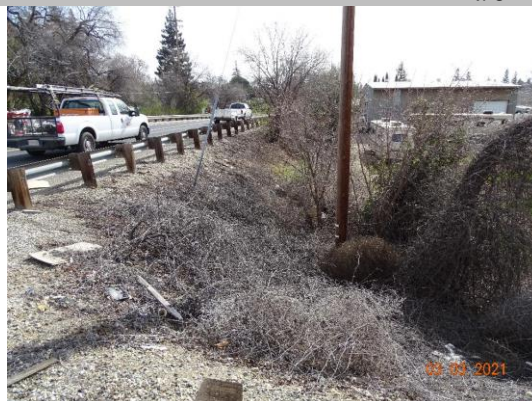
Photo 2 of 3 : UCIP\_SP\_2022\_65111\_97325.jpg

Comment Code						
Inspector Comment						
FS_ID:65111 DS_ID:1765 EP_NO: 5411 Repair Type: Non-Urgent Crossing Status: Not Found UCIP Comments: 03/03/2021 Record updated from No Action Needed to Non-Urgent. Crossing not found. According to description conduit located inside the bridge under the east bound lane. (O.Yakimov - DWR UCIP) 05/15/2017 Crossing appears to be in good condition. (A. Freitag - DWR Sutter Yard)11/15/2016 Crossing appears to be in good condition. (A. Freitag - DWR Sutter Yard)05/09/2016 Crossing appears to be in good condition. (A. Freitag - DWR Sutter Yard)08/05/2015 Crossing is said to be located inside of bridge. (A. Freitag - DWR Sutter Yard)12/08/2014 Same as last inspection. (A. Freitag - DWR Sutter Yard)06/11/2014 Same as last inspection. (A. Freitag - DWR Sutter Yard)11/20/2013 Same as last inspection. (A. Freitag - DWR Sutter Yard)05/29/2013 Same as last inspection. (A. Freitag - DWR Sutter Yard) FIELD_STRUCT_DESC: 3.5-inch steel communication conduit through the levee, 3 feet below the crown. Plans for the bridge place the communication conduits inside the bridge under the east bound lane. (three 3.5-inch pipe conduits authorized under Permit No. 5411, 1966 - Pacific Telephone and Telegraph Company [PT&T]). (New bridge construction authorized under Permit No. 14301, 1986 - Butte County Department of Public Works). [Additional Reference(s): DWR Levee Log, 1990 (HLM 1.50)]. FS Date: 3/3/2021 9:15:32 AM

LM Start	1.47	Rating **	M	Issue No.	16 (cont)
LM End	1.47	Issue Type +	En	Location *	
Category	Supplemental			GPS Latitude/Longitude	
				Start	End
Item	DWR UCIP Field Study			39.677995 °	39.677995 °
				-121.777263 °	-121.777263 °
DWR ID	1765

Land-Side: View of levee slope looking from crown

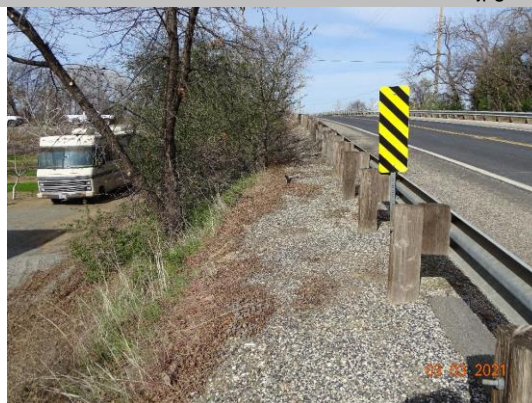
Photo 3 of 3 : UCIP\_SP\_2022\_65111\_97326.jpg

Land-Side: Road shoulder downstream of bridge

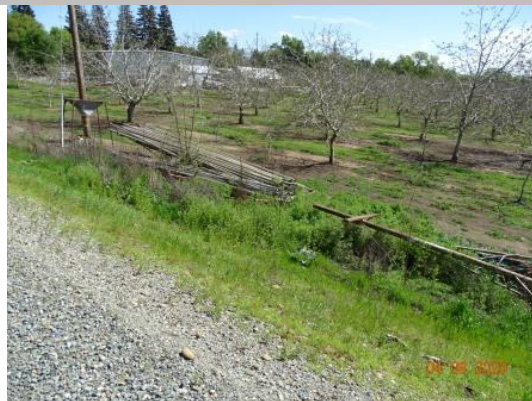
Photo 1 of 1 : SP\_2022\_MA0005\_196\_30\_20220307\_00007.jpg

LM Start	1.53	Rating **	M	Issue No.	30
LM End	1.53	Issue Type +	En	Location *	LS
Category	Earthen Levee			GPS Latitude/Longitude	
				Start	End
Item	Encroachments			39.677130 °	39.677130 °
				-121.777583 °	-121.777583 °
DWR ID	DWR_MA0005_01_f _ 2014_30				
Comment Code					
EQ : Equipment					
Inspector Comment

View of the sprinkler pipe and equipment along the landside toe. Spring 2020.

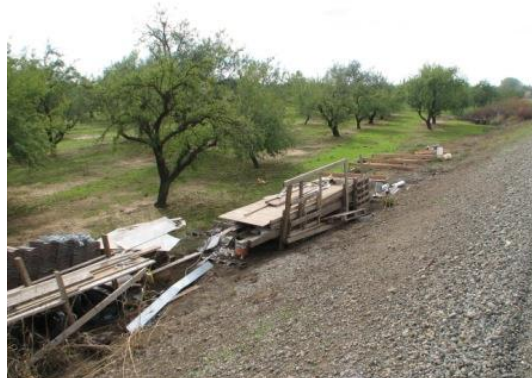
Photo 1 of 1 : SP\_2022\_MA0005\_196\_1\_20220307\_00001.jpg

View of the construction supply on pallets.

LM Start	1.66	Rating **	M	Issue No.	1
LM End	1.66	Issue Type +	En	Location *	LS
Category	Earthen Levee			GPS Latitude/Longitude	
				Start	End
Item	Encroachments			39.675528 °	39.675528 °
				-121.778642 °	-121.778642 °
DWR ID	DWR_MA0005_01_s _ 2012_1				
Comment Code					
MA : Material					
Inspector Comment					
The materials and equipment should be moved ten feet away from the landside toe.

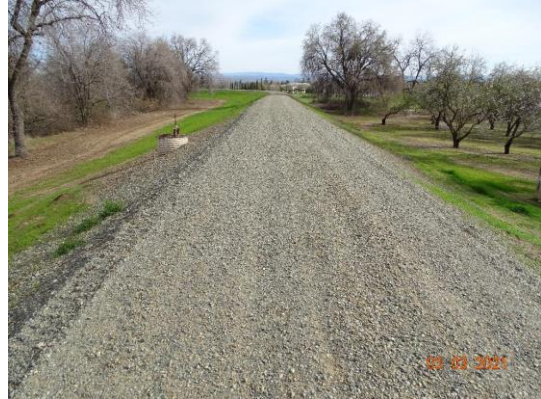
Photo 1 of 3 : UCIP\_SP\_2022\_65126\_97330.jpg

Comment Code					
Inspector Comment					
FS_ID:65126 DS_ID:1614 EP_NO: N/A Repair Type: Non-Urgent Crossing Status: Found UCIP Comments: 03/03/2021 Record updated from No Action Needed to Non-Urgent. Geophysical study indicates presence of pipe through levee. No permit has been identified authorizing pipe. (O.Yakimov - DWR UCIP) 05/15/2017 Crossing appears to be in good condition. This is a siphon that runs under neath Butte Creek channel and crosses through the Unit2 (right bank levee) at CLM 12.064 and is DS_ID 1672. (A. Freitag - DWR Sutter Yard)11/15/2016 Crossing appears to be in good condition. (A. Freitag - DWR Sutter Yard)05/09/2016 Crossing appears to be in good condition. (A. Freitag - DWR Sutter Yard)08/05/2015 Crossing appears in good condition. No noticeable issues to report. (A. Freitag - DWR Sutter Yard)12/08/2014 Same as last inspection. (A. Freitag - DWR Sutter Yard)06/11/2014 Same as last inspection. (A. Freitag - DWR Sutter Yard)11/20/2013 Same as last inspection. (A. Freitag - DWR Sutter Yard)05/29/2013 Same as last inspection. (A. Freitag - DWR Sutter Yard) FIELD_STRUCT_DESC: 36-inch corrugated metal irrigation pipe through the levee, 17.5 feet below the crown. Siphon across the channel. Slide gate in a 48-inch corrugated metal riser on the waterside (WS) slope. 6 foot by 6 foot concrete distribution box with two slide gates 10 feet from the landside (LS) toe. [Additional Reference(s): DWR Levee Log, 1990 (HLM 2.87). USACE Sacramento O&M Manual, Unit 516, April 1960, Revised 3 February 2011, (Station 324+50), listed as 36-inch pipe.]. FS Date: 3/3/2021 9:32:58 AM

Top of Levee: View of levee crown looking upstream

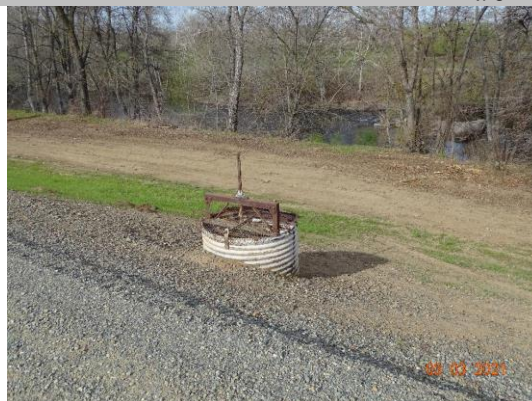
Photo 2 of 3 : UCIP\_SP\_2022\_65126\_97332.jpg

Water-Side: View of levee slope looking from crown

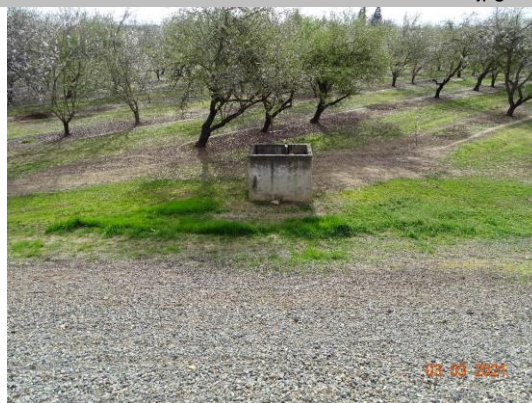
Photo 3 of 3 : UCIP\_SP\_2022\_65126\_97331.jpg

Land-Side: View of levee slope looking from crown

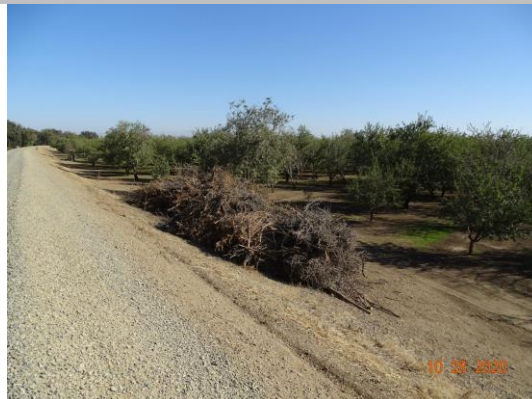
Photo 1 of 1 : SP\_2022\_MA0005\_196\_37\_20220307\_00009.jpg

View of the prunings along the landside toe. Fall 2020.

LM Start	3.06	Rating **	M	Issue No.	37
LM End	3.06	Issue Type +	En	Location *	LS
Category	Earthen Levee			GPS Latitude/Longitude	
				Start	End
Item	Encroachments			39.656911 °	39.656911 °
				-121.787097 °	-121.787097 °
DWR ID	DWR_MA0005_01_f _ 2015_37				
Comment Code					
PR : Prunings					
Inspector Comment					
Remove the prunings from the landside toe.

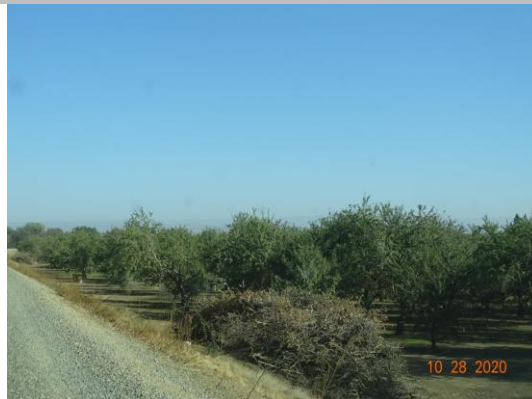
Photo 1 of 1 : SP\_2022\_MA0005\_196\_38\_20220307\_00010.jpg

View of the prunings along the landside toe. Fall 2020.

LM Start	3.21	Rating **	M	Issue No.	38
LM End	3.21	Issue Type +	En	Location *	LS
Category	Earthen Levee			GPS Latitude/Longitude	
				Start	End
Item	Encroachments			39.654938 °	39.654938 °
				-121.787892 °	-121.787892 °
DWR ID	DWR_MA0005_01_f _ 2015_38				
Comment Code					
PR : Prunings					
Inspector Comment					
Remove the prunings from the landside toe.

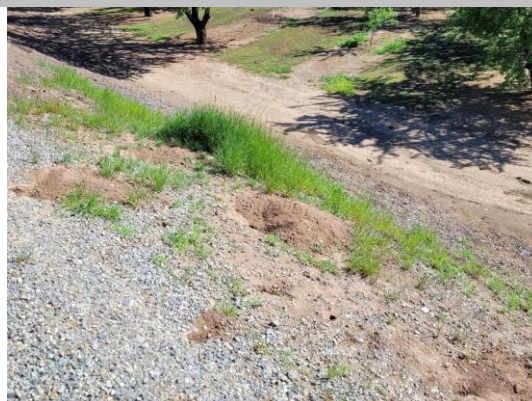
Photo 1 of 1 : SP\_2022\_MA0005\_196\_83\_20220328\_00150.jpg

LM Start	3.24	Rating **	M	Issue No.	83
LM End	3.24	Issue Type +	Ma	Location *	LS
Category	Earthen Levee			GPS Latitude/Longitude	
				Start	End
Item	Animal Control			39.654491 °	39.654491 °
				-121.788095 °	-121.788095 °
DWR ID	DWR_MA0005_01_s_2022_83				
Comment Code					
A3 : No rodents visible, but rodent burrows visible; need to backfill and compact or grout burrows.					
Inspector Comment

View of the rodent holes on the landside slope. Spring 2022.

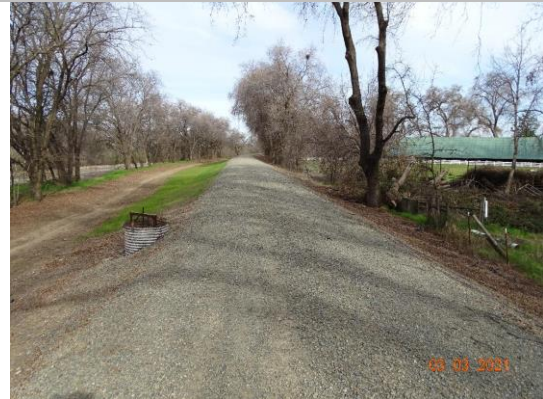
Photo 1 of 3 : UCIP\_SP\_2022\_65176\_97377.jpg

FS\_ID:65176  
DS\_ID:1615  
EP\_NO: N/A  
Repair Type: Non-Urgent  
Crossing Status: Found  
UCIP Comments: 03/03/2021 Record remains Non-Urgent. No permit has been identified authorizing pipe. DMP internal video inspection has not found pipe integrity issues. LOF of crossing is less or equal to 4.0. Recommend next video inspection in 5 years. (O.Yakimov - DWR UCIP)  
07/30/2020 UCIP staff received CVFPB Enforcement Case No. 9708 Compliance Letter confirming repair of screw gate by Durham Mutual Water Company. CVFPB Enforcement Case No. 2019-9708 has been closed. Owner is seeking permit for 30-inch pipe. UCIP record will be update the UCIP record when the permit is issued by the CVFPB. (O. Magana - DWR UCIP)06/05/2019 Durham Mutual Water Company fixed broken slide gate by replacing a stem. Operating wheel is missing. Crossing downgraded to non-urgent. (O. Yakimov - DWR UCIP)10/5/2018 Observed pipe running during inspection. Pipe is used to drain water from LS concrete box to WS. Field structure description was updated to show structure type as drainage pipe. Confirmed that the concrete box on LS receives water from a pipe running along the LS toe from orchards upstream and distributes water between 3 pipes, one of which crosses levee at an angle. Missing closure device on WS. Screw gate stuck in open position inside CMP riser located on WS shoulder and is not operable. (O. Yakimov - DWR)5/15/2017 WS slide gate stem bent and gate is stuck in the open position. Outlet in the the concrete box on the WS berm is opened and allowed water to free flow through the pipe during the Jan/Feb 2017 high water events. Either the screw gate needs to be repaired or a flap gate added to the outlet in the concrete box to not allow high water flows though the levee. Pipe is believed to be owned and operated by Duhram Mutual Water Company at 1807 Duhram Dayton HWY, PO Box 612, Duhram CA 95938 (530)342-9324. (A. Freitag - DWR Sutter Yard) 11/15/2016 Abandoned- slide gate is opened and inoperable. Needs to be properly abandoned. (A. Freitag - DWR Sutter Yard)05/09/2016 Abandoned crossing. Slide gate stem bent and wheel is missing. (A. Freitag - DWR Sutter Yard)08/05/2015 Abandoned crossing. Slide gate stem is bent and gate is inoperable. Needs to be properly abandoned. (A. Freitag - DWR Sutter Yard)12/08/2014 Same as last inspection. (A. Freitag - DWR Sutter Yard)06/11/2014 Same as last inspection. (A. Freitag - DWR Sutter Yard)11/20/2013 Same as last inspection. (A. Freitag - DWR Sutter Yard)05/29/2013 Same as last inspection. (A. Freitag - DWR Sutter Yard)10/30/2012 Pipe appears to be abandoned. Slide gate open and inoperable. Pipe should be properly abandoned. (W. Wylie - DWR UCIP)

Top of Levee: View of levee crown looking upstream

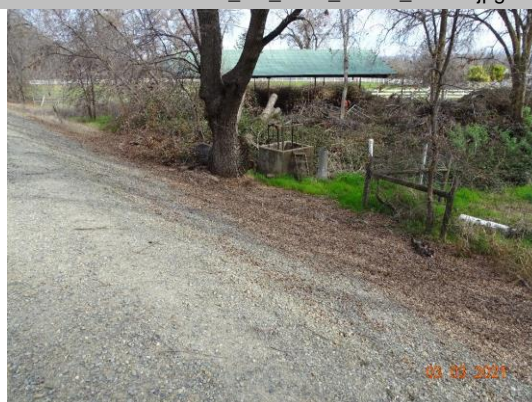
Photo 2 of 3 : UCIP\_SP\_2022\_65176\_97375.jpg

Land-Side: View of levee slope looking from crown

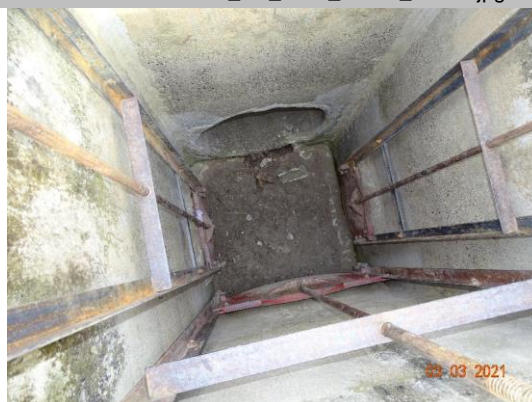
Photo 3 of 3 : UCIP\_SP\_2022\_65176\_97376.jpg

Land-Side: View inside of concrete distribution box at levee toe

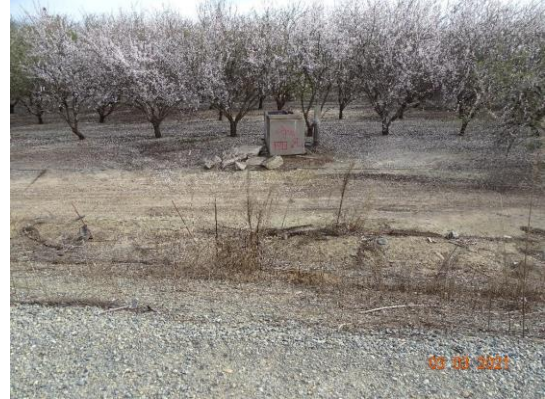
Photo 2 of 3 : UCIP\_SP\_2022\_65178\_97385.jpg

Comment Code					
Inspector Comment					
FS_ID:65178 DS_ID:1616 EP_NO: N/A Repair Type: Non-Urgent Crossing Status: Found UCIP Comments: 03/03/2021 Record remains Non-Urgent. Excavation on landside near concrete distribution box has been backfilled. No permit has been identified authorizing pipe. (O.Yakimov - DWR UCIP) 06/05/2019 No issues recorded during inspection. (O.Yakimov - DWR UCIP) 05/15/2017 Crossing appears to be in good condition. LS inlet is located in the Distribution box on the LS toe. This is an overflow pipe used to regulate water levels in side the box. Pipe has been selected to be internally cleaned and inspected as part fo the DMP project. (A. Freitag - DWR Sutter Yard)11/15/2016 Crossing appears to be in good condition. (A. Freitag - DWR Sutter Yard)05/09/2016 Crossing appears to be in good condition. (A. Freitag - DWR Sutter Yard)08/05/2015 WS pipe end is being overgrown by trees and other vegetation. Needs to be cleared back. (A. Freitag - DWR Sutter Yard)12/08/2014 Same as last inspection. (A. Freitag - DWR Sutter Yard)06/11/2014 Same as last inspection. (A. Freitag - DWR Sutter Yard)11/20/2013 Same as last inspection. (A. Freitag - DWR Sutter Yard)05/29/2013 Same as last inspection. (A. Freitag - DWR Sutter Yard) FIELD_STRUCT_DESC: 24-inch corrugated metal drainage pipe through the levee, 12.0 feet below the crown. Slide gate in a corrugated metal riser on the waterside (WS) slope. Flap gate on the WS toe. Inlet on the landside (LS) toe. [Additional Reference(s): DWR Levee Log, 1990 (HLM 3.95). USACE Sacramento O&M Manual, Unit 516, April 1960, Revised 3 February 2011, (381+36), listed as 24-inch pipe]. FS Date: 3/3/2021 3:22:22 PM

Land-Side: View of levee slope looking from crown

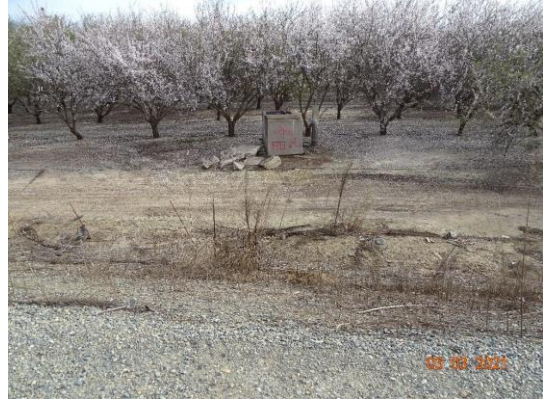
Photo 2 of 3 : UCIP\_SP\_2022\_65180\_97394.jpg

Comment Code						
Inspector Comment						
FS_ID:65180 DS_ID:1617 EP_NO: N/A Repair Type: Non-Urgent Crossing Status: Found UCIP Comments: 03/03/2021 Record remains Non-Urgent. No permit has been identified authorizing pipe. (O.Yakimov - DWR UCIP) 06/05/2019 No issues recorded during inspection. (O.Yakimov - DWR UCIP)05/15/2017 Crossing appears to be in good condition. (A. Freitag - DWR Sutter Yard)11/15/2016 Crossing appears to be in good condition. (A. Freitag - DWR Sutter Yard)05/09/2016 Crossing appears to be in good condition. (A. Freitag - DWR Sutter Yard)08/05/2015 Crossing appears in good condition. No noticeable issues to report. (A. Freitag - DWR Sutter Yard)12/08/2014 Same as last inspection. (A. Freitag - DWR Sutter Yard)06/11/2014 Same as last inspection. (A. Freitag - DWR Sutter Yard)11/20/2013 Same as last inspection. (A. Freitag - DWR Sutter Yard)05/29/2013 Same as last inspection. (A. Freitag - DWR Sutter Yard) FIELD_STRUCT_DESC: 24-inch corrugated metal irrigation siphon pipe through the levee, 16.5 feet below the crown. Slide gate in corrugated metal riser on the waterside (WS) slope. Pipe appears to be currently used for irrigation purposes. Pipe penetrates both levees and goes under Butte Creek channel at angle. 4-foot by 8-foot concrete distribution box on the landside (LS), 40 feet from the LS toe. (Replacement a portion of existing 24-inch CMP pipe with class III 24-inch reinforced concrete pipe (RCP) under Butte Creek between levee toes with a cleanout installed in the center of Butte Creek authorized under Permit No. 4064, 1962 - Durham Mutual WaterCompany). [Additional Reference(s): DWR Levee Log, (HLM 3.95). USACE Sacramento O&M Manual, Unit 516, April 1960, Revised 3 February 2011, (381+42), listed as 24-inch pipe. USACE As-Built Drawing No. 50-4-3367, upstream of Station 227+55, Sheets 2 and 7, April 1958, pipe varies in size: 24-inch pipe (right bank), 24-inch through Butte Creek, and 3-foot by 3-foot (36-inch by 36-inch) culvert (left bank)]. FS Date: 3/3/2021 3:29:52 PM

Land-Side: View of levee slope looking from crown

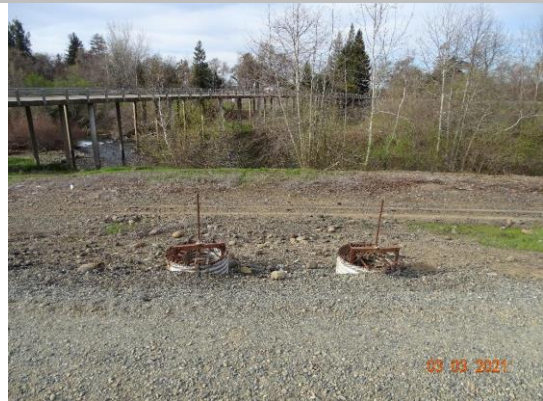
Photo 3 of 3 : UCIP\_SP\_2022\_65180\_97390.jpg

Water-Side: View of levee slope looking from crown

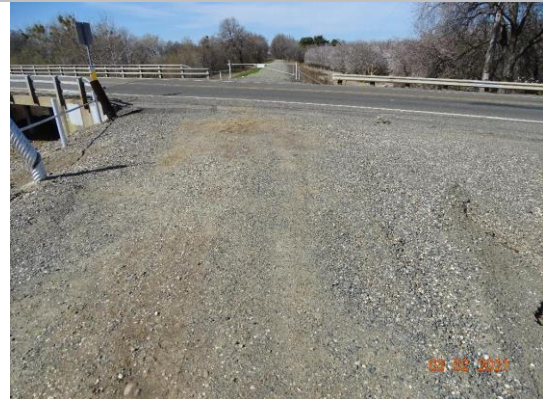
Photo 1 of 3 : UCIP\_SP\_2022\_65181\_97395.jpg

Comment Code						
Inspector Comment						
FS_ID:65181 DS_ID:1618 EP_NO: N/A Repair Type: Non-Urgent Crossing Status: Not Found UCIP Comments: 03/02/2021 Record updated from No Action Needed to Non-Urgent. Crossing not found. Concrete structures on landside don't seem to belong to this crossing. Unauthorized encroachment recorded in Levee Log prior to 2011. (O.Yakimov - DWR UCIP) 05/15/2017 Unable to locate. (A. Freitag - DWR Sutter Yard)11/15/2016 Unable to locate. Description says its abandoned. (A. Freitag - DWR Sutter Yard)05/09/2016 Unable to locate. (A. Freitag - DWR Sutter Yard)08/05/2015 Unable to locate. (A. Freitag - DWR Sutter Yard)12/08/2014 Unable to locate. (A. Freitag - DWR Sutter Yard)06/11/2014 Same as last inspection. (A. Freitag - DWR Sutter Yard)11/20/2013 Unable to locate. (A. Freitag - DWR Sutter Yard)05/29/2013 Same as last inspection. Unable to locate. (A. Freitag - DWR Sutter Yard)10/30/2012 Unable to locate. (W. Wylie - DWR UCIP) FIELD_STRUCT_DESC: 4-inch pipe of unknown type and material, through the levee at an unknown depth below the crown, not found. Pipe was labeled as abandoned in the levee log. [Additional Reference(s): DWR Levee Log, 1990 (HLM 3.98), listed as abandoned 4-inch pipe]. FS Date: 3/2/2021 3:55:39 PM

Top of Levee: View of levee crown looking upstream

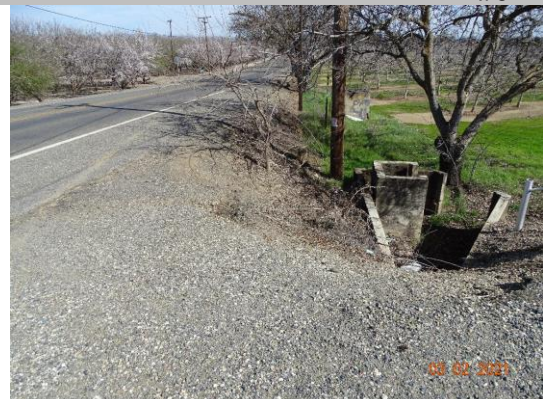
Photo 2 of 3 : UCIP\_SP\_2022\_65181\_97396.jpg

Land-Side: View of levee slope looking from crown. Concrete structure seems to belong to field irrigation system

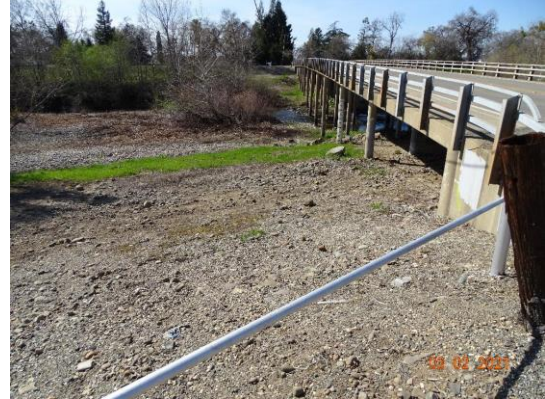
Photo 3 of 3 : UCIP\_SP\_2022\_65181\_97397.jpg

Water-Side: View of levee slope looking from crown

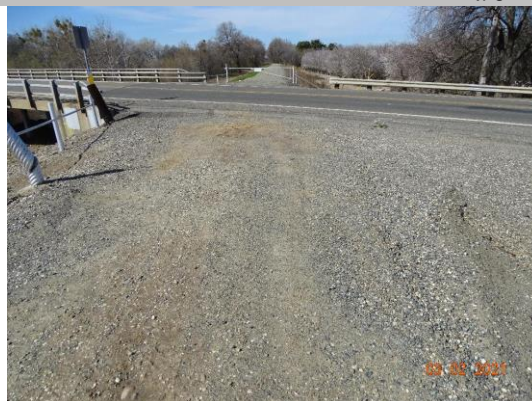
Photo 1 of 3 : UCIP\_SP\_2022\_65258\_97436.jpg

Comment Code						
Inspector Comment						
FS_ID:65258 DS_ID:1619 EP_NO: 6544-A Repair Type: Non-Urgent Crossing Status: Indicator Found UCIP Comments: 03/02/2021 Record remains Non-Urgent. No inspection records were available to determine status of line through the levee. (O.Yakimov - DWR UCIP) 05/15/2017 Crossing appears to be in good condition. (A. Freitag - DWR Sutter Yard)11/15/2016 Crossing appears to be in good condition. (A. Freitag - DWR Sutter Yard)05/09/2016 Crossing appears to be in good condition. (A. Freitag - DWR Sutter Yard)08/05/2015 Pipe is suspected to cross inside of bridge. (A. Freitag - DWR Sutter Yard)12/08/2014 Same as last inspection. (A. Freitag - DWR Sutter Yard)06/11/2014 Same as last inspection. (A. Freitag - DWR Sutter Yard)11/20/2013 Same as last inspection. (A. Freitag - DWR Sutter Yard)05/29/2013 Same as last inspection. (A. Freitag - DWR Sutter Yard)10/30/2012 Pipeline should be marked where pipe crosses levee as it is 4-feet below the surface. (W. Wylie - DWR UCIP) FIELD_STRUCT_DESC: 6-inch concrete encased steel high pressure gas pipeline through the levee, 4 feet below the crown. 8-inch diameter Pacific Gas & Electric Company (PG&E) gas access manhole located on the south side of the road, 250 feet east of the levee crown. (6-inch gas line authorized under Permit No. 6544 and 6544-A, 1969 - Pacific Gas and Electric [PG&E]). [Additional Reference(s): DWR Levee Log, 1990 (HLM 3.99)]. FS Date: 3/2/2021 8:15:28 AM

Top of Levee: View of levee crown looking upstream

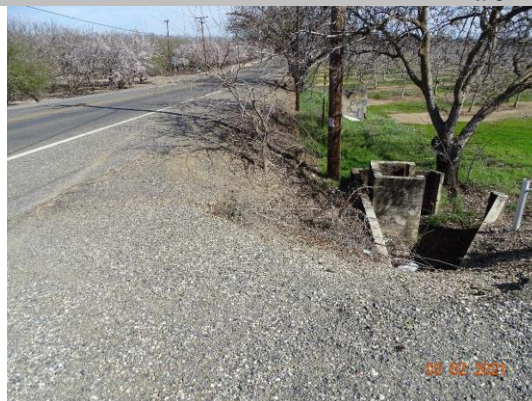
Photo 2 of 3 : UCIP\_SP\_2022\_65258\_97437.jpg

Land-Side: View of levee slope looking from crown

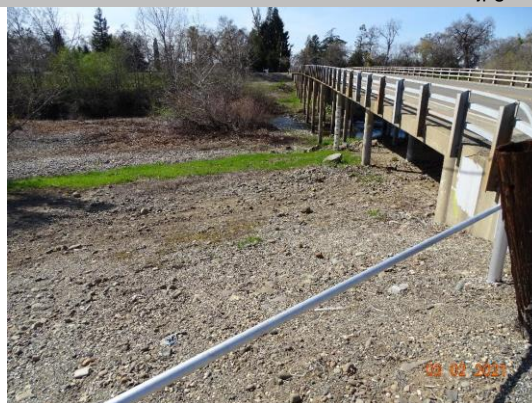
Photo 3 of 3 : UCIP\_SP\_2022\_65258\_97438.jpg

Water-Side: View of levee slope looking from crown

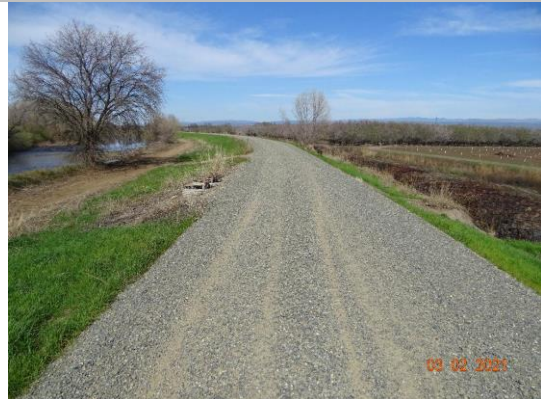
Photo 1 of 3 : UCIP\_SP\_2022\_65267\_97441.jpg

FS\_ID:65267  
DS\_ID:1620  
EP\_NO: N/A  
Repair Type: Non-Urgent  
Crossing Status: Found  
UCIP Comments: 03/02/2021 Record remains Non-Urgent. Missing CMP cover on waterside slope - possible fall hazard. No permit has been identified authorizing pipe. Slide gate in CMP riser closed, crossing doesn't look abandoned. DMP internal video inspection has found pipe integrity issues. LOF of crossing is between 4.1 and 5. Crossing will be monitored until funding becomes available for rehabilitation. (O.Yakimov - DWR UCIP)  
05/23/2019 (O. Magana - DWR UCIP)05/15/2017 Abandoned and needs to be done properly. A sink hole formed in the WS toe road and revealed the location of the WS pipe end. Sink hole will need to be repaired before the next high water season but the pipe has been selected to be internally cleaned and camera inspected as part of the DMP project so it will have needed to be excavated along the WS end anyways. (A. Freitag - DWR Sutter Yard)11/15/2016 Abandoned. Needs cover for the standpipe. (A. Freitag - DWR Sutter Yard)05/09/2016 Abandoned pipe. Needs a cover for the standpipe. (A. Freitag - DWR Sutter Yard)08/05/2015 Abandoned crossing. Covers need to be made for tops of standpipes to prevent falls. (A. Freitag - DWR Sutter Yard)12/08/2014 Same as last inspection. (A. Freitag - DWR Sutter Yard)06/11/2014 Same as last inspection. (A. Freitag - DWR Sutter Yard)11/19/2013 Same as last inspection. (A. Freitag - DWR Sutter Yard)05/29/2013 Same as last inspection. Land owner said pipes are abandoned and no longer used. Covers should be made for top of standpipe to prevent falls. Pipes should be properly abandoned. (A. Freitag - DWR Sutter Yard)10/30/2012 Pipe 1/2 filled with soil at slide gate end. (W. Wylie - DWR UCIP)

FIELD\_STRUCT\_DESC: 1 of 2: 36-inch drainage pipe through the levee, 11 feet below the crown. Slide gate in a 54-inch corrugated metal riser on the waterside (WS) slope. Concrete "U" headwall on the landside (LS). [Additional Reference(s): DWR Levee Log, 1990 (HLM 5.66). USACE Sacramento O&M Manual, Unit 516, April 1960, Revised 3 February 2011, (Station 470+00), listed as 36-inch pipe]. USACE As-Built Drawing No. 50-04-3367, Sheet 8, STA 470+00, July 22 1957].  
FS Date: 3/2/2021 8:23:38 AM

Top of Levee: View of levee crown looking upstream

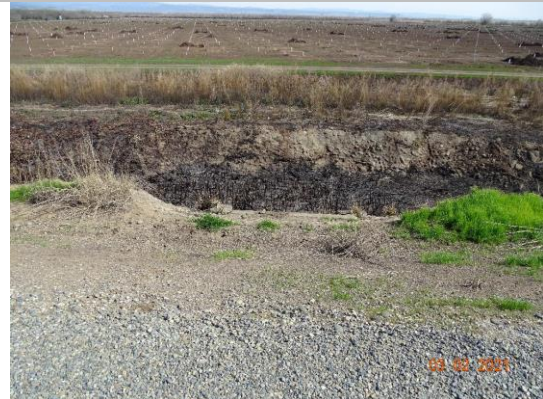
Photo 2 of 3 : UCIP\_SP\_2022\_65267\_97442.jpg

Land-Side: View of levee slope looking from crown

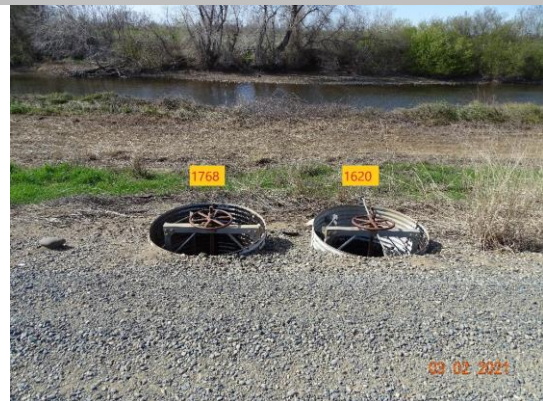
Photo 3 of 3 : UCIP\_SP\_2022\_65267\_97443.jpg

Water-Side: View of levee slope looking from crown

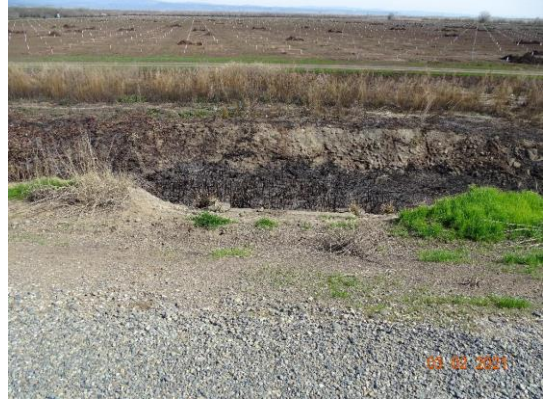
Photo 2 of 3 : UCIP\_SP\_2022\_65271\_97449.jpg

FS\_ID:65271  
DS\_ID:1768  
EP\_NO: N/A  
Repair Type: Urgent  
Crossing Status: Found  
UCIP Comments: 03/02/2021 Record updated from Non-Urgent to Urgent. Sinkhole 4-feet in diameter and 2-feet deep located at waterside toe in pipe alignment. Missing CMP cover on waterside slope - possible fall hazard. No permit has been identified authorizing pipe. Slide gate in CMP riser closed, crossing doesn't look abandoned. (O.Yakimov - DWR UCIP)  
05/23/2019 (O. Magana - DWR UCIP)05/15/2017 Abandoned and needs to be done properly. A sink hole formed in the WS toe road and revealed the location of the WS pipe end. Sink hole will need to be repaired before the next high water season but the pipe has been selected to be internally cleaned and camera inspected as part of the DMP project so it will have needed to be excavated along the WS end anyways. (A. Freitag - DWR Sutter Yard)11/15/2016 Abandoned. Needs standpipe cover. (A. Freitag - DWR Sutter Yard)05/09/2016 Abandoned pipe. Needs a cover for standpipe. (A. Freitag - DWR Sutter Yard)08/05/2015 Abandoned pipes. Need covers made for tops of standpipes to prevent falls. (A. Freitag - DWR Sutter Yard)

Land-Side: View of levee slope looking from crown

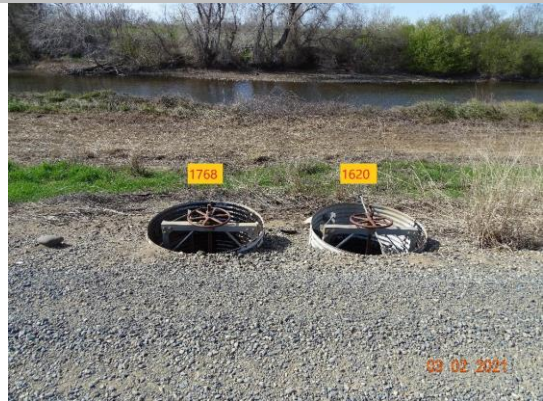
Photo 3 of 3 : UCIP\_SP\_2022\_65271\_97450.jpg

Water-Side: View of levee slope looking from crown

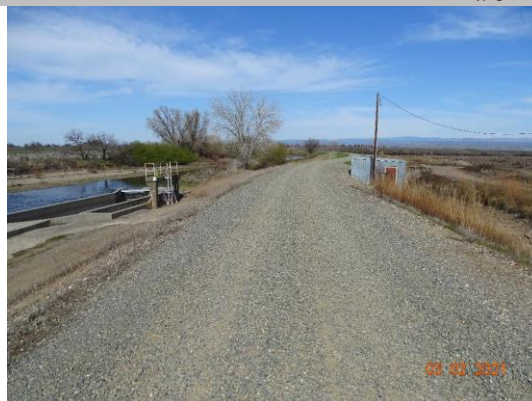
Photo 1 of 3 : UCIP\_SP\_2022\_65284\_97455.jpg

Top of Levee: View of levee crown looking upstream

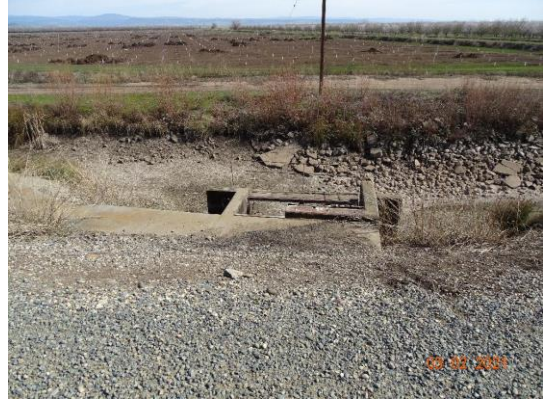
Photo 2 of 3 : UCIP\_SP\_2022\_65284\_97456.jpg

Land-Side: View of levee slope looking from crown

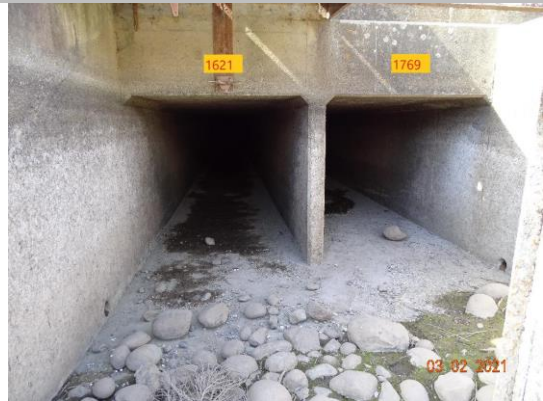
Photo 3 of 3 : UCIP\_SP\_2022\_65284\_97458.jpg

Land-Side: Concrete tunnel at levee toe
