# Flood Control Project Maintenance Levee Inspections LMA District Cover Sheet

## Sutter Maintenance Yard Maintenance Area 0005

**Flood Control Project Maintenance  
Levee Inspections  
Unit Cover Sheet**

Waterway			Bank	Unit Miles
Unit No. 01 Butte Creek			Left	15.08
	Spring (March - May)	Summer (June - August)	(September - November) Fall	Winter (December - February)
Unit Maintenance Rating (Fall Only)				
Date of Inspection	3/23/2022 - 3/23/2022			
DWR Inspector	Makar Sokol			
Accompanied By	Shawn Freitag DWR Sutter Yard

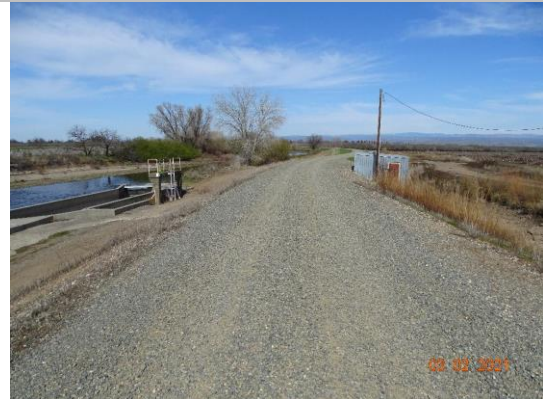
Photo 1 of 3 : UCIP\_SP\_2022\_65300\_97461.jpg

Top of Levee: View of levee crown looking upstream

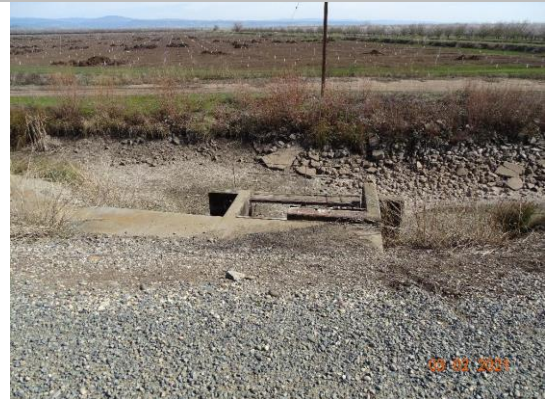
Photo 2 of 3 : UCIP\_SP\_2022\_65300\_97462.jpg

Land-Side: View of levee slope looking from crown

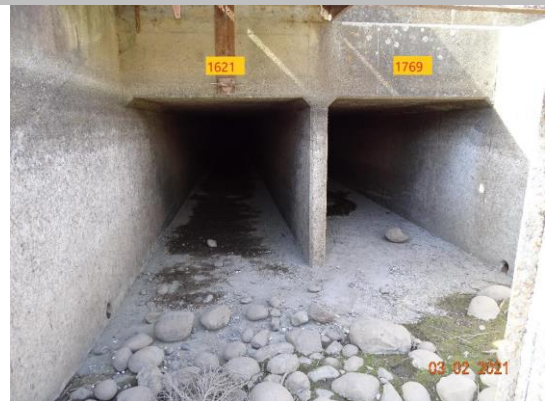
Photo 3 of 3 : UCIP\_SP\_2022\_65300\_97464.jpg

Land-Side: Concrete tunnel at levee toe

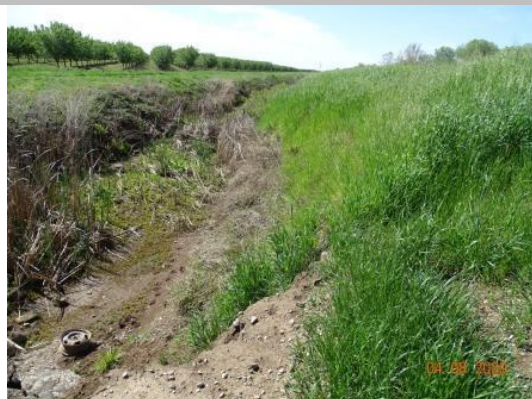
Photo 1 of 1 : SP\_2022\_MA0005\_196\_56\_20220307\_00019.jpg

LM Start	5.81	Rating **	U	Issue No.	56
LM End	5.81	Issue Type +	Ma	Location *	LS
Category	Earthen Levee			GPS Latitude/Longitude	
				Start	End
Item	Erosion / Bank Caving			39.621261 °	39.621261 °
				-121.773973 °	-121.773973 °
DWR ID	DWR_MA0005_01_f_2016_56				
Comment Code					
E2 : Schedule repair of erosion site prior to the next inspection.					
Inspector Comment

View of the erosion at the landside toe. Spring 2020.

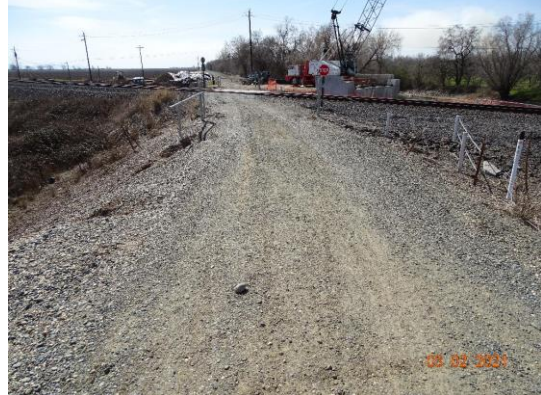
Photo 1 of 3 : UCIP\_SP\_2022\_65356\_97492.jpg

Top of Levee: View of levee crown looking downstream

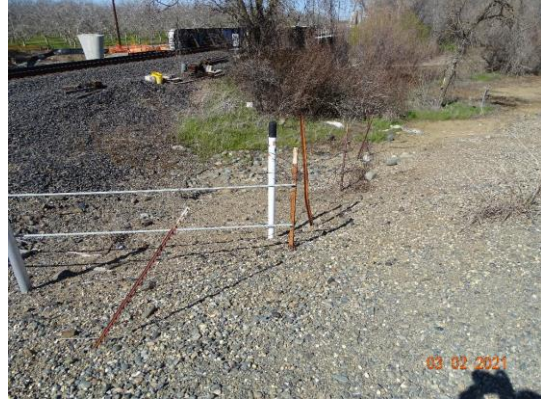
Photo 2 of 3 : UCIP\_SP\_2022\_65356\_97493.jpg

Water-Side: View of levee slope looking from crown

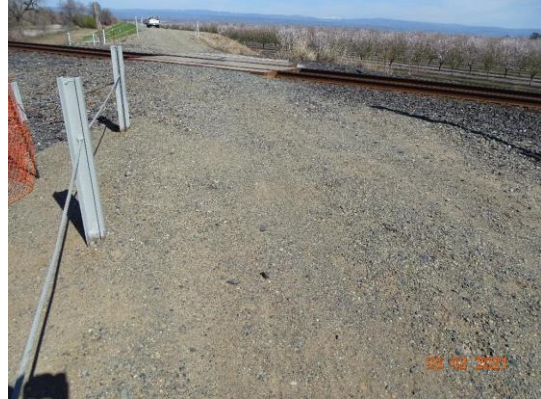
Photo 1 of 3 : UCIP\_SP\_2022\_65357\_97496.jpg

Top of Levee: View of levee crown looking upstream

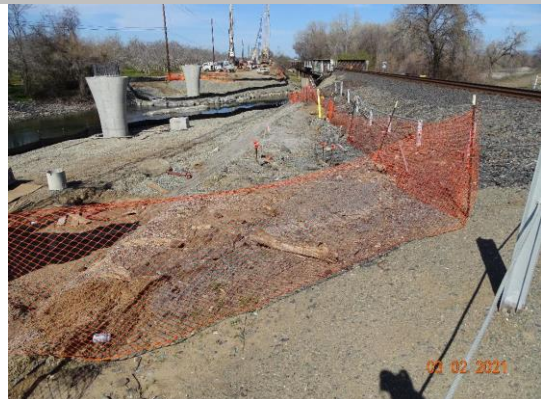
Photo 2 of 3 : UCIP\_SP\_2022\_65357\_97497.jpg

Water-Side: View of levee slope looking from crown. Construction site at this location

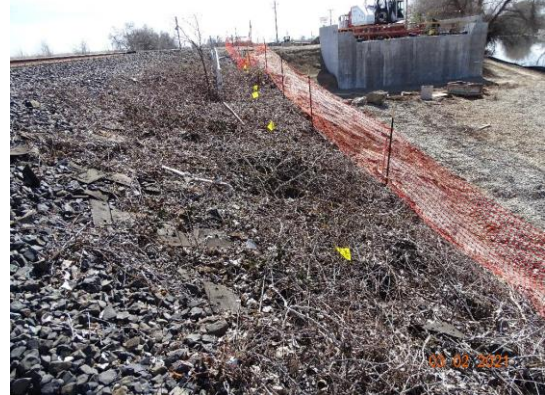
Photo 3 of 3 : UCIP\_SP\_2022\_65357\_97500.jpg

Water-Side: Gas line flags installed along pipe alignment on south side of railroad

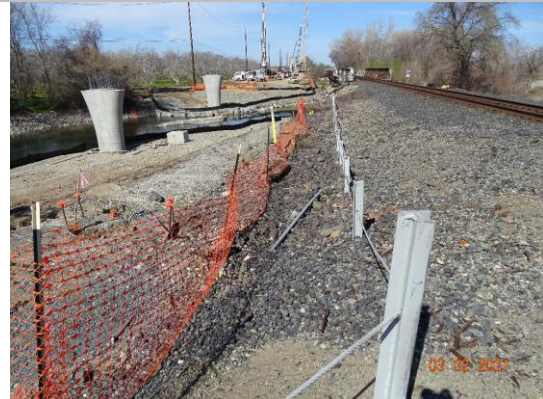
Photo 1 of 2 : UCIP\_SP\_2022\_65368\_97504.jpg

Water-Side: View of construction site

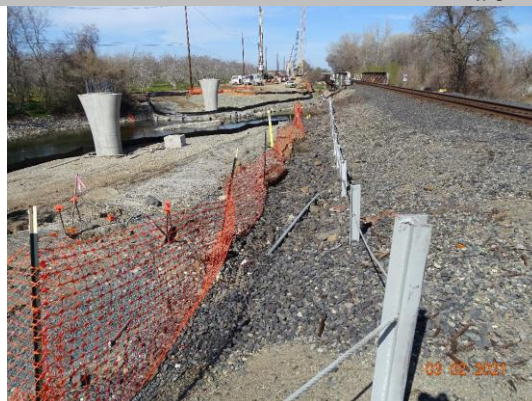
Photo 1 of 2 : UCIP\_SP\_2022\_65377\_97505.jpg

Comment Code						
Inspector Comment						
FS_ID:65377 DS_ID:1626 EP_NO: 14703 Repair Type: Non-Urgent Crossing Status: Found UCIP Comments: 03/02/2021 Record updated from No Action Needed to Non-Urgent. Crossing not found. Construction site prevents inspection of levee at this crossing. Old bridge has been demolished, construction of a new bridge started. (O.Yakimov - DWR UCIP) 05/15/2017 Crossing appears to be in good condition. (A. Freitag - DWR Sutter Yard)11/15/2016 Crossing appears to be in good condition. (A. Freitag - DWR Sutter Yard)05/09/2016 Crossing appears to be in good condition. (A. Freitag - DWR Sutter Yard)08/05/2015 Crossing appears in good condition. No noticeable issues to report. (A. Freitag - DWR Sutter Yard)12/08/2014 Same as last inspection. (A. Freitag - DWR Sutter Yard)06/11/2014 Same as last inspection. (A. Freitag - DWR Sutter Yard)11/19/2013 Same as last inspection. (A. Freitag - DWR Sutter Yard)05/29/2013 Same as last inspection. (A. Freitag - DWR Sutter Yard) FIELD_STRUCT_DESC: 4-inch galvanized steel communication conduit through the levee, 2 feet below the crown. Fiber optics cable passes through the conduit. Conduit is attached to the upstream side of the Midway Road bridge. (4-inch conduit authorized under Permit No. 14703, 1987 - U.S. Sprint). (Midway Road bridge replacement authorized under Permit No. 19316, 2020 - Butte County Department of Public Works). [Additional Reference(s): DWR Levee Log, (HLM 7.24), listed as fiber optic cable]. FS Date: 3/2/2021 10:40:49 AM

Water-Side: View of construction site

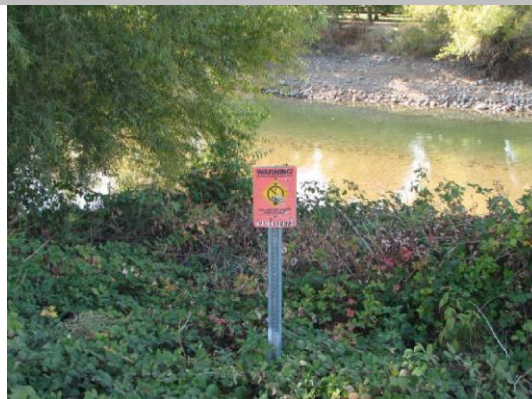
Photo 2 of 3 : UCIP\_SP\_2022\_65388\_67956.jpg

underground cable marker.

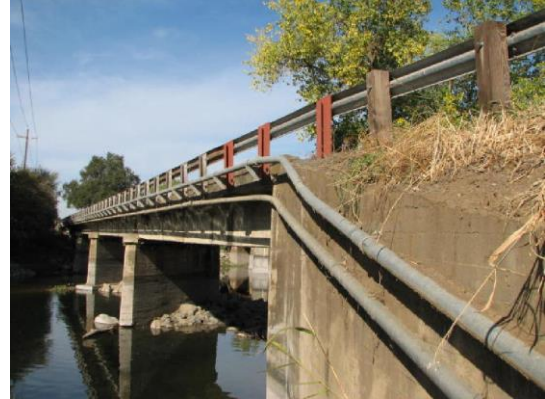
Photo 3 of 3 : UCIP\_SP\_2022\_65388\_67957.jpg

Pipes mounted on downstream side of bridge.

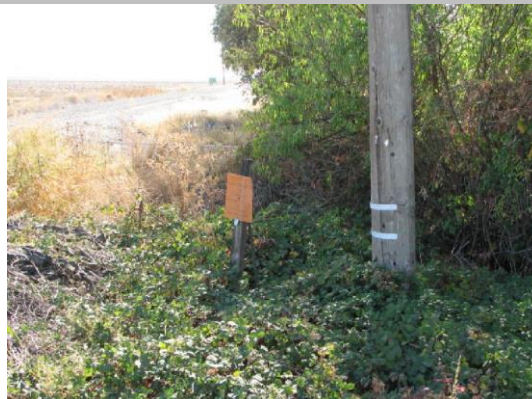
Photo 2 of 3 : UCIP\_SP\_2022\_65401\_67958.jpg

underground communication line marker on west side of roadway.

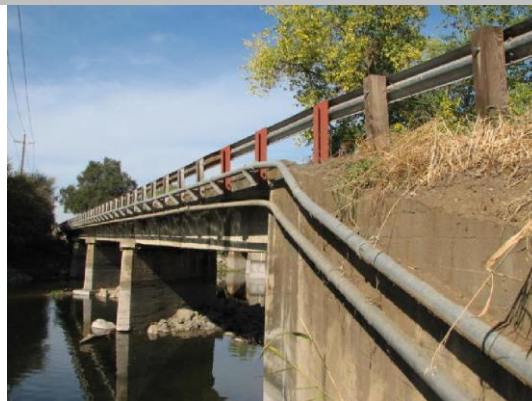
Photo 3 of 3 : UCIP\_SP\_2022\_65401\_67959.jpg

Communication conduit attached to downstream side of bridge.

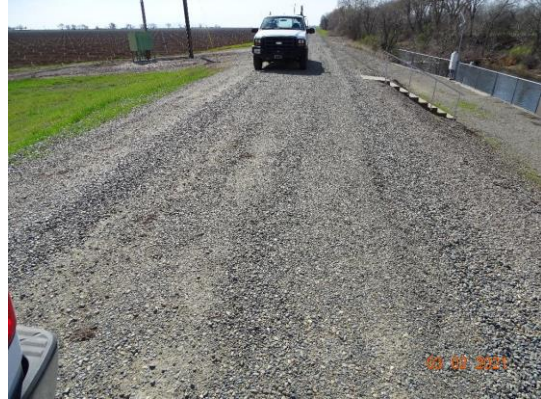
Photo 1 of 3 : UCIP\_SP\_2022\_65432\_97530.jpg

Top of Levee: View of levee crown looking downstream

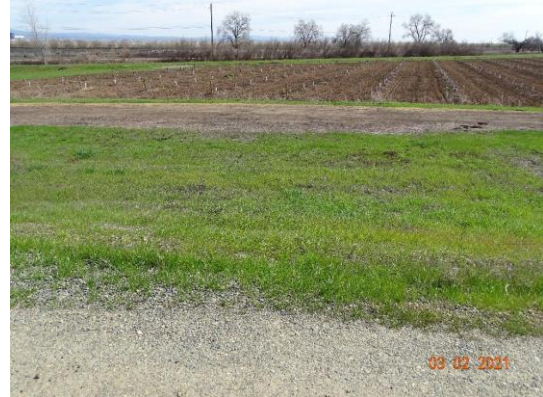
Photo 2 of 3 : UCIP\_SP\_2022\_65432\_97529.jpg

Land-Side: View of levee slope looking from crown

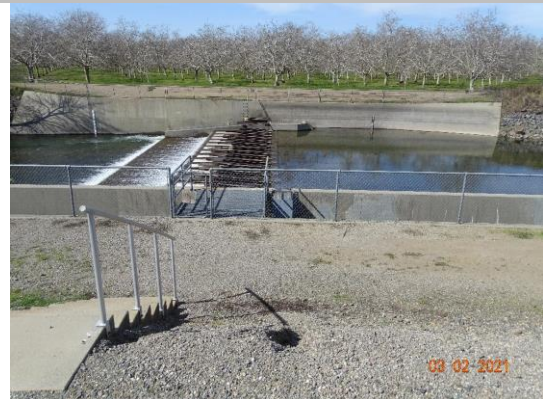
Photo 3 of 3 : UCIP\_SP\_2022\_65432\_97528.jpg

Comment Code						
Inspector Comment						
FS_ID:65432 DS_ID:1627 EP_NO: N/A Repair Type: Non-Urgent Crossing Status: Indicator Found UCIP Comments: 03/02/2021 Record updated from No Action Needed to Non-Urgent. Crossing not found. Geophysical study indicates possible presence of pipe through levee. Coordinates of crossing have been updated to match geophysical report. Owner needs to coordinate with the CVFPB to remove or abandon crossing according to Title 23 requirements. No permit has been identified authorizing pipe. (O.Yakimov - DWR UCIP) 05/16/2017 Unable to locate. (A. Freitag - DWR Sutter Yard) 11/15/2016 Unable to locate. (A. Freitag - DWR Sutter Yard) 05/11/2016 Unable to locate. (A. Freitag - DWR Sutter Yard) 08/04/2015 Unable to locate. (A. Freitag - DWR Sutter Yard) 12/08/2014 Unable to locate. (A. Freitag - DWR Sutter Yard) 06/11/2014 Same as last inspection. (A. Freitag - DWR Sutter Yard) 11/19/2013 Unable to locate. (A. Freitag - DWR Sutter Yard) 05/29/2013 Same as last inspection. Unable to locate. (A. Freitag - DWR Sutter Yard) FIELD_STRUCT_DESC: 48-inch reinforced concrete irrigation pipe through the levee, 12.5 feet below the crown, not found. Slide gate in a pipe well on the waterside (WS) slope. Flashboard diversion weir in the channel. Fish ladder along the side of the weir. Concrete headwalls on the landside (LS) and the WS levee toes. Concrete sack revetment and bulkhead on the WS bank. Three reinforced concrete wing walls on the right bank side of the diversion weir. [Additional Reference(s): DWR Levee Log, 1990 (HLM 7.36). USACE Sacramento O&M Manual, Unit 515, April 1955, Revised 28 December 2010, (Station 558+94), listed as 48-inch pipe. USACE As-Built Drawing No. 50-04-2637, Sheet 2, Station 558+93.72, 7 January 1953]. FS Date: 3/2/2021 1:08:30 PM

Water-Side: View of levee slope looking from crown

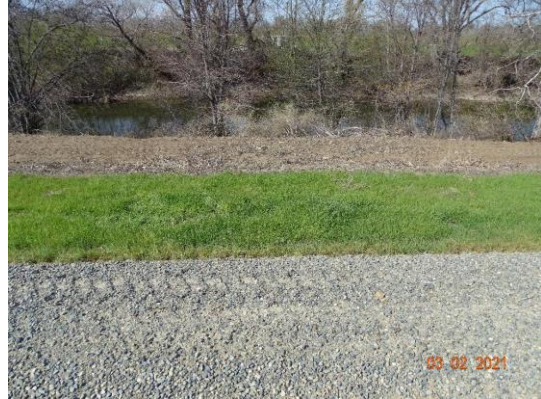
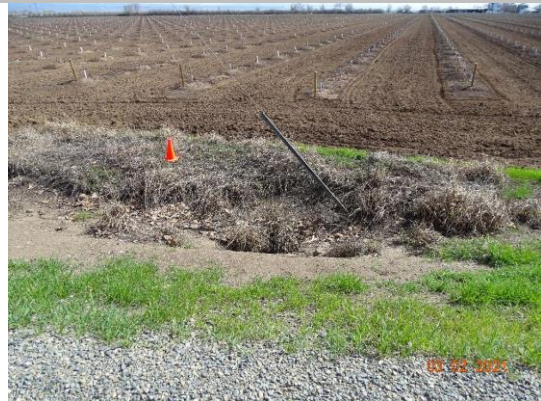
Comment Code					
Inspector Comment					
FS_ID:65433 DS_ID:1628 EP_NO: N/A Repair Type: Non-Urgent Crossing Status: Found UCIP Comments: 03/02/2021 Record remains Non-Urgent. No permit has been identified authorizing pipe. Crossing appears abandoned. Headwall on landside and pipe inlet have been cleared from dirt. Pipe end is still burried in soil on waterside and not found. DMP internal video inspection has not found pipe integrity issues. LOF of crossing is less or equal to 4.0. Recommend next video inspection in 5 years. (O.Yakimov - DWR UCIP) 05/16/2017 LS inlet is almost completely buried. Nothing visible on the WS. Pipe has been selected to be internally cleaned and inspected as part of the DMP poject. (A. Freitag - DWR Sutter Yard)11/15/2016 Appears abandoned and should be done so properly. (A. Freitag - DWR Sutter Yard)05/11/2016 Possibly an abandoned crossing. LS inlet was over 50% buried and nothing was found on the WS. (A. Freitag - DWR Sutter Yard)08/04/2015 LS pipe end filled about 50% with soil and WS pipe end is buried. (A. Freitag - DWR Sutter Yard)12/08/2014 Same as last inspection. (A. Freitag - DWR Sutter Yard)06/11/2014 Same as last inspection. (A. Freitag - DWR Sutter Yard)11/19/2013 Same as last inspection. (A. Freitag - DWR Sutter Yard)05/29/2013 Same as last inspection. (A. Freitag - DWR Sutter Yard)10/30/2012 Pipe filled with soil and outlet/appurtances are burried. (W. Wylie - DWR UCIP) FIELD_STRUCT_DESC: 24-inch corrugated metal drainage pipe through the levee, 8.5 feet below the crown. Flap gate on the waterside (WS). Concrete "U" shaped headwall on the landside (LS) toe. [Additional Reference(s): DWR Levee Log, 1990 (HLM 7.70).USACE Sacramento O&M Manual, Unit 515, April 1955, Revised 28 December 2010, (Station 576+72), listed as 24-inch pipe. USACE As-Built Drawing No. 50-04-2637, Sheet 2, Station 576+72.4, 7 January 1953]. FS Date: 3/2/2021 1:19:57 PM

LM Start	7.58	Rating **	M	Issue No.	51 (cont)
LM End	7.58	Issue Type +	Ma	Location *	
Category	Supplemental			GPS Latitude/Longitude	
				Start	End
Item	DWR UCIP LMA Responsibility			39.597725 °	39.597725 °
				-121.787257 °	-121.787257 °
DWR ID	1628

Water-Side: View of levee slope looking from crown

Land-Side: View of levee slope looking from crown

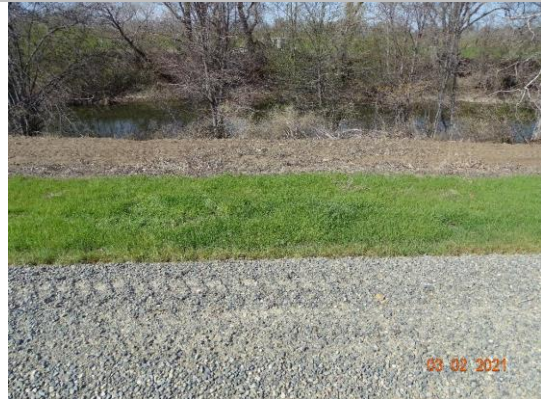
Photo 1 of 1 : UCIP\_SP\_2022\_65467\_97554.jpg

Comment Code						
Inspector Comment						
FS_ID:65467 DS_ID:1733 EP_NO: 4735 Repair Type: Non-Urgent Crossing Status: Not Found UCIP Comments: 03/02/2021 Record updated from No Action Needed to Non-Urgent. Crossing not found. (O.Yakimov - DWR UCIP) 05/16/2017 Unable to locate. (A. Freitag - DWR Sutter Yard) 11/15/2016 Unable to locate. (A. Freitag - DWR Sutter Yard) 05/11/2016 Unable to locate. (A. Freitag - DWR Sutter Yard) 08/05/2015 Unable to locate. (A. Freitag - DWR Sutter Yard) 12/08/2014 Unable to locate. (A. Freitag - DWR Sutter Yard) 06/11/2014 Same as last inspection. (A. Freitag - DWR Sutter Yard) 11/19/2013 Same as last inspection. (A. Freitag - DWR Sutter Yard) 05/29/2013 Same as last inspection. Unable to locate. (A. Freitag - DWR Sutter Yard) FIELD_STRUCT_DESC: *NOT THROUGH LEVEE* 12-inch steel irrigation pipe not through the levee, at an unknown depth. Pipe crosses Butte Creek to a 36-inch concrete standpipe and pump within floodway. Pipe penetrates the waterside (WS) slope and ends open 6 feet from flap gate that belongs to a 24-inch drainage pipe (DS_ID: 1628 that runs through the levee). (12-inch pipe authorized under Permit No. 4735, 1964 - Gorrill Land Company). [Additional Reference(s): DWR Levee Log, 1990 (HLM 7.70), listed as 12-inch pipe discharging into headwall]. FS Date: 3/2/2021 2:58:40 PM

Water-Side: This pipe and adjacent pipe DSID 1628 outlet not found on waterside

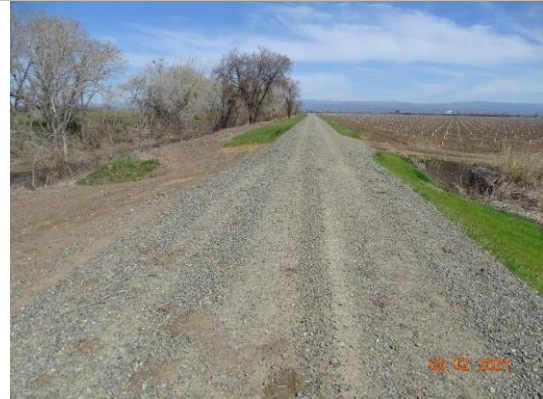
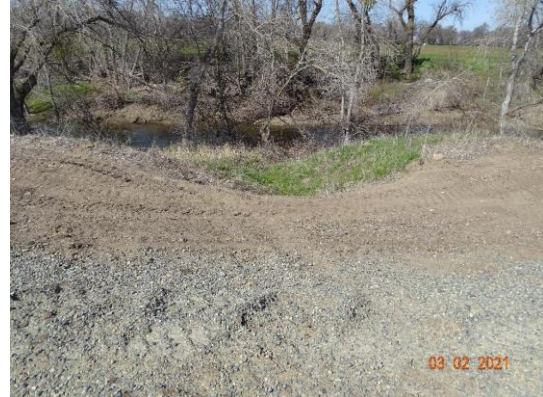
FS\_ID:65470  
DS\_ID:1629  
EP\_NO: N/A  
Repair Type: Non-Urgent  
Crossing Status: Found  
UCIP Comments: 03/02/2021 Record remains Non-Urgent. No permit has been identified authorizing pipe. Crossing has been CIPP-lined, new flap gate installed on waterside. (O.Yakimov - DWR UCIP)  
05/16/2017 LS inlet is half blocked off by flash boards and sediment. WS flap gate is blocked closed by sediment. Pipe has been selected to be internally cleaned and inspected as part of the DMP project. (A. Freitag - DWR Sutter Yard)11/15/2016 LS inlet was unburied and entire pipe is about 25% full of soil. WS flapgate was shut and partially buried. (A. Freitag - DWR Sutter Yard)05/11/2016 WS flap gate was about 50% buried and LS was 100% buried. Appears to be an abandoned crossing. (A. Freitag - DWR Sutter Yard)08/04/2015 WS flap gate is partially buried by soil and being overgrown with vegetation. LS pipe end was underwater and suspected to still be completely buried with soil. (A. Freitag - DWR Sutter Yard)12/08/2014 Same as last inspection. (A. Freitag - DWR Sutter Yard)06/11/2014 Same as last inspection. (A. Freitag - DWR Sutter Yard)11/19/2013 Same as last inspection. (A. Freitag - DWR Sutter Yard)05/29/2013 Same as last inspection. (A. Freitag - DWR Sutter Yard)10/30/2012 Pipe filled with soil. (W. Wylie - DWR UCIP)

FIELD\_STRUCT\_DESC: 24-inch CIPP-lined corrugated metal drainage pipe through the levee, 9.3 feet below the crown. Flap gate on the waterside (WS). Concrete headwalls at the landside (LS) and the WS toes. [Additional Reference(s): DWR Levee Log, 1990 (HLM 8.35). USACE Sacramento O&M Manual, Unit 515, April 1955, Revised 28 December 2010, (Station 609+79), listed as 24-inch pipe. USACE As-Built Drawing No. 50-04-2637, Sheet 3, Station 609+78.5, 7 January 1953].  
FS Date: 3/2/2021 3:05:29 PM

Top of Levee: View of levee crown looking upstream

Water-Side: View of levee slope looking from crown

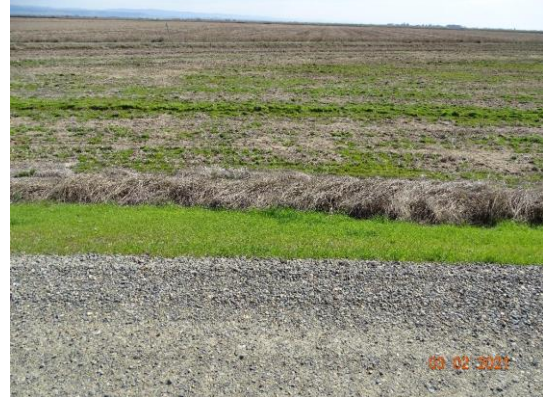
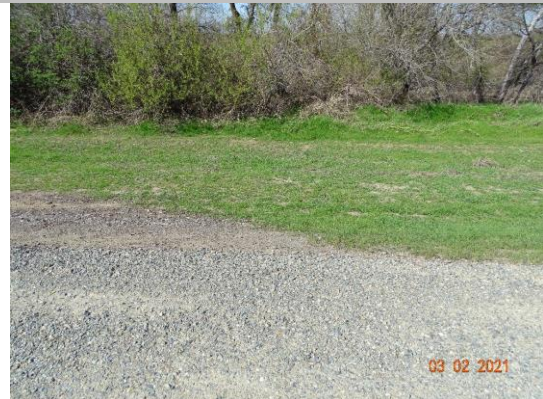
Comment Code					
Inspector Comment					
FS_ID:65495 DS_ID:1630 EP_NO: N/A Repair Type: Non-Urgent Crossing Status: Indicator Found UCIP Comments: 03/02/2021 Record updated from No Action Needed to Non-Urgent. Crossing not found. Geophysical study indicates possible presence of pipe through levee. Coordinates of crossing have been updated to match geophysical report. Location of this crossing also confirmed by calculating Station Number relatively to upstream and downstream crossings. Owner needs to coordinate with the CVFPB to remove or abandon crossing according to Title 23 requirements. No permit has been identified authorizing pipe. (O.Yakimov - DWR UCIP) 06/13/2019 DSID 1744 is duplicate of DSID 1630. This record should not be used for 24-inch pipe updates -- refer to DSID 1744 for updates. (O. Magana - DWR UCIP) 05/16/2017 Unable to locate. (A. Freitag - DWR Sutter Yard)11/15/2016 Unable to locate. (A. Freitag - DWR Sutter Yard)05/11/2016 Unable to locate. (A. Freitag - DWR Sutter Yard)08/04/2015 Unable to locate. (A. Freitag - DWR Sutter Yard)12/08/2014 Unable to locate. (A. Freitag - DWR Sutter Yard)06/11/2014 Same as last inspection. (A. Freitag - DWR Sutter Yard)11/19/2013 Unable to locate. (A. Freitag - DWR Sutter Yard)05/29/2013 Same as last inspection. Unable to locate. (A. Freitag - DWR Sutter Yard) FIELD_STRUCT_DESC: 24-inch drainage pipe of an unknown material through the levee, 9.8 feet below the crown, not found. Flap gate on the waterside (WS). [Additional Reference(s): DWR Levee Log, 1990 (HLM 8.99). USACE Sacramento O&M Manual, Unit 515, April 1955, Revised 28 December 2010, (Station 644+27), listed as 24-inch pipe. USACE As-Built Drawing No. 50-04-2637, Sheet 3, Station 644+27, 7 January 1953]. FS Date: 3/2/2021 3:36:08 PM

LM Start	8.87	Rating **	M	Issue No.	58 (cont)
LM End	8.87	Issue Type +	En	Location *	
Category	Supplemental			GPS Latitude/Longitude	
				Start	End
Item	DWR UCIP Field Study			39.582548 °	39.582548 °
				-121.800917 °	-121.800917 °
DWR ID	1630

Land-Side: View of levee slope looking from crown

Water-Side: View of levee slope looking from crown

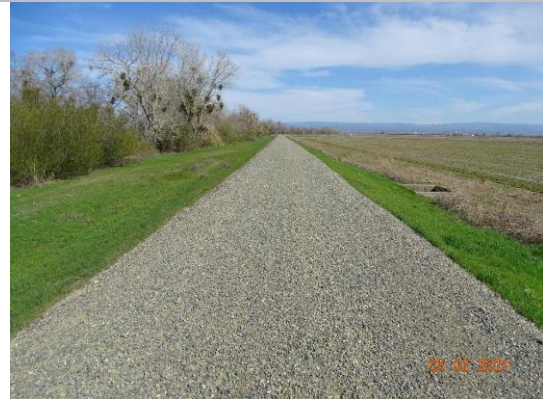
Photo 1 of 3 : UCIP\_SP\_2022\_65744\_98028.jpg

Comment Code						
Inspector Comment						
FS_ID:65744 DS_ID:1631 EP_NO: N/A Repair Type: Urgent Crossing Status: Found UCIP Comments: 03/02/2021 Record updated from Non-Urgent to Urgent. Crossing appears abandoned. DMP internal video inspection has found pipe integrity issues. LOF of crossing is between 5 and 6. Crossing will be monitored until funding becomes available to address the issues. Pipe and pipe appurtenances are not found on waterside. Missing slide gate in concrete distribution box at landside toe. The box is open at ground level, recommend installing a cover for trip and fall protection. No permit has been identified authorizing pipe. (O.Yakimov - DWR UCIP) 05/16/2017 Abandoned and needs to be done so properly. (A. Freitag - DWR Sutter Yard)11/15/2016 Abandoned. (A. Freitag - DWR Sutter Yard)05/11/2016 Abandoned pipe. (A. Freitag - DWR Sutter Yard) 08/04/2015 Abandoned pipe. Casey Wilder has started the steps to have the pipe properly abandoned and removed from the levee. (A. Freitag - DWR Sutter Yard)12/08/2014 Same as last inspection. (A. Freitag - DWR Sutter Yard)06/11/2014 Same as last inspection. (A. Freitag - DWR Sutter Yard)11/19/2013 Same as last inspection. (A. Freitag - DWR Sutter Yard)05/29/2013 Same as last inspection. (A. Freitag - DWR Sutter Yard)10/30/2012 Need to confirm proper abandonment of pipe. Pipe should be plugged on LS. (W. Wylie - DWR UCIP) FIELD_STRUCT_DESC: 16-inch steel irrigation pipe through the levee, 11.5 feet below the crown. Pump located on the waterside (WS). Distribution box at the landside (LS) toe. [Additional Reference(s): DWR Levee Log, 1990 (HLM 9.21). USACE Sacramento O&M Manual, Unit 515, April 1955, Revised 28 December 2010, (Station 655+68), listed as 16-inch pipe. USACE As-Built Drawing No. 50-04-2637, Sheet 3, Station 655+68.2, 7 January 1953]. FS Date: 3/2/2021 6:58:11 AM

Top of Levee: View of levee crown looking upstream

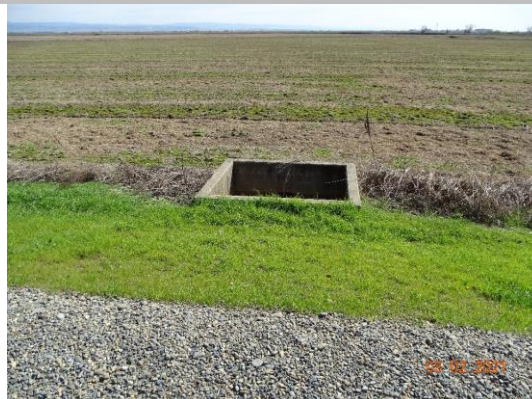
Photo 2 of 3 : UCIP\_SP\_2022\_65744\_98029.jpg

LM Start	9.08	Rating **	U	Issue No.	59 (cont)
LM End	9.08	Issue Type +	En	Location *	
Category	Supplemental			GPS Latitude/Longitude	
				Start	End
Item	DWR UCIP Field Study			39.579908 °	39.579908 °
				-121.802790 °	-121.802790 °
DWR ID	1631

Land-Side: View of levee slope looking from crown. Distribution box at levee toe needs a cover

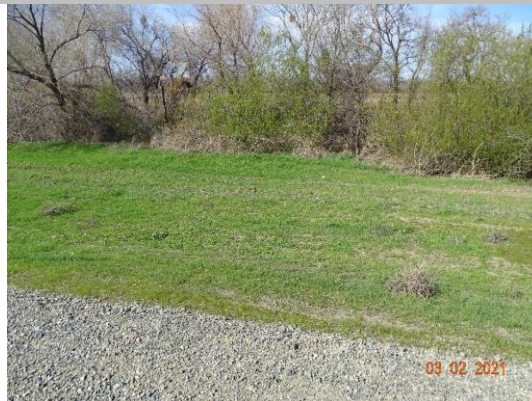
Photo 3 of 3 : UCIP\_SP\_2022\_65744\_98030.jpg

Water-Side: View of levee slope looking from crown. Pipe not found

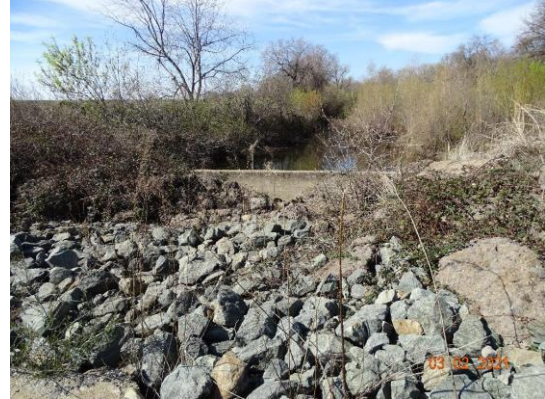
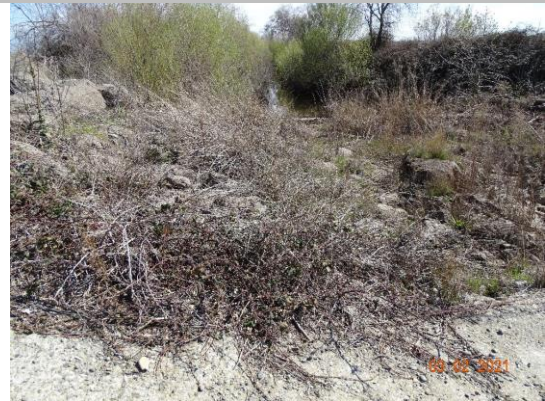
Comment Code						
Inspector Comment						
FS_ID:65745 DS_ID:1775 EP_NO: N/A Repair Type: Non-Urgent Crossing Status: Found UCIP Comments: 03/02/2021 Record updated from No Action Needed to Non-Urgent. No permit has been identified authorizing pipe. This pipe penetrates channel crossing constructed at elevation lower than levee. (O.Yakimov - DWR UCIP) 05/16/2017 Crossing appears to be in good condition. (A. Freitag - DWR Sutter Yard)11/15/2016 Crossing appears to be in good condition. (A. Freitag - DWR Sutter Yard)05/11/2016 Crossing appears to be in good condition. (A. Freitag - DWR Sutter Yard)08/04/2015 Crossing is in good condition. No noticeable issues to report. (A. Freitag - DWR Sutter Yard)12/08/2014 Same as last inspection. (A. Freitag - DWR Sutter Yard)06/11/2014 Same as last inspection. (A. Freitag - DWR Sutter Yard)11/19/2013 Same as last inspection. (A. Freitag - DWR Sutter Yard)05/29/2013 Flap gates were removed by DWR Sutter Maintenance Yard to allow water to flow freely through crossing and not back up in ditch. (A. Freitag - DWR Sutter Yard)10/30/2012 Seems there should be flap gates on this structure. (W. Wylie - DWR UCIP) FIELD_STRUCT_DESC: [Robert's Creek Outlet Structure] 1 of 4: 66-inch corrugated metal drainage pipe through the levee, 17.9 feet below the crown. Concrete headwalls on the landside (LS) and the waterside (WS). Flap gate located on the WS. [Additional Reference(s): DWR Levee Log, 1990 (HLM 9.66). USACE Sacramento O&M Manual, Unit 515, April 1955, Revised 28 December 2010, (Station 678+00), listed as 66-inch pipe. USACE As-Built Drawing No. 50-04-2637, Sheet 3, Station 678+00, 7 January 1953]. FS Date: 3/2/2021 8:28:51 AM

View of channel crossing looking perpendicular to Butte Creek

LM Start	9.52	Rating **	M	Issue No.	62 (cont)
LM End	9.52	Issue Type +	Ma	Location *	
Category	Supplemental			GPS Latitude/Longitude	
				Start	End
Item	DWR UCIP LMA Responsibility			39.575072 °	39.575072 °
				-121.807805 °	-121.807805 °
DWR ID	1775

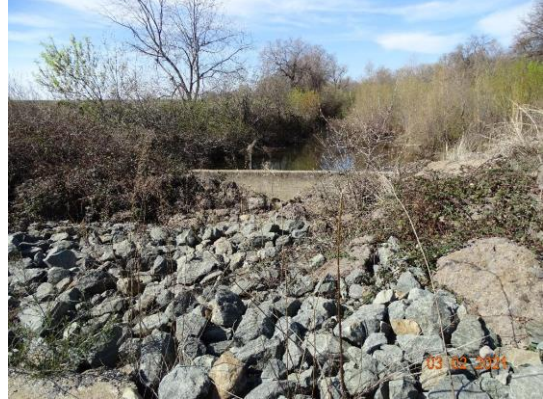
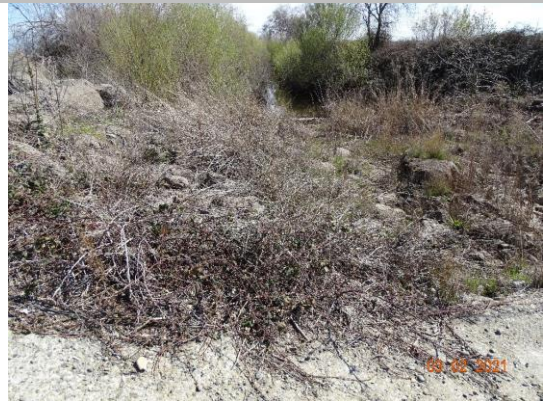
Comment Code					
Inspector Comment					
FS_ID:65746 DS_ID:1774 EP_NO: N/A Repair Type: Non-Urgent Crossing Status: Found UCIP Comments: 03/02/2021 Record updated from No Action Needed to Non-Urgent. No permit has been identified authorizing pipe. This pipe penetrates channel crossing constructed at elevation lower than levee. (O.Yakimov - DWR UCIP) 5/16/2017 Crossing appears to be in good condition. (DWR Sutter Yard- A Freitag)11/15/2016 Crossing appears to be in good condition. (DWR Sutter Yard- A Freitag)5/11/2016 Crossing appears to be in good condition.8/4/2015 Crossing is in good condition. No noticeable issues to report.12/8/2014 Same as last inspection.6/11/2014 Same as last inspection.11/19/2013 Same as last inspection.5/29/2013 Flap gates were removed by DWR Sutter Maintenance Yard to allow water to flow freely through crossing and not back up in ditch.10/30/2012 Seems there should be flap gates on this structure. FIELD_STRUCT_DESC: [Robert's Creek Outlet Structure] 2 of 4: 66-inch corrugated metal drainage pipe through the levee, 17.9 feet below the crown. Concrete headwalls on the landside (LS) and the waterside (WS). Flap gate located on the WS. [Additional Reference(s): DWR Levee Log, 1990 (HLM 9.66). USACE Sacramento O&M Manual, Unit 515, April 1955, Revised 28 December 2010, (Station 678+00), listed as 66-inch pipe. USACE As-Built Drawing No. 50-04-2637, Sheet 3, Station 678+00, 7 January 1953]. FS Date: 3/2/2021 8:49:57 AM

View of channel crossing looking perpendicular to Butte Creek

LM Start	9.52	Rating **	M	Issue No.	63 (cont)	
LM End	9.52	Issue Type +	Ma	Location *		
Category	Supplemental			GPS Latitude/Longitude		
				Start		End
Item	DWR UCIP LMA Responsibility			39.575036 °		39.575036 °
				-121.807807 °		-121.807807 °
DWR ID	1774

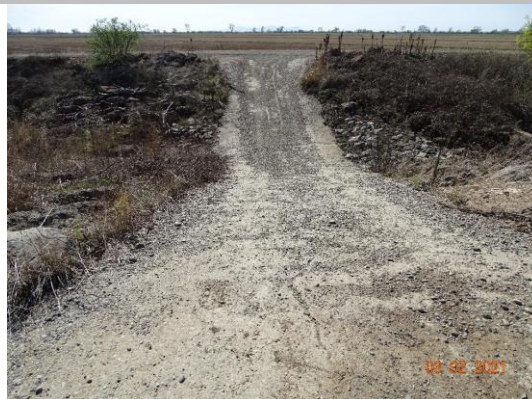
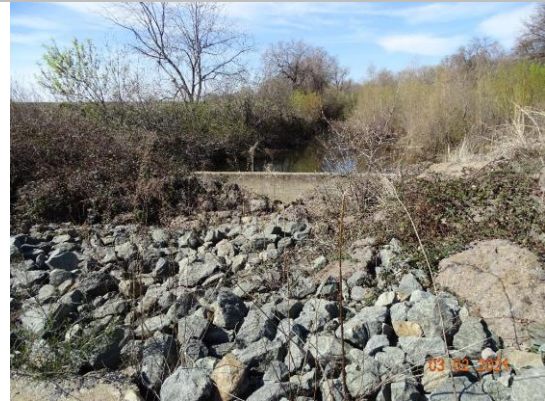
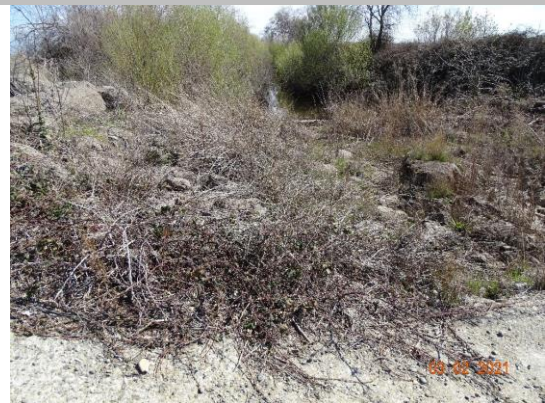
Comment Code						
Inspector Comment						
FS_ID:65747 DS_ID:1632 EP_NO: N/A Repair Type: Non-Urgent Crossing Status: Found UCIP Comments: 03/02/2021 Record updated from No Action Needed to Non-Urgent. No permit has been identified authorizing pipe. This pipe penetrates channel crossing constructed at elevation lower than levee. (O.Yakimov - DWR UCIP) 5/16/2017 Crossing appears to be in good condition. (DWR Sutter Yard- A Freitag)11/15/2016 Crossing appears to be in good condition. (DWR Sutter Yard- A Freitag)5/11/2016 Crossing appears to be in good condition.8/4/2015 Crossing appears in good condition. No noticeable issues to report.12/8/2014 Same as last inspection.6/11/2014 Same as last inspection.11/19/2013 Same as last inspection.5/29/2013 Flap gates were removed by DWR Sutter Maintenance Yard to allow water to flow freely through crossing and not back up in ditch.10/30/2012 Seems there should be flap gates on this structure. FIELD_STRUCT_DESC: [Robert's Creek Outlet Structure] 3 of 4: 66-inch corrugated metal drainage pipe through the levee, 17.9 feet below the crown. Concrete headwalls on the landside (LS) and the waterside (WS). Flap gate located on the WS. [Additional Reference(s): DWR Levee Log, 1990 (HLM 9.66). USACE Sacramento O&M Manual, Unit 515, April 1955, Revised 28 December 2010, (Station 678+00), listed as 66-inch pipe. USACE As-Built Drawing No. 50-04-2637, Sheet 3, Station 678+00, 7 January 1953]. FS Date: 3/2/2021 8:51:11 AM

View of channel crossing looking perpendicular to Butte Creek

LM Start	9.52	Rating **	M	Issue No.	65 (cont)
LM End	9.52	Issue Type +	Ma	Location *	
Category	Supplemental			GPS Latitude/Longitude	
				Start	End
Item	DWR UCIP LMA Responsibility			39.575000 °	39.575000 °
				-121.807808 °	-121.807808 °
DWR ID	1632

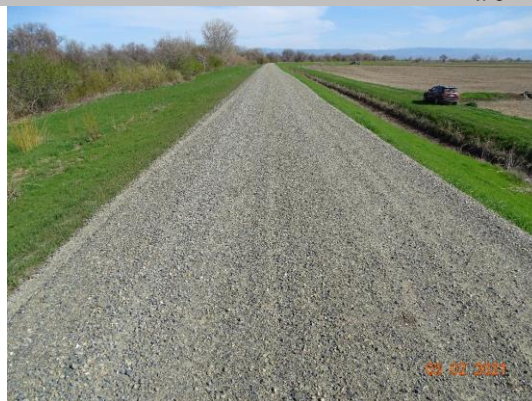
Photo 1 of 3 : UCIP\_SP\_2022\_65749\_98057.jpg

Comment Code						
Inspector Comment						
FS_ID:65749 DS_ID:1633 EP_NO: N/A Repair Type: Non-Urgent Crossing Status: Found UCIP Comments: 03/02/2021 Record remains Non-Urgent. Crossing appears abandoned. Pipe not found on waterside. No permit has been identified authorizing pipe. DMP internal video inspection has not found pipe integrity issues. LOF of crossing is less or equal to 4.0. Recommend next video inspection in 5 years. (O.Yakimov - DWR UCIP) 5/16/2017 Abandoned crossing and needs to be done so properly. Pipe has been selected to be internally cleaned and inspected as part of the DMP project. (DWR Sutter Yard- AFreitag)11/15/2016 Abandoned. (DWR Sutter Yard- AFreitag)5/11/2016 Abandoned crossing.8/4/2015 Abandoned pipe. Casey Wilder has started the steps to have the pipe properly abandoned and removed from the levee.12/8/2014 Same as last inspection.6/11/2014 Same as last inspection.11/19/2013 Same as last inspection.5/29/2013 Same as last inspection.10/30/2012 Pipe and headwall buried on WS, no access to slide gate. FIELD_STRUCT_DESC: 24-inch corrugated metal irrigation pipe through the levee, 12.5 feet below the crown. Slide gate on the waterside (WS). Flap gate and headwall on the landside (LS). Concrete headwall at the WS toe. [Additional Reference(s): DWR Levee Log, 1990 (HLM 10.19). USACE Sacramento O&M Manual, Unit 515, April 1955, Revised 28 December 2010, (Station 706+00), listed as 24-inch pipe. USACE As-Built Drawing No. 50-04-2637, Sheet 3, Station 706+00, 7 January 1953]. FS Date: 3/2/2021 9:41:58 AM

Top of Levee: View of levee crown looking upstream

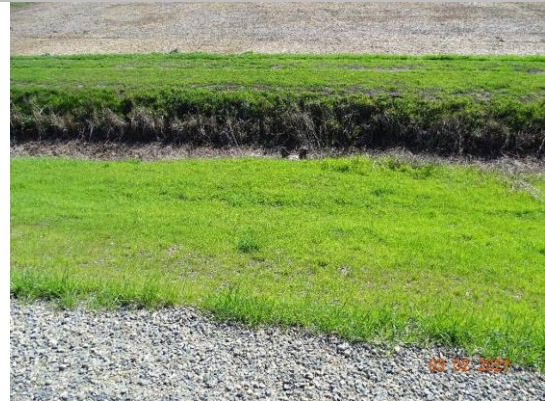
Photo 2 of 3 : UCIP\_SP\_2022\_65749\_98058.jpg

Land-Side: View of levee slope looking from crown

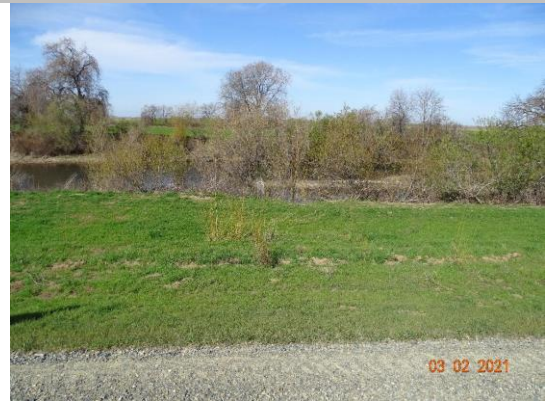
Photo 3 of 3 : UCIP\_SP\_2022\_65749\_98059.jpg

Water-Side: View of levee slope looking from crown

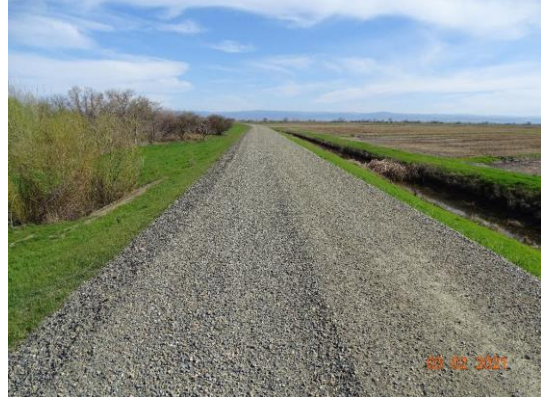
Photo 1 of 3 : UCIP\_SP\_2022\_65750\_98061.jpg

Comment Code						
Inspector Comment						
FS_ID:65750 DS_ID:1634 EP_NO: N/A Repair Type: Non-Urgent Crossing Status: Found UCIP Comments: 03/02/2021 Record remains Non-Urgent. DMP internal video inspection has found pipe integrity issues. LOF of crossing is between 4.1 and 5. Crossing will be monitored until funding becomes available for rehabilitation. Crossing appears abandoned. Headwall and slide gate on waterside buried in soil. Vegetation and debris clearing needed at landside pipe end. No permit has been identified authorizing pipe. (O.Yakimov - DWR UCIP) 5/16/2017 Abandoned- needs to be done so properly. Pipe has been selected to be internally cleaned and inspected as part of the DMP project. (DWR Sutter Yard- AFreitag)11/15/2016 Abandoned. (DWR Sutter Yard- AFreitag)5/11/2016 Abandoned crossing.8/4/2015 Abandoned pipe. Casey Wilder has started the steps to have the pipe properly abandoned and removed from the levee.12/8/2014 Same as last inspection.6/11/2014 Same as last inspection.11/19/2013 Same as last inspection.5/29/2013 Same as last inspection. FIELD_STRUCT_DESC: 24-inch corrugated metal irrigation pipe through the levee, 14.5 feet below the crown. Slide gate on the waterside (WS) on concrete headwall. Flap gate on the landside (LS). [Additional Reference(s): DWR Levee Log, 1990 (HLM 10.41). USACE Sacramento O&M Manual, Unit 515, April 1955, Revised 28 December 2010, (Station 717+50), listed as 24-inch pipe. USACE As-Built Drawing No. 50-04-2637, Sheet 4, Station 717+50, 7 January 1953]. FS Date: 3/2/2021 9:47:39 AM

Top of Levee: View of levee crown looking upstream

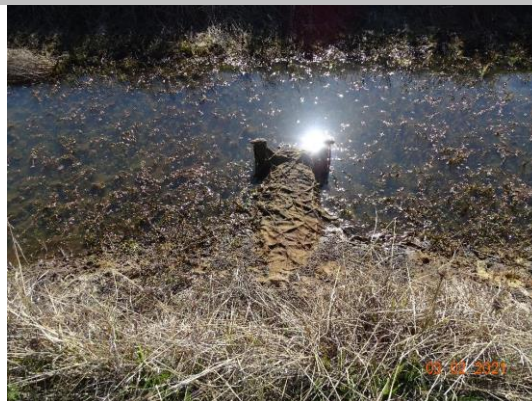
Photo 3 of 3 : UCIP\_SP\_2022\_65750\_98064.jpg

Land-Side: Pipe with flap gate in drainage ditch

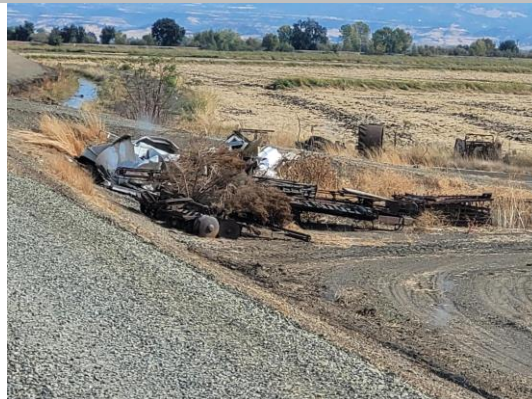
Photo 1 of 1 : SP\_2022\_MA0005\_196\_26\_20220307\_00006.jpg

LM Start	10.37	Rating **	M	Issue No.	26
LM End	10.37	Issue Type +	En	Location *	LS
Category	Earthen Levee			GPS Latitude/Longitude	
				Start	End
Item	Encroachments			39.567541 °	39.567541 °
				-121.819786 °	-121.819786 °
DWR ID	DWR_MA0005_01_s_2016_26				
Comment Code					
EQ : Equipment					
Inspector Comment					
Farm equipment should be removed from the landside toe.

View of the farm equipment at the landside toe. Fall 2021.

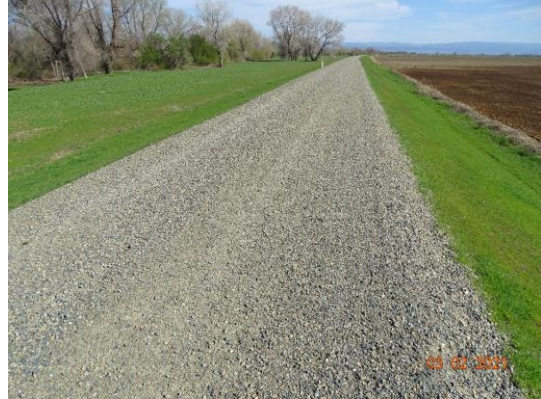
Photo 1 of 3 : UCIP\_SP\_2022\_65751\_98067.jpg

Comment Code					
Inspector Comment					
FS_ID:65751 DS_ID:1635 EP_NO: N/A Repair Type: Non-Urgent Crossing Status: Found UCIP Comments: 03/02/2021 Record remains Non-Urgent. Crossing appears abandoned. Pipe not found on waterside. Concrete headwall and pipe inlet are buried in soil at landside levee toe. Geophysical study indicates possible presence of pipe through levee. Owner needs to coordinate with the CVFPB to remove or abandon crossing according to Title 23 requirements. No permit has been identified authorizing pipe. (O.Yakimov - DWR UCIP) 5/16/2017 Abandoned- needs to be done so properly. (DWR Sutter Yard- A Freitag)11/15/2016 Abandoned. (DWR Sutter Yard- A Freitag)5/11/2016 Abandoned crossing.8/4/2015 Abandoned pipe. Casey Wilder has started the steps to have the pipe properly abandoned and removed from the levee.12/8/2014 Same as last inspection.6/11/2014 Same as last inspection.11/19/2013 Same as last inspection.5/29/2013 Same as last inspection.10/30/2012 Pipe buried on both sides of levee. FIELD_STRUCT_DESC: 30-inch corrugated metal drainage pipe through the levee, 12.2 feet below the crown. Flap gate on the waterside (WS) end. [Additional Reference(s): DWR Levee Log, 1990 (HLM 10.99). USACE Sacramento O&M Manual, Unit 515, April 1955, Revised 28 December 2010, (Station 748+53), listed as 30-inch pipe. USACE As-Built Drawing No. 50-04-2637, Sheet 4, 748+53, 7 January 1953]. FS Date: 3/2/2021 9:59:40 AM

Top of Levee: View of levee crown looking upstream

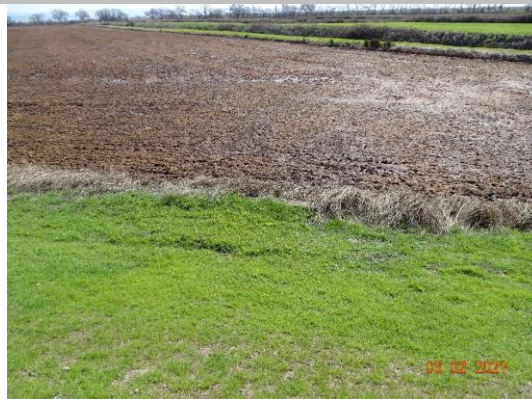
Photo 2 of 3 : UCIP\_SP\_2022\_65751\_98068.jpg

Land-Side: View of levee slope looking from crown

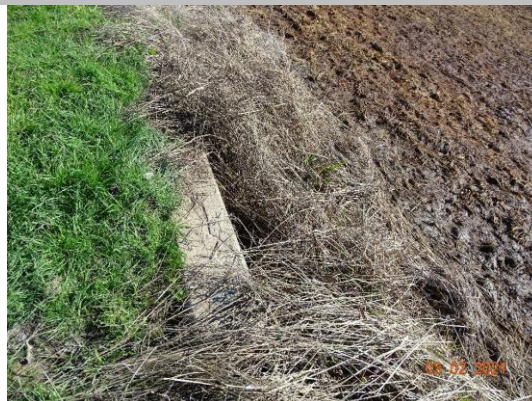
Photo 3 of 3 : UCIP\_SP\_2022\_65751\_98070.jpg

Land-Side: Headwall and pipe inlet at levee toe buried in soil

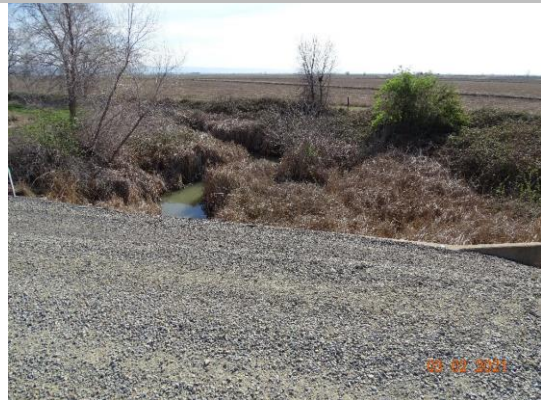
Photo 2 of 3 : UCIP\_SP\_2022\_65802\_98102.jpg

Land-Side: View of levee slope looking from crown

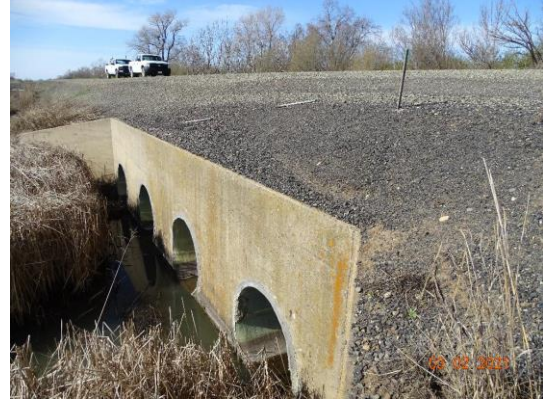
Photo 3 of 3 : UCIP\_SP\_2022\_65802\_98105.jpg

Land-Side: Concrete headwall and CIPP-lined pipe

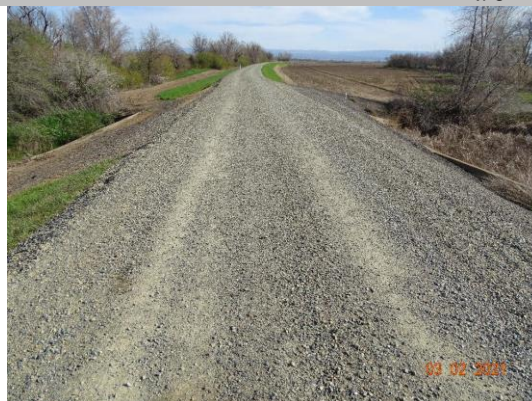
Photo 1 of 3 : UCIP\_SP\_2022\_65803\_98106.jpg

FS\_ID:65803  
DS\_ID:1782  
EP\_NO: N/A  
Repair Type: Non-Urgent  
Crossing Status: Found  
UCIP Comments: 03/02/2021 Record updated from No Action Needed to Non-Urgent. No permit has been identified authorizing pipe. Crossing has been CIPP-lined, new flap gate installed. (O.Yakimov - DWR UCIP) 05/16/2017 Crossing appears to be in good condition. Pipe has been selected to be internally cleaned and inspected as part of the DMP project. (A. Freitag - DWR Sutter Yard)11/15/2016 Crossing appears to be in good condition. (A. Freitag - DWR Sutter Yard)05/11/2016 Crossing appears to be in good condition. (A. Freitag - DWR Sutter Yard)08/04/2015 Crossing appears in good condition. No noticeable issues to report. (A. Freitag - DWR Sutter Yard)06/11/2014 Same as last inspection. (A. Freitag - DWR Sutter Yard)11/19/2013 Same as last inspection. (A. Freitag - DWR Sutter Yard)05/29/2013 Same as last inspection. (A. Freitag - DWR Sutter Yard)

Top of Levee: View of levee crown looking upstream

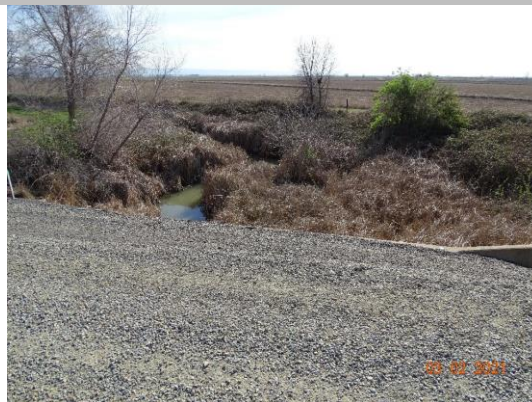
Photo 2 of 3 : UCIP\_SP\_2022\_65803\_98107.jpg

Land-Side: View of levee slope looking from crown

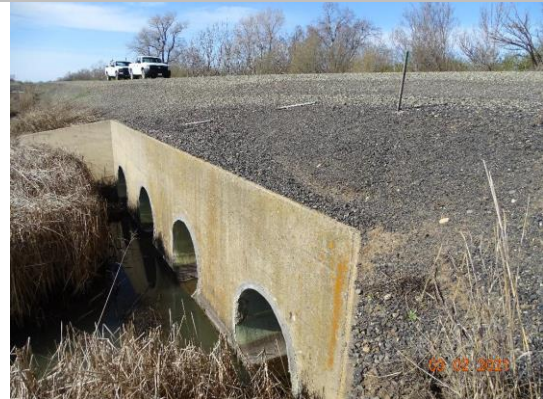
Photo 3 of 3 : UCIP\_SP\_2022\_65803\_98110.jpg

Land-Side: Concrete headwall and CIPP-lined pipe

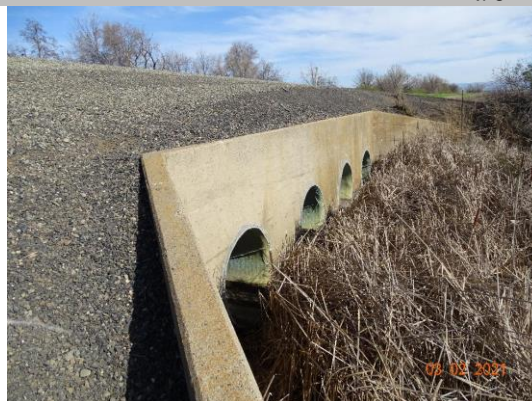
Photo 3 of 3 : UCIP\_SP\_2022\_65805\_98120.jpg

Comment Code						
Inspector Comment						
FS_ID:65805 DS_ID:1784 EP_NO: N/A Repair Type: Non-Urgent Crossing Status: Found UCIP Comments: 03/02/2021 Record updated from No Action Needed to Non-Urgent. No permit has been identified authorizing pipe. Crossing has been CIPP-lined, new flap gate installed. (O.Yakimov - DWR UCIP) 05/16/2017 Crossing appears to be in good condition. Pipe has been selected to be internally cleaned and inspected as part of the DMP project. (A. Freitag - DWR Sutter Yard)11/15/2016 Crossing appears to be in good condition. (A. Freitag - DWR Sutter Yard)05/11/2016 Crossing appears to be in good condition. (A. Freitag - DWR Sutter Yard)08/04/2015 Crossing appears in good condition. No noticeable issues to report. (A. Freitag - DWR Sutter Yard)06/11/2014 Same as last inspection. (A. Freitag - DWR Sutter Yard)11/19/2013 Same as last inspection. (A. Freitag - DWR Sutter Yard)05/29/2013 Same as last inspection. (A. Freitag - DWR Sutter Yard) FIELD_STRUCT_DESC: 4 of 4: 54-inch CIPP-lined corrugated metal drainage pipe through the levee, 13.5 feet below the crown. Flap gate on the waterside (WS). Concrete headwalls on the landside (LS) and the WS toes. [Additional Reference(s): DWR Levee Log, 1990 (HLM 11.52). USACE Sacramento O&M Manual, Unit 515, April 1955, Revised 28 December 2010, (Station 25+18 'A'), listed as 54-inch pipe. USACE As-Built Drawing No. 50-04-2637, Sheet 4, Station 25+18 'A', 7 January 1953]. FS Date: 3/2/2021 12:02:36 PM

Land-Side: Concrete headwall and CIPP-lined pipe

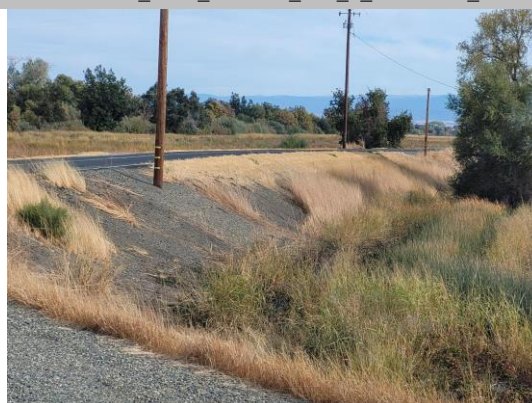
Photo 1 of 1 : SP\_2022\_MA0005\_196\_6\_20220307\_00003.jpg

LM Start	11.85	Rating **	M	Issue No.	6
LM End	13.64	Issue Type +	En	Location *	LS
Category	Earthen Levee			GPS Latitude/Longitude	
				Start	End
Item	Encroachments			39.551235 °	39.531462 °
				-121.837697 °	-121.856165 °
DWR ID	DWR_MA0005_01_s_2012_6				
Comment Code					
DT : Ditch					
Inspector Comment

View of the agricultural ditch along the landside toe. Fall 2021.

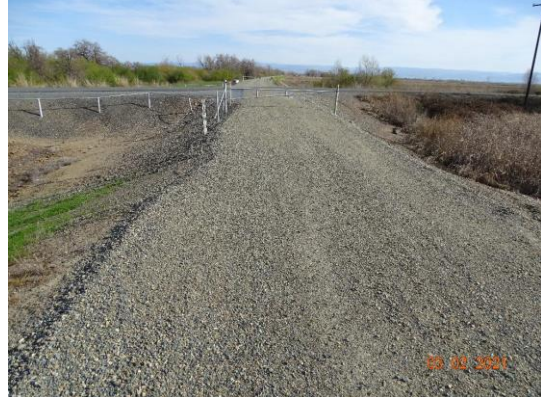
Photo 1 of 3 : UCIP\_SP\_2022\_65839\_98169.jpg

Comment Code						
Inspector Comment						
FS_ID:65839 DS_ID:1747 EP_NO: N/A Repair Type: Non-Urgent Crossing Status: Not Found UCIP Comments: 03/02/2021 Record remains Non-Urgent. Crossing not found. Concrete structure in irrigation ditch on landside at this place likely doesn't belong to this crossing. Geophysical results did not confirm presence of pipe through levee. Record will remain in UCIP's inspection records until future Levee Improvement Project can confirm no crossing was found through the levee. No permit has been identified authorizing pipe. (O.Yakimov - DWR UCIP) 05/16/2017 Pipe is buried on both sides of the levee. Unable to locate. (A. Freitag - DWR Sutter Yard)11/15/2016 Buried on both sides of Levee. (A. Freitag - DWR Sutter Yard)05/11/2016 Buried pipe. (A. Freitag - DWR Sutter Yard)08/04/2015 Pipe is buried on both ends. (A. Freitag - DWR Sutter Yard)06/11/2014 Same as last inspection. (A. Freitag - DWR Sutter Yard)11/19/2013 Same as last inspection. (A. Freitag - DWR Sutter Yard)05/29/2013 Same as last inspection. (A. Freitag - DWR Sutter Yard)10/31/2012 Pipe buried on both LS and WS. (W. Wylie - DWR UCIP) FIELD_STRUCT_DESC: 48-inch corrugated metal irrigation pipe through the levee, at an unknown depth, indicator found. 48-inch corrugated metal riser and a sparring water meter/irrigation structure on the landside (LS). 4-foot by 6-foot concrete distribution box at the LS toe. [Additional Reference(s): USACE Sacramento O&M Manual, Unit 515, April 1955, Revised 28 December 2010, (Station 836+86), listed as 48-inch pipe. USACE As-Built Drawing No. 50-04-2637, Sheet 4, Station 836+85.70, 7 January 1953]. FS Date: 3/2/2021 2:38:44 PM

Top of Levee: View of levee crown looking upstream

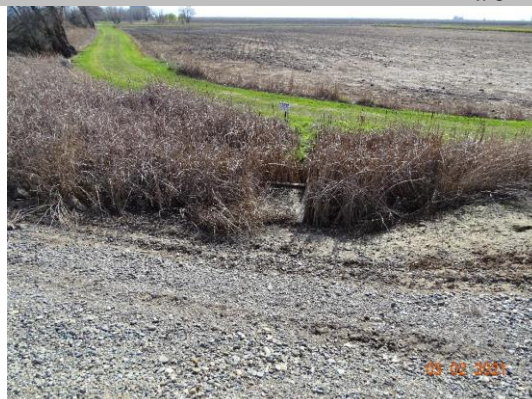
Photo 2 of 3 : UCIP\_SP\_2022\_65839\_98170.jpg

Land-Side: View of levee slope looking from crown

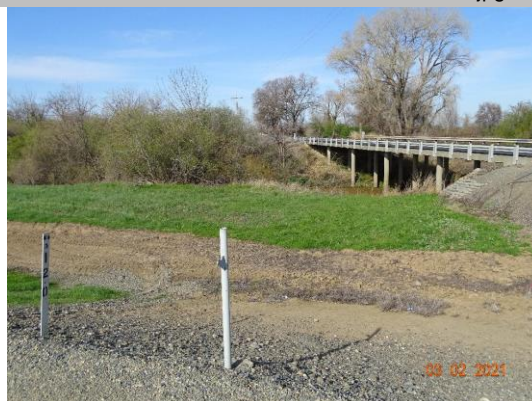
Photo 3 of 3 : UCIP\_SP\_2022\_65839\_98171.jpg

Water-Side: View of levee slope looking from crown

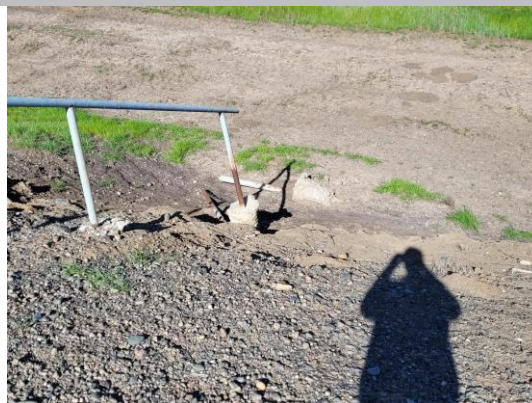
Photo 1 of 1 : SP\_2022\_MA0005\_196\_69\_20220328\_00151.jpg

View of the erosion along the landside slope and toe. Spring 2022.

LM Start	13.69	Rating **	M	Issue No.	69
LM End	13.69	Issue Type +	Ma	Location *	WS
Category	Earthen Levee			GPS Latitude/Longitude	
				Start	End
Item	Erosion / Bank Caving			39.531032 °	39.531032 °
				-121.856977 °	-121.856977 °
DWR ID	DWR_MA0005_01_s_2017_69				
Comment Code					
E2 : Schedule repair of erosion site prior to the next inspection.					
Inspector Comment

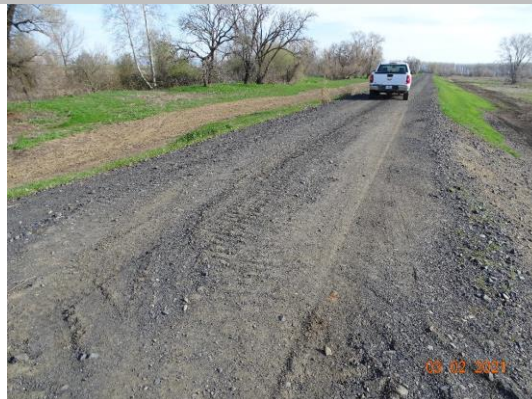
Photo 1 of 3 : UCIP\_SP\_2022\_65842\_98184.jpg

FS\_ID:65842  
DS\_ID:1639  
EP\_NO: N/A  
Repair Type: Non-Urgent  
Crossing Status: Found  
UCIP Comments: 03/02/2021 Record remains Non-Urgent. No permit has been identified authorizing pipe. Pipe has been CIPP-lined, new flap gate installed on waterside pipe end. (O.Yakimov - DWR UCIP) 05/16/2017 Soil still eroded away from the WS wing walls. Pipe has been selected to be internally cleaned and inspected as part of the DMP project. (A. Freitag - DWR Sutter Yard)11/15/2016 No soil supporting the WS wing walls. (A. Freitag - DWR Sutter Yard)05/11/2016 Still no soil supporting the WS wing walls and apron. WS vegetation was thinner and not a problem this time. (A. Freitag - DWR Sutter Yard)08/04/2015 No soil supporting the WS wing walls at the WS pipe end. WS pipe end is also being overgrown with vegetation and should be cleared back. (A. Freitag - DWR Sutter Yard)06/11/2014 Same as last inspection. (A. Freitag - DWR Sutter Yard)11/19/2013 Same as last inspection. (A. Freitag - DWR Sutter Yard)05/29/2013 Same as last inspection. (A. Freitag - DWR Sutter Yard)10/31/2012 Soil under Concrete wing walls on WS toe has been eroded. No soil supporting wing walls. (W. Wylie - DWR UCIP) FIELD\_STRUCT\_DESC: 36-inch CIPP-lined corrugated metal drainage pipe through the levee, 13 feet below the crown. Flap gate on the waterside (WS). Concrete headwalls on the landside (LS) and the WS ends. [Additional Reference(s): DWR Levee Log, 1990 (HLM 14.66). USACE Sacramento O&M Manual, Unit 515, April 1955, Revised 28 December 2010, (Station 978+25), listed as 36-inch pipe. USACE As-Built Drawing No. 50-04-2637, Sheet 5, Station 978+24.95, 7 January 1953].

Top of Levee: View of levee crown looking upstream
