# Flood Control Project Maintenance Levee Inspections LMA District Cover Sheet

## Sutter Maintenance Yard Maintenance Area 0005

**Flood Control Project Maintenance  
Levee Inspections  
Unit Cover Sheet**

Waterway			Bank	Unit Miles
Unit No. 01 Butte Creek			Left	15.08
	Spring (March - May)	Summer (June - August)	(September - November) Fall	Winter (December - February)
Unit Maintenance Rating (Fall Only)				
Date of Inspection	3/23/2022 - 3/23/2022			
DWR Inspector	Makar Sokol			
Accompanied By	Shawn Freitag DWR Sutter Yard

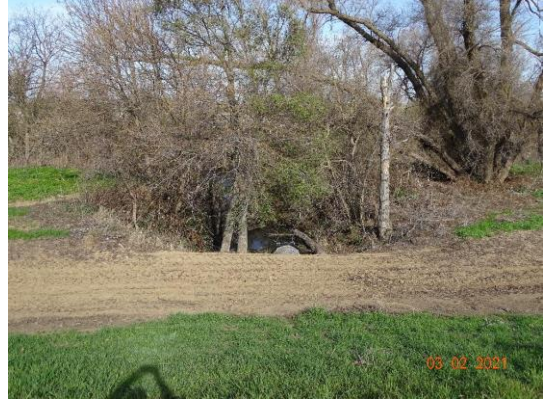
Photo 2 of 3 : UCIP\_SP\_2022\_65842\_98185.jpg

FS\_ID:65842  
DS\_ID:1639  
EP\_NO: N/A  
Repair Type: Non-Urgent  
Crossing Status: Found  
UCIP Comments: 03/02/2021 Record remains Non-Urgent. No permit has been identified authorizing pipe. Pipe has been CIPP-lined, new flap gate installed on waterside pipe end. (O.Yakimov - DWR UCIP) 05/16/2017 Soil still eroded away from the WS wing walls. Pipe has been selected to be internally cleaned and inspected as part of the DMP project. (A. Freitag - DWR Sutter Yard)11/15/2016 No soil supporting the WS wing walls. (A. Freitag - DWR Sutter Yard)05/11/2016 Still no soil supporting the WS wing walls and apron. WS vegetation was thinner and not a problem this time. (A. Freitag - DWR Sutter Yard)08/04/2015 No soil supporting the WS wing walls at the WS pipe end. WS pipe end is also being overgrown with vegetation and should be cleared back. (A. Freitag - DWR Sutter Yard)06/11/2014 Same as last inspection. (A. Freitag - DWR Sutter Yard)11/19/2013 Same as last inspection. (A. Freitag - DWR Sutter Yard)05/29/2013 Same as last inspection. (A. Freitag - DWR Sutter Yard)10/31/2012 Soil under Concrete wing walls on WS toe has been eroded. No soil supporting wing walls. (W. Wylie - DWR UCIP) FIELD\_STRUCT\_DESC: 36-inch CIPP-lined corrugated metal drainage pipe through the levee, 13 feet below the crown. Flap gate on the waterside (WS). Concrete headwalls on the landside (LS) and the WS ends. [Additional Reference(s): DWR Levee Log, 1990 (HLM 14.66). USACE Sacramento O&M Manual, Unit 515, April 1955, Revised 28 December 2010, (Station 978+25), listed as 36-inch pipe. USACE As-Built Drawing No. 50-04-2637, Sheet 5, Station 978+24.95, 7 January 1953].

Water-Side: View of levee slope looking from crown

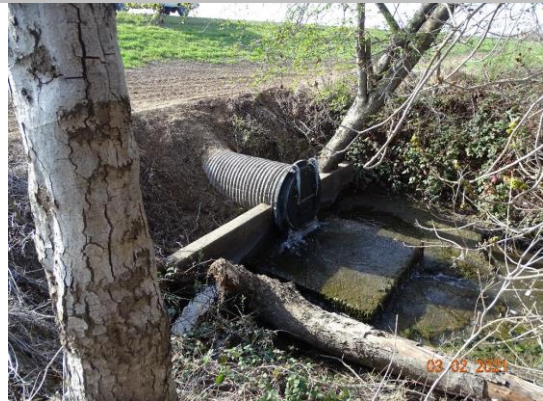
Photo 3 of 3 : UCIP\_SP\_2022\_65842\_98187.jpg

Water-Side: CMP drainage pipe with new flap gate

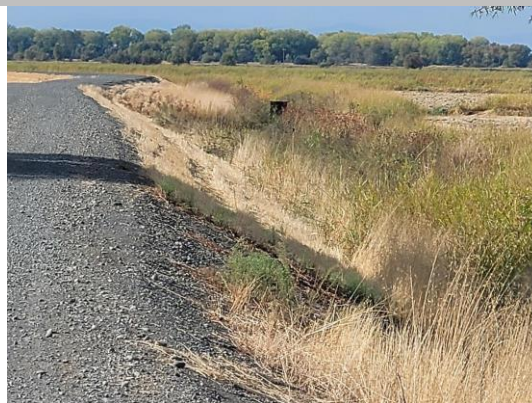
Photo 1 of 1 : SP\_2022\_MA0005\_197\_1\_20220307\_00001.jpg

LM Start	1.21	Rating **	M	Issue No.	1
LM End	1.59	Issue Type +	En	Location *	LS
Category	Earthen Levee			GPS Latitude/Longitude	
				Start	End
Item	Encroachments			39.529933 °	39.534102 °
				-121.861563 °	-121.856947 °
DWR ID	DWR_MA0005_02_s _ 2012_1				
Comment Code					
DT : Ditch					
Inspector Comment

View of the agricultural ditch along the landside toe. Fall 2021.

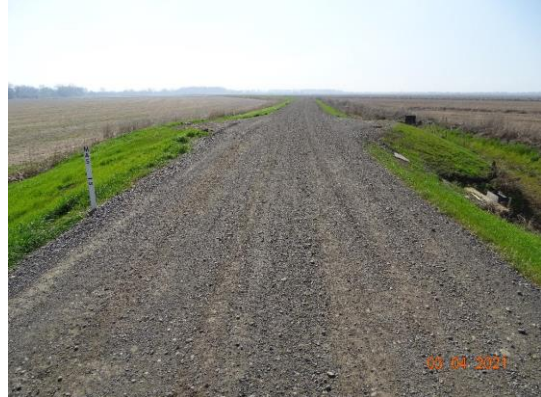
Photo 1 of 3 : UCIP\_SP\_2022\_65855\_98189.jpg

FS\_ID:65855  
DS\_ID:1641  
EP\_NO: N/A  
Repair Type: Non-Urgent  
Crossing Status: Found  
UCIP Comments: 03/04/2021 Record updated from No Action Needed to Non-Urgent. No permit has been identified authorizing pipe. Pipe has been CIPP lined, new flap gate installed on waterside pipe end. (O.Yakimov - DWR UCIP)  
05/18/2017 Crossing appears to be in good condition. Pipe has been selected to be internally cleaned and inspected as part of the DMP project. (A. Freitag - DWR Sutter Yard)11/14/2016 Crossing appears to be in good condition. (A. Freitag - DWR Sutter Yard)05/23/2016 Crossing appears to be in good condition. (A. Freitag - DWR Sutter Yard)07/28/2015 Pipe appears in good condition. No noticeable issues to report. (A. Freitag - DWR Sutter Yard)11/25/2014 Same as last inspection. (A. Freitag - DWR Sutter Yard)06/04/2014 Same as last inspection. (A. Freitag - DWR Sutter Yard)11/12/2013 Same as last inspection. (A. Freitag - DWR Sutter Yard)06/06/2013 Same as last inspection. (A. Freitag - DWR Sutter Yard)

FIELD\_STRUCT\_DESC: 24-inch CIPP-lined corrugated metal irrigation pipe through the levee, 9.7 feet below the crown. Flap gate on the waterside (WS). Concrete headwall and adjustable weir on the landside (LS) toe. [Additional Reference(s): DWR Levee Log, 1990 (HLM 1.49). USACE Sacramento O&M Manual, Unit 515, April 1955, Revised 28 December 2010, (Station 935+00), listed as 24-inch pipe. USACE As-Built Drawing No. 50-04-2637, Sheet 5, Station 935+00, 7 January 1953].  
FS Date: 3/4/2021 9:01:21 AM

Top of Levee: View of levee crown looking downstream

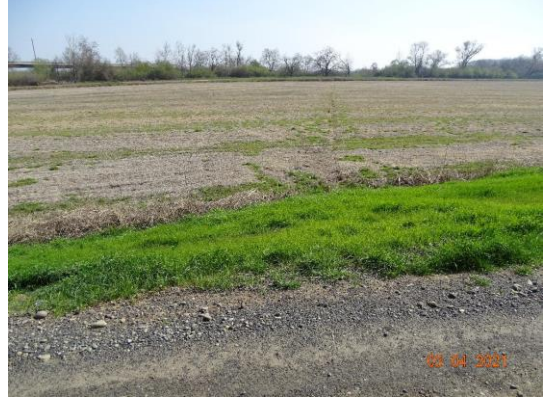
Photo 2 of 3 : UCIP\_SP\_2022\_65855\_98192.jpg

Water-Side: View of levee slope looking from crown

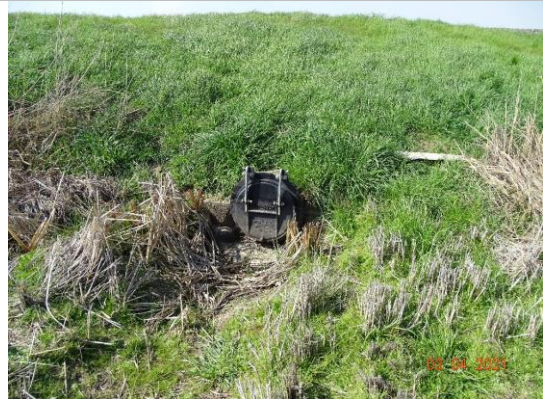
Photo 3 of 3 : UCIP\_SP\_2022\_65855\_98193.jpg

Water-Side: Pipe with new flap gate at levee toe

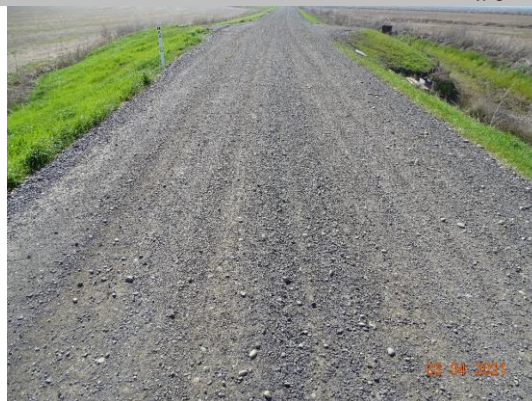
Photo 1 of 3 : UCIP\_SP\_2022\_65861\_98194.jpg

Comment Code						
Inspector Comment						
FS_ID:65861 DS_ID:1642 EP_NO: N/A Repair Type: Non-Urgent Crossing Status: Not Found UCIP Comments: 03/04/2021 Record updated from No Action Needed to Non-Urgent. Crossing not found. Unauthorized encroachment recorded in Levee Log prior to 2011. (O.Yakimov - DWR UCIP) 05/18/2017 Unable to locate. (A. Freitag - DWR Sutter Yard) 11/14/2016 Unable to locate. (A. Freitag - DWR Sutter Yard) 05/23/2016 Unable to locate. (A. Freitag - DWR Sutter Yard) 07/28/2015 Unable to locate. (A. Freitag - DWR Sutter Yard) 11/25/2014 Unable to locate. (A. Freitag - DWR Sutter Yard) 06/04/2014 Same as last inspection. (A. Freitag - DWR Sutter Yard) 11/12/2013 Unable to locate. (A. Freitag - DWR Sutter Yard) 06/06/2013 Same as last inspection. Unable to locate. (A. Freitag - DWR Sutter Yard) FIELD_STRUCT_DESC: 1 of 3: 3.5-inch conduit of an unknown material or purpose through the levee, 3 feet below the crown, not found. [Additional Reference(s): DWR Levee Log, 1990 (HLM 1.50)]. FS Date: 3/4/2021 9:17:32 AM

Top of Levee: View of levee crown looking downstream

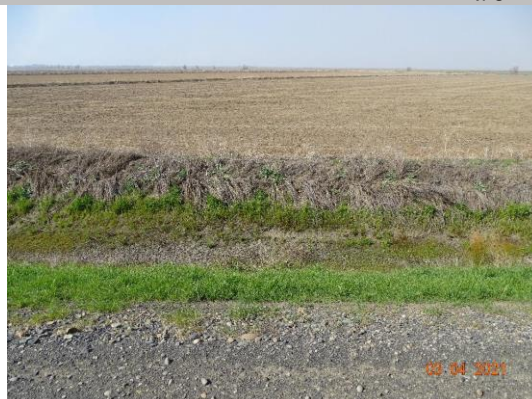
Photo 2 of 3 : UCIP\_SP\_2022\_65861\_98195.jpg

Land-Side: View of levee slope looking from crown

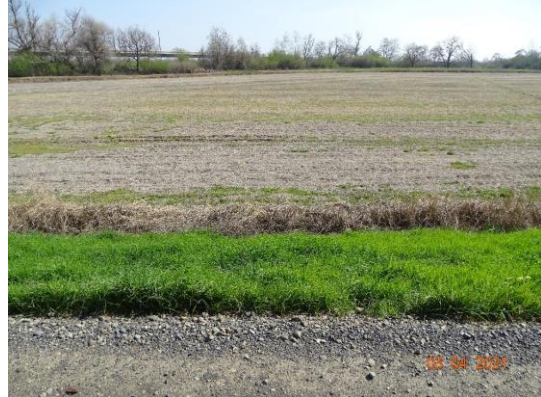
Photo 3 of 3 : UCIP\_SP\_2022\_65861\_98196.jpg

Water-Side: View of levee slope looking from crown

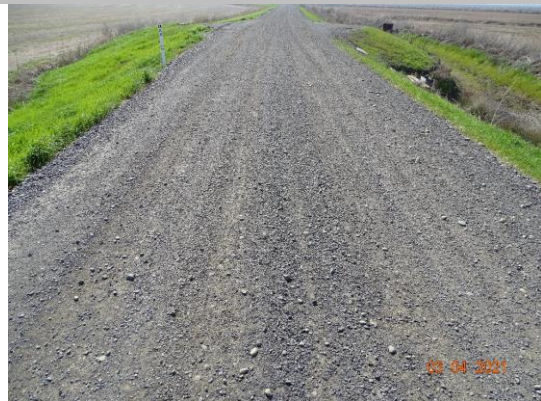
Photo 1 of 3 : UCIP\_SP\_2022\_65862\_98197.jpg

FS\_ID:65862  
 DS\_ID:1785  
 EP\_NO: N/A  
 Repair Type: Non-Urgent  
 Crossing Status: Not Found  
 UCIP Comments: 03/04/2021 Record updated from No Action Needed to Non-Urgent. Crossing not found. Unauthorized encroachment recorded in Levee Log prior to 2011. (O.Yakimov - DWR UCIP)  
 05/18/2017 Unable to locate. (A. Freitag - DWR Sutter Yard)  
 11/14/2016 Unable to locate. (A. Freitag - DWR Sutter Yard)  
 05/23/2016 Unable to locate. (A. Freitag - DWR Sutter Yard)  
 07/28/2015 Unable to locate. (A. Freitag - DWR Sutter Yard)  
 11/25/2014 Unable to locate. (A. Freitag - DWR Sutter Yard)  
 06/04/2014 Same as last inspection. (A. Freitag - DWR Sutter Yard)  
 11/12/2013 Unable to locate. (A. Freitag - DWR Sutter Yard)  
 06/06/2013 Same as last inspection. Unable to locate. (A. Freitag - DWR Sutter Yard)  
 FIELD\_STRUCT\_DESC: 2 of 3: 3.5-inch conduit of an unknown material or purpose through the levee, 3 feet below the crown, not found. [Additional Reference(s): DWR Levee Log, 1990 (HLM 1.50)].

Top of Levee: View of levee crown looking downstream

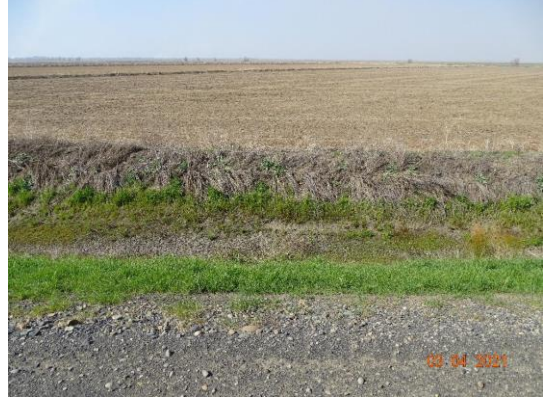
Photo 2 of 3 : UCIP\_SP\_2022\_65862\_98198.jpg

Land-Side: View of levee slope looking from crown

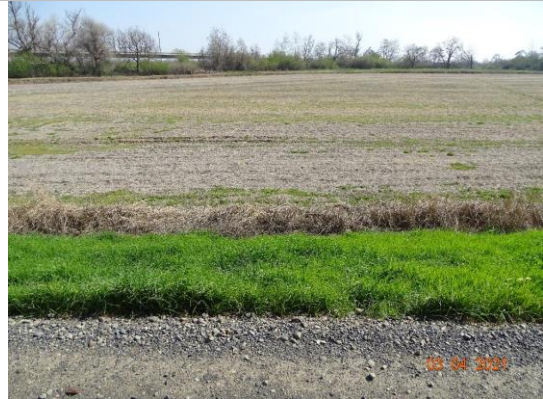
Photo 3 of 3 : UCIP\_SP\_2022\_65862\_98199.jpg

Water-Side: View of levee slope looking from crown

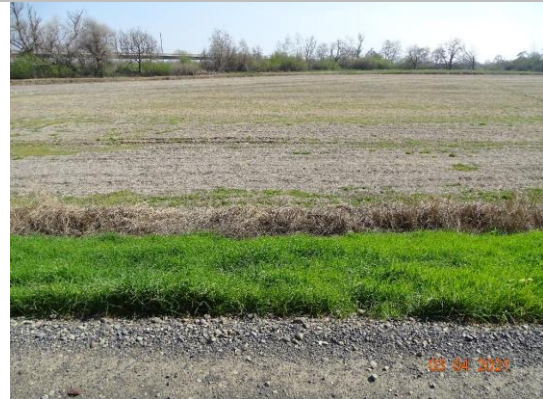
Photo 3 of 3 : UCIP\_SP\_2022\_65863\_98202.jpg

Comment Code						
Inspector Comment						
FS_ID:65863 DS_ID:1786 EP_NO: N/A Repair Type: Non-Urgent Crossing Status: Not Found UCIP Comments: 03/04/2021 Record updated from No Action Needed to Non-Urgent. Crossing not found. Unauthorized encroachment recorded in Levee Log prior to 2011. (O.Yakimov - DWR UCIP) 05/18/2017 Unable to locate. (A. Freitag - DWR Sutter Yard) 11/14/2016 Unable to locate. (A. Freitag - DWR Sutter Yard) 05/23/2016 Unable to locate. (A. Freitag - DWR Sutter Yard) 07/28/2015 Unable to locate. (A. Freitag - DWR Sutter Yard) 11/25/2014 Unable to locate. (A. Freitag - DWR Sutter Yard) 06/04/2014 Same as last inspection. (A. Freitag - DWR Sutter Yard) 11/12/2013 Unable to locate. (A. Freitag - DWR Sutter Yard) 06/06/2013 Same as last inspection. Unable to locate. (A. Freitag - DWR Sutter Yard) FIELD_STRUCT_DESC: 3 of 3: 3.5-inch conduit of an unknown material or purpose through the levee, 3 feet below the crown, not found. [Additional Reference(s): DWR Levee Log, 1990 (HLM 1.50)]. FS Date: 3/4/2021 9:22:36 AM

Water-Side: View of levee slope looking from crown

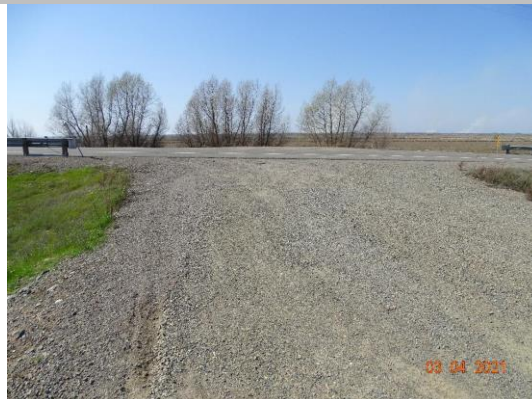
Photo 1 of 3 : UCIP\_SP\_2022\_65889\_98208.jpg

Comment Code						
Inspector Comment						
FS_ID:65889 DS_ID:1751 EP_NO: N/A Repair Type: Non-Urgent Crossing Status: Not Found UCIP Comments: 03/04/2021 Record updated from No Action Needed to Non-Urgent. Crossing not found. Geophysical study indicates possible presence of pipe through levee. Owner needs to coordinate with the CVFPB to remove or abandon crossing according to Title 23 requirements. No permit has been identified authorizing pipe. (O.Yakimov - DWR UCIP) 05/18/2017 Unable to locate. (A. Freitag - DWR Sutter Yard)11/14/2016 Unable to locate. (A. Freitag - DWR Sutter Yard)05/23/2016 Unable to locate. (A. Freitag - DWR Sutter Yard)07/28/2015 Unable to locate. (A. Freitag - DWR Sutter Yard)11/25/2014 Unable to locate. (A. Freitag - DWR Sutter Yard)06/04/2014 Same as last inspection. (A. Freitag - DWR Sutter Yard)11/12/2013 Unable to locate. (A. Freitag - DWR Sutter Yard)06/06/2013 Same as last inspection. Unable to locate. (A. Freitag - DWR Sutter Yard) FIELD_STRUCT_DESC: 16-inch steel irrigation pipe through the levee, at an unknown depth (invert 106.5 feet USED), not found. Pump on the waterside (WS), not found. Calco gate Model 102 - automatic drainage gate, not found. [Additional Reference(s): USACE Sacramento O&M Manual, Unit 515, April 1955, Revised 28 December 2010, (Station 927+50), listed as 16-inch pipe. USACE As-Built Drawing No. 50-4-2637, Exhibit B, Sheet 5, April 1950, (Station 927+50)]. FS Date: 3/4/2021 10:39:08 AM

Top of Levee: View of levee crown looking downstream

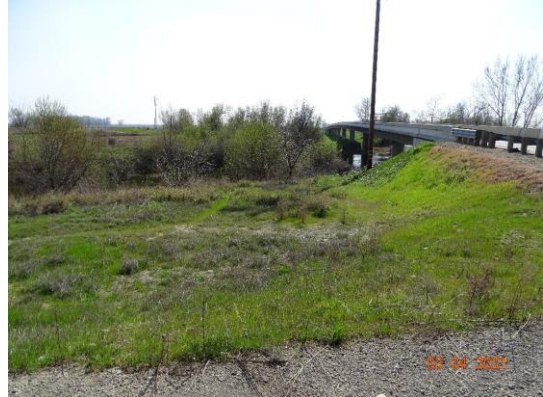
Photo 2 of 3 : UCIP\_SP\_2022\_65889\_98207.jpg

Water-Side: View of levee slope looking from crown. Pipe not found

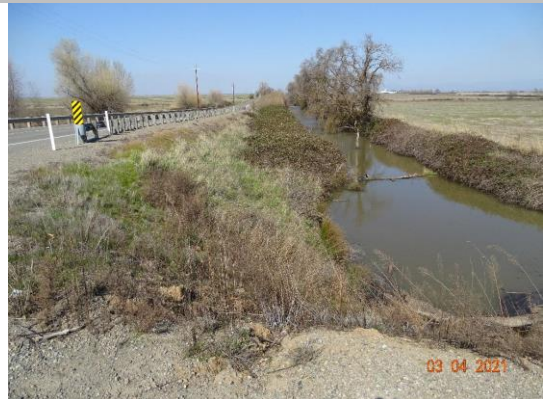
Photo 3 of 3 : UCIP\_SP\_2022\_65889\_98206.jpg

Land-Side: View of levee slope looking from crown. Irrigation canal on landside

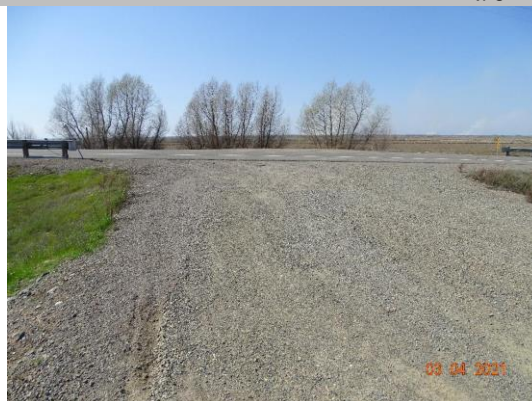
Photo 1 of 3 : UCIP\_SP\_2022\_65896\_98209.jpg

Comment Code					
Inspector Comment					
FS_ID:65896 DS_ID:1643 EP_NO: 3511 Repair Type: Non-Urgent Crossing Status: Not Found UCIP Comments: 03/04/2021 Record updated from No Action Needed to Non-Urgent. Crossing not found. (O.Yakimov - DWR UCIP) 05/18/2017 Unable to locate. (A. Freitag - DWR Sutter Yard)11/14/2016 Unable to locate. (A. Freitag - DWR Sutter Yard)05/23/2016 Unable to locate. (A. Freitag - DWR Sutter Yard)07/28/2015 Unable to locate. (A. Freitag - DWR Sutter Yard)11/25/2014 Unable to locate. (A. Freitag - DWR Sutter Yard)06/04/2014 Same as last inspection. (A. Freitag - DWR Sutter Yard)11/12/2013 Unable to locate. (A. Freitag - DWR Sutter Yard)06/06/2013 Same as last inspection. Unable to locate. (A. Freitag - DWR Sutter Yard) FIELD_STRUCT_DESC: 1-inch communication conduit through the levee, 3 feet below the crown. (Underground cable authorized under Permit No. 3511, 1960 - U.S. Army Engineer District). [Additional Reference(s): DWR Levee Log, 1990 (HLM 1.66)]. FS Date: 3/4/2021 11:10:11 AM

Top of Levee: View of levee crown looking downstream

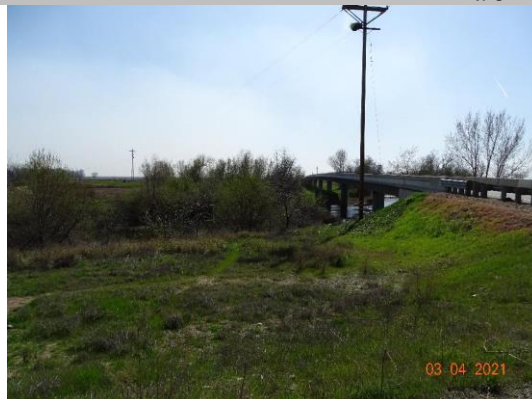
Photo 2 of 3 : UCIP\_SP\_2022\_65896\_98210.jpg

Water-Side: View of levee slope looking from crown

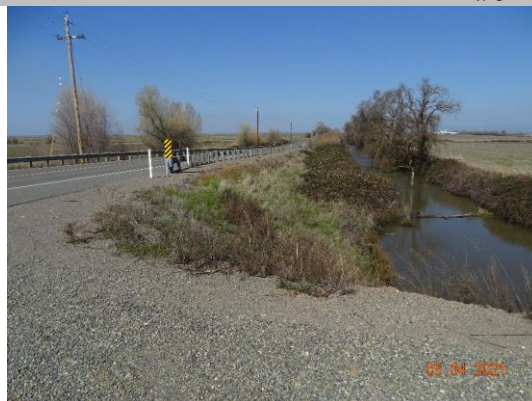
Photo 3 of 3 : UCIP\_SP\_2022\_65896\_98211.jpg

Land-Side: View of levee slope looking from crown. Irrigation canal on landside

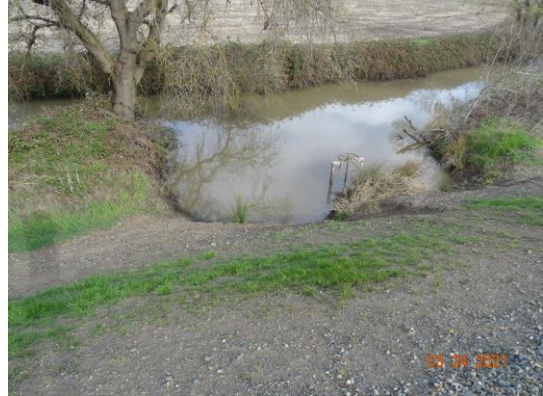
Photo 1 of 1 : SP\_2022\_MA0005\_197\_49\_20220307\_00010.jpg

LM Start	1.90	Rating **	M	Issue No.	49
LM End	1.90	Issue Type +	Ma	Location *	LS
Category	Earthen Levee			GPS Latitude/Longitude	
				Start	End
Item	Erosion / Bank Caving			39.537445 °	39.537445 °
				-121.853112 °	-121.853112 °
DWR ID	DWR_MA0005_02_f _ 2016_49				
Comment Code					
E2 : Schedule repair of erosion site prior to the next inspection.					
Inspector Comment

View of the erosion at the landside toe. Spring 2021.

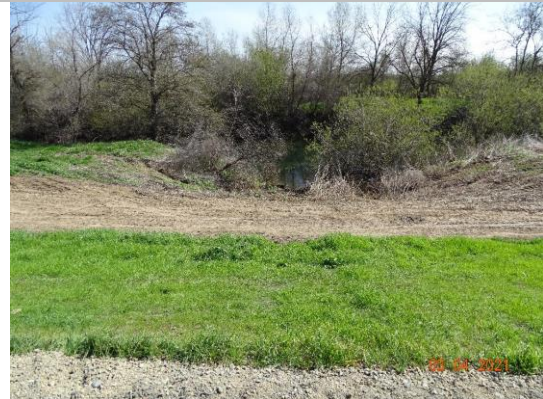
Photo 1 of 3 : UCIP\_SP\_2022\_65959\_98237.jpg

FS\_ID:65959  
DS\_ID:1645  
EP\_NO: N/A  
Repair Type: Urgent  
Crossing Status: Found  
UCIP Comments: 03/04/2021 Record remains Urgent. Erosion around headwall on landside is present. Debris at the bottom of flap gate on waterside prevents flap gate from closing. No permit has been identified authorizing pipe. (O.Yakimov - DWR UCIP)  
10/05/2018 Unable to see pipe on waterside due to high water level in the creek. Erosion is present around headwall on LS. Screw gate on LS blocked with silt approximately halfway in height. (O. Yakimov - DWR UCIP) 05/18/2017 LS erosion still present. Ws flap gate has been completely buried by sediment after the high water flows through the area. Pipe has been selected to be internally cleaned and inspected as part of the DMP project. (A. Freitag - DWR Sutter Yard)11/14/2016 LS erosion still present and is into the prism of the levee. WS flap gate was still mostly buried and non-operational. (A. Freitag - DWR Sutter Yard)05/23/2016 The tree that was overgrowing the WS flapgate has been removed. Flap gate was half buried and unable to open. Erosion on the LS is still present. (A. Freitag - DWR Sutter Yard)07/28/2015 LS inlet is underwater but there appears to be erosion behind the LS headwall. WS pipe end and flap gate are completely overgrown and inaccessible for inspection. (A. Freitag - DWR Sutter Yard)11/25/2014 Tree is overgrowing the WS pipe outlet.. Needs to be trimmed back. (A. Freitag - DWR Sutter Yard)06/04/2014 Same as last inspection. (A. Freitag - DWR Sutter Yard)11/12/2013 Same as last inspection. (A. Freitag - DWR Sutter Yard)06/06/2013 Same as last inspection. (A. Freitag - DWR Sutter Yard)10/31/2012 Vegetation needs to be cleared from outlet. (W. Wylie - DWR UCIP)

FIELD\_STRUCT\_DESC: 36-inch corrugated metal drainage pipe through the levee, 17 feet below the crown. Flap gate on the waterside (WS). Slide gate on the landside (LS) toe. Concrete headwalls at both the LS and the WS toes. [Additional Reference(s): DWR Levee Log, 1990 (HLM 1.92). USACE Sacramento O&M Manual, Unit 515, April 1955, Revised 28 December 2010, (Station 902+50), listed as 36-inch pipe. USACE As-Built Drawing No. 50-04-2637, Sheet 5, 902+50, 7 January 1953].  
FS Date: 3/4/2021 2:44:17 PM

Water-Side: View of levee slope looking from crown

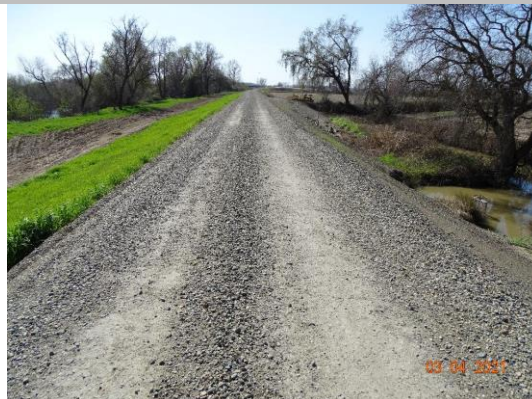
Photo 2 of 3 : UCIP\_SP\_2022\_65959\_98240.jpg

Top of Levee: View of levee crown looking downstream

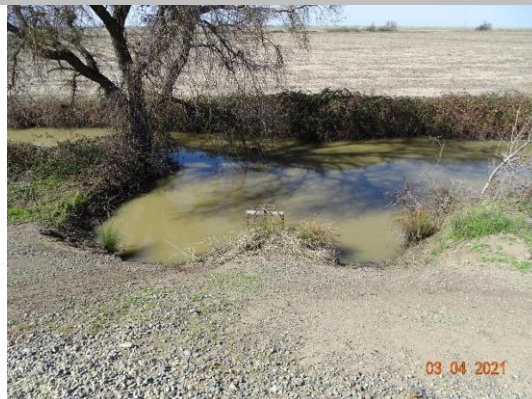
Photo 3 of 3 : UCIP\_SP\_2022\_65959\_98236.jpg

Land-Side: View of levee slope looking from crown. Headwall, slide gate, erosion around headwall

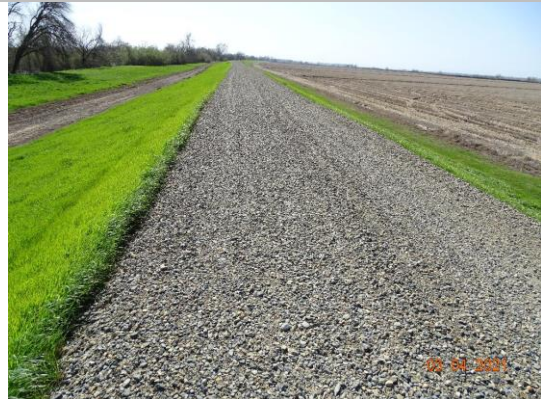
Photo 1 of 3 : UCIP\_SP\_2022\_66056\_98329.jpg

Comment Code						
Inspector Comment						
FS_ID:66056 DS_ID:1646 EP_NO: 3927 Repair Type: Non-Urgent Crossing Status: Found UCIP Comments: 03/04/2021 Record remains Non-Urgent. Crossing appears abandoned. CMP riser and siphon breaker are not found on landside shoulder, electric motor removed from pump at riverbank, pipe not found on landside. (O.Yakimov - DWR UCIP) 05/18/2017 Appears to have been abandoned. Pump is missing from the pier and there is no sign of the riser and siphon breaker on the LS shoulder. (A. Freitag - DWR Sutter Yard)11/14/2016 Appears abandoned- pump removed from pier in Butte Creek also riser and siphon breaker are no longer seen on LS shoulder. (A. Freitag - DWR Sutter Yard)05/23/2016 Crossing appears to have been abandoned and removed. Could not locate the LS riser and siphon breaker. (A. Freitag - DWR Sutter Yard)07/28/2015 No pump present during any of my inspections. Crossing appears abandoned. CMP riser has been knocked out of levee. (A. Freitag - DWR Sutter Yard) 11/25/2014 Same as last inspection. (A. Freitag - DWR Sutter Yard)06/04/2014 Same as last inspection. (A. Freitag - DWR Sutter Yard)11/12/2013 Same as last inspection. (A. Freitag - DWR Sutter Yard)06/06/2013 Same as last inspection. (A. Freitag - DWR Sutter Yard)10/31/2012 Pump does not appear to be in use or is abandoned. (A. Freitag - DWR Sutter Yard) FIELD_STRUCT_DESC: 20-inch exterior coated steel irrigation pipe through the levee, 2.4 feet below the crown. Not found: siphon breaker in a 24-inch corrugated metal riser on the landside (LS) shoulder. Portable pump on the waterside (WS). (18-inch originally authorized however, approval was given for 20-inch pipe (page 6 of 26) under Permit No. 3927, 1962 - Arrowhead Ranch). [Additional Reference(s): DWR Levee Log, (HLM 2.90), listed as 18-inch pipe]. FS Date: 3/4/2021 11:13:21 AM

Top of Levee: View of levee crown looking downstream

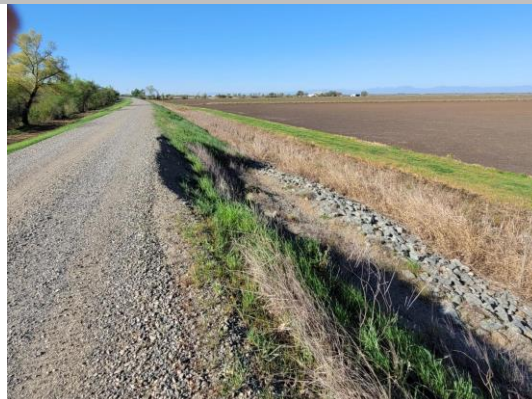
Photo 1 of 1 : SP\_2022\_MA0005\_197\_55\_20220328\_00189.jpg

LM Start	3.38	Rating **	U	Issue No.	55
LM End	3.38	Issue Type +	Ma	Location *	LS
Category	Earthen Levee			GPS Latitude/Longitude	
				Start	End
Item	Erosion / Bank Caving			39.555027 °	39.555027 °
				-121.837555 °	-121.837555 °
DWR ID	DWR_MA0005_02_f _ 2019_55				
Comment Code					
E2 : Schedule repair of erosion site prior to the next inspection.					
Inspector Comment

View of sloughing on the landside slope. Spring 2022.

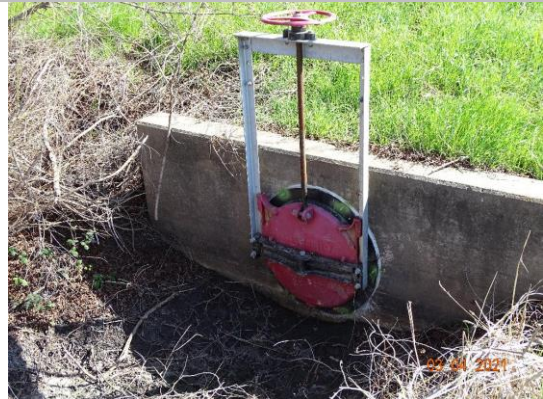
Photo 2 of 3 : UCIP\_SP\_2022\_66057\_98337.jpg

LM Start	4.03	Rating **	M	Issue No.	14 (cont)
LM End	4.03	Issue Type +	Ma	Location *	
Category	Supplemental			GPS Latitude/Longitude	
				Start	End
Item	DWR UCIP LMA Responsibility			39.562271 °	39.562271 °
				-121.829610 °	-121.829610 °
DWR ID	1647

Land-Side: Headwall and new slide gate installed at levee toe

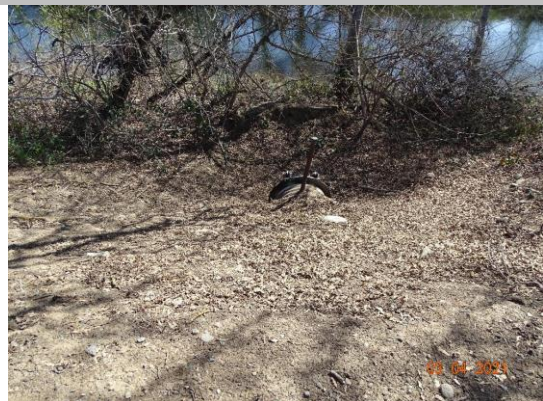
Photo 3 of 3 : UCIP\_SP\_2022\_66057\_98334.jpg

Water-Side: View of levee slope looking from crown

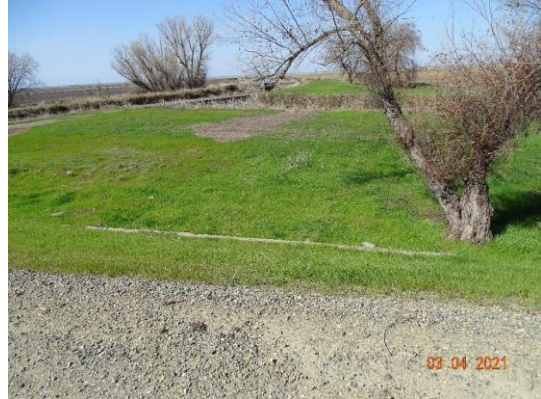
Photo 2 of 3 : UCIP\_SP\_2022\_66077\_98364.jpg

LM Start	<b>4.09</b>	Rating **	M	Issue No.	<b>15 (cont)</b>
LM End	<b>4.09</b>	Issue Type +	En	Location *	
Category	Supplemental		GPS Latitude/Longitude		
			Start	End	
Item	DWR UCIP Field Study		39.562794 °	39.562794 °	
			-121.828880 °	-121.828880 °	
DWR ID	16298

Land-Side: View of levee slope looking from crown

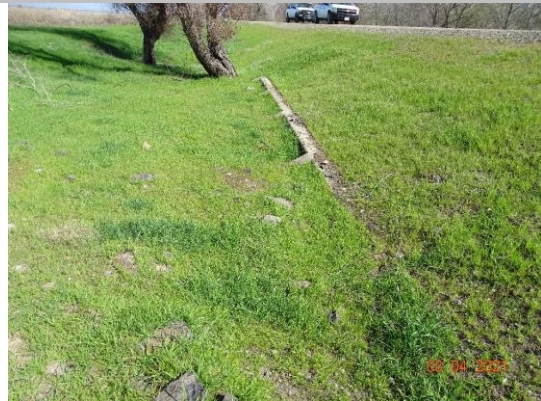
Photo 3 of 3 : UCIP\_SP\_2022\_66077\_98365.jpg

Land-Side: Buried concrete headwall at levee toe

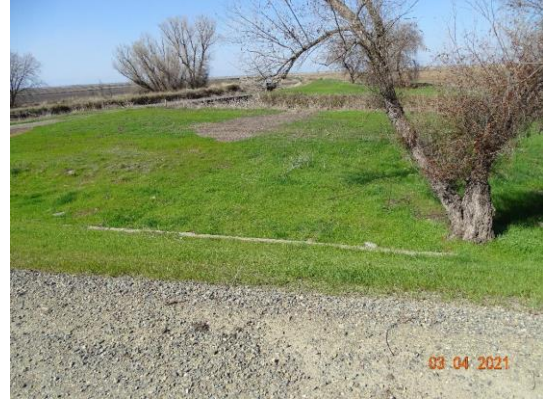
Photo 2 of 3 : UCIP\_SP\_2022\_66078\_98370.jpg

LM Start	<b>4.09</b>	Rating **	M	Issue No.	<b>16 (cont)</b>
LM End	<b>4.09</b>	Issue Type +	En	Location *	
Category	Supplemental		GPS Latitude/Longitude		
			Start	End	
Item	DWR UCIP Field Study		39.562814 °	39.562814 °	
			-121.828855 °	-121.828855 °	
DWR ID	16297

Land-Side: View of levee slope looking from crown

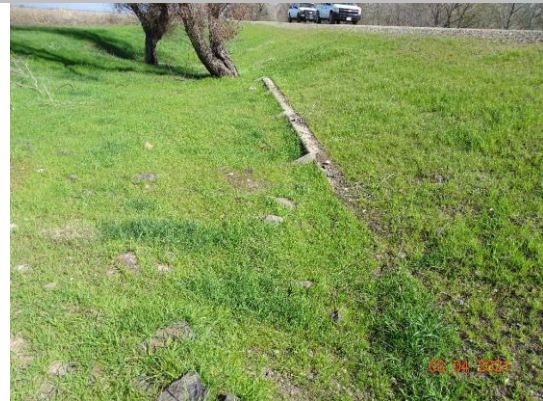
Photo 3 of 3 : UCIP\_SP\_2022\_66078\_98371.jpg

Land-Side: Buried concrete headwall at levee toe

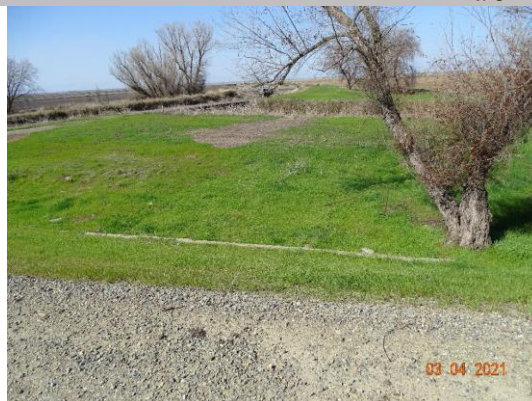
Photo 2 of 3 : UCIP\_SP\_2022\_66079\_98376.jpg

LM Start	4.09	Rating **	M	Issue No.	17 (cont)
LM End	4.09	Issue Type +	En	Location *	
Category	Supplemental			GPS Latitude/Longitude	
				Start	End
Item	DWR UCIP Field Study			39.562834 °	39.562834 °
				-121.828831 °	-121.828831 °
DWR ID	1648

Land-Side: View of levee slope looking from crown

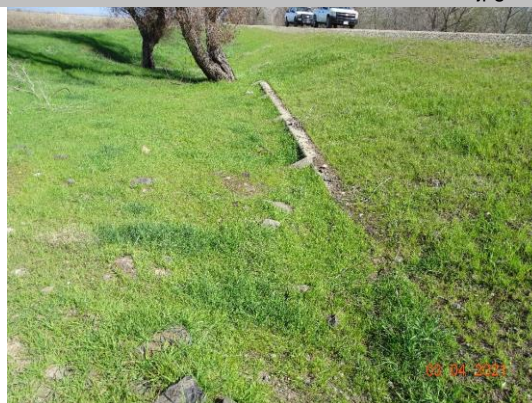
Photo 3 of 3 : UCIP\_SP\_2022\_66079\_98377.jpg

Land-Side: Buried concrete headwall at levee toe

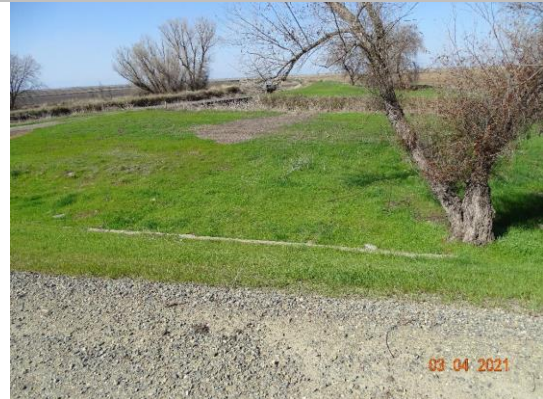
Photo 2 of 3 : UCIP\_SP\_2022\_66080\_98382.jpg

LM Start	4.09	Rating **	M	Issue No.	19 (cont)
LM End	4.09	Issue Type +	En	Location *	
Category	Supplemental			GPS Latitude/Longitude	
				Start	End
Item	DWR UCIP Field Study			39.562855 °	39.562855 °
				-121.828806 °	-121.828806 °
DWR ID	16299

Land-Side: View of levee slope looking from crown

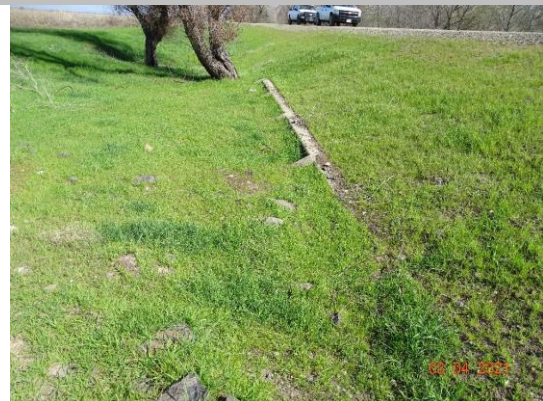
Photo 3 of 3 : UCIP\_SP\_2022\_66080\_98383.jpg

Land-Side: Buried concrete headwall at levee toe

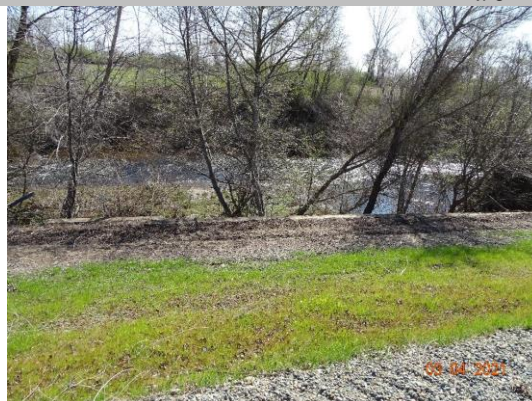
Photo 2 of 3 : UCIP\_SP\_2022\_66081\_98390.jpg

LM Start	4.09	Rating **	U	Issue No.	21 (cont)
LM End	4.09	Issue Type +	En	Location *	
Category	Supplemental			GPS Latitude/Longitude	
				Start	End
Item	DWR UCIP Field Study			39.562875 °	39.562875 °
				-121.828782 °	-121.828782 °
DWR ID	16300

Water-Side: View of levee slope looking from crown

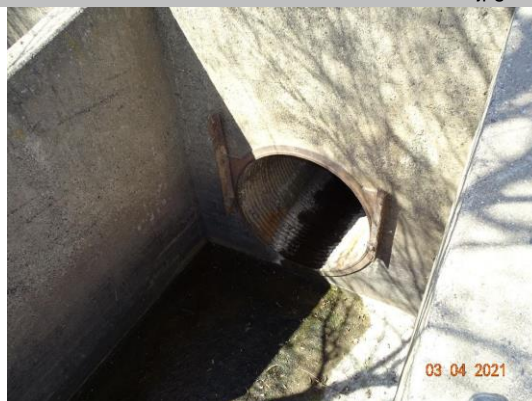
Photo 3 of 3 : UCIP\_SP\_2022\_66081\_98386.jpg

FS\_ID:66081  
DS\_ID:16300  
EP\_NO: N/A  
Repair Type: Urgent  
Crossing Status: Found  
UCIP Comments: 03/04/2021 Record updated from No Action Needed to Urgent. Missing flap gate on pipe end at headwall on waterside. One of the attached photos shows flap gate installed inside the pipe approximately at landside toe. Unable to confirm flap gate integrity. Portion of pipe under levee remains open to flood water that increases risk of levee failure. No permit has been identified authorizing pipe on installation. DMP internal video inspection has found pipe integrity issues. LOF of crossing is between 5 and 6. Crossing will be monitored until funding becomes available to address the issues. (O.Yakimov - DWR UCIP)  
05/18/2017 Crossing appears to be in good condition. Pipe has been selected to be internally cleaned and inspected as part of the DMP project. (A. Freitag - DWR Sutter Yard)05/23/2016 Crossing is not abandoned. Water was flowing through from the LS to WS. LS pipe inlet is about 100 yds from LS levee toe across the LS canal. (A. Freitag - DWR Sutter Yard)07/28/2015 Crossing is listed as abandoned but it is not filled with concrete like crossings 1-4 here. (A. Freitag - DWR Sutter Yard)11/25/2014 Same as last inspection. (A. Freitag - DWR Sutter Yard)06/04/2014 Same as last inspection. (A. Freitag - DWR Sutter Yard)11/13/2013 Same as last inspection. (A. Freitag - DWR Sutter Yard)06/06/2013 Sutter Maintenance Yard supervisor Jason Cooper said there is a flap gate on the LS end of the pipe in the western most ditch to prevent high water flooding. Not sure if this is adequate, will talk to levee inspector to find out. (A. Freitag - DWR Sutter Yard)11/01/2012 Pipe open on WS and is not filled with concrete. (W. Wylie - DWR UCIP)

Water-Side: Pipe missing flap gate at headwall

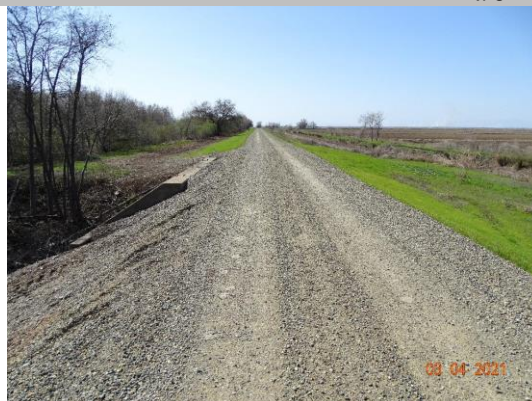
Photo 1 of 3 : UCIP\_SP\_2022\_66375\_98797.jpg

FS\_ID:66375  
DS\_ID:16306  
EP\_NO: N/A  
Repair Type: Non-Urgent  
Crossing Status: Found  
UCIP Comments: 03/04/2021 Record updated from No Action Needed to Non-Urgent. Pipe is plugged with concrete at waterside end, no evidence of pipe on landside. Unable to locate a permit and confirm proper pipe abandonment. Geophysical study indicates possible presence of pipe through levee. Owner needs to coordinate with the CVFPB to remove or abandon crossing according to Title 23 requirements. No permit has been identified authorizing pipe. (O.Yakimov - DWR UCIP)  
05/18/2017 Abandoned and plugged with concrete. Pipe has been selected to be internally cleaned and inspected as part of the DMP project. (A. Freitag - DWR Sutter Yard)11/14/2016 Abandoned. (A. Freitag - DWR Sutter Yard)05/23/2016 Abandoned. (A. Freitag - DWR Sutter Yard)07/28/2015 Abandoned- looks to be in good condition. (A. Freitag - DWR Sutter Yard)11/25/2014 Same as last inspection. (A. Freitag - DWR Sutter Yard)06/04/2014 Same as last inspection. (A. Freitag - DWR Sutter Yard)11/12/2013 Same as last inspection. (A. Freitag - DWR Sutter Yard)06/06/2013 Same as last inspection. (A. Freitag - DWR Sutter Yard)

FIELD\_STRUCT\_DESC: [Western Canal] 1 of 3: 60-inch corrugated metal irrigation pipe through the levee, 14.5 feet below the crown. Concrete headwalls on both the landside (LS) and the waterside (WS) ends. (no permit found authorizing structure; Western Canal Structure was abandoned in place and filled with concrete under Permit No. 16667, 1997 - Western Canal Water District). [Additional Reference(s): DWR Levee Log, 1990 (HLM 4.60). USACE Sacramento O&M Manual, Unit 515, April 1955, Revised 28 December 2010, (Station 730+00), listed as 60-inch pipe. USACE As-Built Drawing No. 50-04-2637, Sheet 4, Station 730+00, 7 January 1953].  
FS Date: 3/4/2021 2:11:30 PM

Top of Levee: View of levee crown looking downstream

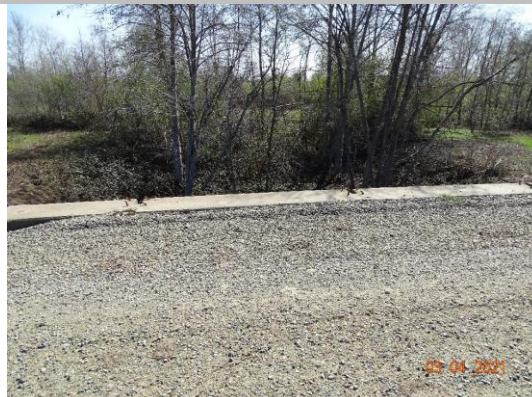
Photo 2 of 3 : UCIP\_SP\_2022\_66375\_98798.jpg

LM Start	4.54	Rating **	M	Issue No.	22 (cont)
LM End	4.54	Issue Type +	En	Location *	
Category	Supplemental			GPS Latitude/Longitude	
				Start	End
Item	DWR UCIP Field Study			39.567534 °	39.567534 °
				-121.822918 °	-121.822918 °
DWR ID	16306

Water-Side: View of levee slope looking from crown. Concrete headwall on levee slope

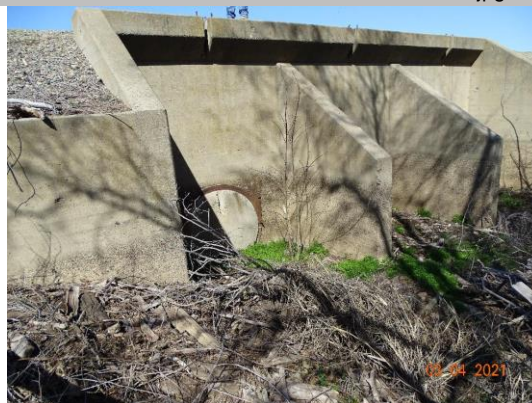
Photo 3 of 3 : UCIP\_SP\_2022\_66375\_98801.jpg

Water-Side: View of headwall and abandoned pipe at levee toe

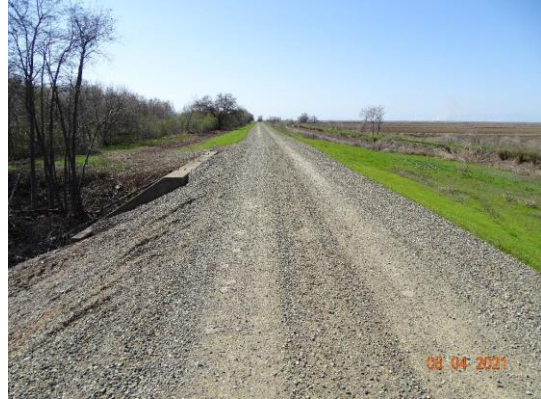
Photo 1 of 3 : UCIP\_SP\_2022\_66376\_98803.jpg

Comment Code					
Inspector Comment					
FS_ID:66376 DS_ID:16307 EP_NO: N/A Repair Type: Non-Urgent Crossing Status: Found UCIP Comments: 03/04/2021 Record updated from No Action Needed to Non-Urgent. Pipe is plugged with concrete at waterside end, no evidence of pipe on landside. Unable to locate a permit and confirm proper pipe abandonment. Geophysical study indicates possible presence of pipe through levee. Owner needs to coordinate with the CVFPB to remove or abandon crossing according to Title 23 requirements. No permit has been identified authorizing pipe. (O.Yakimov - DWR UCIP) 05/18/2017 Abandoned and plugged with concrete. Pipe has been selected to be internally cleaned and inspected as part of the DMP project. (A. Freitag - DWR Sutter Yard)11/14/2016 Abandoned. (A. Freitag - DWR Sutter Yard)05/23/2016 Abandoned. (A. Freitag - DWR Sutter Yard)07/28/2015 Abandoned- looks to be in good condition. (A. Freitag - DWR Sutter Yard)11/25/2014 Same as last inspection. (A. Freitag - DWR Sutter Yard)06/04/2014 Same as last inspection. (A. Freitag - DWR Sutter Yard)11/12/2013 Same as last inspection. (A. Freitag - DWR Sutter Yard)06/06/2013 Same as last inspection. (A. Freitag - DWR Sutter Yard) FIELD_STRUCT_DESC: [Western Canal] 2 of 3: 60-inch corrugated metal irrigation pipe through the levee, 14.5 feet below the crown. Concrete headwalls on both the landside (LS) and the waterside (WS) ends. (no permit found authorizing structure; Western Canal Structure was abandoned in place and filled with concrete under Permit No. 16667, 1997 - Western Canal Water District). [Additional Reference(s): DWR Levee Log, 1990 (HLM 4.60). USACE Sacramento O&M Manual, Unit 515, April 1955, Revised 28 December 2010, (Station 730+00), listed as 60-inch pipe. USACE As-Built Drawing No. 50-04-2637, Sheet 4, Station 730+00, 7 January 1953]. FS Date: 3/4/2021 2:18:57 PM

Top of Levee: View of levee crown looking downstream

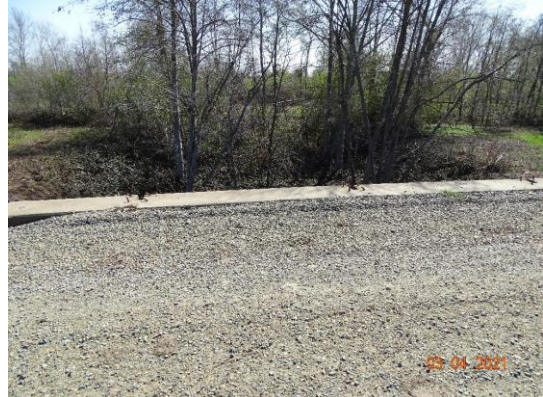
Photo 2 of 3 : UCIP\_SP\_2022\_66376\_98804.jpg

LM Start	<b>4.54</b>	Rating **	M	Issue No.	<b>23 (cont)</b>
LM End	<b>4.54</b>	Issue Type +	En	Location *	
Category	Supplemental		GPS Latitude/Longitude		
			Start	End	
Item	DWR UCIP Field Study		39.567557 °	39.567557 °	
			-121.822886 °	-121.822886 °	
DWR ID	16307

Water-Side: View of levee slope looking from crown. Concrete headwall on levee slope

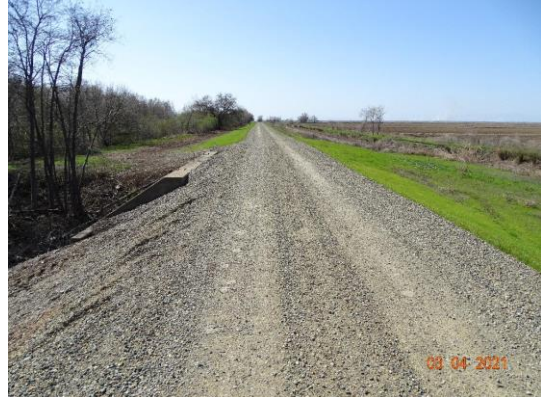
Photo 1 of 3 : UCIP\_SP\_2022\_66377\_98813.jpg

Comment Code					
Inspector Comment					
FS_ID:66377 DS_ID:1649 EP_NO: N/A Repair Type: Non-Urgent Crossing Status: Found UCIP Comments: 03/04/2021 Record updated from No Action Needed to Non-Urgent. Pipe is plugged with concrete at waterside end, no evidence of pipe on landside. Unable to locate a permit and confirm proper pipe abandonment. Geophysical study indicates possible presence of pipe through levee. Owner needs to coordinate with the CVFPB to remove or abandon crossing according to Title 23 requirements. No permit has been identified authorizing pipe. (O.Yakimov - DWR UCIP) 05/18/2017 Abandoned and plugged with concrete. Pipe has been selected to be internally cleaned and inspected as part of the DMP project. (A. Freitag - DWR Sutter Yard)11/14/2016 Abandoned. (A. Freitag - DWR Sutter Yard)05/23/2016 Crossing appears to be in good condition. (A. Freitag - DWR Sutter Yard)07/28/2015 Abandoned- looks to be in good condition. (A. Freitag - DWR Sutter Yard)11/25/2014 Same as last inspection. (A. Freitag - DWR Sutter Yard)06/04/2014 Same as last inspection. (A. Freitag - DWR Sutter Yard)11/12/2013 Same as last inspection. (A. Freitag - DWR Sutter Yard)06/06/2013 Same as last inspection. (A. Freitag - DWR Sutter Yard) FIELD_STRUCT_DESC: [Western Canal] 3 of 3: 60-inch corrugated metal irrigation pipe through the levee, 14.5 feet below the crown. Concrete headwalls on both the landside (LS) and the waterside (WS) ends. (no permit found authorizing structure; Western Canal Structure was abandoned in place and filled with concrete under Permit No. 16667, 1997 - Western Canal Water District). [Additional Reference(s): DWR Levee Log, 1990 (HLM 4.60). USACE Sacramento O&M Manual, Unit 515, April 1955, Revised 28 December 2010, (Station 730+00), listed as 60-inch pipe. USACE As-Built Drawing No. 50-04-2637, Sheet 4, Station 730+00, 7 January 1953]. FS Date: 3/4/2021 2:21:37 PM

Top of Levee: View of levee crown looking downstream

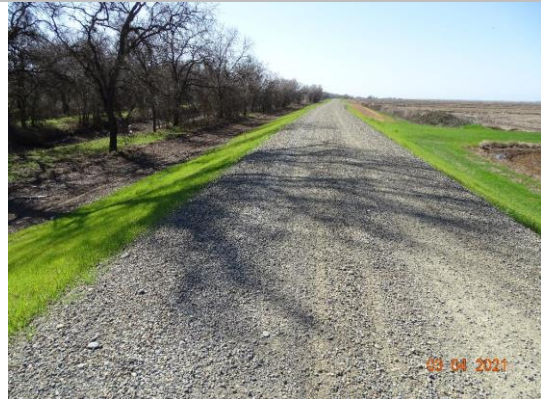
Photo 1 of 3 : UCIP\_SP\_2022\_66386\_98830.jpg

Comment Code						
Inspector Comment						
FS_ID:66386 DS_ID:1650 EP_NO: N/A Repair Type: Non-Urgent Crossing Status: Found UCIP Comments: 03/04/2021 Record remains Non-Urgent. Crossing appears abandoned. Pipe inlet not found on landside. Slide gate inside of CMP riser on waterside berm is in closed position. Geophysical study indicates possible presence of pipe through levee. Owner needs to coordinate with the CVFPB to remove or abandon crossing according to Title 23 requirements. No permit has been identified authorizing pipe. (O.Yakimov - DWR UCIP) 05/23/2019 (O. Magana - DWR UCIP)05/18/2017 Abandoned- only WS riser found. (A. Freitag - DWR Sutter Yard)11/14/2016 Abandoned. (A. Freitag - DWR Sutter Yard)05/23/2016 Abandoned. (A. Freitag - DWR Sutter Yard)07/28/2015 Abandoned- still cannot locate a LS ans WS pipe end. (A. Freitag - DWR Sutter Yard)11/25/2014 Same as last inpection. (A. Freitag - DWR Sutter Yard)06/04/2014 Same as last inspection. (A. Freitag - DWR Sutter Yard)11/12/2013 Same as last inspection. (A. Freitag - DWR Sutter Yard)06/06/2013 Same as last inspection. (A. Freitag - DWR Sutter Yard)10/31/2012 Appears abandoned. Unable to locate outfall on WS. Unable to locate inlet on LS. (W. Wylie - DWR UCIP) FIELD_STRUCT_DESC: 24-inch corrugated metal drainage pipe through the levee, 12.5 feet below the crown. Slide gate and flap gate in a 56-inch corrugated metal riser on the waterside (WS) berm. Flap gate on the WS. [Additional Reference(s): DWR Levee Log, 1990 (HLM 5.41). USACE Sacramento O&M Manual, Unit 515, April 1955, Revised 28 December 2010, (Station 688+40), listed as 24-inch pipe. USACE As-Built Drawing No. 50-04-2637, Sheet 3, Station 688+40, 7 January 1953]. FS Date: 3/4/2021 3:55:12 PM

Top of Levee: View of levee crown looking downstream

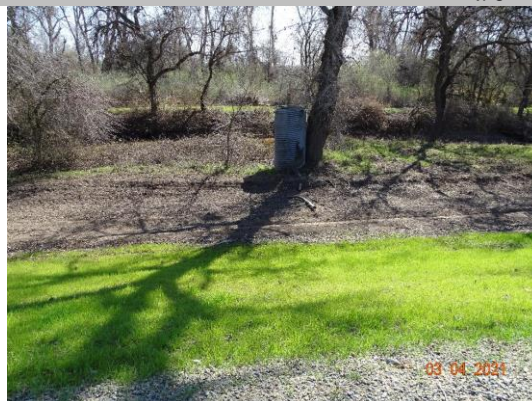
Photo 2 of 3 : UCIP\_SP\_2022\_66386\_98831.jpg

Water-Side: View of levee slope looking from crown. CMP riser with slide gate on levee berm

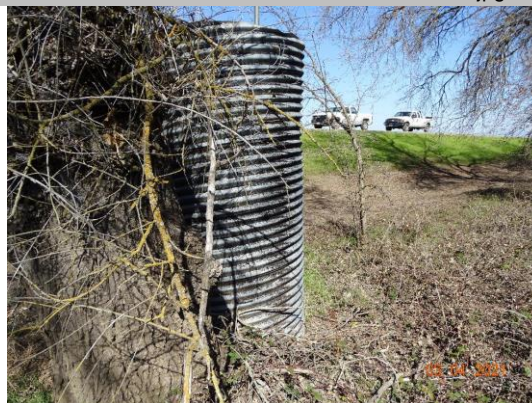
Photo 3 of 3 : UCIP\_SP\_2022\_66386\_98834.jpg

Water-Side: CMP riser on levee berm

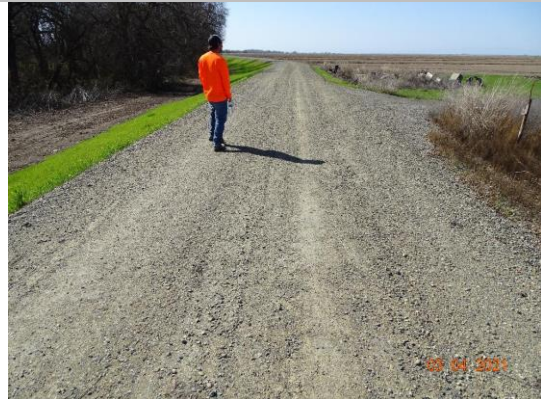
Photo 1 of 3 : UCIP\_SP\_2022\_66452\_98850.jpg

Comment Code						
Inspector Comment						
FS_ID:66452 DS_ID:1653 EP_NO: 14798 Repair Type: Non-Urgent Crossing Status: Not Found UCIP Comments: 03/04/2021 Record updated from No Action Needed to Non-Urgent. Crossing not found. Aerial power line across levee at this location. (O.Yakimov - DWR UCIP) 05/23/2019 (O. Magana - DWR UCIP)07/28/2015 Crossing appears to be in good condition. (A. Freitag - DWR Sutter Yard)11/14/2016 Crossing appears to be in good condition. (A. Freitag - DWR Sutter Yard)05/23/2016 Crossing appears to be in good condition. (A. Freitag - DWR Sutter Yard)07/28/2015 Crossing appears in good condition. No noticeable issues to report. (A. Freitag - DWR Sutter Yard)11/25/2014 Same as last inspection. (A. Freitag - DWR Sutter Yard)06/04/2014 Same as last inspection. (A. Freitag - DWR Sutter Yard)11/12/2013 Same as last inspection. (A. Freitag - DWR Sutter Yard)06/06/2013 Same as last inspection. (A. Freitag - DWR Sutter Yard) FIELD_STRUCT_DESC: 2-inch (Schedule 80) polyvinyl chloride (PVC) electrical conduit through the levee, 1.2 feet below the crown (invert 126.80 feet USED). Conduit extends from an electrical panel located 150 feet from the landside (LS) toe through the levee to an existing pump station in the waterside (WS) overflow area. (2-inch conduit authorized under Permit No. 14798, 1987 - Durham Pump, Inc.). [Additional Reference(s): DWR Levee Log, 1990 (HLM 6.05)]. FS Date: 3/4/2021 11:26:40 AM

Top of Levee: View of levee crown looking downstream

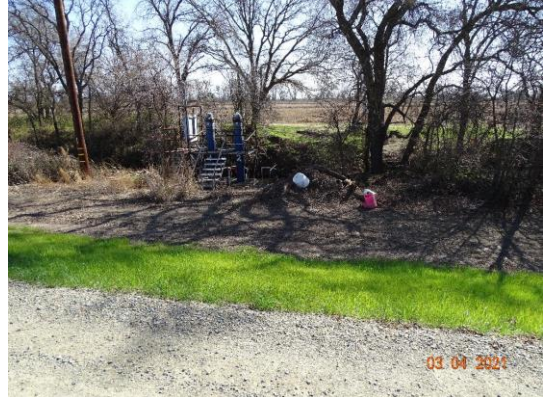
Photo 2 of 3 : UCIP\_SP\_2022\_66452\_98849.jpg

Water-Side: View of levee slope looking from crown. Power pole on levee berm

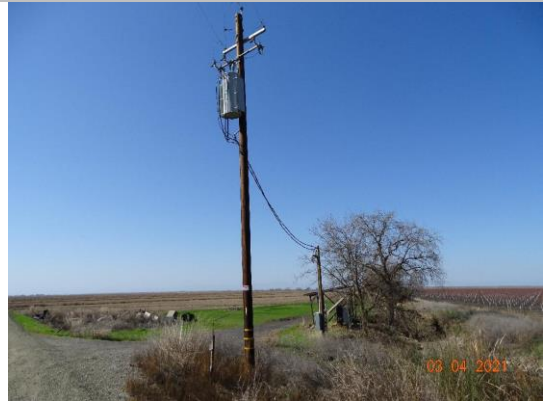
Photo 3 of 3 : UCIP\_SP\_2022\_66452\_98848.jpg

Land-Side: View of overhead line looking from levee crown

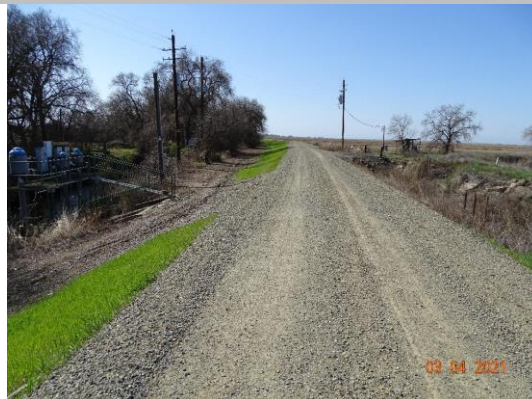
Photo 1 of 3 : UCIP\_SP\_2022\_66453\_98851.jpg

Comment Code					
Inspector Comment					
FS_ID:66453 DS_ID:1652 EP_NO: N/A Repair Type: Non-Urgent Crossing Status: Found UCIP Comments: 03/04/2021 Record updated from No Action Needed to Non-Urgent. No permit has been identified authorizing pipe. (O.Yakimov - DWR UCIP) 05/23/2019 (O. Magana - DWR UCIP)05/18/2017 Crossing appears to be in good condition. (A. Freitag - DWR Sutter Yard)11/14/2016 Crossing appears to be in good condition. (A. Freitag - DWR Sutter Yard)05/23/2016 Crossing appears to be in good condition. (A. Freitag - DWR Sutter Yard)07/28/2015 Crossing appears in good condition. No noticeable issues to report. (A. Freitag - DWR Sutter Yard)11/25/2014 Same as last inspection. (A. Freitag - DWR Sutter Yard)06/04/2014 Same as last inspection. (A. Freitag - DWR Sutter Yard)11/12/2013 Same as last inspection. (A. Freitag - DWR Sutter Yard)06/06/2013 Same as last inspection. (A. Freitag - DWR Sutter Yard) FIELD_STRUCT_DESC: 1 of 3: 16-inch riveted steel irrigation pipe through the levee, 10.4 feet below the crown. Gate valve on the waterside (WS). Flap gate on the landside (LS). As-built drawings show field verified location in Unit 2 (right bank). O&M entry indicates location in Unit 1 (left bank). [Additional Reference(s): DWR Levee Log, 1990 (HLM 6.05). USACE Sacramento O&M Manual, Unit 515, April 1955, Revised 28 December 2010, (Station 649+80), listed as 16-inch pipe. USACE As-Built Drawing No. 50-04-2637, Sheet 3, Station 649+80, 7 January 1953]. FS Date: 3/4/2021 11:52:13 AM

Top of Levee: View of levee crown looking downstream

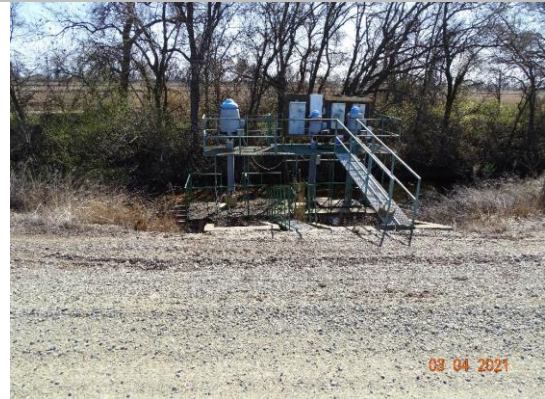
Photo 2 of 3 : UCIP\_SP\_2022\_66453\_98852.jpg

Water-Side: View of levee slope looking from crown. Pump on pile structure on levee berm

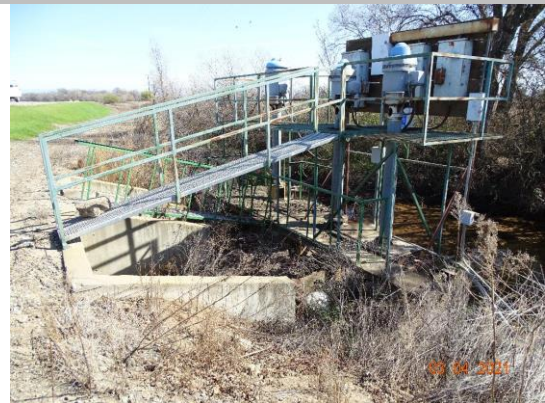
Photo 3 of 3 : UCIP\_SP\_2022\_66453\_98855.jpg

Water-Side: Pump on pumping platform on berm

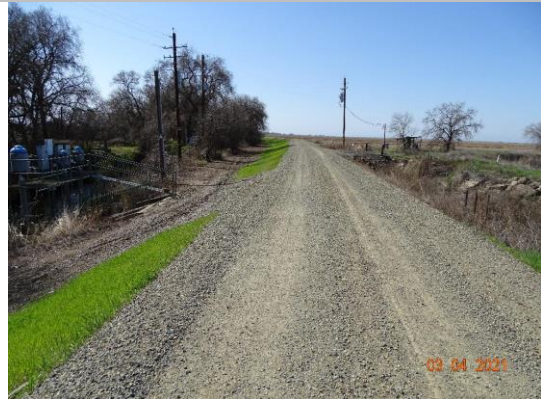
Photo 1 of 3 : UCIP\_SP\_2022\_66456\_98863.jpg

Comment Code					
Inspector Comment					
FS_ID:66456 DS_ID:16311 EP_NO: N/A Repair Type: Non-Urgent Crossing Status: Found UCIP Comments: 03/04/2021 Record updated from No Action Needed to Non-Urgent. No permit has been identified authorizing pipe. (O.Yakimov - DWR UCIP) 05/23/2019 (O. Magana - DWR UCIP)05/18/2017 Crossing appears to be in good condition. (A. Freitag - DWR Sutter Yard)11/14/2016 Crossing appears to be in good condition. (A. Freitag - DWR Sutter Yard)05/23/2016 Crossing appears to be in good condition. (A. Freitag - DWR Sutter Yard)07/28/2015 Crossing appears in good condition. No noticeable issues to report. (A. Freitag - DWR Sutter Yard)11/25/2014 Same as last inspection. (A. Freitag - DWR Sutter Yard)06/04/2014 Same as last inspection. (A. Freitag - DWR Sutter Yard)11/12/2013 Same as last inspection. (A. Freitag - DWR Sutter Yard)06/06/2013 Same as last inspection. (A. Freitag - DWR Sutter Yard) FIELD_STRUCT_DESC: 2 of 3: 16-inch riveted steel irrigation pipe through the levee, 10.4 feet below the crown. Gate valve on the waterside (WS). Flap gate on the landside (LS). As-built drawings show field verified location in Unit 2 (right bank). O&M entry indicates location in Unit 1 (left bank). [Additional Reference(s): DWR Levee Log, 1990 (HLM 6.05). USACE Sacramento O&M Manual, Unit 515, April 1955, Revised 28 December 2010, (Station 649+80), listed as 16-inch pipe. USACE As-Built Drawing No. 50-04-2637, Sheet 3, Station 649+80, 7 January 1953]. FS Date: 3/4/2021 12:52:33 PM

Top of Levee: View of levee crown looking downstream

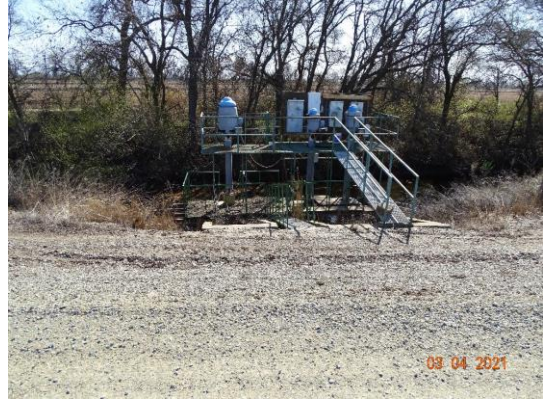
Photo 2 of 3 : UCIP\_SP\_2022\_66456\_98864.jpg

Water-Side: View of levee slope looking from crown. Pump on pile structure on levee berm

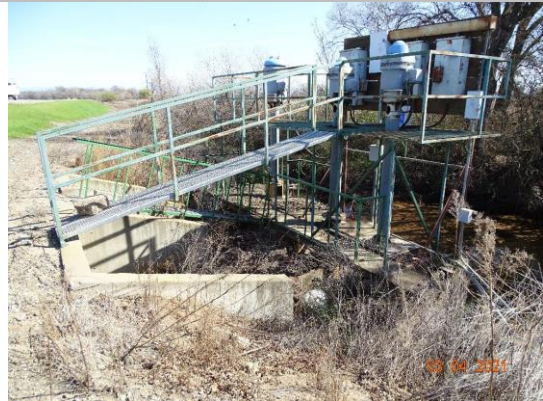
Photo 3 of 3 : UCIP\_SP\_2022\_66456\_98867.jpg

Water-Side: Pump on pumping platform on berm
