# Flood Control Project Maintenance Levee Inspections LMA District Cover Sheet

## Sutter Maintenance Yard Maintenance Area 0005

**Flood Control Project Maintenance  
Levee Inspections  
Unit Cover Sheet**

Waterway			Bank	Unit Miles
Unit No. 01 Butte Creek			Left	15.08
	Spring (March - May)	Summer (June - August)	(September - November) Fall	Winter (December - February)
Unit Maintenance Rating (Fall Only)				
Date of Inspection	3/23/2022 - 3/23/2022			
DWR Inspector	Makar Sokol			
Accompanied By	Shawn Freitag DWR Sutter Yard

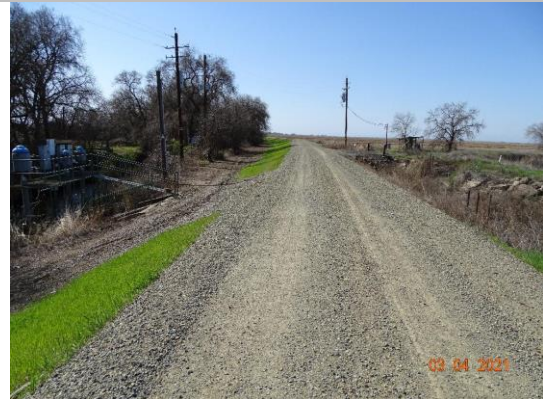
Photo 1 of 3 : UCIP\_SP\_2022\_66457\_98869.jpg

Comment Code						
Inspector Comment						
FS_ID:66457 DS_ID:16312 EP_NO: N/A Repair Type: Non-Urgent Crossing Status: Found UCIP Comments: 03/04/2021 Record updated from No Action Needed to Non-Urgent. No permit has been identified authorizing pipe. (O.Yakimov - DWR UCIP) 05/23/2019 (O. Magana - DWR UCIP)05/18/2017 Crossing appears to be in good condition. (A. Freitag - DWR Sutter Yard)11/14/2016 Crossing appears to be in good condition. (A. Freitag - DWR Sutter Yard)05/23/2016 Crossing appears to be in good condition. (A. Freitag - DWR Sutter Yard)07/28/2015 Crossing appears to be in good condition. No noticeable issues to report. (A. Freitag - DWR Sutter Yard)11/25/2014 Same as last inspection. (A. Freitag - DWR Sutter Yard)06/04/2014 Same as last inspection. (A. Freitag - DWR Sutter Yard)11/12/2013 Same as last inspection. (A. Freitag - DWR Sutter Yard)06/06/2013 Same as last inspection. (A. Freitag - DWR Sutter Yard) FIELD_STRUCT_DESC: 3 of 3: 20-inch SPI-weld steel irrigation pipe through the levee, 10.4 feet below the crown. Gate valve on the waterside (WS). Flap gate on the landside (LS). [Additional Reference(s): DWR Levee Log, 1990 (HLM 6.05). USACE Sacramento O&M Manual, Unit 515, April 1955, Revised 28 December 2010, (Station 649+80), listed as 20-inch pipe. USACE As-Built Drawing No. 50-4-2637, Exhibit B, Sheet 3, December 1949]. USACE As-Built Drawing No. 50-04-2637, Sheet 3, Station 649+80, 7 January 1953]. FS Date: 3/4/2021 12:54:03 PM

Top of Levee: View of levee crown looking downstream

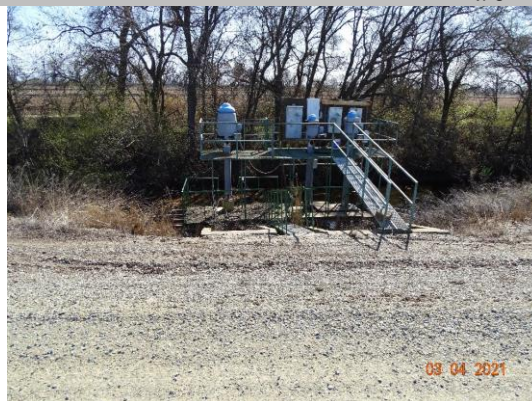
Photo 2 of 3 : UCIP\_SP\_2022\_66457\_98870.jpg

Water-Side: View of levee slope looking from crown. Pump on pile structure on levee berm

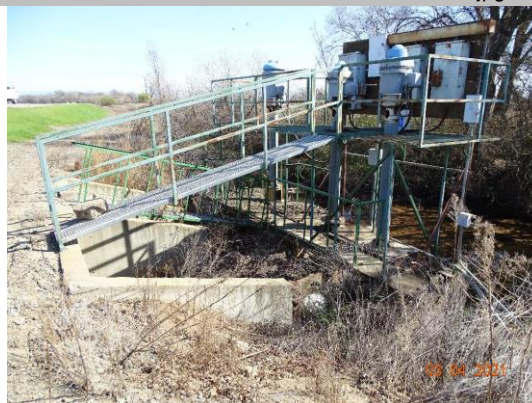
Photo 3 of 3 : UCIP\_SP\_2022\_66457\_98873.jpg

Water-Side: Pump on pumping platform on berm

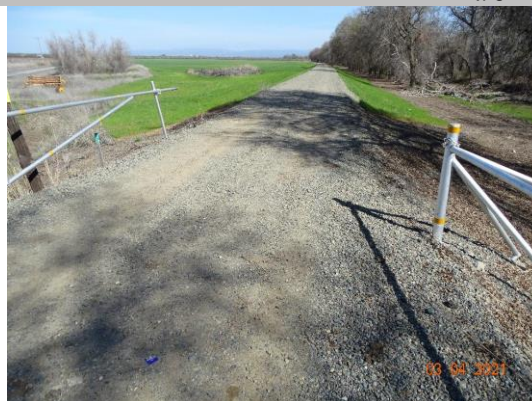
Photo 1 of 3 : UCIP\_SP\_2022\_66463\_98875.jpg

FS\_ID:66463  
DS\_ID:1654  
EP\_NO: N/A  
Repair Type: Non-Urgent  
Crossing Status: Found  
UCIP Comments: 03/04/2021 Record updated from No Action Needed to Non-Urgent. No permit has been identified authorizing pipe. Pipe has been CIPP lined, new flap gate installed on waterside end.  
(O.Yakimov - DWR UCIP)  
05/18/2017 Crossing appears to be in good condition. Pipe has been selected to be internally cleaned and inspected as part of the DMP project. (A. Freitag - DWR Sutter Yard)11/14/2016 Crossing appears to be in good condition. (A. Freitag - DWR Sutter Yard)05/23/2016 Crossing appears to be in good condition. (A. Freitag - DWR Sutter Yard)07/28/2015 Crossing appears in good condition. No noticeable issues to report. (A. Freitag - DWR Sutter Yard)11/24/2014 Same as last inspection. (A. Freitag - DWR Sutter Yard)06/04/2014 Same as last inspection. (A. Freitag - DWR Sutter Yard)11/12/2013 Same as last inspection. (A. Freitag - DWR Sutter Yard)06/06/2013 Same as last inspection. (A. Freitag - DWR Sutter Yard)

FIELD\_STRUCT\_DESC: 24-inch CIPP-lined corrugated metal drainage pipe through the levee, 9.4 feet below the crown. Flap gate on the waterside (WS). Concrete headwalls at both the landside (LS) and the WS toes. [Additional Reference(s): DWR Levee Log, 1990 (HLM 6.56). USACE Sacramento O&M Manual, Unit 515, April 1955, Revised 28 December 2010, (Station 627+00), listed as 24-inch pipe. USACE As-Built Drawing No. 50-04-2637, Sheet 3, Station 627+00, 7 January 1953].  
FS Date: 3/4/2021 1:12:00 PM

Top of Levee: View of levee crown looking upstream

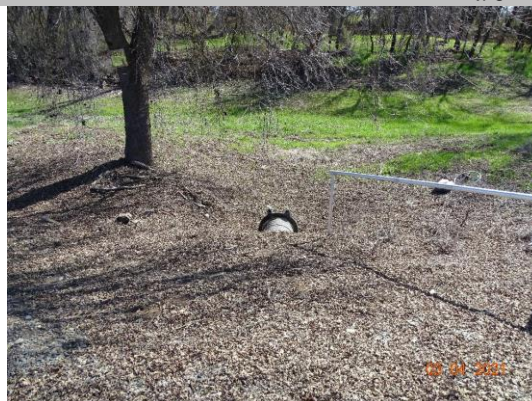
Photo 2 of 3 : UCIP\_SP\_2022\_66463\_98876.jpg

Water-Side: View of levee slope looking from crown

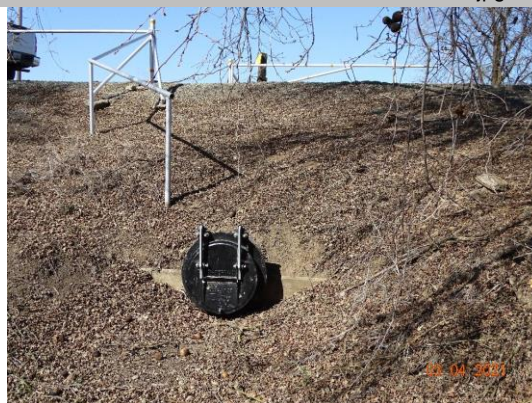
Photo 3 of 3 : UCIP\_SP\_2022\_66463\_98879.jpg

Water-Side: New flap gate installed on pipe end

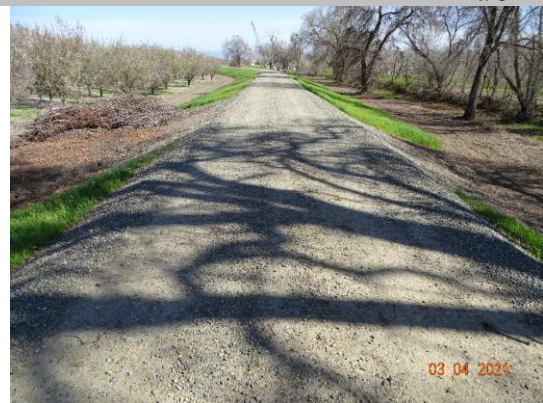
Photo 1 of 3 : UCIP\_SP\_2022\_66470\_98881.jpg

Comment Code						
Inspector Comment						
FS_ID:66470 DS_ID:1655 EP_NO: N/A Repair Type: Non-Urgent Crossing Status: Found UCIP Comments: 03/04/2021 Record updated from No Action Needed to Non-Urgent. Unauthorized encroachment recorded in Levee Log prior to 2011. Pipe has been CIPP lined, new flapgate installed. (O.Yakimov - DWR UCIP) 05/18/2017 Crossing appears to be in good condition. Pipe has been selected to be internally cleaned and inspected as part of the DMP project. (A. Freitag - DWR Sutter Yard)11/14/2016 Crossing appears to be in good condition. (A. Freitag - DWR Sutter Yard)05/23/2016 Crossing appears to be in good condition. (A. Freitag - DWR Sutter Yard)07/28/2015 Crossing appears in good condition. No noticeable issues to report. (A. Freitag - DWR Sutter Yard)11/24/2014 Same as last inspection. (A. Freitag - DWR Sutter Yard)06/04/2014 Same as last inspection. (A. Freitag - DWR Sutter Yard)11/12/2013 Same as last inspection. (A. Freitag - DWR Sutter Yard)06/06/2013 Same as last inspection. (A. Freitag - DWR Sutter Yard) FIELD_STRUCT_DESC: 24-inch CIPP-lined corrugated metal drainage pipe through the levee, 10 feet below the crown. Flap gate on the waterside (WS). Concrete headwalls on both the landside (LS) and the WS toes. [Additional Reference(s): DWR Levee Log, 1990 (HLM 7.87)]. FS Date: 3/4/2021 1:32:05 PM

Top of Levee: View of levee crown looking downstream

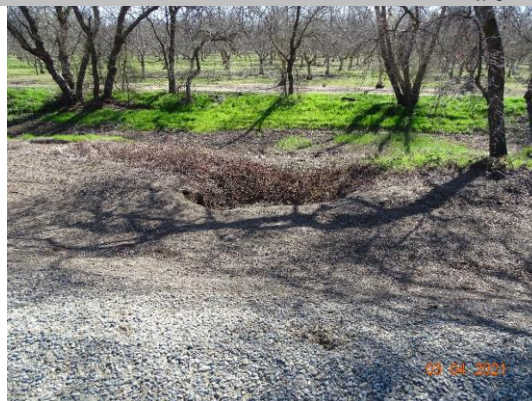
Photo 2 of 3 : UCIP\_SP\_2022\_66470\_98882.jpg

Water-Side: View of levee slope looking from crown

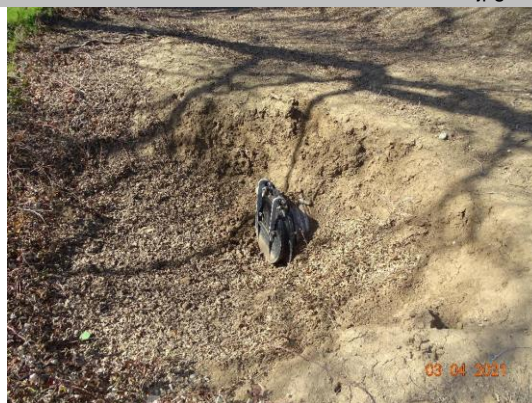
Photo 3 of 3 : UCIP\_SP\_2022\_66470\_98885.jpg

Water-Side: New flap gate installed on pipe end

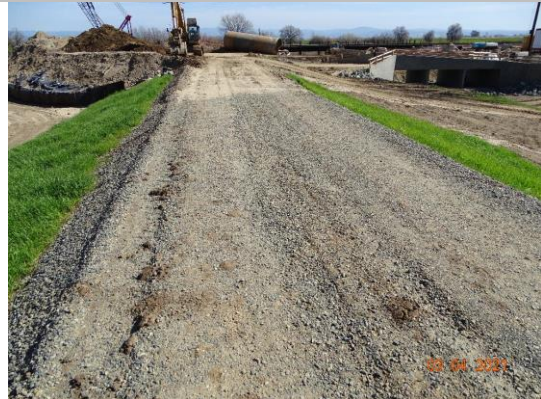
Photo 1 of 3 : UCIP\_SP\_2022\_66495\_98886.jpg

Comment Code						
Inspector Comment						
FS_ID:66495 DS_ID:16850 EP_NO: N/A Repair Type: Non-Urgent Crossing Status: Not Found UCIP Comments: 03/04/2021 Record updated from No Action Needed to Non-Urgent. Crossing not found. Geophysical results did not confirm presence of pipe through levee. Record will remain in UCIP's inspection records until future Levee Improvement Project can confirm no crossing was found through the levee. No permit has been identified authorizing pipe. (O.Yakimov - DWR UCIP) 05/18/2017 Unable to locate. Pipe has been selected to be internally cleaned and inspected as part of the DMP project. (A. Freitag - DWR Sutter Yard)11/14/2016 Unable to locate. (A. Freitag - DWR Sutter Yard)05/23/2016 Unable to locate. (A. Freitag - DWR Sutter Yard)07/28/2015 Unable to locate. (A. Freitag - DWR Sutter Yard)11/24/2015 Unable to locate. (A. Freitag - DWR Sutter Yard)06/04/2014 Same as last inspection. (A. Freitag - DWR Sutter Yard)11/12/2013 Unable to locate. (A. Freitag - DWR Sutter Yard)06/06/2013 Same as last inspection. Unable to locate. (A. Freitag - DWR Sutter Yard) FIELD_STRUCT_DESC: 24-inch corrugated metal drainage pipe through the levee, 9.5 feet below the crown. Flap gate on the waterside (WS). Concrete headwall at the landside (LS) toe. [Additional Reference(s): USACE Sacramento O&M Manual, Unit 515, April 1955, Revised 28 December 2010, (Station 552+60), listed as 24-inch pipe. USACE As-Built Drawing No. 50-04-2637, Sheet 2, Station 552+60, 7 January 1953]. FS Date: 3/4/2021 2:42:10 PM

Top of Levee: View of levee crown looking downstream

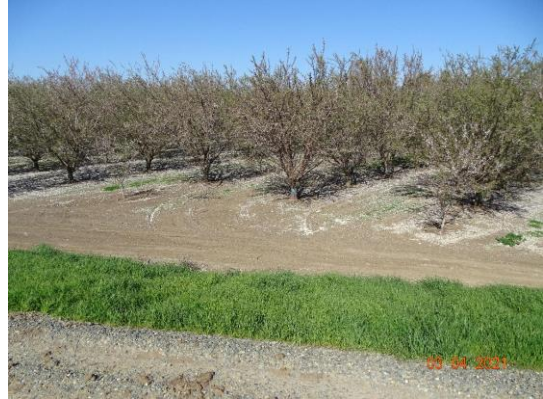
Photo 2 of 3 : UCIP\_SP\_2022\_66495\_98887.jpg

Land-Side: View of levee slope looking from crown

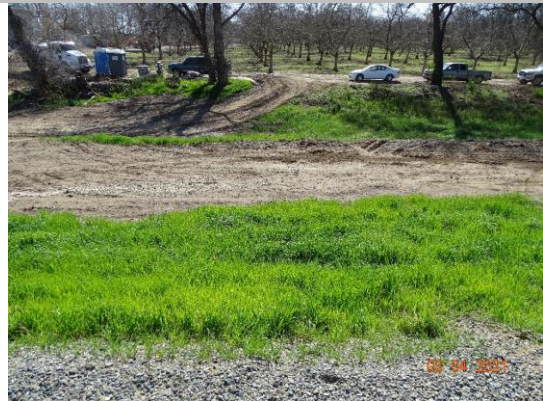
Photo 3 of 3 : UCIP\_SP\_2022\_66495\_98888.jpg

Water-Side: View of levee slope looking from crown

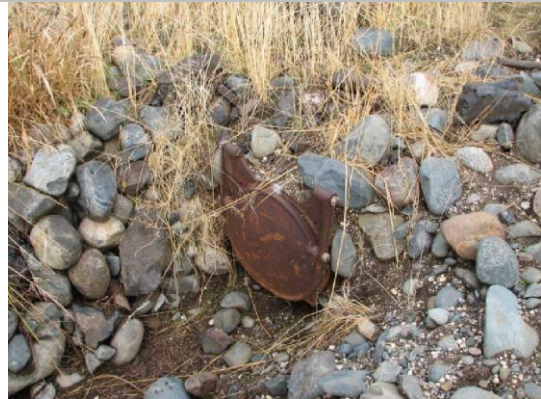
Photo 1 of 2 : UCIP\_SP\_2022\_66502\_68129.jpg

FS\_ID:66502  
DS\_ID:1656  
EP\_NO: N/A  
Repair Type: Non-Urgent  
Crossing Status: Found  
UCIP Comments: 03/04/2021 Record remains Non-Urgent. Unable to inspect crossing due to construction activity. No permit has been identified authorizing pipe. (O.Yakimov - DWR UCIP)  
05/18/2017 LS inlet is almost completely full of soil. Pipe has been selected to be internally cleaned and inspected as part of the DMP project. (A. Freitag - DWR Sutter Yard)11/14/2016 LS inlet almost completely full of soil. (A. Freitag - DWR Sutter Yard)05/23/2016 LS end is almost complete full of soil. (A. Freitag - DWR Sutter Yard)07/28/2015 Pipe is still over 3/4 full of soil. (A. Freitag - DWR Sutter Yard)11/24/2014 Same as last inspection. (A. Freitag - DWR Sutter Yard)06/04/2014 Same as last inspection. (A. Freitag - DWR Sutter Yard)11/12/2013 Same as last inspection. (A. Freitag - DWR Sutter Yard)06/06/2013 Same as last inspection. (A. Freitag - DWR Sutter Yard)10/31/2012 Pipe 3/4 full with soil on LS. (W. Wylie - DWR UCIP)

FIELD\_STRUCT\_DESC: 18-inch corrugated metal drainage pipe through the levee at an unknown depth below the crown. Concrete headwall at the landside (LS) toe. Flap gate on the waterside (WS).  
[Additional Reference(s): USACE Sacramento O&M Manual, Unit 515 - Upper Butte Creek - Part No. 1, April 1955, pipe referenced only in USACE As-Built Drawing No. 50-04-2637, Sheet 2, just downstream of old Hwy 99, 7 January 1953. USACE As-Built Drawing No. 50-04-3367, Sheet 13, just upstream of Station 380+85, 11 April 1958].  
FS Date: 3/4/2021 2:57:43 PM

Flap gate at WS toe.

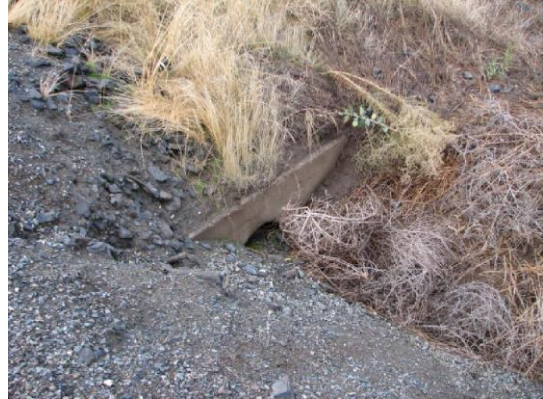
Photo 2 of 2 : UCIP\_SP\_2022\_66502\_68128.jpg

Concrete headwall on LS toe.

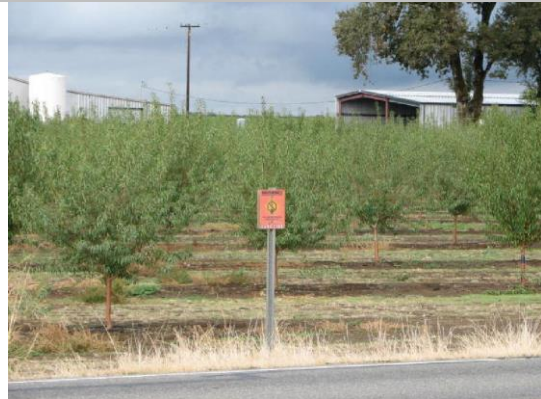
Photo 1 of 1 : UCIP\_SP\_2022\_66510\_68130.jpg

Comment Code						
Inspector Comment						
FS_ID:66510 DS_ID:1659 EP_NO: 9296 Repair Type: Non-Urgent Crossing Status: Found UCIP Comments: 03/04/2021 Record updated from No Action Needed to Non-Urgent. Crossing not found. Construction site prevents inspection of levee at this crossing. Old bridge has been demolished, construction of a new bridge started. (O.Yakimov - DWR UCIP)05/18/2017 Crossing appears to be in good condition. (A. Freitag - DWR Sutter Yard)11/14/2016 Crossing appears to be in good condition. (A. Freitag - DWR Sutter Yard)05/12/2016 Crossing appears to be in good condition. (A. Freitag - DWR Sutter Yard)07/28/2015 Crossing is in good condition. (A. Freitag - DWR Sutter Yard)11/24/2014 Same as last inspection. (A. Freitag - DWR Sutter Yard)06/04/2014 Same as last inspection. (A. Freitag - DWR Sutter Yard)11/12/2013 Same as last inspection. (A. Freitag - DWR Sutter Yard)06/06/2013 Same as last inspection. (A. Freitag - DWR Sutter Yard) FIELD_STRUCT_DESC: 1-inch telephone conduit through the levee, 3 feet below the crown. Cable is located on the U.S. Highway 99E (now Midway Rd.) bridge over Butte Creek. (Telephone cable authorized under Permit No. 9296, 1974 - Pacific Telephone & Telegraph Company). (Midway Road bridge replacement authorized under Permit No. 19316, 2020 - Butte County Department of Public Works). [Additional Reference(s): DWR Levee Log, 1990 (HLM 8.13), listed as buried telephone cable]. FS Date: 3/4/2021 3:13:19 PM

Communication line marker on edge of roadway just north west of levee.

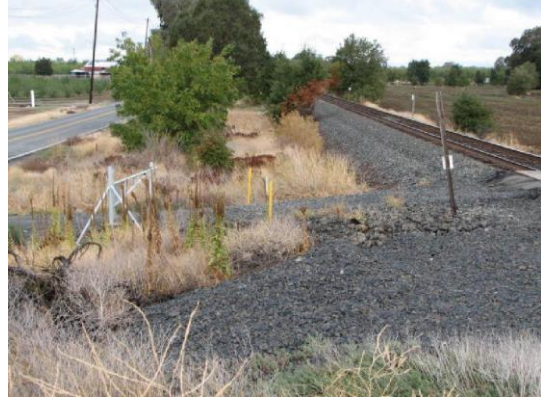
Photo 1 of 1 : UCIP\_SP\_2022\_66512\_68131.jpg

Comment Code					
Inspector Comment					
FS_ID:66512 DS_ID:1657 EP_NO: 13497 Repair Type: Non-Urgent Crossing Status: Found UCIP Comments: 03/04/2021 Record updated from No Action Needed to Non-Urgent. Crossing not found. Construction site prevents inspection of levee at this crossing. Old bridge has been demolished, construction of a new bridge started. (O.Yakimov - DWR UCIP)05/18/2017 Crossing appears to be in good condition. (A. Freitag - DWR Sutter Yard)11/14/2016 Crossing appears to be in good condition. (A. Freitag - DWR Sutter Yard)05/12/2016 Crossing appears to be in good condition. (A. Freitag - DWR Sutter Yard)07/28/2015 Crossing is in good condition. (A. Freitag - DWR Sutter Yard)11/24/2014 Same as last inspection. (A. Freitag - DWR Sutter Yard)06/04/2014 Same as last inspection. (A. Freitag - DWR Sutter Yard)11/12/2013 Same as last inspection. (A. Freitag - DWR Sutter Yard)06/06/2013 Same as last inspection. (A. Freitag - DWR Sutter Yard) FIELD_STRUCT_DESC: 4-inch steel communication conduit through the levee, 2 feet below the crown. Signs for the communication line installed between the roadway and the railroad. Green connection box next to the roadway at the LS toe. (4-inch conduit authorized under Permit No. 13497, 1982 - Pacific Telephone Company). (Midway Road bridge replacement authorized under Permit No. 19316, 2020 - Butte County Department of Public Works). [Additional Reference(s): DWR Levee Log, 1990 (HLM 8.12)]. FS Date: 3/4/2021 3:15:17 PM

Signage at left along NE edge of Midway road.

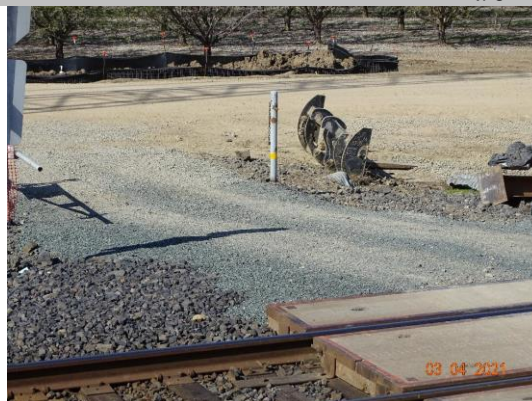
Photo 1 of 3 : UCIP\_SP\_2022\_66515\_98902.jpg

FS\_ID:66515  
DS\_ID:1661  
EP\_NO: 3835  
Repair Type: Non-Urgent  
Crossing Status: Indicator Found  
UCIP Comments: 03/04/2021 Record updated from No Action Needed to Non-Urgent. No inspection records were available to determine status of line through the levee. Gas line markers installed on both sides of levee. (O.Yakimov - DWR UCIP)  
05/18/2017 Crossing appears to be in good condition. (A. Freitag - DWR Sutter Yard)11/14/2016 Crossing appears to be in good condition. (A. Freitag - DWR Sutter Yard)05/12/2016 Crossing appears to be in good condition. (A. Freitag - DWR Sutter Yard)07/30/2015 Crossing is in good condition. (A. Freitag - DWR Sutter Yard)11/24/2014 Same as last inspection. (A. Freitag - DWR Sutter Yard)06/04/2014 Same as last inspection. (A. Freitag - DWR Sutter Yard)11/12/2013 Same as last inspection. (A. Freitag - DWR Sutter Yard)06/06/2013 Same as last inspection. (A. Freitag - DWR Sutter Yard)

Top of Levee: View of levee crown looking downstream

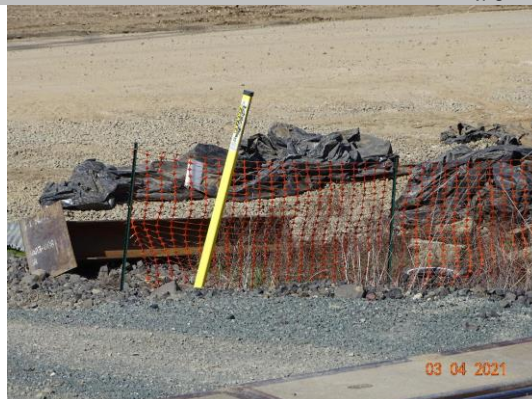
Photo 2 of 3 : UCIP\_SP\_2022\_66515\_98903.jpg

Water-Side: View of levee slope looking from waterside

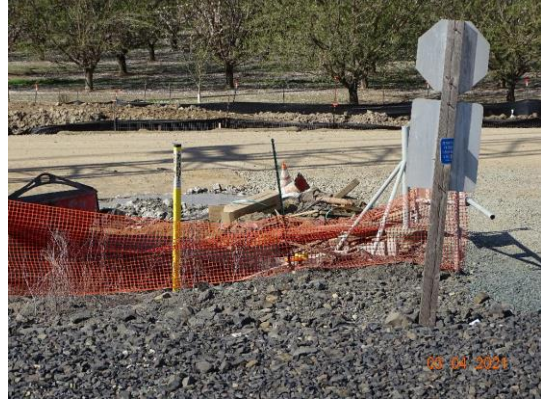
Photo 3 of 3 : UCIP\_SP\_2022\_66515\_98904.jpg

Land-Side: View of levee slope looking from crown

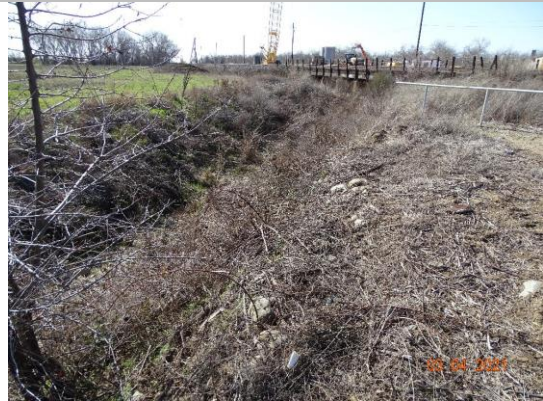
Photo 2 of 3 : UCIP\_SP\_2022\_66520\_98905.jpg

Water-Side: View of levee slope looking from crown

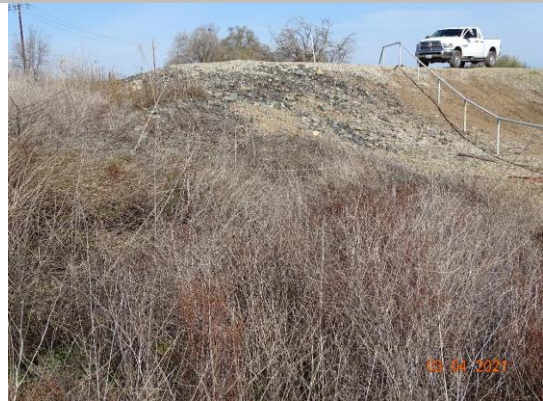
Photo 3 of 3 : UCIP\_SP\_2022\_66520\_98906.jpg

Water-Side: View of levee slope looking from toe

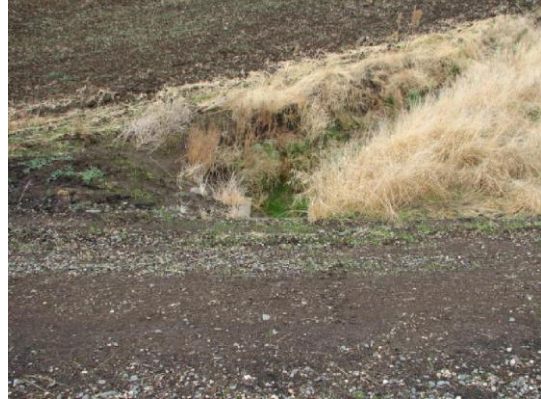
Photo 1 of 3 : UCIP\_SP\_2022\_66669\_68394.jpg

Comment Code						
Inspector Comment						
FS_ID:66669 DS_ID:1662 EP_NO: N/A Repair Type: Non-Urgent Crossing Status: Found UCIP Comments: 03/04/2021 Record updated from No Action Needed to Non-Urgent. No permit has been identified authorizing pipe. This crossing has been CIPP lined, new flap gate installed on waterside end. (O.Yakimov - DWR UCIP) 05/18/2017 Crossing appears to be in good condition. Pipe has been selected to be internally cleaned and inspected as part of the DMP project. (A. Freitag - DWR Sutter Yard)11/14/2016 Crossing appears to be in good condition. (A. Freitag - DWR Sutter Yard)05/12/2016 Crossing appears to be in good condition. (A. Freitag - DWR Sutter Yard)07/30/2015 Crossing is in good condition. No noticeable issues to report. (A. Freitag - DWR Sutter Yard)11/24/2014 Same as last inspection. (A. Freitag - DWR Sutter Yard)06/04/2014 Same as last inspection. (A. Freitag - DWR Sutter Yard)11/13/2013 Same as last inspection. (A. Freitag - DWR Sutter Yard)06/06/2013 Same as last inspection. (A. Freitag - DWR Sutter Yard) FIELD_STRUCT_DESC: 30-inch CIPP-lined corrugated metal drainage pipe through the levee, 16.3 feet below the crown. Flap gate on the waterside (WS). Concrete "U" shaped headwalls on both the landside (LS) and the WS. [Additional Reference(s): DWR Levee Log, 1990 (HLM 8.21). USACE Sacramento O&M Manual, Unit 516, April 1960, Revised 3 February 2011, (Station 374+90), listed as 30-inch pipe. USACE As-Built Drawing No. 50-4-3367, Exhibit B, Sheet 13, April 1957]. FS Date: 3/4/2021 2:33:37 PM

Concrete inlet on LS toe.

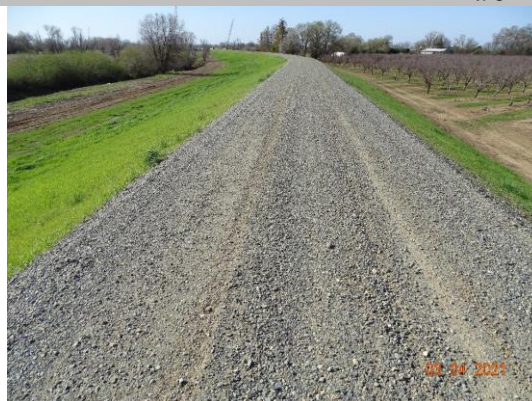
Photo 1 of 3 : UCIP\_SP\_2022\_66670\_98954.jpg

Comment Code					
Inspector Comment					
FS_ID:66670 DS_ID:1739 EP_NO: 8628-B Repair Type: Non-Urgent Crossing Status: Not Found UCIP Comments: 03/04/2021 Record updated from No Action Needed to Non-Urgent. Crossing not found. (O.Yakimov - DWR UCIP) 05/18/2017 Unable to locate. (A. Freitag - DWR Sutter Yard)11/14/2016 Unable to locate. (A. Freitag - DWR Sutter Yard)05/12/2016 Unable to locate. (A. Freitag - DWR Sutter Yard)07/30/2015 Unable to locate. (A. Freitag - DWR Sutter Yard)11/24/2014 Unable to locate. (A. Freitag - DWR Sutter Yard)06/04/2014 Unable to locate. (A. Freitag - DWR Sutter Yard)11/13/2013 Unable to locate. (A. Freitag - DWR Sutter Yard)06/06/2013 Same as last inspection. Unable to locate. (A. Freitag - DWR Sutter Yard) FIELD_STRUCT_DESC: 4-inch polyvinyl chloride (PVC) irrigation pipe, at an unknown depth, not found. Two wells in the floodway. Pipe may not cross the levee. (4-inch irrigation line authorized under Permit No. 8628-B, 1974 - M. J. and M. B. Keeney). FS Date: 3/4/2021 2:43:28 PM

Top of Levee: View of levee crown looking downstream

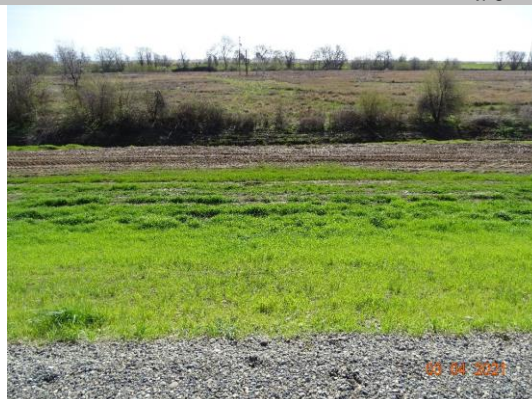
Photo 2 of 3 : UCIP\_SP\_2022\_66670\_98955.jpg

Water-Side: View of levee slope looking from crown

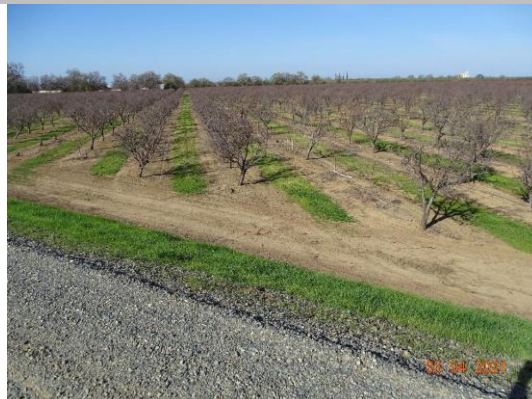
Photo 3 of 3 : UCIP\_SP\_2022\_66670\_98956.jpg

Land-Side: View of levee slope looking from crown

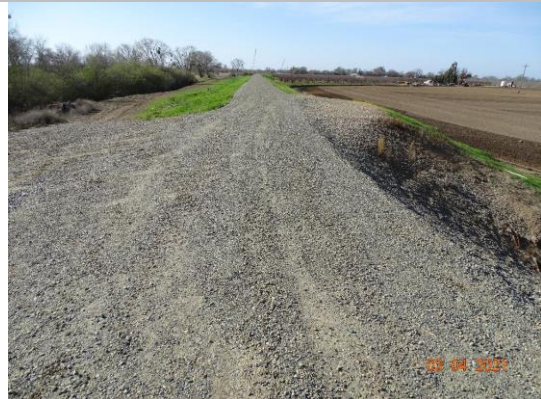
Photo 1 of 3 : UCIP\_SP\_2022\_66671\_98961.jpg

Comment Code					
Inspector Comment					
FS_ID:66671 DS_ID:1663 EP_NO: N/A Repair Type: Non-Urgent Crossing Status: Found UCIP Comments: 03/04/2021 Record updated from No Action Needed to Non-Urgent. No permit has been identified authorizing pipe. This pipe has been CIPP lined, according to Sutter Yard flap gate was replaced in 2019. (O.Yakimov - DWR UCIP) 05/18/2017 Crossing appears to be in good condition. Pipe has been selected to be internally cleaned and inspected as part of the DMP project. (A. Freitag - DWR Sutter Yard)11/14/2016 Crossing appears to be in good condition. (A. Freitag - DWR Sutter Yard)05/12/2016 Crossing appears to be in good condition. (A. Freitag - DWR Sutter Yard)07/30/2015 Crossing appears in good condition. No noticeable issues to report. (A. Freitag - DWR Sutter Yard)11/24/2014 Same as last inspection. (A. Freitag - DWR Sutter Yard)06/04/2014 Same as last inspection. (A. Freitag - DWR Sutter Yard)11/13/2013 Damaged pipe section was dug up and replaced. New WS flapgate with u-shaped wingwall installed on end of pipe. (A. Freitag - DWR Sutter Yard)06/06/2013 Same as last inspection. Plans have been made to repair during summer of 2013 before high water season. (A. Freitag - DWR Sutter Yard)11/01/2012 Pipe rusted through along bottom at WS outlet. Sink hole over pipe on WS berm. WS headwall eroded eternally around backside of headwall. (W. Wylie - DWR UCIP) FIELD_STRUCT_DESC: 24-inch CIPP-lined corrugated metal drainage pipe through the levee, 15 feet below the crown. Flap gate on the waterside (WS). Concrete headwalls on both the landside (LS) and the WS. [Additional Reference(s): DWR Levee Log, 1990 (HLM 8.89). USACE Sacramento O&M Manual, Unit 516 - Upper Butte Creek - Part No. 2, April 1960, pipe is only referenced in USACE As-Built Drawing No. 50-4-3367, Exhibit B, Sheet 11, (Station 340+04)]. FS Date: 3/4/2021 2:48:29 PM

Top of Levee: View of levee crown looking downstream

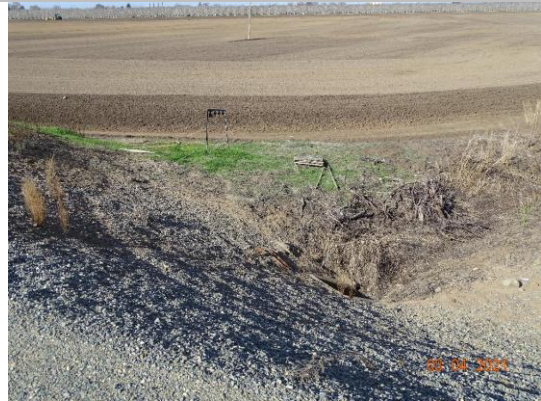
Photo 2 of 3 : UCIP\_SP\_2022\_66671\_98962.jpg

Land-Side: View of levee slope looking from crown

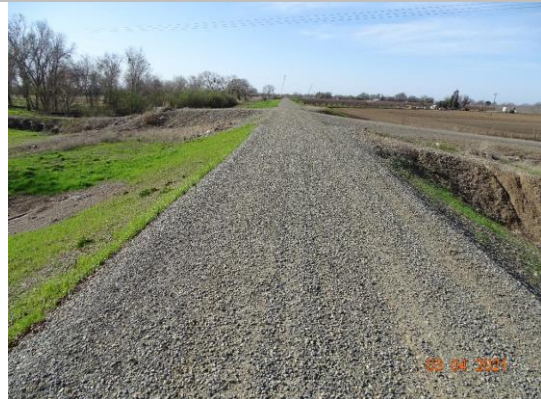
Photo 1 of 3 : UCIP\_SP\_2022\_66672\_98964.jpg

Comment Code						
Inspector Comment						
FS_ID:66672						
DS_ID:1664						
EP_NO: N/A						
Repair Type: Non-Urgent						
Crossing Status: Found						
UCIP Comments: 03/04/2021 Record remains Non-Urgent. No permit has been identified authorizing pipe. Crossing has been CIPP lined, new flap gate installed. (O.Yakimov - DWR UCIP)						
05/18/2017 No LS slide gate but not sure its even needed. Pipe has been selected to be internally cleaned and inspected as part of the DMP project. (A. Freitag - DWR Sutter Yard)11/14/2016 LS slide gate still missing. Rest of crossing appears in good condition. (A. Freitag - DWR Sutter Yard)05/12/2016 LS inlet was unburied. Slide gate still missing. (A. Freitag - DWR Sutter Yard)07/30/2015 LS inlet is still buried. (A. Freitag - DWR Sutter Yard)11/24/2014 Same as last inspection. (A. Freitag - DWR Sutter Yard)06/04/2014 Same as last inspection. (A. Freitag - DWR Sutter Yard)11/13/2013 Same as last inspection. (A. Freitag - DWR Sutter Yard)06/06/2013 Same as last inspection. (A. Freitag - DWR Sutter Yard)11/01/2012 LS inlet is buried under soil and covered with brambles. Slide gate missing from LS. (W. Wylie - DWR UCIP)

FIELD_STRUCT_DESC: 24-inch CIPP-lined corrugated metal drainage pipe through the levee, 12 feet below the crown. Flap gate on the waterside (WS). Concrete headwall on the WS. Concrete headwall on the landside (LS), not found. [Additional Reference(s): DWR Levee Log, 1990 (HLM 8.93). USACE Sacramento O&M Manual, Unit 516, April 1960, Revised 3 February 2011, (Station 338+04), listed as 24-inch pipe. USACE As-Built Drawing No. 50-04-3367, Sheet 11, Station 338+04, 11 April 1958].						
FS Date: 3/4/2021 2:53:06 PM

Top of Levee: View of levee crown looking downstream

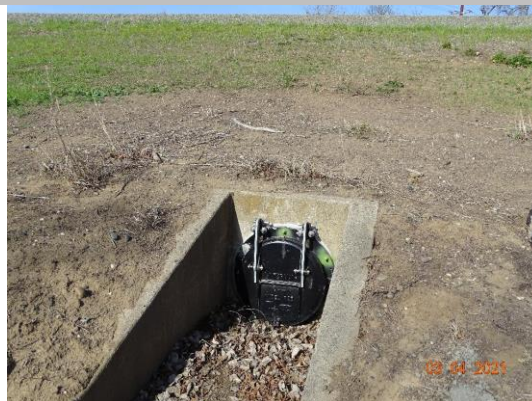
Photo 3 of 3 : UCIP\_SP\_2022\_66672\_98967.jpg

Water-Side: New flap gate installed

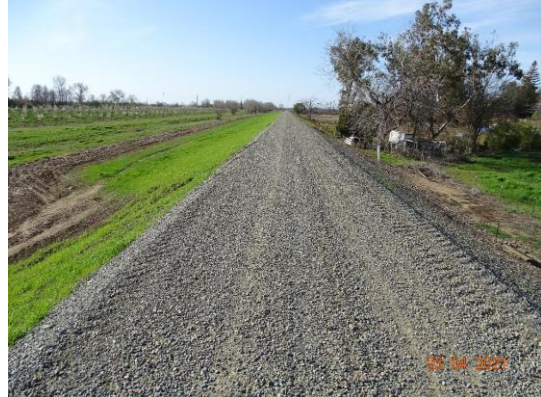
Photo 1 of 3 : UCIP\_SP\_2022\_66673\_98969.jpg

Comment Code						
Inspector Comment						
FS_ID:66673 DS_ID:1665 EP_NO: N/A Repair Type: Non-Urgent Crossing Status: Found UCIP Comments: 03/04/2021 Record remains Non-Urgent. No permit has been identified authorizing pipe. Crossing has been CIPP lined, new flap gate installed. (O.Yakimov - DWR UCIP) 05/18/2017 Crossing appears to be in good condition. Pipe has been selected to be internally cleaned and inspected as part of the DMP project. (A. Freitag - DWR Sutter Yard)11/14/2016 Crossing appears to be in good condition. (A. Freitag - DWR Sutter Yard)05/12/2016 Crossing appears to be in good condition. (A. Freitag - DWR Sutter Yard)07/30/2015 Crossing appears in good condition. No noticeable issues to report. (A. Freitag - DWR Sutter Yard)11/24/2014 Same as last inspection. (A. Freitag - DWR Sutter Yard)06/04/2014 Same as last inspection. (A. Freitag - DWR Sutter Yard)11/13/2013 Same as last inspection. (A. Freitag - DWR Sutter Yard)06/06/2013 Same as last inspection. (A. Freitag - DWR Sutter Yard) FIELD_STRUCT_DESC: 24-inch CIPP-lined corrugated metal drainage pipe through the levee, 11.3 feet below the crown. Flap gate on the waterside (WS). Concrete headwalls on both the landside (LS) and the WS. [Additional Reference(s): DWR Levee Log, 1990 (HLM 9.25). USACE Sacramento O&M Manual, Unit 516, April 1960, Revised 3 February 2011, (Station 321+20), listed as 24-inch pipe]. FS Date: 3/4/2021 2:56:21 PM

Top of Levee: View of levee crown looking downstream

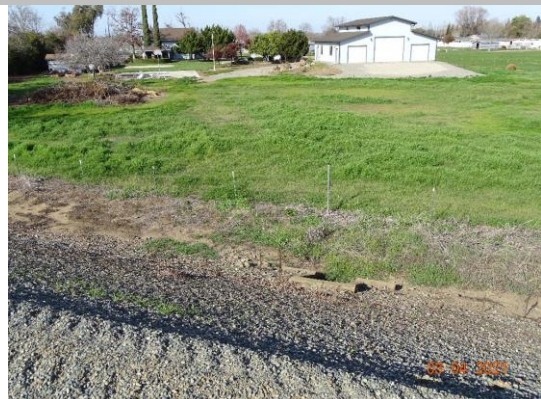
Photo 2 of 3 : UCIP\_SP\_2022\_66673\_98970.jpg

Land-Side: View of levee slope looking from crown

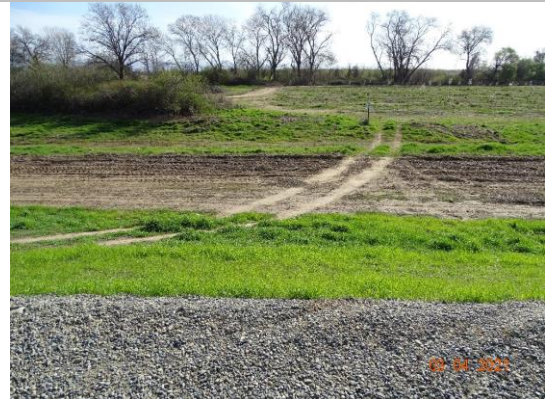
Photo 2 of 3 : UCIP\_SP\_2022\_66675\_98980.jpg

Water-Side: View of levee slope looking from crown

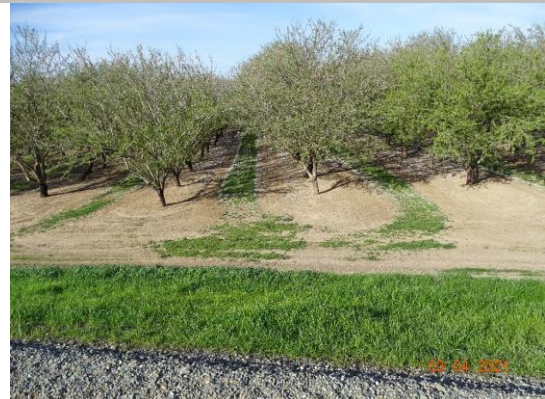
Photo 3 of 3 : UCIP\_SP\_2022\_66675\_98981.jpg

Land-Side: View of levee slope looking from crown

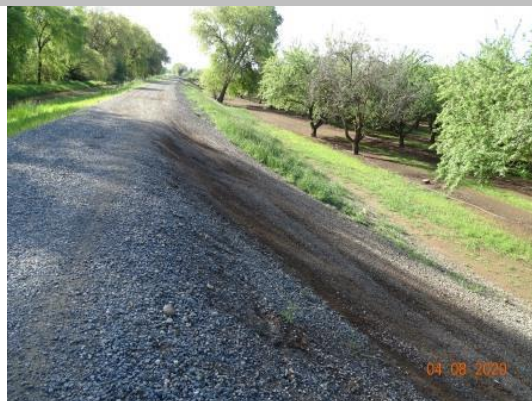
Photo 1 of 1 : SP\_2022\_MA0005\_197\_18\_20220307\_00005.jpg

LM Start	10.63	Rating **	M	Issue No.	18
LM End	10.63	Issue Type +	Ma	Location *	LS
Category	Earthen Levee			GPS Latitude/Longitude	
				Start	End
Item	Erosion / Vehicle Traffic			39.642061 °	39.642061 °
				-121.783861 °	-121.783861 °
DWR ID	DWR_MA0005_02_s_2012_18				
Comment Code					
E6 : Repair the levee slope damaged by vehicle traffic and prevent access where possible.					
Inspector Comment

View of the vehicle erosion along the landside slope. Spring 2020.

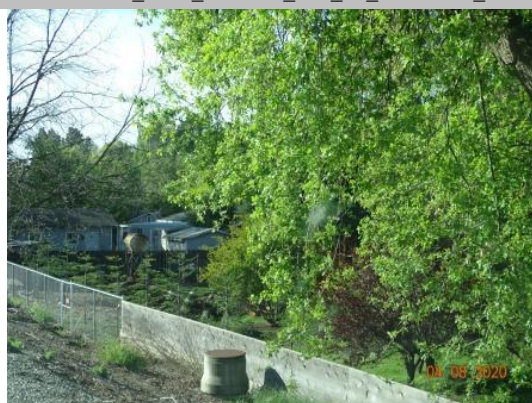
Photo 1 of 1 : SP\_2022\_MA0005\_197\_41\_20220307\_00008.jpg

LM Start	10.90	Rating **	U	Issue No.	41
LM End	10.93	Issue Type +	En	Location *	LS
Category	Earthen Levee			GPS Latitude/Longitude	
				Start	End
Item	Encroachments			39.645508 °	39.645858 °
				-121.786515 °	-121.786742 °
DWR ID	DWR_MA0005_02_f_2014_41				
Comment Code					
FE : Fence					
Inspector Comment					
Remove or apply for permit for the fence along the landside toe.

View of the fence along the landside toe. Spring 2020.

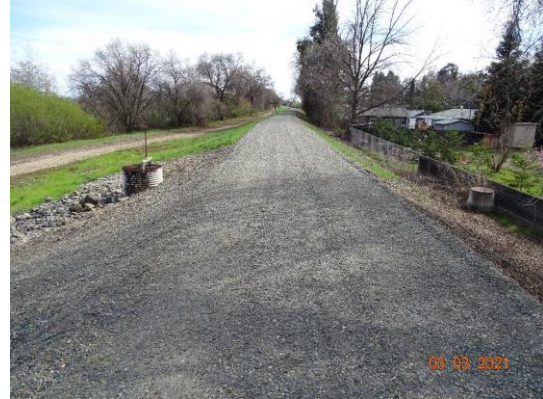
Photo 1 of 3 : UCIP\_SP\_2022\_66676\_98982.jpg

Comment Code					
Inspector Comment					
FS_ID:66676 DS_ID:1667 EP_NO: 4064 Repair Type: Non-Urgent Crossing Status: Found UCIP Comments: 03/03/2021 Record updated from No Action Needed to Non-Urgent. No permit has been identified authorizing original pipe. (O.Yakimov - DWR UCIP) 05/18/2017 Crossing appears to be in good condition. (A. Freitag - DWR Sutter Yard)11/14/2016 Crossing appears to be in good condition. (A. Freitag - DWR Sutter Yard)05/12/2016 Crossing appears to be in good condition. (A. Freitag - DWR Sutter Yard)07/30/2015 Crossing is in good condition. No noticeable issues to report. (A. Freitag - DWR Sutter Yard)11/24/2014 Same as last inspection. (A. Freitag - DWR Sutter Yard)06/04/2014 Same as last inspection. (A. Freitag - DWR Sutter Yard)11/13/2013 Same as last inspection. (A. Freitag - DWR Sutter Yard)06/06/2013 Same as last inspection. (A. Freitag - DWR Sutter Yard) FIELD_STRUCT_DESC: 24-inch corrugated metal irrigation siphon pipe through the levee, 13.5 feet below the crown. Slide gate in a corrugated metal riser on the waterside (WS) slope. 24-inch concrete manhole/standpipe at the landside (LS) toe. (Replacement a portion of existing 24-inch CMP pipe with class III 24-inch reinforced concrete pipe (RCP) under Butte Creek between levee toes with a cleanout installed in the center of Butte Creek authorized under Permit No. 4064, 1962 - Durham Mutual WaterCompany). [Additional Reference(s): DWR Levee Log, 1990 (HLM 11.05). USACE Sacramento O&M Manual, Unit 516, April 1960, Revised 3 February 2011, (Station 226+54), listed as 36-inch pipe. USACE As-Built Drawing No. 50-4-3367, upstream of Station 227+55, Sheets 2 and 7, 11 April 1958, pipe varies in size: 24-inch pipe (right bank), 24-inch through Butte Creek, and 3-foot by 3-foot (36-inch by 36-inch) culvert (left bank)]. FS Date: 3/3/2021 3:06:19 PM

Top of Levee: View of levee crown looking upstream

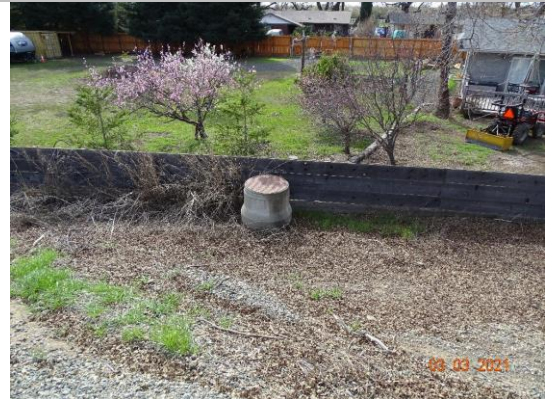
Photo 2 of 3 : UCIP\_SP\_2022\_66676\_98984.jpg

Land-Side: View of levee slope looking from crown

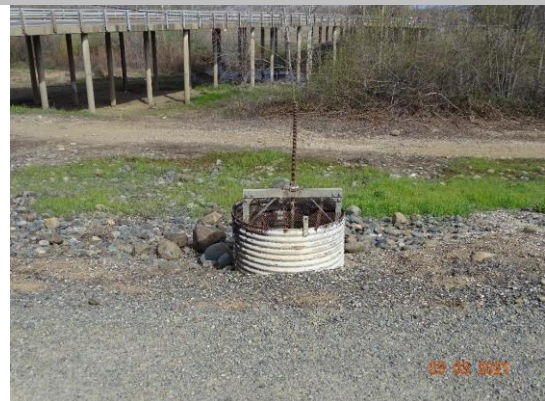
Photo 3 of 3 : UCIP\_SP\_2022\_66676\_98983.jpg

Water-Side: View of levee slope looking from crown

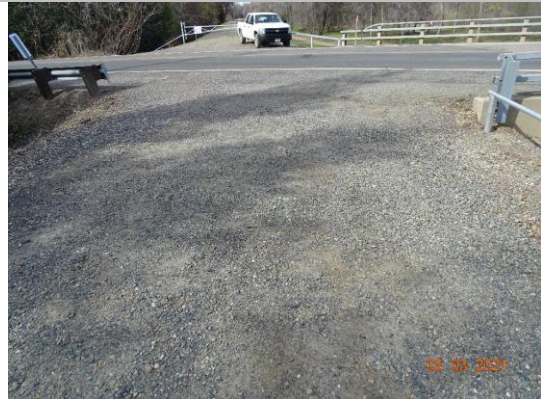
Photo 1 of 3 : UCIP\_SP\_2022\_66677\_98986.jpg

FS\_ID:66677  
DS\_ID:1668  
EP\_NO: 6544-A  
Repair Type: Non-Urgent  
Crossing Status: Indicator Found  
UCIP Comments: 03/03/2021 Record updated from No Action Needed to Non-Urgent. No inspection records were available to determine status of line through the levee. Recommend repairing gas line sign on levee slope. (O.Yakimov - DWR UCIP)  
05/18/2017 Crossing appears to be in good condition. (A. Freitag - DWR Sutter Yard)11/14/2016 Crossing appears to be in good condition. (A. Freitag - DWR Sutter Yard)05/11/2016 Crossing appears to be in good condition. (A. Freitag - DWR Sutter Yard)07/30/2015 Crossing is in good condition. (A. Freitag - DWR Sutter Yard)11/24/2014 Same as last inspection. (A. Freitag - DWR Sutter Yard)06/04/2014 Same as last inspection. (A. Freitag - DWR Sutter Yard)11/13/2013 Same as last inspection. (A. Freitag - DWR Sutter Yard)06/06/2013 Same as last inspection. (A. Freitag - DWR Sutter Yard)

Top of Levee: View of levee crown looking upstream

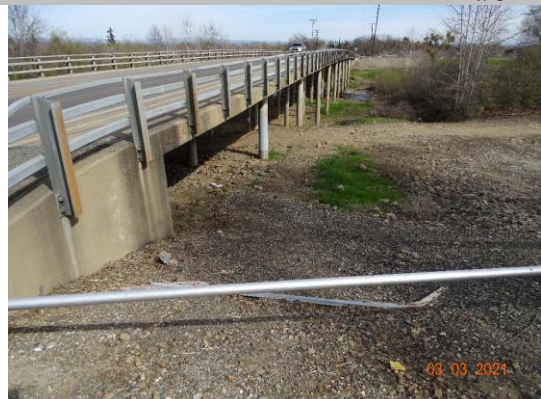
Photo 2 of 3 : UCIP\_SP\_2022\_66677\_98988.jpg

Water-Side: View of levee slope looking from crown

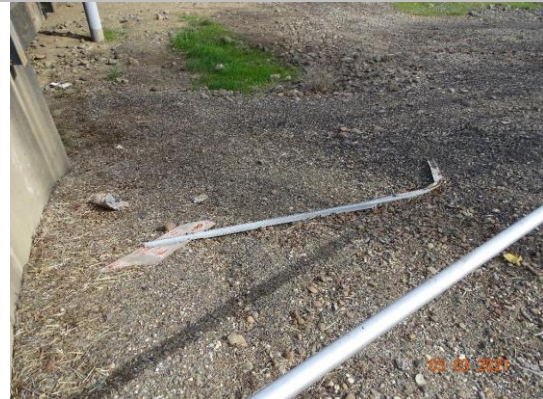
Photo 3 of 3 : UCIP\_SP\_2022\_66677\_98987.jpg

Water-Side: Fallen gas line sign on levee slope

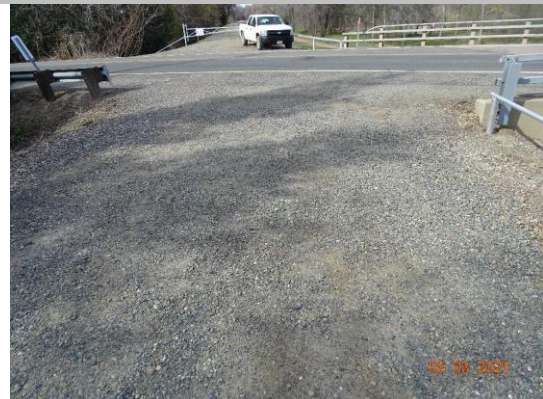
Photo 1 of 3 : UCIP\_SP\_2022\_66678\_98991.jpg

FS\_ID:66678  
DS\_ID:1669  
EP\_NO: N/A  
Repair Type: Non-Urgent  
Crossing Status: Not Found  
UCIP Comments: 03/03/2021 Record updated from No Action Needed to Non-Urgent. No inspection records were available to determine status of line through the levee. Crossing not found. Levee log indicated that the pipe was abandoned. (O.Yakimov - DWR UCIP)  
11/14/2016 Unable to locate/ description says its abandoned. (A. Freitag - DWR Sutter Yard)05/11/2016 Abandoned. (A. Freitag - DWR Sutter Yard)07/30/2015 Unable to locate. (A. Freitag - DWR Sutter Yard)11/24/2014 Unable to locate. (A. Freitag - DWR Sutter Yard)06/04/2014 Same as last inspection. (A. Freitag - DWR Sutter Yard)11/13/2013 Unable to locate. (A. Freitag - DWR Sutter Yard)06/06/2013 Same as last inspection. Unable to locate. (A. Freitag - DWR Sutter Yard)  
FIELD\_STRUCT\_DESC: 4-inch steel gas line through the levee, at an unknown depth, not found. Levee log indicated that the pipe was abandoned. [Additional Reference(s): DWR Levee Log, 1990 (HLM 11.08), listed as abandoned 4-inch steel gas line].

Top of Levee: View of levee crown looking upstream

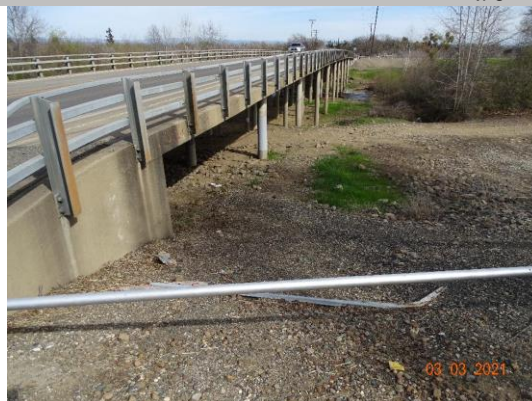
Photo 2 of 3 : UCIP\_SP\_2022\_66678\_98992.jpg

Water-Side: View of levee slope looking from crown

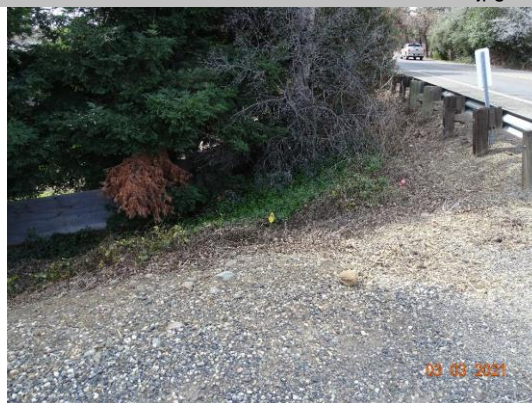
Photo 3 of 3 : UCIP\_SP\_2022\_66678\_98993.jpg

Land-Side: View of levee slope looking from crown

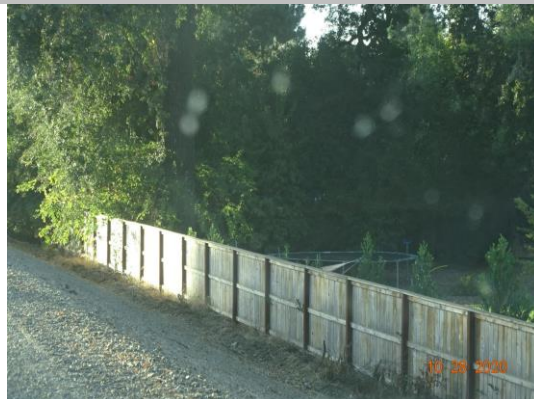
Photo 1 of 1 : SP\_2022\_MA0005\_197\_60\_20220307\_00013.jpg

LM Start	10.98	Rating **	U	Issue No.	60
LM End	11.04	Issue Type +	En	Location *	LS
Category	Earthen Levee			GPS Latitude/Longitude	
				Start	End
Item	Encroachments			39.646523 °	39.647238 °
				-121.787310 °	-121.787866 °
DWR ID	DWR_MA0005_02_f_2016_60				
Comment Code					
FE : Fence					
Inspector Comment

View of a wooden fence along the landside toe. Fall 2020.

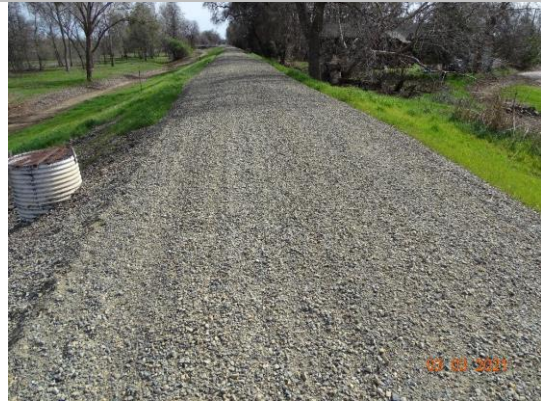
Photo 1 of 3 : UCIP\_SP\_2022\_66679\_98997.jpg

Comment Code						
Inspector Comment						
FS_ID:66679 DS_ID:1670 EP_NO: N/A Repair Type: Non-Urgent Crossing Status: Found UCIP Comments: 03/03/2021 Record remains Non-Urgent. No permit has been identified authorizing pipe. Crossing appears to be user for water level regulating purposes. DMP internal video inspection has not found pipe integrity issues. LOF of crossing is less or equal to 4.0. Recommend next video inspection in 5 years. (O.Yakimov - DWR UCIP) 05/18/2017 Appears abandoned- Slide gates in WS riser and LS distribution box missing. Pipe has been selected to be internally cleaned and inspected as part of the DMP project. (A. Freitag - DWR Sutter Yard)11/14/2016 Appears abandoned- Slide gates in WS riser and LS distribution box missing. (A. Freitag - DWR Sutter Yard)05/11/2016 Crossing appears to be in good condition. (A. Freitag - DWR Sutter Yard)07/30/2015 Crossing appears in good condition. No noticeable issues to report. (A. Freitag - DWR Sutter Yard)11/24/2014 Same as last inspection. (A. Freitag - DWR Sutter Yard)06/04/2014 Same as last inspection. (A. Freitag - DWR Sutter Yard)11/13/2013 Same as last inspection. (A. Freitag - DWR Sutter Yard)06/06/2013 New flap gate installed on WS end of pipe. (A. Freitag - DWR Sutter Yard) FIELD_STRUCT_DESC: 24-inch corrugated metal irrigation pipe through the levee, 9.7 feet below the crown. Slide gate in corrugated metal riser on the waterside (WS) slope. Flap gate on the WS toe. Slide gate in concrete distribution box on the landside (LS). [Additional Reference(s): DWR Levee Log, 1990 (HLM 11.27). USACE Sacramento O&M Manual, Unit 516, April 1960, Revised 3 February 2011, (Station 215+65), listed as 24-inch pipe. USACE As-Built Drawing No. 50-4-3367, Sheet 2, 11 April 1958, drawing shows 18-inch concrete pipe]. FS Date: 3/3/2021 3:51:29 PM

Top of Levee: View of levee crown looking downstream

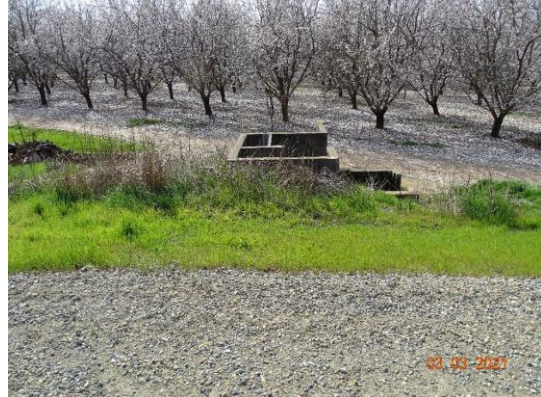
Photo 2 of 3 : UCIP\_SP\_2022\_66679\_98996.jpg

Land-Side: View of levee slope looking from crown. Concrete distribution box at levee toe

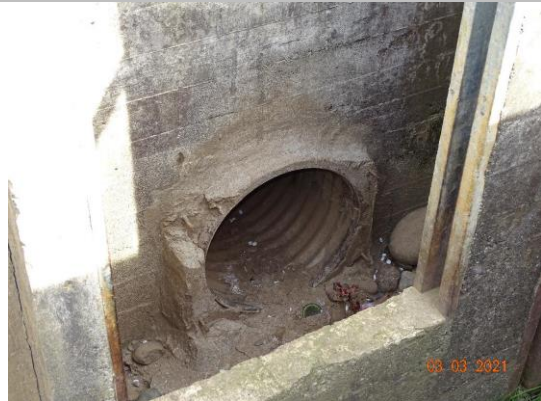
Photo 3 of 3 : UCIP\_SP\_2022\_66679\_98994.jpg

Land-Side: Corrugated metal pipe end inside of concrete distribution box

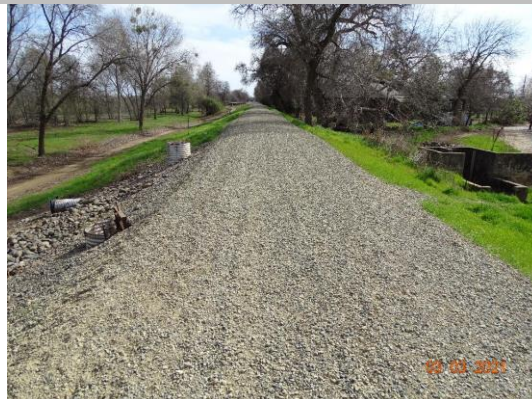
Photo 1 of 3 : UCIP\_SP\_2022\_66857\_99000.jpg

FS\_ID:66857  
DS\_ID:1671  
EP\_NO: N/A  
Repair Type: Non-Urgent  
Crossing Status: Found  
UCIP Comments: 03/03/2021 Record remains Non-Urgent. Crossing appears abandoned. Slide gate is in closed position, stem is bent. Soil and debris at the bottom of CMP riser on waterside shoulder cover slide gate. No permit has been identified authorizing pipe. DMP internal video inspection has not found pipe integrity issues. LOF of crossing is less or equal to 4.0. Recommend next video inspection in 5 years. (O.Yakimov - DWR UCIP)  
05/18/2017 Abandoned- WS end still buried. (A. Freitag - DWR Sutter Yard)11/14/2016 Appears abandoned. (A. Freitag - DWR Sutter Yard)05/11/2016 Abandoned crossing. (A. Freitag - DWR Sutter Yard)07/30/2015 Abandoned crossing. Unable to locate the WS end of pipe. (A. Freitag - DWR Sutter Yard)11/24/2014 Same as last inspection. (A. Freitag - DWR Sutter Yard)06/04/2014 Same as last inspection. (A. Freitag - DWR Sutter Yard)11/13/2013 Same as last inspection. (A. Freitag - DWR Sutter Yard)06/06/2013 Same as last inspection. (A. Freitag - DWR Sutter Yard)11/01/2012 Pipe appears abandoned. It needs to be abandoned properly. (W. Wylie - DWR UCIP)

FIELD\_STRUCT\_DESC: 30-inch corrugated metal irrigation pipe through the levee, 9.4 feet below the crown. Slide gate in a 42-inch corrugated metal riser on the waterside (WS) slope. Concrete distribution box on the landside (LS). [Additional Reference(s): DWR Levee Log, 1990 (HLM 11.27). USACE Sacramento O&M Manual, Unit 516, April 1960, Revised 3 February 2011, (Station 215+46), listed as 30-inch pipe].  
FS Date: 3/3/2021 10:16:09 AM

Top of Levee: View of levee crown looking downstream

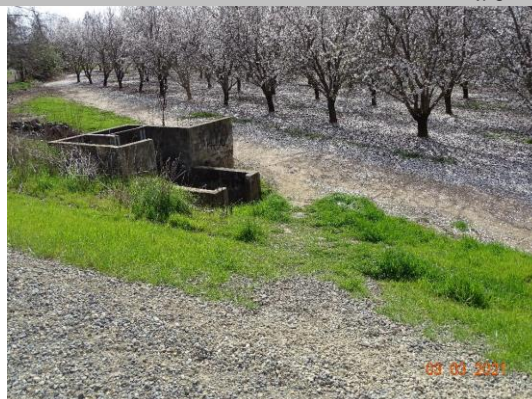
Photo 2 of 3 : UCIP\_SP\_2022\_66857\_99003.jpg

Land-Side: View of levee slope looking from crown. Concrete distribution box at levee toe

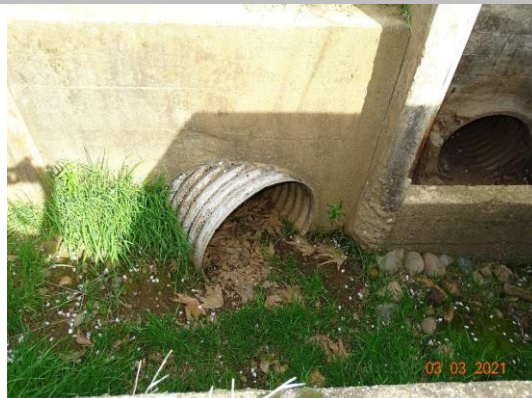
Photo 3 of 3 : UCIP\_SP\_2022\_66857\_99004.jpg

Land-Side: Pipe end in concrete box at levee toe

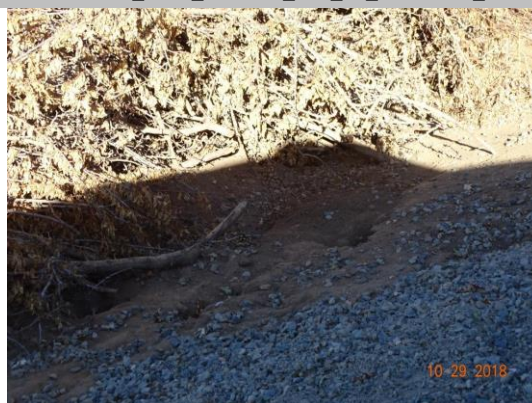
Photo 1 of 1 : SP\_2022\_MA0005\_197\_71\_20220307\_00014.jpg

LM Start	11.77	Rating **	M	Issue No.	71
LM End	11.77	Issue Type +	Ma	Location *	LS
Category	Earthen Levee			GPS Latitude/Longitude	
				Start	End
Item	Animal Control			39.657115 °	39.657115 °
				-121.788703 °	-121.788703 °
DWR ID	DWR_MA0005_02_f_2018_71				
Comment Code					
A3 : No rodents visible, but rodent burrows visible; need to backfill and compact or grout burrows.					
Inspector Comment

View of the rodent holes along the landside slope.

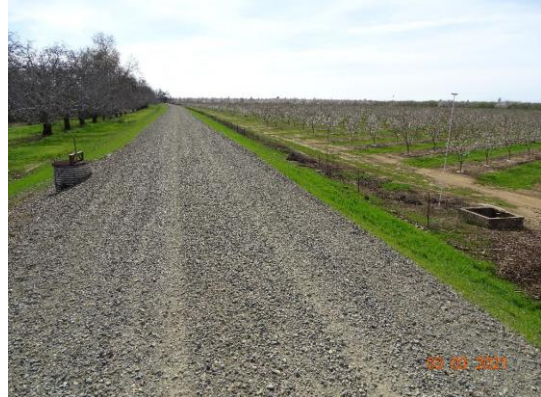
Photo 1 of 3 : UCIP\_SP\_2022\_66858\_99005.jpg

FS\_ID:66858  
DS\_ID:1672  
EP\_NO: N/A  
Repair Type: Non-Urgent  
Crossing Status: Found  
UCIP Comments: 03/03/2021 Record updated from No Action Needed to Non-Urgent. No permit has been identified authorizing pipe. (O.Yakimov - DWR UCIP)  
05/18/2017 Crossing appears to be in good condition. This is believed to be a siphon pipe that crosses under Butte Creek channel and passes through the Unit 2(left bank) levee at CLM 2.807 DS\_ID 1614. (A. Freitag - DWR Sutter Yard)11/14/2016 Crossing appears to be in good condition. (A. Freitag - DWR Sutter Yard)05/11/2016 Crossing appears to be in good condition. (A. Freitag - DWR Sutter Yard)07/30/2015 Crossing is not abandoned. Water was flowing through the standpipe on the WS shoulder. Unable to locate the source of the water or where it was flowing to. (A. Freitag - DWR Sutter Yard)11/24/2014 Same as last inspection. (A. Freitag - DWR Sutter Yard)06/04/2014 Same as last inspection. (A. Freitag - DWR Sutter Yard)11/13/2013 Same as last inspection. (A. Freitag - DWR Sutter Yard)06/06/2013 Same as last inspection. (A. Freitag - DWR Sutter Yard)11/01/2012 This pipe appears to be abandoned. (W. Wylie - DWR UCIP)

FIELD\_STRUCT\_DESC: 30-inch corrugated metal irrigation pipe through the levee, 12.3 feet below the crown. Slide gate in a 42-inch corrugated metal riser on the waterside (WS) slope. 5-foot by 5-foot concrete distribution box at the landside (LS) toe. [Additional Reference(s): DWR Levee Log, 1990 (HLM 12.24). USACE Sacramento O&M Manual, Unit 516, April 1960, Revised 3 February 2011, (Station 165+60), listed as 30-inch pipe].  
FS Date: 3/3/2021 10:21:23 AM

Top of Levee: View of levee crown looking downstream

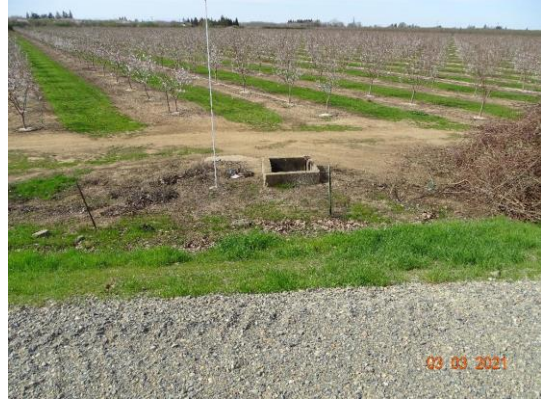
Photo 2 of 3 : UCIP\_SP\_2022\_66858\_99007.jpg

Land-Side: Concrete distribution box off levee toe

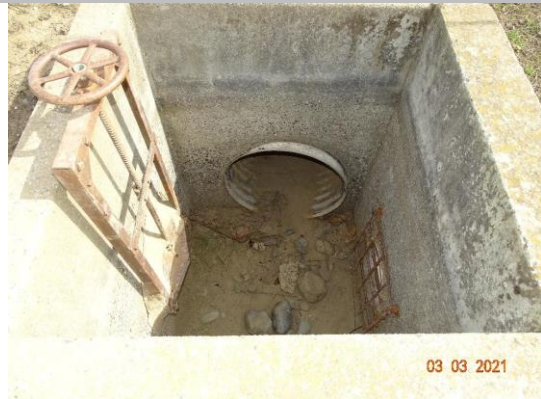
Photo 3 of 3 : UCIP\_SP\_2022\_66858\_99008.jpg

Land-Side: View of pipe inside concrete distribution box
