# Flood Control Project Maintenance Levee Inspections LMA District Cover Sheet

## Sutter Maintenance Yard Maintenance Area 0005

**Flood Control Project Maintenance  
Levee Inspections  
Unit Cover Sheet**

Waterway			Bank	Unit Miles
Unit No. 01 Butte Creek			Left	15.08
	Spring (March - May)	Summer (June - August)	(September - November) Fall	Winter (December - February)
Unit Maintenance Rating (Fall Only)				
Date of Inspection	3/23/2022 - 3/23/2022			
DWR Inspector	Makar Sokol			
Accompanied By	Shawn Freitag DWR Sutter Yard

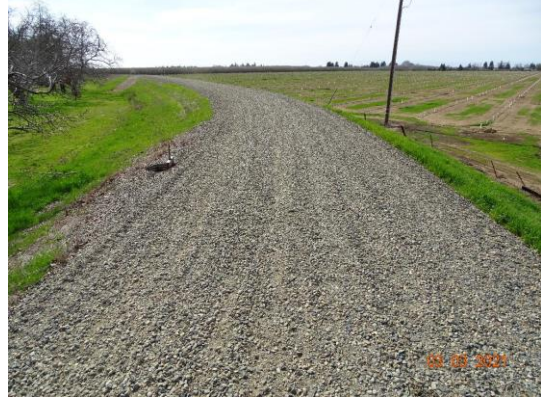
Photo 1 of 3 : UCIP\_SP\_2022\_66886\_99009.jpg

FS\_ID:66886  
DS\_ID:1673  
EP\_NO: N/A  
Repair Type: Non-Urgent  
Crossing Status: Found  
UCIP Comments: 03/03/2021 Record remains Non-Urgent. CMP riser on waterside slope is open at ground level. Recommend installation of top cover. Crossing appears abandoned. Headwall is buried in soil at landside toe, soil at the bottom of CMP riser on waterside slope blocks slide gate from opening. Capped pipe in front of headwall on landside may not belong to this crossing. Geophysical study indicates possible presence of pipe through levee. Owner needs to coordinate with the CVFPB to remove or abandon crossing according to Title 23 requirements. No permit has been identified authorizing pipe. (O.Yakimov - DWR UCIP)  
05/23/2019 (O. Magana - DWR UCIP)05/18/2017 Abandoned- needs to be done properly. Pipe has been selected to be internally cleaned and inspected as part of the DMP project. (A. Freitag - DWR Sutter Yard)11/14/2016 Abandoned- needs a cover for standpipe. (A. Freitag - DWR Sutter Yard)05/11/2016 Abandoned crossing. Needs a cover for the WS riser. (A. Freitag - DWR Sutter Yard)08/03/2015 Crossing appears abandoned. Only the slide gate inside riser on the WS shoulder could be found. Riser needs a cover made for it. (A. Freitag - DWR Sutter Yard)11/24/2014 Same as last inspection. (A. Freitag - DWR Sutter Yard)06/04/2014 Same as last inspection. (A. Freitag - DWR Sutter Yard)11/13/2013 Slide gate top and stem were repaired to make gate operational. (A. Freitag - DWR Sutter Yard)06/06/2013 New slidegate is planned to be installed during summer of 2013. (A. Freitag - DWR Sutter Yard)11/01/2012 Slide gate on WS shoulder bent and damaged (inoperable) Pipe appears abandoned. (W. Wylie - DWR UCIP)

FIELD\_STRUCT\_DESC: 24-inch corrugated metal drainage pipe through the levee, 14 feet below the crown. Slide gate in a corrugated metal riser on the waterside (WS) slope. [Additional Reference(s): DWR Levee Log, 1990 (HLM 12.98). USACE Sacramento O&M Manual, Unit 516, April 1960, Revised 3 February 2011, (Station 126+91), listed as 24-inch pipe].  
FS Date: 3/3/2021 11:13:03 AM

Top of Levee: View of levee crown looking downstream

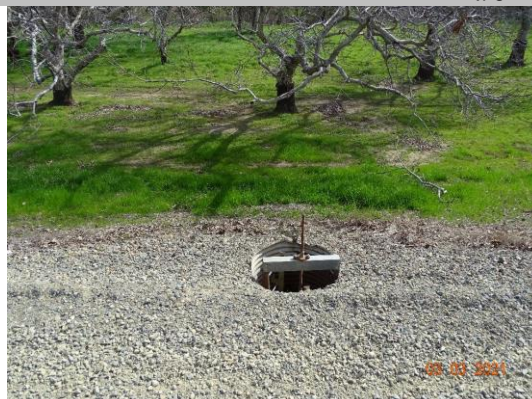
Photo 2 of 3 : UCIP\_SP\_2022\_66886\_99010.jpg

Water-Side: Open CMP riser with slide gate on levee shoulder

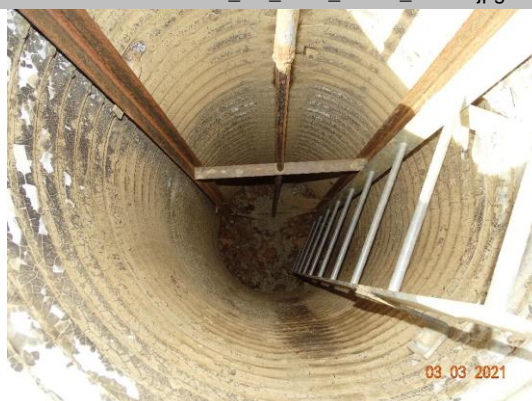
Photo 3 of 3 : UCIP\_SP\_2022\_66886\_99011.jpg

Water-Side: View inside CMP riser. Soil buildup at bottom

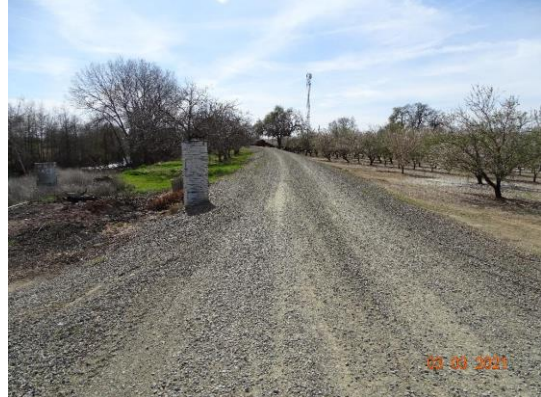
Photo 1 of 3 : UCIP\_SP\_2022\_66890\_99014.jpg

Comment Code						
Inspector Comment						
FS_ID:66890 DS_ID:1674 EP_NO: 1291 Repair Type: Non-Urgent Crossing Status: Indicator Found UCIP Comments: 03/03/2021 Record remains Non-Urgent. Crossing appears abandoned. Evidence of crossing not found on landside. Looking at position of slide gate in CMP riser, pipe appears crossing levee at angle. (O.Yakimov - DWR UCIP) 05/18/2017 Appears abandoned- needs to be done properly. (A. Freitag - DWR Sutter Yard)11/14/2016 Appears abandoned- needs to be done so properly. (A. Freitag - DWR Sutter Yard)05/11/2016 Appears to be an abandoned crossing. (A. Freitag - DWR Sutter Yard)08/03/2015 Pipe appears to be abandoned. Pump on WS berm is still missing. (A. Freitag - DWR Sutter Yard)11/24/2014 Same as last inspection. (A. Freitag - DWR Sutter Yard)06/04/2014 Same as last inspection. (A. Freitag - DWR Sutter Yard)11/13/2013 Same as last inspection. (A. Freitag - DWR Sutter Yard)06/06/2013 Same as last inspection. (A. Freitag - DWR Sutter Yard)11/01/2012 Pipe appears to be abandoned. No pump found. Pipe should be abandoned properly. (W. Wylie - DWR UCIP) FIELD_STRUCT_DESC: 24-inch corrugated metal irrigation pipe through the levee, 9 feet below the crown. Slide gate in a 36-inch corrugated metal riser on the waterside (WS) slope. Pump and a 36-inch concrete standpipe on the WS. (14-inch concrete pipe authorized under Permit No. 1291, 1948 - J. P. Hansen). [Additional Reference(s): DWR Levee Log, 1990 (HLM 13.35). USACE Sacramento O&M Manual, Unit 516, April 1960, Revised 3 February 2011, (Station 106+93), listed as 24-inch pipe]. FS Date: 3/3/2021 11:21:55 AM

Top of Levee: View of levee crown looking downstream

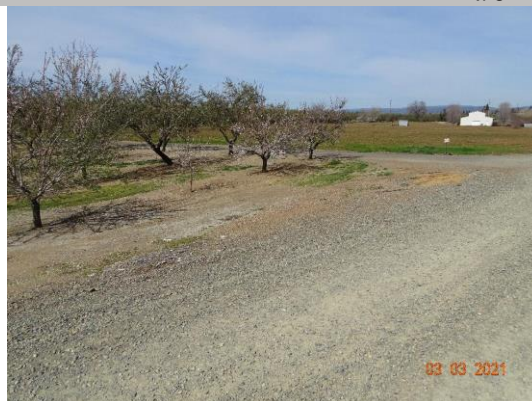
Photo 2 of 3 : UCIP\_SP\_2022\_66890\_99016.jpg

Land-Side: View of levee slope looking from crown

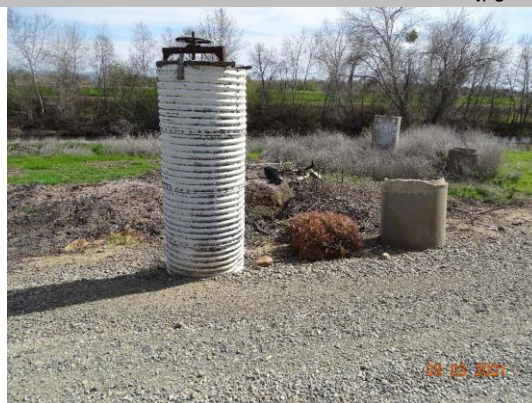
Photo 3 of 3 : UCIP\_SP\_2022\_66890\_99015.jpg

Water-Side: View of levee slope looking from crown. CMP riser with slide gate on levee shoulder

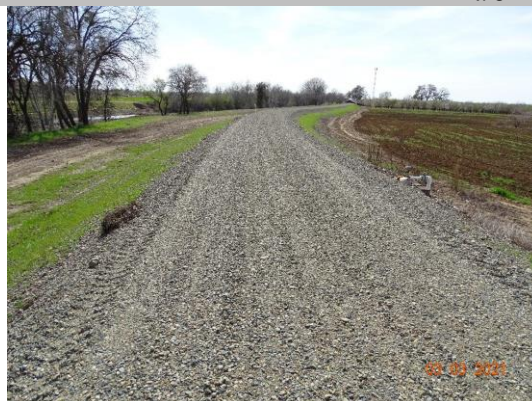
Photo 1 of 3 : UCIP\_SP\_2022\_66895\_99018.jpg

Comment Code						
Inspector Comment						
FS_ID:66895 DS_ID:1675 EP_NO: N/A Repair Type: Non-Urgent Crossing Status: Found UCIP Comments: 03/03/2021 Record remains Non-Urgent. Unauthorized encroachment recorded in Levee Log prior to 2011. Electric meter on service pole is energized, pipe not found on waterside. (O.Yakimov - DWR UCIP) 05/18/2017 LS visible but nothing found on WS of levee. (A. Freitag - DWR Sutter Yard)11/14/2016 Still unable to locate and WS appurtances. (A. Freitag - DWR Sutter Yard)05/11/2016 LS seems fine but nothing was found on the WS. (A. Freitag - DWR Sutter Yard)08/03/2015 Still unable to locate anything on the WS. (A. Freitag - DWR Sutter Yard)11/24/2014 Same as last inspection. (A. Freitag - DWR Sutter Yard)06/04/2014 Same as last inspection. (A. Freitag - DWR Sutter Yard)11/13/2013 Same as last inspection. (A. Freitag - DWR Sutter Yard)06/06/2013 Same as last inspection. (A. Freitag - DWR Sutter Yard)11/01/2012 Unable to locate pipe on WS. (A. Freitag - DWR Sutter Yard) FIELD_STRUCT_DESC: 8-inch steel irrigation pipe, 4 feet below the crown. Pipe is sleeved with a 5-inch aluminum irrigation pipe. Pump on a concrete pad on the landside (LS) slope. Butterfly valve on the LS slope. [Additional Reference(s): DWR Levee Log, 1990 (HLM 13.51), listed as 5-inch aluminum pipe sleeved through 8-inch pipe through the levee]. FS Date: 3/3/2021 11:26:36 AM

Top of Levee: View of levee crown looking downstream

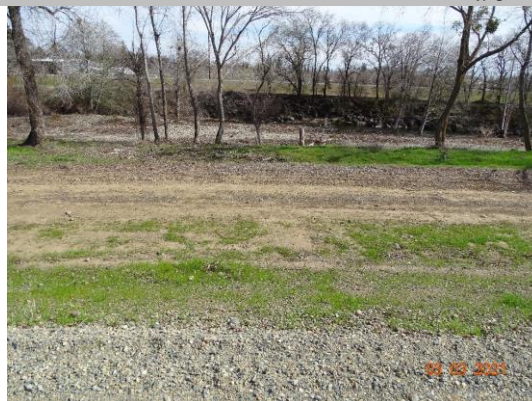
Photo 2 of 3 : UCIP\_SP\_2022\_66895\_99022.jpg

Water-Side: View of levee slope looking from crown. Pipe not found on waterside

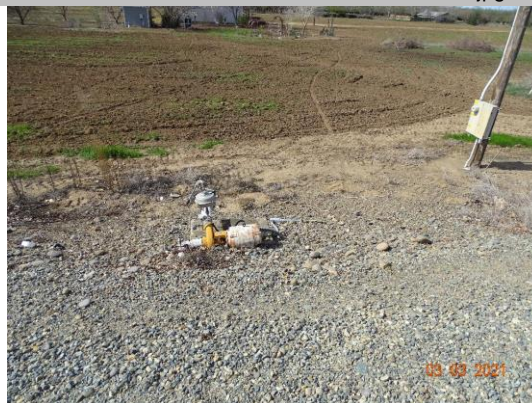
Photo 3 of 3 : UCIP\_SP\_2022\_66895\_99019.jpg

Land-Side: View of levee slope looking from crown. Service pole at levee toe, water pump on slope

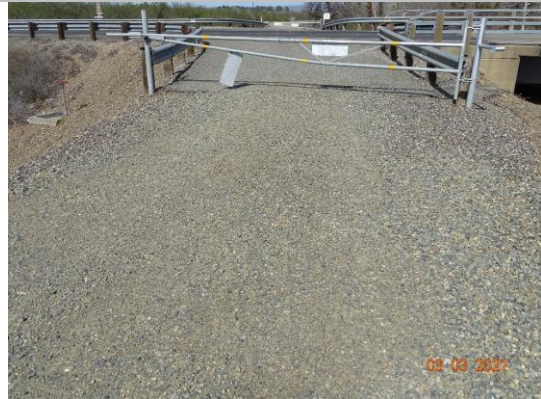
Photo 1 of 3 : UCIP\_SP\_2022\_66904\_99023.jpg

Comment Code						
Inspector Comment						
FS_ID:66904 DS_ID:1676 EP_NO: N/A Repair Type: Non-Urgent Crossing Status: Not Found UCIP Comments: 03/03/2021 Record updated from No Action Needed to Non-Urgent. Crossing not found. Geophysical results did not confirm presence of pipe through levee. Record will remain in UCIP's inspection records until future Levee Improvement Project can confirm no crossing was found through the levee. No permit has been identified authorizing pipe. (O.Yakimov - DWR UCIP) 05/18/2017 Unable to locate. (A. Freitag - DWR Sutter Yard) 11/14/2016 Unable to locate. (A. Freitag - DWR Sutter Yard) 05/11/2016 Unable to locate. (A. Freitag - DWR Sutter Yard) 08/03/2015 Unable to locate. (A. Freitag - DWR Sutter Yard) 11/25/2014 Unable to locate. (A. Freitag - DWR Sutter Yard) 06/04/2014 Unable to locate. (A. Freitag - DWR Sutter Yard) 11/13/2013 Unable to locate. (A. Freitag - DWR Sutter Yard) 06/06/2013 Same as last inspection. Unable to locate. (A. Freitag - DWR Sutter Yard) FIELD_STRUCT_DESC: 8-inch pipe through the levee, 11 feet below the crown. Siphon breaker in corrugated metal riser on the waterside (WS) slope, not found. Pump on the WS berm. [Additional Reference(s): DWR Levee Log, 1990 (HLM 13.59). USACE Sacramento O&M Manual, Unit 516, April 1960, Revised 3 February 2011, (Station 94+76), listed as 8-inch pipe]. FS Date: 3/3/2021 11:32:17 AM

Top of Levee: View of levee crown looking upstream

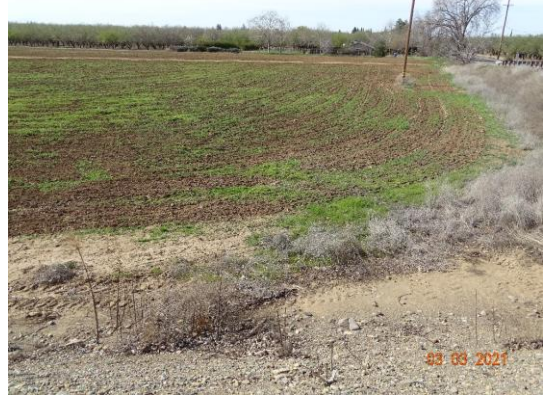
Photo 2 of 3 : UCIP\_SP\_2022\_66904\_99024.jpg

Land-Side: View of levee slope looking from crown

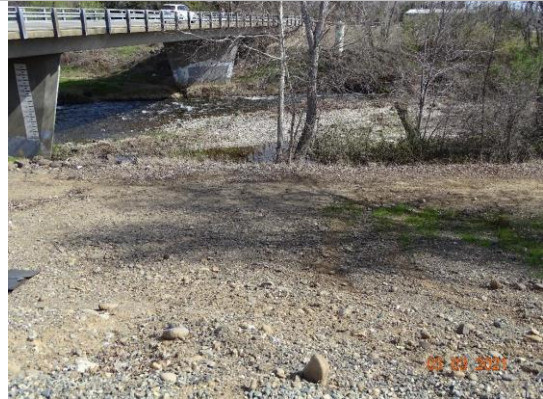
Photo 3 of 3 : UCIP\_SP\_2022\_66904\_99025.jpg

Water-Side: View of levee slope looking from crown

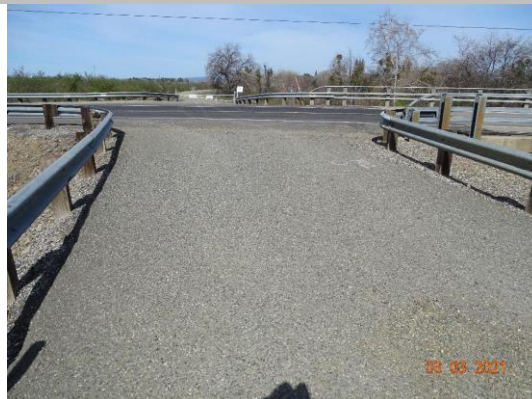
Photo 1 of 3 : UCIP\_SP\_2022\_66915\_99026.jpg

Comment Code						
Inspector Comment						
FS_ID:66915 DS_ID:1740 EP_NO: 17127 Repair Type: Non-Urgent Crossing Status: Found UCIP Comments: 03/03/2021 Record updated from No Action Needed to Non-Urgent. Vegetation and debris around headwall and flap gate on waterside need to be cleared. (O.Yakimov - DWR UCIP) 5/18/2017 Crossing appears to be in good condition. Pipe has been selected to be internally cleaned and inspected as part of the DMP project. (A. Freitag - DWR Sutter Yard)11/14/2016 Crossing appears to be in good condition. (A. Freitag - DWR Sutter Yard)05/11/2016 Ws flap gate is being overgrown by vegetation. (A. Freitag - DWR Sutter Yard)08/03/2015 Crossing appears in good condition. No noticeable issues to report. (A. Freitag - DWR Sutter Yard)11/24/2014 Flap gate needs to be dug out and unblocked. (A. Freitag - DWR Sutter Yard)06/04/2014 Same as last inspection. (A. Freitag - DWR Sutter Yard)11/13/2013 Flap gate is completely blocked from being able to open. (A. Freitag - DWR Sutter Yard)06/06/2013 Same as last inspection. (A. Freitag - DWR Sutter Yard)11/01/2012 Debris, soil, and vegetation creating minor blockage at flap gate outlet. (W. Wylie - DWR UCIP) FIELD_STRUCT_DESC: 36-inch corrugated metal drainage pipe through the levee, 12 feet below the crown. 4-foot by 4-foot concrete box and slide gate on the landside (LS). Concrete headwall and flap gate at the waterside (WS) outlet. (36-inch pipe authorized under Permit No. 17127, 1999 - Butte County, Department of Public Works). FS Date: 3/3/2021 11:34:25 AM

Top of Levee: View of levee crown looking upstream

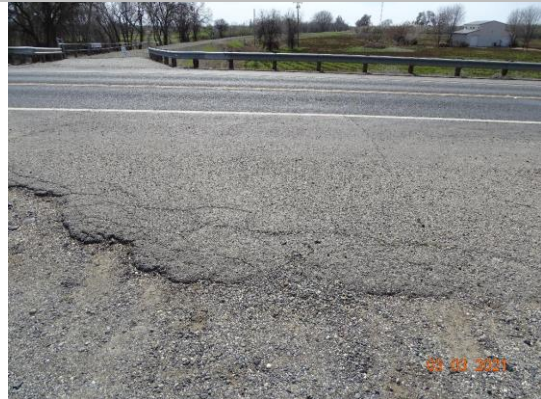
Photo 1 of 3 : UCIP\_SP\_2022\_67135\_99071.jpg

FS\_ID:67135  
DS\_ID:1677  
EP\_NO: 14301  
Repair Type: Non-Urgent  
Crossing Status: Indicator Found  
UCIP Comments: 03/03/2021 Record updated from No Action Needed to Non-Urgent. No permit has been found authorizing this gas line through the levee. No inspection records were available to determine status of line through the levee. Gas line marker installed only on waterside shoulder. (O.Yakimov - DWR UCIP)  
05/18/2017 Crossing appears to be in good condition. (A. Freitag - DWR Sutter Yard)11/14/2016 Crossing appears to be in good condition. (A. Freitag - DWR Sutter Yard)05/11/2016 Crossing appears to be in good condition. (A. Freitag - DWR Sutter Yard)08/03/2015 Crossing is in good condition. (A. Freitag - DWR Sutter Yard)11/25/2014 Same as last inspection. (A. Freitag - DWR Sutter Yard)06/04/2014 Same as last inspection. (A. Freitag - DWR Sutter Yard)11/13/2013 Same as last inspection. (A. Freitag - DWR Sutter Yard)06/06/2013 Same as last inspection. (A. Freitag - DWR Sutter Yard)

Top of Levee: View of levee crown looking downstream

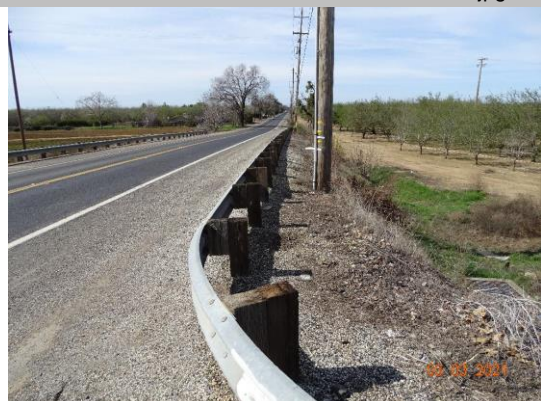
Photo 2 of 3 : UCIP\_SP\_2022\_67135\_99070.jpg

Land-Side: View of levee slope looking from crown

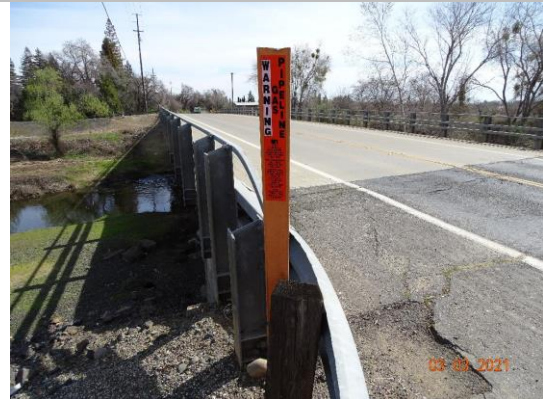
Photo 3 of 3 : UCIP\_SP\_2022\_67135\_99069.jpg

Water-Side: View of gas line marker on levee shoulder

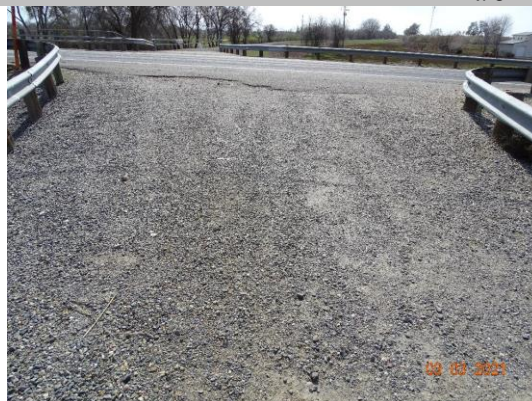
Photo 1 of 3 : UCIP\_SP\_2022\_67136\_99074.jpg

FS\_ID:67136  
DS\_ID:1679  
EP\_NO: N/A  
Repair Type: Non-Urgent  
Crossing Status: Found  
UCIP Comments: 03/03/2021 Record updated from No Action Needed to Non-Urgent. No permit has been identified authorizing pipe. According to DMP records this crossing was CIPP-lined on 07/19/2019. (O.Yakimov - DWR UCIP)  
05/18/2017 Crossing appears to be in good condition. Pipe has been selected to be internally cleaned and inspected as part of the DMP project. (A. Freitag - DWR Sutter Yard)11/14/2016 Crossing appears to be in good condition. (A. Freitag - DWR Sutter Yard)05/11/2016 Crossing appears to be in good condition. (A. Freitag - DWR Sutter Yard)08/03/2015 Crossing appears in good condition. No noticeable issues to report. (A. Freitag - DWR Sutter Yard)11/25/2014 Same as last inspection. (A. Freitag - DWR Sutter Yard)06/04/2014 Same as last inspection. (A. Freitag - DWR Sutter Yard)11/13/2013 Same as last inspection. (A. Freitag - DWR Sutter Yard)06/06/2013 Same as last inspection. (A. Freitag - DWR Sutter Yard)

Top of Levee: View of levee crown looking downstream

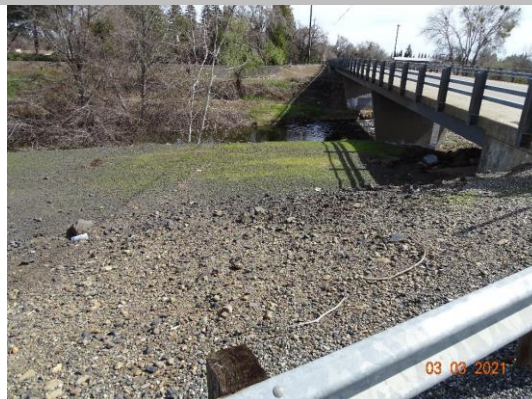
Photo 2 of 3 : UCIP\_SP\_2022\_67136\_99075.jpg

Water-Side: View of levee slope looking from crown

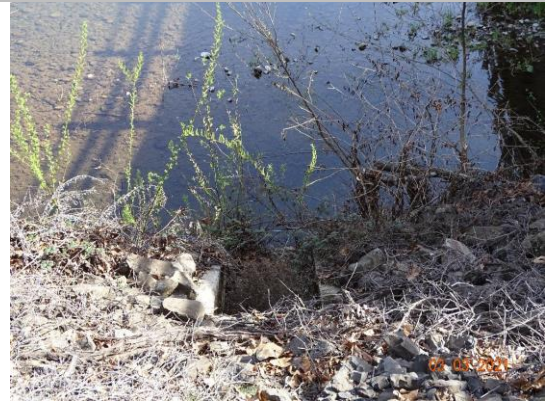
Photo 3 of 3 : UCIP\_SP\_2022\_67136\_99076.jpg

Water-Side: Pipe outlet at riverbank

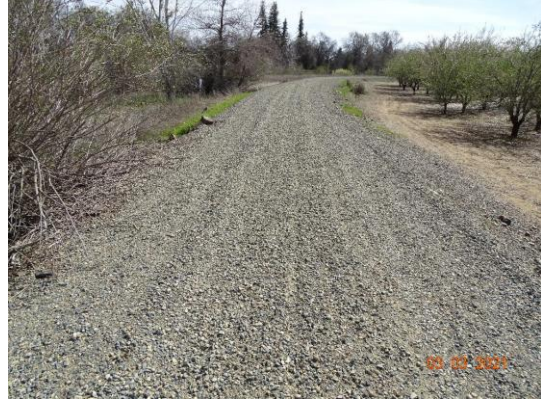
Photo 1 of 3 : UCIP\_SP\_2022\_67137\_99077.jpg

Comment Code						
Inspector Comment						
FS_ID:67137 DS_ID:1680 EP_NO: N/A Repair Type: Non-Urgent Crossing Status: Not Found UCIP Comments: 03/03/2021 Record remains Non-Urgent. Crossing and its appurtenances are not found. No permit has been identified authorizing pipe. (O.Yakimov - DWR UCIP) 05/18/2017 Unable to locate. (A. Freitag - DWR Sutter Yard)11/14/2016 Unable to locate. (A. Freitag - DWR Sutter Yard)05/11/2016 Unable to locate. (A. Freitag - DWR Sutter Yard)08/03/2015 Unable to locate. (A. Freitag - DWR Sutter Yard)11/25/2014 Unable to locate. (A. Freitag - DWR Sutter Yard)06/04/2014 Same as last inspection. Unable to locate. (A. Freitag - DWR Sutter Yard)11/13/2013 Unable to locate. (A. Freitag - DWR Sutter Yard)06/06/2013 Boilr (discharge tank) has been removed and pipe buried on LS. Unable to locate. (A. Freitag - DWR Sutter Yard)11/01/2012 Pipe appears to be abandoned. (W. Wylie - DWR UCIP) FIELD_STRUCT_DESC: 8-inch steel irrigation pipe through the levee, 6.5 feet below the crown. Discharge tank on landside, pump on concrete pump base on waterside berm. (Construction of concrete pump platform and relocating water pump authorized under Permit No. 6856, 1970 - William Coats). [Additional Reference(s): DWR Levee Log, 1990 (HLM 13.99).USACE Sacramento O&M Manual, Unit 516, April 1960, Revised 3 February 2011, (Station 73+27), listed as 8-inch pipe]. FS Date: 3/3/2021 2:49:33 PM

Top of Levee: View of levee crown looking downstream

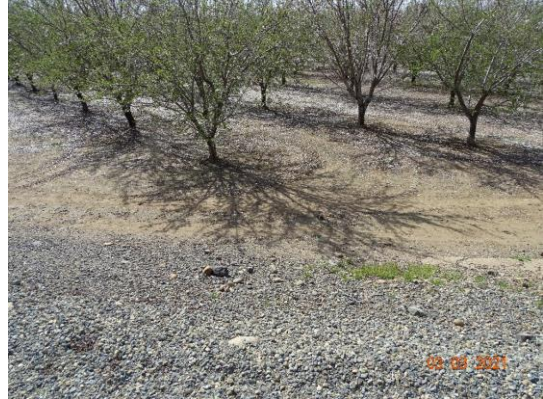
Photo 2 of 3 : UCIP\_SP\_2022\_67137\_99078.jpg

Land-Side: View of levee slope looking from crown

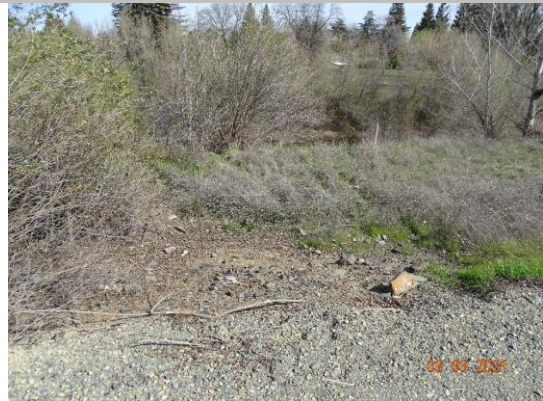
Photo 3 of 3 : UCIP\_SP\_2022\_67137\_99079.jpg

Water-Side: View of levee slope looking from crown

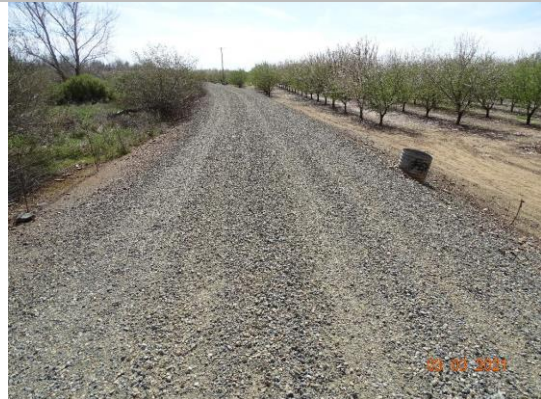
Photo 1 of 3 : UCIP\_SP\_2022\_67138\_99081.jpg

Comment Code						
Inspector Comment						
FS_ID:67138 DS_ID:1681 EP_NO: N/A Repair Type: Non-Urgent Crossing Status: Indicator Found UCIP Comments: 03/03/2021 Record remains Non-Urgent. Crossing appears abandoned. CMP riser on landside shoulder indicates pipe location. Soil at the bottom of CMP covers siphon breaker. Pipe inlet and outfall are not found. Geophysical results did not confirm presence of pipe through levee. Record will remain in UCIP's inspection records until future Levee Improvement Project can confirm no crossing was found through the levee. No permit has been identified authorizing pipe. (O.Yakimov - DWR UCIP) 05/18/2017 Appears abandoned- if so needs to be done so properly. (A. Freitag - DWR Sutter Yard)11/14/2016 Appears abandoned. (A. Freitag - DWR Sutter Yard)05/11/2016 Abandoned crossing. (A. Freitag - DWR Sutter Yard)08/03/2015 Pipe still appears abandoned. (A. Freitag - DWR Sutter Yard)11/25/2014 Same as last inspection. (A. Freitag - DWR Sutter Yard)06/04/2014 Same as last inspection. (A. Freitag - DWR Sutter Yard)11/13/2013 Same as last inspection. (A. Freitag - DWR Sutter Yard)06/06/2013 Same as last inspection. (A. Freitag - DWR Sutter Yard)11/01/2012 Pipe appears to be abandoned. (W. Wylie - DWR UCIP) FIELD_STRUCT_DESC: 6-inch steel irrigation pipe through the levee, 7.1 feet below the crown. Siphon breaker in a corrugated metal riser on the landside (LS) slope. One corrugated metal cutoff wall. Pipe is open on both ends. [Additional Reference(s): DWR Levee Log, 1990 (HLM 14.15). USACE Sacramento O&M Manual, Unit 516, April 1960, Revised 3 February 2011, (Station 65+52), listed as 6-inch pipe]. FS Date: 3/3/2021 2:52:33 PM

Top of Levee: View of levee crown looking downstream

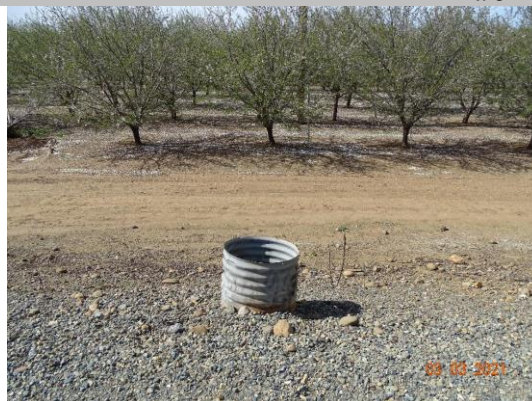
Photo 2 of 3 : UCIP\_SP\_2022\_67138\_99082.jpg

Land-Side: View of levee slope looking from crown. CMP riser on levee shoulder

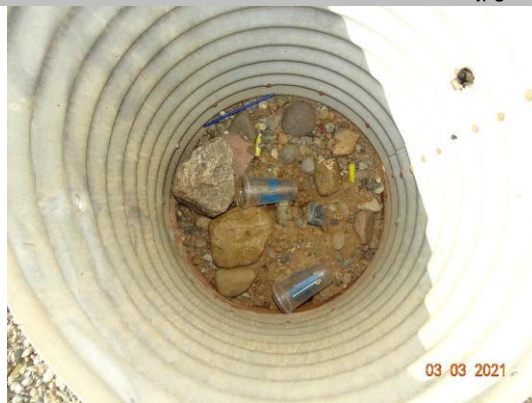
Photo 3 of 3 : UCIP\_SP\_2022\_67138\_99083.jpg

Overview of Levee: View inside of CMP riser. Siphon breaker buried in soil

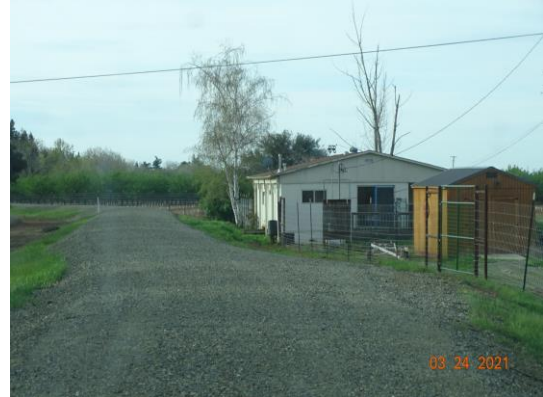
Photo 1 of 1 : SP\_2022\_MA0005\_197\_25\_20220307\_00006.jpg

LM Start	14.33	Rating **	U	Issue No.	25
LM End	14.33	Issue Type +	En	Location *	LS
Category	Earthen Levee			GPS Latitude/Longitude	
				Start	End
Item	Encroachments			39.691580 °	39.691580 °
				-121.779254 °	-121.779254 °
DWR ID	DWR_MA0005_02_s_2012_25				
Comment Code					
BU : Building					
Inspector Comment					
There are unpermitted structures at this location.

View of the buildings at the landside toe. Spring 2021.

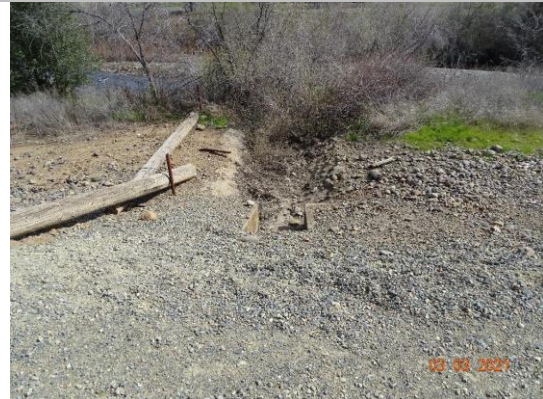
Photo 1 of 3 : UCIP\_SP\_2022\_67139\_99087.jpg

FS\_ID:67139  
DS\_ID:1682  
EP\_NO: N/A  
Repair Type: Urgent  
Crossing Status: Found  
UCIP Comments: 03/03/2021 Record updated from No Action Needed to Urgent. Debris inside the pipe blocks flap gate from complete closing that is posing flood risk to landside. Debris needs to be cleared for proper operation. No permit has been identified authorizing pipe. DMP internal video inspection has not found pipe integrity issues. LOF of crossing is less or equal to 4.0. Recommend next video inspection in 5 years. (O.Yakimov - DWR UCIP)  
05/23/2019 (O. Magana - DWR UCIP)05/18/2017 Crossing appears to be in good condition. Pipe has been selected to be internally cleaned and inspected as part of the DMP project. (A. Freitag - DWR Sutter Yard)11/14/2016 Crossing appears to be in good condition. (A. Freitag - DWR Sutter Yard)05/11/2016 Crossing appears to be in good condition. (A. Freitag - DWR Sutter Yard)08/03/2015 Crossing appears in good condition. No noticeable issues to report. (A. Freitag - DWR Sutter Yard)11/25/2014 Same as last inspection. (A. Freitag - DWR Sutter Yard)06/04/2014 Same as last inspection. (A. Freitag - DWR Sutter Yard)11/13/2013 Same as last inspection. (A. Freitag - DWR Sutter Yard)06/06/2013 Same as last inspection. (A. Freitag - DWR Sutter Yard)

Water-Side: View of levee slope looking from crown

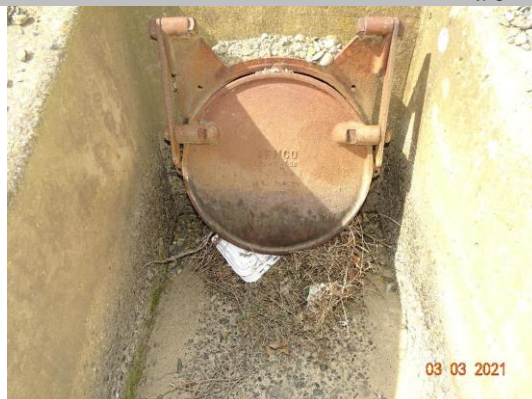
Photo 2 of 3 : UCIP\_SP\_2022\_67139\_99088.jpg

Water-Side: U-shaped headwall, flap gate on pipe end. Clearing of debris in pipe is required

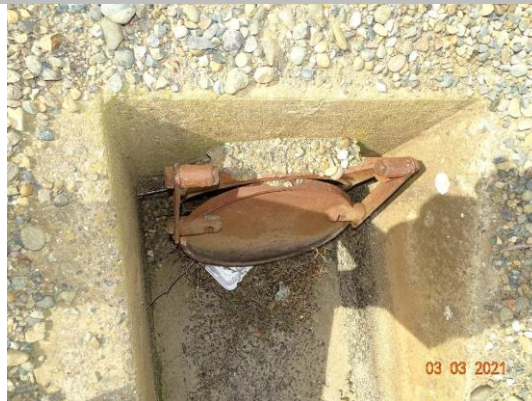
Photo 3 of 3 : UCIP\_SP\_2022\_67139\_99904.jpg

Water-Side: Flap gate not properly closed due to debris inside pipe

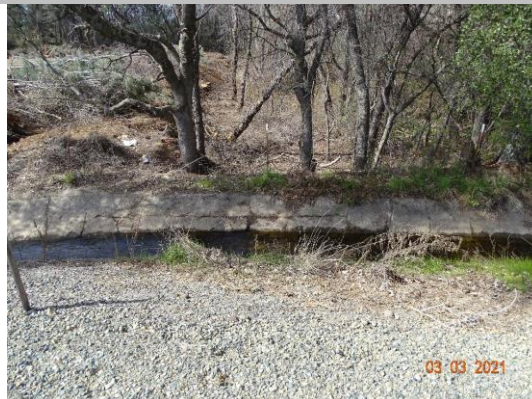
Photo 1 of 3 : UCIP\_SP\_2022\_67140\_99090.jpg

FS\_ID:67140  
DS\_ID:1683  
EP\_NO: N/A  
Repair Type: Non-Urgent  
Crossing Status: Found  
UCIP Comments: 03/03/2021 Record remains Non-Urgent. This crossing has been CIPP lined, new flap gate installed on waterside end. No permit has been identified authorizing pipe. (O.Yakimov - DWR UCIP)  
05/18/2017 WS appears to be in good condition. LS inlet is across a ditch and inaccessible for inspection due to dense vegetation and being down a very steep slope. Pipe has been selected to be internally cleaned and inspected as part of the DMP project. (A. Freitag - DWR Sutter Yard)11/14/2016 Crossing appears to be in good condition. (A. Freitag - DWR Sutter Yard)05/11/2016 Crossing appears to be in good condition. (A. Freitag - DWR Sutter Yard)08/03/2015 Crossing appears in good condition. No noticeable issues to report. (A. Freitag - DWR Sutter Yard)11/25/2014 Same as last inspection. (A. Freitag - DWR Sutter Yard)06/04/2014 Same as last inspection. (A. Freitag - DWR Sutter Yard)11/13/2013 Same as last inspection. (A. Freitag - DWR Sutter Yard)06/06/2013 Same as last inspection. (A. Freitag - DWR Sutter Yard)

Land-Side: View of levee slope looking from crown

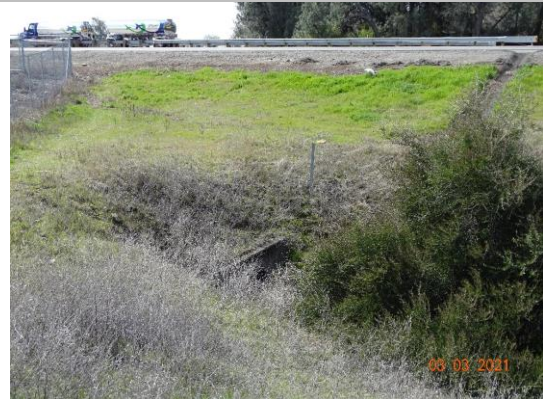
Photo 2 of 3 : UCIP\_SP\_2022\_67141\_99094.jpg

Land-Side: Headwall and pipe inlet at drainage ditch

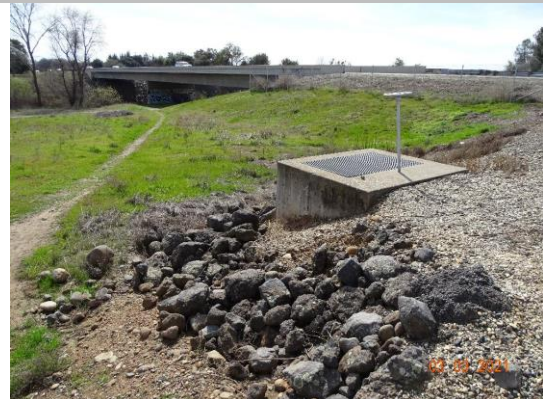
Photo 3 of 3 : UCIP\_SP\_2022\_67141\_99095.jpg

Water-Side: View of levee slope looking from crown. Concrete box with slide gate on levee shoulder

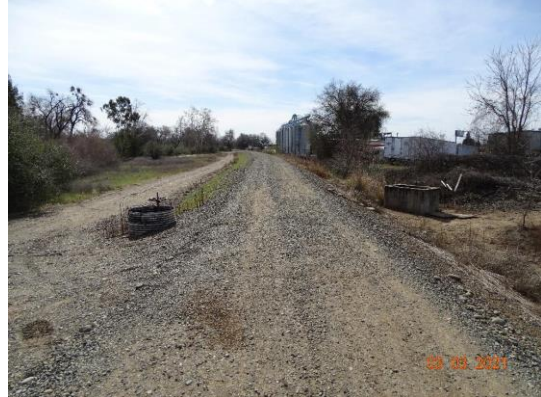
Photo 1 of 3 : UCIP\_SP\_2022\_67142\_99098.jpg

Comment Code						
Inspector Comment						
FS_ID:67142 DS_ID:1685 EP_NO: N/A Repair Type: Non-Urgent Crossing Status: Found UCIP Comments: 03/03/2021 Record remains Non-Urgent. Geophysical study indicates possible presence of pipe through levee. No permit has been identified authorizing pipe. Pipe crossing levee at angle. (O.Yakimov - DWR UCIP) 05/18/2017 Crossing appears to be in good condition. WS riser needs a cover. (A. Freitag - DWR Sutter Yard)11/14/2016 Good condition- needs a cover for the riser. (A. Freitag - DWR Sutter Yard)05/11/2016 Needs a cover for riser. The rest of the crossing appears to be in good condition. (A. Freitag - DWR Sutter Yard)08/03/2015 Crossing appears in good condition but needs a cover made for the riser. (A. Freitag - DWR Sutter Yard)11/25/2014 Same as last inspection. (A. Freitag - DWR Sutter Yard)06/04/2014 Same as last inspection. (A. Freitag - DWR Sutter Yard)11/13/2013 Same as last inspection. (A. Freitag - DWR Sutter Yard)06/06/2013 Same as last inspection. (A. Freitag - DWR Sutter Yard) FIELD_STRUCT_DESC: 42-inch steel irrigation pipe (siphon) through the levee, 10 feet below the crown. Slide gate in a 54-inch corrugated metal riser on the waterside (WS) slope. 5-foot by 8-foot concrete distribution box on the landside (LS). Two corrugated metal cutoff walls installed within the levee. [Additional Reference(s): DWR Levee Log, 1990 (HLM 15.22). USACE Sacramento O&M Manual, Unit 516, April 1960, Revised 3 February 2011, (Station 8+30), listed as 42-inch pipe]. FS Date: 3/3/2021 3:20:29 PM

Top of Levee: View of levee crown looking downstream

LM Start	15.00	Rating **	M	Issue No.	82 (cont)
LM End	15.00	Issue Type +	En	Location *	
Category	Supplemental		GPS Latitude/Longitude		
			Start	End	
Item	DWR UCIP Field Study		39.700903 °	39.700903 °	
			-121.779039 °	-121.779039 °	
DWR ID	1685

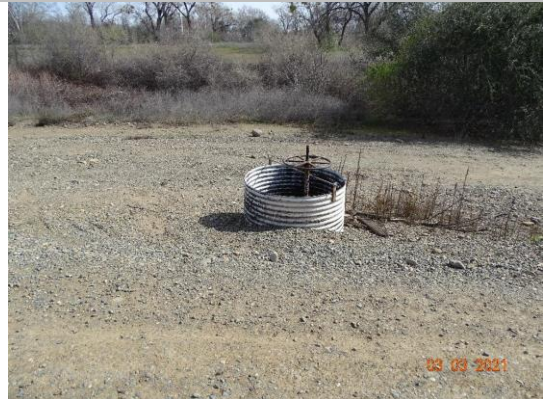
Photo 2 of 3 : UCIP\_SP\_2022\_67142\_99099.jpg

Water-Side: View of levee slope looking from crown. CMP riser with slide gate on levee slope

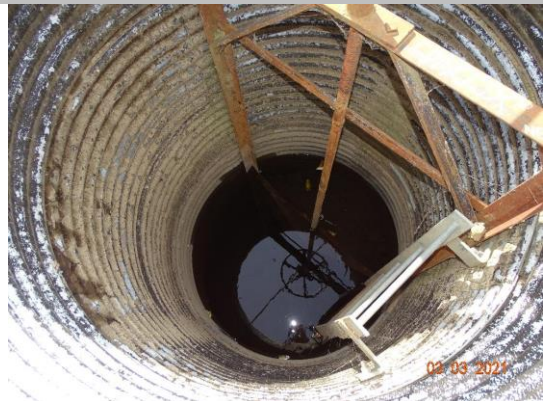
Photo 3 of 3 : UCIP\_SP\_2022\_67142\_99102.jpg

Water-Side: View inside of CMP riser

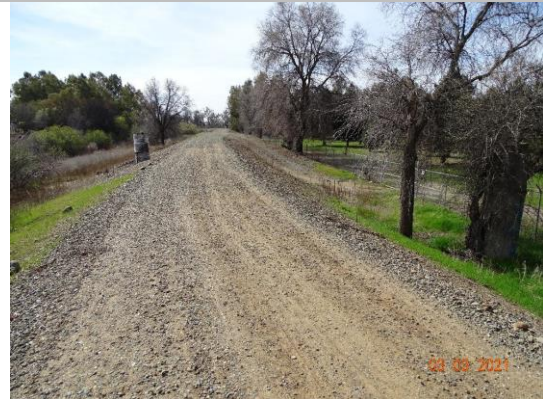
Photo 1 of 3 : UCIP\_SP\_2022\_67143\_99103.jpg

Comment Code						
Inspector Comment						
FS_ID:67143 DS_ID:1686 EP_NO: N/A Repair Type: Urgent Crossing Status: Found UCIP Comments: 03/03/2021 Record updated from Non-Urgent to Urgent. Slide gate in CMP riser on waterside shoulder is in open position. Slide gate stem is bent inside riser. Concrete standpipe on landside slope is in unsound condition. Top concrete ring shifted creating a gap. Crossing appears abandoned. Pipe crossing levee at sharp angle. No permit has been identified authorizing pipe. (O.Yakimov - DWR UCIP) 05/18/2017 Only WS and LS standpipes visible. (A. Freitag - DWR Sutter Yard)11/14/2016 Still only WS standpipe visible. (A. Freitag - DWR Sutter Yard)05/11/2016 Only WS standpipe was visible. (A. Freitag - DWR Sutter Yard)08/03/2015 Only able to locate the standpipe on the WS. (A. Freitag - DWR Sutter Yard)11/25/2014 Same as last inspection. (A. Freitag - DWR Sutter Yard)06/04/2014 Same as last inspection. (A. Freitag - DWR Sutter Yard)11/13/2013 Same as last inspection. (A. Freitag - DWR Sutter Yard)06/06/2013 Same as last inspection. (A. Freitag - DWR Sutter Yard) FIELD_STRUCT_DESC: 12-inch steel irrigation pipe (siphon) through the levee, 10 feet below the crown. Slide gate in a 36-inch corrugated metal riser on the waterside (WS) slope. 30-inch concrete standpipe at the landside (LS) toe. [Additional Reference(s): DWR Levee Log, 1990 (HLM 15.48). USACE Sacramento O&M Manual, Unit 516, April 1960, Revised 3 February 2011, (Station 145+53), listed as 12-inch pipe] FS Date: 3/3/2021 3:24:19 PM

Top of Levee: View of levee crown looking downstream

LM Start	<b>15.26</b>	Rating **	U	Issue No.	<b>83 (cont)</b>
LM End	<b>15.26</b>	Issue Type +	En	Location *	
Category	Supplemental		GPS Latitude/Longitude		
			Start	End	
Item	DWR UCIP Field Study		39.704409 °	39.704409 °	
			-121.777803 °	-121.777803 °	
DWR ID	1686

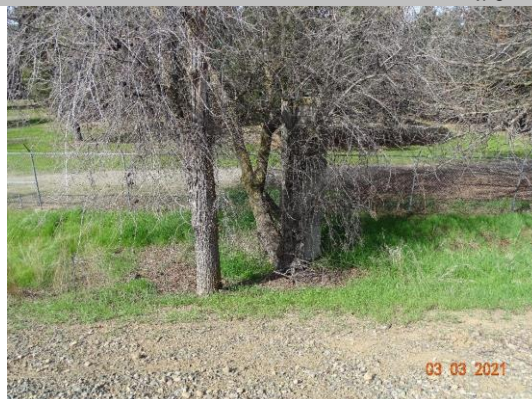
Photo 2 of 3 : UCIP\_SP\_2022\_67143\_99104.jpg

Land-Side: View of levee slope looking from crown. Concrete standpipe at levee toe

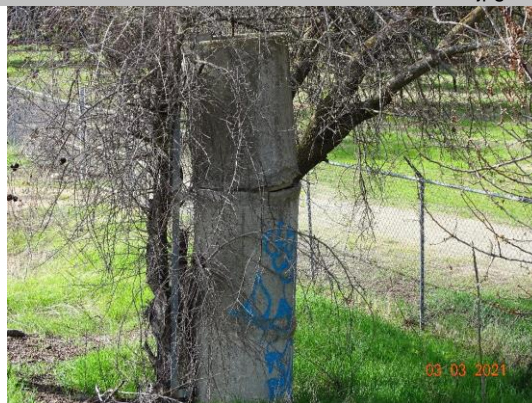
Photo 3 of 3 : UCIP\_SP\_2022\_67143\_99107.jpg

Land-Side: View of concrete standpipe. Gap is visible between top and middle concrete rings

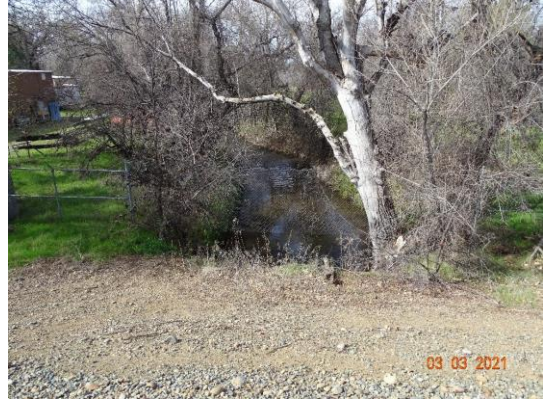
Photo 2 of 3 : UCIP\_SP\_2022\_67144\_99110.jpg

Water-Side: View of levee slope looking from crown

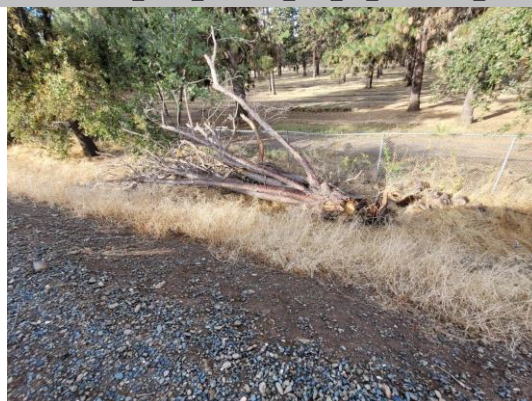
Photo 1 of 1 : SP\_2022\_MA0005\_197\_86\_20220307\_00015.jpg

LM Start	15.54	Rating **	M	Issue No.	86
LM End	15.54	Issue Type +	Ma	Location *	LS
Category	Earthen Levee			GPS Latitude/Longitude	
				Start	End
Item	Encroachments			39.708537 °	39.708537 °
				-121.777722 °	-121.777722 °
DWR ID	DWR_MA0005_02_f_2021_86				
Comment Code					
TR : Tree or limb					
Inspector Comment					
Remove downed tree at the landside toe.

View of the downed tree on the landside, Fall 2021.

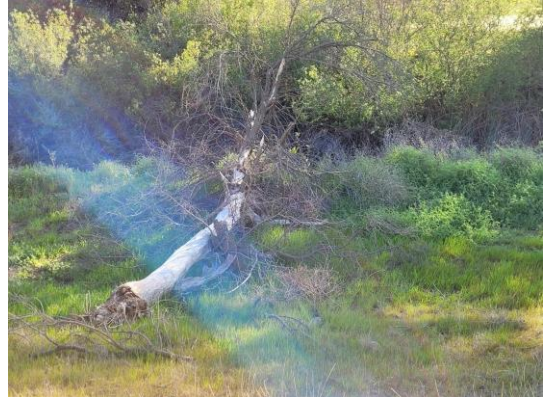
Photo 1 of 1 : SP\_2022\_MA0005\_197\_87\_20220328\_00190.jpg

LM Start	15.69	Rating **	M	Issue No.	87
LM End	15.69	Issue Type +	Ma	Location *	WS
Category	Earthen Levee			GPS Latitude/Longitude	
				Start	End
Item	Encroachments			39.710733 °	39.710733 °
				-121.777836 °	-121.777836 °
DWR ID	DWR_MA0005_02_s _ 2022_87				
Comment Code					
TR : Tree or limb					
Inspector Comment

View of a fallen tree at the waterside toe. Spring 2022.

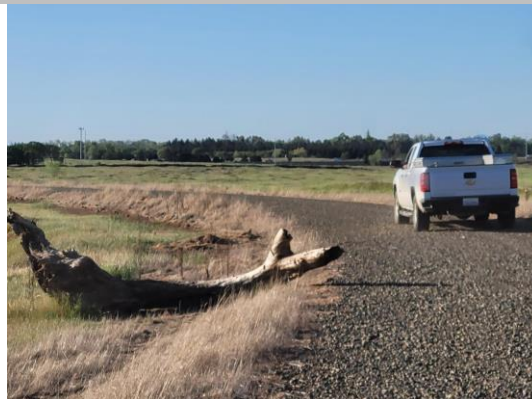
Photo 1 of 1 : SP\_2022\_MA0005\_198\_2\_20220328\_00005.jpg

LM Start	0.62	Rating **	M	Issue No.	2
LM End	0.62	Issue Type +	Ma	Location *	WS
Category	Earthen Levee			GPS Latitude/Longitude	
				Start	End
Item	Encroachments			39.725185 °	39.725185 °
				-121.781575 °	-121.781575 °
DWR ID	DWR_MA0005_03_s_2021_2				
Comment Code					
TR : Tree or limb					
Inspector Comment

View of the tree limb on the waterside slope. Spring 2022.

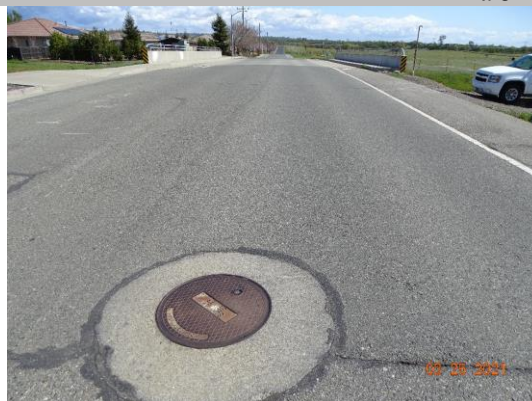
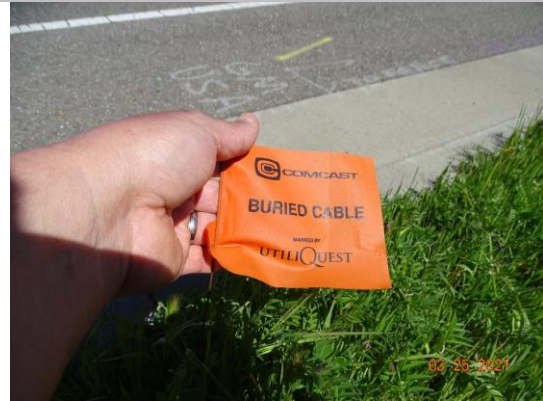
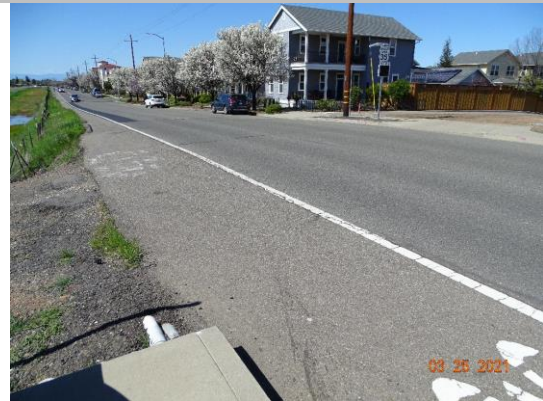
UCIP Comments: 03/25/2021 Record remains Non-Urgent. No permit has been found authorizing these conduits through the levee.

FIELD\_STRUCT\_DESC: Multiple PVC conduits (three 3-inch PVC, one 4-inch PVC, two spare 4-inch PVC) imbedded in bridge under walkway on south side of E 20th Street appear to be in single trench through the levee at unknown depth. Buried cable flag located east of bridge shows Comcast as an owner. Permit authorizing conduit installation not found, Permit No. 17798, 2005 - Jerry Tucker authorizing construction of bridge seems to be related to these crossings.

LM Start	0.70	Rating **	M	Issue No.	1 (cont)	
LM End	0.70	Issue Type +	En	Location *		
Category	Supplemental			GPS Latitude/Longitude		
				Start		End
Item	DWR UCIP Field Study			39.726234 °	39.726234 °	
				-121.781465 °	-121.781465 °	
DWR ID	25668
