**Flood Control Project Maintenance
Levee Inspections
LMA District Cover Sheet**

**Flood Control Project Maintenance
Levee Inspections
Unit Cover Sheet**

Waterway			Bank	Unit Miles
Unit No. 01 Butte Creek			Left	15.08
	Spring (March - May)	Summer (June - August)	(September - November) Fall	Winter (December - February)
Unit Maintenance Rating (Fall Only)				
Date of Inspection	4/26/2023 - 4/26/2023			
DWR Inspector	Makar Sokol			
Accompanied By	Shawn Freitag DWR Sutter Yard

Levee Inspection Report By Mile - Spring 2023

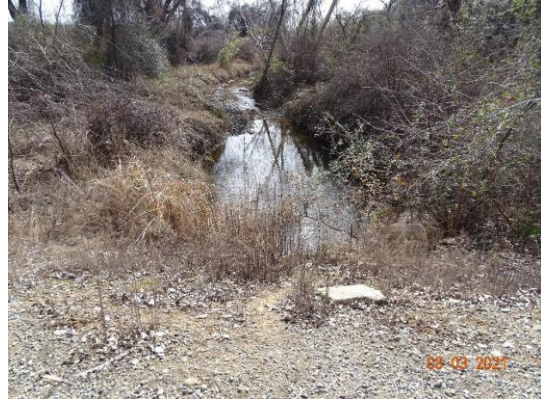
Photo 2 of 3 : UCIP_SP_2023_64542_96649.jpg

Land-Side: View landside from crown

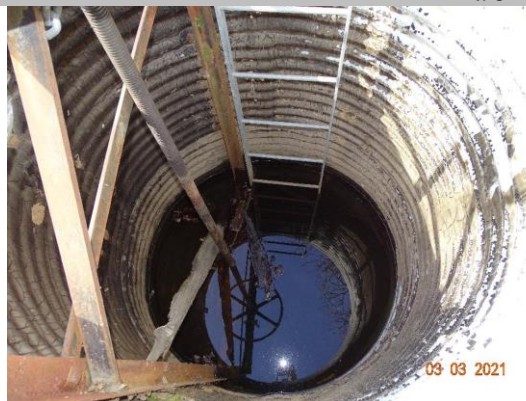
Photo 2 of 3 : UCIP_SP_2023_64543_96656.jpg

Water-Side: View of slide gate in CMP riser

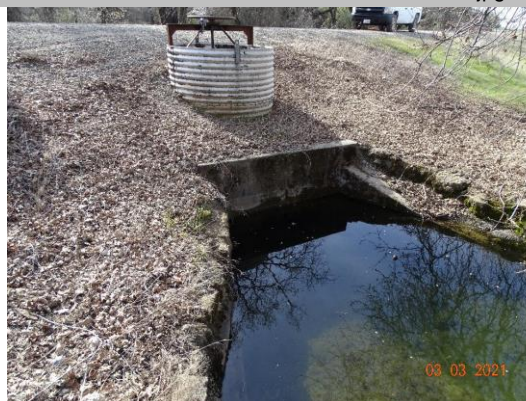
Photo 3 of 3 : UCIP_SP_2023_64543_96657.jpg

Water-Side: Headwall and pipe end on waterside

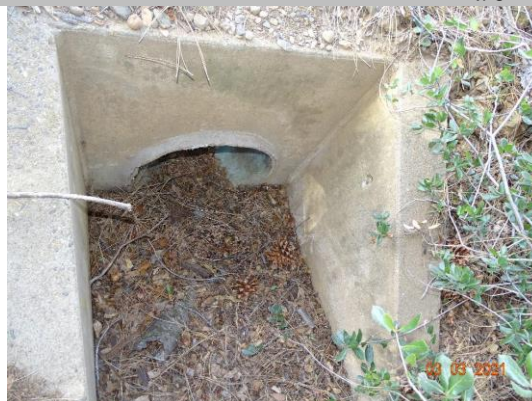
Photo 2 of 3 : UCIP_SP_2023_64548_96682.jpg

Land-Side: Pipe inlet and headwall at levee toe

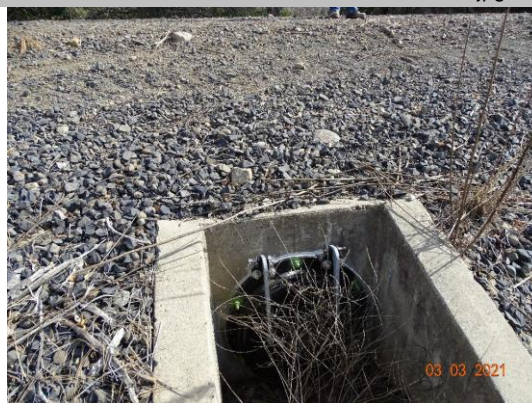
Photo 3 of 3 : UCIP_SP_2023_64548_96683.jpg

Water-Side: Headwall and flap gate on levee slope

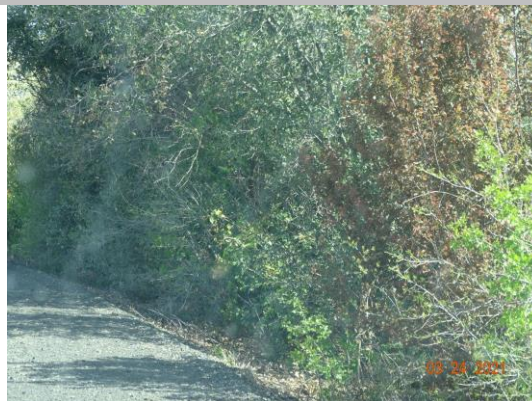
Photo 1 of 1 : SP_2023_MA0005_196_32_20230417_00007.jpg

LM Start	0.58	Rating **	M	Issue No.	32
LM End	0.68	Issue Type +	En	Location *	LS
Category	Earthen Levee			GPS Latitude/Longitude	
				Start	End
Item	Vegetation			39.690496°	39.689137°
				-121.777109°	-121.776938°
DWR ID	DWR_MA0005_01_s_2014_32				
Comment Code					
V6 : Landscaping					
Inspector Comment

View of the trees along the landside toe blocking visibility. Spring 2021.

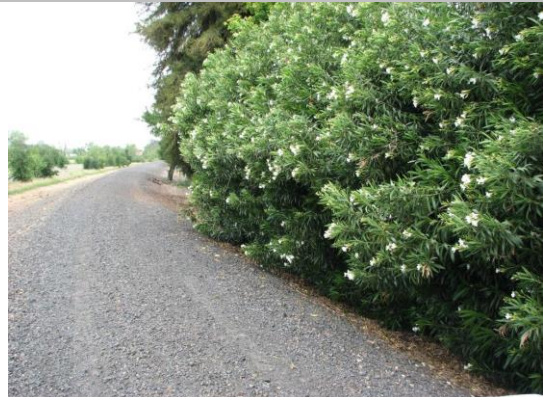
Photo 1 of 1 : SP_2023_MA0005_196_44_20230417_00012.jpg

LM Start	0.68	Rating **	M	Issue No.	44
LM End	0.77	Issue Type +	En	Location *	LS
Category	Earthen Levee			GPS Latitude/Longitude	
				Start	End
Item	Vegetation			39.689135°	39.687968°
				-121.776929°	-121.777387°
DWR ID	DWR_MA0005_01_s_2016_44				
Comment Code					
V6 : Landscaping					
Inspector Comment

View of oleanders along the landside toe.

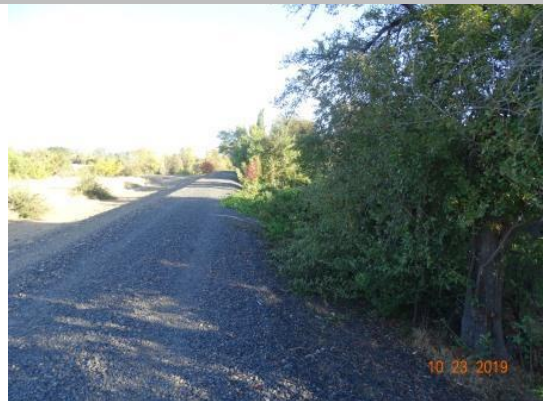
Photo 1 of 1 : SP_2023_MA0005_196_47_20230417_00013.jpg

LM Start	0.79	Rating **	M	Issue No.	47
LM End	0.82	Issue Type +	En	Location *	LS
Category	Earthen Levee			GPS Latitude/Longitude	
				Start	End
Item	Vegetation			39.687676°	39.687193°
				-121.777419°	-121.777461°
DWR ID	DWR_MA0005_01_f_2019_47				
Comment Code					
V6 : Landscaping					
Inspector Comment

View of trees that require trimming along the landside slope. Fall 2019.

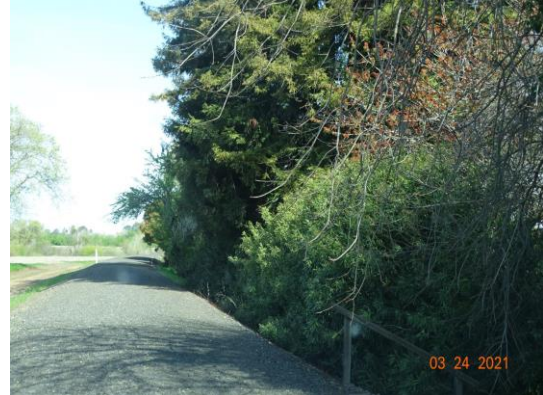
Photo 1 of 1 : SP_2023_MA0005_196_50_20230417_00015.jpg

LM Start	0.98	Rating **	U	Issue No.	50
LM End	1.00	Issue Type +	En	Location *	LS
Category	Earthen Levee			GPS Latitude/Longitude	
				Start	End
Item	Vegetation			39.684843 °	39.684606 °
				-121.777132 °	-121.776975 °
DWR ID	DWR_MA0005_01_f _ 2016_50				
Comment Code					
V6 : Landscaping					
Inspector Comment					
Oleanders are blocking visibility.

View of the landscaping along the landside toe. Spring 2021.

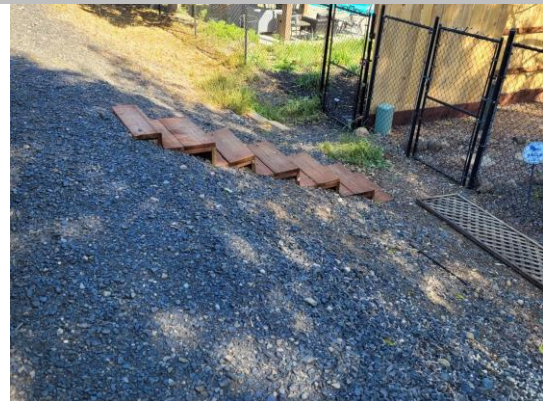
Photo 1 of 1 : SP_2023_MA0005_196_87_20230417_00019.jpg

LM Start	1.02	Rating **	M	Issue No.	87
LM End	1.02	Issue Type +	En	Location *	LS
Category	Earthen Levee			GPS Latitude/Longitude	
				Start	End
Item	Encroachments			39.684334°	39.684334°
				-121.776814°	-121.776814°
DWR ID	DWR_MA0005_01_s_2022_87				
Comment Code					
ST : Stairway					
Inspector Comment

View of the stairway on the landside slope. Spring 2023.

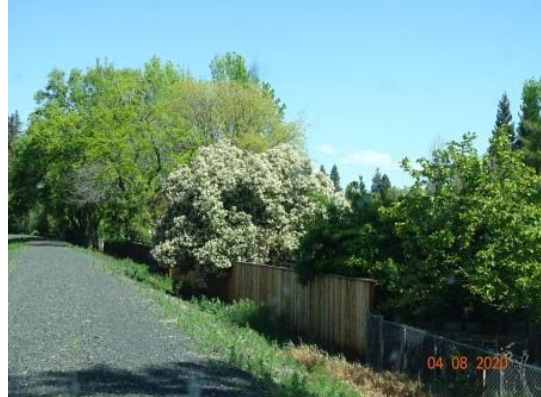
Photo 1 of 1 : SP_2023_MA0005_196_41_20230417_00010.jpg

LM Start	1.30	Rating **	U	Issue No.	41
LM End	1.36	Issue Type +	En	Location *	LS
Category	Earthen Levee			GPS Latitude/Longitude	
				Start	End
Item	Encroachments			39.680452°	39.679551°
				-121.776667°	-121.776904°
DWR ID	DWR_MA0005_01_s_2016_41				
Comment Code					
FE : Fence					
Inspector Comment					
Wood plank fencing across multiple properties.

View of the fence along the landside toe. Spring 2020.

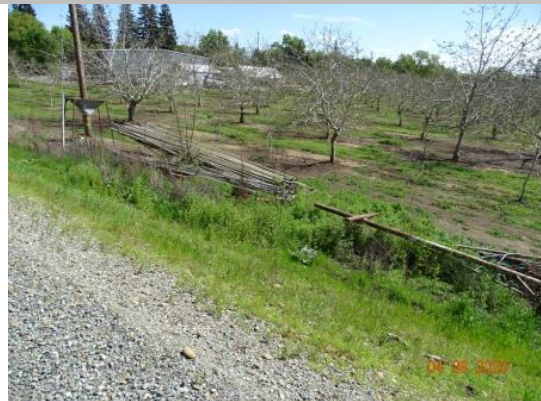
Photo 1 of 1 : SP_2023_MA0005_196_30_20230417_00006.jpg

LM Start	1.53	Rating **	M	Issue No.	30
LM End	1.53	Issue Type +	En	Location *	LS
Category	Earthen Levee			GPS Latitude/Longitude	
				Start	End
Item	Encroachments			39.677130°	39.677130°
				-121.777583°	-121.777583°
DWR ID	DWR_MA0005_01_f_2014_30				
Comment Code					
MA : Material					
Inspector Comment

View of the sprinkler pipe and equipment along the landside toe. Spring 2020.

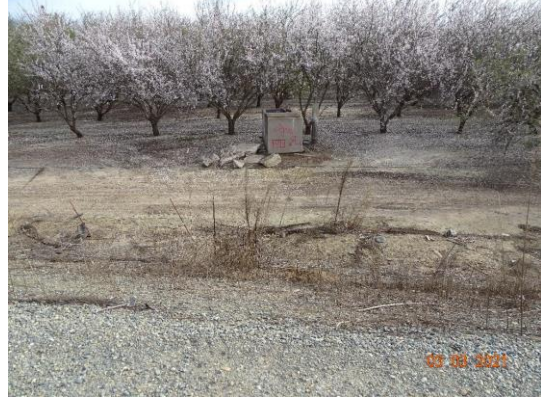
Photo 2 of 3 : UCIP_SP_2023_65178_97385.jpg

Land-Side: View of levee slope looking from crown

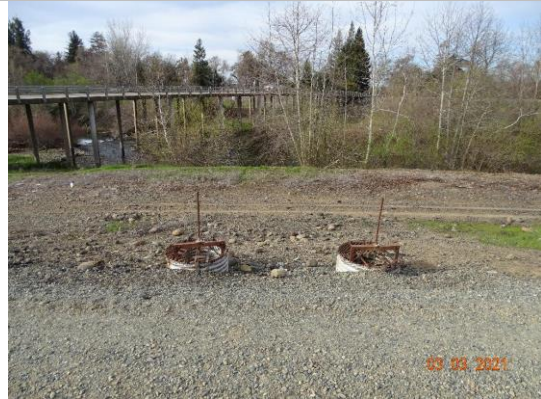
Photo 3 of 3 : UCIP_SP_2023_65178_97386.jpg

Water-Side: View of levee slope looking from crown

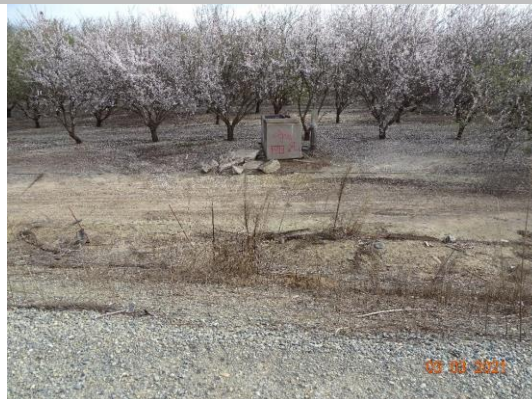
Photo 2 of 3 : UCIP_SP_2023_65180_97394.jpg

Land-Side: View of levee slope looking from crown

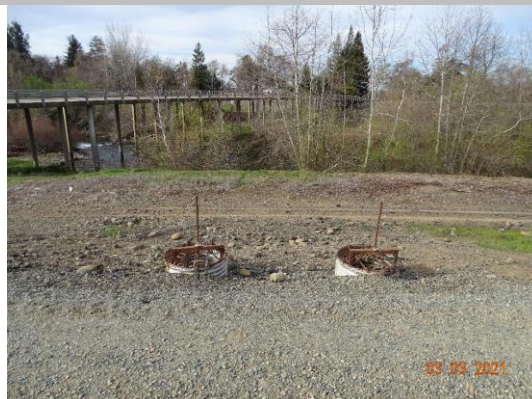
Photo 3 of 3 : UCIP_SP_2023_65180_97390.jpg

Water-Side: View of levee slope looking from crown

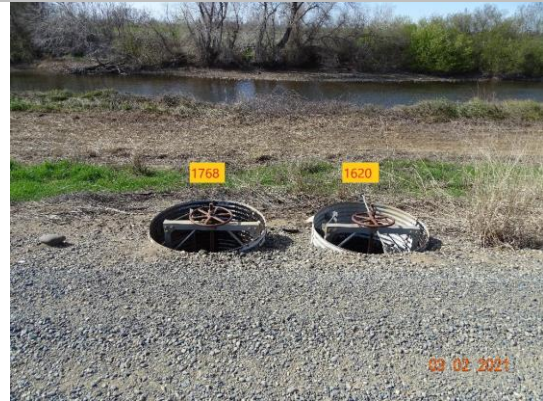
Photo 2 of 3 : UCIP_SP_2023_65267_97443.jpg

Water-Side: View of levee slope looking from crown

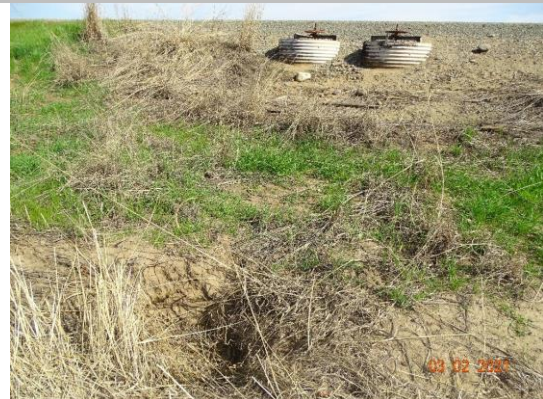
Photo 3 of 3 : UCIP_SP_2023_65271_97453.jpg

DS_ID:1768
FS_ID:65271
EP_NO: N/A
Repair Type: Urgent
EVAL Issue: 2b, Levee Integrity
Crossing Status: Found
UCIP Comments: 03/02/2021 Record updated from Non-Urgent to Urgent. Sinkhole 4-feet in diameter and 2-feet deep located at waterside toe in pipe alignment. Missing CMP cover on waterside slope - possible fall hazard. No permit has been identified authorizing pipe. Slide gate in CMP riser closed, crossing doesn't look abandoned. (O.Yakimov - DWR UCIP)
05/23/2019 (O. Magana - DWR UCIP)05/15/2017 Abandoned and needs to be done properly. A sink hole formed in the WS toe road and revealed the location of the WS pipe end. Sink hole will need to be repaired before the next high water season but the pipe has been selected to be internally cleaned and camera inspected as part of the DMP project so it will have needed to be excavated along the WS end anyways. (A. Freitag - DWR Sutter Yard)11/15/2016 Abandoned. Needs standpipe cover. (A. Freitag - DWR Sutter Yard)05/09/2016 Abandoned pipe. Needs a cover for standpipe. (A. Freitag - DWR Sutter Yard)08/05/2015 Abandoned pipes. Need covers made for tops of standpipes to prevent falls. (A. Freitag - DWR Sutter Yard)

Water-Side: View of levee slope and sinkhole in pipe alignment

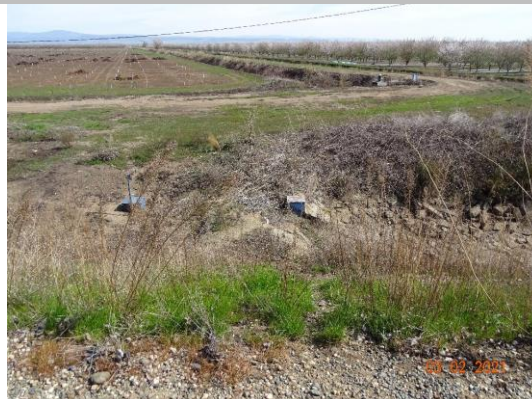
Photo 2 of 3 : UCIP_SP_2023_65315_97467.jpg

Land-Side: View of levee slope looking from crown

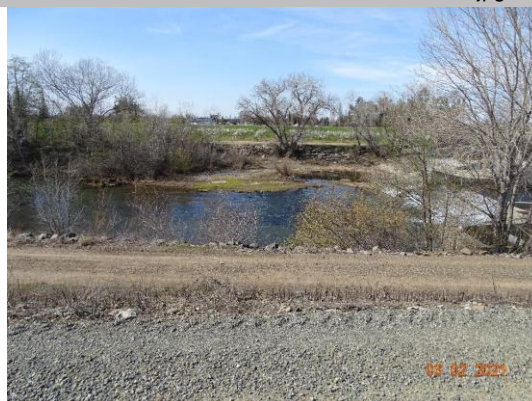
Photo 3 of 3 : UCIP_SP_2023_65315_97468.jpg

Water-Side: View of levee slope looking from crown

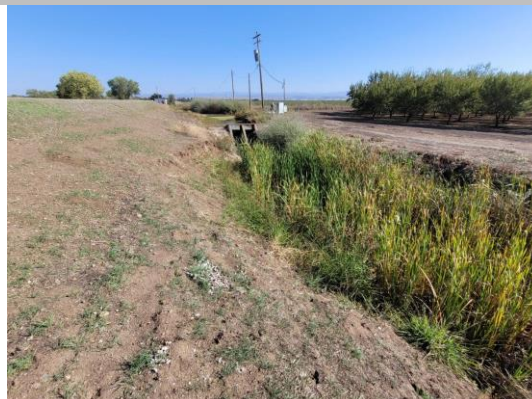
Photo 1 of 1 : SP_2023_MA0005_196_56_20230417_00017.jpg

LM Start	5.81	Rating **	U	Issue No.	56
LM End	5.81	Issue Type +	Ma	Location *	LS
Category	Earthen Levee			GPS Latitude/Longitude	
				Start	End
Item	Erosion / Bank Caving			39.621261°	39.621261°
				-121.773973°	-121.773973°
DWR ID	DWR_MA0005_01_f_2016_56				
Comment Code					
E2 : Schedule repair of erosion site prior to the next inspection.					
Inspector Comment

View of the erosion at the landside toe. Fall 2022.

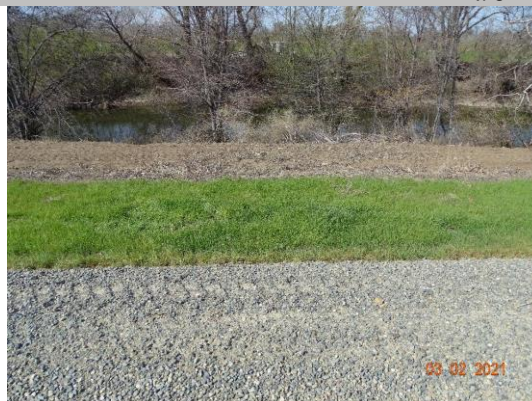
Photo 2 of 3 : UCIP_SP_2023_65433_97533.jpg

Water-Side: View of levee slope looking from crown

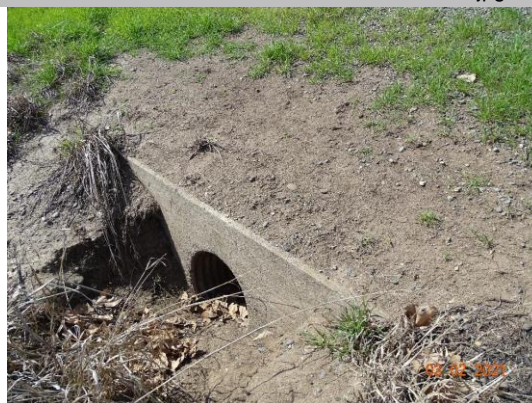
Photo 3 of 3 : UCIP_SP_2023_65433_97534.jpg

Land-Side: Exposed headwall and pipe inlet at landside toe

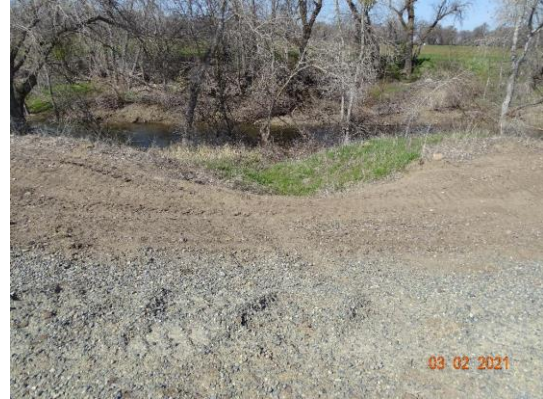
Photo 2 of 3 : UCIP_SP_2023_65470_97557.jpg

Water-Side: View of levee slope looking from crown

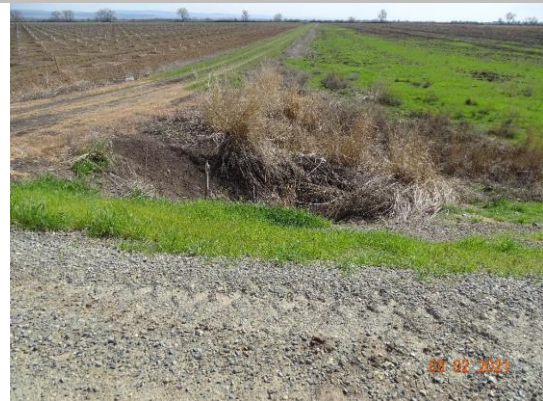
Photo 3 of 3 : UCIP_SP_2023_65470_97556.jpg

Land-Side: View of levee slope looking from crown

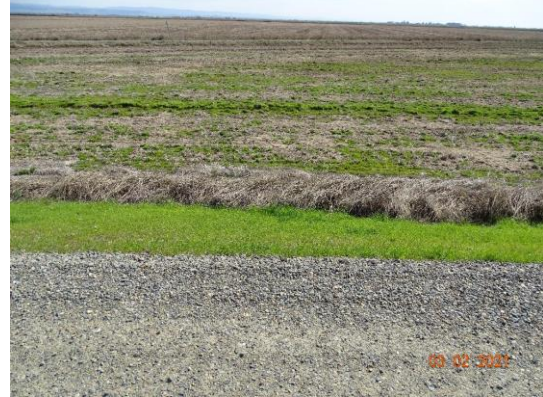
Photo 2 of 3 : UCIP_SP_2023_65495_97571.jpg

Land-Side: View of levee slope looking from crown

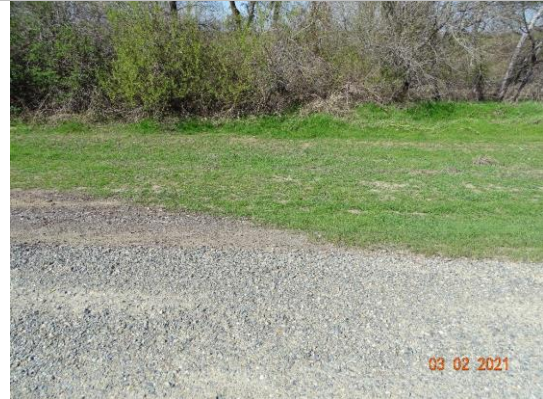
Photo 3 of 3 : UCIP_SP_2023_65495_97572.jpg

Water-Side: View of levee slope looking from crown

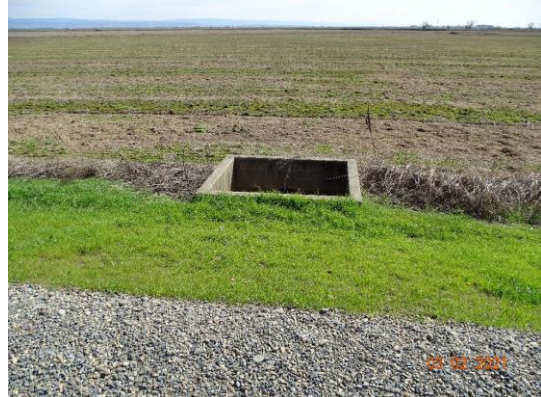
Photo 1 of 3 : UCIP_SP_2023_65744_98029.jpg

Comment Code					
Inspector Comment					
DS_ID:1631 FS_ID:65744 EP_NO: N/A Repair Type: Urgent EVAL Issue: 1, Pipe Integrity Crossing Status: Found UCIP Comments: 03/02/2021 Record updated from Non-Urgent to Urgent. Crossing appears abandoned. DMP internal video inspection has found pipe integrity issues. LOF of crossing is between 5 and 6. Crossing will be monitored until funding becomes available to address the issues. Pipe and pipe appurtenances are not found on waterside. Missing slide gate in concrete distribution box at landside toe. The box is open at ground level, recommend installing a cover for trip and fall protection. No permit has been identified authorizing pipe. (O.Yakimov - DWR UCIP) 05/16/2017 Abandoned and needs to be done so properly. (A. Freitag - DWR Sutter Yard)11/15/2016 Abandoned. (A. Freitag - DWR Sutter Yard)05/11/2016 Abandoned pipe. (A. Freitag - DWR Sutter Yard) 08/04/2015 Abandoned pipe. Casey Wilder has started the steps to have the pipe properly abandoned and removed from the levee. (A. Freitag - DWR Sutter Yard)12/08/2014 Same as last inspection. (A. Freitag - DWR Sutter Yard)06/11/2014 Same as last inspection. (A. Freitag - DWR Sutter Yard)11/19/2013 Same as last inspection. (A. Freitag - DWR Sutter Yard)05/29/2013 Same as last inspection. (A. Freitag - DWR Sutter Yard)10/30/2012 Need to confirm proper abandonment of pipe. Pipe should be plugged on LS. (W. Wylie - DWR UCIP) FIELD_STRUCT_DESC: 16-inch steel irrigation pipe through the levee, 11.5 feet below the crown. Pump located on the waterside (WS). Distribution box at the landside (LS) toe. [Additional Reference(s): DWR Levee Log, 1990 (HLM 9.21). USACE Sacramento O&M Manual, Unit 515, April 1955, Revised 28 December 2010, (Station 655+68), listed as 16-inch pipe. USACE As-Built Drawing No. 50-04-2637, Sheet 3, Station 655+68.2, 7 January 1953]. FS Date: 3/2/2021 6:58:11 AM

Land-Side: View of levee slope looking from crown. Distribution box at levee toe needs a cover

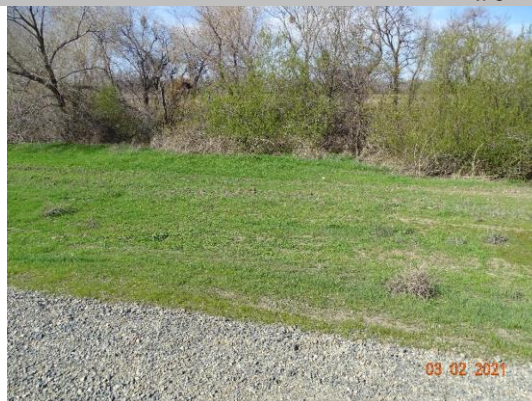
Photo 2 of 3 : UCIP_SP_2023_65744_98030.jpg

Water-Side: View of levee slope looking from crown. Pipe not found

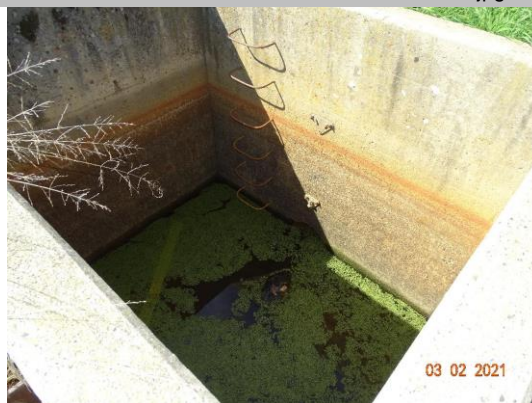
Photo 3 of 3 : UCIP_SP_2023_65744_98032.jpg

Land-Side: Overview of concrete distribution box. Missing slide gate from levee side

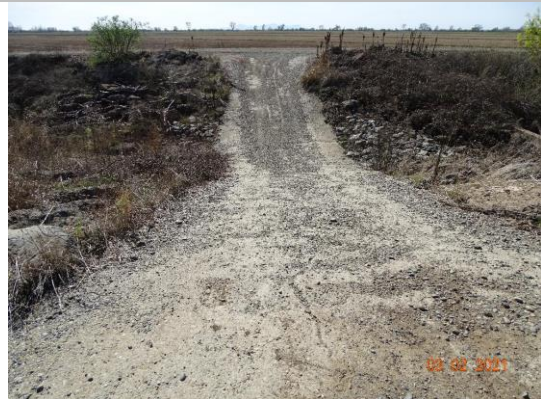
Photo 1 of 3 : UCIP_SP_2023_65745_98033.jpg

Comment Code						
Inspector Comment						
DS_ID:1775 FS_ID:65745 EP_NO: N/A Repair Type: Non-Urgent EVAL Issue: Crossing Status: Found UCIP Comments: 03/02/2021 Record updated from No Action Needed to Non-Urgent. No permit has been identified authorizing pipe. This pipe penetrates channel crossing constructed at elevation lower than levee. (O.Yakimov - DWR UCIP) 05/16/2017 Crossing appears to be in good condition. (A. Freitag - DWR Sutter Yard)11/15/2016 Crossing appears to be in good condition. (A. Freitag - DWR Sutter Yard)05/11/2016 Crossing appears to be in good condition. (A. Freitag - DWR Sutter Yard)08/04/2015 Crossing is in good condition. No noticeable issues to report. (A. Freitag - DWR Sutter Yard)12/08/2014 Same as last inspection. (A. Freitag - DWR Sutter Yard)06/11/2014 Same as last inspection. (A. Freitag - DWR Sutter Yard)11/19/2013 Same as last inspection. (A. Freitag - DWR Sutter Yard)05/29/2013 Flap gates were removed by DWR Sutter Maintenance Yard to allow water to flow freely through crossing and not back up in ditch. (A. Freitag - DWR Sutter Yard)10/30/2012 Seems there should be flap gates on this structure. (W. Wylie - DWR UCIP) FIELD_STRUCT_DESC: [Robert's Creek Outlet Structure] 1 of 4: 66-inch corrugated metal drainage pipe through the levee, 17.9 feet below the crown. Concrete headwalls on the landside (LS) and the waterside (WS). Flap gate located on the WS. [Additional Reference(s): DWR Levee Log, 1990 (HLM 9.66). USACE Sacramento O&M Manual, Unit 515, April 1955, Revised 28 December 2010, (Station 678+00), listed as 66-inch pipe. USACE As-Built Drawing No. 50-04-2637, Sheet 3, Station 678+00, 7 January 1953]. FS Date: 3/2/2021 8:28:51 AM

View of channel crossing looking perpendicular to Butte Creek

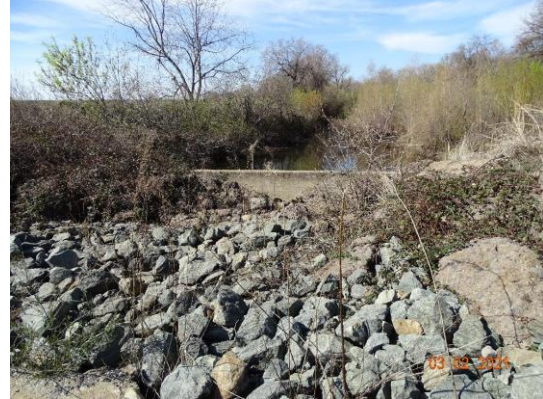
Photo 2 of 3 : UCIP_SP_2023_65745_98034.jpg

View of Butte Creek looking downstream

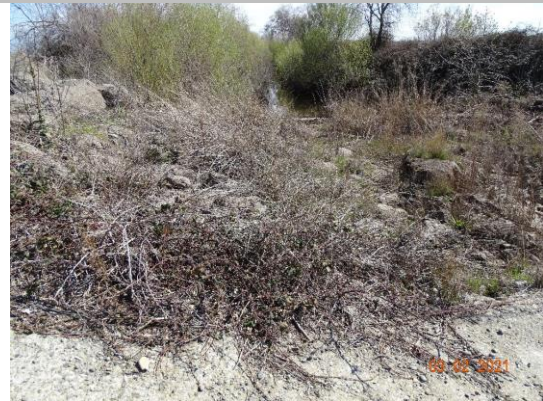
Photo 3 of 3 : UCIP_SP_2023_65745_98035.jpg

View of Butte Creek looking upstream

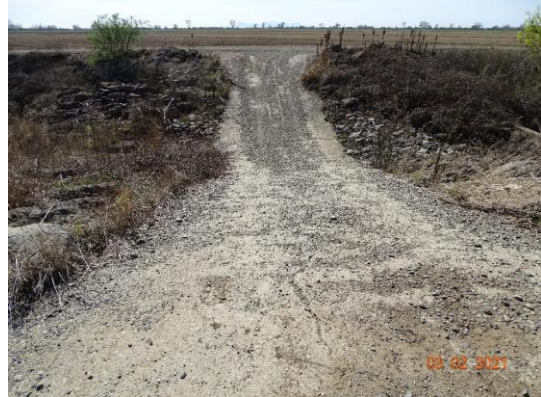
Photo 1 of 3 : UCIP_SP_2023_65746_98039.jpg

Comment Code						
Inspector Comment						
DS_ID:1774 FS_ID:65746 EP_NO: N/A Repair Type: Non-Urgent EVAL Issue: Crossing Status: Found UCIP Comments: 03/02/2021 Record updated from No Action Needed to Non-Urgent. No permit has been identified authorizing pipe. This pipe penetrates channel crossing constructed at elevation lower than levee. (O.Yakimov - DWR UCIP) 5/16/2017 Crossing appears to be in good condition. (DWR Sutter Yard- AFreitag)11/15/2016 Crossing appears to be in good condition. (DWR Sutter Yard- AFreitag)5/11/2016 Crossing appears to be in good condition.8/4/2015 Crossing is in good condition. No noticeable issues to report.12/8/2014 Same as last inspection.6/11/2014 Same as last inspection.11/19/2013 Same as last inspection.5/29/2013 Flap gates were removed by DWR Sutter Maintenance Yard to allow water to flow freely through crossing and not back up in ditch.10/30/2012 Seems there should be flap gates on this structure. FIELD_STRUCT_DESC: [Robert's Creek Outlet Structure] 2 of 4: 66-inch corrugated metal drainage pipe through the levee, 17.9 feet below the crown. Concrete headwalls on the landside (LS) and the waterside (WS). Flap gate located on the WS. [Additional Reference(s): DWR Levee Log, 1990 (HLM 9.66). USACE Sacramento O&M Manual, Unit 515, April 1955, Revised 28 December 2010, (Station 678+00), listed as 66-inch pipe. USACE As-Built Drawing No. 50-04-2637, Sheet 3, Station 678+00, 7 January 1953]. FS Date: 3/2/2021 8:49:57 AM

View of channel crossing looking perpendicular to Butte Creek

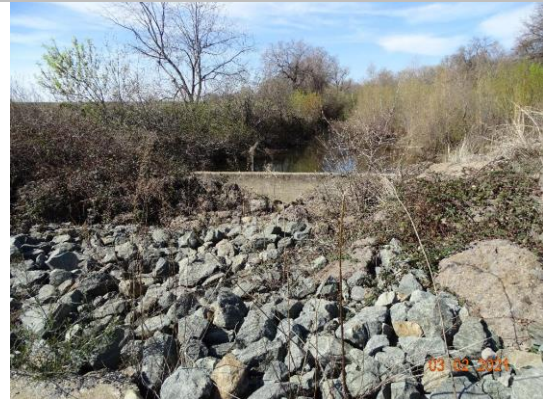
Photo 2 of 3 : UCIP_SP_2023_65746_98040.jpg

View of Butte Creek looking downstream

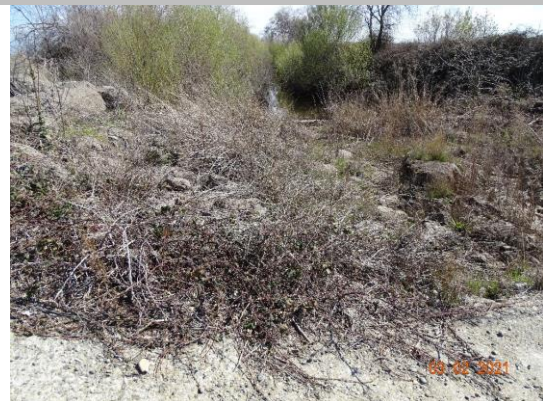
Photo 3 of 3 : UCIP_SP_2023_65746_98041.jpg

View of Butte Creek looking upstream

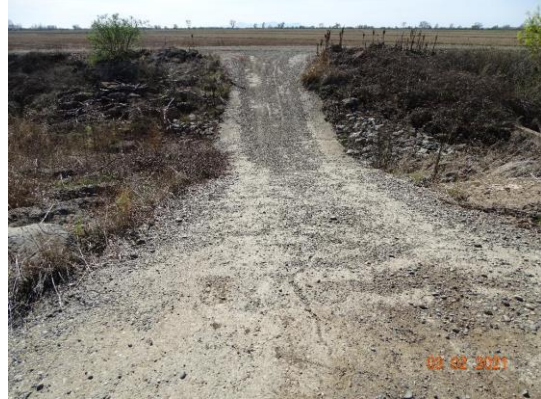
Photo 1 of 3 : UCIP_SP_2023_65747_98045.jpg

Comment Code					
Inspector Comment					
DS_ID:1632 FS_ID:65747 EP_NO: N/A Repair Type: Non-Urgent EVAL Issue: Crossing Status: Found UCIP Comments: 03/02/2021 Record updated from No Action Needed to Non-Urgent. No permit has been identified authorizing pipe. This pipe penetrates channel crossing constructed at elevation lower than levee. (O.Yakimov - DWR UCIP) 5/16/2017 Crossing appears to be in good condition. (DWR Sutter Yard- AFreitag)11/15/2016 Crossing appears to be in good condition. (DWR Sutter Yard- AFreitag)5/11/2016 Crossing appears to be in good condition.8/4/2015 Crossing appears in good condition. No noticeable issues to report.12/8/2014 Same as last inspection.6/11/2014 Same as last inspection.11/19/2013 Same as last inspection.5/29/2013 Flap gates were removed by DWR Sutter Maintenance Yard to allow water to flow freely through crossing and not back up in ditch.10/30/2012 Seems there should be flap gates on this structure. FIELD_STRUCT_DESC: [Robert's Creek Outlet Structure] 3 of 4: 66-inch corrugated metal drainage pipe through the levee, 17.9 feet below the crown. Concrete headwalls on the landside (LS) and the waterside (WS). Flap gate located on the WS. [Additional Reference(s): DWR Levee Log, 1990 (HLM 9.66). USACE Sacramento O&M Manual, Unit 515, April 1955, Revised 28 December 2010, (Station 678+00), listed as 66-inch pipe. USACE As-Built Drawing No. 50-04-2637, Sheet 3, Station 678+00, 7 January 1953]. FS Date: 3/2/2021 8:51:11 AM

View of channel crossing looking perpendicular to Butte Creek

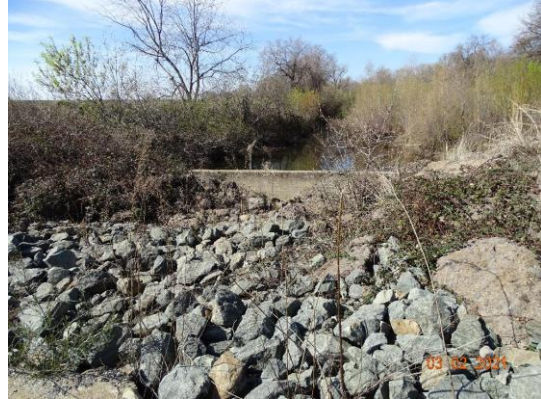
Photo 2 of 3 : UCIP_SP_2023_65747_98046.jpg

View of Butte Creek looking downstream

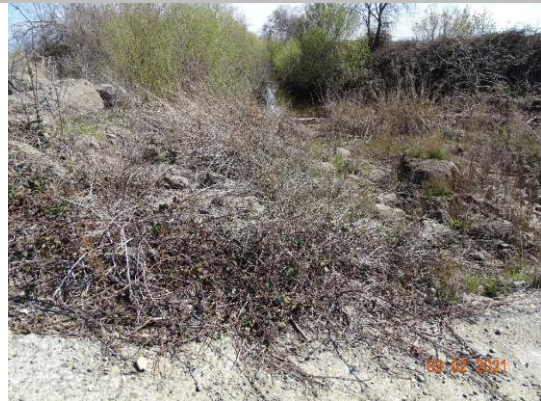
Photo 3 of 3 : UCIP_SP_2023_65747_98047.jpg

View of Butte Creek looking upstream

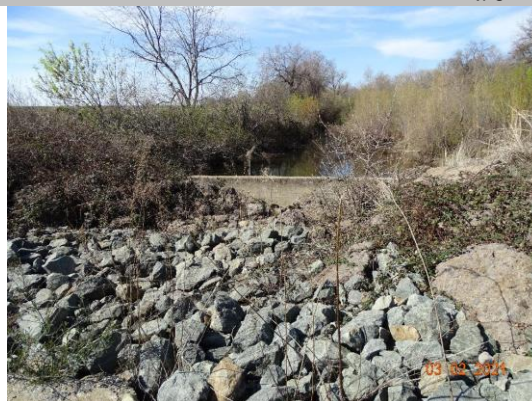
Photo 2 of 3 : UCIP_SP_2023_65748_98052.jpg

View of Butte Creek looking downstream

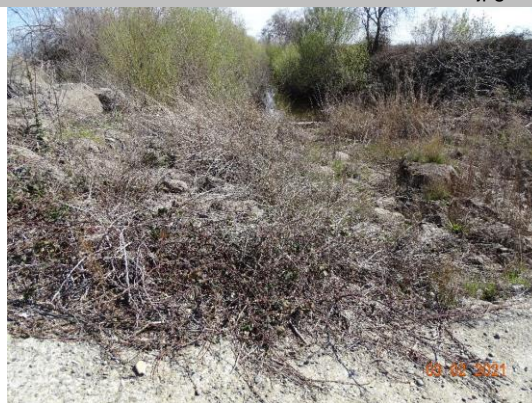
Photo 3 of 3 : UCIP_SP_2023_65748_98053.jpg

View of Butte Creek looking upstream

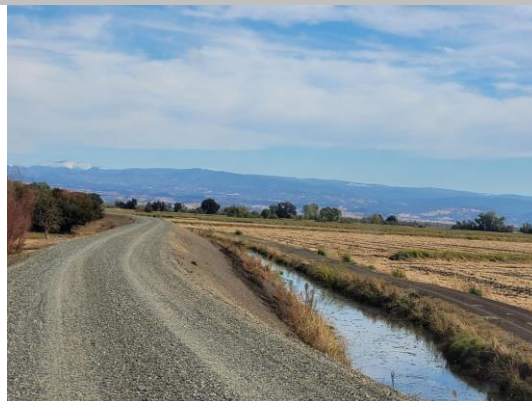
Photo 1 of 1 : SP_2023_MA0005_196_5_20230417_00002.jpg

LM Start	9.54	Rating **	M	Issue No.	5
LM End	10.33	Issue Type +	En	Location *	LS
Category	Earthen Levee			GPS Latitude/Longitude	
				Start	End
Item	Encroachments			39.574837°	39.567892°
				-121.807913°	-121.819283°
DWR ID	DWR_MA0005_01_s_2012_5				
Comment Code					
DT : Ditch					
Inspector Comment

View of the agricultural ditch along the landside toe. Fall 2021.

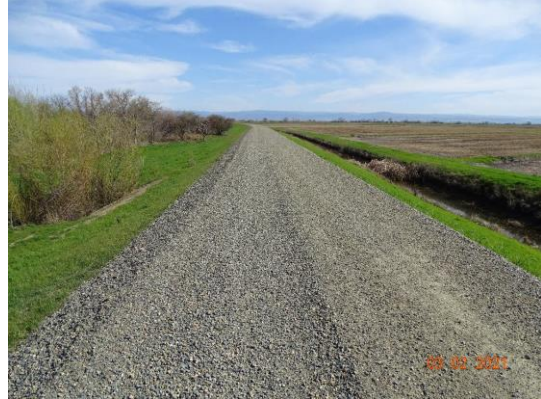
Photo 1 of 3 : UCIP_SP_2023_65750_98061.jpg

Comment Code					
Inspector Comment					
DS_ID:1634 FS_ID:65750 EP_NO: N/A Repair Type: Non-Urgent EVAL Issue: 5, Pipe Damage Crossing Status: Found UCIP Comments: 03/02/2021 Record remains Non-Urgent. DMP internal video inspection has found pipe integrity issues. LOF of crossing is between 4.1 and 5. Crossing will be monitored until funding becomes available for rehabilitation. Crossing appears abandoned. Headwall and slide gate on waterside buried in soil. Vegetation and debris clearing needed at landside pipe end. No permit has been identified authorizing pipe. (O.Yakimov - DWR UCIP) 5/16/2017 Abandoned- needs to be done so properly. Pipe has been selected to be internally cleaned and inspected as part of the DMP project. (DWR Sutter Yard- AFreitag)11/15/2016 Abandoned. (DWR Sutter Yard- AFreitag)5/11/2016 Abandoned crossing.8/4/2015 Abandoned pipe. Casey Wilder has started the steps to have the pipe properly abandoned and removed from the levee.12/8/2014 Same as last inspection.6/11/2014 Same as last inspection.11/19/2013 Same as last inspection.5/29/2013 Same as last inspection. FIELD_STRUCT_DESC: 24-inch corrugated metal irrigation pipe through the levee, 14.5 feet below the crown. Slide gate on the waterside (WS) on concrete headwall. Flap gate on the landside (LS). [Additional Reference(s): DWR Levee Log, 1990 (HLM 10.41). USACE Sacramento O&M Manual, Unit 515, April 1955, Revised 28 December 2010, (Station 717+50), listed as 24-inch pipe. USACE As-Built Drawing No. 50-04-2637, Sheet 4, Station 717+50, 7 January 1953]. FS Date: 3/2/2021 9:47:39 AM

Top of Levee: View of levee crown looking upstream

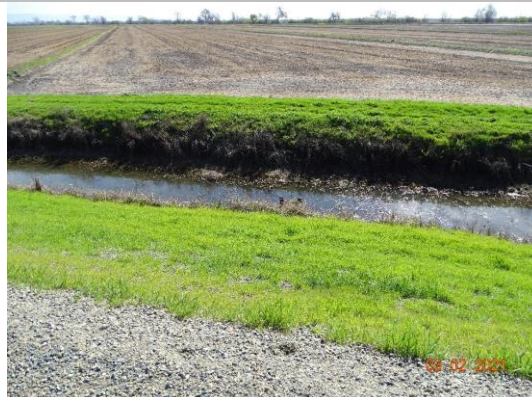
Photo 2 of 3 : UCIP_SP_2023_65750_98062.jpg

Land-Side: View of levee slope looking from crown

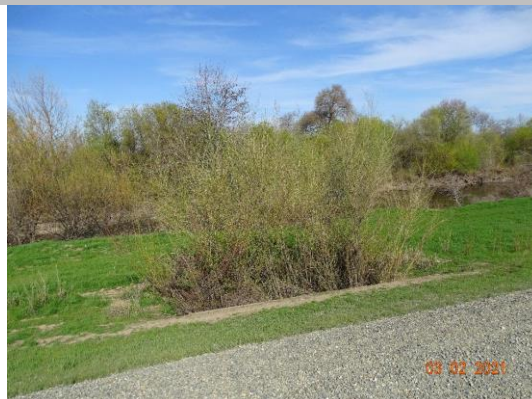
Photo 3 of 3 : UCIP_SP_2023_65750_98063.jpg

Water-Side: View of levee slope looking from crown

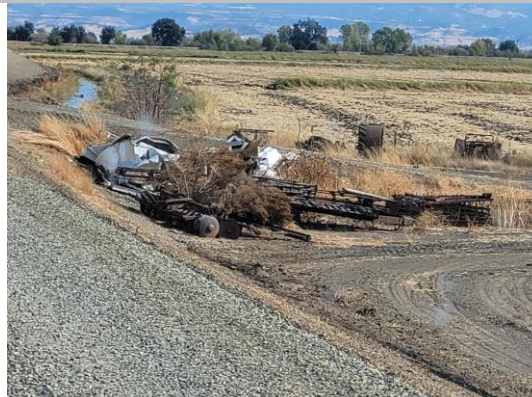
Photo 1 of 1 : SP_2023_MA0005_196_26_20230417_00005.jpg

View of the farm equipment at the landside toe. Fall 2021.

LM Start	10.37	Rating **	M	Issue No.	26
LM End	10.37	Issue Type +	En	Location *	LS
Category	Earthen Levee			GPS Latitude/Longitude	
				Start	End
Item	Encroachments			39.567541 °	39.567541 °
				-121.819786 °	-121.819786 °
DWR ID	DWR_MA0005_01_s_2016_26				
Comment Code					
EQ : Equipment					
Inspector Comment					
Farm equipment should be removed from the landside toe.

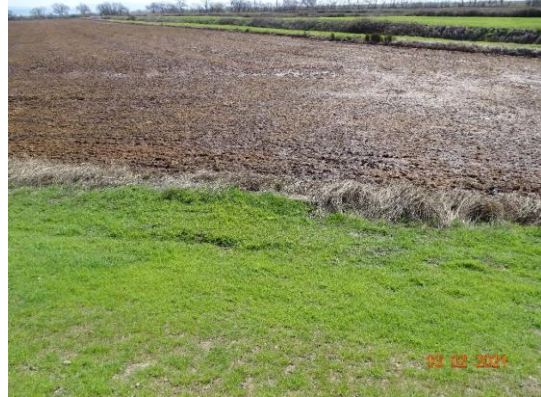
Photo 1 of 3 : UCIP_SP_2023_65751_98068.jpg

Comment Code						
Inspector Comment						
DS_ID:1635 FS_ID:65751 EP_NO: N/A Repair Type: Non-Urgent EVAL Issue: Crossing Status: Found UCIP Comments: 03/02/2021 Record remains Non-Urgent. Crossing appears abandoned. Pipe not found on waterside. Concrete headwall and pipe inlet are buried in soil at landside levee toe. Geophysical study indicates possible presence of pipe through levee. Owner needs to coordinate with the CVFPB to remove or abandon crossing according to Title 23 requirements. No permit has been identified authorizing pipe. (O.Yakimov - DWR UCIP) 5/16/2017 Abandoned- needs to be done so properly. (DWR Sutter Yard- A Freitag)11/15/2016 Abandoned. (DWR Sutter Yard- A Freitag)5/11/2016 Abandoned crossing.8/4/2015 Abandoned pipe. Casey Wilder has started the steps to have the pipe properly abandoned and removed from the levee.12/8/2014 Same as last inspection.6/11/2014 Same as last inspection.11/19/2013 Same as last inspection.5/29/2013 Same as last inspection.10/30/2012 Pipe buried on both sides of levee. FIELD_STRUCT_DESC: 30-inch corrugated metal drainage pipe through the levee, 12.2 feet below the crown. Flap gate on the waterside (WS) end. [Additional Reference(s): DWR Levee Log, 1990 (HLM 10.99). USACE Sacramento O&M Manual, Unit 515, April 1955, Revised 28 December 2010, (Station 748+53), listed as 30-inch pipe. USACE As-Built Drawing No. 50-04-2637, Sheet 4, 748+53, 7 January 1953]. FS Date: 3/2/2021 9:59:40 AM

Land-Side: View of levee slope looking from crown

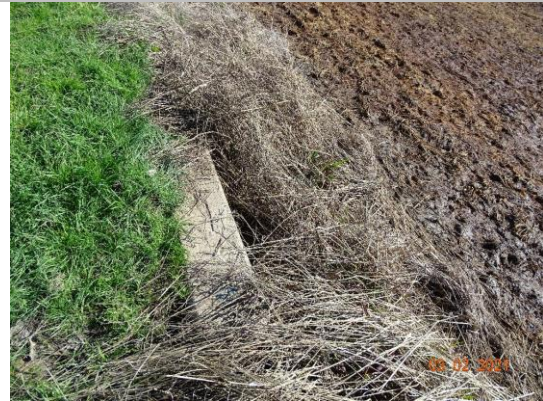
Photo 2 of 3 : UCIP_SP_2023_65751_98070.jpg

Land-Side: Headwall and pipe inlet at levee toe buried in soil

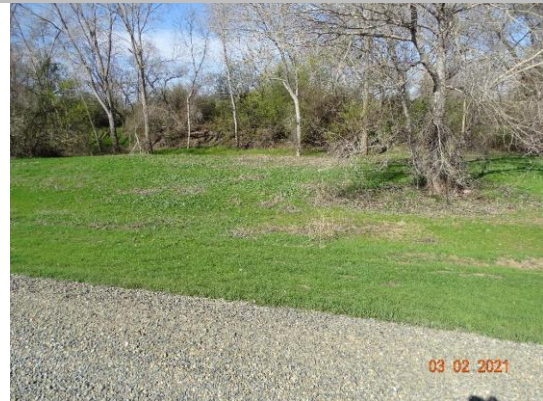
Photo 3 of 3 : UCIP_SP_2023_65751_98069.jpg

Water-Side: View of levee slope looking from crown

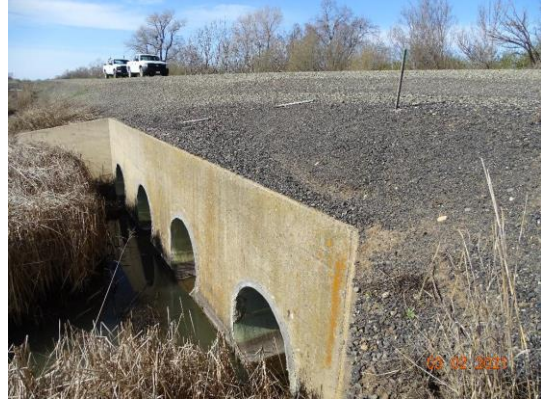
Photo 2 of 3 : UCIP_SP_2023_65802_98105.jpg

Land-Side: Concrete headwall and CIPP-lined pipe

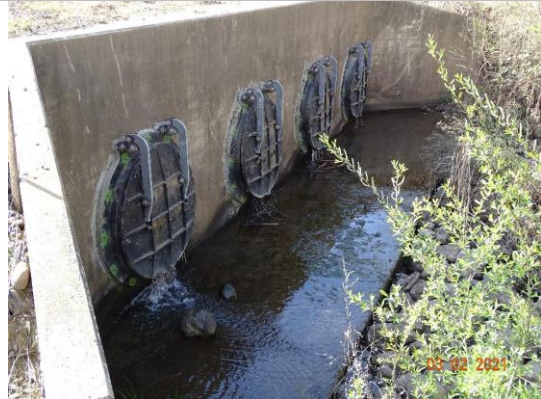
Photo 3 of 3 : UCIP_SP_2023_65802_98104.jpg

Water-Side: Concrete headwall and flap gate on pipe end

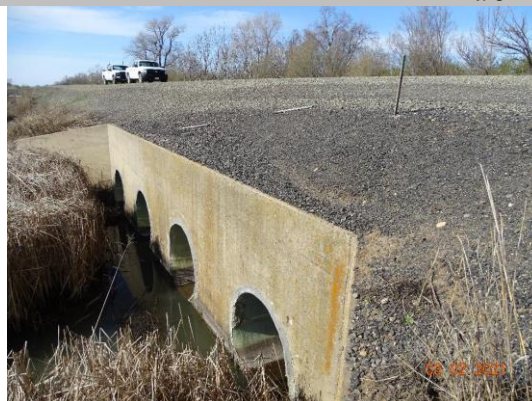
Photo 2 of 3 : UCIP_SP_2023_65803_98110.jpg

Land-Side: Concrete headwall and CIPP-lined pipe

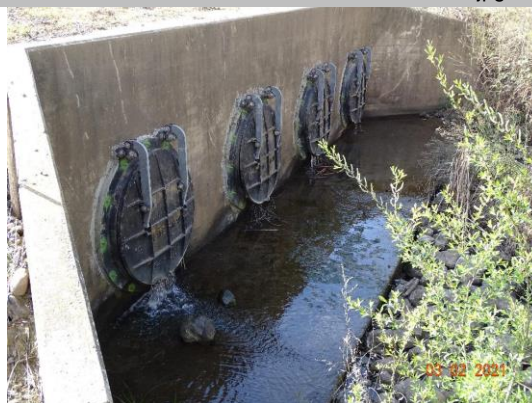
Photo 3 of 3 : UCIP_SP_2023_65803_98109.jpg

Comment Code						
Inspector Comment						
DS_ID:1782 FS_ID:65803 EP_NO: N/A Repair Type: Non-Urgent EVAL Issue: Crossing Status: Found UCIP Comments: 03/02/2021 Record updated from No Action Needed to Non-Urgent. No permit has been identified authorizing pipe. Crossing has been CIPP-lined, new flap gate installed. (O.Yakimov - DWR UCIP) 05/16/2017 Crossing appears to be in good condition. Pipe has been selected to be internally cleaned and inspected as part of the DMP project. (A. Freitag - DWR Sutter Yard)11/15/2016 Crossing appears to be in good condition. (A. Freitag - DWR Sutter Yard)05/11/2016 Crossing appears to be in good condition. (A. Freitag - DWR Sutter Yard)08/04/2015 Crossing appears in good condition. No noticeable issues to report. (A. Freitag - DWR Sutter Yard)06/11/2014 Same as last inspection. (A. Freitag - DWR Sutter Yard)11/19/2013 Same as last inspection. (A. Freitag - DWR Sutter Yard)05/29/2013 Same as last inspection. (A. Freitag - DWR Sutter Yard) FIELD_STRUCT_DESC: 2 of 4: 54-inch CIPP-lined corrugated metal drainage pipe through the levee, 13.5 feet below the crown. Flap gate on the waterside (WS). Concrete headwalls on the landside (LS) and the WS toes. [Additional Reference(s): DWR Levee Log, 1990 (HLM 11.52). USACE Sacramento O&M Manual, Unit 515, April 1955, Revised 28 December 2010, (Station 25+18 'A'), listed as 54-inch pipe. USACE As-Built Drawing No. 50-04-2637, Sheet 4, Station 25+18 'A', 7 January 1953]. FS Date: 3/2/2021 12:00:11 PM

Water-Side: Concrete headwall and flap gate on pipe end

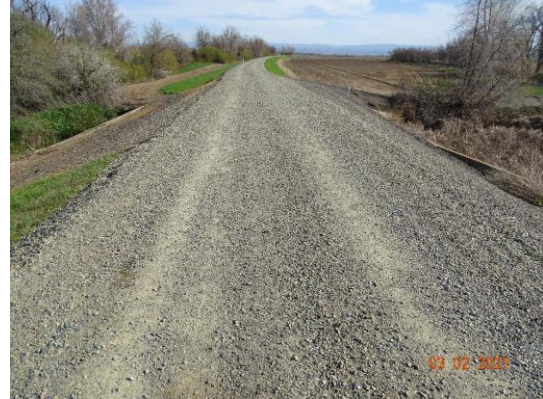
Photo 1 of 3 : UCIP_SP_2023_65804_98111.jpg

Comment Code					
Inspector Comment					
DS_ID:1783 FS_ID:65804 EP_NO: N/A Repair Type: Non-Urgent EVAL Issue: Crossing Status: Found UCIP Comments: 03/02/2021 Record updated from No Action Needed to Non-Urgent. No permit has been identified authorizing pipe. Crossing has been CIPP-lined, new flap gate installed. (O.Yakimov - DWR UCIP) 05/16/2017 Crossing appears to be in good condition. Pipe has been selected to be internally cleaned and inspected as part of the DMP project. (A. Freitag - DWR Sutter Yard)11/15/2016 Crossing appears to be in good condition. (A. Freitag - DWR Sutter Yard)05/11/2016 Crossing appears to be in good condition. (A. Freitag - DWR Sutter Yard)08/04/2015 Crossing appears in good condition. No noticeable issues to report. (A. Freitag - DWR Sutter Yard)06/11/2014 Same as last inspection. (A. Freitag - DWR Sutter Yard)11/19/2013 Same as last inspection. (A. Freitag - DWR Sutter Yard)05/29/2013 Same as last inspection. (A. Freitag - DWR Sutter Yard) FIELD_STRUCT_DESC: 3 of 4: 54-inch CIPP-lined corrugated metal drainage pipe through the levee, 13.5 feet below the crown. Flap gate on the waterside (WS). Concrete headwalls on the landside (LS) and the WS toes. [Additional Reference(s): DWR Levee Log, 1990 (HLM 11.52). USACE Sacramento O&M Manual, Unit 515, April 1955, Revised 28 December 2010, (Station 25+18 'A'), listed as 54-inch pipe. USACE As-Built Drawing No. 50-04-2637, Sheet 4, Station 25+18 'A', 7 January 1953]. FS Date: 3/2/2021 12:01:23 PM

Top of Levee: View of levee crown looking upstream

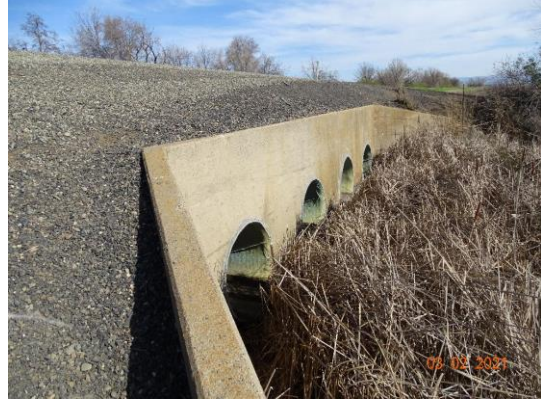
Photo 2 of 3 : UCIP_SP_2023_65804_98115.jpg

LM Start	11.37	Rating **	M	Issue No.	31 (cont)
LM End	11.37	Issue Type +	Ma	Location *	
Category	Supplemental			GPS Latitude/Longitude	
				Start	End
Item	DWR UCIP LMA Responsibility			39.556693 °	39.556693 °
				-121.832119 °	-121.832119 °
DWR ID	1783

Land-Side: Concrete headwall and CIPP-lined pipe

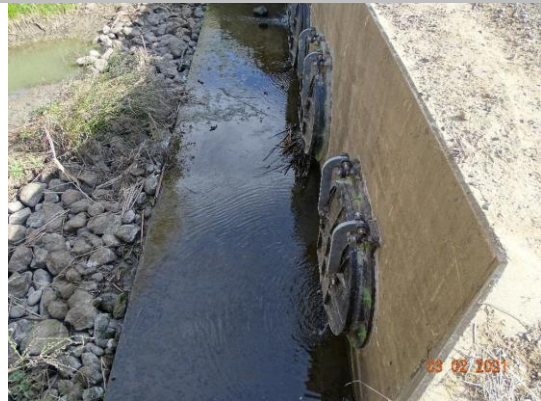
Photo 3 of 3 : UCIP_SP_2023_65804_98114.jpg

Water-Side: Concrete headwall and flap gate on pipe end

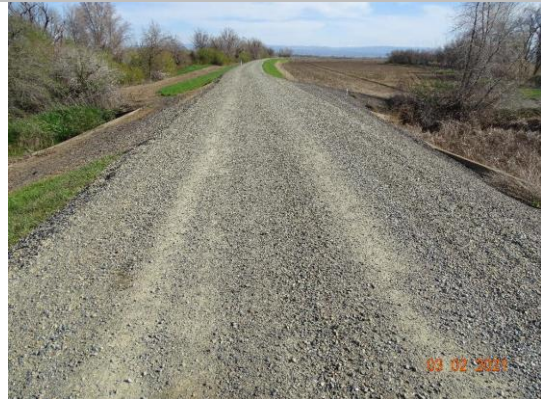
Photo 1 of 3 : UCIP_SP_2023_65805_98116.jpg

Comment Code						
Inspector Comment						
DS_ID:1784 FS_ID:65805 EP_NO: N/A Repair Type: Non-Urgent EVAL Issue: Crossing Status: Found UCIP Comments: 03/02/2021 Record updated from No Action Needed to Non-Urgent. No permit has been identified authorizing pipe. Crossing has been CIPP-lined, new flap gate installed. (O.Yakimov - DWR UCIP) 05/16/2017 Crossing appears to be in good condition. Pipe has been selected to be internally cleaned and inspected as part of the DMP project. (A. Freitag - DWR Sutter Yard)11/15/2016 Crossing appears to be in good condition. (A. Freitag - DWR Sutter Yard)05/11/2016 Crossing appears to be in good condition. (A. Freitag - DWR Sutter Yard)08/04/2015 Crossing appears in good condition. No noticeable issues to report. (A. Freitag - DWR Sutter Yard)06/11/2014 Same as last inspection. (A. Freitag - DWR Sutter Yard)11/19/2013 Same as last inspection. (A. Freitag - DWR Sutter Yard)05/29/2013 Same as last inspection. (A. Freitag - DWR Sutter Yard) FIELD_STRUCT_DESC: 4 of 4: 54-inch CIPP-lined corrugated metal drainage pipe through the levee, 13.5 feet below the crown. Flap gate on the waterside (WS). Concrete headwalls on the landside (LS) and the WS toes. [Additional Reference(s): DWR Levee Log, 1990 (HLM 11.52). USACE Sacramento O&M Manual, Unit 515, April 1955, Revised 28 December 2010, (Station 25+18 'A'), listed as 54-inch pipe. USACE As-Built Drawing No. 50-04-2637, Sheet 4, Station 25+18 'A', 7 January 1953]. FS Date: 3/2/2021 12:02:36 PM

Top of Levee: View of levee crown looking upstream

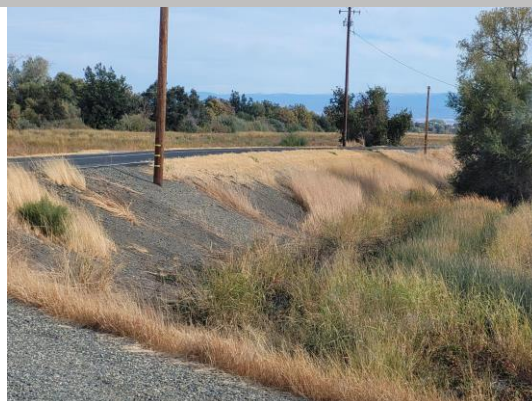
Photo 1 of 1 : SP_2023_MA0005_196_6_20230417_00003.jpg

LM Start	11.85	Rating **	M	Issue No.	6
LM End	13.64	Issue Type +	En	Location *	LS
Category	Earthen Levee			GPS Latitude/Longitude	
				Start	End
Item	Encroachments			39.551235°	39.531462°
				-121.837697°	-121.856165°
DWR ID	DWR_MA0005_01_s_2012_6				
Comment Code					
DT : Ditch					
Inspector Comment

View of the agricultural ditch along the landside toe. Fall 2021.

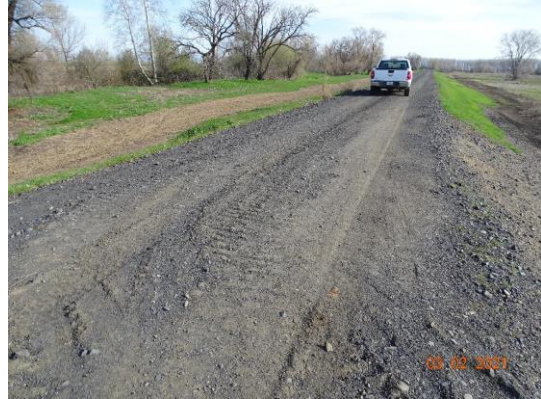
Photo 1 of 3 : UCIP_SP_2023_65842_98184.jpg

DS_ID:1639
FS_ID:65842
EP_NO: N/A
Repair Type: Non-Urgent
EVAL Issue:
Crossing Status: Found
UCIP Comments: 03/02/2021 Record remains Non-Urgent. No permit has been identified authorizing pipe. Pipe has been CIPP-lined, new flap gate installed on waterside pipe end. (O.Yakimov - DWR UCIP) 05/16/2017 Soil still eroded away from the WS wing walls. Pipe has been selected to be internally cleaned and inspected as part of the DMP project. (A. Freitag - DWR Sutter Yard)11/15/2016 No soil supporting the WS wing walls. (A. Freitag - DWR Sutter Yard)05/11/2016 Still no soil supporting the WS wing walls and apron. WS vegetation was thinner and not a problem this time. (A. Freitag - DWR Sutter Yard)08/04/2015 No soil supporting the WS wing walls at the WS pipe end. WS pipe end is also being overgrown with vegetation and should be cleared back. (A. Freitag - DWR Sutter Yard)06/11/2014 Same as last inspection. (A. Freitag - DWR Sutter Yard)11/19/2013 Same as last inspection. (A. Freitag - DWR Sutter Yard)05/29/2013 Same as last inspection. (A. Freitag - DWR Sutter Yard)10/31/2012 Soil under Concrete wing walls on WS toe has been eroded. No soil supporting wing walls. (W. Wylie - DWR UCIP)

FIELD_STRUCT_DESC: 36-inch CIPP-lined corrugated metal drainage pipe through the levee, 13 feet below the crown. Flap gate on the waterside (WS). Concrete headwalls on the landside (LS) and the WS ends. [Additional Reference(s): DWR Levee Log, 1990 (HLM 14.66). USACE Sacramento O&M Manual, Unit 515, April 1955, Revised 28 December 2010, (Station 978+25), listed as 36-inch pipe. USACE As-Built Drawing No. 50-04-2637, Sheet 5, Station 978+24.95, 7 January 1953].
FS Date: 3/2/2021 3:15:18 PM

Top of Levee: View of levee crown looking upstream

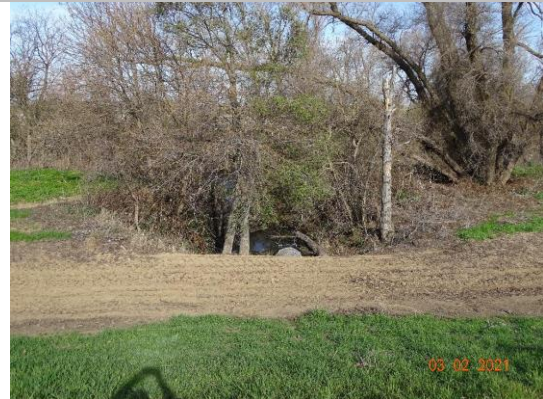
Photo 2 of 3 : UCIP_SP_2023_65842_98185.jpg

LM Start	14.46	Rating **	M	Issue No.	35 (cont)
LM End	14.46	Issue Type +	Ma	Location *	
Category	Supplemental		GPS Latitude/Longitude		
			Start	End	
Item	DWR UCIP LMA Responsibility		39.522200°	39.522200°	
			-121.865592°	-121.865592°	
DWR ID	1639

Water-Side: View of levee slope looking from crown

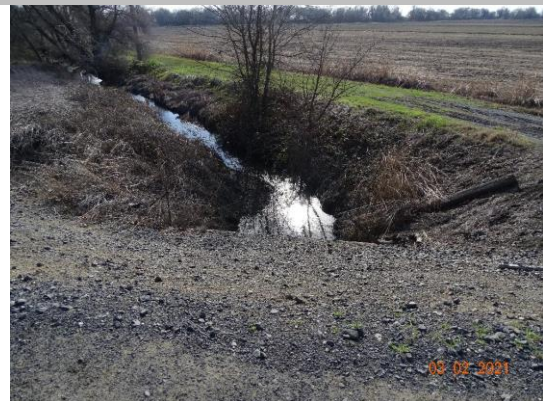
Photo 3 of 3 : UCIP_SP_2023_65842_98186.jpg

Land-Side: View of levee slope looking from crown

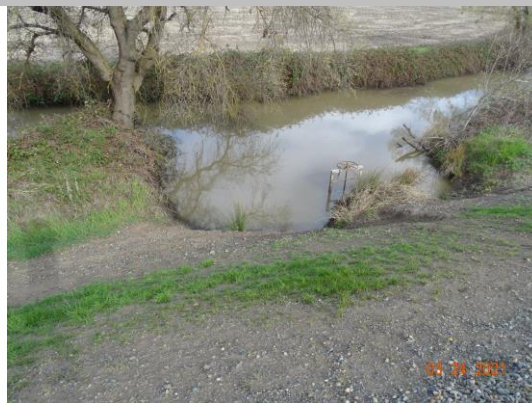
Photo 1 of 1 : SP_2023_MA0005_197_49_20230417_00009.jpg

LM Start	1.90	Rating **	M	Issue No.	49
LM End	1.90	Issue Type +	Ma	Location *	LS
Category	Earthen Levee			GPS Latitude/Longitude	
				Start	End
Item	Erosion / Bank Caving			39.537445°	39.537445°
				-121.853112°	-121.853112°
DWR ID	DWR_MA0005_02_f_2016_49				
Comment Code					
E2 : Schedule repair of erosion site prior to the next inspection.					
Inspector Comment

View of the erosion at the landside toe. Spring 2021.

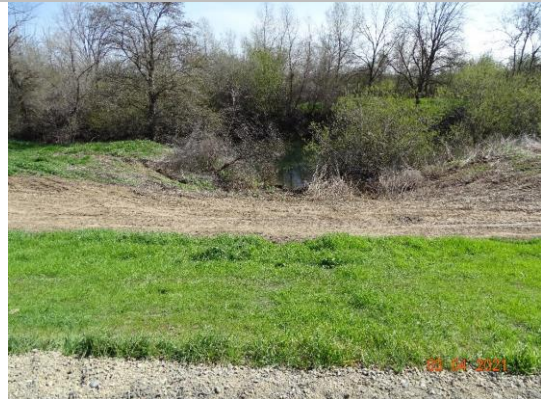
Photo 1 of 3 : UCIP_SP_2023_65959_98237.jpg

DS_ID:1645
FS_ID:65959
EP_NO: N/A
Repair Type: Urgent
EVAL Issue: 2b, Levee Integrity
Crossing Status: Found
UCIP Comments: 03/04/2021 Record remains Urgent. Erosion around headwall on landside is present. Debris at the bottom of flap gate on waterside prevents flap gate from closing. No permit has been identified authorizing pipe. (O.Yakimov - DWR UCIP)
10/05/2018 Unable to see pipe on waterside due to high water level in the creek. Erosion is present around headwall on LS. Screw gate on LS blocked with silt approximately halfway in height. (O. Yakimov - DWR UCIP) 05/18/2017 LS erosion still present. WS flap gate has been completely buried by sediment after the high water flows through the area. Pipe has been selected to be internally cleaned and inspected as part of the DMP project. (A. Freitag - DWR Sutter Yard)11/14/2016 LS erosion still present and is into the prism of the levee. WS flap gate was still mostly buried and non-operational. (A. Freitag - DWR Sutter Yard)05/23/2016 The tree that was overgrowing the WS flapgate has been removed. Flap gate was half buried and unable to open. Erosion on the LS is still present. (A. Freitag - DWR Sutter Yard)07/28/2015 LS inlet is underwater but there appears to be erosion behind the LS headwall. WS pipe end and flap gate are completely overgrown and inaccessible for inspection. (A. Freitag - DWR Sutter Yard)11/25/2014 Tree is overgrowing the WS pipe outlet.. Needs to be trimmed back. (A. Freitag - DWR Sutter Yard)06/04/2014 Same as last inspection. (A. Freitag - DWR Sutter Yard)11/12/2013 Same as last inspection. (A. Freitag - DWR Sutter Yard)06/06/2013 Same as last inspection. (A. Freitag - DWR Sutter Yard)10/31/2012 Vegetation needs to be cleared from outlet. (W. Wylie - DWR UCIP)

FIELD_STRUCT_DESC: 36-inch CIPP-lined corrugated metal drainage pipe through the levee, 17 feet below the crown. Flap gate on the waterside (WS). Slide gate on the landside (LS) toe. Concrete headwalls at both the LS and the WS toes. [Additional Reference(s): DWR Levee Log, 1990 (HLM 1.92). USACE Sacramento O&M Manual, Unit 515, April 1955, Revised 28 December 2010, (Station 902+50), listed as 36-inch pipe. USACE As-Built Drawing No. 50-04-2637, Sheet 5, 902+50, 7 January 1953].
FS Date: 3/4/2021 2:44:17 PM

Water-Side: View of levee slope looking from crown

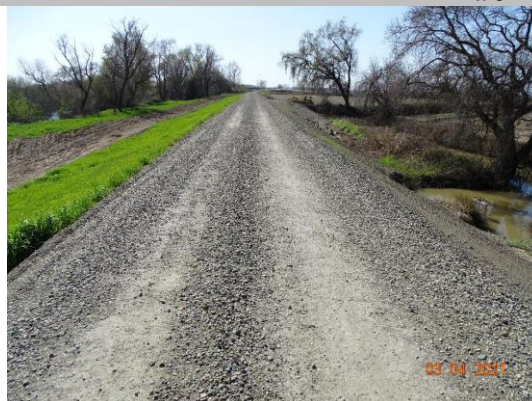
Photo 2 of 3 : UCIP_SP_2023_65959_98240.jpg

LM Start	1.91	Rating **	U	Issue No.	8 (cont)
LM End	1.91	Issue Type +	Ma	Location *	
Category	Supplemental		GPS Latitude/Longitude		
			Start	End	
Item	DWR UCIP LMA Responsibility		39.537455°	39.537455°	
			-121.853061°	-121.853061°	
DWR ID	1645

Top of Levee: View of levee crown looking downstream
