**Flood Control Project Maintenance
Levee Inspections
LMA District Cover Sheet**

**Flood Control Project Maintenance
Levee Inspections
Unit Cover Sheet**

Waterway			Bank	Unit Miles
Unit No. 01 Butte Creek			Left	15.08
	Spring (March - May)	Summer (June - August)	(September - November) Fall	Winter (December - February)
Unit Maintenance Rating (Fall Only)				
Date of Inspection	4/26/2023 - 4/26/2023			
DWR Inspector	Makar Sokol			
Accompanied By	Shawn Freitag DWR Sutter Yard

Levee Inspection Report By Mile - Spring 2023

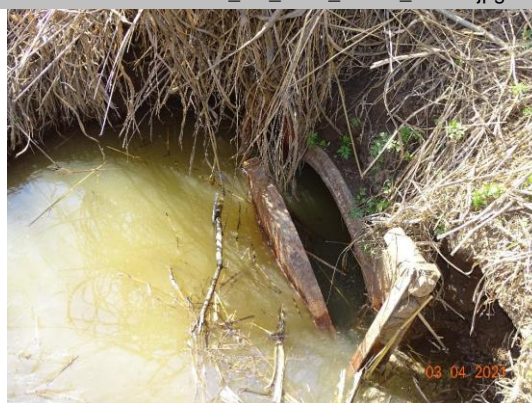
Photo 3 of 3 : UCIP_SP_2023_65959_98239.jpg

LM Start	1.91	Rating **	U	Issue No.	8 (cont)
LM End	1.91	Issue Type +	Ma	Location *

Water-Side: Closeup view of flap gate open due to sediment and debris buildup at the bottom

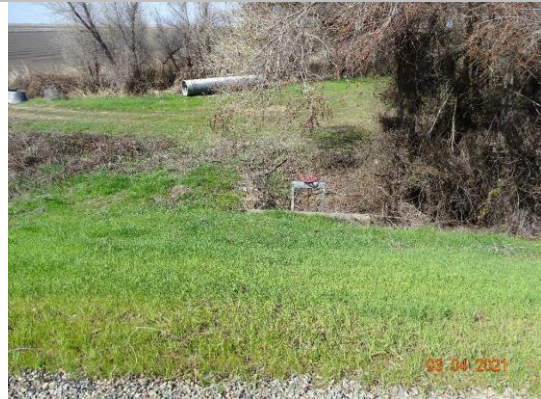
Photo 1 of 3 : UCIP_SP_2023_66057_98336.jpg

DS_ID:1647
FS_ID:66057
EP_NO: N/A
Repair Type: Non-Urgent
EVAL Issue:
Crossing Status: Found
UCIP Comments: 03/04/2021 Record remains Non-Urgent. No permit has been identified authorizing pipe. Pipe has been CIPP lined, new flap gate on waterside pipe end installed, slide gate at landside levee toe was replaced with a new one. (O.Yakimov - DWR UCIP)
05/18/2017 Crossing appears to be in good condition. Tree near the LS screw gate could use some trimming. Pipe has been selected to be internally cleaned and inspected as part of the DMP project. (A. Freitag - DWR Sutter Yard)11/14/2016 Crossing appears to be in good condition. (A. Freitag - DWR Sutter Yard)05/23/2016 Crossing appears to be in good condition. (A. Freitag - DWR Sutter Yard)07/28/2015 Pipe appears in good condition. No noticeable issues to report. (A. Freitag - DWR Sutter Yard)06/06/2013 Same as last inspection. (A. Freitag - DWR Sutter Yard)11/12/2013 Same as last inspection. (A. Freitag - DWR Sutter Yard)06/04/2014 Same as last inspection. (A. Freitag - DWR Sutter Yard)11/25/2014 Same as last inspection. (A. Freitag - DWR Sutter Yard)

FIELD_STRUCT_DESC: 30-inch CIPP-lined corrugated metal drainage pipe through the levee, 14.3 feet below the crown. Slide gate on the landside (LS). Flap gate on the waterside (WS). Concrete headwall at the LS toe. Concrete splash apron on the WS. [Additional Reference(s): DWR Levee Log, 1990 (HLM 4.08). USACE Sacramento O&M Manual, Unit 515, April 1955, Revised 28 December 2010, (Station 5+20 "A"), listed as 30-inch pipe. USACE As-Built Drawing No. 50-04-2637, Sheet 4, Station 5+20 "A", 7 January 1953].
FS Date: 3/4/2021 11:30:54 AM

Land-Side: View of levee slope looking from crown

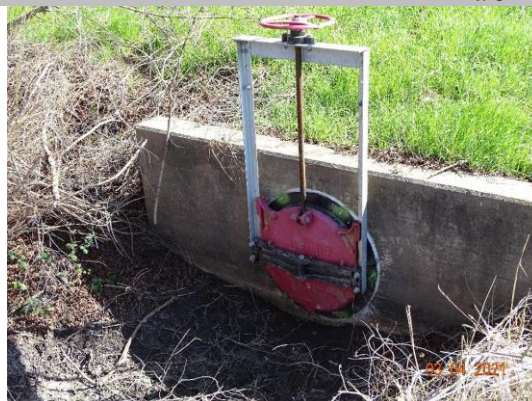
Photo 2 of 3 : UCIP_SP_2023_66057_98337.jpg

Land-Side: Headwall and new slide gate installed at levee toe

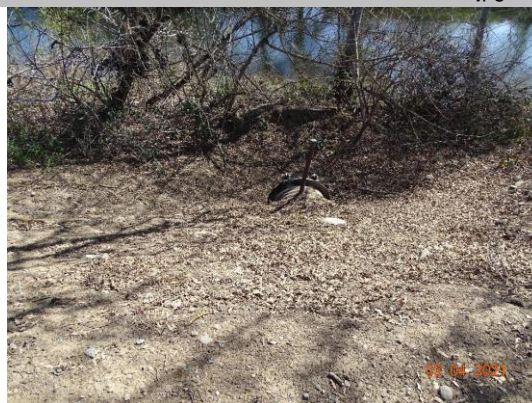
Photo 3 of 3 : UCIP_SP_2023_66057_98334.jpg

Water-Side: View of levee slope looking from crown

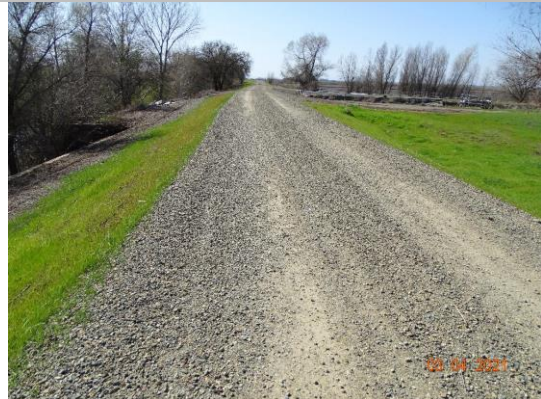
Photo 1 of 3 : UCIP_SP_2023_66081_98389.jpg

DS_ID:16300
FS_ID:66081
EP_NO: N/A
Repair Type: Urgent
EVAL Issue: 1, Pipe Integrity
Crossing Status: Found
UCIP Comments: 03/04/2021 Record updated from No Action Needed to Urgent. Missing flap gate on pipe end at headwall on waterside. One of the attached photos shows flap gate installed inside the pipe approximately at landside toe. Unable to confirm flap gate integrity. Portion of pipe under levee remains open to flood water that increases risk of levee failure. No permit has been identified authorizing pipe onstallation. DMP internal video inspection has found pipe integrity issues. LOF of crossing is between 5 and 6. Crossing will be monitored until funding becomes available to address the issues. (O.Yakimov - DWR UCIP)
05/18/2017 Crossing appears to be in good condition. Pipe has been selected to be internally cleaned and inspected as part of the DMP project. (A. Freitag - DWR Sutter Yard)05/23/2016 Crossing is not abandoned. Water was flowing through from the LS to WS. LS pipe inlet is about 100 yds from LS levee toe across the LS canal. (A. Freitag - DWR Sutter Yard)07/28/2015 Crossing is listed as abandoned but it is not filled with concrete like crossings 1-4 here. (A. Freitag - DWR Sutter Yard)11/25/2014 Same as last inspection. (A. Freitag - DWR Sutter Yard)06/04/2014 Same as last inspection. (A. Freitag - DWR Sutter Yard)11/13/2013 Same as last inspection. (A. Freitag - DWR Sutter Yard)06/06/2013 Sutter Maintenance Yard supervisor Jason Cooper said there is a flap gate on the LS end of the pipe in the western most ditch to prevent high water flooding. Not sure if this is adequate, will talk to levee inspector to find out. (A. Freitag - DWR Sutter Yard)11/01/2012 Pipe open on WS and is not filled with concrete. (W. Wylie - DWR UCIP)

Top of Levee: View of levee crown looking downstream

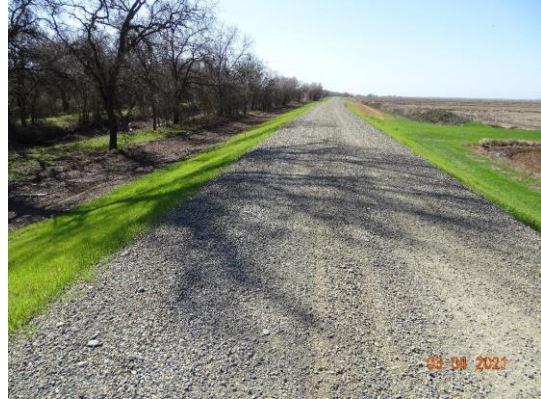
Photo 1 of 3 : UCIP_SP_2023_66386_98830.jpg

Comment Code					
Inspector Comment					
DS_ID:1650 FS_ID:66386 EP_NO: N/A Repair Type: Non-Urgent EVAL Issue: Crossing Status: Found UCIP Comments: 03/04/2021 Record remains Non-Urgent. Crossing appears abandoned. Pipe inlet not found on landside. Slide gate inside of CMP riser on waterside berm is in closed position. Geophysical study indicates possible presence of pipe through levee. Owner needs to coordinate with the CVFPB to remove or abandon crossing according to Title 23 requirements. No permit has been identified authorizing pipe. (O.Yakimov - DWR UCIP) 05/23/2019 (O. Magana - DWR UCIP)05/18/2017 Abandoned- only WS riser found. (A. Freitag - DWR Sutter Yard)11/14/2016 Abandoned. (A. Freitag - DWR Sutter Yard)05/23/2016 Abandoned. (A. Freitag - DWR Sutter Yard)07/28/2015 Abandoned- still cannot locate a LS ans WS pipe end. (A. Freitag - DWR Sutter Yard)11/25/2014 Same as last inpection. (A. Freitag - DWR Sutter Yard)06/04/2014 Same as last inspection. (A. Freitag - DWR Sutter Yard)11/12/2013 Same as last inspection. (A. Freitag - DWR Sutter Yard)06/06/2013 Same as last inspection. (A. Freitag - DWR Sutter Yard)10/31/2012 Appears abandoned. Unable to locate outfall on WS. Unable to locate inlet on LS. (W. Wylie - DWR UCIP) FIELD_STRUCT_DESC: 24-inch corrugated metal drainage pipe through the levee, 12.5 feet below the crown. Slide gate and flap gate in a 56-inch corrugated metal riser on the waterside (WS) berm. Flap gate on the WS. [Additional Reference(s): DWR Levee Log, 1990 (HLM 5.41). USACE Sacramento O&M Manual, Unit 515, April 1955, Revised 28 December 2010, (Station 688+40), listed as 24-inch pipe. USACE As-Built Drawing No. 50-04-2637, Sheet 3, Station 688+40, 7 January 1953]. FS Date: 3/4/2021 3:55:12 PM

Top of Levee: View of levee crown looking downstream

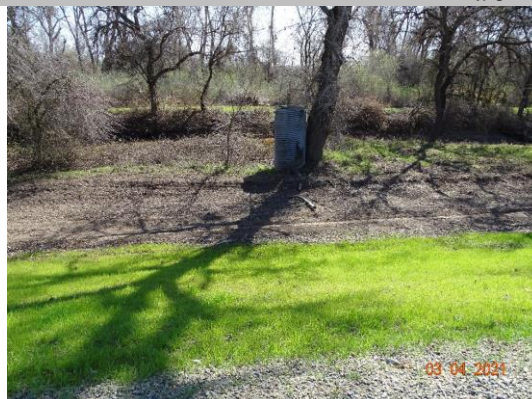
Photo 2 of 3 : UCIP_SP_2023_66386_98831.jpg

Water-Side: View of levee slope looking from crown. CMP riser with slide gate on levee berm

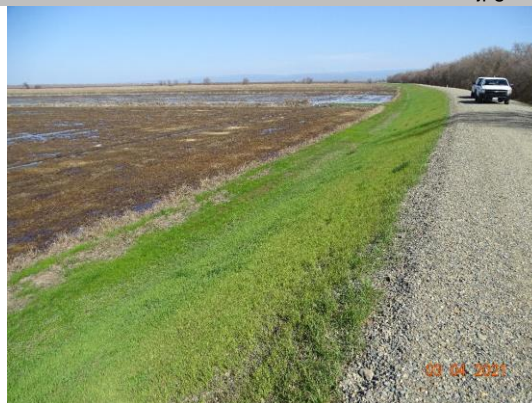
Photo 3 of 3 : UCIP_SP_2023_66386_98833.jpg

Land-Side: Overview of levee slope. Pipe not found on landside

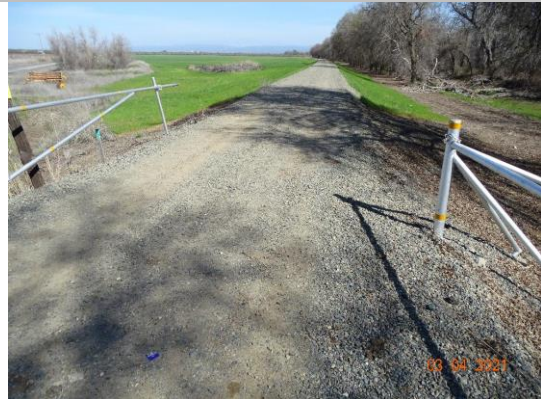
Photo 1 of 3 : UCIP_SP_2023_66463_98875.jpg

Comment Code						
Inspector Comment						
DS_ID:1654 FS_ID:66463 EP_NO: N/A Repair Type: Non-Urgent EVAL Issue: Crossing Status: Found UCIP Comments: 03/04/2021 Record updated from No Action Needed to Non-Urgent. No permit has been identified authorizing pipe. Pipe has been CIPP lined, new flap gate installed on waterside end. (O.Yakimov - DWR UCIP) 05/18/2017 Crossing appears to be in good condition. Pipe has been selected to be internally cleaned and inspected as part of the DMP project. (A. Freitag - DWR Sutter Yard)11/14/2016 Crossing appears to be in good condition. (A. Freitag - DWR Sutter Yard)05/23/2016 Crossing appears to be in good condition. (A. Freitag - DWR Sutter Yard)07/28/2015 Crossing appears in good condition. No noticeable issues to report. (A. Freitag - DWR Sutter Yard)11/24/2014 Same as last inspection. (A. Freitag - DWR Sutter Yard)06/04/2014 Same as last inspection. (A. Freitag - DWR Sutter Yard)11/12/2013 Same as last inspection. (A. Freitag - DWR Sutter Yard)06/06/2013 Same as last inspection. (A. Freitag - DWR Sutter Yard) FIELD_STRUCT_DESC: 24-inch CIPP-lined corrugated metal drainage pipe through the levee, 9.4 feet below the crown. Flap gate on the waterside (WS). Concrete headwalls at both the landside (LS) and the WS toes. [Additional Reference(s): DWR Levee Log, 1990 (HLM 6.56). USACE Sacramento O&M Manual, Unit 515, April 1955, Revised 28 December 2010, (Station 627+00), listed as 24-inch pipe. USACE As-Built Drawing No. 50-04-2637, Sheet 3, Station 627+00, 7 January 1953]. FS Date: 3/4/2021 1:12:00 PM

Top of Levee: View of levee crown looking upstream

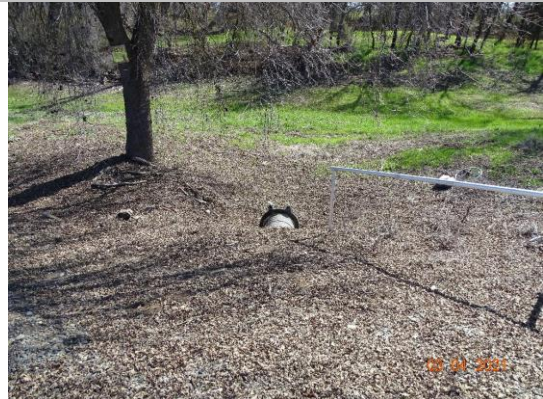
Photo 2 of 3 : UCIP_SP_2023_66463_98876.jpg

Water-Side: View of levee slope looking from crown

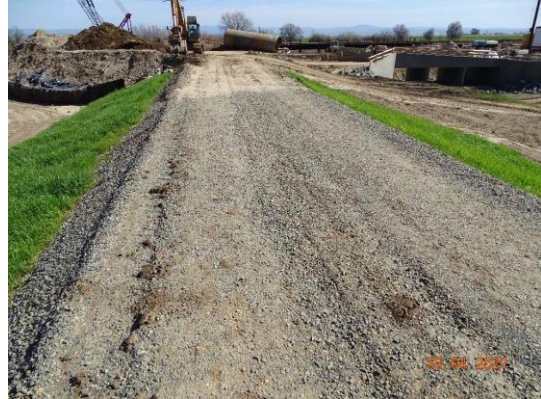
Photo 1 of 3 : UCIP_SP_2023_66495_98886.jpg

Comment Code					
Inspector Comment					
DS_ID:16850 FS_ID:66495 EP_NO: N/A Repair Type: Non-Urgent EVAL Issue: Crossing Status: Not Found UCIP Comments: 03/04/2021 Record updated from No Action Needed to Non-Urgent. Crossing not found. Geophysical results did not confirm presence of pipe through levee. Record will remain in UCIP's inspection records until future Levee Improvement Project can confirm no crossing was found through the levee. No permit has been identified authorizing pipe. (O.Yakimov - DWR UCIP) 05/18/2017 Unable to locate. Pipe has been selected to be internally cleaned and inspected as part of the DMP project. (A. Freitag - DWR Sutter Yard)11/14/2016 Unable to locate. (A. Freitag - DWR Sutter Yard)05/23/2016 Unable to locate. (A. Freitag - DWR Sutter Yard)07/28/2015 Unable to locate. (A. Freitag - DWR Sutter Yard)11/24/2015 Unable to locate. (A. Freitag - DWR Sutter Yard)06/04/2014 Same as last inspection. (A. Freitag - DWR Sutter Yard)11/12/2013 Unable to locate. (A. Freitag - DWR Sutter Yard)06/06/2013 Same as last inspection. Unable to locate. (A. Freitag - DWR Sutter Yard) FIELD_STRUCT_DESC: 24-inch corrugated metal drainage pipe through the levee, 9.5 feet below the crown. Flap gate on the waterside (WS). Concrete headwall at the landside (LS) toe. [Additional Reference(s): USACE Sacramento O&M Manual, Unit 515, April 1955, Revised 28 December 2010, (Station 552+60), listed as 24-inch pipe. USACE As-Built Drawing No. 50-04-2637, Sheet 2, Station 552+60, 7 January 1953]. FS Date: 3/4/2021 2:42:10 PM

Top of Levee: View of levee crown looking downstream

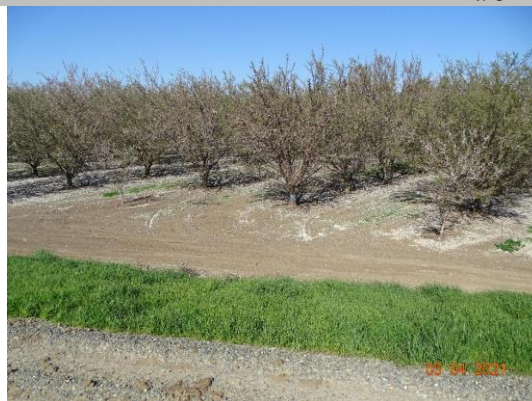
Photo 2 of 3 : UCIP_SP_2023_66495_98887.jpg

Land-Side: View of levee slope looking from crown

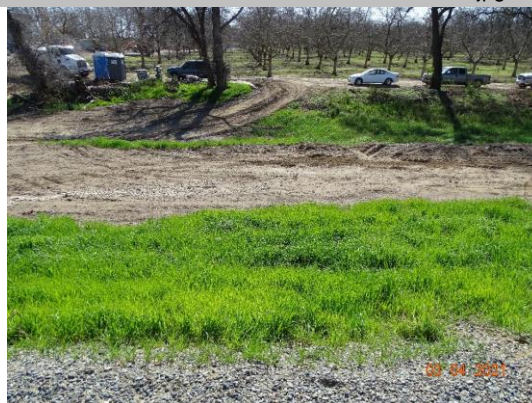
Photo 3 of 3 : UCIP_SP_2023_66495_98888.jpg

Water-Side: View of levee slope looking from crown

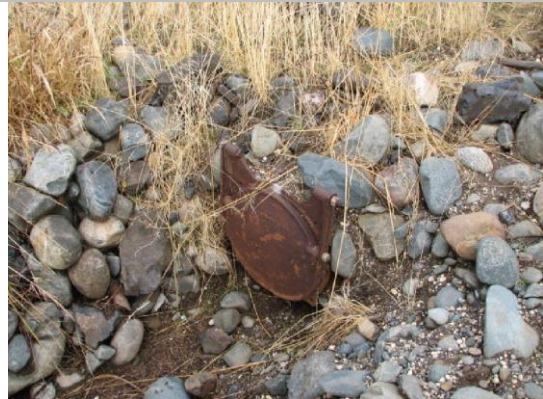
Photo 1 of 2 : UCIP_SP_2023_66502_68129.jpg

Comment Code					
Inspector Comment					
DS_ID:1656 FS_ID:66502 EP_NO: N/A Repair Type: Non-Urgent EVAL Issue: Crossing Status: Found UCIP Comments: 03/04/2021 Record remains Non-Urgent. Unable to inspect crossing due to construction activity. No permit has been identified authorizing pipe. (O.Yakimov - DWR UCIP) 05/18/2017 LS inlet is almost completely full of soil. Pipe has been selected to be internally cleaned and inspected as part of the DMP project. (A. Freitag - DWR Sutter Yard)11/14/2016 LS inlet almost completely full of soil. (A. Freitag - DWR Sutter Yard)05/23/2016 LS end is almost complete full of soil. (A. Freitag - DWR Sutter Yard)07/28/2015 Pipe is still over 3/4 full of soil. (A. Freitag - DWR Sutter Yard)11/24/2014 Same as last inspection. (A. Freitag - DWR Sutter Yard)06/04/2014 Same as last inspection. (A. Freitag - DWR Sutter Yard)11/12/2013 Same as last inspection. (A. Freitag - DWR Sutter Yard)06/06/2013 Same as last inspection. (A. Freitag - DWR Sutter Yard)10/31/2012 Pipe 3/4 full with soil on LS. (W. Wylie - DWR UCIP) FIELD_STRUCT_DESC: 18-inch CIPP-lined corrugated metal drainage pipe through the levee at an unknown depth below the crown. Concrete headwall at the landside (LS) toe. Flap gate on the waterside (WS). [Additional Reference(s): USACE Sacramento O&M Manual, Unit 515 - Upper Butte Creek - Part No. 1, April 1955, pipe referenced only in USACE As-Built Drawing No. 50-04-2637, Sheet 2, just downstream of old Hwy 99, 7 January 1953. USACE As-Built Drawing No. 50-04-3367, Sheet 13, just upstream of Station 380+85, 11 April 1958]. FS Date: 3/4/2021 2:57:43 PM

Flap gate at WS toe.

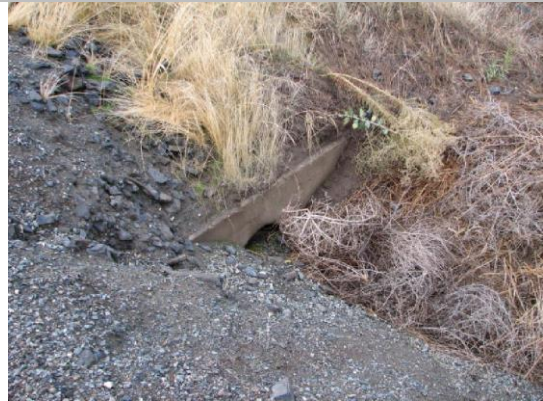
Photo 2 of 2 : UCIP_SP_2023_66502_68128.jpg

Concrete headwall on LS toe.

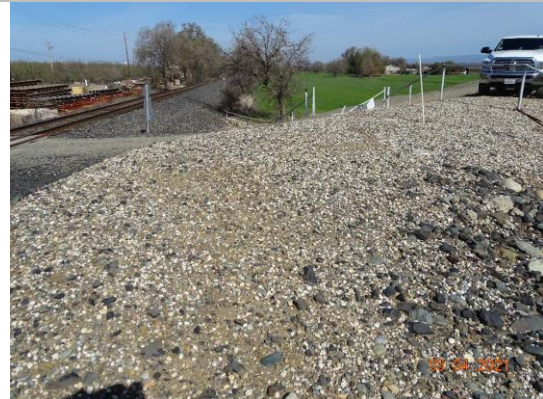
Photo 1 of 3 : UCIP_SP_2023_66520_98907.jpg

Comment Code						
Inspector Comment						
DS_ID:1660 FS_ID:66520 EP_NO: N/A Repair Type: Non-Urgent EVAL Issue: Crossing Status: Not Found UCIP Comments: 03/04/2021 Record updated from No Action Needed to Non-Urgent. Crossing not found. Geophysical results did not confirm presence of pipe through levee. Record will remain in UCIP's inspection records until future Levee Improvement Project can confirm no crossing was found through the levee. No permit has been identified authorizing pipe. (O.Yakimov - DWR UCIP) 06/13/2019 Levee mile and coordinates were updated based on the USACE's as-built drawing no. 50-4-2637 from CLM 8.009 (39.60789, -121.785435) to CLM 8.031 (39.608234, -121.785203). (O. Magana - DWR UCIP) 05/18/2017 Unable to locate. (A. Freitag - DWR Sutter Yard) 11/14/2016 Unable to locate. (A. Freitag - DWR Sutter Yard) 05/12/2016 Unable to locate. (A. Freitag - DWR Sutter Yard) 07/30/2015 Unable to locate. (A. Freitag - DWR Sutter Yard) 11/24/2014 Unable to locate. (A. Freitag - DWR Sutter Yard) 06/04/2014 Same as last inspection. (A. Freitag - DWR Sutter Yard) 11/12/2013 Unable to locate. (A. Freitag - DWR Sutter Yard) 06/06/2013 Same as last inspection. Unable to locate. (A. Freitag - DWR Sutter Yard) FIELD_STRUCT_DESC: 24-inch corrugated metal drainage pipe through the levee, 6.7 feet below the crown. Concrete headwalls at both the landside (LS) and the waterside (WS) toes. Flap gate on the WS. [Additional Reference(s): DWR Levee Log, 1990 (HLM 8.12). USACE Sacramento O&M Manual, Unit 515, April 1955, Revised 28 December 2010, (Station 541+00), listed as 24-inch pipe. USACE As-Built Drawing No. 50-04-2637, Sheet 2, just upstream of SP RR, 7 January 1953]. FS Date: 3/4/2021 3:31:15 PM

Top of Levee: View of levee crown looking across

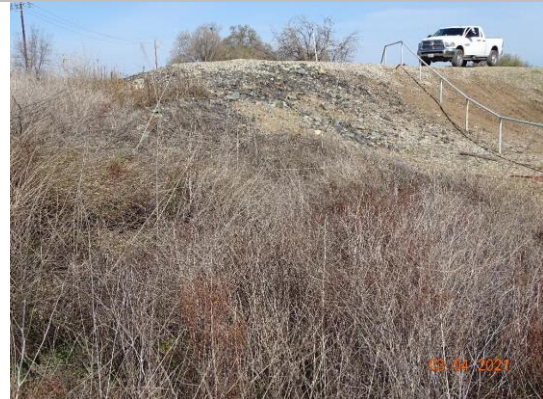
Photo 2 of 3 : UCIP_SP_2023_66520_98906.jpg

Water-Side: View of levee slope looking from toe

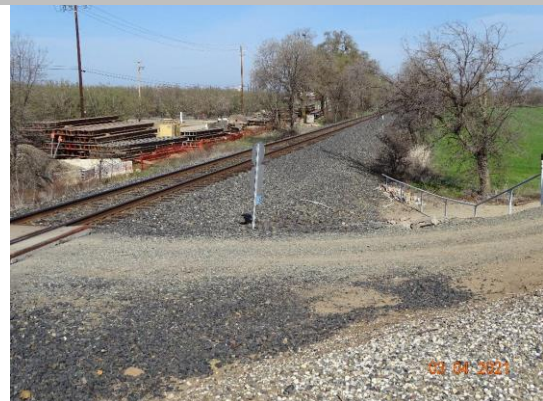
Photo 3 of 3 : UCIP_SP_2023_66520_98908.jpg

Land-Side: View of levee slope looking from crown

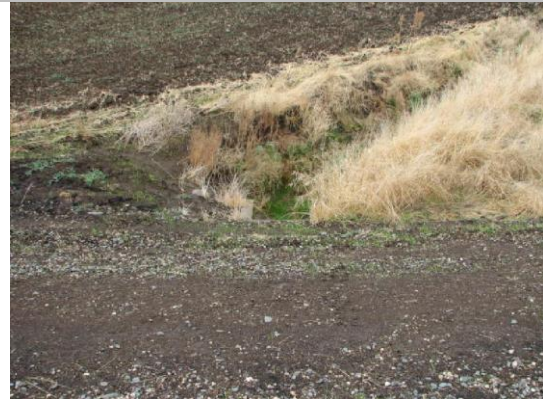
Photo 1 of 3 : UCIP_SP_2023_66669_68394.jpg

Comment Code						
Inspector Comment						
DS_ID:1662 FS_ID:66669 EP_NO: N/A Repair Type: Non-Urgent EVAL Issue: Crossing Status: Found UCIP Comments: 03/04/2021 Record updated from No Action Needed to Non-Urgent. No permit has been identified authorizing pipe. This crossing has been CIPP lined, new flap gate installed on waterside end. (O.Yakimov - DWR UCIP) 05/18/2017 Crossing appears to be in good condition. Pipe has been selected to be internally cleaned and inspected as part of the DMP project. (A. Freitag - DWR Sutter Yard)11/14/2016 Crossing appears to be in good condition. (A. Freitag - DWR Sutter Yard)05/12/2016 Crossing appears to be in good condition. (A. Freitag - DWR Sutter Yard)07/30/2015 Crossing is in good condition. No noticeable issues to report. (A. Freitag - DWR Sutter Yard)11/24/2014 Same as last inspection. (A. Freitag - DWR Sutter Yard)06/04/2014 Same as last inspection. (A. Freitag - DWR Sutter Yard)11/13/2013 Same as last inspection. (A. Freitag - DWR Sutter Yard)06/06/2013 Same as last inspection. (A. Freitag - DWR Sutter Yard) FIELD_STRUCT_DESC: 30-inch CIPP-lined corrugated metal drainage pipe through the levee, 16.3 feet below the crown. Flap gate on the waterside (WS). Concrete "U" shaped headwalls on both the landside (LS) and the WS. [Additional Reference(s): DWR Levee Log, 1990 (HLM 8.21). USACE Sacramento O&M Manual, Unit 516, April 1960, Revised 3 February 2011, (Station 374+90), listed as 30-inch pipe. USACE As-Built Drawing No. 50-4-3367, Exhibit B, Sheet 13, April 1957]. FS Date: 3/4/2021 2:33:37 PM

Concrete inlet on LS toe.

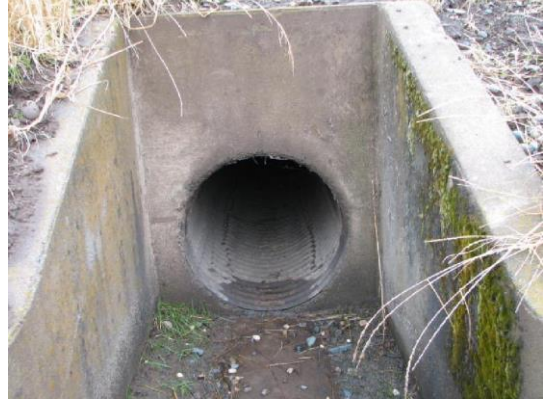
Photo 2 of 3 : UCIP_SP_2023_66669_68393.jpg

Concrete inlet on LS toe.

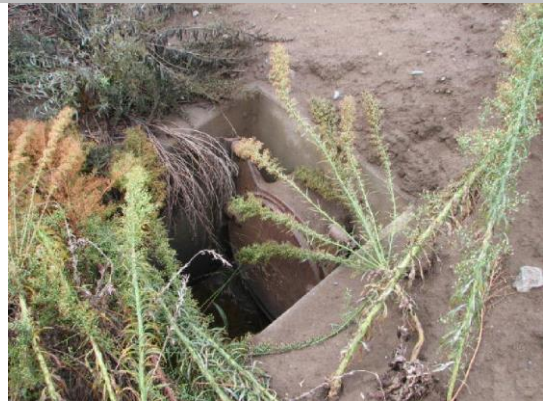
Photo 3 of 3 : UCIP_SP_2023_66669_68392.jpg

Concrete outlet and flap gate on WS toe.

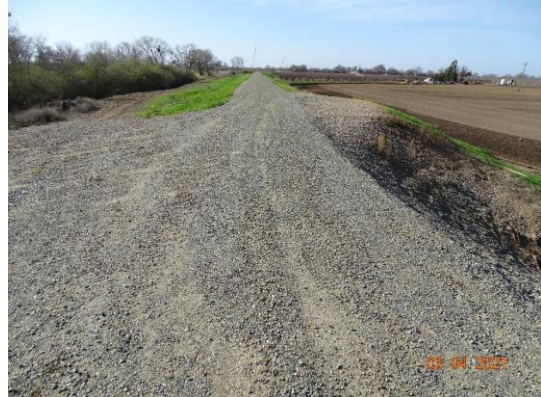
Photo 1 of 3 : UCIP_SP_2023_66671_98961.jpg

DS_ID:1663
FS_ID:66671
EP_NO: N/A
Repair Type: Non-Urgent
EVAL Issue:
Crossing Status: Found
UCIP Comments: 03/04/2021 Record updated from No Action Needed to Non-Urgent. No permit has been identified authorizing pipe. This pipe has been CIPP lined, according to Sutter Yard flap gate was replaced in 2019. (O.Yakimov - DWR UCIP)
05/18/2017 Crossing appears to be in good condition. Pipe has been selected to be internally cleaned and inspected as part of the DMP project. (A. Freitag - DWR Sutter Yard)11/14/2016 Crossing appears to be in good condition. (A. Freitag - DWR Sutter Yard)05/12/2016 Crossing appears to be in good condition. (A. Freitag - DWR Sutter Yard)07/30/2015 Crossing appears in good condition. No noticeable issues to report. (A. Freitag - DWR Sutter Yard)11/24/2014 Same as last inspection. (A. Freitag - DWR Sutter Yard)06/04/2014 Same as last inspection. (A. Freitag - DWR Sutter Yard)11/13/2013 Damaged pipe section was dug up and replaced. New WS flapgate with u-shaped wingwall installed on end of pipe. (A. Freitag - DWR Sutter Yard)06/06/2013 Same as last inspection. Plans have been made to repair during summer of 2013 before high water season. (A. Freitag - DWR Sutter Yard)11/01/2012 Pipe rusted through along bottom at WS outlet. Sink hole over pipe on WS berm. WS headwall eroded eternally around backside of headwall. (W. Wylie - DWR UCIP)

Top of Levee: View of levee crown looking downstream

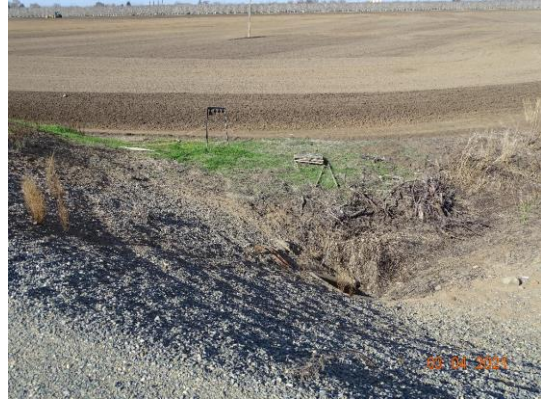
Photo 2 of 3 : UCIP_SP_2023_66671_98962.jpg

Land-Side: View of levee slope looking from crown

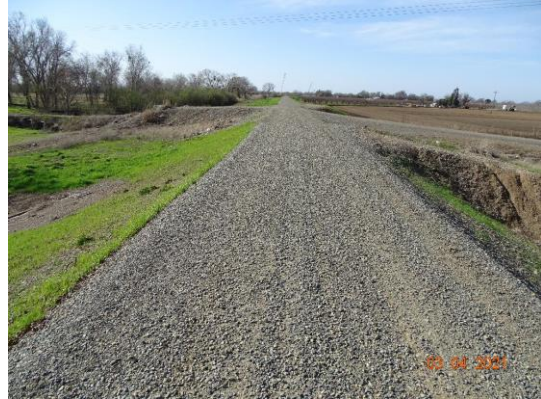
Photo 1 of 3 : UCIP_SP_2023_66672_98964.jpg

Comment Code						
Inspector Comment						
DS_ID:1664 FS_ID:66672 EP_NO: N/A Repair Type: Non-Urgent EVAL Issue: Crossing Status: Found UCIP Comments: 03/04/2021 Record remains Non-Urgent. No permit has been identified authorizing pipe. Crossing has been CIPP lined, new flap gate installed. (O.Yakimov - DWR UCIP) 05/18/2017 No LS slide gate but not sure its even needed. Pipe has been selected to be internally cleaned and inspected as part of the DMP project. (A. Freitag - DWR Sutter Yard)11/14/2016 LS slide gate still missing. Rest of crossing appears in good condition. (A. Freitag - DWR Sutter Yard)05/12/2016 LS inlet was unburied. Slide gate still missing. (A. Freitag - DWR Sutter Yard)07/30/2015 LS inlet is still buried. (A. Freitag - DWR Sutter Yard)11/24/2014 Same as last inspection. (A. Freitag - DWR Sutter Yard)06/04/2014 Same as last inspection. (A. Freitag - DWR Sutter Yard)11/13/2013 Same as last inspection. (A. Freitag - DWR Sutter Yard)06/06/2013 Same as last inspection. (A. Freitag - DWR Sutter Yard)11/01/2012 LS inlet is buried under soil and covered with brambles. Slide gate missing from LS. (W. Wylie - DWR UCIP) FIELD_STRUCT_DESC: 24-inch CIPP-lined corrugated metal drainage pipe through the levee, 12 feet below the crown. Flap gate on the waterside (WS). Concrete headwall on the WS. Concrete headwall on the landside (LS), not found. [Additional Reference(s): DWR Levee Log, 1990 (HLM 8.93). USACE Sacramento O&M Manual, Unit 516, April 1960, Revised 3 February 2011, (Station 338+04), listed as 24-inch pipe. USACE As-Built Drawing No. 50-04-3367, Sheet 11, Station 338+04, 11 April 1958]. FS Date: 3/4/2021 2:53:06 PM

Top of Levee: View of levee crown looking downstream

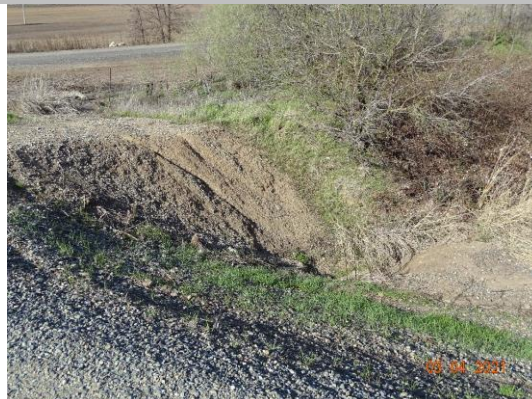
Photo 2 of 3 : UCIP_SP_2023_66672_98965.jpg

Water-Side: View of levee slope looking from crown

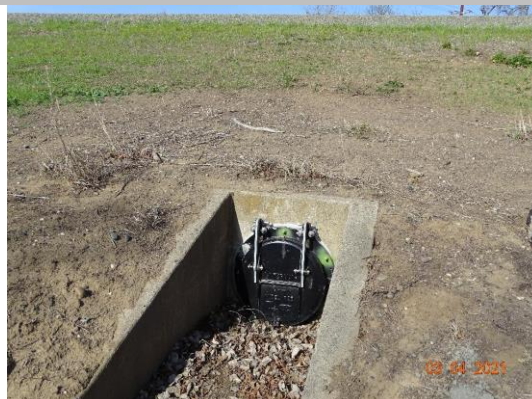
Photo 3 of 3 : UCIP_SP_2023_66672_98967.jpg

Water-Side: New flap gate installed

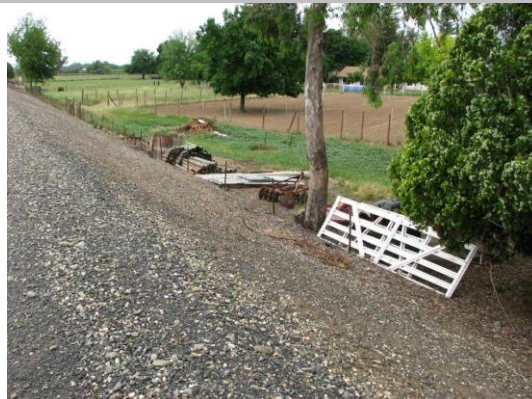
Photo 1 of 1 : SP_2023_MA0005_197_45_20230417_00008.jpg

LM Start	9.09	Rating **	M	Issue No.	45
LM End	9.09	Issue Type +	En	Location *	LS
Category	Earthen Levee			GPS Latitude/Longitude	
				Start	End
Item	Encroachments			39.622017°	39.622017°
				-121.776552°	-121.776552°
DWR ID	DWR_MA0005_02_s_2016_45				
Comment Code					
EQ : Equipment					
Inspector Comment					
Materials and equipment should be removed from the landside toe.

View of equipment and materials from the landside toe.

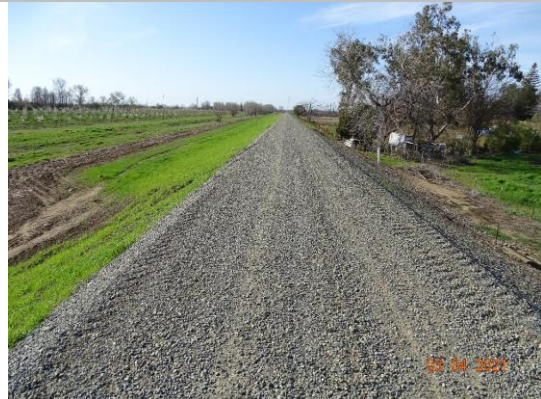
Photo 1 of 3 : UCIP_SP_2023_66673_98969.jpg

Comment Code					
Inspector Comment					
DS_ID:1665 FS_ID:66673 EP_NO: N/A Repair Type: Non-Urgent EVAL Issue: Crossing Status: Found UCIP Comments: 03/04/2021 Record remains Non-Urgent. No permit has been identified authorizing pipe. Crossing has been CIPP lined, new flap gate installed. (O.Yakimov - DWR UCIP) 05/18/2017 Crossing appears to be in good condition. Pipe has been selected to be internally cleaned and inspected as part of the DMP project. (A. Freitag - DWR Sutter Yard)11/14/2016 Crossing appears to be in good condition. (A. Freitag - DWR Sutter Yard)05/12/2016 Crossing appears to be in good condition. (A. Freitag - DWR Sutter Yard)07/30/2015 Crossing appears in good condition. No noticeable issues to report. (A. Freitag - DWR Sutter Yard)11/24/2014 Same as last inspection. (A. Freitag - DWR Sutter Yard)06/04/2014 Same as last inspection. (A. Freitag - DWR Sutter Yard)11/13/2013 Same as last inspection. (A. Freitag - DWR Sutter Yard)06/06/2013 Same as last inspection. (A. Freitag - DWR Sutter Yard) FIELD_STRUCT_DESC: 24-inch CIPP-lined corrugated metal drainage pipe through the levee, 11.3 feet below the crown. Flap gate on the waterside (WS). Concrete headwalls on both the landside (LS) and the WS. [Additional Reference(s): DWR Levee Log, 1990 (HLM 9.25). USACE Sacramento O&M Manual, Unit 516, April 1960, Revised 3 February 2011, (Station 321+20), listed as 24-inch pipe]. FS Date: 3/4/2021 2:56:21 PM

Top of Levee: View of levee crown looking downstream

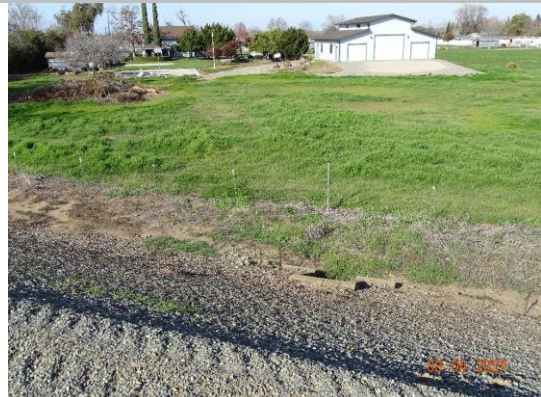
Photo 2 of 3 : UCIP_SP_2023_66673_98970.jpg

Land-Side: View of levee slope looking from crown

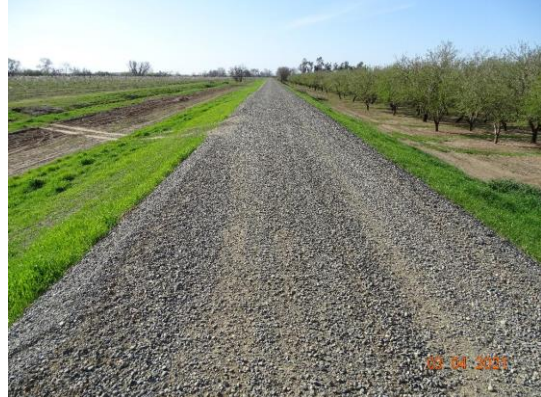
Photo 1 of 3 : UCIP_SP_2023_66675_98979.jpg

Comment Code						
Inspector Comment						
DS_ID:16851 FS_ID:66675 EP_NO: N/A Repair Type: Non-Urgent EVAL Issue: Crossing Status: Not Found UCIP Comments: 10/19/2021 During O&M Manual review this crossing has been identified at STA 309+11 (not STA 304+10). Updated references and coordinates of the crossing. If crossing still not found during next field visit recommend to conduct geophysical survey at new location. (O.Yakimov - DWR UCIP) 03/04/2021 Record updated from No Action Needed to Non-Urgent. Crossing not found. Geophysical results did not confirm presence of pipe through levee. Record will remain in UCIP's inspection records until future Levee Improvement Project can confirm no crossing was found through the levee. No permit has been identified authorizing pipe. (O.Yakimov - DWR UCIP) 05/18/2017 Unable to locate. (A. Freitag - DWR Sutter Yard) 11/14/2016 Unable to locate. (A. Freitag - DWR Sutter Yard) 05/12/2016 Unable to locate. (A. Freitag - DWR Sutter Yard) 07/30/2015 Unable to locate. (A. Freitag - DWR Sutter Yard) 11/24/2014 Unable to locate. (A. Freitag - DWR Sutter Yard) 06/04/2014 Unable to locate. (A. Freitag - DWR Sutter Yard) 11/13/2013 Unable to locate. (A. Freitag - DWR Sutter Yard) 06/06/2013 Same as last inspection. Unable to locate. (A. Freitag - DWR Sutter Yard) FIELD_STRUCT_DESC: 24-inch corrugated metal drainage pipe through the levee, 7.9 feet below the crown, not found. Concrete headwall indicated on the drawing. [Additional Reference(s): USACE Sacramento O&M Manual, Unit 516, April 1960, Revised 3 February 2011, (Station 309+11), listed as 14-inch pipe]. FS Date: 3/4/2021 3:03:26 PM

Top of Levee: View of levee crown looking downstream

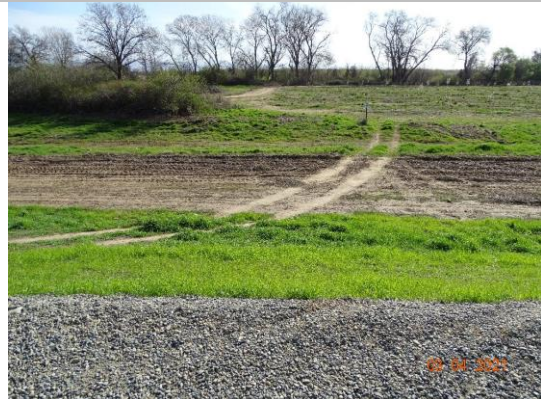
Photo 2 of 3 : UCIP_SP_2023_66675_98980.jpg

Water-Side: View of levee slope looking from crown

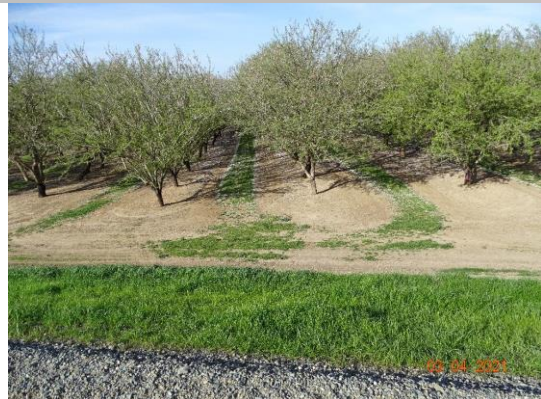
Photo 3 of 3 : UCIP_SP_2023_66675_98981.jpg

Land-Side: View of levee slope looking from crown

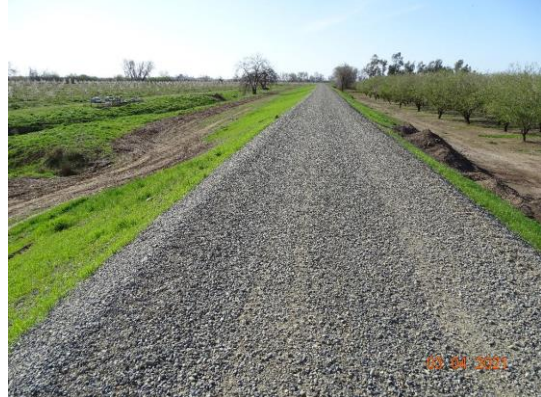
Photo 1 of 3 : UCIP_SP_2023_66674_98974.jpg

DS_ID:1666
FS_ID:66674
EP_NO: N/A
Repair Type: Non-Urgent
EVAL Issue: 11, Maintenance Compliance Issue
Crossing Status: Found
UCIP Comments: 03/04/2021 Record remains Non-Urgent. No permit has been identified authorizing pipe. Crossing has been CIPP lined, new flap gate installed. Recommend clearing sediment around pipe inlet. (O.Yakimov - DWR UCIP)
05/18/2017 LS inlet half full of soil and WS flap gate half buried by sediment. Pipe has been selected to be internally cleaned and inspected as part of the DMP project. (A. Freitag - DWR Sutter Yard)11/14/2016 LS pipe inlet is half full of soil. WS flap gate shut but half buried by sediment. (A. Freitag - DWR Sutter Yard)05/12/2016 Pipe is half full of soil. (A. Freitag - DWR Sutter Yard)07/30/2015 Pipe is 1/4 to 1/2 full of soil still. (A. Freitag - DWR Sutter Yard)11/24/2014 Same as last inspection. (A. Freitag - DWR Sutter Yard)06/04/2014 Same as last inspection. (A. Freitag - DWR Sutter Yard)11/13/2013 Same as last inspection. (A. Freitag - DWR Sutter Yard)06/06/2013 Same as last inspection. (A. Freitag - DWR Sutter Yard)11/01/2012 Pipe 1/2 filled with soil. (W. Wylie - DWR UCIP)

FIELD_STRUCT_DESC: 24-inch CIPP-lined corrugated metal drainage pipe through the levee, 11.2 feet below the crown. Flap gate on the waterside (WS). Concrete "U" shaped headwalls on both the landside (LS) and the WS. [Additional Reference(s): DWR Levee Log, 1990 (HLM 9.57). USACE Sacramento O&M Manual, Unit 516, April 1960, Revised 3 February 2011, (Station 304+10), listed as 24-inch pipe. USACE As-Built Drawing No. 50-4-3367, Sheet 3, no Station referenced, 11 April 1958].
FS Date: 3/4/2021 2:59:17 PM

Top of Levee: View of levee crown looking downstream

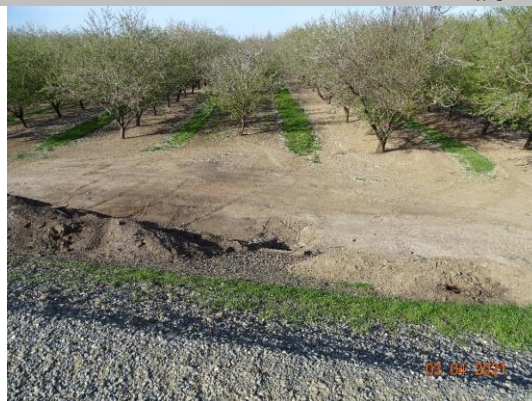
Photo 2 of 3 : UCIP_SP_2023_66674_98975.jpg

Land-Side: View of levee slope looking from crown

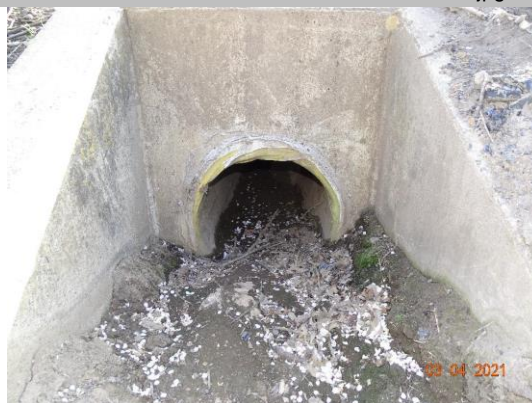
Photo 3 of 3 : UCIP_SP_2023_66674_98978.jpg

Land-Side: CIPP-lined pipe, headwall at levee toe

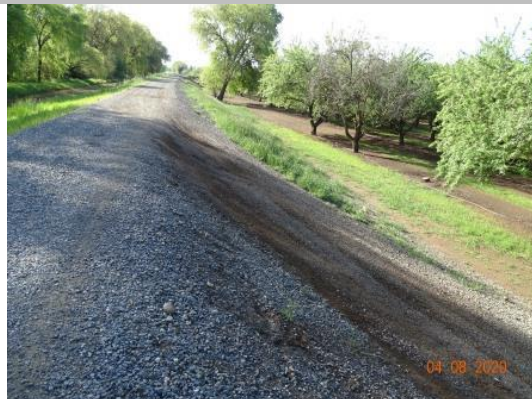
Photo 1 of 1 : SP_2023_MA0005_197_18_20230417_00005.jpg

LM Start	10.63	Rating **	M	Issue No.	18
LM End	10.63	Issue Type +	Ma	Location *	LS
Category	Earthen Levee			GPS Latitude/Longitude	
				Start	End
Item	Erosion / Vehicle Traffic			39.642061°	39.642061°
				-121.783861°	-121.783861°
DWR ID	DWR_MA0005_02_s_2012_18				
Comment Code					
E6 : Repair the levee slope damaged by vehicle traffic and prevent access where possible.					
Inspector Comment

View of the vehicle erosion along the landside slope. Spring 2020.

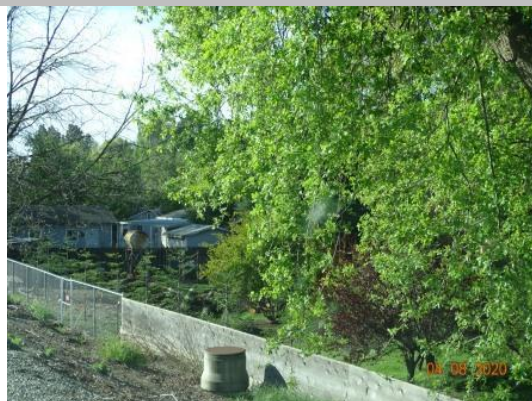
Photo 1 of 1 : SP_2023_MA0005_197_41_20230417_00007.jpg

LM Start	10.90	Rating **	U	Issue No.	41
LM End	10.93	Issue Type +	En	Location *	LS
Category	Earthen Levee			GPS Latitude/Longitude	
				Start	End
Item	Encroachments			39.645508°	39.645858°
				-121.786515°	-121.786742°
DWR ID	DWR_MA0005_02_f _ 2014_41				
Comment Code					
FE : Fence					
Inspector Comment					
Remove or apply for permit for the fence along the landside toe.

View of the fence along the landside toe. Spring 2020.

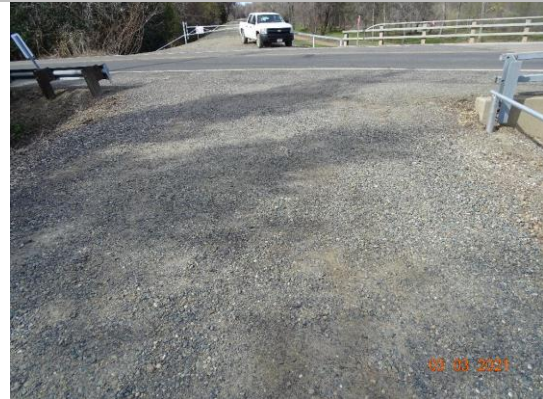
Photo 1 of 3 : UCIP_SP_2023_66677_98986.jpg

Comment Code						
Inspector Comment						
DS_ID:1668 FS_ID:66677 EP_NO: 6544-A Repair Type: Non-Urgent EVAL Issue: 11, Maintenance Compliance Issue Crossing Status: Indicator Found UCIP Comments: 03/03/2021 Record updated from No Action Needed to Non-Urgent. No inspection records were available to determine status of line through the levee. Recommend repairing gas line sign on levee slope. (O.Yakimov - DWR UCIP) 05/18/2017 Crossing appears to be in good condition. (A. Freitag - DWR Sutter Yard)11/14/2016 Crossing appears to be in good condition. (A. Freitag - DWR Sutter Yard)05/11/2016 Crossing appears to be in good condition. (A. Freitag - DWR Sutter Yard)07/30/2015 Crossing is in good condition. (A. Freitag - DWR Sutter Yard)11/24/2014 Same as last inspection. (A. Freitag - DWR Sutter Yard)06/04/2014 Same as last inspection. (A. Freitag - DWR Sutter Yard)11/13/2013 Same as last inspection. (A. Freitag - DWR Sutter Yard)06/06/2013 Same as last inspection. (A. Freitag - DWR Sutter Yard) FIELD_STRUCT_DESC: 6-inch steel high pressure gas line through the levee, 3.3 feet below the crown. Sign on south side of Durham-Dayton Highway. (6-inch gas line authorized under Permit No. 6544 and 6544-A, 1969 - Pacific Gas and Electric Company [PG&E]). [Additional Reference(s): DWR Levee Log, 1990 (HLM 11.07)]. FS Date: 3/3/2021 3:27:47 PM

Top of Levee: View of levee crown looking upstream

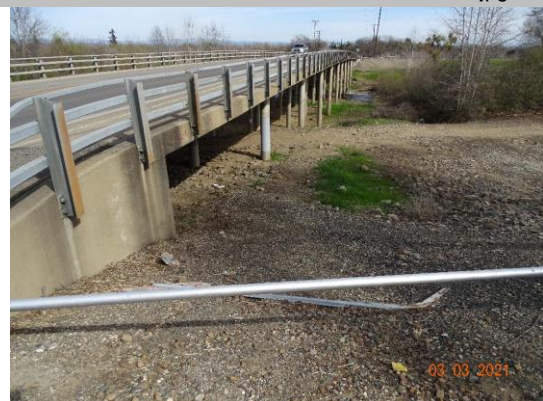
Photo 2 of 3 : UCIP_SP_2023_66677_98988.jpg

Water-Side: View of levee slope looking from crown

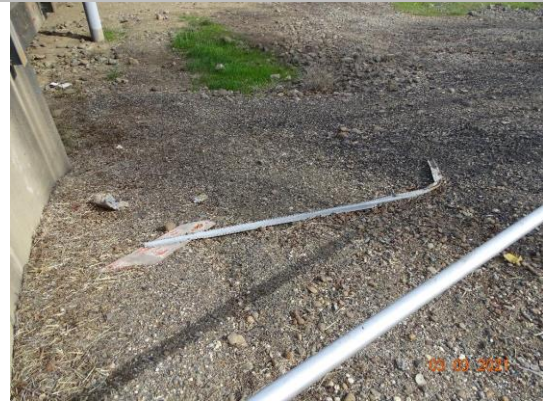
Photo 3 of 3 : UCIP_SP_2023_66677_98987.jpg

Water-Side: Fallen gas line sign on levee slope

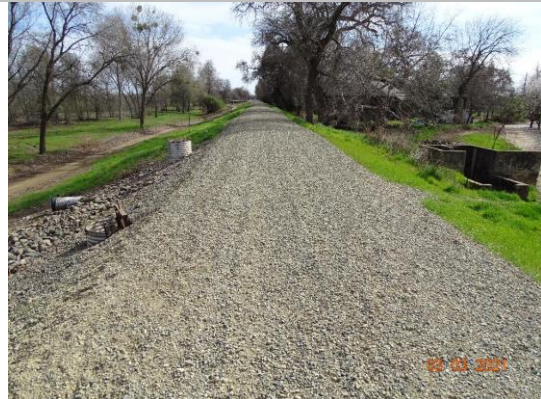
Photo 1 of 3 : UCIP_SP_2023_66857_99000.jpg

Comment Code						
Inspector Comment						
DS_ID:1671 FS_ID:66857 EP_NO: N/A Repair Type: Non-Urgent EVAL Issue: 11, Maintenance Compliance Issue Crossing Status: Found UCIP Comments: 03/03/2021 Record remains Non-Urgent. Crossing appears abandoned. Slide gate is in closed position, stem is bent. Soil and debris at the bottom of CMP riser on waterside shoulder cover slide gate. No permit has been identified authorizing pipe. DMP internal video inspection has not found pipe integrity issues. LOF of crossing is less or equal to 4.0. Recommend next video inspection in 5 years. (O.Yakimov - DWR UCIP) 05/18/2017 Abandoned- WS end still buried. (A. Freitag - DWR Sutter Yard)11/14/2016 Appears abandoned. (A. Freitag - DWR Sutter Yard)05/11/2016 Abandoned crossing. (A. Freitag - DWR Sutter Yard)07/30/2015 Abandoned crossing. Unable to locate the WS end of pipe. (A. Freitag - DWR Sutter Yard)11/24/2014 Same as last inspection. (A. Freitag - DWR Sutter Yard)06/04/2014 Same as last inspection. (A. Freitag - DWR Sutter Yard)11/13/2013 Same as last inspection. (A. Freitag - DWR Sutter Yard)06/06/2013 Same as last inspection. (A. Freitag - DWR Sutter Yard)11/01/2012 Pipe appears abandoned. It needs to be abandoned properly. (W. Wylie - DWR UCIP) FIELD_STRUCT_DESC: 30-inch corrugated metal irrigation pipe through the levee, 9.4 feet below the crown. Slide gate in a 42-inch corrugated metal riser on the waterside (WS) slope. Concrete distribution box on the landside (LS). [Additional Reference(s): DWR Levee Log, 1990 (HLM 11.27). USACE Sacramento O&M Manual, Unit 516, April 1960, Revised 3 February 2011, (Station 215+46), listed as 30-inch pipe]. FS Date: 3/3/2021 10:16:09 AM

Top of Levee: View of levee crown looking downstream

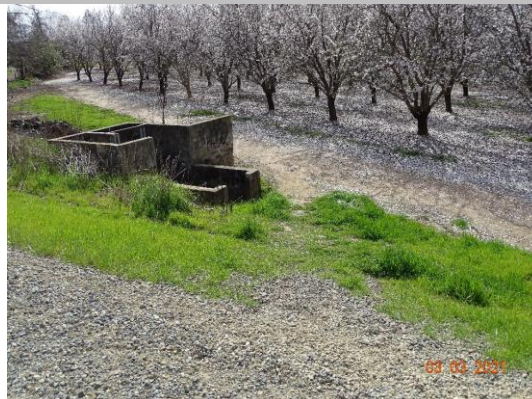
Photo 2 of 3 : UCIP_SP_2023_66857_99003.jpg

Land-Side: View of levee slope looking from crown. Concrete distribution box at levee toe

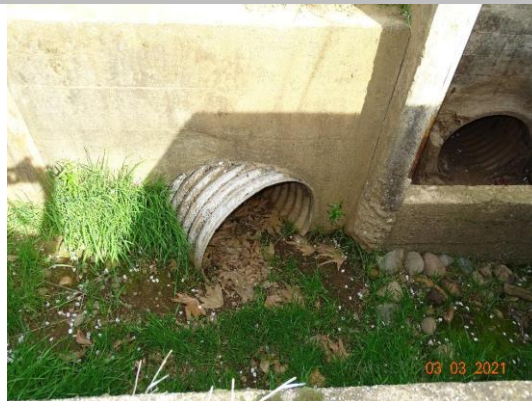
Photo 3 of 3 : UCIP_SP_2023_66857_99004.jpg

Land-Side: Pipe end in concrete box at levee toe

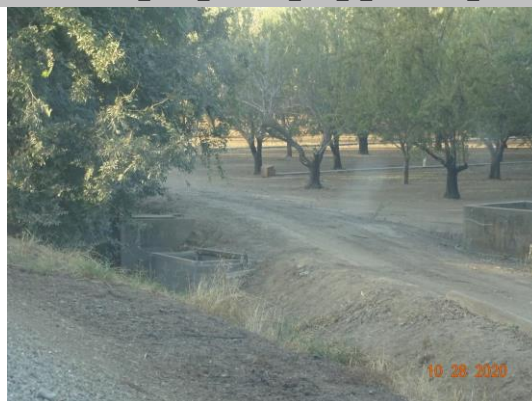
Photo 1 of 1 : SP_2023_MA0005_197_6_20230417_00002.jpg

LM Start	11.27	Rating **	M	Issue No.	6
LM End	11.77	Issue Type +	En	Location *	LS
Category	Earthen Levee			GPS Latitude/Longitude	
				Start	End
Item	Encroachments			39.650046°	39.657142°
				-121.789945°	-121.788690°
DWR ID	DWR_MA0005_02_s_2012_6				
Comment Code					
DT : Ditch					
Inspector Comment

View of the ditch along the landside toe. Fall 2020.

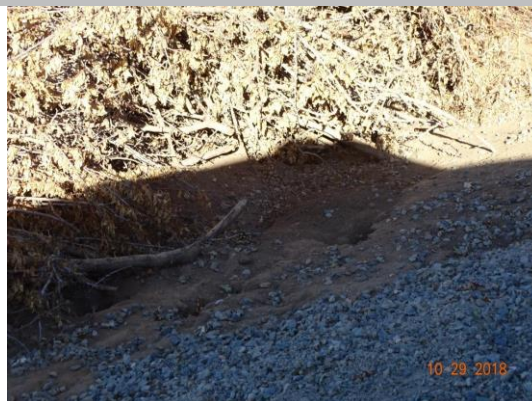
Photo 1 of 1 : SP_2023_MA0005_197_71_20230417_00013.jpg

LM Start	11.77	Rating **	M	Issue No.	71
LM End	11.77	Issue Type +	Ma	Location *	LS
Category	Earthen Levee			GPS Latitude/Longitude	
				Start	End
Item	Animal Control			39.657115°	39.657115°
				-121.788703°	-121.788703°
DWR ID	DWR_MA0005_02_f_2018_71				
Comment Code					
A3 : No rodents visible, but rodent burrows visible; need to backfill and compact or grout burrows.					
Inspector Comment

View of the rodent holes along the landside slope.

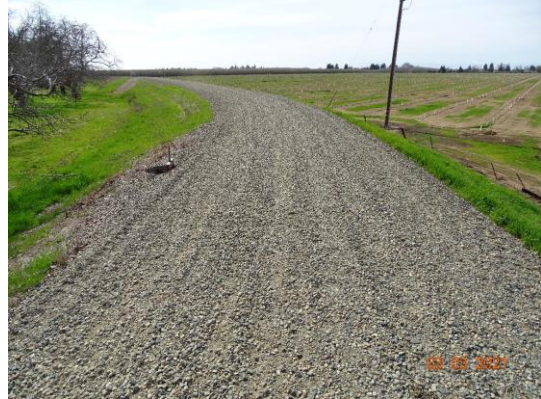
Photo 1 of 3 : UCIP_SP_2023_66886_99009.jpg

DS_ID:1673
FS_ID:66886
EP_NO: N/A
Repair Type: Non-Urgent
EVAL Issue: 4b, Safety Issue
Crossing Status: Found
UCIP Comments: 03/03/2021 Record remains Non-Urgent. CMP riser on waterside slope is open at ground level. Recommend installation of top cover. Crossing appears abandoned. Headwall is buried in soil at landside toe, soil at the bottom of CMP riser on waterside slope blocks slide gate from opening. Capped pipe in front of headwall on landside may not belong to this crossing. Geophysical study indicates possible presence of pipe through levee. Owner needs to coordinate with the CVFPB to remove or abandon crossing according to Title 23 requirements. No permit has been identified authorizing pipe. (O.Yakimov - DWR UCIP)
05/23/2019 (O. Magana - DWR UCIP)05/18/2017 Abandoned- needs to be done properly. Pipe has been selected to be internally cleaned and inspected as part of the DMP project. (A. Freitag - DWR Sutter Yard)11/14/2016 Abandoned- needs a cover for standpipe. (A. Freitag - DWR Sutter Yard)05/11/2016 Abandoned crossing. Needs a cover for the WS riser. (A. Freitag - DWR Sutter Yard)08/03/2015 Crossing appears abandoned. Only the slide gate inside riser on the WS shoulder could be found. Riser needs a cover made for it. (A. Freitag - DWR Sutter Yard)11/24/2014 Same as last inspection. (A. Freitag - DWR Sutter Yard)06/04/2014 Same as last inspection. (A. Freitag - DWR Sutter Yard)11/13/2013 Slide gate top and stem were repaired to make gate operational. (A. Freitag - DWR Sutter Yard)06/06/2013 New slidegate is planned to be installed during summer of 2013. (A. Freitag - DWR Sutter Yard)11/01/2012 Slide gate on WS shoulder bent and damaged (inoperable) Pipe appears abandoned. (W. Wylie - DWR UCIP)

FIELD_STRUCT_DESC: 24-inch corrugated metal drainage pipe through the levee, 14 feet below the crown. Slide gate in a corrugated metal riser on the waterside (WS) slope. [Additional Reference(s): DWR Levee Log, 1990 (HLM 12.98). USACE Sacramento O&M Manual, Unit 516, April 1960, Revised 3 February 2011, (Station 126+91), listed as 24-inch pipe].
FS Date: 3/3/2021 11:13:03 AM

Top of Levee: View of levee crown looking downstream

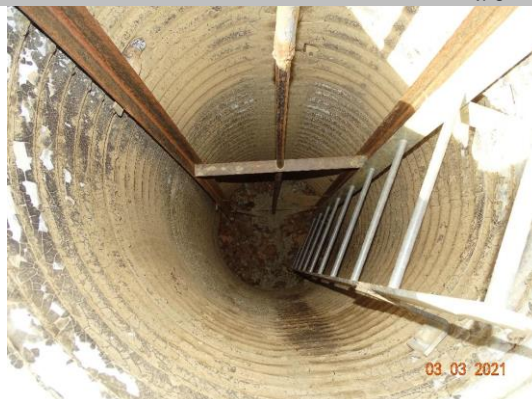
Photo 2 of 3 : UCIP_SP_2023_66886_99011.jpg

Water-Side: View inside CMP riser. Soil buildup at bottom

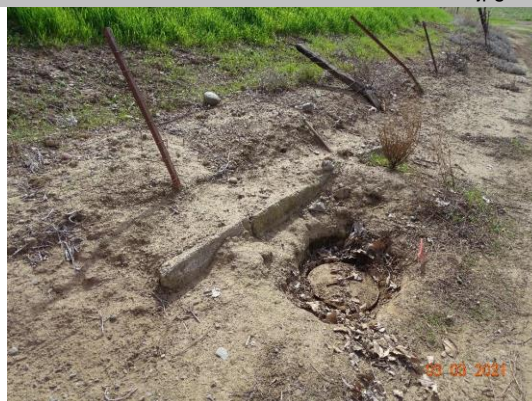
Photo 3 of 3 : UCIP_SP_2023_66886_99013.jpg

Land-Side: Buried in soil headwall at levee toe. Capped pipe in front of headwall

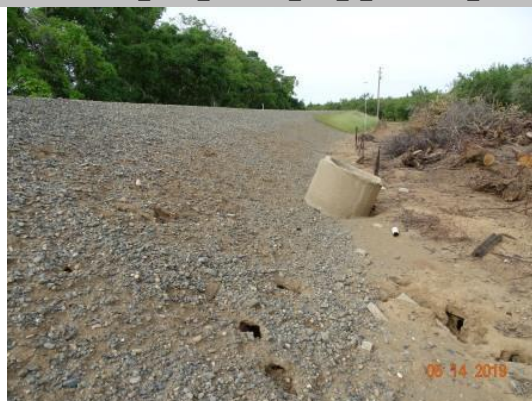
Photo 1 of 1 : SP_2023_MA0005_197_9_20230417_00004.jpg

LM Start	12.84	Rating **	M	Issue No.	9
LM End	12.84	Issue Type +	Ma	Location *	LS
Category	Earthen Levee			GPS Latitude/Longitude	
				Start	End
Item	Animal Control			39.671281°	39.671281°
				-121.782390°	-121.782389°
DWR ID	DWR_MA0005_02_s_2019_9				
Comment Code					
A3 : No rodents visible, but rodent burrows visible; need to backfill and compact or grout burrows.					
Inspector Comment

View of the animal burrows on the landside slope. Spring 2019.

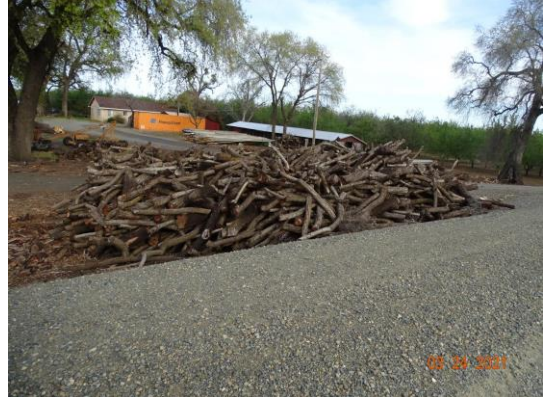
Photo 1 of 1 : SP_2023_MA0005_197_50_20230417_00010.jpg

LM Start	13.07	Rating **	U	Issue No.	50
LM End	13.07	Issue Type +	En	Location *	LS
Category	Earthen Levee			GPS Latitude/Longitude	
				Start	End
Item	Encroachments			39.674321°	39.674321°
				-121.781163°	-121.781163°
DWR ID	DWR_MA0005_02_s_2020_50				
Comment Code					
FW : Firewood					
Inspector Comment

View of the pile of firewood at the landside toe. Spring 2021.

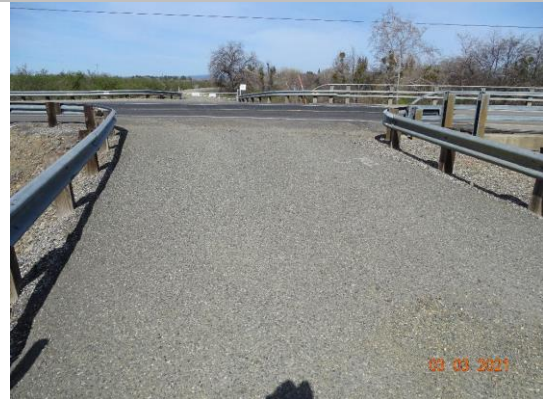
Photo 1 of 3 : UCIP_SP_2023_77839_99026.jpg

Comment Code					
Inspector Comment					
DS_ID:1740 FS_ID:77839 EP_NO: 17127 Repair Type: Urgent EVAL Issue: 1, Pipe Integrity Crossing Status: Found UCIP Comments: 12/13/2022 Record updated from Non-Urgent to Urgent. DMP internal video inspection has found pipe integrity issues. LOF of crossing is between 5 and 6. Crossing will be monitored until funding becomes available to address the issues. (O.Yakimov - DWR UCIP) 03/03/2021 Record updated from No Action Needed to Non-Urgent. Vegetation and debris around headwall and flap gate on waterside need to be cleared. (O.Yakimov - DWR UCIP) 5/18/2017 Crossing appears to be in good condition. Pipe has been selected to be internally cleaned and inspected as part of the DMP project. (A. Freitag - DWR Sutter Yard)11/14/2016 Crossing appears to be in good condition. (A. Freitag - DWR Sutter Yard)05/11/2016 Ws flap gate is being overgrown by vegetation. (A. Freitag - DWR Sutter Yard)08/03/2015 Crossing appears in good condition. No noticeable issues to report. (A. Freitag - DWR Sutter Yard)11/24/2014 Flap gate needs to be dug out and unblocked. (A. Freitag - DWR Sutter Yard)06/04/2014 Same as last inspection. (A. Freitag - DWR Sutter Yard)11/13/2013 Flap gate is completely blocked from being able to open. (A. Freitag - DWR Sutter Yard)06/06/2013 Same as last inspection. (A. Freitag - DWR Sutter Yard)11/01/2012 Debris, soil, and vegetation creating minor blockage at flap gate outlet. (W. Wylie - DWR UCIP) FIELD_STRUCT_DESC: 36-inch corrugated metal drainage pipe through the levee, 12 feet below the crown. 4-foot by 4-foot concrete box and slide gate on the landside (LS). Concrete headwall and flap gate at the waterside (WS) outlet. (36-inch pipe authorized under Permit No. 17127, 1999 - Butte County, Department of Public Works). FS Date: 3/3/2021 8:30:03 PM

Top of Levee: View of levee crown looking upstream

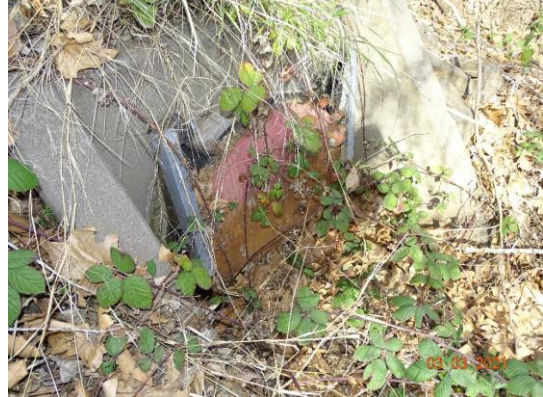
Photo 2 of 3 : UCIP_SP_2023_77839_99029.jpg

LM Start	13.38	Rating **	U	Issue No.	30 (cont)
LM End	13.38	Issue Type +	En	Location *	
Category	Supplemental			GPS Latitude/Longitude	
				Start	End
Item	DWR UCIP Field Study			39.678267°	39.678267°
				-121.778322°	-121.778322°
DWR ID	1740

Water-Side: Flap gate at levee toe buried in vegetation and debris

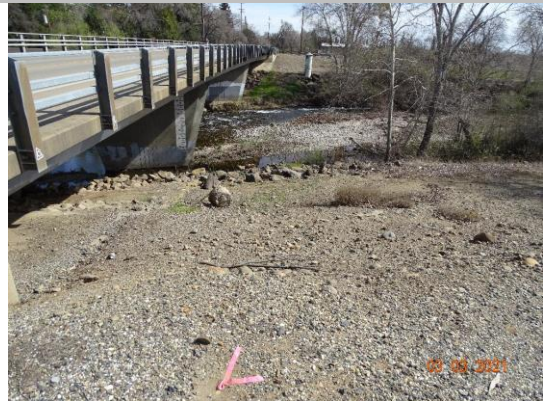
Photo 3 of 3 : UCIP_SP_2023_77839_99028.jpg

Water-Side: View of levee slope looking from crown
