**Flood Control Project Maintenance
Levee Inspections
LMA District Cover Sheet**

**Flood Control Project Maintenance
Levee Inspections
Unit Cover Sheet**

Waterway			Bank	Unit Miles
Unit No. 01 Butte Creek			Left	15.08
	Spring (March - May)	Summer (June - August)	(September - November) Fall	Winter (December - February)
Unit Maintenance Rating (Fall Only)				
Date of Inspection	4/26/2023 - 4/26/2023			
DWR Inspector	Makar Sokol			
Accompanied By	Shawn Freitag DWR Sutter Yard

Levee Inspection Report By Mile - Spring 2023

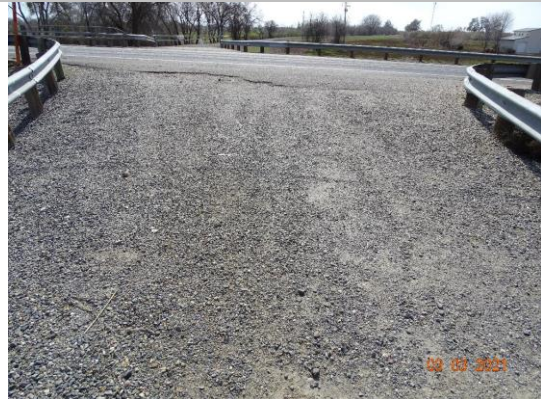
Photo 1 of 3 : UCIP_SP_2023_67136_99074.jpg

Comment Code						
Inspector Comment						
DS_ID:1679 FS_ID:67136 EP_NO: N/A Repair Type: Non-Urgent EVAL Issue: Crossing Status: Found UCIP Comments: 03/03/2021 Record updated from No Action Needed to Non-Urgent. No permit has been identified authorizing pipe. According to DMP records this crossing was CIPP-lined on 07/19/2019. (O.Yakimov - DWR UCIP) 05/18/2017 Crossing appears to be in good condition. Pipe has been selected to be internally cleaned and inspected as part of the DMP project. (A. Freitag - DWR Sutter Yard)11/14/2016 Crossing appears to be in good condition. (A. Freitag - DWR Sutter Yard)05/11/2016 Crossing appears to be in good condition. (A. Freitag - DWR Sutter Yard)08/03/2015 Crossing appears in good condition. No noticeable issues to report. (A. Freitag - DWR Sutter Yard)11/25/2014 Same as last inspection. (A. Freitag - DWR Sutter Yard)06/04/2014 Same as last inspection. (A. Freitag - DWR Sutter Yard)11/13/2013 Same as last inspection. (A. Freitag - DWR Sutter Yard)06/06/2013 Same as last inspection. (A. Freitag - DWR Sutter Yard) FIELD_STRUCT_DESC: 24-inch CIPP-lined corrugated metal drainage pipe through the levee, 14.5 feet below the crown. Concrete "U" shaped headwall on the waterside (WS). Flap gate on the WS. [Additional Reference(s): DWR Levee Log, 1990 (HLM 13.61). USACE Sacramento O&M Manual, Unit 516, April 1960, Revised 3 February 2011, (Station 93+78), listed as 24-inch pipe]. FS Date: 3/3/2021 2:46:16 PM

Top of Levee: View of levee crown looking downstream

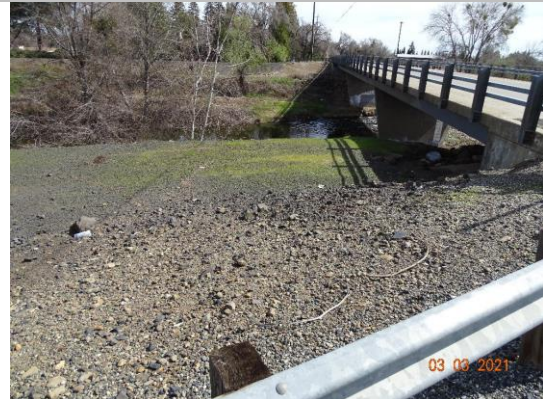
Photo 2 of 3 : UCIP_SP_2023_67136_99075.jpg

LM Start	13.40	Rating **	M	Issue No.	31 (cont)
LM End	13.40	Issue Type +	Ma	Location *	
Category	Supplemental		GPS Latitude/Longitude		
			Start	End	
Item	DWR UCIP LMA Responsibility		39.678550°	39.678550°	
			-121.778339°	-121.778339°	
DWR ID	1679

Water-Side: View of levee slope looking from crown

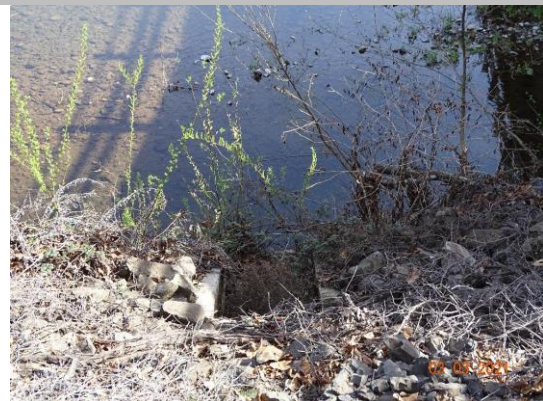
Photo 3 of 3 : UCIP_SP_2023_67136_99076.jpg

Water-Side: Pipe outlet at riverbank

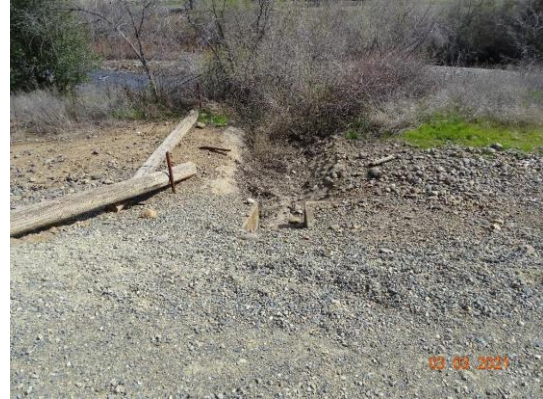
Photo 1 of 3 : UCIP_SP_2023_67139_99087.jpg

Comment Code					
Inspector Comment					
DS_ID:1682 FS_ID:67139 EP_NO: N/A Repair Type: Urgent EVAL Issue: 3a, Flood Risk Crossing Status: Found UCIP Comments: 03/03/2021 Record updated from No Action Needed to Urgent. Debris inside the pipe blocks flap gate from complete closing that is posing flood risk to landside. Debris needs to be cleared for proper operation. No permit has been identified authorizing pipe. DMP internal video inspection has not found pipe integrity issues. LOF of crossing is less or equal to 4.0. Recommend next video inspection in 5 years. (O.Yakimov - DWR UCIP) 05/23/2019 (O. Magana - DWR UCIP)05/18/2017 Crossing appears to be in good condition. Pipe has been selected to be internally cleaned and inspected as part of the DMP project. (A. Freitag - DWR Sutter Yard)11/14/2016 Crossing appears to be in good condition. (A. Freitag - DWR Sutter Yard)05/11/2016 Crossing appears to be in good condition. (A. Freitag - DWR Sutter Yard)08/03/2015 Crossing appears in good condition. No noticeable issues to report. (A. Freitag - DWR Sutter Yard)11/25/2014 Same as last inspection. (A. Freitag - DWR Sutter Yard)06/04/2014 Same as last inspection. (A. Freitag - DWR Sutter Yard)11/13/2013 Same as last inspection. (A. Freitag - DWR Sutter Yard)06/06/2013 Same as last inspection. (A. Freitag - DWR Sutter Yard) FIELD_STRUCT_DESC: 24-inch corrugated metal drainage pipe through the levee, 7.2 feet below the crown. Concrete "U" shaped headwall and grouted spillway on the waterside (WS). Slide gate in a 48-inch concrete standpipe on the landside (LS). Flap gate on the WS. [Additional Reference(s): DWR Levee Log, 1990 (HLM 14.68). USACE Sacramento O&M Manual, Unit 516, April 1960, Revised 3 February 2011, (Station 37+10), listed as 24-inch pipe]. USACE As-Built Drawing No. 50-04-3350, Sheet 20, STA 37+10, 12 August 1959]. FS Date: 3/3/2021

Water-Side: View of levee slope looking from crown

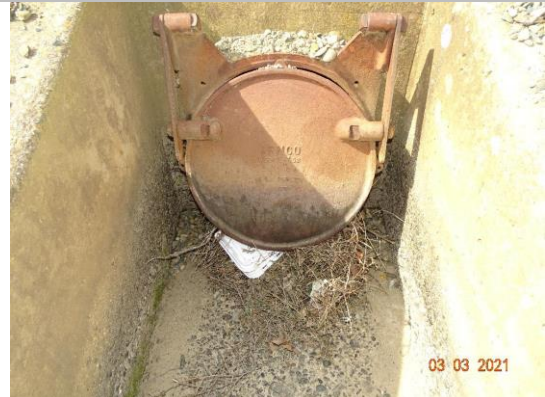
Photo 2 of 3 : UCIP_SP_2023_67139_99088.jpg

LM Start	14.46	Rating **	U	Issue No.	32 (cont)
LM End	14.46	Issue Type +	Ma	Location *	
Category	Supplemental		GPS Latitude/Longitude		
			Start	End	
Item	DWR UCIP LMA Responsibility		39.693331°	39.693331°	
			-121.779556°	-121.779556°	
DWR ID	1682

Water-Side: U-shaped headwall, flap gate on pipe end. Clearing of debris in pipe is required

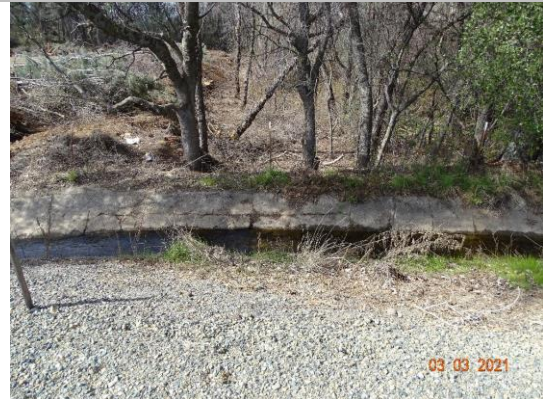
Photo 1 of 3 : UCIP_SP_2023_67140_99090.jpg

DS_ID:1683
FS_ID:67140
EP_NO: N/A
Repair Type: Non-Urgent
EVAL Issue:
Crossing Status: Found
UCIP Comments: 03/03/2021 Record remains Non-Urgent. This crossing has been CIPP lined, new flap gate installed on waterside end. No permit has been identified authorizing pipe. (O.Yakimov - DWR UCIP)
05/18/2017 WS appears to be in good condition. LS inlet is across a ditch and inaccessible for inspection due to dense vegetation and being down a very steep slope. Pipe has been selected to be internally cleaned and inspected as part of the DMP project. (A. Freitag - DWR Sutter Yard)11/14/2016 Crossing appears to be in good condition. (A. Freitag - DWR Sutter Yard)05/11/2016 Crossing appears to be in good condition. (A. Freitag - DWR Sutter Yard)08/03/2015 Crossing appears in good condition. No noticeable issues to report. (A. Freitag - DWR Sutter Yard)11/25/2014 Same as last inspection. (A. Freitag - DWR Sutter Yard)06/04/2014 Same as last inspection. (A. Freitag - DWR Sutter Yard)11/13/2013 Same as last inspection. (A. Freitag - DWR Sutter Yard)06/06/2013 Same as last inspection. (A. Freitag - DWR Sutter Yard)

FIELD_STRUCT_DESC: 24-inch CIPP-lined corrugated metal drainage pipe through the levee, 14.3 feet below the crown. Concrete "U" headwalls on both the landside (LS) and the waterside (WS). Flap gate on the WS. Inlet downhill from a concrete lined channel at the low point on the LS toe. [Additional Reference(s): DWR Levee Log, 1990 (HLM 14.69). USACE Sacramento O&M Manual, Unit 516, April 1960, Revised 3 February 2011, (Station 36+85), listed as 24-inch pipe].
FS Date: 3/3/2021 3:13:40 PM

Land-Side: View of levee slope looking from crown

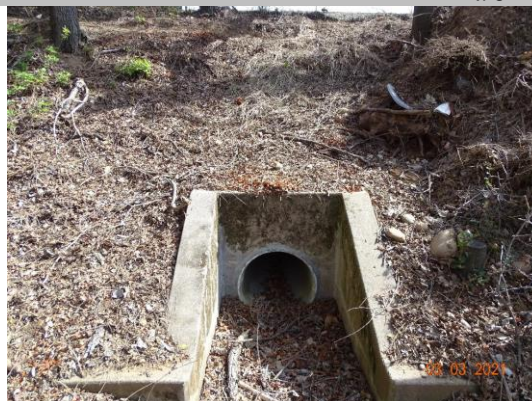
Photo 2 of 3 : UCIP_SP_2023_67140_99091.jpg

LM Start	14.47	Rating **	M	Issue No.	33 (cont)
LM End	14.47	Issue Type +	Ma	Location *	
Category	Supplemental			GPS Latitude/Longitude	
				Start	End
Item	DWR UCIP LMA Responsibility			39.693406°	39.693406°
				-121.779583°	-121.779583°
DWR ID	1683

Land-Side: U-shaped headwall and pipe inlet at levee toe

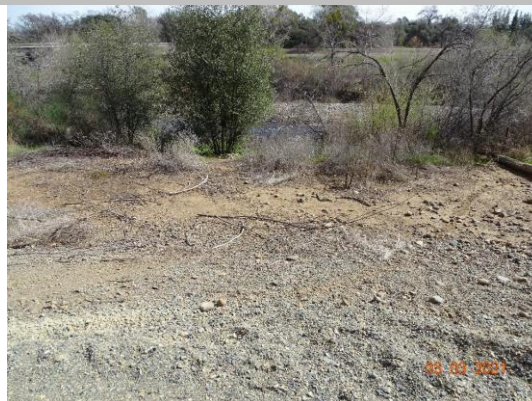
Photo 3 of 3 : UCIP_SP_2023_67140_99089.jpg

Water-Side: View of levee slope looking from crown

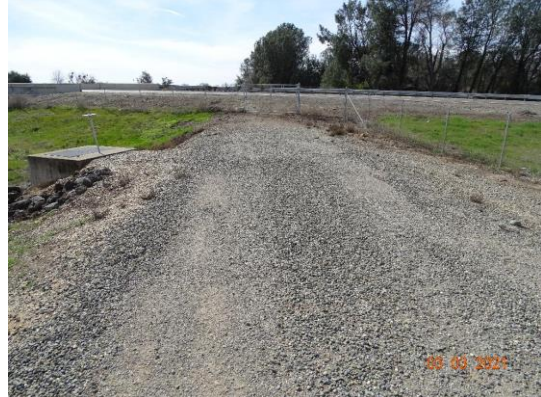
Photo 1 of 3 : UCIP_SP_2023_67141_99093.jpg

Comment Code						
Inspector Comment						
DS_ID:1731 FS_ID:67141 EP_NO: 14519 Repair Type: Non-Urgent EVAL Issue: 11, Maintenance Compliance Issue Crossing Status: Found UCIP Comments: 03/03/2021 Record updated from No Action Needed to Non-Urgent. Flap gate on waterside buried in soil. Recommend clearing flap gate area from soil for proper operation. (O.Yakimov - DWR UCIP) 06/13/2019 DSID 1731 is the official record for any updates related to Permit No. 14519. (O. Magana - DWR UCIP) 05/18/2017 Crossing appears to be in good condition. Pipe has been selected to be internally cleaned and inspected as part of the DMP project. (A. Freitag - DWR Sutter Yard)11/14/2016 Crossing appears to be in good condition. (A. Freitag - DWR Sutter Yard)05/11/2016 Crossing appears to be in good condition. (A. Freitag - DWR Sutter Yard)08/03/2015 Flapgate blocked by minor sediment buildup. (A. Freitag - DWR Sutter Yard)11/25/2014 Pipe outlet needs to be dug up and flap gate closed. (A. Freitag - DWR Sutter Yard)06/04/2014 Same as last inspection. (A. Freitag - DWR Sutter Yard)11/13/2013 Same as last inspection. (A. Freitag - DWR Sutter Yard)06/06/2013 Same as last inspection. (A. Freitag - DWR Sutter Yard)11/02/2012 Pipe outlet burried and flap gate will not function. (W. Wylie - DWR UCIP) FIELD_STRUCT_DESC: 24-inch soil proofed steel drainage pipe through the levee, 12 feet below the crown. Concrete headwall on the landside (LS) toe. 4-foot by 4-foot concrete box with a slide gate on the waterside (WS) shoulder. Outlet with a flap gate near the stream, 275 feet southeast of the concrete box on the WS shoulder. (24-inch pipe authorized under Permit No. 14519, 1987 - California Department of Transportation [Caltrans]). [Additional Reference(s): DWR Levee Log, 1990 (HLM 14.78)]. FS Date: 3/3/2021 3:17:02 PM

Top of Levee: View of levee crown looking downstream

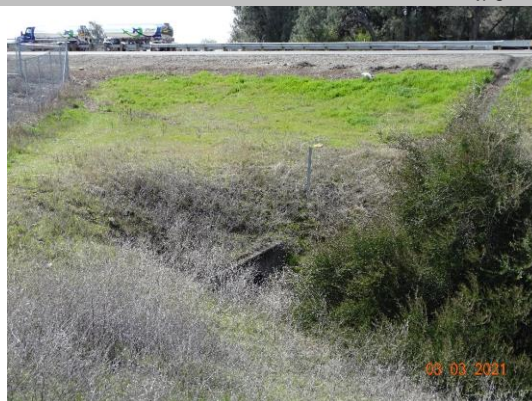
Photo 2 of 3 : UCIP_SP_2023_67141_99094.jpg

LM Start	14.60	Rating **	M	Issue No.	35 (cont)
LM End	14.60	Issue Type +	En	Location *	
Category	Supplemental		GPS Latitude/Longitude		
			Start	End	
Item	DWR UCIP Field Study		39.695204°	39.695204°	
			-121.778557°	-121.778557°	
DWR ID	1731

Land-Side: Headwall and pipe inlet at drainage ditch

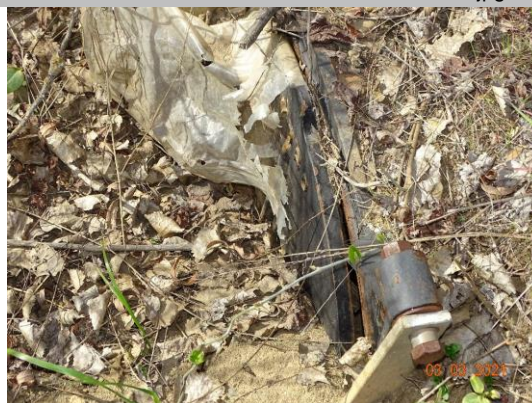
Photo 3 of 3 : UCIP_SP_2023_67141_99097.jpg

Water-Side: Closeup view of flap gate buried in soil

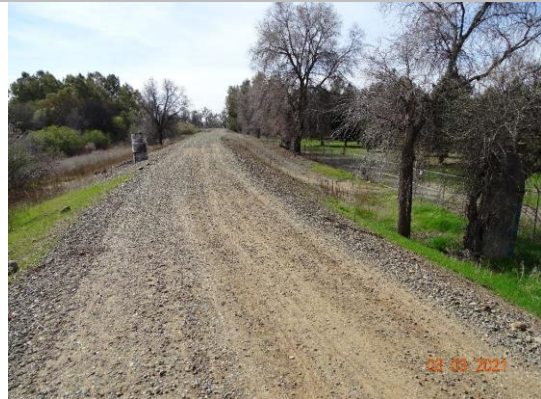
Photo 1 of 3 : UCIP_SP_2023_67143_99103.jpg

DS_ID:1686
FS_ID:67143
EP_NO: N/A
Repair Type: Urgent
EVAL Issue: 3a, Flood Risk
Crossing Status: Found
UCIP Comments: 03/03/2021 Record updated from Non-Urgent to Urgent. Slide gate in CMP riser on waterside shoulder is in open position. Slide gate stem is bent inside riser. Concrete standpipe on landside slope is in unsound condition. Top concrete ring shifted creating a gap. Crossing appears abandoned. Pipe crossing levee at sharp angle. No permit has been identified authorizing pipe. (O.Yakimov - DWR UCIP)
05/18/2017 Only WS and LS standpipes visible. (A. Freitag - DWR Sutter Yard)11/14/2016 Still only WS standpipe visible. (A. Freitag - DWR Sutter Yard)05/11/2016 Only WS standpipe was visible. (A. Freitag - DWR Sutter Yard)08/03/2015 Only able to locate the standpipe on the WS. (A. Freitag - DWR Sutter Yard)11/25/2014 Same as last inspection. (A. Freitag - DWR Sutter Yard)06/04/2014 Same as last inspection. (A. Freitag - DWR Sutter Yard)11/13/2013 Same as last inspection. (A. Freitag - DWR Sutter Yard)06/06/2013 Same as last inspection. (A. Freitag - DWR Sutter Yard)

FIELD_STRUCT_DESC: 12-inch steel irrigation pipe (siphon) through the levee, 10 feet below the crown. Slide gate in a 36-inch corrugated metal riser on the waterside (WS) slope. 30-inch concrete standpipe at the landside (LS) toe. [Additional Reference(s): DWR Levee Log, 1990 (HLM 15.48). USACE Sacramento O&M Manual, Unit 516, April 1960, Revised 3 February 2011, (Station 145+53), listed as 12-inch pipe]
FS Date: 3/3/2021 3:24:19 PM

Top of Levee: View of levee crown looking downstream

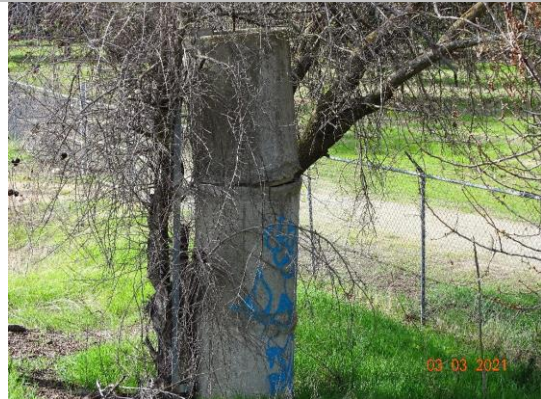
Photo 2 of 3 : UCIP_SP_2023_67143_99107.jpg

LM Start	15.26	Rating **	U	Issue No.	36 (cont)
LM End	15.26	Issue Type +	En	Location *	
Category	Supplemental		GPS Latitude/Longitude		
			Start	End	
Item	DWR UCIP Field Study		39.704409 °	39.704409 °	
			-121.777803 °	-121.777803 °	
DWR ID	1686

Land-Side: View of concrete standpipe. Gap is visible between top and middle concrete rings

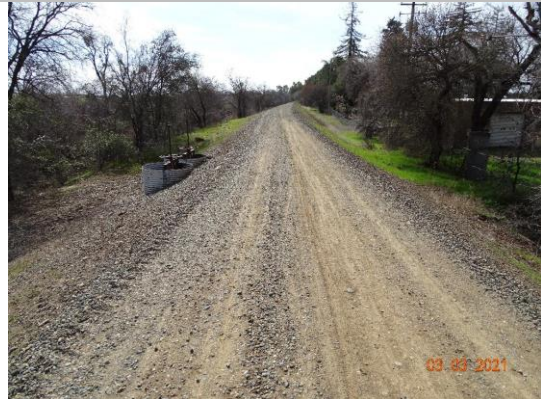
Photo 1 of 3 : UCIP_SP_2023_67144_99108.jpg

Comment Code					
Inspector Comment					
DS_ID:1687 FS_ID:67144 EP_NO: N/A Repair Type: Non-Urgent EVAL Issue: 4b, Safety Issue Crossing Status: Found UCIP Comments: 03/03/2021 Record remains Non-Urgent. CMP riser on waterside shoulder is open at ground level. Recommend installation of top cover. No permit has been identified authorizing pipe. (O.Yakimov - DWR UCIP) 05/18/2017 Crossing appears to be in good condition. WS riser needs a cover. (A. Freitag - DWR Sutter Yard)11/14/2016 Good condition-needs a cover for standpipe. (A. Freitag - DWR Sutter Yard)05/11/2016 Needs a lcover for riser. The rest of the crossing appears in good condition. (A. Freitag - DWR Sutter Yard)08/03/2015 Crossing is in good condition but needs a cover made for the riser. (A. Freitag - DWR Sutter Yard)11/25/2014 Same as last inspection. (A. Freitag - DWR Sutter Yard)06/04/2014 Same as last inspection. (A. Freitag - DWR Sutter Yard)11/13/2013 Same as last inspection. (A. Freitag - DWR Sutter Yard)06/06/2013 Same as last inspection. Need to construct covers for top of standpipe. (A. Freitag - DWR Sutter Yard)11/02/2012 Good candidate for video inspection. (W. Wylie - DWR UCIP) FIELD_STRUCT_DESC: 1 of 2: 54-inch corrugated metal irrigation pipe (siphon) through the levee, 17.8 feet below the crown. Slide gate in a 66-inch corrugated metal riser on the waterside (WS). Concrete headwall and irrigation ditch at the landside (LS) toe. Edgar Slough riser units in the floodway. [Additional Reference(s): DWR Levee Log, 1990 (HLM 15.71). USACE Sacramento O&M Manual, Unit 516, April 1960, Revised 3 February 2011, (Station 132+00), listed as 54-inch pipe]. FS Date: 3/3/2021 3:30:43 PM

Top of Levee: View of levee crown looking downstream

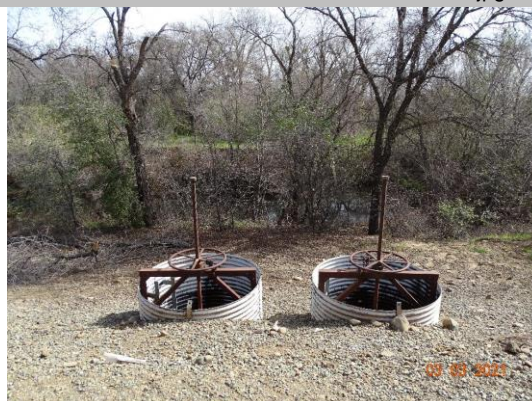
Photo 3 of 3 : UCIP_SP_2023_67144_99109.jpg

Water-Side: View of levee slope looking from crown. CMP riser needs a top cover
