**Flood Control Project Maintenance
Levee Inspections**

Fall 2015 Levee Maintenance Deficiency Summary Report

Sutter Maintenance Yard Maintenance Area 0007

Waterway		Bank	Unit Miles	
Unit No. 01 Feather River		Right	11.90	
	Spring (March - May)	Summer (June - August)	(September - November) Fall	Winter (December - February)
Unit Maintenance Rating (Fall Only)			M	
Date of Inspection	05/05/2015 - 05/05/2015		11/16/2015 - 11/16/2015	
DWR Inspector	Michael Pitta		Bob Duffey	
Accompanied By	Sean Freitag		Sean Freitag

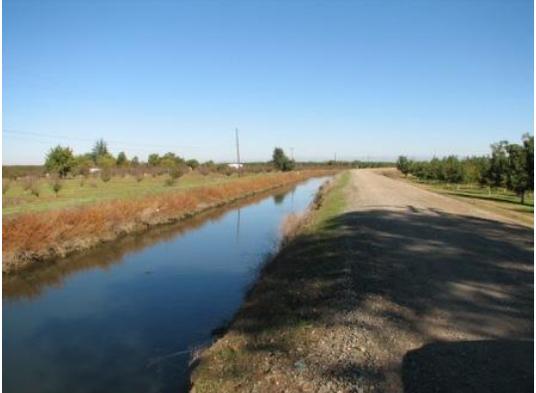
Photo 2 of 2 : FA_2015_MA0007_200_42_20151109_00007.jpg

LM Start	0.03	Rating **	M	Issue No.	42 (cont)
LM End	1.72	Issue Type +	Ma	Location *	LS

Agricultural ditch landside slope and toe.

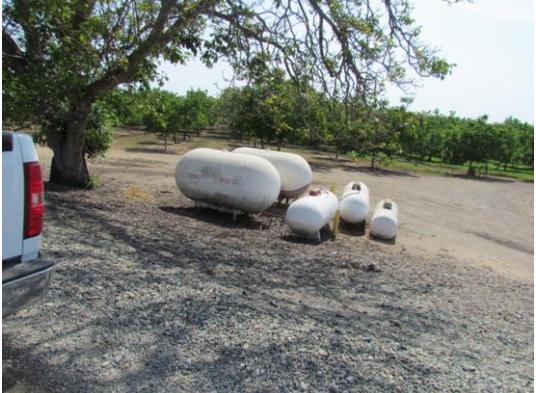
Photo 1 of 1 : FA_2015_MA0007_200_48_20151109_00009.jpg

LM Start	0.47	Rating **	M	Issue No.	48
LM End	0.47	Issue Type +	En	Location *	WS
Category	Earthen Levee		GPS Latitude/Longitude		
			Start	End	
Item	Encroachments		39.316950 °	39.316950 °	
			-121.633438 °	-121.633438 °	
DWR ID	DWR_MA0007_01_s_2015_48				
Action/Comments					
Tank

This view of the tanks was taken looking at the waterside of the levee facing upstream.

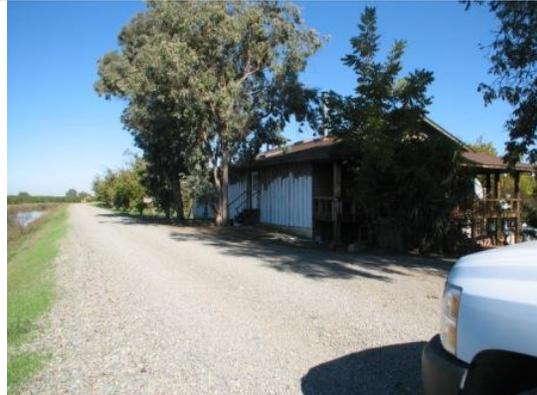
Photo 1 of 1 : FA_2015_MA0007_200_33_20151109_00003.jpg

LM Start	1.21	Rating **	U	Issue No.	33
LM End	1.21	Issue Type +	En	Location *	WS
Category	Earthen Levee			GPS Latitude/Longitude	
				Start	End
Item	Encroachments			39.327187 °	39.327187 °
				-121.632395 °	-121.632395 °
DWR ID	DWR_MA0007_01_s_2012_33				
Action/Comments					
Building

Levee mile 1.21. This is a photo of the building on the waterside slope.

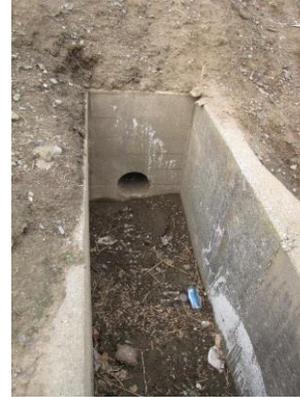
Photo 1 of 3 : UCIP_FA_2015_5360.jpg

LM Start	1.55	Rating **	M	Issue No.	218
LM End	1.55	Issue Type +	En	Location *	WS
Category	Supplemental			GPS Latitude/Longitude	
				Start	End
Item	DWR UCIP Field Study			39.331934 °	39.331934 °
				-121.633246 °	-121.633246 °
DWR ID

Inspector Comments: FS_ID:46095
 DS_ID:16928
 EP_NO: N/A
 FS_HLM: 1.544
 Repair Type: Non-Urgent
 Crossing Status: Found
 UCIP Comments: 6/10/2015 Same as last inspection.crossing appears abandoned, slide gate is missing on landward side; wood frame remains on LS; scour hole present on LS, 3 feet by 3 feet, near wood frame.5/10/2013 Same as last inspection. LS scour behind structure needs to be repaired.5/13/2013 SBFCA project recommends replacing in accordance with title 23.11/6/2013 Same as last inspection.5/19/2014 Same as last inspection.12/29/2014 Same as last inspection.
 FIELD_STRUCT_DESC: Abandoned 12-inch CM pipe through the levee, 8.2 feet below the crown. Slide gate on the landward is no longer present. Concrete "U" headwall at the waterward toe. Irrigation ditch located on landward side.
 FS Date: 07/01/2015

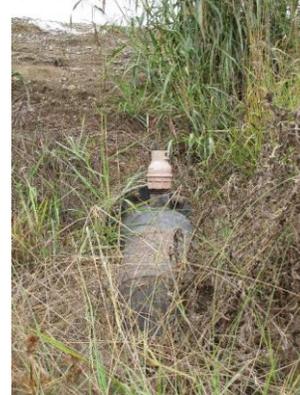
Photo 2 of 3 : UCIP_FA_2015_5364.jpg

LM Start	1.71	Rating **	M	Issue No.	219 (cont)
LM End	1.71	Issue Type +	En	Location *	WS
Category	Supplemental			GPS Latitude/Longitude	
				Start	End
Item	DWR UCIP Field Study			39.334294 °	39.334294 °
				-121.634008 °	-121.634008 °
DWR ID					
Action/Comments					
Inspector Comments: FS_ID:46096 DS_ID:20816 EP_NO: N/A FS_HLM: 1.716 Repair Type: Non-Urgent Crossing Status: Found UCIP Comments: 6/10/2015 Crossing has been modified since last inspection. 3' black plastic pipe is now running through the metal pipe and the difference was capped and welded. Crossing was installed about 1 foot deep--need permit authorizing work5/7/2013 Same as last inspection. Recommend finding owner.5/13/2013 SBFCA project recommends removal. Permit number and owner in detailed report book.11/6/2013 Same as last inspection.5/19/2014 Same as last inspection.12/29/2014 Same as last inspection. FIELD_STRUCT_DESC: 12 inch irrigation pipe through the levee 1 foot below the crown. Crossing on landward side is attached to weir above ground. Siphon breaker on waterward side. No opening on waterward side. FS Date: 07/01/2015

Exposed section of the pipe located on waterward slope.

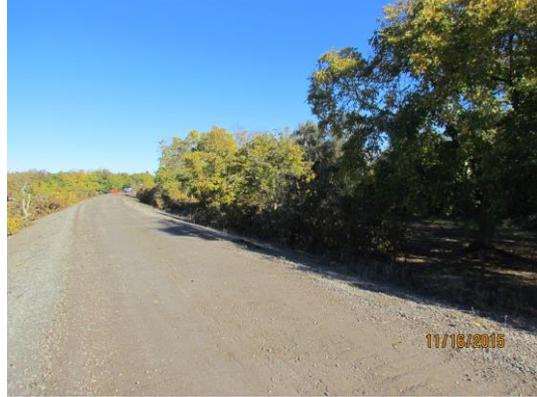
Photo 1 of 1 : FA_2015_MA0007_200_43_20151118_00015.jpg

LM Start	1.77	Rating **	M	Issue No.	43
LM End	1.97	Issue Type +	En	Location *	WS
Category	Earthen Levee		GPS Latitude/Longitude		
			Start	End	
Item	Encroachments		39.334962 °	39.337780 °	
			-121.633793 °	-121.633107 °	
DWR ID	DWR_MA0007_01_f_2015_43				
Action/Comments					
Prunings Inspector Comments: SBFCA Is removing the trees as part of the ongoing construction project

View of the down trees along the waterside slope and toe.

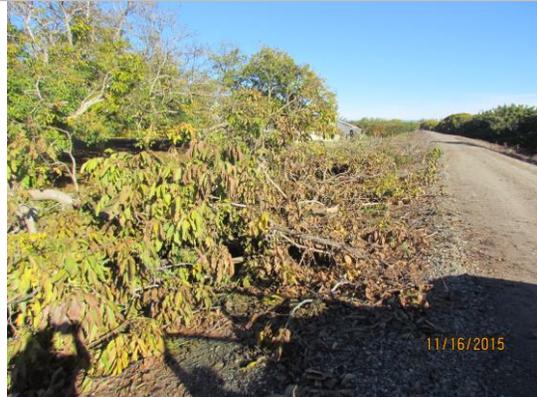
Photo 1 of 1 : FA_2015_MA0007_200_52_20151118_00016.jpg

LM Start	1.93	Rating **	M	Issue No.	52
LM End	1.93	Issue Type +	En	Location *	LS
Category	Earthen Levee		GPS Latitude/Longitude		
			Start	End	
Item	Encroachments		39.337336 °	39.337336 °	
			-121.633536 °	-121.633536 °	
DWR ID	DWR_MA0007_01_s_2015_52				
Action/Comments					
Prunings Inspector Comments: SBFCA Is removing trees as part of their ongoing construction project.

View of the down trees along the landside slope and toe.

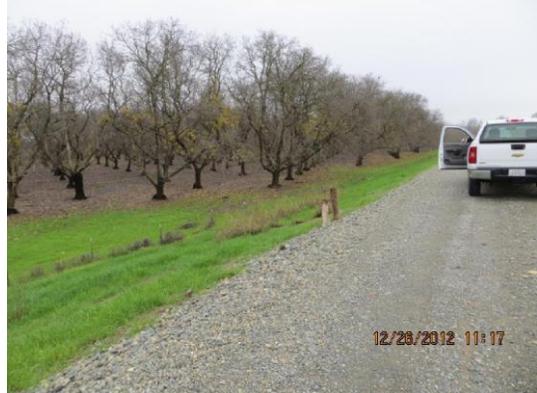
Photo 1 of 2 : UCIP_FA_2015_5458.jpg

LM Start	2.36	Rating **	M	Issue No.	223
LM End	2.36	Issue Type +	En	Location *	LS
Category	Supplemental			GPS Latitude/Longitude	
				Start	End
Item	DWR UCIP Field Study			39.342859 °	39.342859 °
				-121.629909 °	-121.629909 °
DWR ID					
Action/Comments					
Inspector Comments: FS_ID:46106 DS_ID:20817 EP_NO: N/A FS_HLM: 2.372 Repair Type: Non-Urgent Crossing Status: Found UCIP Comments: 6/10/2015 Air vac is still bent over. Need permit authorizing work. 5/7/2013 Need to find owner of structure. 5/13/2013 Permit number and owner in detailed report book. 11/6/2013 Air vac bent over and both metal posts are laying at toe of levee. 5/19/2014 Same as last inspection. 12/29/2014 Same as last inspection. FIELD_STRUCT_DESC: Air vac on waterward shoulder protected by two metal posts. No other signs of encroachment are present. FS Date: 07/01/2015

View of waterward side at crossing.

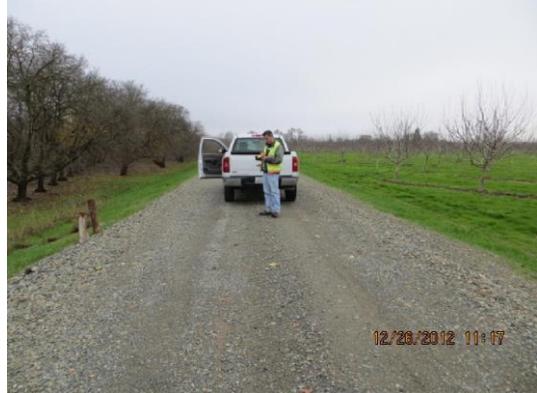
Photo 2 of 2 : UCIP_FA_2015_5459.jpg

Overview of levee crown looking downstream at crossing.

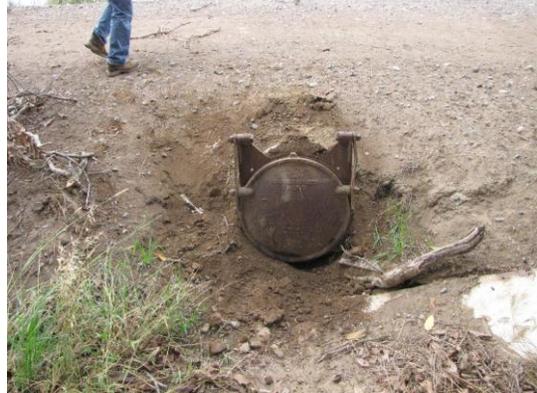
Photo 3 of 3 : UCIP_FA_2015_5462.jpg

LM Start	2.56	Rating **	M	Issue No.	224 (cont)
LM End	2.56	Issue Type +	En	Location *	LS
Category	Supplemental			GPS Latitude/Longitude	
				Start	End
Item	DWR UCIP Field Study			39.345638 °	39.345638 °
				-121.629607 °	-121.629607 °
DWR ID					
Action/Comments					
Inspector Comments: FS_ID:46107 DS_ID:16910 EP_NO: N/A FS_HLM: 2.569 Repair Type: Non-Urgent Crossing Status: Found

View of flap gate located on waterward side.

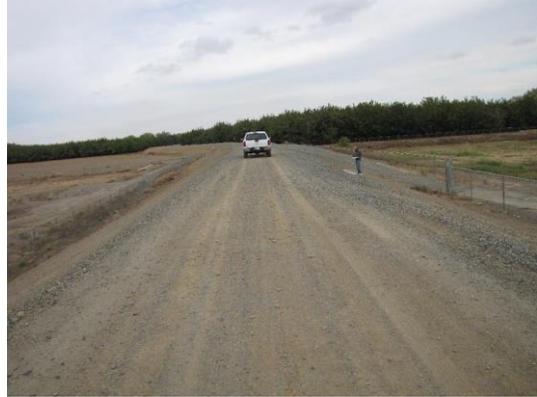
Photo 3 of 3 : UCIP_FA_2015_5465.jpg

LM Start	2.73	Rating **	M	Issue No.	225 (cont)
LM End	2.73	Issue Type +	En	Location *	LS
Category	Supplemental			GPS Latitude/Longitude	
				Start	End
Item	DWR UCIP Field Study			39.347977 °	39.347977 °
				-121.630337 °	-121.630337 °
DWR ID					
Action/Comments					
Inspector Comments: FS_ID:46109 DS_ID:16921 EP_NO: N/A FS_HLM: 2.742 Repair Type: Non-Urgent Crossing Status: Found UCIP Comments: 6/10/2015 Riser is still damaged and cant locate signs of pipe on LS.CMP riser damage-repair needed. Unable to locate pipe on landward side. This crossing was listed in the USACE Periodic Inspections as ID# USACE_CESPK_MA07_2010_a_0090 however, no issues noted.5/7/2013 Same as last inspection, rodent activity near crossing, need to repair rodent hole on WS.5/13/2013 SBFCA project recommends relacing in accordance with title 23.11/6/2013 Same as last inspection.5/19/2014 Same as last inspection.12/29/2014 Same as last inspection. FIELD_STRUCT_DESC: 24-inch CM drain pipe through the levee, 25.5 feet below the crown. Slide gate in 36-inch CM pipe riser on the waterward slope. This entry matches the Drainage or Irrigation Structure referenced in O&M manual (Historic Station 52+50). (USACE O&M Manual, 1957) FS Date: 07/01/2015

Overview of levee crown looking upstream.

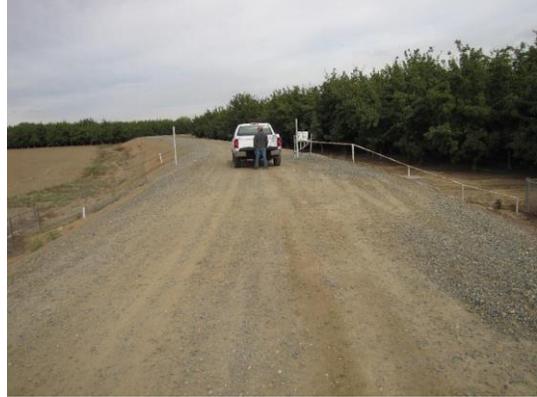
Photo 3 of 3 : UCIP_FA_2015_5529.jpg

LM Start	2.81	Rating **	M	Issue No.	226 (cont)
LM End	2.81	Issue Type +	En	Location *	LS
Category	Supplemental			GPS Latitude/Longitude	
				Start	End
Item	DWR UCIP Field Study			39.349158 °	39.349158 °
				-121.630354 °	-121.630354 °
DWR ID

Inspector Comments: FS_ID:46110
 DS_ID:16919
 EP_NO: 5722
 FS_HLM: 2.825
 Repair Type: Non-Urgent
 Crossing Status: Indicator Found
 UCIP Comments: 6/10/2015 Same as last inspection.dense burrow activity on crown and slopes;5/7/2013 Same as last inspection. WS sediment drop above concrete stand pipe. Coordinate with owner and levee inspector to address issue.5/13/2013 SBFCA project recommends relacing in accordance with title 23.11/6/2013 Same as last inspection.5/19/2014 Same as last inspection.12/29/2014 Same as last inspection.
 FIELD_STRUCT_DESC: 1-12 inch cement coated and lined steel sewer pipe sleeved through the existing 24-inch CM pipe. Annular space pressure grouted. A 36 inch diameter reinforced concrete pipe riser is located on the waterward side. (Permit No. 5722-1968) The existing 24-inch CMP matches the Drainage or Irrigation structure referenced in the O&M manual (historic station 56+90, USACE O&M Manual, 1957) 24-inch CM pipe goes through levee at a depth of 21.4 feet below the crown. Slide gate in 36-inch reinforced concrete pipe riser located on the waterward slope. Crossing 2 of 2 see levee mile 3.35 entry.

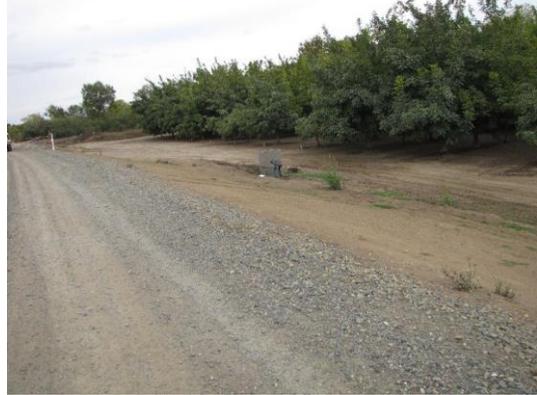
Photo 1 of 3 : UCIP_FA_2015_5530.jpg

LM Start	3.02	Rating **	M	Issue No.	227
LM End	3.02	Issue Type +	En	Location *	LS
Category	Supplemental			GPS Latitude/Longitude	
				Start	End
Item	DWR UCIP Field Study			39.352159 °	39.352159 °
				-121.631209 °	-121.631209 °
DWR ID					
Action/Comments					
Inspector Comments: FS_ID:46111 DS_ID:16918 EP_NO: N/A FS_HLM: 3.044 Repair Type: Non-Urgent Crossing Status: Found UCIP Comments: 6/10/2015 Same as last inspection. Unable to determine if this crossing has been altered, will need to coordinate with levee inspector. This crossing was listed in the USACE Periodic Inspection as ID# USACE_CESPK_MA07_2010_a_0104 however, no issues reported. 5/7/2013 Structure does appear to be altered. Contact Levee Inspector to pursue NOV.5/13/2013 SBFCA project recommends relacing in accordance with title 23.11/6/2013 Same as last inspection. 5/19/2014 Same as last inspection. 12/29/2014 Same as last inspection. FIELD_STRUCT_DESC: 24-inch CM drainpipe through the levee, 15.3 feet below the crown. A reinforced concrete pipe riser located on the waterward side. Flap gate inside riser on the waterward end. 12-inch pipe sleeved through 24-inch pipe. (USACE O&M Manual, 1957) FS Date: 07/01/2015

View of waterward side looking at crossing.

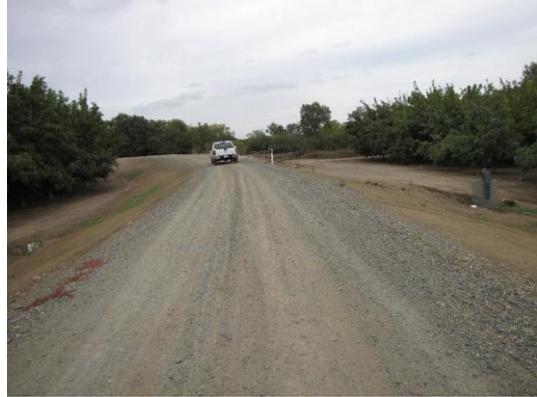
Photo 2 of 3 : UCIP_FA_2015_5531.jpg

LM Start	3.02	Rating **	M	Issue No.	227 (cont)
LM End	3.02	Issue Type +	En	Location *	LS
Category	Supplemental			GPS Latitude/Longitude	
				Start	End
Item	DWR UCIP Field Study			39.352159 °	39.352159 °
				-121.631209 °	-121.631209 °
DWR ID					
Action/Comments					
Inspector Comments: FS_ID:46111 DS_ID:16918 EP_NO: N/A FS_HLM: 3.044 Repair Type: Non-Urgent Crossing Status: Found UCIP Comments: 6/10/2015 Same as last inspection. Unable to determine if this crossing has been altered, will need to coordinate with levee inspector. This crossing was listed in the USACE Periodic Inspection as ID# USACE_CESPK_MA07_2010_a_0104 however, no issues reported. 5/7/2013 Structure does appear to be altered. Contact Levee Inspector to pursue NOV.5/13/2013 SBFCA project recommends relacing in accordance with title 23.11/6/2013 Same as last inspection. 5/19/2014 Same as last inspection. 12/29/2014 Same as last inspection. FIELD_STRUCT_DESC: 24-inch CM drainpipe through the levee, 15.3 feet below the crown. A reinforced concrete pipe riser located on the waterward side. Flap gate inside riser on the waterward end. 12-inch pipe sleeved through 24-inch pipe. (USACE O&M Manual, 1957) FS Date: 07/01/2015

View of levee crown looking upstream at crossing.

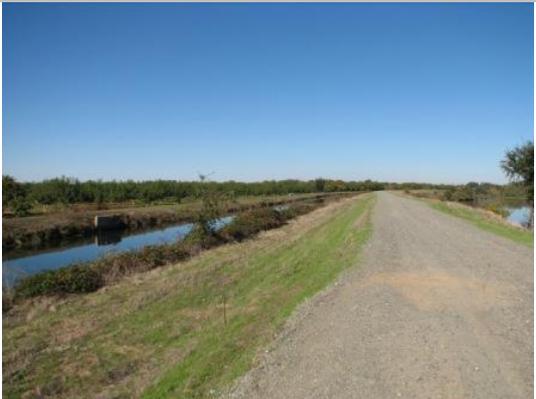
Photo 1 of 2 : FA_2015_MA0007_200_39_20151109_00004.jpg

LM Start	4.39	Rating **	M	Issue No.	39
LM End	5.34	Issue Type +	En	Location *	LS
Category	Earthen Levee		GPS Latitude/Longitude		
			Start	End	
Item	Encroachments		39.366547 °	39.379961 °	
			-121.647523 °	-121.650632 °	
DWR ID	DWR_MA0007_01_s_2012_39				
Action/Comments					
Ditch

Ag ditch landside slope and toe.

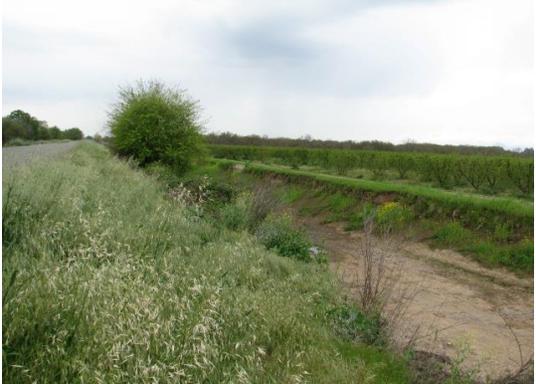
Photo 2 of 2 : FA_2015_MA0007_200_39_20151109_00005.jpg

LM Start	4.39	Rating **	M	Issue No.	39 (cont)
LM End	5.34	Issue Type +	En	Location *	LS

This is a photo of the Ag ditch on the landside slope and toe.

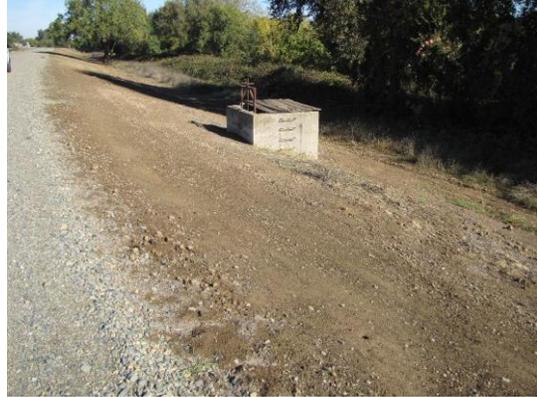
Photo 2 of 3 : UCIP_FA_2015_5605.jpg

LM Start	4.92	Rating **	M	Issue No.	228 (cont)
LM End	4.92	Issue Type +	En	Location *	WS
Category	Supplemental			GPS Latitude/Longitude	
				Start	End
Item	DWR UCIP Field Study			39.373851 °	39.373851 °
				-121.650322 °	-121.650322 °
DWR ID

Inspector Comments: FS_ID:46124
 DS_ID:16943
 EP_NO: N/A
 FS_HLM: 4.978
 Repair Type: Non-Urgent
 Crossing Status: Found
 UCIP Comments: 6/10/2015 Pipe has been removed during the SBFCA project. It was originally listed to be replaced so it may be added back in on a later date.burrow activity on waterward slope. This crossing was listed in the USACE Periodic Inspection as ID# USACE_CESPK_MA07_2010_a_0160 no issues reported.5/10/2013 Barrel down inside standpipe. Slide gate difficult to operate.5/13/2013 SBFCA project recommends relacing in accordance with title 23.11/7/2013 Same as last inspection.5/19/2014 Same as last inspection.12/29/2014 Same as last inspection.
 FIELD_STRUCT_DESC: 42-inch CM pipe through the levee 13.6 feet below the crown. Concrete distribution box with slide gate inside located on waterward side. 36-inch pipe goes through the waterward side berm.
 FS Date: 07/07/2015

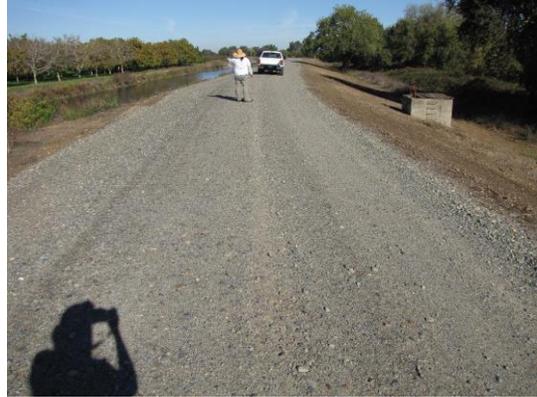
Photo 3 of 3 : UCIP_FA_2015_5606.jpg

LM Start	4.92	Rating **	M	Issue No.	228 (cont)
LM End	4.92	Issue Type +	En	Location *	WS
Category	Supplemental			GPS Latitude/Longitude	
				Start	End
Item	DWR UCIP Field Study			39.373851 °	39.373851 °
				-121.650322 °	-121.650322 °
DWR ID

Inspector Comments: FS_ID:46124
 DS_ID:16943
 EP_NO: N/A
 FS_HLM: 4.978
 Repair Type: Non-Urgent
 Crossing Status: Found
 UCIP Comments: 6/10/2015 Pipe has been removed during the SBFCA project. It was originally listed to be replaced so it may be added back in on a later date.burrow activity on waterward slope. This crossing was listed in the USACE Periodic Inspection as ID# USACE_CESPK_MA07_2010_a_0160 no issues reported.5/10/2013 Barrel down inside standpipe. Slide gate difficult to operate.5/13/2013 SBFCA project recommends relacing in accordance with title 23.11/7/2013 Same as last inspection.5/19/2014 Same as last inspection.12/29/2014 Same as last inspection.
 FIELD_STRUCT_DESC: 42-inch CM pipe through the levee 13.6 feet below the crown. Concrete distribution box with slide gate inside located on waterward side. 36-inch pipe goes through the waterward side berm.
 FS Date: 07/07/2015

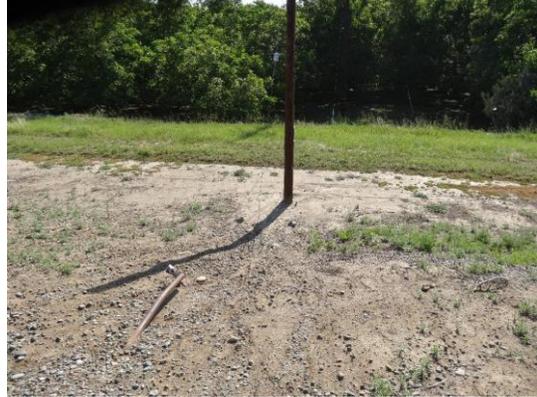
Photo 1 of 3 : UCIP_FA_2015_5607.jpg

LM Start	5.16	Rating **	U	Issue No.	229
LM End	5.16	Issue Type +	En	Location *	WS
Category	Supplemental			GPS Latitude/Longitude	
				Start	End
Item	DWR UCIP Field Study			39.377343 °	39.377343 °
				-121.650450 °	-121.650450 °
DWR ID					
Action/Comments					
Inspector Comments: FS_ID:46125 DS_ID:23095 EP_NO: N/A FS_HLM: 5.22 Repair Type: Urgent Crossing Status: Found UCIP Comments: 6/10/2015 Still damaged at WS slope. Wires are still exposed but crossing is listed to be replaced sometime during the SBFCA project.5/9/2013 Appeared to be damaged where it exits the WS slope, minor settling on LS toe, unable to obtain permit. SBFCA project recommends replacing in accordance with title 23.11/7/2013 More damage has occurred to power wires. Live wires are now exposed. Power company is aware of the problem and are going to fix it.5/19/2014 Same as last inspection.12/29/2014 Same as last inspection. FIELD_STRUCT_DESC: 2.5 inch steel electrical conduit 3-4 feet below crown of levee. FS Date: 07/07/2015

WS slope

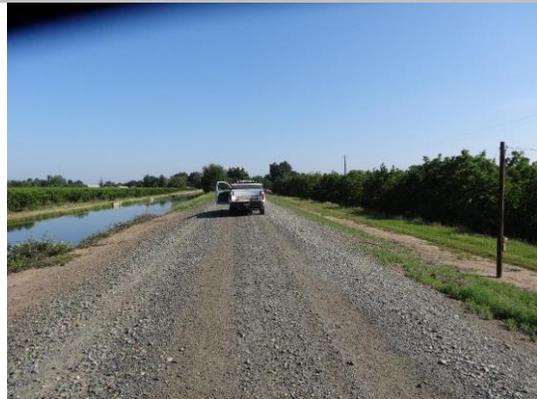
Photo 2 of 3 : UCIP_FA_2015_5608.jpg

LM Start	5.16	Rating **	U	Issue No.	229 (cont)
LM End	5.16	Issue Type +	En	Location *	WS

Overview of crossing from crown looking U/S

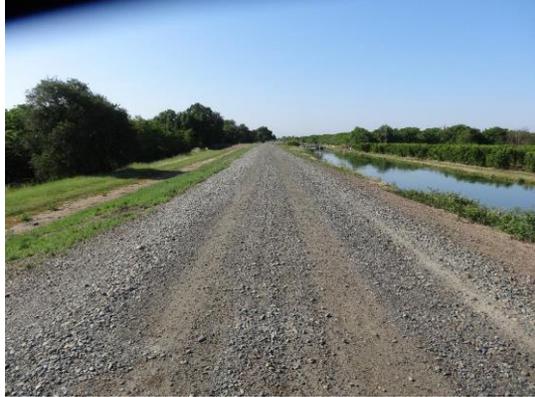
Photo 3 of 3 : UCIP_FA_2015_5609.jpg

LM Start	5.16	Rating **	U	Issue No.	229 (cont)
LM End	5.16	Issue Type +	En	Location *	WS
Category	Supplemental			GPS Latitude/Longitude	
				Start	End
Item	DWR UCIP Field Study			39.377343 °	39.377343 °
				-121.650450 °	-121.650450 °
DWR ID					
Action/Comments					
Inspector Comments: FS_ID:46125 DS_ID:23095 EP_NO: N/A FS_HLM: 5.22 Repair Type: Urgent Crossing Status: Found

Overview of crossing from crown looking D/S

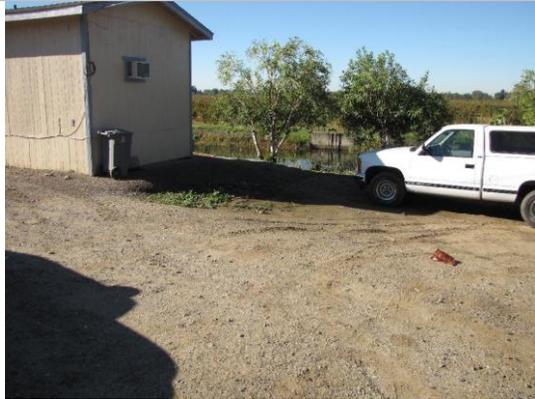
Photo 1 of 2 : UCIP_FA_2015_5619.jpg

LM Start	5.33	Rating **	M	Issue No.	230
LM End	5.33	Issue Type +	En	Location *	WS
Category	Supplemental			GPS Latitude/Longitude	
				Start	End
Item	DWR UCIP Field Study			39.379838 °	39.379838 °
				-121.650611 °	-121.650611 °
DWR ID					
Action/Comments					
Inspector Comments: FS_ID:46126 DS_ID:16920 EP_NO: N/A FS_HLM: 5.398 Repair Type: Non-Urgent Crossing Status: Found UCIP Comments: 6/10/2015 Unable to locate any signs of this crossing during this inspection. Looks to have been removed for the SBFCA project.No access to landward side--residential property; unable to determine the type of abandonment for this crossing; need to determine if there is a positive closure device on waterward side. This crossing was listed in the USACE Periodic Inspection as ID# USACE_CESPK_MA07_2010_a_0173 unknown.5/10/2013 Same as last inspection.5/13/2013 SBFCA project recommends relacing in accordance with title 23.11/7/2013 Same as last inspection.5/19/2014 Same as last inspection.12/29/2014 Same as last inspection. FIELD_STRUCT_DESC: Abandoned 24-inch CM irrigation pipe through the levee, 14.0 feet below the crown. Slide gate on the landward side. Slide gate in concrete pipe riser on the waterward berm. This entry matches the Drainage or Irrigation Structure referenced in O&M manual (Historic Station 191+13). (USACE O&M Manual, 1957) FS Date: 07/07/2015

View of landward side--no access.

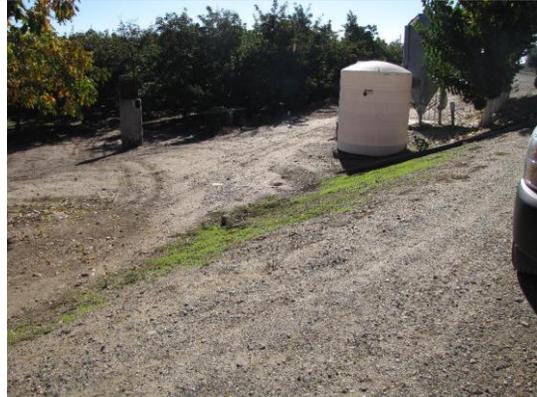
Photo 2 of 2 : UCIP_FA_2015_5620.jpg

LM Start	5.33	Rating **	M	Issue No.	230 (cont)
LM End	5.33	Issue Type +	En	Location *	WS
Category	Supplemental			GPS Latitude/Longitude	
				Start	End
Item	DWR UCIP Field Study			39.379838 °	39.379838 °
				-121.650611 °	-121.650611 °
DWR ID					
Action/Comments					
<p>Inspector Comments: FS_ID:46126 DS_ID:16920 EP_NO: N/A FS_HLM: 5.398 Repair Type: Non-Urgent Crossing Status: Found UCIP Comments: 6/10/2015 Unable to locate any signs of this crossing during this inspection. Looks to have been removed for the SBFCA project.No access to landward side--residential property; unable to determine the type of abandonment for this crossing; need to determine if there is a positive closure device on waterward side. This crossing was listed in the USACE Periodic Inspection as ID# USACE_CESPK_MA07_2010_a_0173 unknown.5/10/2013 Same as last inspection.5/13/2013 SBFCA project recommends relacing in accordance with title 23.11/7/2013 Same as last inspection.5/19/2014 Same as last inspection.12/29/2014 Same as last inspection. FIELD_STRUCT_DESC: Abandoned 24-inch CM irrigation pipe through the levee, 14.0 feet below the crown. Slide gate on the landward side. Slide gate in concrete pipe riser on the waterward berm. This entry matches the Drainage or Irrigation Structure referenced in O&M manual (Historic Station 191+13). (USACE O&M Manual, 1957) FS Date: 07/07/2015</p>

View of waterward side.

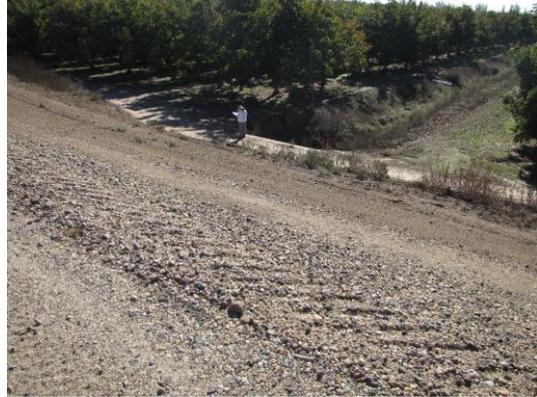
Photo 1 of 3 : UCIP_FA_2015_5621.jpg

LM Start	5.42	Rating **	M	Issue No.	231
LM End	5.42	Issue Type +	En	Location *	WS
Category	Supplemental			GPS Latitude/Longitude	
				Start	End
Item	DWR UCIP Field Study			39.380377 °	39.380377 °
				-121.649344 °	-121.649344 °
DWR ID

Inspector Comments: FS_ID:46127
 DS_ID:16922
 EP_NO: N/A
 FS_HLM: 5.485
 Repair Type: Non-Urgent
 Crossing Status: Found
 UCIP Comments: 6/10/2015 Sediment still blocking the flap gates on WS. LS inlet being overgrown by vegetation in the ditch. Sediment blocking flap gates on waterward side--need to clear sediment. This crossing was listed in the USACE Periodic Inspection as ID# USACE_CESPK_MA07_2010_a_0180 no issues reported.5/10/2013 Same as last inspection.5/13/2013 SBFCA project recommends relacing in accordance with title 23.11/7/2013 Same as last inspection.5/19/2014 Same as last inspection.12/29/2014 Same as last inspection.
 FIELD_STRUCT_DESC: 1 of 2: 60 inch pipe (downstream pipe), through the levee, 23.4 feet below the crown. Flap gate on the waterward end. Concrete headwalls on both ends. Ditch at waterward outlet. This entry matches the Drainage or Irrigation Structure referenced in O&M manual (Historic Station 195+80). (USACE O&M Manual, 1957)

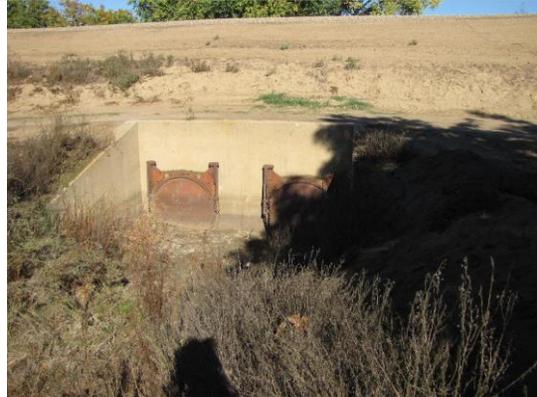
Photo 2 of 3 : UCIP_FA_2015_5622.jpg

LM Start	5.42	Rating **	M	Issue No.	231 (cont)
LM End	5.42	Issue Type +	En	Location *	WS
Category	Supplemental			GPS Latitude/Longitude	
				Start	End
Item	DWR UCIP Field Study			39.380377 °	39.380377 °
				-121.649344 °	-121.649344 °
DWR ID

Inspector Comments: FS_ID:46127
 DS_ID:16922
 EP_NO: N/A
 FS_HLM: 5.485
 Repair Type: Non-Urgent
 Crossing Status: Found
 UCIP Comments: 6/10/2015 Sediment still blocking the flap gates on WS. LS inlet being overgrown by vegetation in the ditch. Sediment blocking flap gates on waterward side--need to clear sediment. This crossing was listed in the USACE Periodic Inspection as ID# USACE_CESPK_MA07_2010_a_0180 no issues reported. 5/10/2013 Same as last inspection. 5/13/2013 SBFCA project recommends relacing in accordance with title 23.11/7/2013 Same as last inspection. 5/19/2014 Same as last inspection. 12/29/2014 Same as last inspection.
 FIELD_STRUCT_DESC: 1 of 2: 60 inch pipe (downstream pipe), through the levee, 23.4 feet below the crown. Flap gate on the waterward end. Concrete headwalls on both ends. Ditch at waterward outlet. This entry matches the Drainage or Irrigation Structure referenced in O&M manual (Historic Station 195+80). (USACE O&M Manual, 1957)

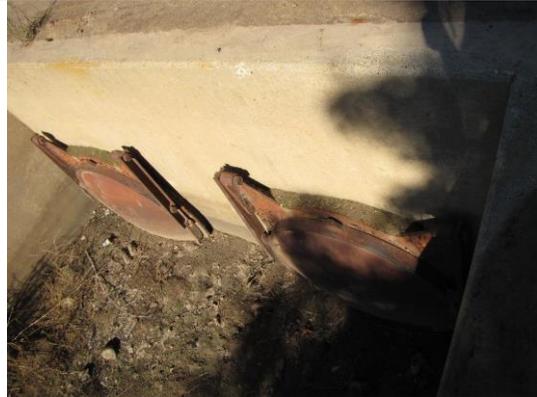
Photo 3 of 3 : UCIP_FA_2015_5623.jpg

LM Start	5.42	Rating **	M	Issue No.	231 (cont)
LM End	5.42	Issue Type +	En	Location *	WS
Category	Supplemental			GPS Latitude/Longitude	
				Start	End
Item	DWR UCIP Field Study			39.380377 °	39.380377 °
				-121.649344 °	-121.649344 °
DWR ID

Inspector Comments: FS_ID:46127
 DS_ID:16922
 EP_NO: N/A
 FS_HLM: 5.485
 Repair Type: Non-Urgent
 Crossing Status: Found
 UCIP Comments: 6/10/2015 Sediment still blocking the flap gates on WS. LS inlet being overgrown by vegetation in the ditch. Sediment blocking flap gates on waterward side--need to clear sediment. This crossing was listed in the USACE Periodic Inspection as ID# USACE_CESPK_MA07_2010_a_0180 no issues reported.5/10/2013 Same as last inspection.5/13/2013 SBFCA project recommends relacing in accordance with title 23.11/7/2013 Same as last inspection.5/19/2014 Same as last inspection.12/29/2014 Same as last inspection.
 FIELD_STRUCT_DESC: 1 of 2: 60 inch pipe (downstream pipe), through the levee, 23.4 feet below the crown. Flap gate on the waterward end. Concrete headwalls on both ends. Ditch at waterward outlet. This entry matches the Drainage or Irrigation Structure referenced in O&M manual (Historic Station 195+80). (USACE O&M Manual, 1957)

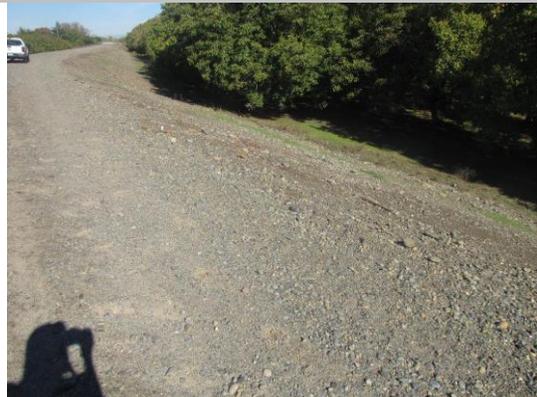
Photo 2 of 3 : UCIP_FA_2015_5722.jpg

LM Start	7.70	Rating **	M	Issue No.	233 (cont)
LM End	7.70	Issue Type +	En	Location *	WS

View of waterward side and levee crown looking upstream towards crossing.

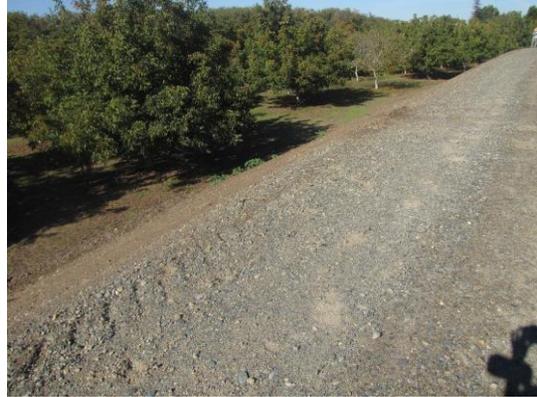
Photo 3 of 3 : UCIP_FA_2015_5723.jpg

LM Start	7.70	Rating **	M	Issue No.	233 (cont)
LM End	7.70	Issue Type +	En	Location *	WS
Category	Supplemental			GPS Latitude/Longitude	
				Start	End
Item	DWR UCIP Field Study			39.398336 °	39.398336 °
				-121.630529 °	-121.630529 °
DWR ID					
Action/Comments					
Inspector Comments: FS_ID:46134 DS_ID:16960 EP_NO: 17895 FS_HLM: 7.85 Repair Type: Non-Urgent Crossing Status: Indicator Found

View of landward side and levee crown looking upstream towards crossing.

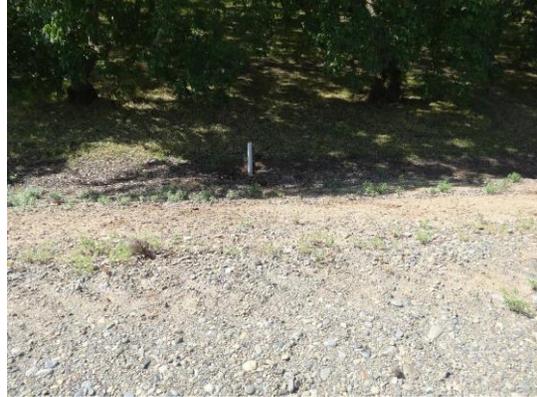
Photo 2 of 3 : UCIP_FA_2015_5725.jpg

LM Start	8.45	Rating **	U	Issue No.	234 (cont)
LM End	8.45	Issue Type +	En	Location *	WS
Category	Supplemental			GPS Latitude/Longitude	
				Start	End
Item	DWR UCIP Field Study			39.404475 °	39.404475 °
				-121.636958 °	-121.636958 °
DWR ID					
Action/Comments					
Inspector Comments: FS_ID:46137 DS_ID:23096 EP_NO: N/A FS_HLM: 8.56 Repair Type: Urgent Crossing Status: Indicator Found UCIP Comments: 6/10/2015 Same as last inspection.5/9/13 Depression along WS slope that could indicate a leak or poor compaction. Unknown permit number need to coordinate with landowner to find out more info.11/7/2013 Same as last inspection.5/19/2014 Same as last inspection.12/30/2014 Same as last inspection. FIELD_STRUCT_DESC: Irrigation crossing through levee depth unknown. Steel stand pipe located on landward toe. Also present is 4.5 inch PVC pipe near stand pipe located on landward toe. FS Date: 07/07/2015

LS slope

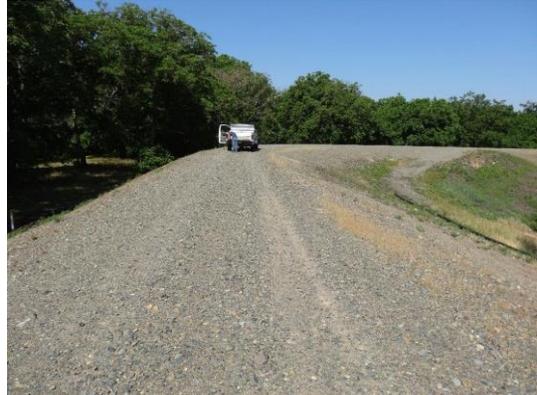
Photo 3 of 3 : UCIP_FA_2015_5726.jpg

Overview from crown looking U/S

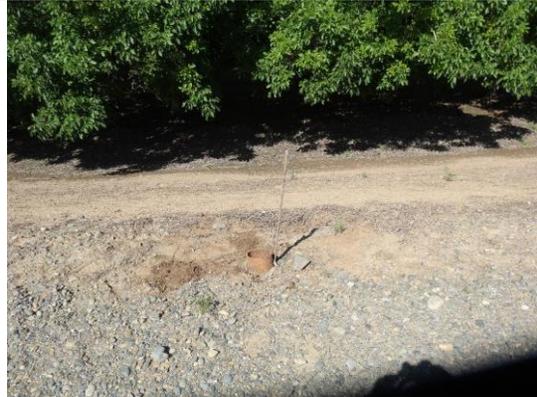
Photo 1 of 2 : UCIP_FA_2015_5727.jpg

LM Start	8.60	Rating **	U	Issue No.	235
LM End	8.60	Issue Type +	En	Location *	WS
Category	Supplemental			GPS Latitude/Longitude	
				Start	End
Item	DWR UCIP Field Study			39.406614 °	39.406614 °
				-121.637384 °	-121.637384 °
DWR ID					
Action/Comments					
Inspector Comments: FS_ID:46138 DS_ID:23094 EP_NO: N/A FS_HLM: 8.72 Repair Type: Urgent Crossing Status: Indicator Found

LS slope with steel standpipe

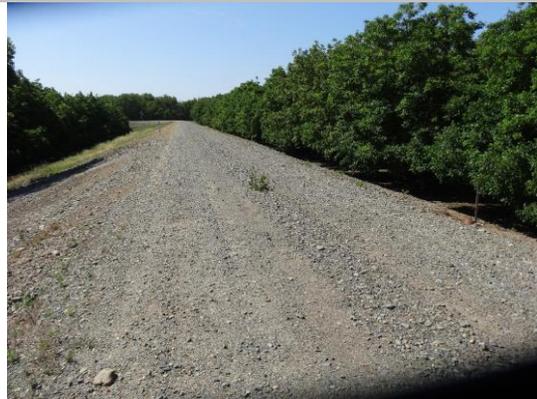
Photo 2 of 2 : UCIP_FA_2015_5728.jpg

LM Start	8.60	Rating **	U	Issue No.	235 (cont)
LM End	8.60	Issue Type +	En	Location *	WS

Overview looking D/S

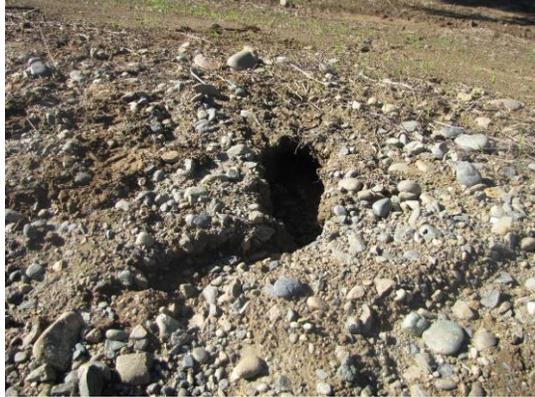
Photo 1 of 3 : UCIP_FA_2015_5729.jpg

LM Start	8.64	Rating **	M	Issue No.	236
LM End	8.64	Issue Type +	En	Location *	WS
Category	Supplemental			GPS Latitude/Longitude	
				Start	End
Item	DWR UCIP Field Study			39.407159 °	39.407159 °
				-121.637409 °	-121.637409 °
DWR ID					
Action/Comments					
Inspector Comments: FS_ID:46139 DS_ID:16949 EP_NO: 14200 FS_HLM: 8.756 Repair Type: Non-Urgent Crossing Status: Indicator Found

View of cavity collapse along assumed pipe alignment located on landward shoulder.

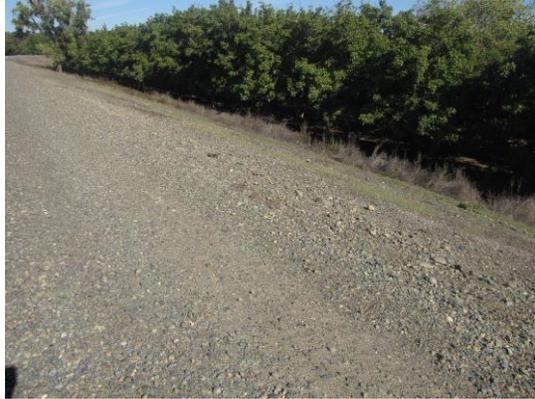
Photo 2 of 3 : UCIP_FA_2015_5730.jpg

LM Start	8.64	Rating **	M	Issue No.	236 (cont)
LM End	8.64	Issue Type +	En	Location *	WS

View of waterward side and levee crown looking upstream at crossing alignment.

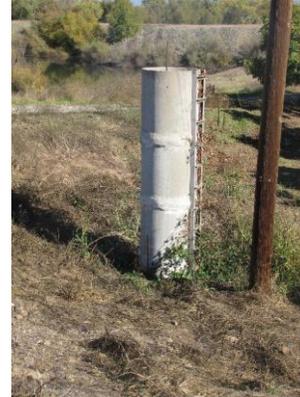
Photo 1 of 3 : UCIP_FA_2015_5732.jpg

LM Start	9.53	Rating **	M	Issue No.	237
LM End	9.53	Issue Type +	En	Location *	WS
Category	Supplemental			GPS Latitude/Longitude	
				Start	End
Item	DWR UCIP Field Study			39.416284 °	39.416284 °
				-121.632224 °	-121.632224 °
DWR ID					
Action/Comments					
Inspector Comments: FS_ID:46140 DS_ID:16948 EP_NO: N/A FS_HLM: 9.667 Repair Type: Non-Urgent Crossing Status: Found UCIP Comments: 6/11/2015 WS standpipe was overgrown with blackberries and unable to be inspected. unable to determine the condition of the slide gate inside waterward concrete standpipe blackberry shrubs overgrown against access latter; 5/10/2013 Same as last inspection. Cleared back some of the black berries but live birds nest on ladder prevented me from inspecting inside of standpipe. Recommend spraying the black berries to clear path to ladder. 5/13/2013 SBFCA project recommends relacing in accordance with title 23. 11/7/2013 Same as last inspection. 5/20/2014 Same as last inspection. 12/30/2014 Same as last inspection. FIELD_STRUCT_DESC: 12-inch steel irrigation pipe through the levee, 14.0 feet below the crown. Slide gate in 36-inch concrete standpipe at the waterward toe. Concrete distribution box at the landward toe. FS Date: 07/07/2015

View of concrete standpipe with blackberry shrubs preventing access to latter.

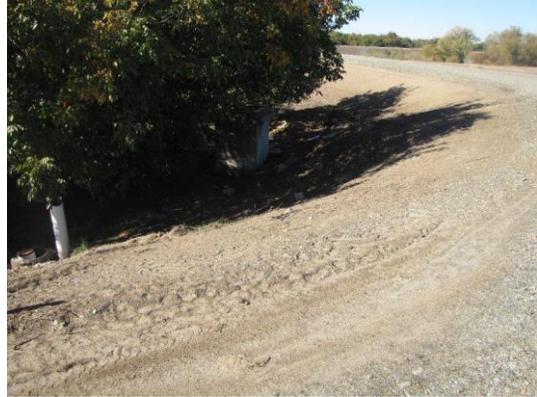
Photo 3 of 3 : UCIP_FA_2015_5734.jpg

LM Start	9.53	Rating **	M	Issue No.	237 (cont)
LM End	9.53	Issue Type +	En	Location *	WS
Category	Supplemental			GPS Latitude/Longitude	
			Start	End	
Item	DWR UCIP Field Study			39.416284 °	39.416284 °
				-121.632224 °	-121.632224 °
DWR ID					
Action/Comments					
Inspector Comments: FS_ID:46140 DS_ID:16948 EP_NO: N/A FS_HLM: 9.667 Repair Type: Non-Urgent Crossing Status: Found UCIP Comments: 6/11/2015 WS standpipe was overgrown with blackberries and unable to be inspected. unable to determine the condition of the slide gate inside waterward concrete standpipe blackberry shrubs overgrown against access ladder; 5/10/2013 Same as last inspection. Cleared back some of the black berries but live birds nest on ladder prevented me from inspecting inside of standpipe. Recommend spraying the black berries to clear path to ladder. 5/13/2013 SBFCA project recommends relacing in accordance with title 23. 11/7/2013 Same as last inspection. 5/20/2014 Same as last inspection. 12/30/2014 Same as last inspection. FIELD_STRUCT_DESC: 12-inch steel irrigation pipe through the levee, 14.0 feet below the crown. Slide gate in 36-inch concrete standpipe at the waterward toe. Concrete distribution box at the landward toe. FS Date: 07/07/2015

View of landward side looking upstream at crossing. Concrete distribution box located on landward toe.

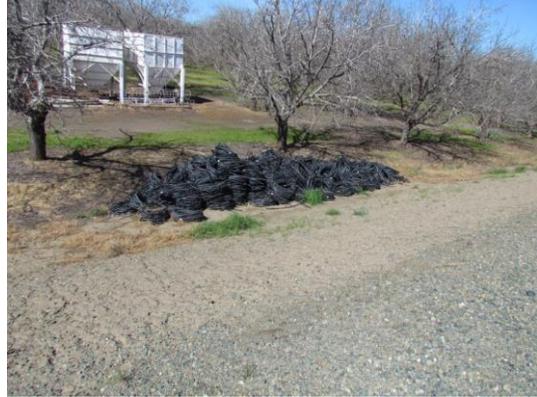
Photo 1 of 1 : FA_2015_MA0007_200_51_20151109_00010.jpg

LM Start	9.69	Rating **	M	Issue No.	51
LM End	9.69	Issue Type +	En	Location *	LS
Category	Earthen Levee		GPS Latitude/Longitude		
			Start	End	
Item	Encroachments		39.416864 °	39.416864 °	
			-121.634822 °	-121.634822 °	
DWR ID	DWR_MA0007_01_s_2014_51				
Action/Comments					
Debris Inspector Comments: Irrigation pipe on landward levee slope. Spring 2014.

This photo was taken from the levee crown facing north looking at irrigation pipe placed on the levee slope near the landward toe. Spring 2014.

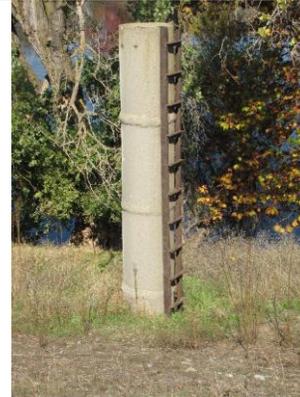
Photo 1 of 3 : UCIP_FA_2015_5752.jpg

LM Start	9.97	Rating **	M	Issue No.	238
LM End	9.97	Issue Type +	En	Location *	LS
Category	Supplemental			GPS Latitude/Longitude	
				Start	End
Item	DWR UCIP Field Study			39.420736 °	39.420736 °
				-121.635321 °	-121.635321 °
DWR ID					
Action/Comments					
Inspector Comments: FS_ID:46142 DS_ID:16947 EP_NO: N/A FS_HLM: 10.116 Repair Type: Non-Urgent Crossing Status: Indicator Found UCIP Comments: 6/11/2015 Abandoned crossing. SBFCA project recommends removal. Crossing appears to be abandoned; slide gate located inside concrete standpipe is buried with trash; no other features were visible during inspection. This crossing needs to be properly abandoned. 5/10/2013 Same as last inspection. 5/13/2013 SBFCA project recommends removal. 11/7/2013 Same as last inspection. 5/20/2014 Same as last inspection. 12/30/2014 Same as last inspection. FIELD_STRUCT_DESC: Abandoned 10-inch reinforced concrete encased steel irrigation pipe through the levee, 14.5 feet below the crown. Slide gate in 24-inch concrete standpipe at the waterward toe. This entry matches the Drainage or Irrigation Structure referenced in O&M manual (Historic Station 437+30). (USACE O&M Manual, 1957) FS Date: 07/07/2015

View of concrete standpipe located at waterward toe. Slide gate inside riser is buried with trash.

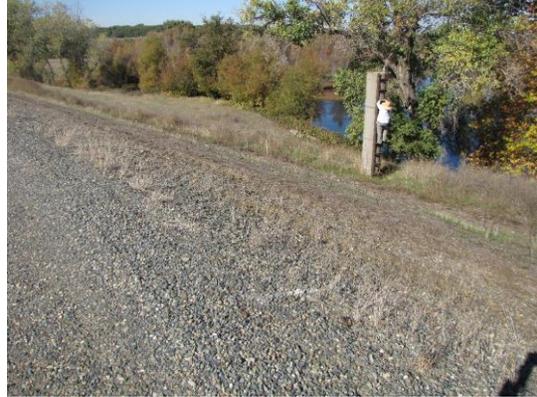
Photo 2 of 3 : UCIP_FA_2015_5753.jpg

LM Start	9.97	Rating **	M	Issue No.	238 (cont)
LM End	9.97	Issue Type +	En	Location *	LS
Category	Supplemental			GPS Latitude/Longitude	
				Start	End
Item	DWR UCIP Field Study			39.420736 °	39.420736 °
				-121.635321 °	-121.635321 °
DWR ID					
Action/Comments					
Inspector Comments: FS_ID:46142 DS_ID:16947 EP_NO: N/A FS_HLM: 10.116 Repair Type: Non-Urgent Crossing Status: Indicator Found UCIP Comments: 6/11/2015 Abandoned crossing. SBFCA project recommends removal. Crossing appears to be abandoned; slide gate located inside concrete standpipe is buried with trash; no other features were visible during inspection. This crossing needs to be properly abandoned. 5/10/2013 Same as last inspection. 5/13/2013 SBFCA project recommends removal. 11/7/2013 Same as last inspection. 5/20/2014 Same as last inspection. 12/30/2014 Same as last inspection. FIELD_STRUCT_DESC: Abandoned 10-inch reinforced concrete encased steel irrigation pipe through the levee, 14.5 feet below the crown. Slide gate in 24-inch concrete standpipe at the waterward toe. This entry matches the Drainage or Irrigation Structure referenced in O&M manual (Historic Station 437+30). (USACE O&M Manual, 1957) FS Date: 07/07/2015

View of waterward shoulder and slope looking upstream at crossing.

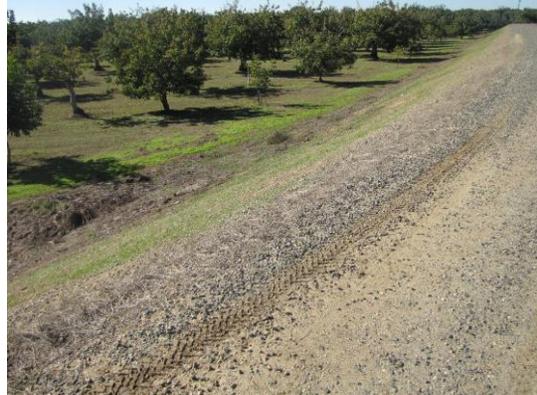
Photo 3 of 3 : UCIP_FA_2015_5754.jpg

LM Start	9.97	Rating **	M	Issue No.	238 (cont)
LM End	9.97	Issue Type +	En	Location *	LS
Category	Supplemental			GPS Latitude/Longitude	
				Start	End
Item	DWR UCIP Field Study			39.420736 °	39.420736 °
				-121.635321 °	-121.635321 °
DWR ID					
Action/Comments					
Inspector Comments: FS_ID:46142 DS_ID:16947 EP_NO: N/A FS_HLM: 10.116 Repair Type: Non-Urgent Crossing Status: Indicator Found UCIP Comments: 6/11/2015 Abandoned crossing. SBFCA project recommends removal. Crossing appears to be abandoned; slide gate located inside concrete standpipe is buried with trash; no other features were visible during inspection. This crossing needs to be properly abandoned. 5/10/2013 Same as last inspection. 5/13/2013 SBFCA project recommends removal. 11/7/2013 Same as last inspection. 5/20/2014 Same as last inspection. 12/30/2014 Same as last inspection. FIELD_STRUCT_DESC: Abandoned 10-inch reinforced concrete encased steel irrigation pipe through the levee, 14.5 feet below the crown. Slide gate in 24-inch concrete standpipe at the waterward toe. This entry matches the Drainage or Irrigation Structure referenced in O&M manual (Historic Station 437+30). (USACE O&M Manual, 1957) FS Date: 07/07/2015

View of landward side and levee crown looking upstream at crossing.

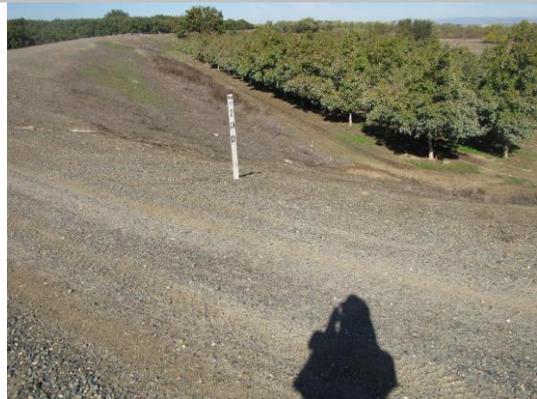
Photo 3 of 3 : UCIP_FA_2015_5757.jpg

LM Start	10.10	Rating **	M	Issue No.	239 (cont)
LM End	10.10	Issue Type +	En	Location *	LS
Category	Supplemental			GPS Latitude/Longitude	
				Start	End
Item	DWR UCIP Field Study			39.420905 °	39.420905 °
				-121.637707 °	-121.637707 °
DWR ID					
Action/Comments					
Inspector Comments: FS_ID:46143 DS_ID:16946 EP_NO: N/A FS_HLM: 10.247 Repair Type: Non-Urgent Crossing Status: Indicator Found UCIP Comments: 6/11/2015 Same as last inspection. unable to determine if this crossing still is in use, signs of depression on waterward shoulder, pump located on LS (GW?) valve on waterward toe. No slide gate or concrete standpipe present; structure appears to have been modified--need permit issued for modifications. 5/10/2013 Same as last inspection. 5/13/2013 SBFCA project recommends removal. 11/7/2013 Same as last inspection. 5/20/2014 Same as last inspection. 12/30/2014 Same as last inspection. FIELD_STRUCT_DESC: 10-inch steel irrigation pipe through the levee, 14.5 feet below the crown. Slide gate in concrete standpipe and pump on the landward side. FS Date: 07/07/2015

View of waterward side and levee crown looking upstream at crossing.

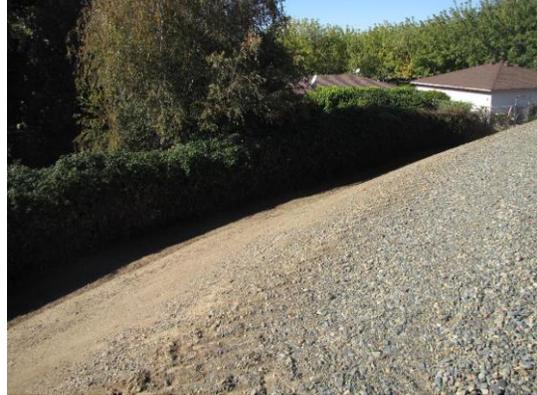
Photo 1 of 3 : UCIP_FA_2015_5758.jpg

LM Start	10.68	Rating **	M	Issue No.	240
LM End	10.68	Issue Type +	En	Location *	LS
Category	Supplemental			GPS Latitude/Longitude	
				Start	End
Item	DWR UCIP Field Study			39.426781 °	39.426781 °
				-121.642078 °	-121.642078 °
DWR ID					
Action/Comments					
Inspector Comments: FS_ID:46144 DS_ID:16933 EP_NO: N/A FS_HLM: 10.833 Repair Type: Non-Urgent Crossing Status: Found

View of landward side--no signs of crossing or appurtances are present.

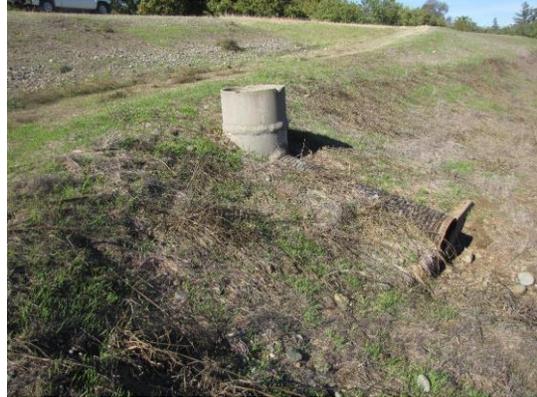
Photo 2 of 3 : UCIP_FA_2015_5759.jpg

View of concrete standpipe located on waterward side.

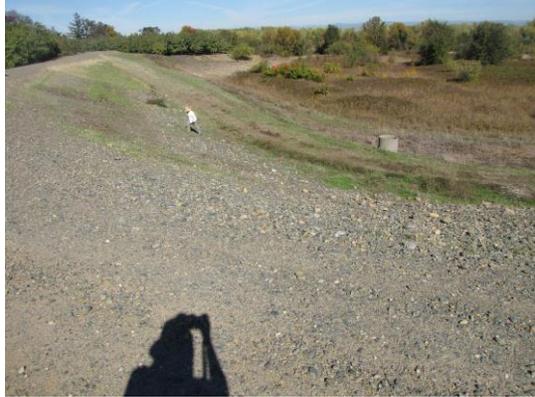
Photo 3 of 3 : UCIP_FA_2015_5760.jpg

LM Start	10.68	Rating **	M	Issue No.	240 (cont)
LM End	10.68	Issue Type +	En	Location *	LS
Category	Supplemental			GPS Latitude/Longitude	
				Start	End
Item	DWR UCIP Field Study			39.426781 °	39.426781 °
				-121.642078 °	-121.642078 °
DWR ID					
Action/Comments					
Inspector Comments: FS_ID:46144 DS_ID:16933 EP_NO: N/A FS_HLM: 10.833 Repair Type: Non-Urgent Crossing Status: Found

View of waterward side looking upstream at slope and concrete standpipe.

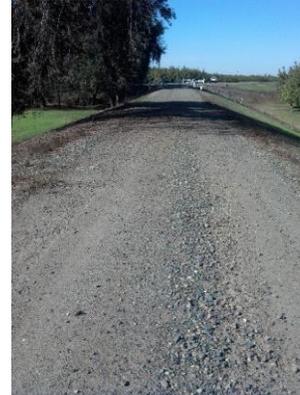
Photo 1 of 3 : UCIP_FA_2015_5345.jpg

LM Start	10.79	Rating **	M	Issue No.	241
LM End	10.79	Issue Type +	En	Location *	LS
Category	Supplemental			GPS Latitude/Longitude	
				Start	End
Item	DWR UCIP Field Study			39.428380 °	39.428380 °
				-121.642228 °	-121.642228 °
DWR ID					
Action/Comments					
Inspector Comments: FS_ID:46145 DS_ID:16944 EP_NO: N/A FS_HLM: 10.947 Repair Type: Non-Urgent Crossing Status: Indicator Found UCIP Comments: 6/11/2015 Headwall still buried. SBFCA project recommends removal.crossing appears to be abandoned--unknown method of abandonment; headwall buried with a small section of headwall exposed.5/10/2013 Same as last inspection.5/13/2013 SBFCA project recommends removal.11/7/2013 Same as last inspection.5/20/2014 Same as last inspection.12/30/2014 Same as last inspection. FIELD_STRUCT_DESC: Abandoned 24-inch CM drainpipe through the levee, 17.5 feet below the crown. Concrete headwall at landward toe. Flap gate on waterward end covered with dirt. This entry matches the Drainage or Irrigation Structure referenced in O&M manual (Historic Station 476+60). (USACE O&M Manual, 1957) FS Date: 07/07/2015

View of levee crown looking upstream from crossing.

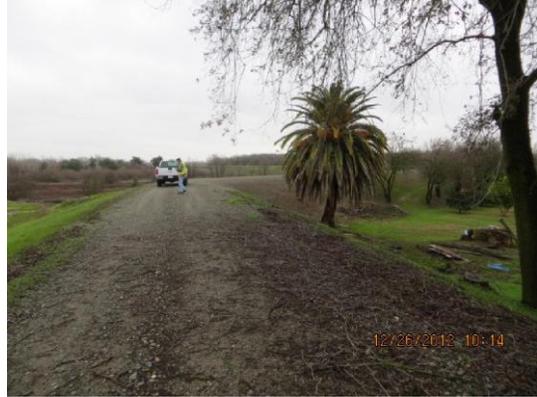
Photo 2 of 3 : UCIP_FA_2015_5346.jpg

Inspector Comments: FS_ID:46145
 DS_ID:16944
 EP_NO: N/A
 FS_HLM: 10.947
 Repair Type: Non-Urgent
 Crossing Status: Indicator Found
 UCIP Comments: 6/11/2015 Headwall still buried. SBFCA project recommends removal.crossing appears to be abandoned--unknown method of abandonment; headwall buried with a small section of headwall exposed.5/10/2013 Same as last inspection.5/13/2013 SBFCA project recommends removal.11/7/2013 Same as last inspection.5/20/2014 Same as last inspection.12/30/2014 Same as last inspection.
 FIELD_STRUCT_DESC: Abandoned 24-inch CM drainpipe through the levee, 17.5 feet below the crown. Concrete headwall at landward toe. Flap gate on waterward end covered with dirt. This entry matches the Drainage or Irrigation Structure referenced in O&M manual (Historic Station 476+60). (USACE O&M Manual, 1957)
 FS Date: 07/07/2015

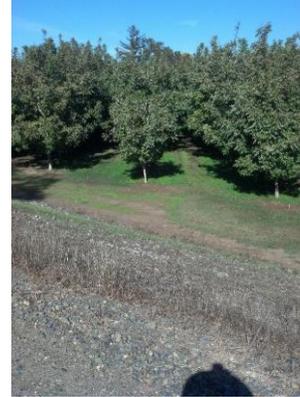
Photo 3 of 3 : UCIP_FA_2015_5761.jpg

LM Start	10.79	Rating **	M	Issue No.	241 (cont)
LM End	10.79	Issue Type +	En	Location *	LS
Category	Supplemental			GPS Latitude/Longitude	
				Start	End
Item	DWR UCIP Field Study			39.428380 °	39.428380 °
				-121.642228 °	-121.642228 °
DWR ID					
Action/Comments					
Inspector Comments: FS_ID:46145 DS_ID:16944 EP_NO: N/A FS_HLM: 10.947 Repair Type: Non-Urgent Crossing Status: Indicator Found UCIP Comments: 6/11/2015 Headwall still buried. SBFCA project recommends removal.crossing appears to be abandoned--unknown method of abandonment; headwall buried with a small section of headwall exposed.5/10/2013 Same as last inspection.5/13/2013 SBFCA project recommends removal.11/7/2013 Same as last inspection.5/20/2014 Same as last inspection.12/30/2014 Same as last inspection. FIELD_STRUCT_DESC: Abandoned 24-inch CM drainpipe through the levee, 17.5 feet below the crown. Concrete headwall at landward toe. Flap gate on waterward end covered with dirt. This entry matches the Drainage or Irrigation Structure referenced in O&M manual (Historic Station 476+60). (USACE O&M Manual, 1957) FS Date: 07/07/2015

View of waterward side.

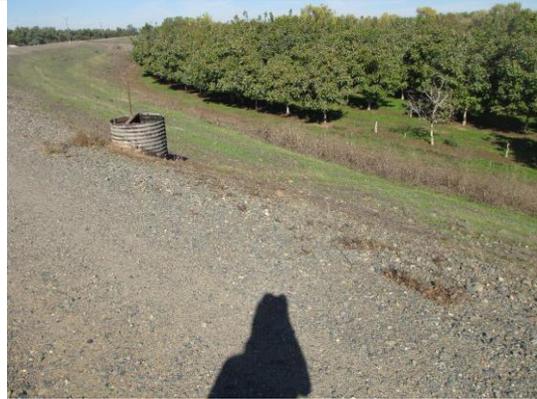
Photo 2 of 3 : UCIP_FA_2015_5348.jpg

LM Start	11.01	Rating **	M	Issue No.	242 (cont)
LM End	11.01	Issue Type +	En	Location *	LS
Category	Supplemental			GPS Latitude/Longitude	
				Start	End
Item	DWR UCIP Field Study			39.430540 °	39.430540 °
				-121.645118 °	-121.645118 °
DWR ID					
Action/Comments					
Inspector Comments: FS_ID:46148 DS_ID:16941 EP_NO: N/A FS_HLM: 11.167 Repair Type: Non-Urgent Crossing Status: Found UCIP Comments: 6/11/2015 Same as last inspection. waterward side-missing top cover of the CMP riser; debris inside CMP riser; wheel handle missing from slide gate. Unable to determine condition of slide gate face. landward side-crossing not visible. This crossing was listed in the USACE Periodic Inspection as ID# USACE_CESPK_MA07_2010_a_0330 no issues reported. 5/10/2013 Top cover has fallen down inside standpipe and may prevent gate from fully closing. Wheel to operate gate still missing. 5/13/2013 SBFCA project recommends removal. 11/7/2013 Same as last inspection. 5/20/2014 Same as last inspection. 12/30/2014 Same as last inspection. FIELD_STRUCT_DESC: 24-inch reinforced concrete encased CM irrigation pipe through the levee, 21.0 feet below the crown. Slide gate in 36-inch CM pipe riser on the waterward slope. This entry matches the Drainage or Irrigation Structure referenced in O&M manual (Historic Station 490+50). (USACE O&M Manual, 1957) FS Date: 07/07/2015

View of waterward side looking upstream at crossing. CMP riser located on waterward shoulder.

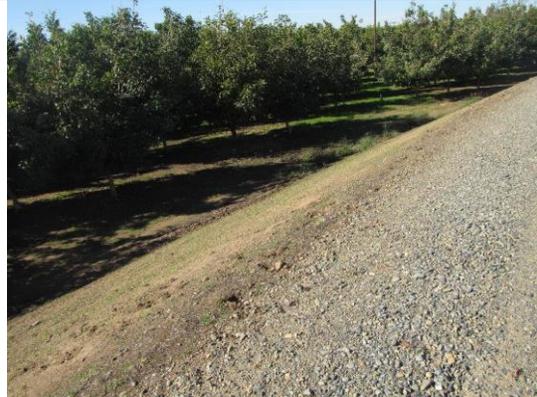
Photo 3 of 3 : UCIP_FA_2015_5349.jpg

LM Start	11.01	Rating **	M	Issue No.	242 (cont)
LM End	11.01	Issue Type +	En	Location *	LS
Category	Supplemental			GPS Latitude/Longitude	
				Start	End
Item	DWR UCIP Field Study			39.430540 °	39.430540 °
				-121.645118 °	-121.645118 °
DWR ID					
Action/Comments					
Inspector Comments: FS_ID:46148 DS_ID:16941 EP_NO: N/A FS_HLM: 11.167 Repair Type: Non-Urgent Crossing Status: Found UCIP Comments: 6/11/2015 Same as last inspection. waterward side-missing top cover of the CMP riser; debris inside CMP riser; wheel handle missing from slide gate. Unable to determine condition of slide gate face. landward side-crossing not visible. This crossing was listed in the USACE Periodic Inspection as ID# USACE_CESPK_MA07_2010_a_0330 no issues reported. 5/10/2013 Top cover has fallen down inside standpipe and may prevent gate from fully closing. Wheel to operate gate still missing. 5/13/2013 SBFCA project recommends removal. 11/7/2013 Same as last inspection. 5/20/2014 Same as last inspection. 12/30/2014 Same as last inspection. FIELD_STRUCT_DESC: 24-inch reinforced concrete encased CM irrigation pipe through the levee, 21.0 feet below the crown. Slide gate in 36-inch CM pipe riser on the waterward slope. This entry matches the Drainage or Irrigation Structure referenced in O&M manual (Historic Station 490+50). (USACE O&M Manual, 1957) FS Date: 07/07/2015

View of landward side looking upstream at crossing.
