**Flood Control Project Maintenance
Levee Inspections**

Fall 2015 Levee Maintenance Deficiency Summary Report

Sutter Maintenance Yard Maintenance Area 0007

Waterway		Bank	Unit Miles	
Unit No. 01 Feather River		Right	11.90	
	Spring (March - May)	Summer (June - August)	(September - November) Fall	Winter (December - February)
Unit Maintenance Rating (Fall Only)			M	
Date of Inspection	05/05/2015 - 05/05/2015		11/16/2015 - 11/16/2015	
DWR Inspector	Michael Pitta		Bob Duffey	
Accompanied By	Sean Freitag		Sean Freitag

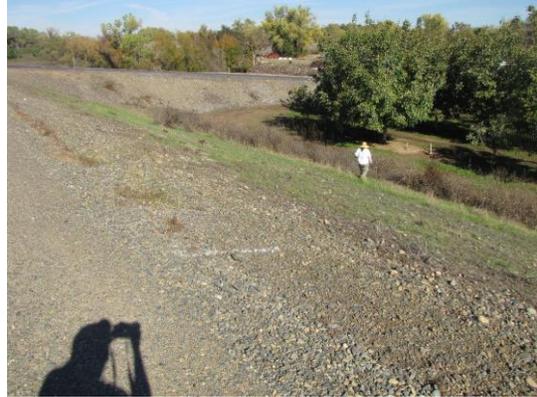
Photo 1 of 3 : UCIP_FA_2015_5350.jpg

LM Start	11.08	Rating **	M	Issue No.	243
LM End	11.08	Issue Type +	En	Location *	LS
Category	Supplemental			GPS Latitude/Longitude	
				Start	End
Item	DWR UCIP Field Study			39.431546 °	39.431546 °
				-121.645474 °	-121.645474 °
DWR ID					
Action/Comments					
Inspector Comments: FS_ID:46150 DS_ID:16939 EP_NO: N/A FS_HLM: 11.24 Repair Type: Non-Urgent Crossing Status: Found UCIP Comments: 6/11/2015 Both pipe ends are beeing overgrown by vegetation and are getting hard to inspect. Vegetation needs to be cleared away.flash boards missing on LS. This crossing was listed in the USACE Periodic Inspection as ID# USACE_CESPK_MA07_2010_a_0332 no issues reported.5/10/2013 Same as last inspection. Talking with farmer he said the pipe may be getting removed.5/13/2013 SBFCA project recommends relacing in accordance with title 23.11/7/2013 Same as last inspection.5/20/2014 Same as last inspection.12/30/2014 Same as last inspection. FIELD_STRUCT_DESC: 24-inch CM drainpipe through the levee. 18.9 feet below the crown. Flap gate on the waterward end. This entry matches the Drainage or Irrigation Structure referenced in O&M manual (Historic Station 494+50). (USACE O&M Manual, 1957) FS Date: 07/07/2015

View of waterward side looking upstream at crossing.

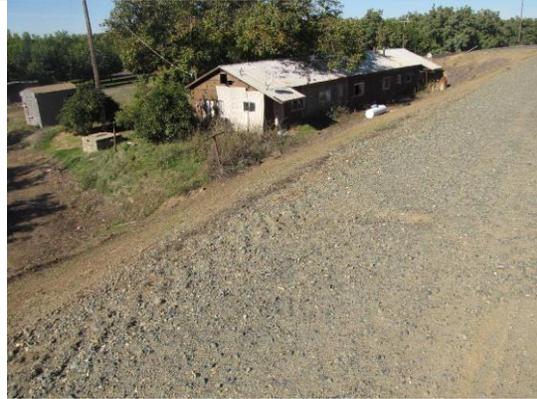
Photo 2 of 3 : UCIP_FA_2015_5351.jpg

LM Start	11.08	Rating **	M	Issue No.	243 (cont)
LM End	11.08	Issue Type +	En	Location *	LS
Category	Supplemental			GPS Latitude/Longitude	
				Start	End
Item	DWR UCIP Field Study			39.431546 °	39.431546 °
				-121.645474 °	-121.645474 °
DWR ID					
Action/Comments					
Inspector Comments: FS_ID:46150 DS_ID:16939 EP_NO: N/A FS_HLM: 11.24 Repair Type: Non-Urgent Crossing Status: Found UCIP Comments: 6/11/2015 Both pipe ends are beeing overgrown by vegetation and are getting hard to inspect. Vegetation needs to be cleared away.flash boards missing on LS. This crossing was listed in the USACE Periodic Inspection as ID# USACE_CESPK_MA07_2010_a_0332 no issues reported.5/10/2013 Same as last inspection. Talking with farmer he said the pipe may be getting removed.5/13/2013 SBFCA project recommends relacing in accordance with title 23.11/7/2013 Same as last inspection.5/20/2014 Same as last inspection.12/30/2014 Same as last inspection. FIELD_STRUCT_DESC: 24-inch CM drainpipe through the levee. 18.9 feet below the crown. Flap gate on the waterward end. This entry matches the Drainage or Irrigation Structure referenced in O&M manual (Historic Station 494+50). (USACE O&M Manual, 1957) FS Date: 07/07/2015

View of landward side looking upstream at crossing.

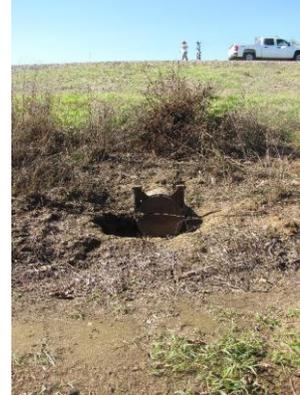
Photo 3 of 3 : UCIP_FA_2015_5352.jpg

LM Start	11.08	Rating **	M	Issue No.	243 (cont)
LM End	11.08	Issue Type +	En	Location *	LS
Category	Supplemental			GPS Latitude/Longitude	
				Start	End
Item	DWR UCIP Field Study			39.431546 °	39.431546 °
				-121.645474 °	-121.645474 °
DWR ID					
Action/Comments					
Inspector Comments: FS_ID:46150 DS_ID:16939 EP_NO: N/A FS_HLM: 11.24 Repair Type: Non-Urgent Crossing Status: Found UCIP Comments: 6/11/2015 Both pipe ends are beeing overgrown by vegetation and are getting hard to inspect. Vegetation needs to be cleared away.flash boards missing on LS. This crossing was listed in the USACE Periodic Inspection as ID# USACE_CESPK_MA07_2010_a_0332 no issues reported.5/10/2013 Same as last inspection. Talking with farmer he said the pipe may be getting removed.5/13/2013 SBFCA project recommends relacing in accordance with title 23.11/7/2013 Same as last inspection.5/20/2014 Same as last inspection.12/30/2014 Same as last inspection. FIELD_STRUCT_DESC: 24-inch CM drainpipe through the levee. 18.9 feet below the crown. Flap gate on the waterward end. This entry matches the Drainage or Irrigation Structure referenced in O&M manual (Historic Station 494+50). (USACE O&M Manual, 1957) FS Date: 07/07/2015

View of waterward slope and outlet.

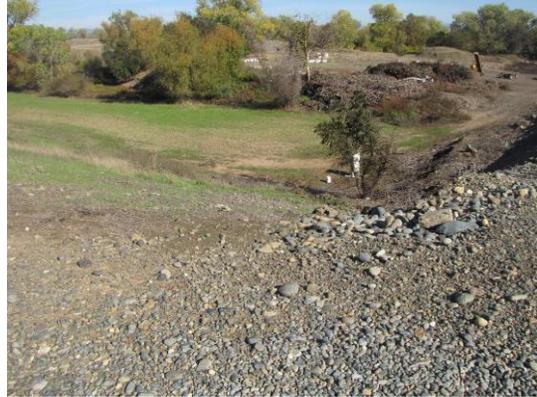
Photo 1 of 2 : UCIP_FA_2015_5353.jpg

LM Start	11.12	Rating **	M	Issue No.	244
LM End	11.12	Issue Type +	En	Location *	LS
Category	Supplemental			GPS Latitude/Longitude	
				Start	End
Item	DWR UCIP Field Study			39.432143 °	39.432143 °
				-121.645516 °	-121.645516 °
DWR ID					
Action/Comments					
Inspector Comments: FS_ID:46151 DS_ID:16938 EP_NO: N/A FS_HLM: 11.282 Repair Type: Non-Urgent Crossing Status: Found UCIP Comments: 6/11/2015 Scour still present near the WS apron. burrow activity near headwall on landward side; scour near concrete apron and below apron; This crossing was listed in the USACE Periodic Inspection as ID# USACE_CESPK_MA07_2010_a_0336 no issues reported.5/10/2013 Same as last inspection.5/13/2013 SBFCA project recommends relacing in accordance with title 23.11/7/2013 Same as last inspection.5/20/2014 Same as last inspection.12/30/2014 Same as last inspection. FIELD_STRUCT_DESC: 24-inch CM drainpipe through the levee, 15.8 feet below the crown. Concrete headwall at both toes. Flap gate on the waterward end. This entry matches the Drainage or Irrigation Structure referenced in O&M manual (Historic Station 496+20). (USACE O&M Manual, 1957) FS Date: 07/07/2015

View of waterward side looking upstream at crossing.

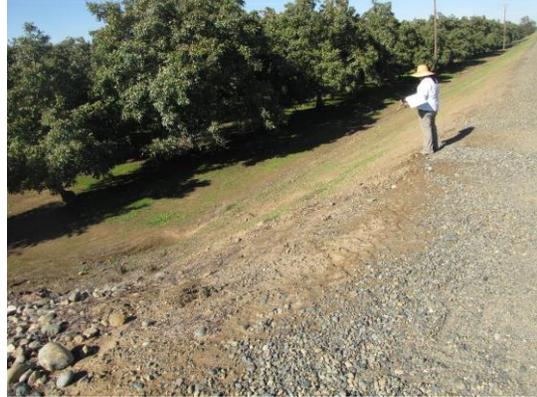
Photo 2 of 2 : UCIP_FA_2015_5354.jpg

LM Start	11.12	Rating **	M	Issue No.	244 (cont)
LM End	11.12	Issue Type +	En	Location *	LS
Category	Supplemental			GPS Latitude/Longitude	
				Start	End
Item	DWR UCIP Field Study			39.432143 °	39.432143 °
				-121.645516 °	-121.645516 °
DWR ID					
Action/Comments					
Inspector Comments: FS_ID:46151 DS_ID:16938 EP_NO: N/A FS_HLM: 11.282 Repair Type: Non-Urgent Crossing Status: Found UCIP Comments: 6/11/2015 Scour still present near the WS apron. burrow activity near headwall on landward side; scour near concrete apron and below apron; This crossing was listed in the USACE Periodic Inspection as ID# USACE_CESPK_MA07_2010_a_0336 no issues reported.5/10/2013 Same as last inspection.5/13/2013 SBFCA project recommends relacing in accordance with title 23.11/7/2013 Same as last inspection.5/20/2014 Same as last inspection.12/30/2014 Same as last inspection. FIELD_STRUCT_DESC: 24-inch CM drainpipe through the levee, 15.8 feet below the crown. Concrete headwall at both toes. Flap gate on the waterward end. This entry matches the Drainage or Irrigation Structure referenced in O&M manual (Historic Station 496+20). (USACE O&M Manual, 1957) FS Date: 07/07/2015

View of landward side looking upstream at crossing.

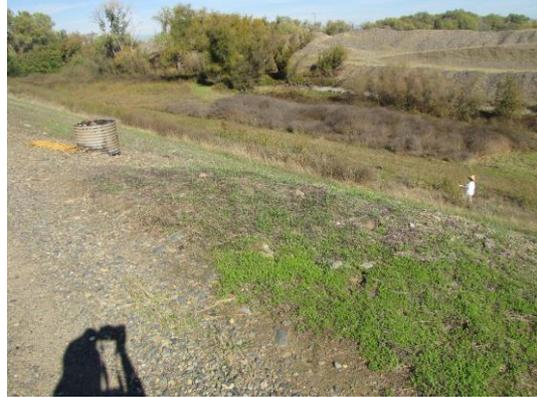
Photo 1 of 3 : UCIP_FA_2015_5372.jpg

LM Start	11.23	Rating **	M	Issue No.	245
LM End	11.23	Issue Type +	En	Location *	LS
Category	Supplemental			GPS Latitude/Longitude	
				Start	End
Item	DWR UCIP Field Study			39.433674 °	39.433674 °
				-121.645591 °	-121.645591 °
DWR ID					
Action/Comments					
Inspector Comments: FS_ID:46152 DS_ID:16937 EP_NO: N/A FS_HLM: 11.39 Repair Type: Non-Urgent Crossing Status: Found UCIP Comments: 6/11/2015 Abandoned crossing. SBFCA project recommends removal. Abandoned pipe-need to properly abandon structure; CMP riser cover missing on WS; WS pipe filled with concrete; LS crossing not visible. 5/10/2013 Same as last inspection. 5/13/2013 SBFCA project recommends removal. 11/7/2013 Same as last inspection. 5/20/2014 Same as last inspection. 12/30/2014 Same as last inspection. FIELD_STRUCT_DESC: Abandoned 24-inch reinforced concrete encased CM irrigation pipe through the levee, 19.5 feet below the crown. Concrete headwall at the landward toe. Slide gate in 36-inch CM riser on the waterward slope. This entry matches the Drainage or Irrigation Structure referenced in O&M manual (Historic Station 502+20). (USACE O&M Manual, 1957) FS Date: 07/07/2015

View of waterward side looking upstream at crossing.

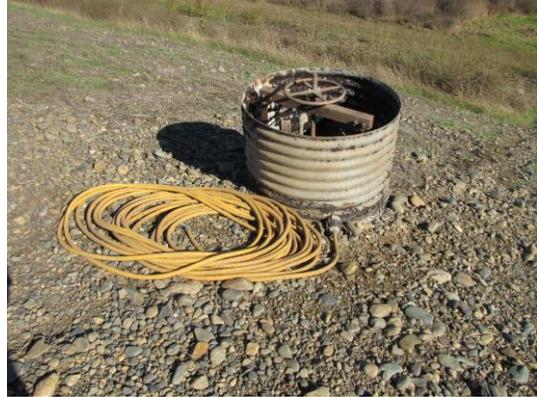
Photo 2 of 3 : UCIP_FA_2015_5373.jpg

LM Start	11.23	Rating **	M	Issue No.	245 (cont)
LM End	11.23	Issue Type +	En	Location *	LS
Category	Supplemental			GPS Latitude/Longitude	
				Start	End
Item	DWR UCIP Field Study			39.433674 °	39.433674 °
				-121.645591 °	-121.645591 °
DWR ID					
Action/Comments					
Inspector Comments: FS_ID:46152 DS_ID:16937 EP_NO: N/A FS_HLM: 11.39 Repair Type: Non-Urgent Crossing Status: Found UCIP Comments: 6/11/2015 Abandoned crossing. SBFCA project recommends removal. Abandoned pipe-need to properly abandon structure; CMP riser cover missing on WS; WS pipe filled with concrete; LS crossing not visible. 5/10/2013 Same as last inspection. 5/13/2013 SBFCA project recommends removal. 11/7/2013 Same as last inspection. 5/20/2014 Same as last inspection. 12/30/2014 Same as last inspection. FIELD_STRUCT_DESC: Abandoned 24-inch reinforced concrete encased CM irrigation pipe through the levee, 19.5 feet below the crown. Concrete headwall at the landward toe. Slide gate in 36-inch CM riser on the waterward slope. This entry matches the Drainage or Irrigation Structure referenced in O&M manual (Historic Station 502+20). (USACE O&M Manual, 1957) FS Date: 07/07/2015

CMP riser located on waterward shoulder.

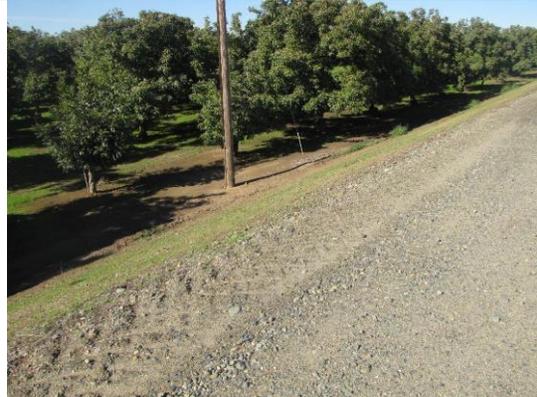
Photo 3 of 3 : UCIP_FA_2015_5374.jpg

LM Start	11.23	Rating **	M	Issue No.	245 (cont)
LM End	11.23	Issue Type +	En	Location *	LS
Category	Supplemental			GPS Latitude/Longitude	
				Start	End
Item	DWR UCIP Field Study			39.433674 °	39.433674 °
				-121.645591 °	-121.645591 °
DWR ID					
Action/Comments					
Inspector Comments: FS_ID:46152 DS_ID:16937 EP_NO: N/A FS_HLM: 11.39 Repair Type: Non-Urgent Crossing Status: Found UCIP Comments: 6/11/2015 Abandoned crossing. SBFCA project recommends removal. Abandoned pipe-need to properly abandon structure; CMP riser cover missing on WS; WS pipe filled with concrete; LS crossing not visible. 5/10/2013 Same as last inspection. 5/13/2013 SBFCA project recommends removal. 11/7/2013 Same as last inspection. 5/20/2014 Same as last inspection. 12/30/2014 Same as last inspection. FIELD_STRUCT_DESC: Abandoned 24-inch reinforced concrete encased CM irrigation pipe through the levee, 19.5 feet below the crown. Concrete headwall at the landward toe. Slide gate in 36-inch CM riser on the waterward slope. This entry matches the Drainage or Irrigation Structure referenced in O&M manual (Historic Station 502+20). (USACE O&M Manual, 1957) FS Date: 07/07/2015

View of landward side looking upstream at crossing.

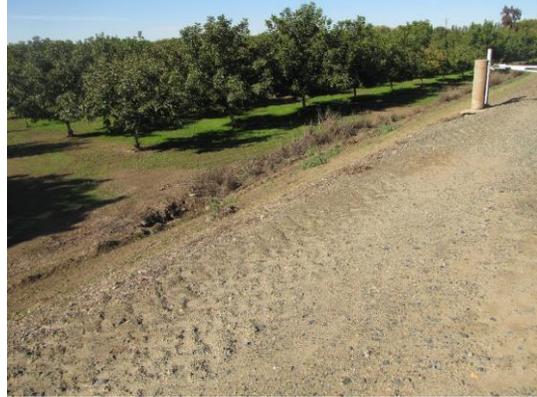
Photo 1 of 3 : UCIP_FA_2015_5375.jpg

Inspector Comments: FS_ID:46153
 DS_ID:16936
 EP_NO: N/A
 FS_HLM: 11.518
 Repair Type: Non-Urgent
 Crossing Status: Found
 UCIP Comments: 6/11/2015 LS inlet is still mostly buried with soil. SBFCA project recommends removal. Non-functional crossing landward inlet buried; waterward side-debris in CMP riser, riser missing lid; This crossing was listed in the USACE Periodic Inspection as ID# USACE_CESPK_MA07_2010_a_0344 for pipes filled > 50 % with soil. 5/10/2013 Same as last inspection. LS inlet excavated but more than 50% still covered by soil. 5/13/2013 SBFCA project recommends removal. 11/7/2013 Same as last inspection. 5/20/2014 Same as last inspection. 12/30/2014 Same as last inspection.
 FIELD_STRUCT_DESC: 24-inch CM drainpipe through the levee, 16.2 feet below the crown. Concrete headwall at both toes. Flap gate on the waterward end. This entry matches the Drainage or Irrigation Structure referenced in O&M manual (Historic Station 508+40). (USACE O&M Manual, 1957)

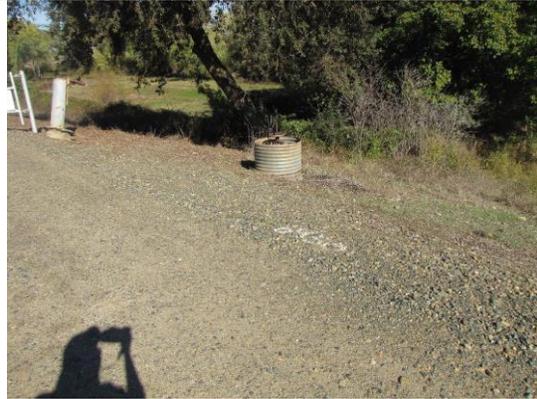
Photo 3 of 3 : UCIP_FA_2015_5377.jpg

LM Start	11.35	Rating **	M	Issue No.	246 (cont)
LM End	11.35	Issue Type +	En	Location *	LS
Category	Supplemental			GPS Latitude/Longitude	
				Start	End
Item	DWR UCIP Field Study			39.435497 °	39.435497 °
				-121.645712 °	-121.645712 °
DWR ID					
Action/Comments					
Inspector Comments: FS_ID:46153 DS_ID:16936 EP_NO: N/A FS_HLM: 11.518 Repair Type: Non-Urgent Crossing Status: Found UCIP Comments: 6/11/2015 LS inlet is still mostly buried with soil. SBFCA project recommends removal. Non-functional crossing landward inlet buried; waterward side-debris in CMP riser, riser missing lid; This crossing was listed in the USACE Periodic Inspection as ID# USACE_CESPK_MA07_2010_a_0344 for pipes filled > 50 % with soil. 5/10/2013 Same as last inspection. LS inlet excavated but more than 50% still covered by soil. 5/13/2013 SBFCA project recommends removal. 11/7/2013 Same as last inspection. 5/20/2014 Same as last inspection. 12/30/2014 Same as last inspection. FIELD_STRUCT_DESC: 24-inch CM drainpipe through the levee, 16.2 feet below the crown. Concrete headwall at both toes. Flap gate on the waterward end. This entry matches the Drainage or Irrigation Structure referenced in O&M manual (Historic Station 508+40). (USACE O&M Manual, 1957) FS Date: 07/07/2015

View of waterward side looking upstream at crossing.

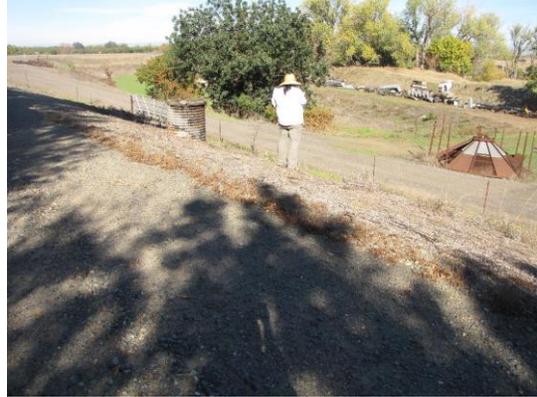
Photo 2 of 3 : UCIP_FA_2015_5378.jpg

LM Start	11.51	Rating **	M	Issue No.	247 (cont)
LM End	11.51	Issue Type +	En	Location *	LS
Category	Supplemental			GPS Latitude/Longitude	
				Start	End
Item	DWR UCIP Field Study			39.437766 °	39.437766 °
				-121.646196 °	-121.646196 °
DWR ID					
Action/Comments					
Inspector Comments: FS_ID:46156 DS_ID:16934 EP_NO: N/A FS_HLM: 11.681 Repair Type: Non-Urgent Crossing Status: Found UCIP Comments: 6/11/2015 same as last inspection.unable to determine the condition of the slide gate inside riser--need to determine condition. This crossing was listed in the USACE Periodic Inspection as ID# USACE_CESPK_MA07_2010_a_0355 no issues reported.5/10/2013 Same as last inspection. Burrow activity above WS riser.5/13/2013 SBFCA project recommends relacing in accordance with title 23.11/7/2013 Same as last inspection. Metal cone structure on WS was removed and a flapgate was under it.5/20/2014 Same as last inspection.12/30/2014 Same as last inspection. FIELD_STRUCT_DESC: 24-inch reinforced concrete encased CM irrigation pipe through the levee, 18.8 feet below the crown. Slide gate in 36-inch CM riser on the waterward slope. This entry matches the Drainage or Irrigation Structure referenced in O&M manual (Historic Station 517+40). (USACE O&M Manual, 1957) FS Date: 07/07/2015

View of waterward side looking upstream at crossing.

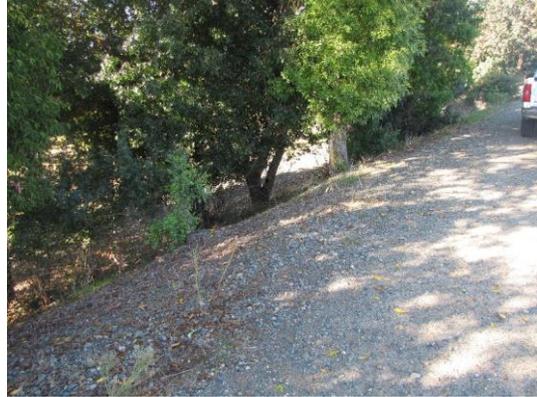
Photo 3 of 3 : UCIP_FA_2015_5379.jpg

LM Start	11.51	Rating **	M	Issue No.	247 (cont)
LM End	11.51	Issue Type +	En	Location *	LS
Category	Supplemental			GPS Latitude/Longitude	
				Start	End
Item	DWR UCIP Field Study			39.437766 °	39.437766 °
DWR ID				-121.646196 °	-121.646196 °
Action/Comments					
Inspector Comments: FS_ID:46156 DS_ID:16934 EP_NO: N/A FS_HLM: 11.681 Repair Type: Non-Urgent Crossing Status: Found UCIP Comments: 6/11/2015 same as last inspection.unable to determine the condition of the slide gate inside riser--need to determine condition. This crossing was listed in the USACE Periodic Inspection as ID# USACE_CESPK_MA07_2010_a_0355 no issues reported.5/10/2013 Same as last inspection. Burrow activity above WS riser.5/13/2013 SBFCA project recommends relacing in accordance with title 23.11/7/2013 Same as last inspection. Metal cone structure on WS was removed and a flapgate was under it.5/20/2014 Same as last inspection.12/30/2014 Same as last inspection. FIELD_STRUCT_DESC: 24-inch reinforced concrete encased CM irrigation pipe through the levee, 18.8 feet below the crown. Slide gate in 36-inch CM riser on the waterward slope. This entry matches the Drainage or Irrigation Structure referenced in O&M manual (Historic Station 517+40). (USACE O&M Manual, 1957) FS Date: 07/07/2015

View of landward side looking upstream at crossing.
