**Flood Control Project Maintenance
Levee Inspections**
LMA District Cover Sheet
Spring 2018 Levee Inspection Results

Sutter Maintenance Yard Maintenance Area 0012

Spring 2018 Levee Inspection Results

Waterway			Bank	Unit Miles
Unit No. 01 Colusa Drain			Left	11.06
	Spring (March - May)	Summer (June - August)	(September - November) Fall	Winter (December - February)
Unit Maintenance Rating (Fall Only)				
Date of Inspection	4/18/2018 - 4/18/2018			
DWR Inspector	Bob Duffey			
Accompanied By	Bryan Reniff Sutter Maintenance Yard

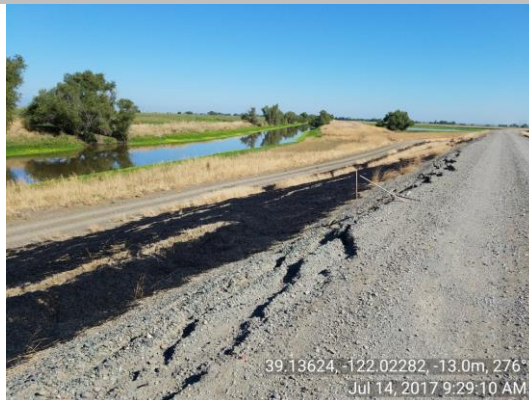
Photo 2 of 4 : LEVAL_SP_2018_6_1774.jpg

Comment Code					
Inspector Comment					
Levee Evaluation Comments					
Description:					
Site ID No:6					
Site Designation:MA12-01					
Repair Type: Stability					
Rating:Critical					
Field Date:7/14/2017					
Notes: Site vegetation recently burned. Entire waterside of the levee is on a slip plane. Bulging on the toe of the levee. Same effect is beginning to be observed on the landside. Levee is between two channels of water. This site is also known as DWR_MA0012_01_R_2012_02 in the FSRP database. The site was temporary repaired by Sutter Maintenance Yard during December 2017. Supposedly Sutter Maintenance Yard is going to come back 2018 summer and do more repair work to the site.

View of the repaired erosion along the waterside slope. The erosion was repaired by Sutter Maintenance Yard.

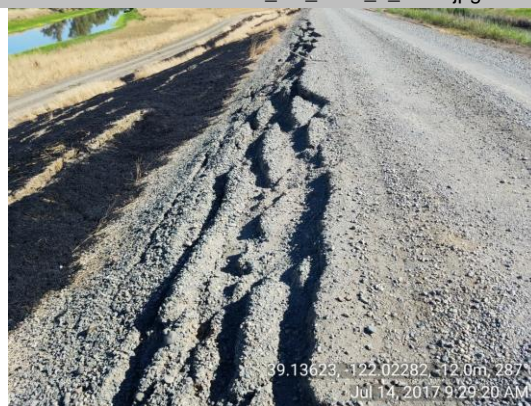
Photo 3 of 4 : LEVAL_SP_2018_6_1775.jpg

Comment Code						
Inspector Comment						
Levee Evaluation Comments						
Description:						
Site ID No:6						
Site Designation:MA12-01						
Repair Type: Stability						
Rating:Critical						
Field Date:7/14/2017						
Notes: Site vegetation recently burned. Entire waterside of the levee is on a slip plane. Bulging on the toe of the levee. Same effect is beginning to be observed on the landside. Levee is between two channels of water. This site is also known as DWR_MA0012_01_R_2012_02 in the FSRP database. The site was temporary repaired by Sutter Maintenance Yard during December 2017. Supposedly Sutter Maintenance Yard is going to come back 2018 summer and do more repair work to the site.
