**Flood Control Project Maintenance
Levee Inspections
Unit Cover Sheet**

Sutter Maintenance Yard Maintenance Area 0012

| Waterway | | | Bank | Unit Miles |
|--|---|---|---|---|
| Unit No. 01 Colusa Drain | | | Left | 11.06 |

Levee Inspection Report By Mile - Spring 2021

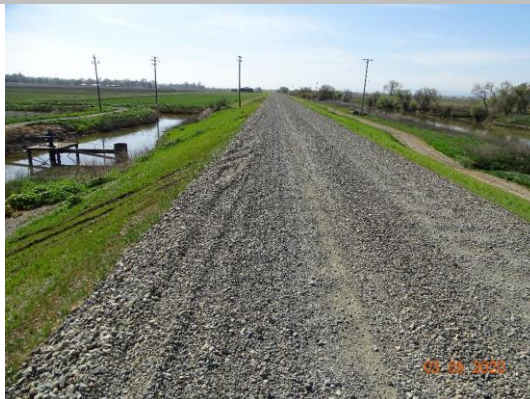
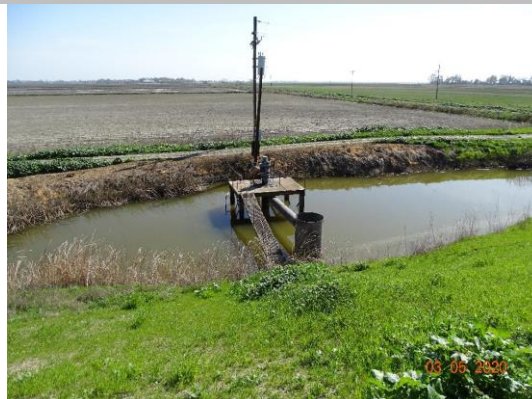
Photo 1 of 3 : UCIP_SP_2021_57231_83547.jpg

FS_ID:57231
DS_ID:17158
EP_NO: 9390
Repair Type: Non-Urgent
Crossing Status: Found
UCIP Comments: 03/05/2020 Record updated from No Action Needed to Non-Urgent. Pump in drainage ditch and standpipe are not designed per O&M As-Built drawing. Unable to locate a permit for modifications. Need to have CVFPB review ABO and determine current owner.
(O.Yakimov - DWR UCIP)05/02/2017 Crossing appears to be in good condition. There is minor sediment build up in front of the WS flap gate.
(A.Freitag - DWR Sutter Yard)10/17/2016 Crossing appears to be in good condition. (A.Freitag - DWR Sutter Yard)05/31/2016 Crossing appears to be in good condition. (A.Freitag - DWR Sutter Yard)05/04/2015 Crossing appears to be in good condition. No noticeable issues to report. (A.Freitag - DWR Sutter Yard)06/17/2014 Same as last inspection. (A.Freitag - DWR Sutter Yard)12/16/2013 Same as last inspection. (A.Freitag - DWR Sutter Yard)07/16/2013 New flapgate installed on WS pipe end. (A.Freitag - DWR Sutter Yard)10/11/2012 Flap gate broken on WS. Pipe shows significant rust at outlet. This is a good candidate for video inspection. (W.Wylie - DWR UCIP)

FIELD_STRUCT_DESC: 36-inch corrugated metal drainage pipe through the levee, 20 feet below the crown. Pump on metal pier in landside (LS) channel. 40-inch steel standpipe at the LS toe. Flap gate and concrete headwall on the waterside (WS). Concrete headwall on the LS. (36-inch pipe [HLM 4.87] authorized under Automatic Board Order (ABO) issued as Permit No. 9390, 1974 - Annie D. Propfe; 24-inch pipe [HLM 4.87] was also authorized under Automatic Board Order (ABO) issued as Permit No. 8233, 1972 - Olive P. Davis Estate).
[Additional Reference(s): DWR Levee Log, 2005 (HLM 4.87). USACE Sacramento O&M Manual, Unit 132, October 1959, Revised 14 January 2019, (HLM 4.87), listed as 36-inch pipe. USACE As-Built Drawing No. 50-4-3081, Sheet 6 and 16, Station 1581+10, 4 April 1957].
FS Date: 3/5/2020 7:55:00 AM

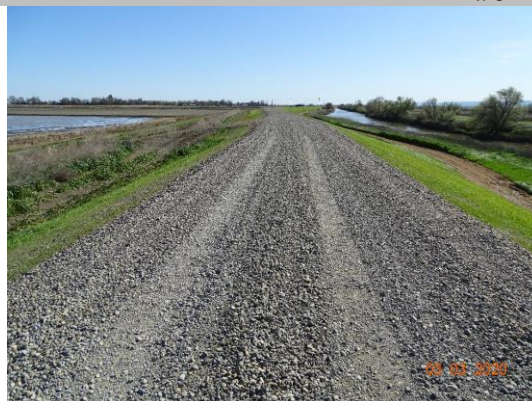
Photo 1 of 3 : UCIP_SP_2021_57232_83554.jpg

FS_ID:57232
DS_ID:17191
EP_NO: 9390
Repair Type: Non-Urgent
Crossing Status: Found
UCIP Comments: 03/03/2020 Record remains Non-Urgent. Pipe inlet in drainage ditch on LS is buried. Flap gate on WS is under water, unable to see if sediment was cleared. Recommend internal video inspection of the pipe. Need to have CVFPB review ABO and determine current owner. (O.Yakimov - DWR UCIP)
05/02/2017 WS headwall and flapgate almost completely buried with only a small portion of the head wall visible. LS end is buried and unable to be located. (A.Freitag - DWR Sutter Yard)
10/17/2016 WS flap gate is still silted over and LS inlet is heavily vegetated and unable to be inspected. (A.Freitag - DWR Sutter Yard)
09/29/2016 Crossing has been downgraded from Urgent to Non-Urgent WS flap gate is closed shut due to sediment build up. For flood season flap gate is required to be closed. Need to coordinate with owner to remove sediment from WS to have WS flap gate be operable after flood season. (O.Magana - DWR UCIP)

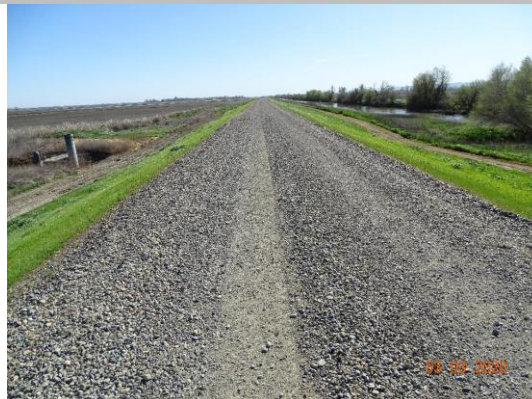
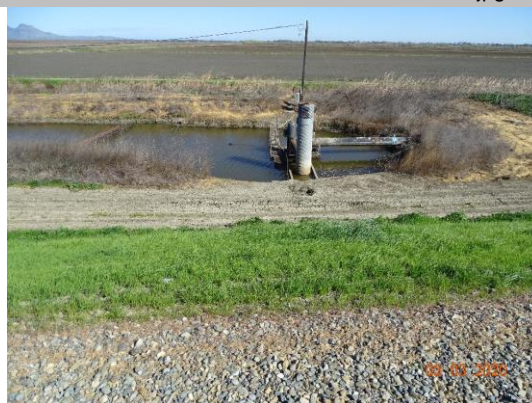
Photo 1 of 3 : UCIP_SP_2021_57234_83561.jpg

FS_ID:57234
DS_ID:17190
EP_NO: 8234
Repair Type: Non-Urgent
Crossing Status: Found
UCIP Comments: 03/03/2020 Record updated from No Action Needed to Non-Urgent. Modifications to the crossings: pump and a standpipe connected to the crossing located in drainage ditch that were not included in original O&M design. Supply pipe is currently disconnected from the pump. Unable to locate a permit authorizing modifications. Recommend internal inspection of crossing. Two soil depression spots apparently from a truck crane found on LS slope and LS berm. Need to have CVFPB review ABO and determine current owner. (O.Yakimov - DWR UCIP)05/02/2017 Crossing appears to be in good condition. (A.Freitag - DWR Sutter Yard)10/17/2016 Crossing appears to be in good condition. Pipe was field verified to be 48-inch CMP. (A.Freitag - DWR Sutter Yard)05/31/2016 Crossing appears to be in good condition. (A.Freitag - DWR Sutter Yard)05/04/2015 Crossing appears to be in good condition. No noticeable issues to report. (A.Freitag - DWR Sutter Yard)06/17/2014 Same as last inspection. (A.Freitag - DWR Sutter Yard)12/16/2013 Same as last inspection. (A.Freitag - DWR Sutter Yard)07/16/2013 Same as last inspection. (A.Freitag - DWR Sutter Yard)

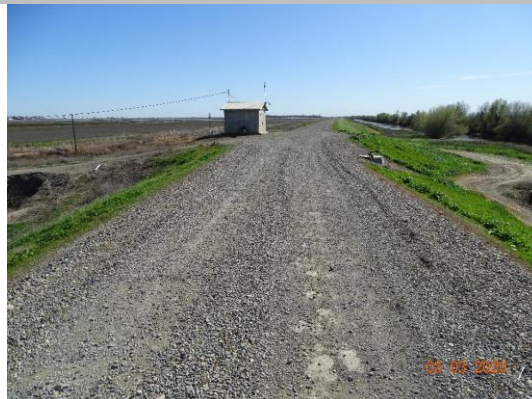
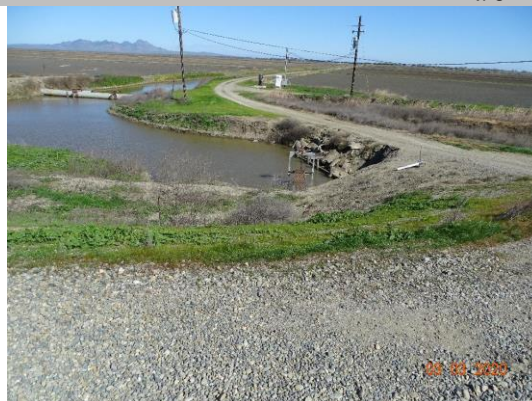
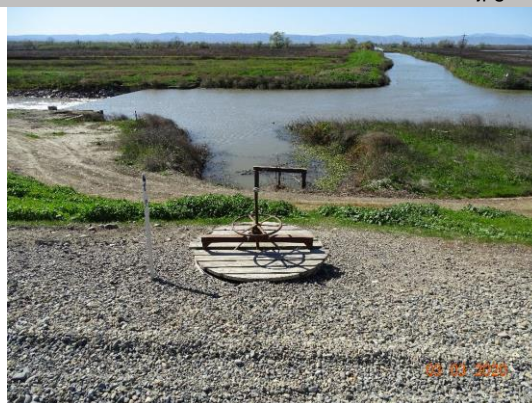
Photo 1 of 3 : UCIP_SP_2021_57280_83569.jpg

| FS_ID:57280 DS_ID:17161 EP_NO: 9390 Repair Type: Non-Urgent Crossing Status: Found UCIP Comments: 03/03/2020 Record updated from No Action Needed to Non-Urgent. Need to have CVFPB review ABO and determine current owner. (O.Yakimov - DWR UCIP) 05/02/2017 Crossing appears to be in good condition. (A.Freitag - DWR Sutter Yard) 10/17/2016 Crossing appears to be in good condition. (A.Freitag - DWR Sutter Yard) 05/31/2016 Crossing appears to be in good condition. (A.Freitag - DWR Sutter Yard) 05/04/2015 Crossing appears to be in good condition. No noticeable issues to report. (A.Freitag - DWR Sutter Yard) 06/17/2014 Same as last inspection. (A.Freitag - DWR Sutter Yard)12/16/2013 Same as last inspection. (A.Freitag - DWR Sutter Yard) 07/16/2013 Same as last inspection. (A.Freitag - DWR Sutter Yard) FIELD_STRUCT_DESC: 48-inch corrugated metal drainage pipe through the levee, 20.3 feet below the crown. Concrete headwall and cobble revetted spillway on the waterside (WS). Slide gate in a 60-inch corrugated metal pipe (CMP) riser on the WS slope. Concrete headwall located on the landside (LS). (48-inch pipe [HLM 6.10] authorized under Automatic Board Order (ABO) issued as Permit No. 9390, 1974 - Annie D. Propfe; 58-inch pipe [HLM 6.10] authorized under Automatic Board Order (ABO) issued as Permit No. 8234, 1972 - Glenn Irrigation District). [Additional Reference(s): DWR Levee Log, 2005 (HLM 6.10). USACE Sacramento O&M Manual, Unit 132, October 1959, Revised 14 January 2019, (HLM 6.10), listed as 48-inch pipe. USACE As-Built Drawing No. 50-4-3081, Sheet 7 and 16, Station 1648+88.2, 4 April 1957]. FS Date: 3/3/2020 1:07:00 PM | | | | | | |

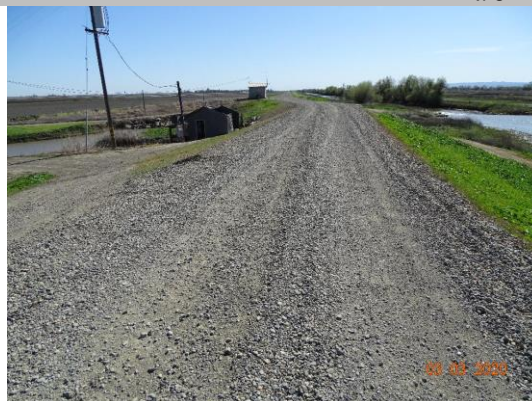
Photo 1 of 3 : UCIP_SP_2021_57238_83594.jpg

| FS_ID:57238 DS_ID:17199 EP_NO: 9390 Repair Type: Non-Urgent Crossing Status: Found UCIP Comments: 03/03/2020 Record remains Non-Urgent. Need to have CVFPB review ABO and determine current owner. (O.Yakimov - DWR UCIP) 05/02/2017 Pipe appears to be in good condition. Minor erosion above the LS pump house. (A.Freitag - DWR Sutter Yard)10/17/2016 Crossing appears to be in good condition. (A.Freitag - DWR Sutter Yard)05/31/2016 Crossing appears to be in good condition. (A.Freitag - DWR Sutter Yard)05/04/2015 Crossing appears to be in good condition. No noticeable issues to report. (A.Freitag - DWR Sutter Yard)06/17/2014 Same as last inspection. (A.Freitag - DWR Sutter Yard)12/16/2013 Same as last inspection. (A.Freitag - DWR Sutter Yard)07/16/2013 Same as last inspection. (W.Wylie - DWR UCIP) FIELD_STRUCT_DESC: 3 of 3: 18-inch steel drainage pipe through the levee, 4.4 feet below the crown. Cobble revetted sump located on the waterside (WS). Siphon breaker in a 16-inch metal riser on the WS shoulder. Pump house at the landside (LS) toe. (18-inch pipe [HLM 6.13] authorized under Automatic Board Order (ABO) issued as Permit No. 9390, 1974 - Annie D. Propfe). [Additional Reference(s): DWR Levee Log, 2005 (HLM 6.13). USACE Sacramento O&M Manual, Unit 132, October 1959, Revised 14 January 2019, (HLM 6.13), listed as 3-18" pipes. Pipe not included to original USACE As-Built Drawing No. 50-4-3081. FS Date: 3/3/2020 3:08:00 PM | | | | | |

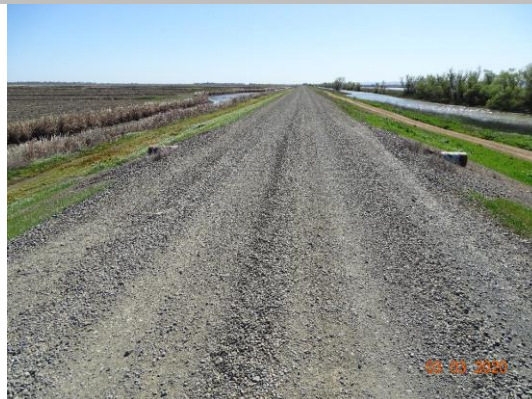
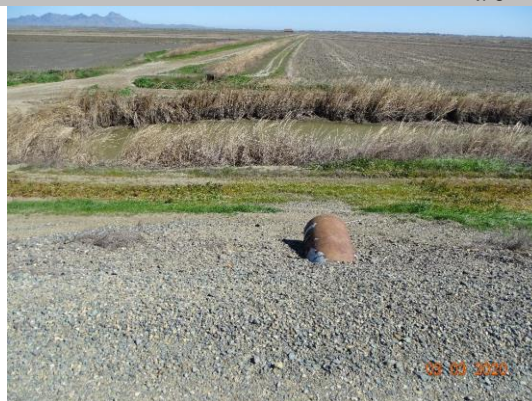
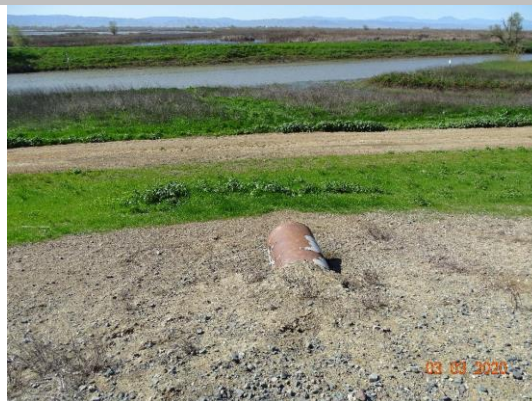
Photo 1 of 3 : UCIP_SP_2021_57239_83602.jpg

FS_ID:57239
DS_ID:17163
EP_NO: 9390
Repair Type: Non-Urgent
Crossing Status: Found
UCIP Comments: 03/03/2020 Record remains Non-Urgent. Pipe is plate welded over both ends. Rodent burrows under pipe on WS. Crossing appears abandoned. Need to have CVFPB review ABO and determine current owner. (O.Yakimov - DWR UCIP)
05/02/2017 Appears abandoned- pipe capped on both ends. Should be removed. (A.Freitag - DWR Sutter Yard)
10/17/2016 Appears abandoned and should be removed. (A.Freitag - DWR Sutter Yard)
05/31/2016 Appears to be abandoned. Pipe is capped on both WS and LS ends. (A.Freitag - DWR Sutter Yard)
05/04/2015 Crossing appears to be in good condition. No noticeable issues to report. (A.Freitag - DWR Sutter Yard)06/17/2014 Same as last inspection. (A.Freitag - DWR Sutter Yard)12/16/2013 Same as last inspection. (A.Freitag - DWR Sutter Yard)
07/16/2013 Same as last inspection. (A.Freitag - DWR Sutter Yard)10/11/2012 Rodent burrowing along sides of pipe on LS. (W.Wylie - DWR UCIP)

FIELD_STRUCT_DESC: 24-inch steel irrigation pipe through the levee, 3 feet below the crown. Both ends capped, terminating on levee slopes. (24-inch pipe [HLM 7.76] authorized under Automatic Board Order (ABO) issued as Permit No. 9390, 1974 -Annie D. Propfe; 24-inch pipe [HLM 7.76] was also authorized under Automatic Board Order (ABO) issued as Permit No. 8233, 1972 - Olive P. Davis Estate). [Additional Reference(s): DWR Levee Log, 2005 (HLM 7.76). USACE Sacramento O&M Manual, Unit 132, October 1959, Revised 14 January 2019, (HLM 7.76), listed as 24-inch pipe. USACE As-Built Drawing No. 50-4-3081, Sheet 8 and 16, Station 1734+67.5, 1/4-inch cover plate continuously welded over each end, 4 April 1957].
FS Date: 3/3/2020

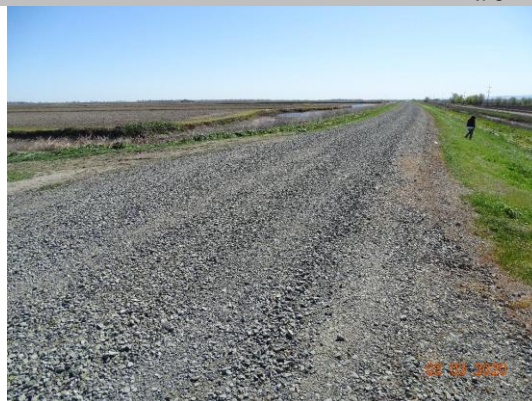
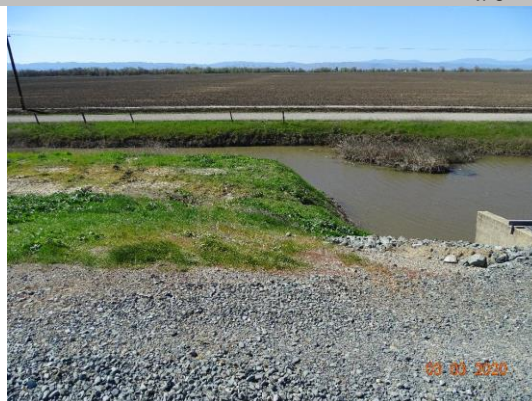
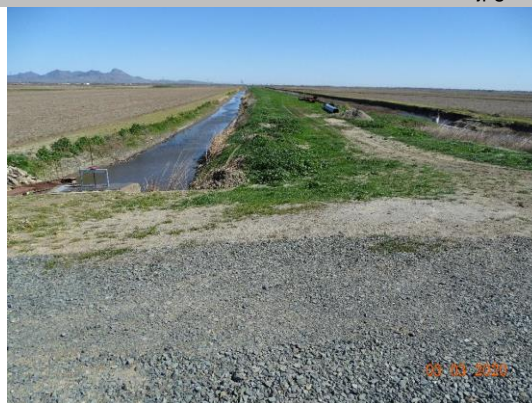
Photo 1 of 3 : UCIP_SP_2021_57240_83629.jpg

FS_ID:57240
 DS_ID:17164
 EP_NO: 9390
 Repair Type: Non-Urgent
 Crossing Status: Not Found
 UCIP Comments: 03/03/2020 Record updated from No Action Needed to Non-Urgent. Crossing not found. Unauthorized encroachment recorded in Levee Log prior to 2011. Recommend geophysical study. Suspect that this pipe is the same record as DSID 17189. (O.Yakimov - DWR UCIP)
 05/02/2017 Unable to locate. (A.Freitag - DWR Sutter Yard)
 10/17/2016 Unable to locate. (A.Freitag - DWR Sutter Yard)
 05/31/2016 Unable to locate. (A.Freitag - DWR Sutter Yard)
 05/04/2015 Unable to locate. (A.Freitag - DWR Sutter Yard)
 06/17/2014 Unable to locate. (A.Freitag - DWR Sutter Yard)
 12/16/2013 Unable to locate. (A.Freitag - DWR Sutter Yard)
 07/16/2013 Same as last inspection. Unable to locate. (A.Freitag - DWR Sutter Yard)
 FIELD_STRUCT_DESC: 24-inch drainage pipe through the levee, 3 feet below the crown. Capped on both waterside (WS) and landside (LS) ends. (24-inch pipe [HLM 9.23] authorized under Automatic Board Order (ABO) issued as Permit No. 9390, 1974 - Annie D. Propfe).

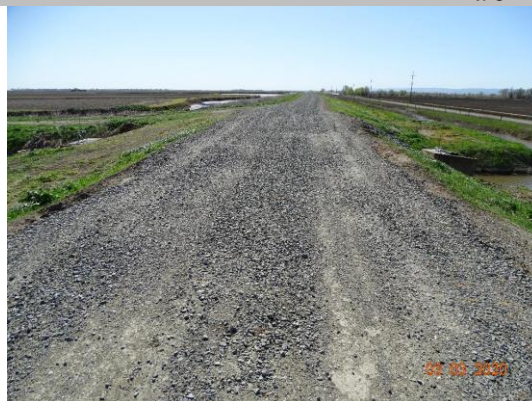
Photo 1 of 3 : UCIP_SP_2021_57243_83618.jpg

FS_ID:57243
DS_ID:17165
EP_NO: 9390
Repair Type: Non-Urgent
Crossing Status: Indicator Found
UCIP Comments: 03/03/2020 Record remains Non-Urgent. Crossing appears abandoned. Only pumping platform and steel walkway found on LS. Unable to confirm pipe removal. According to O&M as-built this pipe was running on the top of pipe DSID 17166 at the time of levee construction and was discharging into a concrete spill box on WS. Need to have CVFPB review ABO and determine current owner.
(O.Yakimov - DWR UCIP)
05/02/2017 Abandoned- only LS steel walkway is visible. (A.Freitag - DWR Sutter Yard)10/17/2016 Abandoned. (A.Freitag - DWR Sutter Yard)
05/31/2016 Abandoned crossing. (A.Freitag - DWR Sutter Yard)
05/04/2015 Abandoned crossing. (A.Freitag - DWR Sutter Yard)
06/17/2014 Same as last inspection. (A.Freitag - DWR Sutter Yard)
12/16/2013 Same as last inspection. (A.Freitag - DWR Sutter Yard)
07/16/2013 Same as last inspection. (A.Freitag - DWR Sutter Yard)

10/11/2012 Pipe abandoned. Steel pump platform remains on LS slope, but all appearances have been removed. (W.Wylie - DWR UCIP)
FIELD_STRUCT_DESC: 18-inch steel drainage pipe through the levee, 3 feet below the crown. Waterside (WS) end open into concrete spill box. Pump located on the landside (LS) on steel pier. (18-inch pipe [HLM 9.24] authorized under Automatic Board Order (ABO) issued as Permit No. 9390, 1974 - Annie D. Propfe). [Additional Reference(s): DWR Levee Log, 2005 (HLM 9.24). USACE Sacramento O&M Manual, Unit 132, October 1959, Revised 14 January 2019, (HLM 9.24), listed as 18-inch pipe. USACE As-Built Drawing No. 50-4-3081, Sheet 9 and 16, Station 1810+96.5, 4 April 1957].
FS Date: 3/3/2020 3:34:00 PM

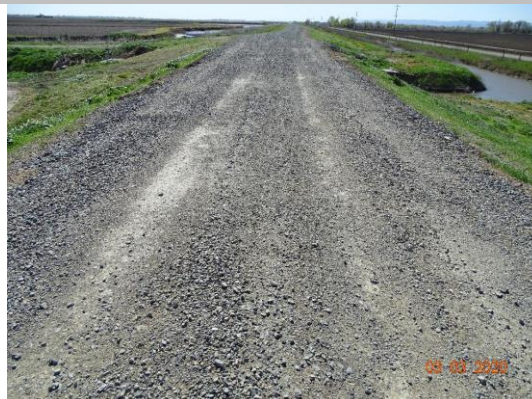
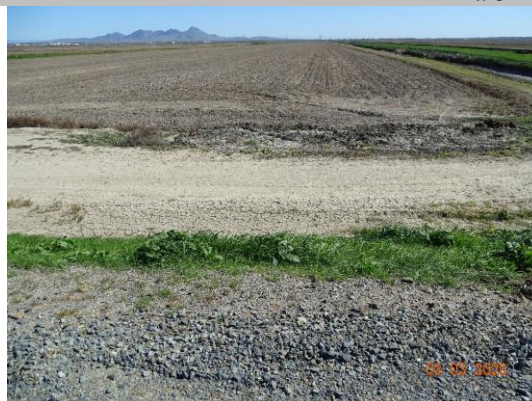
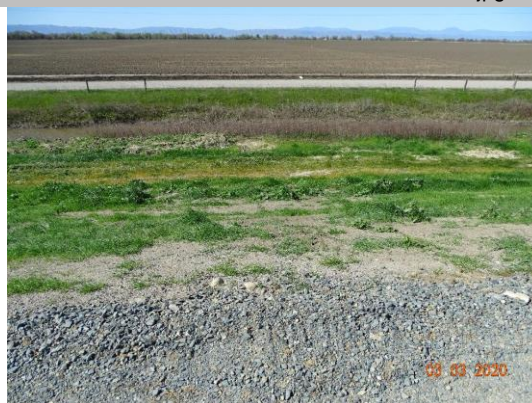
Photo 1 of 3 : UCIP_SP_2021_57244_83623.jpg

| FS_ID:57244 DS_ID:17189 EP_NO: N/A Repair Type: Non-Urgent Crossing Status: Not Found UCIP Comments: 03/03/2020 Record updated from No Action Needed to Non-Urgent. Crossing not found. Geophysical results did not confirm presence of pipe through levee. Record will remain in UCIP's inspection records until future Levee Improvement Project can confirm no crossing was found through the levee. Suspect that this pipe is the same record as DSID 17164. (O.Yakimov - DWR UCIP) 05/02/2017 Unable to locate. (A.Freitag - DWR Sutter Yard) 10/17/2016 Unable to locate. (A.Freitag - DWR Sutter Yard) 05/31/2016 Unable to locate. (A.Freitag - DWR Sutter Yard) 05/04/2015 Unable to locate. (A.Freitag - DWR Sutter Yard) 06/17/2014 Unable to locate. (A.Freitag - DWR Sutter Yard) 12/16/2013 Unable to locate. (A.Freitag - DWR Sutter Yard) 07/16/2013 Same as last inspection. Unable to locate. (A.Freitag - DWR Sutter Yard) FIELD_STRUCT_DESC: 24-inch steel drainage pipe through the levee, at an unknown depth. Corrugated metal cutoff wall at center of levee. 1/4-inch cover plates continuously welded over both the waterside (WS) and the landside (LS) ends. [Additional Reference(s): USACE Sacramento O&M Manual, Unit 132, October 1959, Revised 14 January 2019, (HLM 9.25), listed 24-inch pipe. USACE As-Built Drawing No. 50-4-3081, Sheet 9 and 16, Station 1811+05, 4 April 1957]. FS Date: 3/3/2020 3:43:00 PM | | | | | | |

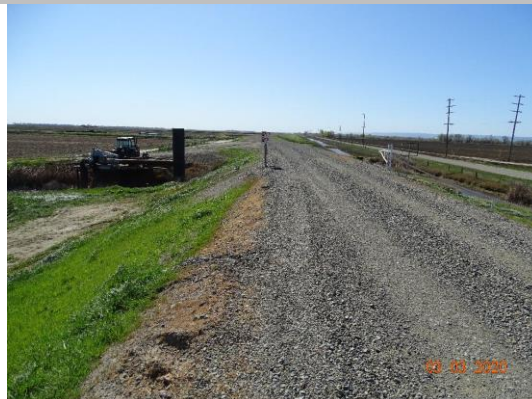
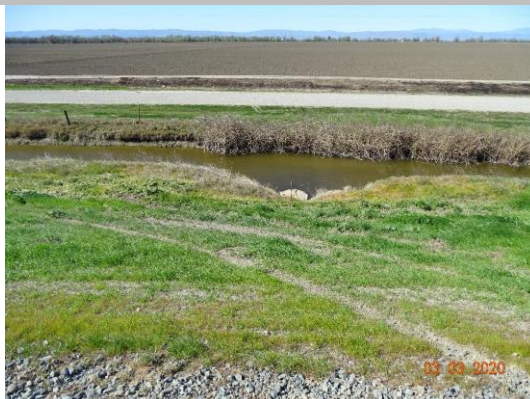
Photo 1 of 3 : UCIP_SP_2021_57219_83633.jpg

FS_ID:57219
DS_ID:17167
EP_NO: 9389
Repair Type: Urgent
Crossing Status: Found
UCIP Comments: 03/03/2020 Record remains Urgent. Pipe is excessively corroded inside at WS end. Recommend internal video inspection of crossing. Need to have CVFPB review ABO and determine current owner. (O.Yakimov - DWR UCIP)
10/05/2018 Flap gate was installed at WS end of the pipe. Pipe is excessively corroded looking inside from WS end. Video inspection is recommended. Cracks more than 1-inch wide were observed on WS slope around pipe alignment that may be a sign of slope instability. (O.Yakimov - DWR UCIP)
05/02/2017 No repairs have been made to this crossing yet. WS flap gate is still disconnected from end of pipe and pipe is showing heavy signs of rust and deterioration as far in as i can see from the WS end. Pipe should be internally camera inspected and repaired/replaced. (A.Freitag - DWR Sutter Yard)
01/31/2017 Informal Notice of Violation (NOV) was sent out January 31, 2017 by DWR Flood Maintenance Office--owner needs to re-attach flap gate to drainage pipe and coordinate with CVFPB to address additional issue(s) identified in NOV. Owner has until Monday February 27th, 2017 to respond to DWR contact: Bryan Reniff. (refer to Official Notice for details). (O.Magana - DWR UCIP)

10/17/2016 WS flapgate has separated from the pipe end. WS pipe end is showing signs of rust and deterioration. Needs a new flapgate or other means of closing off the pipe before flood season. (A.Freitag - DWR Sutter Yard)
05/31/2016 Crossing appears to be in good condition. (A.Freitag - DWR Sutter Yard)05/04/2015 Crossing appears to be in good condition. No noticeable issues to report. (A.Freitag - DWR Sutter Yard)
06/17/2014 Same as last inspection. (A.Freitag - DWR Sutter Yard)12/16/2013 Same as last inspection. (A.Freitag - DWR Sutter Yard)
07/16/2013 Same as last inspection. (A.Freitag - DWR Sutter Yard)
FIELD_STRUCT_DESC: 36-inch corrugated metal drainage pipe through the levee, 15.4 feet below the crown. Concrete headwall and flap gate on the waterside (WS). Concrete headwall on the landside (LS). Pump on steel structure in slough on the LS. Pump discharges into a 42-inch corrugated metal pipe (CMP) riser. Service pole on ramp. Butterfly gate at inlet on the LS toe. (36-inch pipe [HLM 9.33] authorized under Automatic Board Order (ABO) issued as Permit No. 9389, 1974 - Annie D. Propfe). [Additional Reference(s): DWR Levee Log, 2005 (HLM 9.33). USACE Sacramento O&M Manual, Unit 132, October 1959, Revised 14 January 2019, (HLM 9.33), listed as 36-inch pipe. USACE As-Built Drawing No. 50-4-3081, Sheet 9 and 16, Station

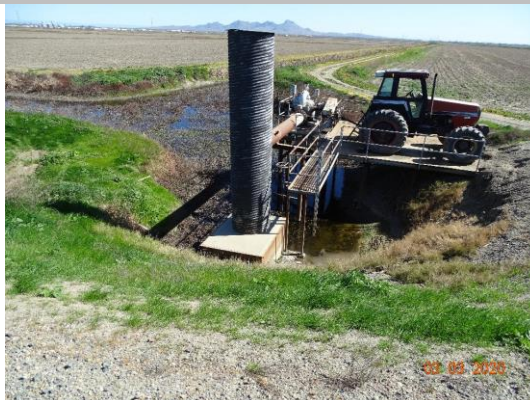
Photo 2 of 3 : UCIP_SP_2021_57219_83634.jpg

Stanspipe, pump in drainage ditch, and tractor used as a pump motor on LS

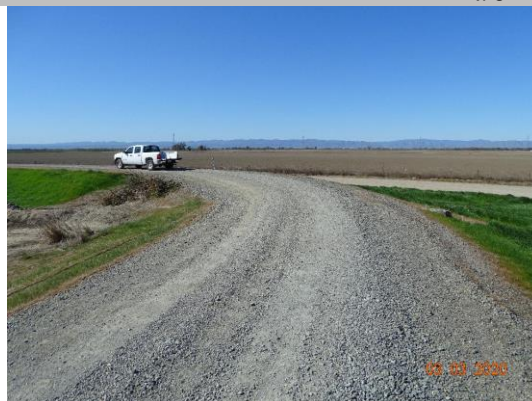
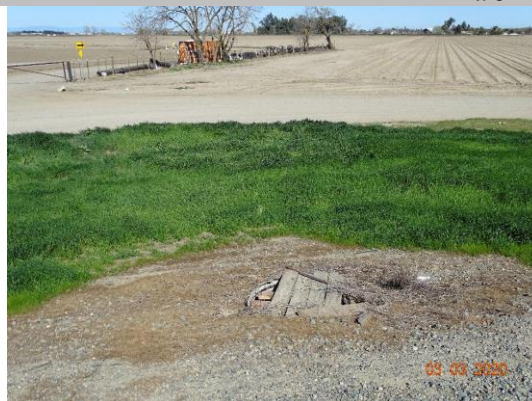
Photo 1 of 3 : UCIP_SP_2021_57245_83418.jpg

FS_ID:57245
DS_ID:17157
EP_NO: 9386
Repair Type: Non-Urgent
Crossing Status: Found
UCIP Comments: 03/03/2020 Record remains Non-Urgent. Crossing appears abandoned. Geophysical study indicates presence of pipe through levee, pipe crossing levee at angle. Pipe inlet on LS not found. Need to have CVFPB review ABO and determine current owner. (O.Yakimov - DWR UCIP)
05/02/2017 Abandoned - needs to be done properly. (A.Freitag - DWR Sutter Yard)
10/17/2016 Abandoned crossing. (A.Freitag - DWR Sutter Yard)
05/31/2016 Abandoned crossing. Both pipe ends and slide gate inside of riser are buried. (A.Freitag - DWR Sutter Yard)
05/04/2015 Both pipe ends and slide gate in riser are plugged with soil. Crossing is inoperable. (A.Freitag - DWR Sutter Yard)
06/17/2014 Same as last inspection. (A.Freitag - DWR Sutter Yard)
12/16/2013 Same as last inspection. (A.Freitag - DWR Sutter Yard)
07/16/2013 Same as last inspection. (A.Freitag - DWR Sutter Yard)

10/11/2012 Pipe plugged with soil on both ends as well as at slide gate on WS slope. Slide gate inoperable. (W.Wylie - DWR UCIP)
FIELD_STRUCT_DESC: 24-inch corrugated metal drainage pipe through the levee, 8 feet below the crown. Slide gate in a 36-inch riser on the waterside (WS) shoulder. Levee turns eastward. (24-inch pipe [HLM 11.17] authorized under Automatic Board Order (ABO) issued as Permit No. 9386, 1974 - C. J. Wescott Jr.). [Additional Reference(s): DWR Levee Log, 2005 (HLM 11.17). USACE Sacramento O&M Manual, Unit 132, October 1959, Revised 14 January 2019, (HLM 11.17), listed as 24-inch pipe. USACE As-Built Drawing No. 50-4-3081, Sheet 10 and 16, Station 1912+40, 4 April 1957].
FS Date: 3/3/2020 11:49:00 AM
