Flood Control Project Maintenance
Levee Inspections
LMA District Cover Sheet

Sutter Maintenance Yard Maintenance Area 0012

Waterway			Bank	Unit Miles
Unit No. 01 Colusa Drain			Left	11.06
	Spring (March - May)	Summer (June - August)	(September - November) Fall	Winter (December - February)
Unit Maintenance Rating (Fall Only)				
Date of Inspection	3/6/2024 - 3/6/2024			
DWR Inspector	Zach Jojola			
Accompanied By	Gregg Ahlers DWR

Levee Inspection Report By Mile - Spring 2024

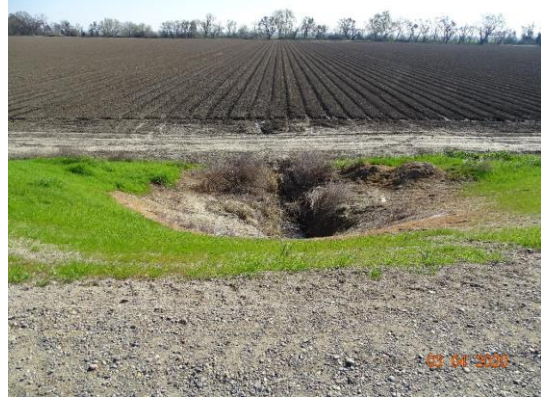
Photo 2 of 3 : UCIP_SP_2024_81150_83459.jpg

View of LS looking from levee crown

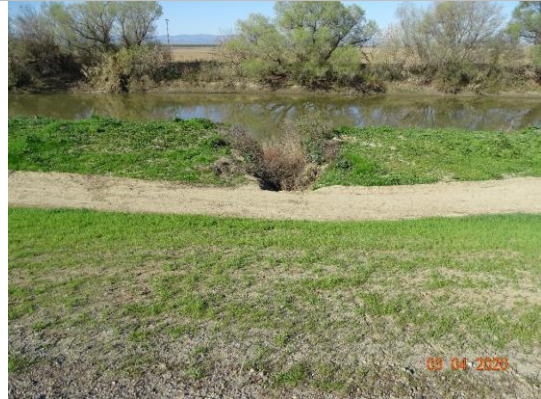
Photo 3 of 3 : UCIP_SP_2024_81150_83460.jpg

View of WS looking from levee crown

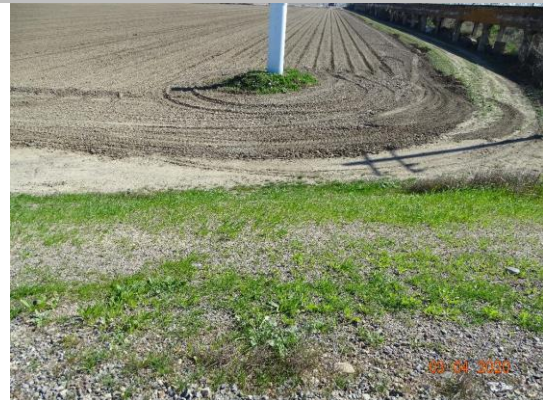
Photo 3 of 3 : UCIP_SP_2024_57227_83487.jpg

View of LS slope looking from levee crown. PVC pipe in the field doesn't belong to this crossing

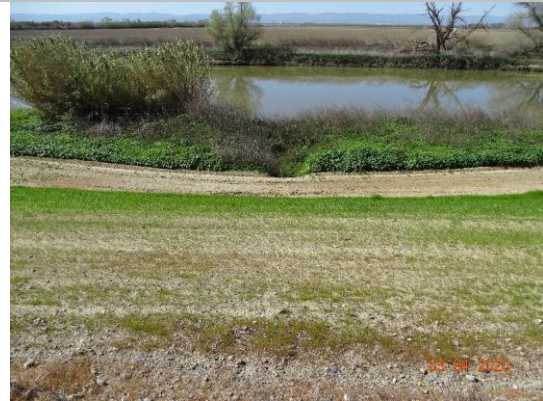
Photo 2 of 3 : UCIP_SP_2024_57228_83500.jpg

DS_ID:17151
FS_ID:57228
EP_NO: 9387
Repair Type: Non-Urgent
EVAL Issue:
Crossing Status: Found
UCIP Comments: 03/04/2020 Record remains Non-Urgent. Need to have CVFPB review ABO and determine current owner. Crossing appears abandoned. Both end of crossing are buried. Recommend performing maintenance of the crossing. (O.Yakimov - DWR UCIP)

View of WS looking from levee crown

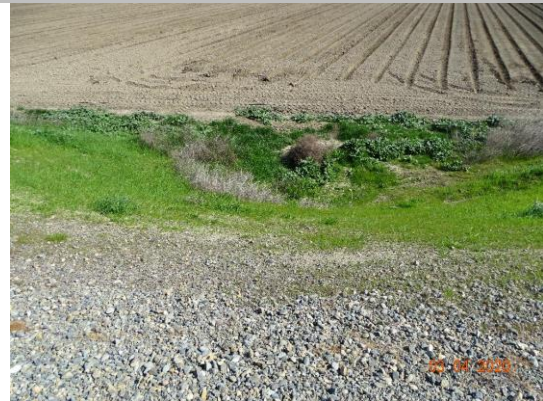
Photo 3 of 3 : UCIP_SP_2024_57228_83499.jpg

View of LS looking from levee crown

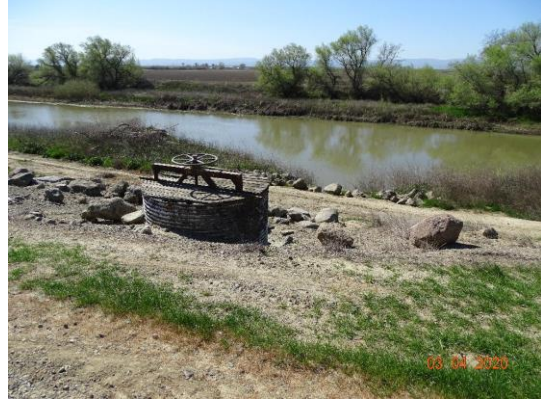
Photo 2 of 3 : UCIP_SP_2024_57194_83506.jpg

DS_ID:17152
FS_ID:57194
EP_NO: 9319
Repair Type: Non-Urgent
EVAL Issue: 4b, Safety Issue
Crossing Status: Found
UCIP Comments: 03/04/2020 Record updated from No Action Needed to Non-Urgent. Metal debris observed at LS levee toe considered trip and fall safety hazard. Need to have CVFPB review ABO and determine current owner. (O.Yakimov - DWR UCIP)05/02/2017 Crossing appears to be in good condition. (A.Freitag - DWR Sutter Yard)10/17/2016 Crossing appears to be in good condition. (A.Freitag - DWR Sutter Yard)05/31/2016 Crossing appears to be in good condition. (A.Freitag - DWR Sutter Yard)05/04/2015 Crossing appears in good condition. No noticeable issues. (A.Freitag - DWR Sutter Yard)06/17/2014 Same as last inspection. (A.Freitag - DWR Sutter Yard)12/16/2013 Same as last inspection. (A.Freitag - DWR Sutter Yard)07/16/2013 Same as last inspection. (A.Freitag - DWR Sutter Yard)
FIELD_STRUCT_DESC: 60-inch corrugated metal irrigation pipe through the levee, 22.7 feet below the crown. Slide gate in a 84-inch corrugated metal riser on the waterside (WS) slope. Three pumps over a sump, and distribution box on the landside (LS). Concrete headwall on the WS. (60-inch pipe [HLM 2.19] authorized under Automatic Board Order (ABO) issued as Permit No. 9319, 1974 - Frederick J. Strain; 60-inch pipe [HLM 2.19] was also authorized under Automatic Board Order (ABO) issued as Permit No. 8230, 1972 - Jack Baber. [Additional Reference(s): DWR Levee Log, 2005 (HLM 2.19). USACE Sacramento O&M Manual, Unit 132, October 1959, Revised 14 January 2019, (HLM 2.19), listed as 60-inch pipe. USACE As-Built Drawing No. 50-4-3081, Sheet 4 and 15, Station 1443+00, 4 April 1957].

84-inch CMP riser with slide gate on WS shoulder

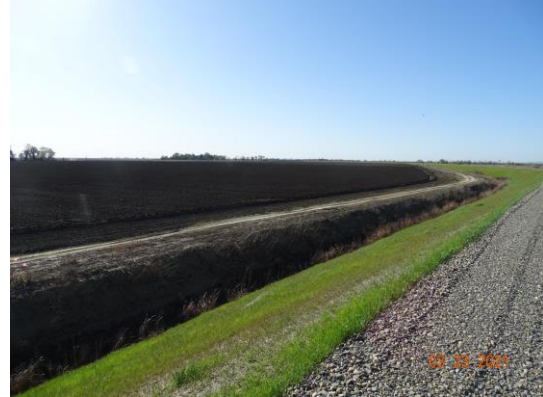
Photo 1 of 1 : SP_2024_MA0012_299_1_20240306_00001.jpg

LM Start	2.59	Rating **	U	Issue No.	1
LM End	3.68	Issue Type +	En	Location *	LS
Category	Earthen Levee			GPS Latitude/Longitude	
				Start	End
Item	Encroachments			39.067419°	39.081684°
				-122.009699°	-122.016243°
DWR ID	DWR_MA0012_01_s_2019_1				
Comment Code					
DT : Ditch					
Inspector Comment					
There is an irrigation ditch at the landside toe.

View of irrigation ditch at the landside toe. Spring 2021.

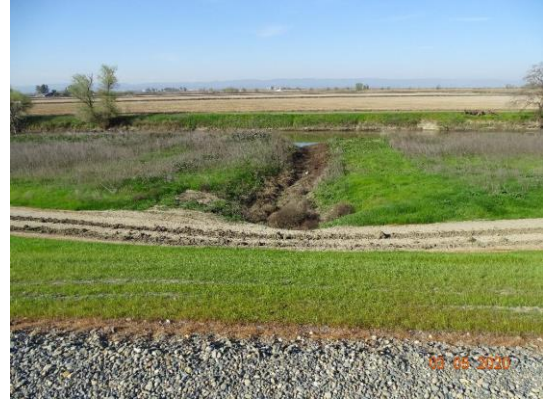
Photo 2 of 3 : UCIP_SP_2024_81152_83515.jpg

Comment Code					
Inspector Comment					
DS_ID:17153 FS_ID:81152 EP_NO: 9384 Repair Type: Non-Urgent EVAL Issue: 11, Maintenance Compliance Issue Crossing Status: Found UCIP Comments: 09/25/2023 DMP internal video inspection has found none or minor pipe defects. Recommend next video inspection in 5 years. (J. Taylor - DWR UCIP)03/05/2020 Record updated from No Action Needed to Non-Urgent. Sediment at LS headwall, vegetation at WS headwall need to be cleared. Need to have CVFPB review ABO and determine current owner. (O.Yakimov - DWR UCIP)05/02/2017 Crossing appears to be in good condition. (A.Freitag - DWR Sutter Yard)10/17/2016 Crossing appears to be in good condition. (A.Freitag - DWR Sutter Yard)05/31/2016 Crossing appears to be in good condition. (A.Freitag - DWR Sutter Yard)05/04/2015 Crossing appears in good condition. No noticeable issues. (A.Freitag - DWR Sutter Yard)06/17/2014 Same as last inspection. (A.Freitag - DWR Sutter Yard)12/16/2013 Same as last inspection. (A.Freitag - DWR Sutter Yard)07/16/2013 Same as last inspection. (A.Freitag - DWR Sutter Yard) FIELD_STRUCT_DESC: 24-inch corrugated metal drainage pipe through the levee, 16 feet below the crown. Flap gate, concrete headwall, and grouted cobble spillway on the waterside (WS). Concrete headwall on the landside (LS). (24-inch pipe [HLM 3.22] authorized under Automatic Board Order (ABO) issued as Permit No. 9384, 1974 - William D. Struckmeyer; 24-inch pipe [HLM 3.22] was also authorized under Automatic Board Order (ABO) issued as Permit No. 8231, 1972 - Roy E. Kitts). [Additional Reference(s): DWR Levee Log, 2005 (HLM 3.22). USACE Sacramento O&M Manual, Unit 132, October 1959, Revised 14 January 2019, (HLM 3.22), listed as 24-inch pipe. USACE As-Built Drawing No. 50-4-3081, Sheet 5 and 15, Station 1495+75, 4 April 1957]. FS Date: 3/5/2020 3:09:00 PM

View of WS looking from levee crown

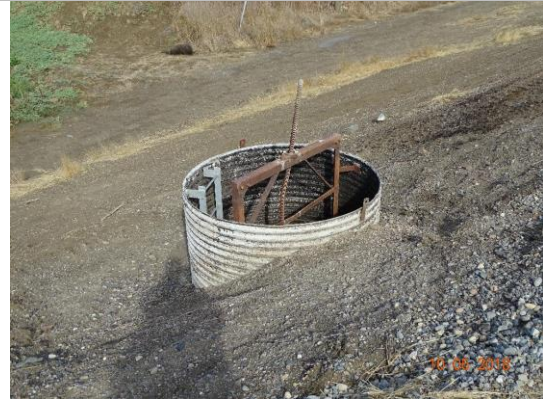
Photo 2 of 3 : UCIP_SP_2024_57196_78199.jpg

DS_ID:17154
FS_ID:57196
EP_NO: 9388
Repair Type: Urgent
EVAL Issue: 1, Pipe Integrity
Crossing Status: Found
UCIP Comments: 03/05/2020 Record remains Non-Urgent. New cover on CMP riser has been installed. Piping around slide gate at LS toe was modified, new 14-inch pipes installed. Unable to locate a permit for system modification. New steel walkway to slide gate on LS. Need to coordinate with LMA for find a permit authorizing modification. Need to have CVFPB review ABO and determine current owner. (O.Yakimov - DWR UCIP)
10/05/2018 Fall hazard: missing cover on CMP riser. Closure devices are present on both ends of crossing and seem to be in operable condition. Downgraded to non-urgent. Recommend owner add cover to CMP riser. (O.Yakimov - DWR UCIP)
05/02/2017 WS slide gate stem is still bent, wheel to operate gate is missing. Needs a cover made for the standpipe to prevent falls. (A.Freitag - DWR Sutter Yard)10/17/2016 Slide gate stem is still and the gate appears to be inoperable. (A.Freitag - DWR Sutter Yard)05/31/2016 Slide gate stem is still bent. WS flap gate is chained open. (A.Freitag - DWR Sutter Yard)

05/04/2015 Slide gate stem is still bent. Gate looks to be unable to close all the way. (A.Freitag - DWR Sutter Yard)06/17/2014 Same as last inspection. (A.Freitag - DWR Sutter Yard)12/16/2013 Slide gate stem is still bent. WS flapgate was closed. (A.Freitag - DWR Sutter Yard)
07/16/2013 Water flowing through pipe so screw gate definitely not closed. Was told NOV's have been sent for owner to replace stem. Flap gate gets closed for flood season. (A.Freitag - DWR Sutter Yard)
10/11/2012 Slide gate inoperable, but appears to be in closed position. Flap gate held in open position. Good candidate for video inspection when, if ever, dry. (W.Wylie - DWR UCIP)
FIELD_STRUCT_DESC: 48-inch corrugated metal drainage pipe through the levee, 28 feet below the crown. Slide gate in a 66-inch riser on the waterside (WS) slope. Concrete headwall on the WS. Grouted cobble spillway from drainage ditch to large canal on the landside (LS). (48-inch pipe [HLM 3.78] authorized under Automatic Board Order (ABO) issued as Permit No. 9388, 1974 - Pauline A. Wallace; 48-inch pipe [HLM 3.78] was also authorized under Automatic Board Order (ABO) issued as Permit No. 8231, 1972 - Roy E. Kitts). [Additional Reference(s): DWR Levee Log, 2005 (HLM 3.78). USACE Sacramento O&M Manual, Unit 132, October 1959, Revised 14 January 2019, (HLM 3.78), listed as 48-inch pipe. USACE As-Built Drawing No. 50-4-3081, Sheet 5 and 15, Station 1524+75, 4 April 1957].

CMP riser with slide gate on WS shoulder.

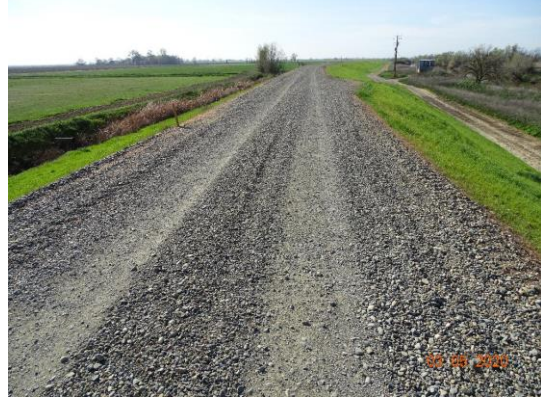
Photo 1 of 3 : UCIP_SP_2024_81153_83531.jpg

DS_ID:17168
FS_ID:81153
EP_NO: 9388
Repair Type: No Action Needed
EVAL Issue:
Crossing Status: Found
UCIP Comments: 09/25/2023 DMP internal video inspection has found none or minor pipe defects. Recommend next video inspection in 5 years. (J. Taylor - DWR UCIP)03/05/2020 Record updated from No Action Needed to Non-Urgent. Need to have CVFPB review ABO and determine current owner. (O.Yakimov - DWR UCIP)05/02/2017 Crossing appears to be in good condition. (A.Freitag - DWR Sutter Yard) 10/17/2016 Crossing appears to be in good condition. (A.Freitag - DWR Sutter Yard)05/31/2016 Crossing appears to be in good condition. (A.Freitag - DWR Sutter Yard)05/04/2015 Crossing appears to be in good condition. No noticeable issues to report. (A.Freitag - DWR Sutter Yard)06/17/2014 Same as last inspection. (A.Freitag - DWR Sutter Yard)12/16/2013 Same as last inspection. (A.Freitag - DWR Sutter Yard)07/16/2013 Same as last inspection. (A.Freitag - DWR Sutter Yard)

View of levee crown at the crossing looking downstream

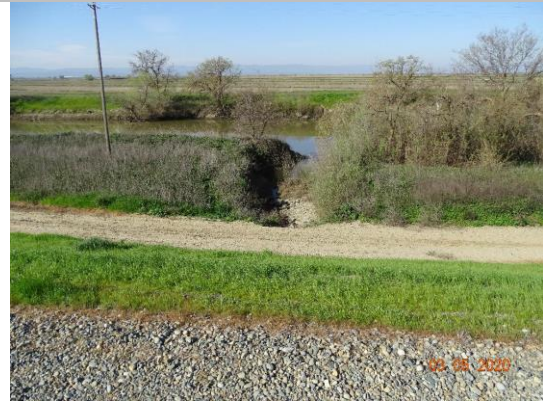
Photo 2 of 3 : UCIP_SP_2024_81153_83532.jpg

View of WS looking from levee crown

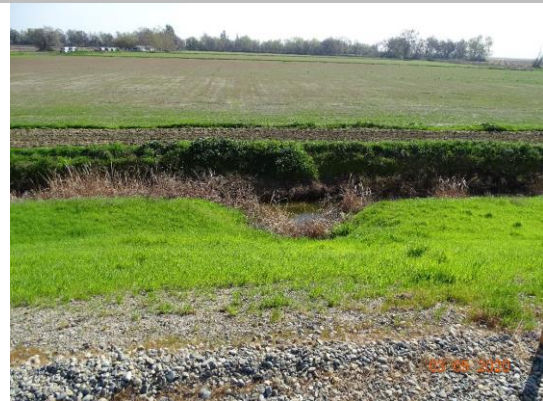
Photo 3 of 3 : UCIP_SP_2024_81153_83533.jpg

View of LS looking from levee crown

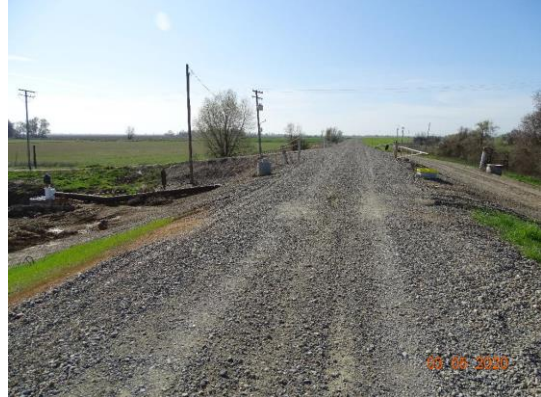
Photo 1 of 3 : UCIP_SP_2024_57199_83540.jpg

Comment Code					
Inspector Comment					
DS_ID:17156 FS_ID:57199 EP_NO: 9388 Repair Type: Non-Urgent EVAL Issue: 10, Unauthorized Modification or Non-Compliant Permit Crossing Status: Found UCIP Comments: 03/05/2020 Record updated from No Action Needed to Non-Urgent. Modifications to the system done: 24-inch steel pipe connected to a CMP pipe at LS toe, pump in irrigation canal on LS. Unable to find pump system in O&M drawings. Steel pipe is currently disconnected from the pump in irrigation canal. Unable to locate a permit authorizing modifications. Need to have CVFPB review ABO and determine current owner. Pipe outlet on WS not found due to dense vegetation. (O.Yakimov - DWR UCIP)05/02/2017 Crossing appears to be in good condition. (A.Freitag - DWR Sutter Yard)10/17/2016 Crossing appears to be in good condition. (A.Freitag - DWR Sutter Yard)05/31/2016 Crossing appears to be in good condition. (A.Freitag - DWR Sutter Yard)05/04/2015 Crossing appears to be in good condition. No noticeable issues to report. (A.Freitag - DWR Sutter Yard)06/17/2014 Same as last inspection. (A. Freitag - DWR Sutter Yard)12/16/2013 Same as last inspection. (A. Freitag - DWR Sutter Yard)07/16/2013 Same as last inspection. (A. Freitag - DWR Sutter Yard) FIELD_STRUCT_DESC: 24-inch corrugated metal drainage pipe through the levee, 9.2 feet below the crown. Slide gate in a 36-inch corrugated metal pipe (CMP) riser on the waterside (WS) slope. Pump on a 60-inch concrete standpipe at the landside (LS) toe. (24-inch pipe [HLM 4.32] authorized under Automatic Board Order (ABO) issued as Permit No. 9388, 1974 - Pauline A. Wallace). [Additional Reference(s): DWR Levee Log, 2005 (HLM 4.32). USACE Sacramento O&M Manual, Unit 132, October 1959, Revised 14 January 2019, (HLM 4.32), listed as 24-inch pipe. USACE As-Built Drawing No. 50-4-3081, Sheet 6 and 19, Station 1552+62, 4 April 1957]. FS Date: 3/5/2020 7:33:00 AM

View of levee crown at the crossing looking downstream

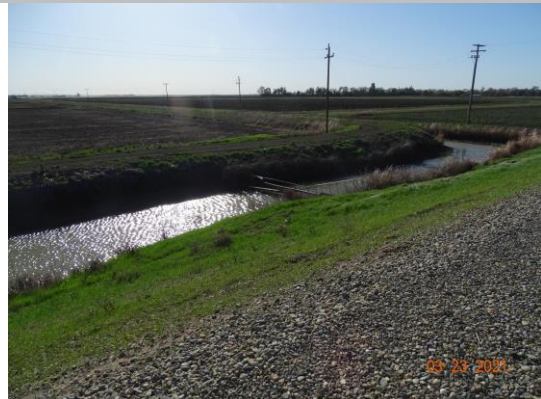
Photo 1 of 1 : SP_2024_MA0012_299_4_20240306_00002.jpg

LM Start	4.72	Rating **	M	Issue No.	4
LM End	4.77	Issue Type +	En	Location *	LS
Category	Earthen Levee			GPS Latitude/Longitude	
				Start	End
Item	Encroachments			39.096839°	39.097455°
				-122.015568°	-122.015581°
DWR ID	DWR_MA0012_01_s_2012_4				
Comment Code					
DT : Ditch					
Inspector Comment					
There is an irrigation ditch at the landside toe.

View of ditch at the landside toe. Spring 2021.

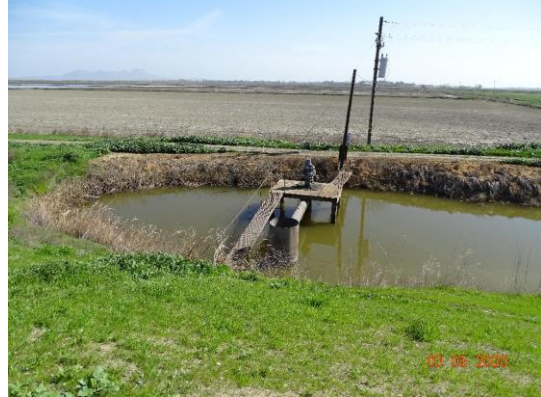
Photo 2 of 3 : UCIP_SP_2024_81287_83550.jpg

Modifications to original O&M construction: Pump in drainage ditch, standpipe connected to CMP pipe through the levee

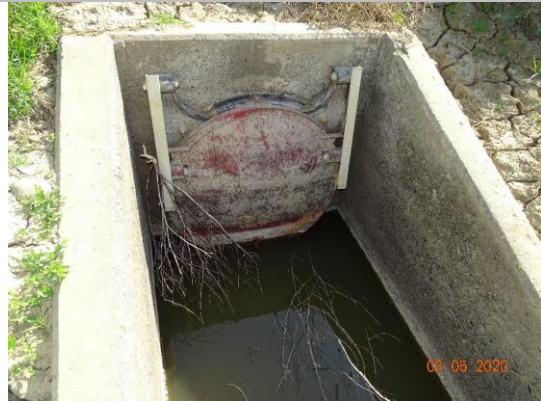
Photo 3 of 3 : UCIP_SP_2024_81287_83552.jpg

U-shaped headwall and flap gate at WS toe

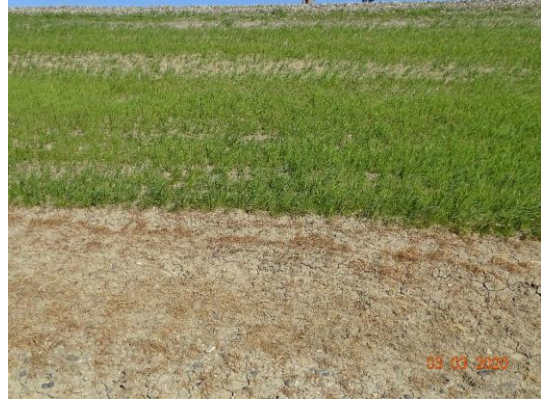
Photo 2 of 3 : UCIP_SP_2024_57232_83558.jpg

View of WS slope looking from levee toe

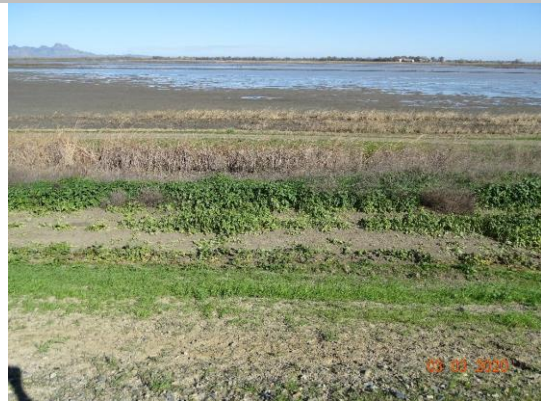
Photo 3 of 3 : UCIP_SP_2024_57232_83556.jpg

View of LS looking from levee crown

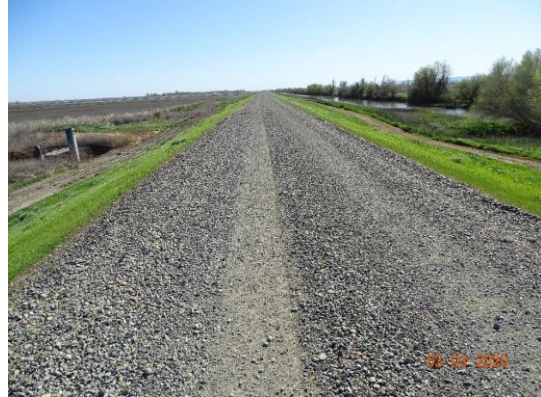
Photo 1 of 3 : UCIP_SP_2024_57234_83561.jpg

Comment Code					
Inspector Comment					
<p>DS_ID:17190 FS_ID:57234 EP_NO: 8234 Repair Type: Non-Urgent EVAL Issue: 10, Unauthorized Modification or Non-Compliant Permit Crossing Status: Found UCIP Comments: 03/03/2020 Record updated from No Action Needed to Non-Urgent. Modifications to the crossings: pump and a standpipe connected to the crossing located in drainage ditch that were not included in original O&M design. Supply pipe is currently disconnected from the pump. Unable to locate a permit authorizing modifications. Recommend internal inspection of crossing. Two soil depression spots apparently from a truck crane found on LS slope and LS berm. Need to have CVFPB review ABO and determine current owner. (O.Yakimov - DWR UCIP)05/02/2017 Crossing appears to be in good condition. (A.Freitag - DWR Sutter Yard)10/17/2016 Crossing appears to be in good condition. Pipe was field verified to be 48-inch CMP. (A.Freitag - DWR Sutter Yard)05/31/2016 Crossing appears to be in good condition. (A.Freitag - DWR Sutter Yard)05/04/2015 Crossing appears to be in good condition. No noticeable issues to report. (A.Freitag - DWR Sutter Yard)06/17/2014 Same as last inspection. (A.Freitag - DWR Sutter Yard)12/16/2013 Same as last inspection. (A.Freitag - DWR Sutter Yard)07/16/2013 Same as last inspection. (A.Freitag - DWR Sutter Yard) FIELD_STRUCT_DESC: 48-inch corrugated metal drainage pipe through the levee, approximately 22 feet below the crown. Concrete headwalls at both the waterside (WS) and the landside (LS) ends with flap gate on the WS. 36-inch corrugated metal pipe (CMP) riser on the LS toe with steel pipe extension for overflow weir of LS ditch. Walkway and pump not associated with this crossing. (36-inch drainage pipe [HLM 6.04] authorized under Automatic board order (ABO) issued as Permit No. 8234, 1972 - Glenn Irrigation District; 36-inch pipe [HLM 6.04] was also authorized under ABO issued as Permit No. 9390, 1974 - Annie D. Propfe). [Additional Reference(s): DWR Levee Log, 2005 (HLM 6.04), listed as 36-inch pipe. USACE Sacramento O&M Manual, Unit 132, October 1959, Revised 14 January 2019, (HLM 6.04), listed as 48-inch pipe. USACE As-Built Drawing No. 50-4-3081, Sheet 7 and 16, Station 1646+00, 4 April 1957]. FS Date: 3/3/2020 11:12:00 AM</p>

View of levee crown at the crossing looking downstreams

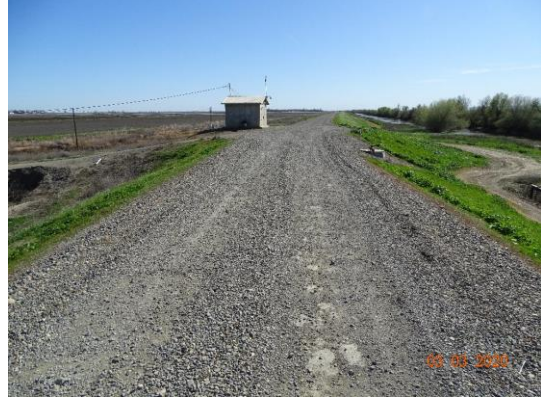
Photo 1 of 3 : UCIP_SP_2024_57280_83569.jpg

FIELD_STRUCT_DESC: 48-inch corrugated metal drainage pipe through the levee, 20.3 feet below the crown. Concrete headwall and cobble revetted spillway on the waterside (WS). Slide gate in a 60-inch corrugated metal pipe (CMP) riser on the WS slope. Concrete headwall located on the landside (LS). (48-inch pipe [HLM 6.10] authorized under Automatic Board Order (ABO) issued as Permit No. 9390, 1974 - Annie D. Propfe; 58-inch pipe [HLM 6.10] authorized under Automatic Board Order (ABO) issued as Permit No. 8234, 1972 - Glenn Irrigation District). [Additional Reference(s): DWR Levee Log, 2005 (HLM 6.10). USACE Sacramento O&M Manual, Unit 132, October 1959, Revised 14 January 2019, (HLM 6.10), listed as 48-inch pipe. USACE As-Built Drawing No. 50-4-3081, Sheet 7 and 16, Station 1648+88.2, 4 April 1957].						
FS Date: 3/3/2020 1:07:00 PM

View of levee crown at the crossing looking downstream

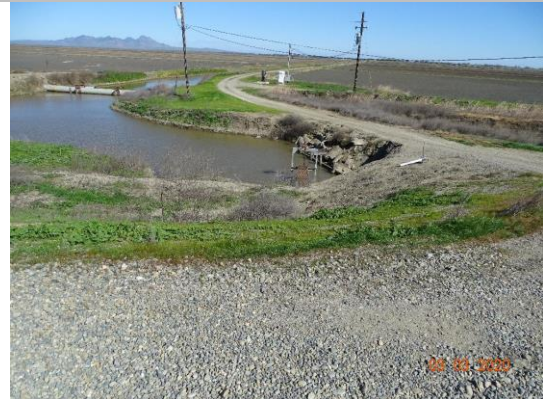
Photo 2 of 3 : UCIP_SP_2024_57280_83570.jpg

View of LS looking from levee crown

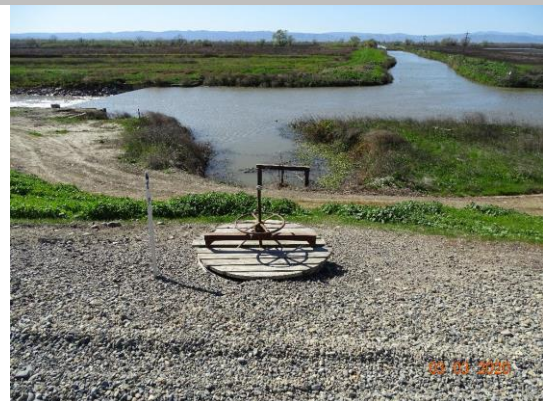
Photo 3 of 3 : UCIP_SP_2024_57280_83571.jpg

View of WS looking from levee crown

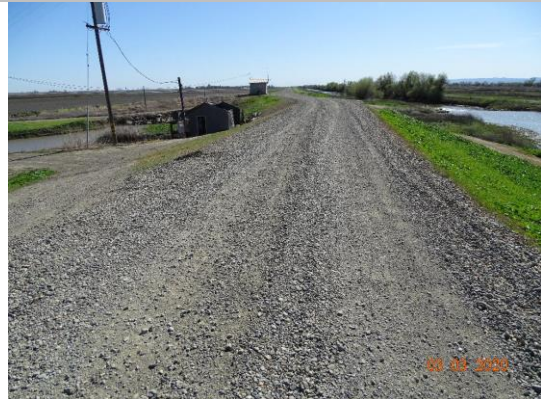
Photo 1 of 3 : UCIP_SP_2024_57238_83594.jpg

Comment Code						
Inspector Comment						
DS_ID:17199 FS_ID:57238 EP_NO: 9390 Repair Type: Non-Urgent EVAL Issue: Crossing Status: Found UCIP Comments: 03/03/2020 Record remains Non-Urgent. Need to have CVFPB review ABO and determine current owner. (O.Yakimov - DWR UCIP) 05/02/2017 Pipe appears to be in good condition. Minor erosion above the LS pump house. (A.Freitag - DWR Sutter Yard)10/17/2016 Crossing appears to be in good condition. (A.Freitag - DWR Sutter Yard)05/31/2016 Crossing appears to be in good condition. (A.Freitag - DWR Sutter Yard)05/04/2015 Crossing appears to be in good condition. No noticeable issues to report. (A.Freitag - DWR Sutter Yard)06/17/2014 Same as last inspection. (A.Freitag - DWR Sutter Yard)12/16/2013 Same as last inspection. (A.Freitag - DWR Sutter Yard)07/16/2013 Same as last inspection. (W.Wylie - DWR UCIP) FIELD_STRUCT_DESC: 3 of 3: 18-inch steel drainage pipe through the levee, 4.4 feet below the crown. Cobble revetted sump located on the waterside (WS). Siphon breaker in a 16-inch metal riser on the WS shoulder. Pump house at the landside (LS) toe. (18-inch pipe [HLM 6.13] authorized under Automatic Board Order (ABO) issued as Permit No. 9390, 1974 - Annie D. Propfe). [Additional Reference(s): DWR Levee Log, 2005 (HLM 6.13). USACE Sacramento O&M Manual, Unit 132, October 1959, Revised 14 January 2019, (HLM 6.13), listed as 3-18" pipes. Pipe not included to original USACE As-Built Drawing No. 50-4-3081. FS Date: 3/3/2020 3:08:00 PM

View of levee crown at the crossing looking downstream

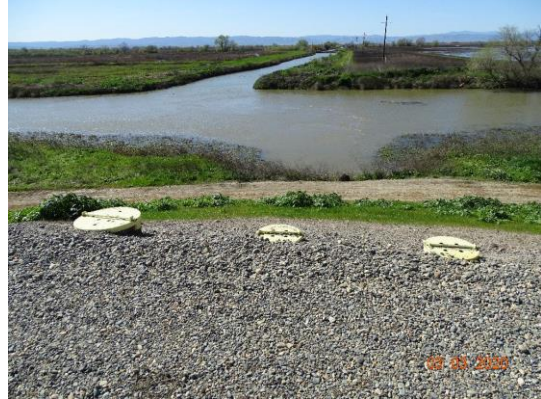
Photo 2 of 3 : UCIP_SP_2024_57238_83595.jpg

View of WS looking from levee crown

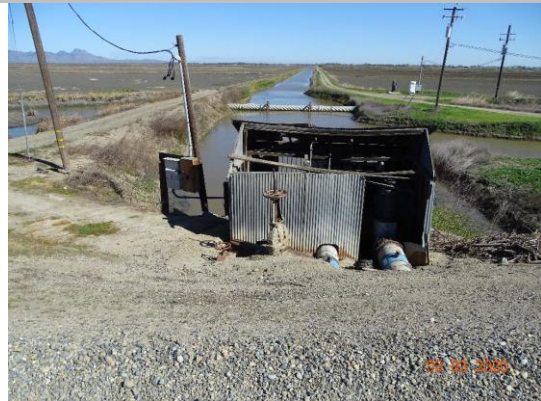
Photo 3 of 3 : UCIP_SP_2024_57238_83596.jpg

View of LS looking from levee crown. Pumphouse with 3 pumps at LS toe

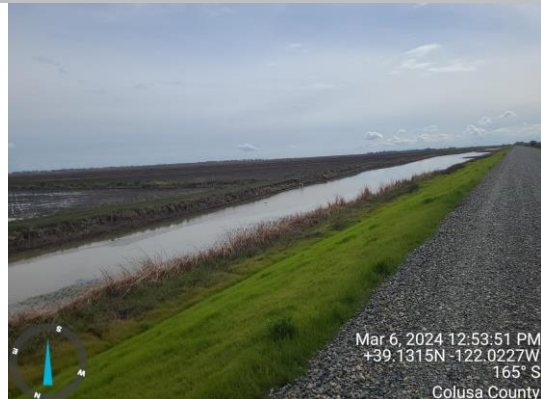
Photo 1 of 1 : SP_2024_MA0012_299_37_20240307_00072.jpg

LM Start	6.02	Rating **	U	Issue No.	37
LM End	7.20	Issue Type +	En	Location *	LS
Category	Earthen Levee			GPS Latitude/Longitude	
				Start	End
Item	Encroachments			39.115518°	39.131618°
				-122.017908°	-122.022785°
DWR ID	DWR_MA0012_01_f_2018_37				
Comment Code					
DT : Ditch					
Inspector Comment					
There is an irrigation ditch at the landside toe.

View of the irrigation ditch at the landside toe. Spring 2024.

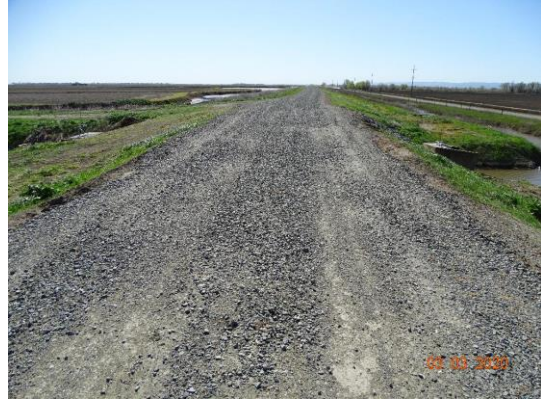
Photo 1 of 3 : UCIP_SP_2024_57243_83618.jpg

Comment Code						
Inspector Comment						
DS_ID:17165 FS_ID:57243 EP_NO: 9390 Repair Type: Non-Urgent EVAL Issue: Crossing Status: Indicator Found UCIP Comments: 03/03/2020 Record remains Non-Urgent. Crossing appears abandoned. Only pumping platform and steel walkway found on LS. Unable to confirm pipe removal. According to O&M as-built this pipe was running on the top of pipe DSID 17166 at the time of levee construction and was discharging into a concrete spill box on WS. Need to have CVFPB review ABO and determine current owner. (O.Yakimov - DWR UCIP) 05/02/2017 Abandoned- only LS steel walkway is visible. (A.Freitag - DWR Sutter Yard)10/17/2016 Abandoned. (A.Freitag - DWR Sutter Yard) 05/31/2016 Abandoned crossing. (A.Freitag - DWR Sutter Yard) 05/04/2015 Abandoned crossing. (A.Freitag - DWR Sutter Yard) 06/17/2014 Same as last inspection. (A.Freitag - DWR Sutter Yard) 12/16/2013 Same as last inspection. (A.Freitag - DWR Sutter Yard) 07/16/2013 Same as last inspection. (A.Freitag - DWR Sutter Yard) 10/11/2012 Pipe abandoned. Steel pump platform remains on LS slope, but all appearances have been removed. (W.Wylie - DWR UCIP) FIELD_STRUCT_DESC: 18-inch steel drainage pipe through the levee, 3 feet below the crown. Waterside (WS) end open into concrete spill box. Pump located on the landside (LS) on steel pier. (18-inch pipe [HLM 9.24] authorized under Automatic Board Order (ABO) issued as Permit No. 9390, 1974 - Annie D. Propfe). [Additional Reference(s): DWR Levee Log, 2005 (HLM 9.24). USACE Sacramento O&M Manual, Unit 132, October 1959, Revised 14 January 2019, (HLM 9.24), listed as 18-inch pipe. USACE As-Built Drawing No. 50-4-3081, Sheet 9 and 16, Station 1810+96.5, 4 April 1957]. FS Date: 3/3/2020 3:34:00 PM

View of levee crown at the crossing looking downstream

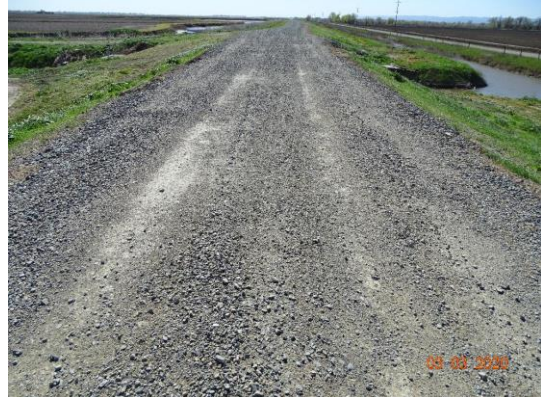
Photo 1 of 3 : UCIP_SP_2024_57244_83623.jpg

Comment Code						
Inspector Comment						
DS_ID:17189 FS_ID:57244 EP_NO: N/A Repair Type: Non-Urgent EVAL Issue: Crossing Status: Not Found UCIP Comments: 03/03/2020 Record updated from No Action Needed to Non-Urgent. Crossing not found. Geophysical results did not confirm presence of pipe through levee. Record will remain in UCIP's inspection records until future Levee Improvement Project can confirm no crossing was found through the levee. Suspect that this pipe is the same record as DSID 17164. (O.Yakimov - DWR UCIP) 05/02/2017 Unable to locate. (A.Freitag - DWR Sutter Yard) 10/17/2016 Unable to locate. (A.Freitag - DWR Sutter Yard) 05/31/2016 Unable to locate. (A.Freitag - DWR Sutter Yard) 05/04/2015 Unable to locate. (A.Freitag - DWR Sutter Yard) 06/17/2014 Unable to locate. (A.Freitag - DWR Sutter Yard) 12/16/2013 Unable to locate. (A.Freitag - DWR Sutter Yard) 07/16/2013 Same as last inspection. Unable to locate. (A.Freitag - DWR Sutter Yard) FIELD_STRUCT_DESC: 24-inch steel drainage pipe through the levee, at an unknown depth. Corrugated metal cutoff wall at center of levee. 1/4-inch cover plates continuously welded over both the waterside (WS) and the landside (LS) ends. [Additional Reference(s): USACE Sacramento O&M Manual, Unit 132, October 1959, Revised 14 January 2019, (HLM 9.25), listed 24-inch pipe. USACE As-Built Drawing No. 50-4-3081, Sheet 9 and 16, Station 1811+05, 4 April 1957]. FS Date: 3/3/2020 3:43:00 PM

View of levee crown at potential crossing looking downstream

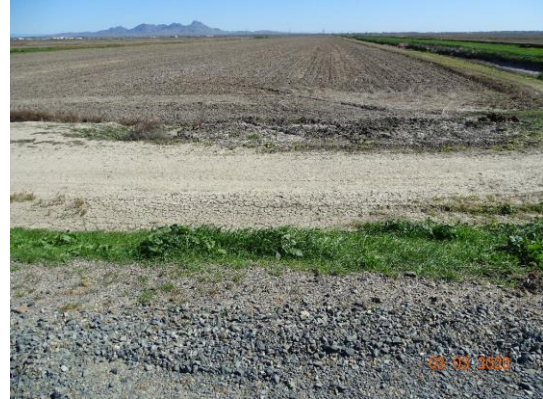
Photo 2 of 3 : UCIP_SP_2024_57244_83624.jpg

View of LS looking from levee crown

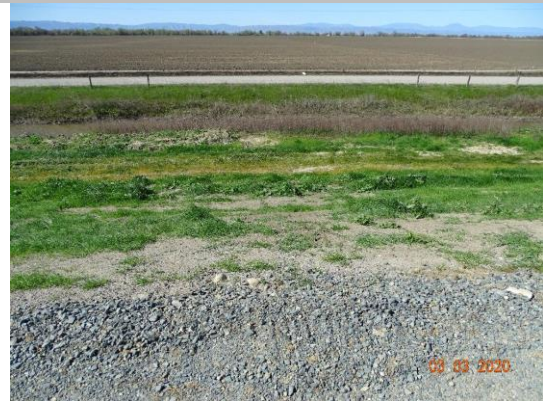
Photo 3 of 3 : UCIP_SP_2024_57244_83625.jpg

View of WS looking from levee crown

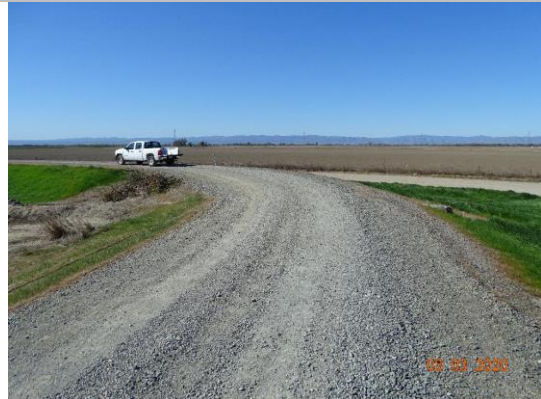
Photo 1 of 3 : UCIP_SP_2024_57245_83418.jpg

Comment Code						
Inspector Comment						
DS_ID:17157 FS_ID:57245 EP_NO: 9386 Repair Type: Non-Urgent EVAL Issue: Crossing Status: Found UCIP Comments: 03/03/2020 Record remains Non-Urgent. Crossing appears abandoned. Geophysical study indicates presence of pipe through levee, pipe crossing levee at angle. Pipe inlet on LS not found. Need to have CVFPB review ABO and determine current owner. (O.Yakimov - DWR UCIP) 05/02/2017 Abandoned on - needs to be done properly. (A.Freitag - DWR Sutter Yard) 10/17/2016 Abandoned crossing. (A.Freitag - DWR Sutter Yard) 05/31/2016 Abandoned crossing. Both pipe ends and slide gate inside of riser are buried. (A.Freitag - DWR Sutter Yard) 05/04/2015 Both pipe ends and slide gate in riser are plugged with soil. Crossing is inoperable. (A.Freitag - DWR Sutter Yard) 06/17/2014 Same as last inspection. (A.Freitag - DWR Sutter Yard) 12/16/2013 Same as last inspection. (A.Freitag - DWR Sutter Yard) 07/16/2013 Same as last inspection. (A.Freitag - DWR Sutter Yard) 10/11/2012 Pipe plugged with soil on both ends as well as at slide gate on WS slope. Slide gate inoperable. (W.Wylie - DWR UCIP) FIELD_STRUCT_DESC: 24-inch corrugated metal drainage pipe through the levee, 8 feet below the crown. Slide gate in a 36-inch riser on the waterside (WS) shoulder. Levee turns eastward. (24-inch pipe [HLM 11.17] authorized under Automatic Board Order (ABO) issued as Permit No. 9386, 1974 - C. J. Wescott Jr.). [Additional Reference(s): DWR Levee Log, 2005 (HLM 11.17). USACE Sacramento O&M Manual, Unit 132, October 1959, Revised 14 January 2019, (HLM 11.17), listed as 24-inch pipe. USACE As-Built Drawing No. 50-4-3081, Sheet 10 and 16, Station 1912+40, 4 April 1957]. FS Date: 3/3/2020 11:49:00 AM

View of levee crown at crossing looking downstream

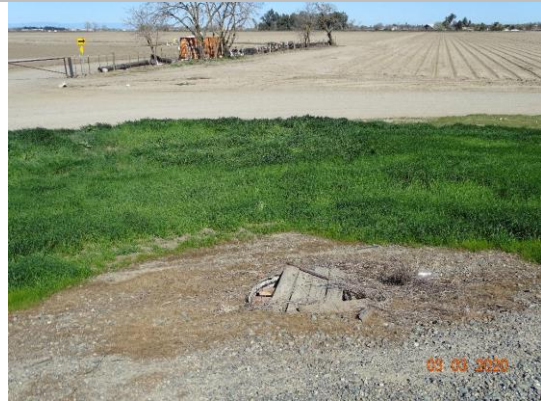
Photo 2 of 3 : UCIP_SP_2024_57245_83421.jpg

Water-Side looking from the crown

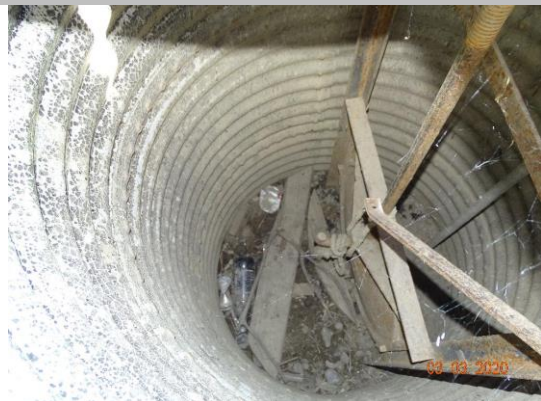
Photo 3 of 3 : UCIP_SP_2024_57245_83422.jpg

View inside of CMP riser on WS shoulder
