**Flood Control Project Maintenance  
Levee Inspections**

**Maintenance Issue Types Only, Levee Inspection Report By Mile - Fall 2020**

**Sutter Maintenance Yard Maintenance Area 0012**

Waterway	Bank	Unit Miles	Inspection Start/End	Inspector
Unit No. 01 Colusa Drain	Left	11.06	09/23/2020 09/23/2020	Zach Jojola

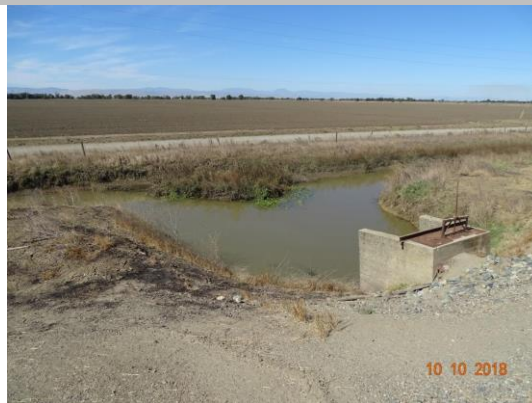
Photo 1 of 2 : FA\_2020\_MA0012\_299\_35\_20200813\_00005.jpg

LM Start	9.02	Rating **	A/W	Issue No.	35
LM End	9.04	Issue Type +	Ma	Location *	WS
Category	Supplemental			GPS Latitude/Longitude	
				Start	End
Item	2017 USACE Erosion Survey			39.157957 °	39.158226 °
				-122.021950 °	-122.021950 °
DWR ID	DWR_MA0012_01_f_2018_35				
Comment Code					
Inspector Comment					
2017 Site ID: SYC 9.3 L					
Status: Eroding					
2017 Field Notes: Access Issues - Could not observe					
Site History: 2011 - Erosion occurring upstream and downstream of an irrigation diversion structure.

View of diversion structure. Fall 2018.
