**Flood Control Project Maintenance  
Levee Inspections****LMA District Cover Sheet****Spring 2014 Levee Inspection Results****Sutter Maintenance Yard Maintenance Area 0013**

**Spring 2014 Levee Inspection Results**

**Sutter Maintenance Yard Maintenance Area 0013**

Waterway			Bank	Unit Miles
Unit No. 01 Cherokee Canal			Right	18.87
	Spring (March - May)	Summer (June - August)	(September - November) Fall	Winter (December - February)
Unit Maintenance Rating (Fall Only)				
Date of Inspection	03/20/2014 - 03/20/2014			
DWR Inspector	Bob Duffey			
Accompanied By	Jason Cooper Sutter Maintenance Yard

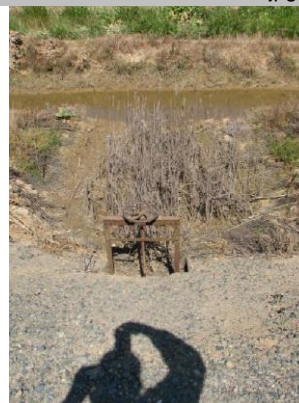
Photo 1 of 1 : UCIP\_4470.jpg

View of LS slope and toe.

LM Start	6.51	Rating **	M	Issue No.	3
LM End	7.09	Issue Type +	En	Location *	LS
Category	Earthen Levee			GPS Latitude/Longitude	
				Start	End
Item	Encroachments			39.508928 °	39.501438 °
				-121.714842 °	-121.719715 °
DWR ID	DWR_MA0013_01_s_2012_3				
Action/Comments					
Ditch

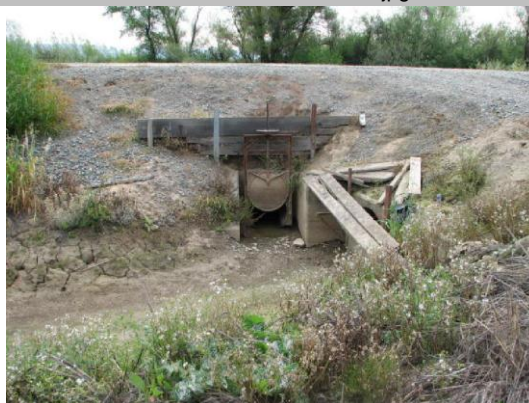
Photo 1 of 1 : UCIP\_4481.jpg

LM Start	6.56	Rating **	M	Issue No.	30
LM End	6.56	Issue Type +	En	Location *	LS
Category	Supplemental			GPS Latitude/Longitude	
				Start	End
Item	DWR UCIP Field Study			39.508298 °	39.508298 °
				-121.715100 °	-121.715100 °
DWR ID	DWR_MA0013_01_s_2014_30				
Action/Comments					
Inspector Comments: FS_ID:25129					
EP_NO: 5200B					
Repair Type:					
Crossing Status:					
UCIP Comments: Clear wooden debris on upstream headwall.					
Upstream location latitude = 39.508298, longitude = -121.715103.					
Downstream location latitude = 39.50797, longitude = -121.71534;					
7/15/2013 Same as last inspection12/2/2013 Same as last inspection.					
FIELD_STRUCT_DESC: 2 of 10 items under Board Order 5200, 5200A, and 5200B: 36-inch concrete reinforced drain pipe through levee along landward shoulder, 11.1 feet below crown. Crossing saddles landward slope, open on both ends. (Board Order 5200B-1967)					
FS Date: 12/10/2013 8:37:33 AM

View of crossing through ramp.

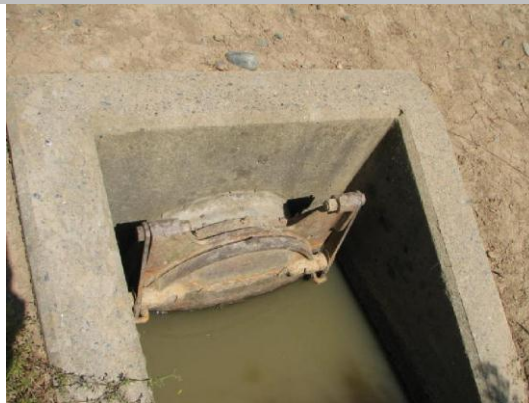
Photo 1 of 1 : UCIP\_4517.jpg

LM Start	8.40	Rating **	M	Issue No.	34
LM End	8.40	Issue Type +	En	Location *	LS
Category	Supplemental			GPS Latitude/Longitude	
				Start	End
Item	DWR UCIP Field Study			39.485432 °	39.485432 °
				-121.731590 °	-121.731590 °
DWR ID	DWR_MA0013_01_s_2014_34				
Action/Comments					
Inspector Comments: FS_ID:25146					
EP_NO: N/A					
Repair Type:					
Crossing Status:					
UCIP Comments: Sediment build up on LS. Debris (broken panels) scattered near LS headwall. Limited inspection on WS and LS slope due to dense vegetation. Need photos of cleared WS and LS slopes7/15/2013 Slopes are cleared of vegetation and are in good condition. WS flapgate is blocked from opening fully by sediment2/3/2013 Same as last inspection.					
FIELD_STRUCT_DESC: 24-inch corrugated metal drainpipe through the levee, 9.3 feet below the crown. Flap gate on the waterward end. Concrete "U" headwalls on both ends (USACE-1960). Flashboards should be present on the landward side. This entry matches the Drainage or Irrigation Structure referenced in O&M manual (HLM 8.40).

View of WS flap gate and headwall.

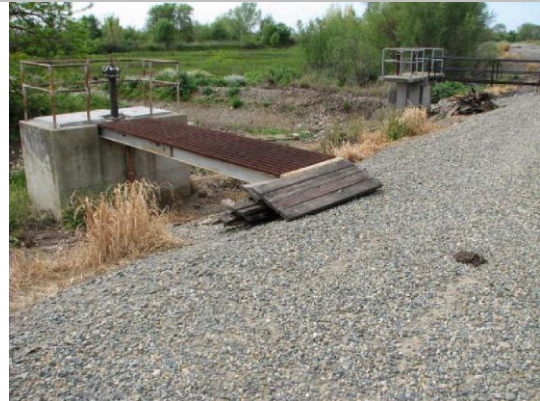
Photo 1 of 1 : UCIP\_4521.jpg

LM Start	8.95	Rating **	M	Issue No.	35
LM End	8.95	Issue Type +	En	Location *	LS
Category	Supplemental			GPS Latitude/Longitude	
				Start	End
Item	DWR UCIP Field Study			39.478573 °	39.478573 °
				-121.736550 °	-121.736550 °
DWR ID	DWR_MA0013_01_s _ 2014_35				
Action/Comments					
Inspector Comments: FS_ID:25147					
EP_NO: N/A					
Repair Type:					
Crossing Status:					
UCIP Comments: Concrete headwall is cracked, erosion behind headwall is also present. LS headwall needs to be repaired/replaced. Remove wooden debris from levee shoulder 7/15/2013 Same as last inspection 12/3/2013 Same as last inspection.					
FIELD_STRUCT_DESC: Richvale Irrigation Canal siphon crosses the channel. Five (5) by seven (7) foot concrete conduit through the levee, 18.4 feet below the crown. Distribution box and walkway are located on waterward side. Concrete headwall on the landward side. 28-foot reinforced concrete protective slab on top of the conduit in the center of the levee (USACE-1960). This entry matches the Drainage or Irrigation Structure referenced in O&M manual (HLM 8.95).

Catwalk and screw gate located on WS.

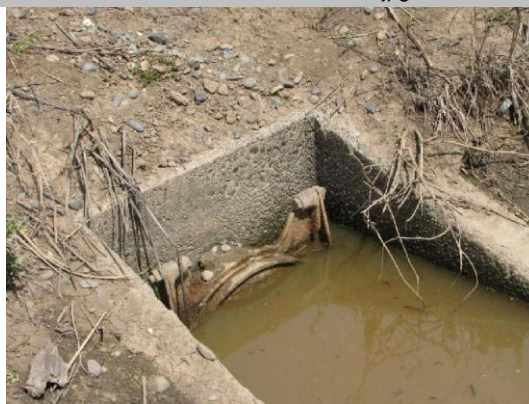
Photo 1 of 1 : UCIP\_4534.jpg

LM Start	13.96	Rating **	M	Issue No.	38
LM End	13.96	Issue Type +	En	Location *	WS
Category	Supplemental			GPS Latitude/Longitude	
				Start	End
Item	DWR UCIP Field Study			39.416833 °	39.416833 °
				-121.781930 °	-121.781930 °
DWR ID	DWR_MA0013_01_s_2014_38				
Action/Comments					
Inspector Comments: FS_ID:25166					
EP_NO: N/A					
Repair Type:					
Crossing Status:					
UCIP Comments: Tree has fallen at LS inlet and damaged slide gate.					
The tree needs to be removed and screw gate repaired. Limited					
inspection on LS due to fallen tree 7/15/2013 Same as last					
inspection 12/3/2013 Same as last inspection.					
FIELD_STRUCT_DESC: 24-inch corrugated metal drainpipe through					
the levee, 12.7 feet below the crown. Flap gate on the waterward side.					
Concrete "U" headwall on both ends (USACE-1960).					
FS Date: 12/10/2013 9:38:13 AM

WS headwall and flap gate.

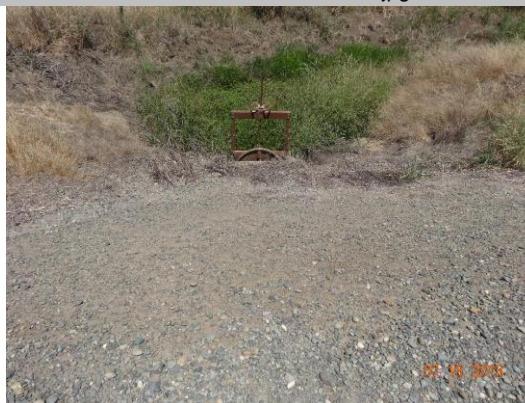
Photo 1 of 1 : UCIP\_4542.jpg

Action/Comments					
Inspector Comments: FS_ID:25168					
EP_NO: N/A					
Repair Type:					
Crossing Status:					
UCIP Comments: Limited inspection on LS slope due to dense vegetation. Need photos of cleared WS & LS slopes. The flap gate is lodged open 12/15/2013 Slopes have been cleared of vegetation and are in good condition. WS flapgate is still lodged open 12/3/2013					
Same as last inspection.					
FIELD_STRUCT_DESC: 36-inch corrugated metal drainpipe through the levee, 12.9 feet below the crown. Flap gate on the waterward end. Concrete "U" headwalls on both ends (USACE-1960). This entry matches the Drainage or Irrigation Structure referenced in O&M manual (HLM 14.79).					
FS Date: 12/10/2013 9:56:15 AM

LS slope cleared of vegetation

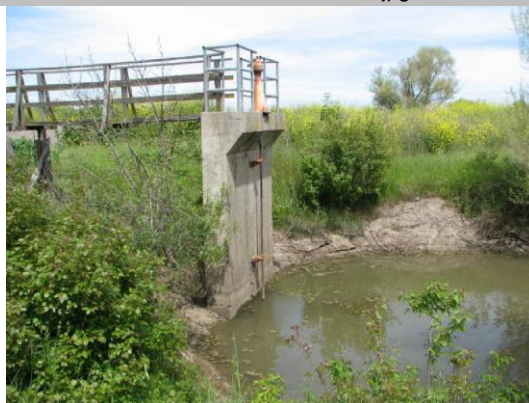
Photo 1 of 1 : UCIP\_4546.jpg

LM Start	15.99	Rating **	M	Issue No.	41
LM End	15.99	Issue Type +	En	Location *	WS
Category	Supplemental			GPS Latitude/Longitude	
				Start	End
Item	DWR UCIP Field Study			39.398615 °	39.398615 °
				-121.811250 °	-121.811250 °
DWR ID	DWR_MA0013_01_s_2014_41				
Action/Comments					
Inspector Comments: FS_ID:25171					
EP_NO: 11805B					
Repair Type:					
Crossing Status:					
UCIP Comments: LS inlet is not visible-underwater. Limited inspection on WS and LS slope/toe due to dense vegetation. Need photos of cleared WS & LS slope3/15/2013 Same as last inspection12/3/2013 Same as last inspection.					
FIELD_STRUCT_DESC: 48-inch diameter reinforced concrete pipe with six concrete collars through the levee, 14.4 feet below the crown to center of conduit. Slide gate, head-wall and wood walkway on two concrete piers on waterward side of levee. Revetment on waterward slope. Irrigation ditch on the landward side. (Permit No. 11805B-1979)

WS view of catwalk, slide/screw gate, and headwall

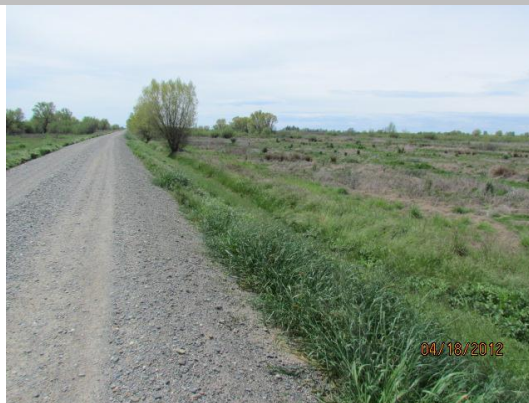
Photo 1 of 1 : rduffey\_s\_20140304\_440.jpg

LM Start	16.45	Rating **	M	Issue No.	7
LM End	17.42	Issue Type +	En	Location *	LS
Category	Earthen Levee			GPS Latitude/Longitude	
				Start	End
Item	Encroachments			39.394523 °	39.385580 °
				-121.817630 °	-121.831282 °
DWR ID	DWR_MA0013_01_s_2012_7				
Action/Comments					
Ditch

View of the ag along the toe of the levee.

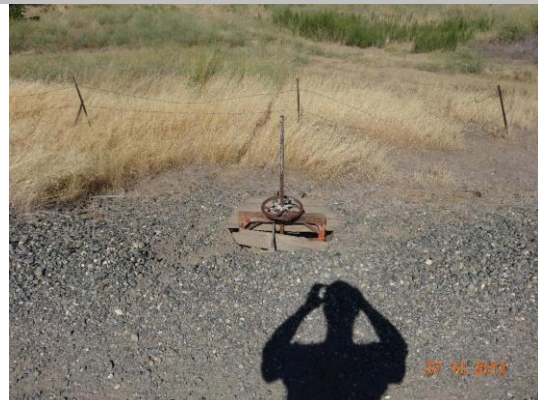
Photo 1 of 1 : UCIP\_4568.jpg

LM Start	0.58	Rating **	M	Issue No.	9
LM End	0.58	Issue Type +	En	Location *	WS
Category	Supplemental			GPS Latitude/Longitude	
				Start	End
Item	DWR UCIP Field Study			39.566479 °	39.566479 °
				-121.702430 °	-121.702430 °
DWR ID	DWR_MA0013_02_s _ 2014_9				
Action/Comments					
Inspector Comments: FS_ID:25344					
EP_NO: N/A					
Repair Type:					
Crossing Status:					
UCIP Comments: Need to fix the top of slide gate cover. The wooden cap on standpipe is broken. Limited evaluation of crossing due to dense vegetation on LS slope. Need photos of cleared slopes during fall inspection7/10/2013 LS and WS slopes have been cleared of vegetation and are in good condition. LS pipe end is half full of sediment. Sediment inside of WS standpipe may hinder slide gate from fully closing. Standpipe cover is still broken12/9/2013 Same as last inspection.					
FIELD_STRUCT_DESC: 24-inch corrugated metal pipe through the levee, 10.6 feet below the crown. Slide gate in corrugated metal pipe riser on the waterward slope. Concrete "U" headwall on the landward side. 36-inch concrete standpipe in the channel with two wooden piles to deflect debris. (USACE-1962) This entry matches the Drainage or Irrigation Structure referenced in O&M manual (HLM 0.57).

WS slope clear of vegetation

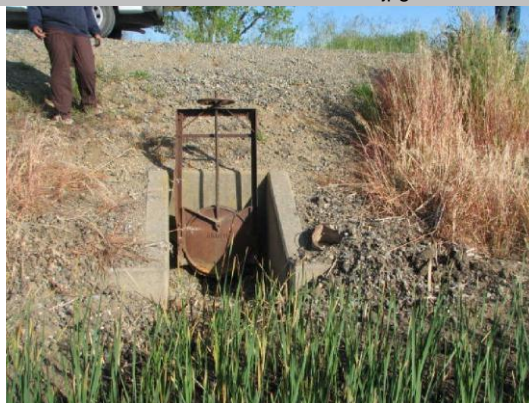
Photo 1 of 1 : UCIP\_4573.jpg

UCIP Comments: Limited inspection dense vegetation on WS. Need photos of clear WS slope & toe. Ditch present in channel? This crossing was listed in the USACE Periodic Inspection report as Corp's Inspect ID# USACE\_CESPK\_M13G\_2011\_p\_0108 for WS flap gate filled with soil and LS gate not functioning because of overgrown vegetation. 7/10/2013 WS slope is cleared of vegetation and is in good condition. LS screw gate frame is twisted and is preventing the gate from opening. 2/9/2013 Same as last inspection.

View of LS slide gate.

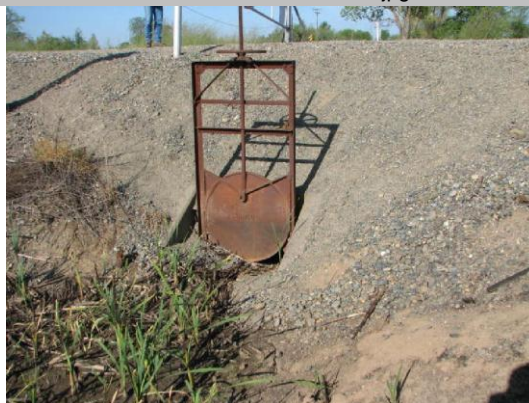
Photo 1 of 1 : UCIP\_4585.jpg

Headwall and screw gate located on land side of levee.

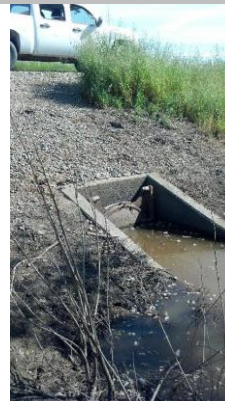
Photo 1 of 1 : UCIP\_4596.jpg

Headwall and flap gate located on water side of levee

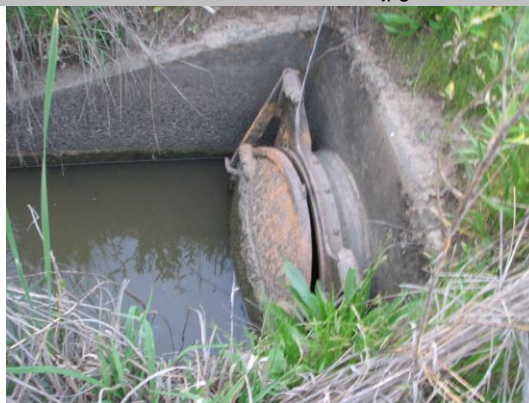
Photo 1 of 1 : UCIP\_4610.jpg

Headwall and flap gate located on water side of levee

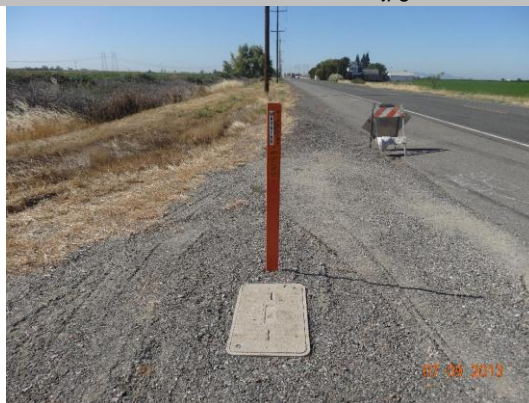
Photo 1 of 1 : UCIP\_4616.jpg

New carsonite gas line marker

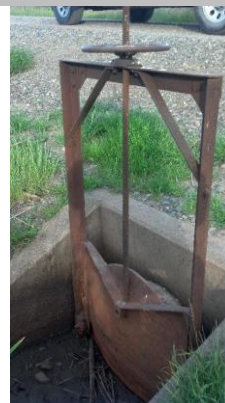
Photo 1 of 1 : UCIP\_4618.jpg

Headwall and screw gate located on land side of levee

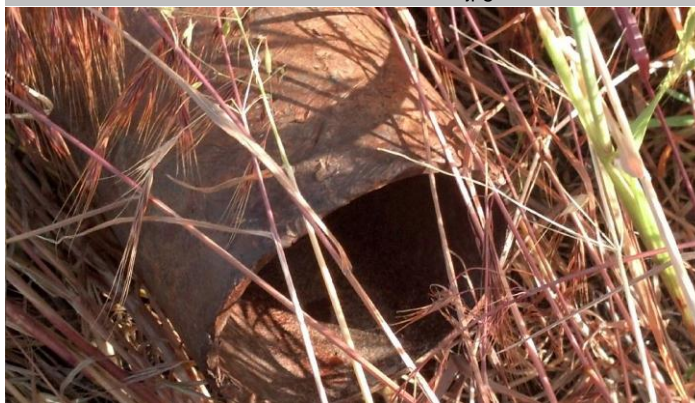
Photo 1 of 1 : UCIP\_4622.jpg

Irrigation crossing located on land side of levee

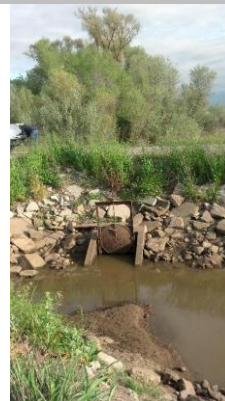
Photo 1 of 1 : UCIP\_4631.jpg

LM Start	5.86	Rating **	M	Issue No.	27
LM End	5.86	Issue Type +	En	Location *	WS
Category	Supplemental			GPS Latitude/Longitude	
				Start	End
Item	DWR UCIP Field Study			39.523370 °	39.523370 °
				-121.701330 °	-121.701330 °
DWR ID	DWR_MA0013_02_s _ 2014_27				
Action/Comments					
Inspector Comments: FS_ID:25365					
EP_NO: 13170					
Repair Type:					
Crossing Status:					
UCIP Comments: Limited inspection on WS and LS slopes due to dense vegetation. Need photos of cleared WS & LS slopes. This crossing was listed in the USACE Periodic Inspection report as Corp's inspect ID# USACE_CESPK_M13H_2011_p_0058 for high water unable to see crossing 7/9/2013 Same as last inspection 12/9/2013 Same as last inspection.					
FIELD_STRUCT_DESC: 36 inch corrugated metal pipe through the levee approximately 7 feet below crown. Flap gate is located on the waterward side. (13170-1981)					
FS Date: 12/11/2013 9:03:13 AM

Headwall and screw gate on land side of levee

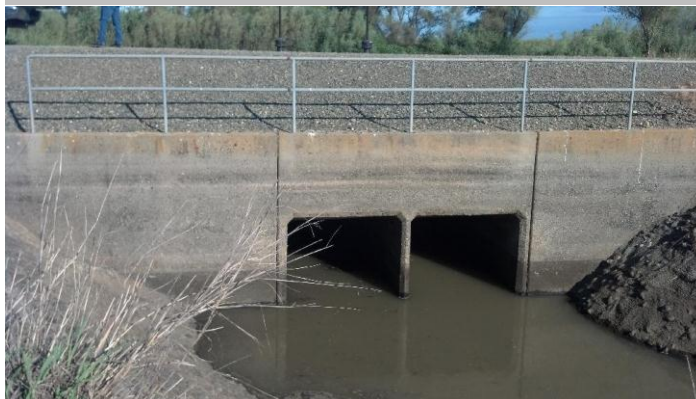
Photo 1 of 1 : UCIP\_4645.jpg

LM Start	7.24	Rating **	M	Issue No.	31
LM End	7.24	Issue Type +	En	Location *	LS
Category	Supplemental			GPS Latitude/Longitude	
				Start	End
Item	DWR UCIP Field Study			39.507705 °	39.507705 °
				-121.713810 °	-121.713810 °
DWR ID	DWR_MA0013_02_s _ 2014_31				
Action/Comments					
Inspector Comments: FS_ID:25370					
EP_NO: 5200B					
Repair Type:					
Crossing Status:					
UCIP Comments: No photo available of WS headwall. If possible take photo of WS headwall 7/9/2013 Same as last inspection 12/9/2013 Same as last inspection.					
FIELD_STRUCT_DESC: 8 of 10 items listed under Board Order 5200, 5200A, 5200B: 6-foot by 6-foot reinforced double box culvert (Box 1 of 2) through the levee, 17.1 feet below the crown. Concrete headwalls on both ends. Slide gate on the waterward side. (Permit No. 5200B-1967)					
FS Date: 12/11/2013 9:29:27 AM

View of double box culvert with hand rail from landside.

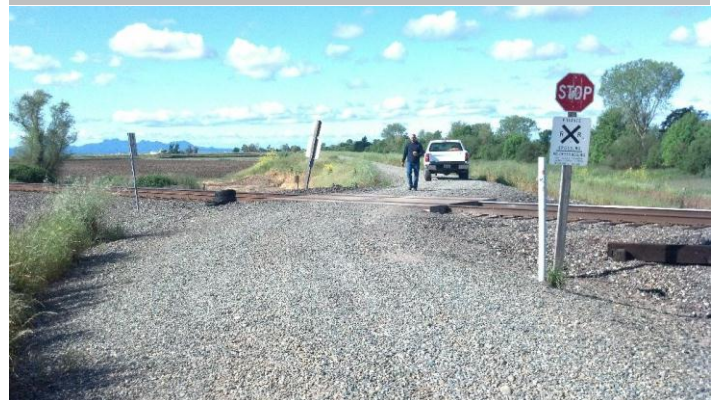
Photo 1 of 1 : UCIP\_4651.jpg

Action/Comments					
Inspector Comments: FS_ID:25389					
EP_NO: N/A					
Repair Type:					
Crossing Status:					
UCIP Comments: Unable to determine if crossing is an authorized or unauthorized encroachment. Unable to find permit number for this encroachment. Will need to coordinate with LMA Superintendent and DWR-Inspector, photo includes utility contact information 7/9/2013 Same as last inspection 12/4/2013 Same as last inspection.					
FIELD_STRUCT_DESC: Buried fiber optic line through the levee at depth unknown. Owner of line is Qwest Communications 1-800 At Fiber Sign ID Number 16601. (Qwest Communication)					
FS Date: 12/11/2013 10:31:41 AM

Overview of levee crown at crossing.

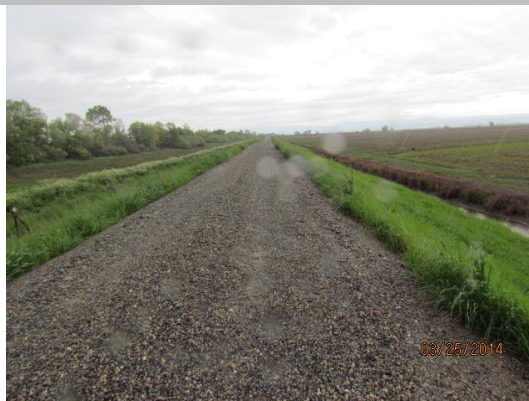
Photo 1 of 1 : rduffey\_s\_20140428\_216.jpg

LM Start	10.63	Rating **	A	Issue No.	54
LM End	10.63	Issue Type +	Ma	Location *	LS
Category	Earthen Levee			GPS Latitude/Longitude	
				Start	End
Item	Vegetation			39.465220 °	39.465220 °
				-121.743521 °	-121.743521 °
DWR ID	DWR_MA0013_02_s _ 2014_54				
Action/Comments					
Control annual grass and weeds on the levee slopes and easements.

View of the native grasses on both slopes.

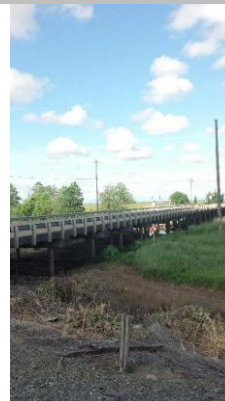
Photo 1 of 1 : UCIP\_4661.jpg

Utility marker is located near the upstream face of the highway bridge.

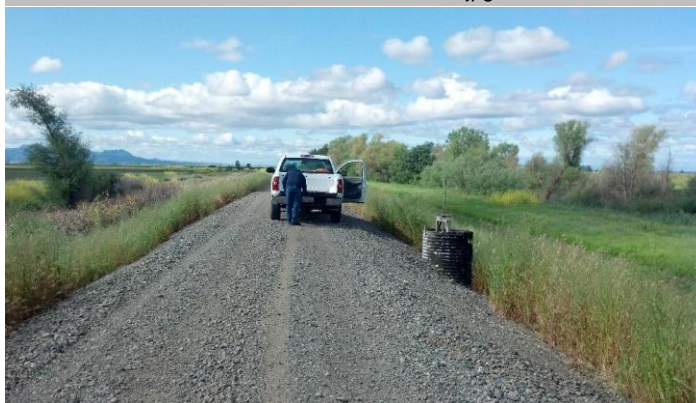
Photo 1 of 1 : UCIP\_4664.jpg

FIELD_STRUCT_DESC: 30-inch corrugated metal pipe through the levee, 13.0 feet below the crown. Slide gate in corrugated metal pipe riser on the waterward slope. Slide gate in ditch on the landward side. Pipe under channel is a 24-inch Delleher siphon (USACE-1960). This entry matches the Drainage or Irrigation Structure referenced in O&M manual (HLM 13.03).					
FS Date: 12/11/2013 12:11:25 PM

Overview of crossing looking downstream at the left bank of Cherokee Canal.

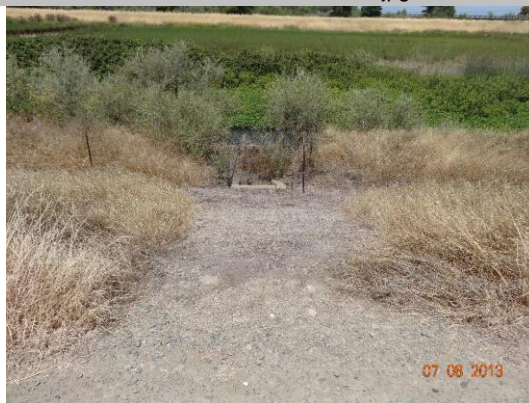
Photo 1 of 1 : UCIP\_4675.jpg

WS slope cleared of vegetation

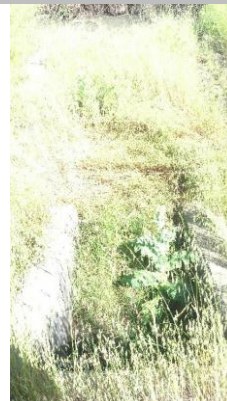
Photo 1 of 1 : UCIP\_4678.jpg

Concrete "U" headwalls on both ends (USACE-1960). This entry matches the Drainage or Irrigation Structure referenced in O&M manual (HLM 15.87).					
FS Date: 12/11/2013 12:16:38 PM

View of WS headwall.

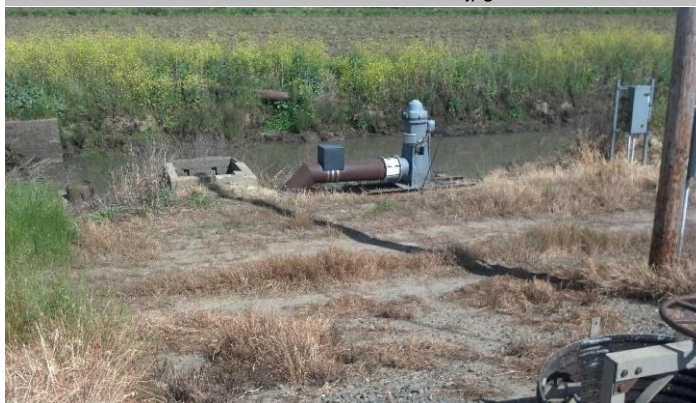
Photo 1 of 1 : UCIP\_4683.jpg

WS view of crossing.

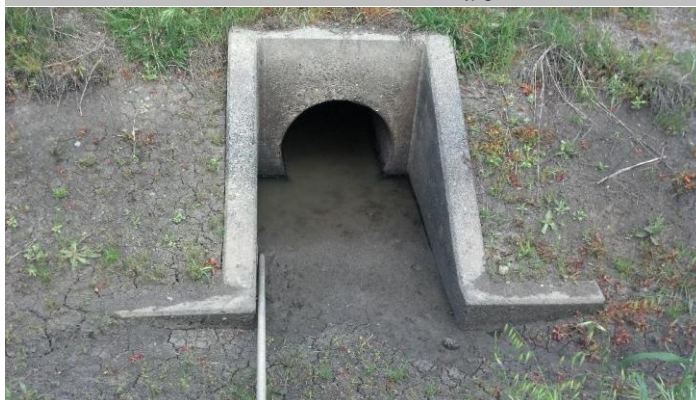
Photo 1 of 1 : UCIP\_4698.jpg

View of LS headwall.

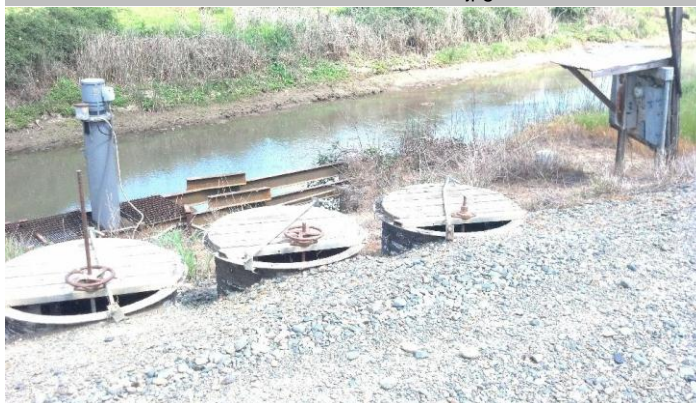
Photo 1 of 1 : UCIP\_4709.jpg

Corrugated metal pipe risers with slide gates located on WS slope.

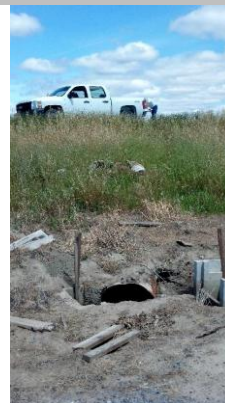
Photo 1 of 1 : UCIP\_4736.jpg

UCIP Comments: Needs repair. Internal piping, severe corrosion.

Debris present--rusted pipe stockpiled on LS slope. Limited inspection on WS and LS slopes due to dense vegetation. Need photos of cleared WS & LS slopes. This crossing was listed in the USACE Periodic Inspection report as Corp's inspect ID#

7/8/2013 Pipe appears to have been repaired. Need to talk to inspections and supervisor to find out more details on repair

Corroded section of existing pipe, 9-feet 8-inches of an 18-inch CMP section, was replaced under Permit 7231 prior to 1974.

View of LS slope and pipe inlet.

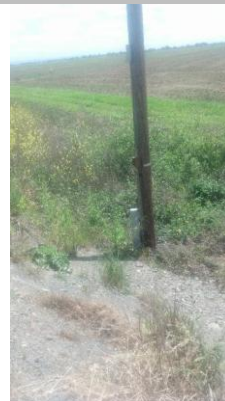
Photo 1 of 1 : UCIP\_4741.jpg

LM Start	22.11	Rating **	M	Issue No.	50
LM End	22.11	Issue Type +	En	Location *	LS
Category	Supplemental			GPS Latitude/Longitude	
				Start	End
Item	DWR UCIP Field Study			39.362103 °	39.362103 °
				-121.867820 °	-121.867820 °
DWR ID	DWR_MA0013_02_s_2014_50				
Action/Comments					
Inspector Comments: FS_ID:25424					
EP_NO: N/A					
Repair Type:					
Crossing Status:					
UCIP Comments: Unauthorized Encroachment. This crossing is listed multiple times in the USACE Periodic Inspection report as USACE_CESPK_M13E_2011_p_0307, 0315, 0317, 0318 for slope failure on LS hinge. DWR-Flood Maintenance Office records shows that CVFPB has requested AT&T to remove conduit in June 2, 2009 letter. LMA working with CVFPB to resolve 7/8/2013 Same as last inspection 12/4/2013 Same as last inspection.					
FIELD_STRUCT_DESC: Illegal encroachment. Underground telephone cable through the levee. Depth unknown. (AT&T) START latitude 39.36210336, longitude -121.8678207 END latitude 39.35458541, longitude -121.8823409. Line extends from Gridley Colusa Highway to the south end of project levee along LS shoulder & levee crown hinge point. Levee sloughs along cable trench after heavy rains.

View of utility line located on LS toe.

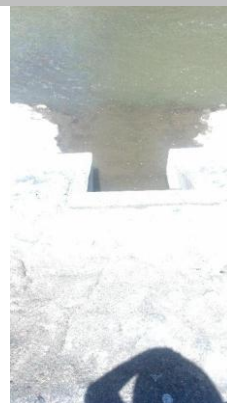
Photo 1 of 1 : UCIP\_4742.jpg

LM Start	22.40	Rating **	M	Issue No.	51
LM End	22.40	Issue Type +	En	Location *	LS
Category	Supplemental			GPS Latitude/Longitude	
				Start	End
Item	DWR UCIP Field Study			39.359827 °	39.359827 °
				-121.872300 °	-121.872300 °
DWR ID	DWR_MA0013_02_s_2014_51				
Action/Comments					
Inspector Comments: FS_ID:25427					
EP_NO: N/A					
Repair Type:					
Crossing Status:					
UCIP Comments: Unable to locate LS headwall. Need photo of LS headwall during next inspection 7/8/2013 Same as last inspection.					
Unable to locate LS headwall 12/4/2013 Same as last inspection.					
FIELD_STRUCT_DESC: 30-inch corrugated metal pipe through the levee, 15.3 feet below the crown. Flap gate on the waterward end.					
Concrete "U" headwalls on both ends. This pipe runs on an angle through the levee, then underground along the landward slope to levee mile 22.39 where it enters a ditch on the landward side (USACE-1960).

View of WS slope looking from WS headwall to levee crown.

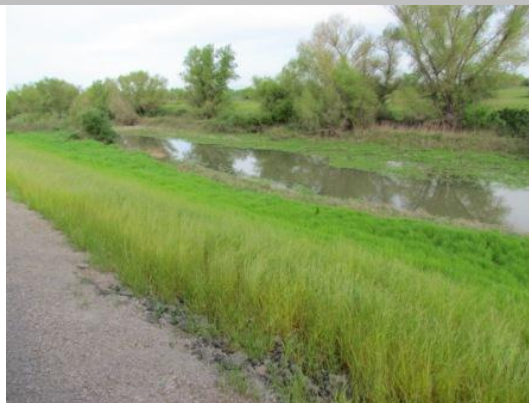
Photo 1 of 1 : rduffey\_s\_20140304\_471.jpg

LM Start	22.83	Rating **	M	Issue No.	7
LM End	22.85	Issue Type +	Ma	Location *	WS
Category	Earthen Levee			GPS Latitude/Longitude	
				Start	End
Item	Erosion / Bank Caving			39.356498 °	39.356303 °
				-121.879030 °	-121.879417 °
DWR ID	DWR_MA0013_02_s _ 2012_7				
Action/Comments					
Note and monitor erosion site.

View of the along the canal.
