**Flood Control Project Maintenance
Levee Inspections****LMA District Cover Sheet****Spring 2016 Levee Inspection Results****Sutter Maintenance Yard Maintenance Area 0013**

Spring 2016 Levee Inspection Results

Sutter Maintenance Yard Maintenance Area 0013

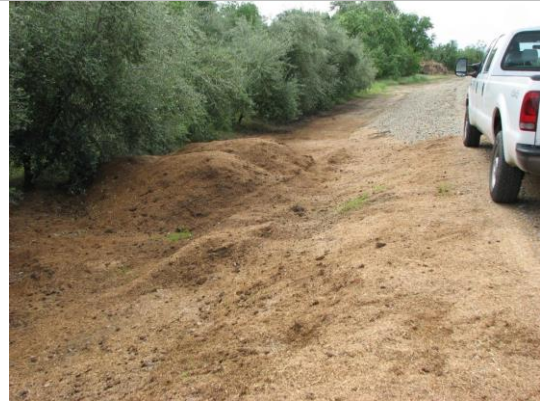
Photo 1 of 1 : SP_2016_MA0013_300_48_20160418_00079.jpg

Comment Code						
Inspector Comment						
FS_ID:48018 DS_ID:16327 EP_NO: 6135 Repair Type: Urgent Crossing Status: Found UCIP Comments: 4/28/2016 8-inch pipe was running water but was leaking at a weld joint on the LS slope. Pipe appears to have been dug out by the landowner but unsure if repairs are being made yet. (see photo 5)7/14/2015 Pipe end is still welded solid.5/21/2014 Same as last inspection.12/2/2013 Same as last inspection.7/10/2013 Same as last inspection. FIELD_STRUCT_DESC: 8-inch steel pipe through the levee 2.8 feet below the crown. Permit requirements are as follow: during the flood season the 5 inch irrigation pipe will be removed and a plate bolted over the waterside (WS) end of the 8 inch. Pipe section is completely buried. Current configuration does not allow for 5 inch irrigation pipe to slide pipe through. 8 inch pipe is welded solid. (Permit No. 6135-1968, George Washington) FS Date: 5/4/2016 7:18:00 AM

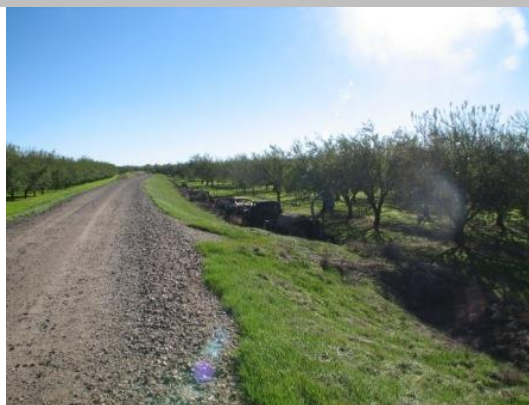
Photo 1 of 1 : SP_2016_MA0013_300_12_20160316_00006.jpg

LM Start	0.73	Rating **	M	Issue No.	12
LM End	0.76	Issue Type +	En	Location *	LS
Category	Earthen Levee			GPS Latitude/Longitude	
				Start	End
Item	Encroachments			39.587905 °	39.587505 °
				-121.700822 °	-121.700880 °
DWR ID	DWR_MA0013_01_s_2012_12				
Comment Code					
EQ : Equipment					
Inspector Comment					
Remove the equipment from the landside toe.

View of the equipment along the landside toe of the levee.

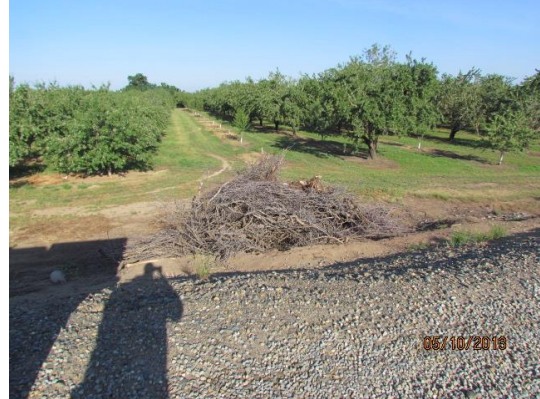
Photo 1 of 1 : SP_2016_MA0013_300_20_20160316_00009.jpg

LM Start	0.94	Rating **	M	Issue No.	20
LM End	0.94	Issue Type +	En	Location *	LS
Category	Earthen Levee			GPS Latitude/Longitude	
				Start	End
Item	Encroachments			39.584885 °	39.584885 °
				-121.700487 °	-121.700487 °
DWR ID	DWR_MA0013_01_s_2013_20				
Comment Code					
PR : Prunings					
Inspector Comment

View of the prunings along the landside toe.

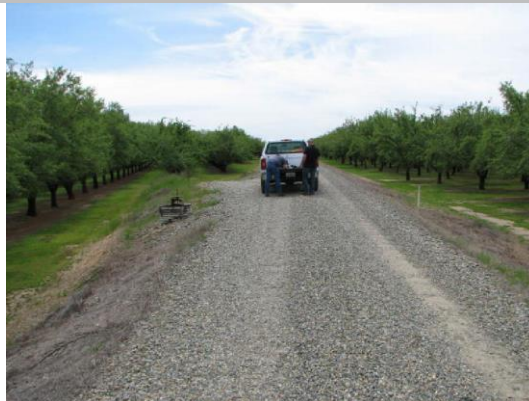
Photo 1 of 2 : UCIP_SP_2016_47623_66700.jpg

FS_ID:47623
DS_ID:16345
EP_NO: N/A
Repair Type: Non-Urgent
Crossing Status: Found
UCIP Comments: 4/28/2016 Pvc pipe is still present through the crossing. Slide gate cannot shut fully.7/14/2015 4-inch pipe still present and blocking the screw gate.5/21/2014 Same as last inspection.12/2/2013 Same as last inspection.7/15/2013 Same as last inspection.4/17/2012 Crossing has 4-inch pipe inside blocking positive closure/notify landowner to remove prior to flood season. LS crossing is blocked about 50% by sediment build up. Burrow activity present on LS near crossing.
FIELD_STRUCT_DESC: 24-inch corrugated metal irrigation pipe through the levee, 7.6 feet below the crown. Slide gate in corrugated metal pipe (CMP) riser on the waterside (WS) slope. Concrete headwall on the landside (LS). 36-inch concrete standpipe in the channel with 2 piles to deflect debris (USACE-1960). This entry matches the Drainage or Irrigation Structure referenced in O&M manual (HLM 1.69).

Overview of levee at crossing looking downstream.

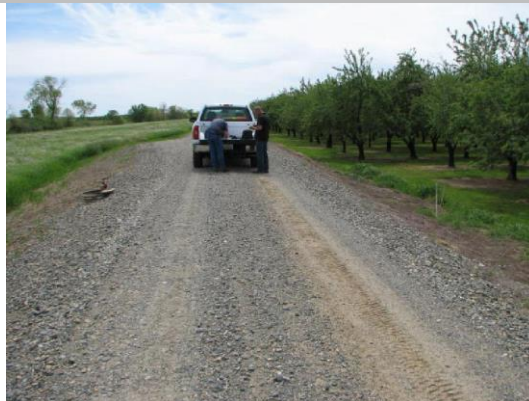
Photo 1 of 2 : UCIP_SP_2016_47624_66708.jpg

FS_ID:47624
DS_ID:16346
EP_NO: N/A
Repair Type: Non-Urgent
Crossing Status: Found
UCIP Comments: 4/28/2016 Appears to be an abandoned crossing. LS headwall and pipe inlet are still completely buried. 7/14/2015 Still cannot find an inlet or outlet. 5/21/2014 Same as last inspection. 12/2/2013 Same as last inspection. 7/15/2013 Same as last inspection. 4/17/2012 Non functional crossing due to LS headwall buried. This crossing was listed in the USACE Periodic Inspection report as Corp's inspect ID#USACE_CESPK_M13D_2011_p_0119 for no inlet or outlet visible.
FIELD_STRUCT_DESC: *ABANDONED* 24-inch corrugated metal irrigation pipe through the levee 7.8 feet below the crown. Slide gate in corrugated metal pipe riser on the waterside (WS) slope. Pipe continues across channel. Concrete "U" headwall on the landside (LS). (USACE-1960). This entry matches the Drainage or Irrigation Structure referenced in O&M manual (HLM 2.35).

Overview of crossing looking DS.

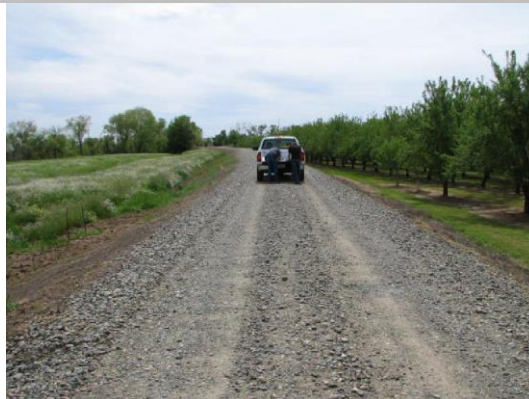
Photo 1 of 2 : UCIP_SP_2016_47640_66718.jpg

FS_ID:47640
DS_ID:17372
EP_NO: N/A
Repair Type: Non-Urgent
Crossing Status: Found
UCIP Comments: 4/28/2016 Pipe on LS is about 50% full of sediment. There is now a concrete pipe that discharges into the LS inlet of this crossing. Not sure where the concrete pipe comes from. 7/14/2015 Crossing appears in good condition. No noticeable issues to report. 5/21/2014 Same as last inspection. 12/2/2013 Pipe section was dug up and repaired. Crossing is now in good condition. 7/15/2013 Pipe appears to have a possible hole in top of pipe about 10ft. in from LS headwall. 4/17/2012 LS headwall blocked by sediment (50 % of opening is covered). LS floor is higher than LS pipe invert. WS headwall has been recently cleared of vegetation and sediment. This crossing was listed in the USACE Periodic Inspection report as Corp's inspect ID#USACE_CESPK_M13D_2011_p_0157 for WS and LS inlet/outlet blocked by sediment.

Overview of levee crown looking downstream at crossing.

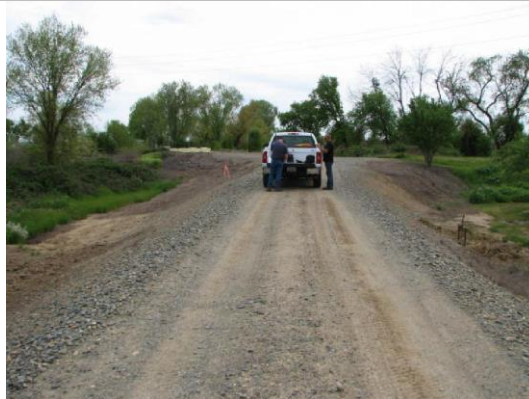
Photo 1 of 2 : UCIP_SP_2016_48019_66725.jpg

FS_ID:48019
DS_ID:16349
EP_NO: N/A
Repair Type: Non-Urgent
Crossing Status: Found
UCIP Comments: 4/28/2016 Sediment build up on both gates blocking them from operating properly.7/14/2015 Crossing appears in good condition. No noticeable issues to report.5/21/2014 Same as last inspection.12/2/2013 Same as last inspection.7/15/2013 Stem on LS screw gate has been replaced and is now full functional.4/17/2012 LS slide gate stem is bent and prevents gate from fully closing. Both WS and LS have been cleared of debris and sediment. This crossing was listed in the USACE Periodic Inspection report as Corp's inspect ID#USACE_CESPK_M13D_2011_p_0162 for inoperable gates on WS & LS due to sediment and grass blocking inlet and outlet.
FIELD_STRUCT_DESC: 24-inch corrugated metal drainpipe through the levee, 8.9 feet below the crown. Flap gate on waterside (WS) end. Concrete "U" headwalls on both ends (USACE-1960). This entry matches the Drainage or Irrigation Structure referenced in O&M manual (HLM 3.29).

Overview of levee crown looking DS at crossing.

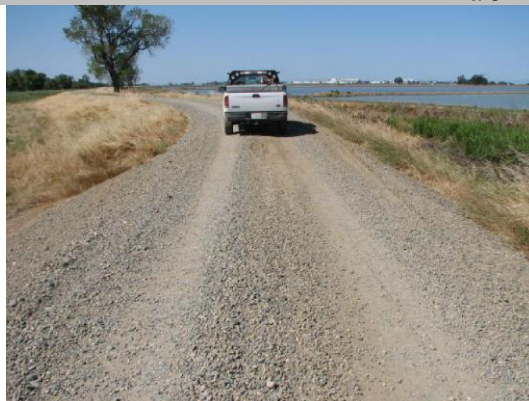
Photo 1 of 2 : UCIP_SP_2016_47642_66793.jpg

Overview of levee crown at crossing looking downstream.

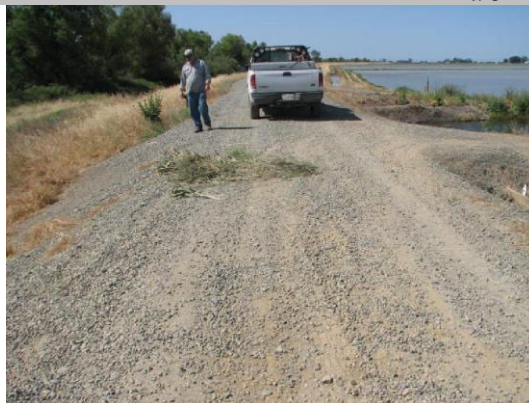
Photo 1 of 2 : UCIP_SP_2016_48134_66814.jpg

Overview of levee crown at crossing looking downstream.

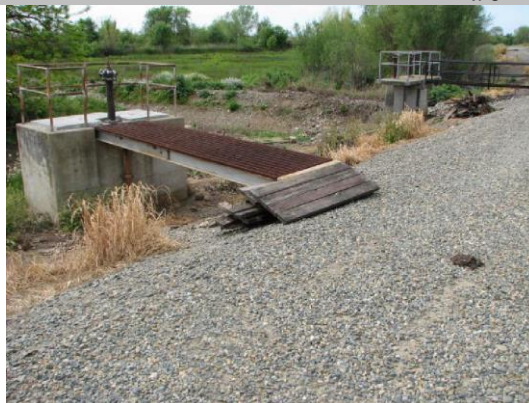
Photo 1 of 2 : UCIP_SP_2016_47659_66881.jpg

Catwalk and screw gate located on WS.

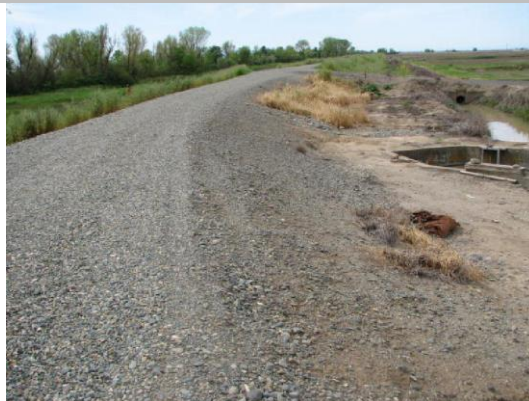
Photo 1 of 2 : UCIP_SP_2016_47664_66908.jpg

Overview picture looking south

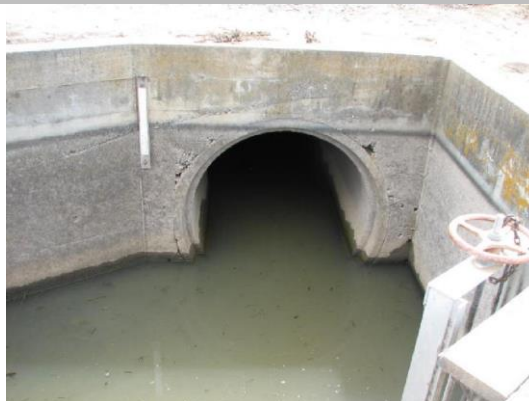
Photo 2 of 2 : UCIP_SP_2016_47664_66907.jpg

Headwall at LS distribution box

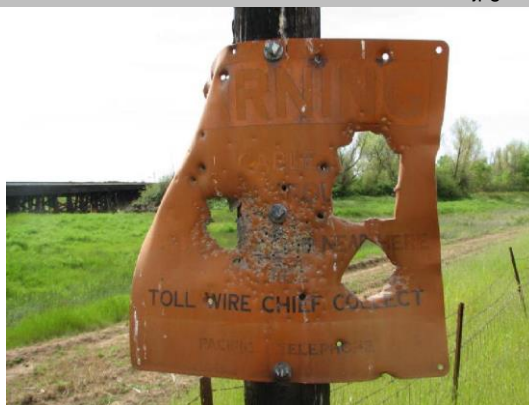
Photo 1 of 1 : UCIP_SP_2016_47447_66909.jpg

LM Start	8.90	Rating **	M	Issue No.	52
LM End	8.90	Issue Type +	En	Location *	LS
Category	Supplemental			GPS Latitude/Longitude	
				Start	End
Item	DWR UCIP Field Study			39.477530 °	39.477530 °
				-121.737060 °	-121.737060 °
DWR ID					
Comment Code					
Inspector Comment					
FS_ID:47447 DS_ID:16328 EP_NO: 1234A Repair Type: Non-Urgent Crossing Status: Indicator Found UCIP Comments: 4/28/2016 Marker missing on WS.7/13/2015 Crossing appears in good condition. No noticeable issues to report.Need to contact owner to replace marker.7/15/2013 Same as last inspection.12/3/2013 Same as last inspection.5/21/2014 Same as last inspection. FIELD_STRUCT_DESC: Underground telephone cable through the levee at an unknown depth. (Permit No. 1234-1947, Pacific Telephone and Telegraph Company) FS Date: 5/4/2016 10:13:29 AM

Underground telephone cable marker located on WS.

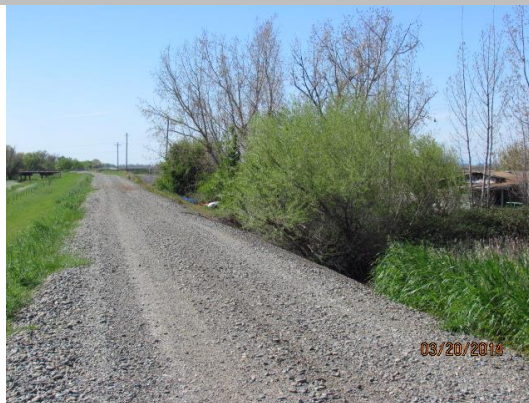
Photo 1 of 1 : SP_2016_MA0013_300_5_20160316_00003.jpg

LM Start	9.70	Rating **	M	Issue No.	5
LM End	9.72	Issue Type +	Ma	Location *	LS
Category	Earthen Levee			GPS Latitude/Longitude	
				Start	End
Item	Trim / Thin Trees			39.467170 °	39.466860 °
				-121.743887 °	-121.744108 °
DWR ID	DWR_MA0013_01_s_2012_5				
Comment Code					
T1 : Trim trees to at least five feet above ground level.					
Inspector Comment

Trim the trees along the landside slope and toe.

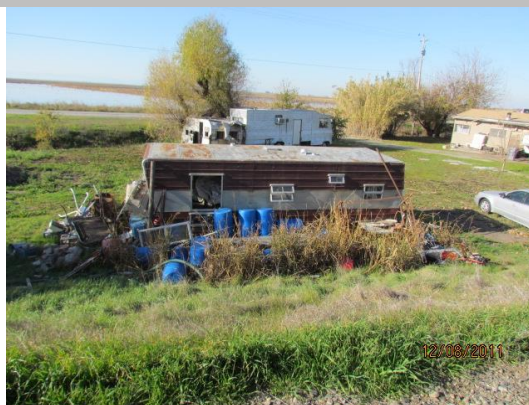
Photo 1 of 1 : SP_2016_MA0013_300_10_20160316_00005.jpg

LM Start	9.74	Rating **	M	Issue No.	10
LM End	9.74	Issue Type +	En	Location *	LS
Category	Earthen Levee			GPS Latitude/Longitude	
				Start	End
Item	Encroachments			39.466635 °	39.466635 °
				-121.744228 °	-121.744228 °
DWR ID	DWR_MA0013_01_f_2013_10				
Comment Code					
MA : Material					
Inspector Comment					
Move the trailer and materials outside the 10 foot easement.

View of a trailer & material along the L/S toe.

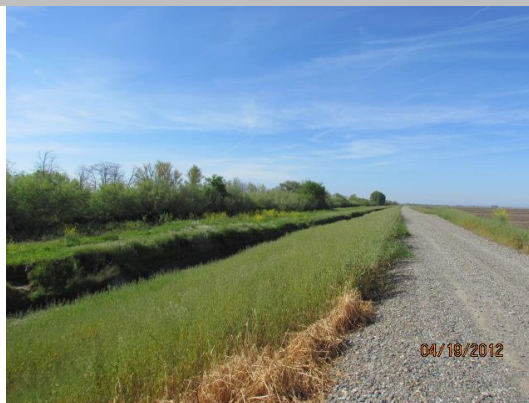
Photo 1 of 1 : SP_2016_MA0013_300_17_20160316_00007.jpg

LM Start	11.04	Rating **	M	Issue No.	17
LM End	13.28	Issue Type +	En	Location *	WS
Category	Earthen Levee			GPS Latitude/Longitude	
				Start	End
Item	Encroachments			39.449777 °	39.421255 °
				-121.755103 °	-121.774893 °
DWR ID	DWR_MA0013_01_s_2012_17				
Comment Code					
DT : Ditch					
Inspector Comment

View of the agricultural ditch along the toe of the levee.

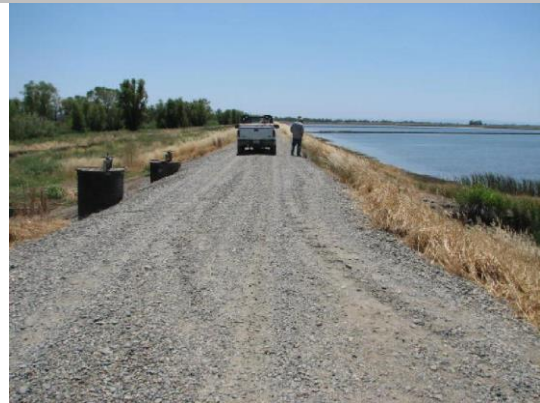
Photo 1 of 2 : UCIP_SP_2016_47672_66940.jpg

Overview of levee crown at crossing looking downstream.

Item	DWR UCIP Field Study			39.435169 °	39.435169 °	
				-121.765290 °	-121.765290 °	
DWR ID						
Comment Code						
Inspector Comment						
FS_ID:47672 DS_ID:16334 EP_NO: N/A Repair Type: Non-Urgent Crossing Status: Found UCIP Comments: 4/28/2016 Crossing appears to be in good condition but could not locate the WS pipe end.7/13/2015 New screw gate installed inside the WS standpipe. 5/21/2014 Same as last inspection.12/3/2013 Same as last inspection.7/15/2013 Slopes have been cleared of vegetation and are in good condition. Still no sign of WS end of pipe.4/18/2012 Limited inspection on WS and LS slope due to dense vegetation. WS outlet of pipe not found. Need photos of cleared WS and LS slopes. Determine if WS outlet daylights after WS slope is cleared. FIELD_STRUCT_DESC: 30-inch corrugated metal pipe through the levee, 11.0 feet below the crown. Slide gate in corrugated metal pipe riser on the waterside (WS) slope. Concrete "U" headwall on the landside (LS). (USACE-1960). This entry matches the Drainage or Irrigation Structure referenced in O&M manual (HLM 12.38). FS Date: 5/4/2016 12:18:00 PM

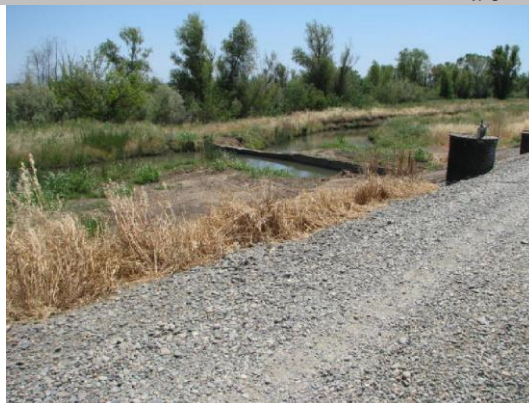
Photo 2 of 2 : UCIP_SP_2016_47672_66936.jpg

View of WS slope and channel.

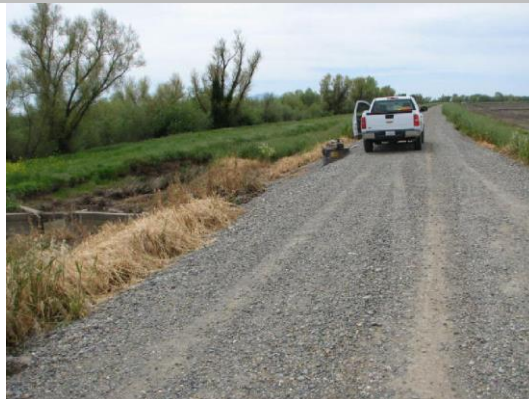
Photo 1 of 2 : UCIP_SP_2016_48049_66952.jpg

Overview picture looking south on right bank of Cherokee Canal.

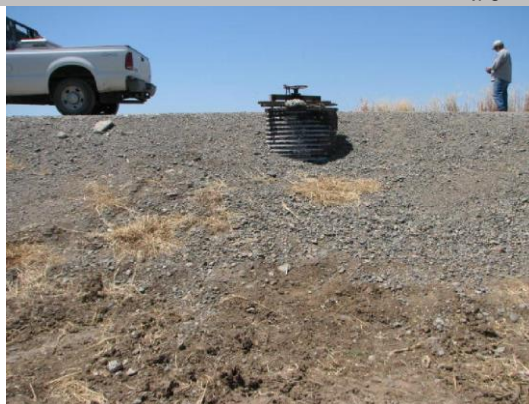
Photo 2 of 2 : UCIP_SP_2016_48049_66959.jpg

View of WS slope.

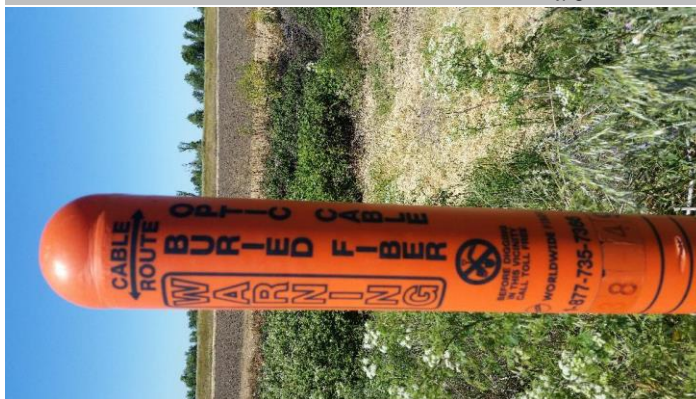
Photo 1 of 2 : UCIP_SP_2016_48060_75014.jpg

Marker located along side of road about 200 yds east of levees

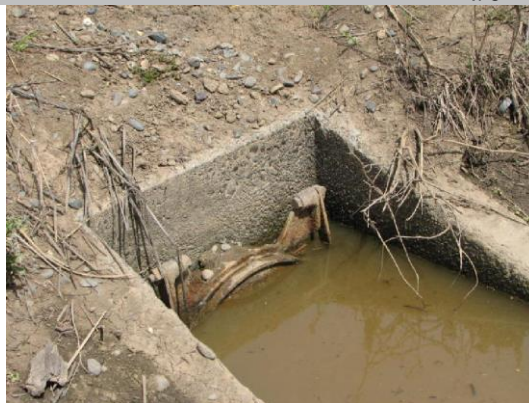
Photo 1 of 2 : UCIP_SP_2016_47677_66970.jpg

WS headwall and flap gate.

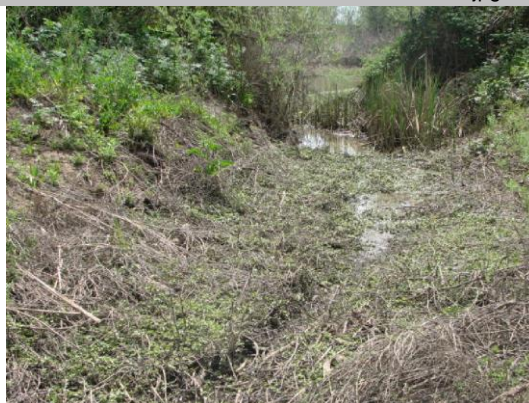
Photo 2 of 2 : UCIP_SP_2016_47677_66971.jpg

View of channel at crossing.

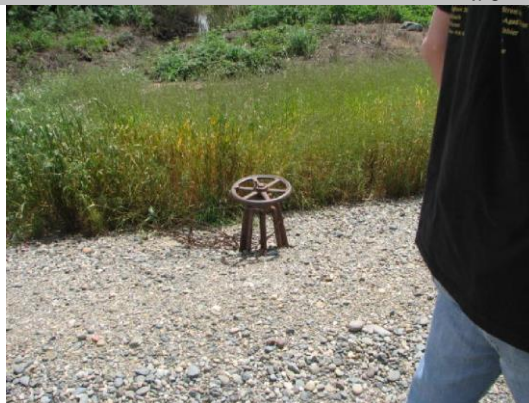
Photo 1 of 2 : UCIP_SP_2016_48050_66972.jpg

Buried slide gate on the WS slope.

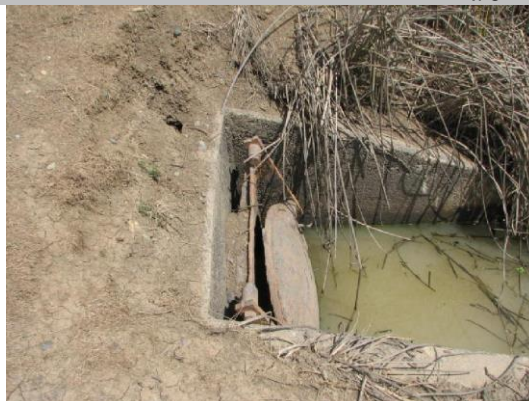
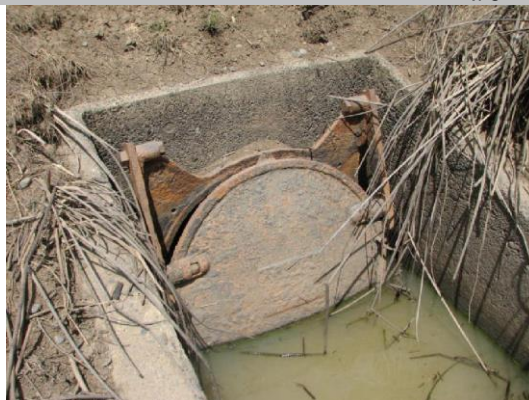
Photo 1 of 2 : UCIP_SP_2016_48054_66976.jpg

Headwall and flapgate located on water side of levee

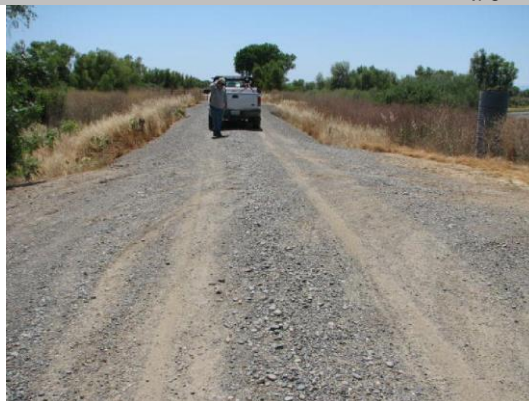
Photo 1 of 2 : UCIP_SP_2016_48494_66989.jpg

Overview of levee crown at crossing looking downstream.

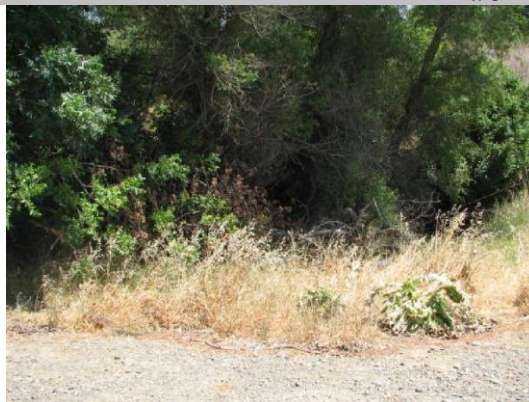
Photo 2 of 2 : UCIP_SP_2016_48494_66987.jpg

View of WS.

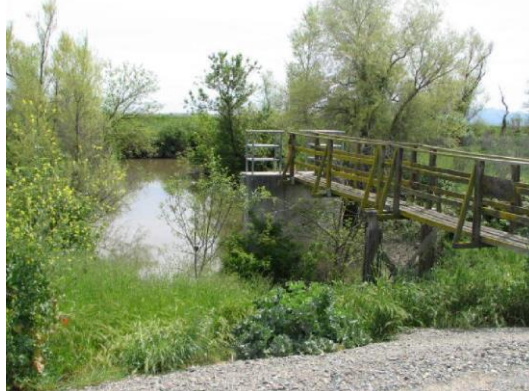
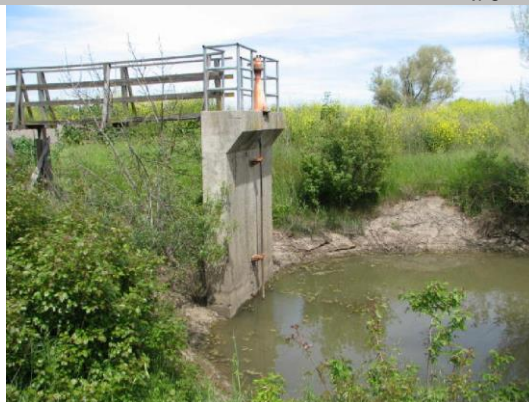
Photo 1 of 2 : UCIP_SP_2016_48059_66993.jpg

WS view of appurtenances (catwalk, slide gate, and headwall)

WS view of catwalk, slide/screw gate, and headwall

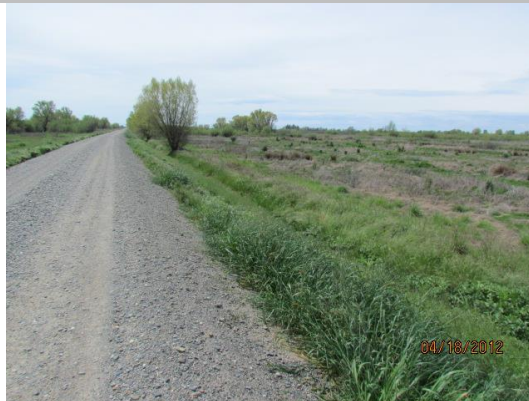
Photo 1 of 1 : SP_2016_MA0013_300_7_20160316_00004.jpg

LM Start	16.22	Rating **	M	Issue No.	7
LM End	17.17	Issue Type +	En	Location *	LS
Category	Earthen Levee			GPS Latitude/Longitude	
				Start	End
Item	Encroachments			39.394523 °	39.385580 °
				-121.817630 °	-121.831282 °
DWR ID	DWR_MA0013_01_s_2012_7				
Comment Code					
DT : Ditch					
Inspector Comment

View of the agricultural along the toe of the levee.

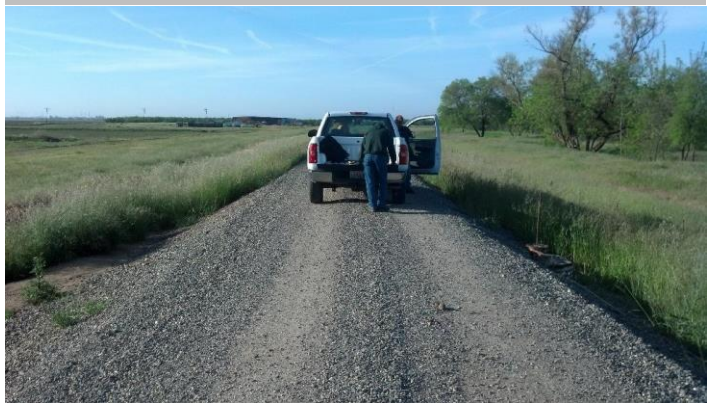
Photo 1 of 2 : UCIP_SP_2016_48038_67047.jpg

Comment Code					
Inspector Comment					
FS_ID:48038 DS_ID:16398 EP_NO: N/A Repair Type: Non-Urgent Crossing Status: Found UCIP Comments: 4/27/2016 Pipe gets used by the landowner to irrigate his rice fields. It appeared to be in good condition.7/01/2015 LS pipe end is still about 50% full of sediment.5/29/2014 Same as last inspection.12/9/2013 Same as last inspection.7/10/2013 LS and WS slopes have been cleared of vegetation and are in good condition. LS pipe end is half full of sediment. Sediment inside of WS standpipe may hinder slide gate from fully closing. Standpipe cover is still broken.4/19/2012 Need to fix the top of slide gate cover. The wooden cap on standpipe is broken. Limited evaluation of crossing due to dense vegetation on LS slope. Need photos of cleared slopes during fall inspection. FIELD_STRUCT_DESC: 24-inch drainage corrugated metal pipe (CMP) through the levee, 10.6 feet below the crown. Slide gate in CMP riser on the waterside (WS) slope. Concrete "U" headwall on the landside (LS). 36-inch concrete standpipe in the channel with two wooden piles to deflect debris. (USACE-1962) This entry matches the Drainage or Irrigation Structure referenced in O&M manual (HLM 0.57). FS Date: 5/3/2016 12:49:00 PM

Overview looking south

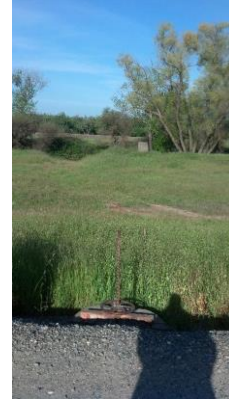
Photo 2 of 2 : UCIP_SP_2016_48038_67048.jpg

Item	DWR UCIP Field Study			39.566479 °	39.566479 °	
				-121.702430 °	-121.702430 °	
DWR ID						
Comment Code						
Inspector Comment						
FS_ID:48038 DS_ID:16398 EP_NO: N/A Repair Type: Non-Urgent Crossing Status: Found UCIP Comments: 4/27/2016 Pipe gets used by the landowner to irrigate his rice fields. It appeared to be in good condition.7/01/2015 LS pipe end is still about 50% full of sediment.5/29/2014 Same as last inspection.12/9/2013 Same as last inspection.7/10/2013 LS and WS slopes have been cleared of vegetation and are in good condition. LS pipe end is half full of sediment. Sediment inside of WS standpipe may hinder slide gate from fully closing. Standpipe cover is still broken.4/19/2012 Need to fix the top of slide gate cover. The wooden cap on standpipe is broken. Limited evaluation of crossing due to dense vegetation on LS slope. Need photos of cleared slopes during fall inspection. FIELD_STRUCT_DESC: 24-inch drainage corrugated metal pipe (CMP) through the levee, 10.6 feet below the crown. Slide gate in CMP riser on the waterside (WS) slope. Concrete "U" headwall on the landside (LS). 36-inch concrete standpipe in the channel with two wooden piles to deflect debris. (USACE-1962) This entry matches the Drainage or Irrigation Structure referenced in O&M manual (HLM 0.57). FS Date: 5/3/2016 12:49:00 PM

View of WS slope and toe.

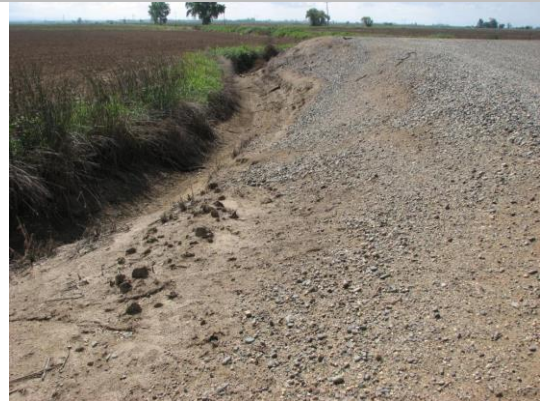
Photo 1 of 1 : SP_2016_MA0013_301_56_20160418_00119.jpg

LM Start	1.60	Rating **	U	Issue No.	56
LM End	1.63	Issue Type +	En	Location *	LS
Category	Earthen Levee			GPS Latitude/Longitude	
				Start	End
Item	Encroachments			39.552195 °	39.551731 °
				-121.704786 °	-121.704721 °
DWR ID	DWR_MA0013_02_s_2016_56				
Comment Code					
DT : Ditch					
Inspector Comment

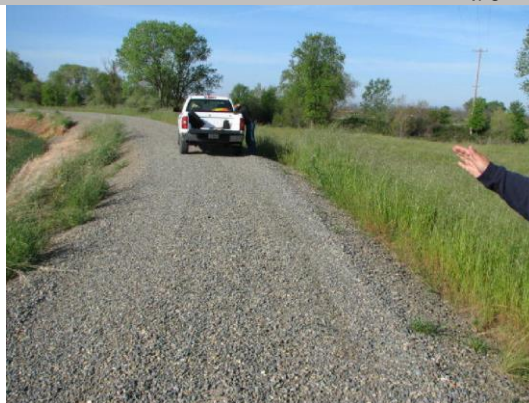
Photo 1 of 2 : UCIP_SP_2016_48039_67059.jpg

FS_ID:48039
DS_ID:16399
EP_NO: N/A
Repair Type: Non-Urgent
Crossing Status: Found
UCIP Comments: 4/27/2016 LS screw gate is still bent. Rest of crossing appeared in good condition.7/01/2015 LS screw gate frame is still twisted and hindering the gate from opening.5/29/2014 Same as last inspection.12/9/2013 Same as last inspection.7/10/2013 WS slope is cleared of vegetation and is in good condition. LS screw gate frame is twisted and is preventing the gate from opening.4/19/2012 Limited inspection dense vegetation on WS. Need photos of clear WS slope & toe. Ditch present in channel? This crossing was listed in the USACE Periodic Inspection report as Corp's Inspect ID# USACE_CESPK_M13G_2011_p_0108 for WS flap gate filled with soil and LS gate not functioning because of overgrown vegetation.
FIELD_STRUCT_DESC: 24-inch corrugated metal (CM) drainage pipe through the levee, 7.9 feet below the crown. Flap gate on the waterside (WS) end. Concrete "U" headwalls on both ends. Slide gate at the landside (LS) toe in headwall (USACE-1960). This entry matches the Drainage or Irrigation Structure referenced in O&M manual (HLM 1.70). In 1962, permit number 3953 was issued for existing pump structure, intake box, ditch and power pole. (Permit No. 3953-1960, Dr. John O. Gibbs, DBA Empire Land Company) In 1963, the pump and intake box were removed.

LM Start	1.70	Rating **	M	Issue No.	941 (cont)
LM End	1.70	Issue Type +	En	Location *	LS

Overview of crossing

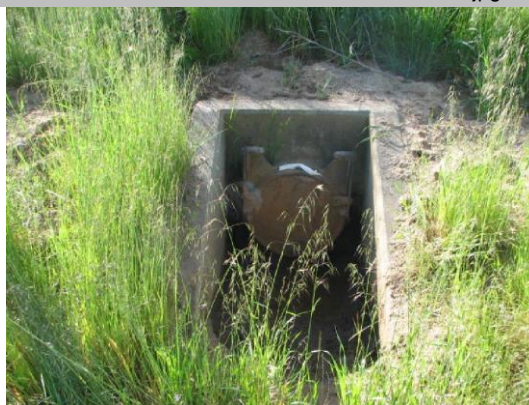
Photo 2 of 2 : UCIP_SP_2016_48039_67058.jpg

View of flap gate on WS.

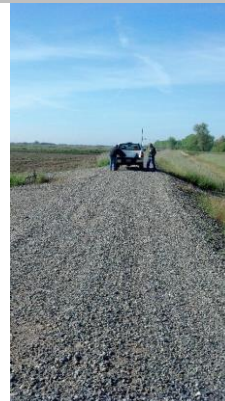
Photo 1 of 2 : UCIP_SP_2016_48040_67063.jpg

FS_ID:48040
DS_ID:16400
EP_NO: N/A
Repair Type: Non-Urgent
Crossing Status: Found
UCIP Comments: 4/27/2016 WS flapgate still blocked from opening by sediment buildup.7/01/2015 New screwgate installed on the LS. WS flapgate is still blocked from opening by sediment.5/29/2014 Same as last inspection.12/9/2013 Same as last inspection.7/10/2013 Sediment is built up against WS flap gate not allowing it to open. Handle for LS slide gate is still missing.4/19/2012 Handle missing on slide gate.
FIELD_STRUCT_DESC: 1 of 2: 36-inch corrugated metal drainpipe through the levee, 9.7 feet below the crown. Flap gate on the waterside (WS) end. Slide gate on the landside (LS) end. Concrete "U" headwalls on both ends (USACE-1960). This entry matches the Drainage or Irrigation Structure referenced in O&M manual (HLM 2.54).
FS Date: 5/3/2016 12:54:00 PM

LM Start	2.53	Rating **	M	Issue No.	942 (cont)
LM End	2.53	Issue Type +	En	Location *	LS

Overview of levee crown looking south

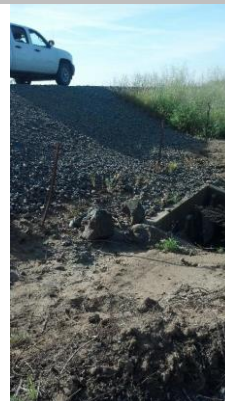
Photo 2 of 2 : UCIP_SP_2016_48040_67068.jpg

View of WS slope.

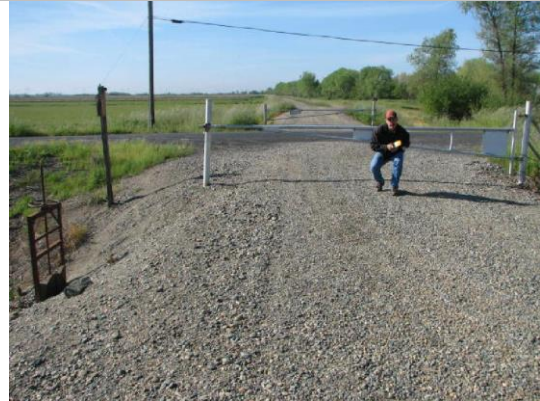
Photo 1 of 2 : UCIP_SP_2016_48042_67077.jpg

FS_ID:48042
DS_ID:16402
EP_NO: N/A
Repair Type: Non-Urgent
Crossing Status: Found
UCIP Comments: 4/27/2016 LS slide gate is full of sediment and needs to be dug out so gate can close fully.7/01/2015 LS screwgate is still silted in and unable to be screwed down all the way. Needs to be cleaned out.5/29/2014 Same as last inspection.12/9/2013 WS flapgate was closed but LS slidegate is heavily vegetated and blocked from closing by sediment.7/10/2013 Same as last inspection.4/19/2012 Minor sediment built up on LS, remove sediment. Need photo of LS slide gate without sediment build up. This crossing was listed in the USACE Periodic Inspection report as Corp's inspect ID# USACE_CESPK_M13G_2011_p_0148 for LS gate obstructed by vegetation and WS flap gate is not functioning (propped open).
FIELD_STRUCT_DESC: 36-inch corrugated metal drainpipe through the levee, 8.8 feet below the crown. Flap gate on the waterside (WS) end. Slide gate on the landside (LS) end. Concrete "U" headwalls on both ends (USACE-1960). Structure used to drain water from Nelson Shippe Road. This entry matches the Drainage or Irrigation Structure referenced in O&M manual (HLM 2.63).

LM Start	2.62	Rating **	M	Issue No.	943 (cont)
LM End	2.62	Issue Type +	En	Location *	LS

Overview looking south from left levee

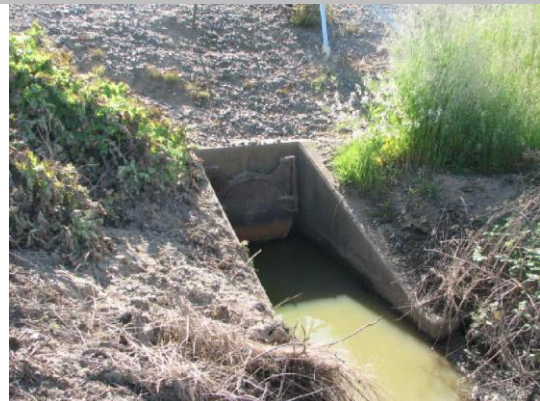
Photo 2 of 2 : UCIP_SP_2016_48042_67076.jpg

Headwall and flap gate located on WS.

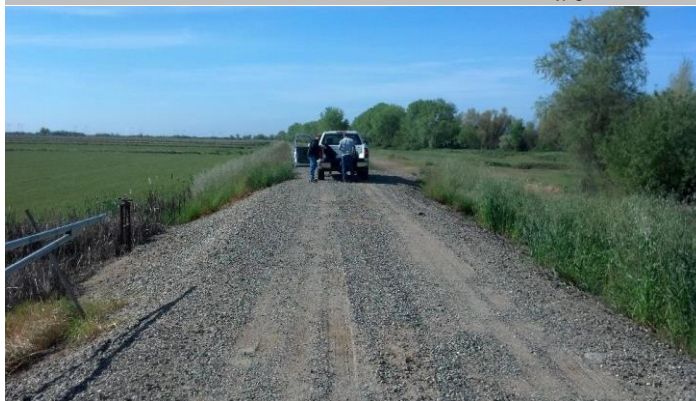
Photo 1 of 2 : UCIP_SP_2016_48048_67090.jpg

FS_ID:48048
DS_ID:16415
EP_NO: N/A
Repair Type: Non-Urgent
Crossing Status: Found
UCIP Comments: 4/27/2016 Both gates were underwater for inspection.7/01/2015 WS flap gate is partially held open by sediment and needs to be dug out to allow it to fully close.5/29/2014 Same as last inspection.12/9/2013 Both gates were out of water and in good condition.7/10/2013 LS and WS slopes are in good condition. Both LS and WS gates were fully submerged in water and unable to be inspected.
FIELD_STRUCT_DESC: 36-inch corrugated metal drainpipe through the levee, 9.0 feet below the crown. Flap gate on the waterside (WS) end. Slide gate on the landside (LS). Concrete "U" headwall on both ends (USACE-1960). This entry matches the Drainage or Irrigation Structure referenced in O&M manual (HLM 2.66).
FS Date: 5/3/2016 1:02:00 PM

LM Start	2.65	Rating **	M	Issue No.	933 (cont)
LM End	2.65	Issue Type +	En	Location *	LS

Overview looking south from left levee

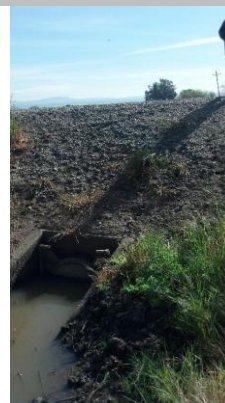
Photo 2 of 2 : UCIP_SP_2016_48048_67091.jpg

Headwall and flap gate located on WS.

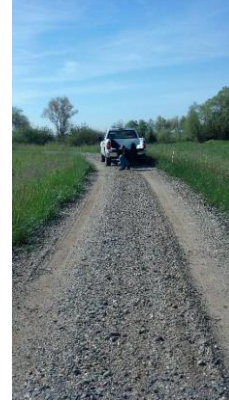
Photo 1 of 2 : UCIP_SP_2016_47735_67094.jpg

FS_ID:47735
DS_ID:16405
EP_NO: N/A
Repair Type: Non-Urgent
Crossing Status: Found
UCIP Comments: 4/27/2016 Crossing appears abandoned. LS screw gate still buried and WS flap gate was 95% buried.7/01/2015 Still a non functioning crossing. LS screw gate is completely buried by sediment with only part of its frame and stem visible. WS flapgate is blocked from opening by sediment and debris.5/29/2014 Same as last inspection.12/9/2013 LS slide gate is completely buried by soil and WS flap gate is blocked from opening by sediment. Crossing appears abandoned and non-function. 7/10/2013 LS and WS slopes have been cleared by vegetation and are in good condition. WS flap gate is out of water but is blocked from opening by sediment build up. LS gate is fully submerged and not able to be inspected.4/19/2012 Non-functioning crossing. Farmer uses pipe located at LM 3.682 to drain field & not this one. Dense vegetation-need photos of cleared WS & LS slopes. This crossing was listed in the USACE Periodic Inspection report as Corp's inspect ID# USACE_CESPK_M13G_2011_p_0172 for no access to WS gate due to high water & dense vegetation.

LM Start	3.59	Rating **	M	Issue No.	913 (cont)
LM End	3.59	Issue Type +	En	Location *	LS

Overview looking south from left levee

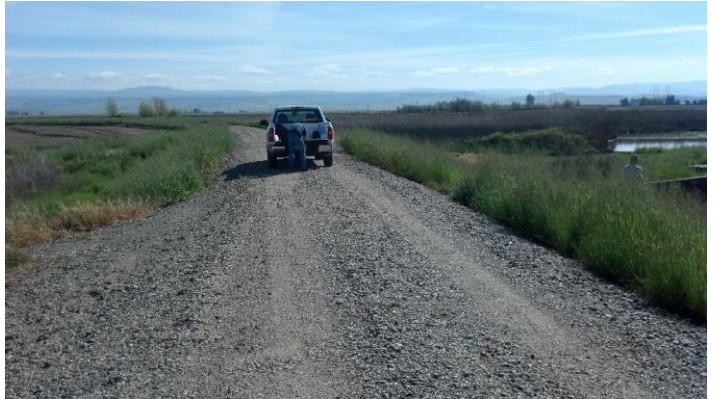
Photo 1 of 2 : UCIP_SP_2016_48046_67107.jpg

FS_ID:48046
DS_ID:16847
EP_NO: N/A
Repair Type: Non-Urgent
Crossing Status: Found
UCIP Comments: 4/27/2016 LS slide gate was still missing. Rest of crossing appears to be in good condition.7/01/2015 There appears to be a LS gate now but both pipe ends were submerged so it was hard to tell for certain.5/29/2014 Same as last inspection.12/9/2013 Pulled sticks from WS flap gate to allow it to close. Ls gate is still missing.7/10/2013 WS and LS slopes have been cleared of vegetation and are in good condition. LS gate is still missing and WS flap gate is still wedged open with sticks.4/19/2012 LS gate missing & limited inspection. Need photos of WS & LS cleared slopes. Description calls for slide gate on LS-slide gate missing. Debris scattered near LS headwall. This crossing was listed in the USACE Periodic Inspection report as Corp's Inspect ID# USACE_CESPK_M13J_2011_p_0010 for WS gate wedged open & missing LS slide gate.

LM Start	3.83	Rating **	M	Issue No.	932 (cont)
LM End	3.83	Issue Type +	En	Location *	LS

Overview looking south on left levee

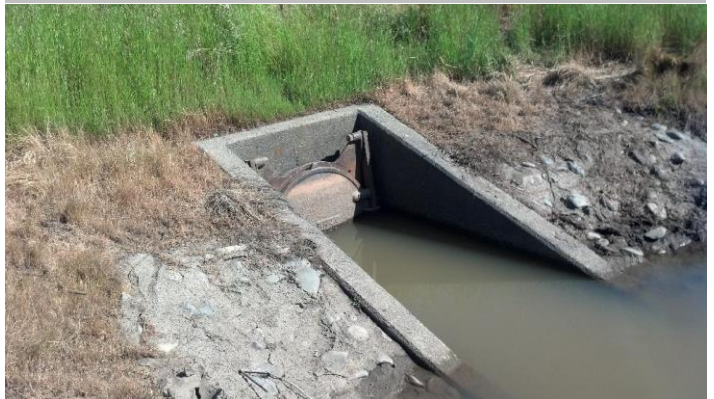
Photo 2 of 2 : UCIP_SP_2016_48046_67108.jpg

Headwall and flap gate located on WS toe.

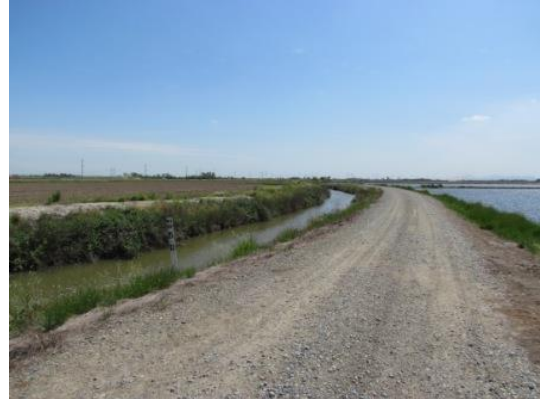
Photo 1 of 1 : SP_2016_MA0013_301_911_20160316_00017.jpg

LM Start	4.04	Rating **	M	Issue No.	911
LM End	4.78	Issue Type +	En	Location *	WS
Category	Earthen Levee			GPS Latitude/Longitude	
				Start	End
Item	Encroachments			39.526653 °	39.534091 °
				-121.699675 °	-121.690404 °
DWR ID	DWR_MA0013_02_s_2012_911				
Comment Code					
DT : Ditch					
Inspector Comment

View of agricultural ditch along the toe.

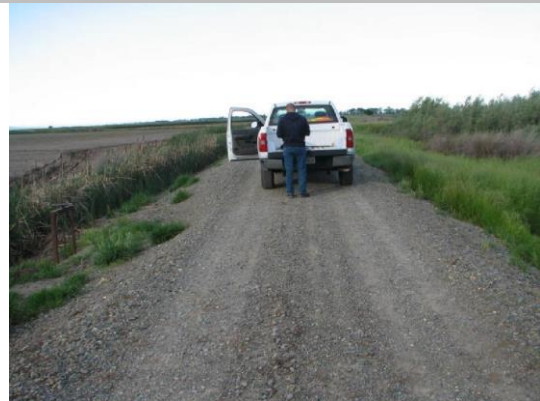
Photo 1 of 2 : UCIP_SP_2016_47723_67146.jpg

LM Start	5.29	Rating **	M	Issue No.	927
LM End	5.29	Issue Type +	En	Location *	WS
Category	Supplemental			GPS Latitude/Longitude	
				Start	End
Item	DWR UCIP Field Study			39.525958 °	39.525958 °
				-121.692730 °	-121.692730 °
DWR ID

Comment Code					
Inspector Comment					
FS_ID:47723 DS_ID:16409 EP_NO: N/A Repair Type: Non-Urgent Crossing Status: Found UCIP Comments: 4/27/2016 LS slide gate is blocked by vegetation. Pipe appears to not be used.6/30/2015 WS flap gate was still overgrown with vegetation. Needs to be cleared away.5/29/2014 Same as last inspection.12/9/2013 Same as last inspection.7/09/2013 Same as last inspection.4/24/2012 Limited inspection on WS slope due to dense vegetation. Need photo of clear WS slope during next inspection. This crossing was listed in the USACE Periodic Inspection report as Corp's inspect ID# USACE_CESPK_M13H_2011_p_0035 non-functional crossing due to overgrown vegetation on WS flap gate. FIELD_STRUCT_DESC: 30-inch corrugated metal drainage pipe through the levee, 5.8 feet below the crown. Flap gate on the waterside (WS). Slide gate on the landside (LS). Concrete "U" headwalls on both ends (USACE-1960). This entry matches the Drainage or Irrigation Structure referenced in O&M manual (HLM 5.34). FS Date: 5/3/2016 1:32:00 PM

Overview of crossing looking downstream.

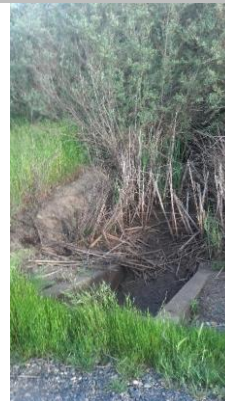
Photo 2 of 2 : UCIP_SP_2016_47723_67149.jpg

Item	DWR UCIP Field Study			39.525958 °	39.525958 °	
				-121.692730 °	-121.692730 °	
DWR ID						
Comment Code						
Inspector Comment						
FS_ID:47723						
DS_ID:16409						
EP_NO: N/A						
Repair Type: Non-Urgent						
Crossing Status: Found						
UCIP Comments: 4/27/2016 LS slide gate is blocked by vegetation.						
Pipe appears to not be used.6/30/2015 WS flap gate was still						
overgrown with vegetation. Needs to be cleared away.5/29/2014						
Same as last inspection.12/9/2013 Same as last						
inspection.7/09/2013 Same as last inspection.4/24/2012 Limited						
inspection on WS slope due to dense vegetation. Need photo of clear						
WS slope during next inspection. This crossing was listed in the						
USACE Periodic Inspection report as Corp's inspect ID#						
USACE_CESPK_M13H_2011_p_0035 non-functional crossing due to						
overgrown vegetation on WS flap gate.						
FIELD_STRUCT_DESC: 30-inch corrugated metal drainage pipe

View of WS headwall with dense vegetation in channel.

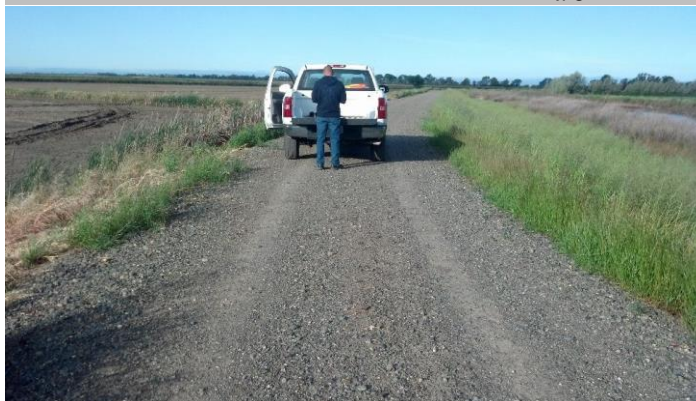
Photo 1 of 2 : UCIP_SP_2016_47724_67152.jpg

FS_ID:47724
DS_ID:16410
EP_NO: N/A
Repair Type: Non-Urgent
Crossing Status: Found
UCIP Comments: 4/27/2016 Pipe appears abandoned. Should be removed.6/30/2015 Pipe still present with the cap on the waterside.5/29/2014 Same as last inspection.12/9/2013 Same as last inspection.7/09/2013 Same as last inspection.4/24/2012 Limited inspection on WS and LS slope due to dense vegetation. Need photos of clear slopes during next inspection. Metal plate bolted on pipe for closure on WS, open on LS.
FIELD_STRUCT_DESC: *ABANDONED* 6-inch steel pipe through the levee, 1.6 feet below the crown. Plate bolted on the waterside (WS) end. Open on the landside (LS) end. (USACE-1962) This entry matches the Drainage or Irrigation Structure referenced in O&M manual (HLM 5.41).
FS Date: 5/3/2016 1:50:00 PM

LM Start	5.36	Rating **	M	Issue No.	928 (cont)
LM End	5.36	Issue Type +	En	Location *	WS

Overview of site

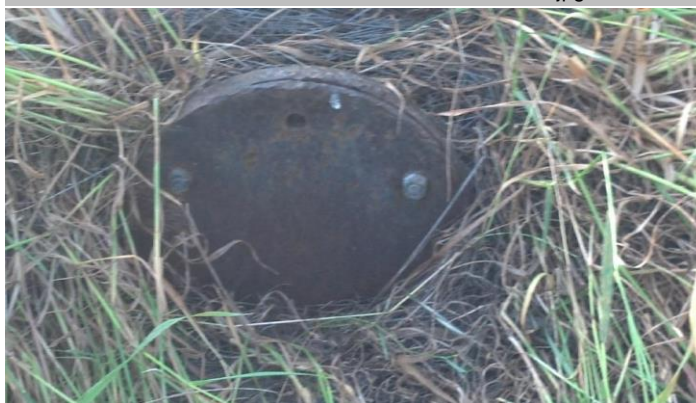
Photo 2 of 2 : UCIP_SP_2016_47724_67150.jpg

Capped irrigation pipe located on water side of levee

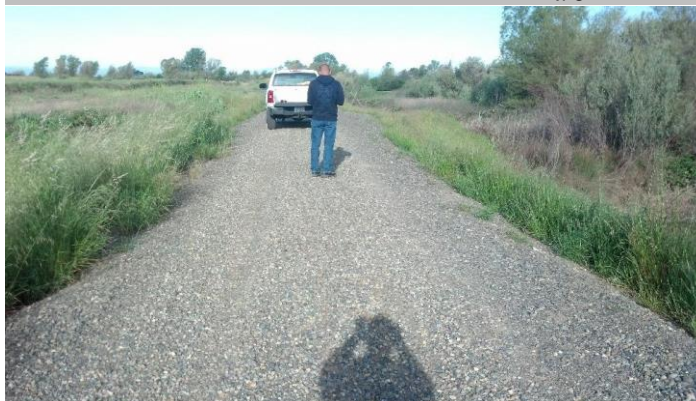
Photo 1 of 2 : UCIP_SP_2016_47725_67155.jpg

FS_ID:47725
DS_ID:16411
EP_NO: N/A
Repair Type: Urgent
Crossing Status: Found
UCIP Comments: 4/27/2016 Both sides of pipe were underwater. Appears that LS gate is still missing.6/30/2015 Slide gate still missing on the LS. WS appears to be in good condition.5/29/2014 Same as last inspection.12/9/2013 Same as last inspection.7/09/2013 Same as last inspection.4/24/2012 Slide gate missing on LS. Limited inspection on WS and LS slopes due to dense vegetation. Need photos of cleared WS & LS slopes. This crossing was listed in the USACE Periodic Inspection report as Corp's inspect ID# USACE_CESPK_M13H_2011_p_0017 for missing slide gate.
FIELD_STRUCT_DESC: 36-inch corrugated metal pipe through the levee, 9.2 feet below the crown. Flap gate on the waterside (WS) end. Slide gate on the landside (LS) end. Concrete "U" headwalls on both ends (USACE-1960) This entry matches the Drainage or Irrigation Structure referenced in O&M manual (HLM 5.85).

LM Start	5.80	Rating **	U	Issue No.	929 (cont)
LM End	5.80	Issue Type +	En	Location *	WS

Overview looking south

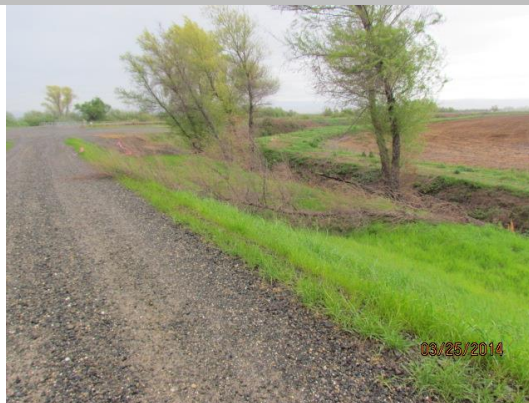
Photo 1 of 1 : SP_2016_MA0013_301_55_20160316_00014.jpg

LM Start	6.12	Rating **	M	Issue No.	55
LM End	6.12	Issue Type +	Ma	Location *	LS
Category	Earthen Levee			GPS Latitude/Longitude	
				Start	End
Item	Encroachments			39.521634 °	39.521634 °
				-121.706184 °	-121.706184 °
DWR ID	DWR_MA0013_02_s_2014_55				
Comment Code					
TR : Tree or limb					
Inspector Comment					
Remove the tree limbs from the landside slope.

View of the tree limbs on the landside slope and toe.

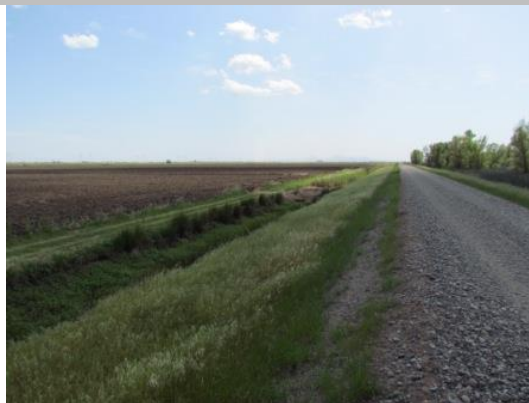
Photo 1 of 1 : SP_2016_MA0013_301_12_20160316_00005.jpg

LM Start	6.18	Rating **	M	Issue No.	12
LM End	7.54	Issue Type +	En	Location *	LS
Category	Earthen Levee			GPS Latitude/Longitude	
				Start	End
Item	Encroachments			39.520843 °	39.502958 °
				-121.706345 °	-121.716953 °
DWR ID	DWR_MA0013_02_s_2012_12				
Comment Code					
DT : Ditch					
Inspector Comment

View of the agricultural ditch along the toe.

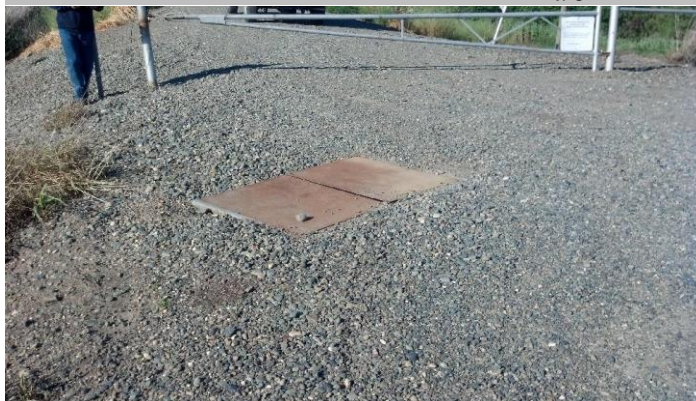
Photo 1 of 2 : UCIP_SP_2016_47733_67191.jpg

FS_ID:47733
DS_ID:16413
EP_NO: 14704
Repair Type: Non-Urgent
Crossing Status: Indicator Found
UCIP Comments: 4/27/2016 Crossing appears to be in good condition.6/30/2015 Crossing is in good condition. Unusre on the permit issues below.11/4/2014 (DWR-Olivia Magana) Need to contact owner to determine whether both communication are still active and same alignment? permit 14704 (LM 8.38) and 10589 (see LM 8.39) Priority changed in Part IX from No Action Needed to Non-Urgent.5/29/2014 Same as last inspection.12/4/2013 Same as last inspection.7/09/2013 Same as last inspection.4/24/2012 Unable to verify whether this crossing includes both communication cable lines under permit 14704 (LM 8.38) and 10589 (see LM 8.39).
FIELD_STRUCT_DESC: Fiber optic cable through levee at approximately 3.5 feet. The cable section across the channel is attached to the Cherokee Canal Dridge. (Permit No. 14704-1987, Sprint)

LM Start	8.30	Rating **	M	Issue No.	931 (cont)
LM End	8.30	Issue Type +	En	Location *	CR

Buried cable box located on the LS edge.

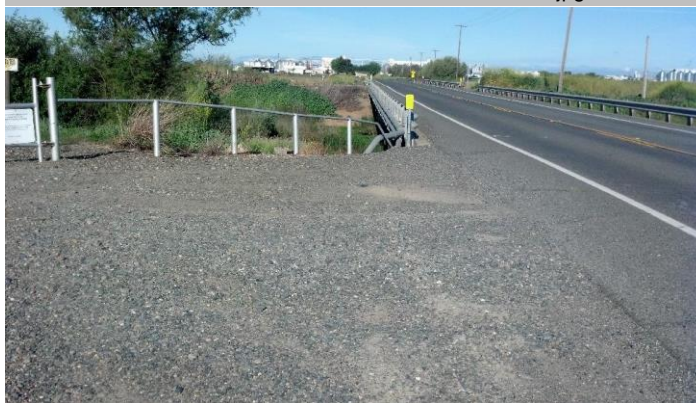
Photo 2 of 2 : UCIP_SP_2016_47733_67192.jpg

WS view cable line attached to highway bridge.

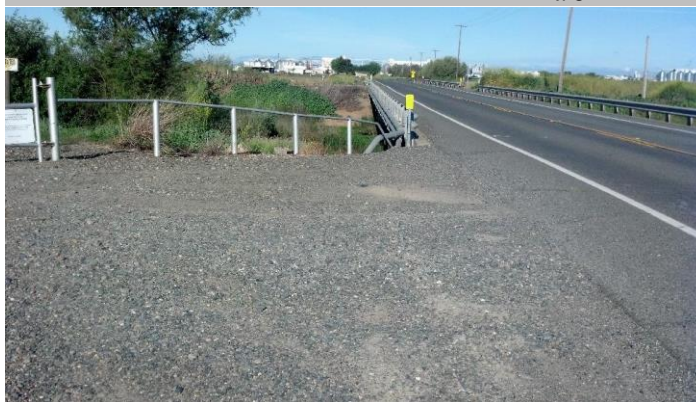
Photo 2 of 2 : UCIP_SP_2016_47734_67210.jpg

FS_ID:47734
DS_ID:16404
EP_NO: 10589A
Repair Type: Non-Urgent
Crossing Status: Indicator Found
UCIP Comments: 4/27/2016 Crossing appears to be in good condition.6/30/2015 Crossing appears in good condition. Unsure on the permit issues listed below.11/4/2014 (DWR-Olivia Magana) Need to contact owner to determine whether both communication are still active and same alignment? permit 14704 (LM 8.38) and 10589 (see LM 8.39) Priority changed in Part IX from No Action Needed to Non-Urgent.5/29/2014 Same as last inspection.12/4/2013 Same as last inspection.7/09/2013 Same as last inspection.4/24/2012 Unable to verify whether this crossing includes both communication cable lines under permit 14704 (LM 8.38) and 10589 (see LM 8.39).
FIELD_STRUCT_DESC: 4 inch steel pipe, contains three telephone cables, through the levee at approximately 4 feet below the crown. The cable through the channel is buried approximately 5 feet deep. (Permit No. 10589-1987, PG&E)

Waterside view of utility line alignment through levee then attached to bridge.

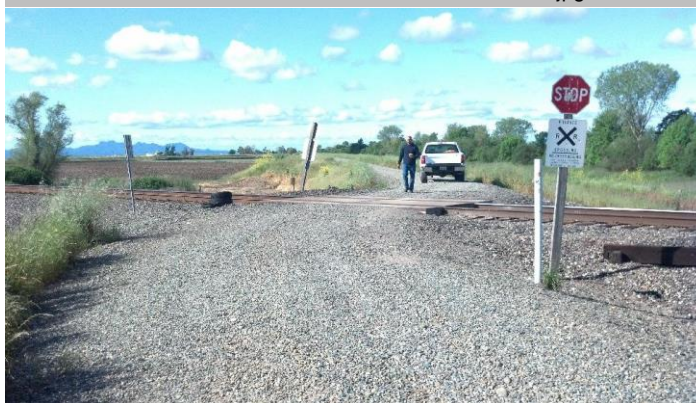
Photo 1 of 2 : UCIP_SP_2016_47742_67292.jpg

Comment Code					
Inspector Comment					
FS_ID:47742 DS_ID:18912 EP_NO: N/A Repair Type: Non-Urgent Crossing Status: Indicator Found UCIP Comments: 4/27/2016 Crossing appears to be in good condition.6/30/2015 Crossing is in good condition.5/28/2014 Same as last inspection.12/4/2013 Same as last inspection.7/09/2013 Same as last inspection.4/24/2012 Unable to determine if crossing is an authorized or unauthorized encroachment. Unable to find permit number for this encroachment. Will need to coordinate with LMA Superintendent and DWR-Inspector, photo includes utility contact information. FIELD_STRUCT_DESC: Buried fiber optic line through the levee at depth unknown. Owner of line is Qwest Communications 1-800 At Fiber Sign ID Number 16601. (Qwest Communication) FS Date: 5/3/2016 2:17:00 PM

Overview of levee crown at crossing.

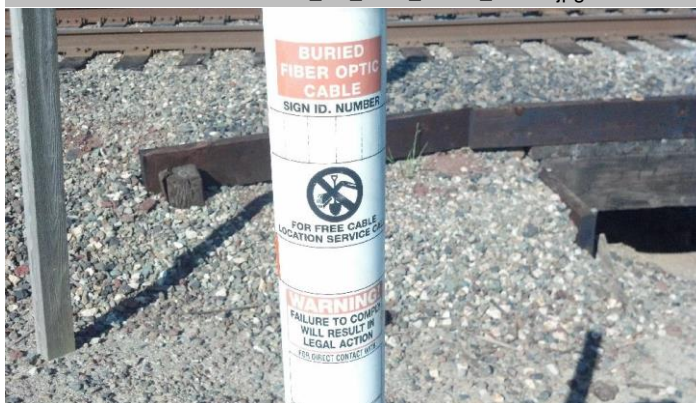
Photo 2 of 2 : UCIP_SP_2016_47742_67291.jpg

Marker for buried fiber optic cable on WS.

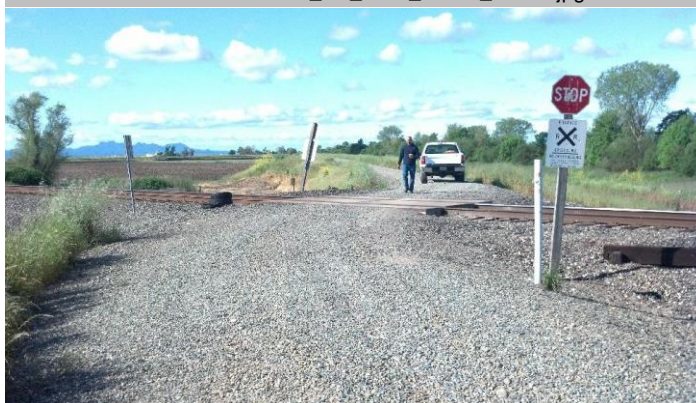
Photo 1 of 2 : UCIP_SP_2016_47743_67295.jpg

FS_ID:47743
DS_ID:18913
EP_NO: N/A
Repair Type: Non-Urgent
Crossing Status: Indicator Found
UCIP Comments: 4/27/2016 Crossing appears to be in good condition.6/30/2015 Crossing appears to be in good condition. But still unknown if this crossing was authorized or unauthorized.5/28/2014 Same as last inspection.12/4/2013 Same as last inspection.7/9/2013 Same as last inspection.4/24/2012 Authorized/unauthorized encroachment? Contact Chico Local Area Manager, Frank Villalovos 530.342.6140 (o) or 530.624.4048 (c) or email villalovosf@kindermorgan.com for additional info. Inquiries pertaining to inspection submit to pipelineinquiries@kindermorgan.com and reference as Engr Station 3173+48 plus include coordinates.
FIELD_STRUCT_DESC: 8-inch diameter high pressure line bored through through levee at depth unknown. Kinder Morgan is the owner of line--contact information is 213.624-9461 or Chico Local Area Manager, Frank Villalovos 530.342.6140 (o) or 530.624.4048 (c) or email villalovosf@kindermorgan.com. Additional contact is Ken Yeo, Sacramento Local Area Manager, at 916.416.7938 or by email yeok@kindermorgan.com. Frank Villalovos is the primary contact for this crossing.

LM Start	9.67	Rating **	M	Issue No.	915 (cont)
LM End	9.67	Issue Type +	En	Location *	CR

Overview of levee crown at crossing.

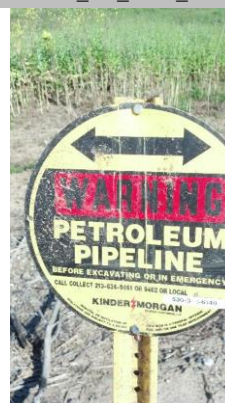
Photo 2 of 2 : UCIP_SP_2016_47743_67294.jpg

WS marker with utility contact information.
