**Flood Control Project Maintenance
Levee Inspections****LMA District Cover Sheet****Spring 2016 Levee Inspection Results****Sutter Maintenance Yard Maintenance Area 0013**

Spring 2016 Levee Inspection Results

Sutter Maintenance Yard Maintenance Area 0013

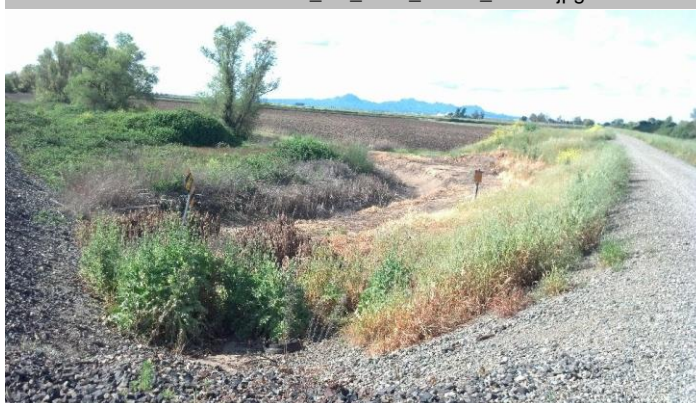
Photo 2 of 2 : UCIP_SP_2016_47744_67300.jpg

FS_ID:47744
DS_ID:18914
EP_NO: N/A
Repair Type: Non-Urgent
Crossing Status: Indicator Found
UCIP Comments: 4/27/2016 Crossing appears to be in good condition.6/30/2015 Crossing appears to be in good condition. It is still unknown whether this crossing was authorized or unauthorized.5/28/2014 Same as last inspection.12/4/2013 Same as last inspection.7/09/2013 Same as last inspection.4/24/2012 Unable to determine if crossing is an authorized or unauthorized encroachment. Unable to find permit number for this crossing. Will need to coordinate with Pacific Telephone to determine if permit exist for this crossing.
FIELD_STRUCT_DESC: Underground cable through the levee at depth unknown. Owner of encroachment is Pacific Telephone.
FS Date: 5/3/2016 2:20:00 PM

Marker located on LS.

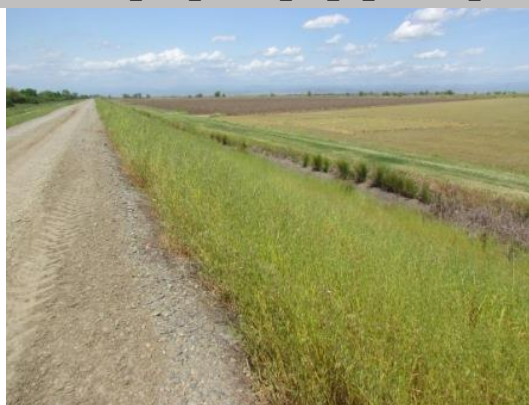
Photo 1 of 1 : SP_2016_MA0013_301_13_20160316_00006.jpg

LM Start	10.03	Rating **	M	Issue No.	13
LM End	10.52	Issue Type +	En	Location *	LS
Category	Earthen Levee			GPS Latitude/Longitude	
				Start	End
Item	Encroachments			39.471517 °	39.465113 °
				-121.739433 °	-121.743592 °
DWR ID	DWR_MA0013_02_s_2012_13				
Comment Code					
DT : Ditch					
Inspector Comment

View of the agricultural ditch along the toe.

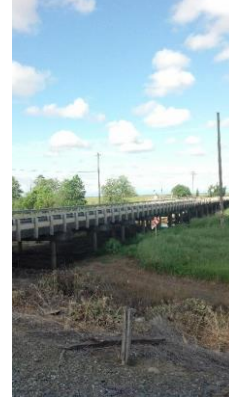
Photo 1 of 2 : UCIP_SP_2016_47746_67332.jpg

Comment Code					
Inspector Comment					
FS_ID:47746 DS_ID:16406 EP_NO: 1238 Repair Type: Non-Urgent Crossing Status: Indicator Found UCIP Comments: 4/26/2016 Crossing appears to be in good condition.6/30/2015 Crossing appears in good condition. 5/28/2014 Same as last inspection. 12/4/2013 Same as last inspection.7/08/2013 Same as last inspection.4/24/2012 Permit was approved for 6-5/8 inch diameter not 8 inch. The permit granted permission to construct pipe to cross Cherokee Canal, Butte Creek, Clear Creek, & Ash Creek. The O&M manual list an 8 inch steel gas line at HLM 10.67, unable to determine if the gas line is the same crossing. Will need to contact applicant to obtain records. FIELD_STRUCT_DESC: 8-inch gas pipe through the levee at unknown elevation. (Permit No. 1238-1947, PG&E) Utility marker visible at the upstream and downstream face of highway bridge and along highway. Buried utility crosses bridge and crosses left bank of Cherokee Canal downstream of highway bridge. This entry matches the Drainage or Irrigation Structure referenced in O&M manual (HLM 10.67). USA marking on highway indicate 6" STL LN 151. FS Date: 5/3/2016 2:23:00 PM

Utility marker is located near the upstream face of the highway bridge.

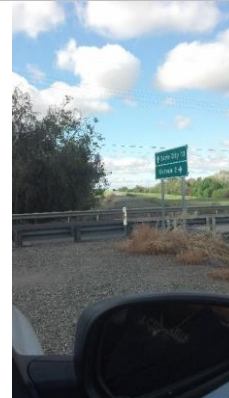
Photo 2 of 2 : UCIP_SP_2016_47746_67333.jpg

Utility is angled. Alignment crosses highway.

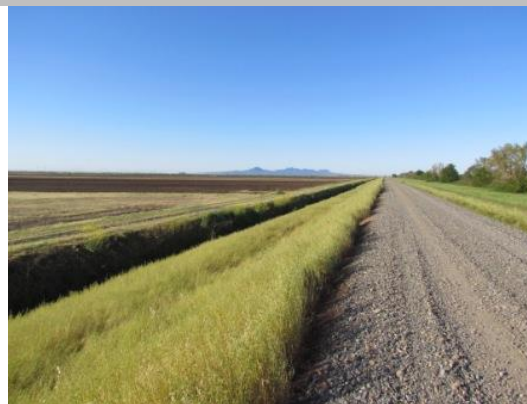
Photo 1 of 1 : SP_2016_MA0013_301_18_20160316_00007.jpg

LM Start	10.59	Rating **	M	Issue No.	18
LM End	11.66	Issue Type +	En	Location *	LS
Category	Earthen Levee			GPS Latitude/Longitude	
				Start	End
Item	Encroachments			39.464305 °	39.450333 °
				-121.744172 °	-121.753157 °
DWR ID	DWR_MA0013_02_s_2012_18				
Comment Code					
DT : Ditch					
Inspector Comment

View of the agricultural ditch along the toe.

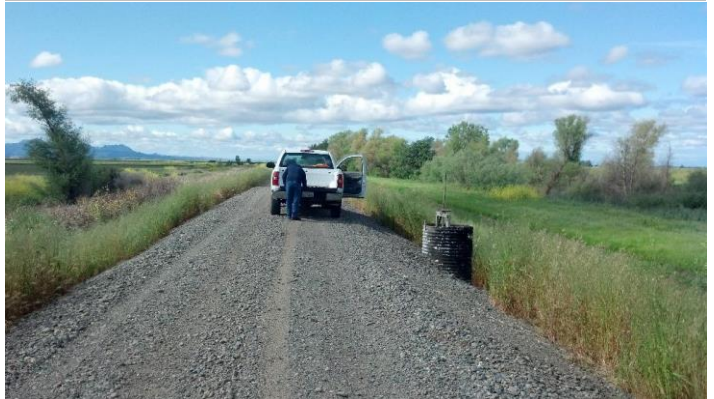
Photo 1 of 2 : UCIP_SP_2016_47748_67336.jpg

FS_ID:47748
DS_ID:16385
EP_NO: N/A
Repair Type: Non-Urgent
Crossing Status: Found
UCIP Comments: 4/26/2016 LS headwall was visible but gate was underwater. WS still heavily vegetated and unable to be inspected. Vegetation needs to be cleared back.6/30/2015 WS heavily vegetated passed the toe-road and could not make it to the WS pipe end for inspection. Vegetation needs to be cleared back. LS pipe end was fully submerged under water.5/28/2014 Same as last inspection.12/4/2013 Same as last inspection.7/08/2013 LS slope has been cleared of vegetation and is in good condition. LS headwall is now visible but mostly underwater so unable to do full inspection. WS is still vegetated.4/24/2012 LS pipe & slide gate sedimented in. Limited inspection WS and LS slopes due to dense vegetation. Need photos of cleared WS and LS slopes during next inspection. This crossing was listed in the USACE Periodic Inspection report as Corp's inspect ID# USACE_CESPK_M13F_2011_p_0147 for limited visibility of LS and WS.

Overview of crossing looking downstream at the left bank of Cherokee Canal.

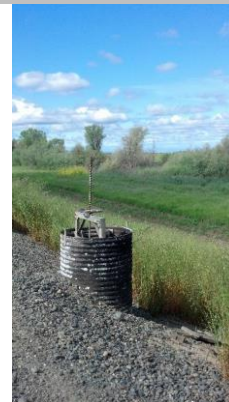
Photo 2 of 2 : UCIP_SP_2016_47748_67337.jpg

Stand pipe with screw gate WS

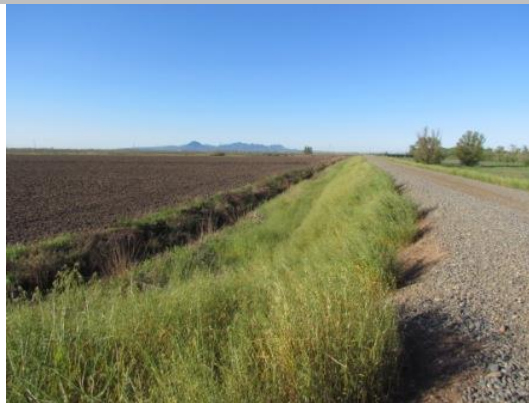
Photo 1 of 1 : SP_2016_MA0013_301_19_20160316_00008.jpg

LM Start	13.40	Rating **	M	Issue No.	19
LM End	16.88	Issue Type +	En	Location *	LS
Category	Earthen Levee			GPS Latitude/Longitude	
				Start	End
Item	Encroachments			39.428192 °	39.406240 °
				-121.768443 °	-121.794863 °
DWR ID	DWR_MA0013_02_s _ 2012_19				
Comment Code					
DT : Ditch					
Inspector Comment

View of the agricultural ditch along the toe.

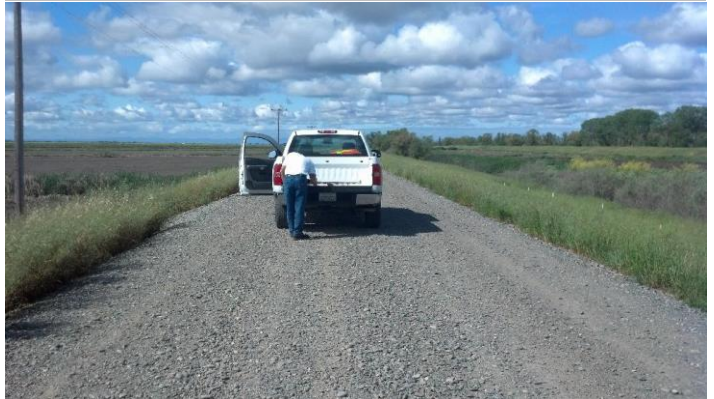
Photo 1 of 2 : UCIP_SP_2016_48066_67341.jpg

Comment Code					
Inspector Comment					
FS_ID:48066 DS_ID:16376 EP_NO: N/A Repair Type: Non-Urgent Crossing Status: Found UCIP Comments: 4/26/2016 LS inlet appears to be buried as could not locate it. Ws flap gate was bolted shut. This appears to be an abandoned crossing.6/30/2015 Still unable to locate the LS pipe end. 5/28/2014 Same as last inspection.12/4/2013 Same as last inspection. WS flapgate was bolted shut to keep LS ricefield flooded.7/08/2013 WS slope has been cleared of vegetation and is in good condition. LS slope also cleared of vegetation but still very dense on LS toe and unable to locate LS headwall.4/24/2012 Could not find LS end of pipe. Limited inspection on WS and LS slopes and toe due to dense vegetation. Need photos of cleared WS and LS slopes, and LS headwall during next inspection. This crossing was listed in the USACE Periodic Inspection report as Corp's inspect ID# USACE_CESPK_M13E_2011_p_0011 for WS gate blocked by vegetation. FIELD_STRUCT_DESC: 24-inch corrugated metal drainage pipe through the levee, 10.1 feet below the crown. Flap gate on the waterside (WS) end. Concrete "U" headwalls on both ends (USACE-1960). This entry matches the Drainage or Irrigation Structure referenced in O&M manual (HLM 15.62). FS Date: 5/3/2016 2:30:00 PM

Overview of crossing looking downstream at the left bank of Cherokee Canal.

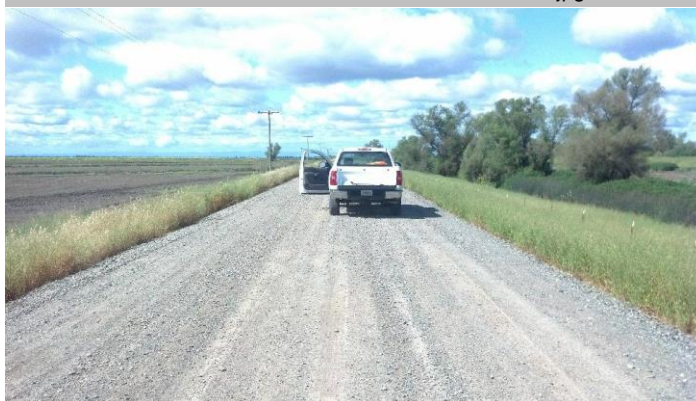
Photo 1 of 2 : UCIP_SP_2016_47751_67352.jpg

FS_ID:47751
DS_ID:16382
EP_NO: N/A
Repair Type: Non-Urgent
Crossing Status: Found
UCIP Comments: 4/26/2016 Appears to be an abandoned crossing. LS pipe end was still buried and WS flap gate was bolted shut.6/30/2015 LS headwall stil buried somewhere. WS looked to be in good condition.5/28/2014 Same as last inspection.12/4/2013 Same as last inspection.7/08/2013 Same as last inspection.4/24/2012 LS headwall buried. Limited inspection on WS and LS slopes due to dense vegetation. Need photos of cleared WS and LS slopes during next inspection. Need to determine the fate of LS headwall. This crossing was listed in the USACE Periodic Inspection report as Corp's inspect ID# USACE_CESPK_M13E_2011_p_0022 -- unknown issue.
FIELD_STRUCT_DESC: *ABANDONED* 24-inch corrugated metal pipe through the levee, 9.0 feet below the crown. Flap gate on waterside (WS) end. Concrete "U" headwalls on both WS and landside (LS) (USACE-1960). WS gate bolted shut and LS crossing is non-operable (ominlet not found). This entry matches the Drainage or Irrigation Structure referenced in O&M manual (HLM 15.87).

Overview of crossing looking downstream of the left bank of Cherokee

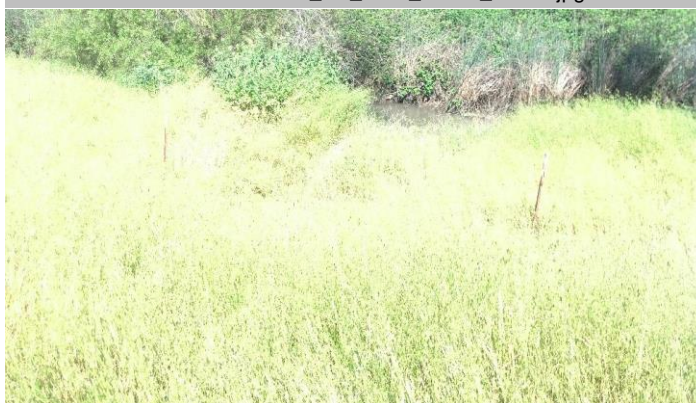
Photo 2 of 2 : UCIP_SP_2016_47751_67351.jpg

View of WS slope. Limited inspection due to the dense vegetation.

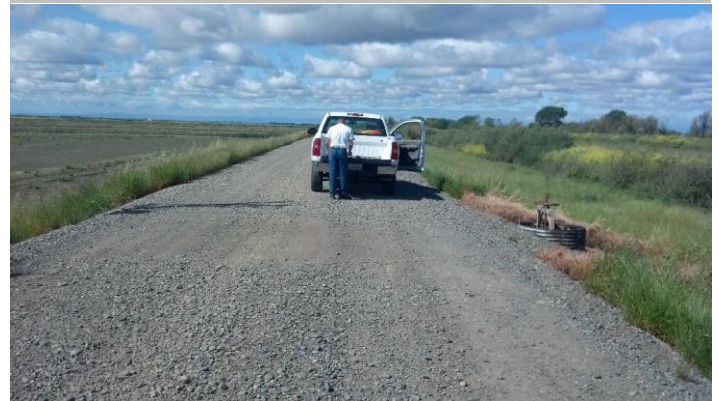
Photo 1 of 2 : UCIP_SP_2016_47752_67353.jpg

FS_ID:47752
DS_ID:16377
EP_NO: N/A
Repair Type: Non-Urgent
Crossing Status: Found
UCIP Comments: 4/26/2016 LS headwall was dry and photographed. LS pipe end was about 50% plugged with soil. WS riser box is still cracked and appears to still be leaking. 6/30/2015 Bee boxes stacked near the riser box on WS so could not get close enough to see if the leak issue had been fixed. 5/28/2014 Water appears to be leaking out of the WS concrete riser box. Causing minor erosion under pipe near pump structure. 12/4/2013 Same as last inspection. 7/08/2013 LS slope has been cleared of vegetation and is in good condition. LS headwall was underwater and unable to be inspected. All WS appurtenances in good condition. 4/24/2012 Limited inspection on LS slope due to dense vegetation. Need photos of cleared LS slope and LS headwall. Cracks in riser box. New pump installed recently this work might be covered under separate permit.

Overview of levee crown.

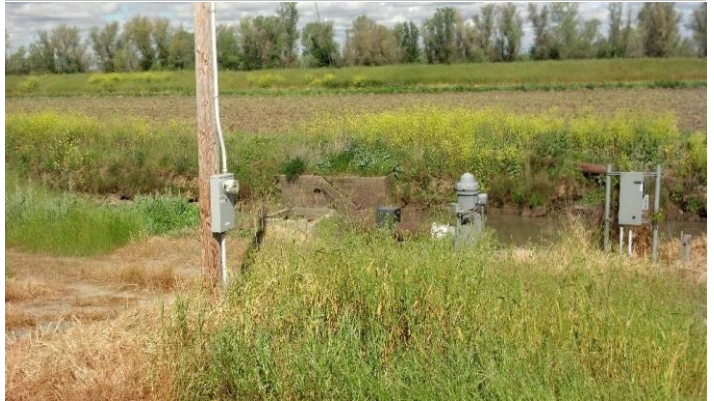
Photo 2 of 2 : UCIP_SP_2016_47752_67359.jpg

Appurtenances on WS.

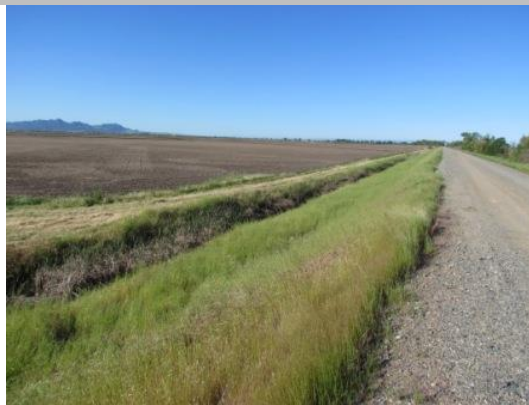
Photo 1 of 1 : SP_2016_MA0013_301_21_20160316_00010.jpg

LM Start	19.37	Rating **	M	Issue No.	21
LM End	19.92	Issue Type +	En	Location *	LS
Category	Earthen Levee			GPS Latitude/Longitude	
				Start	End
Item	Encroachments			39.383252 °	39.378192 °
				-121.830565 °	-121.838543 °
DWR ID	DWR_MA0013_02_s_2012_21				
Comment Code					
DT : Ditch					
Inspector Comment

View of the agricultural ditch along the toe.

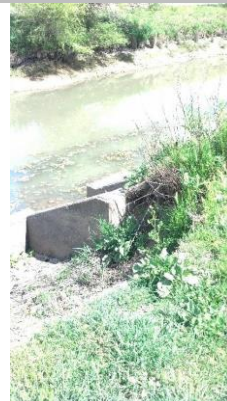
Photo 1 of 2 : UCIP_SP_2016_47758_67401.jpg

FS_ID:47758
DS_ID:16375
EP_NO: N/A
Repair Type: Non-Urgent
Crossing Status: Found
UCIP Comments: 4/26/2016 Erosion still present behind the WS headwall. The rest of the crossing appears in good condition.6/30/2015 Erosion still present behind the WS headwall. Everything thing else with the crossing appeared to be in good condition.12/4/2013 Same as last inspection.5/28/2014 Same as last inspection.7/08/2013 Erosion problem same as last inspection. WS and LS slopes have been cleared of vegetation and are in good shape.4/24/2012 Erosion present behind WS headwall. Limited inspection on WS and LS slopes due to dense vegetation. Need photos of cleared WS and LS slopes during next inspection.
FIELD_STRUCT_DESC: 30-inch corrugated metal drainage pipe through the levee, 13.1 feet below the crown. Flap gate on the waterside (WS) end. Concrete "U" headwalls on both WS and landside (LS). (USACE-1960) This entry matches the Drainage or Irrigation Structure referenced in O&M manual (HLM 20.15).

Erosion behind WS headwall looking at the downstream edge of headwall.

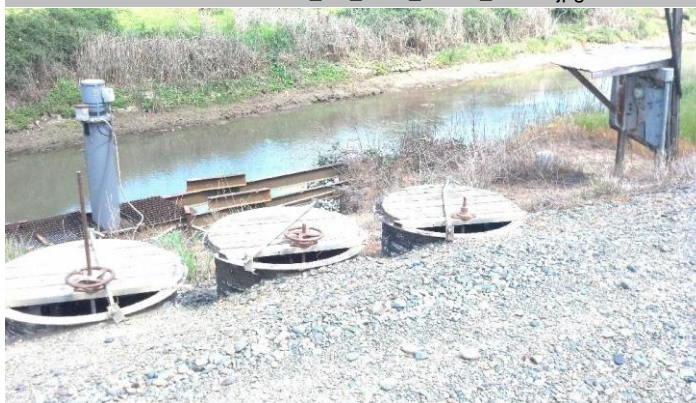
Photo 1 of 2 : UCIP_SP_2016_48035_67406.jpg

FS_ID:48035
DS_ID:16383
EP_NO: N/A
Repair Type: Urgent
Crossing Status: Found
UCIP Comments: 4/26/2016 No repairs have been made at this crossing yet. 6/30/2015 Crossing has not been repaired yet. pipe ends still showing heavy signs of rust and corrosion. 5/28/2014 Same as last inspection. 12/4/2013 Same as last inspection. 7/8/2013 Same as last inspection. 4/19/2012 LS pipe collars severely damaged--section missing at flapgate. Buried section of pipe could be in the same condition. Crossing needs to be repaired; will need to coordinate with applicant. WS slide gate handle missing.
FIELD_STRUCT_DESC: 1 of 3: 16-inch steel irrigation pipe encased in reinforced concrete through the levee, 9.7 feet below the crown. Concrete "U" headwall on both ends. Slide gates on corrugated metal pipe risers on the waterside (WS) slope. Pump structure on the WS end (USACE-1960). This entry matches the Drainage or Irrigation Structure referenced in O&M manual (HLM 21.00).

Corrugated metal pipe risers with slide gates located on WS slope.

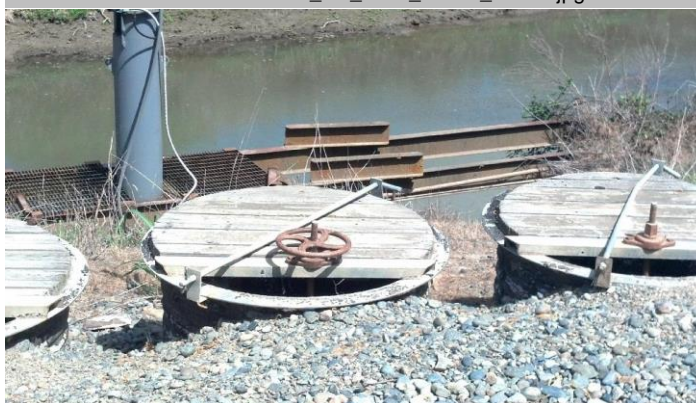
Photo 2 of 2 : UCIP_SP_2016_47760_67418.jpg

FS_ID:47760
DS_ID:17014
EP_NO: N/A
Repair Type: Urgent
Crossing Status: Found
UCIP Comments: 4/26/2016 No repairs have been made at this crossing yet.6/30/2015 Crossing has not been repaired yet. pipe ends still showing heavy signs of rust and corrosion.5/28/2014 Same as last inspection.12/4/2013 Same as last inspection.7/08/2013 Same as last inspection.4/24/2012 LS pipe collars severely damaged--section missing at flapgate. Crossing needs repair. Will need to coordinate with owner.
FIELD_STRUCT_DESC: 2 of 3: 16-inch steel irrigation pipe encased in reinforced concrete through the levee, 9.7 feet below the crown. Concrete "U" headwall on both ends. Slide gates on corrugated metal pipe risers on the waterside (WS) slope. Pump structure on the WS end (USACE-1960). This entry matches the Drainage or Irrigation Structure referenced in O&M manual (HLM 21.00).
FS Date: 5/3/2016 2:51:00 PM

Riser for pipe 2 of 3.

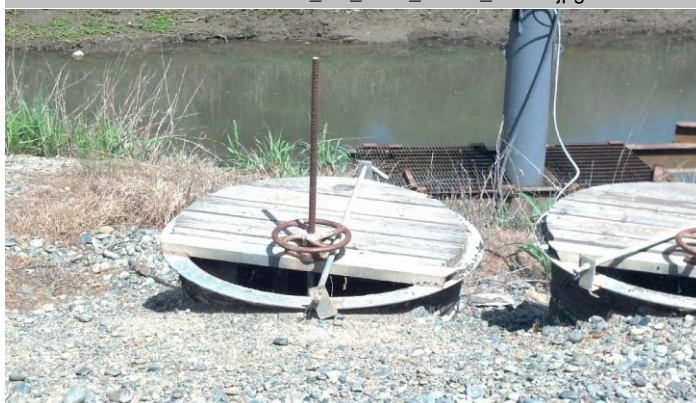
Photo 2 of 2 : UCIP_SP_2016_47761_67443.jpg

FS_ID:47761
DS_ID:17185
EP_NO: N/A
Repair Type: Urgent
Crossing Status: Found
UCIP Comments: 4/26/2016 No repairs have been made at this crossing yet. 6/30/2015 Crossing has not been repaired yet. pipe ends still showing heavy signs of rust and corrosion. 5/28/2014 Same as last inspection. 12/4/2013 Same as last inspection. 7/08/2013 Same as last inspection. 4/24/2012 Sink hole present on WS. LS pipe collars severely damaged--section missing at flapgate. Crossing needs repair. Need to coordinate with owner.
FIELD_STRUCT_DESC: 3 of 3: 16-inch steel irrigation pipe encased in reinforced concrete through the levee, 9.7 feet below the crown. Concrete "U" headwall on both ends. Slide gates on corrugated metal pipe risers on the waterside (WS) slope. Pump structure on the WS end (USACE-1960). This entry matches the Drainage or Irrigation Structure referenced in O&M manual (HLM 21.00).
FS Date: 5/3/2016 2:51:00 PM

View of corrugated metal pipe for pipe 3 of 3.

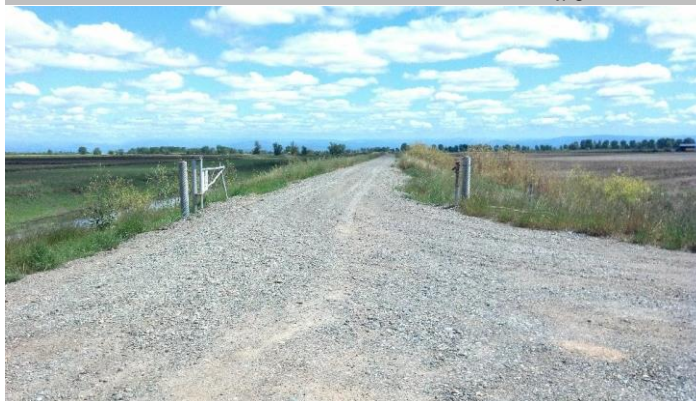
Photo 1 of 2 : UCIP_SP_2016_48036_67462.jpg

Comment Code					
Inspector Comment					
FS_ID:48036 DS_ID:16394 EP_NO: N/A Repair Type: Non-Urgent Crossing Status: Found UCIP Comments: 4/26/2016 WS flap gate is really rusted and deteriorated. May need to be replaced. The rest of the crossing appeared in good condition.6/30/2015 Crossing is in good condition. No noticeable issues to be reported.5/28/2014 Same as last inspection.12/4/2013 WS ans LS slopes are in good condition.7/08/2013 Same as last inpsection.4/24/2012 Limited inspection on WS and LS slopes due to dense vegetation. Need photos of cleared WS and LS slopes. This crossing was listed in the USACE Periodic Inspection report as Corp's inspect ID# USACE_CESPK_M13E_2011_p_0251 for no outlet visible on WS. FIELD_STRUCT_DESC: 24-inch corrugated metal drainage pipe through the levee, 11.6 feet below the crown. Flap gate on the waterside (WS) end. Concrete "U" headwalls on both WS and landside (LS) (USACE-1960). This entry matches the Drainage or Irrigation Structure referenced in O&M manual (HLM 22.08). Rusted gate located on WS (gate stuck). FS Date: 5/3/2016 2:57:00 PM

Overview of crossing looking upstream at the left bank of Cherokee Canal.

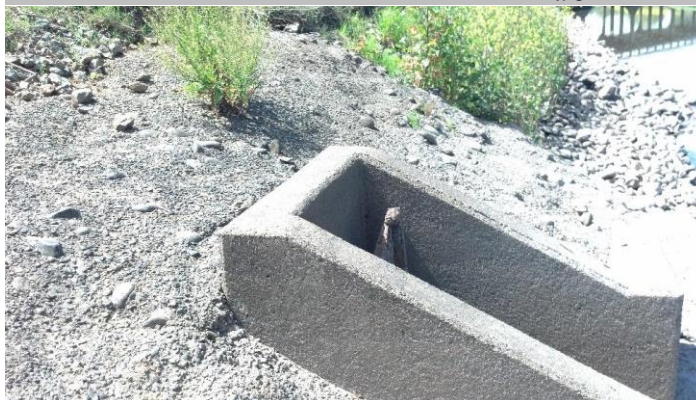
Photo 2 of 2 : UCIP_SP_2016_48036_67460.jpg

View of WS headwall.

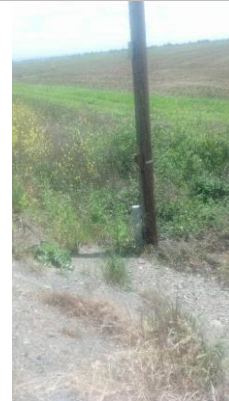
Photo 1 of 1 : UCIP_SP_2016_47766_67480.jpg

Comment Code					
Inspector Comment					
FS_ID:47766 DS_ID:16374 EP_NO: N/A Repair Type: Non-Urgent Crossing Status: Indicator Found UCIP Comments: 4/26/2016 Communication Splice box was still present. Not sure what was done to ever resolve the encroachment issue.6/30/2015 Same as last inspection.5/28/2014 Same as last inspection.12/4/2013 Same as last inspection.7/08/2013 Same as last inspection.4/24/2012 Unauthorized Encroachment. This crossing is listed multiple times in the USACE Periodic Inspection report as USACE_CESPK_M13E_2011_p_0307, 0315, 0317, 0318 for slope failure on LS hinge. DWR-Flood Maintenance Office records shows that CVFPB has requested AT&T to remove conduit in June 2, 2009 letter. LMA working with CVFPB to resolve. FIELD_STRUCT_DESC: *ILLEGAL ENCROACHMENT* Underground telephone cable through the levee. Depth unknown. (AT&T) START latitude 39.36210336, longitude -121.8678207 END latitude 39.35458541, longitude -121.8823409. Line extends from Gridley Colusa Highway to the south end of project levee along landside (LS) shoulder and levee crown hinge point. Levee sloughs along cable trench after heavy rains. FS Date: 5/3/2016 3:01:00 PM

View of utility line located on LS toe.

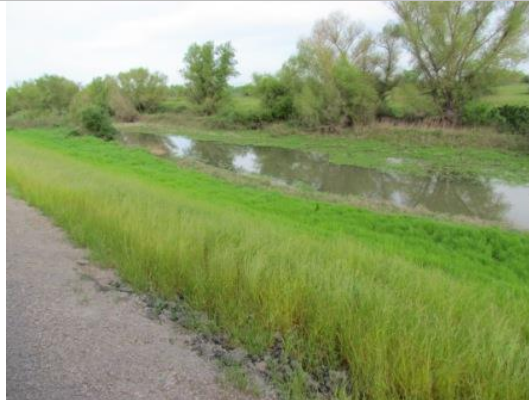
Photo 1 of 1 : SP_2016_MA0013_301_7_20160316_00003.jpg

LM Start	22.58	Rating **	M	Issue No.	7
LM End	22.60	Issue Type +	Ma	Location *	LS
Category	Earthen Levee			GPS Latitude/Longitude	
				Start	End
Item	Erosion / Bank Caving			39.356498 °	39.356303 °
				-121.879030 °	-121.879417 °
DWR ID	DWR_MA0013_02_s _ 2012_7				
Comment Code					
E1 : Note and monitor erosion site.					
Inspector Comment

View of the erosion along the canal.
