**Flood Control Project Maintenance  
Levee Inspections**  
**LMA District Cover Sheet**  
**Spring 2017 Levee Inspection Results**

**Sutter Maintenance Yard Maintenance Area 0013**

**Spring 2017 Levee Inspection Results**

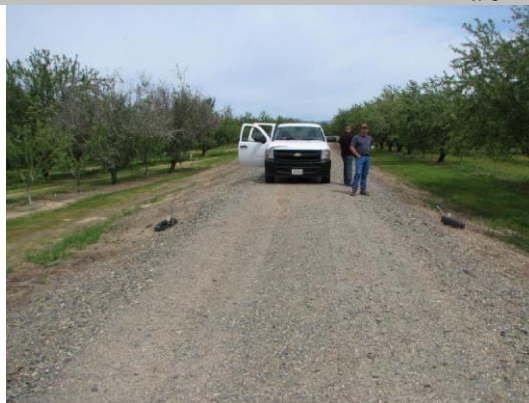
Photo 1 of 3 : UCIP\_SP\_2017\_50973\_66680.jpg

Comment Code					
Inspector Comment					
FS_ID:50973 DS_ID:16327 EP_NO: 6135 Repair Type: Urgent Crossing Status: Found UCIP Comments: 11/16/2016 Appears no repairs have been made here yet as LS slope is still dug away. (DWR Sutter Yard-AFreitag)4/28/2016 8-inch pipe was running water but was leaking at a weld joint on the LS slope. Pipe appears to have been dug out by the landowner but unsure if repairs are being made yet. (see photo 5)7/14/2015 Pipe end is still welded solid.5/21/2014 Same as last inspection.12/2/2013 Same as last inspection.7/10/2013 Same as last inspection. FIELD_STRUCT_DESC: 8-inch steel irrigation pipe through the levee 2.8 feet below the crown. Permit requirements are as follow: during the flood season the 5-inch irrigation pipe will be removed and a plate bolted over the waterside (WS) end of the 8-inch. Pipe section is completely buried. Current configuration does not allow for 5-inch irrigation pipe to slide pipe through. 8-inch pipe is welded solid. (Permit No. 6135, 1968 - George Washington) [Additional Reference(s): DWR Levee Log, 1993] FS Date: 11/28/2016 8:45:31 AM

LM Start	<b>0.27</b>	Rating **	U	Issue No.	<b>90 (cont)</b>
LM End	<b>0.27</b>	Issue Type +	En	Location *	LS

Overview of the crossing.

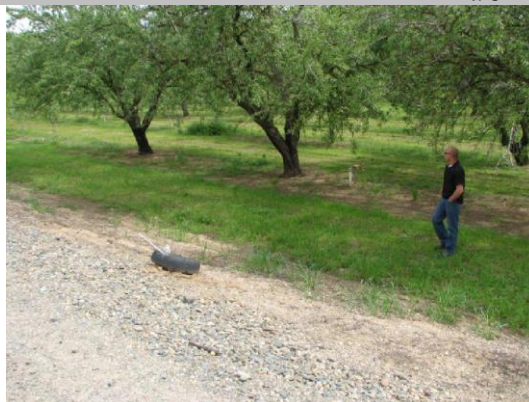
Photo 2 of 3 : UCIP\_SP\_2017\_50973\_66683.jpg

Air Vent located on WS.

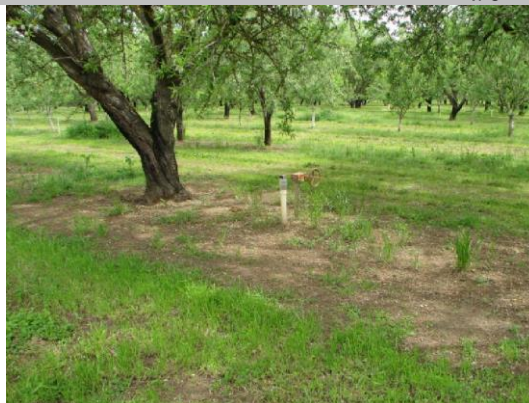
Photo 3 of 3 : UCIP\_SP\_2017\_50973\_66681.jpg

Comment Code					
Inspector Comment					
FS_ID:50973 DS_ID:16327 EP_NO: 6135 Repair Type: Urgent Crossing Status: Found UCIP Comments: 11/16/2016 Appears no repairs have been made here yet as LS slope is still dug away. (DWR Sutter Yard-AFreitag)4/28/2016 8-inch pipe was running water but was leaking at a weld joint on the LS slope. Pipe appears to have been dug out by the landowner but unsure if repairs are being made yet. (see photo 5)7/14/2015 Pipe end is still welded solid.5/21/2014 Same as last inspection.12/2/2013 Same as last inspection.7/10/2013 Same as last inspection. FIELD_STRUCT_DESC: 8-inch steel irrigation pipe through the levee 2.8 feet below the crown. Permit requirements are as follow: during the flood season the 5-inch irrigation pipe will be removed and a plate bolted over the waterside (WS) end of the 8-inch. Pipe section is completely buried. Current configuration does not allow for 5-inch irrigation pipe to slide pipe through. 8-inch pipe is welded solid. (Permit No. 6135, 1968 - George Washington) [Additional Reference(s): DWR Levee Log, 1993] FS Date: 11/28/2016 8:45:31 AM

Air vent and gate located in channel. Unable to determine if part of crossing.

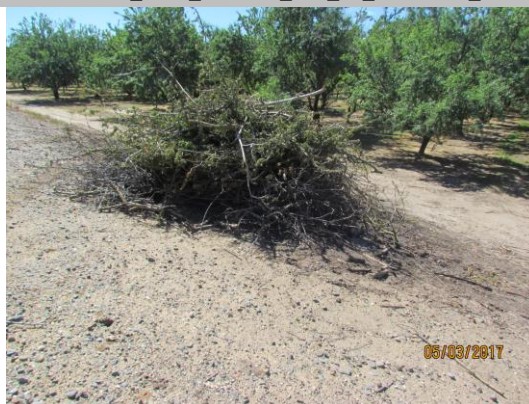
Photo 1 of 1 : SP\_2017\_MA0013\_300\_89\_20170508\_00145.jpg

LM Start	0.46	Rating **	M	Issue No.	89
LM End	0.46	Issue Type +	En	Location *	LS
Category	Earthen Levee			GPS Latitude/Longitude	
				Start	End
Item	Encroachments			39.591162 °	39.591162 °
				-121.701820 °	-121.701820 °
DWR ID	DWR_MA0013_01_s_2017_89				
Comment Code					
PR : Prunings					
Inspector Comment					
Remove the prunings from the landside slope.

View of prunings along the landside slope.

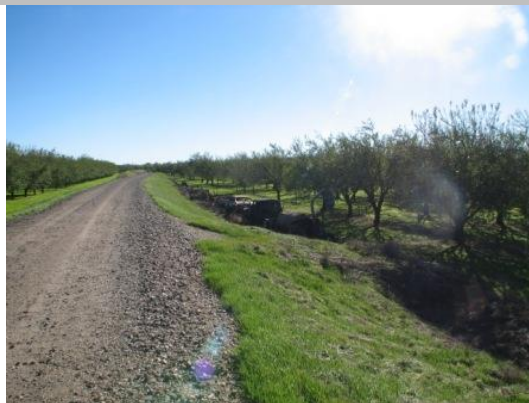
Photo 1 of 1 : SP\_2017\_MA0013\_300\_12\_20170315\_00005.jpg

LM Start	0.73	Rating **	M	Issue No.	12
LM End	0.76	Issue Type +	En	Location *	LS
Category	Earthen Levee			GPS Latitude/Longitude	
				Start	End
Item	Encroachments			39.587905 °	39.587505 °
				-121.700822 °	-121.700880 °
DWR ID	DWR_MA0013_01_s_2012_12				
Comment Code					
EQ : Equipment					
Inspector Comment					
Remove the equipment from the landside toe.

View of the equipment along the landside toe of the levee.

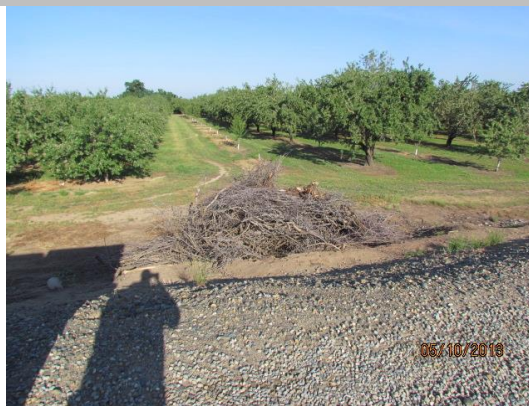
Photo 1 of 1 : SP\_2017\_MA0013\_300\_20\_20170315\_00007.jpg

LM Start	0.94	Rating **	M	Issue No.	20
LM End	0.94	Issue Type +	En	Location *	LS
Category	Earthen Levee			GPS Latitude/Longitude	
				Start	End
Item	Encroachments			39.584885 °	39.584885 °
				-121.700487 °	-121.700487 °
DWR ID	DWR_MA0013_01_s_2013_20				
Comment Code					
PR : Prunings					
Inspector Comment					
Remove prunings from the landside toe.

View of the prunings along the landside toe.

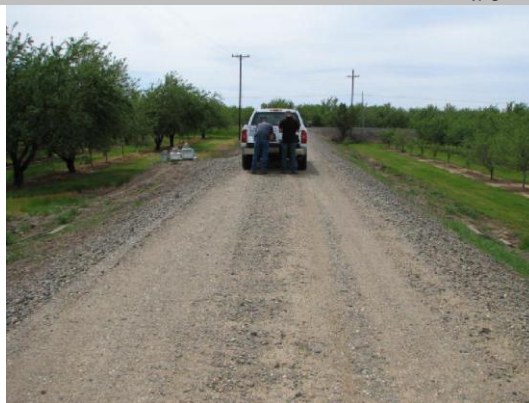
Photo 1 of 3 : UCIP\_SP\_2017\_50975\_66689.jpg

FS\_ID:50975  
DS\_ID:16343  
EP\_NO: N/A  
Repair Type: No Action Needed  
Crossing Status: Found  
UCIP Comments: 11/16/2016 Crossing appears to be in good condition. (DWR Sutter Yard- AFreitag)4/28/2016 Crossing appears to be in good condition.7/14/2015 Crossing appears in good condition. No noticeable issues to report.5/21/2014 Same as last inspection.12/2/2013 Same as last inspection.7/10/2013 Same as last inspection.4/17/2012 Drain is still in use. 4 inch pipe in channel near WS headwall (see photo). The pipe does not appear to impact the crossing.  
FIELD\_STRUCT\_DESC: 24-inch corrugated metal drainage pipe through the levee, 8.6 feet below the crown. Concrete "U" headwalls on both the waterside (WS) and landside (LS). Flap gate on the WS end.  
[Additional Reference(s): DWR Levee Log, 1993. USACE Sacramento O&M Manual 519, June 1962 (HLM 1.15)]  
FS Date: 11/28/2016 8:52:29 AM

LM Start	<b>1.13</b>	Rating **	A/W	Issue No.	<b>91 (cont)</b>
LM End	<b>1.13</b>	Issue Type +	Ma	Location *	LS

Overview of levee crown at crossing looking D/S .

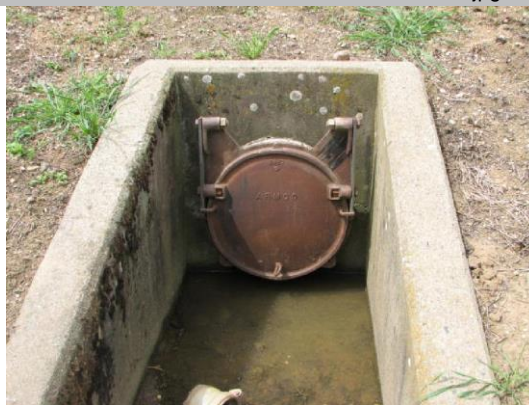
Photo 2 of 3 : UCIP\_SP\_2017\_50975\_66688.jpg

View of WS headwall and flap gate.

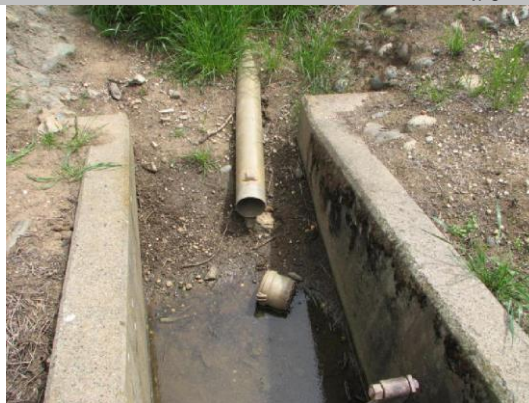
Photo 3 of 3 : UCIP\_SP\_2017\_50975\_66687.jpg

Item	DWR UCIP LMA Responsibility			39.582147 °	39.582147 °	
				-121.700540 °	-121.700540 °	
DWR ID						
Comment Code						
Inspector Comment						
FS_ID:50975 DS_ID:16343 EP_NO: N/A Repair Type: No Action Needed Crossing Status: Found UCIP Comments: 11/16/2016 Crossing appears to be in good condition. (DWR Sutter Yard- A Freitag)4/28/2016 Crossing appears to be in good condition.7/14/2015 Crossing appears in good condition. No noticeable issues to report.5/21/2014 Same as last inspection.12/2/2013 Same as last inspection.7/10/2013 Same as last inspection.4/17/2012 Drain is still in use. 4 inch pipe in channel near WS headwall (see photo). The pipe does not appear to impact the crossing. FIELD_STRUCT_DESC: 24-inch corrugated metal drainage pipe through the levee, 8.6 feet below the crown. Concrete "U" headwalls on both the waterside (WS) and landside (LS). Flap gate on the WS end. [Additional Reference(s): DWR Levee Log, 1993. USACE Sacramento O&M Manual 519, June 1962 (HLM 1.15)] FS Date: 11/28/2016 8:52:29 AM

View of WS with pipe in channel.

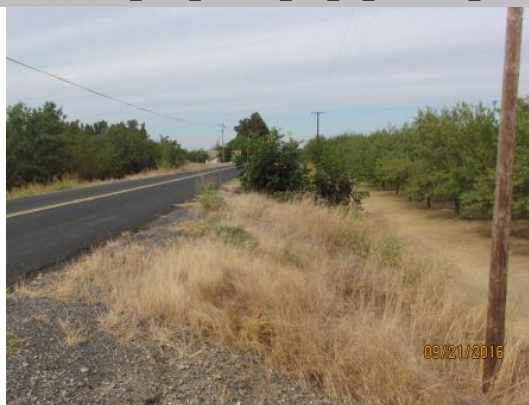
Photo 1 of 1 : SP\_2017\_MA0013\_300\_52\_20170315\_00010.jpg

LM Start	1.17	Rating **	M	Issue No.	52
LM End	1.24	Issue Type +	Ma	Location *	LS
Category	Earthen Levee			GPS Latitude/Longitude	
				Start	End
Item	Vegetation			39.581441 °	39.581385 °
				-121.700532 °	-121.701560 °
DWR ID	DWR_MA0013_01_f_2016_52				
Comment Code					
V1 : Control annual grass and weeds on the levee slopes and easements.					
Inspector Comment

View of the vegetation along the landside slope.

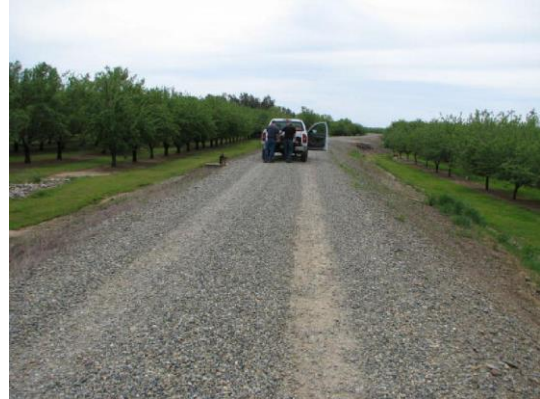
Photo 1 of 3 : UCIP\_SP\_2017\_50976\_66695.jpg

FS\_ID:50976  
DS\_ID:16831  
EP\_NO: N/A  
Repair Type: Urgent  
Crossing Status: Found  
UCIP Comments: 11/16/2016 WS structures still removed. (DWR Sutter Yard- AFreitag)10/17/2016 Landowner removed WS concrete headwall and pipe section through floodway to make room for orchard. The area disturbed appears to be from WS toe to where the mature trees are located within floodway, approximately 45 feet from WS toe. Crossing is classified as Urgent with potential levee integrity issues due to the disturbance of the WS without prior approval from the CVFPB. (DWR UCIP - omagana)  
4/28/2016 Landowner appears to have removed the WS headwall and pipe to make room for planting more orchard trees. LS pipe end was full of water as it has no where to drain to anymore. Changing to urgent listing but it currently does not affect the levee integrity. (see photos 8, 9, & 10) (DWR Sutter Yard - afreitag)7/14/2015 Crossing appears in good condition. No noticeable issues to report. (DWR Sutter Yard - afreitag)5/21/2014 Same as last inspection. (DWR Sutter Yard - afreitag)12/2/2013 Pipe section was dug up and repaired. Crossing is now in good condition. (DWR Sutter Yard - afreitag) 4/17/2012 Pipe collapse on WS 10 feet from toe, needs repair. From WS, sediment is visible inside pipe. (DWR UCIP - omagana)

FIELD\_STRUCT\_DESC: 36-inch corrugated metal drainage pipe through the levee, 7.8 feet below the crown. Concrete "U" headwalls on both waterside (WS) and landside (LS) ends. Slide gate in corrugated metal pipe (CMP) riser on the WS slope. [Additional Reference(s): DWR Levee Log, 1993. USACE Sacramento O&M Manual 519, June 1962 (HLM 1.62)]  
FS Date: 11/28/2016 9:12:52 AM

Overview of levee crown at crossing looking downstream.

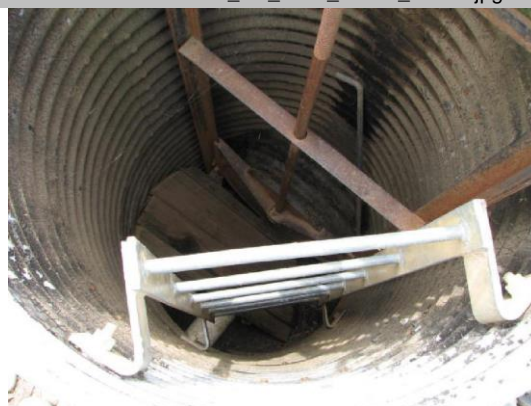
Photo 3 of 3 : UCIP\_SP\_2017\_50977\_66702.jpg

Comment Code						
Inspector Comment						
FS_ID:50977 DS_ID:16345 EP_NO: N/A Repair Type: Non-Urgent Crossing Status: Found UCIP Comments: 11/16/2016 PVC pipe still present blocking the screw gate. (DWR Sutter Yard- A Freitag)4/28/2016 Pvc pipe is still present through the crossing. Slide gate cannot shut fully.7/14/2015 4-inch pipe still present and blocking the screw gate.5/21/2014 Same as last inspection.12/2/2013 Same as last inspection.7/15/2013 Same as last inspection.4/17/2012 Crossing has 4-inch pipe inside blocking positive closure/notify landowner to remove prior to flood season. LS crossing is blocked about 50% by sediment build up. Burrow activity present on LS near crossing. FIELD_STRUCT_DESC: 24-inch corrugated metal irrigation pipe through the levee, 7.6 feet below the crown. Slide gate in corrugated metal pipe (CMP) riser on the waterside (WS) slope. Concrete headwall on the landside (LS). 36-inch concrete standpipe in the channel with 2 piles to deflect debris. [Additional Reference(s): DWR Levee Log, 1993. USACE Sacramento O&M Manual 519, June 1962 (HLM 1.69)] FS Date: 11/28/2016 9:13:39 AM

Positive closure device on WS slope, panel lid fell in.

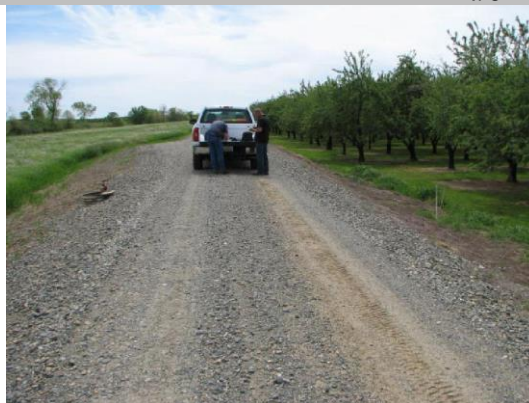
Photo 1 of 3 : UCIP\_SP\_2017\_50978\_66708.jpg

FS\_ID:50978  
DS\_ID:16346  
EP\_NO: N/A  
Repair Type: Non-Urgent  
Crossing Status: Found  
UCIP Comments: 11/16/2016 Appears abandoned. Unable to find anything on LS. (DWR Sutter Yard- A Freitag)4/28/2016 Appears to be an abandoned crossing. LS headwall and pipe inlet are still completely buried.7/14/2015 Still cannot find an inlet or outlet.5/21/2014 Same as last inspection.12/2/2013 Same as last inspection.7/15/2013 Same as last inspection.4/17/2012 Non functional crossing due to LS headwall buried. This crossing was listed in the USACE Periodic Inspection report as Corp's inspect ID#USACE\_CESPK\_M13D\_2011\_p\_0119 for no inlet or outlet visible. FIELD\_STRUCT\_DESC: \*ABANDONED\* 24-inch corrugated metal irrigation pipe through the levee 7.8 feet below the crown. Slide gate in corrugated metal pipe riser on the waterside (WS) slope. Pipe continues across channel. Concrete "U" headwall on the landside (LS). [Additional Reference(s): DWR Levee Log, 1993. USACE Sacramento O&M Manual 519, June 1962 (HLM 2.35)]

LM Start	<b>2.31</b>	Rating **	M	Issue No.	<b>94 (cont)</b>
LM End	<b>2.31</b>	Issue Type +	En	Location *	LS

Overview of crossing looking DS.

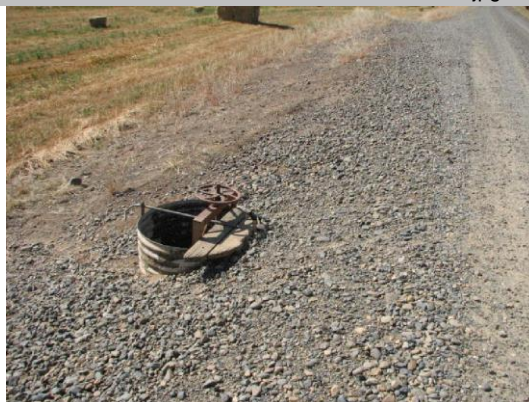
Photo 2 of 3 : UCIP\_SP\_2017\_50978\_66709.jpg

Corrugated riser located on WS slope.

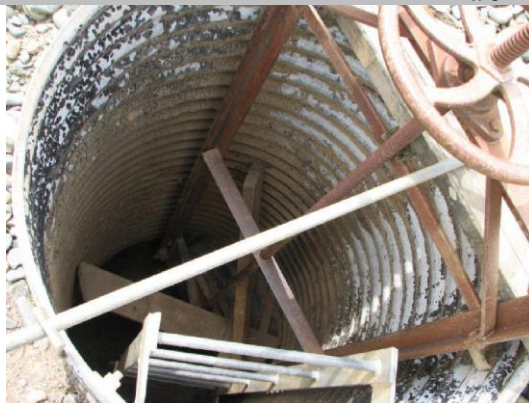
Photo 3 of 3 : UCIP\_SP\_2017\_50978\_66707.jpg

Comment Code					
Inspector Comment					
FS_ID:50978 DS_ID:16346 EP_NO: N/A Repair Type: Non-Urgent Crossing Status: Found UCIP Comments: 11/16/2016 Appears abandoned. Unable to find anything on LS. (DWR Sutter Yard- A Freitag)4/28/2016 Appears to be an abandoned crossing. LS headwall and pipe inlet are still completely buried.7/14/2015 Still cannot find an inlet or outelt.5/21/2014 Same as last inspection.12/2/2013 Same as last inspection.7/15/2013 Same as last inspection.4/17/2012 Non functional crossing due to LS headwall buried. This crossing was listed in the USACE Periodic Inspection report as Corp's inspect ID#USACE_CESPK_M13D_2011_p_0119 for no inlet or outlet visible. FIELD_STRUCT_DESC: *ABANDONED* 24-inch corrugated metal irrigation pipe through the levee 7.8 feet below the crown. Slide gate in corrugated metal pipe riser on the waterside (WS) slope. Pipe continues across channel. Concrete "U" headwall on the landside (LS). [Additional Reference(s): DWR Levee Log, 1993. USACE Sacramento O&M Manual 519, June 1962 (HLM 2.35)] FS Date: 11/28/2016 9:14:42 AM

Corrugated metal riser on WS slope. Lid panel blocking gate.

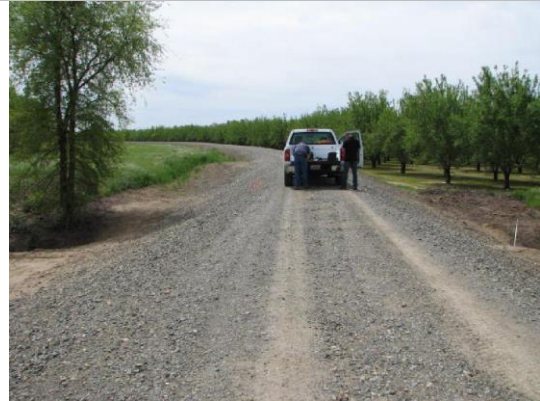
Photo 1 of 3 : UCIP\_SP\_2017\_50979\_66715.jpg

Comment Code						
Inspector Comment						
FS_ID:50979 DS_ID:16347 EP_NO: N/A Repair Type: No Action Needed Crossing Status: Found UCIP Comments: 11/16/2016 Crossing appears to be in good condition. (DWR Sutter Yard- A Freitag)4/28/2016 Crossing appears to be in good condition.7/14/2015 Crossing appears in good condition. No noticeable issues to report.5/21/2014 Same as last inspection.12/2/2013 Same as last inspection.7/15/2013 Same as last inspection.4/17/2012 Vegetation/sedimentation from WS has been removed. This crossing was listed in the USACE Periodic Inspection report as Corp's inspect ID#USACE_CESPK_M13D_2011_p_0130 for WS flap gate closed and blocked by sediment. FIELD_STRUCT_DESC: 24-inch corrugated metal drainage pipe through the levee, 9.4 feet below the crown. Concrete "U" headwall on both waterside (WS) and landside (LS) ends. Flap gate on the WS end. [Additional Reference(s): DWR Levee Log, 1993. USACE Sacramento O&M Manual 519, June 1962 (HLM 2.74)] FS Date: 11/28/2016 9:16:38 AM

LM Start	<b>2.70</b>	Rating **	A/W	Issue No.	<b>95 (cont)</b>
LM End	<b>2.70</b>	Issue Type +	Ma	Location *	LS

Overview of levee crown looking downstream at crossing.

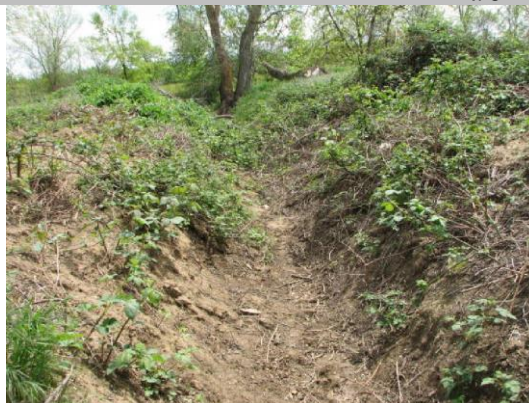
Photo 3 of 3 : UCIP\_SP\_2017\_50979\_66711.jpg

Item	DWR UCIP LMA Responsibility			39.561130 °		39.561130 °
				-121.705140 °		-121.705140 °
DWR ID						
Comment Code						
Inspector Comment						
FS_ID:50979 DS_ID:16347 EP_NO: N/A Repair Type: No Action Needed Crossing Status: Found UCIP Comments: 11/16/2016 Crossing appears to be in good condition. (DWR Sutter Yard- A Freitag)4/28/2016 Crossing appears to be in good condition.7/14/2015 Crossing appears in good condition. No noticeable issues to report.5/21/2014 Same as last inspection.12/2/2013 Same as last inspection.7/15/2013 Same as last inspection.4/17/2012 Vegetation/sedimentation from WS has been removed. This crossing was listed in the USACE Periodic Inspection report as Corp's inspect ID#USACE_CESPK_M13D_2011_p_0130 for WS flap gate closed and blocked by sediment. FIELD_STRUCT_DESC: 24-inch corrugated metal drainage pipe through the levee, 9.4 feet below the crown. Concrete "U" headwall on both waterside (WS) and landside (LS) ends. Flap gate on the WS end. [Additional Reference(s): DWR Levee Log, 1993. USACE Sacramento O&M Manual 519, June 1962 (HLM 2.74)] FS Date: 11/28/2016 9:16:38 AM

View of channel.

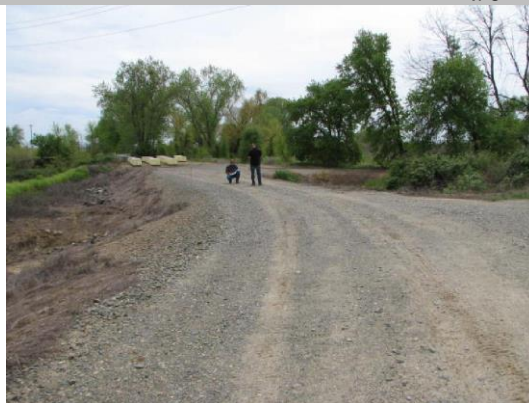
Photo 1 of 3 : UCIP\_SP\_2017\_50983\_66731.jpg

Comment Code					
Inspector Comment					
FS_ID:50983 DS_ID:16350 EP_NO: N/A Repair Type: No Action Needed Crossing Status: Found UCIP Comments: 11/16/2016 Crossing appears to be in good condition. (DWR Sutter Yard- A Freitag)4/28/2016 Crossing appears to be in good condition.7/14/2015 Crossing appears in good condition. No noticeable issues to report.5/21/2014 Same as last inspection.12/2/2013 Same as last inspection.7/15/2013 Same as last inspection.4/17/2012 WS headwall has been cleared of debris and sedimentation. FIELD_STRUCT_DESC: 24-inch corrugated metal drainage pipe through the levee, 8.4 feet below the crown. Concrete "U" headwalls on both the waterside (WS) and landside (LS) ends. Flap gate on the WS end. [Additional Reference(s): DWR Levee Log, 1993. USACE Sacramento O&M Manual 519, June 1962 (HLM 3.31)] FS Date: 11/28/2016 10:04:46 AM

Overview of levee crown at crossing.

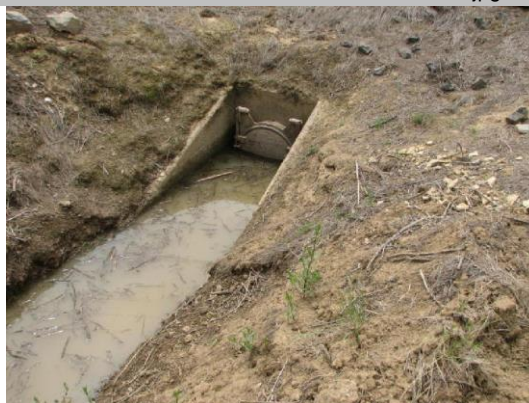
Photo 2 of 3 : UCIP\_SP\_2017\_50983\_66730.jpg

LM Start	<b>3.27</b>	Rating **	A/W	Issue No.	<b>99 (cont)</b>
LM End	<b>3.27</b>	Issue Type +	Ma	Location *	LS

View of WS flap gate.

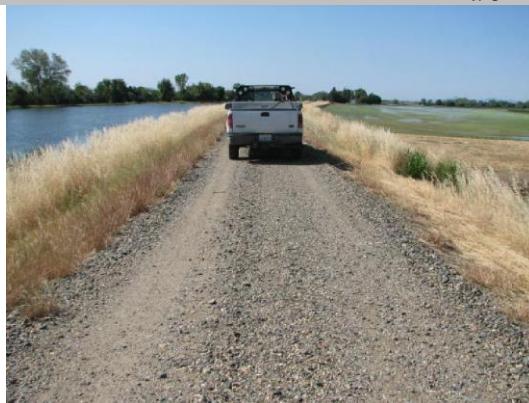
Photo 1 of 3 : UCIP\_SP\_2017\_50984\_66736.jpg

FS\_ID:50984  
DS\_ID:16351  
EP\_NO: N/A  
Repair Type: No Action Needed  
Crossing Status: Found  
UCIP Comments: 11/16/2016 Crossing appears to be in good condition. (DWR Sutter Yard- A Freitag) 4/28/2016 Both sides of the crossing were underwater during time of inspection. 7/14/2015 Crossing appears in good condition. No noticeable issues to report. 5/21/2014 Same as last inspection. 12/2/2013 Same as last inspection. 7/15/2013 Slopes have been cleared of vegetation and are in good condition. 4/18/2012 Limited inspection on WS and LS slope due to dense vegetation. Need photos of cleared slopes.  
FIELD\_STRUCT\_DESC: 24-inch corrugate metal drainage pipe through the levee, 8.1 feet below the crown. Flap gate on the waterside (WS) end. Slide gate located on the landside (LS) end. Concrete "U" headwalls on both ends. [Additional Reference(s): DWR Levee Log, 1993. USACE Sacramento O&M Manual 519, June 1962 (HLM 3.80)]

LM Start	<b>3.72</b>	Rating **	A/W	Issue No.	<b>100 (cont)</b>
LM End	<b>3.72</b>	Issue Type +	Ma	Location *	LS

Overview of levee crown at crossing looking downstream.

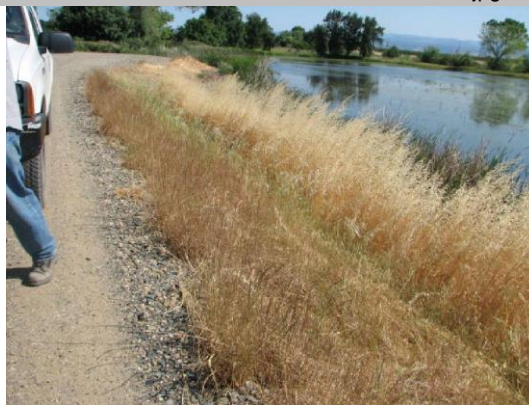
Photo 2 of 3 : UCIP\_SP\_2017\_50984\_66738.jpg

WS slope covered by dense vegetation.

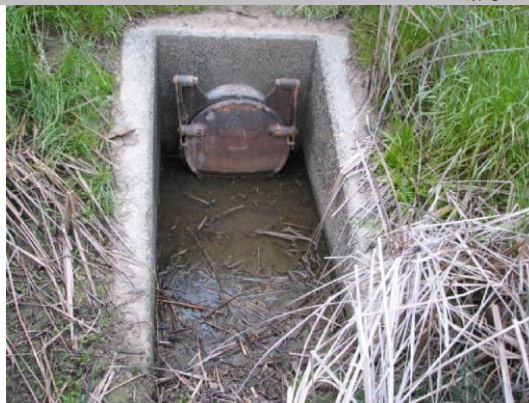
Photo 3 of 3 : UCIP\_SP\_2017\_50984\_66735.jpg

Item	DWR UCIP LMA Responsibility			39.546592 °	39.546592 °	
				-121.707560 °	-121.707560 °	
DWR ID						
Comment Code						
Inspector Comment						
FS_ID:50984 DS_ID:16351 EP_NO: N/A Repair Type: No Action Needed Crossing Status: Found UCIP Comments: 11/16/2016 Crossing appears to be in good condition. (DWR Sutter Yard- A Freitag)4/28/2016 Both sides of the crossing were underwater during time of inspection.7/14/2015 Crossing appears in good condition. No noticeable issues to report.5/21/2014 Same as last inspection.12/2/2013 Same as last inspection.7/15/2013 Slopes have been cleared of vegetation and are in good condition.4/18/2012 Limited inspection on WS and LS slope due to dense vegetation. Need photos of cleared slopes. FIELD_STRUCT_DESC: 24-inch corrugate metal drainage pipe through the levee, 8.1 feet below the crown. Flap gate on the waterside (WS) end. Slide gate located on the landside (LS) end. Concrete "U" headwalls on both ends. [Additional Reference(s): DWR Levee Log, 1993. USACE Sacramento O&M Manual 519, June 1962 (HLM 3.80)] FS Date: 11/28/2016 10:05:20 AM

WS flap gate

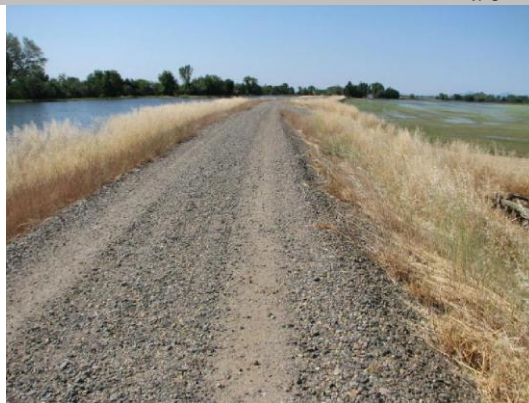
Photo 1 of 3 : UCIP\_SP\_2017\_50985\_66743.jpg

FS\_ID:50985  
DS\_ID:16365  
EP\_NO: N/A  
Repair Type: Non-Urgent  
Crossing Status: Found  
UCIP Comments: 11/16/2016 Both LS and WS gates buried. (DWR Sutter Yard- A Freitag) 4/28/2016 Abandoned crossing. LS screw is still bent and mostly buried. 7/14/2015 LS screw gate is still damaged and buried. Crossing is non-functional. 5/21/2014 Same as last inspection. 12/2/2013 Same as last inspection. 7/15/2013 Slopes have been cleared of vegetation and are in good condition. LS screw gate is still bent and silted over. 4/18/2012 LS slide gate covered with silt. Slide gate is bent. Crossing appears not be in use. Limited inspection on WS and LS slope due to dense vegetation. Need photos of cleared slopes.  
FIELD\_STRUCT\_DESC: \*ABANDONED\* 24-inch corrugated metal drainage pipe through the levee, 7.9 feet below the crown. Flap gate on the waterside (WS) end. Screw gate on the landside (LS) end. Concrete "U" headwalls on both ends. [Additional Reference(s): DWR Levee Log, 1993. USACE Sacramento O&M Manual 519, June 1962 (HLM 3.82)]

LM Start	<b>3.74</b>	Rating **	M	Issue No.	<b>101 (cont)</b>
LM End	<b>3.74</b>	Issue Type +	Ma	Location *	LS

Overview of levee crown at crossing looking downstream.

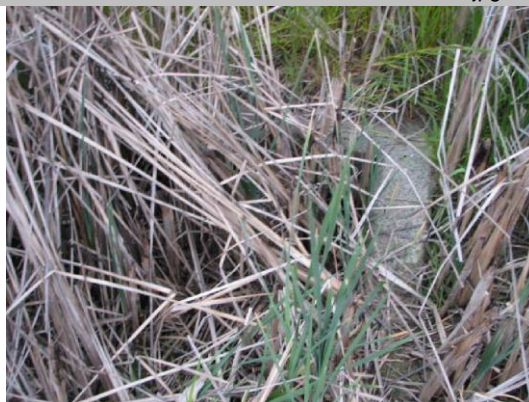
Photo 2 of 3 : UCIP\_SP\_2017\_50985\_66741.jpg

WS flap gate blocked by debris.

Comment Code					
Inspector Comment					
FS_ID:50985 DS_ID:16365 EP_NO: N/A Repair Type: Non-Urgent Crossing Status: Found UCIP Comments: 11/16/2016 Both LS and WS gates buried. (DWR Sutter Yard- AFreitag)4/28/2016 Abandoned crossing. Ls screw is still bent and mostly buried. 7/14/2015 LS screw gate is still damaged and buried. Crossing is non-functional.5/21/2014 Same as last inspection.12/2/2013 Same as last inspection.7/15/2013 Slopes have been cleared of vegetation and are in good condition. LS screw gate is still bent and silted over.4/18/2012 LS slide gate covered with silt. Slide gate is bent. Crossing appears not be in use. Limited inspection on WS and LS slope due to dense vegetation. Need photos of cleared slopes. FIELD_STRUCT_DESC: *ABANDONED* 24-inch corrugated metal drainage pipe through the levee, 7.9 feet below the crown. Flap gate on the waterside (WS) end. Screw gate on the landside (LS) end. Concrete "U" headwalls on both ends. [Additional Reference(s): DWR Levee Log, 1993. USACE Sacramento O&M Manual 519, June 1962 (HLM 3.82)] FS Date: 11/28/2016 10:05:45 AM

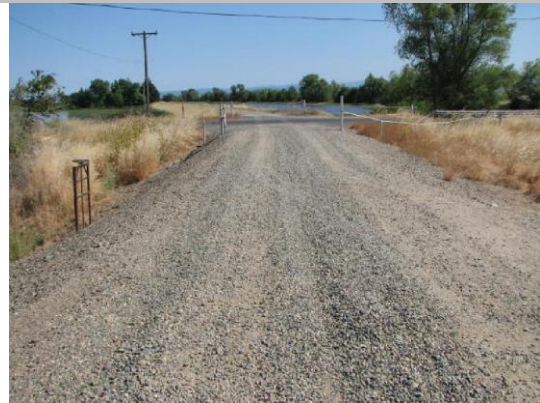
Photo 1 of 3 : UCIP\_SP\_2017\_50988\_66752.jpg

Comment Code					
Inspector Comment					
FS_ID:50988					
DS_ID:16341					
EP_NO: N/A					
Repair Type: No Action Needed					
Crossing Status: Found					
UCIP Comments: 11/16/2016 Crossing appears to be in good condition. (DWR Sutter Yard- A Freitag)4/28/2016 Crossing appears to be in good condition.7/13/2015 Crossing appears in good condition. No noticeable issues to report.5/21/2014 Same as last inspection.12/2/2013 Same as last inspection.7/15/2013 Same as last inspection.4/18/2012 Minor debris on landside inlet. This crossing was listed in the USACE Periodic Inspection report as Corp's inspect ID#USACE_CESPK_M13D_2011_p_0189 for sediment and grass blocking WS and LS.					
FIELD_STRUCT_DESC: 36-inch corrugated metal drainage pipe through the levee, 9.1 feet below the crown. Flap gate on the waterside (WS) end. Slide gate located on the landside (LS) end. Concrete "U" headwalls on both ends. [Additional Reference(s): DWR Levee Log, 1993. USACE Sacramento O&M Manual 519, June 1962 (HLM 4.43)]

Overview of levee crown at crossing looking upstream.

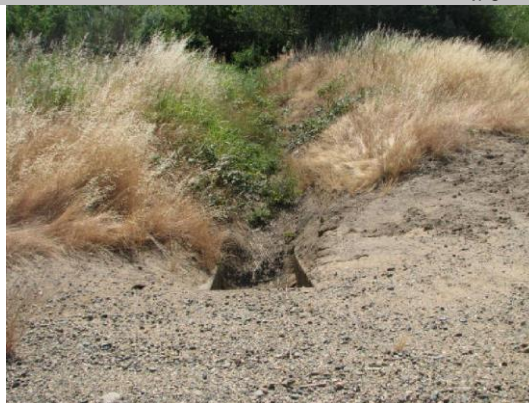
Photo 2 of 3 : UCIP\_SP\_2017\_50988\_66753.jpg

FS\_ID:50988  
DS\_ID:16341  
EP\_NO: N/A  
Repair Type: No Action Needed  
Crossing Status: Found  
UCIP Comments: 11/16/2016 Crossing appears to be in good condition. (DWR Sutter Yard- A Freitag) 4/28/2016 Crossing appears to be in good condition. 7/13/2015 Crossing appears in good condition. No noticeable issues to report. 5/21/2014 Same as last inspection. 12/2/2013 Same as last inspection. 7/15/2013 Same as last inspection. 4/18/2012 Minor debris on landside inlet. This crossing was listed in the USACE Periodic Inspection report as Corp's inspect ID#USACE\_CESPK\_M13D\_2011\_p\_0189 for sediment and grass blocking WS and LS.  
FIELD\_STRUCT\_DESC: 36-inch corrugated metal drainage pipe through the levee, 9.1 feet below the crown. Flap gate on the waterside (WS) end. Slide gate located on the landside (LS) end. Concrete "U" headwalls on both ends. [Additional Reference(s): DWR Levee Log, 1993. USACE Sacramento O&M Manual 519, June 1962 (HLM 4.43)]

View of WS slope and toe.

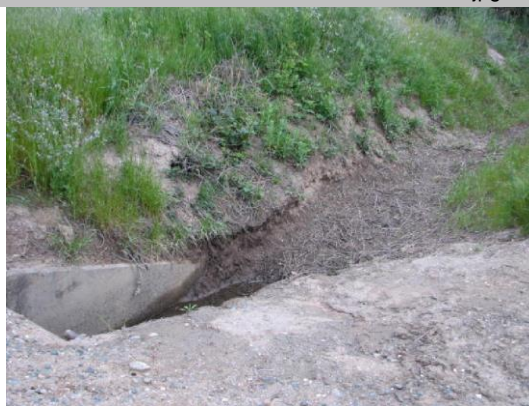
Photo 3 of 3 : UCIP\_SP\_2017\_50988\_66750.jpg

View of WS.

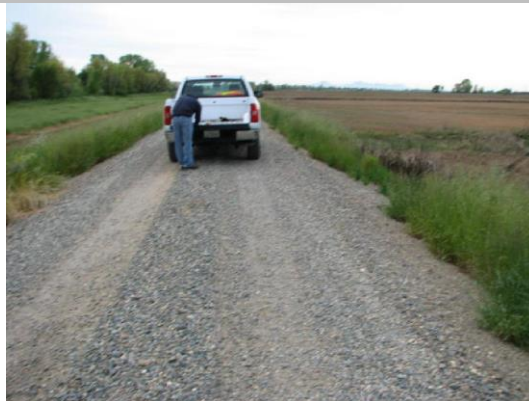
Photo 1 of 3 : UCIP\_SP\_2017\_50989\_66756.jpg

FS\_ID:50989  
DS\_ID:16355  
EP\_NO: N/A  
Repair Type: No Action Needed  
Crossing Status: Found  
UCIP Comments: 11/16/2016 Crossing appears to be in good condition. (DWR Sutter Yard- A Freitag) 4/28/2016 Crossing appears to be in good condition. 7/13/2015 LS screw gate was completely submerged but crossing appears to be in good condition. 5/21/2014 Same as last inspection. 12/2/2013 Same as last inspection. 7/15/2013 No signs of burrowing activity on this inspection. 4/18/2012 Burrow activity near crossing, burrow holes present on WS slope.  
FIELD\_STRUCT\_DESC: 24-inch corrugated metal drainage pipe through the levee 7.7 feet below the crown. Flap gate on the waterside (WS) end. Slide gate located on the landside (LS) end. Concrete "U" headwalls on both ends. [Additional Reference(s): DWR Levee Log, 1993. USACE Sacramento O&M Manual 519, June 1962 (HLM 4.94)]  
FS Date: 11/28/2016 10:48:17 AM

Overview of levee crown at crossing looking downstream at right bank of Cherokee Canal.

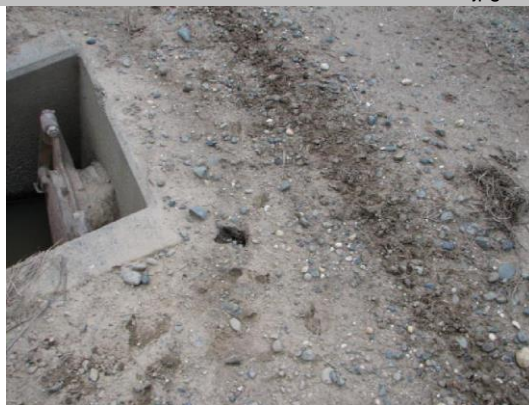
Photo 2 of 3 : UCIP\_SP\_2017\_50989\_66758.jpg

Burrow activity on WS slope.

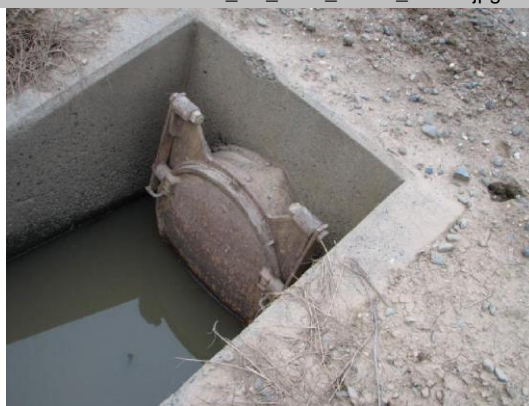
Photo 3 of 3 : UCIP\_SP\_2017\_50989\_66755.jpg

FS\_ID:50989  
DS\_ID:16355  
EP\_NO: N/A  
Repair Type: No Action Needed  
Crossing Status: Found  
UCIP Comments: 11/16/2016 Crossing appears to be in good condition. (DWR Sutter Yard- AFreitag)4/28/2016 Crossing appears to be in good condition.7/13/2015 LS screw gate was completely submerged but crossing appears to be in good condition.5/21/2014 Same as last inspection.12/2/2013 Same as last inspection.7/15/2013 No signs of burrowing activity on this inspection.4/18/2012 Burrow activity near crossing, burrow holes present on WS slope.  
FIELD\_STRUCT\_DESC: 24-inch corrugated metal drainage pipe through the levee 7.7 feet below the crown. Flap gate on the waterside (WS) end. Slide gate located on the landside (LS) end. Concrete "U" headwalls on both ends. [Additional Reference(s): DWR Levee Log, 1993. USACE Sacramento O&M Manual 519, June 1962 (HLM 4.94)]  
FS Date: 11/28/2016 10:48:17 AM

View of WS flap gate.

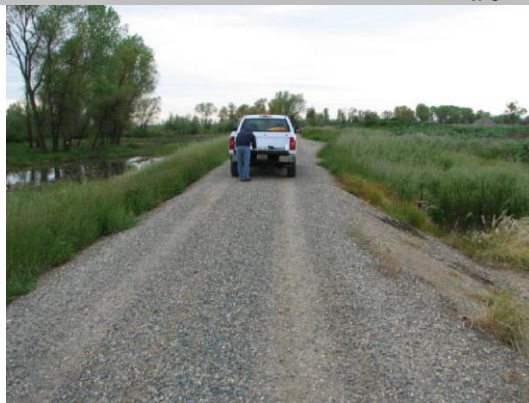
Photo 1 of 3 : UCIP\_SP\_2017\_50990\_66762.jpg

FS\_ID:50990  
DS\_ID:16356  
EP\_NO: N/A  
Repair Type: No Action Needed  
Crossing Status: Found  
UCIP Comments: 11/16/2016 Crossing appears to be in good condition. (DWR Sutter Yard- A Freitag) 4/28/2016 Crossing appears to be in good condition. 7/13/2015 LS screw gate was completely submerged and WS flapgate was propped open by a wood block but crossing appears to be in good condition. 5/21/2014 Same as last inspection. 12/2/2013 Same as last inspection. 7/15/2013 Same as last inspection. 4/18/2012 Minor vegetation on LS slope. This crossing was listed in the USACE Periodic Inspection report as Corp's inspect ID#USACE\_CESPK\_M13D\_2011\_p\_0204 for restriction view of gates. FIELD\_STRUCT\_DESC: 24-inch corrugated metal drainage pipe through the levee, 8.4 feet below the crown. Flap gate on the waterside (WS) end. Slide gate on the landside (LS) end. Concrete "U" headwalls on both ends. [Additional Reference(s): DWR Levee Log, 1993. USACE Sacramento O&M Manual 519, June 1962 (HLM 5.43)]

Overview of levee crown at crossing looking D/S on right bank of Cherokee Canal.

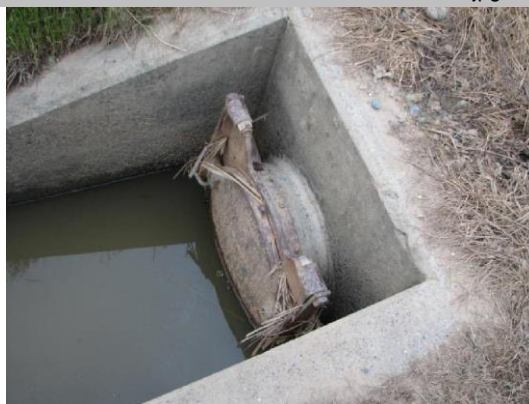
Photo 2 of 3 : UCIP\_SP\_2017\_50990\_66760.jpg

WS Flap Gate

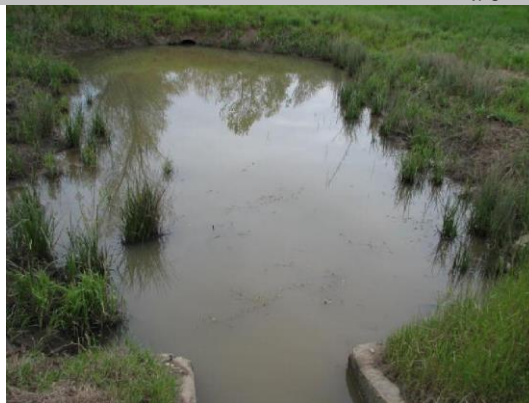
Photo 3 of 3 : UCIP\_SP\_2017\_50990\_66763.jpg

Item	DWR UCIP LMA Responsibility			39.523236 °	39.523236 °	
				-121.707650 °	-121.707650 °	
DWR ID						
Comment Code						
Inspector Comment						
FS_ID:50990 DS_ID:16356 EP_NO: N/A Repair Type: No Action Needed Crossing Status: Found UCIP Comments: 11/16/2016 Crossing appears to be in good condition. (DWR Sutter Yard- AFreitag)4/28/2016 Crossing appears to be in good condition.7/13/2015 LS screw gate was completely submerged and WS flapgate was propped open by a wood block but crossing appears to be in good condition.5/21/2014 Same as last inspection.12/2/2013 Same as last inspection.7/15/2013 Same as last inspection.4/18/2012 Minor vegetation on LS slope. This crossing was listed in the USACE Periodic Inspection report as Corp's inspect ID#USACE_CESPK_M13D_2011_p_0204 for restriction view of gates. FIELD_STRUCT_DESC: 24-inch corrugated metal drainage pipe through the levee, 8.4 feet below the crown. Flap gate on the waterside (WS) end. Slide gate on the landside (LS) end. Concrete "U" headwalls on both ends. [Additional Reference(s): DWR Levee Log, 1993. USACE Sacramento O&M Manual 519, June 1962 (HLM 5.43)] FS Date: 11/28/2016 10:49:24 AM

WS view of outlet cleared of vegetation.

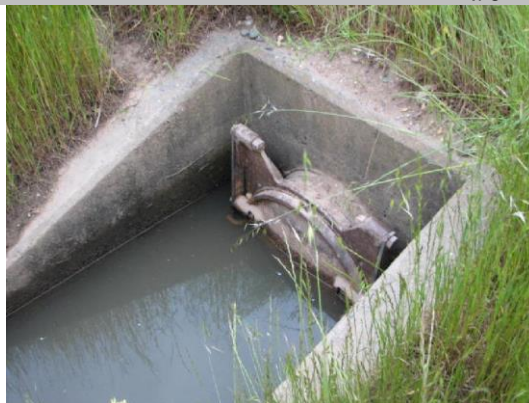
Photo 3 of 3 : UCIP\_SP\_2017\_50992\_66768.jpg

Item	DWR UCIP LMA Responsibility			39.522566 °	39.522566 °	
				-121.707560 °	-121.707560 °	
DWR ID						
Comment Code						
Inspector Comment						
FS_ID:50992 DS_ID:16357 EP_NO: N/A Repair Type: Non-Urgent Crossing Status: Found UCIP Comments: 11/16/2016 WS flap gate closed but blocked from opening by sediment. (DWR Sutter Yard- AFreitag)4/28/2016 WS flap gate blocked from opening by sediment.7/13/2015 WS flap gate is blocked from opening by sediment. Needs to be dug out.5/21/2014 Same as last inspection.12/2/2013 Same as last inspection.7/15/2013 Slopes have been cleared of vegetation and are in good condition.4/18/2012 Limited inspection on WS and LS slopes due to dense vegetation. Need photos of cleared slopes. FIELD_STRUCT_DESC: 24-inch corrugated metal drainage pipe through the levee, 8.6 feet below the crown. Flap gate on the waterside (WS) end. Concrete "U" headwalls an both ends. [Additional Reference(s): DWR Levee Log, 1993. USACE Sacramento O&M Manual 519, June 1962 (HLM 5.48)] FS Date: 11/28/2016 10:50:24 AM

View of WS flap gate.

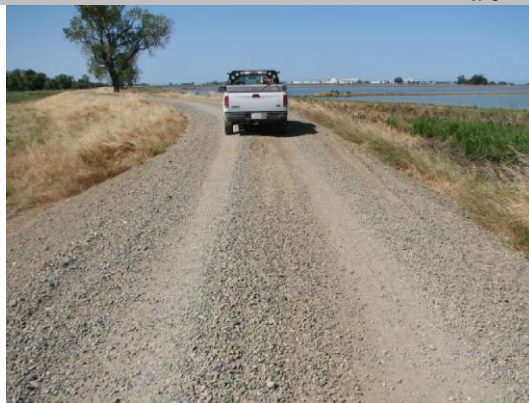
Photo 1 of 3 : UCIP\_SP\_2017\_51018\_66793.jpg

FS\_ID:51018  
DS\_ID:16359  
EP\_NO: N/A  
Repair Type: Non-Urgent  
Crossing Status: Found  
UCIP Comments: 11/16/2016 WS still completely buried. (DWR Sutter Yard- A Freitag) 4/28/2016 WS gate and headwall are buried. Only the top of the headwall was visible. LS appeared ok. 7/13/2015 Both the LS screw gate and WS flapgate are completely buried. 5/21/2014 Same as last inspection. 12/2/2013 Same as last inspection. 7/15/2013 Slopes have been cleared of vegetation and are in good condition. WS headwall and flapgate are fully covered in debris and not visible. Need to clear. 4/18/2012 High sedimentation build up at WS and LS headwall. Limited inspection due to dense vegetation on WS and LS slope. Need photo of cleared WS and LS slopes. This crossing was listed in the USACE Periodic Inspection report as Corp's inspect ID# USACE\_CESPK\_M13D\_2011\_p\_0210 for WS gate submerged.  
FIELD\_STRUCT\_DESC: 24-inch corrugated metal drainage pipe through the levee, 9.2 feet below the crown. Flap gate on the waterside (WS) end. Concrete "U" headwalls on both ends. [Additional Reference(s): DWR Levee Log, 1993. USACE Sacramento O&M Manual 519, June 1962 (HLM 5.73)]

Overview of levee crown at crossing looking downstream.

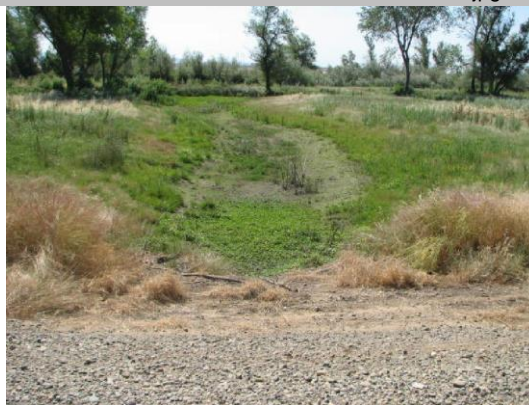
Photo 2 of 3 : UCIP\_SP\_2017\_51018\_66794.jpg

View of WS slope and toe.

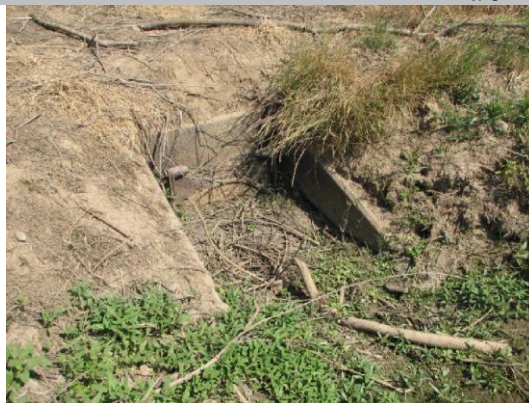
Photo 3 of 3 : UCIP\_SP\_2017\_51018\_66791.jpg

Item	DWR UCIP LMA Responsibility			39.519212 °	39.519212 °	
				-121.709030 °	-121.709030 °	
DWR ID						
Comment Code						
Inspector Comment						
FS_ID:51018 DS_ID:16359 EP_NO: N/A Repair Type: Non-Urgent Crossing Status: Found UCIP Comments: 11/16/2016 WS still completely buried. (DWR Sutter Yard- A Freitag) 4/28/2016 WS gate and headwall are buried. Only the top of the headwall was visible. LS appeared ok.7/13/2015 Both the LS screw gate and WS flapgate are completely buried.5/21/2014 Same as last inspection.12/2/2013 Same as last inspection.7/15/2013 Slopes have been cleared of vegetation and are in good condition. WS headwall and flapgate are fully covered in debris and not visible. Need to clear.4/18/2012 High sedimentation build up at WS and LS headwall. Limited inspection due to dense vegetation on WS and LS slope. Need photo of cleared WS and LS slopes. This crossing was listed in the USACE Periodic Inspection report as Corp's inspect ID# USACE_CESPK_M13D_2011_p_0210 for WS gate submerged. FIELD_STRUCT_DESC: 24-inch corrugated metal drainage pipe through the levee, 9.2 feet below the crown. Flap gate on the waterside (WS) end. Concrete "U" headwalls on both ends. [Additional Reference(s): DWR Levee Log, 1993. USACE Sacramento O&M Manual 519, June 1962 (HLM 5.73)] FS Date: 11/30/2016 7:01:02 AM

View of WS flap gate buried.

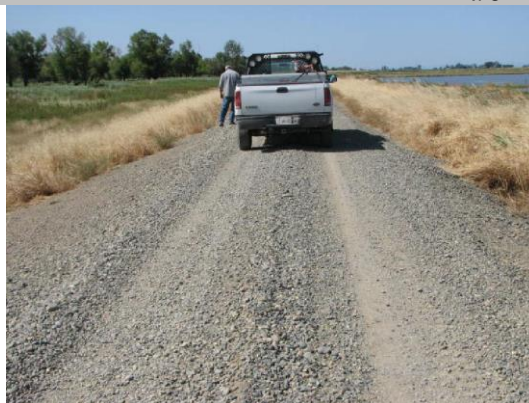
Photo 1 of 3 : UCIP\_SP\_2017\_51019\_66800.jpg

FS\_ID:51019  
DS\_ID:16360  
EP\_NO: N/A  
Repair Type: No Action Needed  
Crossing Status: Found  
UCIP Comments: 11/16/2016 Crossing appears to be in good condition. (DWR Sutter Yard- AFreitag)4/28/2016 Crossing appears to be in good condition.7/13/2015 LS screw gate was completely submerged but crossing appears to be in good condition.5/21/2014 Same as last inspection.12/2/2013 Same as last inspection.7/15/2013 Same as last inspection.4/18/2012 Burrow activity near crossing; burrow holes present on LS.  
FIELD\_STRUCT\_DESC: 24-inch corrugated metal drainage pipe through the levee, 6.2 feet below the crown. Flap gate on the waterside (WS) end. Slide gate on the landside (LS) end. Concrete "U" headwalls on both ends. [Additional Reference(s): DWR Levee Log, 1993. USACE Sacramento O&M Manual 519, June 1962 (HLM 5.97)]  
FS Date: 11/30/2016 7:04:27 AM

Overview of levee crown at crossing looking downstream.

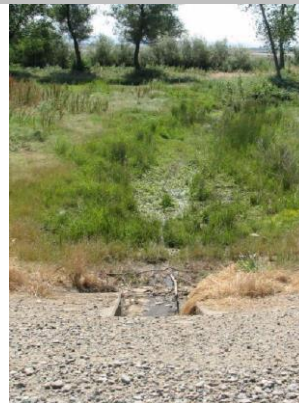
Photo 2 of 3 : UCIP\_SP\_2017\_51019\_66801.jpg

View of WS slope and toe.

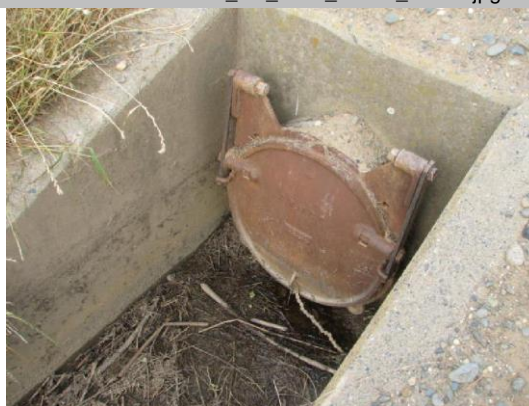
Photo 3 of 3 : UCIP\_SP\_2017\_51019\_66799.jpg

Item	DWR UCIP LMA Responsibility			39.516059 °	39.516059 °	
				-121.710810 °	-121.710810 °	
DWR ID						
Comment Code						
Inspector Comment						
FS_ID:51019 DS_ID:16360 EP_NO: N/A Repair Type: No Action Needed Crossing Status: Found UCIP Comments: 11/16/2016 Crossing appears to be in good condition. (DWR Sutter Yard- A Freitag)4/28/2016 Crossing appears to be in good condition.7/13/2015 LS screw gate was completely submerged but crossing appears to be in good condition.5/21/2014 Same as last inspection.12/2/2013 Same as last inspection.7/15/2013 Same as last inspection.4/18/2012 Burrow activity near crossing; burrow holes present on LS. FIELD_STRUCT_DESC: 24-inch corrugated metal drainage pipe through the levee, 6.2 feet below the crown. Flap gate on the waterside (WS) end. Slide gate on the landside (LS) end. Concrete "U" headwalls on both ends. [Additional Reference(s): DWR Levee Log, 1993. USACE Sacramento O&M Manual 519, June 1962 (HLM 5.97)] FS Date: 11/30/2016 7:04:27 AM

Flap gate WS

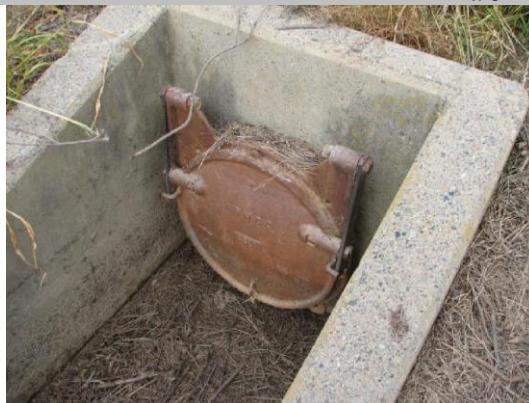
Photo 3 of 3 : UCIP\_SP\_2017\_51020\_66804.jpg

Item	DWR UCIP LMA Responsibility			39.511337 °	39.511337 °	
				-121.713620 °	-121.713620 °	
DWR ID						
Comment Code						
Inspector Comment						
FS_ID:51020 DS_ID:16361 EP_NO: N/A Repair Type: Non-Urgent Crossing Status: Found UCIP Comments: 11/16/2016 LS screwgate is buried and non-operational. (DWR Sutter Yard- A Freitag)4/28/2016 LS screwgate is still completely buried. 7/13/2015 LS screw gate is completely buried.5/21/2014 Same as last inspection.7/15/2013 WS slope has been cleared of vegetation and is in good condition. LS screw gate is still buried.12/2/2013 Same as last inspection.4/18/2012 LS slide gate is buried. Pipe is not visible on LS toe. Limited inspection on WS slope due to dense vegetation. FIELD_STRUCT_DESC: 24-inch corrugated metal drainage pipe through the levee, 7.4 feet below the crown. Flap gate on the waterside (WS) end. Slide gate on the landside (LS) end. Concrete "U" headwalls on both ends. [Additional Reference(s): DWR Levee Log, 1993. USACE Sacramento O&M Manual 519, June 1962 (HLM 6.34)] FS Date: 11/30/2016 7:08:13 AM

View of WS flap gate.

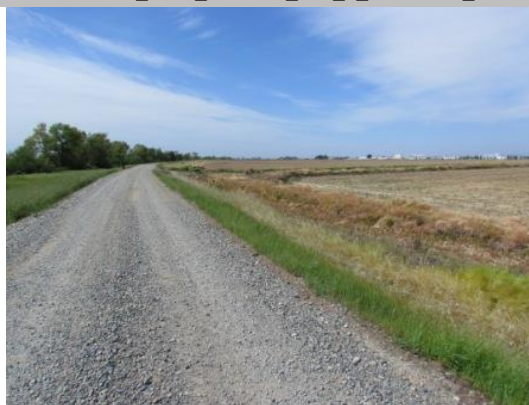
Photo 1 of 1 : SP\_2017\_MA0013\_300\_3\_20170315\_00002.jpg

LM Start	6.41	Rating **	M	Issue No.	3
LM End	6.99	Issue Type +	En	Location *	LS
Category	Earthen Levee			GPS Latitude/Longitude	
				Start	End
Item	Encroachments			39.508928 °	39.501438 °
				-121.714842 °	-121.719715 °
DWR ID	DWR_MA0013_01_s_2012_3				
Comment Code					
DT : Ditch					
Inspector Comment

View of the agricultural ditch along the toe.

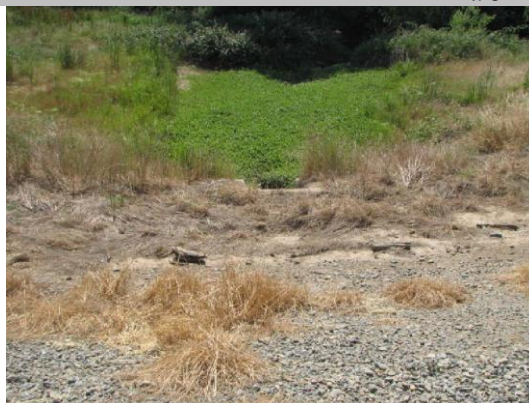
Photo 2 of 3 : UCIP\_SP\_2017\_51021\_66813.jpg

View of WS slope and toe.

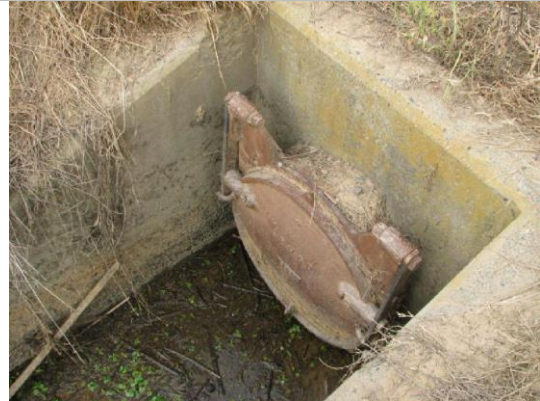
Photo 3 of 3 : UCIP\_SP\_2017\_51021\_66811.jpg

Comment Code					
Inspector Comment					
FS_ID:51021 DS_ID:16362 EP_NO: 5200B Repair Type: Urgent Crossing Status: Found UCIP Comments: 11/16/2016 Hole/erosion still present behind the LS flashboards. (DWR Sutter Yard- AFreitag)4/28/2016 Hole still present behind the LS flashboards. Rest of the crossing appeared in good condition. (DWR Sutter Yard - afreitag)7/13/2015 Hole still present behind the LS flashboards. (DWR Sutter Yard - afreitag)5/21/2014 Same as last inspection. (DWR Sutter Yard - afreitag)12/2/2013 Same as last inspection. (DWR Sutter Yard - afreitag)7/15/2013 WS slope has been cleared of vegetation and is in good condition. Hole is still present behind flash boards on LS. (DWR Sutter Yard - afreitag)4/18/2012 Hole behind flashboards against slide gate on LS slope (Health and Safety Issue). Limited inspection on WS slope due to dense vegetation. Need photo of cleared slope on WS. (DWR UCIP - omagana) FIELD_STRUCT_DESC: 24-inch corrugated metal drainage pipe through the levee, 7.8 feet below the crown. Flap gate on the waterside (WS) end. Slide gate on the landside (LS) end. Concrete headwall on both ends (Permit No. 5200B - 1965, Richvale Irrigation District) (Additional Related Permit(s): Permit No. 5200 and 5200A) [Additional Reference(s): DWR Levee Log, 1992. USACE Sacramento O&M Manual 519, June 1962 (HLM 6.56)] FS Date: 11/30/2016 7:09:30 AM

WS flap gate.

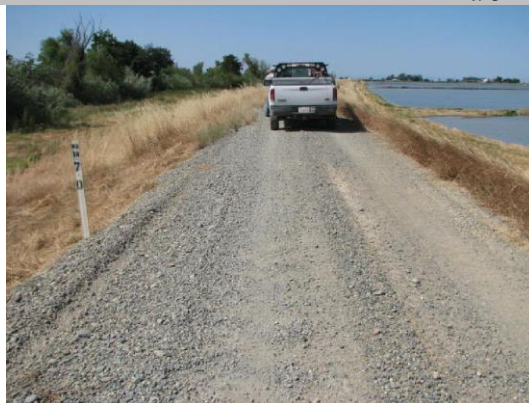
Photo 1 of 3 : UCIP\_SP\_2017\_51028\_66833.jpg

FS\_ID:51028  
DS\_ID:16329  
EP\_NO: N/A  
Repair Type: Non-Urgent  
Crossing Status: Found  
UCIP Comments: 11/16/2016 Needs a new screw gate installed on the LS. (DWR Sutter Yard- A Freitag)4/28/2016 LS slide gate is still bent. Everything else with the crossing appeared ok.7/13/2015 LS screw gate needs to be replaced. Everything else with crossing seems to be in good condition.5/21/2014 Same as last inspection.12/2/2013 Same as last inspection.7/15/2013 Slopes have been cleared of vegetation and are in good condition. There were no apparent signs of settling. LS screw gate is still damaged.4/18/2012 LMA's inspection sheet of 2011 indicates settlement and visible corrosion. Damage/severe corrosion on screw gate where it bolts to headwall. No visible signs of settlement due to high vegetation cover. Limited inspection on WS and LS slopes due to dense vegetation. Need photos of cleared slopes for this crossing.

Overview of levee crown at crossing looking D/S.

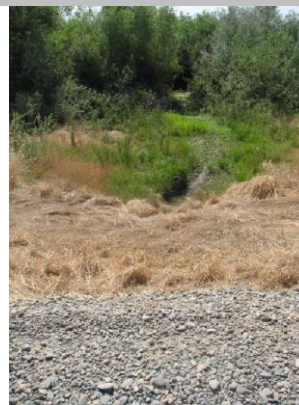
Photo 2 of 3 : UCIP\_SP\_2017\_51028\_66832.jpg

View of WS slope and toe.

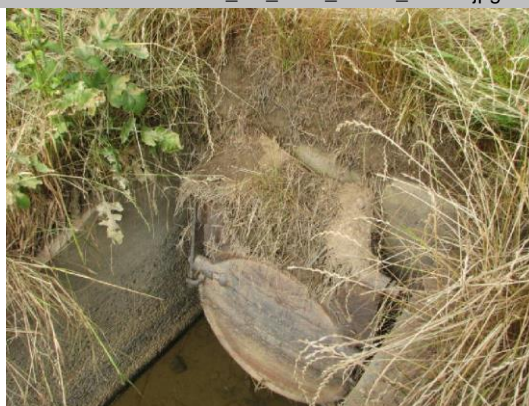
Photo 3 of 3 : UCIP\_SP\_2017\_51028\_66837.jpg

WS Flap Gate

Comment Code					
Inspector Comment					
FS_ID:51028 DS_ID:16329 EP_NO: N/A Repair Type: Non-Urgent Crossing Status: Found UCIP Comments: 11/16/2016 Needs a new screw gate installed on the LS. (DWR Sutter Yard- A Freitag)4/28/2016 LS slide gate is still bent. Everything else with the crossing appeared ok.7/13/2015 LS screw gate needs to be replaced. Everything else with crossing seems to be in good condition.5/21/2014 Same as last inspection.12/2/2013 Same as last inspection.7/15/2013 Slopes have been cleared of vegetation and are in good condition. There were no apparent signs of settling. LS screw gate is still damaged.4/18/2012 LMA's inspection sheet of 2011 indicates settlement and visible corrosion. Damage/severe corrosion on screw gate where it bolts to headwall. No visible signs of settlement due to high vegetation cover. Limited inspection on WS and LS slopes due to dense vegetation. Need photos of cleared slopes for this crossing. FIELD_STRUCT_DESC: 24-inch corrugated metal drainage pipe through the levee, 9.8 feet below the crown. Flap gate on the waterside (WS) end. Slide gate on the landside (LS) end. Concrete headwall on both ends. [Additional Reference(s): DWR Levee Log, 1993. USACE Sacramento O&M Manual 519, June 1962 (HLM 7.10)] FS Date: 11/30/2016 7:16:33 AM

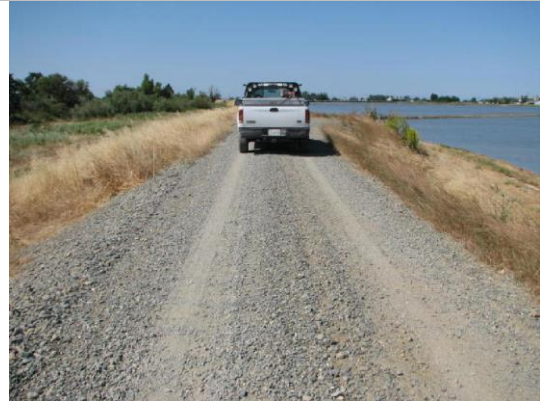
Photo 1 of 3 : UCIP\_SP\_2017\_51029\_66844.jpg

FS\_ID:51029  
DS\_ID:16354  
EP\_NO: N/A  
Repair Type: No Action Needed  
Crossing Status: Found  
UCIP Comments: 11/16/2016 SCrew gate stem bent but gate is still operational. (DWR Sutter Yard- A Freitag)4/28/2106 Tested positive closure device the bent stem on the slide gate did not seem to affect its functions. Gate operable.7/13/2015 LS screw gate stem is still bent. Gate should still be able to close fully. The rest of the crossing seems to be in good condition.5/21/2014 Same as last inspection.12/2/2013 Same as last inspection.7/15/2013 Slopes have been cleared of vegetation and are in good condition. LS screw gate stem is still bent.4/18/2012 LS slide gate stem is bent and needs to be replaced. Limited inspection on WS and LS slope due to dense vegetation. Need photos of cleared slopes during next inspection. Confirmed flap gate on WS. This crossing was listed in the USACE Periodic Inspection report as Corp's inspect ID#USACE\_CESPK\_M13D\_2011\_p\_0244 for submerged WS gate. FIELD\_STRUCT\_DESC: 24-inch corrugated metal drainage pipe through the levee, 11.2 feet below the crown. Flap gate on the waterside (WS) end. Slide gate on the landside (LS) end. Concrete "U" headwall on both ends. [Additional Reference(s): DWR Levee Log, 1993. USACE Sacramento O&M Manual 519, June 1962 (HLM 7.34)]

Overview of levee crown at crossing looking D/S.

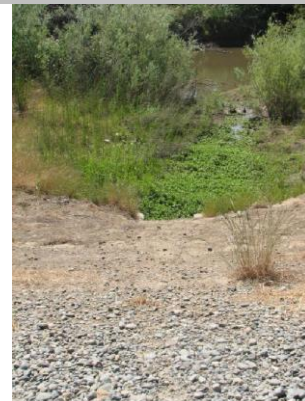
Photo 2 of 3 : UCIP\_SP\_2017\_51029\_66845.jpg

View of WS slope and toe.

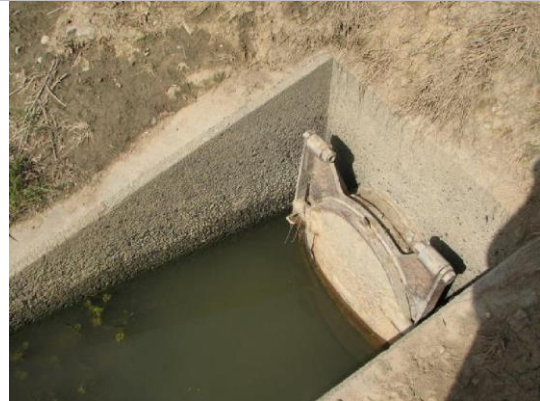
Photo 3 of 3 : UCIP\_SP\_2017\_51029\_66842.jpg

Comment Code					
Inspector Comment					
FS_ID:51029 DS_ID:16354 EP_NO: N/A Repair Type: No Action Needed Crossing Status: Found UCIP Comments: 11/16/2016 SCrew gate stem bent but gate is still operational.12/2/2013 Same as last inspection.7/15/2013 Slopes have been cleared of vegetation and are in good condition. LS screw gate stem is still bent.4/18/2012 LS slide gate stem is bent and needs to be replaced. Limited inspection on WS and LS slope due to dense vegetation. Need photos of cleared slopes during next inspection. Confirmed flap gate on WS. This crossing was listed in the USACE Periodic Inspection report as Corp's inspect ID#USACE_CESPK_M13D_2011_p_0244 for submerged WS gate. FIELD_STRUCT_DESC: 24-inch corrugated metal drainage pipe through the levee, 11.2 feet below the crown. Flap gate on the waterside (WS) end. Slide gate on the landside (LS) end. Concrete "U" headwall on both ends. [Additional Reference(s): DWR Levee Log, 1993. USACE Sacramento O&M Manual 519, June 1962 (HLM 7.34)] FS Date: 11/30/2016 7:28:38 AM

WS Flap Gate
