**Flood Control Project Maintenance  
Levee Inspections**  
**LMA District Cover Sheet**  
**Spring 2017 Levee Inspection Results**

**Sutter Maintenance Yard Maintenance Area 0013**

**Spring 2017 Levee Inspection Results**

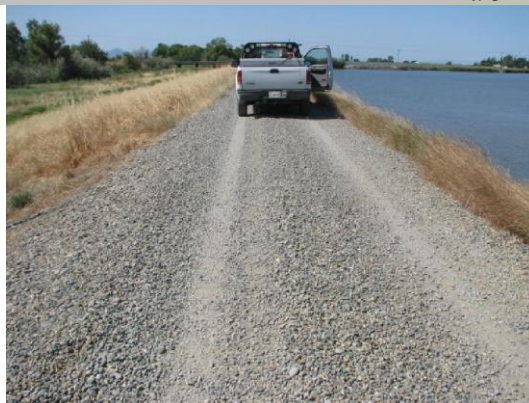
Photo 1 of 3 : UCIP\_SP\_2017\_51030\_66853.jpg

View of levee crown at crossing looking D/S.

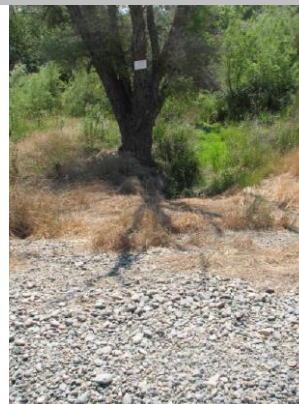
Photo 2 of 3 : UCIP\_SP\_2017\_51030\_66851.jpg

WS view of slope and channel.

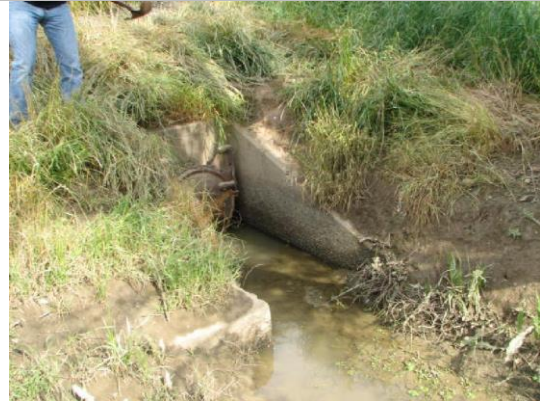
Photo 3 of 3 : UCIP\_SP\_2017\_51030\_66849.jpg

View of WS flap gate. Dense vegetation on WS slope.

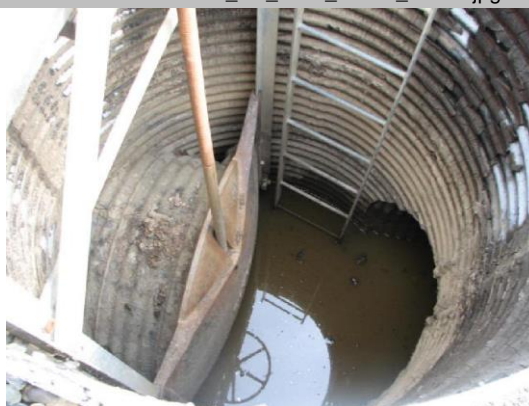
Photo 3 of 3 : UCIP\_SP\_2017\_51033\_66863.jpg

WS Slide gate

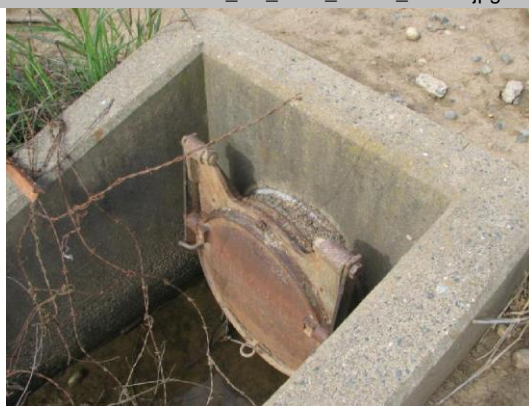
Photo 3 of 3 : UCIP\_SP\_2017\_51034\_66869.jpg

WS Flap gate

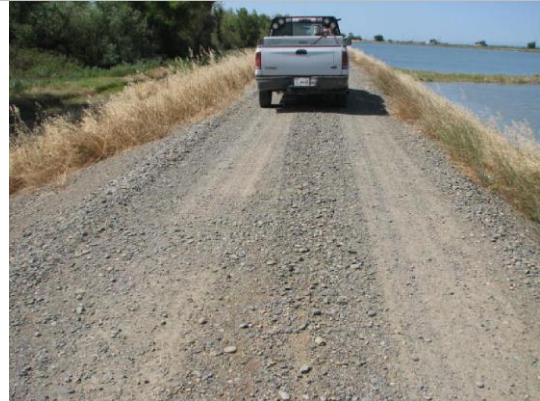
Photo 1 of 3 : UCIP\_SP\_2017\_51035\_66876.jpg

Overview of levee crown at crossing looking D/S.

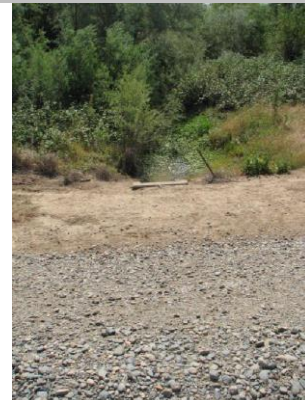
Photo 2 of 3 : UCIP\_SP\_2017\_51035\_66874.jpg

View of WS slope and toe.

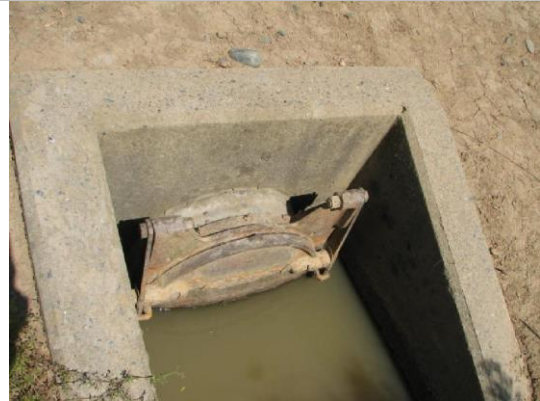
Photo 3 of 3 : UCIP\_SP\_2017\_51035\_66877.jpg

Item	DWR UCIP LMA Responsibility			39.485432 °	39.485432 °	
				-121.731590 °	-121.731590 °	
DWR ID						
Comment Code						
Inspector Comment						
FS_ID:51035 DS_ID:16322 EP_NO: N/A Repair Type: Non-Urgent Crossing Status: Found UCIP Comments: 11/16/2016 WS falp gate is closed but is blocked from opening by sediment. (DWR Sutter Yard- AFreitag)4/28/2016 Crossing appears to be in good condition.7/13/2015 Minor sediment build up blocking flap gate from opening on WS. Needs to be dug out.5/21/2014 Same as last inspection.12/3/2013 Same as last inspection.7/15/2013 Slopes are cleared of vegetation and are in good condition. WS flapgate is blocked from opening fully by sediment.4/18/2012 Sediment build up on LS. Debris (broken panels) scattered near LS headwall. Limited inspection on WS and LS slope due to dense vegetation. Need photos of cleared WS and LS slopes. FIELD_STRUCT_DESC: 24-inch corrugated metal drainage pipe through the levee, 9.3 feet below the crown. Flap gate on the waterside (WS) end. Concrete "U" headwalls on both ends. Flashboards should be present on the landside (LS). [Additional Reference(s): DWR Levee Log, 1993. USACE Sacramento O&M Manual 519, June 1962 (HLM 8.40)] FS Date: 11/30/2016 7:50:53 AM

View of WS flap gate and headwall.

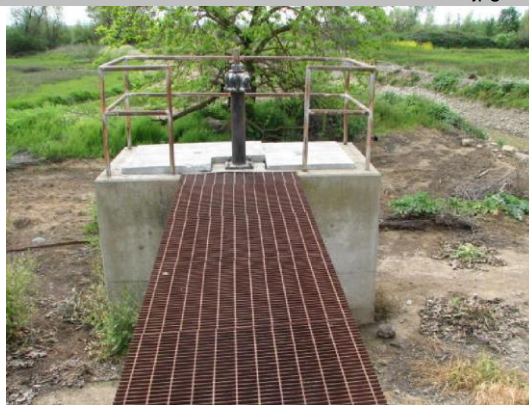
Photo 2 of 3 : UCIP\_SP\_2017\_51036\_66884.jpg

Catwalk & gate located on WS. No daylight point on WS.

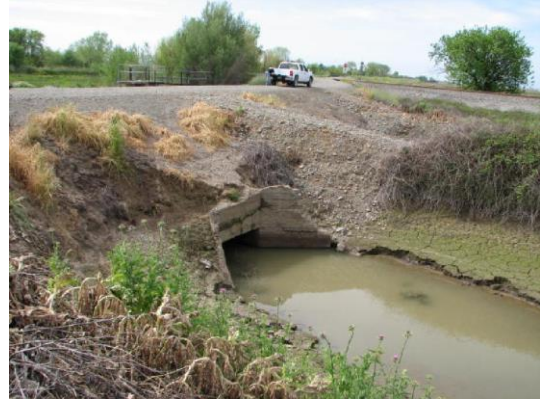
Photo 3 of 3 : UCIP\_SP\_2017\_51036\_66882.jpg

Item	DWR UCIP Field Study			39.478573 °		39.478573 °
				-121.736550 °		-121.736550 °
DWR ID						
Comment Code						
Inspector Comment						
FS_ID:51036 DS_ID:16323 EP_NO: N/A Repair Type: Urgent Crossing Status: Found UCIP Comments: 11/16/2016 LS erosion is still a major problem here. (DWR Sutter Yard- AFreitag)4/28/2016 Erosion still present at the LS headwall. (DWR Sutter Yard - afreitag)7/13/2015 Erosion still present behind the LS headwall. It looks to be getting worse and is starting to affect the levee slope. (DWR Sutter Yard - afreitag)5/21/2014 Same as last inspection. (DWR Sutter Yard - afreitag)12/3/2013 Same as last inspection. (DWR Sutter Yard - afreitag)7/15/2013 Same as last inspection. (DWR Sutter Yard - afreitag)4/18/2012 Concrete headwall is cracked, erosion behind headwall is also present. LS headwall needs to be repaired/replaced. Remove wooden debris from levee shoulder. (DWR UCIP - omagana) FIELD_STRUCT_DESC: [Richvale Irrigation Canal Siphon] 60-inch by 84-inch (5-foot by 7 foot) concrete irrigation conduit through the levee, 18.4 feet below the crown. Distribution box and walkway are located on the waterside (WS). Concrete headwall on the landside (LS). 28-foot reinforced concrete protective slab on top of the conduit in the center of the levee. [Additional Reference(s): DWR Levee Log, 1993. USACE Sacramento O&M Manual 519, June 1962 (HLM 8.95)] FS Date: 11/30/2016 7:54:23 AM

View of LS structure. Erosion present behind headwall.

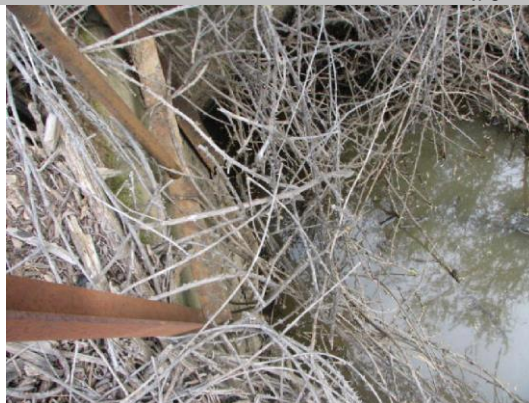
Photo 3 of 3 : UCIP\_SP\_2017\_51039\_66900.jpg

View of slide gate on WS. Debris blocking gate.

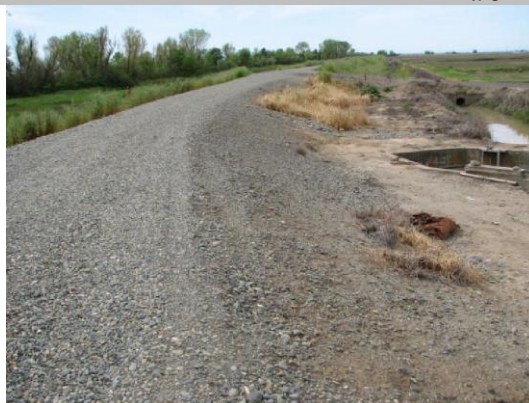
Photo 1 of 3 : UCIP\_SP\_2017\_51041\_66908.jpg

Overview picture looking south

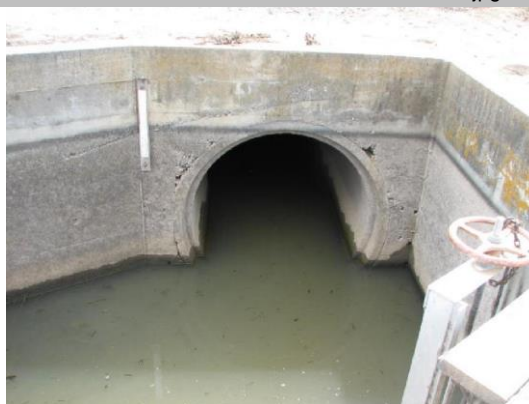
Photo 2 of 3 : UCIP\_SP\_2017\_51041\_66907.jpg

Comment Code					
Inspector Comment					
FS_ID:51041 DS_ID:16828 EP_NO: N/A Repair Type: Non-Urgent Crossing Status: Found UCIP Comments: 11/16/2016 SOome erosion still present near the LS structure. Does not affect the levee yet. (DWR Sutter Yard-AFreitag)4/28/2016 Erosion happening around the concrete structure on LS. Its not yet affecting the levee but will keep monitoring.7/13/2015 Crossing appears in good condition. No noticeable issues to report.5/21/2014 Same as last inspection.12/3/2013 Same as last inspection.7/15/2013 Same as last inspection.4/18/2012 Crossing is not visible on WS. FIELD_STRUCT_DESC: 72-inch irrigation pipe through the levee located 14.2 feet below the crown. Appurtances include concrete pipe siphon, screw gate, and distribution box visible on the landside (LS). No appurtenances found on the waterside (WS). [Additional Reference(s): DWR Levee Log, 1993. USACE Sacramento O&M Manual 519, June 1962 (HLM 9.02)] FS Date: 11/30/2016 9:22:50 AM

Headwall at LS distribution box

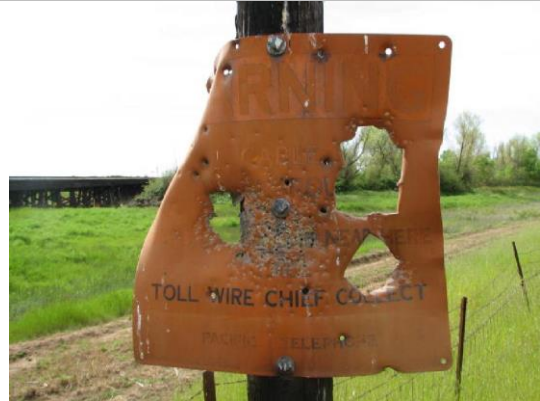
Photo 1 of 1 : UCIP\_SP\_2017\_51042\_66909.jpg

Comment Code					
Inspector Comment					
FS_ID:51042					
DS_ID:16328					
EP_NO: 1234A					
Repair Type: Non-Urgent					
Crossing Status: Indicator Found					
UCIP Comments: 11/16/2016 WS marker is knocked over and laying on the ground. (DWR Sutter Yard- A Freitag)4/28/2016 Marker missing on WS.7/13/2015 Crossing appears in good condition. No noticeable issues to report.Need to contact owner to replace marker.7/15/2013 Same as last inspection.12/3/2013 Same as last inspection.5/21/2014 Same as last inspection.					
FIELD_STRUCT_DESC: Underground telephone cable through the levee at an unknown depth below the crown. (Permit No. 1234, 1234A, 1947 - Pacific Telephone and Telegraph Company [PT&T]) [Additional Reference(s): DWR Levee Log, 1993]					
FS Date: 11/30/2016 9:26:42 AM

Underground telephone cable marker located on WS.

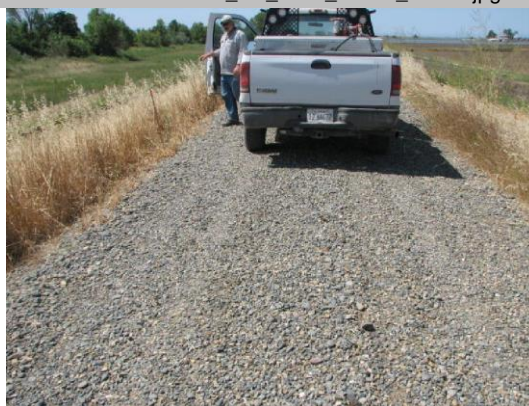
Photo 1 of 3 : UCIP\_SP\_2017\_51043\_66910.jpg

Overview of levee crown at crossing looking downstream.

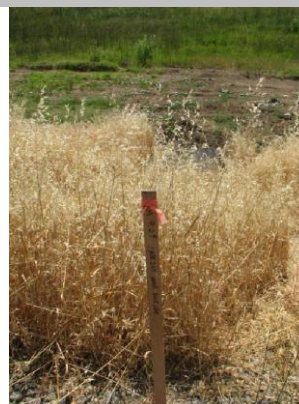
Photo 2 of 3 : UCIP\_SP\_2017\_51043\_66911.jpg

View of WS slope and toe.

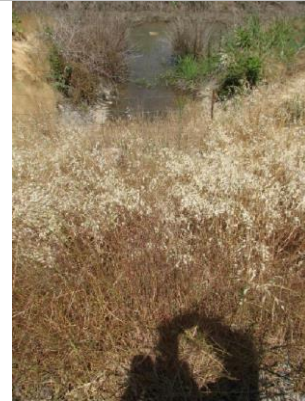
Photo 3 of 3 : UCIP\_SP\_2017\_51043\_66912.jpg

View of LS slope and toe.

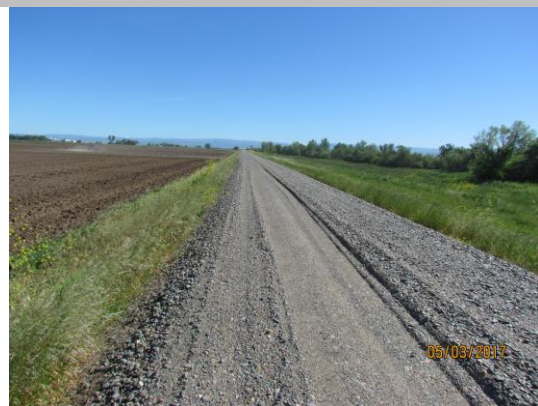
Photo 1 of 1 : SP\_2017\_MA0013\_300\_88\_20170508\_00144.jpg

LM Start	9.60	Rating **	A	Issue No.	88
LM End	9.60	Issue Type +	Ma	Location *	LS
Category	Earthen Levee			GPS Latitude/Longitude	
				Start	End
Item	Vegetation			39.468532 °	39.468532 °
				-121.743045 °	-121.743045 °
DWR ID	DWR_MA0013_01_s_2017_88				
Comment Code					
V1 : Control annual grass and weeds on the levee slopes and easements.					
Inspector Comment					
There are native grasses on both slopes.

View of native grasses on both slopes.

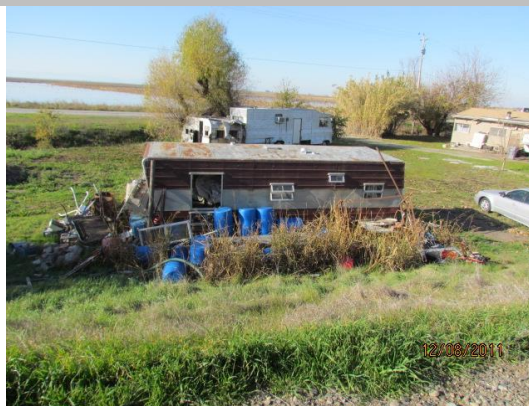
Photo 1 of 1 : SP\_2017\_MA0013\_300\_10\_20170315\_00004.jpg

LM Start	9.73	Rating **	M	Issue No.	10
LM End	9.75	Issue Type +	En	Location *	LS
Category	Earthen Levee			GPS Latitude/Longitude	
				Start	End
Item	Encroachments			39.466732 °	39.466478 °
				-121.744180 °	-121.744338 °
DWR ID	DWR_MA0013_01_f_2013_10				
Comment Code					
MA : Material					
Inspector Comment					
Move the trailer and materials outside the 10 foot easement.

View of a trailer and material along the landside toe.

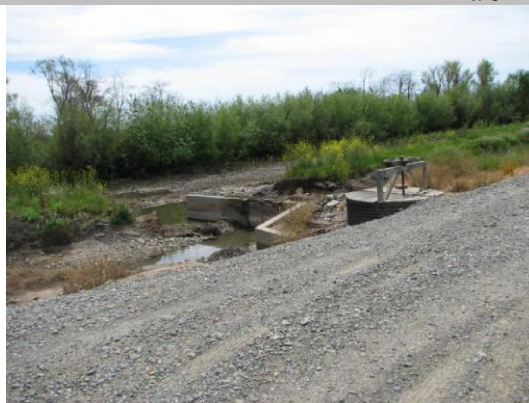
Photo 1 of 3 : UCIP\_SP\_2017\_51048\_66926.jpg

View of WS corrugated metal riser and concrete wall.

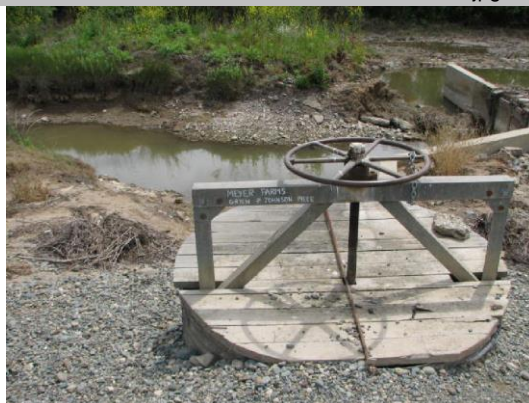
Photo 2 of 3 : UCIP\_SP\_2017\_51048\_66925.jpg

Corrugated metal riser with owner information.

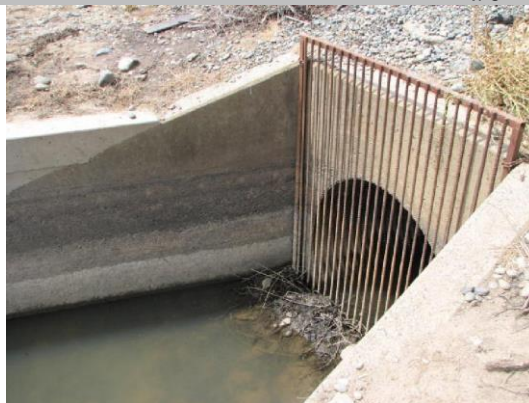
Photo 3 of 3 : UCIP\_SP\_2017\_51048\_66928.jpg

Trash rack on WS headwall.

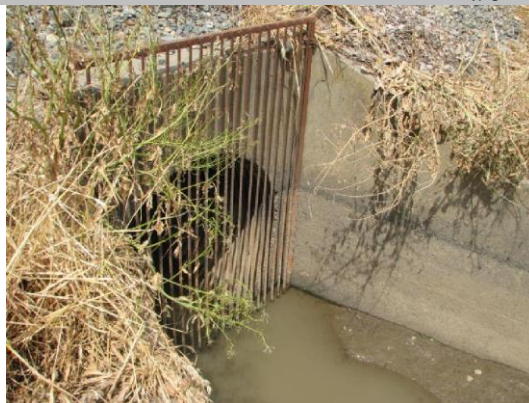
Photo 3 of 3 : UCIP\_SP\_2017\_51049\_66930.jpg

Item	DWR UCIP LMA Responsibility			39.442639 °		39.442639 °
				-121.760070 °		-121.760070 °
DWR ID						
Comment Code						
Inspector Comment						
FS_ID:51049						
DS_ID:16333						
EP_NO: N/A						
Repair Type: No Action Needed						
Crossing Status: Found						
UCIP Comments: 11/17/2016 Crossing appears to be in good condition. (DWR Sutter Yard- A Freitag)4/28/2016 Crossing appears to be in good condition.7/13/2015 Crossing appears in good condition. No noticeable issues to report.5/21/2014 Same as last inspection.12/3/2013 Same as last inspection.7/15/2013 Same as last inspection.						
FIELD_STRUCT_DESC: 60-inch corrugated metal drainage pipe through the levee, 11.3 feet below the crown. Slide gate in corrugated metal pipe riser on the waterside (WS) slope. Concrete "U" headwall on both ends. Crossing is used as an irrigation turnout bar code plate located on the WS slide gate (identified as 145). [Additional Reference(s): DWR Levee Log, 1993. USACE Sacramento O&M Manual 519, June 1962 (HLM 11.78)]

Trash rack on WS headwall.

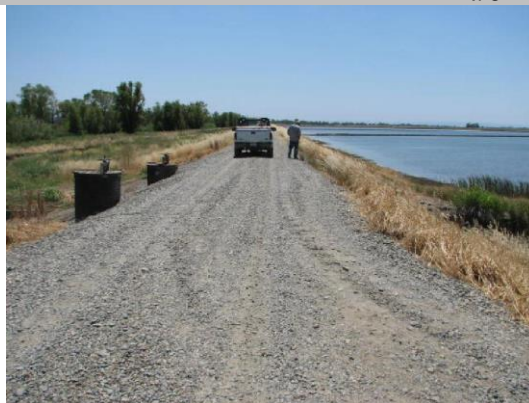
Photo 1 of 3 : UCIP\_SP\_2017\_51050\_66940.jpg

FS\_ID:51050  
DS\_ID:16334  
EP\_NO: N/A  
Repair Type: Non-Urgent  
Crossing Status: Found  
UCIP Comments: 11/17/2016 Cannot locate the WS pipe end. (DWR Sutter Yard- A Freitag) 4/28/2016 Crossing appears to be in good condition but could not locate the WS pipe end. 7/13/2015 New screw gate installed inside the WS standpipe. 5/21/2014 Same as last inspection. 12/3/2013 Same as last inspection. 7/15/2013 Slopes have been cleared of vegetation and are in good condition. Still no sign of WS end of pipe. 4/18/2012 Limited inspection on WS and LS slope due to dense vegetation. WS outlet of pipe not found. Need photos of cleared WS and LS slopes. Determine if WS outlet daylight after WS slope is cleared.  
FIELD\_STRUCT\_DESC: 30-inch corrugated metal drainage pipe through the levee, 11 feet below the crown. Slide gate in corrugated metal pipe riser on the waterside (WS) slope. Concrete "U" headwall on the landside (LS). [Additional Reference(s): DWR Levee Log, 1993. USACE Sacramento O&M Manual 519, June 1962 (HLM 12.38)]

Overview of levee crown at crossing looking downstream.

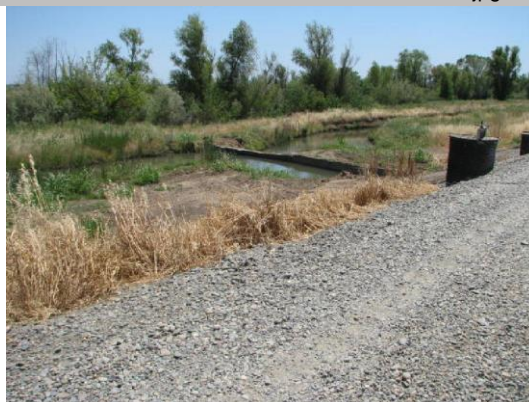
Photo 2 of 3 : UCIP\_SP\_2017\_51050\_66936.jpg

View of WS slope and channel.

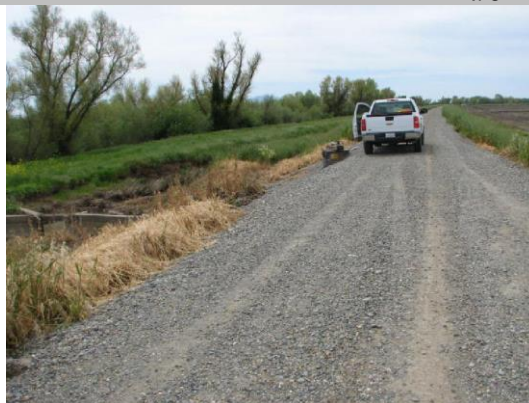
Photo 1 of 3 : UCIP\_SP\_2017\_51052\_66952.jpg

FS\_ID:51052  
DS\_ID:16336  
EP\_NO: N/A  
Repair Type: Non-Urgent  
Crossing Status: Found  
UCIP Comments: 11/17/2016 Slide gate still missing from inside the WS standpipe. (DWR Sutter Yard- A Freitag) 4/28/2016 Slide gate was removed from inside the WS standpipe. 7/13/2015 New screw gate installed on the WS pipe end in the irrigation ditch. 5/21/2014 Same as last inspection. 12/3/2013 Same as last inspection. 7/15/2013 Same as last inspection. 4/18/2012 Irrigation turnout. Not in use during April 2012 Inspection. During the follow up May 2012 Inspection structure was being used as irrigation turnout, reason for barcode tags. FIELD\_STRUCT\_DESC: 30-inch corrugated metal drainage pipe through the levee, 10.7 feet below the crown. Slide gate in corrugated metal pipe (CMP) riser on the waterside (WS) slope. Concrete "U" headwalls on both ends. This crossing is used as an irrigation turnout bar code plate located on the WS slide gate (identified as 141 and 142). [Additional Reference(s): DWR Levee Log, 1993. USACE Sacramento O&M Manual 519, June 1962 (HLM 12.94)]

Overview picture looking south on right bank of Cherokee Canal.

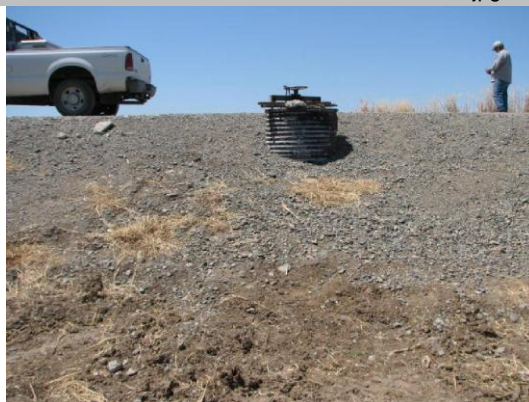
Photo 2 of 3 : UCIP\_SP\_2017\_51052\_66959.jpg

View of WS slope.

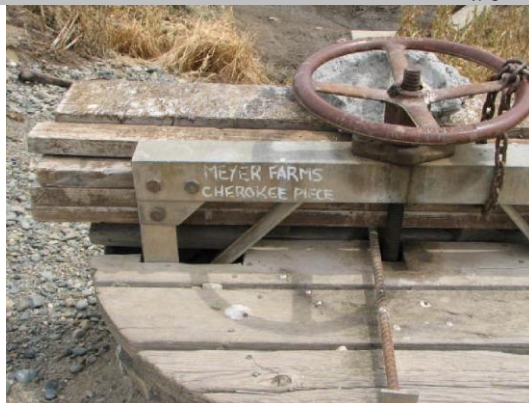
Photo 3 of 3 : UCIP\_SP\_2017\_51052\_66951.jpg

Item	DWR UCIP LMA Responsibility			39.428070 °		39.428070 °
				-121.770080 °		-121.770080 °
DWR ID						
Comment Code						
Inspector Comment						
FS_ID:51052 DS_ID:16336 EP_NO: N/A Repair Type: Non-Urgent Crossing Status: Found UCIP Comments: 11/17/2016 Slide gate still missing from inside the WS standpipe. (DWR Sutter Yard- A Freitag) 4/28/2016 Slide gate was removed from inside the WS standpipe. 7/13/2015 New screw gate installed on the WS pipe end in the irrigation ditch. 5/21/2014 Same as last inspection. 12/3/2013 Same as last inspection. 7/15/2013 Same as last inspection. 4/18/2012 Irrigation turnout. Not in use during April 2012 Inspection. During the follow up May 2012 Inspection structure was being used as irrigation turnout, reason for barcode tags. FIELD_STRUCT_DESC: 30-inch corrugated metal drainage pipe through the levee, 10.7 feet below the crown. Slide gate in corrugated metal pipe (CMP) riser on the waterside (WS) slope. Concrete "U" headwalls on both ends. This crossing is used as an irrigation turnout bar code plate located on the WS slide gate (identified as 141 and 142). [Additional Reference(s): DWR Levee Log, 1993. USACE Sacramento O&M Manual 519, June 1962 (HLM 12.94)] FS Date: 11/30/2016 9:55:46 AM

Slide gate located on WS slope. Owner information marked on gate.

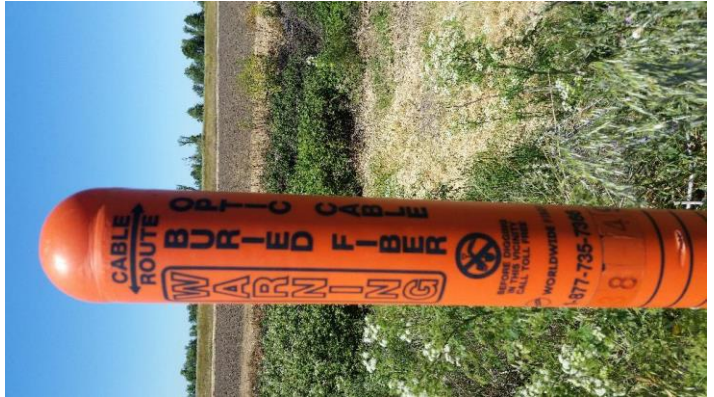
Photo 1 of 2 : UCIP\_SP\_2017\_51054\_75014.jpg

Inspector Comment					
FS_ID:51054 DS_ID:16461 EP_NO: 17030 Repair Type: Non-Urgent Crossing Status: Indicator Found UCIP Comments: 11/17/2016 Markers missing near the levee. Oly marker present is located on the East side of the Unit2 levee. (DWR Sutter Yard- AFreitag)4/28/2016 Lines lines are suspected to be located on the upstream side of the roadway bridge and not the downstream side like the coordinates in this report show. Will need to take new coordinate readings. Markers are missing near levees.7/13/2015 Unable to locate.5/21/2014 Same as last inspection.12/3/2013 Unable to locate.7/15/2013 Same as last inspection. Unable to locate any markers.4/18/2012 Attempt to locate this crossing during next inspection when tall grass is cleared from slopes-look for utility markers. FIELD_STRUCT_DESC: 8-inch high density polyethylene (HDPE) communication conduit, contains three 2-inch and three 1.5-inch fiber optic cables, backfilled with bentonite on the ends of the bore casing through the levee at an unknown depth below the crown. Conduit is bored across and under Cherokee Canal and its levees. Permit records indicates the conduit is at least 5 feet below the bottom of the low flow of the channel. Owner is listed in the permit as Pacific Fiber Link LLC but permit Inspection sheets list Worldwide Fiber. (Permit No. 17030, 2000 - Worldwide Fiber) FS Date: 11/30/2016 9:59:08 AM

Marker located along side of road about 200 yds east of levees

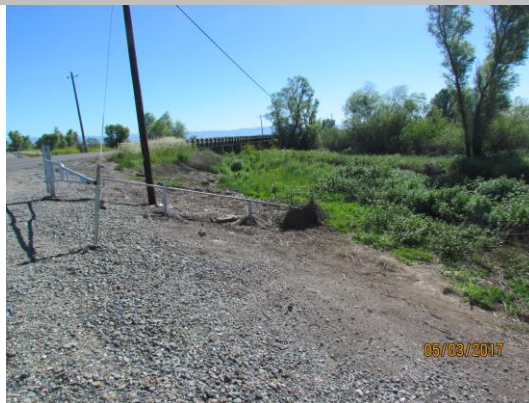
Photo 1 of 1 : SP\_2017\_MA0013\_300\_87\_20170508\_00143.jpg

LM Start	13.32	Rating **	M	Issue No.	87
LM End	13.32	Issue Type +	En	Location *	WS
Category	Earthen Levee			GPS Latitude/Longitude	
				Start	End
Item	Encroachments			39.420783 °	39.420783 °
				-121.775545 °	-121.775545 °
DWR ID	DWR_MA0013_01_s_2017_87				
Comment Code					
DE : Debris					
Inspector Comment					
Remove the debris from the waterside toe.

View of the debris on the waterside toe.

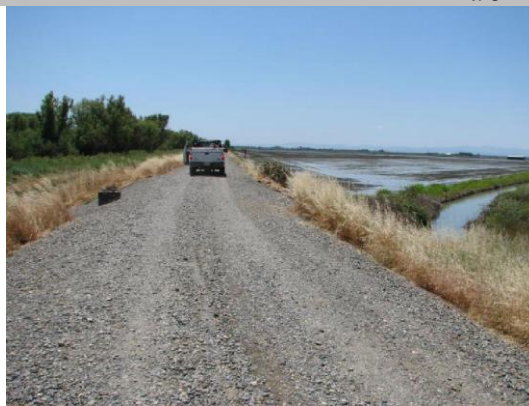
Photo 1 of 3 : UCIP\_SP\_2017\_51055\_66966.jpg

Comment Code					
Inspector Comment					
FS_ID:51055 DS_ID:16337 EP_NO: N/A Repair Type: No Action Needed Crossing Status: Found UCIP Comments: 11/17/2016 Ws pipe end was submerged but crossing appears to be in good condition. (DWR Sutter Yard-AFreitag)5/03/2016 Crossing appears to be in good condition.7/13/2015 New screwgate installed inside of WS standpipe.5/21/2014 Same as last inspection.12/3/2013 Same as last inspection.7/15/2013 Same as last inspection. FIELD_STRUCT_DESC: 24-inch corrugated metal drainage pipe through the levee, 11.1 feet below the crown. Slide gate in corrugated metal pipe (CMP) riser on the waterside (WS) slope. Concrete "U" headwalls on both ends. [Additional Reference(s): DWR Levee Log, 1993. USACE Sacramento O&M Manual 519, June 1962 (HLM 13.53)] FS Date: 11/30/2016 9:59:38 AM

Overview of levee crown at crossing looking downstream.

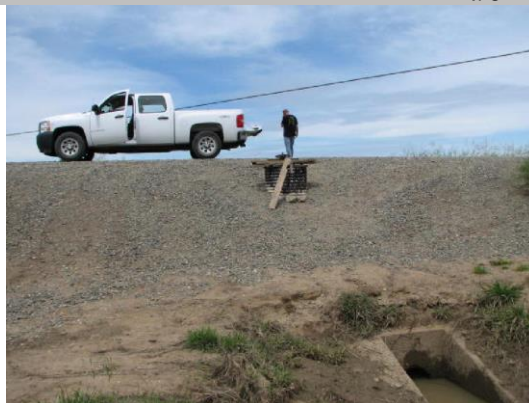
Photo 2 of 3 : UCIP\_SP\_2017\_51055\_66963.jpg

View of WS slope.

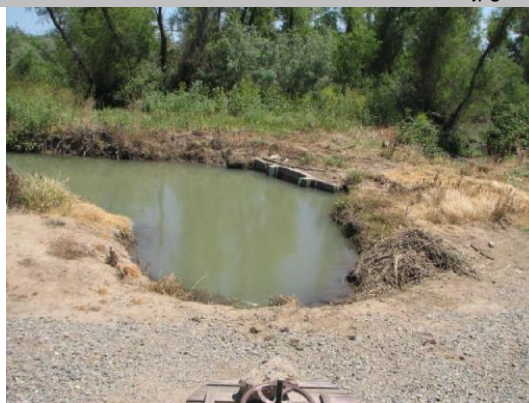
Photo 3 of 3 : UCIP\_SP\_2017\_51055\_66967.jpg

View of WS slope and channel.

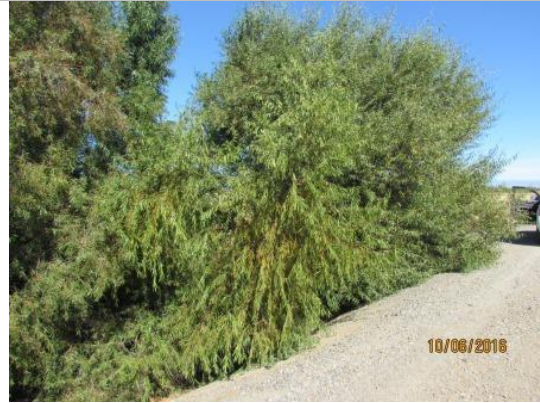
Photo 1 of 1 : SP\_2017\_MA0013\_300\_61\_20170315\_00016.jpg

LM Start	13.76	Rating **	U	Issue No.	61
LM End	13.76	Issue Type +	Ma	Location *	LS
Category	Earthen Levee			GPS Latitude/Longitude	
				Start	End
Item	Trim / Thin Trees			39.416854 °	39.416854 °
				-121.781855 °	-121.781855 °
DWR ID	DWR_MA0013_01_f _ 2016_61				
Comment Code					
T1 : Trim trees to at least five feet above ground level.					
Inspector Comment

View of the overgrown trees and vegetation along the landside slope and toe.

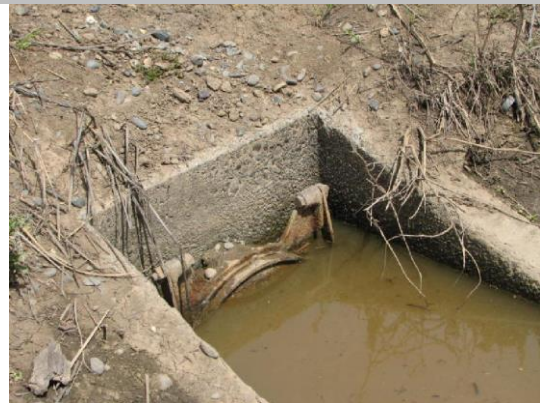
Photo 1 of 3 : UCIP\_SP\_2017\_51056\_66970.jpg

Comment Code					
Inspector Comment					
FS_ID:51056 DS_ID:16338 EP_NO: N/A Repair Type: Non-Urgent Crossing Status: Found UCIP Comments: 11/17/2016 Appears abandoned. WS flap gate completely silted over and LS screw gate is completely overgrown by a tree and is not accessible for inspection. (DWR Sutter Yard-AFreitag)5/3/2016 Crossing appears to be abandoned. WS flap gate was completely silted over and LS slide gate is very overgrown by a tree.7/13/2015 WS flap gate is blocked from opening by sediment and vegetation. Needs to be cleared away. LS opening is being over grown by a tree and needs to be cutback.5/22/2014 Same as last inspection.12/3/2013 Same as last inspection.7/15/2013 Same as last inspection.4/18/2012 Tree has fallen at LS inlet and damaged slide gate. The tree needs to be removed and screw gate repaired. Limited inspection on LS due to fallen tree. FIELD_STRUCT_DESC: 24-inch corrugated metal drainage pipe through the levee, 12.7 feet below the crown. Flap gate on the waterside (WS). Concrete "U" headwall on both ends. [Additional Reference(s): DWR Levee Log, 1993. USACE Sacramento O&M Manual 519, June 1962 (HLM 13.96)] FS Date: 11/30/2016 10:02:08 AM

WS headwall and flap gate.

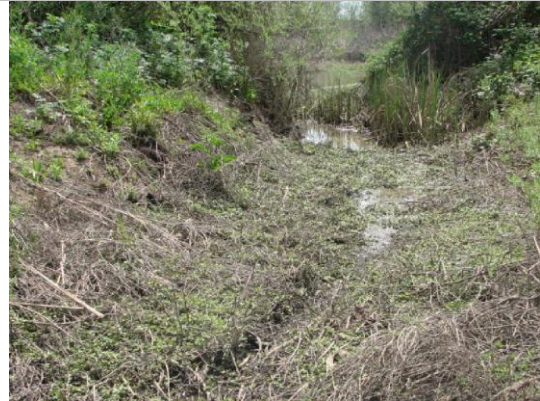
Photo 2 of 3 : UCIP\_SP\_2017\_51056\_66971.jpg

View of channel at crossing.

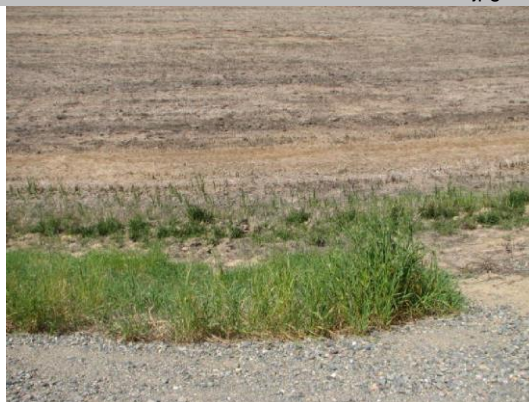
Photo 2 of 2 : UCIP\_SP\_2017\_51057\_66973.jpg

View of LS slope and toe. Unable to find welded plate on LS.

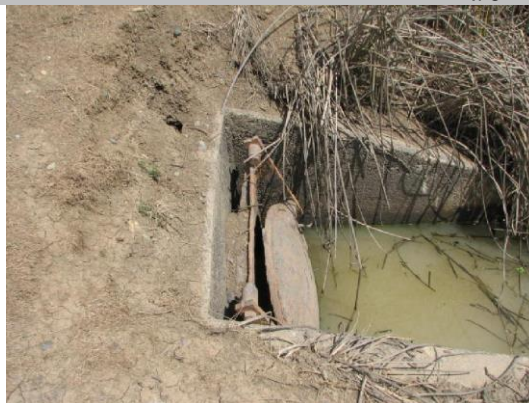
Photo 1 of 3 : UCIP\_SP\_2017\_51058\_66976.jpg

UCIP Comments: 11/17/2016 Top of pipe on WS still showing heavy signs of corrosion with visible holes between the flapgate flange and the concrete headwall. The pipe was mostly underwater so could not internally inspect it for more damage or corrosion. (DWR Sutter Yard - AFreitag)5/03/2016 Top of the pipe on the WS has holes in it between the flapgate flange and headwall. Crossing is showing signs of rust and deterioration but it was mostly underwater so could not inspect the inside of the pipe. (DWR Sutter Yard - afreitag)7/13/2015 Both sides of crossing were underwater at the time of inspection. (DWR Sutter Yard - afreitag)5/22/2014 Same as last inspection. (DWR Sutter Yard - afreitag)12/3/2013 Same as last inspection. (DWR Sutter Yard - afreitag)7/15/2013 Slopes have been cleared of vegetation and are in good condition. WS flapgate is still lodged open. (DWR Sutter Yard - afreitag)4/18/2012 Limited inspection on LS slope due to dense vegetation. Need photos of cleared WS & LS slopes. The flap gate is lodged open. (DWR UCIP - omagana)

Headwall and flapgate located on water side of levee

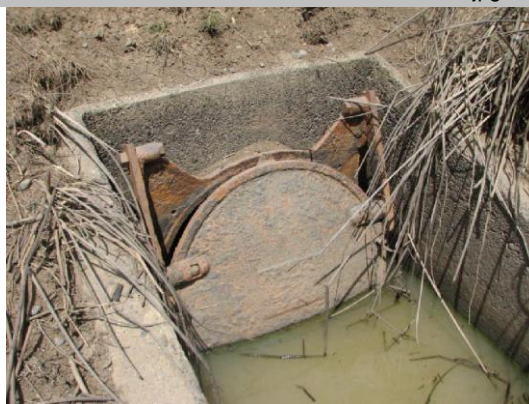
Photo 2 of 3 : UCIP\_SP\_2017\_51058\_66974.jpg

Headwall and flapgate located on water side of levee

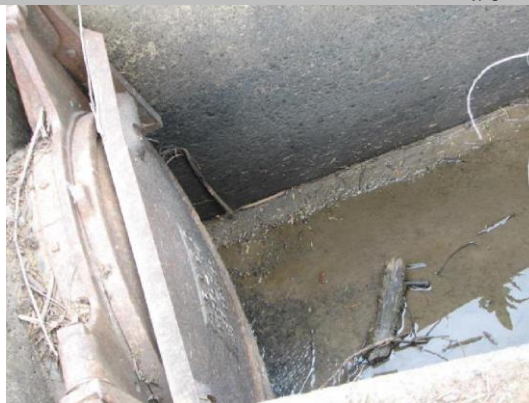
Photo 1 of 3 : UCIP\_SP\_2017\_51059\_66981.jpg

FS\_ID:51059  
DS\_ID:16367  
EP\_NO: N/A  
Repair Type: No Action Needed  
Crossing Status: Found  
UCIP Comments: 11/17/2016 Crossing appears to be in good condition. (DWR Sutter Yard- A Freitag) 5/03/2016 Crossing appears to be in good condition. 7/13/2015 Crossing appears in good condition. No noticeable issues to report. 5/22/2014 Same as last inspection. 12/3/2013 Same as last inspection. 7/15/2013 Slopes have been cleared of vegetation and are in good condition. 4/18/2012 Limited inspection on WS and LS slope due to dense vegetation. Need overall photo of crossing and photos of cleared WS & LS slopes.  
FIELD\_STRUCT\_DESC: 36-inch corrugated metal drainage pipe through the levee, 12.4 feet below the crown. Concrete "U" headwalls on both waterside (WS) and landside (LS). Flap gate on the waterside (WS) end. [Additional Reference(s): DWR Levee Log, 1993. USACE Sacramento O&M Manual 519, June 1962 (HLM 15.12)]

WS headwall and flapgate

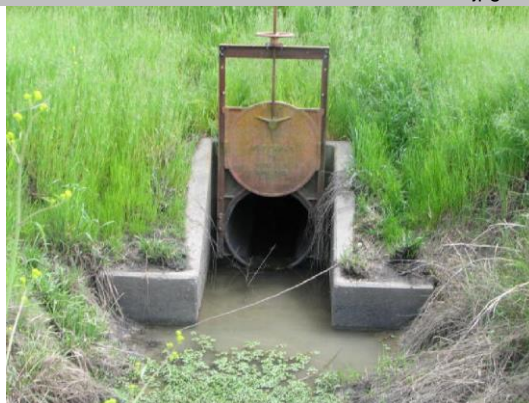
Photo 2 of 3 : UCIP\_SP\_2017\_51059\_66980.jpg

Slide gate located on LS toe. Dense vegetation present on LS slope.

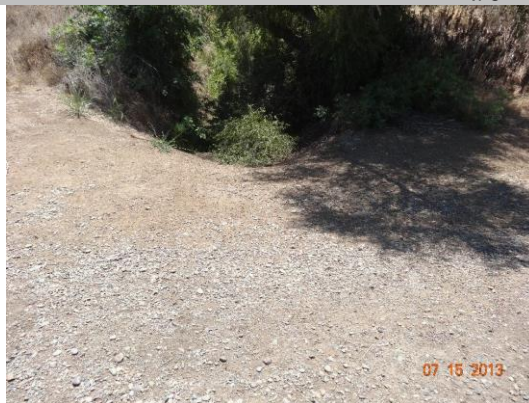
Photo 3 of 3 : UCIP\_SP\_2017\_51059\_66982.jpg

WS slope cleared of vegetation

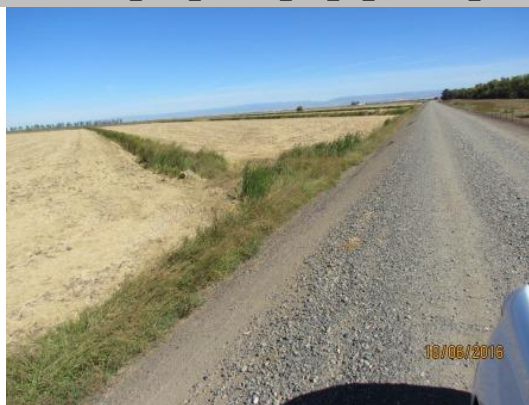
Photo 1 of 1 : SP\_2017\_MA0013\_300\_58\_20170315\_00015.jpg

LM Start	15.01	Rating **	M	Issue No.	58
LM End	15.09	Issue Type +	Ma	Location *	LS
Category	Earthen Levee			GPS Latitude/Longitude	
				Start	End
Item	Vegetation			39.405630 °	39.404872 °
				-121.800265 °	-121.801491 °
DWR ID	DWR_MA0013_01_f_2016_58				
Comment Code					
V1 : Control annual grass and weeds on the levee slopes and easements.					
Inspector Comment

View of the dense vegetation along the landside toe.

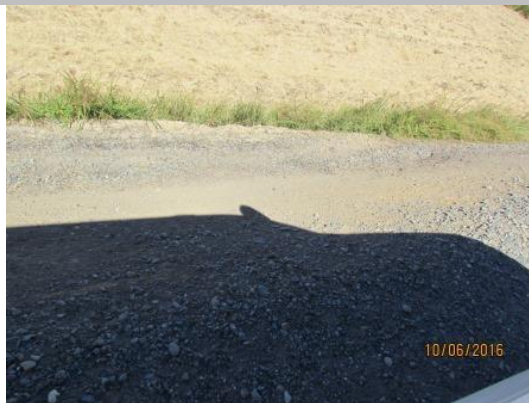
Photo 1 of 1 : SP\_2017\_MA0013\_300\_57\_20170315\_00014.jpg

LM Start	15.58	Rating **	M	Issue No.	57
LM End	15.58	Issue Type +	Ma	Location *	LS
Category	Earthen Levee			GPS Latitude/Longitude	
				Start	End
Item	Slope Stability			39.400380 °	39.400380 °
				-121.808432 °	-121.808432 °
DWR ID	DWR_MA0013_01_f_2016_57				
Comment Code					
S1 : Repair slope instability.					
Inspector Comment

View of slope instability along the landside slope.

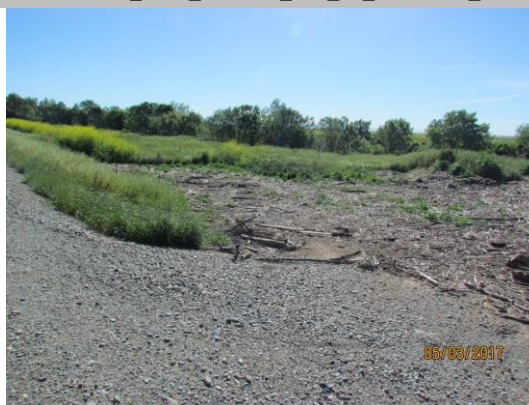
Photo 1 of 1 : SP\_2017\_MA0013\_300\_86\_20170508\_00142.jpg

LM Start	15.71	Rating **	M	Issue No.	86
LM End	15.71	Issue Type +	En	Location *	WS
Category	Earthen Levee			GPS Latitude/Longitude	
				Start	End
Item	Encroachments			39.399168 °	39.399168 °
				-121.810317 °	-121.810317 °
DWR ID	DWR_MA0013_01_s_2017_86				
Comment Code					
DE : Debris					
Inspector Comment					
Remove the debris from the waterside toe.

View of the debris along the waterside toe.

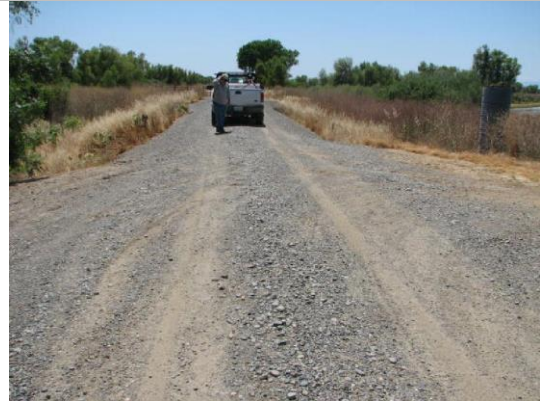
Photo 1 of 3 : UCIP\_SP\_2017\_51060\_66989.jpg

FS\_ID:51060  
DS\_ID:16364  
EP\_NO: 7521  
Repair Type: Non-Urgent  
Crossing Status: Found  
UCIP Comments: 11/17/2016 Both pipe ends underwater at time of inspection. (DWR Sutter Yard- A Freitag) 5/3/2016 Tree near the WS pipe end has been cut down. Stump is still in place. Water was too high to be able to see if the pipe inside was damaged. Minor erosion starting behind the WS headwall. 7/13/2015 WS pipe end is heavily vegetated with trees and is making it almost impossible to inspect. Needs to be cleared out. LS appears in good condition. 5/22/2014 Same as last inspection. 12/3/2013 Same as last inspection. 7/15/2013 Slopes have been cleared of vegetation and are in good condition. 4/18/2012 Limited inspection on WS and LS slopes/toe due to dense vegetation. Erosion behind headwall on WS toe. Need photos of cleared WS & LS slopes.  
FIELD\_STRUCT\_DESC: 30-inch corrugated metal drainage pipe through the levee, 13.6 feet below the crown. Flap gate on the waterside (WS) end. Concrete "U" headwalls on both ends. A 48-inch corrugated metal standpipe located approximately 12 feet from landside (LS) levee toe. (Permit No. 7521, 1972 - Askew Ranch) [Additional Reference(s): DWR Levee Log, 1993. USACE Sacramento O&M Manual 519, June 1962 (HLM 15.95)]

Overview of levee crown at crossing looking downstream.

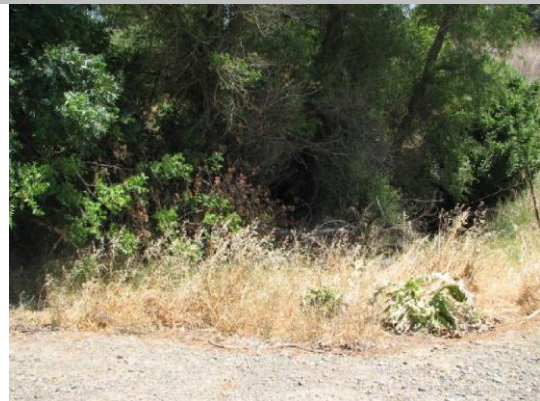
Photo 2 of 3 : UCIP\_SP\_2017\_51060\_66987.jpg

View of WS.

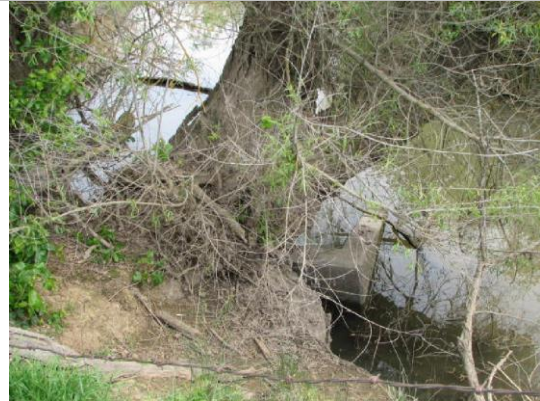
Photo 3 of 3 : UCIP\_SP\_2017\_51060\_66986.jpg

Item	DWR UCIP LMA Responsibility			39.399051 °		39.399051 °
				-121.810550 °		-121.810550 °
DWR ID						
Comment Code						
Inspector Comment						
FS_ID:51060 DS_ID:16364 EP_NO: 7521 Repair Type: Non-Urgent Crossing Status: Found UCIP Comments: 11/17/2016 Both pipe ends underwater at time of inspection. (DWR Sutter Yard- A Freitag)5/3/2016 Tree near the WS pipe end has been cut down. Stump is still in place. Water was too high to be able to see if the pipe inside was damaged. Minor erosion starting behind the WS headwall.7/13/2015 WS pipe end is heavily vegetated with trees and is making it almost impossible to inspect. Needs to be cleared out. LS appears in good condition.5/22/2014 Same as last inspection.12/3/2013 Same as last inspection.7/15/2013 Slopes have been cleared of vegetation and are in good condition.4/18/2012 Limited inspection on WS and LS slopes/toe due to dense vegetation. Erosion behind headwall on WS toe. Need photos of cleared WS & LS slopes. FIELD_STRUCT_DESC: 30-inch corrugated metal drainage pipe through the levee, 13.6 feet below the crown. Flap gate on the waterside (WS) end. Concrete "U" headwalls on both ends. A 48-inch corrugated metal standpipe located approximately 12 feet from landside (LS) levee toe. (Permit No. 7521, 1972 - Askew Ranch) [Additional Reference(s): DWR Levee Log, 1993. USACE Sacramento O&M Manual 519, June 1962 (HLM 15.95)] FS Date: 11/30/2016 10:36:52 AM

View of headwall within channel.

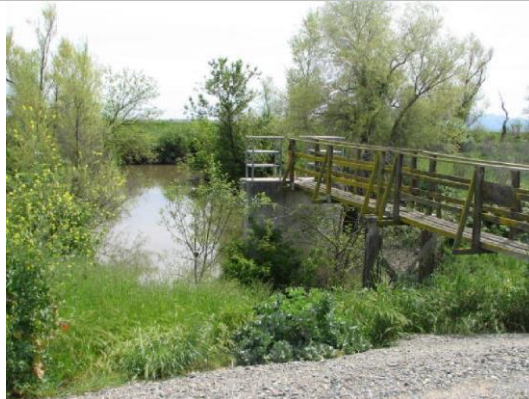
Photo 1 of 3 : UCIP\_SP\_2017\_51061\_66993.jpg

Comment Code					
Inspector Comment					
FS_ID:51061 DS_ID:16373 EP_NO: 11805B Repair Type: Non-Urgent Crossing Status: Found UCIP Comments: 11/17/2016 Both pipe ends underwater at time of inspection. (DWR Sutter Yard- A Freitag)5/03/2016 Crossing was underwater on both sides of levee during this inspection. Looks as if the wodden walkway was the same and no repairs have been made.7/13/2015 LS inlet still underwater. WS screwgate appears in good condition. Wooden walkway to the screwgate needs repairs.5/22/2014 Same as last inspection.12/3/2013 Same as last inspection.7/15/2013 Same as last inspection.4/18/2012 LS inlet is not visible-underwater. Limited inspection on WS and LS slope/toe due to dense vegetation. Need photos of cleared WS & LS slopes. FIELD_STRUCT_DESC: 48-inch reinforced concrete irrigation pipe with six concrete collars through the levee, 14.4 feet below the crown to center of conduit. Slide gate, head-wall and wood walkway on two concrete piers on the waterside (WS) of levee. Revetment on the WS slope. Irrigation ditch on the landside (LS). (Permit No. 11805, 11805B, 1979 - Elna Schohr, Inc.) [Additional Reference(s): DWR Levee Log, 1993] FS Date: 11/30/2016 10:40:33 AM

WS view of appurtenances (catwalk, slide gate, and headwall)

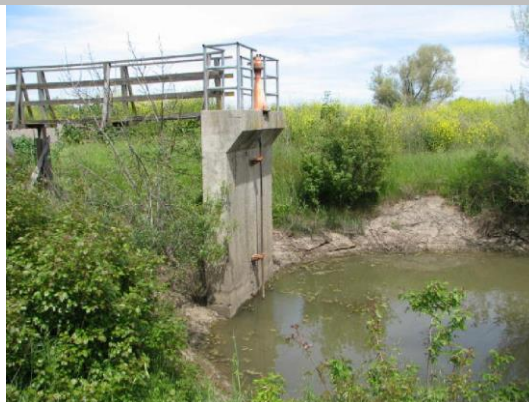
Photo 2 of 3 : UCIP\_SP\_2017\_51061\_66995.jpg

WS view of catwalk, slide/screw gate, and headwall

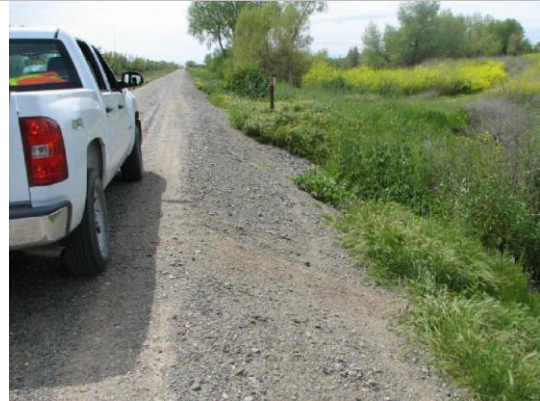
Photo 3 of 3 : UCIP\_SP\_2017\_51061\_66996.jpg

Item	DWR UCIP Field Study			39.398615 °	39.398615 °	
				-121.811250 °	-121.811250 °	
DWR ID						
Comment Code						
Inspector Comment						
FS_ID:51061 DS_ID:16373 EP_NO: 11805B Repair Type: Non-Urgent Crossing Status: Found UCIP Comments: 11/17/2016 Both pipe ends underwater at time of inspection. (DWR Sutter Yard- A Freitag)5/03/2016 Crossing was underwater on both sides of levee during this inspection. Looks as if the wooden walkway was the same and no repairs have been made.7/13/2015 LS inlet still underwater. WS screwgate appears in good condition. Wooden walkway to the screwgate needs repairs.5/22/2014 Same as last inspection.12/3/2013 Same as last inspection.7/15/2013 Same as last inspection.4/18/2012 LS inlet is not visible-underwater. Limited inspection on WS and LS slope/toe due to dense vegetation. Need photos of cleared WS & LS slopes. FIELD_STRUCT_DESC: 48-inch reinforced concrete irrigation pipe with six concrete collars through the levee, 14.4 feet below the crown to center of conduit. Slide gate, head-wall and wood walkway on two concrete piers on the waterside (WS) of levee. Revetment on the WS slope. Irrigation ditch on the landside (LS). (Permit No. 11805, 11805B, 1979 - Elna Schohr, Inc.) [Additional Reference(s): DWR Levee Log, 1993] FS Date: 11/30/2016 10:40:33 AM

LS view of shoulder and slope.

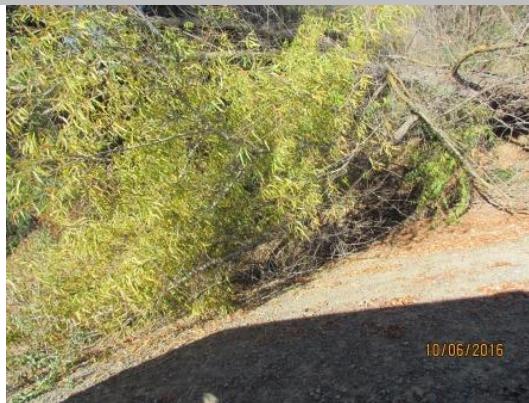
Photo 1 of 1 : SP\_2017\_MA0013\_300\_56\_20170315\_00013.jpg

LM Start	16.52	Rating **	M	Issue No.	56
LM End	16.52	Issue Type +	Ma	Location *	LS
Category	Earthen Levee			GPS Latitude/Longitude	
				Start	End
Item	Trim / Thin Trees			39.391675 °	39.391675 °
				-121.821932 °	-121.821932 °
DWR ID	DWR_MA0013_01_f_2016_56				
Comment Code					
T1 : Trim trees to at least five feet above ground level.					
Inspector Comment

View of dense trees along the landside toe.

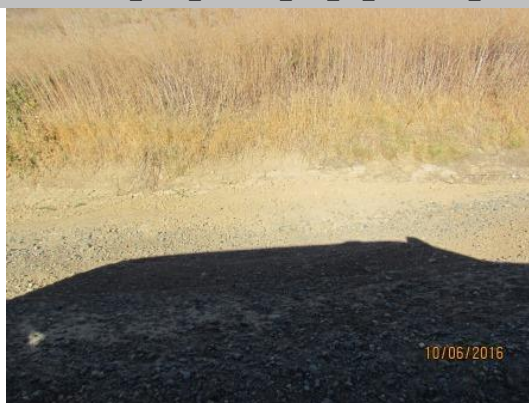
Photo 1 of 1 : SP\_2017\_MA0013\_300\_55\_20170315\_00012.jpg

LM Start	16.88	Rating **	M	Issue No.	55
LM End	16.88	Issue Type +	Ma	Location *	LS
Category	Earthen Levee			GPS Latitude/Longitude	
				Start	End
Item	Slope Stability			39.388326 °	39.388326 °
				-121.827137 °	-121.827137 °
DWR ID	DWR_MA0013_01_f_2016_55				
Comment Code					
S1 : Repair slope instability.					
Inspector Comment

View of slope instability issue along the landside slope.

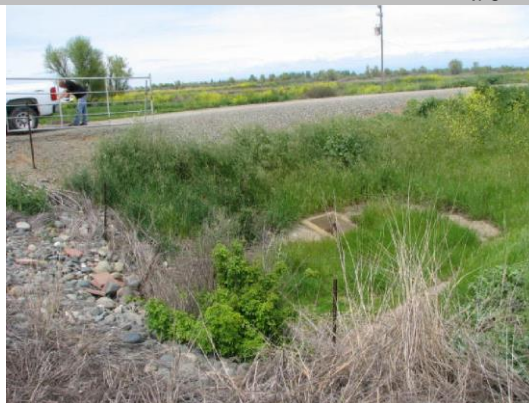
Photo 1 of 3 : UCIP\_SP\_2017\_51066\_67017.jpg

FS\_ID:51066  
DS\_ID:16369  
EP\_NO: N/A  
Repair Type: No Action Needed  
Crossing Status: Found  
UCIP Comments: 11/17/2016 Crossing appears to be in good condition. (DWR Sutter Yard- A Freitag) 5/03/2016 Crossing appears to be in good condition. 7/13/2015 WS flap gate is blocked from opening by sediment. Needs to be dug out. 5/22/2014 Same as last inspection. 12/3/2013 Sediment was dug out from WS flapgate allowing it to open. 7/15/2013 Slopes have been sprayed and cleared of vegetation and are in good condition. WS flapgate is blocked from opening by sediment buildup. 4/18/2012 Limited inspection on WS and LS slope due to dense vegetation and steep slopes. Need photos of cleared WS & LS slopes.  
FIELD\_STRUCT\_DESC: 24-inch corrugated metal drainage pipe through the levee, 8.1 feet below the crown. Flap gate on the waterside (WS). Concrete "U" headwalls on both WS and landside (LS).  
[Additional Reference(s): DWR Levee Log, 1993. USACE Sacramento O&M Manual 519, June 1962 (HLM 17.47)]

View of WS slope and toe.

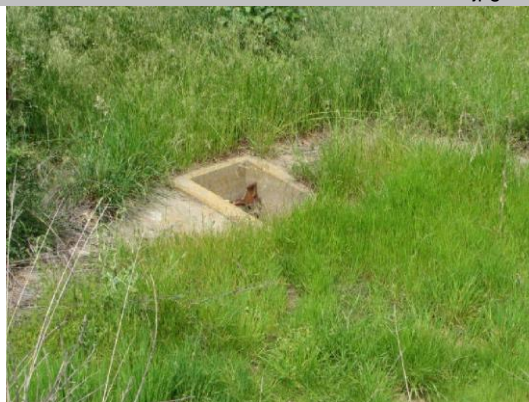
Photo 2 of 3 : UCIP\_SP\_2017\_51066\_67019.jpg

View of WS headwall and flap gate.

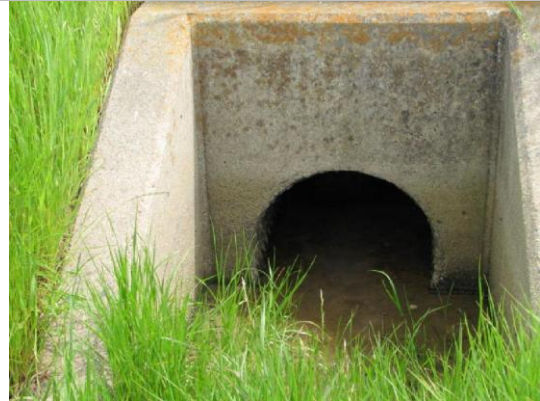
Photo 3 of 3 : UCIP\_SP\_2017\_51066\_67018.jpg

Item	DWR UCIP LMA Responsibility			39.385172 °	39.385172 °
				-121.832060 °	-121.832060 °
DWR ID					
Comment Code					
Inspector Comment					
FS_ID:51066 DS_ID:16369 EP_NO: N/A Repair Type: No Action Needed Crossing Status: Found UCIP Comments: 11/17/2016 Crossing appears to be in good condition. (DWR Sutter Yard- A Freitag)5/03/2016 Crossing appears to be in good condition.7/13/2015 WS flap gate is blocked from opening by sediment. Needs to be dug out.5/22/2014 Same as last inspection.12/3/2013 Sediment was dug out from WS flapgate allowing it to open.7/15/2013 Slopes have been sprayed and cleared of vegetation and are in good condition. WS flapgate is blocked from opening by sediment buildup.4/18/2012 Limited inspection on WS and LS slope due to dense vegetation and steep slopes. Need photos of cleared WS & LS slopes. FIELD_STRUCT_DESC: 24-inch corrugated metal drainage pipe through the levee, 8.1 feet below the crown. Flap gate on the waterside (WS). Concrete "U" headwalls on both WS and landside (LS). [Additional Reference(s): DWR Levee Log, 1993. USACE Sacramento O&M Manual 519, June 1962 (HLM 17.47)] FS Date: 11/30/2016 10:48:14 AM

View of LS headwall.

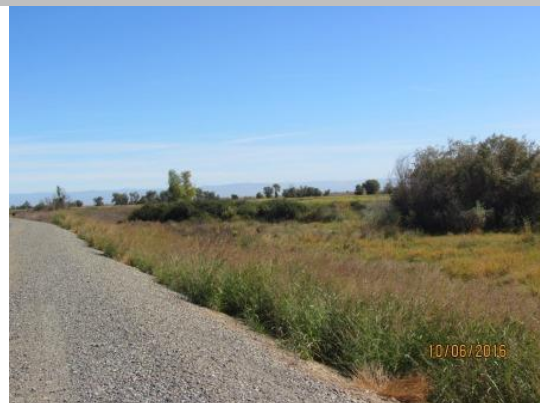
Photo 1 of 1 : SP\_2017\_MA0013\_300\_53\_20170315\_00011.jpg

LM Start	18.53	Rating **	M	Issue No.	53
LM End	18.59	Issue Type +	Ma	Location *	WS
Category	Earthen Levee			GPS Latitude/Longitude	
				Start	End
Item	Vegetation			39.373165 °	39.372718 °
				-121.850902 °	-121.851840 °
DWR ID	DWR_MA0013_01_f_2016_53				
Comment Code					
V1 : Control annual grass and weeds on the levee slopes and easements.					
Inspector Comment

View of the dense vegetation along the landside slope and toe.

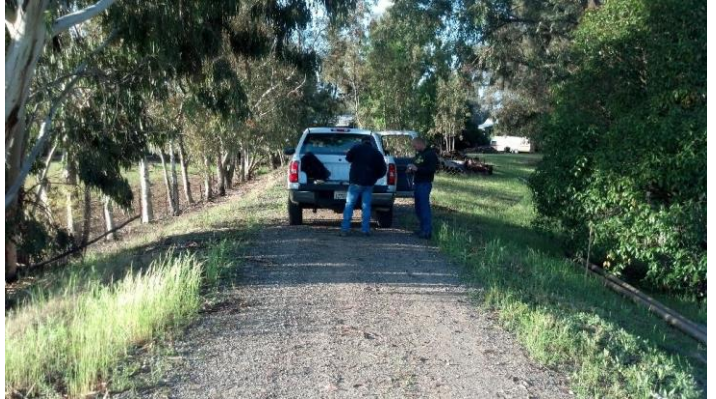
Photo 1 of 3 : UCIP\_SP\_2017\_51068\_45640.jpg

FS\_ID:51068  
DS\_ID:16397  
EP\_NO: N/A  
Repair Type: Non-Urgent  
Crossing Status: Found  
UCIP Comments: 11/18/2016 Crossing appears to be in good condition. 4inch pipe still present on LS but it does not affect the function of the crossing. (DWR Sutter Yard- AFreitag)9/27/2016 Crossing has been downgraded from Urgent to Non-Urgent--sleeved pipe does not prevent flap gate from closing on WS. Still need to coordinate with owner to remove sleeved pipe through existing crossing per Title 23. (DWR UCIP - omagana)4/27/2016 Crossing appears to be in good condition. 4 inch pipe is still present in LS opening but does not go all the way through to the WS. (DWR Sutter Yard - afreitag)7/01/2015 Crossing appears in good condition. No noticeable issues to report. (DWR Sutter Yard - afreitag)5/29/2014 Same as last inspection. (DWR Sutter Yard - afreitag)12/9/2013 4in. Pipe was removed and flapgate is closed and ready for high water. (DWR Sutter Yard - afreitag)7/10/2013 Same as last inspection. Urgency rating carry over from last entry. (DWR Sutter Yard - afreitag)4/19/2012 4-6 inch pipe is not part of original crossing--remove pipe. WS-pipe stockpile on WS slope. LS-Overgrown branches limit inspection. This crossing was listed in the USACE Periodic Inspection report listed as Corp's Inspect ID# USACE\_CESPK\_M13G\_2011\_p\_0009 for WS flap gate not functioning properly as irrigation pipe passes inside crossing. (DWR UCIP - omagana)

Overview looking south on left levee

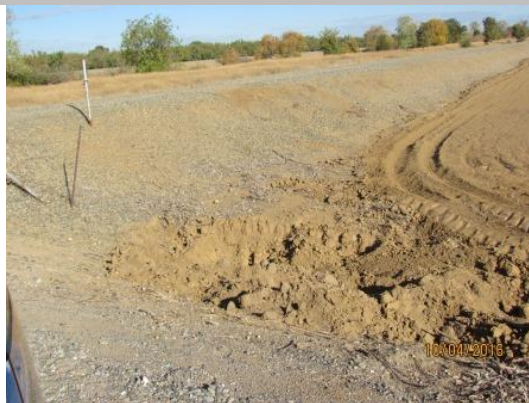
Photo 1 of 1 : SP\_2017\_MA0013\_301\_53\_20170315\_00013.jpg

LM Start	0.21	Rating **	M	Issue No.	53
LM End	0.56	Issue Type +	En	Location *	LS
Category	Earthen Levee			GPS Latitude/Longitude	
				Start	End
Item	Encroachments			39.571821 °	39.566737 °
				-121.702372 °	-121.702316 °
DWR ID	DWR_MA0013_02_f_2016_53				
Comment Code					
AT : Agricultural tilling					
Inspector Comment					
Monitor the tilling to make sure farmer is not encroaching into the levee.

View of ag tilling at the landside levee toe.

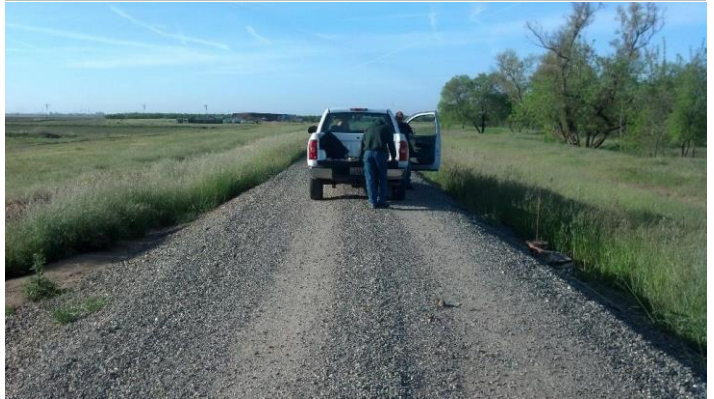
Photo 1 of 3 : UCIP\_SP\_2017\_51069\_67047.jpg

FS\_ID:51069  
DS\_ID:16398  
EP\_NO: N/A  
Repair Type: Non-Urgent  
Crossing Status: Found  
UCIP Comments: 11/18/2016 Between the screwgate on the WS shoulder and the LS pipe end the pipe is about 50% full of soil. Crossing is still actively used by landowner for irrigation purposes. (DWR Sutter Yard- A/Freitag)4/27/2016 Pipe gets used by the landowner to irrigate his rice fields. It appeared to be in good condition.7/01/2015 LS pipe end is still about 50% full of sediment.5/29/2014 Same as last inspection.12/9/2013 Same as last inspection.7/10/2013 LS and WS slopes have been cleared of vegetation and are in good condition. LS pipe end is half full of sediment. Sediment inside of WS standpipe may hinder slide gate from fully closing. Standpipe cover is still broken.4/19/2012 Need to fix the top of slide gate cover. The wooden cap on standpipe is broken. Limited evaluation of crossing due to dense vegetation on LS slope. Need photos of cleared slopes during fall inspection.

Overview looking south

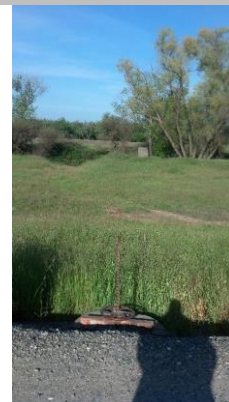
Photo 2 of 3 : UCIP\_SP\_2017\_51069\_67048.jpg

View of WS slope and toe.
