**Flood Control Project Maintenance  
Levee Inspections**  
**LMA District Cover Sheet**  
**Spring 2017 Levee Inspection Results**

**Sutter Maintenance Yard Maintenance Area 0013**

**Spring 2017 Levee Inspection Results**

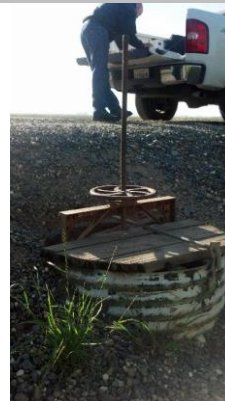
Photo 3 of 3 : UCIP\_SP\_2017\_51069\_67045.jpg

Item	DWR UCIP LMA Responsibility			39.566479 °		39.566479 °
				-121.702430 °		-121.702430 °
DWR ID						
Comment Code						
Inspector Comment						
FS_ID:51069 DS_ID:16398 EP_NO: N/A Repair Type: Non-Urgent Crossing Status: Found UCIP Comments: 11/18/2016 Between the screwgate on the WS shoulder and the LS pipe end the pipe is about 50% full of soil. Crossing is still actively used by landowner for irrigation purposes. (DWR Sutter Yard- A/Freitag)4/27/2016 Pipe gets used by the landowner to irrigate his rice fields. It appeared to be in good condition.7/01/2015 LS pipe end is still about 50% full of sediment.5/29/2014 Same as last inspection.12/9/2013 Same as last inspection.7/10/2013 LS and WS slopes have been cleared of vegetation and are in good condition. LS pipe end is half full of sediment. Sediment inside of WS standpipe may hinder slide gate from fully closing. Standpipe cover is still broken.4/19/2012 Need to fix the top of slide gate cover. The wooden cap on standpipe is broken. Limited evaluation of crossing due to dense vegetation on LS slope. Need photos of cleared slopes during fall inspection. FIELD_STRUCT_DESC: 24-inch corrugated metal drainage pipe through the levee, 10.6 feet below the crown. Slide gate in corrugated metal pipe (CMP) riser on the waterside (WS) slope. Concrete "U" headwall on the landside (LS). 36-inch concrete standpipe in the channel with two wooden piles to deflect debris. [Additional Reference(s): DWR Levee Log, 1993. USACE Sacramento O&M Manual 519, June 1962 (HLM 0.57)] FS Date: 11/30/2016 12:38:12 PM

Screw gate located on WS of levee. Screw gate covers needs to be repaired.

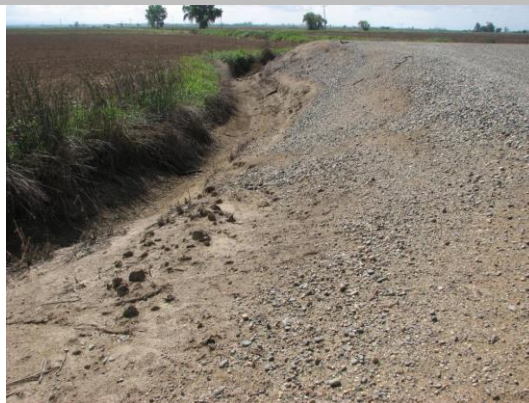
Photo 1 of 1 : SP\_2017\_MA0013\_301\_56\_20170315\_00016.jpg

LM Start	1.60	Rating **	U	Issue No.	56
LM End	1.63	Issue Type +	En	Location *	LS
Category	Earthen Levee			GPS Latitude/Longitude	
				Start	End
Item	Encroachments			39.552195 °	39.551731 °
				-121.704786 °	-121.704721 °
DWR ID	DWR_MA0013_02_s_2016_56				
Comment Code					
DT : Ditch					
Inspector Comment

View of the agricultural ditch along the landside toe.

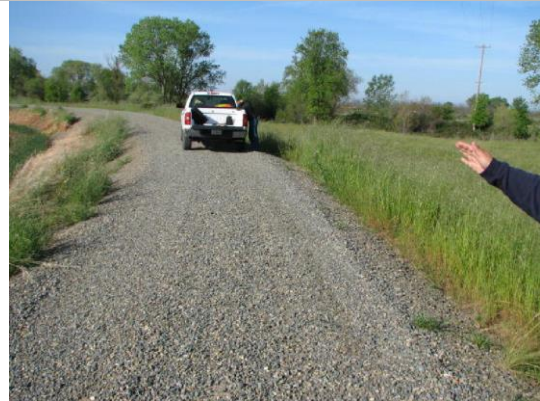
Photo 1 of 3 : UCIP\_SP\_2017\_51071\_67059.jpg

FS\_ID:51071  
DS\_ID:16399  
EP\_NO: N/A  
Repair Type: Non-Urgent  
Crossing Status: Found  
UCIP Comments: 11/18/2016 LS screw gate still bent and in-operable. (DWR Sutter Yard- A Freitag) 4/27/2016 LS screw gate is still bent. Rest of crossing appeared in good condition. 7/01/2015 LS screw gate frame is still twisted and hindering the gate from opening. 5/29/2014 Same as last inspection. 12/9/2013 Same as last inspection. 7/10/2013 WS slope is cleared of vegetation and is in good condition. LS screw gate frame is twisted and is preventing the gate from opening. 4/19/2012 Limited inspection dense vegetation on WS. Need photos of clear WS slope & toe. Ditch present in channel? This crossing was listed in the USACE Periodic Inspection report as Corp's Inspect ID# USACE\_CESPK\_M13G\_2011\_p\_0108 for WS flap gate filled with soil and LS gate not functioning because of overgrown vegetation.  
FIELD\_STRUCT\_DESC: 24-inch corrugated metal drainage pipe through the levee, 7.9 feet below the crown. Concrete "U" headwalls on both waterside (WS) and landside (LS) ends. Flap gate on the WS end. Slide gate at the LS toe in headwall. In 1962, permit number 3953 was issue for existing pump structure, intake box, ditch and power pole. In 1963, the pump and intake box were removed. (Permit No. 3953, 1960 - Dr. John O. Gibbs, DBA Empire Land Company) [Additional Reference(s): DWR Levee Log, 1993. USACE Sacramento O&M Manual 519, June 1962 (HLM 1.70)]

Overview of crossing

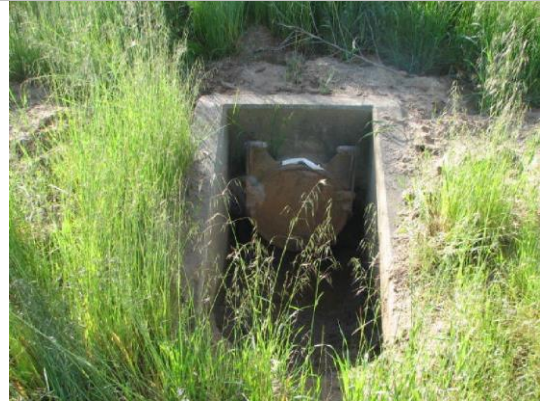
Photo 2 of 3 : UCIP\_SP\_2017\_51071\_67058.jpg

FS\_ID:51071  
DS\_ID:16399  
EP\_NO: N/A  
Repair Type: Non-Urgent  
Crossing Status: Found  
UCIP Comments: 11/18/2016 LS screw gate still bent and in-operable. (DWR Sutter Yard- A Freitag) 4/27/2016 LS screw gate is still bent. Rest of crossing appeared in good condition. 7/01/2015 LS screw gate frame is still twisted and hindering the gate from opening. 5/29/2014 Same as last inspection. 12/9/2013 Same as last inspection. 7/10/2013 WS slope is cleared of vegetation and is in good condition. LS screw gate frame is twisted and is preventing the gate from opening. 4/19/2012 Limited inspection dense vegetation on WS. Need photos of clear WS slope & toe. Ditch present in channel? This crossing was listed in the USACE Periodic Inspection report as Corp's Inspect ID# USACE\_CESPK\_M13G\_2011\_p\_0108 for WS flap gate filled with soil and LS gate not functioning because of overgrown vegetation.  
FIELD\_STRUCT\_DESC: 24-inch corrugated metal drainage pipe through the levee, 7.9 feet below the crown. Concrete "U" headwalls on both waterside (WS) and landside (LS) ends. Flap gate on the WS end. Slide gate at the LS toe in headwall. In 1962, permit number 3953 was issued for existing pump structure, intake box, ditch and power pole. In 1963, the pump and intake box were removed. (Permit No. 3953, 1960 - Dr. John O. Gibbs, DBA Empire Land Company) [Additional Reference(s): DWR Levee Log, 1993. USACE Sacramento O&M Manual 519, June 1962 (HLM 1.70)]

View of flap gate on WS.

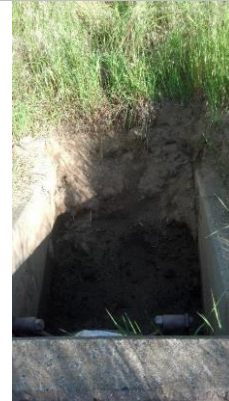
Photo 3 of 3 : UCIP\_SP\_2017\_51071\_67057.jpg

Comment Code					
Inspector Comment					
FS_ID:51071 DS_ID:16399 EP_NO: N/A Repair Type: Non-Urgent Crossing Status: Found UCIP Comments: 11/18/2016 LS screw gate still bent and in-operable. (DWR Sutter Yard- A Freitag)4/27/2016 LS screw gate is still bent. Rest of crossing appeared in good condition.7/01/2015 LS screw gate frame is still twisted and hindering the gate from opening.5/29/2014 Same as last inspection.12/9/2013 Same as last inspection.7/10/2013 WS slope is cleared of vegetation and is in good condition. LS screw gate frame is twisted and is preventing the gate from opening.4/19/2012 Limited inspection dense vegetation on WS. Need photos of clear WS slope & toe. Ditch present in channel? This crossing was listed in the USACE Periodic Inspection report as Corp's Inspect ID# USACE_CESPK_M13G_2011_p_0108 for WS flap gate filled with soil and LS gate not functioning because of overgrown vegetation. FIELD_STRUCT_DESC: 24-inch corrugated metal drainage pipe through the levee, 7.9 feet below the crown. Concrete "U" headwalls on both waterside (WS) and landside (LS) ends. Flap gate on the WS end. Slide gate at the LS toe in headwall. In 1962, permit number 3953 was issue for existing pump structure, intake box, ditch and power pole. In 1963, the pump and intake box were removed. (Permit No. 3953, 1960 - Dr. John O. Gibbs, DBA Empire Land Company) [Additional Reference(s): DWR Levee Log, 1993. USACE Sacramento O&M Manual 519, June 1962 (HLM 1.70)] FS Date: 11/30/2016 12:41:27 PM

View of WS toe.

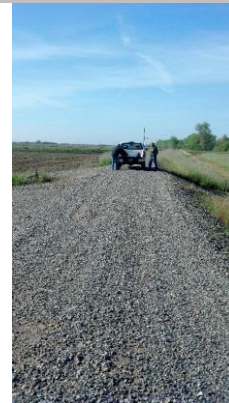
Photo 1 of 3 : UCIP\_SP\_2017\_51072\_67063.jpg

Comment Code					
Inspector Comment					
FS_ID:51072 DS_ID:16400 EP_NO: N/A Repair Type: No Action Needed Crossing Status: Found UCIP Comments: 11/18/2016 Sediment dug out from in front of flap gate. Gate can now function properly. (DWR Sutter Yard-AFreitag)4/27/2016 WS flapgate still blocked from opening by sediment buildup.7/01/2015 New screwgate installed on the LS. WS flapgate is still blocked from opening by sediment.5/29/2014 Same as last inspection.12/9/2013 Same as last inspection.7/10/2013 Sediment is built up against WS flap gate not allowing it to open. Handle for LS slide gate is still missing.4/19/2012 Handle missing on slide gate. FIELD_STRUCT_DESC: 1 of 2: 36-inch corrugated metal drainage pipe through the levee, 9.7 feet below the crown. Concrete "U" headwalls located on the waterside (WS) and landside (LS) ends. Flap gate on the WS end. Slide gate on the LS end. [Additional Reference(s): DWR Levee Log, 1993. USACE Sacramento O&M Manual 519, June 1962 (HLM 2.54)] FS Date: 11/30/2016 12:42:19 PM

Overview of levee crown looking south

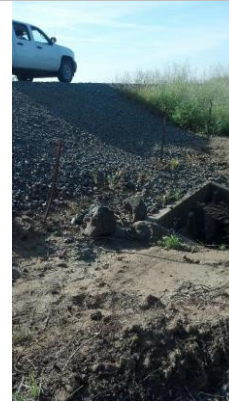
Photo 2 of 3 : UCIP\_SP\_2017\_51072\_67068.jpg

LM Start	<b>2.53</b>	Rating **	A/W	Issue No.	<b>915 (cont)</b>
LM End	<b>2.53</b>	Issue Type +	Ma	Location *	WS

View of WS slope.

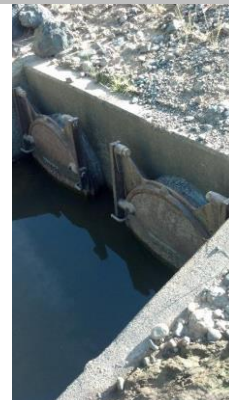
Photo 3 of 3 : UCIP\_SP\_2017\_51072\_67064.jpg

Comment Code					
Inspector Comment					
FS_ID:51072 DS_ID:16400 EP_NO: N/A Repair Type: No Action Needed Crossing Status: Found UCIP Comments: 11/18/2016 Sediment dug out from in front of flap gate. Gate can now function properly. (DWR Sutter Yard-AFreitag)4/27/2016 WS flapgate still blocked from opening by sediment buildup.7/01/2015 New screwgate installed on the LS. WS flapgate is still blocked from opening by sediment.5/29/2014 Same as last inspection.12/9/2013 Same as last inspection.7/10/2013 Sediment is built up against WS flap gate not allowing it to open. Handle for LS slide gate is still missing.4/19/2012 Handle missing on slide gate. FIELD_STRUCT_DESC: 1 of 2: 36-inch corrugated metal drainage pipe through the levee, 9.7 feet below the crown. Concrete "U" headwalls located on the waterside (WS) and landside (LS) ends. Flap gate on the WS end. Slide gate on the LS end. [Additional Reference(s): DWR Levee Log, 1993. USACE Sacramento O&M Manual 519, June 1962 (HLM 2.54)] FS Date: 11/30/2016 12:42:19 PM

Headwall and flap gates (2) located on WS

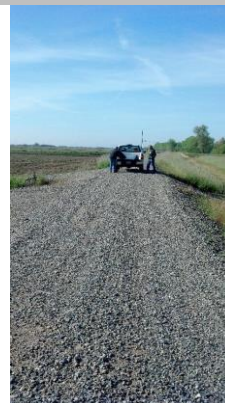
Photo 1 of 3 : UCIP\_SP\_2017\_51073\_67075.jpg

Comment Code					
Inspector Comment					
FS_ID:51073 DS_ID:17169 EP_NO: N/A Repair Type: No Action Needed Crossing Status: Found UCIP Comments: 11/18/2016 Crossing appears to be in good condition. (DWR Sutter Yard- AFreitag)4/27/2016 Crossing appears to be in good condition.7/01/2015 New screwgate installed on the LS. WS appears to be in good condition.5/29/2014 Same as last inspection.12/9/2013 Same as last inspection.7/10/2013 Same as last inspection. FIELD_STRUCT_DESC: 2 of 2: 36-inch corrugated metal drainage pipe through the levee, 9.7 feet below the crown. Concrete "U" headwalls on both the waterside (WS) and landside (LS) ends. Flap gate on the waterside (WS) end. Slide gate on the landside (LS) end. [Additional Reference(s): DWR Levee Log, 1993. USACE Sacramento O&M Manual 519, June 1962 (HLM 2.54)] FS Date: 11/30/2016 12:45:01 PM

Overview at levee crown looking south

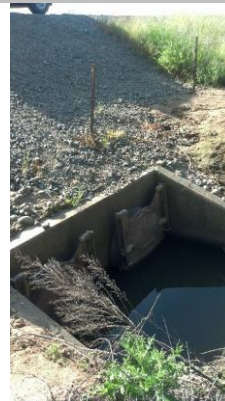
Photo 3 of 3 : UCIP\_SP\_2017\_51073\_67071.jpg

Comment Code					
Inspector Comment					
FS_ID:51073 DS_ID:17169 EP_NO: N/A Repair Type: No Action Needed Crossing Status: Found UCIP Comments: 11/18/2016 Crossing appears to be in good condition. (DWR Sutter Yard- AFreitag)4/27/2016 Crossing appears to be in good condition.7/01/2015 New screwgate installed on the LS. WS appears to be in good condition.5/29/2014 Same as last inspection.12/9/2013 Same as last inspection.7/10/2013 Same as last inspection. FIELD_STRUCT_DESC: 2 of 2: 36-inch corrugated metal drainage pipe through the levee, 9.7 feet below the crown. Concrete "U" headwalls on both the waterside (WS) and landside (LS) ends. Flap gate on the waterside (WS) end. Slide gate on the landside (LS) end. [Additional Reference(s): DWR Levee Log, 1993. USACE Sacramento O&M Manual 519, June 1962 (HLM 2.54)] FS Date: 11/30/2016 12:45:01 PM

Headwall and flap gates (2) located on the WS.

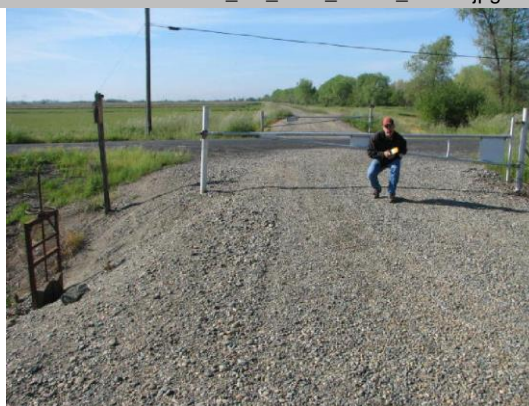
Photo 1 of 3 : UCIP\_SP\_2017\_51074\_67077.jpg

LM Start	<b>2.62</b>	Rating **	M	Issue No.	<b>917 (cont)</b>
LM End	<b>2.62</b>	Issue Type +	Ma	Location *	WS

Overview looking south from left levee

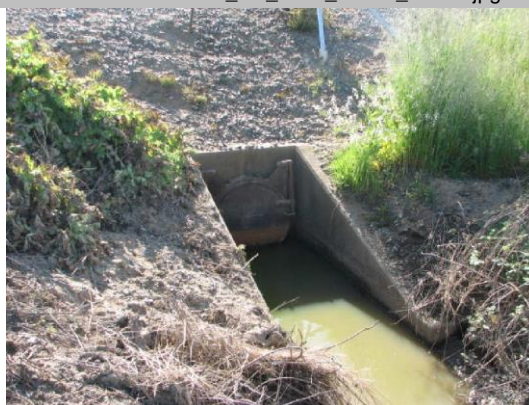
Photo 2 of 3 : UCIP\_SP\_2017\_51074\_67076.jpg

FS\_ID:51074  
DS\_ID:16402  
EP\_NO: N/A  
Repair Type: Non-Urgent  
Crossing Status: Found  
UCIP Comments: 11/18/2016 Sediment still blocking screw gate from fully closing. (DWR Sutter Yard- AFreitag)4/27/2016 LS slide gate is full of sediment and needs to be dug out so gate can close fully.7/01/2015 LS screwgate is still silted in and unable to be screwed down all the way. Needs to be cleaned out.5/29/2014 Same as last inspection.12/9/2013 WS flapgate was closed but LS slidegate is heavily vegetated and blocked from closing by sediment.7/10/2013 Same as last inspection.4/19/2012 Minor sediment built up on LS, remove sediment. Need photo of LS slide gate without sediment build up. This crossing was listed in the USACE Periodic Inspection report as Corp's inspect ID# USACE\_CESPK\_M13G\_2011\_p\_0148 for LS gate obstructed by vegetation and WS flap gate is not functioning (propped open). FIELD\_STRUCT\_DESC: 36-inch corrugated metal drainage pipe through the levee, 8.8 feet below the crown. Concrete "U" headwalls located on both the waterside (WS) and landside (LS) ends. Flap gate on the WS end. Slide gate on the LS end. Structure used to drain water from Nelson Shippe Road. [Additional Reference(s): DWR Levee Log, 1993. USACE Sacramento O&M Manual 519, June 1962 (HLM 2.63)]

Headwall and flap gate located on WS.

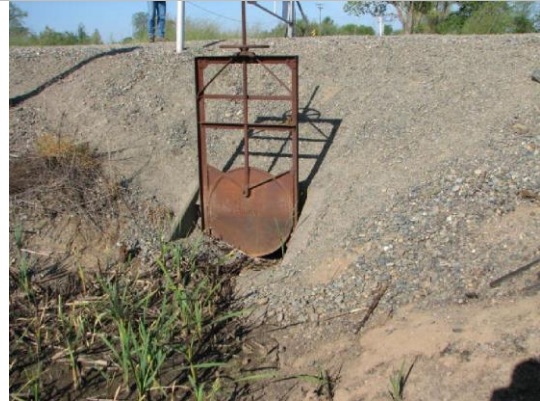
Photo 3 of 3 : UCIP\_SP\_2017\_51074\_67078.jpg

FS\_ID:51074  
DS\_ID:16402  
EP\_NO: N/A  
Repair Type: Non-Urgent  
Crossing Status: Found  
UCIP Comments: 11/18/2016 Sediment still blocking screw gate from fully closing. (DWR Sutter Yard- AFreitag)4/27/2016 LS slide gate is full of sediment and needs to be dug out so gate can close fully.7/01/2015 LS screwgate is still silted in and unable to be screwed down all the way. Needs to be cleaned out.5/29/2014 Same as last inspection.12/9/2013 WS flapgate was closed but LS slidegate is heavily vegetated and blocked from closing by sediment.7/10/2013 Same as last inspection.4/19/2012 Minor sediment built up on LS, remove sediment. Need photo of LS slide gate without sediment build up. This crossing was listed in the USACE Periodic Inspection report as Corp's inspect ID# USACE\_CESPK\_M13G\_2011\_p\_0148 for LS gate obstructed by vegetation and WS flap gate is not functioning (propped open). FIELD\_STRUCT\_DESC: 36-inch corrugated metal drainage pipe through the levee, 8.8 feet below the crown. Concrete "U" headwalls located on both the waterside (WS) and landside (LS) ends. Flap gate on the WS end. Slide gate on the LS end. Structure used to drain water from Nelson Shippe Road. [Additional Reference(s): DWR Levee Log, 1993. USACE Sacramento O&M Manual 519, June 1962 (HLM 2.63)]

Headwall and screw gate located on LS.

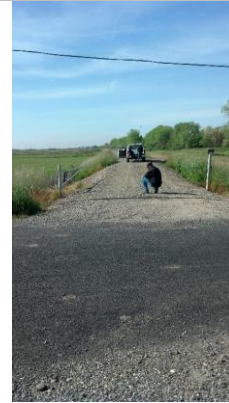
Photo 1 of 3 : UCIP\_SP\_2017\_51076\_67087.jpg

LM Start	<b>2.63</b>	Rating **	M	Issue No.	<b>918 (cont)</b>
LM End	<b>2.63</b>	Issue Type +	Ma	Location *	WS

Overview at levee crown looking south

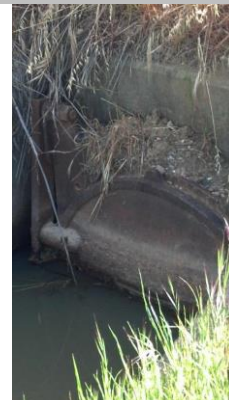
Photo 2 of 3 : UCIP\_SP\_2017\_51076\_67084.jpg

Comment Code					
Inspector Comment					
FS_ID:51076 DS_ID:16403 EP_NO: N/A Repair Type: Non-Urgent Crossing Status: Found UCIP Comments: 11/18/2016 Crossing appears to be in good condition. (DWR Sutter Yard- AFreitag)4/27/2016 Crossing appears to be in good condition.7/01/2015 WS flap gate is partially blocked by sediment and needs to be cleaned.5/29/2014 Same as last inspection.12/9/2013 Same as last inspection.7/10/2013 LS and WS slopes have been cleared of vegetation and are in good condition.4/19/2012 Burrowing holes located above WS headwall. Limited inspection on WS and LS slopes due to dense vegetation. Need photos of cleared WS & LS slopes. FIELD_STRUCT_DESC: 36-inch corrugated metal drainage pipe through the levee, 8.7 feet below the crown. Concrete "U" headwalls located on the waterside (WS) and landside (LS) ends. Flap gate on the WS end. Slide gate on the LS end. [Additional Reference(s): DWR Levee Log, 1993. USACE Sacramento O&M Manual 519, June 1962 (HLM 2.65)] FS Date: 11/30/2016 1:02:00 PM

Headwall and flap gate located on WS

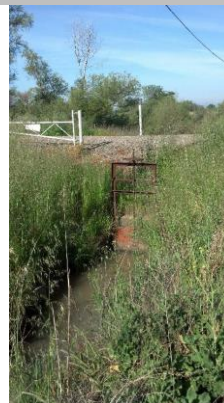
Photo 3 of 3 : UCIP\_SP\_2017\_51076\_67086.jpg

Item	DWR UCIP LMA Responsibility			39.537671 °		39.537671 °
				-121.706210 °		-121.706210 °
DWR ID						
Comment Code						
Inspector Comment						
FS_ID:51076 DS_ID:16403 EP_NO: N/A Repair Type: Non-Urgent Crossing Status: Found UCIP Comments: 11/18/2016 Crossing appears to be in good condition. (DWR Sutter Yard- AFreitag)4/27/2016 Crossing appears to be in good condition.7/01/2015 WS flap gate is partially blocked by sediment and needs to be cleaned.5/29/2014 Same as last inspection.12/9/2013 Same as last inspection.7/10/2013 LS and WS slopes have been cleared of vegetation and are in good condition.4/19/2012 Burrowing holes located above WS headwall. Limited inspection on WS and LS slopes due to dense vegetation. Need photos of cleared WS & LS slopes. FIELD_STRUCT_DESC: 36-inch corrugated metal drainage pipe through the levee, 8.7 feet below the crown. Concrete "U" headwalls located on the waterside (WS) and landside (LS) ends. Flap gate on the WS end. Slide gate on the LS end. [Additional Reference(s): DWR Levee Log, 1993. USACE Sacramento O&M Manual 519, June 1962 (HLM 2.65)] FS Date: 11/30/2016 1:02:00 PM

Headwall and screw gate located on the LS

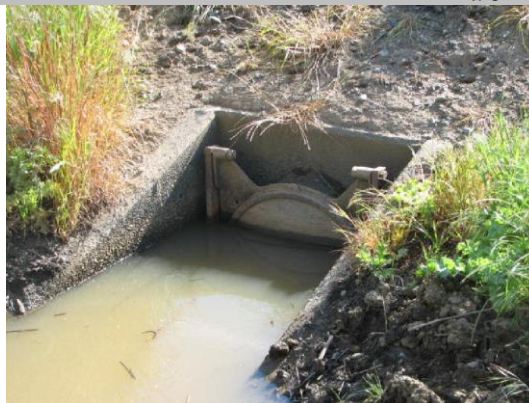
Photo 3 of 3 : UCIP\_SP\_2017\_51078\_67092.jpg

Item	DWR UCIP LMA Responsibility			39.537466 °		39.537466 °
				-121.706240 °		-121.706240 °
DWR ID						
Comment Code						
Inspector Comment						
FS_ID:51078 DS_ID:16415 EP_NO: N/A Repair Type: Non-Urgent Crossing Status: Found UCIP Comments: 11/18/2016 LS screw gate closed but partially buried. WS flapgate was half submerged for inspection. (DWR Sutter Yard- A Freitag)4/27/2016 Both gates were underwater for inspection.7/01/2015 WS flap gate is partially held open by sediment and needs to be dug out to allow it to fully close.5/29/2014 Same as last inspection.12/9/2013 Both gates were out of water and in good condition.7/10/2013 LS and WS slopes are in good condition. Both LS and WS gates were fully submerged in water and unable to be inspected. FIELD_STRUCT_DESC: 36-inch corrugated metal drainage pipe through the levee, 9 feet below the crown. Concrete "U" headwall on both waterside (WS) and landside (LS) ends. Flap gate on the WS end. Slide gate on the LS. [Additional Reference(s): DWR Levee Log, 1993. USACE Sacramento O&M Manual 519, June 1962 (HLM 2.66)] FS Date: 11/30/2016 1:04:40 PM

WS headwall and flap gate.

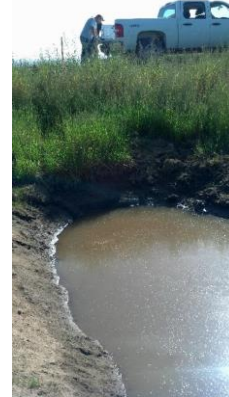
Photo 2 of 3 : UCIP\_SP\_2017\_51079\_67095.jpg

FS\_ID:51079  
DS\_ID:16405  
EP\_NO: N/A  
Repair Type: Non-Urgent  
Crossing Status: Found  
UCIP Comments: 11/18/2016 appears abandoned. Both gates completely buried. (DWR Sutter Yard- A Freitag) 4/27/2016 Crossing appears abandoned. LS screw gate still buried and WS flap gate was 95% buried. 7/01/2015 Still a non functioning crossing. LS screw gate is completely buried by sediment with only part of its frame and stem visible. WS flapgate is blocked from opening by sediment and debris. 5/29/2014 Same as last inspection. 12/9/2013 LS slide gate is completely buried by soil and WS flap gate is blocked from opening by sediment. Crossing appears abandoned and non-function.

7/10/2013 LS and WS slopes have been cleared by vegetation and are in good condition. WS flap gate is out of water but is blocked from opening by sediment build up. LS gate is fully submerged and not able to be inspected. 4/19/2012 Non-functioning crossing. Farmer uses pipe located at LM 3.682 to drain field & not this one. Dense vegetation- need photos of cleared WS & LS slopes. This crossing was listed in the USACE Periodic Inspection report as Corp's inspect ID# USACE\_CESPK\_M13G\_2011\_p\_0172 for no access to WS gate due to high water & dense vegetation.

Flap gate submerged in water on WS of levee

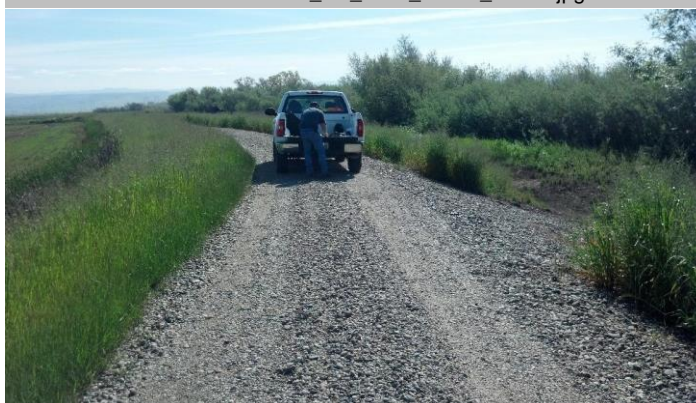
Photo 1 of 3 : UCIP\_SP\_2017\_51080\_67102.jpg

LM Start	<b>3.65</b>	Rating **	A/W	Issue No.	<b>921 (cont)</b>
LM End	<b>3.65</b>	Issue Type +	Ma	Location *	WS

Overview looking south on left levee

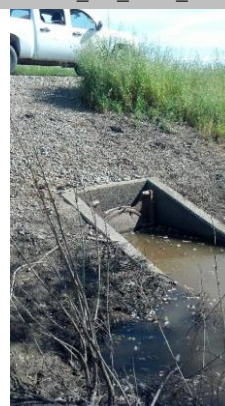
Photo 2 of 3 : UCIP\_SP\_2017\_51080\_67103.jpg

FS\_ID:51080  
DS\_ID:16848  
EP\_NO: N/A  
Repair Type: No Action Needed  
Crossing Status: Found  
UCIP Comments: 11/18/2016 Crossing appears to be in good condition. (DWR Sutter Yard- A Freitag) 4/27/2016 Crossing appears to be in good condition. New slide gate installed on LS. 7/01/2015 Both gates were still submerged in water. Levee slopes were in good condition. 5/29/2014 Same as last inspection. 12/9/2013 Same as last inspection. 7/10/2013 LS slope has been cleared of vegetation and is in good condition. Both gates are still underwater and not able to be inspected. 4/19/2012 Dense vegetation makes it difficult to evaluate the condition of the LS slope. Both gates underwater. Recommend taking photos of clear slopes and gates during fall inspection.  
FIELD\_STRUCT\_DESC: 36-inch corrugated metal drainage pipe through the levee, 9.2 feet below the crown. Concrete "U" headwalls on both the waterside (WS) and landside (LS) ends. Flap gate on the WS end. Slide gate on the LS end. [Additional Reference(s): DWR Levee Log, 1993. USACE Sacramento O&M Manual 519, June 1962 (HLM 3.67)]

Headwall and flap gate located on WS.

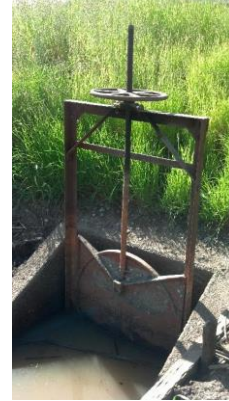
Photo 3 of 3 : UCIP\_SP\_2017\_51080\_67101.jpg

Item	DWR UCIP LMA Responsibility			39.523556 °	39.523556 °	
				-121.705340 °	-121.705340 °	
DWR ID						
Comment Code						
Inspector Comment						
FS_ID:51080 DS_ID:16848 EP_NO: N/A Repair Type: No Action Needed Crossing Status: Found UCIP Comments: 11/18/2016 Crossing appears to be in good condition. (DWR Sutter Yard- AFreitag)4/27/2016 Crossing appears to be in good condition. New slide gate installed on LS.7/01/2015 Both gates were still submerged in water. Levee slopes were in good condition.5/29/2014 Same as last inspection.12/9/2013 Same as last inspection.7/10/2013 LS slope has been cleared of vegetation and is in good condition. Both gates are still underwater and not able to be inspected.4/19/2012 Dense vegetation makes it difficult to evaluate the condition of the LS slope. Both gates underwater. Recommend taking photos of clear slopes and gates during fall inspection. FIELD_STRUCT_DESC: 36-inch corrugated metal drainage pipe through the levee, 9.2 feet below the crown. Concrete "U" headwalls on both the waterside (WS) and landside (LS) ends. Flap gate on the WS end. Slide gate on the LS end. [Additional Reference(s): DWR Levee Log, 1993. USACE Sacramento O&M Manual 519, June 1962 (HLM 3.67)] FS Date: 11/30/2016 1:06:54 PM

Headwall and screw gate located on LS.

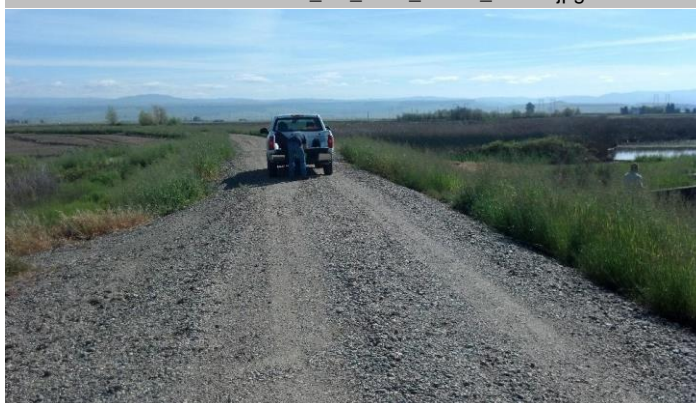
Photo 1 of 3 : UCIP\_SP\_2017\_51081\_67107.jpg

LM Start	<b>3.83</b>	Rating **	M	Issue No.	<b>922 (cont)</b>
LM End	<b>3.83</b>	Issue Type +	Ma	Location *	LS

Overview looking south on left levee

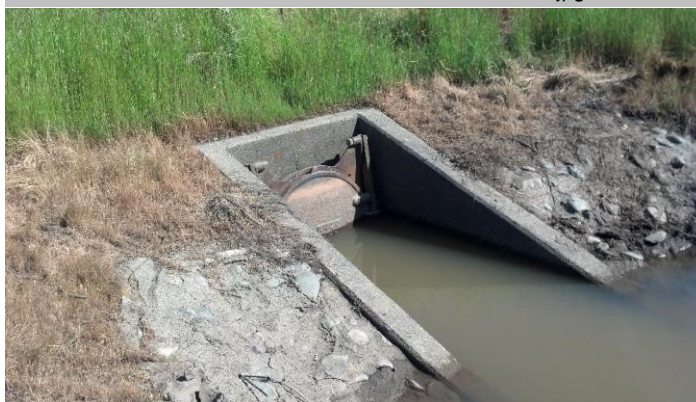
Photo 2 of 3 : UCIP\_SP\_2017\_51081\_67108.jpg

FS\_ID:51081  
DS\_ID:16847  
EP\_NO: N/A  
Repair Type: Non-Urgent  
Crossing Status: Found  
UCIP Comments: 11/18/2016 Crossing appears to be in good condition. It appears that this crossing does not require a slide gate. (DWR Sutter Yard- A Freitag)4/27/2016 LS slide gate was still missing. Rest of crossing appears to be in good condition.7/01/2015 There appears to be a LS gate now but both pipe ends were submerged so it was hard to tell for certain.5/29/2014 Same as last inspection.12/9/2013 Pulled sticks from WS flap gate to allow it to close. Ls gate is still missing.7/10/2013 WS and LS slopes have been cleared of vegetation and are in good condition. LS gate is still missing and WS flap gate is still wedged open with sticks.4/19/2012 LS gate missing & limited inspection. Need photos of WS & LS cleared slopes. Description calls for slide gate on LS-slide gate missing. Debris scattered near LS headwall. This crossing was listed in the USACE Periodic Inspection report as Corp's Inspect ID# USACE\_CESPK\_M13J\_2011\_p\_0010 for WS gate wedged open & missing LS slide gate.

Headwall and flap gate located on WS toe.

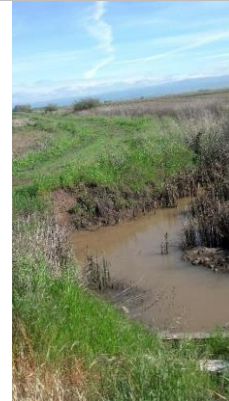
Photo 3 of 3 : UCIP\_SP\_2017\_51081\_67110.jpg

Item	DWR UCIP LMA Responsibility			39.524350 °	39.524350 °	
				-121.702180 °	-121.702180 °	
DWR ID						
Comment Code						
Inspector Comment						
FS_ID:51081 DS_ID:16847 EP_NO: N/A Repair Type: Non-Urgent Crossing Status: Found UCIP Comments: 11/18/2016 Crossing appears to be in good condition. It appears that this crossing does not require a slide gate. (DWR Sutter Yard- A Freitag)4/27/2016 LS slide gate was still missing. Rest of crossing appears to be in good condition.7/01/2015 There appears to be a LS gate now but both pipe ends were submerged so it was hard to tell for certain.5/29/2014 Same as last inspection.12/9/2013 Pulled sticks from WS flap gate to allow it to close. Ls gate is still missing.7/10/2013 WS and LS slopes have been cleared of vegetation and are in good condition. LS gate is still missing and WS flap gate is still wedged open with sticks.4/19/2012 LS gate missing & limited inspection. Need photos of WS & LS cleared slopes. Description calls for slide gate on LS-slide gate missing. Debris scattered near LS headwall. This crossing was listed in the USACE Periodic Inspection report as Corp's Inspect ID# USACE_CESPK_M13J_2011_p_0010 for WS gate wedged open & missing LS slide gate. FIELD_STRUCT_DESC: 36-inch corrugated metal drainage pipe through the levee, 8.8 feet below the crown. Flap gate on the waterside (WS) end. Slide gate on the landside (LS) end. Concrete "U" headwalls on both ends. [Additional Reference(s): DWR Levee Log, 1993. USACE Sacramento O&M Manual 519, June 1962 (HLM 3.85)] FS Date: 11/30/2016 1:07:36 PM

View of channel at crossing looking D/S.

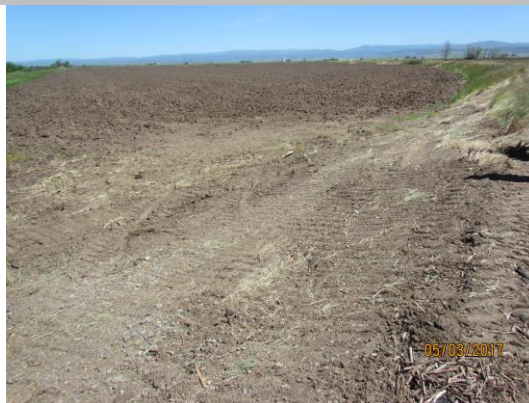
Photo 1 of 1 : SP\_2017\_MA0013\_301\_84\_20170508\_00141.jpg

LM Start	3.85	Rating **	M	Issue No.	84
LM End	3.85	Issue Type +	Ma	Location *	LS
Category	Earthen Levee			GPS Latitude/Longitude	
				Start	End
Item	Slope Stability			39.524503 °	39.524503 °
				-121.701777 °	-121.701777 °
DWR ID	DWR_MA0013_02_s_2017_84				
Comment Code					
S1 : Repair slope instability.					
Inspector Comment					
Repair the erosion along the landside slope caused by flood waters over topping levee.

View of the erosion along the landside slope.

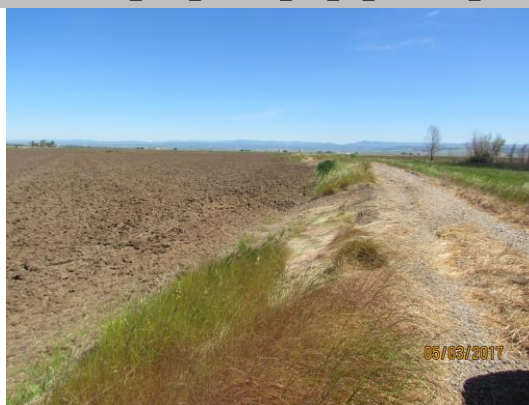
Photo 1 of 1 : SP\_2017\_MA0013\_301\_85\_20170508\_00142.jpg

LM Start	3.93	Rating **	M	Issue No.	85
LM End	3.93	Issue Type +	Ma	Location *	LS
Category	Earthen Levee			GPS Latitude/Longitude	
				Start	End
Item	Slope Stability			39.525242 °	39.525242 °
				-121.700710 °	-121.700710 °
DWR ID	DWR_MA0013_02_s_2017_85				
Comment Code					
S1 : Repair slope instability.					
Inspector Comment					
Repair the erosion along the landside slope caused by flood waters over topping levee.

View of erosion along the landside slope.

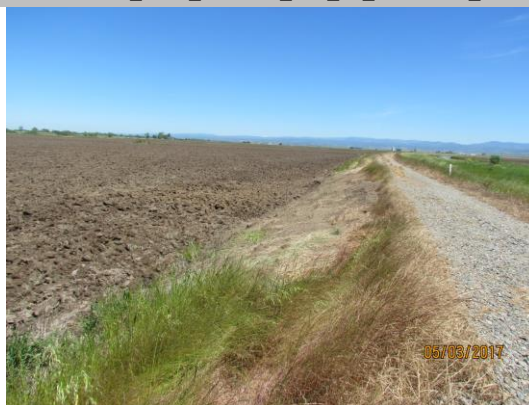
Photo 1 of 1 : SP\_2017\_MA0013\_301\_87\_20170508\_00143.jpg

LM Start	3.96	Rating **	M	Issue No.	87
LM End	4.04	Issue Type +	Ma	Location *	LS
Category	Earthen Levee			GPS Latitude/Longitude	
				Start	End
Item	Slope Stability			39.525660 °	39.526603 °
				-121.700322 °	-121.699742 °
DWR ID	DWR_MA0013_02_s_2017_87				
Comment Code					
S1 : Repair slope instability.					
Inspector Comment					
Repair the erosion along the landside slope caused by flood waters over topping levee.

View of the erosion on the landside slope.

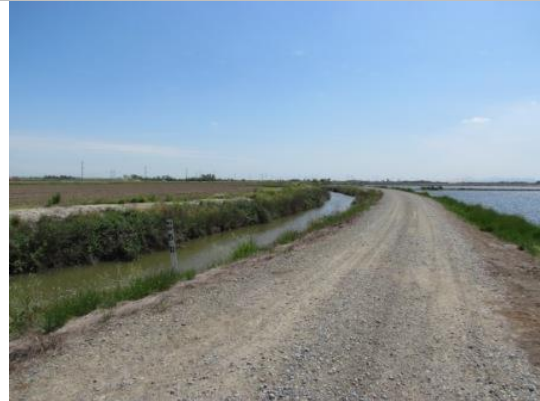
Photo 1 of 1 : SP\_2017\_MA0013\_301\_911\_20170315\_00027.jpg

LM Start	4.04	Rating **	M	Issue No.	911
LM End	4.78	Issue Type +	En	Location *	WS
Category	Earthen Levee			GPS Latitude/Longitude	
				Start	End
Item	Encroachments			39.526653 °	39.534091 °
				-121.699675 °	-121.690404 °
DWR ID	DWR_MA0013_02_s_2012_911				
Comment Code					
DT : Ditch					
Inspector Comment

View of agricultural ditch along the toe.

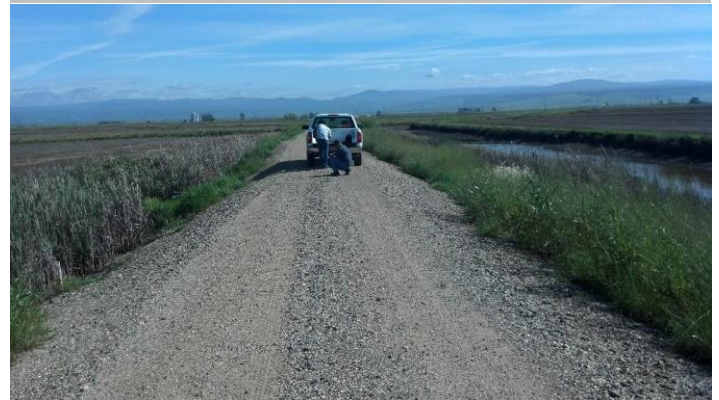
Photo 1 of 3 : UCIP\_SP\_2017\_51082\_67115.jpg

LM Start	4.17	Rating **	M	Issue No.	923
LM End	4.17	Issue Type +	Ma	Location *	WS
Category	Supplemental			GPS Latitude/Longitude	
				Start	End
Item	DWR UCIP LMA Responsibility			39.528210 °	39.528210 °
				-121.698410 °	-121.698410 °
DWR ID

Comment Code					
Inspector Comment					
FS_ID:51082 DS_ID:16846 EP_NO: N/A Repair Type: Non-Urgent Crossing Status: Found UCIP Comments: 11/18/2016 Both pipe ends underwater for this inspection. (DWR Sutter Yard- A Freitag)4/27/2016 Both pipe ends were underwater for inspection.7/01/2015 Both pipe ends and gates were fully submerged.5/29/2014 Same as last inspection.12/9/2013 Same as last inspection.7/10/2013 WS slope is cleared of vegetation and is in good condition. Both gates were fully submerged under water and unable to be inspected.4/19/2012 Rodent activity caused partial collapse on LS of levee in the vicinity of pipe. Limited inspection on WS slope due to dense vegetation. Limited inspection on gates due to both gates submerged under water. FIELD_STRUCT_DESC: 36-inch corrugated metal drainage pipe through the levee, 9.3 feet below the crown. Flap gate on the waterside (WS) end. Slide gate on the landside (LS) end. Concrete "U" headwalls on both ends. Concrete sump area with flash boards to drain farmers field is located on farmer's property near drain inlet. [Additional Reference(s): DWR Levee Log, 1993. USACE Sacramento O&M Manual 519, June 1962 (HLM 4.20)] FS Date: 11/30/2016 1:12:08 PM

Overview looking east on right bank of Cottonwood

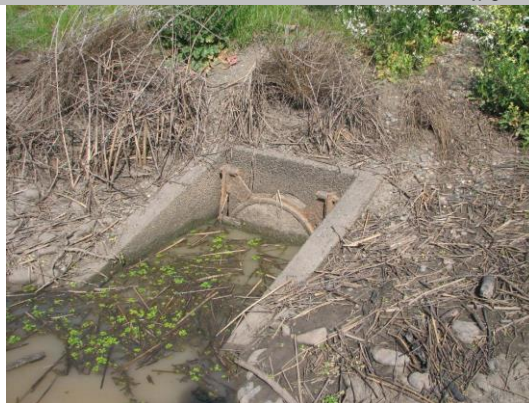
Photo 2 of 3 : UCIP\_SP\_2017\_51082\_67116.jpg

FS\_ID:51082  
DS\_ID:16846  
EP\_NO: N/A  
Repair Type: Non-Urgent  
Crossing Status: Found  
UCIP Comments: 11/18/2016 Both pipe ends underwater for this inspection. (DWR Sutter Yard- AFreitag)4/27/2016 Both pipe ends were underwater for inspection.7/01/2015 Both pipe ends and gates were fully submerged.5/29/2014 Same as last inspection.12/9/2013 Same as last inspection.7/10/2013 WS slope is cleared of vegetation and is in good condition. Both gates were fully submerged under water and unable to be inspected.4/19/2012 Rodent activity caused partial collapse on LS of levee in the vicinity of pipe. Limited inspection on WS slope due to dense vegetation. Limited inspection on gates due to both gates submerged under water.  
FIELD\_STRUCT\_DESC: 36-inch corrugated metal drainage pipe through the levee, 9.3 feet below the crown. Flap gate on the waterside (WS) end. Slide gate on the landside (LS) end. Concrete "U" headwalls on both ends. Concrete sump area with flash boards to drain farmers field is located on farmer's property near drain inlet. [Additional Reference(s): DWR Levee Log, 1993. USACE Sacramento O&M Manual 519, June 1962 (HLM 4.20)]

Unable to determine condition of flap gate on WS due to high water.

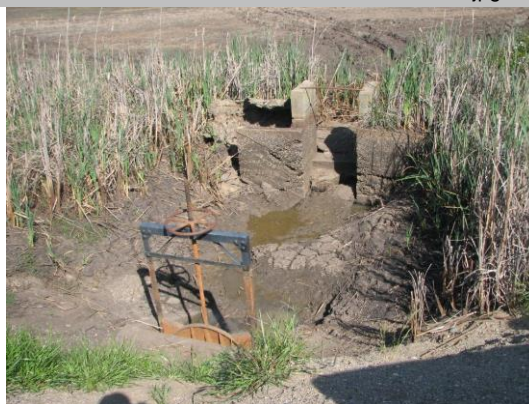
Photo 3 of 3 : UCIP\_SP\_2017\_51082\_67113.jpg

Overview of LS screw gate and concrete sump structure.

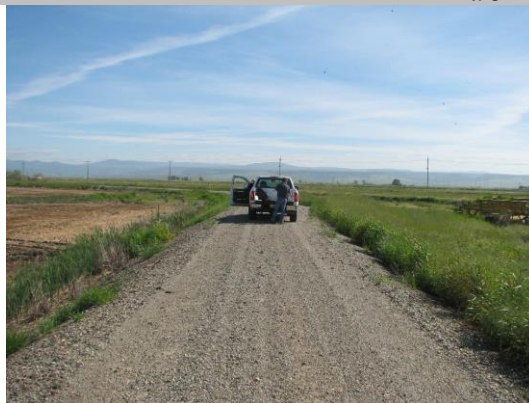
Photo 1 of 3 : UCIP\_SP\_2017\_51083\_67119.jpg

Overview looking east on right levee of Gold Run Creek (referred to Unit 2 of Cherokee Canal).

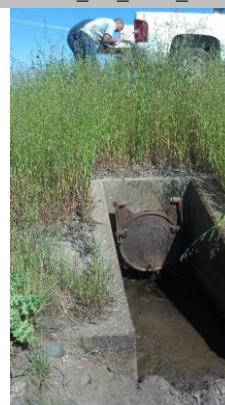
Photo 2 of 3 : UCIP\_SP\_2017\_51083\_67122.jpg

Headwall and flap gate located on WS.

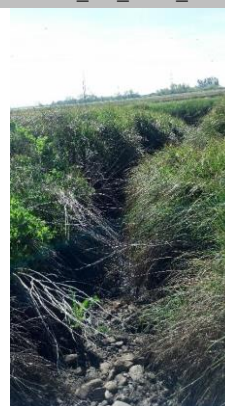
Photo 3 of 3 : UCIP\_SP\_2017\_51083\_67123.jpg

View of channel at crossing.

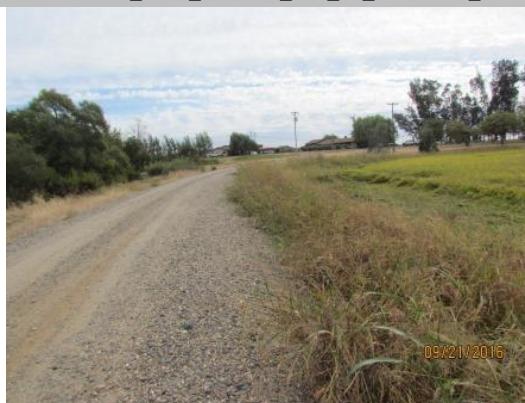
Photo 1 of 1 : SP\_2017\_MA0013\_301\_47\_20170315\_00010.jpg

LM Start	4.80	Rating **	M	Issue No.	47
LM End	5.01	Issue Type +	Ma	Location *	LS
Category	Earthen Levee			GPS Latitude/Longitude	
				Start	End
Item	Vegetation			39.526924 °	39.526272 °
				-121.684802 °	-121.688169 °
DWR ID	DWR_MA0013_02_f_2016_47				
Comment Code					
V1 : Control annual grass and weeds on the levee slopes and easements.					
Inspector Comment

View of dense vegetation at the landside levee toe.

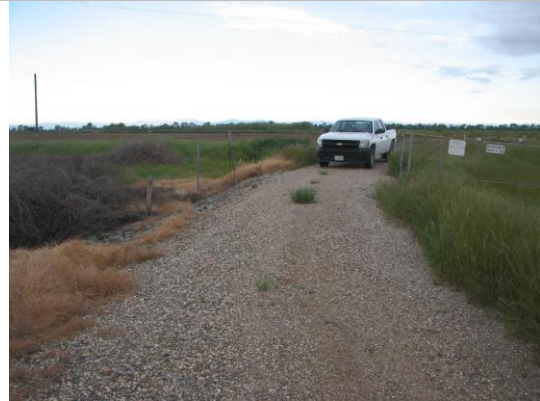
Photo 1 of 3 : UCIP\_SP\_2017\_51084\_67131.jpg

Overview looking west on the left levee of Cottonwood

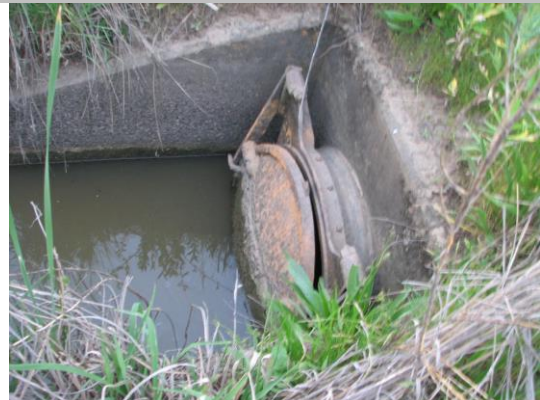
Photo 2 of 3 : UCIP\_SP\_2017\_51084\_67129.jpg

Headwall and flap gate located on WS.

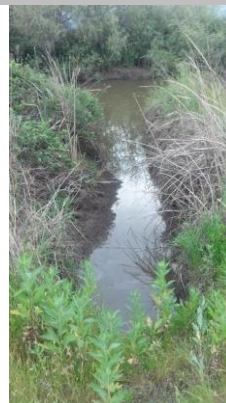
Photo 3 of 3 : UCIP\_SP\_2017\_51084\_67126.jpg

View of channel at crossing.

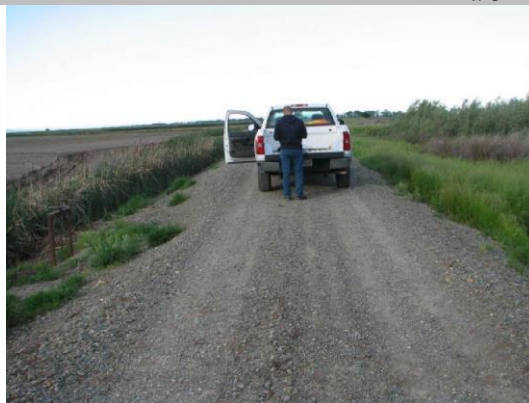
Photo 1 of 3 : UCIP\_SP\_2017\_51088\_67146.jpg

FS\_ID:51088  
DS\_ID:16409  
EP\_NO: N/A  
Repair Type: Non-Urgent  
Crossing Status: Found  
UCIP Comments: 11/18/2016 There is a flapgate on the WS and a slide gate on the LS. The LS slide gate appears to be partially buried and blocked by vegetation. (DWR Sutter Yard- AFreitag)4/27/2016 LS slide gate is blocked by vegetation. Pipe appears to not be used.6/30/2015 WS flap gate was still overgrown with vegetation. Needs to be cleared away.5/29/2014 Same as last inspection.12/9/2013 Same as last inspection.7/09/2013 Same as last inspection.4/24/2012 Limited inspection on WS slope due to dense vegetation. Need photo of clear WS slope during next inspection. This crossing was listed in the USACE Periodic Inspection report as Corp's inspect ID# USACE\_CESPK\_M13H\_2011\_p\_0035 non-functional crossing due to overgrown vegetation on WS flap gate. FIELD\_STRUCT\_DESC: 30-inch corrugated metal drainage pipe through the levee, 5.8 feet below the crown. Flap gate on the waterside (WS). Slide gate on the landside (LS). Concrete "U" headwalls located on both ends. [Additional Reference(s): DWR Levee Log, 1993. USACE Sacramento O&M Manual 519, June 1962 (HLM 5.34)]

Overview of crossing looking downstream.

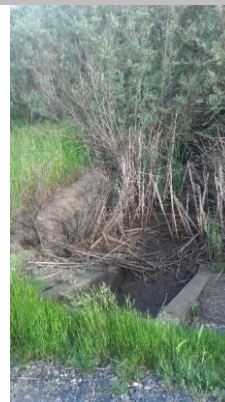
Photo 2 of 3 : UCIP\_SP\_2017\_51088\_67149.jpg

View of WS headwall with dense vegetation in channel.

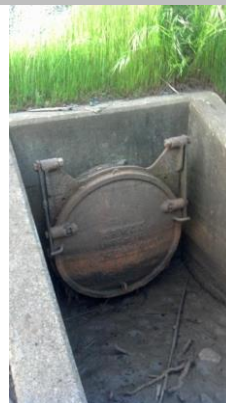
Photo 3 of 3 : UCIP\_SP\_2017\_51088\_67148.jpg

Headwall and flap gate located on WS.

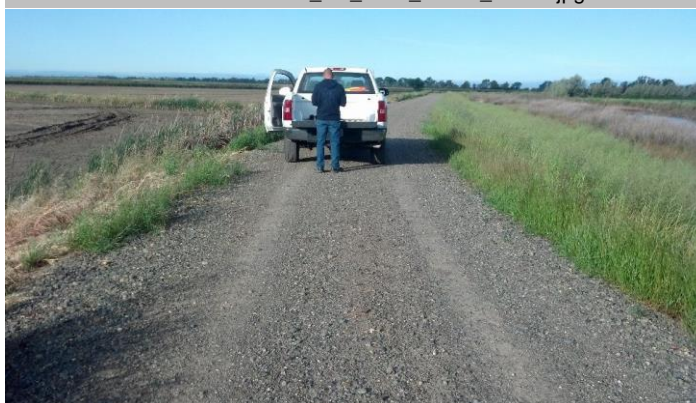
Photo 1 of 3 : UCIP\_SP\_2017\_51089\_67152.jpg

FS\_ID:51089  
DS\_ID:16410  
EP\_NO: N/A  
Repair Type: Non-Urgent  
Crossing Status: Found  
UCIP Comments: 11/18/2016 Abandoned pipe. It is still present on both sides of the levee and capped on the WS. (DWR Sutter Yard-AFreitag)4/27/2016 Pipe appears abandoned. Should be removed.6/30/2015 Pipe still present with the cap on the waterside.5/29/2014 Same as last inspection.12/9/2013 Same as last inspection.7/09/2013 Same as last inspection.4/24/2012 Limited inspection on WS and LS slope due to dense vegetation. Need photos of clear slopes during next inspection. Metal plate bolted on pipe for closure on WS, open on LS.  
FIELD\_STRUCT\_DESC: \*ABANDONED\* 6-inch steel pipe through the levee, 1.6 feet below the crown. Plate bolted on the waterside (WS) end. Open on the landside (LS) end. [Additional Reference(s): DWR Levee Log, 1993. USACE Sacramento O&M Manual 519, June 1962 (HLM 5.41)]  
FS Date: 11/30/2016 1:33:28 PM

Overview of site

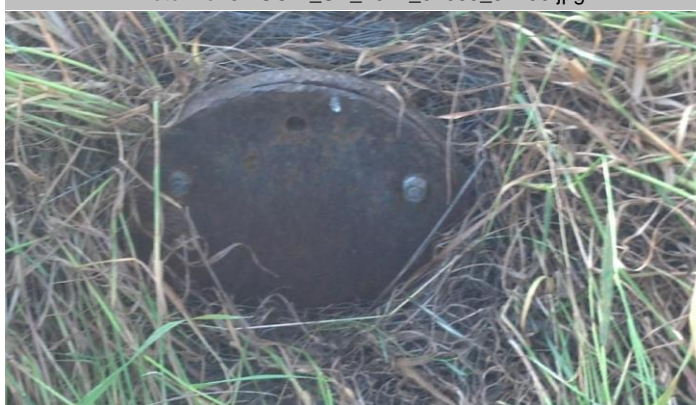
Photo 2 of 3 : UCIP\_SP\_2017\_51089\_67150.jpg

Capped irrigation pipe located on water side of levee

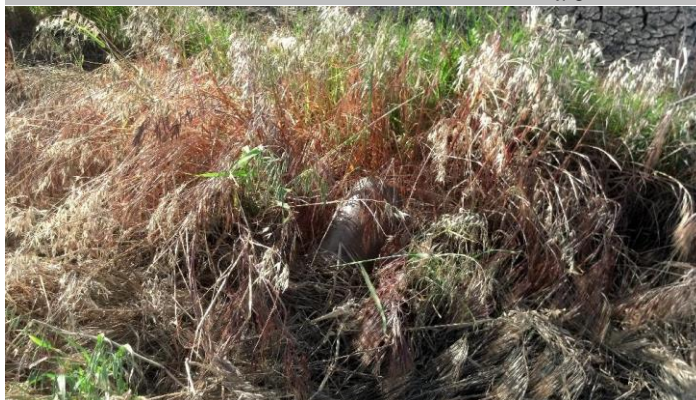
Photo 3 of 3 : UCIP\_SP\_2017\_51089\_67153.jpg

View of LS toe.

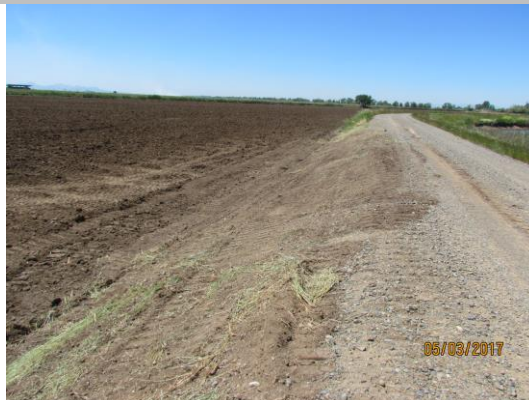
Photo 1 of 1 : SP\_2017\_MA0013\_301\_88\_20170508\_00145.jpg

LM Start	5.45	Rating **	M	Issue No.	88
LM End	5.47	Issue Type +	Ma	Location *	LS
Category	Earthen Levee			GPS Latitude/Longitude	
				Start	End
Item	Slope Stability			39.524738 °	39.524588 °
				-121.695135 °	-121.695455 °
DWR ID	DWR_MA0013_02_s_2017_88				
Comment Code					
S1 : Repair slope instability.					
Inspector Comment					
Repair the erosion along the landside slope caused by flood water over topping the levee.

View of erosion along the landside slope.

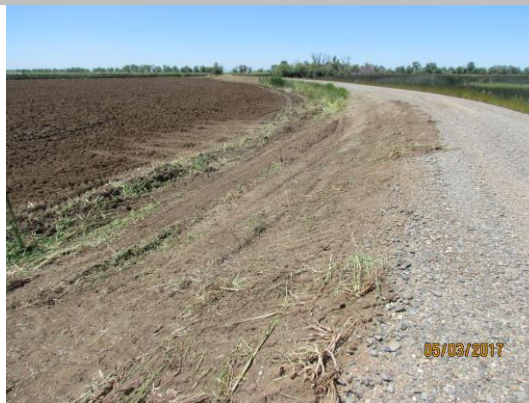
Photo 1 of 1 : SP\_2017\_MA0013\_301\_89\_20170508\_00146.jpg

LM Start	5.63	Rating **	M	Issue No.	89
LM End	5.64	Issue Type +	Ma	Location *	LS
Category	Earthen Levee			GPS Latitude/Longitude	
				Start	End
Item	Slope Stability			39.524357 °	39.524327 °
				-121.698360 °	-121.698687 °
DWR ID	DWR_MA0013_02_s_2017_89				
Comment Code					
S1 : Repair slope instability.					
Inspector Comment					
Repair the erosion along the landside slope caused by flood waters over topping levee.

View of erosion along the landside slope.

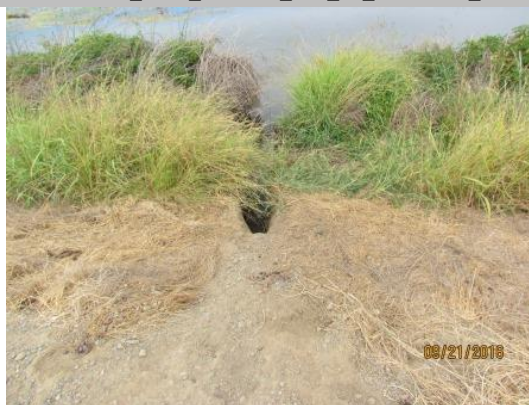
Photo 1 of 1 : SP\_2017\_MA0013\_301\_49\_20170315\_00011.jpg

LM Start	5.71	Rating **	M	Issue No.	49
LM End	5.71	Issue Type +	Ma	Location *	WS
Category	Earthen Levee			GPS Latitude/Longitude	
				Start	End
Item	Erosion / Bank Caving			39.523803 °	39.523803 °
				-121.699804 °	-121.699804 °
DWR ID	DWR_MA0013_02_f_2016_49				
Comment Code					
E2 : Schedule repair of erosion site prior to the next inspection.					
Inspector Comment					
1' by 2' by 4' hole in the levee toe that appears to be a temporary pump intake.

View of the man made hole at the waterside levee toe.

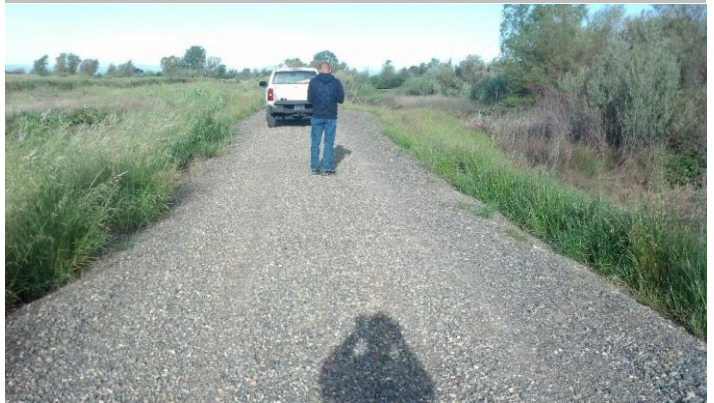
Photo 1 of 3 : UCIP\_SP\_2017\_51090\_67155.jpg

FS\_ID:51090  
DS\_ID:16411  
EP\_NO: N/A  
Repair Type: Non-Urgent  
Crossing Status: Found  
UCIP Comments: 11/18/2016 LS slide gate still missing. Both pipe ends were submerged during inspection. (DWR Sutter Yard - afreitag)9/27/2016 Crossing has been downgraded from Urgent to Non-Urgent--flap gate on WS is present only LS gate missing. (DWR UCIP - omagana)4/27/2016 Both sides of pipe were underwater. Appears that LS gate is still missing. (DWR Sutter Yard - afreitag)6/30/2015 Slide gate still missing on the LS. WS appears to be in good condition. (DWR Sutter Yard - afreitag)5/29/2014 Same as last inspection. (DWR Sutter Yard - afreitag)12/9/2013 Same as last inspection. (DWR Sutter Yard - afreitag)7/09/2013 Same as last inspection. (DWR Sutter Yard - afreitag)4/24/2012 Slide gate missing on LS. Limited inspection on WS and LS slopes due to dense vegetation. Need photos of cleared WS & LS slopes. This crossing was listed in the USACE Periodic Inspection report as Corp's inspect ID# USACE\_CESPK\_M13H\_2011\_p\_0017 for missing slide gate. (DWR Sutter Yard - omagana)

Overview looking south

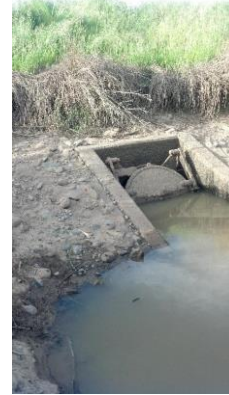
Photo 2 of 3 : UCIP\_SP\_2017\_51090\_67157.jpg

Headwall and flap gate on WS.

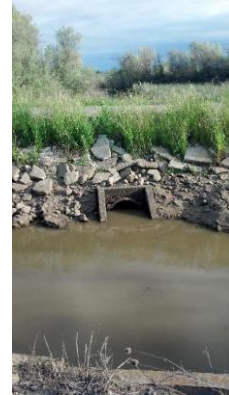
Photo 3 of 3 : UCIP\_SP\_2017\_51090\_67156.jpg

Headwall and damaged/missing screw gate on LS.

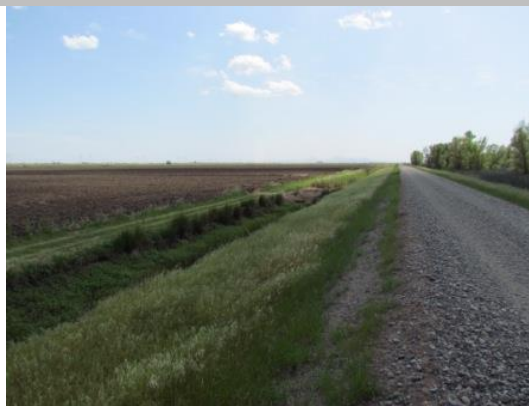
Photo 1 of 1 : SP\_2017\_MA0013\_301\_12\_20170315\_00004.jpg

LM Start	6.18	Rating **	M	Issue No.	12
LM End	7.54	Issue Type +	En	Location *	LS
Category	Earthen Levee			GPS Latitude/Longitude	
				Start	End
Item	Encroachments			39.520843 °	39.502958 °
				-121.706345 °	-121.716953 °
DWR ID	DWR_MA0013_02_s_2012_12				
Comment Code					
DT : Ditch					
Inspector Comment

View of the agricultural ditch along the toe.

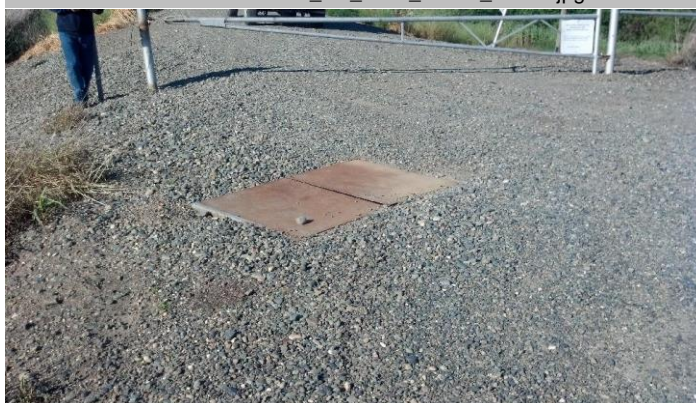
Photo 1 of 2 : UCIP\_SP\_2017\_51098\_67191.jpg

FS\_ID:51098  
DS\_ID:16413  
EP\_NO: 14704  
Repair Type: Non-Urgent  
Crossing Status: Indicator Found  
UCIP Comments: 11/18/2016 Crossing appears to be in good condition. (DWR Sutter Yard- A Freitag) 4/27/2016 Crossing appears to be in good condition. 6/30/2015 Crossing is in good condition. Unusre on the permit issues below. 11/4/2014 (DWR-Olivia Magana) Need to contact owner to determine whether both communication are still active and same alignment? permit 14704 (LM 8.38) and 10589 (see LM 8.39) Priority changed in Part IX from No Action Needed to Non-Urgent. 5/29/2014 Same as last inspection. 12/4/2013 Same as last inspection. 7/09/2013 Same as last inspection. 4/24/2012 Unable to verify whether this crossing includes both communication cable lines under permit 14704 (LM 8.38) and 10589 (see LM 8.39). FIELD\_STRUCT\_DESC: Steel fiber optic cable through the levee, approximately 3.5 feet below the crown. The cable section across the channel is attached to the Cherokee Canal Dridge. (Permit No. 14704, 1987 - Sprint) [Additional Reference(s): DWR Levee Log, 1993]

Buried cable box located on the LS edge.

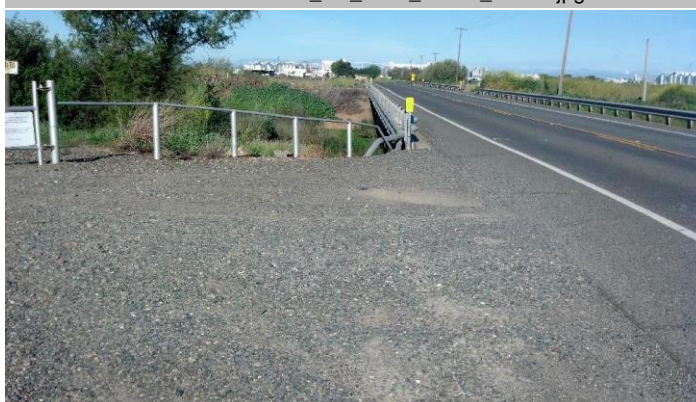
Photo 2 of 2 : UCIP\_SP\_2017\_51098\_67192.jpg

WS view cable line attached to highway bridge.

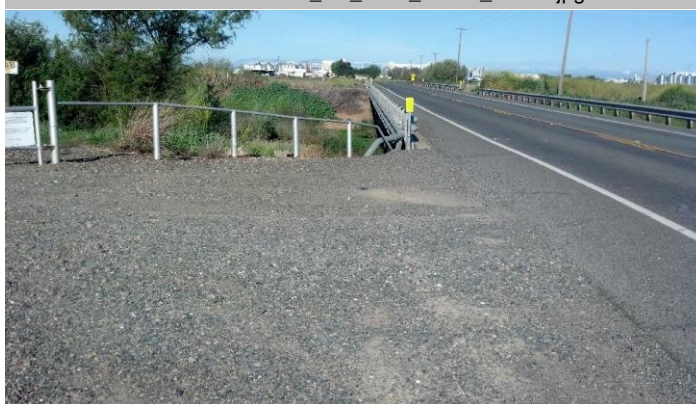
Photo 2 of 2 : UCIP\_SP\_2017\_51099\_67210.jpg

Waterside view of utility line alignment through levee then attached to bridge.

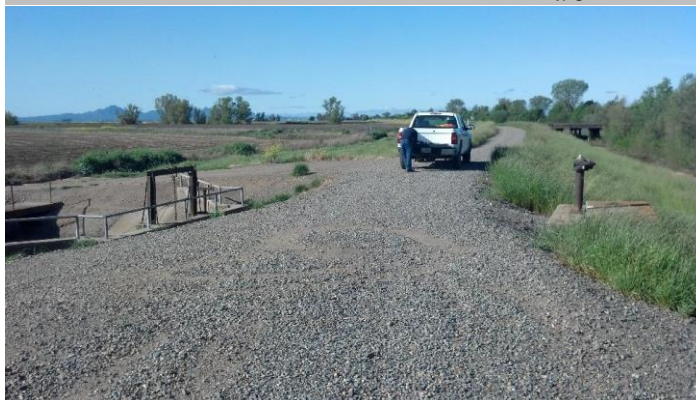
Photo 1 of 3 : UCIP\_SP\_2017\_51103\_67280.jpg

Overview of levee crown at crossing looking D/S.

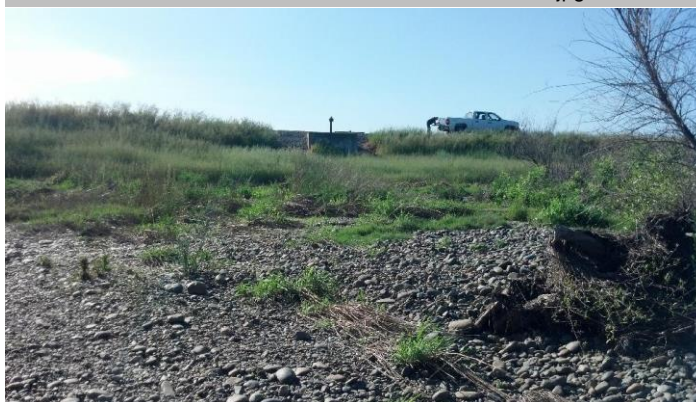
Photo 2 of 3 : UCIP\_SP\_2017\_51103\_67285.jpg

View of crossing looking from channel towards WS levee.

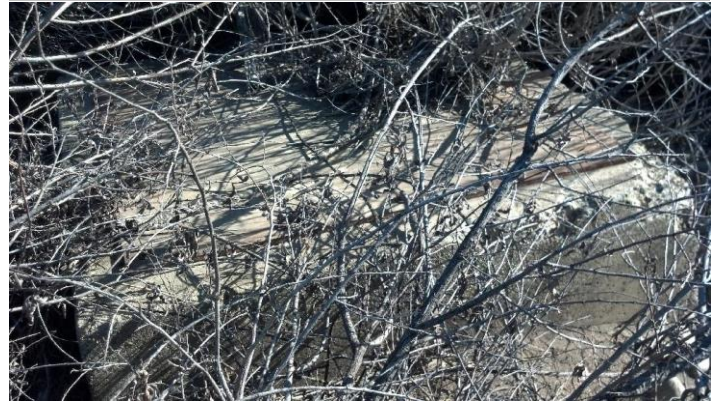
Photo 3 of 3 : UCIP\_SP\_2017\_51103\_67283.jpg

WS view-access well located 60 feet from WS toe.

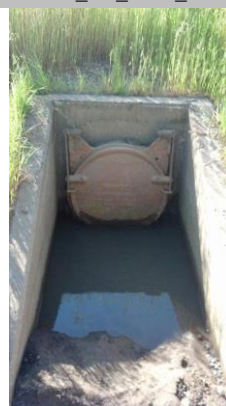
Photo 1 of 3 : UCIP\_SP\_2017\_51104\_67289.jpg

WS view of crossing. Dense vegetation along WS slope limited visual inspection. (WS Photo 1 of 2)

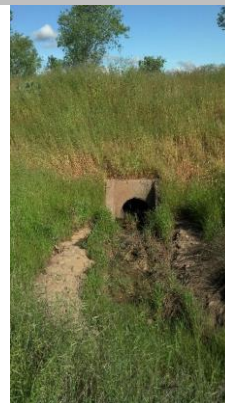
Photo 3 of 3 : UCIP\_SP\_2017\_51104\_67286.jpg

View of crossing from LS. Dense vegetation along LS slope limited visual inspection. (LS Photo 1 of 2)

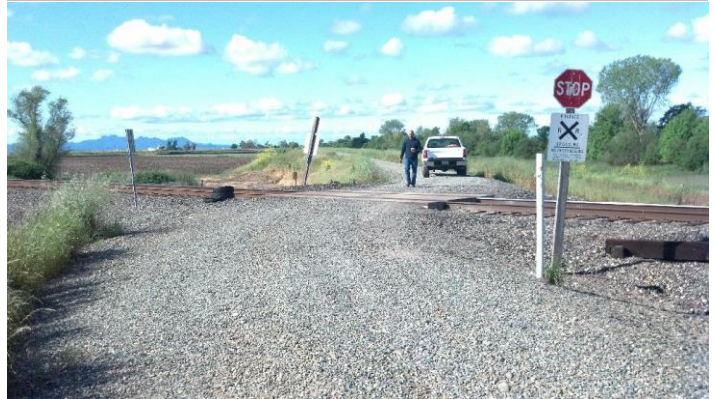
Photo 1 of 3 : UCIP\_SP\_2017\_51106\_67292.jpg

Overview of levee crown at crossing.
