**Flood Control Project Maintenance  
Levee Inspections**  
**LMA District Cover Sheet**  
**Spring 2017 Levee Inspection Results**

**Sutter Maintenance Yard Maintenance Area 0013**

**Spring 2017 Levee Inspection Results**

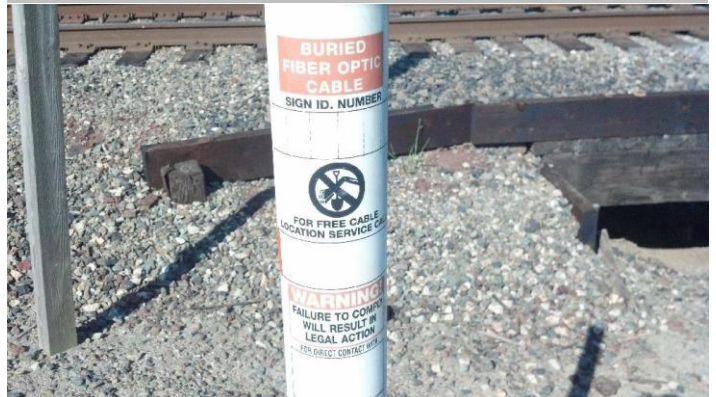
Photo 2 of 3 : UCIP\_SP\_2017\_51106\_67291.jpg

Marker for buried fiber optic cable on WS.

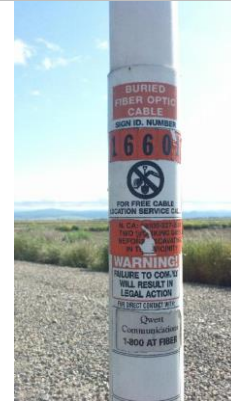
Photo 3 of 3 : UCIP\_SP\_2017\_51106\_67290.jpg

Marker for buried fiber optic cable on LS with contact information.

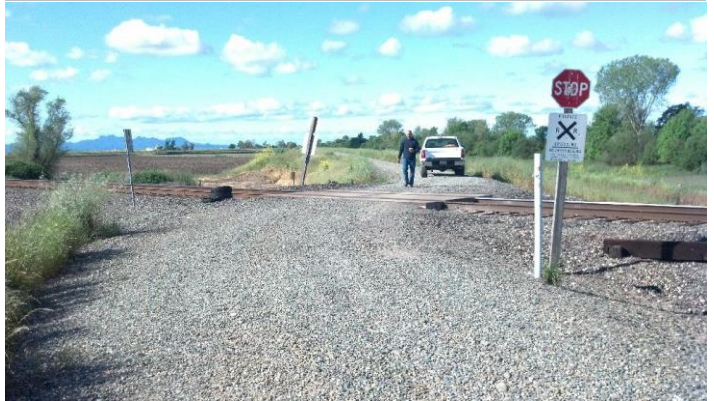
Photo 1 of 3 : UCIP\_SP\_2017\_51107\_67295.jpg

Overview of levee crown at crossing.

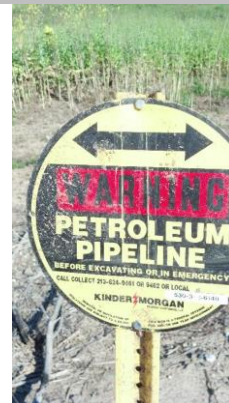
Photo 2 of 3 : UCIP\_SP\_2017\_51107\_67294.jpg

WS marker with utility contact information.

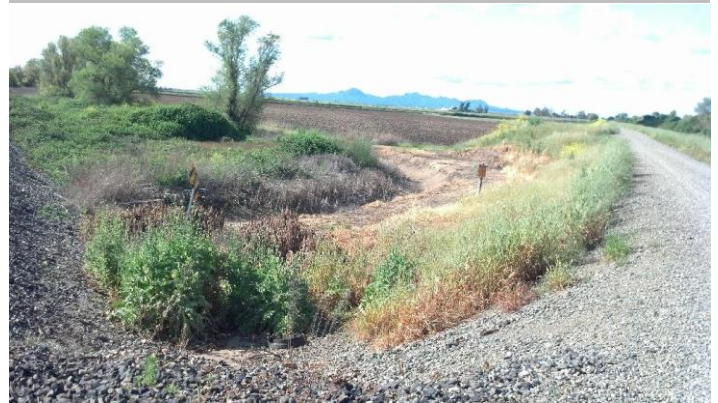
Photo 3 of 3 : UCIP\_SP\_2017\_51107\_67293.jpg

View of LS slope and marker.

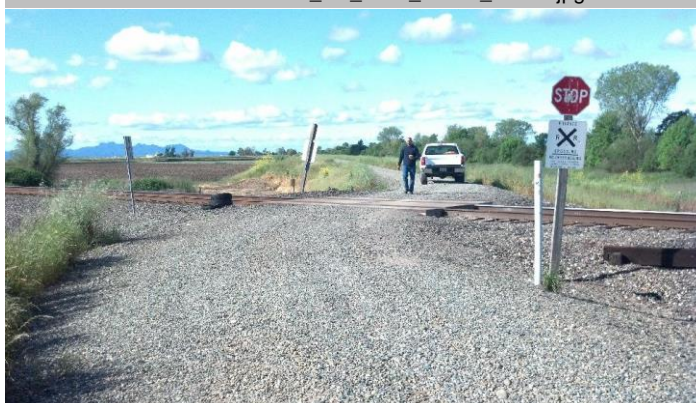
Photo 1 of 3 : UCIP\_SP\_2017\_51108\_67299.jpg

Overview of levee crown at crossing.

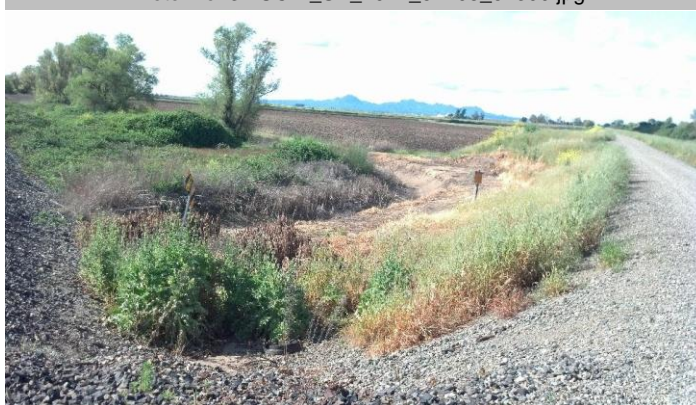
Photo 2 of 3 : UCIP\_SP\_2017\_51108\_67300.jpg

Marker located on LS.

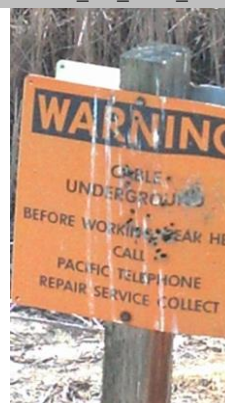
Photo 3 of 3 : UCIP\_SP\_2017\_51108\_67298.jpg

Underground cable marker with contact information.

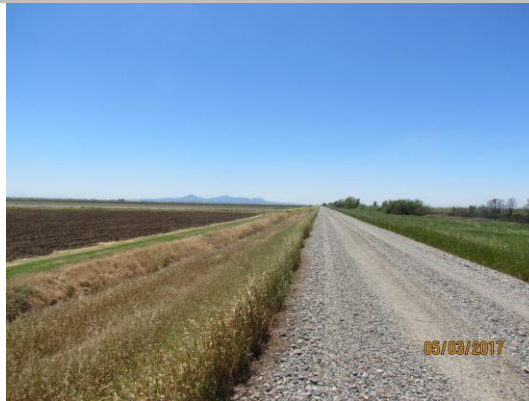
Photo 1 of 1 : SP\_2017\_MA0013\_301\_91\_20170508\_00148.jpg

LM Start	10.98	Rating **	A	Issue No.	91
LM End	10.98	Issue Type +	Ma	Location *	LS
Category	Earthen Levee			GPS Latitude/Longitude	
				Start	End
Item	Vegetation			39.459237 °	39.459237 °
				-121.747393 °	-121.747393 °
DWR ID	DWR_MA0013_02_s_2017_91				
Comment Code					
V1 : Control annual grass and weeds on the levee slopes and easements.					
Inspector Comment					
There is native grasses on both slopes.

View of native grasses on both slopes.

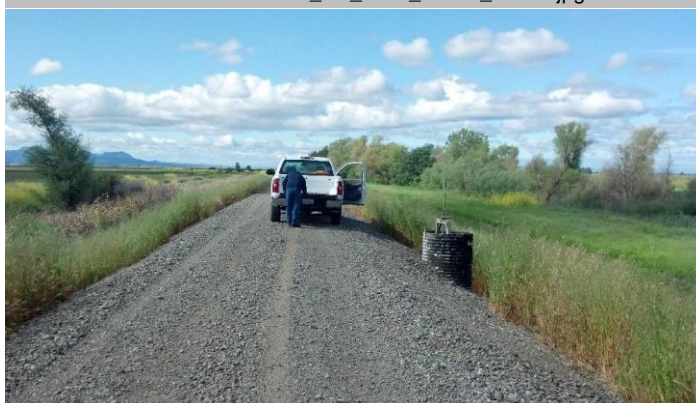
Photo 1 of 3 : UCIP\_SP\_2017\_51112\_67336.jpg

FS\_ID:51112  
DS\_ID:16385  
EP\_NO: N/A  
Repair Type: Non-Urgent  
Crossing Status: Found  
UCIP Comments: 11/17/2016 WS still heavily vegetated and cannot access the WS pipe end for inspection. Vegetation needs to be cleared back. (DWR Sutter Yard- AFreitag)4/26/2016 LS headwall was visible but gate was underwater. WS still heavily vegetated and unable to be inspected. Vegetation needs to be cleared back.6/30/2015 WS heavily vegetated passed the toe-road and could not make it to the WS pipe end for inspection. Vegetation needs to be cleared back. LS pipe end was fully submerged under water.5/28/2014 Same as last inspection.12/4/2013 Same as last inspection.7/08/2013 LS slope has been cleared of vegetation and is in good condition. LS headwall is now visible but mostly underwater so unable to do full inspection. WS is still vegetated.4/24/2012 LS pipe & slide gate sedimented in. Limited inspection WS and LS slopes due to dense vegetation. Need photos of cleared WS and LS slopes during next inspection. This crossing was listed in the USACE Periodic Inspection report as Corp's inspect ID# USACE\_CESPK\_M13F\_2011\_p\_0147 for limited visibility of LS and WS.

Overview of crossing looking downstream at the left bank of Cherokee Canal.

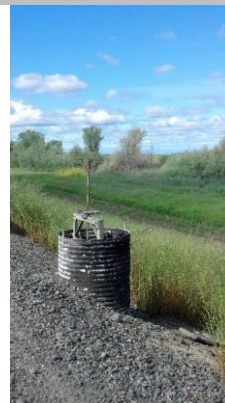
Photo 2 of 3 : UCIP\_SP\_2017\_51112\_67337.jpg

Stand pipe with screw gate WS

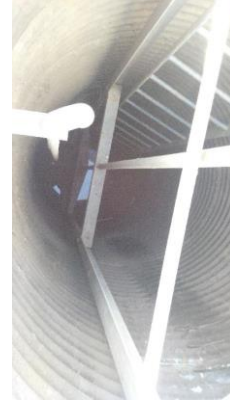
Photo 3 of 3 : UCIP\_SP\_2017\_51112\_67335.jpg

View of the inside of the WS stand pipe. No obstructions blocking slide gate.

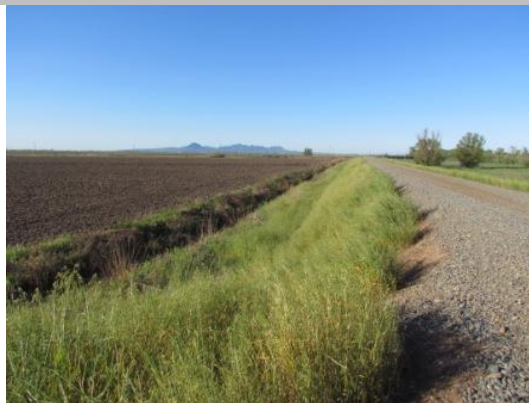
Photo 1 of 1 : SP\_2017\_MA0013\_301\_19\_20170315\_00007.jpg

LM Start	13.40	Rating **	M	Issue No.	19
LM End	16.00	Issue Type +	En	Location *	LS
Category	Earthen Levee			GPS Latitude/Longitude	
				Start	End
Item	Encroachments			39.428192 °	39.414202 °
				-121.768443 °	-121.781863 °
DWR ID	DWR_MA0013_02_s_2012_19				
Comment Code					
DT : Ditch					
Inspector Comment

View of the agricultural ditch along the toe.

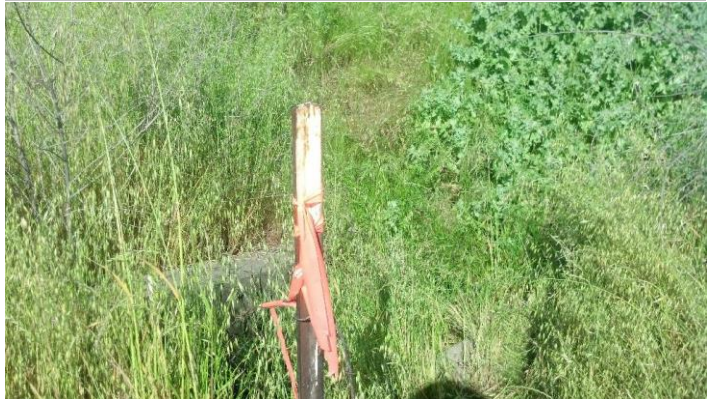
Photo 2 of 3 : UCIP\_SP\_2017\_51132\_67343.jpg

Dense vegetation covering the majority of the WS. WS headwall difficult to see through dense vegetation.

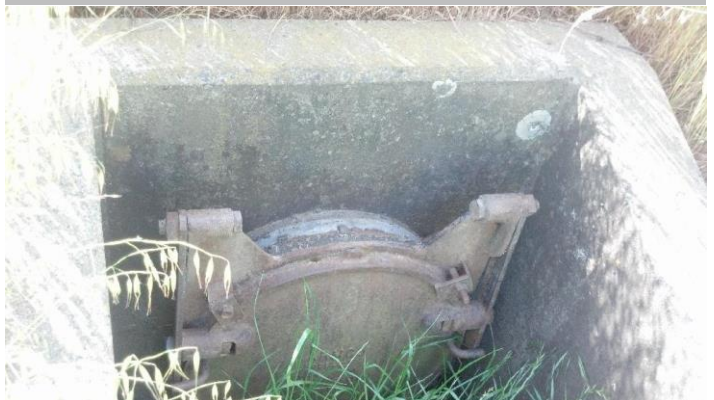
Photo 3 of 3 : UCIP\_SP\_2017\_51132\_67342.jpg

View of WS headwall and flap gate.

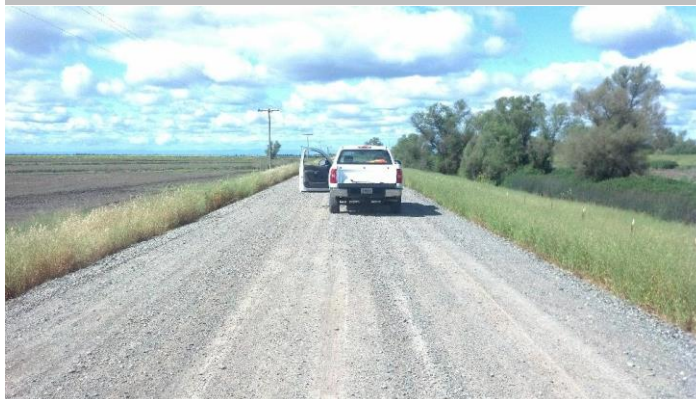
Photo 1 of 3 : UCIP\_SP\_2017\_51133\_67352.jpg

Overview of crossing looking downstream of the left bank of Cherokee

Comment Code					
Inspector Comment					
FS_ID:51133 DS_ID:16382 EP_NO: N/A Repair Type: Non-Urgent Crossing Status: Found UCIP Comments: 11/17/2016 Unable to locate LS pipe end. WS flap gate bolted shut. (DWR Sutter Yard- AFreitag)4/26/2016 Appears to be an abandoned crossing. LS pipe end was still buried and WS flap gate was bolted shut.6/30/2015 LS headwall stil buried somewhere. WS looked to be in good condition.5/28/2014 Same as last inspection.12/4/2013 Same as last inspection.7/08/2013 Same as last inspection.4/24/2012 LS headwall buried. Limited inspection on WS and LS slopes due to dense vegetation. Need photos of cleared WS and LS slopes during next inspection. Need to determine the fate of LS headwall. This crossing was listed in the USACE Periodic Inspection report as Corp's inspect ID# USACE_CESPK_M13E_2011_p_0022 -- unknown issue. FIELD_STRUCT_DESC: *ABANDONED* 24-inch corrugated metal drainage pipe through the levee, 9 feet below the crown. Flap gate located on the waterside (WS) end. Concrete "U" headwalls on both WS and landside (LS). WS gate bolted shut and LS crossing is non-operable (inlet not found). Additional Reference(s): DWR Levee Log, 1993. USACE Sacramento O&M Manual 519, June 1962 (HLM 15.87)] FS Date: 12/2/2016 9:25:24 AM

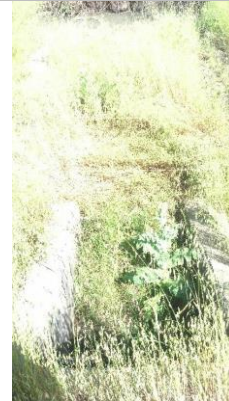
Photo 3 of 3 : UCIP\_SP\_2017\_51133\_67350.jpg

View of WS headwall.

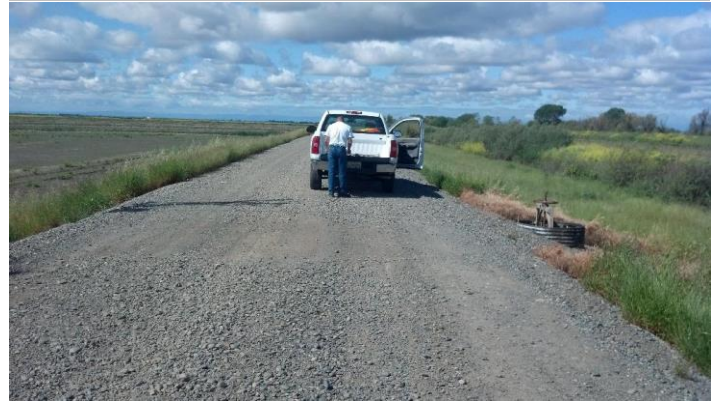
Photo 1 of 3 : UCIP\_SP\_2017\_51134\_67353.jpg

FS\_ID:51134  
DS\_ID:16377  
EP\_NO: N/A  
Repair Type: Non-Urgent  
Crossing Status: Found  
UCIP Comments: 11/17/2016 LS pipe end was about 50% plugged with soil. WS riser box is still cracked and appears to still be leaking. (DWR Sutter Yard- A Freitag)4/26/2016 LS headwall was dry and photographed. LS pipe end was about 50% plugged with soil. WS riser box is still cracked and appears to still be leaking.6/30/2015 Bee boxes stacked near the riser box on WS so could not get close enough to see if the leak issue had been fixed. 5/28/2014 Water appears to be leaking out of the WS concrete riser box. Causing minor erosion under pipe near pump structure.12/4/2013 Same as last inspection.7/08/2013 LS slope has been cleared of vegetation and is in good condition. LS headwall was underwater and unable to be inspected. All WS appurtenances in good condition.4/24/2012 Limited inspection on LS slope due to dense vegetation. Need photos of cleared LS slope and LS headwall. Cracks in riser box. New pump installed recently this work might be covered under seperate permit. FIELD\_STRUCT\_DESC: 36-inch corrugated metal irrigation pipe through the levee, 11.7 feet below the crown. Slide gate in corrugated metal pipe riser on the waterside (WS) slope. Concrete "U" headwall on the landside (LS). Pipe discharges into distribution box on the WS. Divers on dam in stream. Pump located on the WS berm, pumps water from diversion dam into distribution box. Water then flows back through the levee to the LS field. Provision can be made to send water over streambed to irrigation overflow area. [Additional Reference(s): DWR Levee Log, 1993. USACE Sacramento O&M Manual 519, June 1962 (HLM 16.26)]

Overview of levee crown.

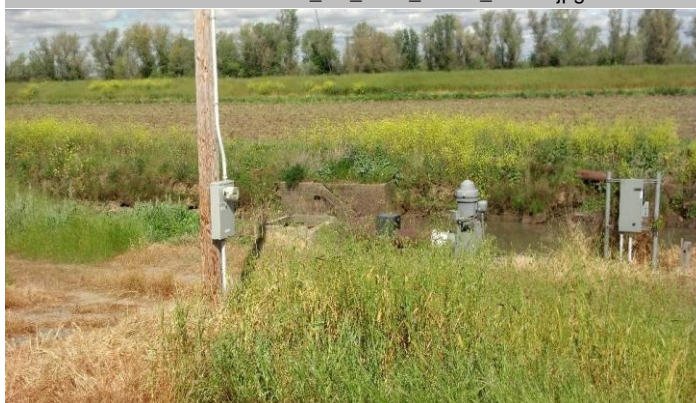
Photo 2 of 3 : UCIP\_SP\_2017\_51134\_67359.jpg

FS\_ID:51134  
DS\_ID:16377  
EP\_NO: N/A  
Repair Type: Non-Urgent  
Crossing Status: Found  
UCIP Comments: 11/17/2016 LS pipe end was about 50% plugged with soil. WS riser box is still cracked and appears to still be leaking. (DWR Sutter Yard- AFreitag)4/26/2016 LS headwall was dry and photographed. LS pipe end was about 50% plugged with soil. WS riser box is still cracked and appears to still be leaking.6/30/2015 Bee boxes stacked near the riser box on WS so could not get close enough to see if the leak issue had been fixed. 5/28/2014 Water appears to be leaking out of the WS concrete riser box. Causing minor erosion under pipe near pump structure.12/4/2013 Same as last inspection.7/08/2013 LS slope has been cleared of vegetation and is in good condition. LS headwall was underwater and unable to be inspected. All WS appurtances in good condition.4/24/2012 Limited inspection on LS slope due to dense vegetation. Need photos of cleared LS slope and LS headwall. Cracks in riser box. New pump installed recently this work might be covered under seperate permit. FIELD\_STRUCT\_DESC: 36-inch corrugated metal irrigation pipe through the levee, 11.7 feet below the crown. Slide gate in corrugated metal pipe riser on the waterside (WS) slope. Concrete "U" headwall on the landside (LS). Pipe discharges into distribution box on the WS. Divers on dam in stream. Pump located on the WS berm, pumps water from diversion dam into distribution box. Water then flows back through the levee to the LS field. Provision can be made to send water over streambed to irrigation overflow area. [Additional Reference(s): DWR Levee Log, 1993. USACE Sacramento O&M Manual 519, June 1962 (HLM 16.26)]

Appurtances on WS.

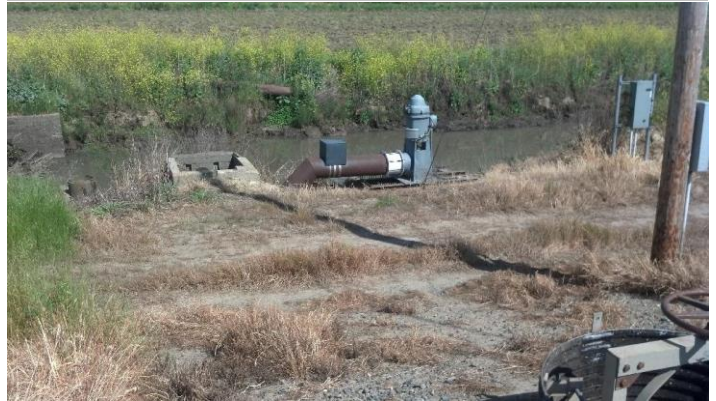
Photo 3 of 3 : UCIP\_SP\_2017\_51134\_67355.jpg

FS\_ID:51134  
DS\_ID:16377  
EP\_NO: N/A  
Repair Type: Non-Urgent  
Crossing Status: Found  
UCIP Comments: 11/17/2016 LS pipe end was about 50% plugged with soil. WS riser box is still cracked and appears to still be leaking. (DWR Sutter Yard- AFreitag)4/26/2016 LS headwall was dry and photographed. LS pipe end was about 50% plugged with soil. WS riser box is still cracked and appears to still be leaking.6/30/2015 Bee boxes stacked near the riser box on WS so could not get close enough to see if the leak issue had been fixed. 5/28/2014 Water appears to be leaking out of the WS concrete riser box. Causing minor erosion under pipe near pump structure.12/4/2013 Same as last inspection.7/08/2013 LS slope has been cleared of vegetation and is in good condition. LS headwall was underwater and unable to be inspected. All WS appurtances in good condition.4/24/2012 Limited inspection on LS slope due to dense vegetation. Need photos of cleared LS slope and LS headwall. Cracks in riser box. New pump installed recently this work might be covered under seperate permit. FIELD\_STRUCT\_DESC: 36-inch corrugated metal irrigation pipe through the levee, 11.7 feet below the crown. Slide gate in corrugated metal pipe riser on the waterside (WS) slope. Concrete "U" headwall on the landside (LS). Pipe discharges into distribution box on the WS. Divers on dam in stream. Pump located on the WS berm, pumps water from diversion dam into distribution box. Water then flows back through the levee to the LS field. Provision can be made to send water over streambed to irrigation overflow area. [Additional Reference(s): DWR Levee Log, 1993. USACE Sacramento O&M Manual 519, June 1962 (HLM 16.26)]

WS view of crossing.

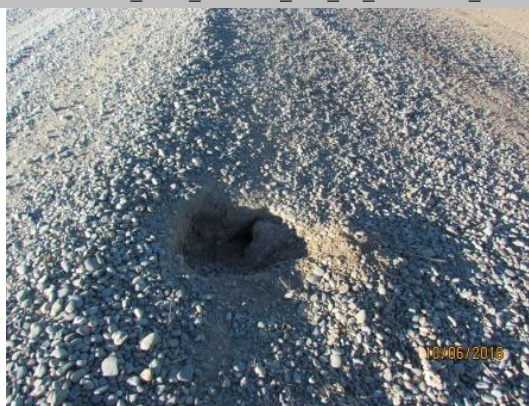
Photo 1 of 1 : SP\_2017\_MA0013\_301\_54\_20170315\_00014.jpg

LM Start	16.52	Rating **	U	Issue No.	54
LM End	16.52	Issue Type +	Ma	Location *	WS
Category	Earthen Levee			GPS Latitude/Longitude	
				Start	End
Item	Animal Control			39.409548 °	39.409548 °
				-121.789668 °	-121.789668 °
DWR ID	DWR_MA0013_02_f_2014_54				
Comment Code					
A3 : No rodents visible, but rodent burrows visible; need to backfill and compact or grout burrows.					
Inspector Comment

View of the rodent holes along the waterside slope.

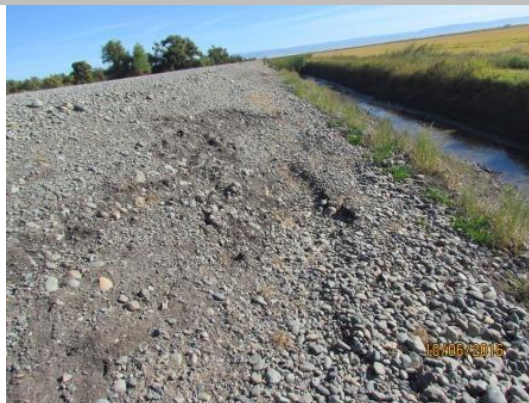
Photo 1 of 1 : SP\_2017\_MA0013\_301\_69\_20170315\_00021.jpg

LM Start	17.64	Rating **	M	Issue No.	69
LM End	17.64	Issue Type +	Ma	Location *	LS
Category	Earthen Levee			GPS Latitude/Longitude	
				Start	End
Item	Slope Stability			39.399164 °	39.399164 °
				-121.805787 °	-121.805787 °
DWR ID	DWR_MA0013_02_f_2016_69				
Comment Code					
S1 : Repair slope instability.					
Inspector Comment

View of slope instability issue along the landside slope.

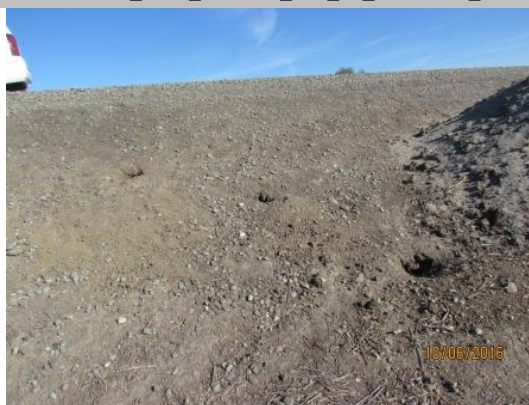
Photo 1 of 1 : SP\_2017\_MA0013\_301\_70\_20170315\_00022.jpg

LM Start	17.90	Rating **	M	Issue No.	70
LM End	17.90	Issue Type +	Ma	Location *	LS
Category	Earthen Levee			GPS Latitude/Longitude	
				Start	End
Item	Animal Control			39.396809 °	39.396809 °
				-121.809422 °	-121.809422 °
DWR ID	DWR_MA0013_02_f_2016_70				
Comment Code					
A3 : No rodents visible, but rodent burrows visible; need to backfill and compact or grout burrows.					
Inspector Comment

View of the rodent holes along the landside slope.

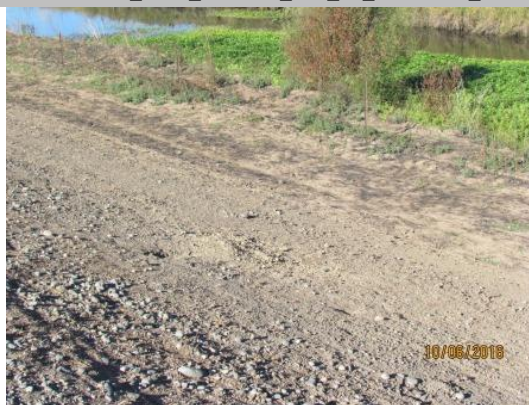
Photo 1 of 1 : SP\_2017\_MA0013\_301\_71\_20170315\_00023.jpg

LM Start	17.93	Rating **	M	Issue No.	71
LM End	17.93	Issue Type +	Ma	Location *	LS
Category	Earthen Levee			GPS Latitude/Longitude	
				Start	End
Item	Animal Control			39.396465 °	39.396465 °
				-121.809935 °	-121.809935 °
DWR ID	DWR_MA0013_02_f_2016_71				
Comment Code					
A3 : No rodents visible, but rodent burrows visible; need to backfill and compact or grout burrows.					
Inspector Comment

View of the rodent holes along the landside slope.

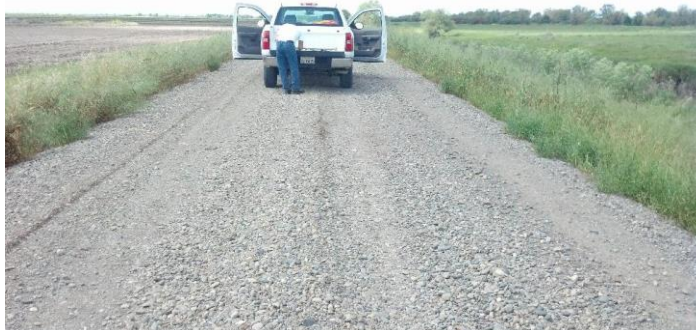
Photo 1 of 3 : UCIP\_SP\_2017\_51138\_67387.jpg

FS\_ID:51138  
DS\_ID:16379  
EP\_NO: N/A  
Repair Type: No Action Needed  
Crossing Status: Found  
UCIP Comments: 11/17/2016 Crossing appears to be in good condition. (DWR Sutter Yard- AFreitag)4/26/2016 Crossing appears to be in good condition.6/30/2015 Vegetation still present on WS. LS side was underwater during inspection.5/28/2014 Same as last inspection.12/4/2013 Same as last inspection.7/08/2013 LS slope cleared of vegetation and is in good condition. WS is still vegetated. LS pipe end under water and blocked off by plywood so unable to measure culvert size.4/24/2012 Limited inspection on WS and LS slopes due to dense vegetation. Need photos of cleared WS and LS slopes. This crossing was listed in the USACE Periodic Inspection report as Corp's inspect ID# USACE\_CESPK\_M13E\_2011\_p\_0134 for unknown culvert size on LS and no outlet visible on WS.  
FIELD\_STRUCT\_DESC: 36-inch corrugated metal drainage pipe through the levee, 13.2 feet below the crown. Flap gate on the waterside (WS) end. Concrete "U" headwalls on both ends. [Additional Reference(s): DWR Levee Log, 1993. USACE Sacramento O&M Manual 519, June 1962 (HLM 18.37)]

Overview of crossing looking D/S at left bank of Cherokee Canal.

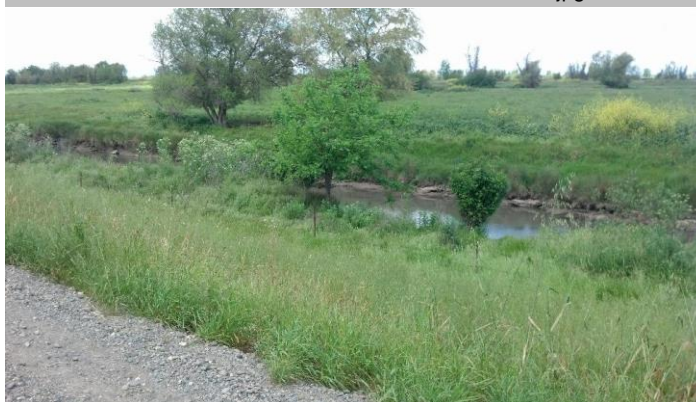
Photo 2 of 3 : UCIP\_SP\_2017\_51138\_67386.jpg

View of WS slope and berm.

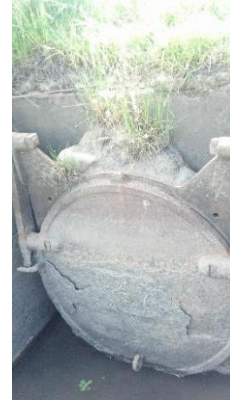
Photo 3 of 3 : UCIP\_SP\_2017\_51138\_67390.jpg

Item	DWR UCIP LMA Responsibility			39.394406 °	39.394406 °
				-121.813180 °	-121.813180 °
DWR ID					
Comment Code					
Inspector Comment					
FS_ID:51138 DS_ID:16379 EP_NO: N/A Repair Type: No Action Needed Crossing Status: Found UCIP Comments: 11/17/2016 Crossing appears to be in good condition. (DWR Sutter Yard- AFreitag)4/26/2016 Crossing appears to be in good condition.6/30/2015 Vegetation still presenton WS. LS side was underwater during inspection.5/28/2014 Same as last inspection.12/4/2013 Same as last inspection.7/08/2013 LS slope cleared of vegetation and is in good condition. WS is still vegetated. LS pipe end under water and blocked off by plywood so unable to measure culvert size.4/24/2012 Limited inspection on WS and LS slopes due to dense vegetation. Need photos of cleared WS and LS slopes. This crossing was listed in the USACE Periodic Inspection report as Corp's inspect ID# USACE_CESPK_M13E_2011_p_0134 for unknown culvert size on LS and no outlet visible on WS. FIELD_STRUCT_DESC: 36-inch corrugated metal drainage pipe through the levee, 13.2 feet below the crown. Flap gate on the waterside (WS) end. Concrete "U" headwalls on both ends. [Additional Reference(s): DWR Levee Log, 1993. USACE Sacramento O&M Manual 519, June 1962 (HLM 18.37)] FS Date: 12/2/2016 9:40:13 AM

View of flap gate located on WS.

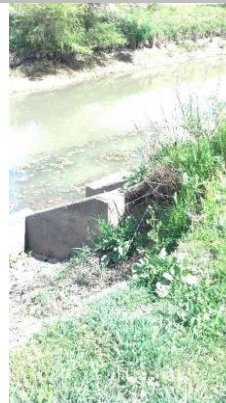
Photo 1 of 3 : UCIP\_SP\_2017\_51141\_67401.jpg

FS\_ID:51141  
DS\_ID:16375  
EP\_NO: N/A  
Repair Type: Non-Urgent  
Crossing Status: Found  
UCIP Comments: 11/17/2016 Erosion still present at WS headwall. (DWR Sutter Yard- A Freitag) 4/26/2016 Erosion still present behind the WS headwall. The rest of the crossing appears in good condition. 6/30/2015 Erosion still present behind the WS headwall. Everything thing else with the crossing appeared to be in good condition. 12/4/2013 Same as last inspection. 5/28/2014 Same as last inspection. 7/08/2013 Erosion problem same as last inspection. WS and LS slopes have been cleared of vegetation and are in good shape. 4/24/2012 Erosion present behind WS headwall. Limited inspection on WS and LS slopes due to dense vegetation. Need photos of cleared WS and LS slopes during next inspection.  
FIELD\_STRUCT\_DESC: 30-inch corrugated metal drainage pipe through the levee, 13.1 feet below the crown. Flap gate on the waterside (WS) end. Concrete "U" headwalls on both WS and landside (LS). [Additional Reference(s): DWR Levee Log, 1993. USACE Sacramento O&M Manual 519, June 1962 (HLM 20.15)]

Erosion behind WS headwall looking at the downstream edge of headwall.

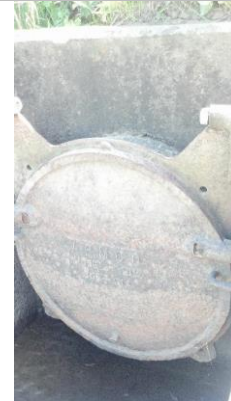
Photo 3 of 3 : UCIP\_SP\_2017\_51141\_67402.jpg

Comment Code					
Inspector Comment					
FS_ID:51141 DS_ID:16375 EP_NO: N/A Repair Type: Non-Urgent Crossing Status: Found UCIP Comments: 11/17/2016 Erosion still present at WS headwall. (DWR Sutter Yard- A Freitag)4/26/2016 Erosion still present behind the WS headwall. The rest of the crossing appears in good condition.6/30/2015 Erosion still present behind the WS headwall. Everything thing else with the crossing appeared to be in good condition.12/4/2013 Same as last inspection.5/28/2014 Same as last inspection.7/08/2013 Erosion problem same as last inspection. WS and LS slopes have been cleared of vegetation and are in good shape.4/24/2012 Erosion present behind WS headwall. Limited inspection on WS and LS slopes due to dense vegetation. Need photos of cleared WS and LS slopes during next inspection. FIELD_STRUCT_DESC: 30-inch corrugated metal drainage pipe through the levee, 13.1 feet below the crown. Flap gate on the waterside (WS) end. Concrete "U" headwalls on both WS and landside (LS). [Additional Reference(s): DWR Levee Log, 1993. USACE Sacramento O&M Manual 519, June 1962 (HLM 20.15)] FS Date: 12/2/2016 9:42:22 AM

Flap gate located on the WS.

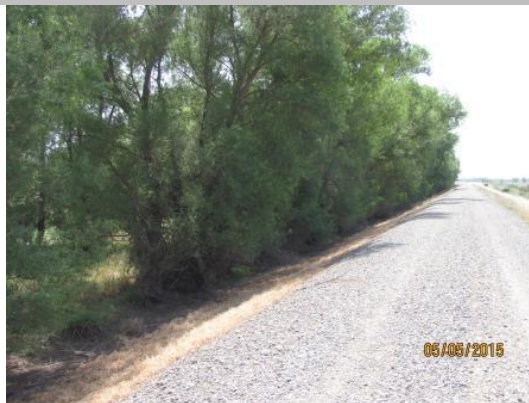
Photo 1 of 1 : SP\_2017\_MA0013\_301\_6\_20170315\_00002.jpg

LM Start	20.43	Rating **	M	Issue No.	6
LM End	20.74	Issue Type +	Ma	Location *	LS
Category	Earthen Levee			GPS Latitude/Longitude	
				Start	End
Item	Trim / Thin Trees			39.373091 °	39.370795 °
				-121.845225 °	-121.850124 °
DWR ID	DWR_MA0013_02_s_2013_6				
Comment Code					
T1 : Trim trees to at least five feet above ground level.					
Inspector Comment

View of the overgrown trees along the landside slope.

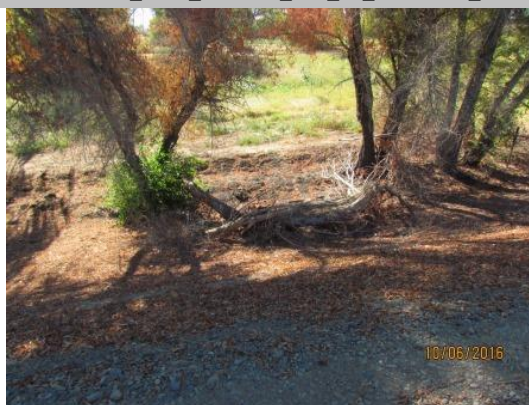
Photo 1 of 1 : SP\_2017\_MA0013\_301\_73\_20170315\_00024.jpg

LM Start	20.52	Rating **	M	Issue No.	73
LM End	20.52	Issue Type +	Ma	Location *	LS
Category	Earthen Levee			GPS Latitude/Longitude	
				Start	End
Item	Encroachments			39.372486 °	39.372486 °
				-121.846537 °	-121.846537 °
DWR ID	DWR_MA0013_02_f_2016_73				
Comment Code					
TR : Tree or limb					
Inspector Comment					
Remove the tree limbs from the landside slope and toe.

View of the tree limbs along the landside levee toe.

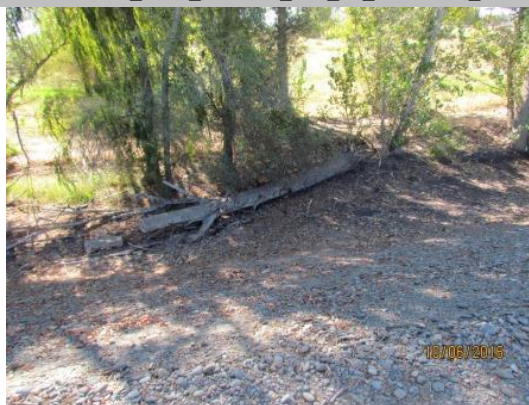
Photo 1 of 1 : SP\_2017\_MA0013\_301\_52\_20170315\_00012.jpg

LM Start	20.65	Rating **	M	Issue No.	52
LM End	20.65	Issue Type +	Ma	Location *	LS
Category	Earthen Levee			GPS Latitude/Longitude	
				Start	End
Item	Encroachments			39.371433 °	39.371433 °
				-121.848753 °	-121.848753 °
DWR ID	DWR_MA0013_02_s_2014_52				
Comment Code					
TR : Tree or limb					
Inspector Comment					
Remove the tree limbs from the landside slope and toe.

View of the tree limbs along the landside toe.

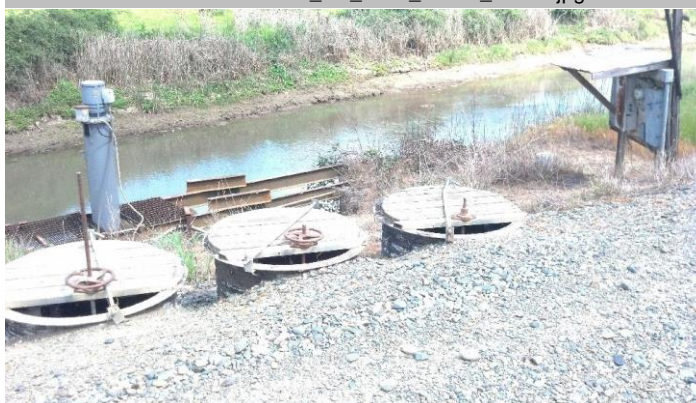
Photo 1 of 3 : UCIP\_SP\_2017\_51145\_67416.jpg

FS\_ID:51145  
DS\_ID:17014  
EP\_NO: N/A  
Repair Type: Urgent  
Crossing Status: Found  
UCIP Comments: 11/17/2016 Crossing has not been repaired yet. pipe ends still showing heavy signs of rust and corrosion. (DWR Sutter Yard - A Freitag) 4/26/2016 No repairs have been made at this crossing yet. (DWR Sutter Yard - Freitag) 6/30/2015 Crossing has not been repaired yet. pipe ends still showing heavy signs of rust and corrosion. (DWR Sutter Yard - Freitag) 5/28/2014 Same as last inspection. (DWR Sutter Yard - Freitag) 12/4/2013 Same as last inspection. (DWR Sutter Yard - Freitag) 7/08/2013 Same as last inspection. (DWR Sutter Yard - Freitag) 4/24/2012 LS pipe collars severely damaged--section missing at flapgate. Crossing needs repair. Will need to coordinate with owner. (DWR UCIP - omagana)  
FIELD\_STRUCT\_DESC: 2 of 3: 16-inch steel irrigation pipe encased in reinforced concrete through the levee, 9.7 feet below the crown. Concrete "U" headwall on both ends. Slide gates on corrugated metal pipe risers on the waterside (WS) slope. Pump structure on the WS end. [Additional Reference(s): DWR Levee Log, 1993. USACE Sacramento O&M Manual 519, June 1962 (HLM 21.00)]

WS view of corrugated metal pipe risers .

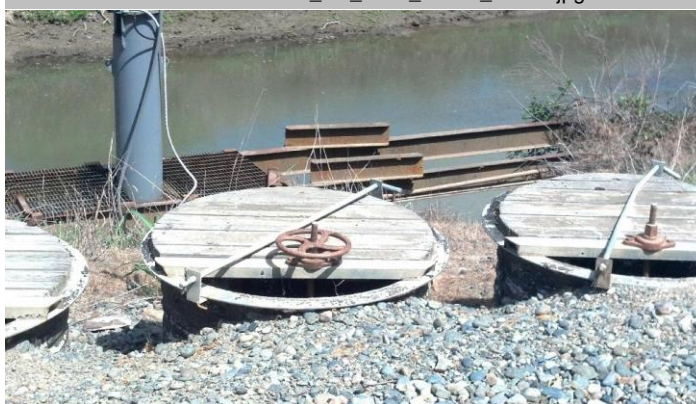
Photo 2 of 3 : UCIP\_SP\_2017\_51145\_67418.jpg

Riser for pipe 2 of 3.

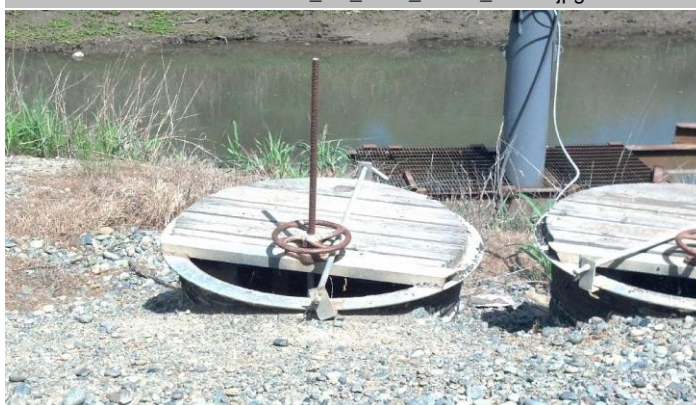
Photo 2 of 3 : UCIP\_SP\_2017\_51144\_67443.jpg

FS\_ID:51144  
DS\_ID:17185  
EP\_NO: N/A  
Repair Type: Urgent  
Crossing Status: Found  
UCIP Comments: 11/17/2016 Crossing has not been repaired yet. pipe ends still showing heavy signs of rust and corrosion. (DWR Sutter Yard - A Freitag) 4/26/2016 No repairs have been made at this crossing yet. (DWR Sutter Yard - Freitag) 6/30/2015 Crossing has not been repaired yet. pipe ends still showing heavy signs of rust and corrosion. (DWR Sutter Yard - Freitag) 5/28/2014 Same as last inspection. (DWR Sutter Yard - Freitag) 12/4/2013 Same as last inspection. (DWR Sutter Yard - Freitag) 7/08/2013 Same as last inspection. (DWR Sutter Yard - Freitag) 4/24/2012 Sink hole present on WS. LS pipe collars severely damaged--section missing at flapgate. Crossing needs repair. Need to coordinate with owner. (DWR UCIP - omagana)  
FIELD\_STRUCT\_DESC: 3 of 3: 16-inch steel irrigation pipe encased in reinforced concrete through the levee, 9.7 feet below the crown. Concrete "U" headwall on both ends. Slide gates in corrugated metal pipe risers on the waterside (WS) slope. Pump structure located on the WS end. [Additional Reference(s): DWR Levee Log, 1993. USACE Sacramento O&M Manual 519, June 1962 (HLM 21.00)]

View of corrugated metal pipe for pipe 3 of 3.

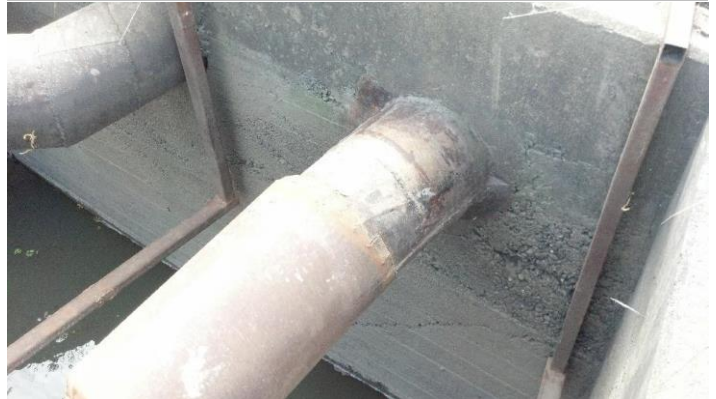
Photo 3 of 3 : UCIP\_SP\_2017\_51144\_67442.jpg

Comment Code					
Inspector Comment					
FS_ID:51144 DS_ID:17185 EP_NO: N/A Repair Type: Urgent Crossing Status: Found UCIP Comments: 11/17/2016 Crossing has not been repaired yet. pipe ends still showing heavy signs of rust and corrosion. (DWR Sutter Yard - A Freitag)4/26/2016 No repairs have been made at this crossing yet. (DWR Sutter Yard - a Freitag)6/30/2015 Crossing has not been repaired yet. pipe ends still showing heavy signs of rust and corrosion. (DWR Sutter Yard - a Freitag)5/28/2014 Same as last inspection. (DWR Sutter Yard - a Freitag)12/4/2013 Same as last inspection. (DWR Sutter Yard - a Freitag)7/08/2013 Same as last inspection. (DWR Sutter Yard - a Freitag)4/24/2012 Sink hole present on WS. LS pipe collars severely damaged--section missing at flapgate. Crossing needs repair. Need to coordinate with owner. (DWR UCIP - omagana) FIELD_STRUCT_DESC: 3 of 3: 16-inch steel irrigation pipe encased in reinforced concrete through the levee, 9.7 feet below the crown. Concrete "U" headwall on both ends. Slide gates in corrugated metal pipe risers on the waterside (WS) slope. Pump structure located on the WS end. [Additional Reference(s): DWR Levee Log, 1993. USACE Sacramento O&M Manual 519, June 1962 (HLM 21.00)] FS Date: 12/2/2016 9:44:48 AM

View of Pipe 3 of 3 from WS headwall.

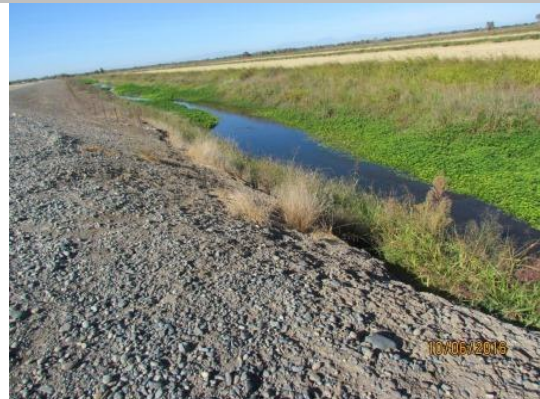
Photo 1 of 1 : SP\_2017\_MA0013\_301\_75\_20170315\_00025.jpg

LM Start	20.77	Rating **	M	Issue No.	75
LM End	20.77	Issue Type +	Ma	Location *	WS
Category	Earthen Levee			GPS Latitude/Longitude	
				Start	End
Item	Erosion / Bank Caving			39.370641 °	39.370641 °
				-121.850572 °	-121.850572 °
DWR ID	DWR_MA0013_02_f_2016_75				
Comment Code					
E1 : Note and monitor erosion site.					
Inspector Comment

View of the erosion along the waterside toe.

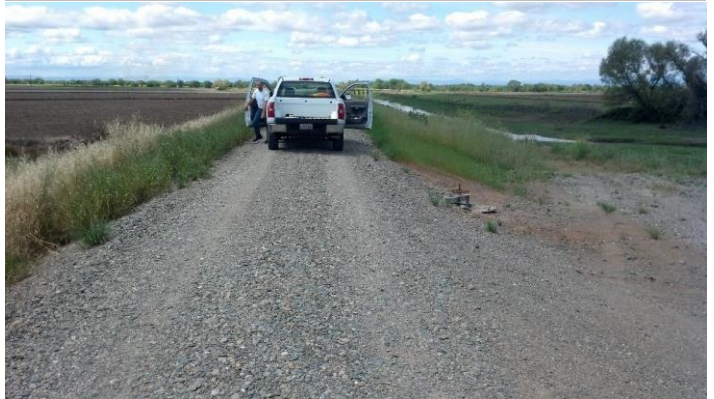
Photo 1 of 3 : UCIP\_SP\_2017\_51147\_67447.jpg

FS\_ID:51147  
DS\_ID:16384  
EP\_NO: N/A  
Repair Type: Non-Urgent  
Crossing Status: Found  
UCIP Comments: 11/17/2016 Pipe section that crosses through the levee appears to be in good condition. (DWR Sutter Yard - AFreitag)4/26/2016 Pipe appears to have been repaired. Not sure on the extent of the repairs or if they were approved by the Central Valley Flood Control Board.6/30/2015 Pipe is currently undergoing repairs. Not sure what all is planed to be fixed but will update the photos and inspection report with new details when its completed.5/28/2014 Same as last inspection.12/4/2013 Same as last inspection.7/08/2013 Pipe appears to have been repaired. Need to talk to inspections and supervisor to find out more deatils on repair.4/24/2012 Needs repair. Internal piping, severe corrosion. Debris present--rusted pipe stockpiled on LS slope. Limited inspection on WS and LS slopes due to dense vegetation. Need photos of cleared WS & LS slopes. This crossing was listed in the USACE Periodic Inspection report as Corp's inspect ID# USACE\_CESPK\_M13E\_2011\_p\_0234 for no WS gate but sluice gate present.

Overview of crossing looking downstream.

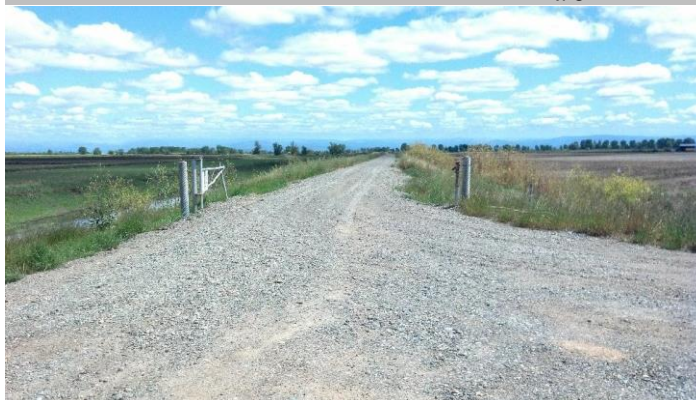
Photo 1 of 3 : UCIP\_SP\_2017\_51149\_67462.jpg

Overview of crossing looking upstream at the left bank of Cherokee Canal.

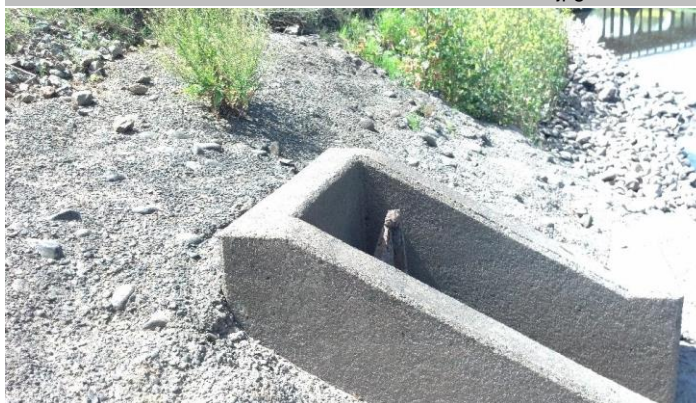
Photo 2 of 3 : UCIP\_SP\_2017\_51149\_67460.jpg

View of WS headwall.

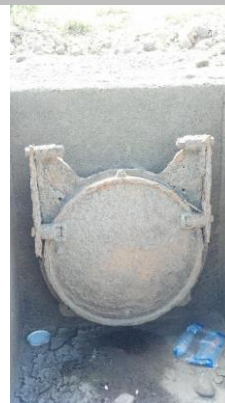
Photo 3 of 3 : UCIP\_SP\_2017\_51149\_67461.jpg

Item	DWR UCIP LMA Responsibility			39.362378 °		39.362378 °
				-121.867350 °		-121.867350 °
DWR ID						
Comment Code						
Inspector Comment						
FS_ID:51149 DS_ID:16394 EP_NO: N/A Repair Type: Non-Urgent Crossing Status: Found UCIP Comments: 11/17/2016 WS flap gate is really rusted and deteriorated but it appears to still function properly. (DWR Sutter Yard - A/Freitag)4/26/2016 WS flap gate is really rusted and deteriorated. May need to be replaced. The rest of the crossing appeared in good condition.6/30/2015 Crossing is in good condition. No noticeable issues to be reported.5/28/2014 Same as last inspection.12/4/2013 WS ans LS slopes are in good condition.7/08/2013 Same as last inpection.4/24/2012 Limited inspection on WS and LS slopes due to dense vegetation. Need photos of cleared WS and LS slopes. This crossing was listed in the USACE Periodic Inspection report as Corp's inspect ID# USACE_CESPK_M13E_2011_p_0251 for no outlet visible on WS. FIELD_STRUCT_DESC: 24-inch corrugated metal drainage pipe through the levee, 11.6 feet below the crown. Flap gate on the waterside (WS) end. Concrete "U" headwalls on both WS and landside (LS). Rusted gate located on the WS (gate stuck). [Additional Reference(s): DWR Levee Log, 1993. USACE Sacramento O&M Manual 519, June 1962 (HLM 22.08)] FS Date: 12/2/2016 9:58:16 AM

Flap gate located on WS.

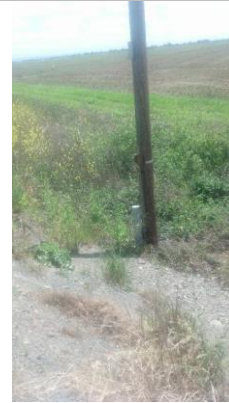
Photo 1 of 1 : UCIP\_SP\_2017\_51151\_67480.jpg

Comment Code					
Inspector Comment					
FS_ID:51151 DS_ID:16374 EP_NO: N/A Repair Type: Non-Urgent Crossing Status: Indicator Found UCIP Comments: 11/17/2016 Splice box still present at LS toe. (DWR Sutter Yard - A Freitag) 4/26/2016 Communication Splice box was still present. Not sure what was done to ever resolve the encroachment issue.6/30/2015 Same as last inspection.5/28/2014 Same as last inspection.12/4/2013 Same as last inspection.7/08/2013 Same as last inspection.4/24/2012 Unauthorized Encroachment. This crossing is listed multiple times in the USACE Periodic Inspection report as USACE_CESPK_M13E_2011_p_0307, 0315, 0317, 0318 for slope failure on LS hinge. DWR-Flood Maintenance Office records shows that CVFPB has requested AT&T to remove conduit in June 2, 2009 letter. LMA working with CVFPB to resolve. FIELD_STRUCT_DESC: *ILLEGAL ENCROACHMENT* Underground telephone cable through the levee. Depth unknown. (AT&T) START latitude 39.36210336, longitude -121.8678207 END latitude 39.35458541, longitude -121.8823409. Line extends from Gridley Colusa Highway to the south end of project levee along landside (LS) shoulder and levee crown hinge point. Levee sloughs along cable trench after heavy rains. [Additional Reference(s): DWR Levee Log, 1993] FS Date: 12/2/2016 10:00:38 AM

View of utility line located on LS toe.

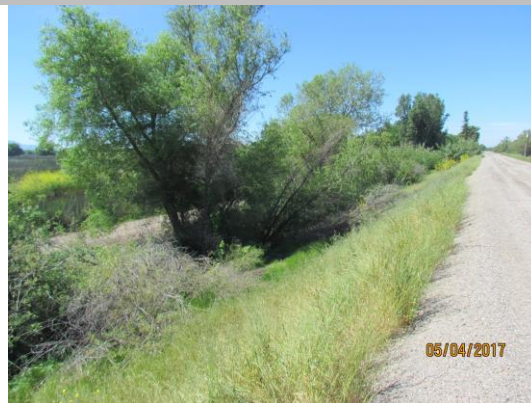
Photo 1 of 1 : SP\_2017\_MA0013\_301\_63\_20170508\_00149.jpg

LM Start	22.02	Rating **	M	Issue No.	63
LM End	22.09	Issue Type +	Ma	Location *	LS
Category	Earthen Levee			GPS Latitude/Longitude	
				Start	End
Item	Trim / Thin Trees			39.360842 °	39.360322 °
				-121.870300 °	-121.871318 °
DWR ID	DWR_MA0013_02_s _ 2017_63				
Comment Code					
T3 : Trim and thin trees to allow visibility of the ground and room to flood fight.					
Inspector Comment					
Trim the trees along the landside toe for visibility.

View of the trees along the landside toe.

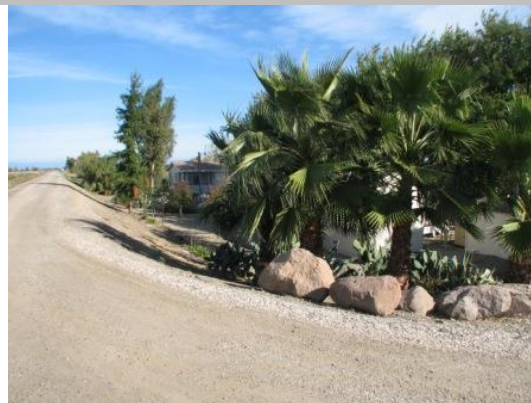
Photo 1 of 1 : SP\_2017\_MA0013\_301\_4\_20170315\_00001.jpg

LM Start	22.07	Rating **	M	Issue No.	4
LM End	22.13	Issue Type +	En	Location *	LS
Category	Earthen Levee			GPS Latitude/Longitude	
				Start	End
Item	Vegetation			39.360410 °	39.359920 °
				-121.871125 °	-121.872067 °
DWR ID	DWR_MA0013_02_s _ 2012_4				
Comment Code					
V6 : Landscaping					
Inspector Comment

View of landscaping along the toe.

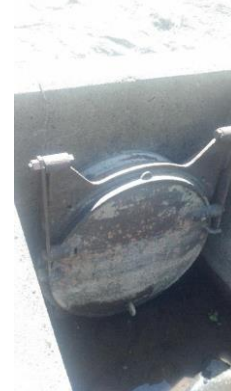
Photo 3 of 3 : UCIP\_SP\_2017\_51154\_67497.jpg

Item	DWR UCIP LMA Responsibility			39.359827 °	39.359827 °	
				-121.872300 °	-121.872300 °	
DWR ID						
Comment Code						
Inspector Comment						
FS_ID:51154 DS_ID:16391 EP_NO: N/A Repair Type: Non-Urgent Crossing Status: Found UCIP Comments: 11/17/2016 Unable to locate LS pipe end. Ws appears to be in good condition. (DWR Sutter Yard - A/Freitag)4/26/2016 Still unable to locate the LS headwall and end of pipe. Pipe is still being used. Pipe was draining to WS.6/30/2015 Still unable to locate the LS headwall and pipe end.5/28/2014 Same as last inspection.12/4/2013 Same as last inspection.7/08/2013 Same as last inspection. Unable to locate LS headwall.4/24/2012 Unable to locate LS headwall. Need photo of LS headwall during next inspection. FIELD_STRUCT_DESC: 30-inch corrugated metal drainage pipe through the levee, 15.3 feet below the crown. Concrete "U" headwalls on both waterside (WS) and landside (LS) ends. Flap gate on the WS end. This pipe runs on an angle through the levee, then underground along the LS slope to historic levee mile (HLM) 22.39 where it enters a ditch on the LS. [Additional Reference(s): DWR Levee Log, 1993. USACE Sacramento O&M Manual 519, June 1962 (HLM 22.41)] FS Date: 12/2/2016 10:02:34 AM

View of flap gate on WS.

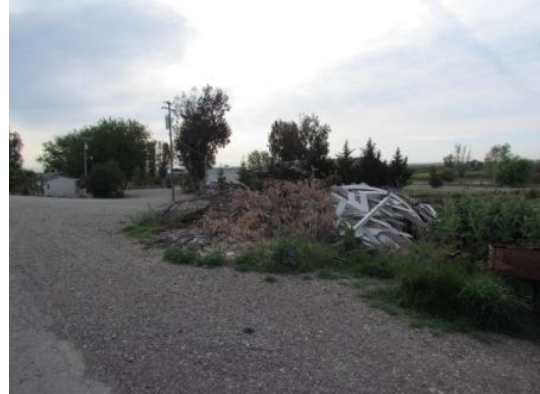
Photo 1 of 1 : SP\_2017\_MA0013\_301\_8\_20170315\_00003.jpg

LM Start	22.16	Rating **	M	Issue No.	8
LM End	22.16	Issue Type +	Ma	Location *	LS
Category	Earthen Levee			GPS Latitude/Longitude	
				Start	End
Item	Encroachments			39.359707 °	39.359707 °
				-121.872555 °	-121.872555 °
DWR ID	DWR_MA0013_02_s_2012_8				
Comment Code					
PR : Prunings					
Inspector Comment

View of the debris and prunings along the landside toe.

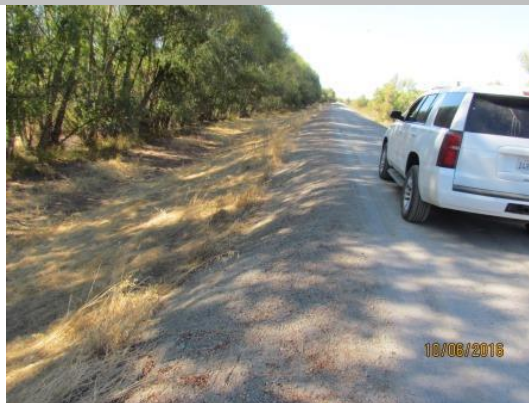
Photo 1 of 1 : SP\_2017\_MA0013\_301\_62\_20170315\_00018.jpg

LM Start	22.33	Rating **	A/W	Issue No.	62
LM End	22.33	Issue Type +	Ma	Location *	LS
Category	Earthen Levee			GPS Latitude/Longitude	
				Start	End
Item	Slope Stability			39.358419 °	39.358419 °
				-121.875088 °	-121.875088 °
DWR ID	DWR_MA0013_02_s_2016_62				
Comment Code					
Inspector Comment

View of slope instability issue along the landside slope.

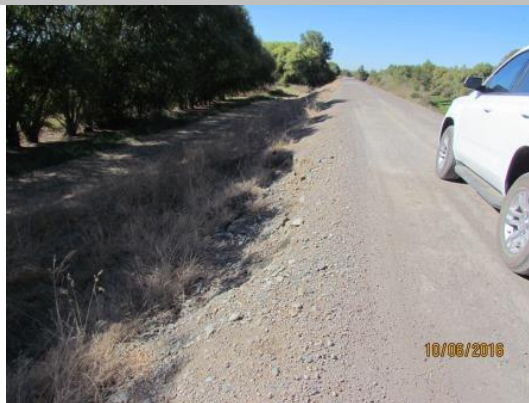
Photo 1 of 1 : SP\_2017\_MA0013\_301\_77\_20170315\_00026.jpg

LM Start	22.54	Rating **	M	Issue No.	77
LM End	22.54	Issue Type +	Ma	Location *	LS
Category	Earthen Levee			GPS Latitude/Longitude	
				Start	End
Item	Slope Stability			39.356775 °	39.356775 °
				-121.878417 °	-121.878417 °
DWR ID	DWR_MA0013_02_f_2016_77				
Comment Code					
S1 : Repair slope instability.					
Inspector Comment

View of slope instability issue along the landside slope.

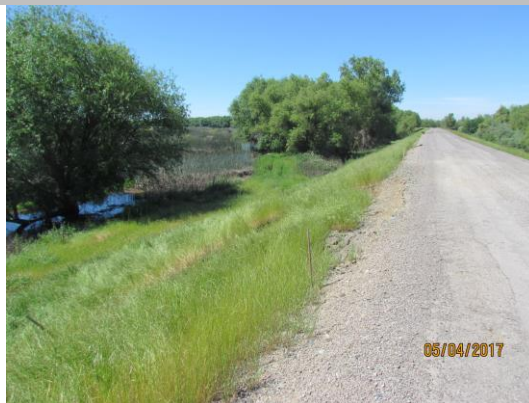
Photo 1 of 1 : SP\_2017\_MA0013\_301\_66\_20170508\_00150.jpg

LM Start	22.58	Rating **	U	Issue No.	66
LM End	22.58	Issue Type +	Ma	Location *	LS
Category	Earthen Levee			GPS Latitude/Longitude	
				Start	End
Item	Slope Stability			39.356423 °	39.356423 °
				-121.879110 °	-121.879110 °
DWR ID	DWR_MA0013_02_s_2017_66				
Comment Code					
S1 : Repair slope instability.					
Inspector Comment					
Repair the erosion along the landside slope.

View of the erosion along the landside slope.
