**Flood Control Project Maintenance
Levee Inspections**
LMA District Cover Sheet
Spring 2018 Levee Inspection Results

Sutter Maintenance Yard Maintenance Area 0013

Spring 2018 Levee Inspection Results

Waterway			Bank	Unit Miles
Unit No. 01 Cherokee Canal			Right	18.19
	Spring (March - May)	Summer (June - August)	(September - November) Fall	Winter (December - February)
Unit Maintenance Rating (Fall Only)				
Date of Inspection	4/17/2018 - 4/17/2018			
DWR Inspector	Bob Duffey			
Accompanied By	Shawn Freitag Sutter Maintenance Yard

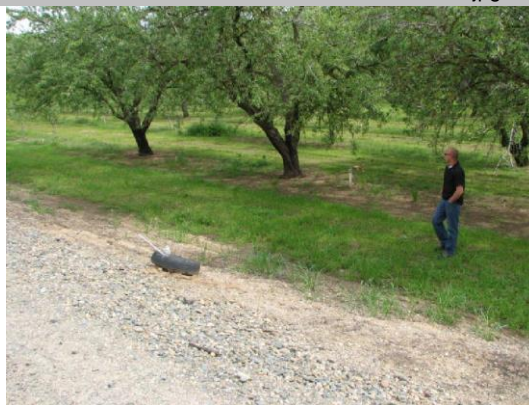
Photo 2 of 3 : UCIP_SP_2018_52178_66683.jpg

Air Vent located on WS.

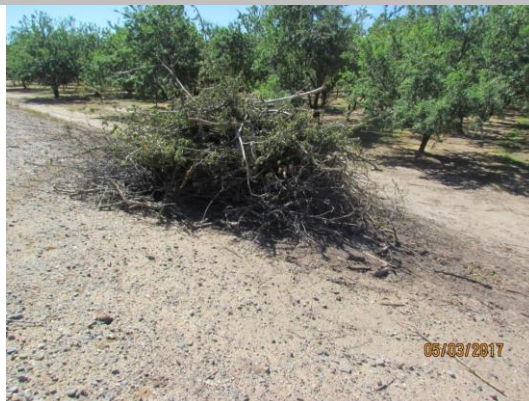
Photo 1 of 1 : SP_2018_MA0013_300_89_20180305_00013.jpg

LM Start	0.46	Rating **	M	Issue No.	89
LM End	0.46	Issue Type +	En	Location *	LS
Category	Earthen Levee			GPS Latitude/Longitude	
				Start	End
Item	Encroachments			39.591162 °	39.591162 °
				-121.701820 °	-121.701820 °
DWR ID	DWR_MA0013_01_s_2017_89				
Comment Code					
PR : Prunings					
Inspector Comment					
Remove the prunings from the landside slope.

View of prunings along the landside slope.

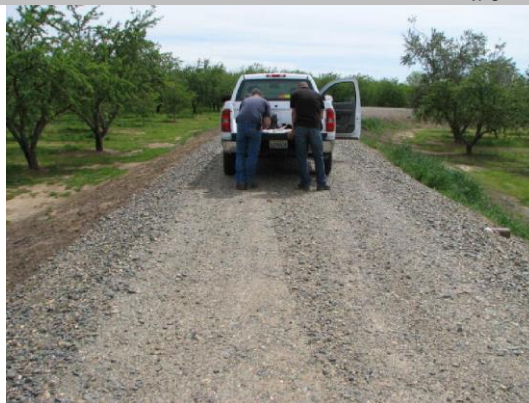
Photo 1 of 3 : UCIP_SP_2018_52179_66686.jpg

FS_ID:52179
DS_ID:16342
EP_NO: 12129
Repair Type: Non-Urgent
Crossing Status: Found
UCIP Comments: 6/14/2017 Abandoned- needs to be done properly. (DWR Sutter Yard- AFreitag)11/16/2016 Abandoned. WS end still has plate bolted on. (DWR Sutter Yard- AFreitag)4/28/2016 Crossing still has plate bolted on it at the WS end and LS end was mostly buried.7/14/2015 WS pipe end still had plate bolted on it.5/21/2014 Same as last inspection.12/2/2013 Same as last inspection.7/10/2013 Same as last inspection.4/12/2012 WS pipe daylight has bolted plate.
FIELD_STRUCT_DESC: *ABANDONED* 6-inch steel irrigation pipe through the levee, 2.4 feet below the crown. Steel plate bolted on the waterside (WS) end. (Permit No. 12129, 12129A, 1977 - John & Jerie Malina) [Additional Reference(s): DWR Levee Log, 1993]
FS Date: 6/16/2017 10:08:54 AM

View of levee crown at crossing looking downstream at right bank of Cherokee Canal.

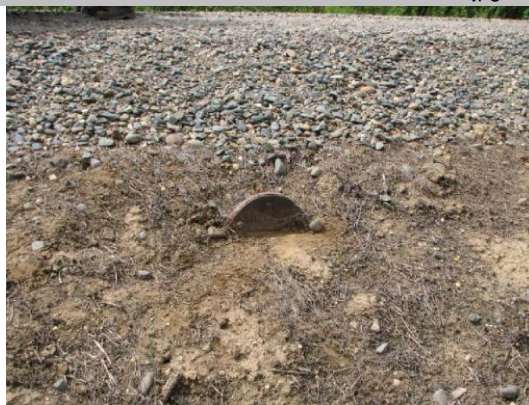
Photo 2 of 3 : UCIP_SP_2018_52179_66684.jpg

WS-Bolted plate

Comment Code						
Inspector Comment						
FS_ID:52179 DS_ID:16342 EP_NO: 12129 Repair Type: Non-Urgent Crossing Status: Found UCIP Comments: 6/14/2017 Abandoned- needs to be done properly. (DWR Sutter Yard- A Freitag)11/16/2016 Abandoned. WS end still has plate bolted on. (DWR Sutter Yard- A Freitag)4/28/2016 Crossing still has plate bolted on it at the WS end and LS end was mostly buried.7/14/2015 WS pipe end still had plate bolted on it.5/21/2014 Same as last inspection.12/2/2013 Same as last inspection.7/10/2013 Same as last inspection.4/12/2012 WS pipe daylight has bolted plate. FIELD_STRUCT_DESC: *ABANDONED* 6-inch steel irrigation pipe through the levee, 2.4 feet below the crown. Steel plate bolted on the waterside (WS) end. (Permit No. 12129, 12129A, 1977 - John & Jerie Malina) [Additional Reference(s): DWR Levee Log, 1993] FS Date: 6/16/2017 10:08:54 AM

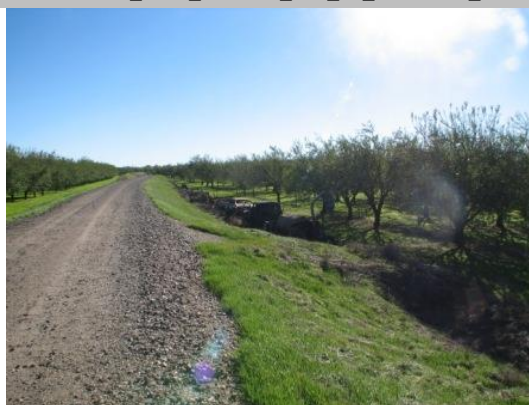
Photo 1 of 1 : SP_2018_MA0013_300_12_20180305_00004.jpg

LM Start	0.73	Rating **	M	Issue No.	12
LM End	0.76	Issue Type +	En	Location *	LS
Category	Earthen Levee			GPS Latitude/Longitude	
				Start	End
Item	Encroachments			39.587905 °	39.587505 °
				-121.700822 °	-121.700880 °
DWR ID	DWR_MA0013_01_s_2012_12				
Comment Code					
EQ : Equipment					
Inspector Comment					
Remove the equipment from the landside toe.

View of the equipment along the landside toe of the levee.

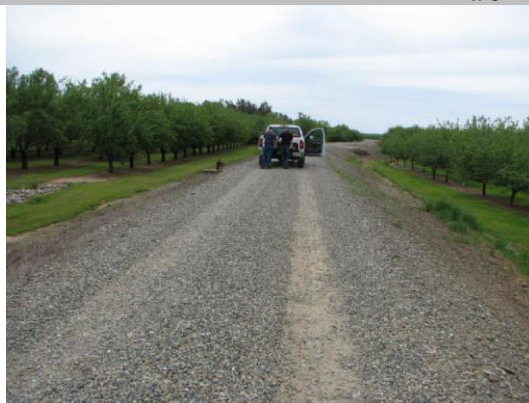
Photo 1 of 3 : UCIP_SP_2018_52182_66695.jpg

FS_ID:52182
DS_ID:16831
EP_NO: N/A
Repair Type: Urgent
Crossing Status: Found
UCIP Comments: 6/14/2017 Still no sign of WS pipe end. Pipe may need to be traced with GPR and excavated to determine if the WS end was properly capped after the Headwall and pipe sections were removed. Pipe has been selected to be internally cleaned and inspected as part of the DMP project. (DWR Sutter Yard - AFreitag)11/16/2016 WS structures still removed. (DWR Sutter Yard - AFreitag)10/17/2016 Landowner removed WS concrete headwall and pipe section through floodway to make room for orchard. The area disturbed appears to be from WS toe to where the mature trees are located within floodway, approximately 45 feet from WS toe. Crossing is classified as Urgent with potential levee integrity issues due to the disturbance of the WS without prior approval from the CVFPB. (DWR UCIP - omagana)
4/28/2016 Landowner appears to have removed the WS headwall and pipe to make room for planting more orchard trees. LS pipe end was full of water as it has no where to drain to anymore. Changing to urgent listing but it currently does not affect the levee integrity. (see photos 8, 9, & 10) (DWR Sutter Yard - afreitag)7/14/2015 Crossing appears in good condition. No noticeable issues to report. (DWR Sutter Yard - afreitag)5/21/2014 Same as last inspection. (DWR Sutter Yard - afreitag)12/2/2013 Pipe section was dug up and repaired. Crossing is now in good condition. (DWR Sutter Yard - afreitag) 4/17/2012 Pipe collapse on WS 10 feet from toe, needs repair. From WS, sediment is visible inside pipe. (DWR UCIP - omagana)

FIELD_STRUCT_DESC: 36-inch corrugated metal drainage pipe through the levee, 7.8 feet below the crown. Concrete "U" headwalls on both waterside (WS) and landside (LS) ends. Slide gate in corrugated metal pipe (CMP) riser on the WS slope. [Additional Reference(s): DWR Levee Log, 1993. USACE Sacramento O&M Manual 519, June 1962 (HLM 1.62)]
FS Date: 6/16/2017 10:21:08 AM

Overview of levee crown at crossing looking downstream.

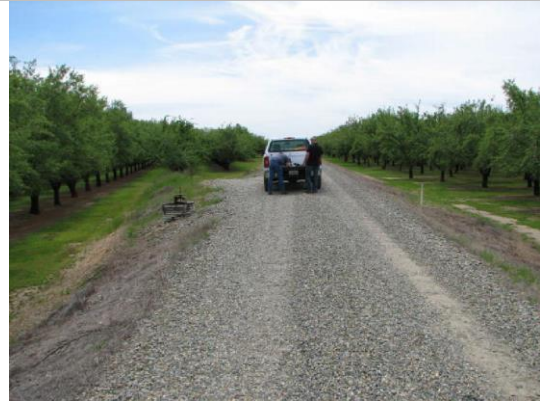
Photo 1 of 3 : UCIP_SP_2018_52183_66700.jpg

Comment Code						
Inspector Comment						
FS_ID:52183 DS_ID:16345 EP_NO: N/A Repair Type: Non-Urgent Crossing Status: Found UCIP Comments: 6/14/2017 PVC pipe still present blocking screw gate. LS inlet of the 24" cmp pipe is about 75% blocked by sediment. (DWR Sutter Yard- A Freitag)11/16/2016 PVC pipe still present blocking the screw gate. (DWR Sutter Yard- A Freitag)4/28/2016 Pvc pipe is still present through the crossing. Slide gate cannot shut fully.7/14/2015 4-inch pipe still present and blocking the screw gate.5/21/2014 Same as last inspection.12/2/2013 Same as last inspection.7/15/2013 Same as last inspection.4/17/2012 Crossing has 4-inch pipe inside blocking positive closure/notify landowner to remove prior to flood season. LS crossing is blocked about 50% by sediment build up. Burrow activity present on LS near crossing. FIELD_STRUCT_DESC: 24-inch corrugated metal irrigation pipe through the levee, 7.6 feet below the crown. Slide gate in corrugated metal pipe (CMP) riser on the waterside (WS) slope. Concrete headwall on the landside (LS). 36-inch concrete standpipe in the channel with 2 piles to deflect debris. [Additional Reference(s): DWR Levee Log, 1993. USACE Sacramento O&M Manual 519, June 1962 (HLM 1.69)] FS Date: 6/16/2017 12:21:04 PM

Overview of levee at crossing looking downstream.

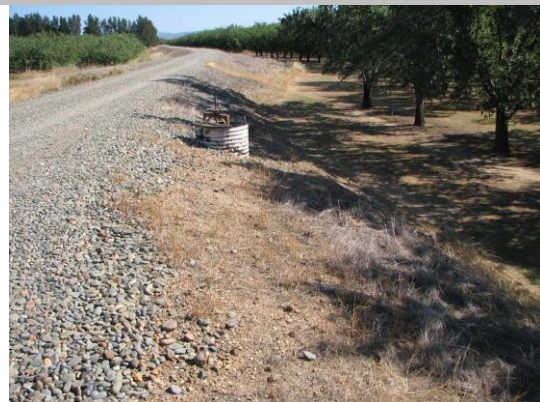
Photo 2 of 3 : UCIP_SP_2018_52183_66704.jpg

WS view looking upstream.

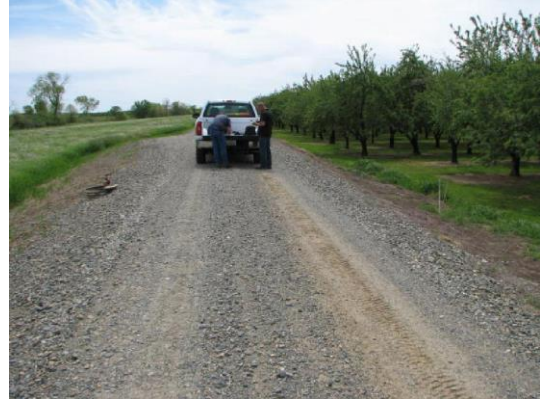
Photo 1 of 3 : UCIP_SP_2018_52184_66708.jpg

Comment Code						
Inspector Comment						
FS_ID:52184 DS_ID:16346 EP_NO: N/A Repair Type: Non-Urgent Crossing Status: Found UCIP Comments: 6/14/2017 Still no LS inlet visible- trace with locator/GPR to try and locate. Wooden debris down inside of WS standpipe. Pipe has been selected to be internally cleaned and inspected as part of the DMP project. (DWR Sutter Yard-AFreitag)11/16/2016 Appears abandoned. Unable to find anything on LS. (DWR Sutter Yard- AFreitag)4/28/2016 Appears to be an abandoned crossing. LS headwall and pipe inlet are still completely buried.7/14/2015 Still cannot find an inlet or outelt.5/21/2014 Same as last inspection.12/2/2013 Same as last inspection.7/15/2013 Same as last inspection.4/17/2012 Non functional crossing due to LS headwall buried. This crossing was listed in the USACE Periodic Inspection report as Corp's inspect ID#USACE_CESPK_M13D_2011_p_0119 for no inlet or outlet visible. FIELD_STRUCT_DESC: *ABANDONED* 24-inch corrugated metal irrigation pipe through the levee 7.8 feet below the crown. Slide gate in corrugated metal pipe riser on the waterside (WS) slope. Pipe continues across channel. Concrete "U" headwall on the landside (LS). [Additional Reference(s): DWR Levee Log, 1993. USACE Sacramento O&M Manual 519, June 1962 (HLM 2.35)] FS Date: 6/16/2017 12:24:07 PM

Overview of crossing looking DS.

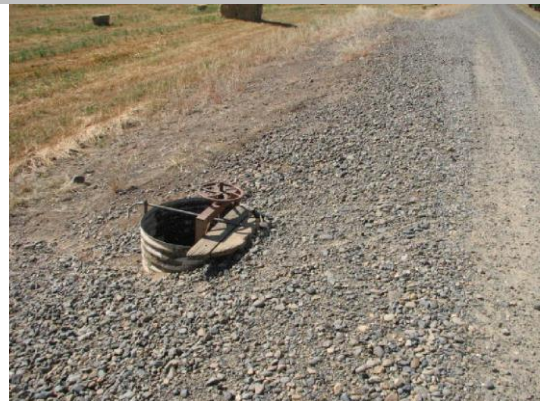
Photo 2 of 3 : UCIP_SP_2018_52184_66709.jpg

Corrugated riser located on WS slope.

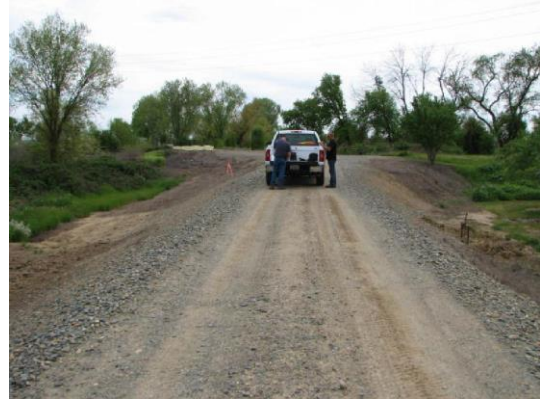
Photo 1 of 3 : UCIP_SP_2018_52188_66725.jpg

FS_ID:52188
DS_ID:16349
EP_NO: N/A
Repair Type: Non-Urgent
Crossing Status: Found
UCIP Comments: 6/14/2017 Both pipe ends and gates are mostly buried- need to be dug out. Pipe has been selected to be internally cleaned and inspected as part of the DMP project. (DWR Sutter Yard- A/Freitag)11/16/2016 Both gates closed but partially buried and unable to open. (DWR Sutter Yard- A/Freitag)4/28/2016 Sediment build up on both gates blocking them from operating properly.7/14/2015 Crossing appears in good condition. No noticeable issues to report.5/21/2014 Same as last inspection.12/2/2013 Same as last inspection.7/15/2013 Stem on LS screw gate has been replaced and is now full functional.4/17/2012 LS slide gate stem is bent and prevents gate from fully closing. Both WS and LS have been cleared of debris and sediment. This crossing was listed in the USACE Periodic Inspection report as Corp's inspect ID#USACE_CESPK_M13D_2011_p_0162 for inoperable gates on WS & LS due to sediment and grass blocking inlet and outlet. FIELD_STRUCT_DESC: 24-inch corrugated metal drainage pipe through the levee, 8.9 feet below the crown. Concrete "U" headwalls on both the waterside (WS) and landside (LS) ends. Flap gate visible on the waterside (WS) end. [Additional Reference(s): DWR Levee Log, 1993. USACE Sacramento O&M Manual 519, June 1962 (HLM 3.29)]

Overview of levee crown looking DS at crossing.

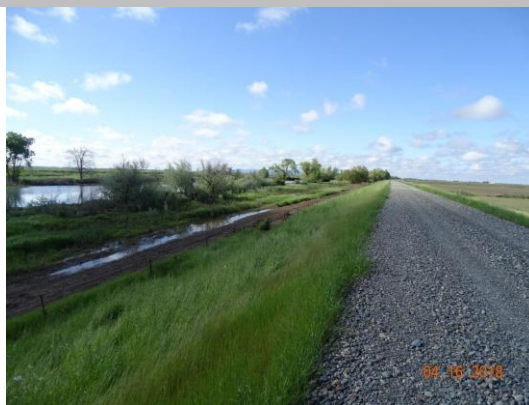
Photo 1 of 1 : SP_2018_MA0013_300_76_20180425_00145.jpg

LM Start	3.71	Rating **	M	Issue No.	76
LM End	18.50	Issue Type +	Ma	Location *	WS
Category	Earthen Levee			GPS Latitude/Longitude	
				Start	End
Item	Vegetation			39.546738 °	39.373430 °
				-121.707600 °	-121.850527 °
DWR ID	DWR_MA0013_01_s_2018_76				
Comment Code					
V1 : Control annual grass and weeds on the levee slopes and easements.					
Inspector Comment					
Remove the native vegetation from the waterside slope.

View of the native grasses along the waterside slope.

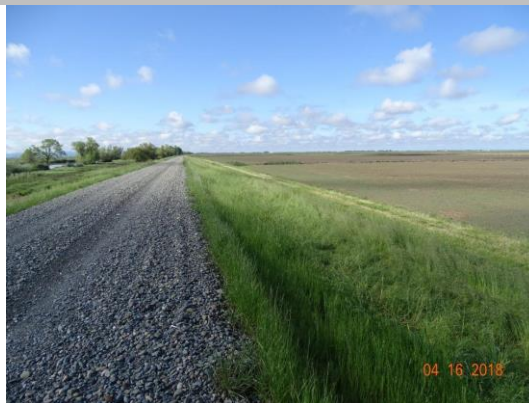
Photo 1 of 1 : SP_2018_MA0013_300_77_20180425_00146.jpg

LM Start	3.71	Rating **	M	Issue No.	77
LM End	15.75	Issue Type +	Ma	Location *	LS
Category	Earthen Levee			GPS Latitude/Longitude	
				Start	End
Item	Vegetation			39.546727 °	39.398780 °
				-121.707600 °	-121.810932 °
DWR ID	DWR_MA0013_01_s_2018_77				
Comment Code					
V1 : Control annual grass and weeds on the levee slopes and easements.					
Inspector Comment					
Remove the native vegetation from the landside slope.

View of the native vegetation along the landside slope.

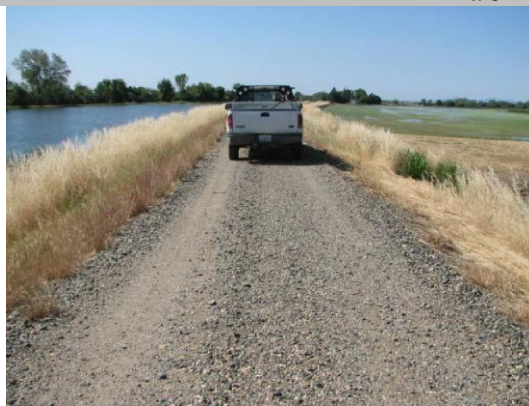
Photo 1 of 3 : UCIP_SP_2018_52190_66736.jpg

Comment Code						
Inspector Comment						
FS_ID:52190 DS_ID:16351 EP_NO: N/A Repair Type: No Action Needed Crossing Status: Found UCIP Comments: 6/14/2017 Both pipe ends were underwater during site visit. Pipe has been selected to be internally cleaned and inspected as part of the DMP project. (DWR Sutter Yard- AFreitag)11/16/2016 Crossing appears to be in good condition. (DWR Sutter Yard- AFreitag)4/28/2016 Both sides of the crossing were underwater during time of inspection.7/14/2015 Crossing appears in good condition. No noticeable issues to report.5/21/2014 Same as last inspection.12/2/2013 Same as last inspection.7/15/2013 Slopes have been cleared of vegetation and are in good condition.4/18/2012 Limited inspection on WS and LS slope due to dense vegetation. Need photos of cleared slopes. FIELD_STRUCT_DESC: 24-inch corrugate metal drainage pipe through the levee, 8.1 feet below the crown. Flap gate on the waterside (WS) end. Slide gate located on the landside (LS) end. Concrete "U" headwalls on both ends. [Additional Reference(s): DWR Levee Log, 1993. USACE Sacramento O&M Manual 519, June 1962 (HLM 3.80)] FS Date: 6/16/2017 12:33:16 PM

Overview of levee crown at crossing looking downstream.

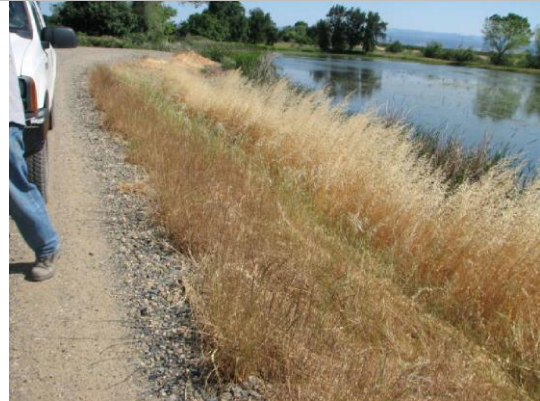
Photo 2 of 3 : UCIP_SP_2018_52190_66738.jpg

WS slope covered by dense vegetation.

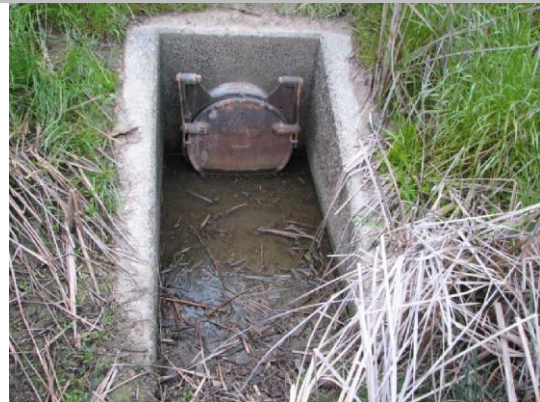
Photo 3 of 3 : UCIP_SP_2018_52190_66735.jpg

WS flap gate

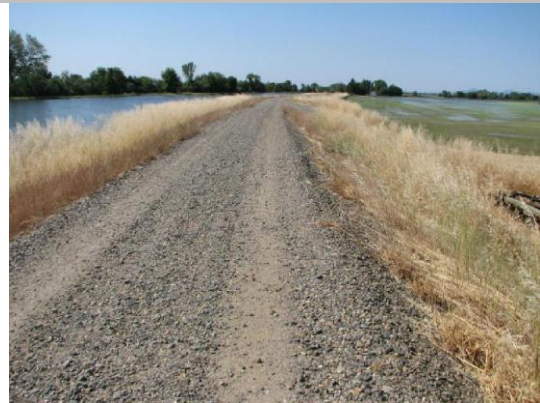
Photo 1 of 3 : UCIP_SP_2018_52191_66743.jpg

Comment Code						
Inspector Comment						
FS_ID:52191 DS_ID:16365 EP_NO: N/A Repair Type: Non-Urgent Crossing Status: Found UCIP Comments: 6/14/2017 Appears abandoned- needs to be done properly. WS gate was buried/submerged and the LS slide gate is still damaged and buried. Pipe has been selected to be internally cleaned and inspected as part of the DMP project. (DWR Sutter Yard-AFreitag)11/16/2016 Both LS and WS gates buried. (DWR Sutter Yard- AFreitag)4/28/2016 Abandoned crossing. Ls screw is still bent and mostly buried.7/14/2015 LS screw gate is still damaged and buried. Crossing is non-functional.5/21/2014 Same as last inspection.12/2/2013 Same as last inspection.7/15/2013 Slopes have been cleared of vegetation and are in good condition. LS screw gate is still bent and silted over.4/18/2012 LS slide gate covered with silt. Slide gate is bent. Crossing appears not be in use. Limited inspection on WS and LS slope due to dense vegetation. Need photos of cleared slopes. FIELD_STRUCT_DESC: *ABANDONED* 24-inch corrugated metal drainage pipe through the levee, 7.9 feet below the crown. Flap gate on the waterside (WS) end. Screw gate on the landside (LS) end. Concrete "U" headwalls on both ends. [Additional Reference(s): DWR Levee Log, 1993. USACE Sacramento O&M Manual 519, June 1962 (HLM 3.82)] FS Date: 6/16/2017 12:35:50 PM

Overview of levee crown at crossing looking downstream.

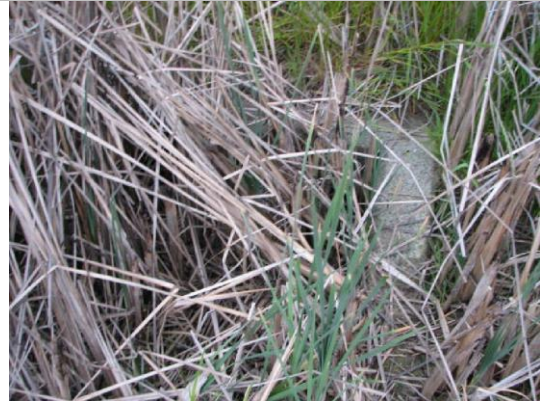
Photo 2 of 3 : UCIP_SP_2018_52191_66741.jpg

WS flap gate blocked by debris.

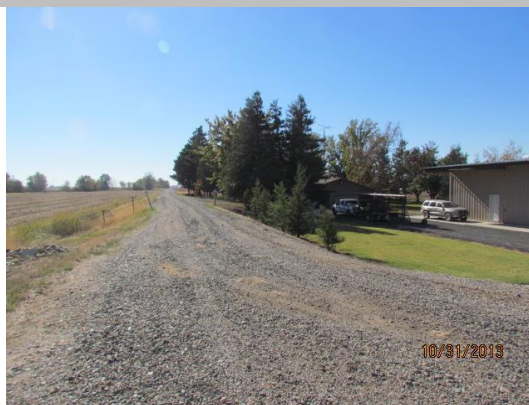
Photo 1 of 1 : SP_2018_MA0013_300_18_20180305_00005.jpg

LM Start	4.06	Rating **	M	Issue No.	18
LM End	4.13	Issue Type +	En	Location *	LS
Category	Earthen Levee		GPS Latitude/Longitude		
			Start	End	
Item	Vegetation		39.541660 °	39.540651 °	
			-121.707408 °	-121.707404 °	
DWR ID	DWR_MA0013_01_s_2013_18				
Comment Code					
V6 : Landscaping					
Inspector Comment

View of the redwood trees along the landside slope.

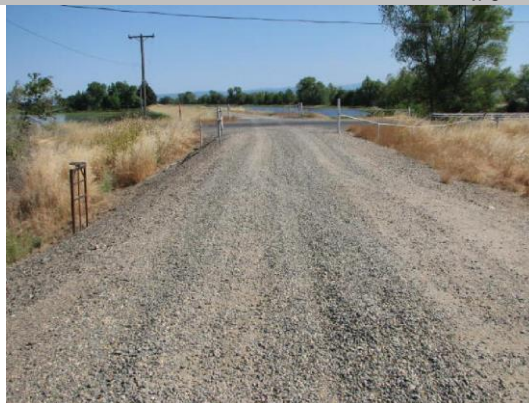
Photo 1 of 3 : UCIP_SP_2018_52193_66752.jpg

Overview of levee crown at crossing looking upstream.

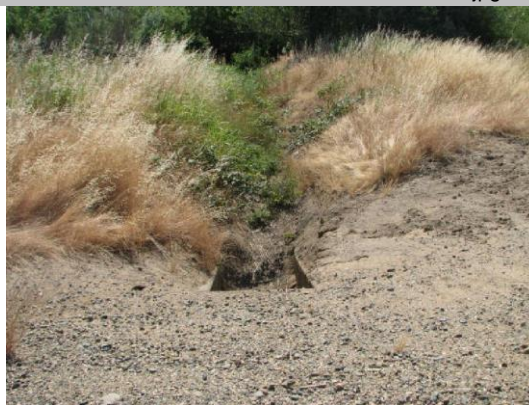
Photo 2 of 3 : UCIP_SP_2018_52193_66753.jpg

View of WS slope and toe.

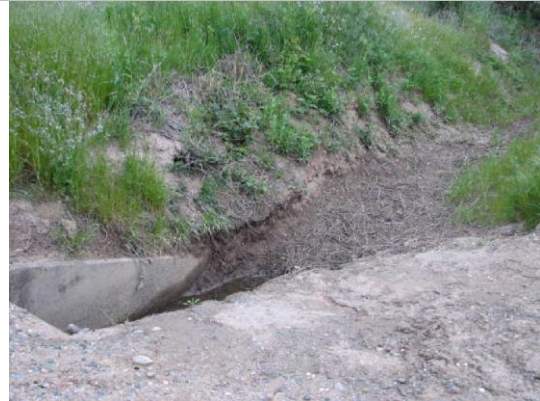
Photo 3 of 3 : UCIP_SP_2018_52193_66750.jpg

Item	DWR UCIP LMA Responsibility			39.537516 °	39.537516 °	
				-121.707580 °	-121.707580 °	
DWR ID						
Comment Code						
Inspector Comment						
FS_ID:52193 DS_ID:16341 EP_NO: N/A Repair Type: No Action Needed Crossing Status: Found UCIP Comments: 6/14/2017 WS flapgate is shut but blocked by sediment- needs to be dug out. LS slide gate has some minor sediment built up against it. Pipe has been selected to be internally cleaned and inspected as part of the DMP project. (DWR Sutter Yard- A/Freitag)11/16/2016 Crossing appears to be in good condition. (DWR Sutter Yard- A/Freitag)4/28/2016 Crossing appears to be in good condition.7/13/2015 Crossing appears in good condition. No noticeable issues to report.5/21/2014 Same as last inspection.12/2/2013 Same as last inspection.7/15/2013 Same as last inspection.4/18/2012 Minor debris on landside inlet. This crossing was listed in the USACE Periodic Inspection report as Corp's inspect ID#USACE_CESPK_M13D_2011_p_0189 for sediment and grass blocking WS and LS. FIELD_STRUCT_DESC: 36-inch corrugated metal drainage pipe through the levee, 9.1 feet below the crown. Flap gate on the waterside (WS) end. Slide gate located on the landside (LS) end. Concrete "U" headwalls on both ends. [Additional Reference(s): DWR Levee Log, 1993. USACE Sacramento O&M Manual 519, June 1962 (HLM 4.43)] FS Date: 6/16/2017 12:52:19 PM

View of WS.

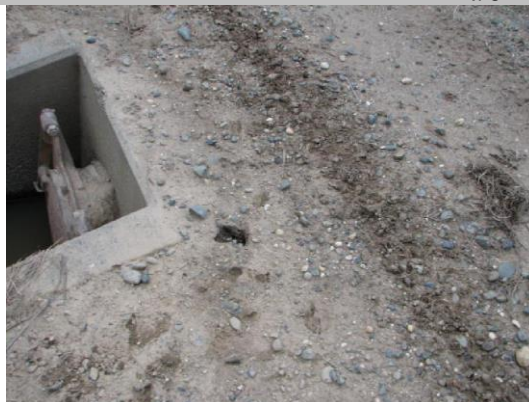
Photo 2 of 3 : UCIP_SP_2018_52194_66758.jpg

Burrow activity on WS slope.

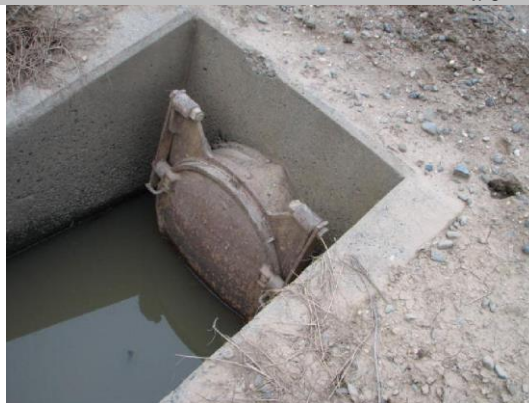
Photo 3 of 3 : UCIP_SP_2018_52194_66755.jpg

Item	DWR UCIP LMA Responsibility			39.530220°		39.530220°
				-121.707940°		-121.707940°
DWR ID						
Comment Code						
Inspector Comment						
FS_ID:52194 DS_ID:16355 EP_NO: N/A Repair Type: No Action Needed Crossing Status: Found UCIP Comments: 6/14/2017 WS flapgate is submerged and appears to be half buried by sediment. LS slide gate is fully submerged on the edge of the rice field. Pipe has been selected to be internally cleaned and inspected as part of the DMP project. (DWR Sutter Yard- A/Freitag)11/16/2016 Crossing appears to be in good condition. (DWR Sutter Yard- A/Freitag)4/28/2016 Crossing appears to be in good condition.7/13/2015 LS screw gate was completely submerged but crossing appears to be in good condition.5/21/2014 Same as last inspection.12/2/2013 Same as last inspection.7/15/2013 No signs of burrowing activity on this inspection.4/18/2012 Burrow activity near crossing, burrow holes present on WS slope. FIELD_STRUCT_DESC: 24-inch corrugated metal drainage pipe through the levee 7.7 feet below the crown. Flap gate on the waterside (WS) end. Slide gate located on the landside (LS) end. Concrete "U" headwalls on both ends. [Additional Reference(s): DWR Levee Log, 1993. USACE Sacramento O&M Manual 519, June 1962 (HLM 4.94)] FS Date: 6/16/2017 12:55:37 PM

View of WS flap gate.

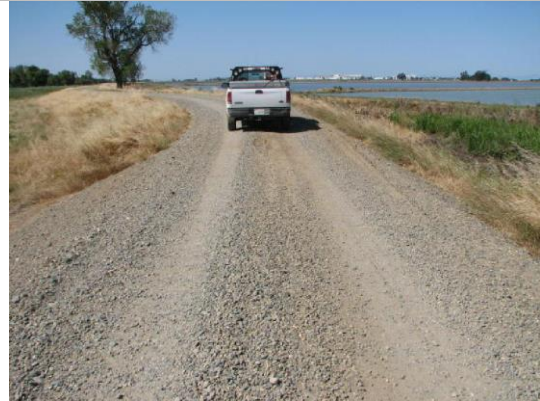
Photo 1 of 3 : UCIP_SP_2018_52201_66793.jpg

FS_ID:52201
DS_ID:16359
EP_NO: N/A
Repair Type: Non-Urgent
Crossing Status: Found
UCIP Comments: 6/14/2017 WS Flap gate is completely buried- needs to be dug out. LS is blocked off by flashboards that are partially buried. Pipe has been selected to be internally cleaned and inspected as part of the DMP project. (DWR Sutter Yard- A Freitag) 11/16/2016 WS still completely buried. (DWR Sutter Yard- A Freitag) 4/28/2016 WS gate and headwall are buried. Only the top of the headwall was visible. LS appeared ok. 7/13/2015 Both the LS screw gate and WS flapgate are completely buried. 5/21/2014 Same as last inspection. 12/2/2013 Same as last inspection. 7/15/2013 Slopes have been cleared of vegetation and are in good condition. WS headwall and flapgate are fully covered in debris and not visible. Need to clear. 4/18/2012 High sedimentation build up at WS and LS headwall. Limited inspection due to dense vegetation on WS and LS slope. Need photo of cleared WS and LS slopes. This crossing was listed in the USACE Periodic Inspection report as Corp's inspect ID# USACE_CESPK_M13D_2011_p_0210 for WS gate submerged. FIELD_STRUCT_DESC: 24-inch corrugated metal drainage pipe through the levee, 9.2 feet below the crown. Flap gate on the waterside (WS) end. Concrete "U" headwalls on both ends. [Additional Reference(s): DWR Levee Log, 1993. USACE Sacramento O&M Manual 519, June 1962 (HLM 5.73)]

Overview of levee crown at crossing looking downstream.

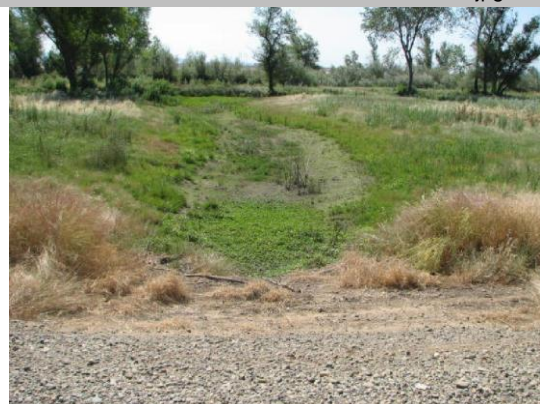
Photo 2 of 3 : UCIP_SP_2018_52201_66794.jpg

View of WS slope and toe.

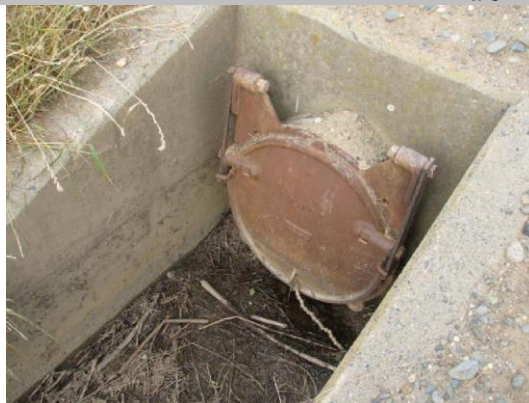
Photo 3 of 3 : UCIP_SP_2018_52202_66799.jpg

Item	DWR UCIP LMA Responsibility			39.516059 °	39.516059 °	
				-121.710810 °	-121.710810 °	
DWR ID						
Comment Code						
Inspector Comment						
FS_ID:52202 DS_ID:16360 EP_NO: N/A Repair Type: No Action Needed Crossing Status: Found UCIP Comments: 6/14/2017 Crossing appears to be in good condition. LS is completely submerged in an irrigation ditch. Pipe has been selected to be internally cleaned and inspected as part of the DMP project. (DWR Sutter Yard- A/Freitag)11/16/2016 Crossing appears to be in good condition. (DWR Sutter Yard- A/Freitag)4/28/2016 Crossing appears to be in good condition.7/13/2015 LS screw gate was completely submerged but crossing appears to be in good condition.5/21/2014 Same as last inspection.12/2/2013 Same as last inspection.7/15/2013 Same as last inspection.4/18/2012 Burrow activity near crossing; burrow holes present on LS. FIELD_STRUCT_DESC: 24-inch corrugated metal drainage pipe through the levee, 6.2 feet below the crown. Flap gate on the waterside (WS) end. Slide gate on the landside (LS) end. Concrete "U" headwalls on both ends. [Additional Reference(s): DWR Levee Log, 1993. USACE Sacramento O&M Manual 519, June 1962 (HLM 5.97)] FS Date: 6/16/2017 1:49:28 PM

Flap gate WS

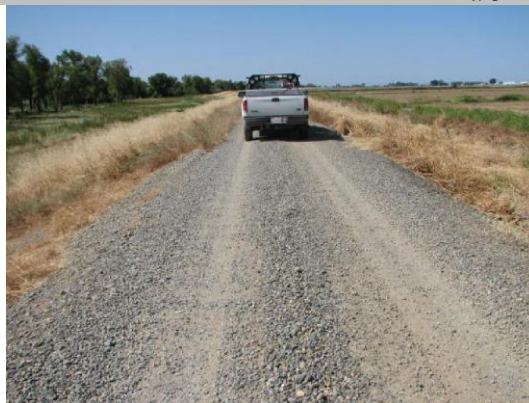
Photo 1 of 3 : UCIP_SP_2018_52203_66808.jpg

Comment Code						
Inspector Comment						
FS_ID:52203						
DS_ID:16361						
EP_NO: N/A						
Repair Type: Non-Urgent						
Crossing Status: Found						
UCIP Comments: 6/14/2017 WS appears to be in good condition. LS slide gate is buried and submerged. Pipe has been selected to be internally cleaned and inspected as part of the DMP project. (DWR Sutter Yard- AFreitag)11/16/2016 LS screwgate is buried and non-operational. (DWR Sutter Yard- AFreitag)4/28/2016 LS screwgate is still completely buried. 7/13/2015 LS screw gate is completely buried.5/21/2014 Same as last inspection.7/15/2013 WS slope has been cleared of vegetation and is in good condition. LS screw gate is still buried.12/2/2013 Same as last inspection.4/18/2012 LS slide gate is buried. Pipe is not visible on LS toe. Limited inspection on WS slope due to dense vegetation.						
FIELD_STRUCT_DESC: 24-inch corrugated metal drainage pipe through the levee, 7.4 feet below the crown. Flap gate on the waterside (WS) end. Slide gate on the landside (LS) end. Concrete "U" headwalls on both ends. [Additional Reference(s): DWR Levee Log, 1993. USACE Sacramento O&M Manual 519, June 1962 (HLM 6.34)]

Overview of levee crown at crossing looking downstream.

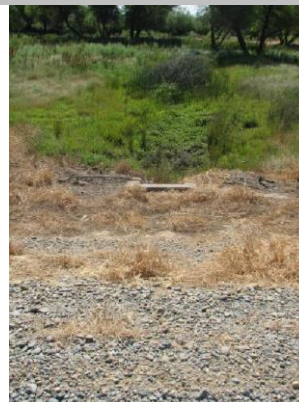
Photo 2 of 3 : UCIP_SP_2018_52203_66806.jpg

View of WS slope and toe.

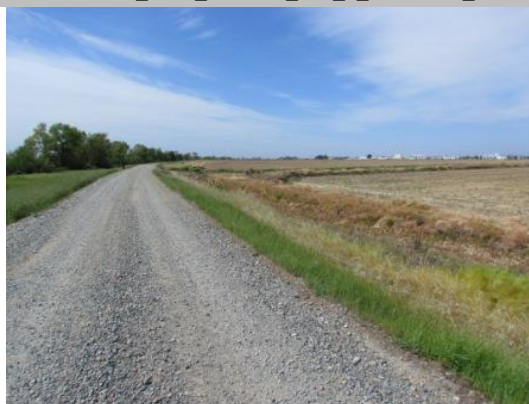
Photo 1 of 1 : SP_2018_MA0013_300_3_20180305_00001.jpg

LM Start	6.41	Rating **	M	Issue No.	3
LM End	6.99	Issue Type +	En	Location *	LS
Category	Earthen Levee			GPS Latitude/Longitude	
				Start	End
Item	Encroachments			39.508928 °	39.501438 °
				-121.714842 °	-121.719715 °
DWR ID	DWR_MA0013_01_s_2012_3				
Comment Code					
DT : Ditch					
Inspector Comment

View of the agricultural ditch along the toe.

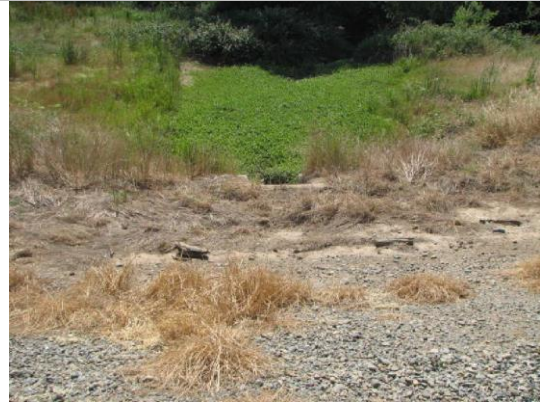
Photo 2 of 3 : UCIP_SP_2018_52204_66813.jpg

FS_ID:52204
DS_ID:16362
EP_NO: 5200B
Repair Type: No Action Needed
Crossing Status: Found
UCIP Comments: 6/14/2017 Hole/erosion behind the flashboards was repaired. New flash boards were installed and the erosion hole filled back in. Pipe has been selected to be internally cleaned and inspected as part of the DMP project. (DWR Sutter Yard- AFreitag)11/16/2016 Hole/erosion still present behind the LS flashboards. (DWR Sutter Yard- AFreitag)4/28/2016 Hole still present behind the LS flashboards. Rest of the crossing appeared in good condition. (DWR Sutter Yard - afreitag)7/13/2015 Hole still present behind the LS flashboards. (DWR Sutter Yard - afreitag)5/21/2014 Same as last inspection. (DWR Sutter Yard - afreitag)12/2/2013 Same as last inspection. (DWR Sutter Yard - afreitag)7/15/2013 WS slope has been cleared of vegetation and is in good condition. Hole is still present behind flash boards on LS. (DWR Sutter Yard - afreitag)4/18/2012 Hole behind flashboards against slide gate on LS slope (Health and Safety Issue). Limited inspection on WS slope due to dense vegetation. Need photo of cleared slope on WS. (DWR UCIP - omagana)

View of WS slope and toe.

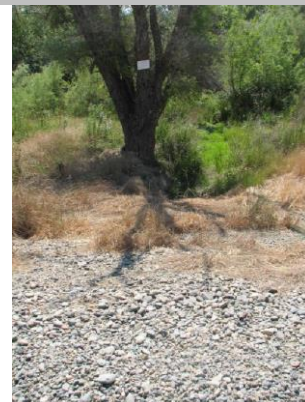
Photo 2 of 3 : UCIP_SP_2018_52213_66851.jpg

WS view of slope and channel.

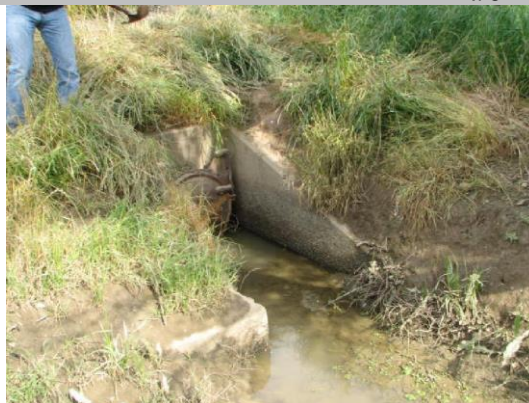
Photo 3 of 3 : UCIP_SP_2018_52213_66849.jpg

Item	DWR UCIP LMA Responsibility			39.496146 °	39.496146 °	
				-121.725160 °	-121.725160 °	
DWR ID						
Comment Code						
Inspector Comment						
FS_ID:52213 DS_ID:16352 EP_NO: N/A Repair Type: No Action Needed Crossing Status: Found UCIP Comments: 6/14/2017 Crossing appears to be in good condition. Pipe has been selected to be internally cleaned and inspected as part of the DMP project. (DWR Sutter Yard- A Freitag)11/16/2016 Crossing appears to be in good condition. (DWR Sutter Yard- A Freitag)4/28/2016 Crossing appears to be in good condition.7/13/2015 WS ditch is getting to be heavily vegetated but it is not yet affecting flap gate operation. Vegetation needs to be cleared back some.5/21/2014 Same as last inspection.12/2/2013 Same as last inspection.7/15/2013 Slopes have been cleared of vegetation and are in good condition.4/18/2012 Limited inspection on WS and LS slopes due to dense vegetation. Need photos of cleared WS and LS slopes during next inspection. FIELD_STRUCT_DESC: 24-inch corrugated metal drainage pipe through the levee, 10.2 feet below the crown. Flap gate on the waterside (WS) end. Screw gate on the landside (LS) end. Concrete headwall on both ends. [Additional Reference(s): DWR Levee Log, 1993. USACE Sacramento O&M Manual 519, June 1962 (HLM 7.58)] FS Date: 6/19/2017 10:29:30 AM

View of WS flap gate. Dense vegetation on WS slope.

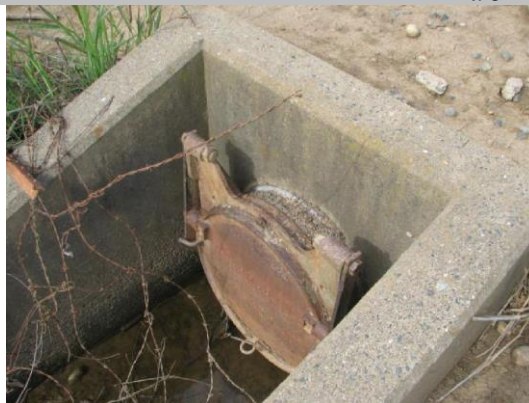
Photo 3 of 3 : UCIP_SP_2018_52218_66869.jpg

Item	DWR UCIP LMA Responsibility			39.489061 °	39.489061 °	
				-121.729430 °	-121.729430 °	
DWR ID						
Comment Code						
Inspector Comment						
FS_ID:52218 DS_ID:16321 EP_NO: N/A Repair Type: No Action Needed Crossing Status: Found UCIP Comments: 6/14/2017 Crossing appears to be in good condition. Pipe has been selected to be internally cleaned and inspected as part of the DMP project. (DWR Sutter Yard- AFreitag)11/16/2016 Crossing appears to be in good condition. (DWR Sutter Yard- AFreitag)4/28/2016 Crossing appears to be in good condition.7/13/2015 Crossing appears to be in good condition. 5/21/2014 Same as last inspection.12/3/2013 Same as last inspection.7/15/2013 Same as last inspection.4/18/2012 Sediment build up against flashboards. Flashboards are in use on landside of levee. FIELD_STRUCT_DESC: 24-inch corrugated metal drainage pipe through the levee, 8.2 feet below the crown. Flap gate on the waterside (WS) end. Concrete "U" headwalls on both ends. Flashboards should be present on the landside (LS). [Additional Reference(s): DWR Levee Log, 1993. USACE Sacramento O&M Manual 519, June 1962 (HLM 8.12)] FS Date: 6/19/2017 12:45:23 PM

WS Flap gate

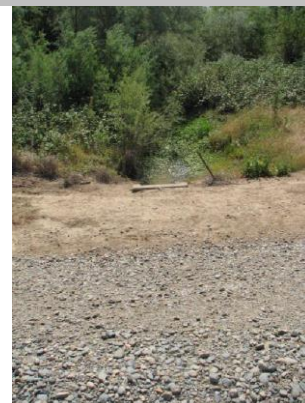
Photo 2 of 3 : UCIP_SP_2018_52219_66874.jpg

View of WS slope and toe.

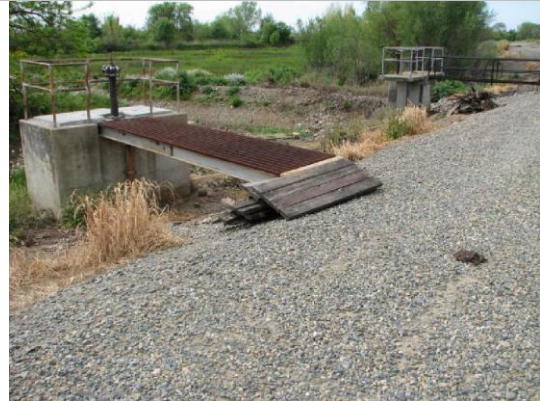
Photo 1 of 3 : UCIP_SP_2018_52220_66881.jpg

Comment Code						
Inspector Comment						
FS_ID:52220 DS_ID:16323 EP_NO: N/A Repair Type: Urgent Crossing Status: Found UCIP Comments: 6/14/2017 LS underwater but levee erosion is still present- needs to be repaired. Pipe has been selected to be internally cleaned and inspected as part of the DMP project. (DWR Sutter Yard- A Freitag)11/16/2016 LS erosion is still a major problem here. (DWR Sutter Yard- A Freitag)4/28/2016 Erosion still present at the LS headwall. (DWR Sutter Yard - a Freitag)7/13/2015 Erosion still present behind the LS headwall. It looks to be getting worse and is starting to affect the levee slope. (DWR Sutter Yard - a Freitag)5/21/2014 Same as last inspection. (DWR Sutter Yard - a Freitag)12/3/2013 Same as last inspection. (DWR Sutter Yard - a Freitag)7/15/2013 Same as last inspection. (DWR Sutter Yard - a Freitag)4/18/2012 Concrete headwall is cracked, erosion behind headwall is also present. LS headwall needs to be repaired/replaced. Remove wooden debris from levee shoulder. (DWR UCIP - omagana) FIELD_STRUCT_DESC: [Richvale Irrigation Canal Siphon] 60-inch by 84-inch (5-foot by 7 foot) concrete irrigation conduit through the levee, 18.4 feet below the crown. Distribution box and walkway are located on the waterside (WS). Concrete headwall on the landside (LS). 28-foot reinforced concrete protective slab on top of the conduit in the center of the levee. [Additional Reference(s): DWR Levee Log, 1993. USACE Sacramento O&M Manual 519, June 1962 (HLM 8.95)] FS Date: 6/19/2017 12:50:55 PM

Catwalk and screw gate located on WS.

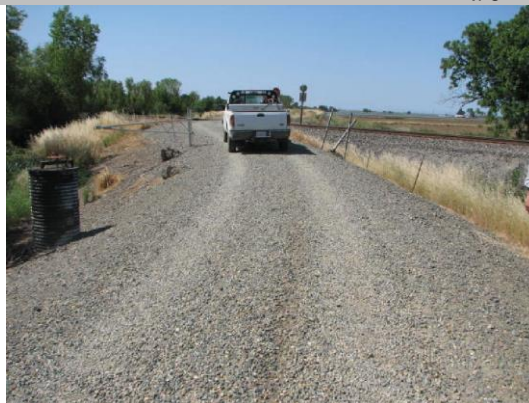
Photo 1 of 3 : UCIP_SP_2018_52223_66895.jpg

FS_ID:52223
DS_ID:16325
EP_NO: N/A
Repair Type: Non-Urgent
Crossing Status: Found
UCIP Comments: 6/14/2017 Debris drifts built up around the WS slide gates- needs to be cleared away. LS appears to be in good condition. Pipe has been selected to be internally cleaned and inspected as part of the DMP project. (DWR Sutter Yard- AFreitag)11/16/2016 Crossing appears to be in good condition. (DWR Sutter Yard- AFreitag)4/28/2016 Crossing appears to be in good condition.7/13/2015 Crossing appears in good condition. No noticeable issues to report.5/21/2014 Same as last inspection.12/3/2013 Same as last inspection.7/15/2013 LS slope has been sprayed and cleared of vegetation and is in good condition.4/18/2012 Limited inspection on LS slope due to dense vegetation. Need photo of cleared vegetation from slopes and WS headwall. Minor debris scattered on WS slope.
FIELD_STRUCT_DESC: 24-inch corrugated metal drainage pipe through the levee, 12.6 feet below the crown. Slide gate in corrugated metal pipe riser on the waterside (WS) slope. Slide gate on the WS end. Concrete "U" headwall on both ends. [Additional Reference(s): DWR Levee Log, 1993. USACE Sacramento O&M Manual 519, June 1962 (HLM 8.98)]

Overview of levee crown at crossing looking D/S.

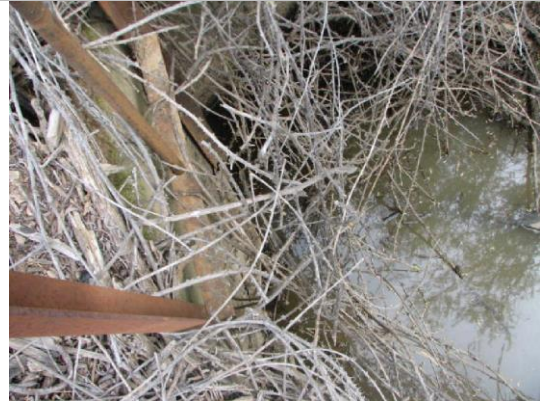
Photo 3 of 3 : UCIP_SP_2018_52223_66900.jpg

Comment Code						
Inspector Comment						
FS_ID:52223 DS_ID:16325 EP_NO: N/A Repair Type: Non-Urgent Crossing Status: Found UCIP Comments: 6/14/2017 Debris drifts built up around the WS slide gates- needs to be cleared away. LS appears to be in good condition. Pipe has been selected to be internally cleaned and inspected as part of the DMP project. (DWR Sutter Yard- A Freitag)11/16/2016 Crossing appears to be in good condition. (DWR Sutter Yard- A Freitag)4/28/2016 Crossing appears to be in good condition.7/13/2015 Crossing appears in good condition. No noticeable issues to report.5/21/2014 Same as last inspection.12/3/2013 Same as last inspection.7/15/2013 LS slope has been sprayed and cleared of vegetation and is in good condition.4/18/2012 Limited inspection on LS slope due to dense vegetation. Need photo of cleared vegetation from slopes and WS headwall. Minor debris scattered on WS slope. FIELD_STRUCT_DESC: 24-inch corrugated metal drainage pipe through the levee, 12.6 feet below the crown. Slide gate in corrugated metal pipe riser on the waterside (WS) slope. Slide gate on the WS end. Concrete "U" headwall on both ends. [Additional Reference(s): DWR Levee Log, 1993. USACE Sacramento O&M Manual 519, June 1962 (HLM 8.98)] FS Date: 6/19/2017 12:59:24 PM

View of slide gate on WS. Debris blocking gate.

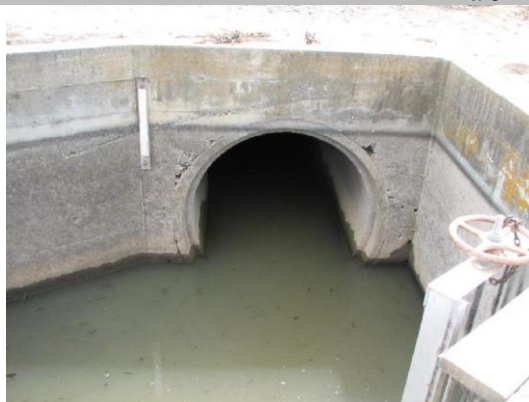
Photo 2 of 3 : UCIP_SP_2018_52225_66907.jpg

Headwall at LS distribution box

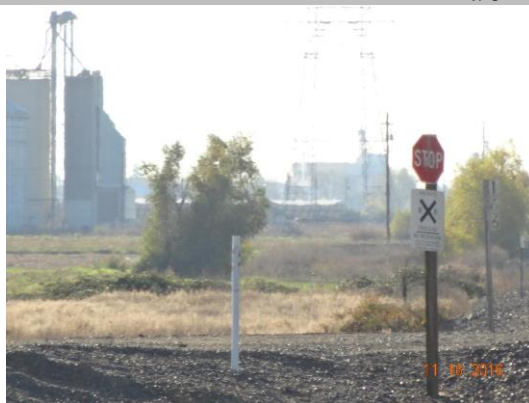
Photo 3 of 3 : UCIP_SP_2018_52225_76257.jpg

Comment Code						
Inspector Comment						
FS_ID:52225 DS_ID:16828 EP_NO: N/A Repair Type: Non-Urgent Crossing Status: Found UCIP Comments: 6/14/2017 Erosion still present on the side of the LS structure- still not affecting levee yet. (DWR Sutter Yard-AFreitag)11/16/2016 Some erosion still present near the LS structure. Does not affect the levee yet. (DWR Sutter Yard-AFreitag)4/28/2016 Erosion happening around the concrete structure on LS. Its not yet affecting the levee but will keep monitoring.7/13/2015 Crossing appears in good condition. No noticeable issues to report.5/21/2014 Same as last inspection.12/3/2013 Same as last inspection.7/15/2013 Same as last inspection.4/18/2012 Crossing is not visible on WS. FIELD_STRUCT_DESC: 72-inch irrigation pipe through the levee located 14.2 feet below the crown. Appurtenances include concrete pipe siphon, screw gate, and distribution box visible on the landside (LS). No appurtenances found on the waterside (WS). [Additional Reference(s): DWR Levee Log, 1993. USACE Sacramento O&M Manual 519, June 1962 (HLM 9.02)] FS Date: 6/19/2017 1:05:30 PM

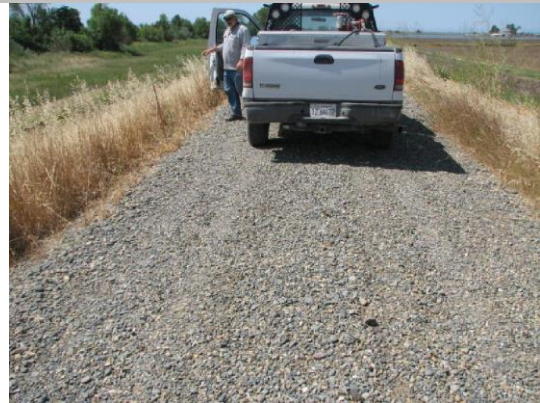
Photo 1 of 3 : UCIP_SP_2018_52227_66910.jpg

Comment Code					
Inspector Comment					
FS_ID:52227 DS_ID:16317 EP_NO: N/A Repair Type: No Action Needed Crossing Status: Found UCIP Comments: 6/14/2017 Crossing appears to be in good condition. Pipe has been selected to be internally cleaned and inspected as part of the DMP project. (DWR Sutter Yard- AFreitag)11/16/2016 Crossing appears to be in good condition. (DWR Sutter Yard- AFreitag)4/28/2016 Crossing appears to be in good condition.7/13/2015 LS inlet has minor vegetation still. WS appears in good condition.5/21/2014 Same as last inspection.12/3/2013 Same as last inspection.7/15/2013 Slopes have been cleared of vegetation and are in good condition.4/18/2012 Limited inspection on WS and LS slopes due to dense vegetation. Need photos of cleared WS and LS slopes. This crossing was listed in the USACE Periodic Inspections as Corp's Insect ID# USACE_CESPK_M13D_2011_p_0278 for WS outlet sedimentation and sediment/grass at LS inlet. FIELD_STRUCT_DESC: 36-inch corrugated metal drainage pipe through the levee, 10.2 feet below the crown. Flap gate on the waterside (WS) end. Concrete "U" headwalls on both ends. Flashboards should be present on the landside (LS). [Additional Reference(s): DWR Levee Log, 1993. USACE Sacramento O&M Manual 519, June 1962 (HLM 9.09)] FS Date: 6/19/2017 1:09:21 PM

Overview of levee crown at crossing looking downstream.

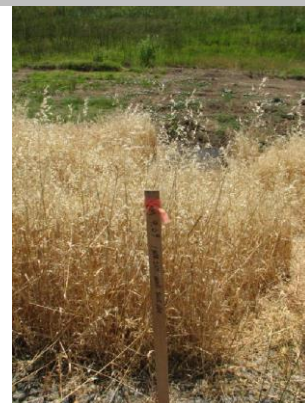
Photo 2 of 3 : UCIP_SP_2018_52227_66911.jpg

View of WS slope and toe.

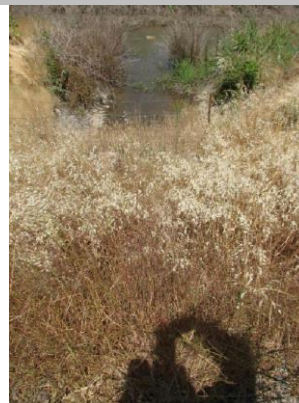
Photo 3 of 3 : UCIP_SP_2018_52227_66912.jpg

Item	DWR UCIP LMA Responsibility			39.476839 °	39.476839 °	
				-121.737540 °	-121.737540 °	
DWR ID						
Comment Code						
Inspector Comment						
FS_ID:52227						
DS_ID:16317						
EP_NO: N/A						
Repair Type: No Action Needed						
Crossing Status: Found						
UCIP Comments: 6/14/2017 Crossing appears to be in good condition. Pipe has been selected to be internally cleaned and inspected as part of the DMP project. (DWR Sutter Yard- AFreitag)11/16/2016 Crossing appears to be in good condition. (DWR Sutter Yard- AFreitag)4/28/2016 Crossing appears to be in good condition. 7/13/2015 LS inlet has minor vegetation still. WS appears in good condition. 5/21/2014 Same as last inspection. 12/3/2013 Same as last inspection. 7/15/2013 Slopes have been cleared of vegetation and are in good condition. 4/18/2012 Limited inspection on WS and LS slopes due to dense vegetation. Need photos of cleared WS and LS slopes. This crossing was listed in the USACE Periodic Inspections as Corp's Insect ID# USACE_CESPK_M13D_2011_p_0278 for WS outlet sedimentation and sediment/grass at LS inlet. FIELD_STRUCT_DESC: 36-inch corrugated metal drainage pipe through the levee, 10.2 feet below the crown. Flap gate on the waterside (WS) end. Concrete "U" headwalls on both ends. Flashboards should be present on the landside (LS). [Additional Reference(s): DWR Levee Log, 1993. USACE Sacramento O&M Manual 519, June 1962 (HLM 9.09)]

View of LS slope and toe.

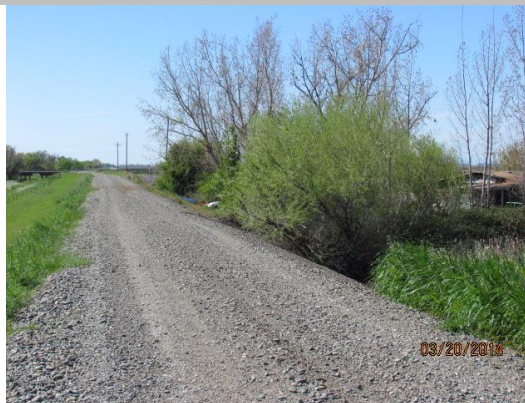
Photo 1 of 1 : SP_2018_MA0013_300_5_20180305_00002.jpg

LM Start	9.70	Rating **	M	Issue No.	5
LM End	9.72	Issue Type +	Ma	Location *	LS
Category	Earthen Levee			GPS Latitude/Longitude	
				Start	End
Item	Trim / Thin Trees			39.467170 °	39.466860 °
				-121.743887 °	-121.744108 °
DWR ID	DWR_MA0013_01_s_2012_5				
Comment Code					
T1 : Trim trees to at least five feet above ground level.					
Inspector Comment

View of the overgrown trees along the landside slope and toe.

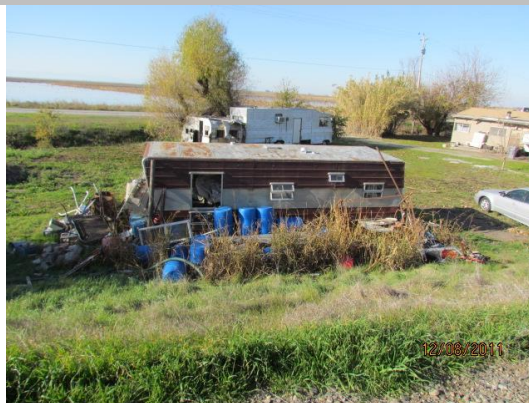
Photo 1 of 1 : SP_2018_MA0013_300_10_20180305_00003.jpg

LM Start	9.73	Rating **	M	Issue No.	10
LM End	9.75	Issue Type +	En	Location *	LS
Category	Earthen Levee			GPS Latitude/Longitude	
				Start	End
Item	Encroachments			39.466732 °	39.466478 °
				-121.744180 °	-121.744338 °
DWR ID	DWR_MA0013_01_f_2013_10				
Comment Code					
MA : Material					
Inspector Comment					
Move the trailer and materials outside the 10 foot easement.

View of a trailer and material along the landside toe.

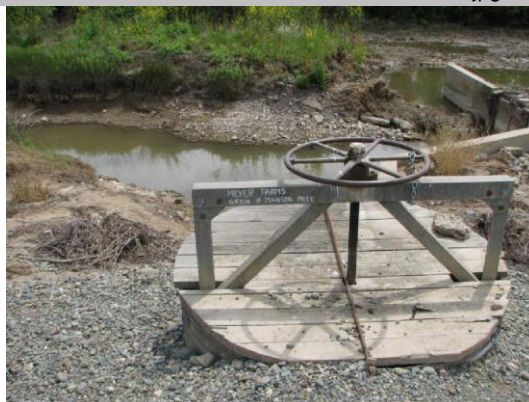
Photo 2 of 3 : UCIP_SP_2018_52232_66925.jpg

Corrugated metal riser with owner information.

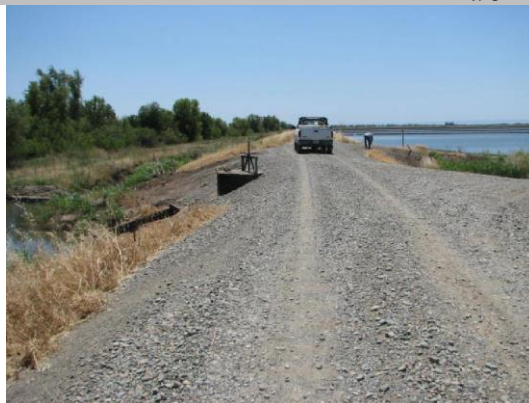
Photo 1 of 3 : UCIP_SP_2018_52233_66934.jpg

Comment Code					
Inspector Comment					
FS_ID:52233 DS_ID:16333 EP_NO: N/A Repair Type: No Action Needed Crossing Status: Found UCIP Comments: 6/15/2017 Crossing appears to be in good condition. Pipe has been selected to be internally cleaned and inspected as part of the DMP project. (DWR Sutter Yard- AFreitag)11/17/2016 Crossing appears to be in good condition. (DWR Sutter Yard- AFreitag)4/28/2016 Crossing appears to be in good condition. 7/13/2015 Crossing appears in good condition. No noticeable issues to report.5/21/2014 Same as last inspection. 12/3/2013 Same as last inspection. 7/15/2013 Same as last inspection. FIELD_STRUCT_DESC: 60-inch corrugated metal drainage pipe through the levee, 11.3 feet below the crown. Slide gate in corrugated metal pipe riser on the waterside (WS) slope. Concrete "U" headwall on both ends. Crossing is used as an irrigation turnout bar code plate located on the WS slide gate (identified as 145). [Additional Reference(s): DWR Levee Log, 1993. USACE Sacramento O&M Manual 519, June 1962 (HLM 11.78)] FS Date: 6/19/2017 1:20:52 PM

Overview of levee crown at crossing looking downstream.

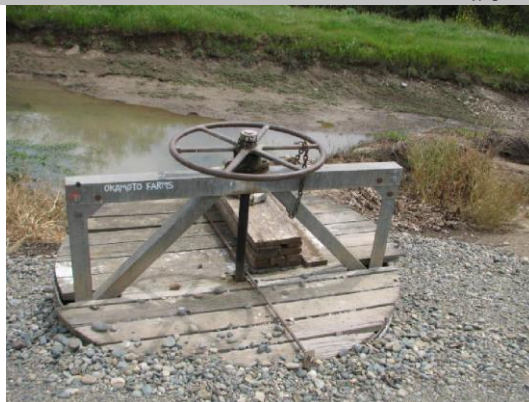
Photo 2 of 3 : UCIP_SP_2018_52233_66932.jpg

WS slide gate with owner information.

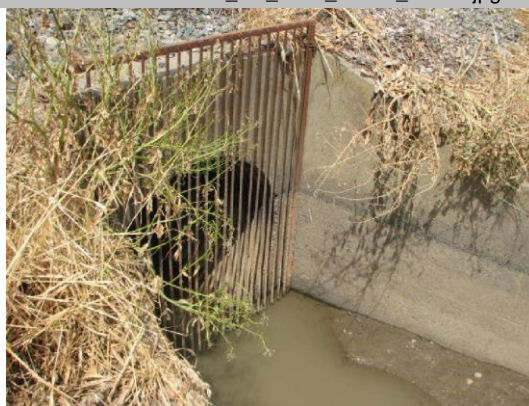
Photo 3 of 3 : UCIP_SP_2018_52233_66930.jpg

Trash rack on WS headwall.

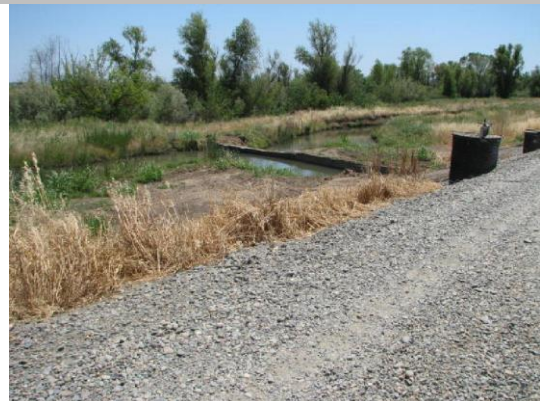
Photo 2 of 3 : UCIP_SP_2018_52234_66936.jpg

View of WS slope and channel.

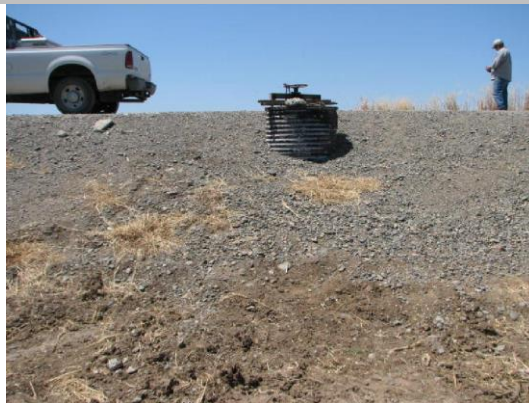
Photo 2 of 3 : UCIP_SP_2018_52236_66959.jpg

View of WS slope.

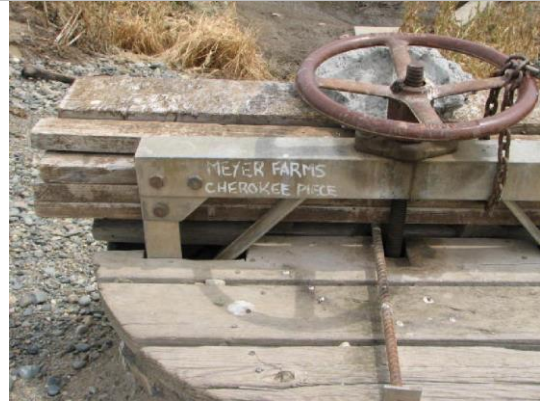
Photo 3 of 3 : UCIP_SP_2018_52236_66951.jpg

Slide gate located on WS slope. Owner information marked on gate.

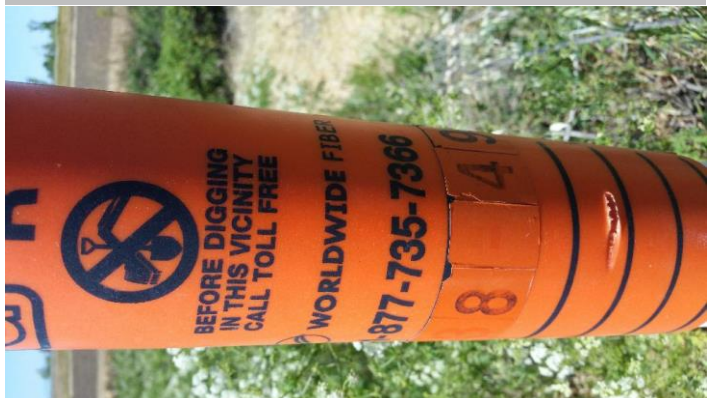
Photo 2 of 2 : UCIP_SP_2018_52237_75015.jpg

Crossing owner contact info

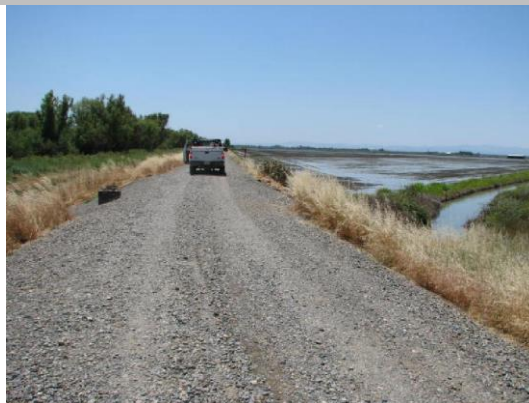
Photo 1 of 3 : UCIP_SP_2018_52238_66966.jpg

Comment Code						
Inspector Comment						
FS_ID:52238 DS_ID:16337 EP_NO: N/A Repair Type: No Action Needed Crossing Status: Found UCIP Comments: 6/15/2017 Crossing appears to be in good condition. Pipe has been selected to be internally cleaned and inspected as part of the DMP project. (DWR Sutter Yard- A/Freitag)11/17/2016 Ws pipe end was submerged but crossing appears to be in good condition. (DWR Sutter Yard- A/Freitag)5/03/2016 Crossing appears to be in good condition.7/13/2015 New screwgate installed inside of WS standpipe.5/21/2014 Same as last inspection.12/3/2013 Same as last inspection.7/15/2013 Same as last inspection. FIELD_STRUCT_DESC: 24-inch corrugated metal drainage pipe through the levee, 11.1 feet below the crown. Slide gate in corrugated metal pipe (CMP) riser on the waterside (WS) slope. Concrete "U" headwalls on both ends. [Additional Reference(s): DWR Levee Log, 1993. USACE Sacramento O&M Manual 519, June 1962 (HLM 13.53)] FS Date: 6/19/2017 1:33:59 PM

Overview of levee crown at crossing looking downstream.

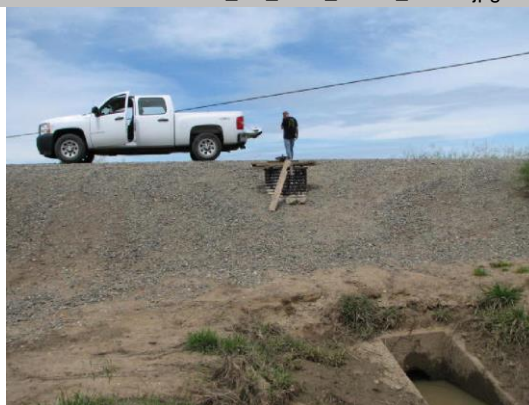
Photo 2 of 3 : UCIP_SP_2018_52238_66963.jpg

View of WS slope.
