**Flood Control Project Maintenance
Levee Inspections**
LMA District Cover Sheet
Spring 2018 Levee Inspection Results

Sutter Maintenance Yard Maintenance Area 0013

Spring 2018 Levee Inspection Results

Waterway			Bank	Unit Miles
Unit No. 01 Cherokee Canal			Right	18.19
	Spring (March - May)	Summer (June - August)	(September - November) Fall	Winter (December - February)
Unit Maintenance Rating (Fall Only)				
Date of Inspection	4/17/2018 - 4/17/2018			
DWR Inspector	Bob Duffey			
Accompanied By	Shawn Freitag Sutter Maintenance Yard

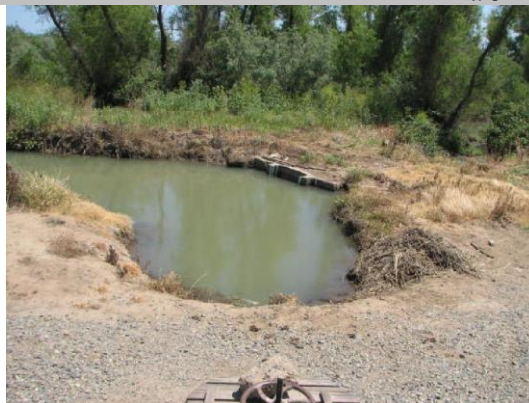
Photo 3 of 3 : UCIP_SP_2018_52238_66967.jpg

View of WS slope and channel.

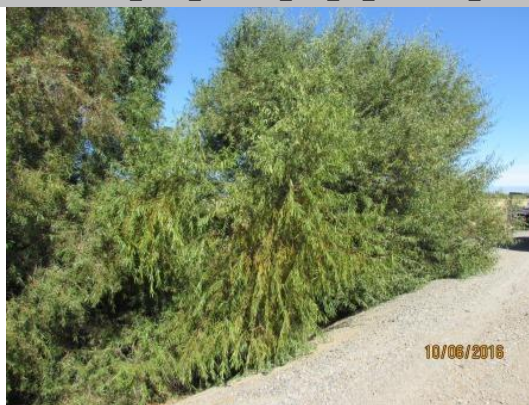
Photo 1 of 1 : SP_2018_MA0013_300_61_20180305_00011.jpg

LM Start	13.76	Rating **	U	Issue No.	61
LM End	13.76	Issue Type +	Ma	Location *	LS
Category	Earthen Levee			GPS Latitude/Longitude	
				Start	End
Item	Trim / Thin Trees			39.416854 °	39.416854 °
				-121.781855 °	-121.781855 °
DWR ID	DWR_MA0013_01_f_2016_61				
Comment Code					
T1 : Trim trees to at least five feet above ground level.					
Inspector Comment

View of the overgrown trees and vegetation along the landside slope and toe.

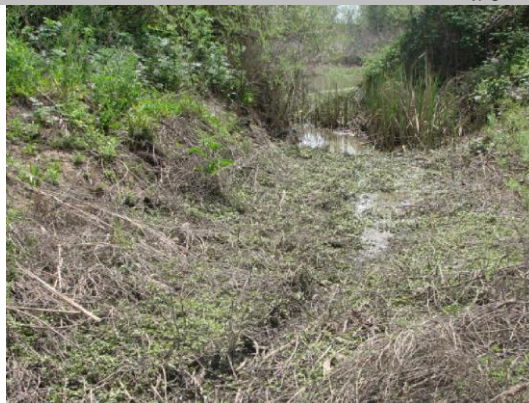
Photo 2 of 3 : UCIP_SP_2018_52239_66971.jpg

View of channel at crossing.

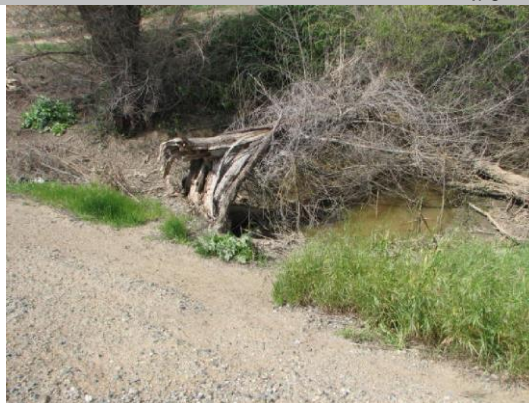
Photo 3 of 3 : UCIP_SP_2018_52239_66969.jpg

Tree fallen at LS headwall.

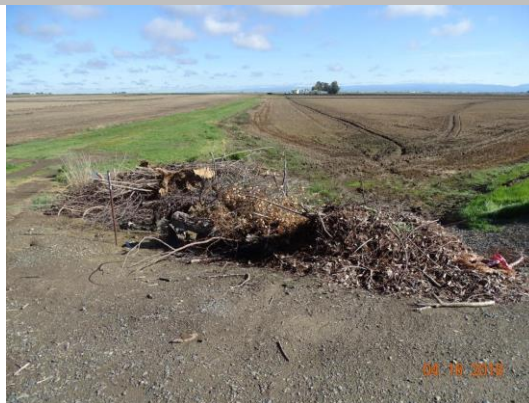
Photo 1 of 1 : SP_2018_MA0013_300_59_20180425_00143.jpg

LM Start	14.22	Rating **	M	Issue No.	59
LM End	14.22	Issue Type +	En	Location *	LS
Category	Earthen Levee			GPS Latitude/Longitude	
				Start	End
Item	Encroachments			39.412726 °	39.412726 °
				-121.788658 °	-121.788658 °
DWR ID	DWR_MA0013_01_f_2016_59				
Comment Code					
DE : Debris					
Inspector Comment					
Remove the debris from the landside slope.

View of the debris along the landside slope.

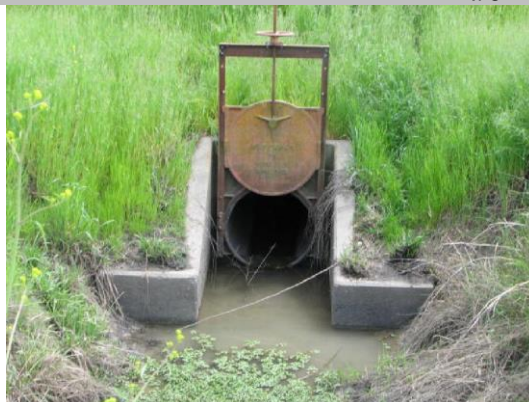
Photo 2 of 3 : UCIP_SP_2018_52242_66980.jpg

Slide gate located on LS toe. Dense vegetation present on LS slope.

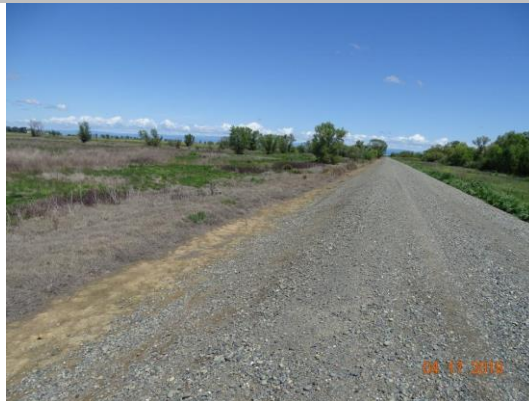
Photo 1 of 1 : SP_2018_MA0013_300_20_20180425_00147.jpg

LM Start	15.75	Rating **	A	Issue No.	20
LM End	18.50	Issue Type +	Ma	Location *	LS
Category	Earthen Levee			GPS Latitude/Longitude	
				Start	End
Item	Vegetation			39.398780 °	39.373430 °
				-121.810932 °	-121.850527 °
DWR ID	DWR_MA0013_01_s_2018_20				
Comment Code					
V1 : Control annual grass and weeds on the levee slopes and easements.					
Inspector Comment					
The vegetation was removed from the landside slope.

View of no vegetation along the landside slope.

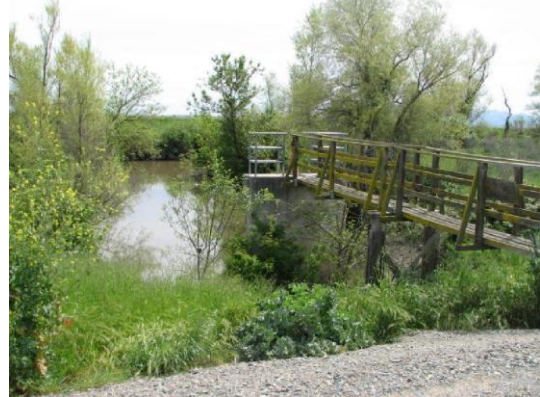
Photo 1 of 3 : UCIP_SP_2018_52244_66993.jpg

FS_ID:52244
DS_ID:16373
EP_NO: 11805B
Repair Type: Non-Urgent
Crossing Status: Found
UCIP Comments: 6/15/2017 Both pipe ends submerged during site visit. LS ditch near pipe end is heavily vegetated and covering the pipe end. There is some erosion happening at the LS levee toe but this is more of a ditch problem and not a problem with the pipe. (DWR Sutter Yard- A Freitag)11/17/2016 Both pipe ends underwater at time of inspection. (DWR Sutter Yard- A Freitag)5/03/2016 Crossing was underwater on both sides of levee during this inspection. Looks as if the wooden walkway was the same and no repairs have been made.7/13/2015 LS inlet still underwater. WS screwgate appears in good condition. Wooden walkway to the screwgate needs repairs.5/22/2014 Same as last inspection.12/3/2013 Same as last inspection.7/15/2013 Same as last inspection.4/18/2012 LS inlet is not visible-underwater. Limited inspection on WS and LS slope/toe due to dense vegetation. Need photos of cleared WS & LS slopes.

WS view of appurtenances (catwalk, slide gate, and headwall)

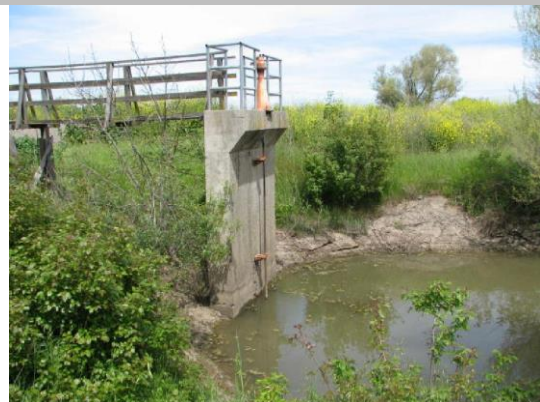
Photo 2 of 3 : UCIP_SP_2018_52244_66995.jpg

WS view of catwalk, slide/screw gate, and headwall

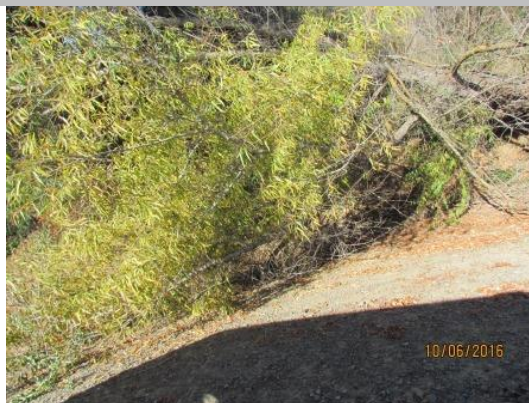
Photo 1 of 1 : SP_2018_MA0013_300_56_20180305_00009.jpg

LM Start	16.52	Rating **	M	Issue No.	56
LM End	16.52	Issue Type +	Ma	Location *	LS
Category	Earthen Levee			GPS Latitude/Longitude	
				Start	End
Item	Trim / Thin Trees			39.391675 °	39.391675 °
				-121.821932 °	-121.821932 °
DWR ID	DWR_MA0013_01_f_2016_56				
Comment Code					
T1 : Trim trees to at least five feet above ground level.					
Inspector Comment

View of dense trees along the landside toe.

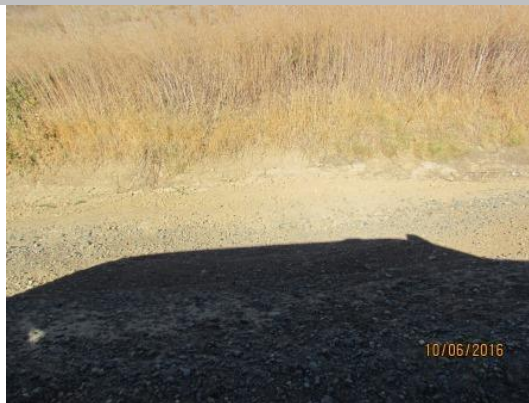
Photo 1 of 1 : SP_2018_MA0013_300_55_20180305_00008.jpg

LM Start	16.88	Rating **	M	Issue No.	55
LM End	16.88	Issue Type +	Ma	Location *	LS
Category	Earthen Levee			GPS Latitude/Longitude	
				Start	End
Item	Slope Stability			39.388326 °	39.388326 °
				-121.827137 °	-121.827137 °
DWR ID	DWR_MA0013_01_f_2016_55				
Comment Code					
S1 : Repair slope instability.					
Inspector Comment

View of slope instability issue along the landside slope.

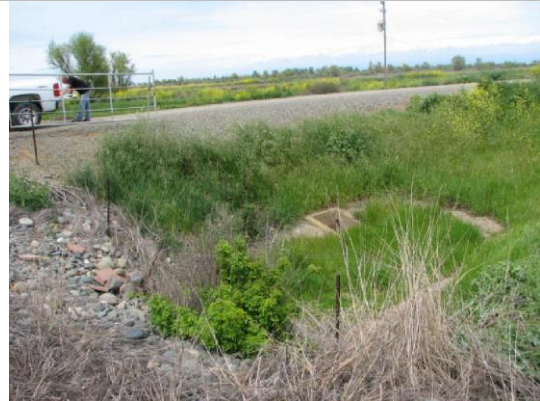
Photo 1 of 3 : UCIP_SP_2018_52249_67017.jpg

FS_ID:52249
DS_ID:16369
EP_NO: N/A
Repair Type: Non-Urgent
Crossing Status: Found
UCIP Comments: 6/15/2017 Flapgate bolted shut. Hinges seem very stiff to operate as gate will not fully close and has about a 1/2" gap near the top. Land owner claims the gate leaks during high water times. Pipe has been selected to be internally cleaned and inspected as part of the DMP project. (DWR Sutter Yard- A Freitag) 11/17/2016 Crossing appears to be in good condition. (DWR Sutter Yard- A Freitag) 5/03/2016 Crossing appears to be in good condition. 7/13/2015 WS flap gate is blocked from opening by sediment. Needs to be dug out. 5/22/2014 Same as last inspection. 12/3/2013 Sediment was dug out from WS flapgate allowing it to open. 7/15/2013 Slopes have been sprayed and cleared of vegetation and are in good condition. WS flapgate is blocked from opening by sediment buildup. 4/18/2012 Limited inspection on WS and LS slope due to dense vegetation and steep slopes. Need photos of cleared WS & LS slopes.

View of WS slope and toe.

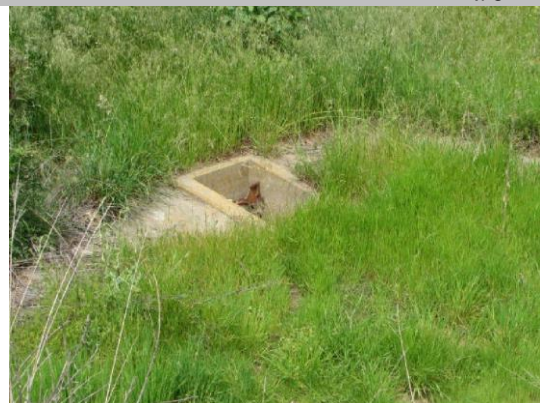
Photo 2 of 3 : UCIP_SP_2018_52249_67019.jpg

View of WS headwall and flap gate.

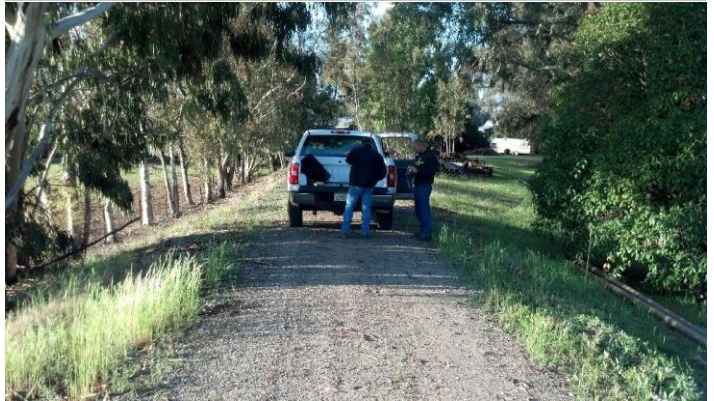
Photo 1 of 3 : UCIP_SP_2018_52111_45640.jpg

FS_ID:52111
DS_ID:16397
EP_NO: N/A
Repair Type: Non-Urgent
Crossing Status: Found
UCIP Comments: 6/5/2017 Crossing appears to be in good condition. (DWR Sutter Yard- AFreitag)11/18/2016 Crossing appears to be in good condition. 4inch pipe still present on LS but it does not affect the function of the crossing. (DWR Sutter Yard- AFreitag)9/27/2016 Crossing has been downgraded from Urgent to Non-Urgent--sleeved pipe does not prevent flap gate from closing on WS. Still need to coordinate with owner to remove sleeved pipe through existing crossing per Title 23. (DWR UCIP - omagana)4/27/2016 Crossing appears to be in good condition. 4 inch pipe is still present in LS opening but does not go all the way through to the WS. (DWR Sutter Yard - afreitag)7/01/2015 Crossing appears in good condition. No noticeable issues to report. (DWR Sutter Yard - afreitag)5/29/2014 Same as last inspection. (DWR Sutter Yard - afreitag)12/9/2013 4in. Pipe was removed and flapgate is closed and ready for high water. (DWR Sutter Yard - afreitag)7/10/2013 Same as last inspection. Urgency rating carry over from last entry. (DWR Sutter Yard - afreitag)4/19/2012 4-6 inch pipe is not part of original crossing--remove pipe. WS-pipe stockpile on WS slope. LS-Overgrown branches limit inspection. This crossing was listed in the USACE Periodic Inspection report listed as Corp's Inspect ID# USACE_CESPK_M13G_2011_p_0009 for WS flap gate not functioning properly as irrigation pipe passes inside crossing. (DWR UCIP - omagana)

Overview looking south on left levee

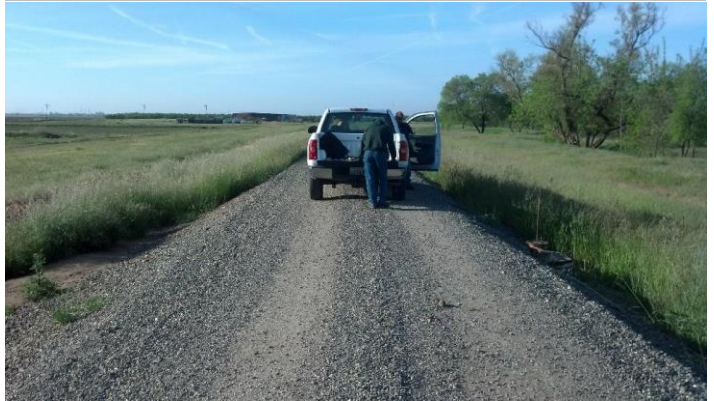
Photo 1 of 3 : UCIP_SP_2018_52112_67047.jpg

FS_ID:52112
DS_ID:16398
EP_NO: N/A
Repair Type: Non-Urgent
Crossing Status: Found
UCIP Comments: 6/5/2017 LS ditch at outlet is getting over grown with vegetation. WS near concrete standpipe is overgrown with vegetation. Pipe has been selected to be internally cleaned and inspected as part of the DMP project. (DWR Sutter Yard- A/Freitag)11/18/2016 Between the screwgate on the WS shoulder and the LS pipe end the pipe is about 50% full of soil. Crossing is still actively used by landowner for irrigation purposes. (DWR Sutter Yard- A/Freitag)4/27/2016 Pipe gets used by the landowner to irrigate his rice fields. It appeared to be in good condition.7/01/2015 LS pipe end is still about 50% full of sediment.5/29/2014 Same as last inspection.12/9/2013 Same as last inspection.7/10/2013 LS and WS slopes have been cleared of vegetation and are in good condition. LS pipe end is half full of sediment. Sediment inside of WS standpipe may hinder slide gate from fully closing. Standpipe cover is still broken.4/19/2012 Need to fix the top of slide gate cover. The wooden cap on standpipe is broken. Limited evaluation of crossing due to dense vegetation on LS slope. Need photos of cleared slopes during fall inspection.

Overview looking south

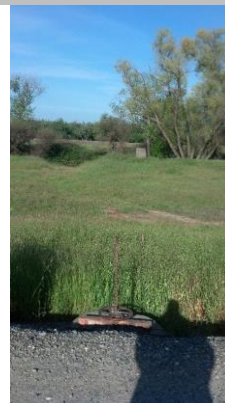
Photo 2 of 3 : UCIP_SP_2018_52112_67048.jpg

View of WS slope and toe.

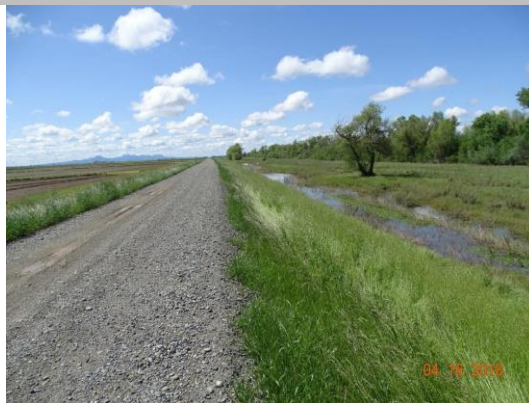
Photo 1 of 1 : SP_2018_MA0013_301_77_20180425_00139.jpg

LM Start	0.59	Rating **	M	Issue No.	77
LM End	22.34	Issue Type +	Ma	Location *	WS
Category	Earthen Levee			GPS Latitude/Longitude	
				Start	End
Item	Vegetation			39.566287 °	39.358318 °
				-121.702435 °	-121.875355 °
DWR ID	DWR_MA0013_02_s_2018_77				
Comment Code					
V1 : Control annual grass and weeds on the levee slopes and easements.					
Inspector Comment					
Trim the native vegetation on the waterside slope.

View of the native vegetation along the waterside slope.

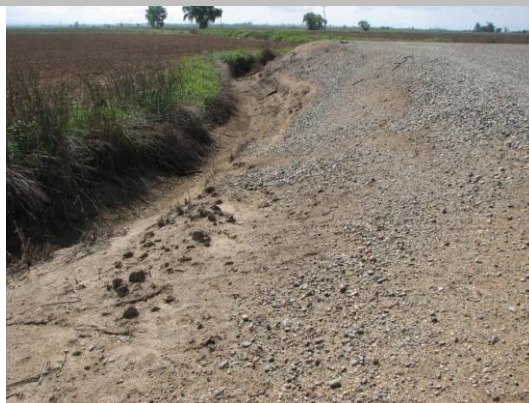
Photo 1 of 1 : SP_2018_MA0013_301_56_20180305_00015.jpg

LM Start	1.60	Rating **	U	Issue No.	56
LM End	1.63	Issue Type +	En	Location *	LS
Category	Earthen Levee			GPS Latitude/Longitude	
				Start	End
Item	Encroachments			39.552195 °	39.551731 °
				-121.704786 °	-121.704721 °
DWR ID	DWR_MA0013_02_s_2016_56				
Comment Code					
DT : Ditch					
Inspector Comment

View of the agricultural ditch along the landside toe.

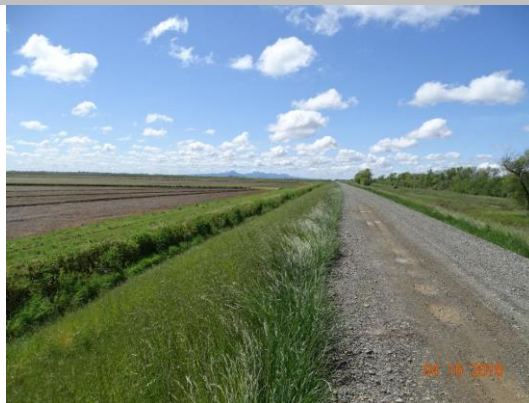
Photo 1 of 1 : SP_2018_MA0013_301_76_20180425_00138.jpg

LM Start	1.63	Rating **	M	Issue No.	76
LM End	17.21	Issue Type +	Ma	Location *	LS
Category	Earthen Levee			GPS Latitude/Longitude	
				Start	End
Item	Vegetation			39.551775 °	39.403280 °
				-121.704725 °	-121.799552 °
DWR ID	DWR_MA0013_02_s_2018_76				
Comment Code					
V1 : Control annual grass and weeds on the levee slopes and easements.					
Inspector Comment					
Trim the native vegetation on the landside slope.

View of the native vegetation along the landside slope.

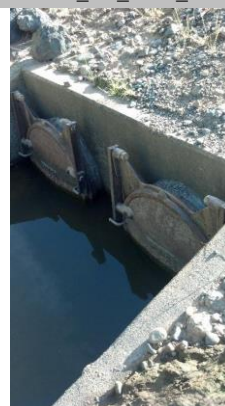
Photo 3 of 3 : UCIP_SP_2018_52115_67064.jpg

Item	DWR UCIP LMA Responsibility			39.539195 °	39.539195 °	
				-121.706070 °	-121.706070 °	
DWR ID						
Comment Code						
Inspector Comment						
FS_ID:52115 DS_ID:16400 EP_NO: N/A Repair Type: No Action Needed Crossing Status: Found UCIP Comments: 6/5/2017 LS inlet was underwater. WS flapgate blocked shut by sediment. Pipe has been selected to be internally cleaned and inspected as part of the DMP project. (DWR Sutter Yard-AFreitag)11/18/2016 Sediment dug out from in front of flap gate. Gate can now function properly. (DWR Sutter Yard-AFreitag)4/27/2016 WS flapgate still blocked from opening by sediment buildup.7/01/2015 New screwgate installed on the LS. WS flapgate is still blocked from opening by sediment.5/29/2014 Same as last inspection.12/9/2013 Same as last inspection.7/10/2013 Sediment is built up against WS flap gate not allowing it to open. Handle for LS slide gate is still missing.4/19/2012 Handle missing on slide gate. FIELD_STRUCT_DESC: 1 of 2: 36-inch corrugated metal drainage pipe through the levee, 9.7 feet below the crown. Concrete "U" headwalls located on the waterside (WS) and landside (LS) ends. Flap gate on the WS end. Slide gate on the LS end. [Additional Reference(s): DWR Levee Log, 1993. USACE Sacramento O&M Manual 519, June 1962 (HLM 2.54)] FS Date: 6/7/2017 12:18:14 PM

Headwall and flap gates (2) located on WS

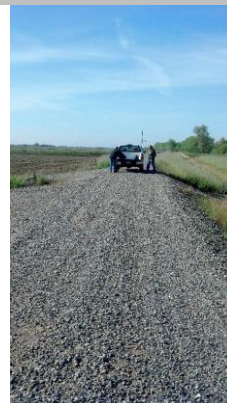
Photo 1 of 3 : UCIP_SP_2018_52116_67075.jpg

Comment Code					
Inspector Comment					
FS_ID:52116 DS_ID:17169 EP_NO: N/A Repair Type: No Action Needed Crossing Status: Found UCIP Comments: 6/5/2017 LS inlet was underwater. WS appears to be in good condition. Pipe has been selected to be internally cleaned and inspected as part of the DMP project. (DWR Sutter Yard- A/Freitag)11/18/2016 Crossing appears to be in good condition. (DWR Sutter Yard- A/Freitag)4/27/2016 Crossing appears to be in good condition.7/01/2015 New screwgate installed on the LS. WS appears to be in good condition.5/29/2014 Same as last inspection.12/9/2013 Same as last inspection.7/10/2013 Same as last inspection. FIELD_STRUCT_DESC: 2 of 2: 36-inch corrugated metal drainage pipe through the levee, 9.7 feet below the crown. Concrete "U" headwalls on both the waterside (WS) and landside (LS) ends. Flap gate on the waterside (WS) end. Slide gate on the landside (LS) end. [Additional Reference(s): DWR Levee Log, 1993. USACE Sacramento O&M Manual 519, June 1962 (HLM 2.54)] FS Date: 6/7/2017 12:28:51 PM

Overview at levee crown looking south

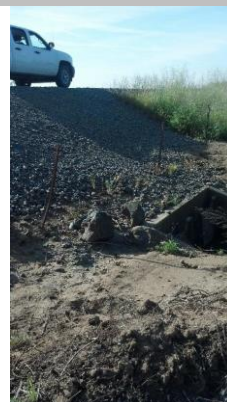
Photo 2 of 3 : UCIP_SP_2018_52116_67074.jpg

View of WS slope.

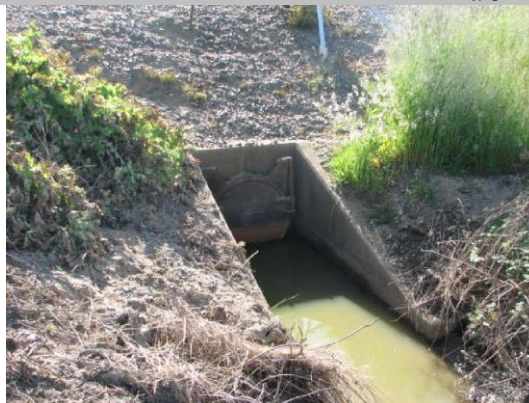
Photo 2 of 3 : UCIP_SP_2018_52117_67076.jpg

Comment Code						
Inspector Comment						
FS_ID:52117 DS_ID:16402 EP_NO: N/A Repair Type: Non-Urgent Crossing Status: Found UCIP Comments: 6/5/2017 Sediment blocking LS slide gate from closing fully. Pipe has been selected to be internally cleaned and inspected as part of the DMP project. (DWR Sutter Yard-AFreitag)11/18/2016 Sediment still blocking screw gate from fully closing. (DWR Sutter Yard- AFreitag)4/27/2016 LS slide gate is full of sediment and needs to be dug out so gate can close fully.7/01/2015 LS screwgate is still silted in and unable to be screwed down all the way. Needs to be cleaned out.5/29/2014 Same as last inspection.12/9/2013 WS flapgate was closed but LS slidegate is heavily vegetated and blocked from closing by sediment.7/10/2013 Same as last inspection.4/19/2012 Minor sediment built up on LS, remove sediment. Need photo of LS slide gate without sediment build up. This crossing was listed in the USACE Periodic Inspection report as Corp's inspect ID# USACE_CESPK_M13G_2011_p_0148 for LS gate obstructed by vegetation and WS flap gate is not functioning (propped open). FIELD_STRUCT_DESC: 36-inch corrugated metal drainage pipe through the levee, 8.8 feet below the crown. Concrete "U" headwalls located on both the waterside (WS) and landside (LS) ends. Flap gate on the WS end. Slide gate on the LS end. Structure used to drain water from Nelson Shippe Road. [Additional Reference(s): DWR Levee Log, 1993. USACE Sacramento O&M Manual 519, June 1962 (HLM 2.63)] FS Date: 6/7/2017 12:45:23 PM

Headwall and flap gate located on WS.

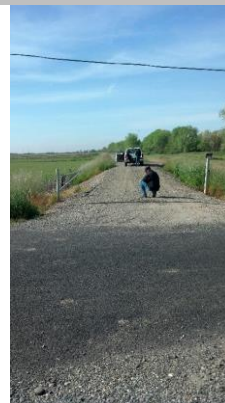
Photo 1 of 3 : UCIP_SP_2018_52119_67087.jpg

FS_ID:52119
DS_ID:16403
EP_NO: N/A
Repair Type: Non-Urgent
Crossing Status: Found
UCIP Comments: 6/5/2017 Crossing appears to be in good condition. Pipe has been selected to be internally cleaned and inspected as part of the DMP project. (DWR Sutter Yard- A Freitag)11/18/2016 Crossing appears to be in good condition. (DWR Sutter Yard- A Freitag)4/27/2016 Crossing appears to be in good condition.7/01/2015 WS flap gate is partially blocked by sediment and needs to be cleaned.5/29/2014 Same as last inspection.12/9/2013 Same as last inspection.7/10/2013 LS and WS slopes have been cleared of vegetation and are in good condition.4/19/2012 Burrowing holes located above WS headwall. Limited inspection on WS and LS slopes due to dense vegetation. Need photos of cleared WS & LS slopes.
FIELD_STRUCT_DESC: 36-inch corrugated metal drainage pipe through the levee, 8.7 feet below the crown. Concrete "U" headwalls located on the waterside (WS) and landside (LS) ends. Flap gate on the WS end. Slide gate on the LS end. [Additional Reference(s): DWR Levee Log, 1993. USACE Sacramento O&M Manual 519, June 1962 (HLM 2.65)]

Overview at levee crown looking south

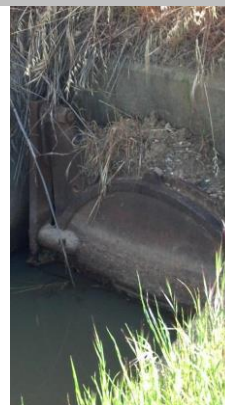
Photo 2 of 3 : UCIP_SP_2018_52119_67084.jpg

Headwall and flap gate located on WS

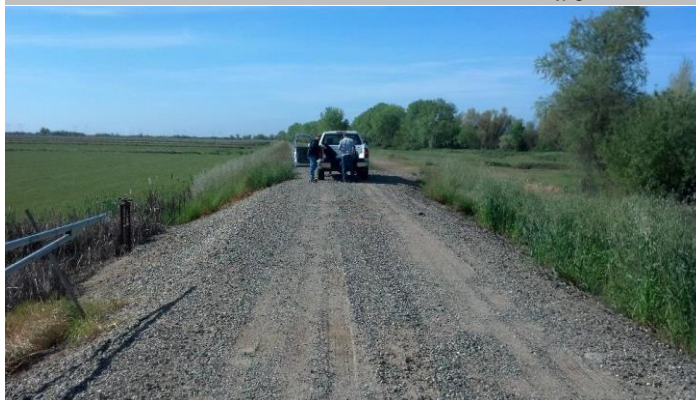
Photo 1 of 3 : UCIP_SP_2018_52120_67090.jpg

FS_ID:52120
DS_ID:16415
EP_NO: N/A
Repair Type: Non-Urgent
Crossing Status: Found
UCIP Comments: 6/5/2017 Both gates partially submerged during site visit. Appears to be in good condition. Pipe has been selected to be internally cleaned and inspected as part of the DMP project. (DWR Sutter Yard- A Freitag) 11/18/2016 LS screw gate closed but partially buried. WS flapgate was half submerged for inspection. (DWR Sutter Yard- A Freitag) 4/27/2016 Both gates were underwater for inspection. 7/01/2015 WS flap gate is partially held open by sediment and needs to be dug out to allow it to fully close. 5/29/2014 Same as last inspection. 12/9/2013 Both gates were out of water and in good condition. 7/10/2013 LS and WS slopes are in good condition. Both LS and WS gates were fully submerged in water and unable to be inspected.
FIELD_STRUCT_DESC: 36-inch corrugated metal drainage pipe through the levee, 9 feet below the crown. Concrete "U" headwall on both waterside (WS) and landside (LS) ends. Flap gate on the WS end. Slide gate on the LS. [Additional Reference(s): DWR Levee Log, 1993. USACE Sacramento O&M Manual 519, June 1962 (HLM 2.66)]

Overview looking south from left levee

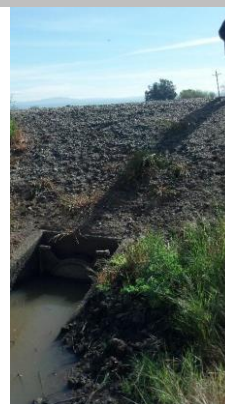
Photo 2 of 3 : UCIP_SP_2018_52120_67091.jpg

Headwall and flap gate located on WS.

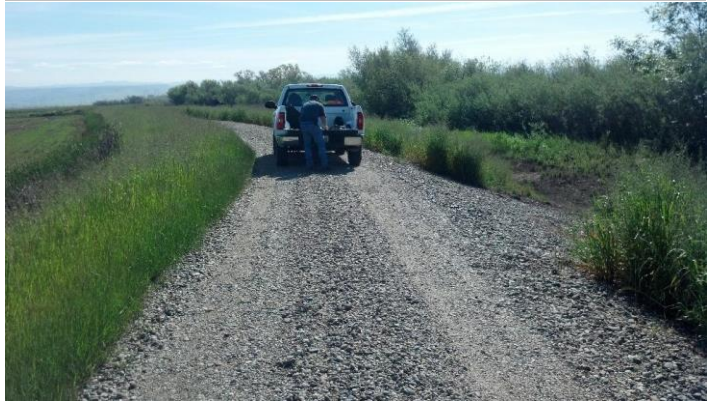
Photo 1 of 3 : UCIP_SP_2018_52122_67102.jpg

FS_ID:52122
DS_ID:16848
EP_NO: N/A
Repair Type: No Action Needed
Crossing Status: Found
UCIP Comments: 6/5/2017 Both ends submerged but appear to be in good condition. Pipe has been selected to be internally cleaned and inspected as part of the DMP project. (DWR Sutter Yard- A/Freitag)11/18/2016 Crossing appears to be in good condition. (DWR Sutter Yard- A/Freitag)4/27/2016 Crossing appears to be in good condition. New slide gate installed on LS.7/01/2015 Both gates were still submerged in water. Levee slopes were in good condition.5/29/2014 Same as last inspection.12/9/2013 Same as last inspection.7/10/2013 LS slope has been cleared of vegetation and is in good condition. Both gates are still underwater and not able to be inspected.4/19/2012 Dense vegetation makes it difficult to evaluate the condition of the LS slope. Both gates underwater. Recommend taking photos of clear slopes and gates during fall inspection.

Overview looking south on left levee

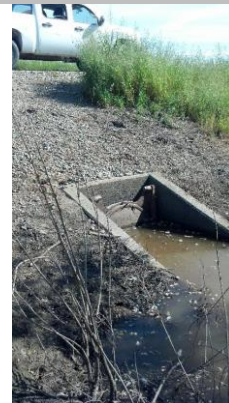
Photo 2 of 3 : UCIP_SP_2018_52122_67103.jpg

Headwall and flap gate located on WS.

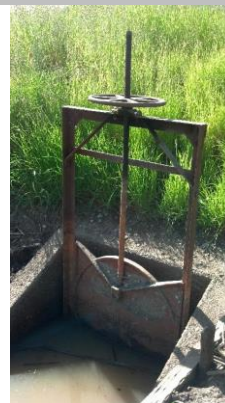
Photo 3 of 3 : UCIP_SP_2018_52122_67101.jpg

Headwall and screw gate located on LS.

FS_ID:52122
DS_ID:16848
EP_NO: N/A
Repair Type: No Action Needed
Crossing Status: Found
UCIP Comments: 6/5/2017 Both ends submerged but appear to be in good condition. Pipe has been selected to be internally cleaned and inspected as part of the DMP project. (DWR Sutter Yard- AFreitag)11/18/2016 Crossing appears to be in good condition. (DWR Sutter Yard- AFreitag)4/27/2016 Crossing appears to be in good condition. New slide gate installed on LS.7/01/2015 Both gates were still submerged in water. Levee slopes were in good condition.5/29/2014 Same as last inspection.12/9/2013 Same as last inspection.7/10/2013 LS slope has been cleared of vegetation and is in good condition. Both gates are still underwater and not able to be inspected.4/19/2012 Dense vegetation makes it difficult to evaluate the condition of the LS slope. Both gates underwater. Recommend taking photos of clear slopes and gates during fall inspection.

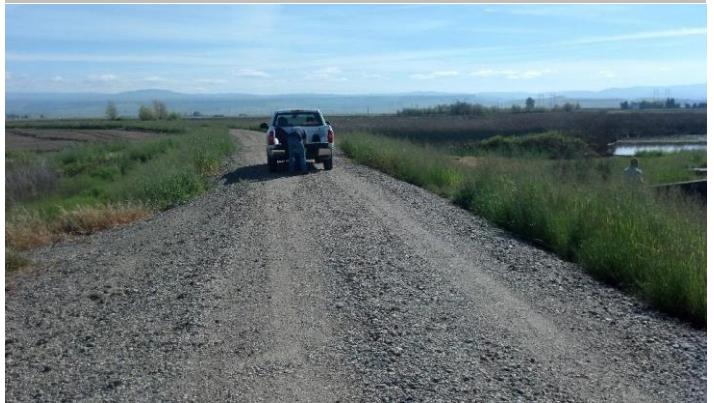
Photo 1 of 3 : UCIP_SP_2018_52123_67107.jpg

FS_ID:52123
DS_ID:16847
EP_NO: N/A
Repair Type: Non-Urgent
Crossing Status: Found
UCIP Comments: 6/5/2017 Both ends submerged but crossing appears to be in good condition. (DWR Sutter Yard-AFreitag)11/18/2016 Crossing appears to be in good condition. It appears that this crossing does not require a slide gate. (DWR Sutter Yard-AFreitag)4/27/2016 LS slide gate was still missing. Rest of crossing appears to be in good condition.7/01/2015 There appears to be a LS gate now but both pipe ends were submerged so it was hard to tell for certain.5/29/2014 Same as last inspection.12/9/2013 Pulled sticks from WS flap gate to allow it to close. Ls gate is still missing.7/10/2013 WS and LS slopes have been cleared of vegetation and are in good condition. LS gate is still missing and WS flap gate is still wedged open with sticks.4/19/2012 LS gate missing & limited inspection. Need photos of WS & LS cleared slopes. Description calls for slide gate on LS-slide gate missing. Debris scattered near LS headwall. This crossing was listed in the USACE Periodic Inspection report as Corp's Inspect ID# USACE_CESPK_M13J_2011_p_0010 for WS gate wedged open & missing LS slide gate.

Overview looking south on left levee

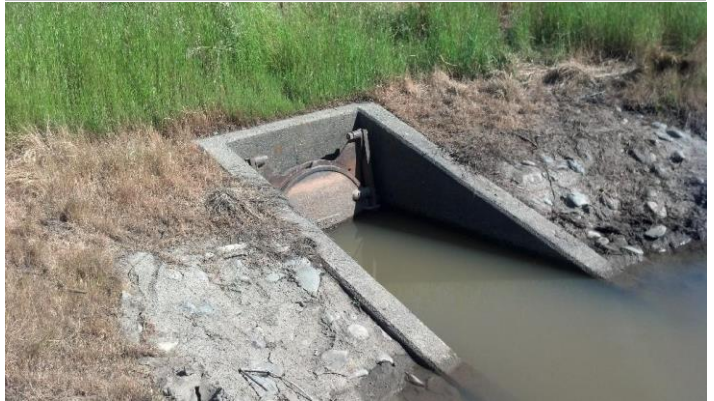
Photo 2 of 3 : UCIP_SP_2018_52123_67108.jpg

FS_ID:52123
DS_ID:16847
EP_NO: N/A
Repair Type: Non-Urgent
Crossing Status: Found
UCIP Comments: 6/5/2017 Both ends submerged but crossing appears to be in good condition. (DWR Sutter Yard-AFreitag)11/18/2016 Crossing appears to be in good condition. It appears that this crossing does not require a slide gate. (DWR Sutter Yard- AFreitag)4/27/2016 LS slide gate was still missing. Rest of crossing appears to be in good condition.7/01/2015 There appears to be a LS gate now but both pipe ends were submerged so it was hard to tell for certain.5/29/2014 Same as last inspection.12/9/2013 Pulled sticks from WS flap gate to allow it to close. Ls gate is still missing.7/10/2013 WS and LS slopes have been cleared of vegetation and are in good condition. LS gate is still missing and WS flap gate is still wedged open with sticks.4/19/2012 LS gate missing & limited inspection. Need photos of WS & LS cleared slopes. Description calls for slide gate on LS-slide gate missing. Debris scattered near LS headwall. This crossing was listed in the USACE Periodic Inspection report as Corp's Inspect ID# USACE_CESPK_M13J_2011_p_0010 for WS gate wedged open & missing LS slide gate.

Headwall and flap gate located on WS toe.

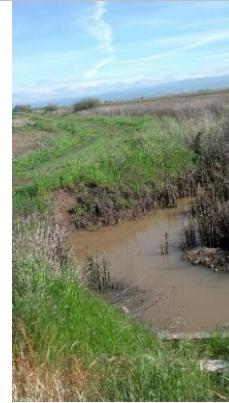
Photo 3 of 3 : UCIP_SP_2018_52123_67110.jpg

Comment Code						
Inspector Comment						
FS_ID:52123 DS_ID:16847 EP_NO: N/A Repair Type: Non-Urgent Crossing Status: Found UCIP Comments: 6/5/2017 Both ends submerged but crossing appears to be in good condition. (DWR Sutter Yard-AFreitag)11/18/2016 Crossing appears to be in good condition. It appears that this crossing does not require a slide gate. (DWR Sutter Yard- AFreitag)4/27/2016 LS slide gate was still missing. Rest of crossing appears to be in good condition.7/01/2015 There appears to be a LS gate now but both pipe ends were submerged so it was hard to tell for certain.5/29/2014 Same as last inspection.12/9/2013 Pulled sticks from WS flap gate to allow it to close. Ls gate is still missing.7/10/2013 WS and LS slopes have been cleared of vegetation and are in good condition. LS gate is still missing and WS flap gate is still wedged open with sticks.4/19/2012 LS gate missing & limited inspection. Need photos of WS & LS cleared slopes. Description calls for slide gate on LS-slide gate missing. Debris scattered near LS headwall. This crossing was listed in the USACE Periodic Inspection report as Corp's Inspect ID# USACE_CESPK_M13J_2011_p_0010 for WS gate wedged open & missing LS slide gate. FIELD_STRUCT_DESC: 36-inch corrugated metal drainage pipe through the levee, 8.8 feet below the crown. Flap gate on the waterside (WS) end. Slide gate on the landside (LS) end. Concrete "U" headwalls on both ends. [Additional Reference(s): DWR Levee Log, 1993. USACE Sacramento O&M Manual 519, June 1962 (HLM 3.85)] FS Date: 6/7/2017 1:24:40 PM

View of channel at crossing looking D/S.

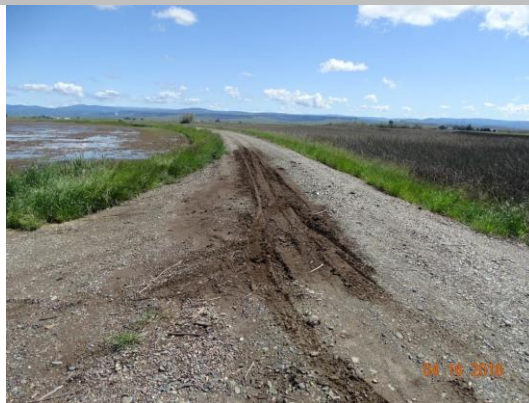
Photo 1 of 1 : SP_2018_MA0013_301_66_20180425_00136.jpg

LM Start	3.84	Rating **	M	Issue No.	66
LM End	3.84	Issue Type +	Ma	Location *	LS
Category	Earthen Levee			GPS Latitude/Longitude	
				Start	End
Item	Crown Surface / Depressions / Rutting			39.524467 °	39.524467 °
				-121.701878 °	-121.701878 °
DWR ID	DWR_MA0013_02_s_2018_66				
Comment Code					
C1 : Add appropriate material and re-grade the levee to bring the crown above the design elevation.					
Inspector Comment					
Repair the crown roadway.

View of the erosion on the crown roadway caused by flood water over topping.

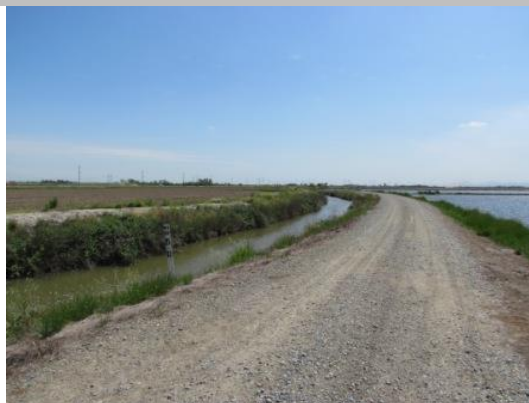
Photo 1 of 1 : SP_2018_MA0013_301_911_20180305_00023.jpg

LM Start	4.04	Rating **	M	Issue No.	911
LM End	4.78	Issue Type +	En	Location *	WS
Category	Earthen Levee			GPS Latitude/Longitude	
				Start	End
Item	Encroachments			39.526653 °	39.534091 °
				-121.699675 °	-121.690404 °
DWR ID	DWR_MA0013_02_s_2012_911				
Comment Code					
DT : Ditch					
Inspector Comment

View of agricultural ditch along the toe.

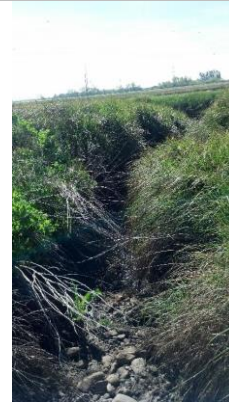
Photo 3 of 3 : UCIP_SP_2018_52125_67123.jpg

Item	DWR UCIP LMA Responsibility			39.532510 °	39.532510 °	
				-121.691340 °	-121.691340 °	
DWR ID						
Comment Code						
Inspector Comment						
FS_ID:52125 DS_ID:16845 EP_NO: N/A Repair Type: No Action Needed Crossing Status: Found UCIP Comments: 6/5/2017 LS Slide gate mostly underwater due to rice field being flooded but crossing appears to be in good condition. Pipe has been selected to be internally cleaned and inspected as part of the DMP project. (DWR Sutter Yard- AFreitag)11/18/2016 Crossing appears to be in good condition. (DWR Sutter Yard- AFreitag)4/27/2016 Crossing appears to be in good condition.7/01/2015 Crossing appears to be in good condition. No noticeable issues to report.5/29/2014 Same as last inspection.12/9/2013 Same as last inspection.7/10/2013 WS slope has been cleared of vegetation and is in good condition.4/19/2012 Limited inspection due to dense vegetation on WS slope. Need photos of clear WS slope. FIELD_STRUCT_DESC: 24-inch corrugated metal drainage pipe through the levee, 5.6 feet below the crown. Flap gate on the waterside (WS) end. Slide gate on the landside (LS) end. Concrete "U" headwalls on both ends. [Additional Reference(s): DWR Levee Log, 1993. USACE Sacramento O&M Manual 519, June 1962 (HLM 4.69)] FS Date: 6/7/2017 1:41:34 PM

View of channel at crossing.

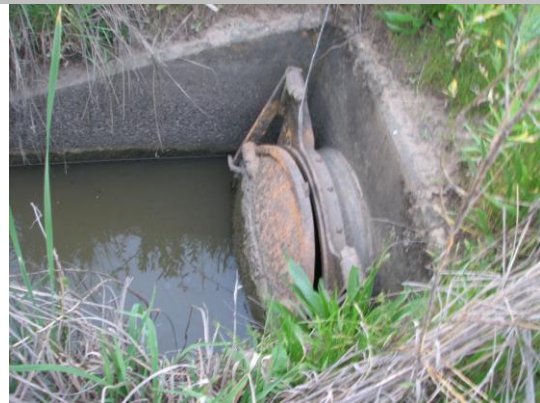
Photo 2 of 3 : UCIP_SP_2018_52126_67129.jpg

Headwall and flap gate located on WS.

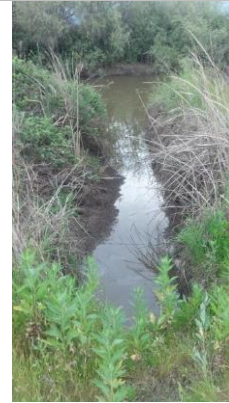
Photo 3 of 3 : UCIP_SP_2018_52126_67126.jpg

View of channel at crossing.

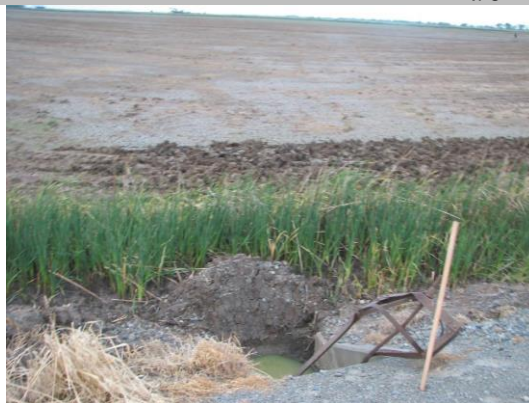
Photo 3 of 3 : UCIP_SP_2018_52129_67141.jpg

Overview of LS floor is higher in elevation than pipe invert causing build up sediment.

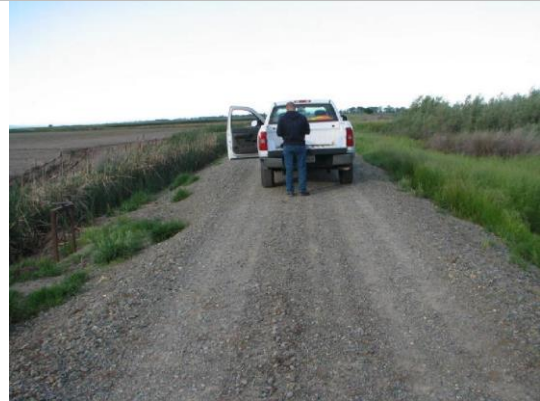
Photo 1 of 3 : UCIP_SP_2018_52130_67146.jpg

FS_ID:52130
DS_ID:16409
EP_NO: N/A
Repair Type: Non-Urgent
Crossing Status: Found
UCIP Comments: 6/5/2017 WS fully submerged and LS slide gate mostly buried by sediment. Pipe has been selected to be internally cleaned and inspected as part of the DMP project. (DWR Sutter Yard-AFreitag)11/18/2016 There is a flapgate on the WS and a slide gate on the LS. The LS slide gate appears to be partially buried and blocked by vegetation. (DWR Sutter Yard- AFreitag)4/27/2016 LS slide gate is blocked by vegetation. Pipe appears to not be used.6/30/2015 WS flap gate was still overgrown with vegetation. Needs to be cleared away.5/29/2014 Same as last inspection.12/9/2013 Same as last inspection.7/09/2013 Same as last inspection.4/24/2012 Limited inspection on WS slope due to dense vegetation. Need photo of clear WS slope during next inspection. This crossing was listed in the USACE Periodic Inspection report as Corp's inspect ID# USACE_CESPK_M13H_2011_p_0035 non-functional crossing due to overgrown vegetation on WS flap gate.

Overview of crossing looking downstream.

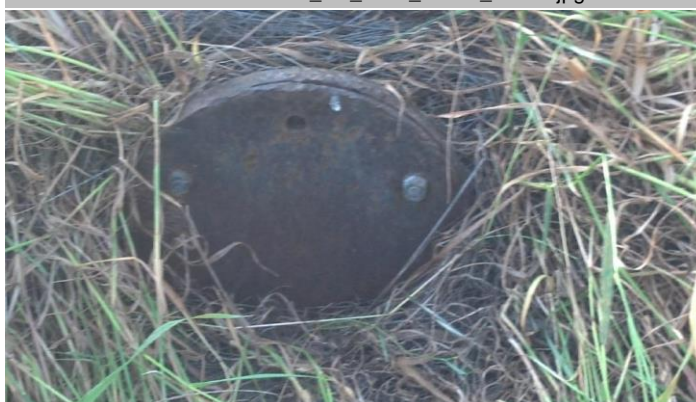
Photo 2 of 3 : UCIP_SP_2018_52131_67150.jpg

Capped irrigation pipe located on water side of levee

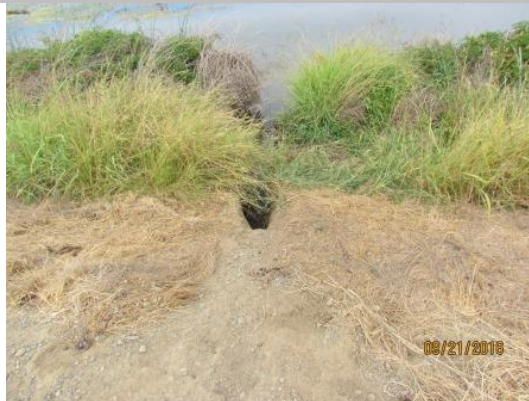
Photo 1 of 1 : SP_2018_MA0013_301_49_20180305_00011.jpg

LM Start	5.71	Rating **	M	Issue No.	49
LM End	5.71	Issue Type +	Ma	Location *	WS
Category	Earthen Levee			GPS Latitude/Longitude	
				Start	End
Item	Erosion / Bank Caving			39.523803 °	39.523803 °
				-121.699804 °	-121.699804 °
DWR ID	DWR_MA0013_02_f_2016_49				
Comment Code					
E2 : Schedule repair of erosion site prior to the next inspection.					
Inspector Comment					
1' by 2' by 4' hole in the levee toe that appears to be a temporary pump intake.

View of the man made hole at the waterside levee toe.

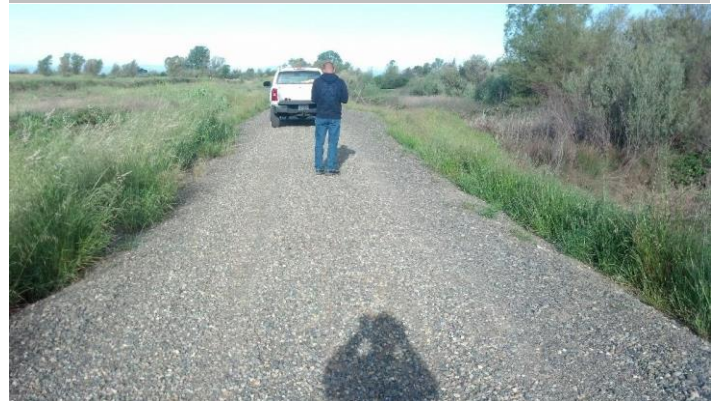
Photo 1 of 3 : UCIP_SP_2018_52132_67155.jpg

Comment Code					
Inspector Comment					
FS_ID:52132 DS_ID:16411 EP_NO: N/A Repair Type: Non-Urgent Crossing Status: Found UCIP Comments: 6/5/2017 Both ends were underwater but it appears that the LS slide gate is still missing. (DWR Sutter Yard- AFreitag)11/18/2016 LS slide gate still missing. Both pipe ends were submerged during inspection. (DWR Sutter Yard- AFreitag)9/27/2016 Crossing has been downgraded from Urgent to Non-Urgent--flap gate on WS is present only LS gate missing. (DWR UCIP - omagana)4/27/2016 Both sides of pipe were underwater. Appears that LS gate is still missing. (DWR Sutter Yard - afreitag)6/30/2015 Slide gate still missing on the LS. WS appears to be in good condition. (DWR Sutter Yard - afreitag)5/29/2014 Same as last inspection. (DWR Sutter Yard - afreitag)12/9/2013 Same as last inspection. (DWR Sutter Yard - afreitag)7/09/2013 Same as last inspection. (DWR Sutter Yard - afreitag)4/24/2012 Slide gate missing on LS. Limited inspection on WS and LS slopes due to dense vegetation. Need photos of cleared WS & LS slopes. This crossing was listed in the USACE Periodic Inspection report as Corp's inspect ID# USACE_CESPK_M13H_2011_p_0017 for missing slide gate. (DWR Sutter Yard - omagana) FIELD_STRUCT_DESC: 36-inch corrugated metal drainage pipe through the levee, 9.2 feet below the crown. Flap gate on the waterside (WS) end. Slide gate on the landside (LS) end. Concrete "U" headwalls located on both WS and LS toes. [Additional Reference(s): DWR Levee Log, 1993. USACE Sacramento O&M Manual 519, June 1962 (HLM 5.85)] FS Date: 6/7/2017 2:06:17 PM

Overview looking south

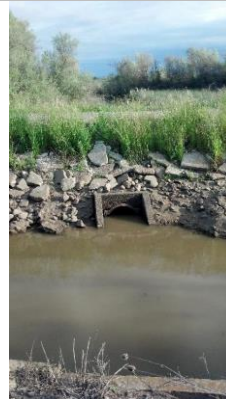
Photo 3 of 3 : UCIP_SP_2018_52132_67156.jpg

Comment Code						
Inspector Comment						
FS_ID:52132 DS_ID:16411 EP_NO: N/A Repair Type: Non-Urgent Crossing Status: Found UCIP Comments: 6/5/2017 Both ends were underwater but it appears that the LS slide gate is still missing. (DWR Sutter Yard- AFreitag)11/18/2016 LS slide gate still missing. Both pipe ends were submerged during inspection. (DWR Sutter Yard- AFreitag)9/27/2016 Crossing has been downgraded from Urgent to Non-Urgent--flap gate on WS is present only LS gate missing. (DWR UCIP - omagana)4/27/2016 Both sides of pipe were underwater. Appears that LS gate is still missing. (DWR Sutter Yard - afreitag)6/30/2015 Slide gate still missing on the LS. WS appears to be in good condition. (DWR Sutter Yard - afreitag)5/29/2014 Same as last inspection. (DWR Sutter Yard - afreitag)12/9/2013 Same as last inspection. (DWR Sutter Yard - afreitag)7/09/2013 Same as last inspection. (DWR Sutter Yard - afreitag)4/24/2012 Slide gate missing on LS. Limited inspection on WS and LS slopes due to dense vegetation. Need photos of cleared WS & LS slopes. This crossing was listed in the USACE Periodic Inspection report as Corp's inspect ID# USACE_CESPK_M13H_2011_p_0017 for missing slide gate. (DWR Sutter Yard - omagana) FIELD_STRUCT_DESC: 36-inch corrugated metal drainage pipe through the levee, 9.2 feet below the crown. Flap gate on the waterside (WS) end. Slide gate on the landside (LS) end. Concrete "U" headwalls located on both WS and LS toes. [Additional Reference(s): DWR Levee Log, 1993. USACE Sacramento O&M Manual 519, June 1962 (HLM 5.85)] FS Date: 6/7/2017 2:06:17 PM

Headwall and damaged/missing screw gate on LS.

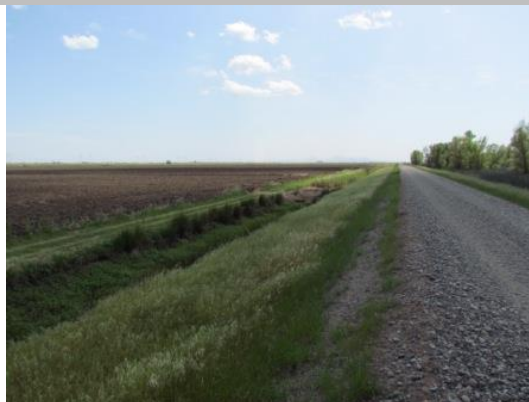
Photo 1 of 1 : SP_2018_MA0013_301_12_20180305_00004.jpg

LM Start	6.18	Rating **	M	Issue No.	12
LM End	7.54	Issue Type +	En	Location *	LS
Category	Earthen Levee			GPS Latitude/Longitude	
				Start	End
Item	Encroachments			39.520843 °	39.502958 °
				-121.706345 °	-121.716953 °
DWR ID	DWR_MA0013_02_s_2012_12				
Comment Code					
DT : Ditch					
Inspector Comment

View of the agricultural ditch along the toe.

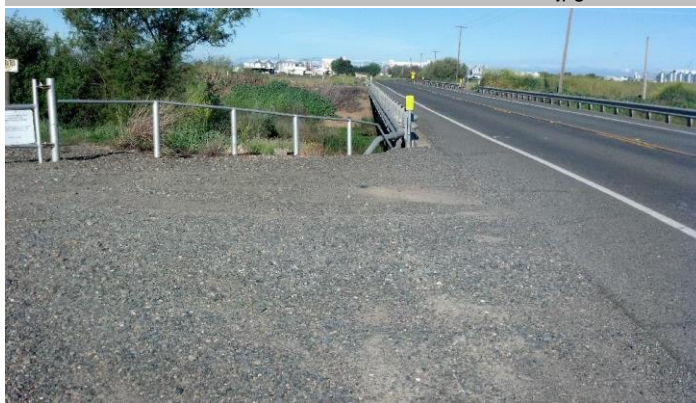
Photo 2 of 2 : UCIP_SP_2018_52141_67210.jpg

Waterside view of utility line alignment through levee then attached to bridge.

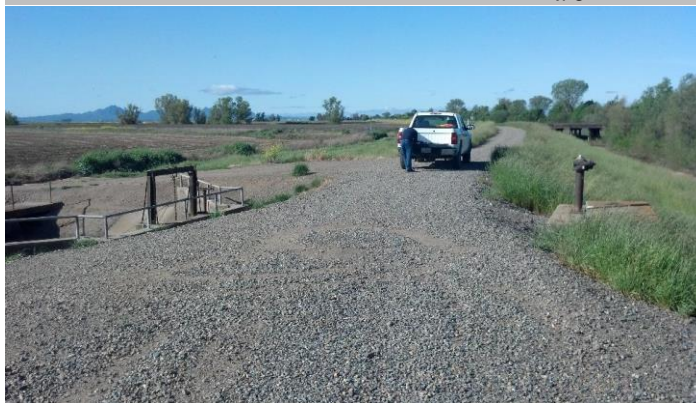
Photo 1 of 3 : UCIP_SP_2018_52145_67280.jpg

Overview of levee crown at crossing looking D/S.

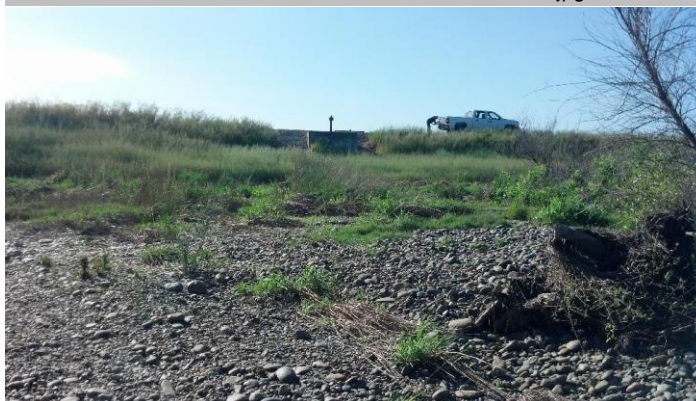
Photo 2 of 3 : UCIP_SP_2018_52145_67285.jpg

View of crossing looking from channel towards WS levee.

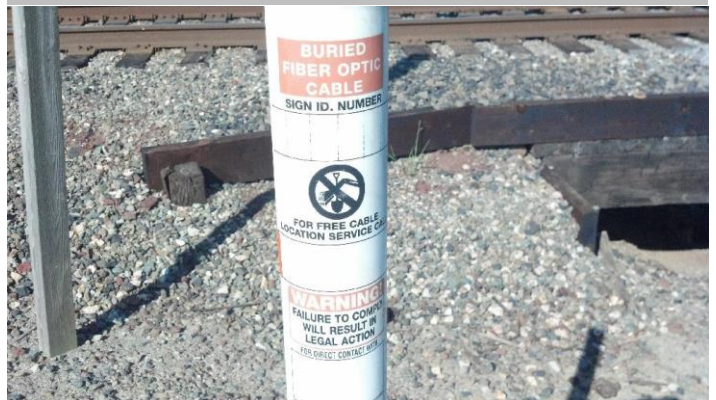
Photo 2 of 3 : UCIP_SP_2018_52148_67291.jpg

Marker for buried fiber optic cable on WS.

Comment Code						
Inspector Comment						
FS_ID:52148 DS_ID:18912 EP_NO: N/A Repair Type: Non-Urgent Crossing Status: Indicator Found UCIP Comments: 6/5/2017 Crossing appears to be in good condition. (DWR Sutter Yard- AFreitag)11/18/2016 Crossing appears to be in good condition. Another marker was found/photographed near the LS toe. Crossing also appears to cross through the Unit1 levee around CLM8.860. (DWR Sutter Yard- AFreitag)4/27/2016 Crossing appears to be in good condition.6/30/2015 Crossing is in good condition.5/28/2014 Same as last inspection.12/4/2013 Same as last inspection.7/09/2013 Same as last inspection.4/24/2012 Unable to determine if crossing is an authorized or unauthorized encroachment. Unable to find permit number for this encroachment. Will need to coordinate with LMA Superintendent and DWR-Inspector, photo includes utility contact information. FIELD_STRUCT_DESC: Buried communication line of unknown material through the levee at an unknown depth below the crown. Owner of line is Qwest Communications 1-800 At Fiber Sign ID Number 16601 as indicated by marker. (Qwest Communication) No permit has been identified since crossing was field discovered in 2012. FS Date: 6/8/2017 8:23:22 AM

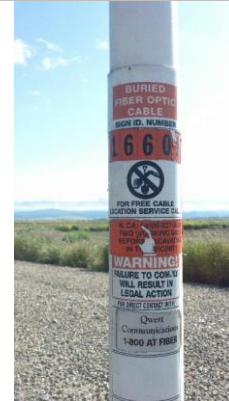
Photo 3 of 3 : UCIP_SP_2018_52148_67290.jpg

Marker for buried fiber optic cable on LS with contact information.

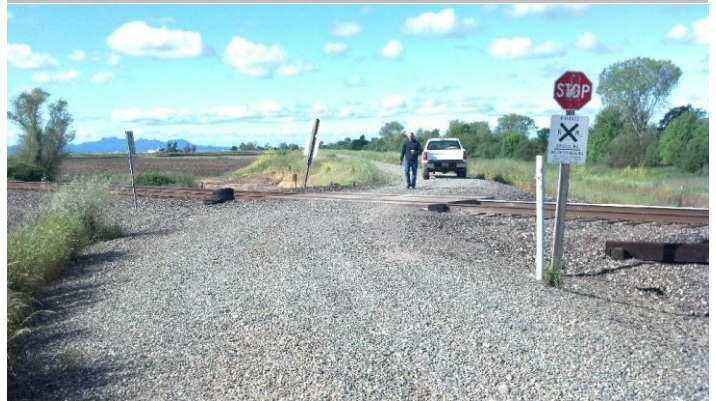
Photo 1 of 3 : UCIP_SP_2018_52149_67295.jpg

FS_ID:52149
DS_ID:18913
EP_NO: N/A
Repair Type: Non-Urgent
Crossing Status: Indicator Found
UCIP Comments: 6/5/2017 Crossing appears to be in good condition.
(DWR Sutter Yard- AFreitag)11/18/2016 Crossing appears to be in good condition. (DWR Sutter Yard- AFreitag)4/27/2016 Crossing appears to be in good condition.6/30/2015 Crossing appears to be in good condition. But still unknown if this crossing was authorized or unauthorized.5/28/2014 Same as last inspection.12/4/2013 Same as last inspection.7/9/2013 Same as last inspection.4/24/2012 Authorized/unauthorized encroachment? Contact Chico Local Area Manager, Frank Villalovos 530.342.6140 (o) or 530.624.4048 (c) or email villalovosf@kindermorgan.com for additional info. Inquiries pertaining to inspection submit to pipelineinquiries@kindermorgan.com and reference as Engr Station 3173+48 plus include coordinates.
FIELD_STRUCT_DESC: 8-inch high pressure line bored through the levee at depth unknown. Kinder Morgan is the owner of line--contact information is 213.624-9461 or Chico Local Area Manager, Frank Villalovos 530.342.6140 (o) or 530.624.4048 (c) or email villalovosf@kindermorgan.com. Additional contact is Ken Yeo, Sacramento Local Area Manager, at 916.416.7938 or by email yeok@kindermorgan.com. Frank Villalovos is the primary contact for this crossing. No permit has been identified since crossing was field discovered in 2012.

Overview of levee crown at crossing.

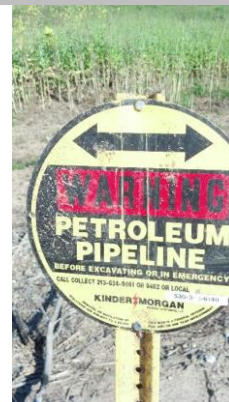
Photo 2 of 3 : UCIP_SP_2018_52149_67294.jpg

WS marker with utility contact information.

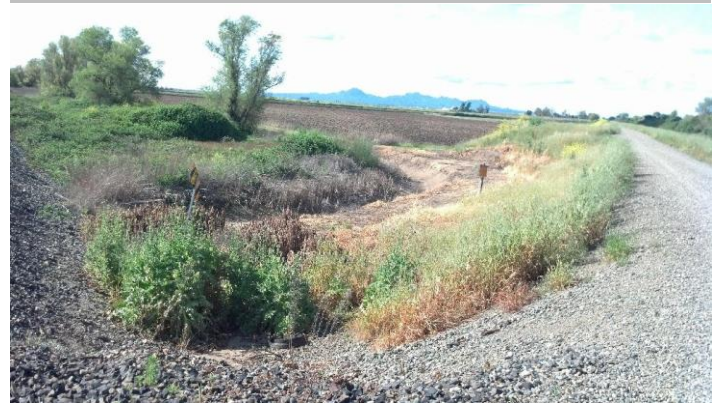
Photo 3 of 3 : UCIP_SP_2018_52149_67293.jpg

FS_ID:52149
 DS_ID:18913
 EP_NO: N/A
 Repair Type: Non-Urgent
 Crossing Status: Indicator Found
 UCIP Comments: 6/5/2017 Crossing appears to be in good condition.
 (DWR Sutter Yard- AFreitag)11/18/2016 Crossing appears to be in good condition. (DWR Sutter Yard- AFreitag)4/27/2016 Crossing appears to be in good condition.6/30/2015 Crossing appears to be in good condition. But still unknown if this crossing was authorized or unauthorized.5/28/2014 Same as last inspection.12/4/2013 Same as last inspection.7/9/2013 Same as last inspection.4/24/2012 Authorized/unauthorized encroachment? Contact Chico Local Area Manager, Frank Villalovos 530.342.6140 (o) or 530.624.4048 (c) or email villalovosf@kindermorgan.com for additional info. Inquiries pertaining to inspeciton submit to pipelineinquiries@kindermorgan.com and reference as Engr Station 3173+48 plus include coordinates.
 FIELD_STRUCT_DESC: 8-inch high pressure line bored through the levee at depth unknown. Kinder Morgan is the owner of line--contact information is 213.624-9461 or Chico Local Area Manager, Frank Villalovos 530.342.6140 (o) or 530.624.4048 (c) or email villalovosf@kindermorgan.com. Additional contact is Ken Yeo, Sacramento Local Area Manager, at 916.416.7938 or by email yeok@kindermorgan.com. Frank Villalovos is the primary contact for this crossing. No permit has been identified since crossing was field discovered in 2012.

View of LS slope and marker.

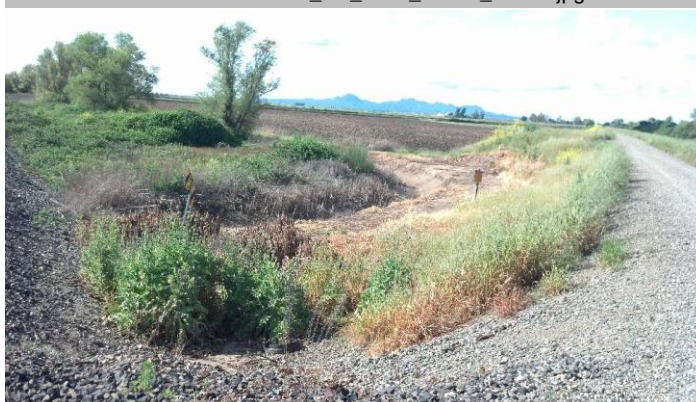
Photo 2 of 3 : UCIP_SP_2018_52150_67300.jpg

Marker located on LS.

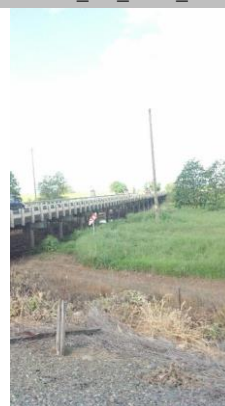
Photo 1 of 1 : UCIP_SP_2018_52153_67334.jpg

Comment Code						
Inspector Comment						
FS_ID:52153 DS_ID:16472 EP_NO: 10939 Repair Type: Non-Urgent Crossing Status: Indicator Found UCIP Comments: 6/5/2017 Pole still present. (DWR Sutter Yard-AFreitag)11/17/2016 Pole still present within channel. (DWR Sutter Yard- AFreitag)4/26/2016 Pole within the channel not removed per permit description.6/30/2015 same as last inspection.5/28/2014 Same as last inspection.12/4/2013 Same as last inspection.7/08/2013 Same as last inspection.4/24/2012 According to permit the existing pole and buried cable in the overflow area were to be removed. Pole is present in the channel. FIELD_STRUCT_DESC: Reroute a buried wire across the left bank levee of Cherokee Canal at State Highway 162 Bridge abutment from that point to the downstream side of the bridge. From there the wire extends to the gaging station at the center of the bridge. The facility maintains service to the Department of Water Resources' Metering Station midspan of the bridge. (Permit No. 10939, 1976 - Pacific Telephone and Telegraph Company [PT&T]) FS Date: 6/8/2017 8:52:41 AM

Pole within the channel was not removed.

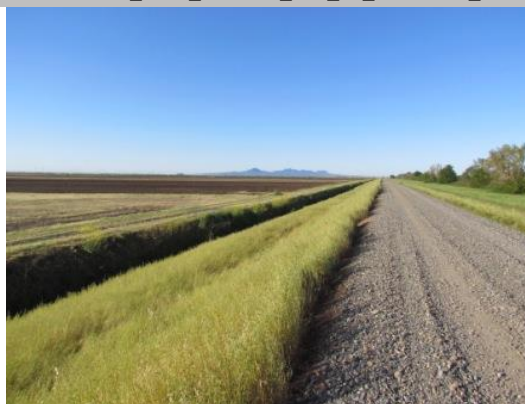
Photo 1 of 1 : SP_2018_MA0013_301_18_20180305_00006.jpg

LM Start	10.59	Rating **	M	Issue No.	18
LM End	11.66	Issue Type +	En	Location *	LS
Category	Earthen Levee			GPS Latitude/Longitude	
				Start	End
Item	Encroachments			39.464305 °	39.450333 °
				-121.744172 °	-121.753157 °
DWR ID	DWR_MA0013_02_s_ 2012_18				
Comment Code					
DT : Ditch					
Inspector Comment

View of the agricultural ditch along the toe.

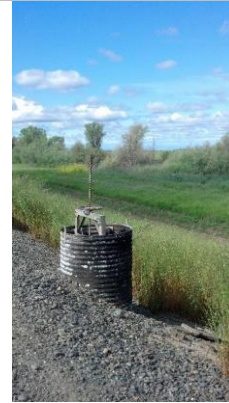
Photo 2 of 3 : UCIP_SP_2018_52154_67337.jpg

FS_ID:52154
DS_ID:16385
EP_NO: N/A
Repair Type: Non-Urgent
Crossing Status: Found
UCIP Comments: 5/30/2017 WS end cannot be located due to heavy vegetation. LS screwgate was mostly submerged during site visit. Pipe has been selected to be internally cleaned and inspected as part of the DMP project. (DWR Sutter Yard- A Freitag)11/17/2016 WS still heavily vegetated and cannot access the WS pipe end for inspection. Vegetation needs to be cleared back. (DWR Sutter Yard- A Freitag)4/26/2016 LS headwall was visible but gate was underwater. WS still heavily vegetated and unable to be inspected. Vegetation needs to be cleared back.6/30/2015 WS heavily vegetated passed the toe-road and could not make it to the WS pipe end for inspection. Vegetation needs to be cleared back. LS pipe end was fully submerged under water.5/28/2014 Same as last inspection.12/4/2013 Same as last inspection.7/08/2013 LS slope has been cleared of vegetation and is in good condition. LS headwall is now visible but mostly underwater so unable to do full inspection. WS is still vegetated.4/24/2012 LS pipe & slide gate sedimented in. Limited inspection WS and LS slopes due to dense vegetation. Need photos of cleared WS and LS slopes during next inspection. This crossing was listed in the USACE Periodic Inspection report as Corp's inspect ID# USACE_CESPK_M13F_2011_p_0147 for limited visibility of LS and WS.

Stand pipe with screw gate WS
