**Flood Control Project Maintenance
Levee Inspections**
LMA District Cover Sheet
Spring 2018 Levee Inspection Results

Sutter Maintenance Yard Maintenance Area 0013

Spring 2018 Levee Inspection Results

Waterway			Bank	Unit Miles
Unit No. 01 Cherokee Canal			Right	18.19
	Spring (March - May)	Summer (June - August)	(September - November) Fall	Winter (December - February)
Unit Maintenance Rating (Fall Only)				
Date of Inspection	4/17/2018 - 4/17/2018			
DWR Inspector	Bob Duffey			
Accompanied By	Shawn Freitag Sutter Maintenance Yard

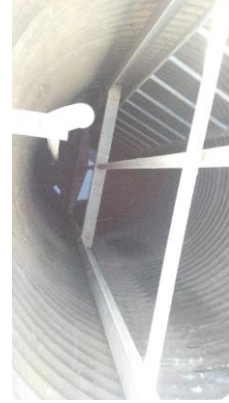
Photo 3 of 3 : UCIP_SP_2018_52154_67335.jpg

Item	DWR UCIP LMA Responsibility			39.434779 °	39.434779 °	
				-121.763940 °	-121.763940 °	
DWR ID						
Comment Code						
Inspector Comment						
FS_ID:52154 DS_ID:16385 EP_NO: N/A Repair Type: Non-Urgent Crossing Status: Found UCIP Comments: 5/30/2017 WS end cannot be located due to heavy vegetation. LS screwgate was mostly submerged during site visit. Pipe has been selected to be internally cleaned and inspected as part of the DMP project. (DWR Sutter Yard- A Freitag)11/17/2016 WS still heavily vegetated and cannot access the WS pipe end for inspection. Vegetation needs to be cleared back. (DWR Sutter Yard- A Freitag)4/26/2016 LS headwall was visible but gate was underwater. WS still heavily vegetated and unable to be inspected. Vegetation needs to be cleared back.6/30/2015 WS heavily vegetated passed the toe-road and could not make it to the WS pipe end for inspection. Vegetation needs to be cleared back. LS pipe end was fully submerged under water.5/28/2014 Same as last inspection.12/4/2013 Same as last inspection.7/08/2013 LS slope has been cleared of vegetation and is in good condition. LS headwall is now visible but mostly underwater so unable to do full inspection. WS is still vegetated.4/24/2012 LS pipe & slide gate sedimented in. Limited inspection WS and LS slopes due to dense vegetation. Need photos of cleared WS and LS slopes during next inspection. This crossing was listed in the USACE Periodic Inspection report as Corp's inspect ID# USACE_CESPK_M13F_2011_p_0147 for limited visibility of LS and WS. FIELD_STRUCT_DESC: 30-inch corrugated metal drainage pipe through the levee, 13 feet below the crown. Slide gate in corrugated metal pipe riser on the waterside (WS) slope. Slide gate in ditch on the landside (LS). Pipe under channel is a 24-inch siphon. [Additional Reference(s): DWR Levee Log, 1993. USACE Sacramento O&M Manual 519, June 1962 (HLM 13.03)] FS Date: 6/8/2017 8:57:36 AM

View of the inside of the WS stand pipe. No obstructions blocking slide gate.

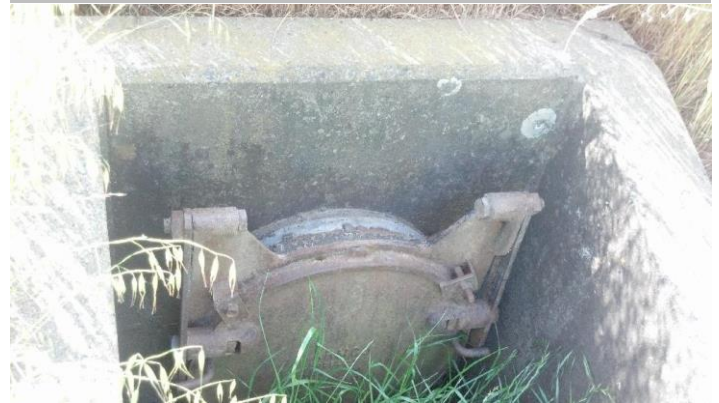
Photo 3 of 3 : UCIP_SP_2018_52156_67342.jpg

FS_ID:52156
DS_ID:16376
EP_NO: N/A
Repair Type: Non-Urgent
Crossing Status: Found
UCIP Comments: 5/30/2017 LS pipe end is buried and location unknown. WS flap gate is bolted shut. Pipe has been selected to be internally cleaned and inspected as part of the DMP project. (DWR Sutter Yard- AFreitag)11/17/2016 Unable to locate LS pipe end. WS flap gate bolted shut. (DWR Sutter Yard- AFreitag)4/26/2016 LS inlet appears to be buried as could not locate it. WS flap gate was bolted shut. This appears to be an abandoned crossing.6/30/2015 Still unable to locate the LS pipe end. 5/28/2014 Same as last inspection.12/4/2013 Same as last inspection. WS flapgate was bolted shut to keep LS ricefield flooded.7/08/2013 WS slope has been cleared of vegetation and is in good condition. LS slope also cleared of vegetation but still very dense on LS toe and unable to locate LS headwall.4/24/2012 Could not find LS end of pipe. Limited inspection on WS and LS slopes and toe due to dense vegetation. Need photos of cleared WS and LS slopes, and LS headwall during next inspection. This crossing was listed in the USACE Periodic Inspection report as Corp's inspect ID# USACE_CESPK_M13E_2011_p_0011 for WS gate blocked by vegetation.

View of WS headwall and flap gate.

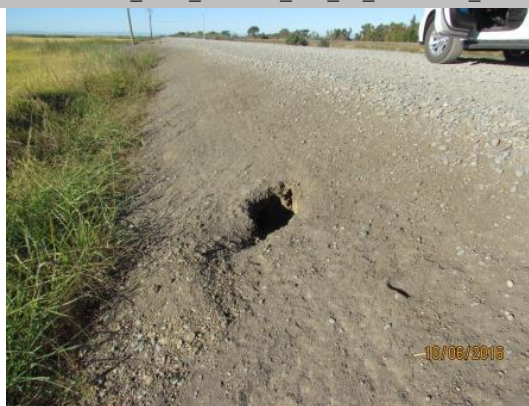
Photo 1 of 1 : SP_2018_MA0013_301_64_20180305_00017.jpg

LM Start	15.98	Rating **	U	Issue No.	64
LM End	15.98	Issue Type +	Ma	Location *	LS
Category	Earthen Levee			GPS Latitude/Longitude	
				Start	End
Item	Animal Control			39.414397 °	39.414397 °
				-121.781596 °	-121.781596 °
DWR ID	DWR_MA0013_02_f_2016_64				
Comment Code					
A3 : No rodents visible, but rodent burrows visible; need to backfill and compact or grout burrows.					
Inspector Comment

View of the rodent holes along the landside slope.

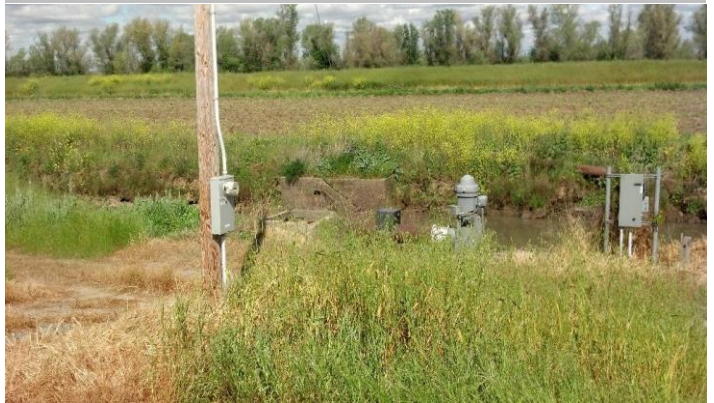
Photo 2 of 3 : UCIP_SP_2018_52158_67359.jpg

FS_ID:52158
DS_ID:16377
EP_NO: N/A
Repair Type: Non-Urgent
Crossing Status: Found
UCIP Comments: 5/30/2017 LS headwall was mostly buried and pipe end over 50% full of sediment. WS distribution box appears to have not been repaired yet but it does not seem to affect the integrity of the levee. (DWR Sutter Yard- A Freitag) 11/17/2016 LS pipe end was about 50% plugged with soil. WS riser box is still cracked and appears to still be leaking. (DWR Sutter Yard- A Freitag) 4/26/2016 LS headwall was dry and photographed. LS pipe end was about 50% plugged with soil. WS riser box is still cracked and appears to still be leaking. 6/30/2015 Bee boxes stacked near the riser box on WS so could not get close enough to see if the leak issue had been fixed.

Appurtenances on WS.

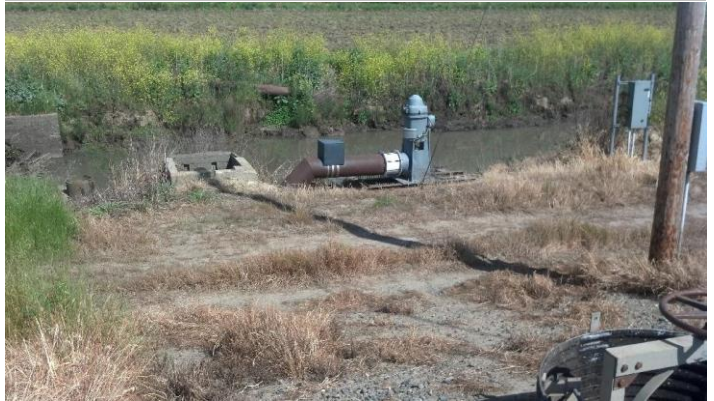
Photo 3 of 3 : UCIP_SP_2018_52158_67355.jpg

FS_ID:52158
DS_ID:16377
EP_NO: N/A
Repair Type: Non-Urgent
Crossing Status: Found
UCIP Comments: 5/30/2017 LS headwall was mostly buried and pipe end over 50% full of sediment. WS distribution box appears to have not been repaired yet but it does not seem to affect the integrity of the levee. (DWR Sutter Yard- AFreitag)11/17/2016 LS pipe end was about 50% plugged with soil. WS riser box is still cracked and appears to still be leaking. (DWR Sutter Yard- AFreitag)4/26/2016 LS headwall was dry and photographed. LS pipe end was about 50% plugged with soil. WS riser box is still cracked and appears to still be leaking.6/30/2015 Bee boxes stacked near the riser box on WS so could not get close enough to see if the leak issue had been fixed.

WS view of crossing.

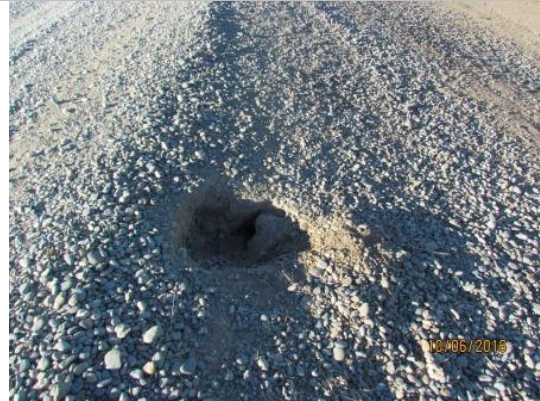
Photo 1 of 1 : SP_2018_MA0013_301_54_20180305_00014.jpg

LM Start	16.52	Rating **	U	Issue No.	54
LM End	16.52	Issue Type +	Ma	Location *	WS
Category	Earthen Levee			GPS Latitude/Longitude	
				Start	End
Item	Animal Control			39.409548 °	39.409548 °
				-121.789668 °	-121.789668 °
DWR ID	DWR_MA0013_02_f_2014_54				
Comment Code					
A3 : No rodents visible, but rodent burrows visible; need to backfill and compact or grout burrows.					
Inspector Comment

View of the rodent holes along the waterside slope.

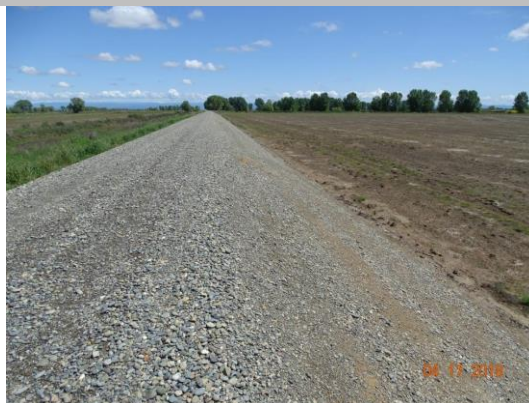
Photo 1 of 1 : SP_2018_MA0013_301_72_20180425_00142.jpg

LM Start	17.21	Rating **	A	Issue No.	72
LM End	22.17	Issue Type +	Ma	Location *	LS
Category	Earthen Levee			GPS Latitude/Longitude	
				Start	End
Item	Vegetation			39.403280 °	39.359625 °
				-121.799552 °	-121.872652 °
DWR ID	DWR_MA0013_02_s_2018_72				
Comment Code					
V1 : Control annual grass and weeds on the levee slopes and easements.					
Inspector Comment					
There is no vegetation along the landside slope.

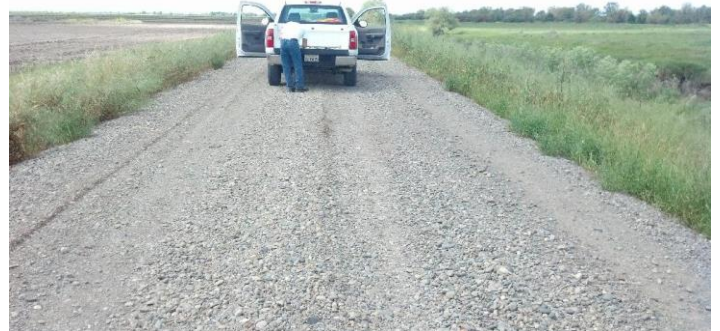
Photo 1 of 3 : UCIP_SP_2018_52161_67387.jpg

FS_ID:52161
DS_ID:16379
EP_NO: N/A
Repair Type: No Action Needed
Crossing Status: Found
UCIP Comments: 5/30/2017 Crossing appears to be in good condition. Pipe has been selected to be internally cleaned and inspected as part of the DMP project. (DWR Sutter Yard- AFreitag)11/17/2016 Crossing appears to be in good condition. (DWR Sutter Yard- AFreitag)4/26/2016 Crossing appears to be in good condition.6/30/2015 Vegetation still present on WS. LS side was underwater during inspection.5/28/2014 Same as last inspection.12/4/2013 Same as last inspection.7/08/2013 LS slope cleared of vegetation and is in good condition. WS is still vegetated. LS pipe end under water and blocked off by plywood so unable to measure culvert size.4/24/2012 Limited inspection on WS and LS slopes due to dense vegetation. Need photos of cleared WS and LS slopes. This crossing was listed in the USACE Periodic Inspection report as Corp's inspect ID# USACE_CESPK_M13E_2011_p_0134 for unknown culvert size on LS and no outlet visible on WS.

Overview of crossing looking D/S at left bank of Cherokee Canal.

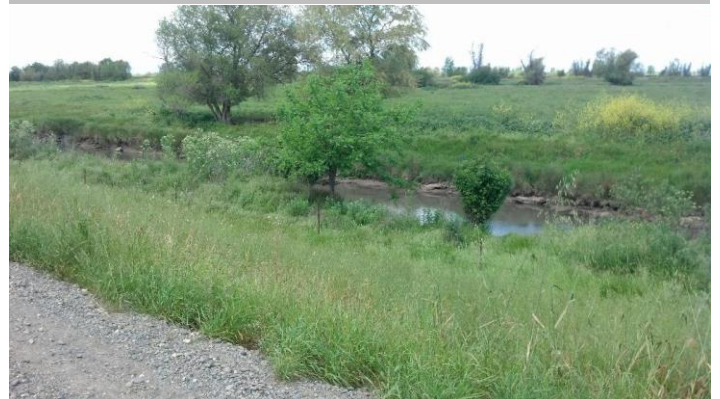
Photo 2 of 3 : UCIP_SP_2018_52161_67386.jpg

View of WS slope and berm.

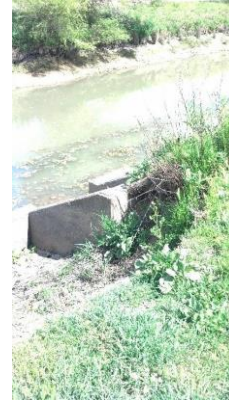
Photo 1 of 3 : UCIP_SP_2018_52164_67401.jpg

FS_ID:52164
DS_ID:16375
EP_NO: N/A
Repair Type: Non-Urgent
Crossing Status: Found
UCIP Comments: 5/30/2017 Erosion still present at WS headwall. Pipe has been selected to be internally cleaned and inspected as part of the DMP project. (DWR Sutter Yard- A/Freitag)11/17/2016 Erosion still present at WS headwall. (DWR Sutter Yard- A/Freitag)4/26/2016 Erosion still present behind the WS headwall. The rest of the crossing appears in good condition.6/30/2015 Erosion still present behind the WS headwall. Everything thing else with the crossing appeared to be in good condition.12/4/2013 Same as last inspection.5/28/2014 Same as last inspection.7/08/2013 Erosion problem same as last inspection. WS and LS slopes have been cleared of vegetation and are in good shape.4/24/2012 Erosion present behind WS headwall. Limited inspection on WS and LS slopes due to dense vegetation. Need photos of cleared WS and LS slopes during next inspection.

Erosion behind WS headwall looking at the downstream edge of headwall.

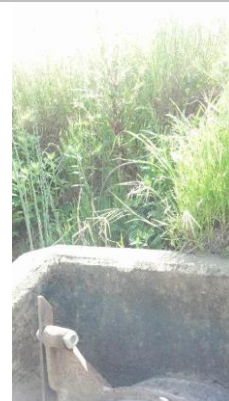
Photo 2 of 3 : UCIP_SP_2018_52164_67400.jpg

Erosion behind WS headwall at the upstream edge of headwall.

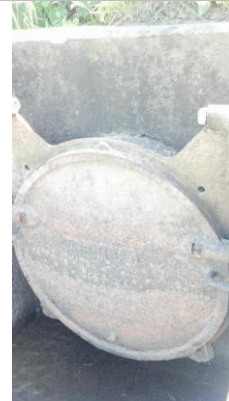
Photo 3 of 3 : UCIP_SP_2018_52164_67402.jpg

Flap gate located on the WS.

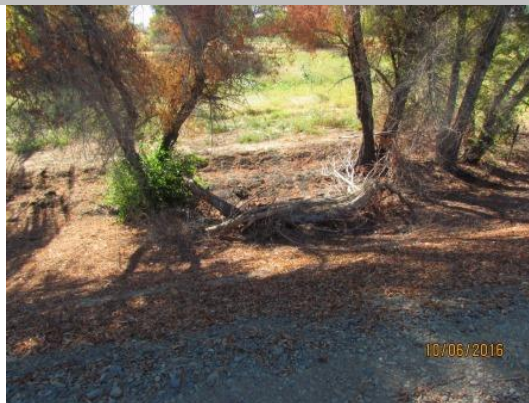
Photo 1 of 1 : SP_2018_MA0013_301_73_20180305_00021.jpg

LM Start	20.52	Rating **	M	Issue No.	73
LM End	20.52	Issue Type +	Ma	Location *	LS
Category	Earthen Levee			GPS Latitude/Longitude	
				Start	End
Item	Encroachments			39.372486 °	39.372486 °
				-121.846537 °	-121.846537 °
DWR ID	DWR_MA0013_02_f_2016_73				
Comment Code					
TR : Tree or limb					
Inspector Comment					
Remove the tree limbs from the landside slope and toe.

View of the tree limbs along the landside levee toe.

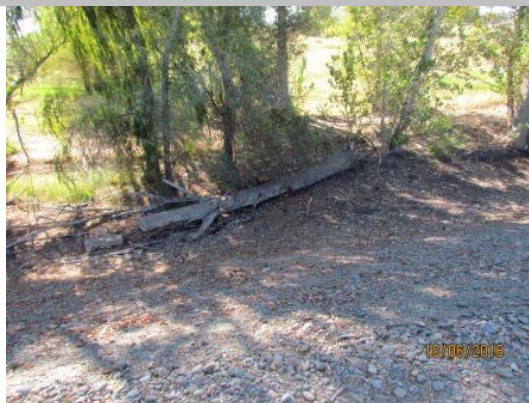
Photo 1 of 1 : SP_2018_MA0013_301_52_20180305_00012.jpg

LM Start	20.65	Rating **	M	Issue No.	52
LM End	20.65	Issue Type +	Ma	Location *	LS
Category	Earthen Levee			GPS Latitude/Longitude	
				Start	End
Item	Encroachments			39.371433 °	39.371433 °
				-121.848753 °	-121.848753 °
DWR ID	DWR_MA0013_02_s_2014_52				
Comment Code					
TR : Tree or limb					
Inspector Comment					
Remove the tree limbs from the landside slope and toe.

View of the tree limbs along the landside toe.

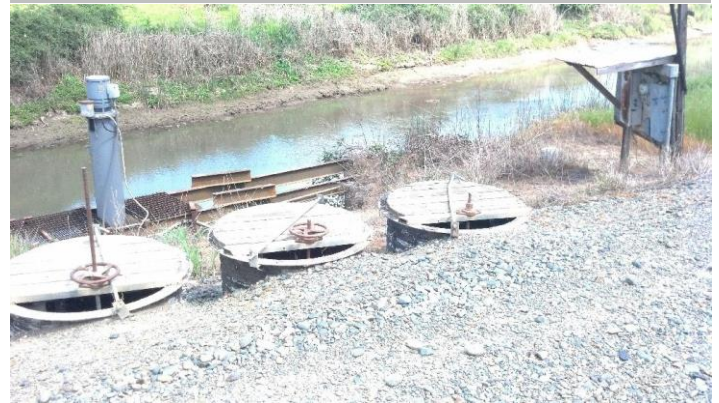
Photo 1 of 3 : UCIP_SP_2018_52165_67406.jpg

FS_ID:52165
DS_ID:16383
EP_NO: N/A
Repair Type: Urgent
Crossing Status: Found
UCIP Comments: 5/30/2017 No repairs have been made here yet. WS still has depressions above the pipe alignment. LS pipe end still showing heavy signs of rusting and deterioration. Sediment build up inside of concrete distribution box on the LS. (DWR Sutter Yard - A Freitag) 11/17/2016 Crossing has not been repaired yet. pipe ends still showing heavy signs of rust and corrosion. (DWR Sutter Yard - A Freitag) 4/26/2016 No repairs have been made at this crossing yet. (DWR Sutter Yard - A Freitag) 6/30/2015 Crossing has not been repaired yet. pipe ends still showing heavy signs of rust and corrosion. (DWR Sutter Yard - A Freitag) 5/28/2014 Same as last inspection. (DWR Sutter Yard - A Freitag) 12/4/2013 Same as last inspection. (DWR Sutter Yard - A Freitag) 7/8/2013 Same as last inspection. (DWR Sutter Yard - A Freitag) 4/19/2012 LS pipe collars severely damaged--section missing at flapgate. Buried section of pipe could be in the same condition. Crossing needs to be repaired; will need to coordinate with applicant. WS slide gate handle missing. (DWR UCIP - O Magana)

Corrugated metal pipe risers with slide gates located on WS slope.

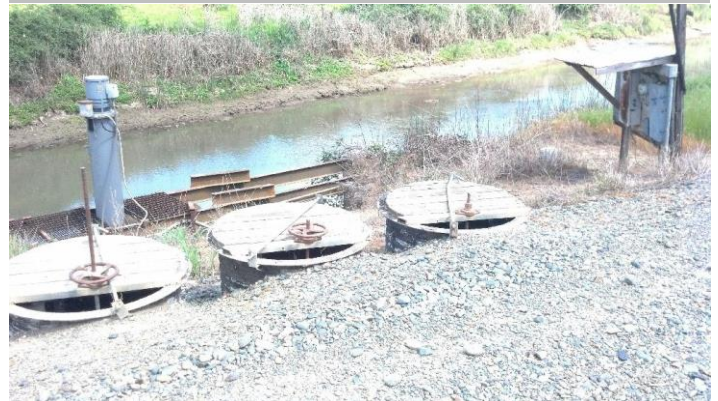
Photo 1 of 3 : UCIP_SP_2018_52166_67416.jpg

FS_ID:52166
DS_ID:17014
EP_NO: N/A
Repair Type: Urgent
Crossing Status: Found
UCIP Comments: 5/30/2017 No repairs have been made here yet. WS still has depressions above the pipe alignment. LS pipe end still showing heavy signs of rusting and deterioration. Sediment build up inside of concrete distribution box on the LS. (DWR Sutter Yard - A Freitag) 11/17/2016 Crossing has not been repaired yet. pipe ends still showing heavy signs of rust and corrosion. (DWR Sutter Yard - A Freitag) 4/26/2016 No repairs have been made at this crossing yet. (DWR Sutter Yard - A Freitag) 6/30/2015 Crossing has not been repaired yet. pipe ends still showing heavy signs of rust and corrosion. (DWR Sutter Yard - A Freitag) 5/28/2014 Same as last inspection. (DWR Sutter Yard - A Freitag) 12/4/2013 Same as last inspection. (DWR Sutter Yard - A Freitag) 7/08/2013 Same as last inspection. (DWR Sutter Yard - A Freitag) 4/24/2012 LS pipe collars severely damaged--section missing at flapgate. Crossing needs repair. Will need to coordinate with owner. (DWR UCIP - omagana)

WS view of corrugated metal pipe risers .

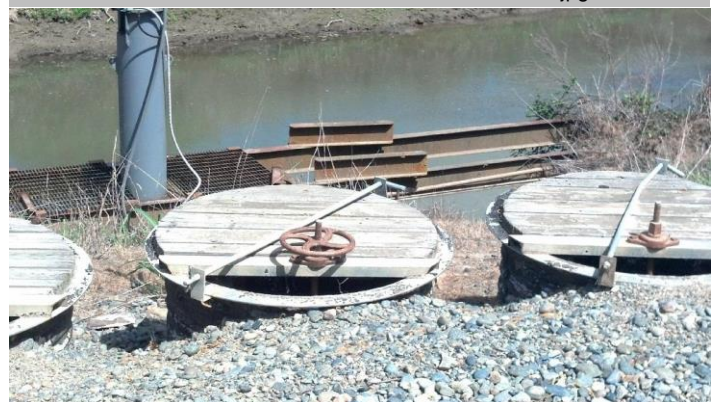
Photo 2 of 3 : UCIP_SP_2018_52166_67418.jpg

Riser for pipe 2 of 3.

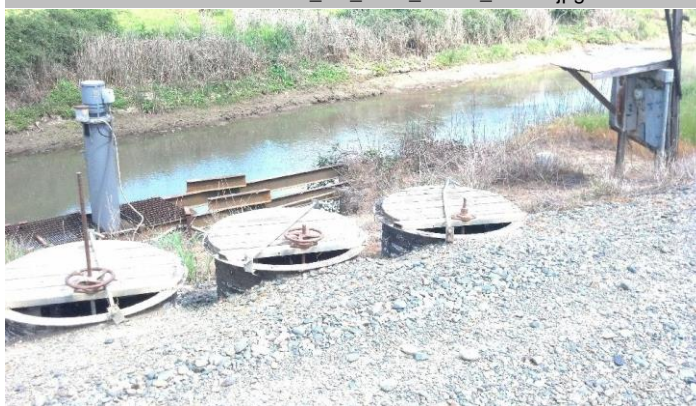
Photo 1 of 3 : UCIP_SP_2018_52167_67441.jpg

FS_ID:52167
DS_ID:17185
EP_NO: N/A
Repair Type: Urgent
Crossing Status: Found
UCIP Comments: 5/30/2017 No repairs have been made here yet. WS still has depressions above the pipe alignment. LS pipe end still showing heavy signs of rusting and deterioration. Sediment build up inside of concrete distribution box on the LS. (DWR Sutter Yard - AFreitag)11/17/2016 Crossing has not been repaired yet. pipe ends still showing heavy signs of rust and corrosion. (DWR Sutter Yard - AFreitag)4/26/2016 No repairs have been made at this crossing yet. (DWR Sutter Yard - afreitag)6/30/2015 Crossing has not been repaired yet. pipe ends still showing heavy signs of rust and corrosion. (DWR Sutter Yard - afreitag)5/28/2014 Same as last inspection. (DWR Sutter Yard - afreitag)12/4/2013 Same as last inspection. (DWR Sutter Yard - afreitag)7/08/2013 Same as last inspection. (DWR Sutter Yard - afreitag)4/24/2012 Sink hole present on WS. LS pipe collars severely damaged--section missing at flapgate. Crossing needs repair. Need to coordinate with owner. (DWR UCIP - omagana)

View of corrugated metal risers located on WS.

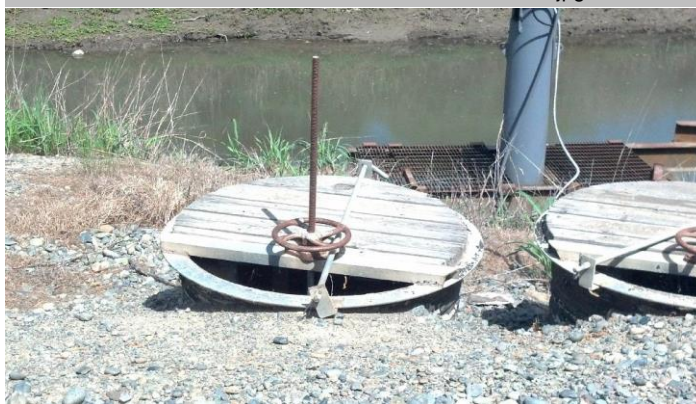
Photo 2 of 3 : UCIP_SP_2018_52167_67443.jpg

View of corrugated metal pipe for pipe 3 of 3.

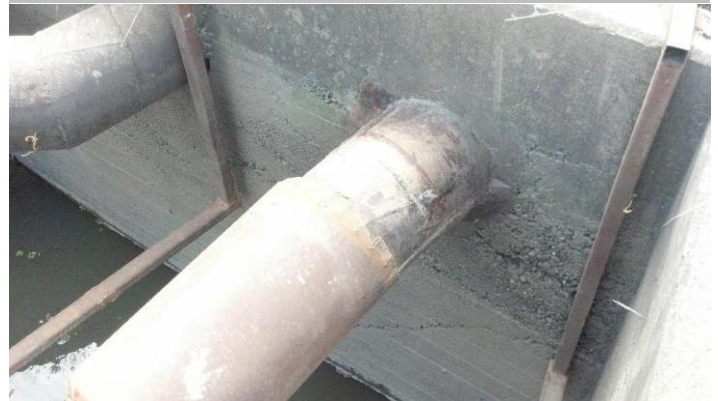
Photo 3 of 3 : UCIP_SP_2018_52167_67442.jpg

View of Pipe 3 of 3 from WS headwall.

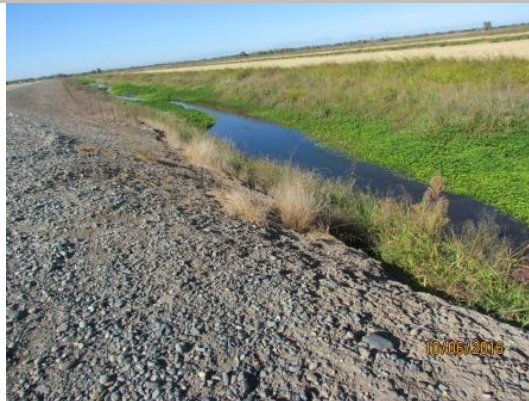
Photo 1 of 1 : SP_2018_MA0013_301_75_20180305_00022.jpg

LM Start	20.77	Rating **	M	Issue No.	75
LM End	20.77	Issue Type +	Ma	Location *	WS
Category	Earthen Levee			GPS Latitude/Longitude	
				Start	End
Item	Erosion / Bank Caving			39.370641 °	39.370641 °
				-121.850572 °	-121.850572 °
DWR ID	DWR_MA0013_02_f_2016_75				
Comment Code					
E1 : Note and monitor erosion site.					
Inspector Comment

View of the erosion along the waterside toe.

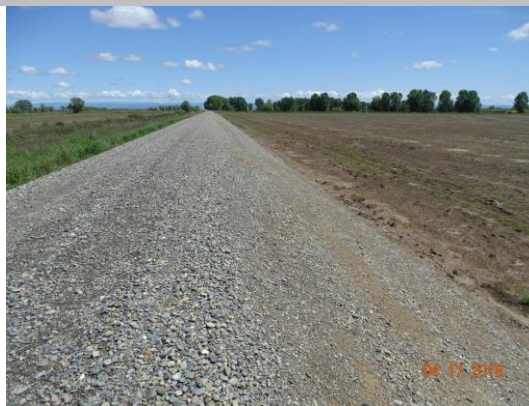
Photo 1 of 1 : SP_2018_MA0013_301_68_20180425_00140.jpg

LM Start	21.03	Rating **	M	Issue No.	68
LM End	21.03	Issue Type +	Ma	Location *	LS
Category	Earthen Levee			GPS Latitude/Longitude	
				Start	End
Item	Animal Control			39.368682 °	39.368682 °
				-121.854817 °	-121.854817 °
DWR ID	DWR_MA0013_02_s_2018_68				
Comment Code					
A1 : Exterminate rodents and backfill and compact or grout burrows.					
Inspector Comment					
Repair the rodent holes along the landside slope.

View of the rodent holes along the landside slope.

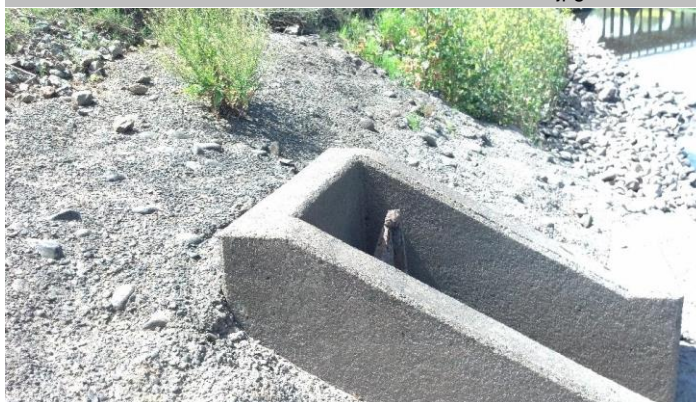
Photo 2 of 3 : UCIP_SP_2018_52170_67460.jpg

View of WS headwall.

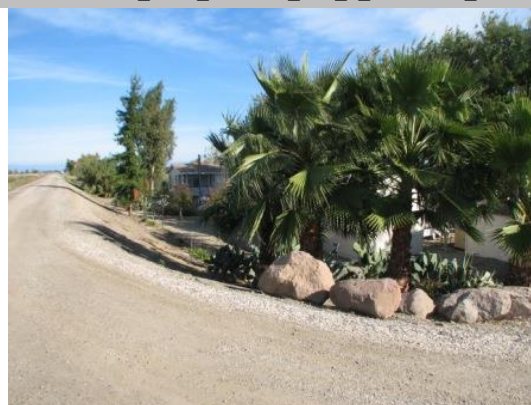
Photo 1 of 1 : SP_2018_MA0013_301_4_20180305_00001.jpg

LM Start	22.07	Rating **	M	Issue No.	4
LM End	22.13	Issue Type +	En	Location *	LS
Category	Earthen Levee			GPS Latitude/Longitude	
				Start	End
Item	Vegetation			39.360410 °	39.359920 °
				-121.871125 °	-121.872067 °
DWR ID	DWR_MA0013_02_s _ 2012_4				
Comment Code					
V6 : Landscaping					
Inspector Comment

View of landscaping along the toe.

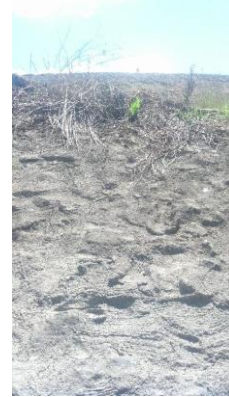
Photo 1 of 3 : UCIP_SP_2018_52175_67498.jpg

FS_ID:52175
DS_ID:16391
EP_NO: N/A
Repair Type: Non-Urgent
Crossing Status: Found
UCIP Comments: 5/30/2017 Location of LS inlet still unknown. Need to trace with utility locator/GPR to find. Pipe has been selected to be internally cleaned and inspected as part of the DMP project. (DWR Sutter Yard - A Freitag) 11/17/2016 Unable to locate LS pipe end. Ws appears to be in good condition. (DWR Sutter Yard - A Freitag) 4/26/2016 Still unable to locate the LS headwall and end of pipe. Pipe is still being used. Pipe was draining to WS. 6/30/2015 Still unable to locate the LS headwall and pipe end. 5/28/2014 Same as last inspection. 12/4/2013 Same as last inspection. 7/08/2013 Same as last inspection. Unable to locate LS headwall. 4/24/2012 Unable to locate LS headwall. Need photo of LS headwall during next inspection. FIELD_STRUCT_DESC: 30-inch corrugated metal drainage pipe through the levee, 15.3 feet below the crown. Concrete "U" headwalls on both waterside (WS) and landside (LS) ends. Flap gate on the WS end. This pipe runs on an angle through the levee, then underground along the LS slope to historic levee mile (HLM) 22.39 where it enters a ditch on the LS. [Additional Reference(s): DWR Levee Log, 1993. USACE Sacramento O&M Manual 519, June 1962 (HLM 22.41)]

LM Start	22.15	Rating **	M	Issue No.	953 (cont)
LM End	22.15	Issue Type +	Ma	Location *

View of WS slope looking from WS headwall to levee crown.

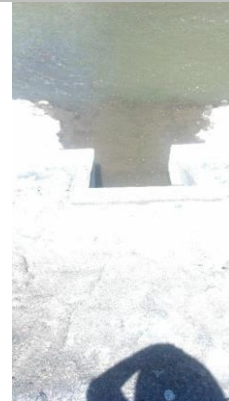
Photo 2 of 3 : UCIP_SP_2018_52175_67496.jpg

View of WS slope looking from WS headwall to levee crown.

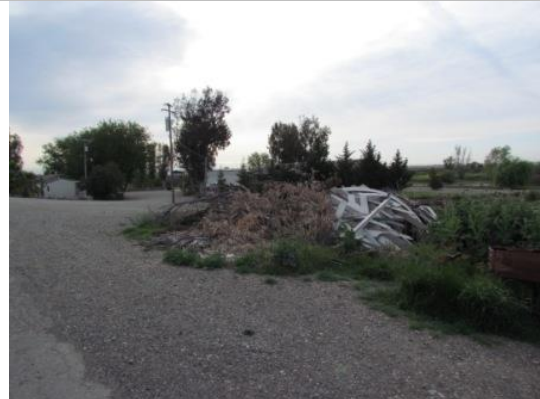
Photo 1 of 1 : SP_2018_MA0013_301_8_20180305_00003.jpg

LM Start	22.16	Rating **	M	Issue No.	8
LM End	22.16	Issue Type +	En	Location *	LS
Category	Earthen Levee			GPS Latitude/Longitude	
				Start	End
Item	Encroachments			39.359707 °	39.359707 °
				-121.872555 °	-121.872555 °
DWR ID	DWR_MA0013_02_s_2012_8				
Comment Code					
PR : Prunings					
Inspector Comment

View of the debris and prunings along the landside toe.
