**Flood Control Project Maintenance
Levee Inspections**
LMA District Cover Sheet
Spring 2019 Levee Inspection Results

Sutter Maintenance Yard Maintenance Area 0013

Spring 2019 Levee Inspection Results

Waterway			Bank	Unit Miles
Unit No. 01 Cherokee Canal			Right	18.19
	Spring (March - May)	Summer (June - August)	(September - November) Fall	Winter (December - February)
Unit Maintenance Rating (Fall Only)				
Date of Inspection	5/15/2019 - 5/15/2019			
DWR Inspector	Makar Sokol			
Accompanied By	Shawn Freitag Sutter Maintenance Yard

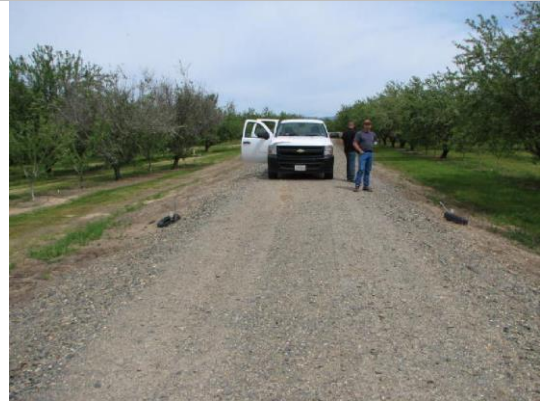
Photo 1 of 3 : UCIP_SP_2019_53313_66680.jpg

LM Start	0.27	Rating **	U	Issue No.	90 (cont)
LM End	0.27	Issue Type +	En	Location *

Overview of the crossing.

Comment Code						
Inspector Comment						
FS_ID:53313 DS_ID:16327 EP_NO: 6135 Repair Type: Urgent Crossing Status: Found UCIP Comments: 8/23/2018 Same as last inspection; crossing remains Urgent because levee erosion on both WS and LS still present (D. Sanoski - DWR UCIP).6/14/2017 LS slope still dug away from around the pipe. Appears no repairs have been made to the pipe yet. (DWR Sutter Yard- AFreitag)11/16/2016 Appears no repairs have been made here yet as LS slope is still dug away. (DWR Sutter Yard- AFreitag)4/28/2016 8-inch pipe was running water but was leaking at a weld joint on the LS slope. Pipe appears to have been dug out by the landowner but unsure if repairs are being made yet. (see photo 5)7/14/2015 Pipe end is still welded solid.5/21/2014 Same as last inspection.12/2/2013 Same as last inspection.7/10/2013 Same as last inspection. FIELD_STRUCT_DESC: 8-inch steel irrigation pipe through the levee 2.8 feet below the crown. Permit requirements are as follow: during the flood season the 5-inch irrigation pipe will be removed and a plate bolted over the waterside (WS) end of the 8-inch. Pipe section is completely buried. Current configuration does not allow for 5-inch irrigation pipe to slide pipe through. 8-inch pipe is welded solid. (Permit No. 6135, 1968 - George Washington) [Additional Reference(s): DWR Levee Log, 1993] FS Date: 8/23/2018 1:29:00 PM

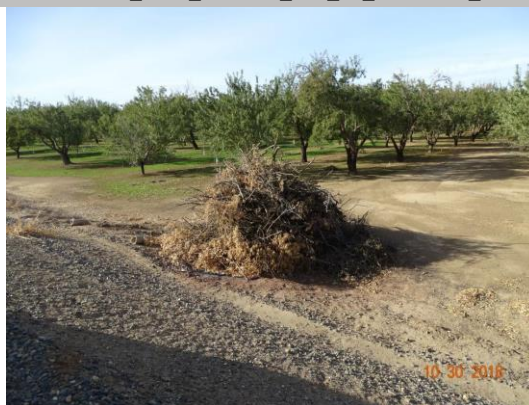
Photo 1 of 1 : SP_2019_MA0013_300_61_20190327_00010.jpg

LM Start	0.83	Rating **	M	Issue No.	61
LM End	0.83	Issue Type +	En	Location *	LS
Category	Earthen Levee			GPS Latitude/Longitude	
				Start	End
Item	Encroachments			39.586417 °	39.586417 °
				-121.700585 °	-121.700585 °
DWR ID	DWR_MA0013_01_f_2018_61				
Comment Code					
PR : Prunings					
Inspector Comment					
Remove the prunings from the landside slope.

View of the prunings along the landside slope.

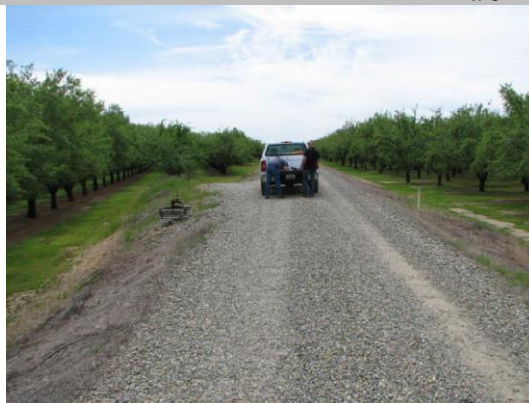
Photo 1 of 3 : UCIP_SP_2019_52183_66700.jpg

Comment Code						
Inspector Comment						
FS_ID:52183 DS_ID:16345 EP_NO: N/A Repair Type: Non-Urgent Crossing Status: Found UCIP Comments: 6/14/2017 PVC pipe still present blocking screw gate. LS inlet of the 24" cmp pipe is about 75% blocked by sediment. (DWR Sutter Yard- AFreitag)11/16/2016 PVC pipe still present blocking the screw gate. (DWR Sutter Yard- AFreitag)4/28/2016 Pvc pipe is still present through the crossing. Slide gate cannot shut fully.7/14/2015 4-inch pipe still present and blocking the screw gate.5/21/2014 Same as last inspection.12/2/2013 Same as last inspection.7/15/2013 Same as last inspection.4/17/2012 Crossing has 4-inch pipe inside blocking positive closure/notify landowner to remove prior to flood season. LS crossing is blocked about 50% by sediment build up. Burrow activity present on LS near crossing. FIELD_STRUCT_DESC: 24-inch corrugated metal irrigation pipe through the levee, 7.6 feet below the crown. Slide gate in corrugated metal pipe (CMP) riser on the waterside (WS) slope. Concrete headwall on the landside (LS). 36-inch concrete standpipe in the channel with 2 piles to deflect debris. [Additional Reference(s): DWR Levee Log, 1993. USACE Sacramento O&M Manual 519, June 1962 (HLM 1.69)] FS Date: 6/16/2017 12:21:04 PM

LM Start	1.66	Rating **	M	Issue No.	94 (cont)
LM End	1.66	Issue Type +	En	Location *

Overview of levee at crossing looking downstream.

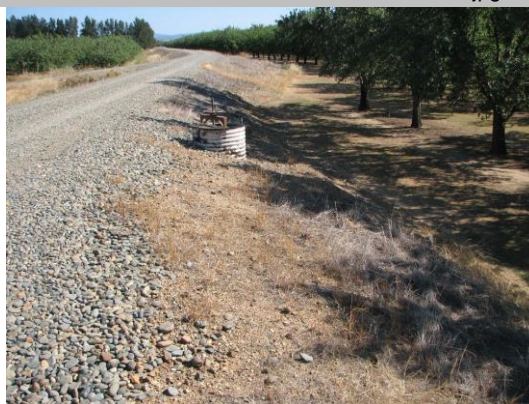
Photo 2 of 3 : UCIP_SP_2019_52183_66704.jpg

WS view looking upstream.

Comment Code						
Inspector Comment						
FS_ID:52183 DS_ID:16345 EP_NO: N/A Repair Type: Non-Urgent Crossing Status: Found UCIP Comments: 6/14/2017 PVC pipe still present blocking screw gate. LS inlet of the 24" cmp pipe is about 75% blocked by sediment. (DWR Sutter Yard- AFreitag)11/16/2016 PVC pipe still present blocking the screw gate. (DWR Sutter Yard- AFreitag)4/28/2016 Pvc pipe is still present through the crossing. Slide gate cannot shut fully.7/14/2015 4-inch pipe still present and blocking the screw gate.5/21/2014 Same as last inspection.12/2/2013 Same as last inspection.7/15/2013 Same as last inspection.4/17/2012 Crossing has 4-inch pipe inside blocking positive closure/notify landowner to remove prior to flood season. LS crossing is blocked about 50% by sediment build up. Burrow activity present on LS near crossing. FIELD_STRUCT_DESC: 24-inch corrugated metal irrigation pipe through the levee, 7.6 feet below the crown. Slide gate in corrugated metal pipe (CMP) riser on the waterside (WS) slope. Concrete headwall on the landside (LS). 36-inch concrete standpipe in the channel with 2 piles to deflect debris. [Additional Reference(s): DWR Levee Log, 1993. USACE Sacramento O&M Manual 519, June 1962 (HLM 1.69)] FS Date: 6/16/2017 12:21:04 PM

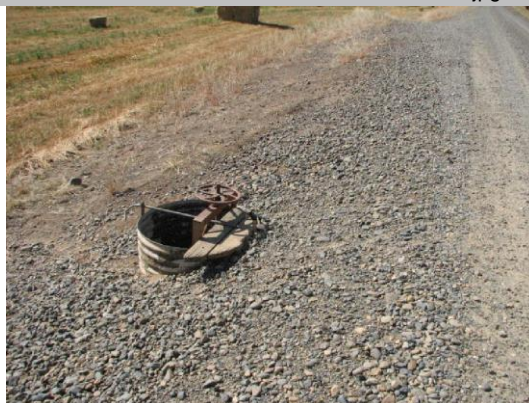
Photo 2 of 3 : UCIP_SP_2019_52184_66709.jpg

Corrugated riser located on WS slope.

Comment Code						
Inspector Comment						
FS_ID:52184 DS_ID:16346 EP_NO: N/A Repair Type: Non-Urgent Crossing Status: Found UCIP Comments: 6/14/2017 Still no LS inlet visible- trace with locator/GPR to try and locate. Wooden debris down inside of WS standpipe. Pipe has been selected to be internally cleaned and inspected as part of the DMP project. (DWR Sutter Yard-AFreitag)11/16/2016 Appears abandoned. Unable to find anything on LS. (DWR Sutter Yard- AFreitag)4/28/2016 Appears to be an abandoned crossing. LS headwall and pipe inlet are still completely buried.7/14/2015 Still cannot find an inlet or outelt.5/21/2014 Same as last inspection.12/2/2013 Same as last inspection.7/15/2013 Same as last inspection.4/17/2012 Non functional crossing due to LS headwall buried. This crossing was listed in the USACE Periodic Inspection report as Corp's inspect ID#USACE_CESPK_M13D_2011_p_0119 for no inlet or outlet visible. FIELD_STRUCT_DESC: *ABANDONED* 24-inch corrugated metal irrigation pipe through the levee 7.8 feet below the crown. Slide gate in corrugated metal pipe riser on the waterside (WS) slope. Pipe continues across channel. Concrete "U" headwall on the landside (LS). [Additional Reference(s): DWR Levee Log, 1993. USACE Sacramento O&M Manual 519, June 1962 (HLM 2.35)] FS Date: 6/16/2017 12:24:07 PM

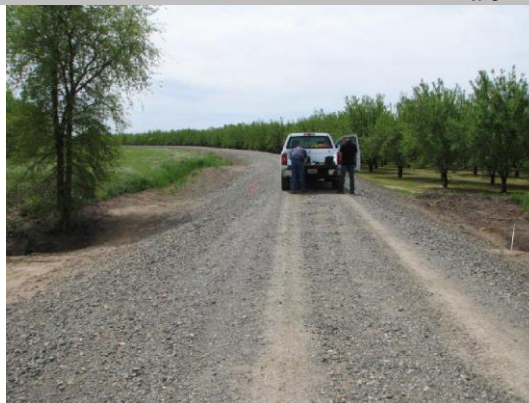
Photo 1 of 3 : UCIP_SP_2019_52185_66715.jpg

FS_ID:52185
DS_ID:16347
EP_NO: N/A
Repair Type: No Action Needed
Crossing Status: Found
UCIP Comments: 6/14/2017 Crossing appears to be in good condition.
(DWR Sutter Yard- AFreitag)11/16/2016 Crossing appears to be in good condition. (DWR Sutter Yard- AFreitag)4/28/2016 Crossing appears to be in good condition.7/14/2015 Crossing appears in good condition. No noticeable issues to report.5/21/2014 Same as last inspection.12/2/2013 Same as last inspection.7/15/2013 Same as last inspection.4/17/2012 Vegetation/sedimentation from WS has been removed. This crossing was listed in the USACE Periodic Inspection report as Corp's inspect
ID#USACE_CESPK_M13D_2011_p_0130 for WS flap gate closed and blocked by sediment.
FIELD_STRUCT_DESC: 24-inch corrugated metal drainage pipe through the levee, 9.4 feet below the crown. Concrete "U" headwall on both waterside (WS) and landside (LS) ends. Flap gate on the WS end. [Additional Reference(s): DWR Levee Log, 1993. USACE Sacramento O&M Manual 519, June 1962 (HLM 2.74)]

LM Start	2.70	Rating **	A/W	Issue No.	96 (cont)
LM End	2.70	Issue Type +	Ma	Location *

Overview of levee crown looking downstream at crossing.

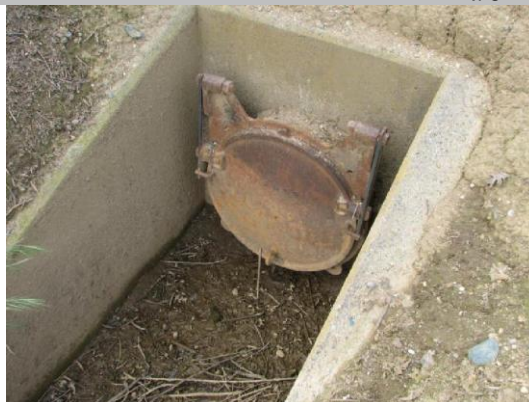
Photo 2 of 3 : UCIP_SP_2019_52185_66714.jpg

Flap gate at WS.

Comment Code						
Inspector Comment						
FS_ID:52185 DS_ID:16347 EP_NO: N/A Repair Type: No Action Needed Crossing Status: Found UCIP Comments: 6/14/2017 Crossing appears to be in good condition. (DWR Sutter Yard- A Freitag)11/16/2016 Crossing appears to be in good condition. (DWR Sutter Yard- A Freitag)4/28/2016 Crossing appears to be in good condition. 7/14/2015 Crossing appears in good condition. No noticeable issues to report.5/21/2014 Same as last inspection.12/2/2013 Same as last inspection.7/15/2013 Same as last inspection.4/17/2012 Vegetation/sedimentation from WS has been removed. This crossing was listed in the USACE Periodic Inspection report as Corp's inspect ID#USACE_CESPK_M13D_2011_p_0130 for WS flap gate closed and blocked by sediment. FIELD_STRUCT_DESC: 24-inch corrugated metal drainage pipe through the levee, 9.4 feet below the crown. Concrete "U" headwall on both waterside (WS) and landside (LS) ends. Flap gate on the WS end. [Additional Reference(s): DWR Levee Log, 1993. USACE Sacramento O&M Manual 519, June 1962 (HLM 2.74)] FS Date: 6/16/2017 12:27:02 PM

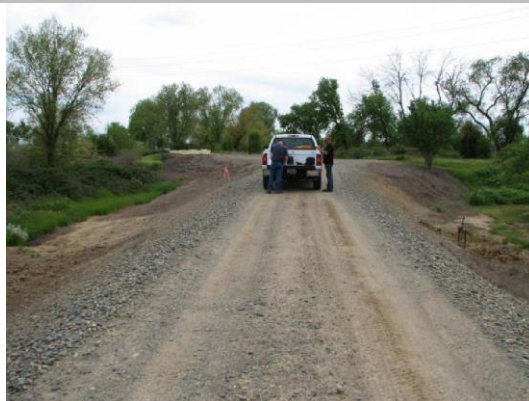
Photo 1 of 3 : UCIP_SP_2019_52188_66725.jpg

LM Start	3.24	Rating **	M	Issue No.	99 (cont)
LM End	3.24	Issue Type +	Ma	Location *

Overview of levee crown looking DS at crossing.

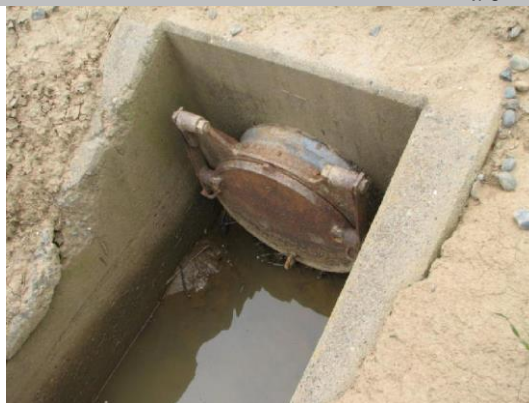
Photo 2 of 3 : UCIP_SP_2019_52188_66724.jpg

Flap gate on WS.

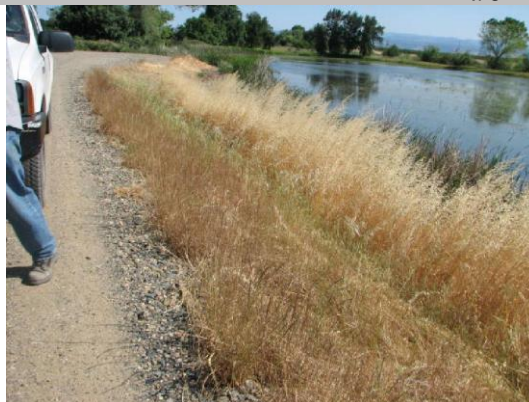
Photo 2 of 3 : UCIP_SP_2019_52190_66738.jpg

WS slope covered by dense vegetation.

Comment Code					
Inspector Comment					
FS_ID:52190 DS_ID:16351 EP_NO: N/A Repair Type: No Action Needed Crossing Status: Found UCIP Comments: 6/14/2017 Both pipe ends were underwater during site visit. Pipe has been selected to be internally cleaned and inspected as part of the DMP project. (DWR Sutter Yard- A/Freitag)11/16/2016 Crossing appears to be in good condition. (DWR Sutter Yard- A/Freitag)4/28/2016 Both sides of the crossing were underwater during time of inspection.7/14/2015 Crossing appears in good condition. No noticeable issues to report.5/21/2014 Same as last inspection.12/2/2013 Same as last inspection.7/15/2013 Slopes have been cleared of vegetation and are in good condition.4/18/2012 Limited inspection on WS and LS slope due to dense vegetation. Need photos of cleared slopes. FIELD_STRUCT_DESC: 24-inch corrugate metal drainage pipe through the levee, 8.1 feet below the crown. Flap gate on the waterside (WS) end. Slide gate located on the landside (LS) end. Concrete "U" headwalls on both ends. [Additional Reference(s): DWR Levee Log, 1993. USACE Sacramento O&M Manual 519, June 1962 (HLM 3.80)] FS Date: 6/16/2017 12:33:16 PM

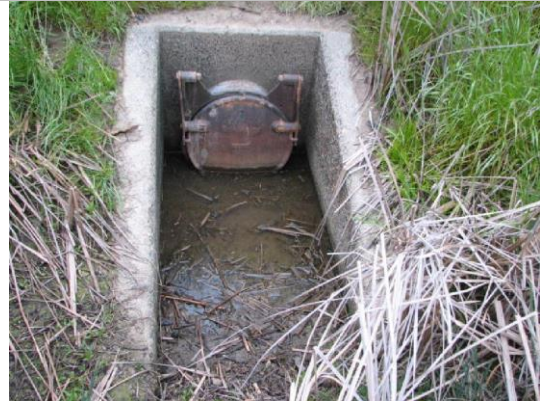
Photo 3 of 3 : UCIP_SP_2019_52190_66735.jpg

WS flap gate

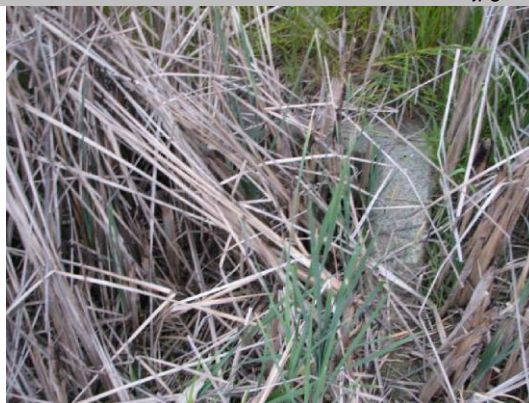
Photo 2 of 3 : UCIP_SP_2019_52191_66741.jpg

WS flap gate blocked by debris.

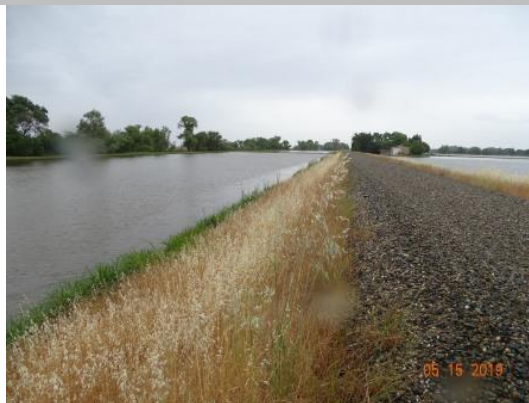
Photo 1 of 1 : SP_2019_MA0013_300_74_20190520_00144.jpg

LM Start	3.79	Rating **	U	Issue No.	74
LM End	18.50	Issue Type +	Ma	Location *	WS
Category	Earthen Levee			GPS Latitude/Longitude	
				Start	End
Item	Vegetation			39.545589 °	39.373436 °
				-121.707384 °	-121.850430 °
DWR ID	DWR_MA0013_01_s_2019_74				
Comment Code					
V1 : Control annual grass and weeds on the levee slopes and easements.					
Inspector Comment

View of the vegetation on the waterside slope. Spring 2019.

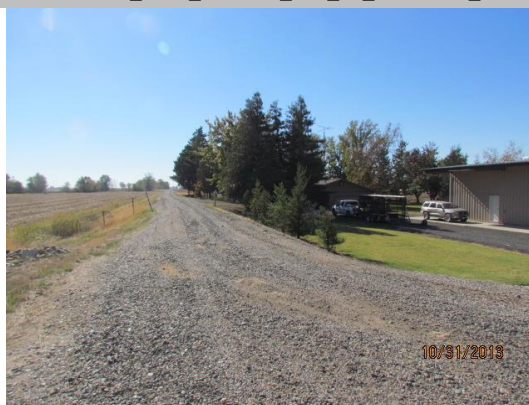
Photo 1 of 1 : SP_2019_MA0013_300_18_20190327_00005.jpg

LM Start	4.06	Rating **	M	Issue No.	18
LM End	4.13	Issue Type +	En	Location *	LS
Category	Earthen Levee			GPS Latitude/Longitude	
				Start	End
Item	Vegetation			39.541660 °	39.540651 °
				-121.707408 °	-121.707404 °
DWR ID	DWR_MA0013_01_s_2013_18				
Comment Code					
V6 : Landscaping					
Inspector Comment

View of the redwood trees along the landside slope.

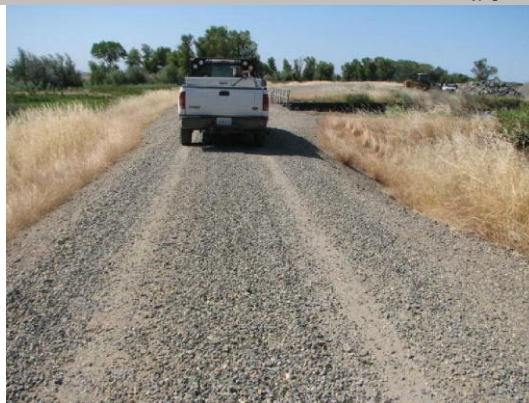
Photo 1 of 3 : UCIP_SP_2019_52196_66764.jpg

Comment Code						
Inspector Comment						
FS_ID:52196 DS_ID:16357 EP_NO: N/A Repair Type: Non-Urgent Crossing Status: Found UCIP Comments: 6/14/2017 WS flapgate is partially buried by sediment- needs to be dug out. LS appears to be in good condition. Pipe has been selected to be internally cleaned and inspected as part of the DMP project. (DWR Sutter Yard- AFreitag)11/16/2016 WS flap gate closed but blocked from opening by sediment. (DWR Sutter Yard- AFreitag)4/28/2016 WS flap gate blocked from opening by sediment.7/13/2015 WS flap gate is blocked from opening by sediment. Needs to be dug out.5/21/2014 Same as last inspection.12/2/2013 Same as last inspection.7/15/2013 Slopes have been cleared of vegetation and are in good condition.4/18/2012 Limited inspection on WS and LS slopes due to dense vegetation. Need photos of cleared slopes. FIELD_STRUCT_DESC: 24-inch corrugated metal drainage pipe through the levee, 8.6 feet below the crown. Flap gate on the waterside (WS) end. Concrete "U" headwalls an both ends. [Additional Reference(s): DWR Levee Log, 1993. USACE Sacramento O&M Manual 519, June 1962 (HLM 5.48)] FS Date: 6/16/2017 1:05:09 PM

Overview of levee crown at crossing looking downstream.

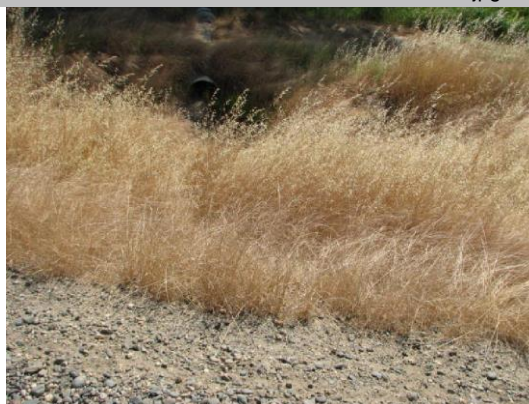
Photo 2 of 3 : UCIP_SP_2019_52196_66765.jpg

View of WS slope and channel.

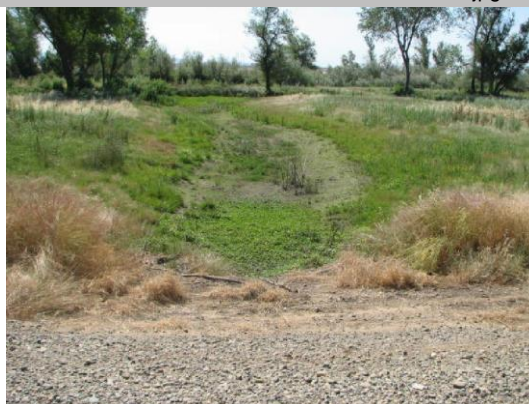
Photo 2 of 3 : UCIP_SP_2019_52201_66794.jpg

View of WS slope and toe.

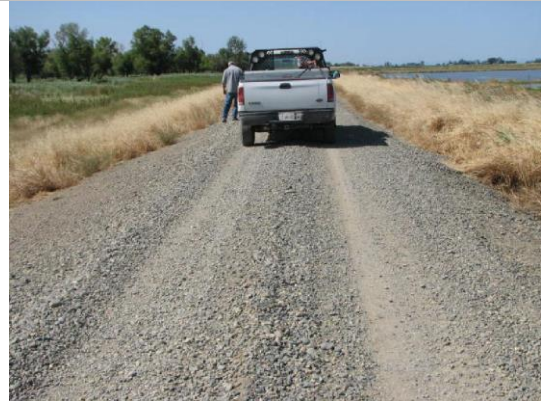
Photo 1 of 3 : UCIP_SP_2019_52202_66800.jpg

Comment Code						
Inspector Comment						
FS_ID:52202						
DS_ID:16360						
EP_NO: N/A						
Repair Type: No Action Needed						
Crossing Status: Found						
UCIP Comments: 6/14/2017 Crossing appears to be in good condition.						
LS is completely submerged in an irrigation ditch. Pipe has been						
selected to be internally cleaned and inspected as part of the DMP						
project. (DWR Sutter Yard- A/Freitag)11/16/2016 Crossing appears to						
be in good condition. (DWR Sutter Yard- A/Freitag)4/28/2016						
Crossing appears to be in good condition.7/13/2015 LS screw gate						
was completely submerged but crossing appears to be in good						
condition.5/21/2014 Same as last inspection.12/2/2013 Same as						
last inspection.7/15/2013 Same as last inspection.4/18/2012						
Burrow activity near crossing; burrow holes present on LS.						
FIELD_STRUCT_DESC: 24-inch corrugated metal drainage pipe						
through the levee, 6.2 feet below the crown. Flap gate on the waterside

Overview of levee crown at crossing looking downstream.

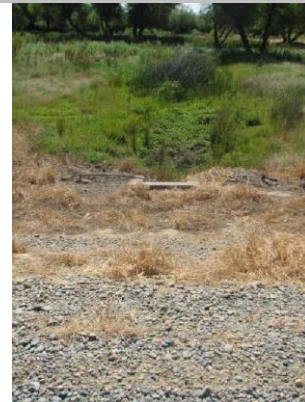
Photo 2 of 3 : UCIP_SP_2019_52203_66806.jpg

View of WS slope and toe.

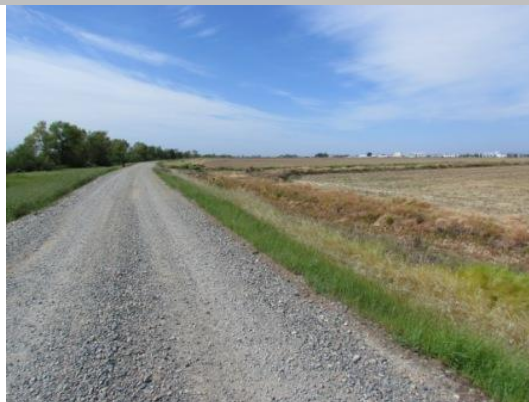
Photo 1 of 1 : SP_2019_MA0013_300_3_20190327_00001.jpg

LM Start	6.41	Rating **	M	Issue No.	3
LM End	6.99	Issue Type +	En	Location *	LS
Category	Earthen Levee			GPS Latitude/Longitude	
				Start	End
Item	Encroachments			39.508928 °	39.501438 °
				-121.714842 °	-121.719715 °
DWR ID	DWR_MA0013_01_s_2012_3				
Comment Code					
DT : Ditch					
Inspector Comment

View of the agricultural ditch along the toe.

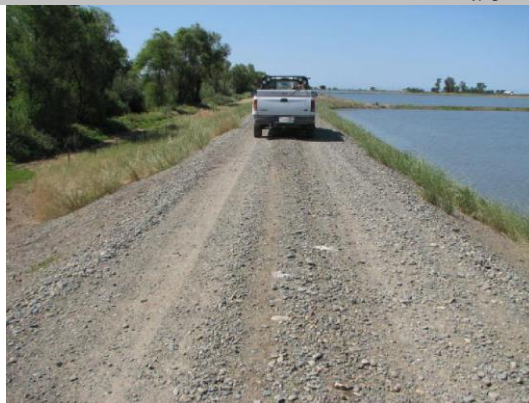
Photo 1 of 3 : UCIP_SP_2019_52218_66872.jpg

Comment Code					
Inspector Comment					
FS_ID:52218 DS_ID:16321 EP_NO: N/A Repair Type: No Action Needed Crossing Status: Found UCIP Comments: 6/14/2017 Crossing appears to be in good condition. Pipe has been selected to be internally cleaned and inspected as part of the DMP project. (DWR Sutter Yard- AFreitag)11/16/2016 Crossing appears to be in good condition. (DWR Sutter Yard- AFreitag)4/28/2016 Crossing appears to be in good condition.7/13/2015 Crossing appears to be in good condition. 5/21/2014 Same as last inspection.12/3/2013 Same as last inspection.7/15/2013 Same as last inspection.4/18/2012 Sediment build up against flashboards. Flashboards are in use on landside of levee. FIELD_STRUCT_DESC: 24-inch corrugated metal drainage pipe through the levee, 8.2 feet below the crown. Flap gate on the waterside (WS) end. Concrete "U" headwalls on both ends. Flashboards should be present on the landside (LS). [Additional Reference(s): DWR Levee Log, 1993. USACE Sacramento O&M Manual 519, June 1962 (HLM 8.12)] FS Date: 6/19/2017 12:45:23 PM

Overview of levee crown at crossing looking D/S.

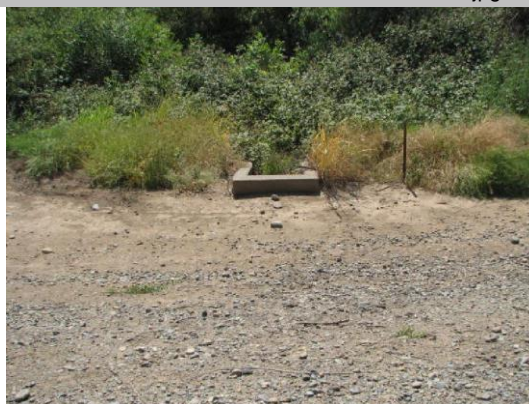
Photo 2 of 3 : UCIP_SP_2019_52218_66873.jpg

View of WS slope and toe.

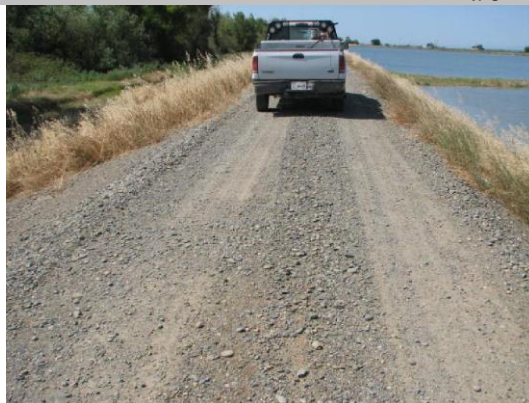
Photo 1 of 3 : UCIP_SP_2019_52219_66876.jpg

FS_ID:52219
DS_ID:16322
EP_NO: N/A
Repair Type: Non-Urgent
Crossing Status: Found
UCIP Comments: 6/14/2017 Both sides of the crossing were buried with sediment- needs to be cleared away. Pipe has been selected to be internally cleaned and inspected as part of the DMP project. (DWR Sutter Yard- AFreitag)11/16/2016 WS flap gate is closed but is blocked from opening by sediment. (DWR Sutter Yard- AFreitag)4/28/2016 Crossing appears to be in good condition.7/13/2015 Minor sediment build up blocking flap gate from opening on WS. Needs to be dug out.5/21/2014 Same as last inspection.12/3/2013 Same as last inspection.7/15/2013 Slopes are cleared of vegetation and are in good condition. WS flapgate is blocked from opening fully by sediment.4/18/2012 Sediment build up on LS. Debris (broken panels) scattered near LS headwall. Limited inspection on WS and LS slope due to dense vegetation. Need photos of cleared WS and LS slopes.

Overview of levee crown at crossing looking D/S.

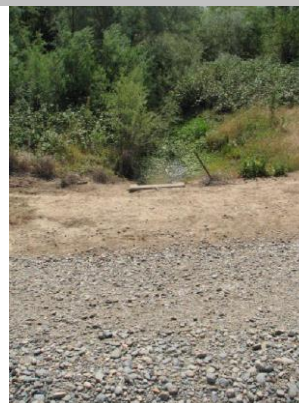
Photo 2 of 3 : UCIP_SP_2019_52219_66874.jpg

View of WS slope and toe.

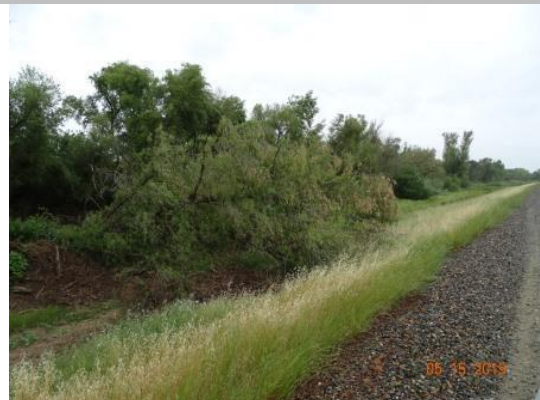
Photo 1 of 1 : SP_2019_MA0013_300_76_20190520_00146.jpg

LM Start	8.60	Rating **	U	Issue No.	76
LM End	8.60	Issue Type +	Ma	Location *	WS
Category	Earthen Levee			GPS Latitude/Longitude	
				Start	End
Item	Encroachments			39.481123 °	39.481123 °
				-121.734162 °	-121.734162 °
DWR ID	DWR_MA0013_01_s_2019_76				
Comment Code					
TR : Tree or limb					
Inspector Comment					
The large fallen tree should be removed from the waterside slope.

View of the large fallen tree on the waterside slope. Spring 2019.

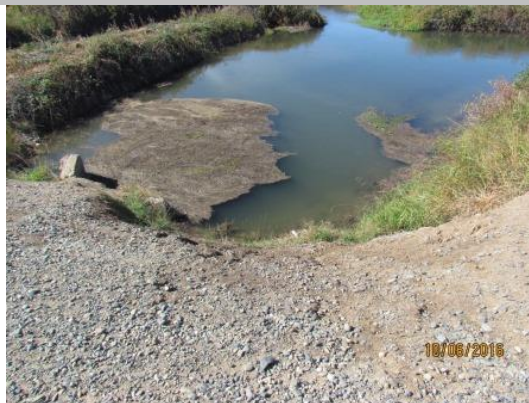
Photo 1 of 1 : SP_2019_MA0013_300_49_20190327_00006.jpg

LM Start	8.81	Rating **	M	Issue No.	49
LM End	8.81	Issue Type +	Ma	Location *	LS
Category	Earthen Levee			GPS Latitude/Longitude	
				Start	End
Item	Erosion / Bank Caving			39.478648 °	39.478648 °
				-121.736477 °	-121.736477 °
DWR ID	DWR_MA0013_01_f_2016_49				
Comment Code					
E2 : Schedule repair of erosion site prior to the next inspection.					
Inspector Comment

View of the erosion site along the landside toe.

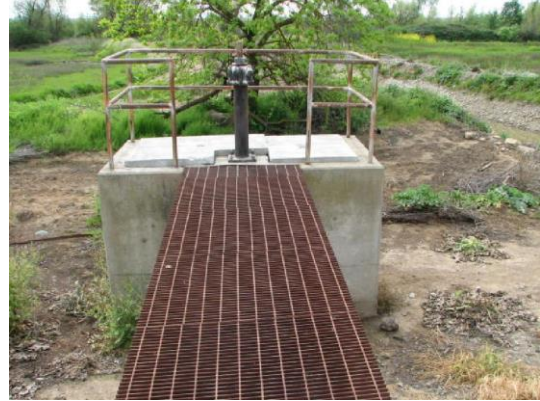
Photo 2 of 3 : UCIP_SP_2019_53310_66884.jpg

FS_ID:53310
DS_ID:16323
EP_NO: N/A
Repair Type: Urgent
Crossing Status: Found
UCIP Comments: 8/23/2018 Same as last inspection; crossing remains Urgent because LS erosion is still present and poses a levee integrity risk (D. Sanoski - DWR UCIP).6/14/2017 LS underwater but levee erosion is still present- needs to be repaired. Pipe has been selected to be internally cleaned and inspected as part of the DMP project. (DWR Sutter Yard- AFreitag)11/16/2016 LS erosion is still a major problem here. (DWR Sutter Yard- AFreitag)4/28/2016 Erosion still present at the LS headwall. (DWR Sutter Yard - afreitag)7/13/2015 Erosion still present behind the LS headwall. It looks to be getting worse and is starting to affect the levee slope. (DWR Sutter Yard - afreitag)5/21/2014 Same as last inspection. (DWR Sutter Yard - afreitag)12/3/2013 Same as last inspection. (DWR Sutter Yard - afreitag)7/15/2013 Same as last inspection. (DWR Sutter Yard - afreitag)4/18/2012 Concrete headwall is cracked, erosion behind headwall is also present. LS headwall needs to be repaired/replaced. Remove wooden debris from levee shoulder. (DWR UCIP - omagana) FIELD_STRUCT_DESC: [Richvale Irrigation Canal Siphon] 60-inch by 84-inch (5-foot by 7 foot) concrete irrigation conduit through the levee, 18.4 feet below the crown. Distribution box and walkway are located on the waterside (WS). Concrete headwall on the landside (LS). 28-foot reinforced concrete protective slab on top of the conduit in the center of the levee. [Additional Reference(s): DWR Levee Log, 1993. USACE Sacramento O&M Manual 519, June 1962 (HLM 8.95)]

Catwalk & gate located on WS. No daylight point on WS.

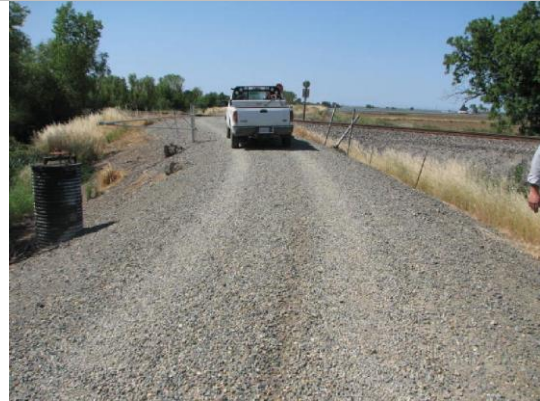
Photo 1 of 3 : UCIP_SP_2019_52223_66895.jpg

Comment Code						
Inspector Comment						
FS_ID:52223 DS_ID:16325 EP_NO: N/A Repair Type: Non-Urgent Crossing Status: Found UCIP Comments: 6/14/2017 Debris drifts built up around the WS slide gates- needs to be cleared away. LS appears to be n good condition. Pipe has been selected to be internally cleaned and inspected as part of the DMP project. (DWR Sutter Yard- A Freitag)11/16/2016 Crossing appears to be in good condition. (DWR Sutter Yard- A Freitag)4/28/2016 Crossing appears to be in good condition.7/13/2015 Crossing appears in good condition. No noticeable issues to report.5/21/2014 Same as last inspection.12/3/2013 Same as last inspection.7/15/2013 LS slope has been sprayed and cleared of vegetation and is in good condition.4/18/2012 Limited inspection on LS slope due to dense vegetation. Need photo of cleared vegetation from slopes and WS headwall. Minor debris scattered on WS slope. FIELD_STRUCT_DESC: 24-inch corrugated metal drainage pipe through the levee, 12.6 feet below the crown. Slide gate in corrugated metal pipe riser on the waterside (WS) slope. Slide gate on the WS end. Concrete "U" headwall on both ends. [Additional Reference(s): DWR Levee Log, 1993. USACE Sacramento O&M Manual 519, June 1962 (HLM 8.98)] FS Date: 6/19/2017 12:59:24 PM

Overview of levee crown at crossing looking D/S.

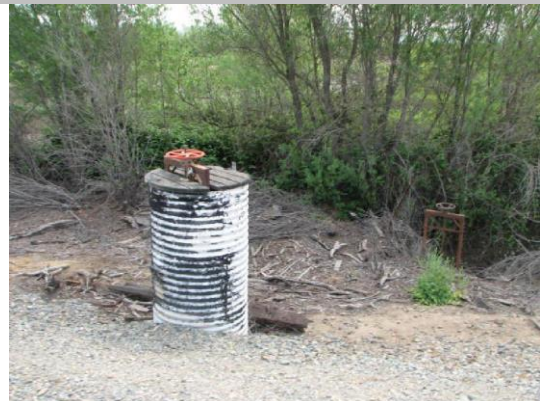
Photo 2 of 3 : UCIP_SP_2019_52223_66897.jpg

View of WS slope with 2 slide gates.

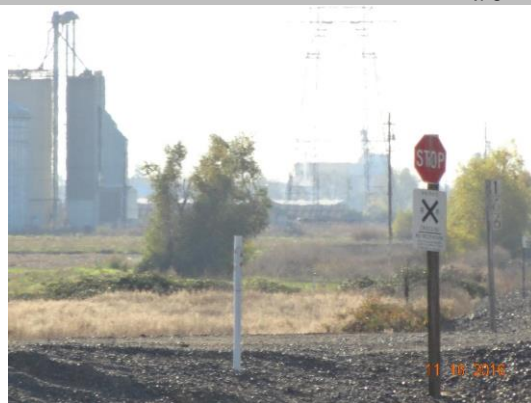
Photo 3 of 3 : UCIP_SP_2019_52225_76257.jpg

Comment Code						
Inspector Comment						
FS_ID:52225 DS_ID:16828 EP_NO: N/A Repair Type: Non-Urgent Crossing Status: Found UCIP Comments: 6/14/2017 Erosion still present on the side of the LS structure- still not affecting levee yet. (DWR Sutter Yard-AFreitag)11/16/2016 Some erosion still present near the LS structure. Does not affect the levee yet. (DWR Sutter Yard-AFreitag)4/28/2016 Erosion happening around the concrete structure on LS. Its not yet affecting the levee but will keep monitoring.7/13/2015 Crossing appears in good condition. No noticeable issues to report.5/21/2014 Same as last inspection.12/3/2013 Same as last inspection.7/15/2013 Same as last inspection.4/18/2012 Crossing is not visible on WS. FIELD_STRUCT_DESC: 72-inch irrigation pipe through the levee located 14.2 feet below the crown. Appurtenances include concrete pipe siphon, screw gate, and distribution box visible on the landside (LS). No appurtenances found on the waterside (WS). [Additional Reference(s): DWR Levee Log, 1993. USACE Sacramento O&M Manual 519, June 1962 (HLM 9.02)] FS Date: 6/19/2017 1:05:30 PM

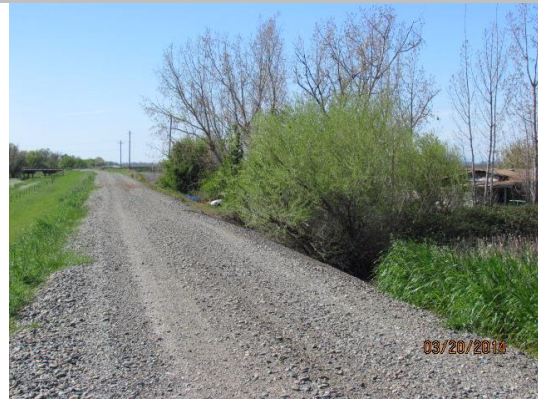
Photo 1 of 1 : SP_2019_MA0013_300_5_20190327_00002.jpg

LM Start	9.70	Rating **	M	Issue No.	5	
LM End	9.72	Issue Type +	Ma	Location *	LS	
Category	Earthen Levee			GPS Latitude/Longitude		
				Start		End
Item	Trim / Thin Trees			39.467170 °		39.466860 °
				-121.743887 °		-121.744108 °
DWR ID	DWR_MA0013_01_s_2012_5					
Comment Code						
T1 : Trim trees to at least five feet above ground level.						
Inspector Comment

View of the overgrown trees along the landside slope and toe.

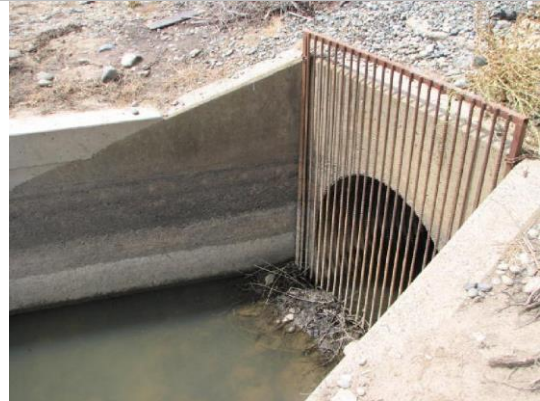
Trash rack on WS headwall.

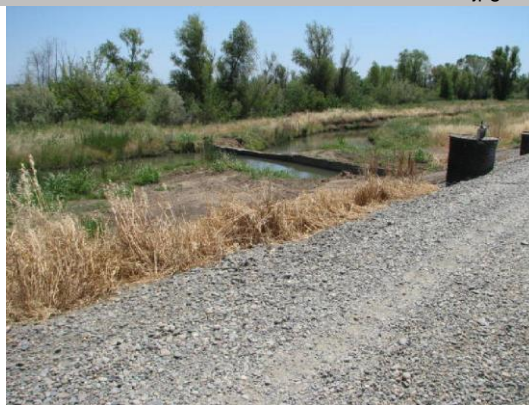
View of WS slope and channel.

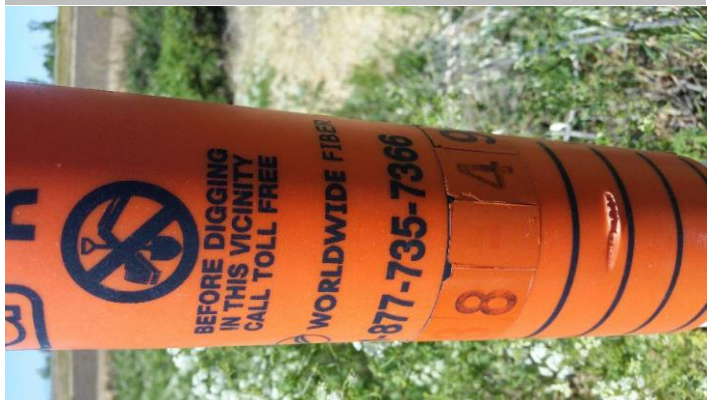
Crossing owner contact info

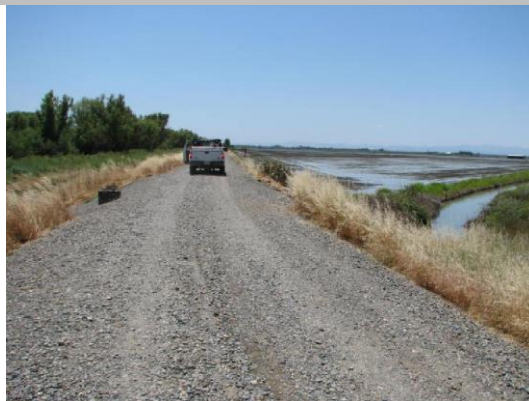
FS_ID:52238
DS_ID:16337
EP_NO: N/A
Repair Type: No Action Needed
Crossing Status: Found
UCIP Comments: 6/15/2017 Crossing appears to be in good condition. Pipe has been selected to be internally cleaned and inspected as part of the DMP project. (DWR Sutter Yard- A Freitag)11/17/2016 Ws pipe end was submerged but crossing appears to be in good condition. (DWR Sutter Yard- A Freitag)5/03/2016 Crossing appears to be in good condition.7/13/2015 New screwgate installed inside of WS standpipe.5/21/2014 Same as last inspection.12/3/2013 Same as last inspection.7/15/2013 Same as last inspection.
FIELD_STRUCT_DESC: 24-inch corrugated metal drainage pipe through the levee, 11.1 feet below the crown. Slide gate in corrugated metal pipe (CMP) riser on the waterside (WS) slope. Concrete "U" headwalls on both ends. [Additional Reference(s): DWR Levee Log, 1993. USACE Sacramento O&M Manual 519, June 1962 (HLM 13.53)]

Overview of levee crown at crossing looking downstream.

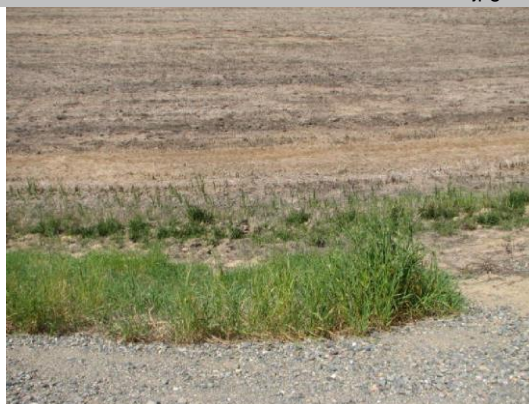
View of LS slope and toe. Unable to find welded plate on LS.

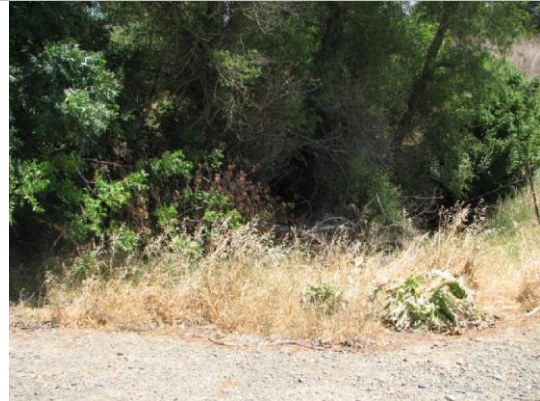
Photo 2 of 3 : UCIP_SP_2019_52243_66987.jpg

Item	DWR UCIP Field Study			39.399051 °	39.399051 °	
				-121.810550 °	-121.810550 °	
DWR ID	16364					
Comment Code						
Inspector Comment						
FS_ID:52243 DS_ID:16364 EP_NO: 7521 Repair Type: Non-Urgent Crossing Status: Found UCIP Comments: 6/15/2017 Both pipe ends completely submerged during site visit. Pipe has been selected to be internally cleaned and inspected as part of the DMP project. (DWR Sutter Yard-AFreitag)11/17/2016 Both pipe ends underwater at time of inspection. (DWR Sutter Yard- AFreitag)5/3/2016 Tree near the WS pipe end has been cut down. Stump is still in place. Water was too high to be able to see if the pipe inside was damaged. Minor erosion starting behind the WS headwall.7/13/2015 WS pipe end is heavily vegetated with trees and is making it almost impossible to inspect. Needs to be cleared out. LS appears in good condition.5/22/2014 Same as last inspection.12/3/2013 Same as last inspection.7/15/2013 Slopes have been cleared of vegetation and are in good condition.4/18/2012 Limited inspection on WS and LS slopes/toe due to dense vegetation. Erosion behind headwall on WS toe. Need photos of cleared WS & LS slopes. FIELD_STRUCT_DESC: 30-inch corrugated metal drainage pipe through the levee, 13.6 feet below the crown. Flap gate on the waterside (WS) end. Concrete "U" headwalls on both ends. A 48-inch corrugated metal standpipe located approximately 12 feet from landside (LS) levee toe. (Permit No. 7521, 1972 - Askew Ranch) [Additional Reference(s): DWR Levee Log, 1993. USACE Sacramento O&M Manual 519, June 1962 (HLM 15.95)] FS Date: 6/19/2017 2:02:42 PM

View of WS.

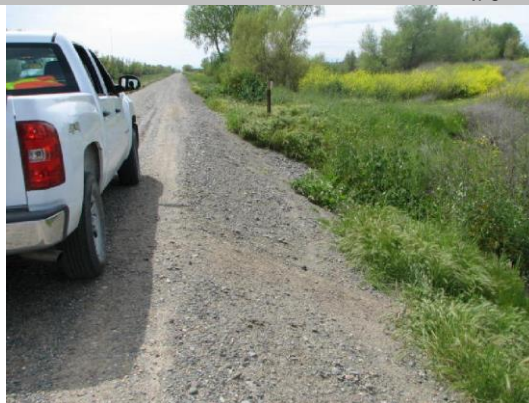
Photo 3 of 3 : UCIP_SP_2019_52244_66996.jpg

Item	DWR UCIP Field Study			39.398615 °	39.398615 °	
				-121.811250 °	-121.811250 °	
DWR ID	16373					
Comment Code						
Inspector Comment						
FS_ID:52244 DS_ID:16373 EP_NO: 11805B Repair Type: Non-Urgent Crossing Status: Found UCIP Comments: 6/15/2017 Both pipe ends submerged during site visit. LS ditch near pipe end is heavily vegetated and covering the pipe end. There is some erosion happening at the LS levee toe but this is more of a ditch problem and not a problem with the pipe. (DWR Sutter Yard- AFreitag)11/17/2016 Both pipe ends underwater at time of inspection. (DWR Sutter Yard- AFreitag)5/03/2016 Crossing was underwater on both sides of levee during this inspection. Looks as if the wooden walkway was the same and no repairs have been made.7/13/2015 LS inlet still underwater. WS screwgate appears in good condition. Wooden walkway to the screwgate needs repairs.5/22/2014 Same as last inspection.12/3/2013 Same as last inspection.7/15/2013 Same as last inspection.4/18/2012 LS inlet is not visible-underwater. Limited inspection on WS and LS slope/toe due to dense vegetation. Need photos of cleared WS & LS slopes. FIELD_STRUCT_DESC: 48-inch reinforced concrete irrigation pipe with six concrete collars through the levee, 14.4 feet below the crown to center of conduit. Slide gate, head-wall and wood walkway on two concrete piers on the waterside (WS) of levee. Revetment on the WS slope. Irrigation ditch on the landside (LS). (Permit No. 11805, 11805B, 1979 - Elna Schohr, Inc.) [Additional Reference(s): DWR Levee Log, 1993] FS Date: 6/19/2017 2:04:34 PM

LS view of shoulder and slope.

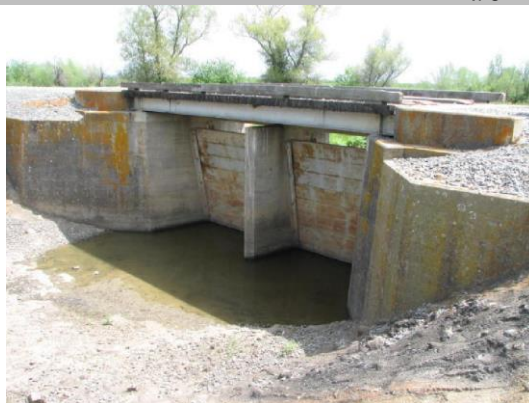
Photo 3 of 3 : UCIP_SP_2019_52245_74501.jpg

Item	DWR UCIP LMA Responsibility			39.394748 °	39.394748 °	
				-121.817360 °	-121.817360 °	
DWR ID	16372					
Comment Code						
Inspector Comment						
FS_ID:52245 DS_ID:16372 EP_NO: N/A Repair Type: No Action Needed Crossing Status: Found UCIP Comments: 6/15/2017 Crossing appears to be in good condition. Pipe has been selected to be internally cleaned and inspected as part of the DMP project. (DWR Sutter Yard- AFreitag)11/17/2016 Crossing appears to be in good condition. (DWR Sutter Yard- AFreitag)5/03/2016 Crossing appears to be in good condition. 7/13/2015 Crossing appears in good condition. No noticeable issues to report.5/22/2014 Same as last inspection.12/3/2013 Same as last inspection.7/15/2013 Same as last inspection.4/18/2012 The structures are closed with metal stop logs (weir type structure). The stop logs appear to be removable, however; there is a wooden bridge over the structure that would have to be removed in order to raise the stop logs. There is 1-foot of clearance between the bottom of the bridge and the top of the stop logs. FIELD_STRUCT_DESC: Two 10-foot by 10-foot concrete drain openings through the levee at an unknown depth below the crown. Wooden bridge, 10 ton load limit. [Additional Reference(s): DWR Levee Log, 1993. USACE Sacramento O&M Manual 519, June 1962 (HLM 16.43)] FS Date: 6/19/2017 2:09:30 PM

LS view of structure

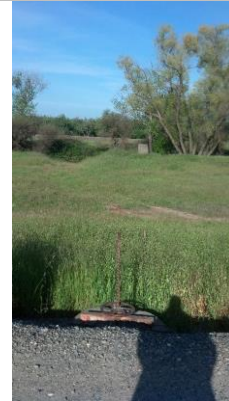
Photo 2 of 3 : UCIP_SP_2019_52112_67048.jpg

Comment Code						
Inspector Comment						
FS_ID:52112 DS_ID:16398 EP_NO: N/A Repair Type: Non-Urgent Crossing Status: Found UCIP Comments: 6/5/2017 LS ditch at outlet is getting over grown with vegetation. WS near concrete standpipe is overgrown with vegetation. Pipe has been selected to be internally cleaned and inspected as part of the DMP project. (DWR Sutter Yard- AFreitag)11/18/2016 Between the screwgate on the WS shoulder and the LS pipe end the pipe is about 50% full of soil. Crossing is still actively used by landowner for irrigation purposes. (DWR Sutter Yard- AFreitag)4/27/2016 Pipe gets used by the landowner to irrigate his rice fields. It appeared to be in good condition.7/01/2015 LS pipe end is still about 50% full of sediment.5/29/2014 Same as last inspection.12/9/2013 Same as last inspection.7/10/2013 LS and WS slopes have been cleared of vegetation and are in good condition. LS pipe end is half full of sediment. Sediment inside of WS standpipe may hinder slide gate from fully closing. Standpipe cover is still broken.4/19/2012 Need to fix the top of slide gate cover. The wooden cap on standpipe is broken. Limited evaluation of crossing due to dense vegetation on LS slope. Need photos of cleared slopes during fall inspection. FIELD_STRUCT_DESC: 24-inch corrugated metal drainage pipe through the levee, 10.6 feet below the crown. Slide gate in corrugated metal pipe (CMP) riser on the waterside (WS) slope. Concrete "U" headwall on the landside (LS). 36-inch concrete standpipe in the channel with two wooden piles to deflect debris. [Additional Reference(s): DWR Levee Log, 1993. USACE Sacramento O&M Manual 519, June 1962 (HLM 0.57)] FS Date: 6/7/2017 12:03:30 PM

View of WS slope and toe.

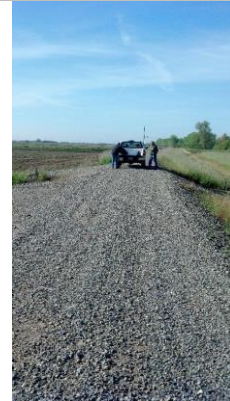
Photo 1 of 3 : UCIP_SP_2019_52115_67063.jpg

Comment Code						
Inspector Comment						
FS_ID:52115 DS_ID:16400 EP_NO: N/A Repair Type: No Action Needed Crossing Status: Found UCIP Comments: 6/5/2017 LS inlet was underwater. WS flapgate blocked shut by sediment. Pipe has been selected to be internally cleaned and inspected as part of the DMP project. (DWR Sutter Yard-AFreitag)11/18/2016 Sediment dug out from in front of flap gate. Gate can now function properly. (DWR Sutter Yard-AFreitag)4/27/2016 WS flapgate still blocked from opening by sediment buildup.7/01/2015 New screwgate installed on the LS. WS flapgate is still blocked from opening by sediment.5/29/2014 Same as last inspection.12/9/2013 Same as last inspection.7/10/2013 Sediment is built up against WS flap gate not allowing it to open. Handle for LS slide gate is still missing.4/19/2012 Handle missing on slide gate. FIELD_STRUCT_DESC: 1 of 2: 36-inch corrugated metal drainage pipe through the levee, 9.7 feet below the crown. Concrete "U" headwalls located on the waterside (WS) and landside (LS) ends. Flap gate on the WS end. Slide gate on the LS end. [Additional Reference(s): DWR Levee Log, 1993. USACE Sacramento O&M Manual 519, June 1962 (HLM 2.54)] FS Date: 6/7/2017 12:18:14 PM

Overview of levee crown looking south

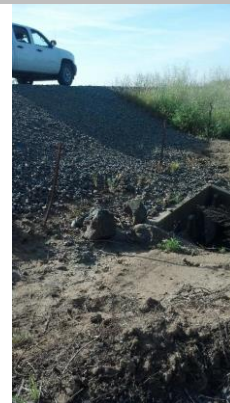
Photo 2 of 3 : UCIP_SP_2019_52115_67068.jpg

View of WS slope.

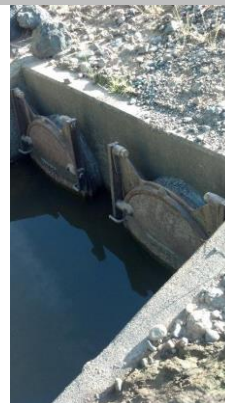
Photo 3 of 3 : UCIP_SP_2019_52115_67064.jpg

Item	DWR UCIP LMA Responsibility			39.539195 °	39.539195 °	
				-121.706070 °	-121.706070 °	
DWR ID	16400					
Comment Code						
Inspector Comment						
FS_ID:52115 DS_ID:16400 EP_NO: N/A Repair Type: No Action Needed Crossing Status: Found UCIP Comments: 6/5/2017 LS inlet was underwater. WS flapgate blocked shut by sediment. Pipe has been selected to be internally cleaned and inspected as part of the DMP project. (DWR Sutter Yard-AFreitag)11/18/2016 Sediment dug out from in front of flap gate. Gate can now function properly. (DWR Sutter Yard-AFreitag)4/27/2016 WS flapgate still blocked from opening by sediment buildup.7/01/2015 New screwgate installed on the LS. WS flapgate is still blocked from opening by sediment.5/29/2014 Same as last inspection.12/9/2013 Same as last inspection.7/10/2013 Sediment is built up against WS flap gate not allowing it to open. Handle for LS slide gate is still missing.4/19/2012 Handle missing on slide gate. FIELD_STRUCT_DESC: 1 of 2: 36-inch corrugated metal drainage pipe through the levee, 9.7 feet below the crown. Concrete "U" headwalls located on the waterside (WS) and landside (LS) ends. Flap gate on the WS end. Slide gate on the LS end. [Additional Reference(s): DWR Levee Log, 1993. USACE Sacramento O&M Manual 519, June 1962 (HLM 2.54)] FS Date: 6/7/2017 12:18:14 PM

Headwall and flap gates (2) located on WS

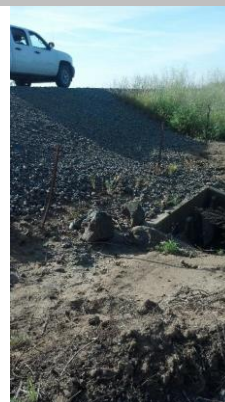
Photo 2 of 3 : UCIP_SP_2019_52116_67074.jpg

View of WS slope.

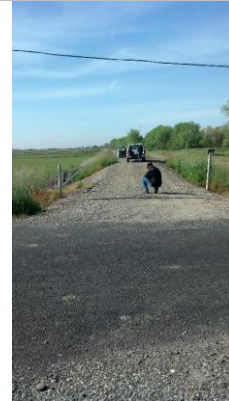
Photo 1 of 3 : UCIP_SP_2019_52119_67087.jpg

FS_ID:52119
DS_ID:16403
EP_NO: N/A
Repair Type: Non-Urgent
Crossing Status: Found
UCIP Comments: 6/5/2017 Crossing appears to be in good condition. Pipe has been selected to be internally cleaned and inspected as part of the DMP project. (DWR Sutter Yard- A Freitag)11/18/2016 Crossing appears to be in good condition. (DWR Sutter Yard- A Freitag)4/27/2016 Crossing appears to be in good condition.7/01/2015 WS flap gate is partially blocked by sediment and needs to be cleaned.5/29/2014 Same as last inspection.12/9/2013 Same as last inspection.7/10/2013 LS and WS slopes have been cleared of vegetation and are in good condition.4/19/2012 Burrowing holes located above WS headwall. Limited inspection on WS and LS slopes due to dense vegetation. Need photos of cleared WS & LS slopes.
FIELD_STRUCT_DESC: 36-inch corrugated metal drainage pipe through the levee, 8.7 feet below the crown. Concrete "U" headwalls located on the waterside (WS) and landside (LS) ends. Flap gate on the WS end. Slide gate on the LS end. [Additional Reference(s): DWR Levee Log, 1993. USACE Sacramento O&M Manual 519, June 1962 (HLM 2.65)]

Overview at levee crown looking south

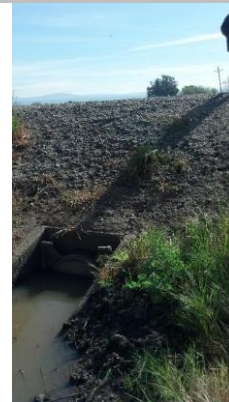
Photo 2 of 3 : UCIP_SP_2019_52120_67091.jpg

Headwall and flap gate located on WS.

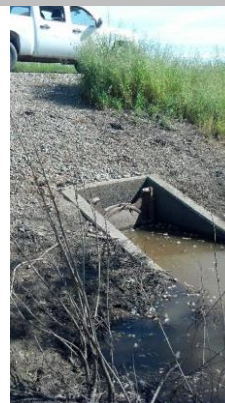
Photo 2 of 3 : UCIP_SP_2019_52122_67103.jpg

Headwall and flap gate located on WS.

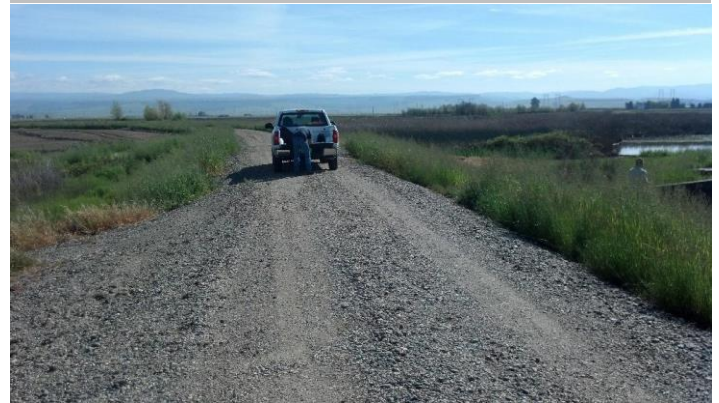
Photo 1 of 3 : UCIP_SP_2019_52123_67107.jpg

Comment Code					
Inspector Comment					
FS_ID:52123 DS_ID:16847 EP_NO: N/A Repair Type: Non-Urgent Crossing Status: Found UCIP Comments: 6/5/2017 Both ends submerged but crossing appears to be in good condition. (DWR Sutter Yard-AFreitag)11/18/2016 Crossing appears to be in good condition. It appears that this crossing does not require a slide gate. (DWR Sutter Yard- AFreitag)4/27/2016 LS slide gate was still missing. Rest of crossing appears to be in good condition.7/01/2015 There appears to be a LS gate now but both pipe ends were submerged so it was hard to tell for certain.5/29/2014 Same as last inspection.12/9/2013 Pulled sticks from WS flap gate to allow it to close. Ls gate is still missing.7/10/2013 WS and LS slopes have been cleared of vegetation and are in good condition. LS gate is still missing and WS flap gate is still wedged open with sticks.4/19/2012 LS gate missing & limited inspection. Need photos of WS & LS cleared slopes. Description calls for slide gate on LS-slide gate missing. Debris scattered near LS headwall. This crossing was listed in the USACE Periodic Inspection report as Corp's Inspect ID# USACE_CESPK_M13J_2011_p_0010 for WS gate wedged open & missing LS slide gate. FIELD_STRUCT_DESC: 36-inch corrugated metal drainage pipe through the levee, 8.8 feet below the crown. Flap gate on the waterside (WS) end. Slide gate on the landside (LS) end. Concrete "U" headwalls on both ends. [Additional Reference(s): DWR Levee Log, 1993. USACE Sacramento O&M Manual 519, June 1962 (HLM 3.85)] FS Date: 6/7/2017 1:24:40 PM

Overview looking south on left levee

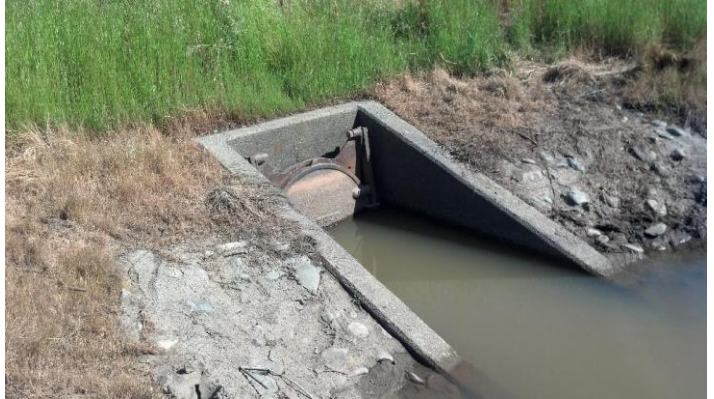
Photo 2 of 3 : UCIP_SP_2019_52123_67108.jpg

FS_ID:52123
DS_ID:16847
EP_NO: N/A
Repair Type: Non-Urgent
Crossing Status: Found
UCIP Comments: 6/5/2017 Both ends submerged but crossing appears to be in good condition. (DWR Sutter Yard-AFreitag)11/18/2016 Crossing appears to be in good condition. It appears that this crossing does not require a slide gate. (DWR Sutter Yard-AFreitag)4/27/2016 LS slide gate was still missing. Rest of crossing appears to be in good condition.7/01/2015 There appears to be a LS gate now but both pipe ends were submerged so it was hard to tell for certain.5/29/2014 Same as last inspection.12/9/2013 Pulled sticks from WS flap gate to allow it to close. Ls gate is still missing.7/10/2013 WS and LS slopes have been cleared of vegetation and are in good condition. LS gate is still missing and WS flap gate is still wedged open with sticks.4/19/2012 LS gate missing & limited inspection. Need photos of WS & LS cleared slopes. Description calls for slide gate on LS-slide gate missing. Debris scattered near LS headwall. This crossing was listed in the USACE Periodic Inspection report as Corp's Inspect ID# USACE_CESPK_M13J_2011_p_0010 for WS gate wedged open & missing LS slide gate.

Headwall and flap gate located on WS toe.

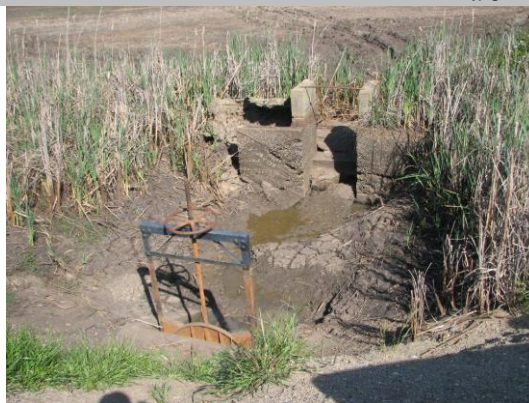
Photo 3 of 3 : UCIP_SP_2019_52124_67113.jpg

Overview of LS screw gate and concrete sump structure.

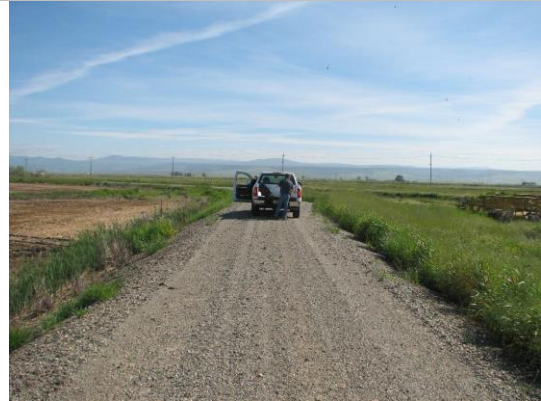
Photo 1 of 3 : UCIP_SP_2019_52125_67119.jpg

Comment Code						
Inspector Comment						
FS_ID:52125 DS_ID:16845 EP_NO: N/A Repair Type: No Action Needed Crossing Status: Found UCIP Comments: 6/5/2017 LS Slide gate mostly underwater due to rice field being flooded but crossing appears to be in good condition. Pipe has been selected to be internally cleaned and inspected as part of the DMP project. (DWR Sutter Yard- AFreitag)11/18/2016 Crossing appears to be in good condition. (DWR Sutter Yard- AFreitag)4/27/2016 Crossing appears to be in good condition.7/01/2015 Crossing appears to be in good condition. No noticeable issues to report.5/29/2014 Same as last inspection.12/9/2013 Same as last inspection.7/10/2013 WS slope has been cleared of vegetation and is in good condition.4/19/2012 Limited inspection due to dense vegetation on WS slope. Need photos of clear WS slope. FIELD_STRUCT_DESC: 24-inch corrugated metal drainage pipe through the levee, 5.6 feet below the crown. Flap gate on the waterside (WS) end. Slide gate on the landside (LS) end. Concrete "U" headwalls on both ends. [Additional Reference(s): DWR Levee Log, 1993. USACE Sacramento O&M Manual 519, June 1962 (HLM 4.69)] FS Date: 6/7/2017 1:41:34 PM

LM Start	4.65	Rating **	A/W	Issue No.	924 (cont)
LM End	4.65	Issue Type +	Ma	Location *

Overview looking east on right levee of Gold Run Creek (referred to Unit 2 of Cherokee Canal).

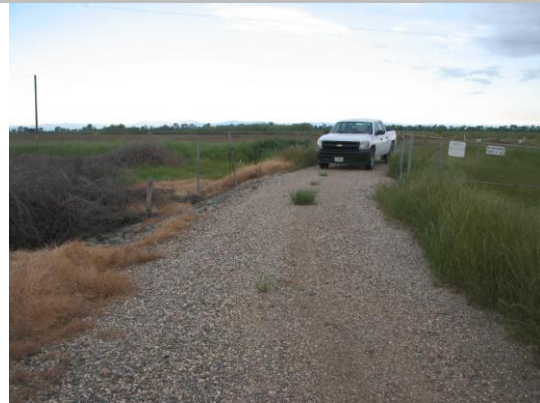
Photo 1 of 3 : UCIP_SP_2019_52126_67131.jpg

LM Start	5.01	Rating **	A/W	Issue No.	925
LM End	5.01	Issue Type +	Ma	Location *	
Category	Supplemental			GPS Latitude/Longitude	
				Start	End
Item	DWR UCIP LMA Responsibility			39.526298 °	39.526298 °
				-121.688320 °	-121.688320 °
DWR ID	16395

Comment Code					
Inspector Comment					
FS_ID:52126 DS_ID:16395 EP_NO: N/A Repair Type: No Action Needed Crossing Status: Found UCIP Comments: 6/5/2017 WS mostly submerged but crossing appears to be in good condition.(DWR Sutter Yard-AFreitag)11/18/2016 Crossing appears to be in good condition. Pipe is a 30" cmp. (DWR Sutter Yard- AFreitag)4/27/2016 Crossing appears to be in good condition.6/30/2015 Erosion on LS does not appear to be getting any worse with the rip-rap there. WS pipe end and gate appeared in good condition.5/29/2014 Same as last inspection.12/9/2013 Same as last inspection.7/09/2013 Same as last inspection.4/19/2012 Rusted pipe debris located on WS. Remove pipe debris on WS and monitor the LS erosion near headwall. Rip-rap used to protect LS headwall from erosion. Was pipe exposed prior to dumping rock? Erosion on the LS could have exposed pipe. Dense shrub on the LS could restrict flow. FIELD_STRUCT_DESC: 30-inch corrugated metal drainage pipe through the levee, 8.6 feet below the crown. Flap gate on the waterside (WS) end. Concrete "U" headwalls on both ends. [Additional Reference(s): DWR Levee Log, 1993. USACE Sacramento O&M Manual 519, June 1962 (HLM 5.06)] FS Date: 6/7/2017 1:54:08 PM

Overview looking west on the left levee of Cottonwood

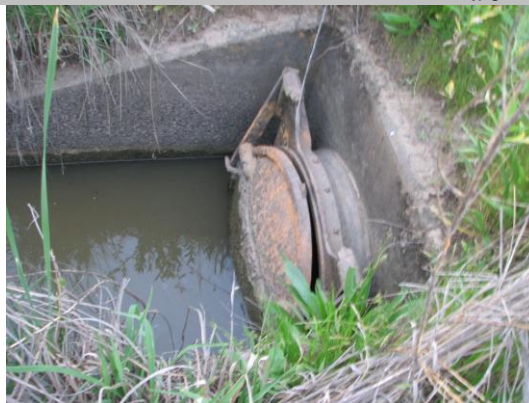
Photo 2 of 3 : UCIP_SP_2019_52126_67129.jpg

Headwall and flap gate located on WS.

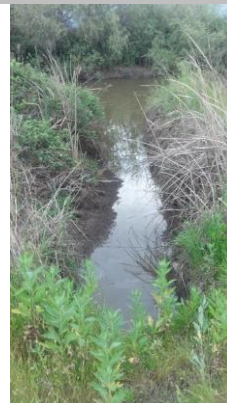
Photo 3 of 3 : UCIP_SP_2019_52126_67126.jpg

View of channel at crossing.
