**Flood Control Project Maintenance
Levee Inspections**
LMA District Cover Sheet
Spring 2019 Levee Inspection Results

Sutter Maintenance Yard Maintenance Area 0013

Spring 2019 Levee Inspection Results

Waterway			Bank	Unit Miles
Unit No. 01 Cherokee Canal			Right	18.19
	Spring (March - May)	Summer (June - August)	(September - November) Fall	Winter (December - February)
Unit Maintenance Rating (Fall Only)				
Date of Inspection	5/15/2019 - 5/15/2019			
DWR Inspector	Makar Sokol			
Accompanied By	Shawn Freitag Sutter Maintenance Yard

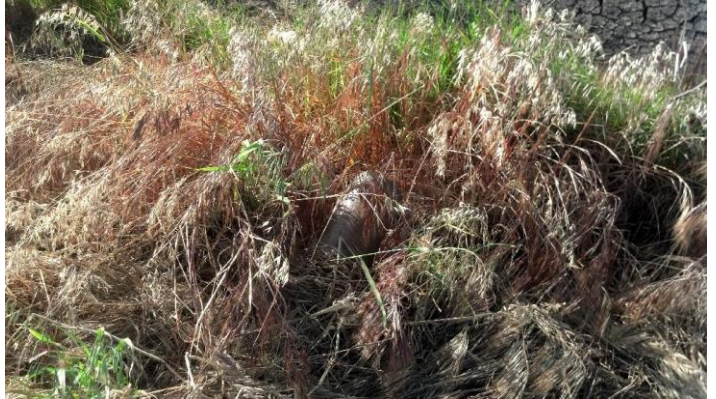
Photo 3 of 3 : UCIP_SP_2019_52131_67153.jpg

View of LS toe.

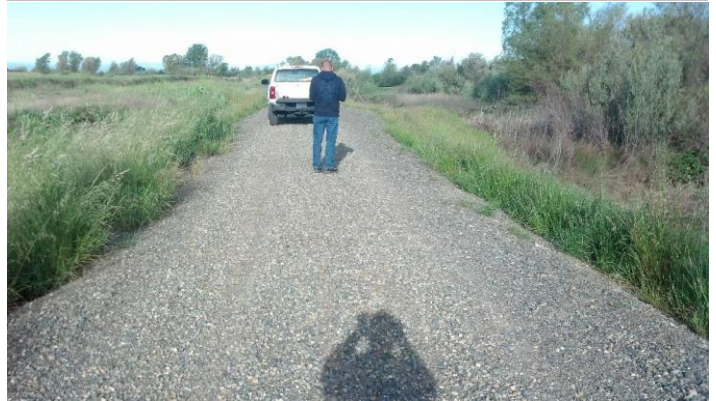
Photo 1 of 3 : UCIP_SP_2019_52132_67155.jpg

Comment Code					
Inspector Comment					
FS_ID:52132 DS_ID:16411 EP_NO: N/A Repair Type: Non-Urgent Crossing Status: Found UCIP Comments: 6/5/2017 Both ends were underwater but it appears that the LS slide gate is still missing. (DWR Sutter Yard- AFreitag)11/18/2016 LS slide gate still missing. Both pipe ends were submerged during inspection. (DWR Sutter Yard- AFreitag)9/27/2016 Crossing has been downgraded from Urgent to Non-Urgent--flap gate on WS is present only LS gate missing. (DWR UCIP - omagana)4/27/2016 Both sides of pipe were underwater. Appears that LS gate is still missing. (DWR Sutter Yard - afreitag)6/30/2015 Slide gate still missing on the LS. WS appears to be in good condition. (DWR Sutter Yard - afreitag)5/29/2014 Same as last inspection. (DWR Sutter Yard - afreitag)12/9/2013 Same as last inspection. (DWR Sutter Yard - afreitag)7/09/2013 Same as last inspection. (DWR Sutter Yard - afreitag)4/24/2012 Slide gate missing on LS. Limited inspection on WS and LS slopes due to dense vegetation. Need photos of cleared WS & LS slopes. This crossing was listed in the USACE Periodic Inspection report as Corp's inspect ID# USACE_CESPK_M13H_2011_p_0017 for missing slide gate. (DWR Sutter Yard - omagana) FIELD_STRUCT_DESC: 36-inch corrugated metal drainage pipe through the levee, 9.2 feet below the crown. Flap gate on the waterside (WS) end. Slide gate on the landside (LS) end. Concrete "U" headwalls located on both WS and LS toes. [Additional Reference(s): DWR Levee Log, 1993. USACE Sacramento O&M Manual 519, June 1962 (HLM 5.85)] FS Date: 6/7/2017 2:06:17 PM

Overview looking south

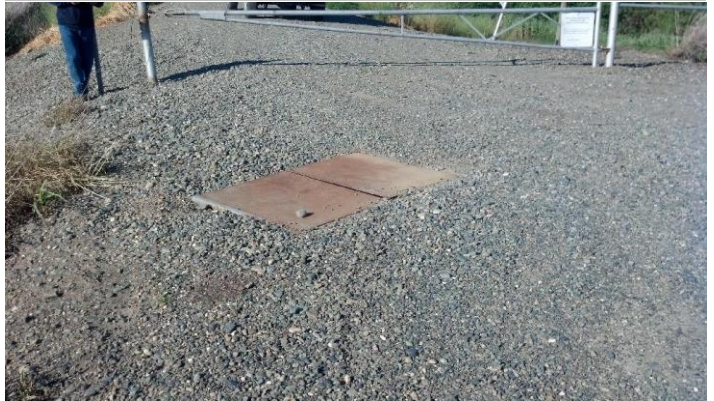
Photo 1 of 2 : UCIP_SP_2019_52140_67191.jpg

Comment Code						
Inspector Comment						
FS_ID:52140 DS_ID:16413 EP_NO: 14704 Repair Type: Non-Urgent Crossing Status: Indicator Found UCIP Comments: 6/5/2017 Crossing appears to be in good condition. (DWR Sutter Yard- AFreitag)11/18/2016 Crossing appears to be in good condition. (DWR Sutter Yard- AFreitag)4/27/2016 Crossing appears to be in good condition.6/30/2015 Crossing is in good condition. Unusre on the permit issues below.11/4/2014 (DWR-Olivia Magana) Need to contact owner to determine whether both communication are still active and same alignment? permit 14704 (LM 8.38) and 10589 (see LM 8.39) Priority changed in Part IX from No Action Needed to Non-Urgent.5/29/2014 Same as last inspection.12/4/2013 Same as last inspection.7/09/2013 Same as last inspection.4/24/2012 Unable to verify whether this crossing includes both communication cable lines under permit 14704 (LM 8.38) and 10589 (see LM 8.39). FIELD_STRUCT_DESC: Steel fiber optic cable through the levee, approximately 3.5 feet below the crown. The cable section across the channel is attached to the Cherokee Canal Dridge. (Permit No. 14704, 1987 - Sprint) [Additional Reference(s): DWR Levee Log, 1993] FS Date: 6/7/2017 2:34:57 PM

LM Start	8.30	Rating **	M	Issue No.	931 (cont)
LM End	8.30	Issue Type +	En	Location *

Buried cable box located on the LS edge.

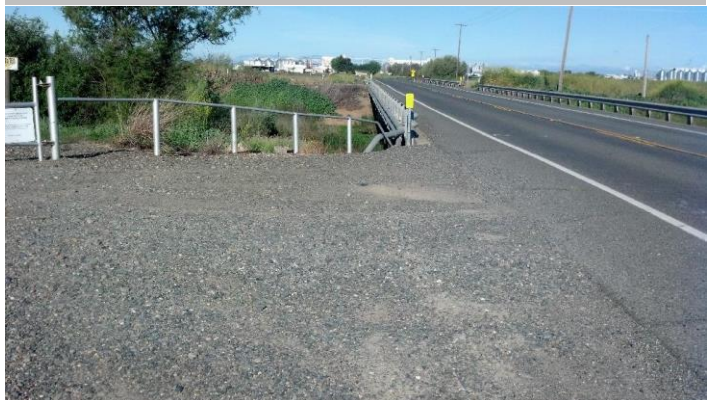
Photo 2 of 2 : UCIP_SP_2019_52140_67192.jpg

WS view cable line attached to highway bridge.

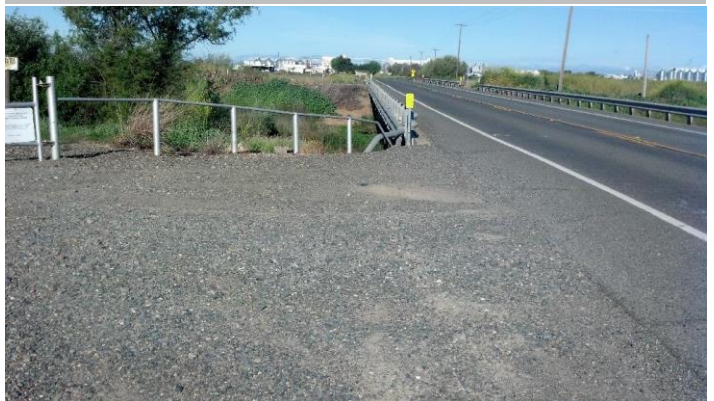
Photo 2 of 2 : UCIP_SP_2019_52141_67210.jpg

FS_ID:52141
DS_ID:16404
EP_NO: 10589A
Repair Type: Non-Urgent
Crossing Status: Indicator Found
UCIP Comments: 6/5/2017 Crossing appears to be in good condition.
(DWR Sutter Yard- AFreitag)11/18/2016 Crossing appears to be in good condition. (DWR Sutter Yard- AFreitag)4/27/2016 Crossing appears to be in good condition.6/30/2015 Crossing appears in good condition. Unsure on the permit issues listed below.11/4/2014 (DWR- Olivia Magana) Need to contact owner to determine whether both communication are still active and same alignment? permit 14704 (LM 8.38) and 10589 (see LM 8.39) Priority changed in Part IX from No Action Needed to Non-Urgent.5/29/2014 Same as last inspection.12/4/2013 Same as last inspection.7/09/2013 Same as last inspection.4/24/2012 Unable to verify whether this crossing includes both communication cable lines under permit 14704 (LM 8.38) and 10589 (see LM 8.39).
FIELD_STRUCT_DESC: 4-inch steel communication pipe, contains three telephone cables, through the levee, approximately 4 feet below the crown. The cable through the channel is buried approximately 5 feet deep. (Permit No. 10589, 1987 - Pacific Telephone and Telegraph Company [PT&T]) [Additional Reference(s): DWR Levee Log, 1993]

Waterside view of utility line alignment through levee then attached to bridge.

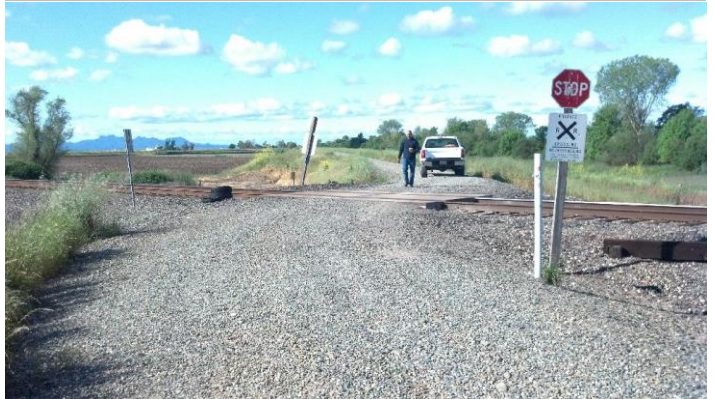
Photo 1 of 3 : UCIP_SP_2019_52148_67292.jpg

LM Start	9.66	Rating **	M	Issue No.	935 (cont)
LM End	9.66	Issue Type +	En	Location *

Overview of levee crown at crossing.

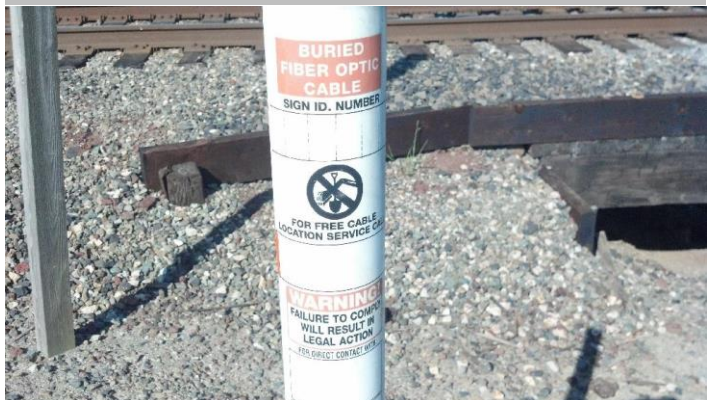
Photo 2 of 3 : UCIP_SP_2019_52148_67291.jpg

Marker for buried fiber optic cable on WS.

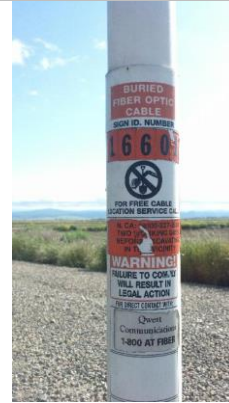
Photo 3 of 3 : UCIP_SP_2019_52148_67290.jpg

Marker for buried fiber optic cable on LS with contact information.

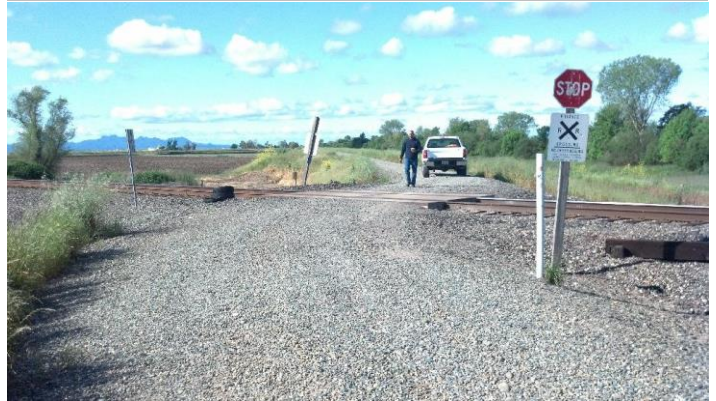
Photo 1 of 3 : UCIP_SP_2019_52149_67295.jpg

LM Start	9.67	Rating **	M	Issue No.	936 (cont)
LM End	9.67	Issue Type +	En	Location *

Overview of levee crown at crossing.

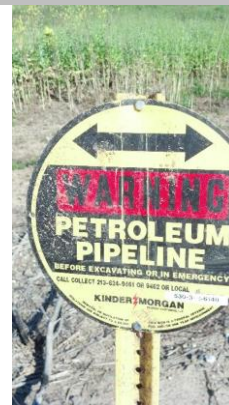
Photo 2 of 3 : UCIP_SP_2019_52149_67294.jpg

WS marker with utility contact information.

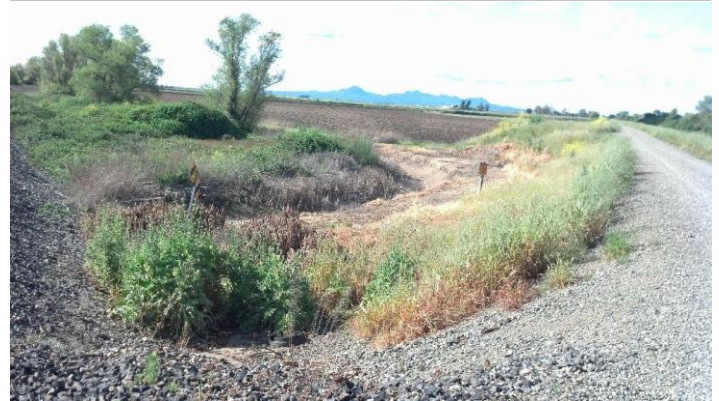
Photo 3 of 3 : UCIP_SP_2019_52149_67293.jpg

View of LS slope and marker.

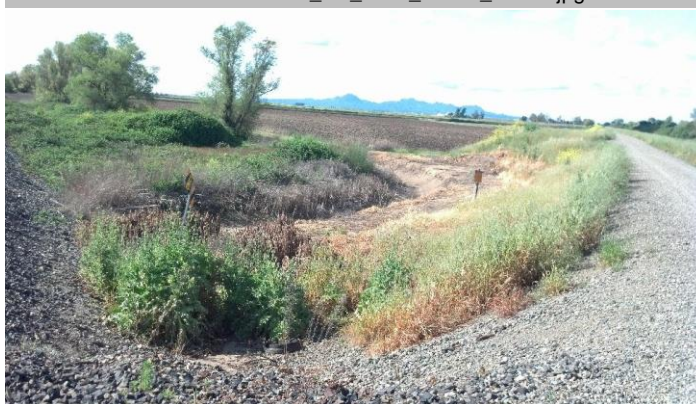
Photo 2 of 3 : UCIP_SP_2019_52150_67300.jpg

Marker located on LS.

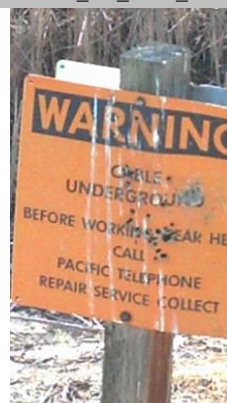
Photo 3 of 3 : UCIP_SP_2019_52150_67298.jpg

Underground cable marker with contact information.

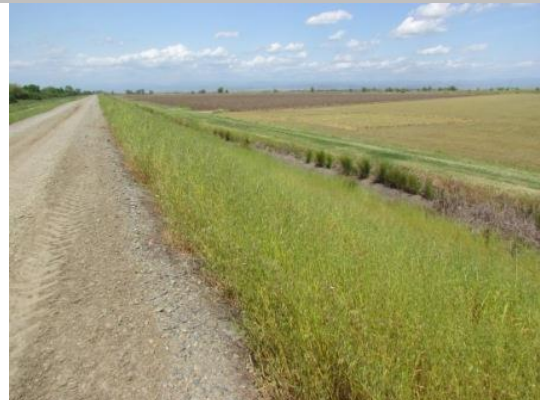
Photo 1 of 1 : SP_2019_MA0013_301_13_20190327_00004.jpg

LM Start	10.03	Rating **	M	Issue No.	13
LM End	10.52	Issue Type +	En	Location *	LS
Category	Earthen Levee			GPS Latitude/Longitude	
				Start	End
Item	Encroachments			39.471517 °	39.465113 °
				-121.739433 °	-121.743592 °
DWR ID	DWR_MA0013_02_s_ 2012_13				
Comment Code					
DT : Ditch					
Inspector Comment

View of the agricultural ditch along the toe.

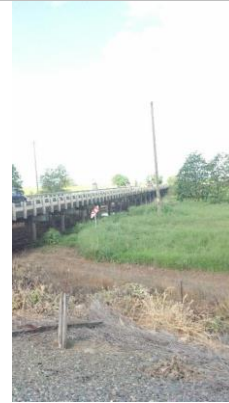
Photo 1 of 1 : UCIP_SP_2019_52153_67334.jpg

Comment Code					
Inspector Comment					
FS_ID:52153 DS_ID:16472 EP_NO: 10939 Repair Type: Non-Urgent Crossing Status: Indicator Found UCIP Comments: 6/5/2017 Pole still present. (DWR Sutter Yard-AFreitag)11/17/2016 Pole still present within channel. (DWR Sutter Yard- AFreitag)4/26/2016 Pole within the channel not removed per permit description.6/30/2015 same as last inspection.5/28/2014 Same as last inspection.12/4/2013 Same as last inspection.7/08/2013 Same as last inspection.4/24/2012 According to permit the existing pole and buried cable in the overflow area were to be removed. Pole is present in the channel. FIELD_STRUCT_DESC: Reroute a buried wire across the left bank levee of Cherokee Canal at State Highway 162 Bridge abutment from that point to the downstream side of the bridge. From there the wire extends to the gaging station at the center of the bridge. The facility maintains service to the Department of Water Resources' Metering Station midspan of the bridge. (Permit No. 10939, 1976 - Pacific Telephone and Telegraph Company [PT&T]) FS Date: 6/8/2017 8:52:41 AM

Pole within the channel was not removed.

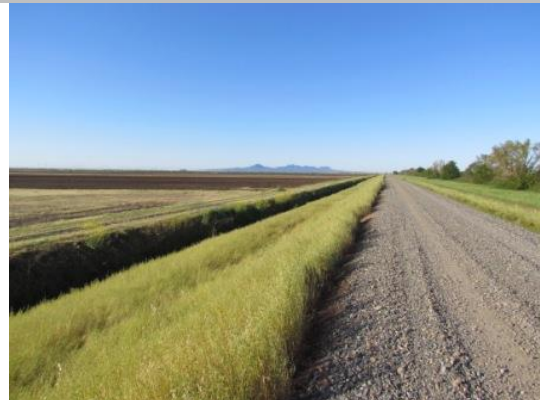
Photo 1 of 1 : SP_2019_MA0013_301_18_20190327_00005.jpg

LM Start	10.59	Rating **	M	Issue No.	18
LM End	11.66	Issue Type +	En	Location *	LS
Category	Earthen Levee			GPS Latitude/Longitude	
				Start	End
Item	Encroachments			39.464305 °	39.450333 °
				-121.744172 °	-121.753157 °
DWR ID	DWR_MA0013_02_s_ 2012_18				
Comment Code					
DT : Ditch					
Inspector Comment

View of the agricultural ditch along the toe.

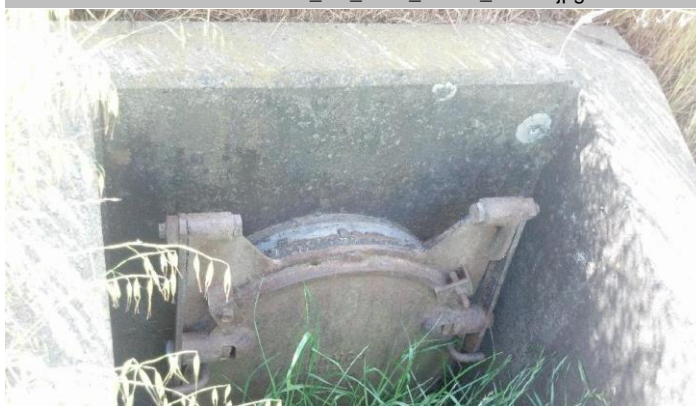
Photo 3 of 3 : UCIP_SP_2019_52156_67342.jpg

FS_ID:52156
DS_ID:16376
EP_NO: N/A
Repair Type: Non-Urgent
Crossing Status: Found
UCIP Comments: 5/30/2017 LS pipe end is buried and location unknown. WS flap gate is bolted shut. Pipe has been selected to be internally cleaned and inspected as part of the DMP project. (DWR Sutter Yard- AFreitag)11/17/2016 Unable to locate LS pipe end. WS flap gate bolted shut. (DWR Sutter Yard- AFreitag)4/26/2016 LS inlet appears to be buried as could not locate it. WS flap gate was bolted shut. This appears to be an abandoned crossing.6/30/2015 Still unable to locate the LS pipe end. 5/28/2014 Same as last inspection.12/4/2013 Same as last inspection. WS flapgate was bolted shut to keep LS ricefield flooded.7/08/2013 WS slope has been cleared of vegetation and is in good condition. LS slope also cleared of vegetation but still very dense on LS toe and unable to locate LS headwall.4/24/2012 Could not find LS end of pipe. Limited inspection on WS and LS slopes and toe due to dense vegetation. Need photos of cleared WS and LS slopes, and LS headwall during next inspection. This crossing was listed in the USACE Periodic Inspection report as Corp's inspect ID# USACE_CESPK_M13E_2011_p_0011 for WS gate blocked by vegetation.

View of WS headwall and flap gate.

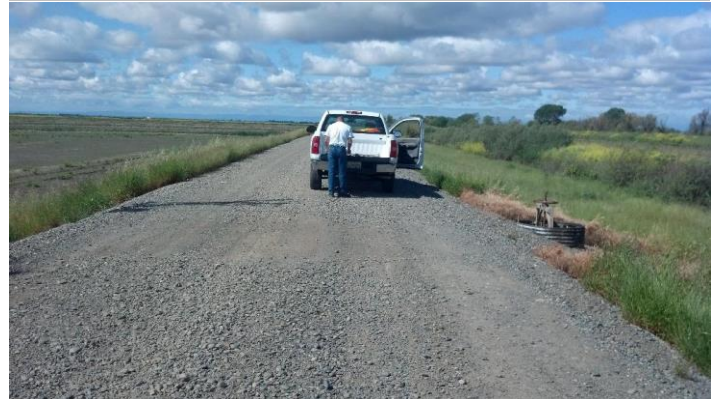
Photo 1 of 3 : UCIP_SP_2019_52158_67353.jpg

FS_ID:52158
DS_ID:16377
EP_NO: N/A
Repair Type: Non-Urgent
Crossing Status: Found
UCIP Comments: 5/30/2017 LS headwall was mostly buried and pipe end over 50% full of sediment. WS distribution box appears to have not been repaired yet but it does not seem to affect the integrity of the levee. (DWR Sutter Yard- A Freitag)11/17/2016 LS pipe end was about 50% plugged with soil. WS riser box is still cracked and appears to still be leaking. (DWR Sutter Yard- A Freitag)4/26/2016 LS headwall was dry and photographed. LS pipe end was about 50% plugged with soil. WS riser box is still cracked and appears to still be leaking.6/30/2015 Bee boxes stacked near the riser box on WS so could not get close enough to see if the leak issue had been fixed.

5/28/2014 Water appears to be leaking out of the WS concrete riser box. Causing minor erosion under pipe near pump structure.12/4/2013 Same as last inspection.7/08/2013 LS slope has been cleared of vegetation and is in good condition. LS headwall was underwater and unable to be inspected. All WS appurtenances in good condition.4/24/2012 Limited inspection on LS slope due to dense vegetation. Need photos of cleared LS slope and LS headwall. Cracks in riser box. New pump installed recently this work might be covered under separate permit.

Overview of levee crown.

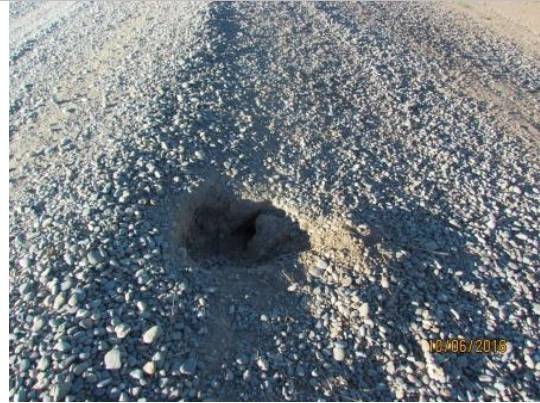
Photo 1 of 1 : SP_2019_MA0013_301_54_20190327_00010.jpg

LM Start	16.52	Rating **	M	Issue No.	54
LM End	16.52	Issue Type +	Ma	Location *	WS
Category	Earthen Levee			GPS Latitude/Longitude	
				Start	End
Item	Animal Control			39.409548 °	39.409548 °
				-121.789668 °	-121.789668 °
DWR ID	DWR_MA0013_02_f_2014_54				
Comment Code					
A3 : No rodents visible, but rodent burrows visible; need to backfill and compact or grout burrows.					
Inspector Comment

View of the rodent holes along the waterside slope.

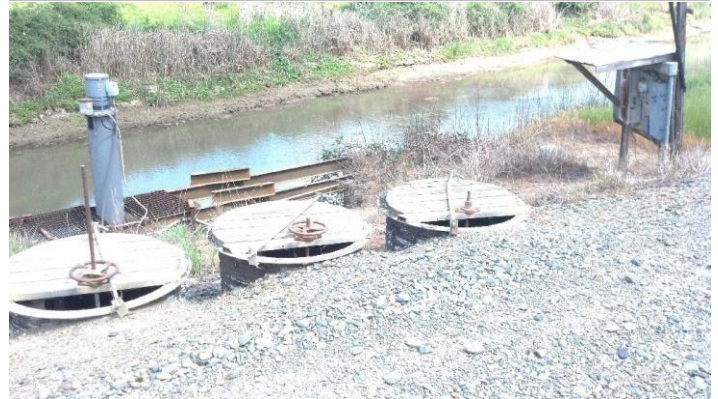
Photo 1 of 3 : UCIP_SP_2019_53320_67406.jpg

FS_ID:53320
DS_ID:16383
EP_NO: N/A
Repair Type: Urgent
Crossing Status: Found
UCIP Comments: 8/23/2018 The CVFPB has filed an enforcement for this crossing, Enforcement Case: 2018-723. There is still massive erosion around the WS headwall and corrosion and degradation of the LS outlet pipes, so the crossing remains Urgent (D. Sanoski - DWR UCIP).5/30/2017 No repairs have been made here yet. WS still has depressions above the pipe alignment. LS pipe end still showing heavy signs of rusting and deterioration. Sediment build up inside of concrete distribution box on the LS. (DWR Sutter Yard - AFreitag)11/17/2016 Crossing has not been repaired yet. pipe ends still showing heavy signs of rust and corrosion. (DWR Sutter Yard - AFreitag)4/26/2016 No repairs have been made at this crossing yet. (DWR Sutter Yard - AFreitag)6/30/2015 Crossing has not been repaired yet. pipe ends still showing heavy signs of rust and corrosion. (DWR Sutter Yard - AFreitag)5/28/2014 Same as last inspection. (DWR Sutter Yard - afreitag)12/4/2013 Same as last inspection. (DWR Sutter Yard - afreitag)7/8/2013 Same as last inspection. (DWR Sutter Yard - afreitag)4/19/2012 LS pipe collars severely damaged--section missing at flapgate. Buried section of pipe could be in the same condition. Crossing needs to be repaired; will need to coordinate with applicant. WS slide gate handle missing. (DWR UCIP - omagana) FIELD_STRUCT_DESC: 1 of 3: 16-inch steel irrigation pipe encased in reinforced concrete through the levee, 9.7 feet below the crown. Concrete "U" headwall on both ends. Slide gates on corrugated metal pipe risers on the waterside (WS) slope. Pump structure on the WS end. [Additional Reference(s): DWR Levee Log, 1993. USACE Sacramento O&M Manual 519, June 1962 (HLM 21.00)]

Corrugated metal pipe risers with slide gates located on WS slope.

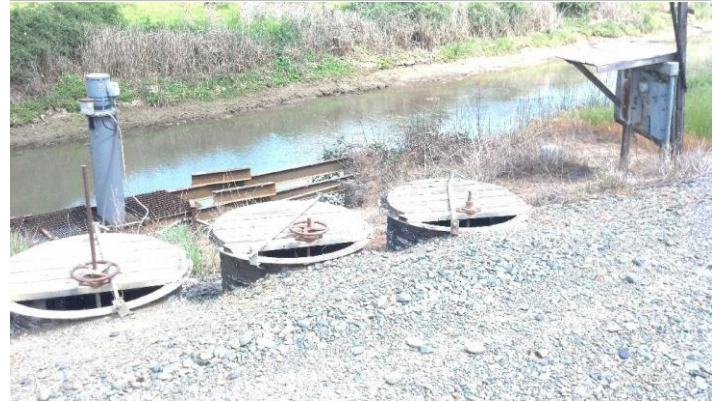
Photo 1 of 3 : UCIP_SP_2019_53321_67416.jpg

FS_ID:53321
DS_ID:17014
EP_NO: N/A
Repair Type: Urgent
Crossing Status: Found
UCIP Comments: 8/23/2018 The CVFPB has filed an enforcement for this crossing, Enforcement Case: 2018-723. There is still massive erosion around the WS headwall and corrosion and degradation of the LS outlet pipes, so the crossing remains Urgent (D. Sanoski - DWR UCIP).5/30/2017 No repairs have been made here yet. WS still has depressions above the pipe alignment. LS pipe end still showing heavy signs of rusting and deterioration. Sediment build up inside of concrete distribution box on the LS. (DWR Sutter Yard - AFreitag)11/17/2016 Crossing has not been repaired yet. pipe ends still showing heavy signs of rust and corrosion. (DWR Sutter Yard - AFreitag)4/26/2016 No repairs have been made at this crossing yet. (DWR Sutter Yard - afreitag)6/30/2015 Crossing has not been repaired yet. pipe ends still showing heavy signs of rust and corrosion. (DWR Sutter Yard - afreitag)5/28/2014 Same as last inspection. (DWR Sutter Yard - afreitag)12/4/2013 Same as last inspection. (DWR Sutter Yard - afreitag)7/08/2013 Same as last inspection. (DWR Sutter Yard - afreitag)4/24/2012 LS pipe collars severely damaged--section missing at flapgate. Crossing needs repair. Will need to coordinate with owner. (DWR UCIP - omagana)

WS view of corrugated metal pipe risers .

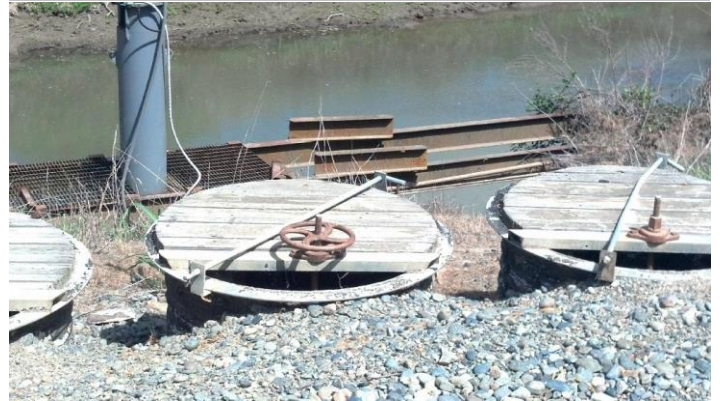
Photo 2 of 3 : UCIP_SP_2019_53321_67418.jpg

Item	DWR UCIP Field Study			39.370679 °	39.370679 °	
				-121.850500 °	-121.850500 °	
DWR ID	17014					
Comment Code						
Inspector Comment						
FS_ID:53321 DS_ID:17014 EP_NO: N/A Repair Type: Urgent Crossing Status: Found UCIP Comments: 8/23/2018 The CVFPB has filed an enforcement for this crossing, Enforcement Case: 2018-723. There is still massive erosion around the WS headwall and corrosion and degradation of the LS outlet pipes, so the crossing remains Urgent (D. Sanoski - DWR UCIP).5/30/2017 No repairs have been made here yet. WS still has depressions above the pipe alignment. LS pipe end still showing heavy signs of rusting and deterioration. Sediment build up inside of concrete distribution box on the LS. (DWR Sutter Yard - AFreitag)11/17/2016 Crossing has not been repaired yet. pipe ends still shoowing heavy signs of rust and corrosion. (DWR Sutter Yard - AFreitag)4/26/2016 No repairs have been made at this crossing yet. (DWR Sutter Yard - afreitag)6/30/2015 Crossing has not been repaired yet. pipe ends still showing heavy signs of rust and corrosion. (DWR Sutter Yard - afreitag)5/28/2014 Same as last inspection. (DWR Sutter Yard - afreitag)12/4/2013 Same as last inspection. (DWR Sutter Yard - afreitag)7/08/2013 Same as last inspection. (DWR Sutter Yard - afreitag)4/24/2012 LS pipe collars severely damaged--section missing at flapgate. Crossing needs repair. Will need to coordinate with owner. (DWR UCIP - omagana) FIELD_STRUCT_DESC: 2 of 3: 16-inch steel irrigation pipe encased in reinforced concrete through the levee, 9.7 feet below the crown. Concrete "U" headwall on both ends. Slide gates on corrugated metal pipe risers on the waterside (WS) slope. Pump structure on the WS end. [Additional Reference(s): DWR Levee Log, 1993. USACE Sacramento O&M Manual 519, June 1962 (HLM 21.00)] FS Date: 8/23/2018 9:50:00 AM

Riser for pipe 2 of 3.

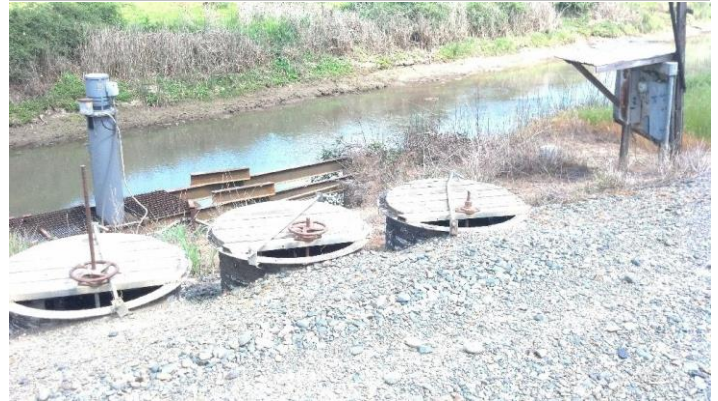
Photo 1 of 3 : UCIP_SP_2019_53322_67441.jpg

FS_ID:53322
DS_ID:17185
EP_NO: N/A
Repair Type: Urgent
Crossing Status: Found
UCIP Comments: 8/23/2018 The CVFPB has filed an enforcement for this crossing, Enforcement Case: 2018-723. There is still massive erosion around the WS headwall and corrosion and degradation of the LS outlet pipes, so the crossing remains Urgent (D. Sanoski - DWR UCIP).5/30/2017 No repairs have been made here yet. WS still has depressions above the pipe alignment. LS pipe end still showing heavy signs of rusting and deterioration. Sediment build up inside of concrete distribution box on the LS. (DWR Sutter Yard - AFreitag)11/17/2016 Crossing has not been repaired yet. pipe ends still showing heavy signs of rust and corrosion. (DWR Sutter Yard - AFreitag)4/26/2016 No repairs have been made at this crossing yet. (DWR Sutter Yard - afreitag)6/30/2015 Crossing has not been repaired yet. pipe ends still showing heavy signs of rust and corrosion. (DWR Sutter Yard - afreitag)5/28/2014 Same as last inspection. (DWR Sutter Yard - afreitag)12/4/2013 Same as last inspection. (DWR Sutter Yard - afreitag)7/08/2013 Same as last inspection. (DWR Sutter Yard - afreitag)4/24/2012 Sink hole present on WS. LS pipe collars severely damaged--section missing at flapgate. Crossing needs repair. Need to coordinate with owner. (DWR UCIP - omagana)

View of corrugated metal risers located on WS.

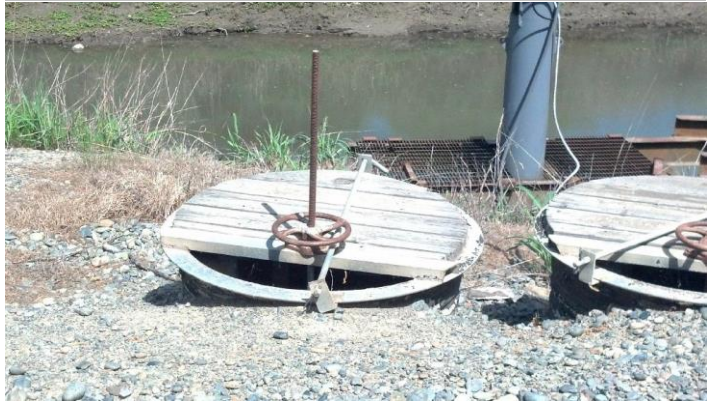
Photo 2 of 3 : UCIP_SP_2019_53322_67443.jpg

FS_ID:53322
DS_ID:17185
EP_NO: N/A
Repair Type: Urgent
Crossing Status: Found
UCIP Comments: 8/23/2018 The CVFPB has filed an enforcement for this crossing, Enforcement Case: 2018-723. There is still massive erosion around the WS headwall and corrosion and degradation of the LS outlet pipes, so the crossing remains Urgent (D. Sanoski - DWR UCIP).5/30/2017 No repairs have been made here yet. WS still has depressions above the pipe alignment. LS pipe end still showing heavy signs of rusting and deterioration. Sediment build up inside of concrete distribution box on the LS. (DWR Sutter Yard - AFreitag)11/17/2016 Crossing has not been repaired yet. pipe ends still shwoing heavy signs of rust and corrosion. (DWR Sutter Yard - AFreitag)4/26/2016 No repairs have been made at this crossing yet. (DWR Sutter Yard - afreitag)6/30/2015 Crossing has not been repaired yet. pipe ends still shwoing heavy signs of rust and corrosion. (DWR Sutter Yard - afreitag)5/28/2014 Same as last inspection. (DWR Sutter Yard - afreitag)12/4/2013 Same as last inspection. (DWR Sutter Yard - afreitag)7/08/2013 Same as last inspection. (DWR Sutter Yard - afreitag)4/24/2012 Sink hole present on WS. LS pipe collars severely damaged--section missing at flapgate. Crossing needs repair. Need to coordinate with owner. (DWR UCIP - omagana)

View of corrugated metal pipe for pipe 3 of 3.

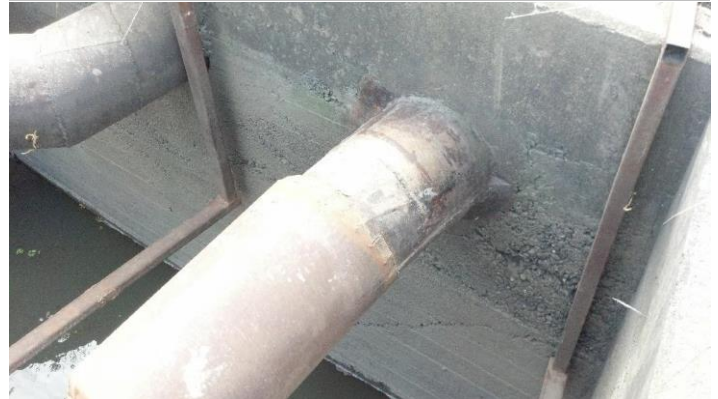
Photo 3 of 3 : UCIP_SP_2019_53322_67442.jpg

FS_ID:53322
DS_ID:17185
EP_NO: N/A
Repair Type: Urgent
Crossing Status: Found
UCIP Comments: 8/23/2018 The CVFPB has filed an enforcement for this crossing, Enforcement Case: 2018-723. There is still massive erosion around the WS headwall and corrosion and degradation of the LS outlet pipes, so the crossing remains Urgent (D. Sanoski - DWR UCIP).5/30/2017 No repairs have been made here yet. WS still has depressions above the pipe alignment. LS pipe end still showing heavy signs of rusting and deterioration. Sediment build up inside of concrete distribution box on the LS. (DWR Sutter Yard - AFreitag)11/17/2016 Crossing has not been repaired yet. pipe ends still shwoing heavy signs of rust and corrosion. (DWR Sutter Yard - AFreitag)4/26/2016 No repairs have been made at this crossing yet. (DWR Sutter Yard - afreitag)6/30/2015 Crossing has not been repaired yet. pipe ends still shwoing heavy signs of rust and corrosion. (DWR Sutter Yard - afreitag)5/28/2014 Same as last inspection. (DWR Sutter Yard - afreitag)12/4/2013 Same as last inspection. (DWR Sutter Yard - afreitag)7/08/2013 Same as last inspection. (DWR Sutter Yard - afreitag)4/24/2012 Sink hole present on WS. LS pipe collars severely damaged--section missing at flapgate. Crossing needs repair. Need to coordinate with owner. (DWR UCIP - omagana)

View of Pipe 3 of 3 from WS headwall.

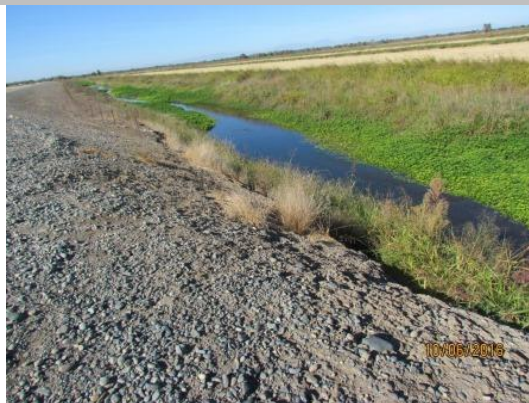
Photo 1 of 1 : SP_2019_MA0013_301_75_20190327_00018.jpg

LM Start	20.77	Rating **	M	Issue No.	75
LM End	20.77	Issue Type +	Ma	Location *	WS
Category	Earthen Levee			GPS Latitude/Longitude	
				Start	End
Item	Erosion / Bank Caving			39.370641 °	39.370641 °
				-121.850572 °	-121.850572 °
DWR ID	DWR_MA0013_02_f_2016_75				
Comment Code					
E2 : Schedule repair of erosion site prior to the next inspection.					
Inspector Comment

View of the erosion along the waterside toe.

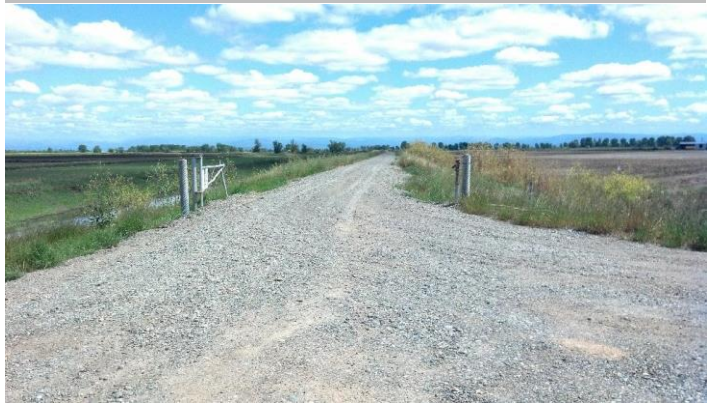
Photo 1 of 3 : UCIP_SP_2019_52170_67462.jpg

Overview of crossing looking upstream at the left bank of Cherokee Canal.

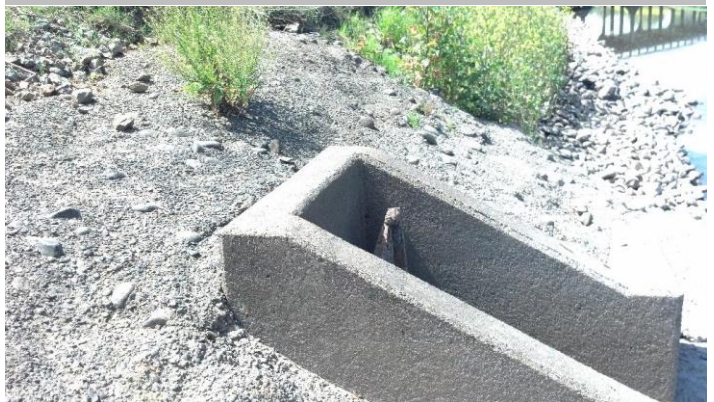
Photo 2 of 3 : UCIP_SP_2019_52170_67460.jpg

View of WS headwall.

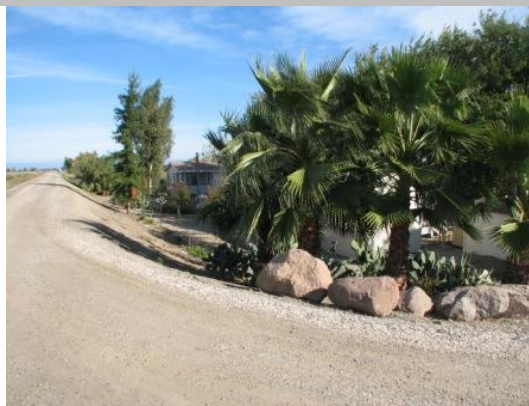
Photo 1 of 1 : SP_2019_MA0013_301_4_20190327_00001.jpg

LM Start	22.07	Rating **	M	Issue No.	4
LM End	22.13	Issue Type +	En	Location *	LS
Category	Earthen Levee			GPS Latitude/Longitude	
				Start	End
Item	Vegetation			39.360410 °	39.359920 °
				-121.871125 °	-121.872067 °
DWR ID	DWR_MA0013_02_s_2012_4				
Comment Code					
V6 : Landscaping					
Inspector Comment

View of landscaping along the toe.

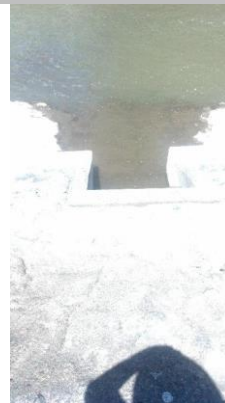
Photo 2 of 3 : UCIP_SP_2019_52175_67496.jpg

View of WS slope looking from WS headwall to levee crown.
