**Flood Control Project Maintenance
Levee Inspections
LMA District Cover Sheet**

Sutter Maintenance Yard Maintenance Area 0013

Waterway			Bank	Unit Miles
Unit No. 01 Cherokee Canal			Right	18.19
	Spring (March - May)	Summer (June - August)	(September - November) Fall	Winter (December - February)
Unit Maintenance Rating (Fall Only)				
Date of Inspection	3/24/2021 - 3/24/2021			
DWR Inspector	Makar Sokol			
Accompanied By	Bob Duffey Sutter Maintenance Yard

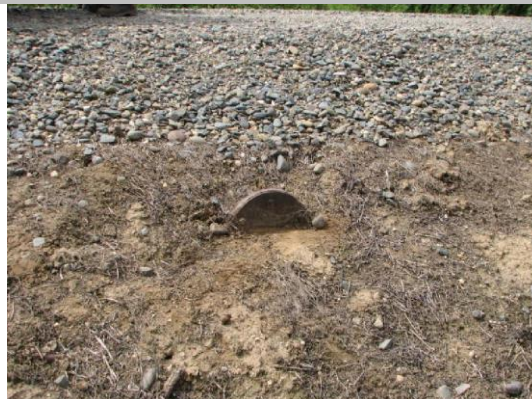
Photo 2 of 3 : UCIP_SP_2021_57515_66684.jpg

Comment Code						
Inspector Comment						
FS_ID:57515 DS_ID:16342 EP_NO: 12129 Repair Type: Non-Urgent Crossing Status: Found UCIP Comments: 08/06/2019 Need to contact owner to address proper abandonment per Title 23. Owner will need to coordinate with CVFPB. (O. Magana - DWR UCIP, A. Freitag - DWR Sutter Yard)06/14/2017 Abandoned- needs to be done properly. (A. Freitag - DWR Sutter Yard)11/16/2016 Abandoned. WS end still has plate bolted on. (A. Freitag - DWR Sutter Yard)04/28/2016 Crossing still has plate bolted on it at the WS end and LS end was mostly buried. (A. Freitag - DWR Sutter Yard)07/14/2015 WS pipe end still had plate bolted on it. (A. Freitag - DWR Sutter Yard)05/21/2014 Same as last inspection. (A. Freitag - DWR Sutter Yard)12/02/2013 Same as last inspection. (A. Freitag - DWR Sutter Yard)07/10/2013 Same as last inspection. (A. Freitag - DWR Sutter Yard)04/12/2012 WS pipe daylight has bolted plate. (O. Magana - DWR UCIP) FIELD_STRUCT_DESC: 6-inch steel irrigation pipe through the levee, 2.4 feet below the crown. Steel plate bolted on the waterside (WS) end. (5-inch water pipe authorized under Permit No. 12129, 12129A, 1977 - John & Jerie Malina) [Additional Reference(s): DWR Levee Log, 1993 (HLM 0.52)] FS Date: 8/6/2019 8:35:00 AM

LM Start	0.50	Rating **	M	Issue No.	4 (cont)
LM End	0.50	Issue Type +	En	Location *	
Category	Supplemental		GPS Latitude/Longitude		
			Start	End	
Item	DWR UCIP Field Study		39.590968 °	39.590968 °	
			-121.701240 °	-121.701240 °	
DWR ID	16342

WS-Bolted plate

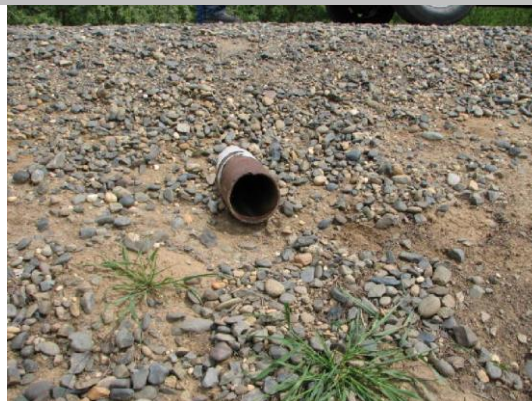
Photo 3 of 3 : UCIP_SP_2021_57515_66685.jpg

LS-Outlet

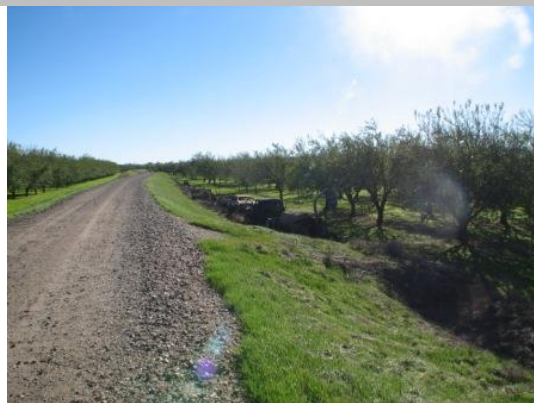
Photo 1 of 1 : SP_2021_MA0013_300_12_20210224_00003.jpg

LM Start	0.73	Rating **	M	Issue No.	12
LM End	0.76	Issue Type +	En	Location *	LS
Category	Earthen Levee			GPS Latitude/Longitude	
				Start	End
Item	Encroachments			39.587905 °	39.587505 °
				-121.700822 °	-121.700880 °
DWR ID	DWR_MA0013_01_s_2012_12				
Comment Code					
EQ : Equipment					
Inspector Comment					
Remove the equipment from the landside toe.

View of the equipment along the landside toe of the levee.

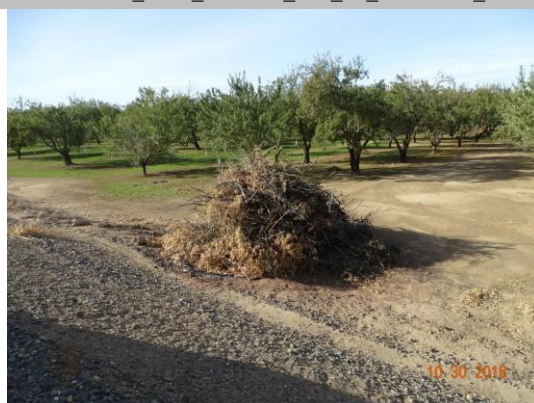
Photo 1 of 1 : SP_2021_MA0013_300_61_20210224_00007.jpg

LM Start	0.83	Rating **	M	Issue No.	61
LM End	0.83	Issue Type +	En	Location *	LS
Category	Earthen Levee			GPS Latitude/Longitude	
				Start	End
Item	Encroachments			39.586417 °	39.586417 °
				-121.700585 °	-121.700585 °
DWR ID	DWR_MA0013_01_f _ 2018_61				
Comment Code					
PR : Prunings					
Inspector Comment					
Remove the prunings from the landside slope.

View of the prunings along the landside slope.

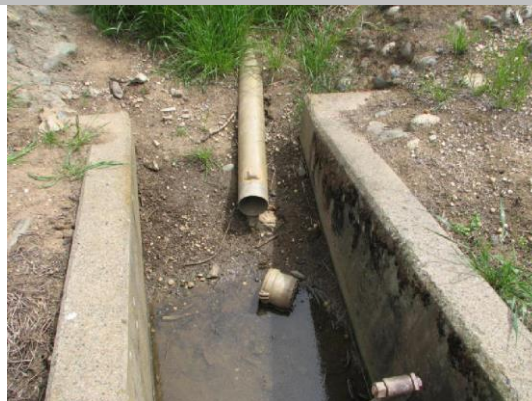
Photo 3 of 3 : UCIP_SP_2021_58576_66687.jpg

View of WS with pipe in channel.

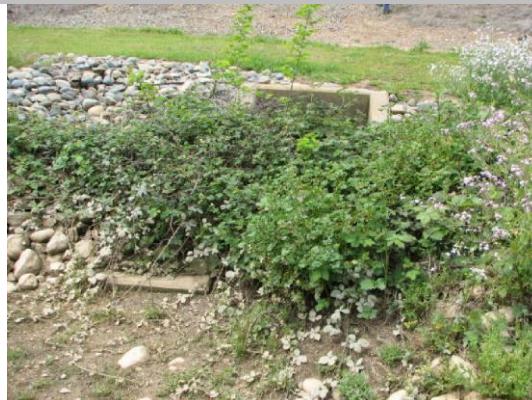
Photo 3 of 3 : UCIP_SP_2021_58462_66698.jpg

WS headwall, rock protection, and outlet blocked by shrub.

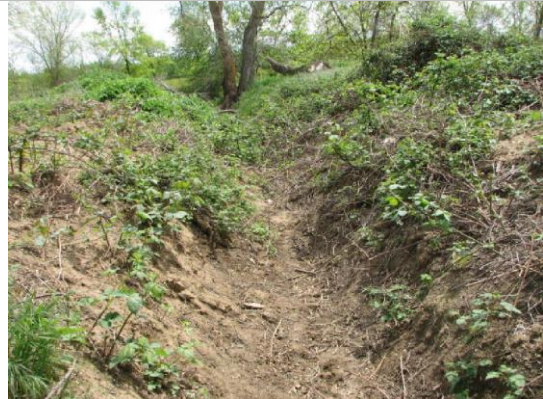
Photo 3 of 3 : UCIP_SP_2021_58465_66711.jpg

View of channel.

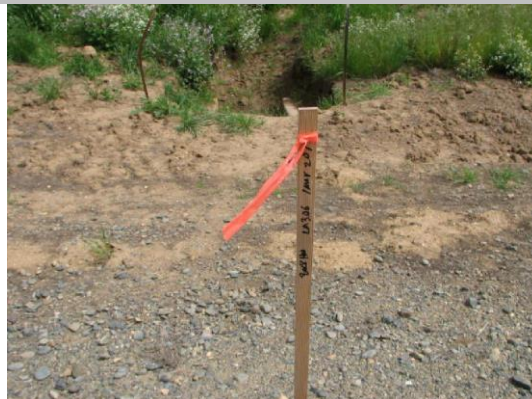
Photo 2 of 3 : UCIP_SP_2021_58466_66716.jpg

LM Start	3.05	Rating **	M	Issue No.	17 (cont)	
LM End	3.05	Issue Type +	Ma	Location *		
Category	Supplemental			GPS Latitude/Longitude		
				Start		End
Item	DWR UCIP LMA Responsibility			39.556310 °	39.556310 °	
				-121.706470 °	-121.706470 °	
DWR ID	17372

WS levee slope.

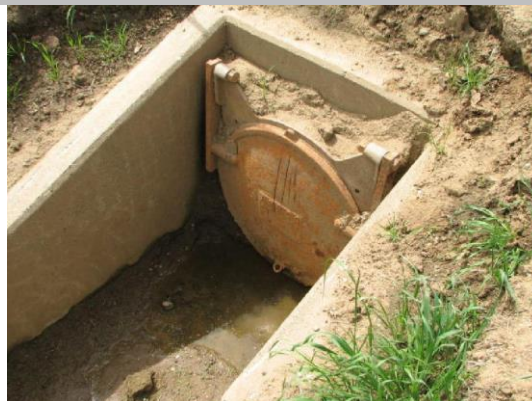
Photo 3 of 3 : UCIP_SP_2021_58466_66720.jpg

Flap gate on waterside.

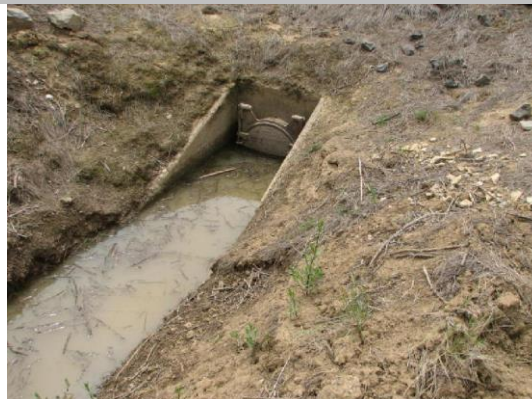
Photo 2 of 3 : UCIP_SP_2021_58578_66730.jpg

LM Start	3.27	Rating **	M	Issue No.	20 (cont)
LM End	3.27	Issue Type +	Ma	Location *	
Category	Supplemental			GPS Latitude/Longitude	
				Start	End
Item	DWR UCIP LMA Responsibility			39.553129 °	39.553129 °
				-121.706640 °	-121.706640 °
DWR ID	16350

View of WS flap gate.

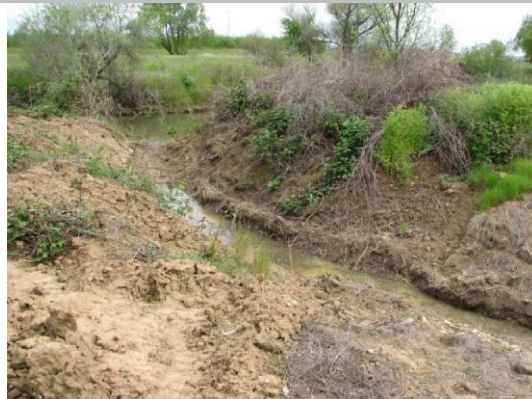
Photo 3 of 3 : UCIP_SP_2021_58578_66732.jpg

Sedimentation cleared on WS.

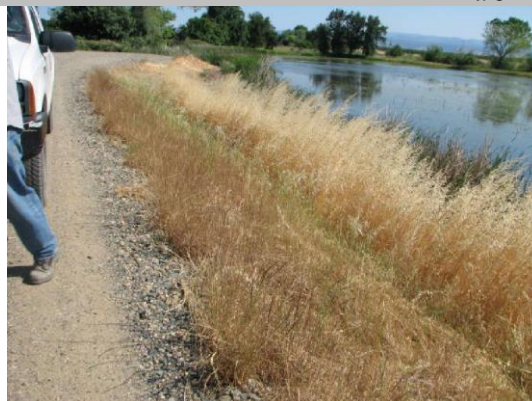
Photo 2 of 3 : UCIP_SP_2021_58469_66738.jpg

WS slope covered by dense vegetation.

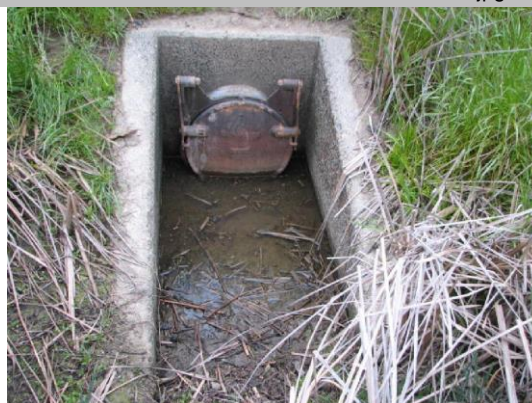
Photo 3 of 3 : UCIP_SP_2021_58469_66735.jpg

WS flap gate

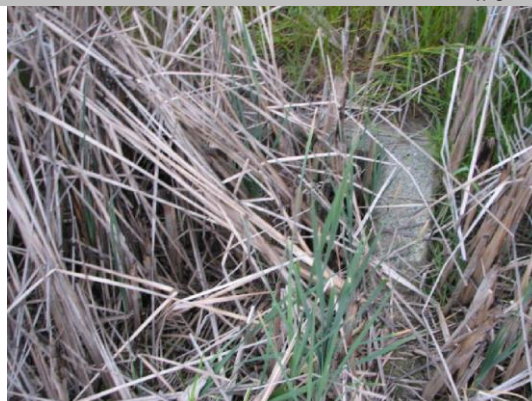
Photo 2 of 3 : UCIP_SP_2021_58470_66741.jpg

WS flap gate blocked by debris.

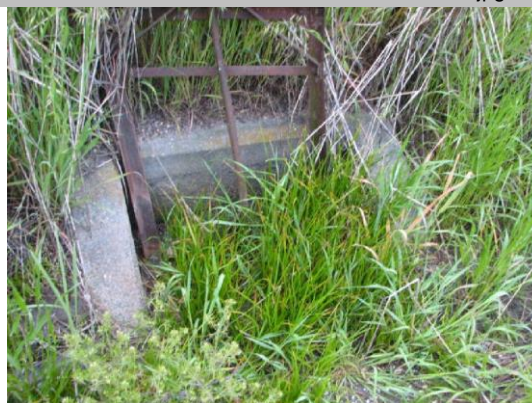
Photo 3 of 3 : UCIP_SP_2021_58470_66742.jpg

LS slide gate covered with silt. Slide gate is bent.

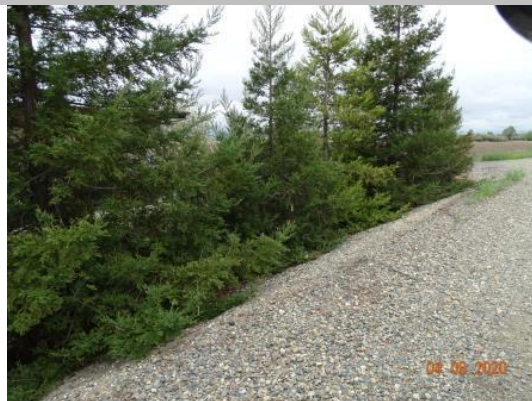
Photo 1 of 1 : SP_2021_MA0013_300_18_20210224_00004.jpg

LM Start	4.06	Rating **	M	Issue No.	18
LM End	4.13	Issue Type +	En	Location *	LS
Category	Earthen Levee			GPS Latitude/Longitude	
				Start	End
Item	Vegetation			39.541660 °	39.540651 °
				-121.707408 °	-121.707404 °
DWR ID	DWR_MA0013_01_s_2013_18				
Comment Code					
V6 : Landscaping					
Inspector Comment

View of the trees along the landside slope. Spring 2020.

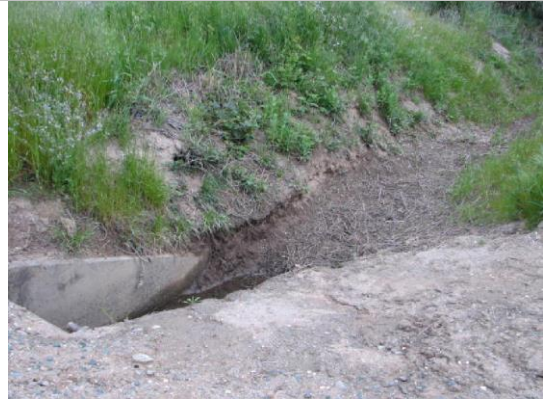
Photo 3 of 3 : UCIP_SP_2021_58471_66750.jpg

View of WS.

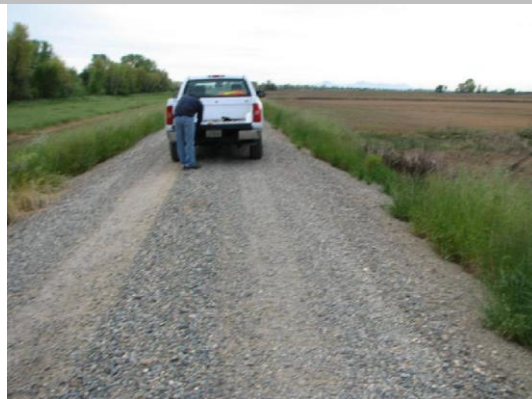
Photo 1 of 3 : UCIP_SP_2021_58472_66756.jpg

FS_ID:58472
DS_ID:16355
EP_NO: N/A
Repair Type: Non-Urgent
Crossing Status: Found
UCIP Comments: 08/26/2019 Record has been updated from No Action Needed to Non-Urgent, no permit has been identified for this pipe. Pipe is scheduled to be lined. (O. Magana - DWR UCIP, A. Freitag - DWR Sutter Yard)06/14/2017 WS flap gate is submerged and appears to be half buried by sediment. LS slide gate is fully submerged on the edge of the rice field. Pipe has been selected to be internally cleaned and inspected as part of the DMP project. (A. Freitag - DWR Sutter Yard) 11/16/2016 Crossing appears to be in good condition. (A. Freitag - DWR Sutter Yard)04/28/2016 Crossing appears to be in good condition. (A. Freitag - DWR Sutter Yard)07/13/2015 LS screw gate was completely submerged but crossing appears to be in good condition. (A. Freitag - DWR Sutter Yard)05/21/2014 Same as last inspection. (A. Freitag - DWR Sutter Yard)12/02/2013 Same as last inspection. (A. Freitag - DWR Sutter Yard)07/15/2013 No signs of burrowing activity on this inspection. (A. Freitag - DWR Sutter Yard)04/18/2012 Burrow activity near crossing, burrow holes present on WS slope. (O. Magana - DWR UCIP)

Overview of levee crown at crossing looking downstream at right bank of Cherokee Canal.

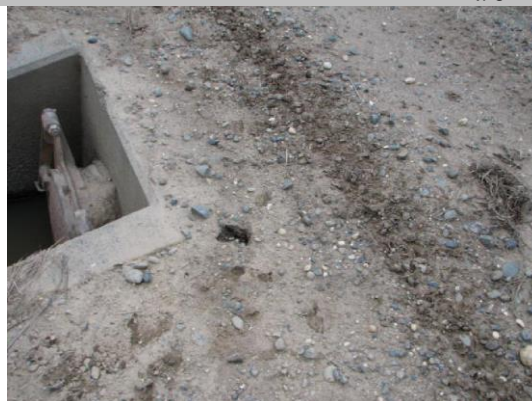
Photo 2 of 3 : UCIP_SP_2021_58472_66758.jpg

Burrow activity on WS slope.

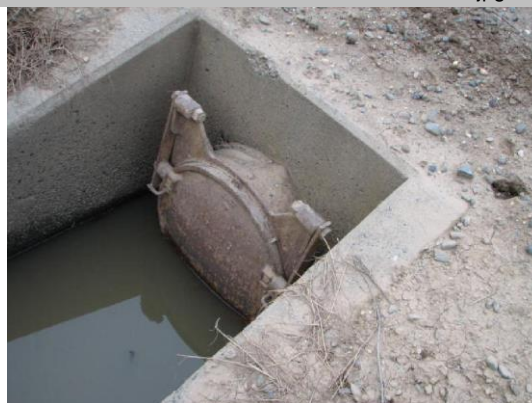
Photo 3 of 3 : UCIP_SP_2021_58472_66755.jpg

View of WS flap gate.

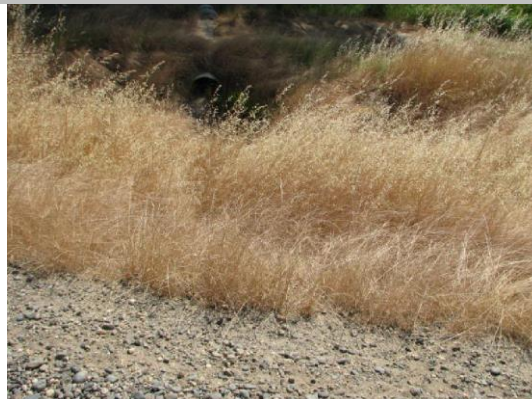
Photo 2 of 3 : UCIP_SP_2021_58579_66765.jpg

View of WS slope and channel.

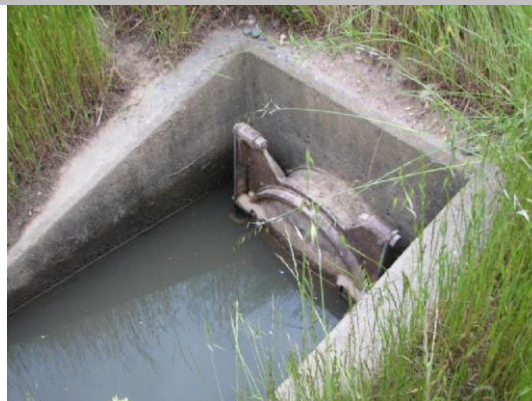
Photo 3 of 3 : UCIP_SP_2021_58579_66768.jpg

View of WS flap gate.

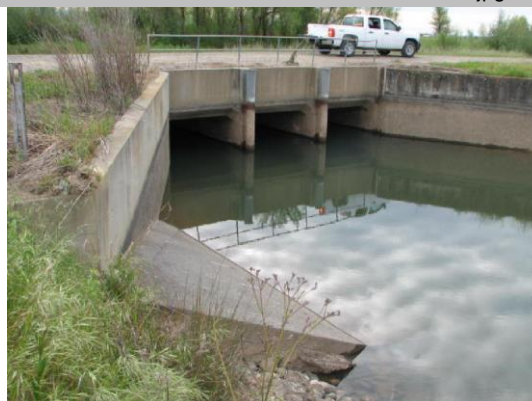
Photo 3 of 3 : UCIP_SP_2021_58475_66776.jpg

Siphon - LS. View of U/S wingwall.

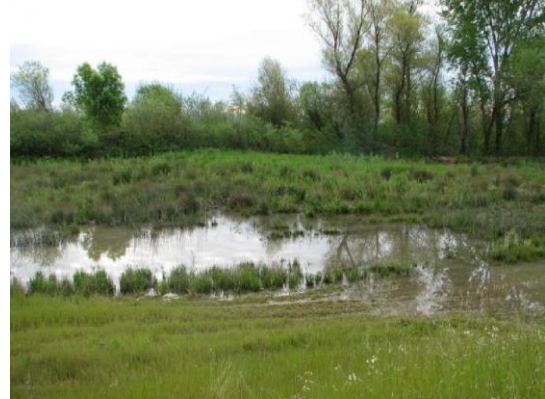
Photo 2 of 3 : UCIP_SP_2021_58476_66773.jpg

View of flood channel over siphon.

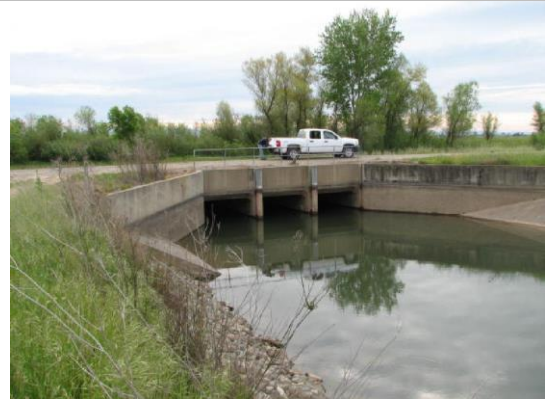
Photo 3 of 3 : UCIP_SP_2021_58476_66774.jpg

Comment Code						
Inspector Comment						
FS_ID:58476 DS_ID:17375 EP_NO: N/A Repair Type: Non-Urgent Crossing Status: Found UCIP Comments: 08/26/2019 Record has been updated from No Action Needed to Non-Urgent, no permit has been identified for this crossing. Western Canal Siphon was running during inspection. WS was dry and no signs of leaks were observed during inspection. No other issues were noted during inspection. (O. Magana - DWR UCIP, A. Freitag - DWR Sutter Yard)06/14/2017 Crossing appears to be in good condition. (A. Freitag - DWR Sutter Yard)11/16/2016 Crossing appears to be in good condition. (A. Freitag - DWR Sutter Yard)04/28/2016 Crossing appears to be in good condition. (A. Freitag - DWR Sutter Yard)07/13/2015 Crossing appears in good condition. No noticeable issues to report. (A. Freitag - DWR Sutter Yard)05/21/2014 Same as last inspection. (A. Freitag - DWR Sutter Yard)12/02/2013 Same as last inspection. (A. Freitag - DWR Sutter Yard)07/15/2013 Same as last inspection. (A. Freitag - DWR Sutter Yard) FIELD_STRUCT_DESC: [Western Canal Siphon] 2 of 3: 8-foot by 10-foot concrete irrigation conduit through the levee and channel. Top of concrete conduit, 4 feet below the crown. Conduit on the downstream end is closed off with a removable concrete flashboard. Concrete "U" headwall on the landside (LS) with slots for flashboards for other two openings. Guardrails around headwall. [Additional Reference(s): DWR Levee Log, 1993 (HLM 5.50). USACE Sacramento O&M Manual, Unit 519, June 1962, Revised 3 Feb 2011, (HLM 5.49), listed as three 8-foot by 10-foot concrete conduit, no as-built referenced found] FS Date: 8/26/2019 12:31:00 PM

LM Start	5.40	Rating **	M	Issue No.	29 (cont)
LM End	5.40	Issue Type +	En	Location *

View of LS structure.

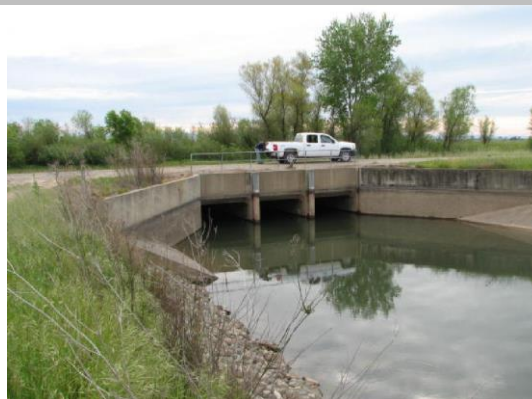
Photo 3 of 3 : UCIP_SP_2021_58477_66780.jpg

FS_ID:58477
DS_ID:17376
EP_NO: N/A
Repair Type: Non-Urgent
Crossing Status: Found
UCIP Comments: 08/26/2019 Record has been updated from No Action Needed to Non-Urgent, no permit has been identified for this crossing. Western Canal Siphon was running during inspection. WS was dry and no signs of leaks were observed during inspection. No other issues were noted during inspection. (O. Magana - DWR UCIP, A. Freitag - DWR Sutter Yard)06/14/2017 Crossing appears to be in good condition. (A. Freitag - DWR Sutter Yard)11/16/2016 Crossing appears to be in good condition. (A. Freitag - DWR Sutter Yard)04/28/2016 Crossing appears to be in good condition. (A. Freitag - DWR Sutter Yard)07/13/2015 Crossing appears in good condition. No noticeable issues to report. (A. Freitag - DWR Sutter Yard)05/21/2014 Same as last inspection. (A. Freitag - DWR Sutter Yard)07/15/2013 Same as last inspection. (A. Freitag - DWR Sutter Yard)12/02/2013 Same as last inspection. (A. Freitag - DWR Sutter Yard)

LM Start	5.40	Rating **	M	Issue No.	30 (cont)
LM End	5.40	Issue Type +	En	Location *

View of LS structure.

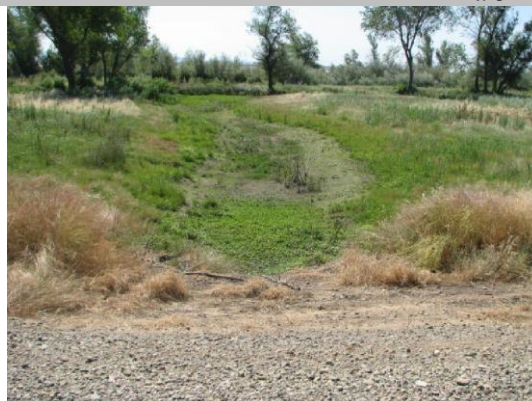
Photo 2 of 3 : UCIP_SP_2021_58478_66794.jpg

LM Start	5.63	Rating **	M	Issue No.	31 (cont)
LM End	5.63	Issue Type +	Ma	Location *	
Category	Supplemental		GPS Latitude/Longitude		
			Start	End	
Item	DWR UCIP LMA Responsibility		39.519212 °	39.519212 °	
			-121.709030 °	-121.709030 °	
DWR ID	16359

View of WS slope and toe.

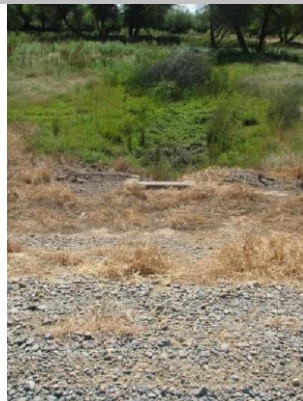
Photo 2 of 3 : UCIP_SP_2021_58480_66806.jpg

LM Start	6.23	Rating **	M	Issue No.	33 (cont)
LM End	6.23	Issue Type +	Ma	Location *	
Category	Supplemental		GPS Latitude/Longitude		
			Start	End	
Item	DWR UCIP LMA Responsibility		39.511337 °	39.511337 °	
			-121.713620 °	-121.713620 °	
DWR ID	16361

View of WS slope and toe.

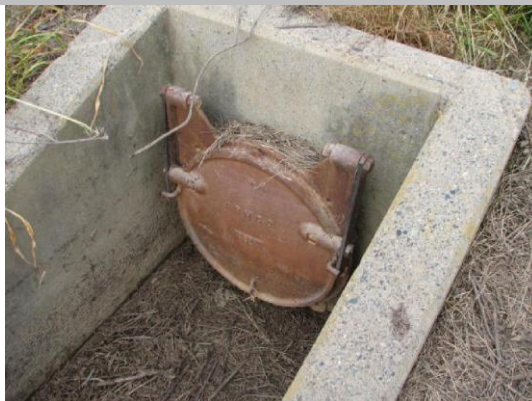
Photo 3 of 3 : UCIP_SP_2021_58480_66804.jpg

LM Start	6.23	Rating **	M	Issue No.	33 (cont)
LM End	6.23	Issue Type +	Ma	Location *

View of WS flap gate.

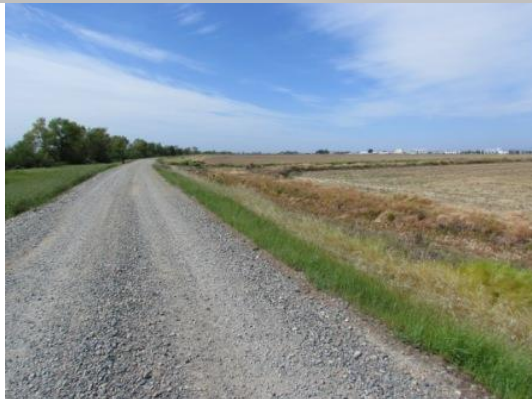
Photo 1 of 1 : SP_2021_MA0013_300_3_20210224_00001.jpg

LM Start	6.41	Rating **	M	Issue No.	3
LM End	6.99	Issue Type +	En	Location *	LS
Category	Earthen Levee			GPS Latitude/Longitude	
				Start	End
Item	Encroachments			39.508928 °	39.501438 °
				-121.714842 °	-121.719715 °
DWR ID	DWR_MA0013_01_s_2012_3				
Comment Code					
DT : Ditch					
Inspector Comment

View of the agricultural ditch along the toe.

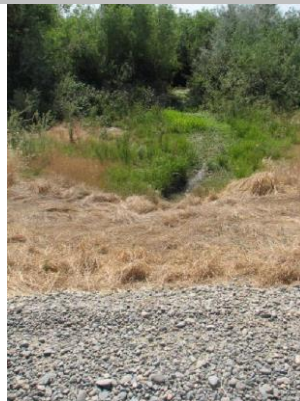
Photo 2 of 3 : UCIP_SP_2021_58483_66832.jpg

LM Start	6.99	Rating **	M	Issue No.	35 (cont)
LM End	6.99	Issue Type +	Ma	Location *	
Category	Supplemental			GPS Latitude/Longitude	
				Start	End
Item	DWR UCIP LMA Responsibility			39.501479 °	39.501479 °
				-121.719710 °	-121.719710 °
DWR ID	16329

View of WS slope and toe.

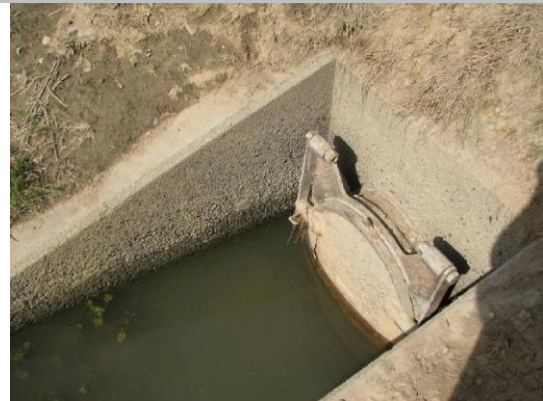
Photo 3 of 3 : UCIP_SP_2021_58484_66842.jpg

LM Start	7.22	Rating **	M	Issue No.	36 (cont)
LM End	7.22	Issue Type +	Ma	Location *

WS Flap Gate

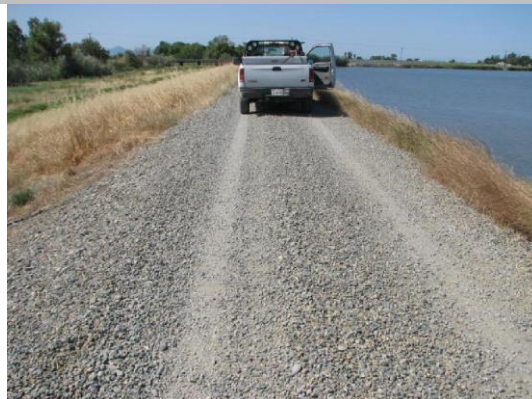
Photo 1 of 3 : UCIP_SP_2021_58485_66853.jpg

FS_ID:58485
DS_ID:16352
EP_NO: N/A
Repair Type: Non-Urgent
Crossing Status: Found
UCIP Comments: 08/26/2019 Record has been updated from No Action Needed to Non-Urgent, no permit has been identified authorizing pipe. Pipe is scheduled to be lined. (O. Magana - DWR UCIP, A. Freitag - DWR Sutter Yard)06/14/2017 Crossing appears to be in good condition. Pipe has been selected to be internally cleaned and inspected as part of the DMP project. (A. Freitag - DWR Sutter Yard)11/16/2016 Crossing appears to be in good condition. (A. Freitag - DWR Sutter Yard)04/28/2016 Crossing appears to be in good condition. (A. Freitag - DWR Sutter Yard)07/13/2015 WS ditch is getting to be heavily vegetated but it is not yet affecting flap gate operation. Vegetation needs to be cleared back some. (A. Freitag - DWR Sutter Yard)05/21/2014 Same as last inspection. (A. Freitag - DWR Sutter Yard)12/02/2013 Same as last inspection. (A. Freitag - DWR Sutter Yard)07/15/2013 Slopes have been cleared of vegetation and are in good condition. (A. Freitag - DWR Sutter Yard)04/18/2012 Limited inspection on WS and LS slopes due to dense vegetation. Need photos of cleared WS and LS slopes during next inspection. (O. Magana - DWR UCIP)

FIELD_STRUCT_DESC: 24-inch corrugated metal drainage pipe through the levee, 10.2 feet below the crown. Flap gate on the waterside (WS) end. Screw gate on the landside (LS) end. Concrete headwall on both ends. [Additional Reference(s): DWR Levee Log, 1993 (HLM 7.58). USACE Sacramento O&M Manual, Unit 519, June 1962, Revised 3 Feb 2011, (HLM 7.58), As-built DWG No. 50-4-3608, Sheet No. 3608/18, STA 724+32E, page 19 of 28 electronic file, listed as 24-inch CMP; As-built DWG No 50-4-3037 referenced not available]
FS Date: 8/26/2019 1:03:00 PM

View of levee crown at crossing looking D/S.

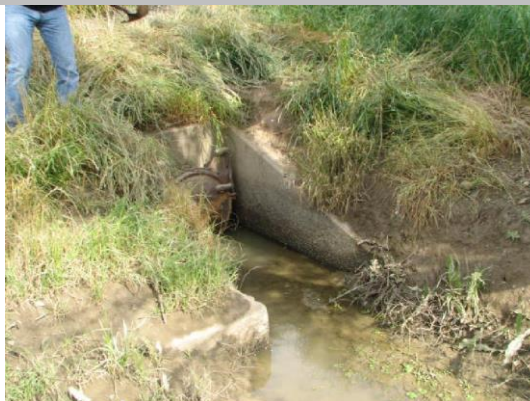
Photo 3 of 3 : UCIP_SP_2021_58485_66849.jpg

LM Start	7.46	Rating **	M	Issue No.	37 (cont)
LM End	7.46	Issue Type +	Ma	Location *

View of WS flap gate. Dense vegetation on WS slope.

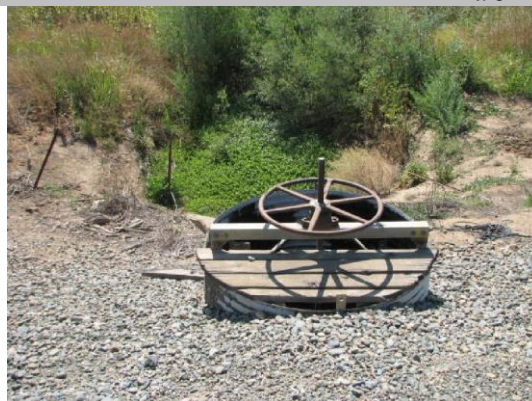
Photo 2 of 3 : UCIP_SP_2021_58487_66865.jpg

View of WS slope, corrugated metal riser with slide gate.

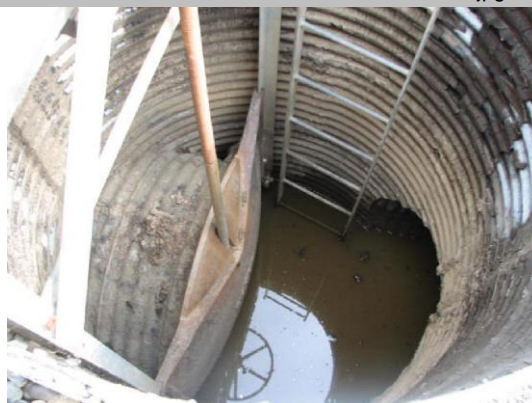
Photo 3 of 3 : UCIP_SP_2021_58487_66863.jpg

WS Slide gate

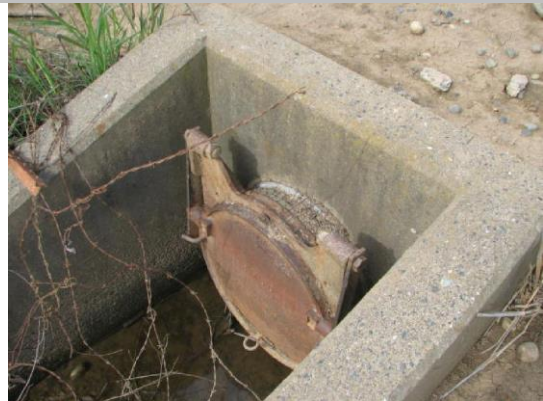
Photo 3 of 3 : UCIP_SP_2021_58488_66869.jpg

WS Flap gate

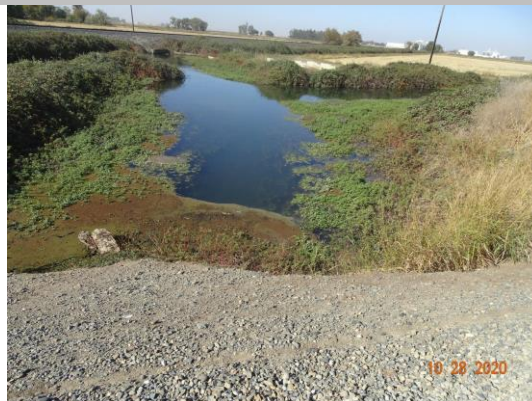
Photo 1 of 1 : SP_2021_MA0013_300_49_20210224_00005.jpg

LM Start	8.81	Rating **	M	Issue No.	49
LM End	8.81	Issue Type +	Ma	Location *	LS
Category	Earthen Levee			GPS Latitude/Longitude	
				Start	End
Item	Erosion / Bank Caving			39.478648 °	39.478648 °
				-121.736477 °	-121.736477 °
DWR ID	DWR_MA0013_01_f _ 2016_49				
Comment Code					
E2 : Schedule repair of erosion site prior to the next inspection.					
Inspector Comment

View of the erosion site along the landside toe. Fall 2020.

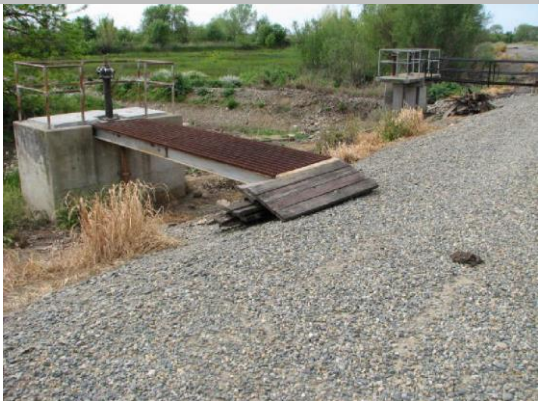
Photo 1 of 3 : UCIP_SP_2021_58490_66881.jpg

Catwalk and screw gate located on WS.

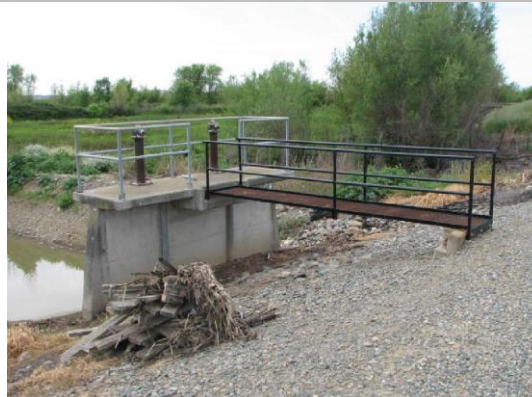
Photo 2 of 3 : UCIP_SP_2021_58491_66892.jpg

Catwalk, sluice gates, & headwall on WS.

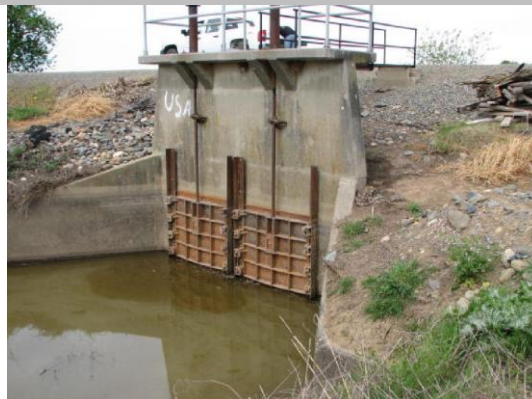
Photo 3 of 3 : UCIP_SP_2021_58491_66891.jpg

Headwall and sluice gates located on WS.

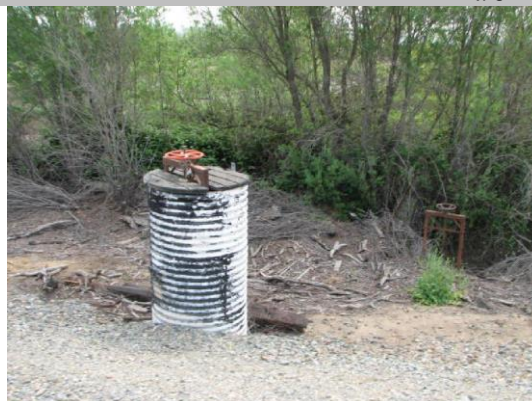
Photo 2 of 3 : UCIP_SP_2021_58493_66897.jpg

View of WS slope with 2 slide gates.

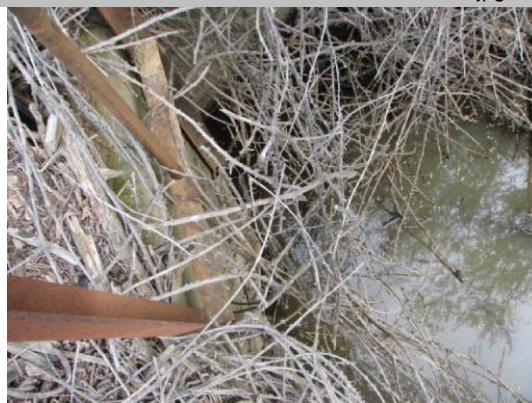
Photo 3 of 3 : UCIP_SP_2021_58493_66900.jpg

View of slide gate on WS. Debris blocking gate.

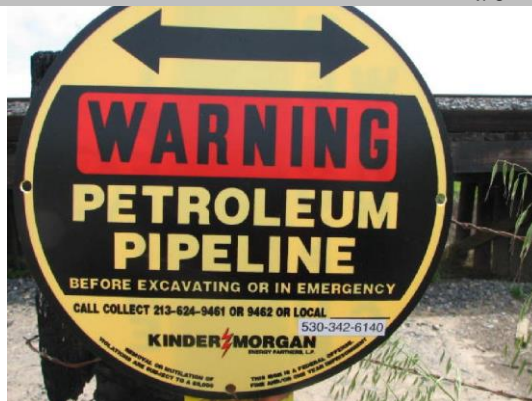
Photo 2 of 3 : UCIP_SP_2021_57571_66903.jpg

Petroleum information marker.

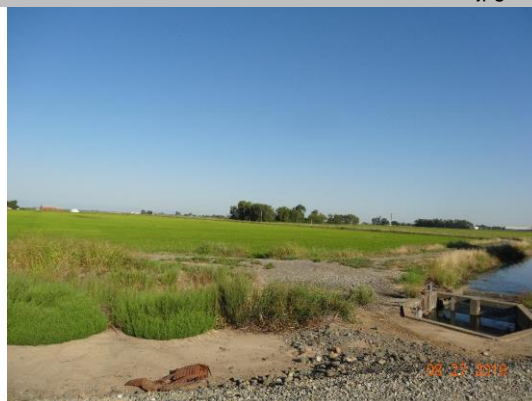
Photo 2 of 3 : UCIP_SP_2021_58516_80467.jpg

LS view: overview of LS, no marker found.

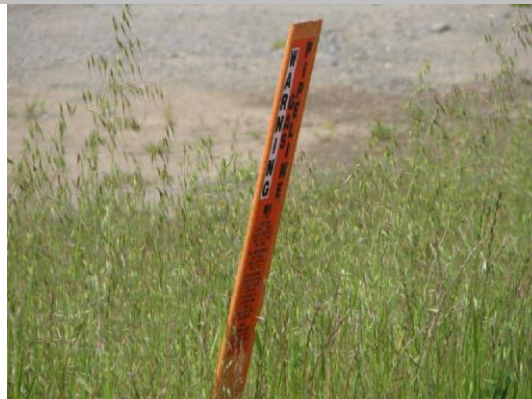
Photo 1 of 3 : UCIP_SP_2021_57608_66917.jpg

FS_ID:57608
DS_ID:16331
EP_NO: 1238
Repair Type: Non-Urgent
Crossing Status: Indicator Found
UCIP Comments: 08/27/2019 Record has been updated from No Action Needed to Non-Urgent, no maintenance records were made available to determine condition of line through levee. Need to contact owner to request maintenance records to confirm integrity of line. (O. Magana - DWR UCIP, A. Freitag - DWR Sutter Yard)06/14/2017 Crossing appears to be in good condition. (A. Freitag - DWR Sutter Yard)11/16/2016 Crossing appears to be in good condition. (A. Freitag - DWR Sutter Yard) 04/28/2016 Crossing appears to be in good condition. (A. Freitag - DWR Sutter Yard)07/13/2015 Crossing appears in good condition. No noticeable issues to report. (A. Freitag - DWR Sutter Yard)05/21/2014 Same as last inspection. (A. Freitag - DWR Sutter Yard)12/03/2013 Same as last inspection. (A. Freitag - DWR Sutter Yard)07/15/2013 New structure with shutoff valve installed about 5ft. from LS toe. (A. Freitag - DWR Sutter Yard) FIELD_STRUCT_DESC: 8-inch high pressure gas line through the levee, 13.3 feet below the crown. Substation with wire enclosure at the landside (LS) toe. (6.625-inch gas line authorized under Permit No. 1238, 1947 - Pacific Gas and Electric Company [PG&E]) [Additional Reference(s): DWR Levee Log, 1993 (HLM 10.03). USACE Sacramento O&M Manual 519, June 1962 (HLM 10.03), listed as 8-inch gas line]

Underground gas line marker on LS.

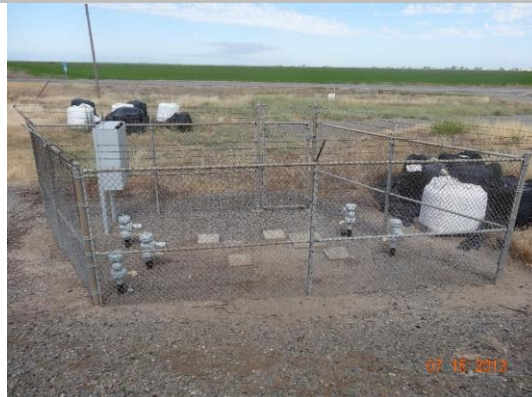
Photo 2 of 3 : UCIP_SP_2021_57608_66919.jpg

Substation near LS toe

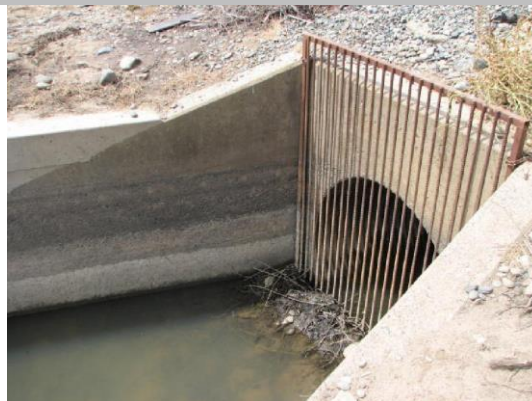
Photo 3 of 3 : UCIP_SP_2021_58496_66928.jpg

Trash rack on WS headwall.

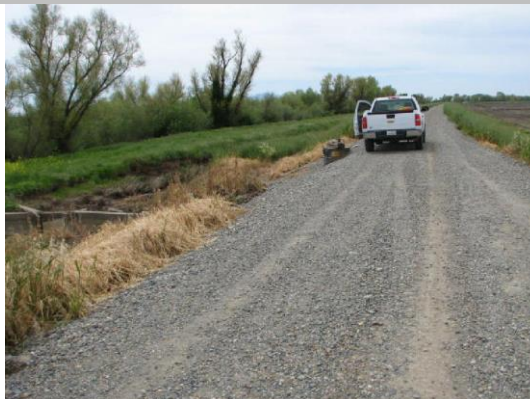
Photo 1 of 3 : UCIP_SP_2021_58501_66952.jpg

FS_ID:58501
DS_ID:16336
EP_NO: N/A
Repair Type: Non-Urgent
Crossing Status: Found
UCIP Comments: 08/27/2019 Record remains Non-Urgent, no permit has been identified authorizing the dual purpose of this crossing and slide gate is still missing from the WS CMP riser. Crossing is used as an irrigation turnout. Flow from Cherokee Canal is diverted upstream by weir and feed into an irrigation canal that runs parallel along WS levee toe for about 2.5 miles. The irrigation turnout is used to divert water from WS irrigation canal to LS. Need to update crossing type from Drainage to Other. This crossing is not maintained or operated by LMA-Sutter Yard. (O. Magana - DWR UCIP, A. Freitag - DWR Sutter Yard)06/15/2017 Slide gate still missing from inside of WS standpipe. Pipe has been selected to be internally cleaned and inspected as part of the DMP project. (A. Freitag - DWR Sutter Yard)11/17/2016 Slide gate still missing from inside the WS standpipe. (A. Freitag - DWR Sutter Yard)04/28/2016 Slide gate was removed from inside the WS standpipe. (A. Freitag - DWR Sutter Yard)07/13/2015 New screw gate installed on the WS pipe end in the irrigation ditch. (A. Freitag - DWR Sutter Yard)05/21/2014 Same as last inspection. (A. Freitag - DWR Sutter Yard)12/03/2013 Same as last inspection. (A. Freitag - DWR Sutter Yard)07/15/2013 Same as last inspection. (A. Freitag - DWR Sutter Yard)04/18/2012 Irrigation turnout. Not in use during April 2012 Inspection. During the follow up May 2012 Inspection structure was being used as irrigation turnout, reason for barcode tags. (O. Magana - DWR UCIP)

Overview picture looking south on right bank of Cherokee Canal.

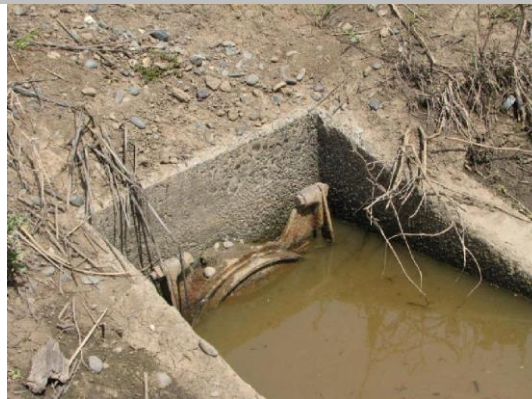
Photo 1 of 3 : UCIP_SP_2021_58515_66970.jpg

FS_ID:58515
DS_ID:16338
EP_NO: N/A
Repair Type: Non-Urgent
Crossing Status: Found
UCIP Comments: 08/27/2019 Record remains Non-Urgent, no permit has been identified authorizing pipe. Pipe is scheduled to be lined. (O. Magana - DWR UCIP, A. Freitag - DWR Sutter Yard)08/23/2018 WS flap gate has been replaced. LS outlet still has a lot of vegetation, but overall levee integrity looks good at time of this inspection. Downgrading to Non-Urgent from Urgent due to fixed flap gate and current levee condition. (D. Sanoski - DWR UCIP)06/15/2017 Not abandoned- WS flap gate was dug out and opened draining water from the LS ditch. WS flap gate is heavily corroded and has a broken hinge-needs to be replaced. LS is still very overgrown and needs to be cleared. Pipe has been selected to be internally cleaned and inspected as part of the DMP project. (A. Freitag - DWR Sutter Yard)11/17/2016 Appears abandoned. WS flap gate completely silted over and LS screw gate is completely overgrown by a tree and is not accessible for inspection. (A. Freitag - DWR Sutter Yard)05/03/2016 Crossing appears to be abandoned. WS flap gate was completely silted over and LS slide gate is very overgrown by a tree. (A. Freitag - DWR Sutter Yard)07/13/2015 WS flap gate is blocked from opening by sediment and vegetation. Needs to be cleared away. LS opening is being over grown by a tree and needs to be cutback. (A. Freitag - DWR Sutter Yard)05/22/2014 Same as last inspection. (A. Freitag - DWR Sutter Yard)12/03/2013 Same as last inspection. (A. Freitag - DWR Sutter Yard)07/15/2013 Same as last inspection. (A. Freitag - DWR Sutter Yard)04/18/2012 Tree has fallen at LS inlet and damaged slide gate. The tree needs to be removed and screw gate repaired. Limited inspection on LS due to fallen tree. (O. Magana - DWR UCIP)

WS headwall and flap gate.

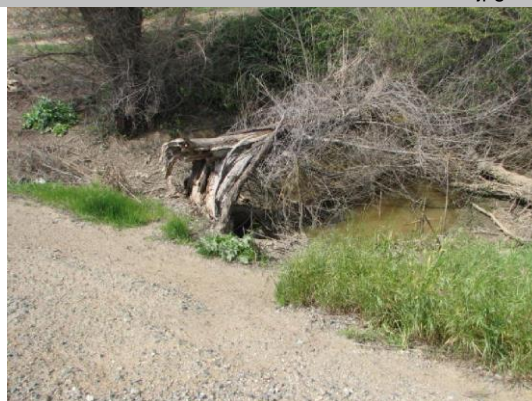
Photo 3 of 3 : UCIP_SP_2021_58515_66969.jpg

Tree fallen at LS headwall.

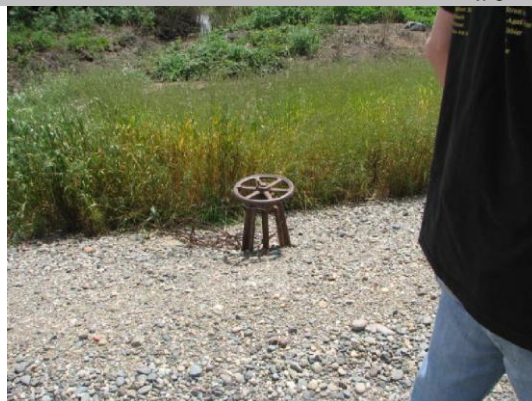
Photo 1 of 3 : UCIP_SP_2021_58504_66972.jpg

FS_ID:58504
DS_ID:16339
EP_NO: N/A
Repair Type: Non-Urgent
Crossing Status: Found
UCIP Comments: 08/27/2019 Record remains Non-Urgent, crossing has been abandoned. Need to update crossing type from Drainage to Irrigation. Crossing was used as a irrigation line and not drainage. This crossing is not maintained or operated by LMA-Sutter Yard. (O. Magana - DWR UCIP, A. Freitag - DWR Sutter Yard)06/15/2017 Abandoned- still only the structure on the WS shoulder found. (A. Freitag - DWR Sutter Yard)11/17/2016 Abandoned. (A. Freitag - DWR Sutter Yard)05/03/2016 ABANDONED CROSSING. (A. Freitag - DWR Sutter Yard)07/13/2015 Abandoned crossing. Slide gate is buried on the WS. (A. Freitag - DWR Sutter Yard)05/22/2014 Same as last inspection. (A. Freitag - DWR Sutter Yard)12/03/2013 Same as last inspection. (A. Freitag - DWR Sutter Yard)07/15/2013 Same as last inspection. (A. Freitag - DWR Sutter Yard)04/18/2012 Non-functional crossing-buried slide gate on WS. Limited inspection on WS and LS slope/toe due to dense vegetation. Need photo of cleared WS & LS slopes or toe. This crossing is listed in the USACE periodic inspection report as Corp's Inspection ID# USACE_CESPK_M13D_2011_p_0352 for abandoned gate on WS slope. (O. Magana - DWR UCIP)

Buried slide gate on the WS slope.

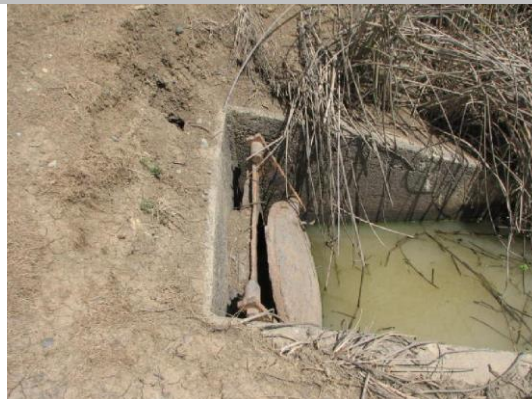
Photo 1 of 3 : UCIP_SP_2021_58505_66976.jpg

FS_ID:58505
DS_ID:16368
EP_NO: N/A
Repair Type: Urgent
Crossing Status: Found
UCIP Comments: 08/27/2019 Record remains Urgent due to pipe integrity and levee integrity issues. Previously noted holes on the pipe collar located at WS have been sealed using splash zone epoxy. Two holes (possible sink holes) were observed behind WS concrete headwall. Recommend internal inspection of pipe through levee to determine if sink holes are attributed to holes in pipe. (O. Magana - DWR UCIP, A. Freitag - DWR Sutter Yard)08/23/2018 WS pipe unable to be inspected due to heavy vegetation at inlet, so assume same as last inspection. Noticed a long crack a couple feet above WS headwall that could be of concern; possible future slough if soil gets saturated during next high water event and could be a sign of internal pipe degradation. LS outlet and slope looked good. Urgent due to long crack, obstructed inspection view of WS inlet, and 2016 photos of holes in pipe. (D. Sanoski - DWR UCIP)06/15/2017 WS pipe end still showing heavy signs of corrosion and deterioration with visible holes between the concrete headwall and flap gate flange. Pipe was almost 100% full of water so could not visually inspect inside of the pipe to see if theres any damage inside of the levee segment. Pipe has been selected to be internally cleaned and inspected as part of the DMP project. (A. Freitag - DWR Sutter Yard)11/17/2016 Top of pipe on WS still showing heavy signs of corrosion with visible holes between the flap gate flange and the concrete headwall. The pipe was mostly underwater so could not internally inspect it for more damage or corrosion. (A. Freitag - DWR Sutter Yard)05/03/2016 Top of the pipe on the WS has holes in it between the flap gate flange and headwall. Crossing is showing signs of rust and deterioration but it was mostly underwater so could not inspect the inside of the pipe. (A. Freitag - DWR Sutter Yard)07/13/2015 Both sides of crossing were underwater at the time of inspection. (A. Freitag - DWR Sutter Yard)05/22/2014 Same as last inspection. (A. Freitag - DWR Sutter Yard)12/03/2013 Same as last inspection. (A. Freitag - DWR Sutter Yard)07/15/2013 Slopes have been cleared of vegetation and are in good condition. WS flap gate is still lodged open. (A. Freitag - DWR Sutter Yard)04/18/2012 Limited inspection on LS slope due to dense vegetation. Need photos of cleared WS & LS slopes. The flap gate is lodged open. (O. Magana - DWR UCIP)

Headwall and flapgate located on water side of levee

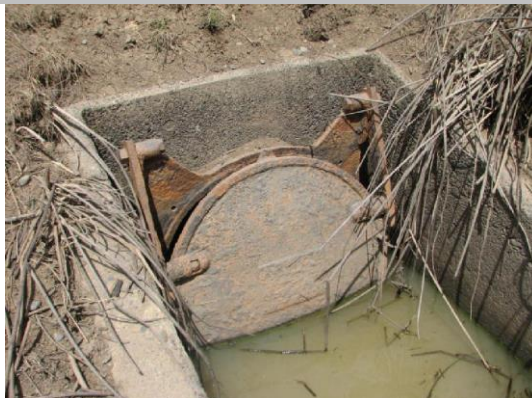
Photo 2 of 3 : UCIP_SP_2021_58505_66974.jpg

Headwall and flapgate located on water side of levee

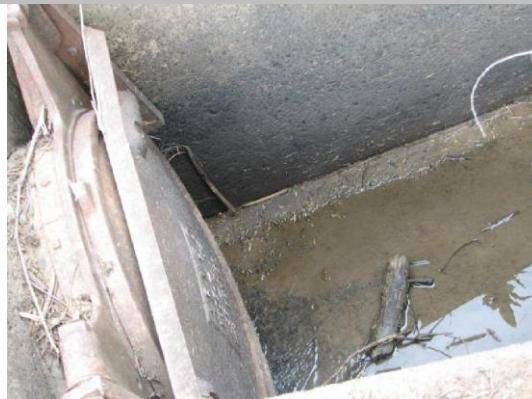
Photo 1 of 3 : UCIP_SP_2021_58506_66981.jpg

FS_ID:58506
DS_ID:16367
EP_NO: N/A
Repair Type: Non-Urgent
Crossing Status: Found
UCIP Comments: 08/27/2019 Record has been updated from No Action Needed to Non-Urgent, no permit has been identified authorizing pipe. Pipe is scheduled to be lined. (O. Magana - DWR UCIP, A. Freitag - DWR Sutter Yard)06/15/2017 Crossing appears to be in good condition. Pipe has been selected to be internally cleaned and inspected as part of the DMP project. (A. Freitag - DWR Sutter Yard)11/17/2016 Crossing appears to be in good condition. (A. Freitag - DWR Sutter Yard)05/03/2016 Crossing appears to be in good condition. (A. Freitag - DWR Sutter Yard)07/13/2015 Crossing appears in good condition. No noticeable issues to report. (A. Freitag - DWR Sutter Yard)05/22/2014 Same as last inspection. (A. Freitag - DWR Sutter Yard)12/03/2013 Same as last inspection. (A. Freitag - DWR Sutter Yard)07/15/2013 Slopes have been cleared of vegetation and are in good condition. (A. Freitag - DWR Sutter Yard)04/18/2012 Limited inspection on WS and LS slope due to dense vegetation. Need overall photo of crossing and photos of cleared WS & LS slopes. (O. Magana - DWR UCIP)

WS headwall and flapgate

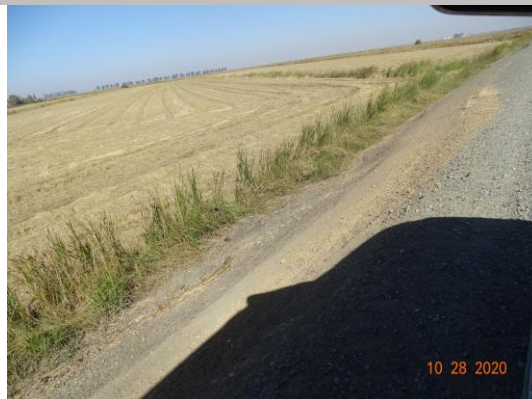
Photo 1 of 1 : SP_2021_MA0013_300_57_20210224_00006.jpg

LM Start	15.58	Rating **	M	Issue No.	57
LM End	15.58	Issue Type +	Ma	Location *	LS
Category	Earthen Levee			GPS Latitude/Longitude	
				Start	End
Item	Slope Stability			39.400380 °	39.400380 °
				-121.808432 °	-121.808432 °
DWR ID	DWR_MA0013_01_f _ 2016_57				
Comment Code					
S1 : Repair slope instability.					
Inspector Comment

View of the slope instability along the landside slope. Fall 2020.

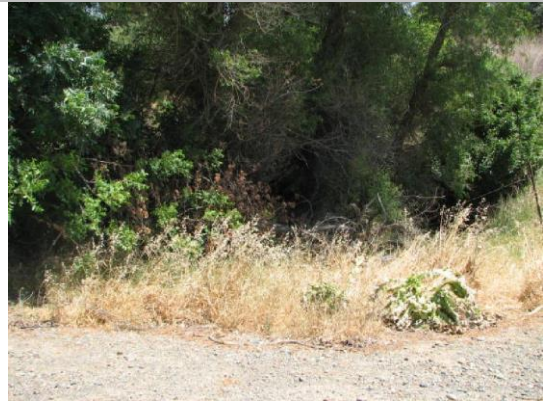
Photo 2 of 3 : UCIP_SP_2021_58507_66987.jpg

View of WS.

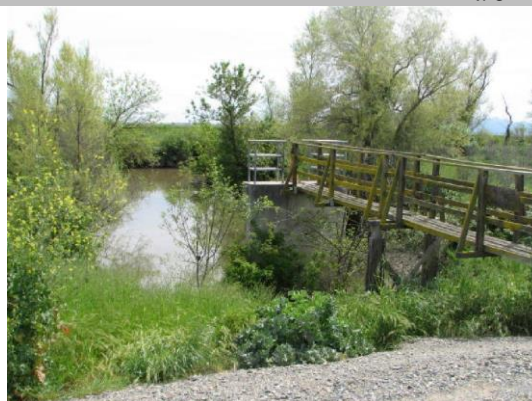
Photo 1 of 3 : UCIP_SP_2021_57621_66993.jpg

Comment Code						
Inspector Comment						
FS_ID:57621 DS_ID:16373 EP_NO: 11805B Repair Type: Non-Urgent Crossing Status: Found UCIP Comments: 08/27/2019 Record remains Non-Urgent, sloughing/erosion observed on the LS toe during inspection. Recommend monitoring to determine progression of sloughing/erosion. (O. Magana - DWR UCIP, A. Freitag - DWR Sutter Yard)06/15/2017 Both pipe ends submerged during site visit. LS ditch near pipe end is heavily vegetated and covering the pipe end. There is some erosion happening at the LS levee toe but this is more of a ditch problem and not a problem with the pipe. (A. Freitag - DWR Sutter Yard)11/17/2016 Both pipe ends underwater at time of inspection. (A. Freitag - DWR Sutter Yard)05/03/2016 Crossing was underwater on both sides of levee during this inspection. Looks as if the wooden walkway was the same and no repairs have been made. (A. Freitag - DWR Sutter Yard)07/13/2015 LS inlet still underwater. WS screw gate appears in good condition. Wooden walkway to the screw gate needs repairs. (A. Freitag - DWR Sutter Yard)05/22/2014 Same as last inspection. (A. Freitag - DWR Sutter Yard)12/03/2013 Same as last inspection. (A. Freitag - DWR Sutter Yard)07/15/2013 Same as last inspection. (A. Freitag - DWR Sutter Yard)04/18/2012 LS inlet is not visible-underwater. Limited inspection on WS and LS slope/toe due to dense vegetation. Need photos of cleared WS & LS slopes. (O. Magana - DWR UCIP) FIELD_STRUCT_DESC: 48-inch reinforced concrete irrigation pipe with six concrete collars through the levee, 14.4 feet below the crown to center of conduit. Slide gate, head-wall and wood walkway on two concrete piers on the waterside (WS) of levee. Revetment on the WS slope. Irrigation ditch on the landside (LS). (two 30-inch pipes and one 48-inch pipe authorized under Permit No. 11805, -A, -B, and -C 1979 - Elna Schohr, Inc.) [Additional Reference(s): DWR Levee Log, 1993 (HLM 16.00)] FS Date: 8/27/2019 2:22:00 PM

WS view of appurtenances (catwalk, slide gate, and headwall)

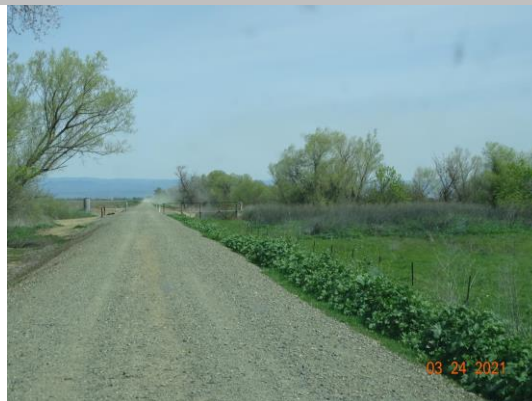
Photo 1 of 1 : SP_2021_MA0013_300_75_20210407_00176.jpg

LM Start	15.80	Rating **	M	Issue No.	75
LM End	15.86	Issue Type +	Ma	Location *	WS
Category	Earthen Levee			GPS Latitude/Longitude	
				Start	End
Item	Vegetation			39.398286 °	39.397806 °
				-121.811721 °	-121.812465 °
DWR ID	DWR_MA0013_01_s_2021_75				
Comment Code					
V1 : Control annual grass and weeds on the levee slopes and easements.					
Inspector Comment

View of the vegetation along the waterside slope. Spring 2021.

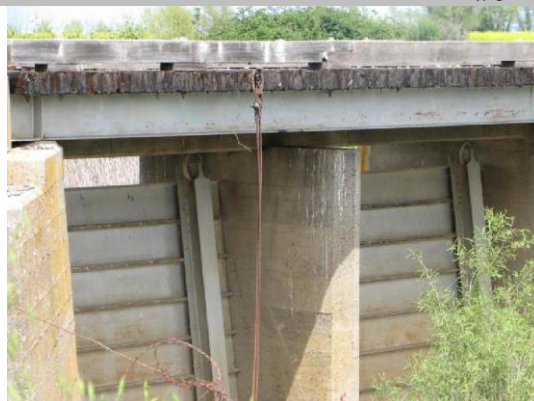
Photo 2 of 3 : UCIP_SP_2021_58508_74503.jpg

View of crossing and panels attached to concrete walls.

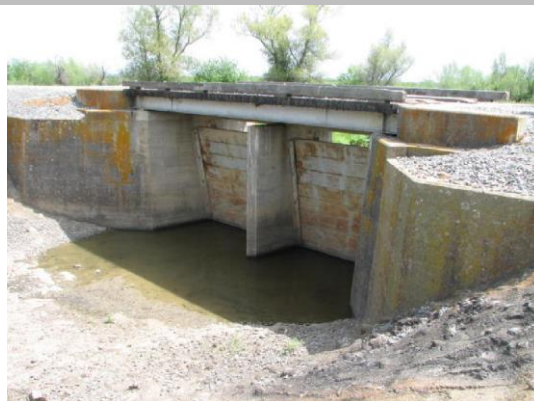
Photo 3 of 3 : UCIP_SP_2021_58508_74501.jpg

LS view of structure

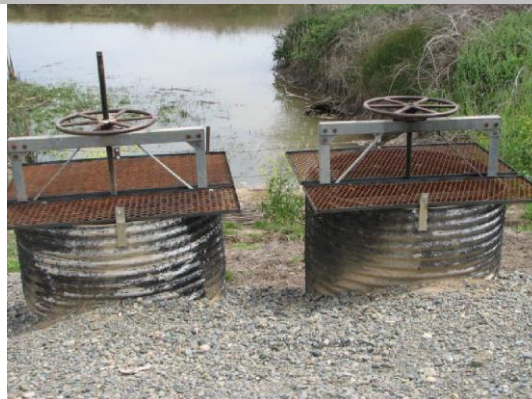
Photo 1 of 3 : UCIP_SP_2021_58510_67011.jpg

FS_ID:58510
DS_ID:16370
EP_NO: N/A
Repair Type: Non-Urgent
Crossing Status: Found
UCIP Comments: 08/27/2019 Record has been updated from No Action Needed to Non-Urgent due to maintenance issue. Minor scour is present at the concrete wingwalls located on LS. Need to contact owner to address maintenance issue (minor scour). No permit has been identified authorizing pipe. Structure is referenced in permit number 11805. Need to pull permit to review details and update structure description to reference correct permit. (O. Magana - DWR UCIP, A. Freitag - DWR Sutter Yard)06/15/2017 Crossing appears to be in good condition. (A. Freitag - DWR Sutter Yard)11/17/2016 Crossing appears to be in good condition. (A. Freitag - DWR Sutter Yard)05/03/2016 Crossing appears to be in good condition. (A. Freitag - DWR Sutter Yard)07/13/2015 Crossing appears in good condition. No noticeable issues to report. (A. Freitag - DWR Sutter Yard)05/22/2014 Same as last inspection. (A. Freitag - DWR Sutter Yard)12/03/2013 Same as last inspection. (A. Freitag - DWR Sutter Yard)07/15/2013 Same as last inspection. (A. Freitag - DWR Sutter Yard)04/18/2012 42 inch pipes transport water to LS sump. Quantity (4) irrigation pumps push water to adjacent irrigation ditches. WS crossing underwater. (O. Magana - DWR UCIP)

WS View of slope, risers, and channel.

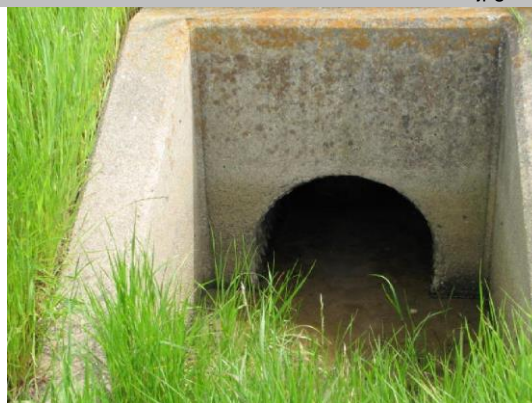
Photo 3 of 3 : UCIP_SP_2021_58512_67018.jpg

View of LS headwall.

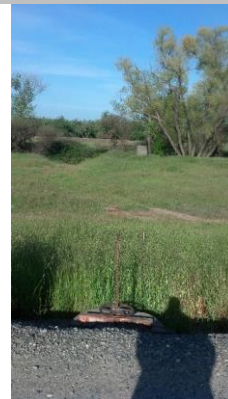
Photo 2 of 3 : UCIP_SP_2021_58519_67048.jpg

View of WS slope and toe.

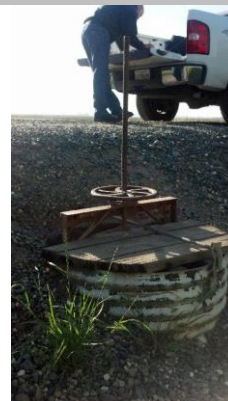
Photo 3 of 3 : UCIP_SP_2021_58519_67045.jpg

Screw gate located on WS of levee. Screw gate covers needs to be repaired.

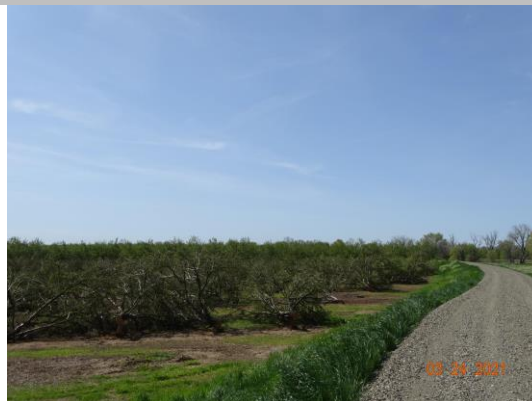
Photo 1 of 1 : SP_2021_MA0013_301_91_20210407_00179.jpg

LM Start	0.93	Rating **	M	Issue No.	91
LM End	1.11	Issue Type +	Ma	Location *	LS
Category	Earthen Levee			GPS Latitude/Longitude	
				Start	End
Item	Vegetation			39.561421 °	39.559244 °
				-121.703055 °	-121.704734 °
DWR ID	DWR_MA0013_02_s_2021_91				
Comment Code					
V1 : Control annual grass and weeds on the levee slopes and easements.					
Inspector Comment

View of the vegetation along the landside slope. Spring 2021.
