**Flood Control Project Maintenance
Levee Inspections
LMA District Cover Sheet**

Sutter Maintenance Yard Maintenance Area 0013

Waterway			Bank	Unit Miles
Unit No. 01 Cherokee Canal			Right	18.19
	Spring (March - May)	Summer (June - August)	(September - November) Fall	Winter (December - February)
Unit Maintenance Rating (Fall Only)				
Date of Inspection	3/24/2021 - 3/24/2021			
DWR Inspector	Makar Sokol			
Accompanied By	Bob Duffey Sutter Maintenance Yard

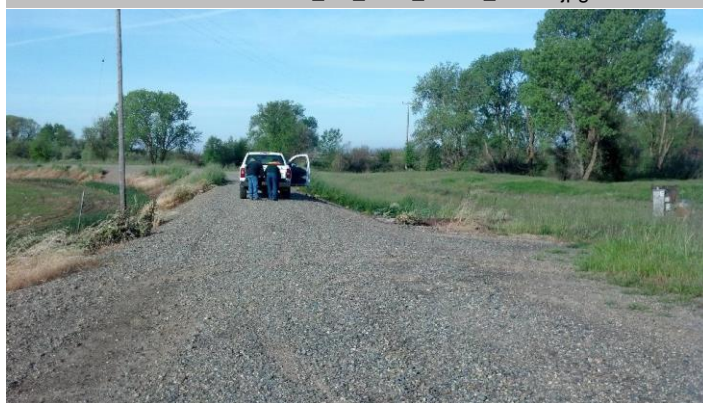
Photo 1 of 3 : UCIP_SP_2021_58520_67055.jpg

FS_ID:58520
DS_ID:16833
EP_NO: N/A
Repair Type: Non-Urgent
Crossing Status: Found
UCIP Comments: 08/28/2019 Record has been updated from No Action Needed to Non-Urgent, no permit has been identified for this crossing. No other issues were recorded during inspection. (O. Magana - DWR UCIP, A. Freitag - DWR Sutter Yard)6/5/2017 Crossing appears to be in good condition. Pump was running during site visit. (A. Freitag - DWR Sutter Yard)11/18/2016 Crossing appears to be in good condition. (A. Freitag - DWR Sutter Yard)04/27/2016 Crossing appears to be in good condition. (A. Freitag - DWR Sutter Yard)07/01/2015 Same as last inspection. (A. Freitag - DWR Sutter Yard)05/29/2014 Same as last inspection. (A. Freitag - DWR Sutter Yard)12/09/2013 Same as last inspection. (A. Freitag - DWR Sutter Yard)07/10/2013 Same as last inspection. (A. Freitag - DWR Sutter Yard)04/19/2012 This crossing was listed in the USACE Periodic Inspection report as Corp's Inspect ID# USACE_CESPK_M13G_2011_p_0106 for pump station. Permit 3953 is not associated to this crossing. This 16 inch crossing is listed under the USACE O&M Manual with pump on WS. Permit information was incorrect in USACE's report. (O. Magana - DWR UCIP)

Overview looking south

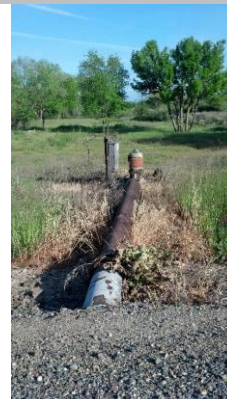
Photo 2 of 3 : UCIP_SP_2021_58520_67054.jpg

Pump located on water side of levee

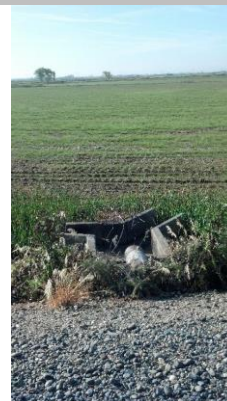
Photo 3 of 3 : UCIP_SP_2021_58520_67053.jpg

Discharge pipe and distribution box located on land side of levee

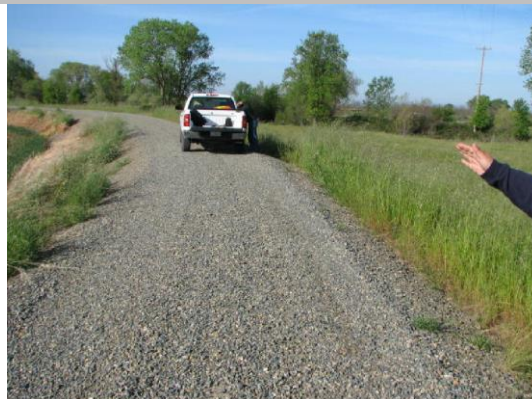
Photo 1 of 3 : UCIP_SP_2021_58573_67059.jpg

FS_ID:58573
DS_ID:16399
EP_NO: N/A
Repair Type: Non-Urgent
Crossing Status: Found
UCIP Comments: 08/28/2019 Record remains Non-Urgent, no permit has been identified authorizing pipe. Pipe has been lined. (O. Magana - DWR UCIP, A. Freitag - DWR Sutter Yard)06/05/2017 LS slide gate stem is bent and the gate appears as if it will not open. LS inlet is becoming heavily vegetated next to rice field. WS flap gate is blocked shut by sediment. Pipe has been selected to be internally cleaned and inspected as part of the DMP project. (A. Freitag - DWR Sutter Yard)11/18/2016 LS screw gate still bent and in-operable. (A. Freitag - DWR Sutter Yard)04/27/2016 LS screw gate is still bent. Rest of crossing appeared in good condition. (A. Freitag - DWR Sutter Yard)07/01/2015 LS screw gate frame is still twisted and hindering the gate from opening. (A. Freitag - DWR Sutter Yard)05/29/2014 Same as last inspection. (A. Freitag - DWR Sutter Yard)12/09/2013 Same as last inspection. (A. Freitag - DWR Sutter Yard)07/10/2013 WS slope is cleared of vegetation and is in good condition. LS screw gate frame is twisted and is preventing the gate from opening. (A. Freitag - DWR Sutter Yard)04/19/2012 Limited inspection dense vegetation on WS. Need photos of clear WS slope & toe. Ditch present in channel? This crossing was listed in the USACE Periodic Inspection report as Corp's Inspect ID# USACE_CESPK_M13G_2011_p_0108 for WS flap gate filled with soil and LS gate not functioning because of overgrown vegetation. (O. Magana - DWR UCIP)

Overview of crossing

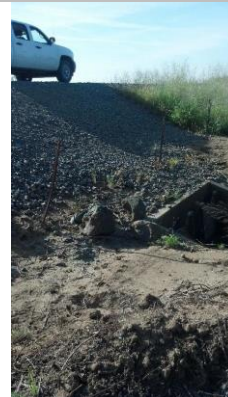
Photo 2 of 3 : UCIP_SP_2021_58522_67068.jpg

View of WS slope.

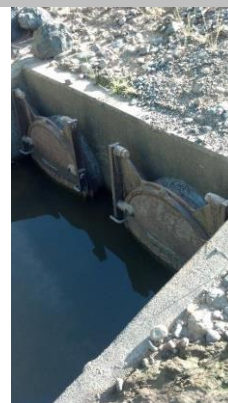
Photo 3 of 3 : UCIP_SP_2021_58522_67064.jpg

Headwall and flap gates (2) located on WS

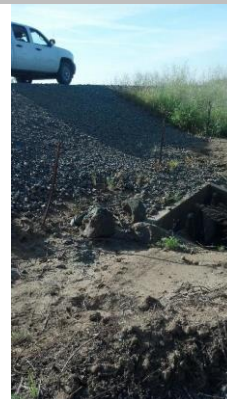
Photo 2 of 3 : UCIP_SP_2021_58523_67074.jpg

Comment Code						
Inspector Comment						
FS_ID:58523 DS_ID:17169 EP_NO: N/A Repair Type: Non-Urgent Crossing Status: Found UCIP Comments: 08/28/2019 Record has been updated from No Action Needed to Non-Urgent, no permit has been identified authorizing pipe. Pipe is scheduled to be lined. (O. Magana - DWR UCIP, A. Freitag - DWR Sutter Yard)06/05/2017 LS inlet was underwater. WS appears to be in good condition. Pipe has been selected to be internally cleaned and inspected as part of the DMP project. (A. Freitag - DWR Sutter Yard)11/18/2016 Crossing appears to be in good condition. (A. Freitag - DWR Sutter Yard)04/27/2016 Crossing appears to be in good condition. (A. Freitag - DWR Sutter Yard)07/01/2015 New screw gate installed on the LS. WS appears to be in good condition. (A. Freitag - DWR Sutter Yard)05/29/2014 Same as last inspection. (A. Freitag - DWR Sutter Yard)12/09/2013 Same as last inspection. (A. Freitag - DWR Sutter Yard)07/10/2013 Same as last inspection. (A. Freitag - DWR Sutter Yard) FIELD_STRUCT_DESC: 2 of 2: 36-inch corrugated metal drainage pipe through the levee, 9.7 feet below the crown. Concrete "U" headwalls on both the waterside (WS) and landside (LS) ends. Flap gate on the waterside (WS) end. Slide gate on the landside (LS) end. [Additional Reference(s): DWR Levee Log, 1993 (HLM 2.53). USACE Sacramento O&M Manual, Unit 519, June 1962, Revised 3 Feb 2011, (HLM 2.54), As-built DWG No. 50-4-3608, Sheet No. 3608/19.1, STA 899+10E LT BK, page 20 of 28 electronic file, listed as two 36-inch CMP; As-built DWG No 50-4-3037 referenced not available] FS Date: 8/28/2019 1:11:00 PM

View of WS slope.

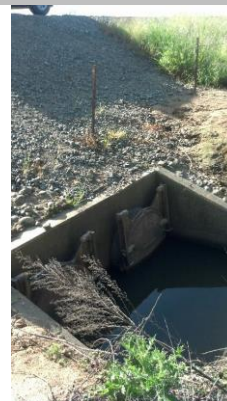
Photo 3 of 3 : UCIP_SP_2021_58523_67071.jpg

Headwall and flap gates (2) located on the WS.

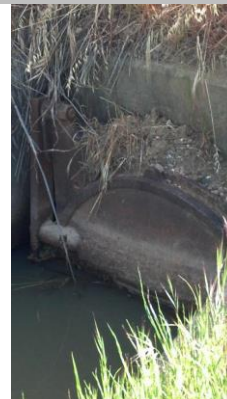
Photo 2 of 3 : UCIP_SP_2021_58525_67084.jpg

Headwall and flap gate located on WS

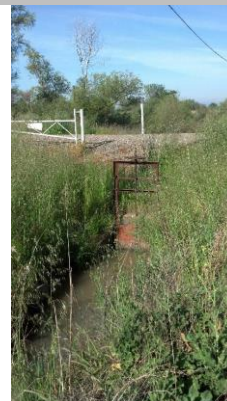
Photo 3 of 3 : UCIP_SP_2021_58525_67086.jpg

Headwall and screw gate located on the LS

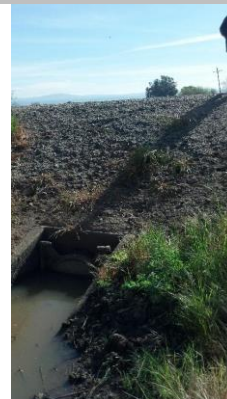
Photo 2 of 3 : UCIP_SP_2021_58526_67091.jpg

Headwall and flap gate located on WS.

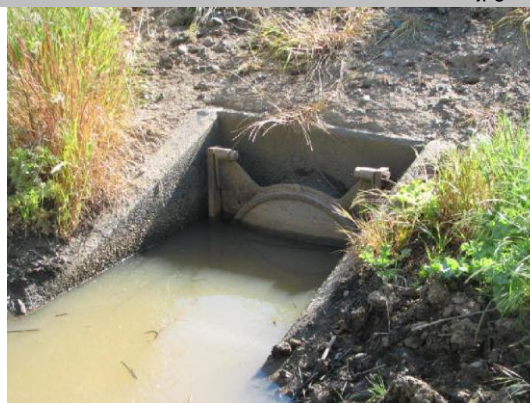
Photo 3 of 3 : UCIP_SP_2021_58526_67092.jpg

WS headwall and flap gate.

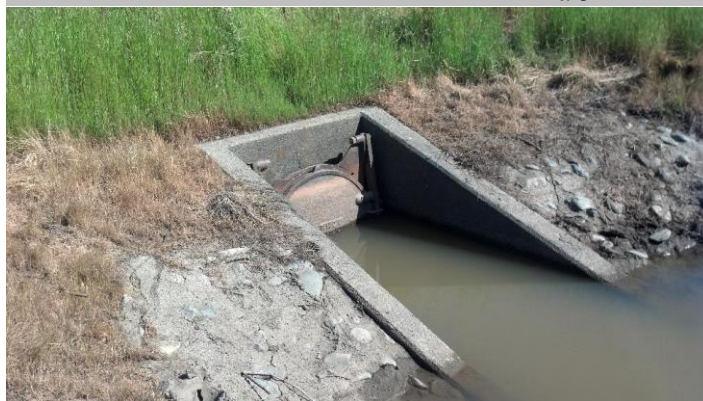
Photo 2 of 3 : UCIP_SP_2021_58529_67108.jpg

Headwall and flap gate located on WS toe.

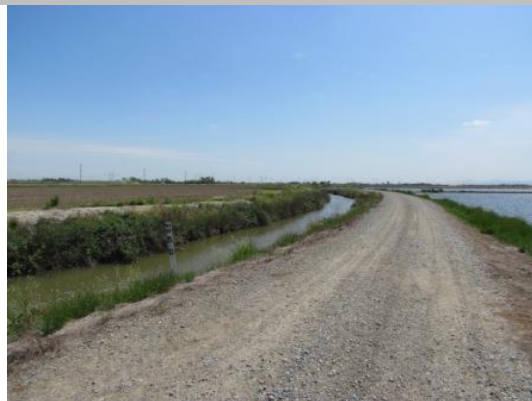
Photo 1 of 1 : SP_2021_MA0013_301_911_20210224_00015.jpg

LM Start	4.04	Rating **	M	Issue No.	911
LM End	4.78	Issue Type +	En	Location *	WS
Category	Earthen Levee			GPS Latitude/Longitude	
				Start	End
Item	Encroachments			39.526653 °	39.534091 °
				-121.699675 °	-121.690404 °
DWR ID	DWR_MA0013_02_s_2012_911				
Comment Code					
DT : Ditch					
Inspector Comment

View of agricultural ditch along the toe.

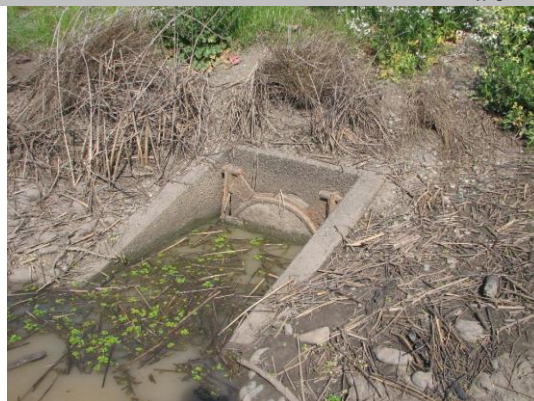
Photo 2 of 3 : UCIP_SP_2021_58530_67116.jpg

Unable to determine condition of flap gate on WS due to high water.

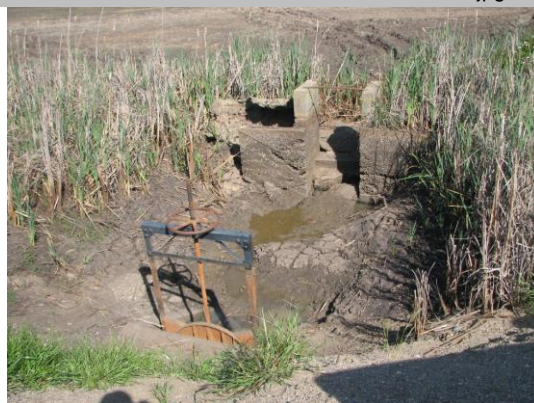
Photo 3 of 3 : UCIP_SP_2021_58530_67113.jpg

Overview of LS screw gate and concrete sump structure.

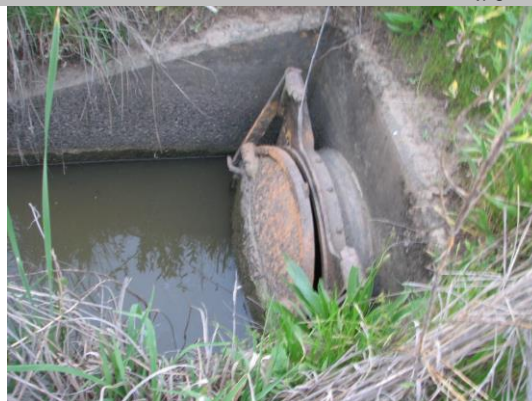
Photo 2 of 3 : UCIP_SP_2021_58533_67129.jpg

Headwall and flap gate located on WS.

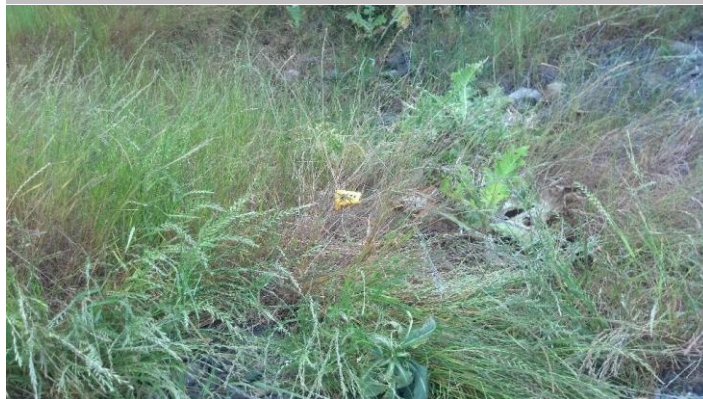
Photo 2 of 3 : UCIP_SP_2021_58534_67133.jpg

USA indicator located at land side of levee

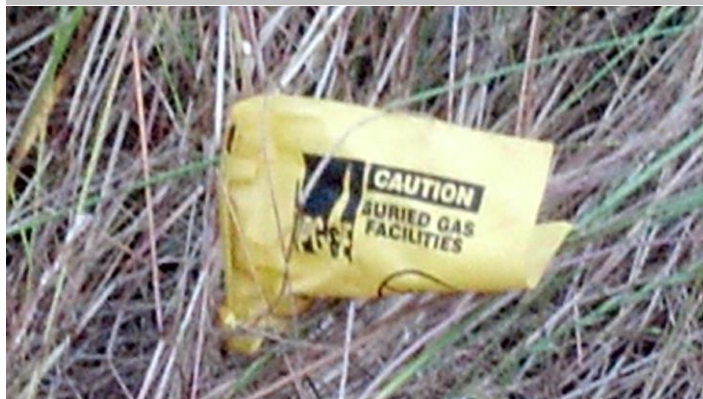
Photo 3 of 3 : UCIP_SP_2021_58534_67134.jpg

USA indicator located at land side of levee

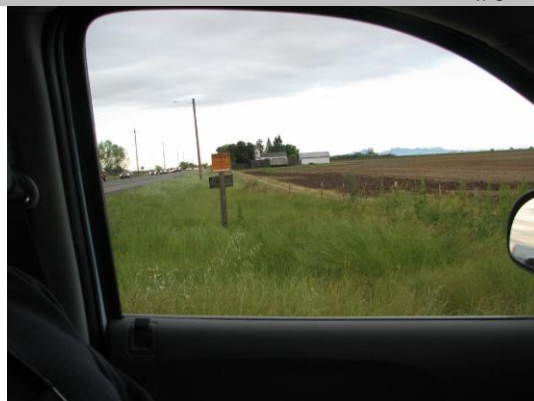
Photo 1 of 3 : UCIP_SP_2021_57645_67136.jpg

FS_ID:57645
DS_ID:16407
EP_NO: 6084
Repair Type: Non-Urgent
Crossing Status: Indicator Found
UCIP Comments: 08/28/2019 Record has been updated from No Action Needed to Non-Urgent due to maintenance issues. Sign knocked over. Unable to determine if line has been abandoned. Need to contact owner to make them aware of the sign knocked over and to determine whether line is still in use. (O. Magana - DWR UCIP, A. Freitag - DWR Sutter Yard)06/05/2017 Crossing appears to be in good condition. (A. Freitag - DWR Sutter Yard)11/18/2016 Crossing appears to be in good condition. (A. Freitag - DWR Sutter Yard)04/27/2016 Crossing appears to be in good condition. (A. Freitag - DWR Sutter Yard)06/30/2015 Crossing is in good condition. (A. Freitag - DWR Sutter Yard)05/29/2014 Same as last inspection. (A. Freitag - DWR Sutter Yard)12/09/2013 Same as last inspection. (A. Freitag - DWR Sutter Yard)07/09/2013 Same as last inspection. (A. Freitag - DWR Sutter Yard)

Underground telephone line indicator on LS of Cottonwood left levee looking South on highway.

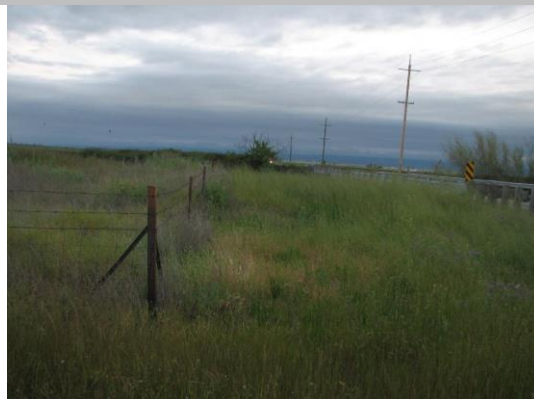
Photo 2 of 3 : UCIP_SP_2021_57645_67137.jpg

Underground telephone line looking North towards highway.

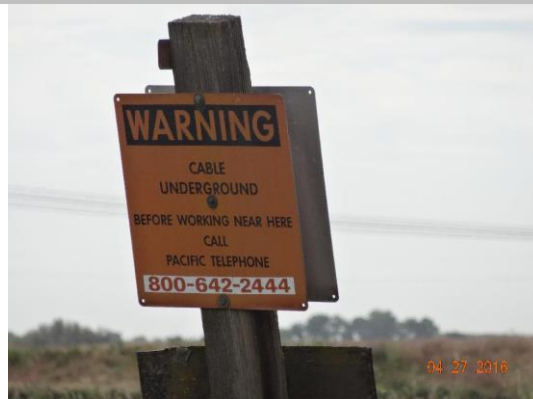
Photo 3 of 3 : UCIP_SP_2021_57645_74975.jpg

close up of marker sign LS.

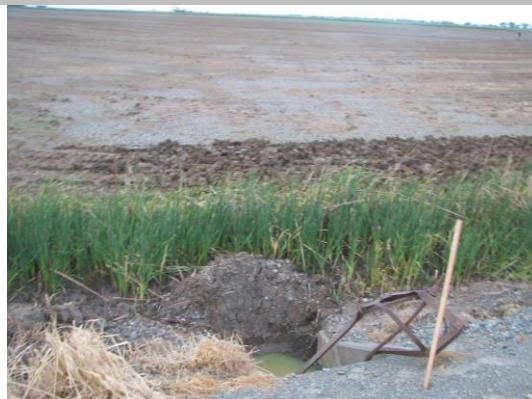
Photo 3 of 3 : UCIP_SP_2021_58574_67141.jpg

Overview of LS floor is higher in elevation than pipe invert causing build up sediment.

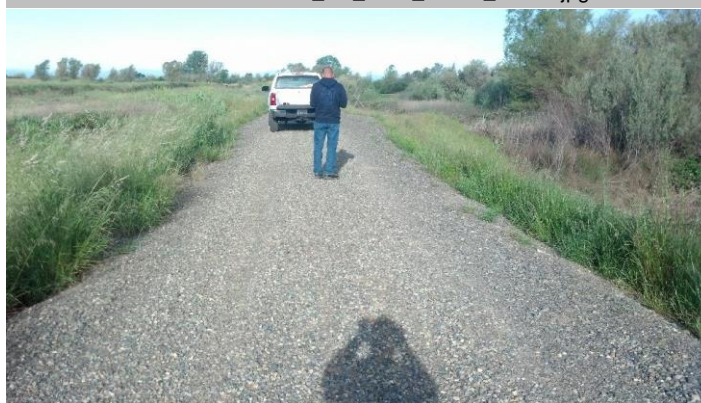
Photo 1 of 3 : UCIP_SP_2021_58538_67155.jpg

FS_ID:58538
DS_ID:16411
EP_NO: N/A
Repair Type: Non-Urgent
Crossing Status: Found
UCIP Comments: 08/28/2019 Record remains Non-Urgent, unable to determine if crossing is in use. Need to audit record to determine if Permit No. 13170 is associated with 36-inch. Slide gate that is supposed to be located on the WS is still missing. Need to check permit 13170 to see if this pipe crossing is also part of permit. (O. Magana - DWR UCIP, A. Freitag - DWR Sutter Yard)06/05/2017 Both ends were underwater but it appears that the LS slide gate is still missing. (A. Freitag - DWR Sutter Yard)11/18/2016 LS slide gate still missing. Both pipe ends were submerged during inspection. (A. Freitag - DWR Sutter Yard)09/27/2016 Crossing has been downgraded from Urgent to Non-Urgent-flap gate on WS is present only LS gate missing. (O. Magana - DWR UCIP)04/27/2016 Both sides of pipe were underwater. Appears that LS gate is still missing. (A. Freitag - DWR Sutter Yard)06/30/2015 Slide gate still missing on the LS. WS appears to be in good condition. (A. Freitag - DWR Sutter Yard)05/29/2014 Same as last inspection. (A. Freitag - DWR Sutter Yard)12/09/2013 Same as last inspection. (A. Freitag - DWR Sutter Yard)07/09/2013 Same as last inspection. (A. Freitag - DWR Sutter Yard)04/24/2012 Slide gate missing on LS. Limited inspection on WS and LS slopes due to dense vegetation. Need photos of cleared WS & LS slopes. This crossing was listed in the USACE Periodic Inspection report as Corp's inspect ID# USACE_CESPK_M13H_2011_p_0017 for missing slide gate. (O. Magana - DWR UCIP)

FIELD_STRUCT_DESC: 36-inch corrugated metal drainage pipe through the levee, 9.2 feet below the crown. Flap gate on the waterside (WS) end. Slide gate on the landside (LS) end. Concrete "U" headwalls located on both WS and LS toes. (secondary permit reference: 48-inch irrigation pipe authorized under Permit No. 13170, 1981 - S. S. Hinaman, Jr., USACE letter covers installation of a 36-inch pipe dated 14 July 1981, Board summary report references 36-inch pipe and not 48-inch pipe)[Additional Reference(s): DWR Levee Log, 1993 (HLM 5.85). USACE Sacramento O&M Manual, Unit 519, June 1962, Revised 3 Feb 2011, (HLM 5.85), As-built DWG No. 50-4-3608, Sheet No. 3608/22.3, STA 19+30 LT. BK. (Cottonwood), page 23 of 28 electronic file, listed as 36-inch pipe; As-built DWG No. 50-4-3037 referenced not available]
FS Date: 8/28/2019 3:17:00 PM

Overview looking south

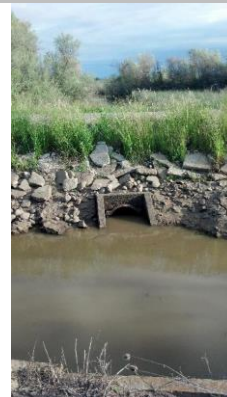
Photo 3 of 3 : UCIP_SP_2021_58538_67156.jpg

Headwall and damaged/missing screw gate on LS.

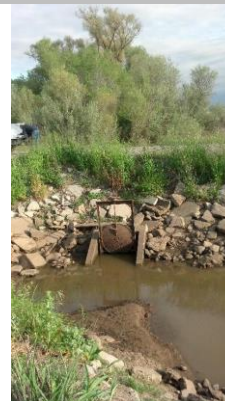
Photo 3 of 3 : UCIP_SP_2021_57650_67160.jpg

Headwall and screw gate on land side of levee

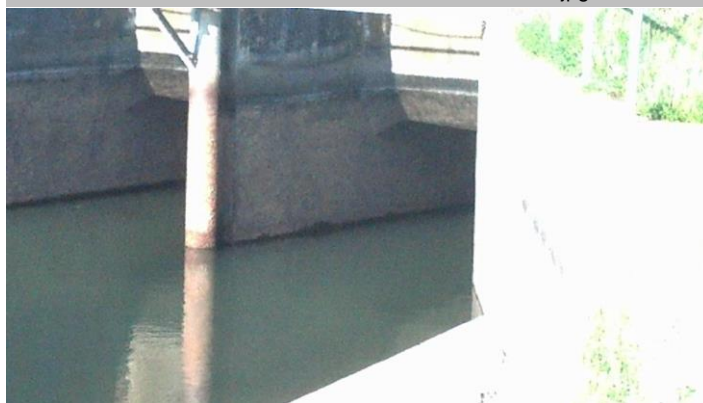
Photo 3 of 3 : UCIP_SP_2021_58539_67162.jpg

FIELD_STRUCT_DESC: [Western Canal Siphon] 1 of 3: 8-foot by 10-foot concrete irrigation conduit through the levee and channel. Top of concrete conduit 4 feet below the crown. Catwalk and guardrails around headwall. Debris catchment line located at the wings of the headwall. [Additional Reference(s): DWR Levee Log, 1993 (HLM 6.13). USACE Sacramento O&M Manual, Unit 519, June 1962, Revised 3 Feb 2011, (HLM 6.13), listed as three 8-foot by 10-foot concrete conduit, no As-built reference found]
FS Date: 8/28/2019 3:26:00 PM

1 of 3 Eight (8) foot by Ten (10) foot concrete conduit (upstream conduit).

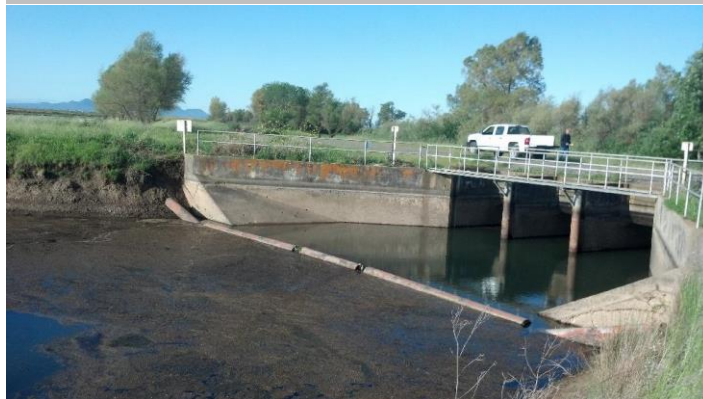
Photo 2 of 3 : UCIP_SP_2021_58540_67168.jpg

LM Start	6.06	Rating **	M	Issue No.	31 (cont)
LM End	6.06	Issue Type +	En	Location *	
Category	Supplemental		GPS Latitude/Longitude		
			Start	End	
Item	DWR UCIP Field Study		39.522488 °	39.522488 °	
			-121.706030 °	-121.706030 °	
DWR ID	17373

Debris catchment line across structure.

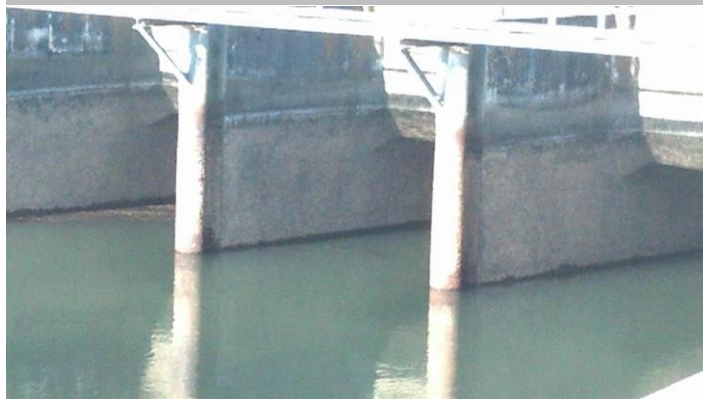
Photo 3 of 3 : UCIP_SP_2021_58540_67166.jpg

2 of 3 Eight (8) foot by Ten (10) foot conduit (middle conduit).

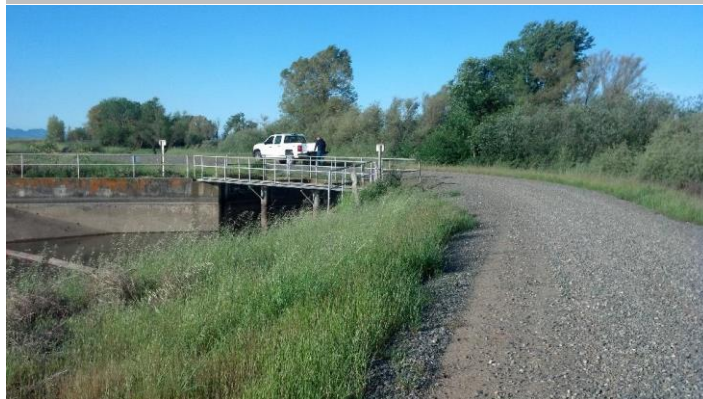
Photo 2 of 3 : UCIP_SP_2021_58541_67171.jpg

LM Start	6.07	Rating **	M	Issue No.	32 (cont)
LM End	6.07	Issue Type +	En	Location *	
Category	Supplemental		GPS Latitude/Longitude		
			Start	End	
Item	DWR UCIP Field Study		39.522457 °	39.522457 °	
			-121.706030 °	-121.706030 °	
DWR ID	17374

Overview looking south from levee

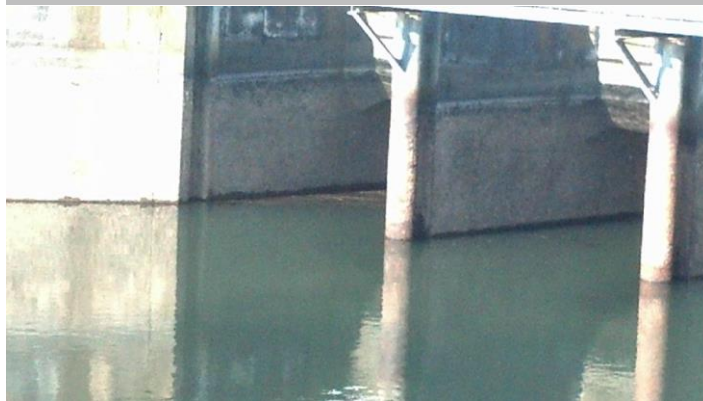
Photo 3 of 3 : UCIP_SP_2021_58541_67170.jpg

FIELD_STRUCT_DESC: [Western Canal Siphon] 3 of 3: 8-foot by 10-foot concrete irrigation conduit through the levee and channel. Top of concrete conduit 4 feet below the crown. Catwalk and guardrails around headwall. Debris catchment line located at the wings of the headwall. All conduits are open. [Additional Reference(s): DWR Levee Log, 1993 (HLM 6.13). USACE Sacramento O&M Manual, Unit 519, June 1962, Revised 3 Feb 2011, (HLM 6.13), listed as three 8-foot by 10-foot concrete conduit, no As-built reference found]
FS Date: 8/28/2019 3:43:00 PM

3 of 3 Eight (8) foot by Ten (10) foot siphon. (downstream conduit)

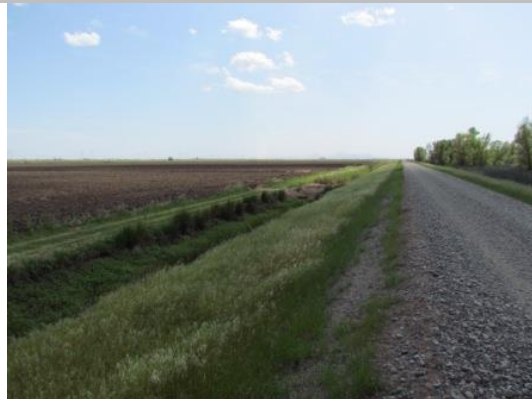
Photo 1 of 1 : SP_2021_MA0013_301_12_20210224_00001.jpg

LM Start	6.16	Rating **	M	Issue No.	12
LM End	7.54	Issue Type +	En	Location *	LS
Category	Earthen Levee			GPS Latitude/Longitude	
				Start	End
Item	Encroachments			39.521089 °	39.502958 °
				-121.706303 °	-121.716953 °
DWR ID	DWR_MA0013_02_s_2012_12				
Comment Code					
DT : Ditch					
Inspector Comment

View of the agricultural ditch along the toe.

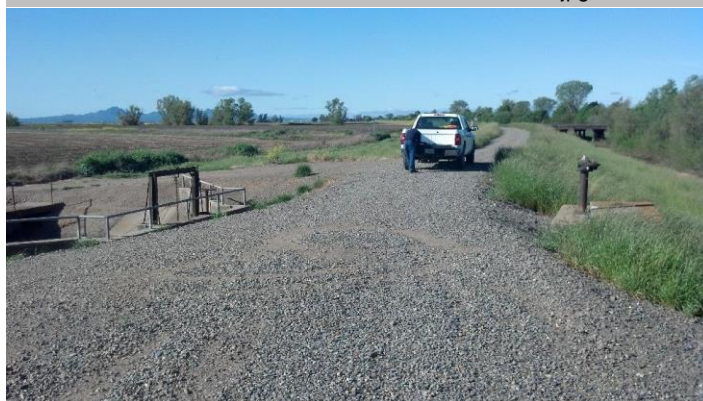
Photo 1 of 3 : UCIP_SP_2021_58545_67212.jpg

Comment Code					
Inspector Comment					
FS_ID:58545 DS_ID:16414 EP_NO: N/A Repair Type: Non-Urgent Crossing Status: Found UCIP Comments: 08/28/2019 Record has been updated from No Action Needed to Non-Urgent, no permit has been identified authorizing structure. (O. Magana - DWR UCIP, A. Freitag - DWR Sutter Yard)06/05/2017 Crossing appears to be in good condition. (A. Freitag - DWR Sutter Yard)11/18/2016 Crossing appears to be in good condition. (A. Freitag - DWR Sutter Yard)04/27/2016 Crossing appears to be in good condition. (A. Freitag - DWR Sutter Yard)06/30/2015 Crossing appears in good condition. No noticeable issues to report. (A. Freitag - DWR Sutter Yard)05/28/2014 Same as last inspection. (A. Freitag - DWR Sutter Yard)12/04/2013 Same as last inspection. (A. Freitag - DWR Sutter Yard)07/09/2013 Same as last inspection. (A. Freitag - DWR Sutter Yard) FIELD_STRUCT_DESC: [Richvale Irrigation District Siphon] 1 of 3: 6-foot by 6.5-foot reinforced concrete irrigation culverts through the levee 17.5 feet below the crown. Concrete "U" headwall with slots for flashboards on the landside (LS). Slide gate in gate well on downstream culvert on the waterside (WS) slope. Access well on downstream culvert 60 feet from the WS toe, manhole flush with the top of the ground. 36-inch corrugated metal pipe through the levee, 11.2 feet below the crown. Flap gate on the WS end. Concrete "U" headwalls on both ends. This pipe drains excess water from the District's canal into Cherokee Canal. The pipe runs through the levee on an angle and discharges opposite historic levee mile (HLM) 9.58. Richvale Irrigation District siphon crosses the channel and levee. [Additional Reference(s): DWR Levee Log, 1993 (HLM 9.66). USACE Sacramento O&M Manual, Unit 519, June 1962, Revised 3 Feb 2011, (HLM 9.66), listed as three 6-foot by 6.5-foot concrete conduit, As-built DWG No. 50-4-3608, Sheet No. 3608/20, ~ STA 650+00E, page 21 of 28 electronic file, listed as conduit] FS Date: 8/28/2019 4:04:00 PM

Overview of crossing looking downstream at the left bank of Cherokee Canal.

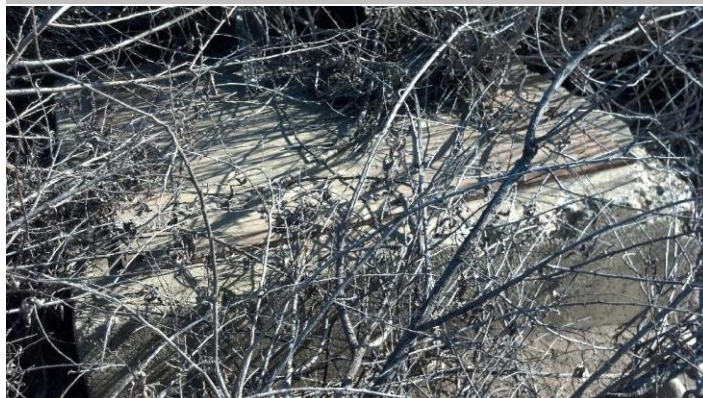
Photo 3 of 3 : UCIP_SP_2021_58546_67234.jpg

WS view, close up of access well located approximately 60 feet from WS toe.

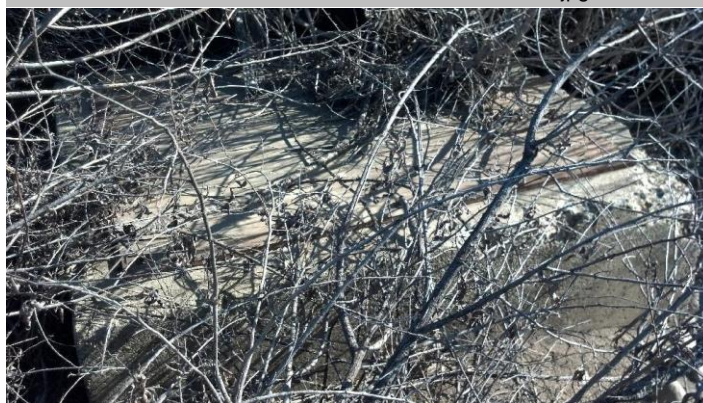
Photo 3 of 3 : UCIP_SP_2021_58548_67283.jpg

FS_ID:58548
DS_ID:16838
EP_NO: N/A
Repair Type: Non-Urgent
Crossing Status: Found
UCIP Comments: 08/28/2019 Record has been updated from No Action Needed to Non-Urgent, no permit has been identified authorizing structure. (O. Magana - DWR UCIP, A. Freitag - DWR Sutter Yard)06/05/2017 Crossing appears to be in good condition. (A. Freitag - DWR Sutter Yard)11/18/2016 Crossing appears to be in good condition. (A. Freitag - DWR Sutter Yard)04/27/2016 Crossing appears to be in good condition. (A. Freitag - DWR Sutter Yard)06/30/2015 Path to access the WS flap gate was getting overgrown with vegetation but other than that everything with the crossing looked in good condition. (A. Freitag - DWR Sutter Yard)05/28/2014 Same as last inspection. (A. Freitag - DWR Sutter Yard)12/04/2013 Same as last inspection. (A. Freitag - DWR Sutter Yard)07/09/2013 Same as last inspection. (A. Freitag - DWR Sutter Yard)04/24/2012 This crossing was listed in the USACE Periodic Inspection report as Corp's inspect ID# USACE_CESPK_M13F_2011_p_0080 for limited visibility of LS slide gate and WS flap gate. (O. Magana - DWR UCIP)

WS view-access well located 60 feet from WS toe.

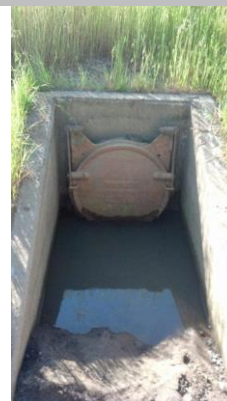
Photo 1 of 3 : UCIP_SP_2021_58549_67289.jpg

Comment Code						
Inspector Comment						
FS_ID:58549 DS_ID:16839 EP_NO: N/A Repair Type: Non-Urgent Crossing Status: Found UCIP Comments: 08/28/2019 Record has been updated from No Action Needed to Non-Urgent, no permit has been identified authorizing structure. (O. Magana - DWR UCIP, A. Freitag - DWR Sutter Yard)06/05/2017 Crossing appears to be in good condition. (A. Freitag - DWR Sutter Yard)11/18/2016 Crossing appears to be in good condition. (A. Freitag - DWR Sutter Yard)04/27/2016 Crossing appears to be in good condition. (A. Freitag - DWR Sutter Yard)06/30/2015 WS flap gate is silted over and unable to open. Needs to be dug out. (A. Freitag - DWR Sutter Yard)05/28/2014 Same as last inspection. (A. Freitag - DWR Sutter Yard)12/04/2013 Slopes were cleared of vegetation and are in good condition. (A. Freitag - DWR Sutter Yard)07/09/2013 Same as last inspection. (A. Freitag - DWR Sutter Yard)04/24/2012 Limited inspection on WS and LS slopes due to dense vegetation. Need photos of WS and LS slopes during next inspection with cleared slopes. (O. Magana - DWR UCIP) FIELD_STRUCT_DESC: 30-inch corrugated metal drainage pipe through the levee, 11.5 feet below the crown. Flap gate on the waterside (WS). [Additional Reference(s): USACE Sacramento O&M Manual, Unit 519, June 1962, Revised 3 Feb 2011, (HLM 9.68), As-built DWG No. 50-4-3608, Sheet No. 3608/20, ~ STA 648+82E, page 21 of 28 electronic file, listed as 30-inch; As-built DWG No. 50-4-3037 referenced not available] FS Date: 8/28/2019 4:05:00 PM

WS view of crossing. Dense vegetation along WS slope limited visual inspection. (WS Photo 1 of 2)

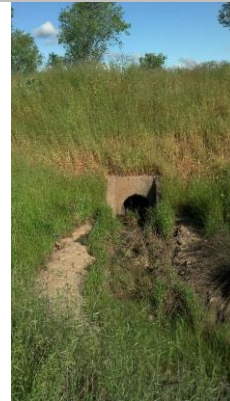
Photo 3 of 3 : UCIP_SP_2021_58549_67286.jpg

View of crossing from LS. Dense vegetation along LS slope limited visual inspection. (LS Photo 1 of 2)

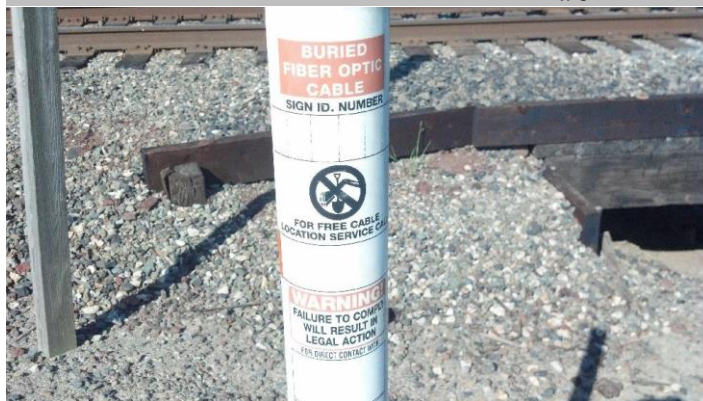
Photo 2 of 3 : UCIP_SP_2021_57670_67291.jpg

Marker for buried fiber optic cable on WS.

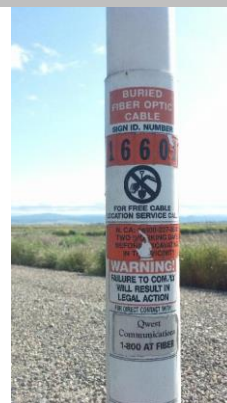
Photo 3 of 3 : UCIP_SP_2021_57670_67290.jpg

Marker for buried fiber optic cable on LS with contact information.

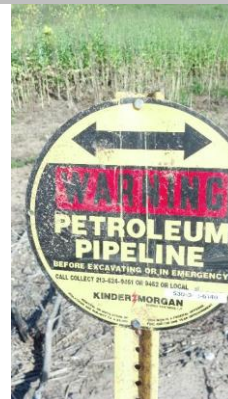
Photo 2 of 3 : UCIP_SP_2021_57671_67294.jpg

FS_ID:57671
DS_ID:18913
EP_NO: N/A
Repair Type: Non-Urgent
Crossing Status: Indicator Found
UCIP Comments: 08/28/2019 Record remains Non-Urgent, no permit has been found authorizing this crossing. Also need maintenance records to determine condition of line. (O. Magana - DWR UCIP, A. Freitag - DWR Sutter Yard)06/05/2017 Crossing appears to be in good condition. (A. Freitag - DWR Sutter Yard)11/18/2016 Crossing appears to be in good condition. (A. Freitag - DWR Sutter Yard)04/27/2016 Crossing appears to be in good condition. (A. Freitag - DWR Sutter Yard)06/30/2015 Crossing appears to be in good condition. But still unknown if this crossing was authorized or unauthorized. (A. Freitag - DWR Sutter Yard)05/28/2014 Same as last inspection. (A. Freitag - DWR Sutter Yard)12/04/2013 Same as last inspection. (A. Freitag - DWR Sutter Yard)07/09/2013 Same as last inspection. (A. Freitag - DWR Sutter Yard)04/24/2012 Authorized/unauthorized encroachment? Contact Chico Local Area Manager, Frank Villalovos 530.342.6140 (o) or 530.624.4048 (c) or email villalovosf@kindermorgan.com for additional info. Inquiries pertaining to inspection submit to pipelineinquiries@kindermorgan.com and reference as Engr Station 3173+48 plus include coordinates. (O. Magana - DWR UCIP)

WS marker with utility contact information.

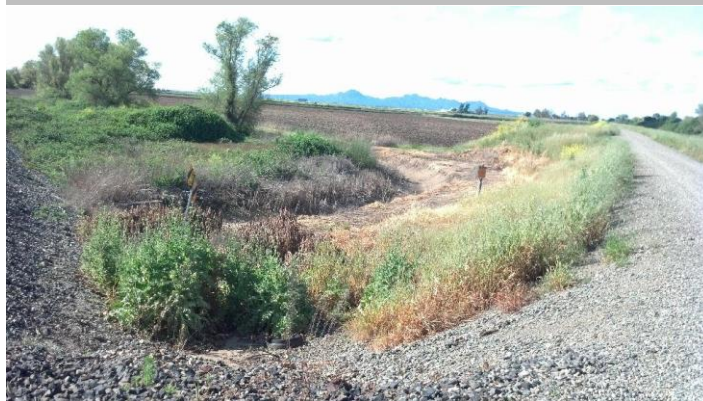
Photo 3 of 3 : UCIP_SP_2021_57671_67293.jpg

View of LS slope and marker.

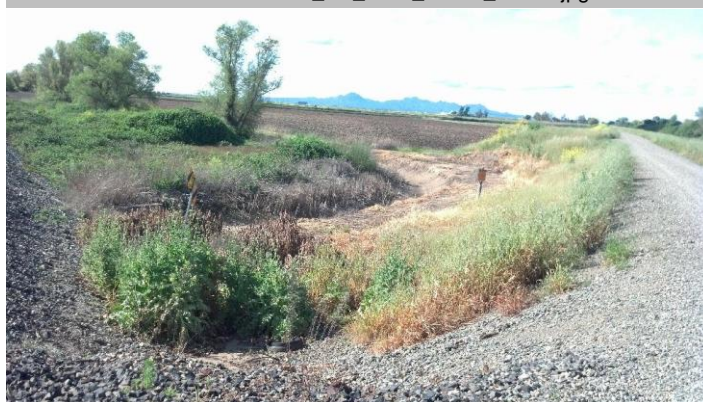
Photo 2 of 3 : UCIP_SP_2021_57672_67300.jpg

FS_ID:57672
DS_ID:18914
EP_NO: N/A
Repair Type: Non-Urgent
Crossing Status: Indicator Found
UCIP Comments: 08/28/2019 Record remains Non-Urgent, no permit has been found authorizing this crossing. Utility marker previously present on LS is missing. (O. Magana - DWR UCIP, A. Freitag - DWR Sutter Yard)06/05/2017 Crossing appears to be in good condition. (A. Freitag - DWR Sutter Yard)11/18/2016 Crossing appears to be in good condition. (A. Freitag - DWR Sutter Yard)04/27/2016 Crossing appears to be in good condition. (A. Freitag - DWR Sutter Yard)06/30/2015 Crossing appears to be in good condition. It is still unknown whether this crossing was authorized or unauthorized. (A. Freitag - DWR Sutter Yard)05/28/2014 Same as last inspection. (A. Freitag - DWR Sutter Yard)12/04/2013 Same as last inspection. (A. Freitag - DWR Sutter Yard)07/09/2013 Same as last inspection. (A. Freitag - DWR Sutter Yard)04/24/2012 Unable to determine if crossing is an authorized or unauthorized encroachment. Unable to find permit number for this crossing. Will need to coordinate with Pacific Telephone to determine if permit exist for this crossing. (O. Magana - DWR UCIP)

Marker located on LS.

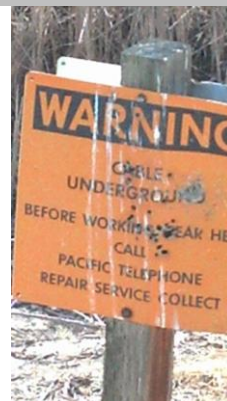
Photo 3 of 3 : UCIP_SP_2021_57672_67298.jpg

Underground cable marker with contact information.

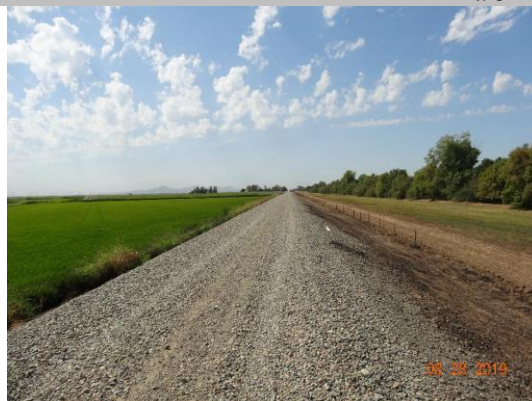
Photo 1 of 3 : UCIP_SP_2021_57673_80923.jpg

Comment Code						
Inspector Comment						
FS_ID:57673 DS_ID:17731 EP_NO: 16994 Repair Type: Non-Urgent Crossing Status: Not Found UCIP Comments: 08/28/2019 Record remains Non-Urgent, no crossing found. Will need to review permit in detail to determine status of crossing. (O. Magana - DWR UCIP, A. Freitag - DWR Sutter Yard)06/05/2017 Unable to locate. (A. Freitag - DWR Sutter Yard)11/18/2016 Unable to locate. (A. Freitag - DWR Sutter Yard)04/27/2016 Unable to locate. (A. Freitag - DWR Sutter Yard)06/30/2015 Unable to locate. (A. Freitag - DWR Sutter Yard)05/28/2014 Same as last inspection. (A. Freitag - DWR Sutter Yard)12/04/2013 Unable to locate. (A. Freitag - DWR Sutter Yard)07/09/2013 Same as last inspection. Unable to locate any signs of this crossing. (A. Freitag - DWR Sutter Yard)04/24/2012 Unable to find any indicators for this crossing. It appears that this encroachment was not built. Check again during next inspection. (O. Magana - DWR UCIP) FIELD_STRUCT_DESC: 10-inch high-density polyethylene (HDPE) communication conduit through the levee, unknown depth below the crown. Conduit contains fiber-optic cables that goes across and under (bored) Cherokee Canal and its levees. Twelve inner ducts through casing with hand holes placed at each end for initial and future installation of fiber optic telecommunications cable. (10-inch HDPE conduit across and under (bored) Cherokee Canal and its levees authorized under Permit No. 16994, 2000 - Level 3 Comm) FS Date: 8/28/2019 4:10:00 PM

Overview of levee crown looking d/s towards where crossing should be.

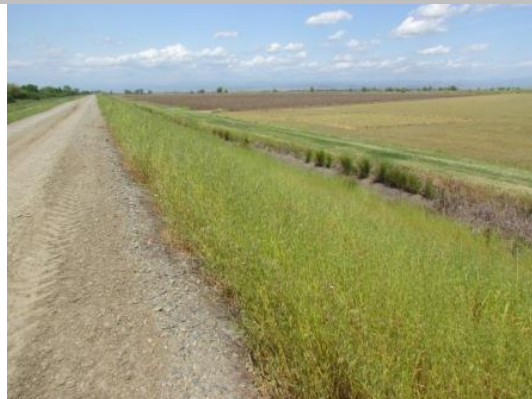
Photo 1 of 1 : SP_2021_MA0013_301_13_20210224_00002.jpg

LM Start	10.03	Rating **	M	Issue No.	13
LM End	10.52	Issue Type +	En	Location *	LS
Category	Earthen Levee			GPS Latitude/Longitude	
				Start	End
Item	Encroachments			39.471517 °	39.465113 °
				-121.739433 °	-121.743592 °
DWR ID	DWR_MA0013_02_s _ 2012_13				
Comment Code					
DT : Ditch					
Inspector Comment

View of the agricultural ditch along the toe.

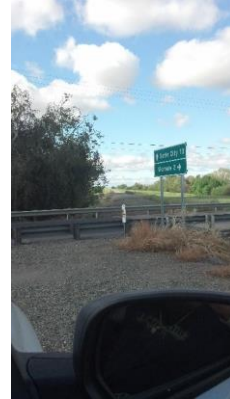
Photo 2 of 3 : UCIP_SP_2021_58550_67333.jpg

Utility is angled. Alignment crosses highway.

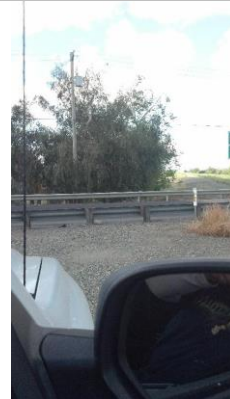
Photo 3 of 3 : UCIP_SP_2021_58550_67331.jpg

Downstream utility marker is located across highway.

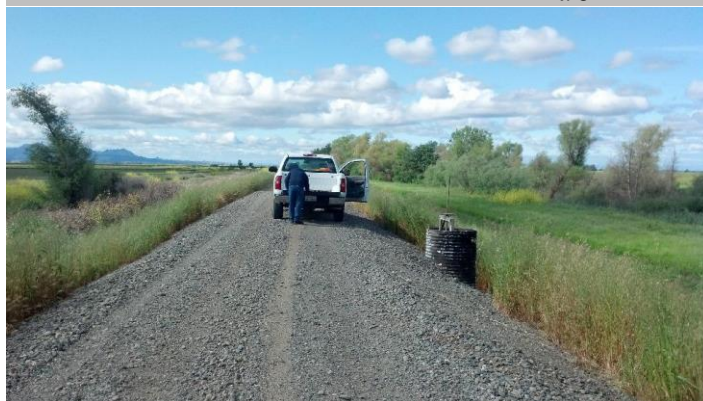
Photo 1 of 3 : UCIP_SP_2021_58551_67336.jpg

FS_ID:58551
DS_ID:16385
EP_NO: N/A
Repair Type: Non-Urgent
Crossing Status: Found
UCIP Comments: 08/29/2019 Record remains Non-Urgent, no permit has been identified authorizing pipe. Need to change structure type from drainage to irrigation siphon. This crossing is associated with DSID 16334 in Unit 1. LS slide gate was under water during inspection. This structure is not maintained or operated by LMA-DWR Sutter Yard. (O. Magana - DWR UCIP, A. Freitag - DWR Sutter Yard)05/30/2017 WS end cannot be located due to heavy vegetation. LS screw gate was mostly submerged during site visit. Pipe has been selected to be internally cleaned and inspected as part of the DMP project. (A. Freitag - DWR Sutter Yard)11/17/2016 WS still heavily vegetated and cannot access the WS pipe end for inspection. Vegetation needs to be cleared back. (A. Freitag - DWR Sutter Yard)04/26/2016 LS headwall was visible but gate was underwater. WS still heavily vegetated and unable to be inspected. Vegetation needs to be cleared back. (A. Freitag - DWR Sutter Yard)06/30/2015 WS heavily vegetated passed the toe-road and could not make it to the WS pipe end for inspection. Vegetation needs to be cleared back. LS pipe end was fully submerged under water. (A. Freitag - DWR Sutter Yard)05/28/2014 Same as last inspection. (A. Freitag - DWR Sutter Yard)12/04/2013 Same as last inspection. (A. Freitag - DWR Sutter Yard)07/08/2013 LS slope has been cleared of vegetation and is in good condition. LS headwall is now visible but mostly underwater so unable to do full inspection. WS is still vegetated. (A. Freitag - DWR Sutter Yard)04/24/2012 LS pipe & slide gate sedimented in. Limited inspection WS and LS slopes due to dense vegetation. Need photos of cleared WS and LS slopes during next inspection. This crossing was listed in the USACE Periodic Inspection report as Corp's inspect ID# USACE_CESPK_M13F_2011_p_0147 for limited visibility of LS and WS. (O. Magana - DWR UCIP)

FIELD_STRUCT_DESC: 30-inch corrugated metal drainage pipe through the levee, 13 feet below the crown. Slide gate in corrugated metal pipe riser on the waterside (WS) slope. Slide gate in ditch on the landside (LS). Pipe under channel is a 24-inch siphon. [Additional Reference(s): DWR Levee Log, 1993 (HLM 13.02). USACE Sacramento O&M Manual, Unit 519, June 1962, Revised 3 Feb 2011, (HLM 13.03), listed as 30-inch pipe, As-built DWG No. 50-4-3511, Sheet No. 3511/9.3, 24.1, STA 474+13E, page 9, 24 of 31 electronic file, listed as combination of new 30-inch section pipe through the levee and existing 24-inch concrete siphon pipe through the channel (Keller Siphon structure, irrigation facilities); As-built DWG No. 50-4-3037 referenced not available]
FS Date: 8/29/2019 7:31:00 AM

Overview of crossing looking downstream at the left bank of Cherokee Canal.

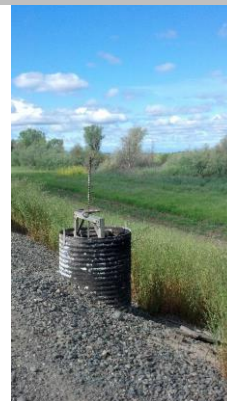
Photo 2 of 3 : UCIP_SP_2021_58551_67337.jpg

Stand pipe with screw gate WS

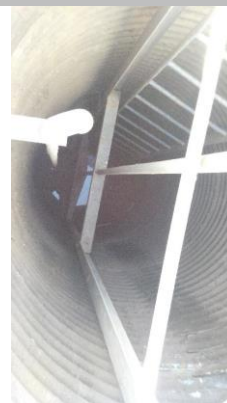
Photo 3 of 3 : UCIP_SP_2021_58551_67335.jpg

View of the inside of the WS stand pipe. No obstructions blocking slide gate.

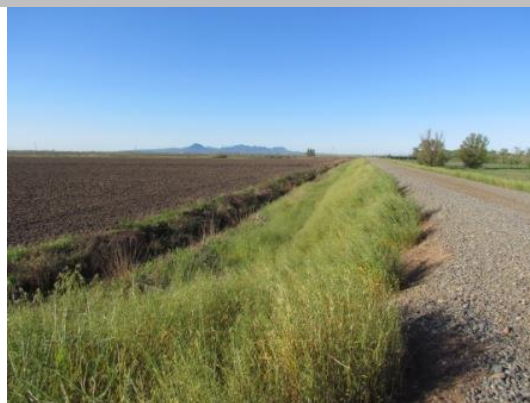
Photo 1 of 1 : SP_2021_MA0013_301_19_20210224_00004.jpg

LM Start	13.40	Rating **	M	Issue No.	19
LM End	16.00	Issue Type +	En	Location *	LS
Category	Earthen Levee			GPS Latitude/Longitude	
				Start	End
Item	Encroachments			39.428192 °	39.414202 °
				-121.768443 °	-121.781863 °
DWR ID	DWR_MA0013_02_s_2012_19				
Comment Code					
DT : Ditch					
Inspector Comment

View of the agricultural ditch along the toe.

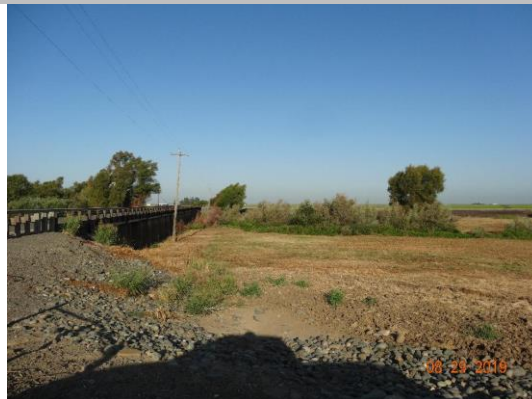
Photo 1 of 3 : UCIP_SP_2021_57654_80938.jpg

Comment Code						
Inspector Comment						
FS_ID:57654 DS_ID:16474 EP_NO: 17030 Repair Type: Non-Urgent Crossing Status: Not Found UCIP Comments: 08/29/2019 Record has been updated from No Action Needed to Non-Urgent, crossing is not found. Need to contact owner to determine status of crossing. Need to determine status of pipe through the levee. (O. Magana - DWR UCIP, A. Freitag - DWR Sutter Yard)05/30/2017 Unable to locate. (A. Freitag - DWR Sutter Yard)11/17/2016 Unable to locate. (A. Freitag - DWR Sutter Yard)04/26/2016 Unable to locate. (A. Freitag - DWR Sutter Yard)06/30/2015 Unable to locate. (A. Freitag - DWR Sutter Yard)05/28/2014 Same as last inspection. (A. Freitag - DWR Sutter Yard)12/04/2013 Unable to locate. (A. Freitag - DWR Sutter Yard)07/08/2013 Same as last inspection. Unable to locate. (A. Freitag - DWR Sutter Yard) FIELD_STRUCT_DESC: 8-inch high density polyethylene (HDPE), contains three 2-inch and three 1.5-inch fiber optic cables, backfilled with bentonite on the ends of the bore casing through the levee at an unknown depth below the crown. Conduit is bored across and under Cherokee Canal and its levees. Permit records indicates the conduit is buried 5 feet below the bottom of the low flow of the channel. Permit indicates work was completed as shown in submitted plans. Owner is listed in the permit as Pacific Fiber Link LLC but permit Inspection sheets list Worldwide Fiber. (three 2-inch and three 1.5-inch pipes containing fiber optic cables across and under (bored) Cherokee Canal and its levees authorized under Permit No. 17030, 2000 - Worldwide Fiber) FS Date: 8/29/2019 7:32:00 AM

WS view: overview of WS. No signs of crossing.

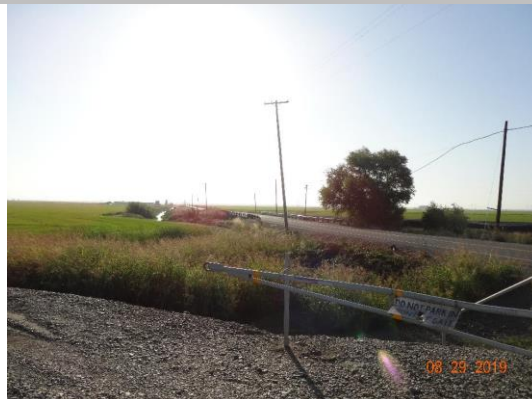
Photo 2 of 3 : UCIP_SP_2021_57654_80939.jpg

LS view: overview of LS. No signs of crossing.

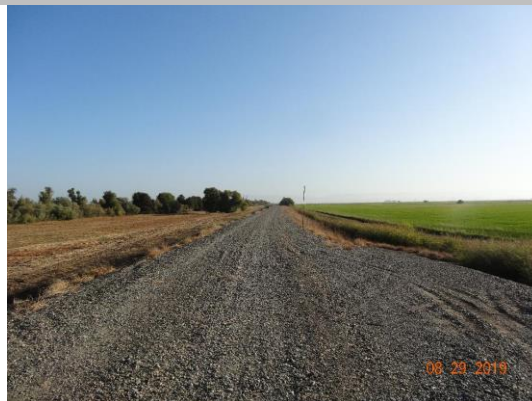
Photo 3 of 3 : UCIP_SP_2021_57654_80940.jpg

Overview of levee crown looking u/s towards where pipe should cross.

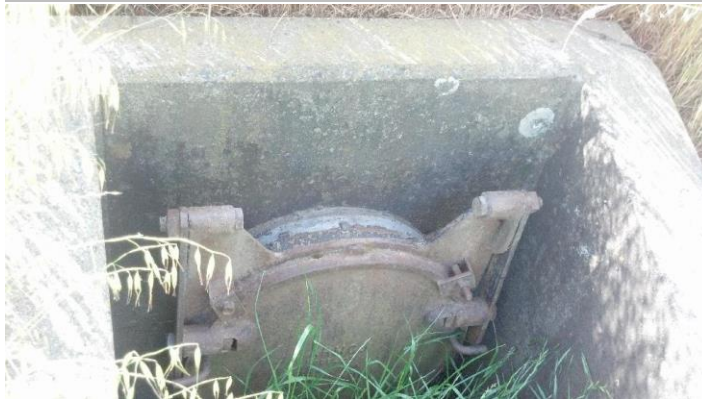
Photo 3 of 3 : UCIP_SP_2021_58552_67342.jpg

View of WS headwall and flap gate.

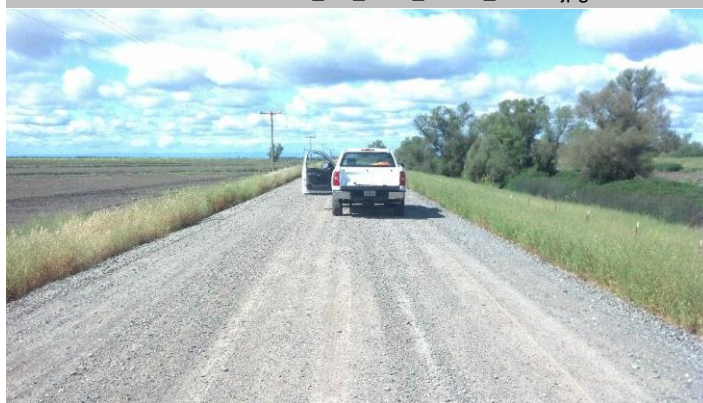
Photo 1 of 3 : UCIP_SP_2021_58553_67352.jpg

FS_ID:58553
DS_ID:16382
EP_NO: N/A
Repair Type: Non-Urgent
Crossing Status: Found
UCIP Comments: 08/29/2019 Record remains Non-Urgent, structure is non-functional and abandoned. Structure is abandoned. LMA will need to coordinate with landowner to determine if pipe is still needed as drainage structure. Dense vegetation covers the WS outlet and only LS headwall is visible at LS toe. If structure is no longer needed then structure will need to be abandoned properly or removed according to Title 23. DWR DMP internal inspection shows pipe has been filled with grout starting at about 47 feet from WS flap gate. No permit has been identified authorizing pipe. (O. Magana - DWR UCIP, A. Freitag - DWR Sutter Yard)05/30/2017 LS pipe end is buried and location unknown. WS flap gate bolted shut. Pipe has been selected to be internally cleaned and inspected as part of the DMP project. (A. Freitag - DWR Sutter Yard)11/17/2016 Unable to locate LS pipe end. WS flap gate bolted shut. (A. Freitag - DWR Sutter Yard)04/26/2016 Appears to be an abandoned crossing. LS pipe end was still buried and WS flap gate was bolted shut. (A. Freitag - DWR Sutter Yard)06/30/2015 LS headwall still buried somewhere. WS looked to be in good condition. (A. Freitag - DWR Sutter Yard)05/28/2014 Same as last inspection. (A. Freitag - DWR Sutter Yard)12/04/2013 Same as last inspection. (A. Freitag - DWR Sutter Yard)07/08/2013 Same as last inspection. (A. Freitag - DWR Sutter Yard)04/24/2012 LS headwall buried. Limited inspection on WS and LS slopes due to dense vegetation. Need photos of cleared WS and LS slopes during next inspection. Need to determine the status of LS headwall. This crossing was listed in the USACE Periodic Inspection report as Corp's inspect ID# USACE_CESPK_M13E_2011_p_0022 -- unknown issue. (O. Magana - DWR UCIP)

FIELD_STRUCT_DESC: 24-inch corrugated metal drainage pipe through the levee, 9 feet below the crown. Flap gate located on the waterside (WS) end. Concrete "U" headwalls on both WS and landside (LS). WS gate bolted shut and LS crossing is non-operable (inlet not found). Additional Reference(s): DWR Levee Log, 1993 (HLM 15.87). USACE Sacramento O&M Manual, Unit 519, June 1962, Revised 3 Feb 2011, (HLM 15.87), As-built DWG No. 50-4-3511, Sheet No. 3511/8.3, STA 392+42E, page 8 of 31 electronic file, listed as 24-inch CMP; As-built DWG No 50-4-3037 referenced not available]
FS Date: 8/29/2019 7:33:00 AM

Overview of crossing looking downstream of the left bank of Cherokee

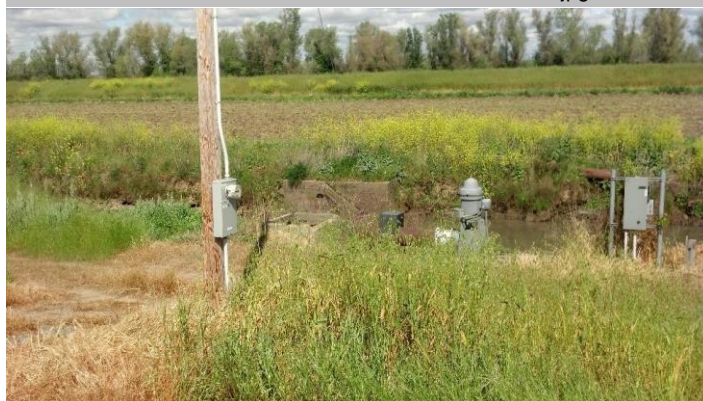
Photo 2 of 3 : UCIP_SP_2021_58554_67359.jpg

Appurtenances on WS.

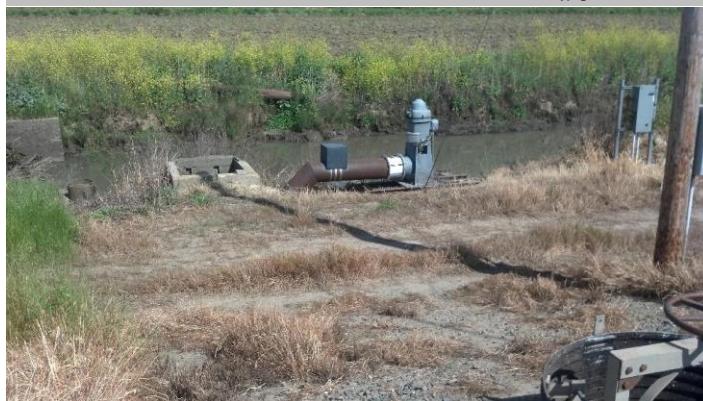
Photo 3 of 3 : UCIP_SP_2021_58554_67355.jpg

WS view of crossing.

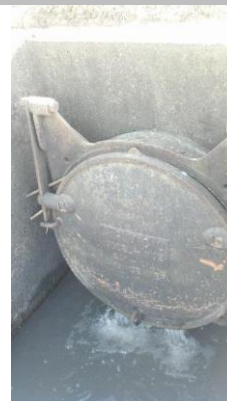
Photo 3 of 3 : UCIP_SP_2021_58556_67380.jpg

View of flap gate slightly propped open by the sticks on the left.

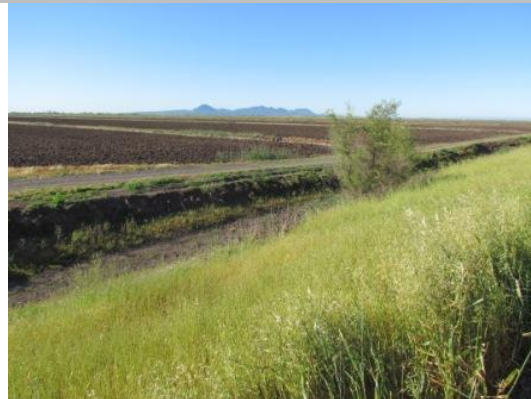
Photo 1 of 1 : SP_2021_MA0013_301_20_20210224_00005.jpg

LM Start	16.89	Rating **	M	Issue No.	20
LM End	18.72	Issue Type +	En	Location *	LS
Category	Earthen Levee			GPS Latitude/Longitude	
				Start	End
Item	Encroachments			39.406217 °	39.389187 °
				-121.794945 °	-121.821233 °
DWR ID	DWR_MA0013_02_s_2012_20				
Comment Code					
DT : Ditch					
Inspector Comment

View of the agricultural ditch along the toe.

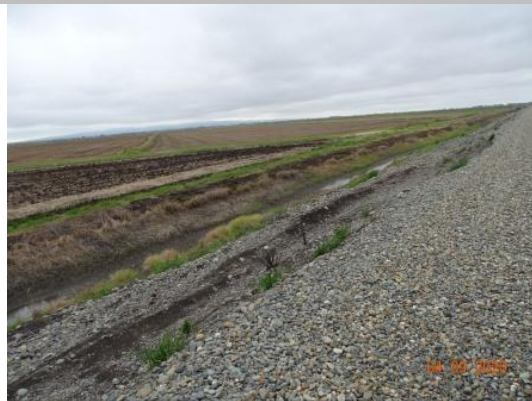
Photo 1 of 1 : SP_2021_MA0013_301_69_20210224_00013.jpg

LM Start	17.63	Rating **	U	Issue No.	69
LM End	17.65	Issue Type +	Ma	Location *	LS
Category	Earthen Levee			GPS Latitude/Longitude	
				Start	End
Item	Slope Stability			39.399319 °	39.399147 °
				-121.805524 °	-121.805783 °
DWR ID	DWR_MA0013_02_f_2016_69				
Comment Code					
S1 : Repair slope instability.					
Inspector Comment

View of slope instability along the landside slope. Spring 2020.

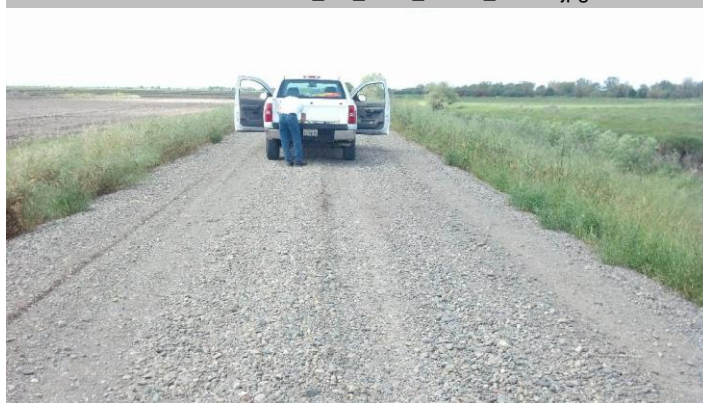
Photo 1 of 3 : UCIP_SP_2021_58557_67387.jpg

FS_ID:58557
DS_ID:16379
EP_NO: N/A
Repair Type: Non-Urgent
Crossing Status: Found
UCIP Comments: 08/29/2019 Record has been updated from No Action Needed to Non-Urgent, no permit has been identified authorizing pipe. Pipe is under water. Pipe is scheduled to be lined. (O. Magana - DWR UCIP, A. Freitag - DWR Sutter Yard)05/30/2017 Crossing appears to be in good condition. Pipe has been selected to be internally cleaned and inspected as part of the DMP project. (A. Freitag - DWR Sutter Yard)11/17/2016 Crossing appears to be in good condition. (A. Freitag - DWR Sutter Yard)04/26/2016 Crossing appears to be in good condition. (A. Freitag - DWR Sutter Yard)06/30/2015 Vegetation still present on WS. LS side was underwater during inspection. (A. Freitag - DWR Sutter Yard)05/28/2014 Same as last inspection. (A. Freitag - DWR Sutter Yard)12/04/2013 Same as last inspection. (A. Freitag - DWR Sutter Yard)07/08/2013 LS slope cleared of vegetation and is in good condition. WS is still vegetated. LS pipe end under water and blocked off by plywood so unable to measure culvert size. (A. Freitag - DWR Sutter Yard)04/24/2012 Limited inspection on WS and LS slopes due to dense vegetation. Need photos of cleared WS and LS slopes. This crossing was listed in the USACE Periodic Inspection report as Corp's inspect ID# USACE_CESPK_M13E_2011_p_0134 for unknown culvert size on LS and no outlet visible on WS. (O. Magana - DWR UCIP) FIELD_STRUCT_DESC: 36-inch corrugated metal drainage pipe through the levee, 13.2 feet below the crown. Flap gate on the waterside (WS) end. Concrete "U" headwalls on both ends. [Additional Reference(s): DWR Levee Log, 1993 (HLM 18.37). USACE Sacramento O&M Manual, Unit 519, June 1962, Revised 3 Feb 2011, (HLM 18.37), As-built DWG No. 50-4-3511, Sheet No. 3511/6. unable to read exact page, STA 261+67E, page 6 of 31 electronic file, listed as 36-inch CMP]

Overview of crossing looking D/S at left bank of Cherokee Canal.

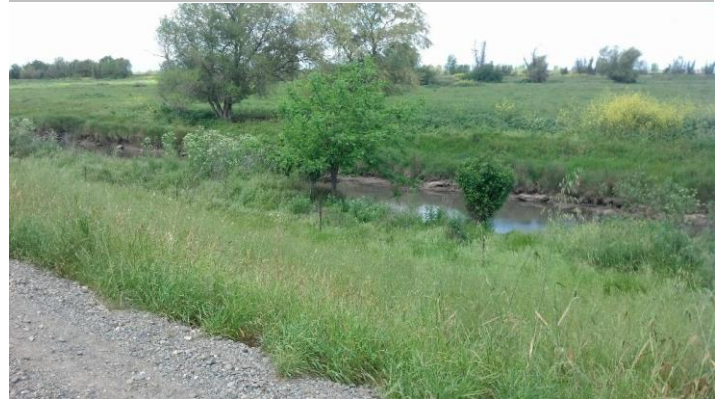
Photo 2 of 3 : UCIP_SP_2021_58557_67386.jpg

View of WS slope and berm.
