**Flood Control Project Maintenance
Levee Inspections
LMA District Cover Sheet**

Sutter Maintenance Yard Maintenance Area 0013

Waterway			Bank	Unit Miles
Unit No. 01 Cherokee Canal			Right	18.19
	Spring (March - May)	Summer (June - August)	(September - November) Fall	Winter (December - February)
Unit Maintenance Rating (Fall Only)				
Date of Inspection	3/24/2021 - 3/24/2021			
DWR Inspector	Makar Sokol			
Accompanied By	Bob Duffey Sutter Maintenance Yard

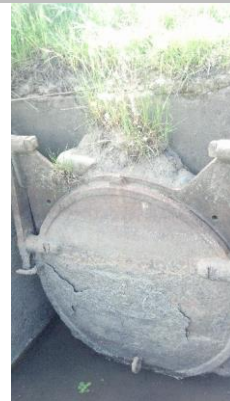
Photo 3 of 3 : UCIP_SP_2021_58557_67390.jpg

View of flap gate located on WS.

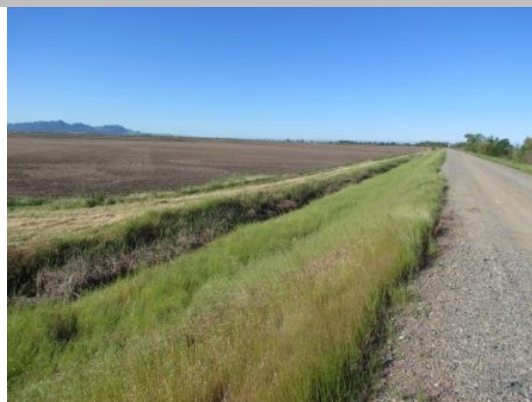
Photo 1 of 1 : SP_2021_MA0013_301_21_20210224_00006.jpg

LM Start	19.37	Rating **	M	Issue No.	21
LM End	19.92	Issue Type +	En	Location *	LS
Category	Earthen Levee			GPS Latitude/Longitude	
				Start	End
Item	Encroachments			39.383252 °	39.378192 °
				-121.830565 °	-121.838543 °
DWR ID	DWR_MA0013_02_s_2012_21				
Comment Code					
DT : Ditch					
Inspector Comment

View of the agricultural ditch along the toe.

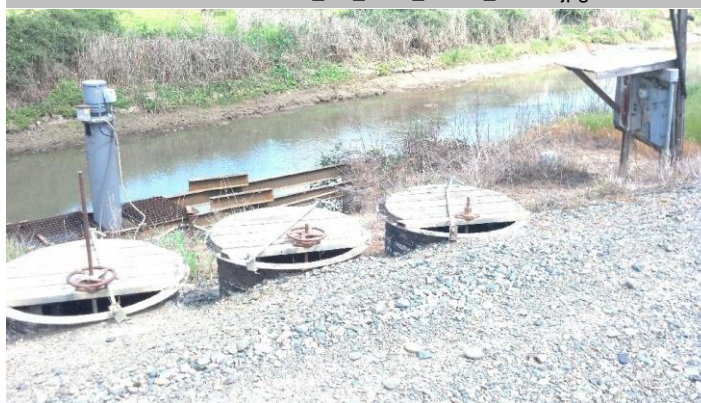
Photo 1 of 3 : UCIP_SP_2021_58560_67416.jpg

FS_ID:58560
DS_ID:17014
EP_NO: N/A
Repair Type: Urgent
Crossing Status: Found
UCIP Comments: 08/29/2019 Record remains Urgent due to pipe and levee integrity concerns. Also no permit has been identified authorizing pump station. Pump station is still active. Crossing shows sloughing on the WS with visible holes in pipe on the LS. This crossing is under investigation under CVFPB enforcement case (ENF ID) 723. (O. Magana - DWR UCIP, A. Freitag - DWR Sutter Yard)08/23/2018 The CVFPB has filed an enforcement for this crossing, Enforcement Case: 2018-723. There is still massive erosion around the WS headwall and corrosion and degradation of the LS outlet pipes, so the crossing remains Urgent. (D. Sanoski - DWR UCIP)05/30/2017 No repairs have been made here yet. WS still has depressions above the pipe alignment. LS pipe end still showing heavy signs of rusting and deterioration. Sediment build up inside of concrete distribution box on the LS. (A. Freitag - DWR Sutter Yard)11/17/2016 Crossing has not been repaired yet. pipe ends still showing heavy signs of rust and corrosion. (A. Freitag - DWR Sutter Yard)04/26/2016 No repairs have been made at this crossing yet. (A. Freitag - DWR Sutter Yard)06/30/2015 Crossing has not been repaired yet. pipe ends still showing heavy signs of rust and corrosion. (A. Freitag - DWR Sutter Yard)05/28/2014 Same as last inspection. (A. Freitag - DWR Sutter Yard)12/04/2013 Same as last inspection. (A. Freitag - DWR Sutter Yard)07/08/2013 Same as last inspection. (A. Freitag - DWR Sutter Yard)04/24/2012 LS pipe collars severely damaged--section missing at flap gate. Crossing needs repair. Will need to coordinate with owner. (O. Magana - DWR UCIP)

WS view of corrugated metal pipe risers .

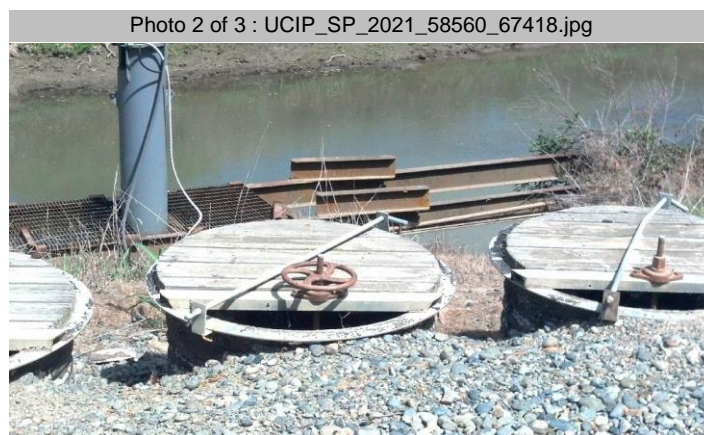
Riser for pipe 2 of 3.

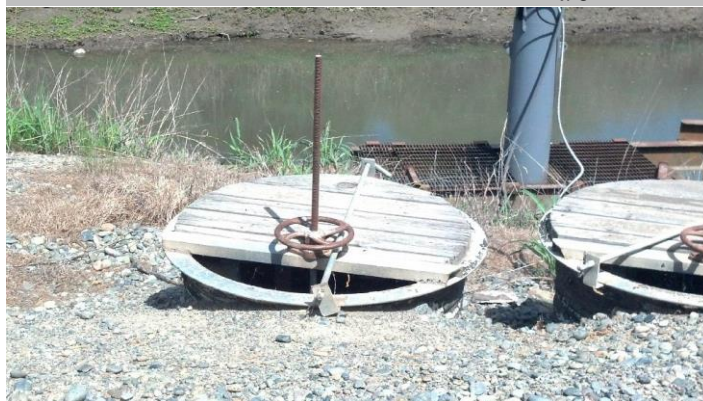
Photo 2 of 3 : UCIP_SP_2021_58561_67443.jpg

FS_ID:58561
DS_ID:17185
EP_NO: N/A
Repair Type: Urgent
Crossing Status: Found
UCIP Comments: 08/29/2019 Record remains Urgent due to pipe and levee integrity concerns. Also no permit has been identified authorizing pump station. Pump station is still active. Crossing shows sloughing on the WS with visible holes in pipe on the LS. This crossing is under investigation under CVFPB enforcement case (ENF ID) 723. (O. Magana - DWR UCIP, A. Freitag - DWR Sutter Yard)08/23/2018 The CVFPB has filed an enforcement for this crossing, Enforcement Case: 2018-723. There is still massive erosion around the WS headwall and corrosion and degradation of the LS outlet pipes, so the crossing remains Urgent. (D. Sanoski - DWR UCIP)05/30/2017 No repairs have been made here yet. WS still has depressions above the pipe alignment. LS pipe end still showing heavy signs of rusting and deterioration. Sediment build up inside of concrete distribution box on the LS. (A. Freitag - DWR Sutter Yard)11/17/2016 Crossing has not been repaired yet. pipe ends still showing heavy signs of rust and corrosion. (A. Freitag - DWR Sutter Yard)04/26/2016 No repairs have been made at this crossing yet. (A. Freitag - DWR Sutter Yard)06/30/2015 Crossing has not been repaired yet. pipe ends still showing heavy signs of rust and corrosion. (A. Freitag - DWR Sutter Yard)05/28/2014 Same as last inspection. (A. Freitag - DWR Sutter Yard)12/04/2013 Same as last inspection. (A. Freitag - DWR Sutter Yard)07/08/2013 Same as last inspection. (A. Freitag - DWR Sutter Yard)04/24/2012 Sink hole present on WS. LS pipe collars severely damaged--section missing at flap gate. Crossing needs repair. Need to coordinate with owner. (O. Magana - DWR UCIP)

View of corrugated metal pipe for pipe 3 of 3.

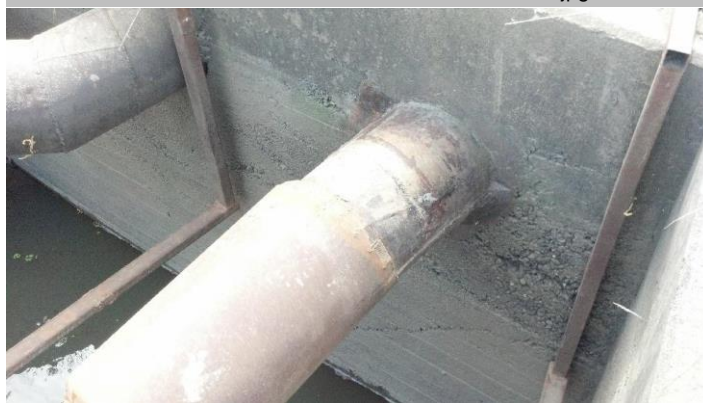
Photo 3 of 3 : UCIP_SP_2021_58561_67442.jpg

View of Pipe 3 of 3 from WS headwall.

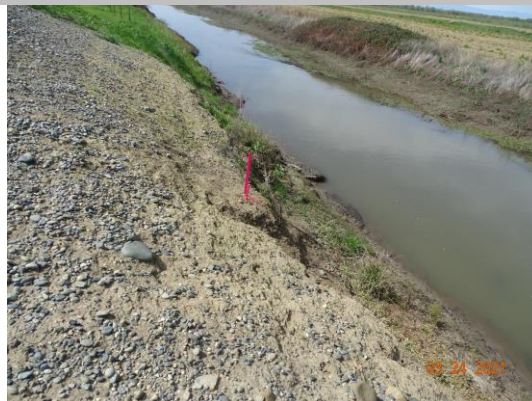
Photo 1 of 1 : SP_2021_MA0013_301_75_20210407_00180.jpg

LM Start	20.77	Rating **	M	Issue No.	75
LM End	20.77	Issue Type +	Ma	Location *	WS
Category	Earthen Levee			GPS Latitude/Longitude	
				Start	End
Item	Erosion / Bank Caving			39.370641 °	39.370641 °
				-121.850572 °	-121.850572 °
DWR ID	DWR_MA0013_02_f _ 2016_75				
Comment Code					
E2 : Schedule repair of erosion site prior to the next inspection.					
Inspector Comment

View of the erosion along the waterside toe. Spring 2021.

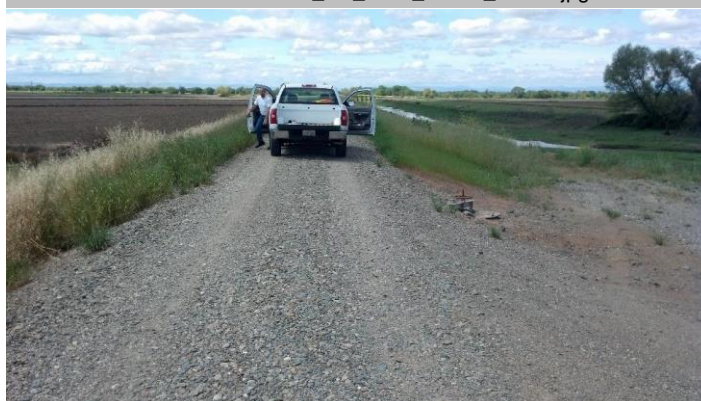
Photo 1 of 3 : UCIP_SP_2021_58562_67447.jpg

FS_ID:58562
DS_ID:16384
EP_NO: N/A
Repair Type: Non-Urgent
Crossing Status: Found
UCIP Comments: 08/29/2019 Record remains Non-Urgent due to unauthorized encroachment with recent modifications. Structure type needs to be corrected from Drainage to Irrigation. During inspection water was flowing from WS to LS to irrigate the rice fields. Structure has been modified since 2012, unable to determine extent of repair through levee. Need to contact owner to determine section replaced through levee. Structure is not maintained or operated by LMA-DWR Sutter Yard. (O. Magana - DWR UCIP, A. Freitag - DWR Sutter Yard)05/30/2017 Crossing appears to be in good condition. Pipe has been selected to be internally cleaned and inspected as part of the DMP project. (A. Freitag - DWR Sutter Yard)11/17/2016 Pipe section that crosses through the levee appears to be in good condition. (A. Freitag - DWR Sutter Yard)04/26/2016 Pipe appears to have been repaired. Not sure on the extent of the repairs or if they were approved by the Central Valley Flood Control Board. (A. Freitag - DWR Sutter Yard)06/30/2015 Pipe is currently undergoing repairs. Not sure what all is planed to be fixed but will update the photos and inspection report with new details when its completed. (A. Freitag - DWR Sutter Yard)05/28/2014 Same as last inspection. (A. Freitag - DWR Sutter Yard)12/04/2013 Same as last inspection. (A. Freitag - DWR Sutter Yard)07/08/2013 Pipe appears to have been repaired. Need to talk to inspections and supervisor to find out more details on repair. (A. Freitag - DWR Sutter Yard)04/24/2012 Needs repair. Internal piping, severe corrosion. Debris present--rusted pipe stockpiled on LS slope. Limited inspection on WS and LS slopes due to dense vegetation. Need photos of cleared WS & LS slopes. This crossing was listed in the USACE Periodic Inspection report as Corp's inspect ID# USACE_CESPK_M13E_2011_p_0234 for no WS gate but sluice gate present. (O. Magana - DWR UCIP)

Overview of crossing looking downstream.

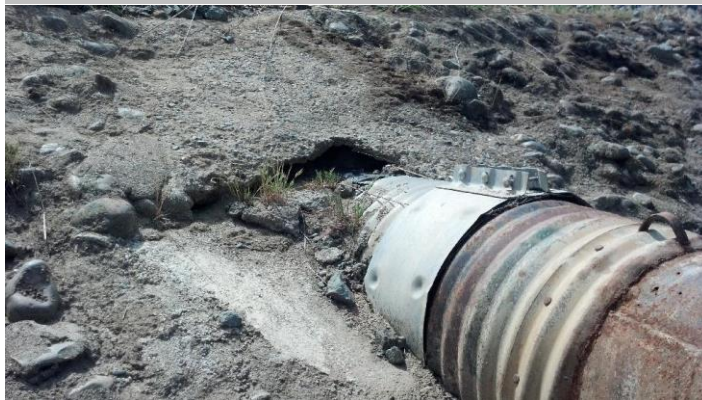
Photo 2 of 3 : UCIP_SP_2021_58562_67451.jpg

View of WS daylight. Hole present at pipe daylight.

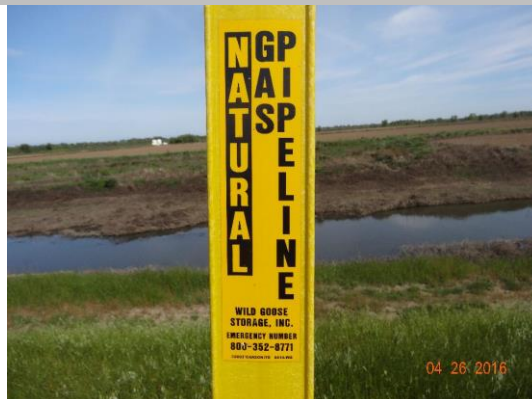
Photo 2 of 3 : UCIP_SP_2021_58707_74994.jpg

Close up of marker with contact info

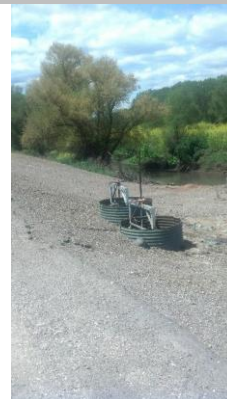
Photo 2 of 3 : UCIP_SP_2021_58570_67482.jpg

LM Start	22.14	Rating **	M	Issue No.	82 (cont)	
LM End	22.14	Issue Type +	En	Location *		
Category	Supplemental			GPS Latitude/Longitude		
				Start		End
Item	DWR UCIP Field Study			39.359910 °	39.359910 °	
				-121.872130 °	-121.872130 °	
DWR ID	16842

View of corrugated metal risers located on WS slope.

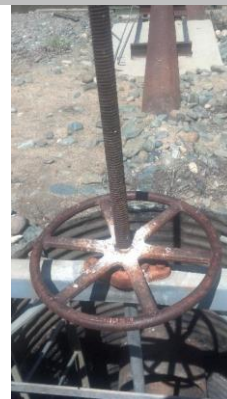
Photo 3 of 3 : UCIP_SP_2021_58570_67485.jpg

WS view of 18 inch line through corrugated metal riser.

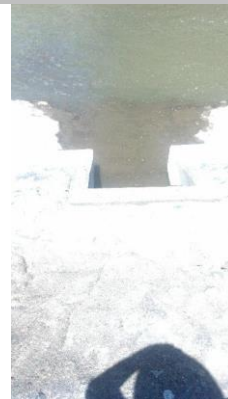
Photo 2 of 3 : UCIP_SP_2021_58572_67496.jpg

LM Start	22.15	Rating **	M	Issue No.	84 (cont)
LM End	22.15	Issue Type +	Ma	Location *	
Category	Supplemental		GPS Latitude/Longitude		
			Start	End	
Item	DWR UCIP LMA Responsibility		39.359827 °	39.359827 °	
			-121.872300 °	-121.872300 °	
DWR ID	16391

View of WS slope looking from WS headwall to levee crown.

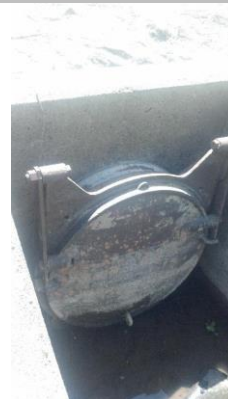
Photo 3 of 3 : UCIP_SP_2021_58572_67497.jpg

View of flap gate on WS.
