**Flood Control Project Maintenance
Levee Inspections
LMA District Cover Sheet**

**Flood Control Project Maintenance
Levee Inspections
Unit Cover Sheet**

Waterway			Bank	Unit Miles
Unit No. 01 Cherokee Canal			Right	18.19
	Spring (March - May)	Summer (June - August)	(September - November) Fall	Winter (December - February)
Unit Maintenance Rating (Fall Only)				
Date of Inspection	4/26/2023 - 4/26/2023			
DWR Inspector	Makar Sokol			
Accompanied By	Shawn Freitag DWR Sutter Yard

Levee Inspection Report By Mile - Spring 2023

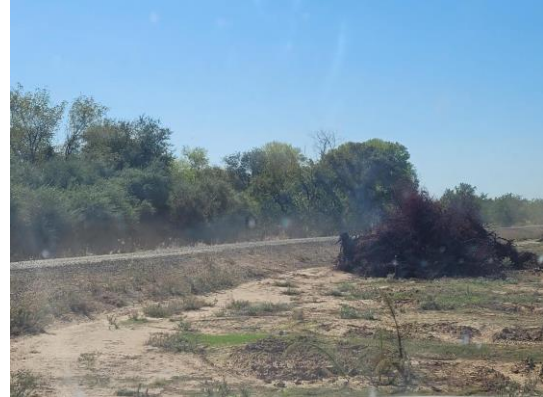
Photo 1 of 1 : SP_2023_MA0013_300_74_20230417_00007.jpg

LM Start	0.02	Rating **	M	Issue No.	74
LM End	0.02	Issue Type +	En	Location *	LS
Category	Earthen Levee			GPS Latitude/Longitude	
				Start	End
Item	Encroachments			39.596568 °	39.596568 °
				-121.702787 °	-121.702787 °
DWR ID	DWR_MA0013_01_f _ 2022_74				
Comment Code					
PR : Prunings					
Inspector Comment

View of a pile of prunings at the landside toe. Fall 2022.

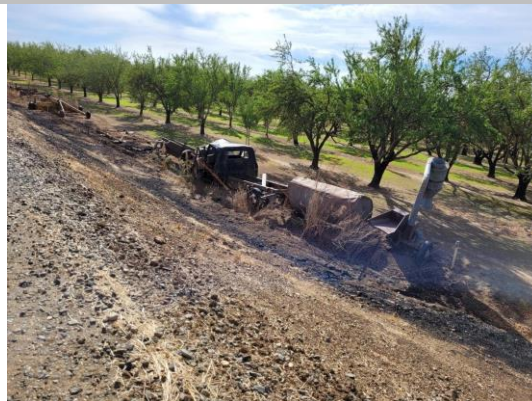
Photo 1 of 1 : SP_2023_MA0013_300_12_20230417_00004.jpg

LM Start	0.73	Rating **	M	Issue No.	12
LM End	0.76	Issue Type +	En	Location *	LS
Category	Earthen Levee			GPS Latitude/Longitude	
				Start	End
Item	Encroachments			39.587905°	39.587505°
				-121.700822°	-121.700880°
DWR ID	DWR_MA0013_01_s_2012_12				
Comment Code					
EQ : Equipment					
Inspector Comment					
Remove the equipment from the landside toe.

View of the equipment along the landside toe. Fall 2021.

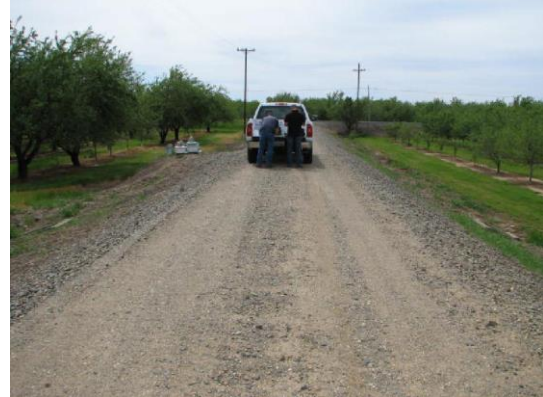
Photo 1 of 3 : UCIP_SP_2023_58576_66689.jpg

Comment Code						
Inspector Comment						
DS_ID:16343 FS_ID:58576 EP_NO: N/A Repair Type: Non-Urgent EVAL Issue: Crossing Status: Found UCIP Comments: 08/06/2019 Record has been updated from No Action Needed to Non-Urgent, due to unauthorized encroachment. Pipe has been lined. (O. Magana - DWR UCIP, A. Freitag - DWR Sutter Yard)06/14/2017 Crossing appears to be in good condition. Pipe has been selected to be internally cleaned and inspected as part of the DMP project. (A. Freitag - DWR Sutter Yard)11/16/2016 Crossing appears to be in good condition. (A. Freitag - DWR Sutter Yard)04/28/2016 Crossing appears to be in good condition. (A. Freitag - DWR Sutter Yard)07/14/2015 Crossing appears in good condition. No noticeable issues to report. (A. Freitag - DWR Sutter Yard)05/21/2014 Same as last inspection. (A. Freitag - DWR Sutter Yard)12/02/2013 Same as last inspection. (A. Freitag - DWR Sutter Yard)07/10/2013 Same as last inspection. (A. Freitag - DWR Sutter Yard)04/17/2012 Drain is still in use. 4 inch pipe in channel near WS headwall (see photo). The pipe does not appear to impact the crossing. (O. Magana - DWR UCIP) FIELD_STRUCT_DESC: 24-inch CIPP-lined corrugated metal drainage pipe through the levee, 8.6 feet below the crown. Concrete "U" headwalls on both the waterside (WS) and landside (LS). Flap gate on the WS end. [Additional Reference(s): DWR Levee Log, 1993 (HLM 1.15). USACE Sacramento O&M Manual, Unit 519, June 1962, Revised 3 Feb 2011, (HLM 1.15), As-built DWG No. 50-4-3608, Sheet No. 3608/19.1, STA 1072+20E, page 20 of 28 electronic file, listed as 24-inch CMP; As-built DWG No 50-4-3037 referenced not available] FS Date: 8/6/2019 8:46:00 AM

Overview of levee crown at crossing looking D/S .

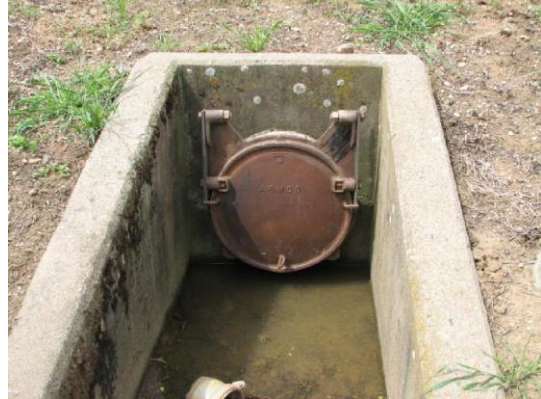
Photo 2 of 3 : UCIP_SP_2023_58576_66688.jpg

LM Start	1.13	Rating **	M	Issue No.	2 (cont)
LM End	1.13	Issue Type +	Ma	Location *	
Category	Supplemental			GPS Latitude/Longitude	
				Start	End
Item	DWR UCIP LMA Responsibility			39.582147°	39.582147°
				-121.700540°	-121.700540°
DWR ID	16343

View of WS headwall and flap gate.

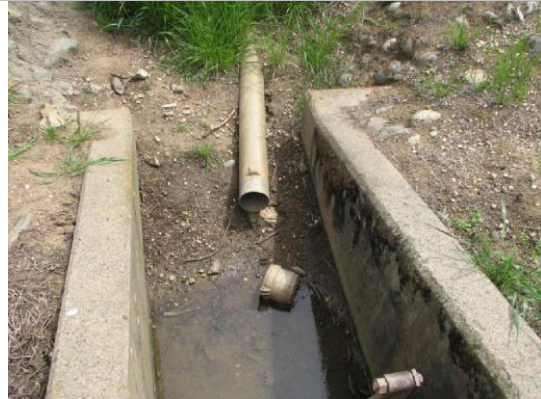
Photo 3 of 3 : UCIP_SP_2023_58576_66687.jpg

View of WS with pipe in channel.

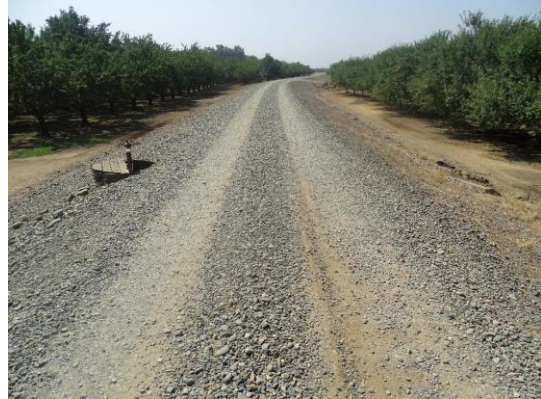
Photo 1 of 3 : UCIP_SP_2023_58462_77935.jpg

DS_ID:16831
FS_ID:58462
EP_NO: N/A
Repair Type: Non-Urgent
EVAL Issue: 10, Unauthorized Modification or Non-Compliant Permit
Crossing Status: Found
UCIP Comments: 08/06/2019 Record remains Non-Urgent, need to clarify owner for this crossing. This pipe has been identified as an LMA responsible drainage pipe. However, adjacent property owner has modified the WS outlet by burying the concrete headwall. No permit has been found authorizing the modification to the WS. LMA and adjacent property owner will need to coordinate with the CVFPB to comply with Title 23. DMP internal video inspection has not found pipe integrity issues. LOF of crossing is less or equal to 4. Recommend next video inspection in 5 years. (O. Magana - DWR UCIP, A. Freitag - DWR Sutter Yard)08/23/2018 Same as last inspection; still no sign of WS pipe end. Unclear if this SD crossing is still in use. The WS toe has standing, mucky, water around where the pipe end should be. Downgrading to Non-Urgent from Urgent because there appears no immediate threat to levee. Recommend follow up with owner to determine pipe use, and an internal pipe inspection to determine pipe integrity and threat to levee. (D. Sanoski - DWR UCIP)06/14/2017 Still no sign of WS pipe end. Pipe may need to be traced with GPR and excavated to determine if the WS end was properly capped after the Headwall and pipe sections were removed. Pipe has been selected to be internally cleaned and inspected as part of the DMP project. (A. Freitag - DWR Sutter Yard)11/16/2016 WS structures still removed. (A. Freitag - DWR Sutter Yard)10/17/2016 Landowner removed WS concrete headwall and pipe section through floodway to make room for orchard. The area disturbed appears to be from WS toe to where the mature trees are located within floodway, approximately 45 feet from WS toe. Crossing is classified as Urgent with potential levee integrity issues due to the disturbance of the WS without prior approval from the CVFPB. (O. Magana - DWR UCIP)

04/28/2016 Landowner appears to have removed the WS headwall and pipe to make room for planting more orchard trees. LS pipe end was full of water as it has no where to drain to anymore. Changing to urgent listing but it currently does not affect the levee integrity. (see photos 8, 9, & 10) (A. Freitag - DWR Sutter Yard)07/14/2015 Crossing appears in good condition. No noticeable issues to report. (A. Freitag - DWR Sutter Yard)05/21/2014 Same as last inspection. (A. Freitag - DWR Sutter Yard)12/02/2013 Pipe section was dug up and repaired. Crossing is now in good condition. (A. Freitag - DWR Sutter Yard)
04/17/2012 Pipe collapse on WS 10 feet from toe, needs repair. From WS, sediment is visible inside pipe. (O. Magana - DWR UCIP)
FIELD_STRUCT_DESC: 36-inch corrugated metal drainage pipe

Crown view: no sign of levee integrity issues.

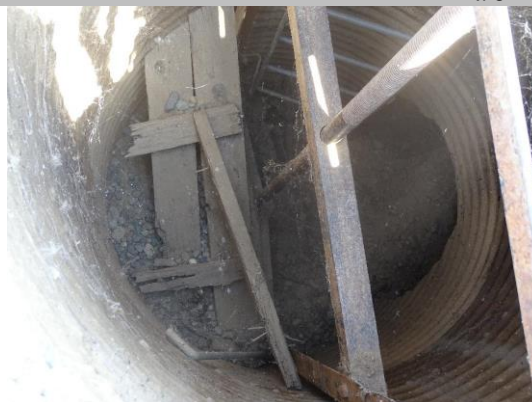
Photo 2 of 3 : UCIP_SP_2023_58462_77936.jpg

WS view: riser appears not in use.

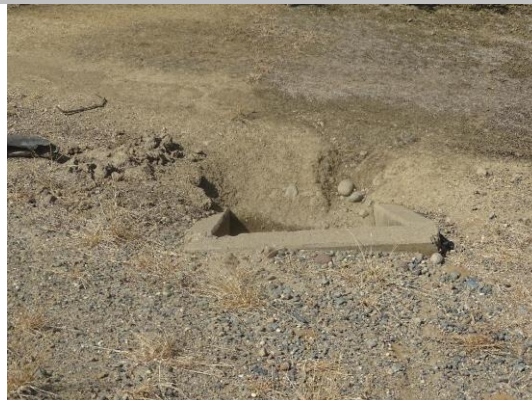
Photo 3 of 3 : UCIP_SP_2023_58462_77937.jpg

LS view: outlet appears in good condition.

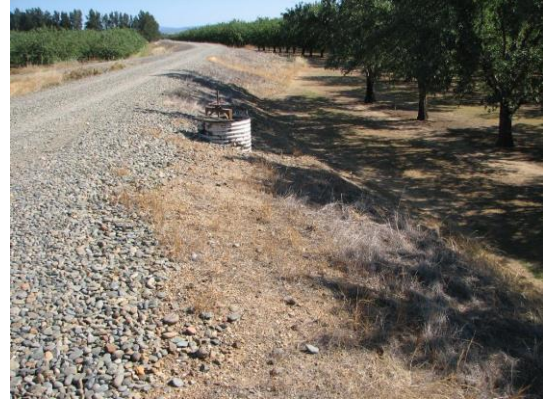
Photo 2 of 3 : UCIP_SP_2023_58463_66704.jpg

WS view looking upstream.

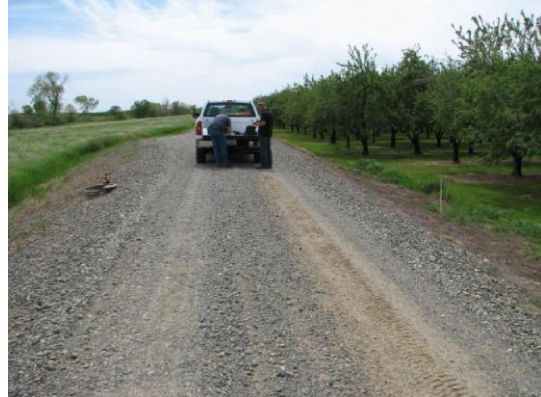
Photo 1 of 3 : UCIP_SP_2023_58464_66708.jpg

Comment Code						
Inspector Comment						
DS_ID:16346 FS_ID:58464 EP_NO: N/A Repair Type: Non-Urgent EVAL Issue: 4b, Safety Issue Crossing Status: Found UCIP Comments: 08/06/2019 Record remains Non-Urgent, pipe has been abandoned. Crossing needs to be abandoned properly per Title 23. No owner has been identified for this irrigation pipe. Recommend adding cover to riser as a safety measure. DMP internal video inspection has not found pipe integrity issues. LOF of crossing is less or equal to 4. Recommend next video inspection in 5 years. (O. Magana - DWR UCIP, A. Freitag - DWR Sutter Yard)06/14/2017 Still no LS inlet visible- trace with locator/GPR to try and locate. Wooden debris down inside of WS standpipe. Pipe has been selected to be internally cleaned and inspected as part of the DMP project. (A. Freitag - DWR Sutter Yard)11/16/2016 Appears abandoned. Unable to find anything on LS. (A. Freitag - DWR Sutter Yard)04/28/2016 Appears to be an abandoned crossing. LS headwall and pipe inlet are still completely buried. (A. Freitag - DWR Sutter Yard)07/14/2015 Still cannot find an inlet or outlet. (A. Freitag - DWR Sutter Yard)05/21/2014 Same as last inspection. (A. Freitag - DWR Sutter Yard)12/02/2013 Same as last inspection. (A. Freitag - DWR Sutter Yard)07/15/2013 Same as last inspection. (A. Freitag - DWR Sutter Yard)04/17/2012 Non functional crossing due to LS headwall buried. This crossing was listed in the USACE Periodic Inspection report as Corp's inspect ID#USACE_CESPK_M13D_2011_p_0119 for no inlet or outlet visible. (O. Magana - DWR UCIP) FIELD_STRUCT_DESC: 24-inch corrugated metal irrigation pipe through the levee 7.8 feet below the crown. Slide gate in corrugated metal pipe riser on the waterside (WS) slope. Pipe continues across channel. Concrete "U" headwall on the landside (LS). [Additional Reference(s): DWR Levee Log, 1993 (HLM 2.35). USACE Sacramento O&M Manual, Unit 519, June 1962, Revised 2 Feb 2011, (HLM 2.35), listed as 24-inch pipe, no as-built referenced found] FS Date: 8/6/2019 9:30:00 AM

Overview of crossing looking DS.

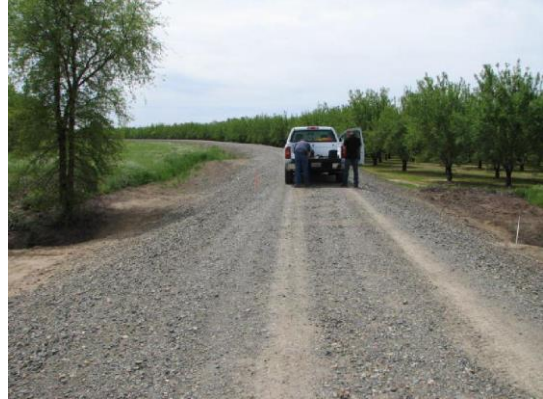
Photo 1 of 3 : UCIP_SP_2023_58465_66715.jpg

Comment Code						
Inspector Comment						
DS_ID:16347 FS_ID:58465 EP_NO: N/A Repair Type: Non-Urgent EVAL Issue: Crossing Status: Found UCIP Comments: 08/06/2019 Record has been updated from No Action Needed to Non-Urgent, no permit identified. Crossing is scheduled to be lined. (O. Magana - DWR UCIP, A. Freitag - DWR Sutter Yard)06/14/2017 Crossing appears to be in good condition. (A. Freitag - DWR Sutter Yard)11/16/2016 Crossing appears to be in good condition. (A. Freitag - DWR Sutter Yard)04/28/2016 Crossing appears to be in good condition. (A. Freitag - DWR Sutter Yard)07/14/2015 Crossing appears in good condition. No noticeable issues to report. (A. Freitag - DWR Sutter Yard)05/21/2014 Same as last inspection. (A. Freitag - DWR Sutter Yard)12/02/2013 Same as last inspection. (A. Freitag - DWR Sutter Yard)07/15/2013 Same as last inspection. (A. Freitag - DWR Sutter Yard)04/17/2012 Vegetation/sedimentation from WS has been removed. This crossing was listed in the USACE Periodic Inspection report as Corp's inspect ID#USACE_CESPK_M13D_2011_p_0130 for WS flap gate closed and blocked by sediment. (O. Magana - DWR UCIP) FIELD_STRUCT_DESC: 24-inch CIPP-lined corrugated metal drainage pipe through the levee, 9.4 feet below the crown. Concrete "U" headwall on both waterside (WS) and landside (LS) ends. Flap gate on the WS end. [Additional Reference(s): DWR Levee Log, 1993 (HLM 2.74). USACE Sacramento O&M Manual, Unit 519, June 1962, Revised 3 Feb 2011, (HLM 2.74), listed as 24-inch pipe, no as-built referenced found] FS Date: 8/6/2019 9:39:00 AM

Overview of levee crown looking downstream at crossing.

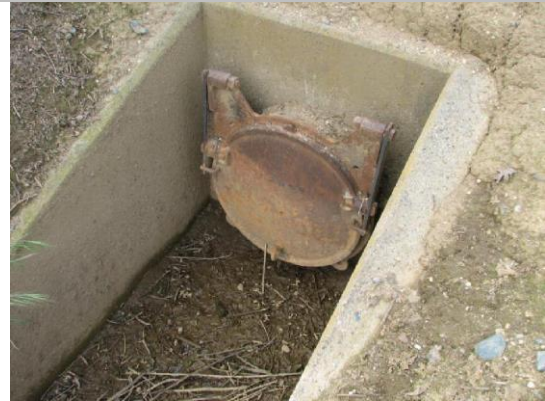
Photo 2 of 3 : UCIP_SP_2023_58465_66714.jpg

Flap gate at WS.

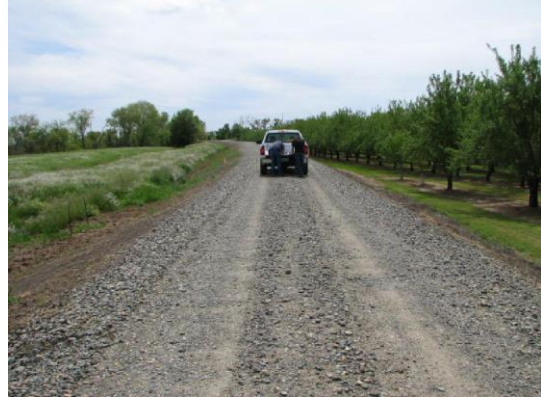
Photo 1 of 3 : UCIP_SP_2023_58466_66718.jpg

DS_ID:17372
FS_ID:58466
EP_NO: N/A
Repair Type: Non-Urgent
EVAL Issue:
Crossing Status: Found
UCIP Comments: 08/06/2019 Record remains Non-Urgent, no permit identified authorizing pipe. Pipe has been internally cleaned and cleared of any obstructions on the WS and LS. DMP internal inspection pending. (O. Magana - DWR UCIP, A. Freitag - DWR Sutter Yard)06/14/2017 WS flap gate is completely buried by sediment-needs to be dug out. Pipe is about 50% full of sediment inside. Pipe has been selected to be internally cleaned and inspected as part of the DMP project. (A. Freitag - DWR Sutter Yard)11/16/2016 Pipe about 50% full of sediment. (A. Freitag - DWR Sutter Yard)04/28/2016 Pipe on LS is about 50% full of sediment. There is now a concrete pipe that discharges into the LS inlet of this crossing. Not sure where the concrete pipe comes from. (A. Freitag - DWR Sutter Yard)07/14/2015 Crossing appears in good condition. No noticeable issues to report. (A. Freitag - DWR Sutter Yard)05/21/2014 Same as last inspection. (A. Freitag - DWR Sutter Yard)12/02/2013 Pipe section was dug up and repaired. Crossing is now in good condition. (A. Freitag - DWR Sutter Yard)07/15/2013 Pipe appears to have a possible hole in top of pipe about 10ft. in from LS headwall. (A. Freitag - DWR Sutter Yard)04/17/2012 LS headwall blocked by sediment (50 % of opening is covered). LS floor is higher than LS pipe invert. WS headwall has been recently cleared of vegetation and sediment. This crossing was listed in the USACE Periodic Inspection report as Corp's inspect ID#USACE_CESPK_M13D_2011_p_0157 for WS and LS inlet/outlet blocked by sediment. (O. Magana - DWR UCIP)

FIELD_STRUCT_DESC: 36-inch corrugated metal drainage pipe through the levee, 11.8 feet below the crown. Flap gate is located on the waterside (WS). Concrete headwall located on the landside (LS).
[Additional Reference(s): DWR Levee Log, 1993 (HLM 3.07), listed as 24-inch pipe. USACE Sacramento O&M Manual, Unit 519, June 1962, Revised 3 Feb 2011, (HLM 3.10), listed as 36-inch pipe, no as-built referenced found]
FS Date: 8/6/2019 9:47:00 AM

Overview of levee crown looking downstream at crossing.

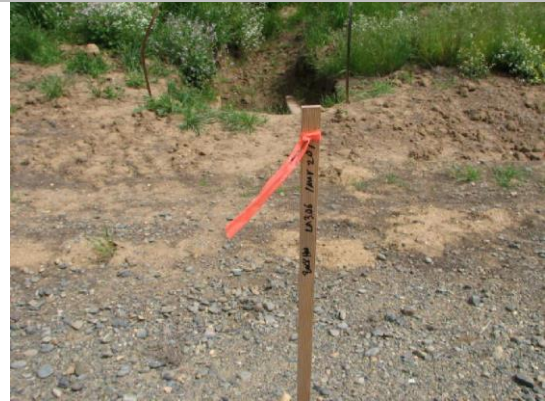
Photo 2 of 3 : UCIP_SP_2023_58466_66716.jpg

WS levee slope.

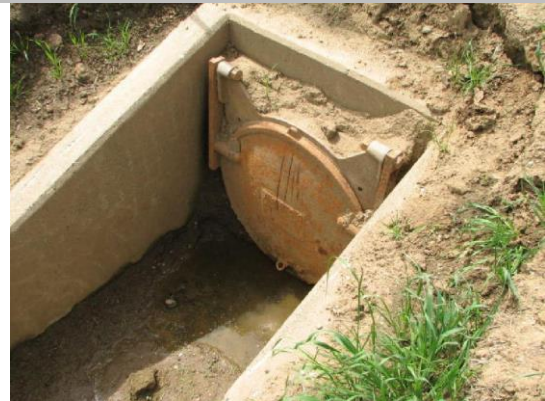
Photo 3 of 3 : UCIP_SP_2023_58466_66720.jpg

Flap gate on waterside.

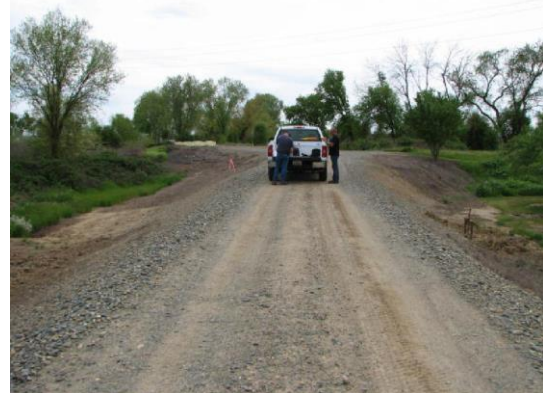
Photo 1 of 3 : UCIP_SP_2023_58577_66725.jpg

Comment Code					
Inspector Comment					
DS_ID:16349 FS_ID:58577 EP_NO: N/A Repair Type: Non-Urgent EVAL Issue: Crossing Status: Found UCIP Comments: 08/06/2019 Record remains Non-Urgent, no permit found authorizing pipe. Pipe has been lined. (O. Magana - DWR UCIP, A. Freitag - DWR Sutter Yard)06/14/2017 Both pipe ends and gates are mostly buried- need to be dug out. Pipe has been selected to be internally cleaned and inspected as part of the DMP project. (A. Freitag - DWR Sutter Yard)11/16/2016 Both gates closed but partially buried and unable to open. (A. Freitag - DWR Sutter Yard)04/28/2016 Sediment build up on both gates blocking them from operating properly. (A. Freitag - DWR Sutter Yard)07/14/2015 Crossing appears in good condition. No noticeable issues to report. (A. Freitag - DWR Sutter Yard)05/21/2014 Same as last inspection. (A. Freitag - DWR Sutter Yard)12/02/2013 Same as last inspection. (A. Freitag - DWR Sutter Yard)07/15/2013 Stem on LS screw gate has been replaced and is now full functional. (A. Freitag - DWR Sutter Yard)04/17/2012 LS slide gate stem is bent and prevents gate from fully closing. Both WS and LS have been cleared of debris and sediment. This crossing was listed in the USACE Periodic Inspection report as Corp's inspect ID#USACE_CESPK_M13D_2011_p_0162 for inoperable gates on WS & LS due to sediment and grass blocking inlet and outlet. (O. Magana - DWR UCIP) FIELD_STRUCT_DESC: 24-inch CIPP-lined corrugated metal drainage pipe through the levee, 8.9 feet below the crown. Concrete "U" headwalls on both the waterside (WS) and landside (LS) ends. Flap gate visible on the waterside (WS) end. [Additional Reference(s): DWR Levee Log, 1993 (HLM 3.29). USACE Sacramento O&M Manual, Unit 519, June 1962, Revised 3 Feb 2011, (HLM 3.29), listed as 24-inch pipe, no as-built referenced found] FS Date: 8/6/2019 10:02:00 AM

Overview of levee crown looking DS at crossing.

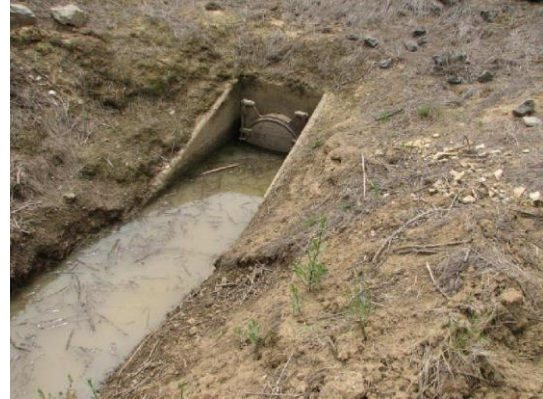
Photo 2 of 3 : UCIP_SP_2023_58578_66730.jpg

View of WS flap gate.

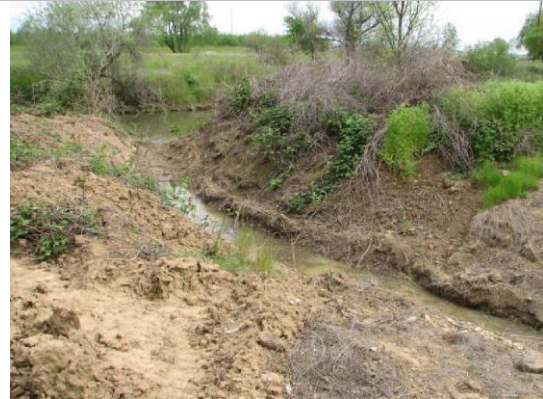
Photo 3 of 3 : UCIP_SP_2023_58578_66732.jpg

Sedimentation cleared on WS.

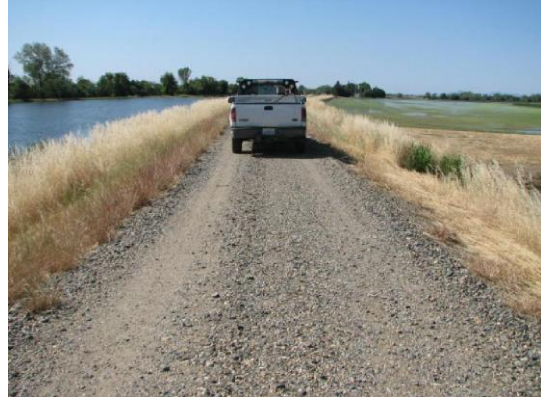
Photo 1 of 3 : UCIP_SP_2023_58469_66736.jpg

DS_ID:16351
FS_ID:58469
EP_NO: N/A
Repair Type: Non-Urgent
EVAL Issue:
Crossing Status: Found
UCIP Comments: 08/26/2019 Record has been updated from No Action Needed to Non-Urgent, no permit has been identified for this crossing. Crossing is scheduled to be lined. (O. Magana - DWR UCIP, A. Freitag - DWR Sutter Yard)06/14/2017 Both pipe ends were underwater during site visit. Pipe has been selected to be internally cleaned and inspected as part of the DMP project. (A. Freitag - DWR Sutter Yard)11/16/2016 Crossing appears to be in good condition. (A. Freitag - DWR Sutter Yard)04/28/2016 Both sides of the crossing were underwater during time of inspection. (A. Freitag - DWR Sutter Yard)07/14/2015 Crossing appears in good condition. No noticeable issues to report. (A. Freitag - DWR Sutter Yard)05/21/2014 Same as last inspection. (A. Freitag - DWR Sutter Yard)12/02/2013 Same as last inspection. (A. Freitag - DWR Sutter Yard)07/15/2013 Slopes have been cleared of vegetation and are in good condition. (A. Freitag - DWR Sutter Yard)04/18/2012 Limited inspection on WS and LS slope due to dense vegetation. Need photos of cleared slopes. (O. Magana - DWR UCIP)

FIELD_STRUCT_DESC: 24-inch CIPP-lined corrugate metal drainage pipe through the levee, 8.1 feet below the crown. Flap gate on the waterside (WS) end. Slide gate located on the landside (LS) end. Concrete "U" headwalls on both ends. [Additional Reference(s): DWR Levee Log, 1993 (HLM 3.80). USACE Sacramento O&M Manual, Unit 519, June 1962, Revised 3 Feb 2011, (HLM 3.80), listed as 24-inch pipe, no as-built referenced found]
FS Date: 8/26/2019 12:22:00 PM

Overview of levee crown at crossing looking downstream.

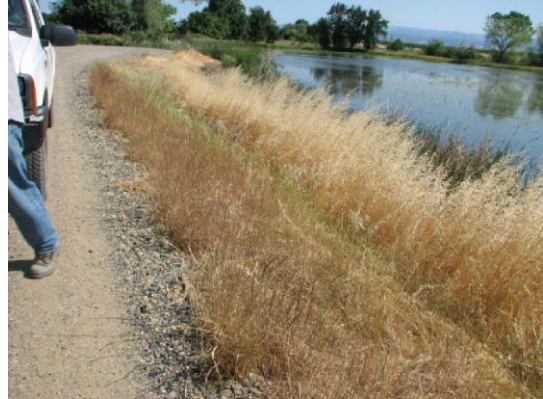
Photo 2 of 3 : UCIP_SP_2023_58469_66738.jpg

WS slope covered by dense vegetation.

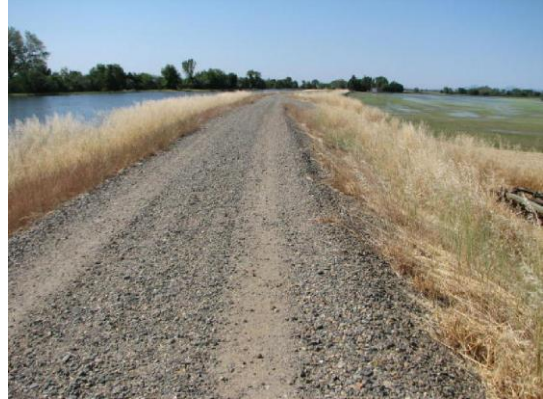
Photo 1 of 3 : UCIP_SP_2023_58470_66743.jpg

DS_ID:16365
FS_ID:58470
EP_NO: N/A
Repair Type: Non-Urgent
EVAL Issue:
Crossing Status: Found
UCIP Comments: 08/26/2019 Record remains Non-Urgent, pipe has been abandoned. No permit has been identified for this crossing. DMP internal inspection has not been completed. (O. Magana - DWR UCIP, A. Freitag - DWR Sutter Yard)06/14/2017 Appears abandoned- needs to be done properly. WS gate was buried/submerged and the LS slide gate is still damaged and buried. Pipe has been selected to be internally cleaned and inspected as part of the DMP project. (A. Freitag - DWR Sutter Yard)11/16/2016 Both LS and WS gates buried. (A. Freitag - DWR Sutter Yard)04/28/2016 Abandoned crossing. Ls screw is still bent and mostly buried. (A. Freitag - DWR Sutter Yard)07/14/2015 LS screw gate is still damaged and buried. Crossing is non-functional. (A. Freitag - DWR Sutter Yard)05/21/2014 Same as last inspection. (A. Freitag - DWR Sutter Yard)12/02/2013 Same as last inspection. (A. Freitag - DWR Sutter Yard)07/15/2013 Slopes have been cleared of vegetation and are in good condition. LS screw gate is still bent and silted over. (A. Freitag - DWR Sutter Yard)04/18/2012 LS slide gate covered with silt. Slide gate is bent. Crossing appears not be in use. Limited inspection on WS and LS slope due to dense vegetation. Need photos of cleared slopes. (O. Magana - DWR UCIP)

FIELD_STRUCT_DESC: 24-inch corrugated metal drainage pipe through the levee, 7.9 feet below the crown. Flap gate on the waterside (WS) end. Screw gate on the landside (LS) end. Concrete "U" headwalls on both ends. [Additional Reference(s): DWR Levee Log, 1993 (HLM 3.80). USACE Sacramento O&M Manual, Unit 519, June 1962, Revised 3 Feb 2011, (HLM 3.82), listed as 24-inch pipe, no as-built referenced found]
FS Date: 8/26/2019 12:24:00 PM

Overview of levee crown at crossing looking downstream.

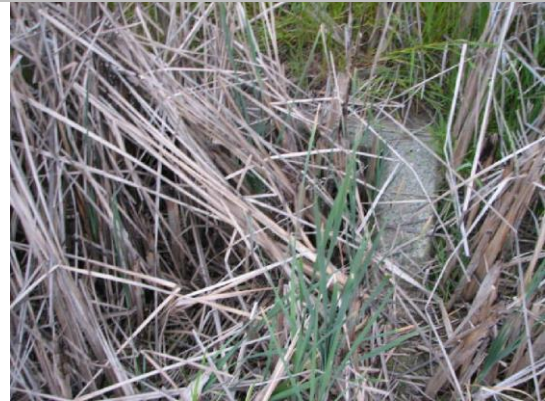
Photo 2 of 3 : UCIP_SP_2023_58470_66741.jpg

WS flap gate blocked by debris.

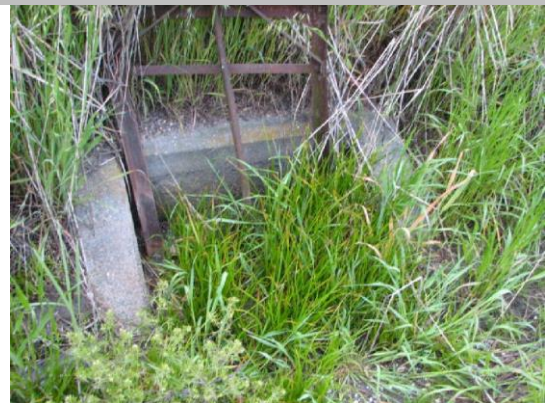
Photo 3 of 3 : UCIP_SP_2023_58470_66742.jpg

LS slide gate covered with silt. Slide gate is bent.

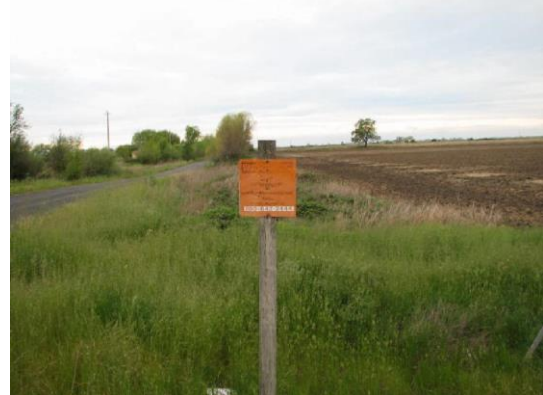
Photo 1 of 3 : UCIP_SP_2023_57531_66747.jpg

Comment Code						
Inspector Comment						
DS_ID:16353 FS_ID:57531 EP_NO: 6084 Repair Type: Non-Urgent EVAL Issue: 11, Maintenance Compliance Issue Crossing Status: Indicator Found UCIP Comments: 08/26/2019 Record has been updated from No Action Needed to Non-Urgent, maintenance required. Sign is down on LS. (O. Magana - DWR UCIP, A. Freitag - DWR Sutter Yard)06/14/2017 Crossing appears to be in good condition. (A. Freitag - DWR Sutter Yard)11/16/2016 Crossing appears to be in good condition. (A. Freitag - DWR Sutter Yard)04/28/2016 Crossing appears to be in good condition. (A. Freitag - DWR Sutter Yard)07/14/2015 Crossing appears in good condition. (A. Freitag - DWR Sutter Yard)05/21/2014 Same as last inspection. (A. Freitag - DWR Sutter Yard)12/02/2013 Same as last inspection. (A. Freitag - DWR Sutter Yard)07/15/2013 Same as last inspection. (A. Freitag - DWR Sutter Yard)04/18/2012 Visible marker on LS. (O. Magana - DWR UCIP) FIELD_STRUCT_DESC: Underground telephone cable, 1.5-inch through the levee at approximately 2 feet below the crown. (buried cable authorized to go through Cherokee Canal and across Cottonwood Creek under Permit No. 6084, 1968 - Pacific Telephone and Telegraph Company [PT&T]) Contact No. listed in case of emergencies is 1-800-642-2444. [Additional Reference(s): DWR Levee Log, 1993 (HLM 4.41)] FS Date: 8/26/2019 12:25:00 PM

Visible marker for underground cable on LS.

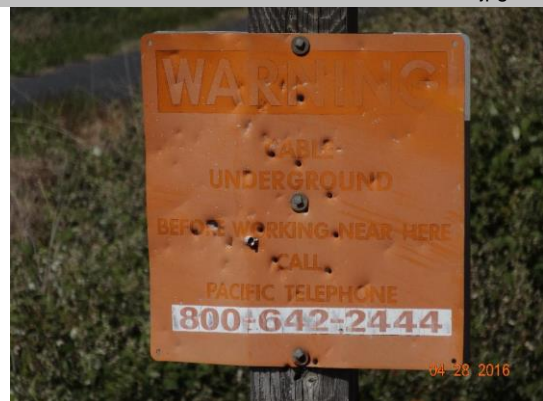
Photo 2 of 3 : UCIP_SP_2023_57531_75003.jpg

Marker sign with contact info

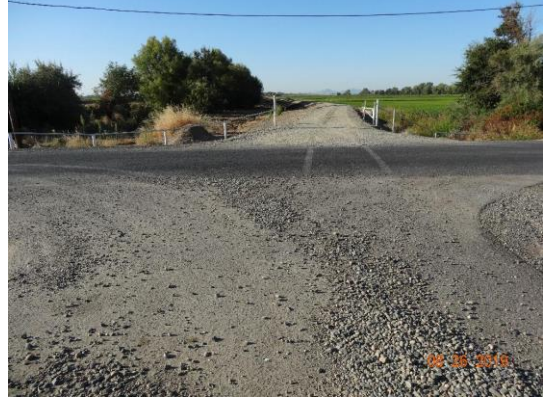
Photo 3 of 3 : UCIP_SP_2023_57531_80281.jpg

Overview of levee crown looking d/s towards crossing.

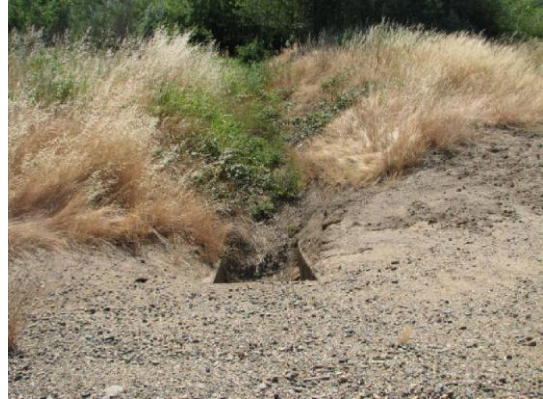
Photo 2 of 3 : UCIP_SP_2023_58471_66753.jpg

View of WS slope and toe.

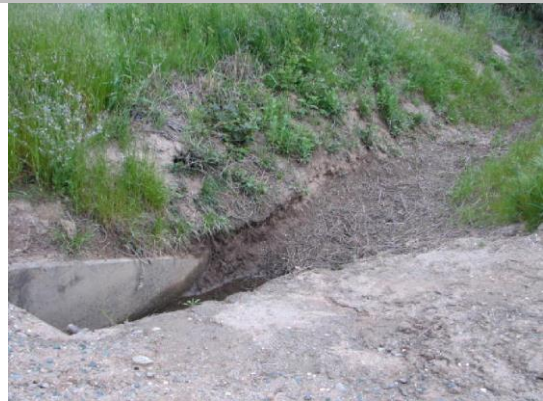
Photo 3 of 3 : UCIP_SP_2023_58471_66750.jpg

View of WS.

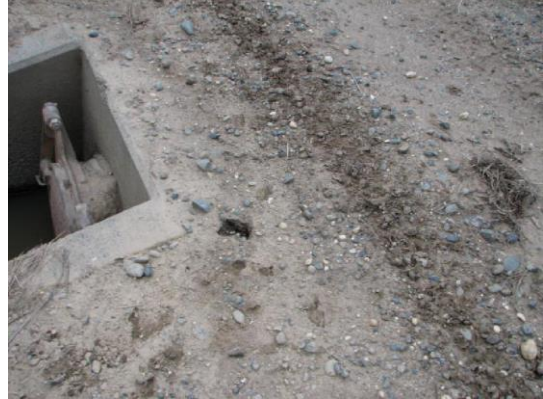
Photo 2 of 3 : UCIP_SP_2023_58472_66758.jpg

Burrow activity on WS slope.

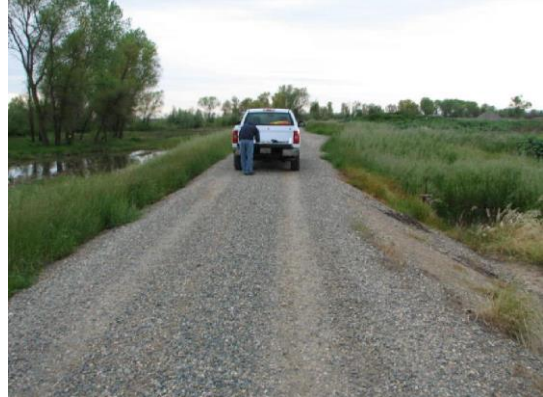
Photo 1 of 3 : UCIP_SP_2023_58473_66762.jpg

Comment Code						
Inspector Comment						
DS_ID:16356 FS_ID:58473 EP_NO: N/A Repair Type: Non-Urgent EVAL Issue: Crossing Status: Found UCIP Comments: 08/26/2019 Record has been updated from No Action Needed to Non-Urgent, no permit has been identified authorizing this pipe. Pipe is scheduled to be lined. Minor sloughing observed on LS just immediately d/s of concrete headwall (see photo). (O. Magana - DWR UCIP, A. Freitag - DWR Sutter Yard)06/14/2017 Crossing appears to be in good condition. Pipe has been selected to be internally cleaned and inspected as part of the DMP project. (A. Freitag - DWR Sutter Yard)11/16/2016 Crossing appears to be in good condition. (A. Freitag - DWR Sutter Yard)04/28/2016 Crossing appears to be in good condition. (A. Freitag - DWR Sutter Yard)07/13/2015 LS screw gate was completely submerged and WS flap gate was propped open by a wood block but crossing appears to be in good condition. (A. Freitag - DWR Sutter Yard)05/21/2014 Same as last inspection. (A. Freitag - DWR Sutter Yard)12/02/2013 Same as last inspection. (A. Freitag - DWR Sutter Yard)07/15/2013 Same as last inspection. (A. Freitag - DWR Sutter Yard)04/18/2012 Minor vegetation on LS slope. This crossing was listed in the USACE Periodic Inspection report as Corp's inspect ID#USACE_CESPK_M13D_2011_p_0204 for restriction view of gates. (O. Magana - DWR UCIP) FIELD_STRUCT_DESC: 24-inch CIPP-lined corrugated metal drainage pipe through the levee, 8.4 feet below the crown. Flap gate on the waterside (WS) end. Slide gate on the landside (LS) end. Concrete "U" headwalls on both ends. [Additional Reference(s): DWR Levee Log, 1993 (HLM 5.43). USACE Sacramento O&M Manual, Unit 519, June 1962, Revised 3 Feb 2011, (HLM 5.43), As-built DWG No. 50-4-3608, Sheet No. 3608/18, STA 839+50E, page 19 of 28 electronic file, listed as 24-inch CMP; As-built DWG No 50-4-3037 referenced not available] FS Date: 8/26/2019 12:29:00 PM

Overview of levee crown at crossing looking D/S on right bank of Cherokee Canal.

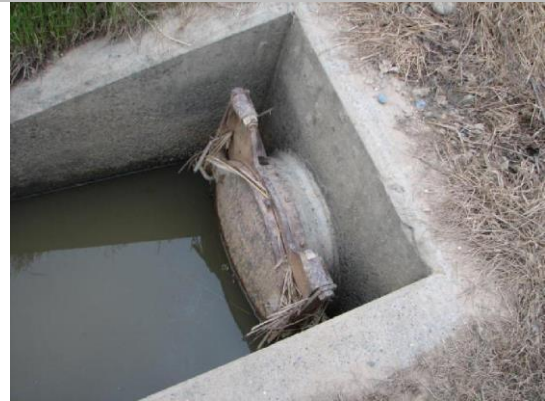
Photo 2 of 3 : UCIP_SP_2023_58473_66760.jpg

WS Flap Gate

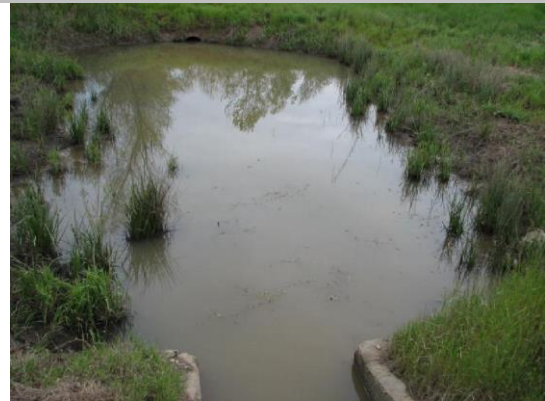
Photo 3 of 3 : UCIP_SP_2023_58473_66763.jpg

WS view of outlet cleared of vegetation.

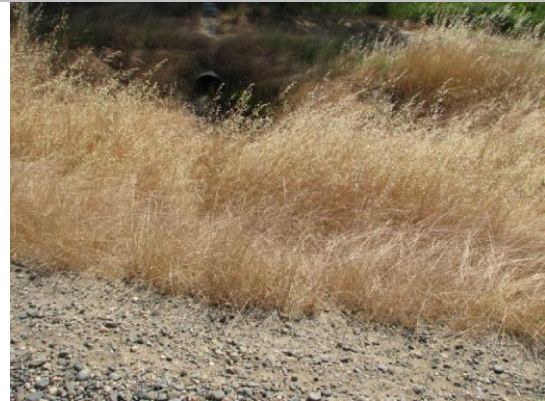
Photo 2 of 3 : UCIP_SP_2023_58579_66765.jpg

View of WS slope and channel.

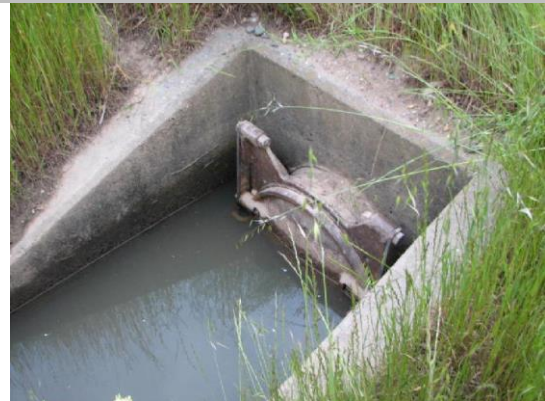
Photo 3 of 3 : UCIP_SP_2023_58579_66768.jpg

View of WS flap gate.

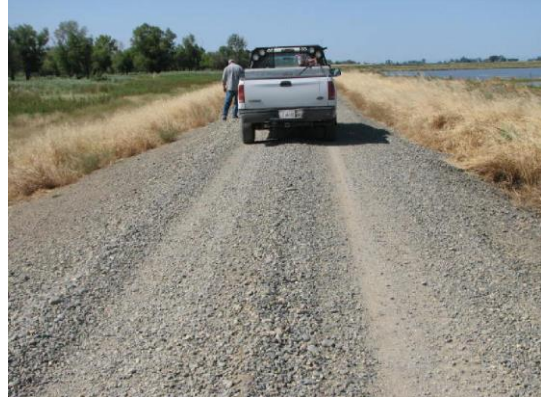
Photo 1 of 3 : UCIP_SP_2023_58479_66800.jpg

Comment Code						
Inspector Comment						
DS_ID:16360 FS_ID:58479 EP_NO: N/A Repair Type: Non-Urgent EVAL Issue: Crossing Status: Found UCIP Comments: 08/26/2019 Record has been updated from No Action Needed to Non-Urgent, no permit has been identified authorizing pipe. Pipe is scheduled to be lined. (O. Magana - DWR UCIP, A. Freitag - DWR Sutter Yard)06/14/2017 Crossing appears to be in good condition. LS is completely submerged in an irrigation ditch. Pipe has been selected to be internally cleaned and inspected as part of the DMP project. (A. Freitag - DWR Sutter Yard)11/16/2016 Crossing appears to be in good condition. (A. Freitag - DWR Sutter Yard)04/28/2016 Crossing appears to be in good condition. (A. Freitag - DWR Sutter Yard)07/13/2015 LS screw gate was completely submerged but crossing appears to be in good condition. (A. Freitag - DWR Sutter Yard)05/21/2014 Same as last inspection. (A. Freitag - DWR Sutter Yard)12/02/2013 Same as last inspection. (A. Freitag - DWR Sutter Yard)07/15/2013 Same as last inspection. (A. Freitag - DWR Sutter Yard)04/18/2012 Burrow activity near crossing; burrow holes present on LS. (O. Magana - DWR UCIP) FIELD_STRUCT_DESC: 24-inch CIPP-lined corrugated metal drainage pipe through the levee, 6.2 feet below the crown. Flap gate on the waterside (WS) end. Slide gate on the landside (LS) end. Concrete "U" headwalls on both ends. [Additional Reference(s): DWR Levee Log, 1993 (HLM 5.97). USACE Sacramento O&M Manual, Unit 519, June 1962, Revised 3 Feb 2011, (HLM 5.97), As-built DWG No. 50-4-3608, Sheet No. 3608/18, STA 808+00E, page 19 of 28 electronic file, listed as 24-inch CMP; As-built DWG No 50-4-3037 referenced not available] FS Date: 8/26/2019 12:40:00 PM

Overview of levee crown at crossing looking downstream.

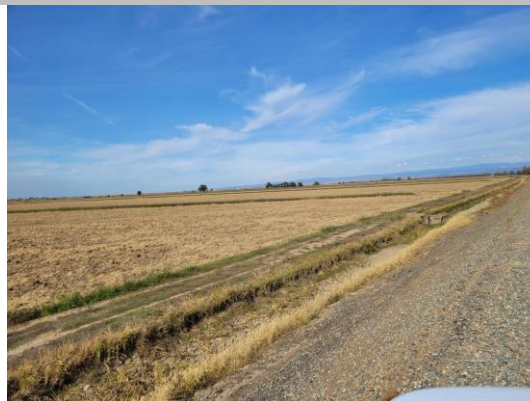
Photo 1 of 1 : SP_2023_MA0013_300_3_20230417_00001.jpg

LM Start	6.41	Rating **	M	Issue No.	3
LM End	6.99	Issue Type +	En	Location *	LS
Category	Earthen Levee			GPS Latitude/Longitude	
				Start	End
Item	Encroachments			39.508928°	39.501438°
				-121.714842°	-121.719715°
DWR ID	DWR_MA0013_01_s_2012_3				
Comment Code					
DT : Ditch					
Inspector Comment

View of the agricultural ditch along the toe. Fall 2021.

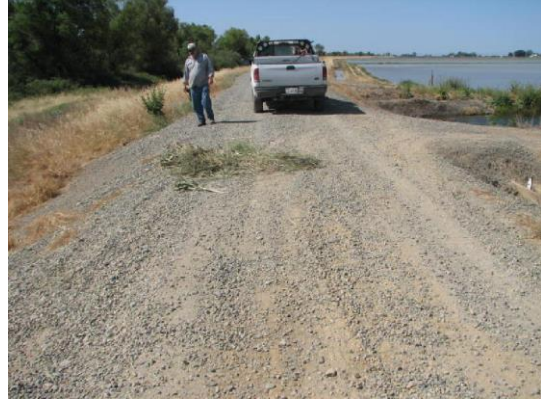
Photo 1 of 3 : UCIP_SP_2023_77840_66814.jpg

DS_ID:16362
FS_ID:77840
EP_NO: 5200B
Repair Type: Urgent
EVAL Issue: 1, Pipe Integrity
Crossing Status: Found
UCIP Comments: 12/13/2022 Record updated from Non-Urgent to Urgent. DMP internal video inspection has found pipe integrity issues. LOF of crossing is between 5 and 6. Crossing will be monitored until funding becomes available to address the issues. (O.Yakimov - DWR UCIP)
08/26/2019 Record has been updated from No Action Needed to Non-Urgent, potential levee integrity issues. This crossing is part of DMP's Phase 1 eligibility. No internal inspection has been completed for this crossing. Minor holes visible on LS that could be associated with burrow activity or signs of sink hole. Need internal inspection of pipe to determine condition of pipe through the levee. (O. Magana - DWR UCIP, A. Freitag - DWR Sutter Yard)06/14/2017 Hole/erosion behind the flashboards was repaired. New flash boards were installed and the erosion hole filled back in. Pipe has been selected to be internally cleaned and inspected as part of the DMP project. (A. Freitag - DWR Sutter Yard)11/16/2016 Hole/erosion still present behind the LS flashboards. (DWR Sutter Yard- A.Freitag)04/28/2016 Hole still present behind the LS flashboards. Rest of the crossing appeared in good condition. (A. Freitag - DWR Sutter Yard)07/13/2015 Hole still present behind the LS flashboards. (A. Freitag - DWR Sutter Yard)05/21/2014 Same as last inspection. (A. Freitag - DWR Sutter Yard)12/02/2013 Same as last inspection. (A. Freitag - DWR Sutter Yard)07/15/2013 WS slope has been cleared of vegetation and is in good condition. Hole is still present behind flash boards on LS. (A. Freitag - DWR Sutter Yard)04/18/2012 Hole behind flashboards against slide gate on LS slope (Health and Safety Issue). Limited inspection on WS slope due to dense vegetation. Need photo of cleared slope on WS. (O. Magana - DWR UCIP)

FIELD_STRUCT_DESC: 24-inch corrugated metal drainage pipe through the levee, 7.8 feet below the crown. Flap gate on the waterside (WS) end. Slide gate on the landside (LS) end. Concrete headwall on both ends (Permit No. 5200B - 1965, Richvale Irrigation District) (Additional Related Permit(s): Permit No. 5200 and 5200A) [Additional Reference(s): DWR Levee Log, 1993 (HLM 6.56). USACE Sacramento O&M Manual, Unit 519, June 1962, Revised 3 Feb 2011, (HLM 6.56), As-built DWG No. 50-4-3608, Sheet No. 3608/18, STA 777+00E, page 19 of 28 electronic file, listed as 24-inch CMP; As-built DWG No 50-4-3037 referenced not available]
FS Date: 8/26/2019 8:32:49 PM

Overview of levee crown at crossing looking downstream.

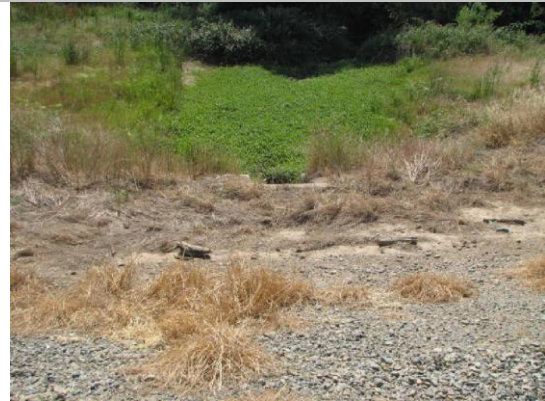
Photo 2 of 3 : UCIP_SP_2023_77840_66813.jpg

View of WS slope and toe.

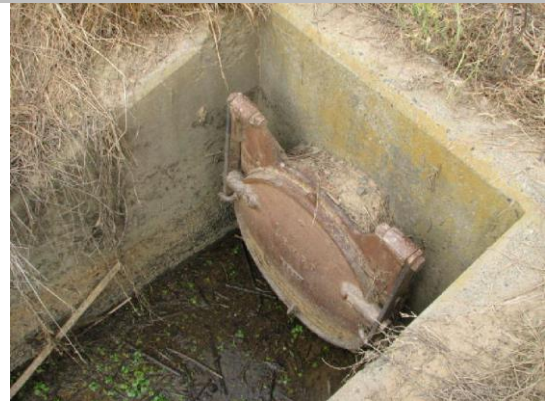
Photo 3 of 3 : UCIP_SP_2023_77840_66811.jpg

WS flap gate.

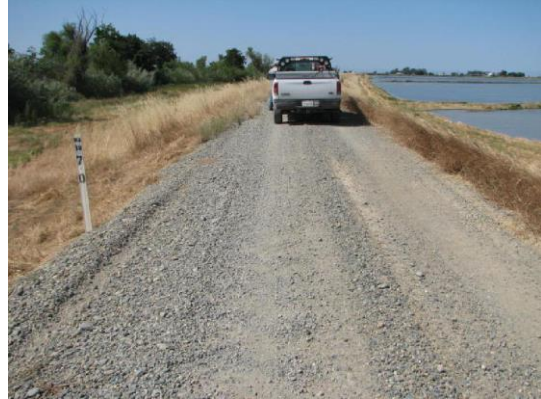
Photo 1 of 3 : UCIP_SP_2023_58483_66833.jpg

Comment Code					
Inspector Comment					
DS_ID:16329 FS_ID:58483 EP_NO: N/A Repair Type: Non-Urgent EVAL Issue: 11, Maintenance Compliance Issue Crossing Status: Found UCIP Comments: 08/26/2019 Record remains Non-Urgent, due to no permit found authorizing pipe and maintenance issue. Pipe is scheduled to be lined. Slide gate detached and sitting on the side of concrete wingwall. Slide gate will need to be re-attached. (O. Magana - DWR UCIP, A. Freitag - DWR Sutter Yard)06/14/2017 LS slide gate is still damaged and needing to be replaced. WS appeared to be in good condition. Pipe has been selected to be internally cleaned and inspected as part of the DMP project. (A. Freitag - DWR Sutter Yard)11/16/2016 Needs a new screw gate installed on the LS. (A. Freitag - DWR Sutter Yard)04/28/2016 LS slide gate is still bent. Everything else with the crossing appeared ok. (A. Freitag - DWR Sutter Yard)07/13/2015 LS screw gate needs to be replaced. Everything else with crossing seems to be in good condition. (A. Freitag - DWR Sutter Yard)05/21/2014 Same as last inspection. (A. Freitag - DWR Sutter Yard)12/02/2013 Same as last inspection. (A. Freitag - DWR Sutter Yard)07/15/2013 Slopes have been cleared of vegetation and are in good condition. There were no apparent signs of settling. LS screw gate is still damaged. (A. Freitag - DWR Sutter Yard)04/18/2012 LMA's inspection sheet of 2011 indicates settlement and visible corrosion. Damage/severe corrosion on screw gate where it bolts to headwall. No visible signs of settlement due to high vegetation cover. Limited inspection on WS and LS slopes due to dense vegetation. Need photos of cleared slopes for this crossing. (O. Magana - DWR UCIP) FIELD_STRUCT_DESC: 24-inch CIPP-lined corrugated metal drainage pipe through the levee, 9.8 feet below the crown. Flap gate on the waterside (WS) end. Slide gate on the landside (LS) end. Concrete headwall on both ends. [Additional Reference(s): DWR Levee Log, 1993 (HLM 7.10). USACE Sacramento O&M Manual, Unit 519, June 1962, Revised 3 Feb 2011, (HLM 7.10), As-built DWG No. 50-4-3608, Sheet No. 3608/18, STA 748+50E, page 19 of 28 electronic file, listed as 24-inch CMP; As-built DWG No 50-4-3037 referenced not available] FS Date: 8/26/2019 12:59:00 PM

Overview of levee crown at crossing looking D/S.

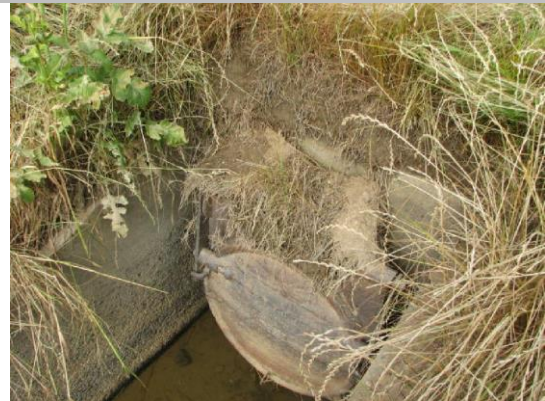
Photo 3 of 3 : UCIP_SP_2023_58483_66837.jpg

WS Flap Gate

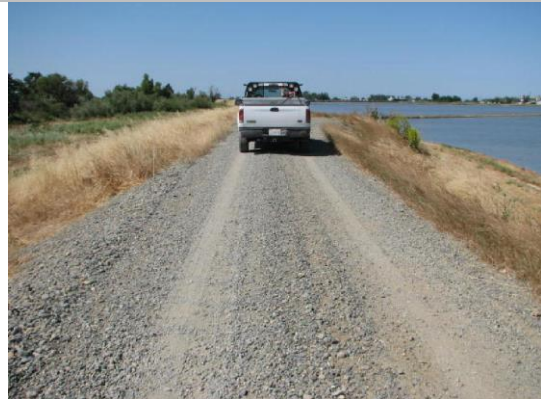
Photo 1 of 3 : UCIP_SP_2023_58484_66844.jpg

DS_ID:16354
FS_ID:58484
EP_NO: N/A
Repair Type: Non-Urgent
EVAL Issue:
Crossing Status: Found
UCIP Comments: 08/26/2019 Record remains Non-Urgent, no permit has been identified authorizing pipe. Pipe is scheduled to be lined. (O. Magana - DWR UCIP, A. Freitag - DWR Sutter Yard)06/14/2017 LS slide gate stem still bent. WS appeared to be in good condition. Pipe has been selected to be internally cleaned and inspected as part of the DMP project. (A. Freitag - DWR Sutter Yard)11/16/2016 Screw gate stem bent but gate is still operational. (A. Freitag - DWR Sutter Yard)04/28/2016 Tested positive closure device the bent stem on the slide gate did not seem to affect its functions. Gate operable. (A. Freitag - DWR Sutter Yard)07/13/2015 LS screw gate stem is still bent. Gate should still be able to close fully. The rest of the crossing seems to be in good condition. (A. Freitag - DWR Sutter Yard)05/21/2014 Same as last inspection. (A. Freitag - DWR Sutter Yard)12/02/2013 Same as last inspection. (A. Freitag - DWR Sutter Yard)07/15/2013 Slopes have been cleared of vegetation and are in good condition. LS screw gate stem is still bent. (A. Freitag - DWR Sutter Yard)04/18/2012 LS slide gate stem is bent and needs to be replaced. Limited inspection on WS and LS slope due to dense vegetation. Need photos of cleared slopes during next inspection. Confirmed flap gate on WS. This crossing was listed in the USACE Periodic Inspection report as Corp's inspect ID#USACE_CESPK_M13D_2011_p_0244 for submerged WS gate. (O. Magana - DWR UCIP)

FIELD_STRUCT_DESC: 24-inch CIPP-lined corrugated metal drainage pipe through the levee, 11.2 feet below the crown. Flap gate on the waterside (WS) end. Slide gate on the landside (LS) end. Concrete "U" headwall on both ends. [Additional Reference(s): DWR Levee Log, 1993 (HLM 7.34). USACE Sacramento O&M Manual, Unit 519, June 1962, Revised 3 Feb 2011, (HLM 7.34), As-built DWG No. 50-4-3608, Sheet No. 3608/18, STA 736+00E, page 19 of 28 electronic file, listed as 24-inch CMP; As-built DWG No 50-4-3037 referenced not available]
FS Date: 8/26/2019 1:02:00 PM

Overview of levee crown at crossing looking D/S.

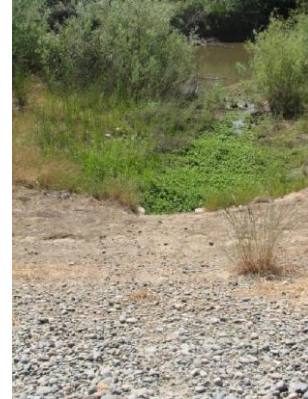
Photo 2 of 3 : UCIP_SP_2023_58484_66845.jpg

View of WS slope and toe.

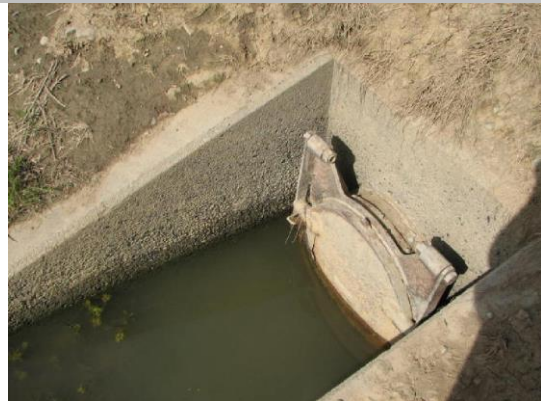
Photo 3 of 3 : UCIP_SP_2023_58484_66842.jpg

WS Flap Gate

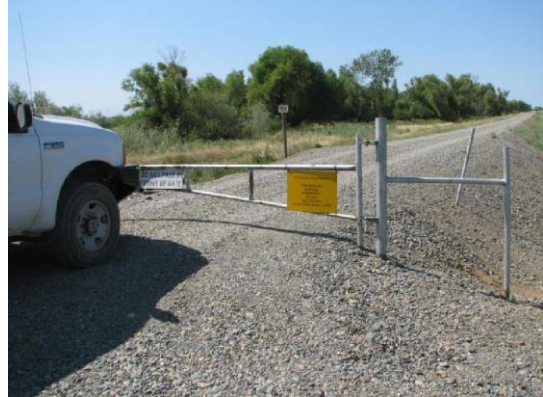
Photo 1 of 3 : UCIP_SP_2023_58487_66867.jpg

Comment Code					
Inspector Comment					
DS_ID:16320 FS_ID:58487 EP_NO: N/A Repair Type: Non-Urgent EVAL Issue: 4b, Safety Issue Crossing Status: Found UCIP Comments: 08/26/2019 Record has been updated from No Action Needed to Non-Urgent, no permit has been identified authorizing pipe. Pipe is scheduled to be lined. DMP internal video inspection has not found pipe integrity issues. LOF of crossing is less or equal to 4. Recommend next video inspection in 5 years. The following maintenance issues should be addressed: clear vegetation from LS inlet and repair CMP riser lid (safety measure). (O. Magana - DWR UCIP, A. Freitag - DWR Sutter Yard)06/14/2017 Debris down inside of WS riser. The rest of the crossing appears to be in good condition. Pipe has been selected to be internally cleaned and inspected as part of the DMP project. (A. Freitag - DWR Sutter Yard)11/16/2016 Crossing appears to be in good condition. (A. Freitag - DWR Sutter Yard)04/28/2016 Crossing appears to be in good condition. (A. Freitag - DWR Sutter Yard)07/13/2015 The bottom of the entire pipe has about 8inch of sediment in it. Sediment is preventing the screw gate from fully closing. WS flap gate seems to be in good condition. (A. Freitag - DWR Sutter Yard)05/21/2014 Same as last inspection. (A. Freitag - DWR Sutter Yard)12/03/2013 Same as last inspection. (A. Freitag - DWR Sutter Yard)07/15/2013 Same as last inspection. (A. Freitag - DWR Sutter Yard) FIELD_STRUCT_DESC: 48-inch corrugated metal drainage pipe through the levee, 9.9 feet below the crown. Flap gate on the waterside (WS) end. Slide gate in corrugated metal pipe riser on the WS slope. Concrete "U" headwalls on both ends. Spillway grouted for 35 feet. [Additional Reference(s): DWR Levee Log, 1993 (HLM 7.76). USACE Sacramento O&M Manual, Unit 519, June 1962, Revised 3 Feb 2011, (HLM 7.76), As-built DWG No. 50-4-3608, Sheet No. 3608/18, STA 714+28E, page 19 of 28 electronic file, listed as 48-inch CMP; As-built DWG No 50-4-3037 referenced not available] FS Date: 8/26/2019 1:06:00 PM

Overview of levee crown at crossing (past gate) looking D/S.

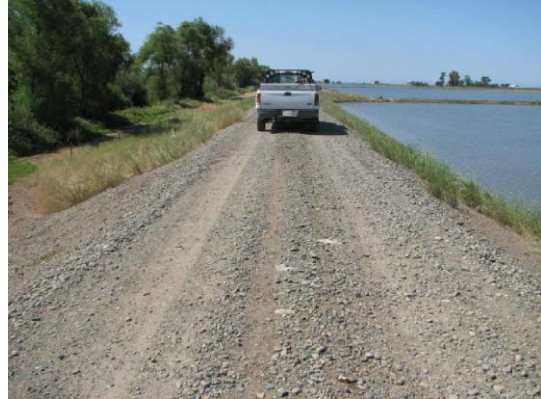
Photo 1 of 3 : UCIP_SP_2023_58488_66872.jpg

Comment Code						
Inspector Comment						
DS_ID:16321 FS_ID:58488 EP_NO: N/A Repair Type: Non-Urgent EVAL Issue: Crossing Status: Found UCIP Comments: 08/27/2019 Record has been updated from No Action Needed to Non-Urgent, no permit has been identified authorizing pipe. Pipe is scheduled to be lined. (O. Magana - DWR UCIP, A. Freitag - DWR Sutter Yard)06/14/2017 Crossing appears to be in good condition. Pipe has been selected to be internally cleaned and inspected as part of the DMP project. (A. Freitag - DWR Sutter Yard)11/16/2016 Crossing appears to be in good condition. (A. Freitag - DWR Sutter Yard)04/28/2016 Crossing appears to be in good condition. (A. Freitag - DWR Sutter Yard)07/13/2015 Crossing appears to be in good condition. (A. Freitag - DWR Sutter Yard)05/21/2014 Same as last inspection. (A. Freitag - DWR Sutter Yard)12/03/2013 Same as last inspection. (A. Freitag - DWR Sutter Yard)07/15/2013 Same as last inspection. (A. Freitag - DWR Sutter Yard)04/18/2012 Sediment build up against flashboards. Flashboards are in use on landside of levee. (O. Magana - DWR UCIP) FIELD_STRUCT_DESC: 24-inch CIPP-lined corrugated metal drainage pipe through the levee, 8.2 feet below the crown. Flap gate on the waterside (WS) end. Concrete "U" headwalls on both ends. Flashboards should be present on the landside (LS). [Additional Reference(s): DWR Levee Log, 1993 (HLM 8.11). USACE Sacramento O&M Manual, Unit 519, June 1962, Revised 3 Feb 2011, (HLM 8.12), As-built DWG No. 50-4-3608, Sheet No. 3608/18, STA 696+00E, page 19 of 28 electronic file, listed as 24-inch CMP; As-built DWG No 50-4-3037 referenced not available] FS Date: 8/27/2019 2:07:00 PM

Overview of levee crown at crossing looking D/S.

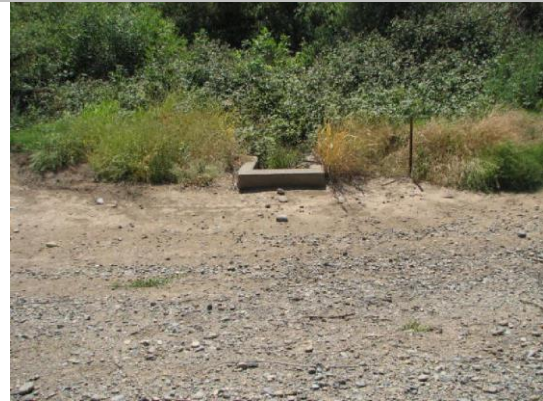
Photo 2 of 3 : UCIP_SP_2023_58488_66873.jpg

View of WS slope and toe.

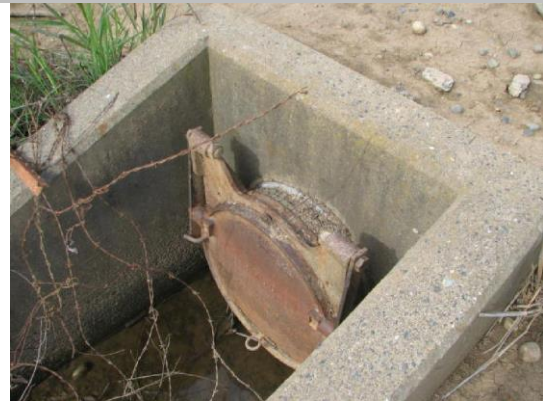
Photo 3 of 3 : UCIP_SP_2023_58488_66869.jpg

WS Flap gate

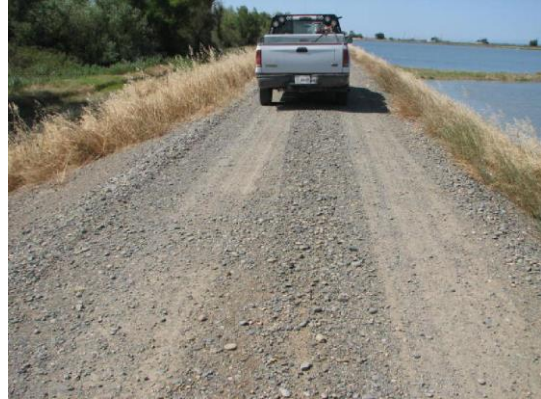
Photo 1 of 3 : UCIP_SP_2023_58489_66876.jpg

DS_ID:16322
FS_ID:58489
EP_NO: N/A
Repair Type: Non-Urgent
EVAL Issue: 11, Maintenance Compliance Issue
Crossing Status: Found
UCIP Comments: 08/27/2019 Record remains Non-Urgent, no permit has been identified authorizing pipe. Vegetation needs to be cleared from inlet/outlet. Pipe is scheduled to be lined. (O. Magana - DWR UCIP, A. Freitag - DWR Sutter Yard)06/14/2017 Both sides of the crossing were buried with sediment- needs to be cleared away. Pipe has been selected to be internally cleaned and inspected as part of the DMP project. (A. Freitag - DWR Sutter Yard)11/16/2016 WS flap gate is closed but is blocked from opening by sediment. (A. Freitag - DWR Sutter Yard)04/28/2016 Crossing appears to be in good condition. (A. Freitag - DWR Sutter Yard)07/13/2015 Minor sediment build up blocking flap gate from opening on WS. Needs to be dug out. (A. Freitag - DWR Sutter Yard)05/21/2014 Same as last inspection. (A. Freitag - DWR Sutter Yard)12/03/2013 Same as last inspection. (A. Freitag - DWR Sutter Yard)07/15/2013 Slopes are cleared of vegetation and are in good condition. WS flap gate is blocked from opening fully by sediment. (A. Freitag - DWR Sutter Yard)04/18/2012 Sediment build up on LS. Debris (broken panels) scattered near LS headwall. Limited inspection on WS and LS slope due to dense vegetation. Need photos of cleared WS and LS slopes. (O. Magana - DWR UCIP)

Overview of levee crown at crossing looking D/S.

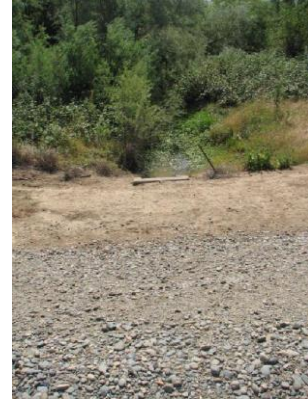
Photo 2 of 3 : UCIP_SP_2023_58489_66874.jpg

View of WS slope and toe.

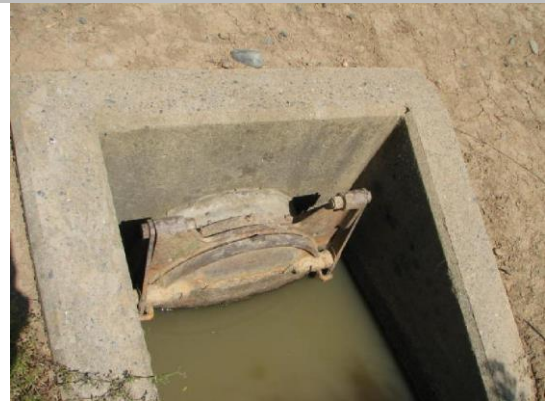
Photo 3 of 3 : UCIP_SP_2023_58489_66877.jpg

View of WS flap gate and headwall.

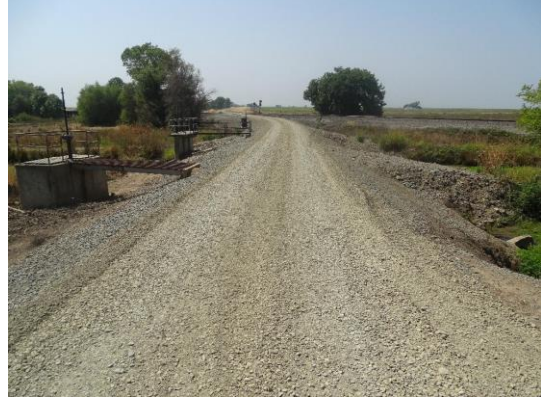
Photo 1 of 3 : UCIP_SP_2023_58490_77939.jpg

Crown view: recently repaved levee crown.
