**Flood Control Project Maintenance
Levee Inspections
LMA District Cover Sheet**

**Flood Control Project Maintenance
Levee Inspections
Unit Cover Sheet**

Waterway			Bank	Unit Miles
Unit No. 01 Cherokee Canal			Right	18.19
	Spring (March - May)	Summer (June - August)	(September - November) Fall	Winter (December - February)
Unit Maintenance Rating (Fall Only)				
Date of Inspection	4/26/2023 - 4/26/2023			
DWR Inspector	Makar Sokol			
Accompanied By	Shawn Freitag DWR Sutter Yard

Levee Inspection Report By Mile - Spring 2023

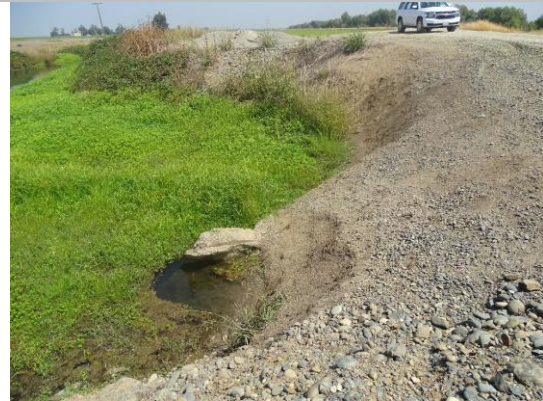
Photo 2 of 3 : UCIP_SP_2023_58490_77940.jpg

Comment Code					
Inspector Comment					
DS_ID:16323 FS_ID:58490 EP_NO: N/A Repair Type: Urgent EVAL Issue: 2b, Levee Integrity Crossing Status: Found UCIP Comments: 08/27/2019 Same as last inspection; crossing remains Urgent due to LS toe erosion. No permit has been identified authorizing irrigation structure. (O. Magana - DWR UCIP, A. Freitag - DWR Sutter Yard)08/23/2018 Same as last inspection; crossing remains Urgent because LS erosion is still present and poses a levee integrity risk (D. Sanoski - DWR UCIP).06/14/2017 LS underwater but levee erosion is still present- needs to be repaired. Pipe has been selected to be internally cleaned and inspected as part of the DMP project. (A. Freitag - DWR Sutter Yard)11/16/2016 LS erosion is still a major problem here. (A. Freitag - DWR Sutter Yard)04/28/2016 Erosion still present at the LS headwall. (A. Freitag - DWR Sutter Yard)07/13/2015 Erosion still present behind the LS headwall. It looks to be getting worse and is starting to affect the levee slope. (A. Freitag - DWR Sutter Yard)05/21/2014 Same as last inspection. (A. Freitag - DWR Sutter Yard)12/03/2013 Same as last inspection. (A. Freitag - DWR Sutter Yard)07/15/2013 Same as last inspection. (A. Freitag - DWR Sutter Yard)04/18/2012 Concrete headwall is cracked, erosion behind headwall is also present. LS headwall needs to be repaired/replaced. Remove wooden debris from levee shoulder. (O. Magana - DWR UCIP) FIELD_STRUCT_DESC: [Richvale Irrigation Canal Siphon] 60-inch by 84-inch (5-foot by 7 foot) concrete irrigation conduit through the levee, 18.4 feet below the crown. Distribution box and walkway are located on the waterside (WS). Concrete headwall on the landside (LS). 28-foot reinforced concrete protective slab on top of the conduit in the center of the levee. [Additional Reference(s): DWR Levee Log, 1993 (HLM 8.95). USACE Sacramento O&M Manual, Unit 519, June 1962, Revised 3 Feb 2011, (HLM 8.95), listed as 5-foot by 7-foot concrete conduit, As-built DWG No. 50-4-3608, Sheet No. 3608/20, STA 651+66E, page 21 of 28 electronic file, listed as 6-foot diameter concrete pipe (siphon)] FS Date: 8/27/2019 2:09:00 PM

LS view: erosion still present around headwall.

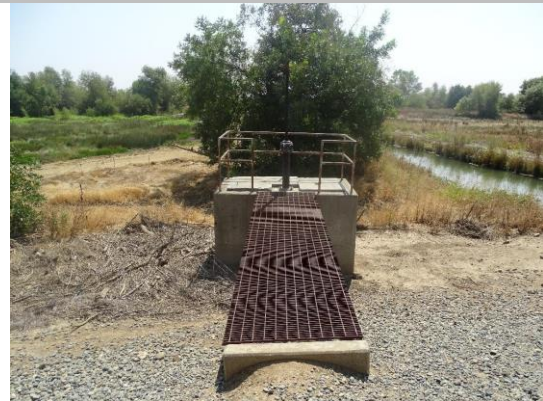
Photo 3 of 3 : UCIP_SP_2023_58490_77941.jpg

WS view: catwalk and gate; no pipe daylight on WS.

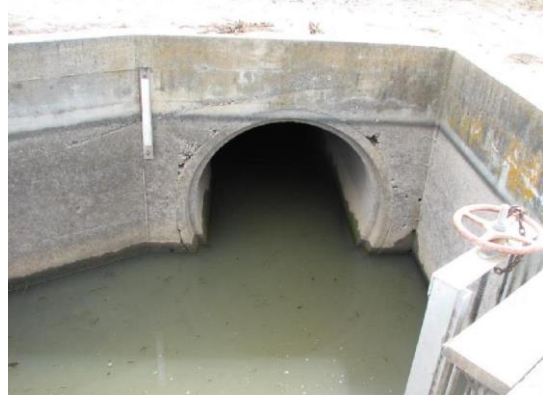
Photo 2 of 3 : UCIP_SP_2023_58494_66907.jpg

Headwall at LS distribution box

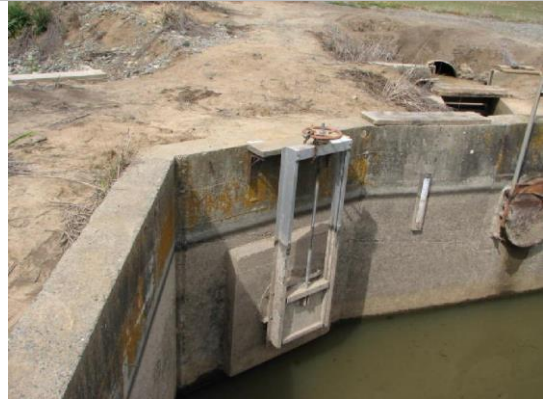
Photo 3 of 3 : UCIP_SP_2023_58494_66905.jpg

LS Screw gate in distribution box (downstream view)

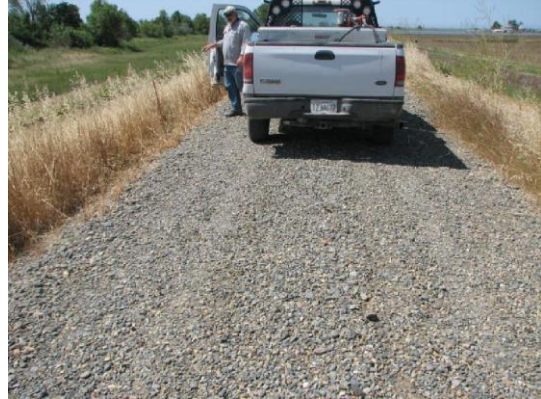
Photo 1 of 3 : UCIP_SP_2023_58495_66910.jpg

Overview of levee crown at crossing looking downstream.

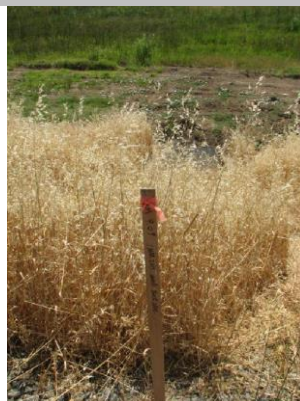
Photo 2 of 3 : UCIP_SP_2023_58495_66911.jpg

View of WS slope and toe.

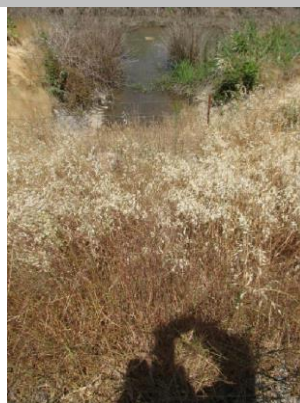
Photo 3 of 3 : UCIP_SP_2023_58495_66912.jpg

View of LS slope and toe.

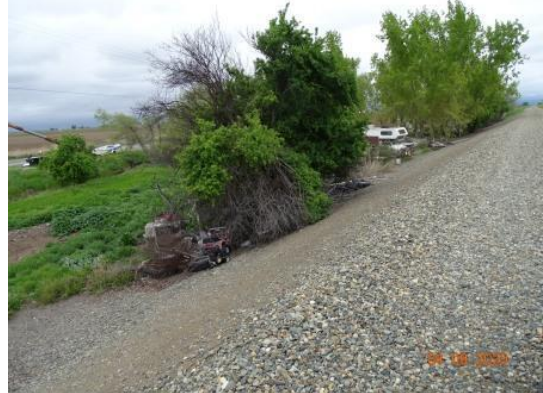
Photo 1 of 1 : SP_2023_MA0013_300_10_20230417_00003.jpg

View of trailer and material along the landside toe. Spring 2020.

LM Start	9.73	Rating **	M	Issue No.	10
LM End	9.75	Issue Type +	En	Location *	LS
Category	Earthen Levee			GPS Latitude/Longitude	
				Start	End
Item	Encroachments			39.466732°	39.466478°
				-121.744180°	-121.744338°
DWR ID	DWR_MA0013_01_f_2013_10				
Comment Code					
MA : Material					
Inspector Comment					
Move the trailer and materials outside the 10 foot easement.

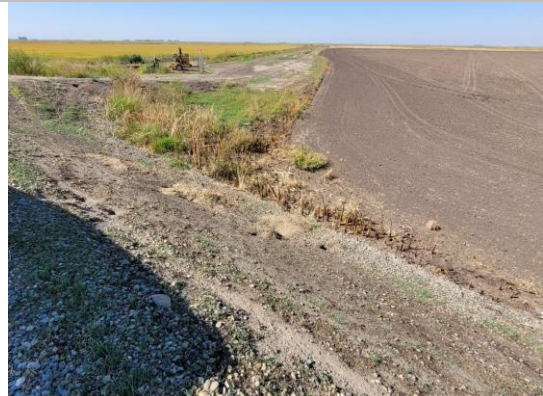
Photo 1 of 1 : SP_2023_MA0013_300_76_20230417_00008.jpg

LM Start	11.58	Rating **	M	Issue No.	76
LM End	11.58	Issue Type +	Ma	Location *	LS
Category	Earthen Levee			GPS Latitude/Longitude	
				Start	End
Item	Animal Control			39.442868°	39.442868°
				-121.759906°	-121.759906°
DWR ID	DWR_MA0013_01_f_2022_76				
Comment Code					
A3 : No rodents visible, but rodent burrows visible; need to backfill and compact or grout burrows.					
Inspector Comment

View of rodent activity along the landside slope. Fall 2022.

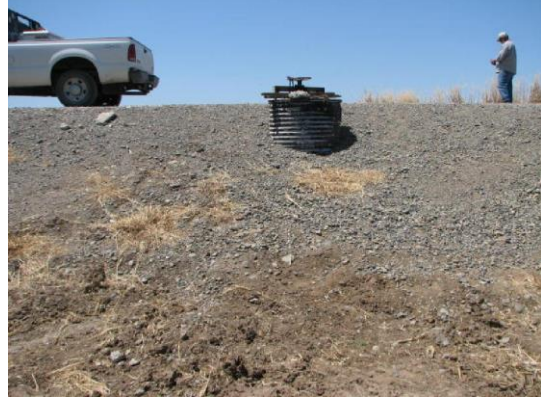
Photo 2 of 3 : UCIP_SP_2023_58501_66959.jpg

View of WS slope.

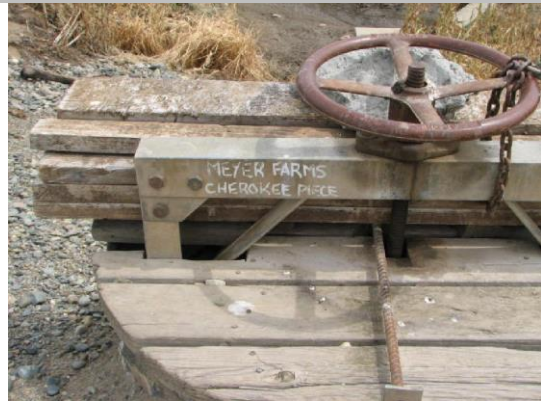
Photo 3 of 3 : UCIP_SP_2023_58501_66951.jpg

Slide gate located on WS slope. Owner information marked on gate.

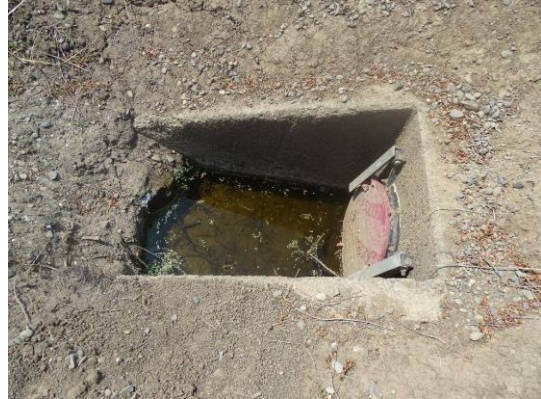
Photo 1 of 3 : UCIP_SP_2023_58515_77942.jpg

WS view: flapgate appears fixed.

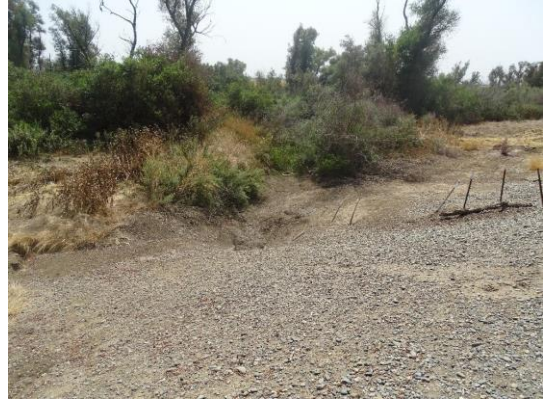
Photo 2 of 3 : UCIP_SP_2023_58515_77945.jpg

WS view: levee slope looks in good condition.

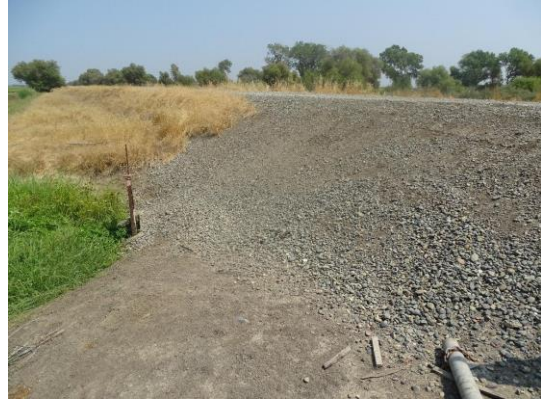
Photo 1 of 3 : UCIP_SP_2023_58505_77946.jpg

LS view: levee slope and headwall with screw gate.

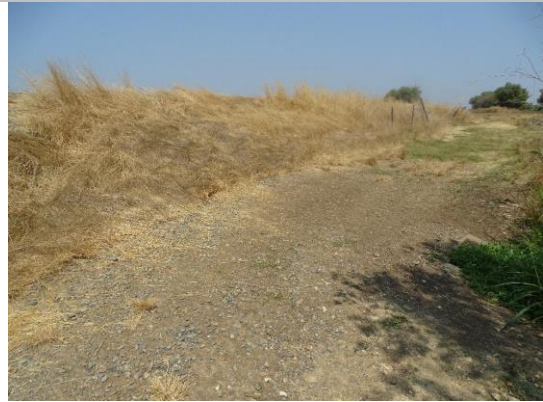
Photo 2 of 3 : UCIP_SP_2023_58505_77947.jpg

WS view: levee slope and WS headwall.

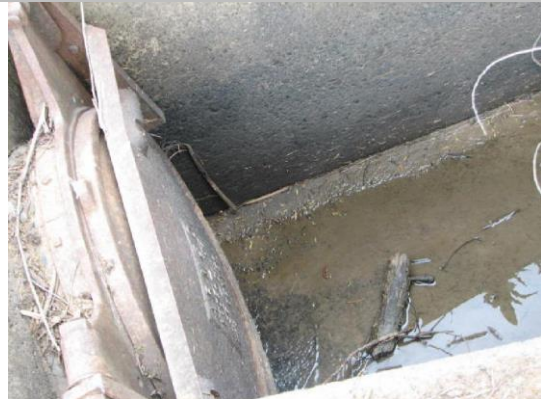
Photo 1 of 3 : UCIP_SP_2023_58506_66981.jpg

DS_ID:16367
FS_ID:58506
EP_NO: N/A
Repair Type: Non-Urgent
EVAL Issue:
Crossing Status: Found
UCIP Comments: 08/27/2019 Record has been updated from No Action Needed to Non-Urgent, no permit has been identified authorizing pipe. Pipe is scheduled to be lined. (O. Magana - DWR UCIP, A. Freitag - DWR Sutter Yard)06/15/2017 Crossing appears to be in good condition. Pipe has been selected to be internally cleaned and inspected as part of the DMP project. (A. Freitag - DWR Sutter Yard)11/17/2016 Crossing appears to be in good condition. (A. Freitag - DWR Sutter Yard)05/03/2016 Crossing appears to be in good condition. (A. Freitag - DWR Sutter Yard)07/13/2015 Crossing appears in good condition. No noticeable issues to report. (A. Freitag - DWR Sutter Yard)05/22/2014 Same as last inspection. (A. Freitag - DWR Sutter Yard)12/03/2013 Same as last inspection. (A. Freitag - DWR Sutter Yard)07/15/2013 Slopes have been cleared of vegetation and are in good condition. (A. Freitag - DWR Sutter Yard)04/18/2012 Limited inspection on WS and LS slope due to dense vegetation. Need overall photo of crossing and photos of cleared WS & LS slopes. (O. Magana - DWR UCIP)

WS headwall and flapgate

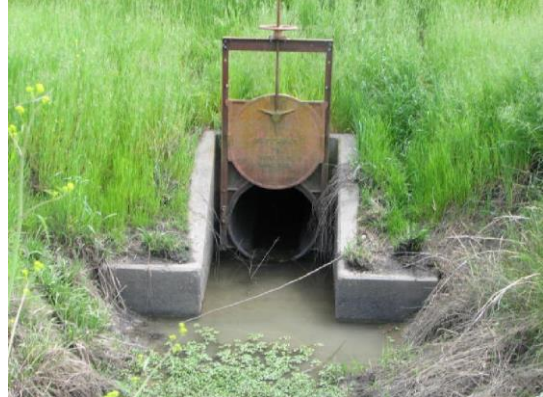
Photo 2 of 3 : UCIP_SP_2023_58506_66980.jpg

Slide gate located on LS toe. Dense vegetation present on LS slope.

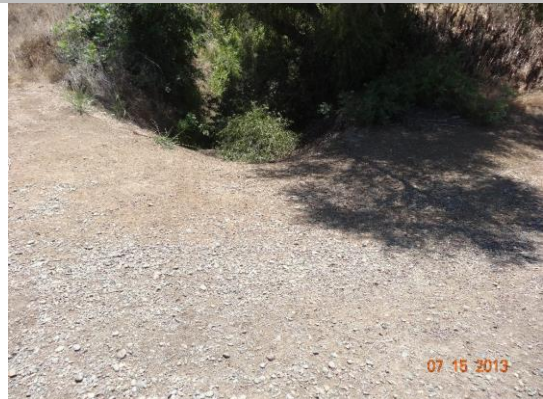
Photo 3 of 3 : UCIP_SP_2023_58506_66982.jpg

WS slope cleared of vegetation

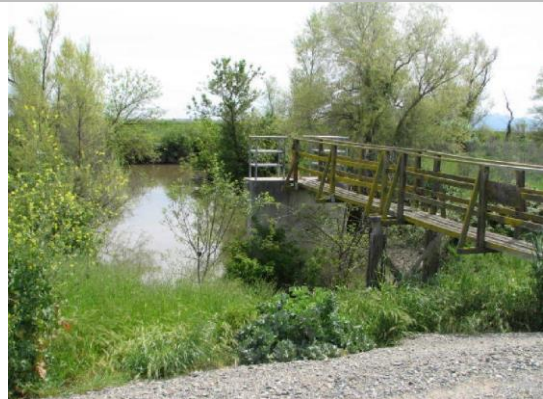
Photo 1 of 3 : UCIP_SP_2023_57621_66993.jpg

DS_ID:16373
FS_ID:57621
EP_NO: 11805B
Repair Type: Non-Urgent
EVAL Issue: 6, Levee Damage or Threat for Levee Damage
Crossing Status: Found
UCIP Comments: 08/27/2019 Record remains Non-Urgent, sloughing/erosion observed on the LS toe during inspection. Recommend monitoring to determine progression of sloughing/erosion. (O. Magana - DWR UCIP, A. Freitag - DWR Sutter Yard)06/15/2017 Both pipe ends submerged during site visit. LS ditch near pipe end is heavily vegetated and covering the pipe end. There is some erosion happening at the LS levee toe but this is more of a ditch problem and not a problem with the pipe. (A. Freitag - DWR Sutter Yard)11/17/2016 Both pipe ends underwater at time of inspection. (A. Freitag - DWR Sutter Yard)05/03/2016 Crossing was underwater on both sides of levee during this inspection. Looks as if the wooden walkway was the same and no repairs have been made. (A. Freitag - DWR Sutter Yard)07/13/2015 LS inlet still underwater. WS screw gate appears in good condition. Wooden walkway to the screw gate needs repairs. (A. Freitag - DWR Sutter Yard)05/22/2014 Same as last inspection. (A. Freitag - DWR Sutter Yard)12/03/2013 Same as last inspection. (A. Freitag - DWR Sutter Yard)07/15/2013 Same as last inspection. (A. Freitag - DWR Sutter Yard)04/18/2012 LS inlet is not visible-underwater. Limited inspection on WS and LS slope/toe due to dense vegetation. Need photos of cleared WS & LS slopes. (O. Magana - DWR UCIP)

WS view of appurtenances (catwalk, slide gate, and headwall)

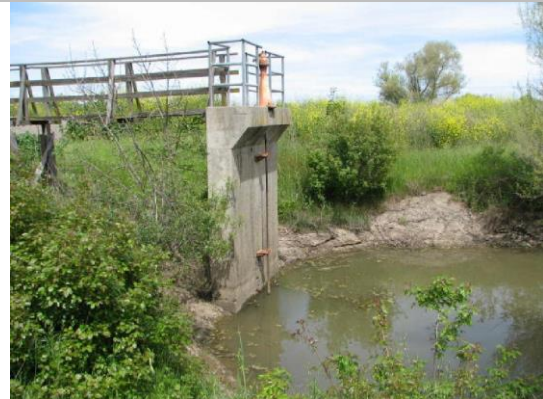
Photo 2 of 3 : UCIP_SP_2023_57621_66995.jpg

WS view of catwalk, slide/screw gate, and headwall

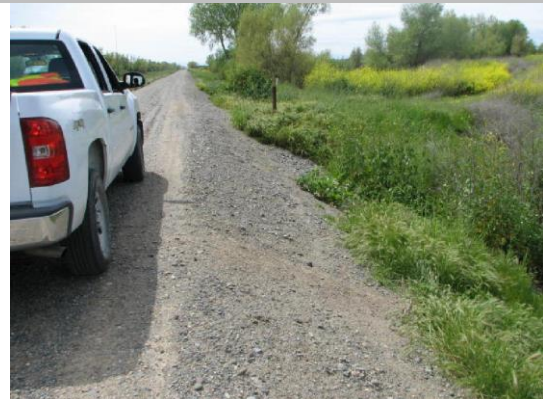
Photo 3 of 3 : UCIP_SP_2023_57621_66996.jpg

LS view of shoulder and slope.

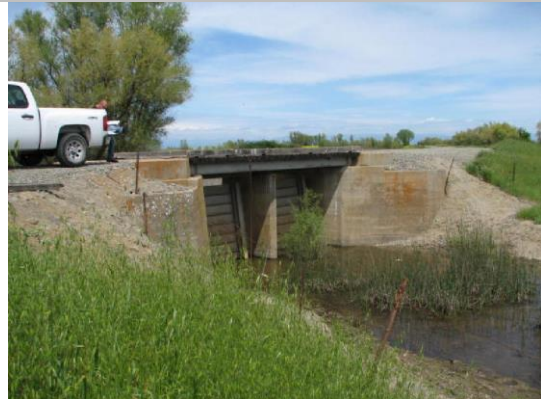
Photo 1 of 3 : UCIP_SP_2023_58508_74500.jpg

WS view of structure.

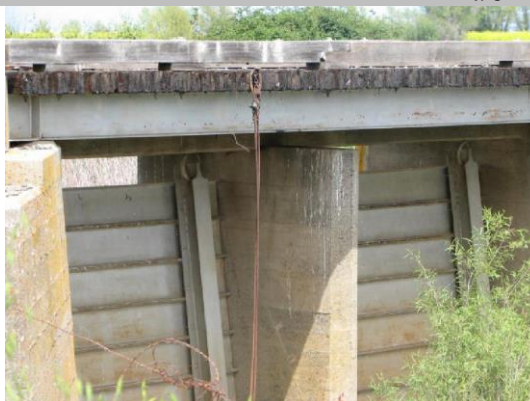
Photo 2 of 3 : UCIP_SP_2023_58508_74503.jpg

View of crossing and panels attached to concrete walls.

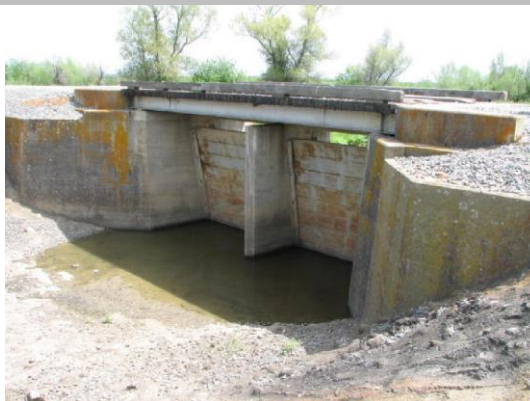
Photo 3 of 3 : UCIP_SP_2023_58508_74501.jpg

LS view of structure

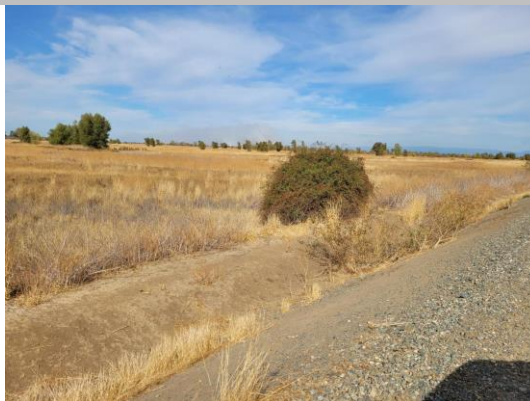
Photo 1 of 1 : SP_2023_MA0013_300_7_20230417_00002.jpg

LM Start	16.22	Rating **	M	Issue No.	7
LM End	17.17	Issue Type +	En	Location *	LS
Category	Earthen Levee			GPS Latitude/Longitude	
				Start	End
Item	Encroachments			39.394523 °	39.385580 °
				-121.817630 °	-121.831282 °
DWR ID	DWR_MA0013_01_s_2012_7				
Comment Code					
DT : Ditch					
Inspector Comment

View of the ditch along the landside toe. Fall 2021.

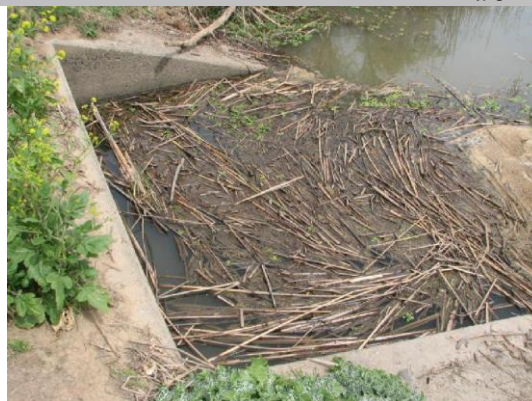
Photo 2 of 3 : UCIP_SP_2023_58511_67002.jpg

View of WS headwall.

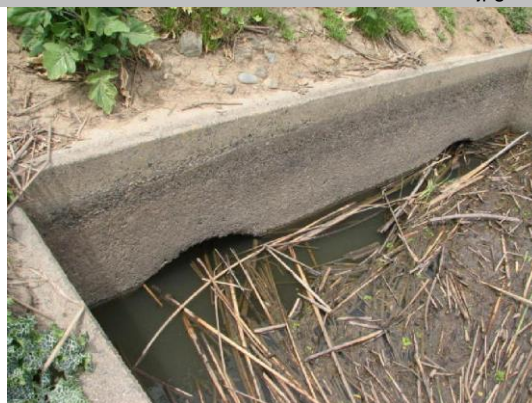
Photo 3 of 3 : UCIP_SP_2023_58511_67001.jpg

View of WS headwall during normal water flow in April.

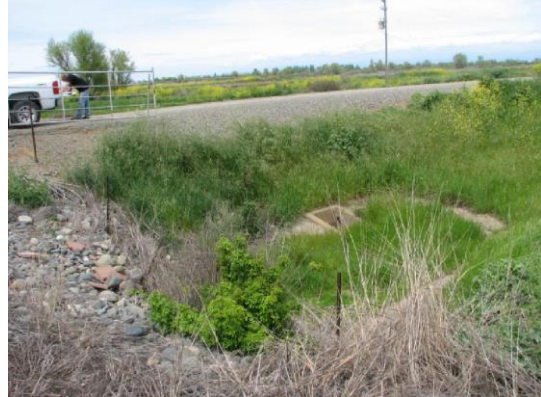
Photo 1 of 3 : UCIP_SP_2023_58512_67017.jpg

DS_ID:16369
FS_ID:58512
EP_NO: N/A
Repair Type: Non-Urgent
EVAL Issue:
Crossing Status: Found
UCIP Comments: 08/27/2019 Record remains Non-Urgent, no permit has been identified authorizing pipe. Pipe has been lined. (O. Magana - DWR UCIP, A. Freitag - DWR Sutter Yard)06/15/2017 Flap gate bolted shut. Hinges seem very stiff to operate as gate will not fully close and has about a 1/2" gap near the top. Land owner claims the gate leaks during high water times. Pipe has been selected to be internally cleaned and inspected as part of the DMP project. (A. Freitag - DWR Sutter Yard)11/17/2016 Crossing appears to be in good condition. (A. Freitag - DWR Sutter Yard)05/03/2016 Crossing appears to be in good condition. (A. Freitag - DWR Sutter Yard)07/13/2015 WS flap gate is blocked from opening by sediment. Needs to be dug out. (A. Freitag - DWR Sutter Yard)05/22/2014 Same as last inspection. (A. Freitag - DWR Sutter Yard)12/03/2013 Sediment was dug out from WS flap gate allowing it to open. (A. Freitag - DWR Sutter Yard)07/15/2013 Slopes have been sprayed and cleared of vegetation and are in good condition. WS flap gate is blocked from opening by sediment buildup. (A. Freitag - DWR Sutter Yard)04/18/2012 Limited inspection on WS and LS slope due to dense vegetation and steep slopes. Need photos of cleared WS & LS slopes. (O. Magana - DWR UCIP)

View of WS slope and toe.

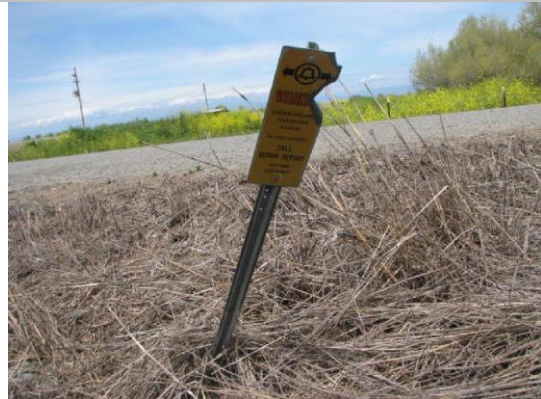
Photo 1 of 3 : UCIP_SP_2023_57627_67024.jpg

DS_ID:16366
FS_ID:57627
EP_NO: 10918
Repair Type: Non-Urgent
EVAL Issue: 11, Maintenance Compliance Issue
Crossing Status: Indicator Found
UCIP Comments: 08/27/2019 Record has been updated from No Action Needed to Non-Urgent due to maintenance issue. Marker is no longer available on WS side. Recommend contacting owner to determine if line is still in use. (O. Magana - DWR UCIP, A. Freitag - DWR Sutter Yard)06/15/2017 Crossing appears to be in good condition. (A. Freitag - DWR Sutter Yard)11/17/2016 Crossing appears to be in good condition. (A. Freitag - DWR Sutter Yard)05/03/2016 Crossing appears to be in good condition. (A. Freitag - DWR Sutter Yard)07/13/2015 Crossing is in god condition. (A. Freitag - DWR Sutter Yard)05/22/2014 Same as last inspection. (A. Freitag - DWR Sutter Yard)12/03/2013 Same as last inspection. (A. Freitag - DWR Sutter Yard)07/15/2013 Same as last inspection. (A. Freitag - DWR Sutter Yard)

Underground telephone line marker.

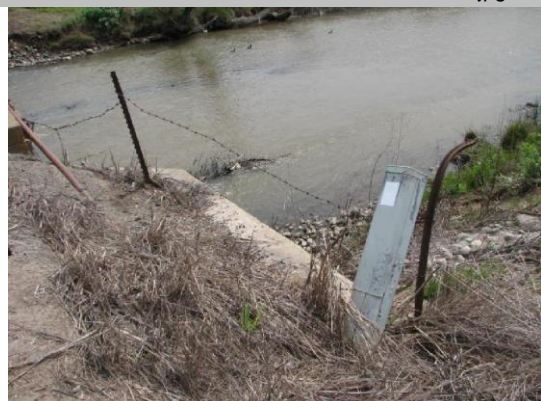
Photo 2 of 3 : UCIP_SP_2023_57627_67025.jpg

Underground telephone cable splice box.

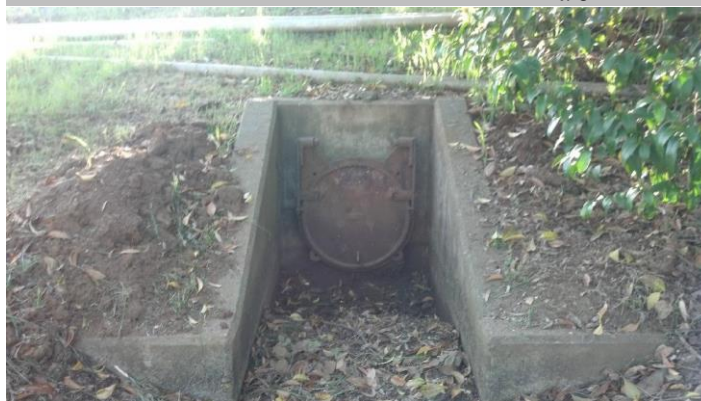
Photo 2 of 3 : UCIP_SP_2023_58518_45642.jpg

Headwall and flap gate on WS. Soil and pipes stockpiled next to headwall.

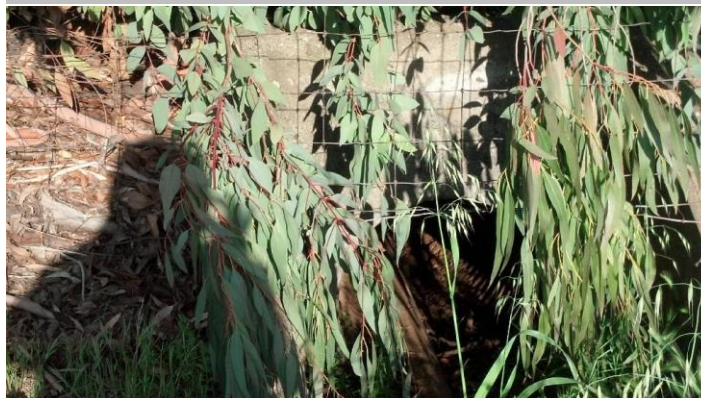
Photo 3 of 3 : UCIP_SP_2023_58518_45643.jpg

LM Start	0.05	Rating **	M	Issue No.	2 (cont)
LM End	0.05	Issue Type +	Ma	Location *

LS headwall blocked by overgrown branches.

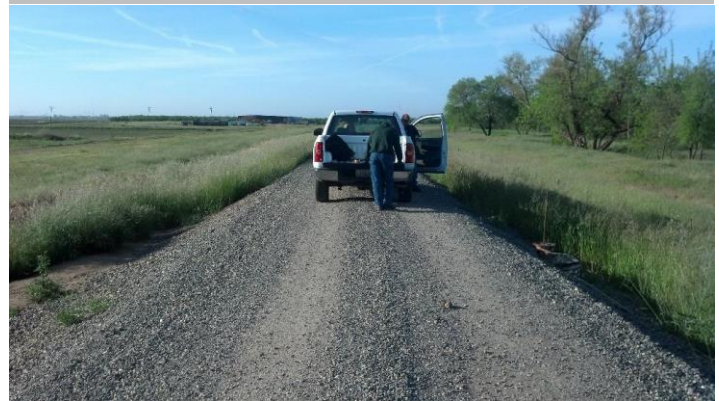
Photo 1 of 3 : UCIP_SP_2023_58519_67047.jpg

DS_ID:16398
FS_ID:58519
EP_NO: N/A
Repair Type: Non-Urgent
EVAL Issue: 10, Unauthorized Modification or Non-Compliant Permit
Crossing Status: Found
UCIP Comments: 08/28/2019 Record remains Non-Urgent, no permit has been identified authorizing pipe and modifications. Structure type has been changed from drainage to irrigation. Mr. Sohnrey property owner mentioned that this pipe is being used as irrigation line. DMP internal video inspection has not found pipe integrity issues. LOF of crossing is less or equal to 4. Recommend next video inspection in 5 years. (O. Magana - DWR UCIP, A. Freitag - DWR Sutter Yard)06/05/2017 LS ditch at outlet is getting over grown with vegetation. WS near concrete standpipe is overgrown with vegetation. Pipe has been selected to be internally cleaned and inspected as part of the DMP project. (A. Freitag - DWR Sutter Yard)11/18/2016 Between the screw gate on the WS shoulder and the LS pipe end the pipe is about 50% full of soil. Crossing is still actively used by landowner for irrigation purposes. (A. Freitag - DWR Sutter Yard)04/27/2016 Pipe gets used by the landowner to irrigate his rice fields. It appeared to be in good condition. (A. Freitag - DWR Sutter Yard)07/01/2015 LS pipe end is still about 50% full of sediment. (A. Freitag - DWR Sutter Yard)05/29/2014 Same as last inspection. (A. Freitag - DWR Sutter Yard)12/09/2013 Same as last inspection. (A. Freitag - DWR Sutter Yard)07/10/2013 LS and WS slopes have been cleared of vegetation and are in good condition. LS pipe end is half full of sediment. Sediment inside of WS standpipe may hinder slide gate from fully closing. Standpipe cover is still broken. (A. Freitag - DWR Sutter Yard)04/19/2012 Need to fix the top of slide gate cover. The wooden cap on standpipe is broken. Limited evaluation of crossing due to dense vegetation on LS slope. Need photos of cleared slopes during fall inspection. (O. Magana - DWR UCIP)

Overview looking south

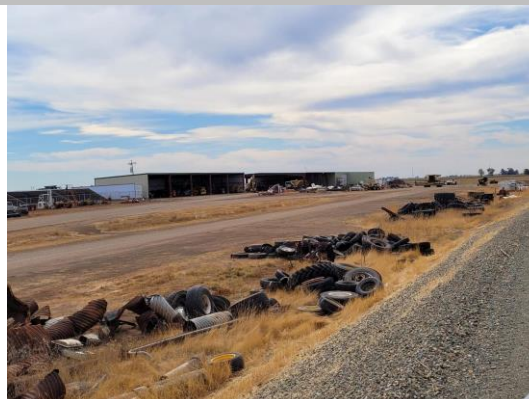
Photo 1 of 1 : SP_2023_MA0013_301_91_20230417_00013.jpg

LM Start	0.77	Rating **	M	Issue No.	91
LM End	0.85	Issue Type +	En	Location *	LS
Category	Earthen Levee			GPS Latitude/Longitude	
				Start	End
Item	Encroachments			39.563684°	39.562508°
				-121.702413°	-121.702535°
DWR ID	DWR_MA0013_02_f_2021_91				
Comment Code					
EQ : Equipment					
Inspector Comment

View of the equipment along the landside toe. Fall 2021.

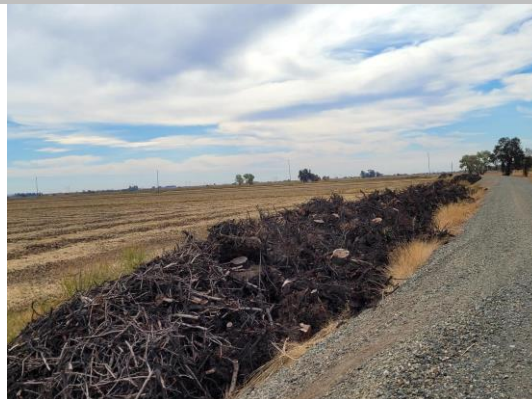
Photo 1 of 1 : SP_2023_MA0013_301_93_20230417_00015.jpg

LM Start	1.26	Rating **	U	Issue No.	93
LM End	1.29	Issue Type +	En	Location *	LS
Category	Earthen Levee			GPS Latitude/Longitude	
				Start	End
Item	Encroachments			39.557153°	39.556600°
				-121.704880°	-121.704936°
DWR ID	DWR_MA0013_02_f_2021_93				
Comment Code					
FW : Firewood					
Inspector Comment

View of the pile of tree limbs along landside toe. Fall 2021.

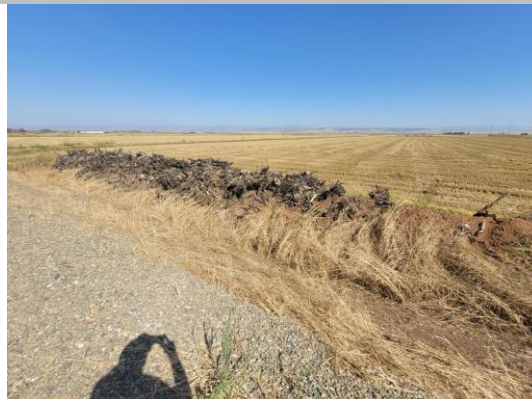
Photo 1 of 1 : SP_2023_MA0013_301_95_20230417_00016.jpg

LM Start	1.51	Rating **	U	Issue No.	95
LM End	1.51	Issue Type +	En	Location *	LS
Category	Earthen Levee			GPS Latitude/Longitude	
				Start	End
Item	Encroachments			39.553457°	39.553457°
				-121.704923°	-121.704923°
DWR ID	DWR_MA0013_02_f_2021_95				
Comment Code					
FW : Firewood					
Inspector Comment

View of a large pile of tree limbs along the landside toe. Fall 2022.

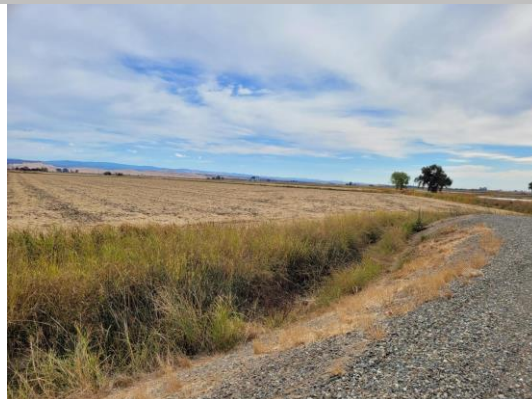
Photo 1 of 1 : SP_2023_MA0013_301_56_20230417_00007.jpg

LM Start	1.60	Rating **	U	Issue No.	56
LM End	1.63	Issue Type +	En	Location *	LS
Category	Earthen Levee			GPS Latitude/Longitude	
				Start	End
Item	Encroachments			39.552195°	39.551731°
				-121.704786°	-121.704721°
DWR ID	DWR_MA0013_02_s_2016_56				
Comment Code					
DT : Ditch					
Inspector Comment

View of the agricultural ditch along the landside toe. Fall 2021.

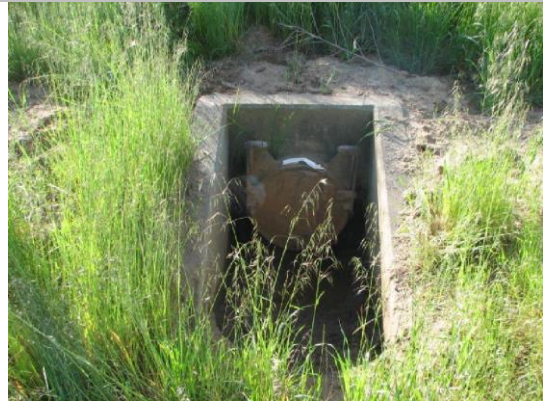
Photo 2 of 3 : UCIP_SP_2023_58573_67058.jpg

LM Start	1.70	Rating **	M	Issue No.	4 (cont)
LM End	1.70	Issue Type +	Ma	Location *	
Category	Supplemental			GPS Latitude/Longitude	
				Start	End
Item	DWR UCIP LMA Responsibility			39.551178 °	39.551178 °
				-121.705660 °	-121.705660 °
DWR ID	16399

View of flap gate on WS.

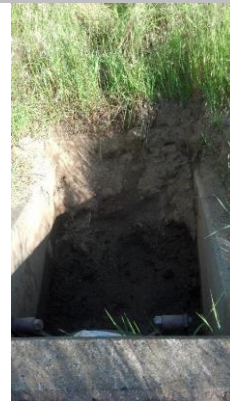
Photo 3 of 3 : UCIP_SP_2023_58573_67057.jpg

LM Start	1.70	Rating **	M	Issue No.	4 (cont)
LM End	1.70	Issue Type +	Ma	Location *

View of WS toe.

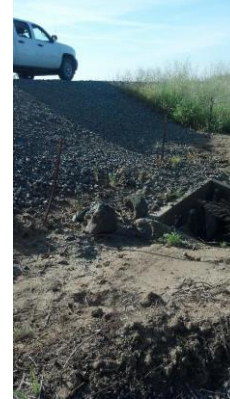
Photo 2 of 3 : UCIP_SP_2023_58523_67074.jpg

LM Start	2.53	Rating **	M	Issue No.	6 (cont)	
LM End	2.53	Issue Type +	Ma	Location *		
Category	Supplemental			GPS Latitude/Longitude		
				Start	End	
Item	DWR UCIP LMA Responsibility			39.539179°	39.539179°	
				-121.706060°	-121.706060°	
DWR ID	17169

View of WS slope.

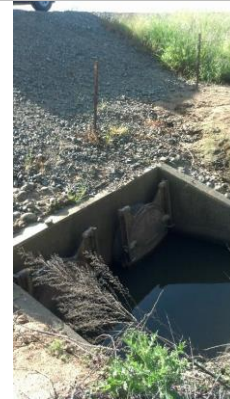
Photo 3 of 3 : UCIP_SP_2023_58523_67071.jpg

LM Start	2.53	Rating **	M	Issue No.	6 (cont)
LM End	2.53	Issue Type +	Ma	Location *

Headwall and flap gates (2) located on the WS.

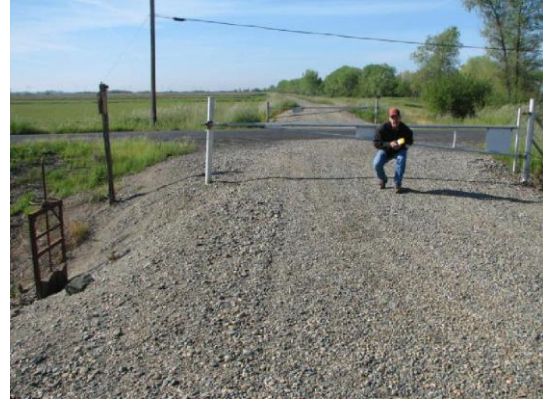
Photo 1 of 3 : UCIP_SP_2023_58524_67077.jpg

DS_ID:16402
FS_ID:58524
EP_NO: N/A
Repair Type: Non-Urgent
EVAL Issue:
Crossing Status: Found
UCIP Comments: 08/28/2019 Record remains Non-Urgent, no permit has been identified authorizing pipe. Pipe is scheduled to be lined (O. Magana - DWR UCIP, A. Freitag - DWR Sutter Yard)06/05/2017
Sediment blocking LS slide gate from closing fully. Pipe has been selected to be internally cleaned and inspected as part of the DMP project. (A. Freitag - DWR Sutter Yard)11/18/2016 Sediment still blocking screw gate from fully closing. (A. Freitag - DWR Sutter Yard)04/27/2016 LS slide gate is full of sediment and needs to be dug out so gate can close fully. (A. Freitag - DWR Sutter Yard)07/01/2015 LS screw gate is still silted in and unable to be screwed down all the way. Needs to be cleaned out. (A. Freitag - DWR Sutter Yard)05/29/2014 Same as last inspection. (A. Freitag - DWR Sutter Yard)12/09/2013 WS flap gate was closed but LS slide gate is heavily vegetated and blocked from closing by sediment. (A. Freitag - DWR Sutter Yard)07/10/2013 Same as last inspection. (A. Freitag - DWR Sutter Yard)04/19/2012 Minor sediment built up on LS, remove sediment. Need photo of LS slide gate without sediment build up. This crossing was listed in the USACE Periodic Inspection report as Corp's inspect ID# USACE_CESPK_M13G_2011_p_0148 for LS gate obstructed by vegetation and WS flap gate is not functioning (propped open). (O. Magana - DWR UCIP)

Overview looking south from left levee

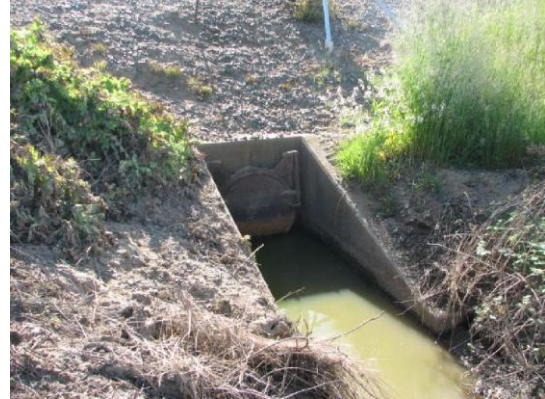
Photo 2 of 3 : UCIP_SP_2023_58524_67076.jpg

LM Start	2.62	Rating **	M	Issue No.	7 (cont)
LM End	2.62	Issue Type +	Ma	Location *	
Category	Supplemental			GPS Latitude/Longitude	
				Start	End
Item	DWR UCIP LMA Responsibility			39.537864°	39.537864°
				-121.706190°	-121.706190°
DWR ID	16402

Headwall and flap gate located on WS.

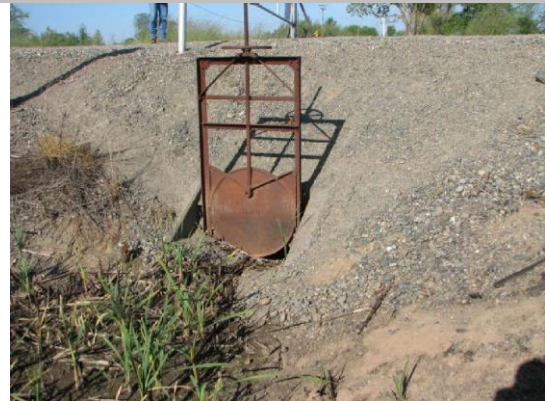
Photo 3 of 3 : UCIP_SP_2023_58524_67078.jpg

LM Start	2.62	Rating **	M	Issue No.	7 (cont)
LM End	2.62	Issue Type +	Ma	Location *

Headwall and screw gate located on LS.

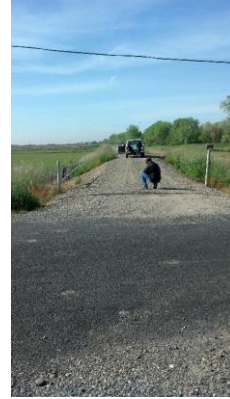
Photo 1 of 3 : UCIP_SP_2023_58525_67087.jpg

Comment Code						
Inspector Comment						
DS_ID:16403 FS_ID:58525 EP_NO: N/A Repair Type: Non-Urgent EVAL Issue: Crossing Status: Found UCIP Comments: 08/28/2019 Record remains Non-Urgent, no permit has been identified authorizing pipe. Pipe is scheduled to be lined. (O. Magana - DWR UCIP, A. Freitag - DWR Sutter Yard)06/05/2017 Crossing appears to be in good condition. Pipe has been selected to be internally cleaned and inspected as part of the DMP project. (A. Freitag - DWR Sutter Yard)11/18/2016 Crossing appears to be in good condition. (A. Freitag - DWR Sutter Yard)04/27/2016 Crossing appears to be in good condition. (A. Freitag - DWR Sutter Yard)07/01/2015 WS flap gate is partially blocked by sediment and needs to be cleaned. (A. Freitag - DWR Sutter Yard)05/29/2014 Same as last inspection. (A. Freitag - DWR Sutter Yard)12/09/2013 Same as last inspection. (A. Freitag - DWR Sutter Yard)07/10/2013 LS and WS slopes have been cleared of vegetation and are in good condition. (A. Freitag - DWR Sutter Yard)04/19/2012 Burrowing holes located above WS headwall. Limited inspection on WS and LS slopes due to dense vegetation. Need photos of cleared WS & LS slopes. (O. Magana - DWR UCIP) FIELD_STRUCT_DESC: 36-inch CIPP-lined corrugated metal drainage pipe through the levee, 8.7 feet below the crown. Concrete "U" headwalls located on the waterside (WS) and landside (LS) ends. Flap gate on the WS end. Slide gate on the LS end. [Additional Reference(s): DWR Levee Log, 1993 (HLM 2.64). USACE Sacramento O&M Manual, Unit 519, June 1962, Revised 3 Feb 2011, (HLM 2.65), As-built DWG No. 50-4-3608, Sheet No. 3608/19.1, STA 892+57E LT BK, page 20 of 28 electronic file, listed as 36-inch CMP; As-built DWG No 50-4-3037 referenced not available] FS Date: 8/28/2019 1:15:00 PM

Overview at levee crown looking south

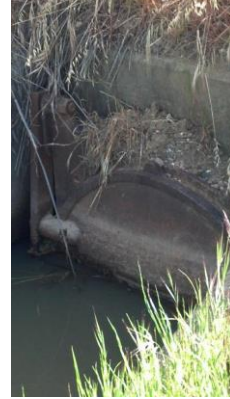
Photo 2 of 3 : UCIP_SP_2023_58525_67084.jpg

LM Start	2.63	Rating **	M	Issue No.	8 (cont)
LM End	2.63	Issue Type +	Ma	Location *	
Category	Supplemental		GPS Latitude/Longitude		
			Start	End	
Item	DWR UCIP LMA Responsibility		39.537671 °	39.537671 °	
			-121.706210 °	-121.706210 °	
DWR ID	16403

Headwall and flap gate located on WS

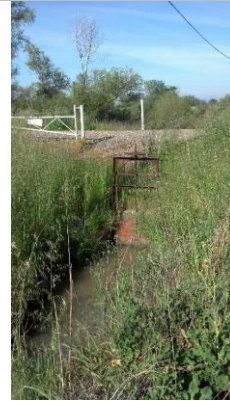
Photo 3 of 3 : UCIP_SP_2023_58525_67086.jpg

LM Start	2.63	Rating **	M	Issue No.	8 (cont)
LM End	2.63	Issue Type +	Ma	Location *

Headwall and screw gate located on the LS

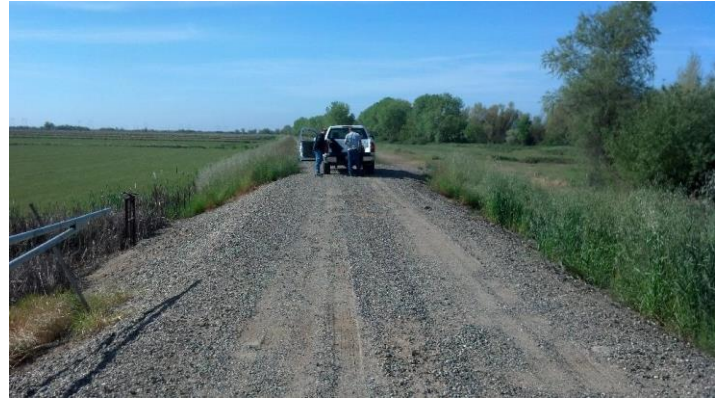
Photo 1 of 3 : UCIP_SP_2023_58526_67090.jpg

Comment Code						
Inspector Comment						
DS_ID:16415 FS_ID:58526 EP_NO: N/A Repair Type: Non-Urgent EVAL Issue: Crossing Status: Found UCIP Comments: 08/28/2019 Record remains Non-Urgent, no permit has been identified authorizing pipe. Both inlet/outlet were underwater during inspection. Pipe is scheduled to be lined. (O. Magana - DWR UCIP, A. Freitag - DWR Sutter Yard)06/05/2017 Both gates partially submerged during site visit. Appears to be in good condition. Pipe has been selected to be internally cleaned and inspected as part of the DMP project. (A. Freitag - DWR Sutter Yard)11/18/2016 LS screw gate closed but partially buried. WS flap gate was half submerged for inspection. (A. Freitag - DWR Sutter Yard)04/27/2016 Both gates were underwater for inspection. (A. Freitag - DWR Sutter Yard)07/01/2015 WS flap gate is partially held open by sediment and needs to be dug out to allow it to fully close. (A. Freitag - DWR Sutter Yard)05/29/2014 Same as last inspection. (A. Freitag - DWR Sutter Yard)12/09/2013 Both gates were out of water and in good condition. (A. Freitag - DWR Sutter Yard)07/10/2013 LS and WS slopes are in good condition. Both LS and WS gates were fully submerged in water and unable to be inspected. (A. Freitag - DWR Sutter Yard) FIELD_STRUCT_DESC: 36-inch CIPP-lined corrugated metal drainage pipe through the levee, 9 feet below the crown. Concrete "U" headwall on both waterside (WS) and landside (LS) ends. Flap gate on the WS end. Slide gate on the LS. [Additional Reference(s): DWR Levee Log, 1993 (HLM 2.65). USACE Sacramento O&M Manual, Unit 519, June 1962, Revised 3 Feb 2011, (HLM 2.66), As-built DWG No. 50-4-3608, Sheet No. 3608/19.1, STA 891+80E LT BK, page 20 of 28 electronic file, listed as 36-inch CMP; As-built DWG No 50-4-3037 referenced not available] FS Date: 8/28/2019 1:16:00 PM

Overview looking south from left levee

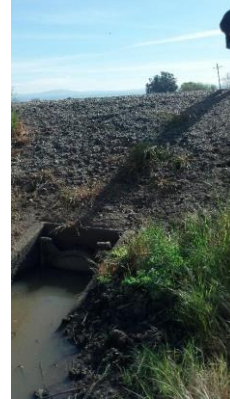
Photo 2 of 3 : UCIP_SP_2023_58526_67091.jpg

LM Start	2.65	Rating **	M	Issue No.	9 (cont)	
LM End	2.65	Issue Type +	Ma	Location *		
Category	Supplemental			GPS Latitude/Longitude		
				Start	End	
Item	DWR UCIP LMA Responsibility			39.537466°	39.537466°	
				-121.706240°	-121.706240°	
DWR ID	16415

Headwall and flap gate located on WS.

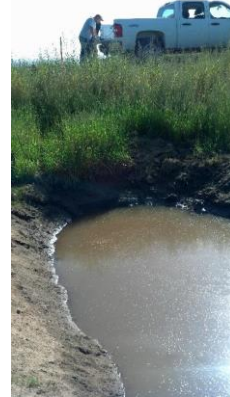
Photo 2 of 3 : UCIP_SP_2023_58527_67095.jpg

Flap gate submerged in water on WS of levee

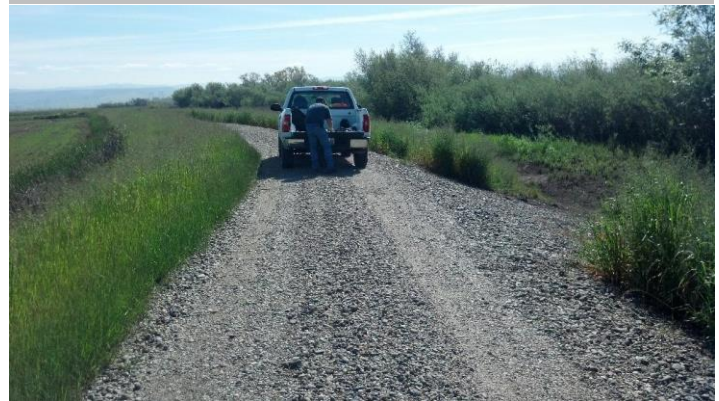
Photo 1 of 3 : UCIP_SP_2023_58528_67102.jpg

DS_ID:16848
FS_ID:58528
EP_NO: N/A
Repair Type: Non-Urgent
EVAL Issue:
Crossing Status: Found
UCIP Comments: 08/28/2019 Record has been updated from No Action Needed to Non-Urgent, no permit has been identified authorizing pipe. Pending internal inspection under DMP Phase 1 both inlet and outlet underwater. (O. Magana - DWR UCIP, A. Freitag - DWR Sutter Yard)06/05/2017 Both ends submerged but appear to be in good condition. Pipe has been selected to be internally cleaned and inspected as part of the DMP project. (A. Freitag - DWR Sutter Yard)11/18/2016 Crossing appears to be in good condition. (A. Freitag - DWR Sutter Yard)04/27/2016 Crossing appears to be in good condition. New slide gate installed on LS. (A. Freitag - DWR Sutter Yard)07/01/2015 Both gates were still submerged in water. Levee slopes were in good condition. (A. Freitag - DWR Sutter Yard)05/29/2014 Same as last inspection. (A. Freitag - DWR Sutter Yard)12/09/2013 Same as last inspection. (A. Freitag - DWR Sutter Yard)07/10/2013 LS slope has been cleared of vegetation and is in good condition. Both gates are still underwater and not able to be inspected. (A. Freitag - DWR Sutter Yard)04/19/2012 Dense vegetation makes it difficult to evaluate the condition of the LS slope. Both gates underwater. Recommend taking photos of clear slopes and gates during fall inspection. (O. Magana - DWR UCIP)

Overview looking south on left levee

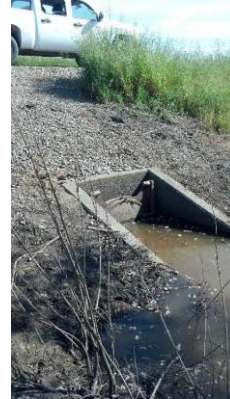
Photo 2 of 3 : UCIP_SP_2023_58528_67103.jpg

Headwall and flap gate located on WS.

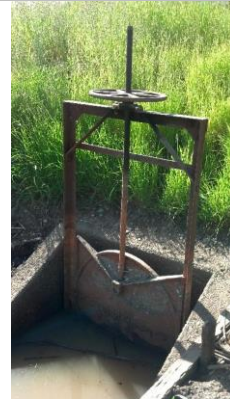
Photo 3 of 3 : UCIP_SP_2023_58528_67101.jpg

Headwall and screw gate located on LS.

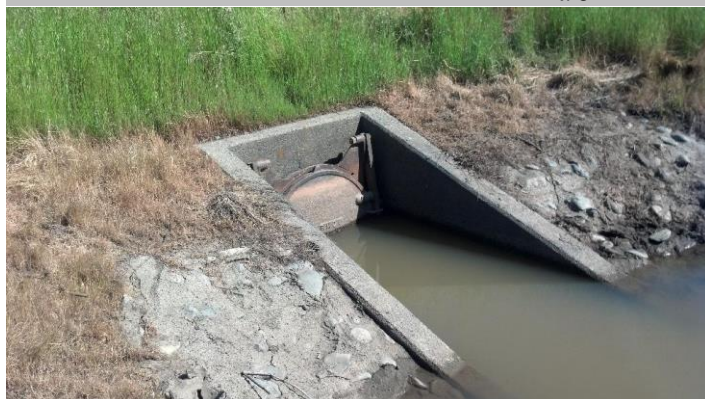
Photo 2 of 3 : UCIP_SP_2023_58529_67108.jpg

Headwall and flap gate located on WS toe.

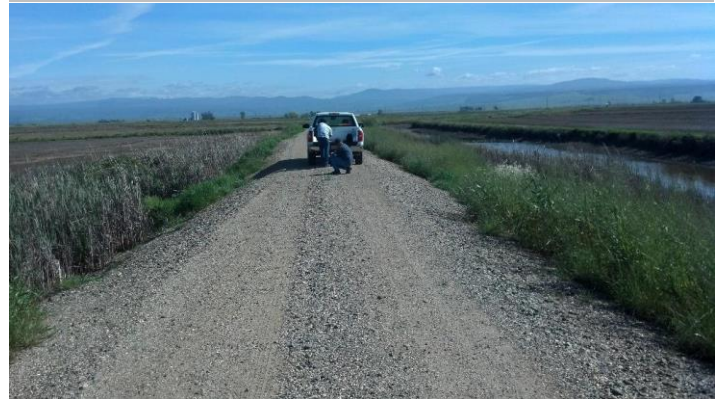
Photo 1 of 3 : UCIP_SP_2023_58530_67115.jpg

DS_ID:16846
FS_ID:58530
EP_NO: N/A
Repair Type: Non-Urgent
EVAL Issue: 6, Levee Damage or Threat for Levee Damage
Crossing Status: Found
UCIP Comments: 08/28/2019 Record remains Non-Urgent due to potential levee threat. Minor scour was visible on both WS and LS toe. No permit has been identified authorizing pipe. Pending internal inspection under DMP Phase 1 both inlet and outlet underwater. (O. Magana - DWR UCIP, A. Freitag - DWR Sutter Yard)6/5/2017 Both ends submerged during site visit. Pipe has been selected to be internally cleaned and inspected as part of the DMP project. (A. Freitag - DWR Sutter Yard)11/18/2016 Both pipe ends underwater for this inspection. (A. Freitag - DWR Sutter Yard)04/27/2016 Both pipe ends were underwater for inspection. (A. Freitag - DWR Sutter Yard)07/01/2015 Both pipe ends and gates were fully submerged. (A. Freitag - DWR Sutter Yard)05/29/2014 Same as last inspection. (A. Freitag - DWR Sutter Yard)12/09/2013 Same as last inspection. (A. Freitag - DWR Sutter Yard)07/10/2013 WS slope is cleared of vegetation and is in good condition. Both gates were fully submerged under water and unable to be inspected. (A. Freitag - DWR Sutter Yard)04/19/2012 Rodent activity caused partial collapse on LS of levee in the vicinity of pipe. Limited inspection on WS slope due to dense vegetation. Limited inspection on gates due to both gates submerged under water. (O. Magana - DWR UCIP)

Overview looking east on right bank of Cottonwood

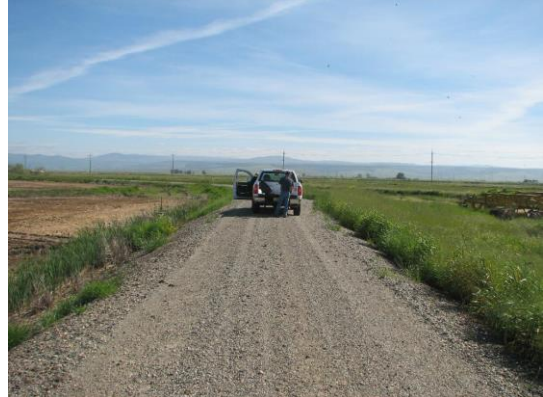
Photo 1 of 3 : UCIP_SP_2023_58532_67119.jpg

Comment Code						
Inspector Comment						
DS_ID:16845 FS_ID:58532 EP_NO: N/A Repair Type: Non-Urgent EVAL Issue: Crossing Status: Found UCIP Comments: 08/28/2019 Record has been updated from No Action Needed to Non-Urgent, no permit has been identified authorizing pipe. Pipe is scheduled to be lined. (O. Magana - DWR UCIP, A. Freitag - DWR Sutter Yard)06/05/2017 LS Slide gate mostly underwater due to rice field being flooded but crossing appears to be in good condition. Pipe has been selected to be internally cleaned and inspected as part of the DMP project. (A. Freitag - DWR Sutter Yard)11/18/2016 Crossing appears to be in good condition. (A. Freitag - DWR Sutter Yard)04/27/2016 Crossing appears to be in good condition. (A. Freitag - DWR Sutter Yard)07/01/2015 Crossing appears to be in good condition. No noticeable issues to report. (A. Freitag - DWR Sutter Yard)05/29/2014 Same as last inspection. (A. Freitag - DWR Sutter Yard)12/09/2013 Same as last inspection. (A. Freitag - DWR Sutter Yard)07/10/2013 WS slope has been cleared of vegetation and is in good condition. (A. Freitag - DWR Sutter Yard)04/19/2012 Limited inspection due to dense vegetation on WS slope. Need photos of clear WS slope. (O. Magana - DWR UCIP) FIELD_STRUCT_DESC: 24-inch CIPP-lined corrugated metal drainage pipe through the levee, 5.6 feet below the crown. Flap gate on the waterside (WS) end. Slide gate on the landside (LS) end. Concrete "U" headwalls on both ends. [Additional Reference(s): DWR Levee Log, 1993 (HLM 4.69). USACE Sacramento O&M Manual, Unit 519, June 1962, Revised 3 Feb 2011, (HLM 4.69), listed as 24-inch pipe, no As-built reference found] FS Date: 8/28/2019 3:31:00 PM

Overview looking east on right levee of Gold Run Creek (referred to Unit 2 of Cherokee Canal).

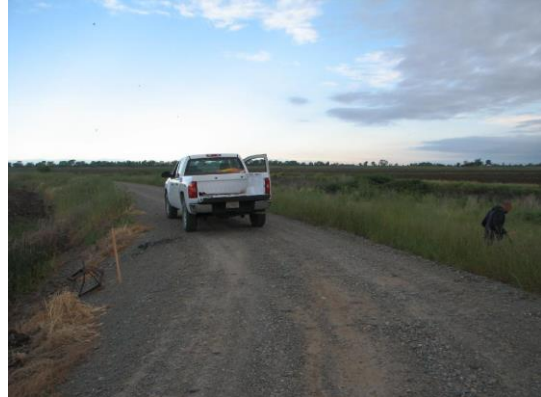
Photo 1 of 3 : UCIP_SP_2023_58574_67138.jpg

Comment Code					
Inspector Comment					
DS_ID:16408 FS_ID:58574 EP_NO: N/A Repair Type: Non-Urgent EVAL Issue: Crossing Status: Found UCIP Comments: 08/28/2019 Record has been updated from No Action Needed to Non-Urgent, no permit has been identified authorizing pipe. Pipe has been lined. (O. Magana - DWR UCIP, A. Freitag - DWR Sutter Yard)06/05/2017 Crossing appears to be in good condition. Pipe has been selected to be internally cleaned and inspected as part of the DMP project. (A. Freitag - DWR Sutter Yard)11/18/2016 Crossing appears to be in good condition. (A. Freitag - DWR Sutter Yard)04/27/2016 Crossing appears to be in good condition. (A. Freitag - DWR Sutter Yard)06/30/2015 Crossing appears to be in good condition. No apparent issues to report. (A. Freitag - DWR Sutter Yard)05/29/2014 Same as last inspection. (A. Freitag - DWR Sutter Yard)12/09/2013 Same as last inspection. (A. Freitag - DWR Sutter Yard)07/09/2013 WS and LS slopes have been cleared of vegetation and are in good condition. Slide gate on LS has been replaced. (A. Freitag - DWR Sutter Yard)04/24/2012 Slide gate is damaged, needs to be replaced. Limited inspection on WS slope and toe due to dense vegetation. Need photos of clear WS slope and toe. This crossing was listed in the USACE Periodic Inspection report as Corp's inspection ID# USACE_CESPK_M13H_2011_p_0026 for broken gate on LS. (O. Magana - DWR UCIP) FIELD_STRUCT_DESC: 24-inch CIPP-lined corrugated metal drainage pipe through the levee, 5.7 feet below the crown. Flap gate on the waterside (WS). Slide gate on the landside (LS). Concrete "U" headwalls located on both WS and LS ends. [Additional Reference(s): DWR Levee Log, 1993 (HLM 5.13). USACE Sacramento O&M Manual, Unit 519, June 1962, Revised 3 Feb 2011, (HLM 5.13), listed as 24-inch pipe, no As-built reference found] FS Date: 8/28/2019 3:11:00 PM

Overview of levee crown at crossing looking west.

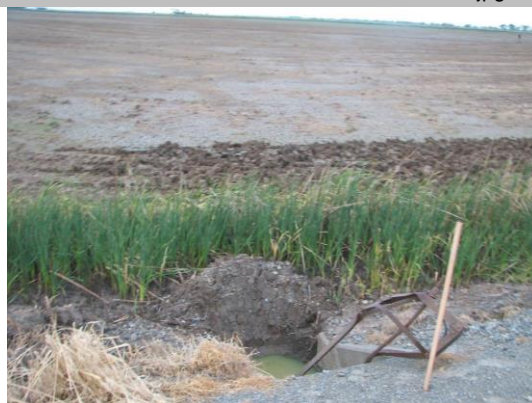
Photo 3 of 3 : UCIP_SP_2023_58574_67141.jpg

Overview of LS floor is higher in elevation than pipe invert causing build up sediment.

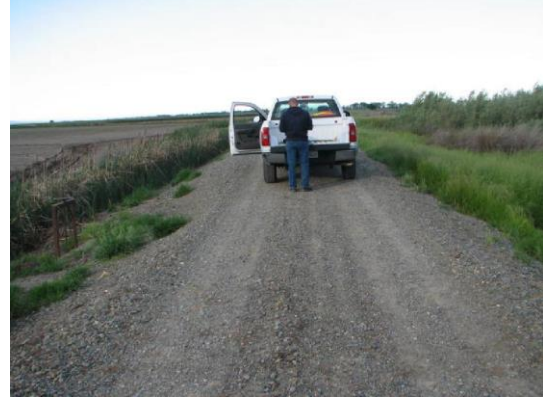
Photo 1 of 3 : UCIP_SP_2023_58536_67146.jpg

Comment Code					
Inspector Comment					
DS_ID:16409 FS_ID:58536 EP_NO: N/A Repair Type: Non-Urgent EVAL Issue: Crossing Status: Found UCIP Comments: 08/28/2019 Record remains Non-Urgent, no permit has been identified authorizing pipe. Internal inspection under DMP Phase 1 is still pending, both inlet and outlet are underwater. (O. Magana - DWR UCIP, A. Freitag - DWR Sutter Yard)06/05/2017 WS fully submerged and LS slide gate mostly buried by sediment. Pipe has been selected to be internally cleaned and inspected as part of the DMP project. (A. Freitag - DWR Sutter Yard)11/18/2016 There is a flap gate on the WS and a slide gate on the LS. The LS slide gate appears to be partially buried and blocked by vegetation. (A. Freitag - DWR Sutter Yard)04/27/2016 LS slide gate is blocked by vegetation. Pipe appears to not be used. (A. Freitag - DWR Sutter Yard)06/30/2015 WS flap gate was still overgrown with vegetation. Needs to be cleared away. (A. Freitag - DWR Sutter Yard)05/29/2014 Same as last inspection. (A. Freitag - DWR Sutter Yard)12/09/2013 Same as last inspection. (A. Freitag - DWR Sutter Yard)07/09/2013 Same as last inspection. (A. Freitag - DWR Sutter Yard)04/24/2012 Limited inspection on WS slope due to dense vegetation. Need photo of clear WS slope during next inspection. This crossing was listed in the USACE Periodic Inspection report as Corp's inspect ID# USACE_CESPK_M13H_2011_p_0035 non-functional crossing due to overgrown vegetation on WS flap gate. (O. Magana - DWR UCIP) FIELD_STRUCT_DESC: 30-inch CIPP-lined corrugated metal drainage pipe through the levee, 5.8 feet below the crown. Flap gate on the waterside (WS). Slide gate on the landside (LS). Concrete "U" headwalls located on both ends. [Additional Reference(s): DWR Levee Log, 1993 (HLM 5.34). USACE Sacramento O&M Manual, Unit 519, June 1962, Revised 3 Feb 2011, (HLM 5.34), listed as 30-inch pipe, no As-built reference found] FS Date: 8/28/2019 3:22:00 PM

Overview of crossing looking downstream.

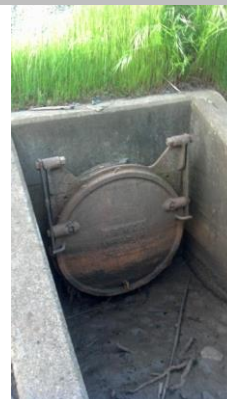
Photo 3 of 3 : UCIP_SP_2023_58536_67148.jpg

Headwall and flap gate located on WS.

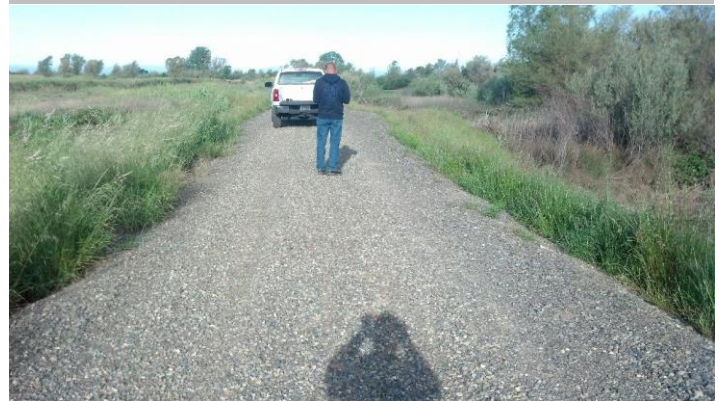
Photo 1 of 3 : UCIP_SP_2023_58538_67155.jpg

DS_ID:16411
FS_ID:58538
EP_NO: N/A
Repair Type: Non-Urgent
EVAL Issue: 11, Maintenance Compliance Issue
Crossing Status: Found
UCIP Comments: 08/28/2019 Record remains Non-Urgent, unable to determine if crossing is in use. Need to audit record to determine if Permit No. 13170 is associated with 36-inch. Slide gate that is supposed to be located on the WS is still missing. Need to check permit 13170 to see if this pipe crossing is also part of permit. (O. Magana - DWR UCIP, A. Freitag - DWR Sutter Yard)06/05/2017 Both ends were underwater but it appears that the LS slide gate is still missing. (A. Freitag - DWR Sutter Yard)11/18/2016 LS slide gate still missing. Both pipe ends were submerged during inspection. (A. Freitag - DWR Sutter Yard)09/27/2016 Crossing has been downgraded from Urgent to Non-Urgent--flap gate on WS is present only LS gate missing. (O. Magana - DWR UCIP)04/27/2016 Both sides of pipe were underwater. Appears that LS gate is still missing. (A. Freitag - DWR Sutter Yard)06/30/2015 Slide gate still missing on the LS. WS appears to be in good condition. (A. Freitag - DWR Sutter Yard)05/29/2014 Same as last inspection. (A. Freitag - DWR Sutter Yard)12/09/2013 Same as last inspection. (A. Freitag - DWR Sutter Yard)07/09/2013 Same as last inspection. (A. Freitag - DWR Sutter Yard)04/24/2012 Slide gate missing on LS. Limited inspection on WS and LS slopes due to dense vegetation. Need photos of cleared WS & LS slopes. This crossing was listed in the USACE Periodic Inspection report as Corp's inspect ID# USACE_CESPK_M13H_2011_p_0017 for missing slide gate. (O. Magana - DWR UCIP)

FIELD_STRUCT_DESC: 36-inch corrugated metal drainage pipe through the levee, 9.2 feet below the crown. Flap gate on the waterside (WS) end. Slide gate on the landside (LS) end. Concrete "U" headwalls located on both WS and LS toes. (secondary permit reference: 48-inch irrigation pipe authorized under Permit No. 13170, 1981 - S. S. Hinaman, Jr., USACE letter covers installation of a 36-inch pipe dated 14 July 1981, Board summary report references 36-inch pipe and not 48-inch pipe)[Additional Reference(s): DWR Levee Log, 1993 (HLM 5.85). USACE Sacramento O&M Manual, Unit 519, June 1962, Revised 3 Feb 2011, (HLM 5.85), As-built DWG No. 50-4-3608, Sheet No. 3608/22.3, STA 19+30 LT. BK. (Cottonwood), page 23 of 28 electronic file, listed as 36-inch pipe; As-built DWG No. 50-4-3037 referenced not available]
FS Date: 8/28/2019 3:17:00 PM

Overview looking south

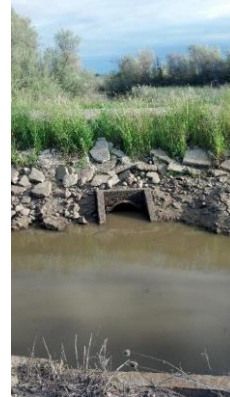
Photo 3 of 3 : UCIP_SP_2023_58538_67156.jpg

Headwall and damaged/missing screw gate on LS.

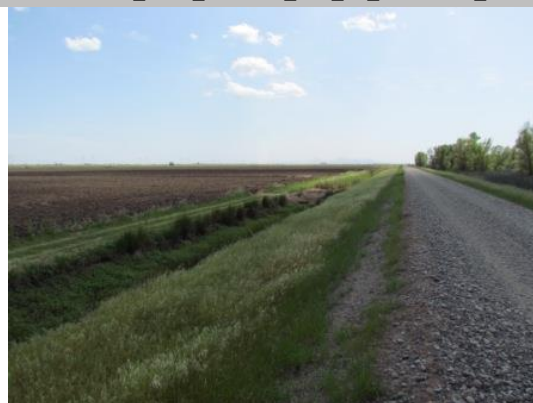
Photo 1 of 1 : SP_2023_MA0013_301_12_20230417_00001.jpg

LM Start	6.16	Rating **	M	Issue No.	12
LM End	7.54	Issue Type +	En	Location *	LS
Category	Earthen Levee			GPS Latitude/Longitude	
				Start	End
Item	Encroachments			39.521089°	39.502958°
				-121.706303°	-121.716953°
DWR ID	DWR_MA0013_02_s_2012_12				
Comment Code					
DT : Ditch					
Inspector Comment

View of the agricultural ditch along the toe.
