**Flood Control Project Maintenance
Levee Inspections
LMA District Cover Sheet**

**Flood Control Project Maintenance
Levee Inspections
Unit Cover Sheet**

Waterway			Bank	Unit Miles
Unit No. 01 Cherokee Canal			Right	18.19
	Spring (March - May)	Summer (June - August)	(September - November) Fall	Winter (December - February)
Unit Maintenance Rating (Fall Only)				
Date of Inspection	4/26/2023 - 4/26/2023			
DWR Inspector	Makar Sokol			
Accompanied By	Shawn Freitag DWR Sutter Yard

Levee Inspection Report By Mile - Spring 2023

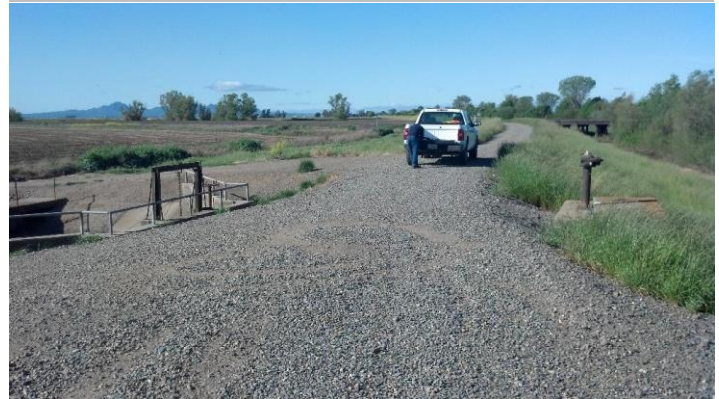
Photo 1 of 3 : UCIP_SP_2023_58548_67280.jpg

Comment Code					
Inspector Comment					
DS_ID:16838 FS_ID:58548 EP_NO: N/A Repair Type: Non-Urgent EVAL Issue: Crossing Status: Found UCIP Comments: 08/28/2019 Record has been updated from No Action Needed to Non-Urgent, no permit has been identified authorizing structure. (O. Magana - DWR UCIP, A. Freitag - DWR Sutter Yard)06/05/2017 Crossing appears to be in good condition. (A. Freitag - DWR Sutter Yard)11/18/2016 Crossing appears to be in good condition. (A. Freitag - DWR Sutter Yard)04/27/2016 Crossing appears to be in good condition. (A. Freitag - DWR Sutter Yard)06/30/2015 Path to access the WS flap gate was getting overgrown with vegetation but other than that everything with the crossing looked in good condition. (A. Freitag - DWR Sutter Yard)05/28/2014 Same as last inspection. (A. Freitag - DWR Sutter Yard)12/04/2013 Same as last inspection. (A. Freitag - DWR Sutter Yard)07/09/2013 Same as last inspection. (A. Freitag - DWR Sutter Yard)04/24/2012 This crossing was listed in the USACE Periodic Inspection report as Corp's inspect ID# USACE_CESPK_M13F_2011_p_0080 for limited visibility of LS slide gate and WS flap gate. (O. Magana - DWR UCIP) FIELD_STRUCT_DESC: 36-inch corrugated metal drainage pipe through the levee, 11.2 feet below the crown. Crossing drains into Cherokee Canal and is part of the Richvale Irrigation District siphon structure. Slide gate is located on the landside (LS). Flap gate is located on the waterside (WS). Crossing angles to the southwest to a flap gate and headwall located about 60 feet from WS toe. [Additional Reference(s): USACE Sacramento O&M Manual, Unit 519, June 1962, Revised 3 Feb 2011, (HLM 9.66), listed as 36-inch pipe drain into Cherokee Canal, As-built DWG No. 50-4-3608, Sheet No. 3608/20, ~ STA 649+85E, page 21 of 28 electronic file] FS Date: 8/28/2019 4:05:00 PM

Overview of levee crown at crossing looking D/S.

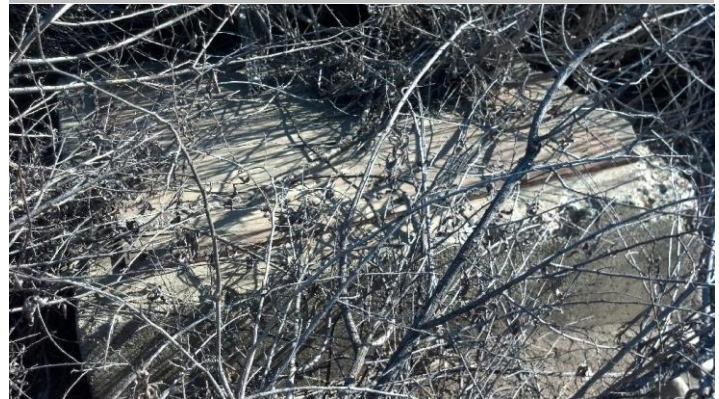
Photo 3 of 3 : UCIP_SP_2023_58548_67283.jpg

WS view-access well located 60 feet from WS toe.

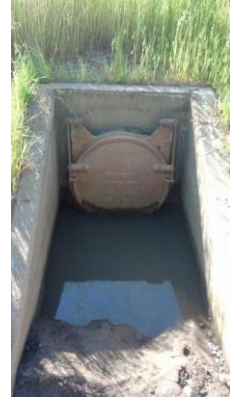
Photo 1 of 3 : UCIP_SP_2023_58549_67289.jpg

Comment Code					
Inspector Comment					
DS_ID:16839 FS_ID:58549 EP_NO: N/A Repair Type: Non-Urgent EVAL Issue: Crossing Status: Found UCIP Comments: 08/28/2019 Record has been updated from No Action Needed to Non-Urgent, no permit has been identified authorizing structure. (O. Magana - DWR UCIP, A. Freitag - DWR Sutter Yard)06/05/2017 Crossing appears to be in good condition. (A. Freitag - DWR Sutter Yard)11/18/2016 Crossing appears to be in good condition. (A. Freitag - DWR Sutter Yard)04/27/2016 Crossing appears to be in good condition. (A. Freitag - DWR Sutter Yard)06/30/2015 WS flap gate is silted over and unable to open. Needs to be dug out. (A. Freitag - DWR Sutter Yard)05/28/2014 Same as last inspection. (A. Freitag - DWR Sutter Yard)12/04/2013 Slopes were cleared of vegetation and are in good condition. (A. Freitag - DWR Sutter Yard)07/09/2013 Same as last inspection. (A. Freitag - DWR Sutter Yard)04/24/2012 Limited inspection on WS and LS slopes due to dense vegetation. Need photos of WS and LS slopes during next inspection with cleared slopes. (O. Magana - DWR UCIP) FIELD_STRUCT_DESC: 30-inch CIPP-lined corrugated metal drainage pipe through the levee, 11.5 feet below the crown. Flap gate on the waterside (WS). [Additional Reference(s): USACE Sacramento O&M Manual, Unit 519, June 1962, Revised 3 Feb 2011, (HLM 9.68), As-built DWG No. 50-4-3608, Sheet No. 3608/20, ~ STA 648+82E, page 21 of 28 electronic file, listed as 30-inch; As-built DWG No. 50-4-3037 referenced not available] FS Date: 8/28/2019 4:05:00 PM

WS view of crossing. Dense vegetation along WS slope limited visual inspection. (WS Photo 1 of 2)

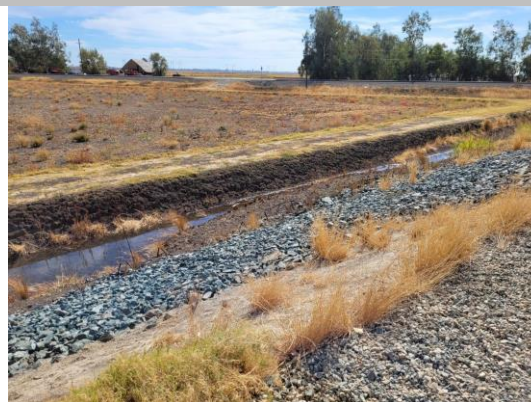
Photo 1 of 1 : SP_2023_MA0013_301_13_20230417_00002.jpg

LM Start	10.03	Rating **	M	Issue No.	13
LM End	10.52	Issue Type +	En	Location *	LS
Category	Earthen Levee			GPS Latitude/Longitude	
				Start	End
Item	Encroachments			39.471517°	39.465113°
				-121.739433°	-121.743592°
DWR ID	DWR_MA0013_02_s_2012_13				
Comment Code					
DT : Ditch					
Inspector Comment

View of the agricultural ditch along the toe. Fall 2021.

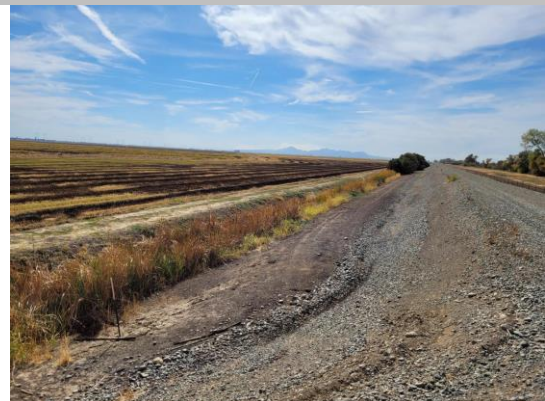
Photo 1 of 1 : SP_2023_MA0013_301_18_20230417_00003.jpg

LM Start	10.59	Rating **	M	Issue No.	18
LM End	11.66	Issue Type +	En	Location *	LS
Category	Earthen Levee			GPS Latitude/Longitude	
				Start	End
Item	Encroachments			39.464305°	39.450333°
				-121.744172°	-121.753157°
DWR ID	DWR_MA0013_02_s_2012_18				
Comment Code					
DT : Ditch					
Inspector Comment

View of the agricultural ditch along the landside toe. Fall 2021.

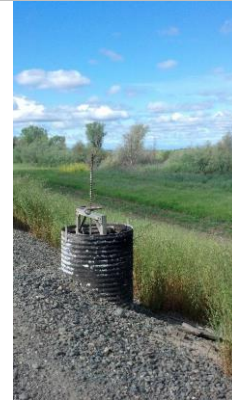
Photo 2 of 3 : UCIP_SP_2023_77841_67337.jpg

LM Start	12.88	Rating **	U	Issue No.	29 (cont)
LM End	12.88	Issue Type +	En	Location *

Stand pipe with screw gate WS

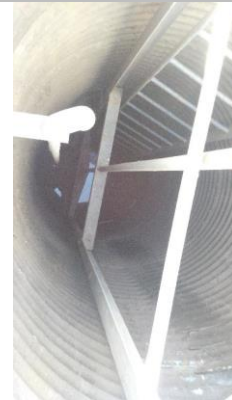
Photo 3 of 3 : UCIP_SP_2023_77841_67335.jpg

View of the inside of the WS stand pipe. No obstructions blocking slide gate.

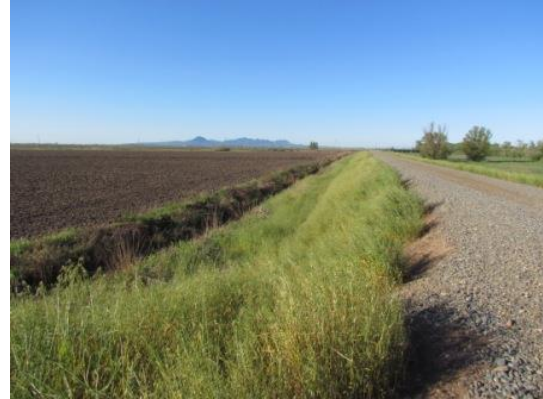
Photo 1 of 1 : SP_2023_MA0013_301_19_20230417_00004.jpg

LM Start	13.40	Rating **	M	Issue No.	19
LM End	16.00	Issue Type +	En	Location *	LS
Category	Earthen Levee			GPS Latitude/Longitude	
				Start	End
Item	Encroachments			39.428192°	39.414202°
				-121.768443°	-121.781863°
DWR ID	DWR_MA0013_02_s_2012_19				
Comment Code					
DT : Ditch					
Inspector Comment

View of the agricultural ditch along the toe.

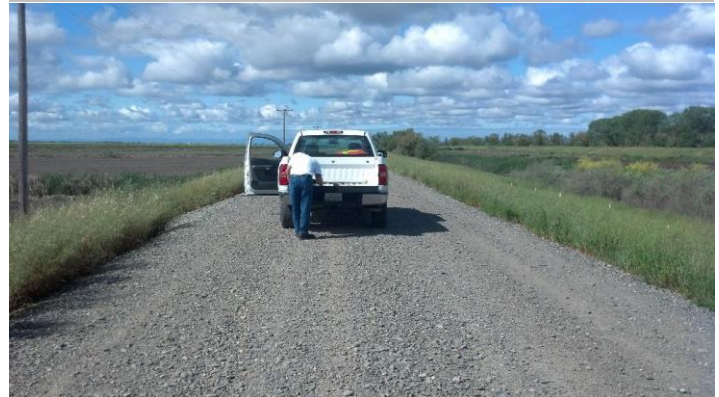
Photo 1 of 3 : UCIP_SP_2023_58552_67341.jpg

DS_ID:16376
FS_ID:58552
EP_NO: N/A
Repair Type: Non-Urgent
EVAL Issue:
Crossing Status: Found
UCIP Comments: 08/29/2019 Record remains Non-Urgent, no permit has been identified authorizing pipe. Crossing appears abandoned. LMA will need to coordinate with landowner to determine is drainage structure is still needed. DMP internal inspection shows that 90% of the pipe is filled with soil at a length of about 42 feet from WS flap gate. If crossing is not in use anymore, crossing will need to be abandoned properly or removed. DMP internal video inspection has not found pipe integrity issues. LOF of crossing is less or equal to 4. Recommend next video inspection in 5 years. (O. Magana - DWR UCIP, A. Freitag - DWR Sutter Yard)05/30/2017 LS pipe end is buried and location unknown. WS flap gate is bolted shut. Pipe has been selected to be internally cleaned and inspected as part of the DMP project. (A. Freitag - DWR Sutter Yard)11/17/2016 Unable to locate LS pipe end. WS flap gate bolted shut. (A. Freitag - DWR Sutter Yard)04/26/2016 LS inlet appears to be buried as could not locate it. WS flap gate was bolted shut. This appears to be an abandoned crossing. (A. Freitag - DWR Sutter Yard)06/30/2015 Still unable to locate the LS pipe end. (A. Freitag - DWR Sutter Yard) 05/28/2014 Same as last inspection. (A. Freitag - DWR Sutter Yard)12/04/2013 Same as last inspection. WS flap gate was bolted shut to keep LS rice field flooded. (A. Freitag - DWR Sutter Yard)07/08/2013 WS slope has been cleared of vegetation and is in good condition. LS slope also cleared of vegetation but still very dense on LS toe and unable to locate LS headwall. (A. Freitag - DWR Sutter Yard)04/24/2012 Could not find LS end of pipe. Limited inspection on WS and LS slopes and toe due to dense vegetation. Need photos of cleared WS and LS slopes, and LS headwall during next inspection. This crossing was listed in the USACE Periodic Inspection report as Corp's inspect ID# USACE_CESPK_M13E_2011_p_0011 for WS gate blocked by vegetation. (O. Magana - DWR UCIP)

FIELD_STRUCT_DESC: 24-inch corrugated metal drainage pipe through the levee, 10.1 feet below the crown. Flap gate on the waterside (WS) end. Concrete "U" headwalls on both ends. [Additional Reference(s): DWR Levee Log, 1993 (HLM 15.62). USACE Sacramento O&M Manual, Unit 519, June 1962, Revised 3 Feb 2011, (HLM 15.62), As-built DWG No. 50-4-3511, Sheet No. 3511/8.3, STA 405+05E, page 8 of 31 electronic file, listed as 24-inch CMP; As-built DWG No 50-4-3037 referenced not available]
FS Date: 8/29/2019 7:32:00 AM

Overview of crossing looking downstream at the left bank of Cherokee Canal.

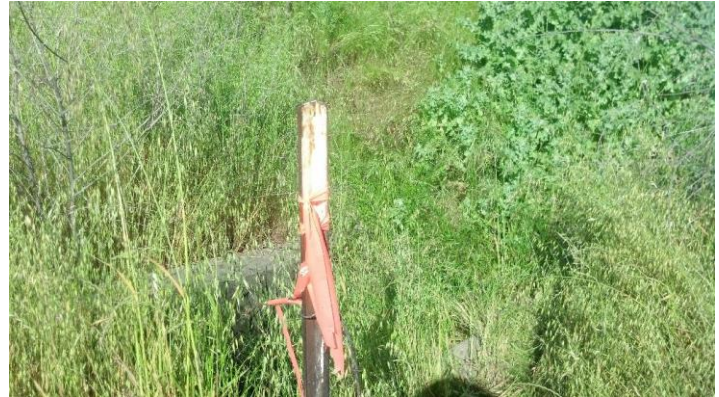
Photo 2 of 3 : UCIP_SP_2023_58552_67343.jpg

LM Start	15.44	Rating **	M	Issue No.	30 (cont)
LM End	15.44	Issue Type +	Ma	Location *	
Category	Supplemental			GPS Latitude/Longitude	
				Start	End
Item	DWR UCIP LMA Responsibility			39.419209 °	39.419209 °
				-121.773680 °	-121.773680 °
DWR ID	16376

Dense vegetation covering the majority of the WS. WS headwall difficult to see through dense vegetation.

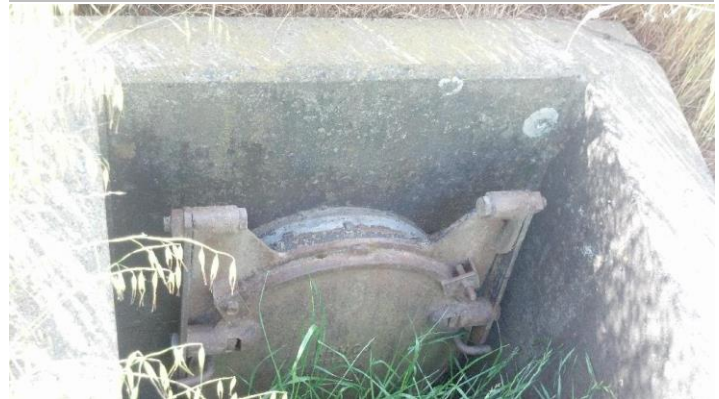
Photo 3 of 3 : UCIP_SP_2023_58552_67342.jpg

View of WS headwall and flap gate.

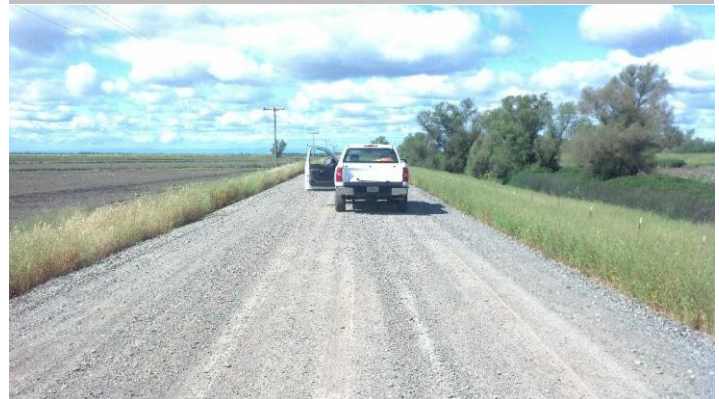
Photo 1 of 3 : UCIP_SP_2023_58553_67352.jpg

DS_ID:16382
FS_ID:58553
EP_NO: N/A
Repair Type: Non-Urgent
EVAL Issue:
Crossing Status: Found
UCIP Comments: 08/29/2019 Record remains Non-Urgent, structure is non-functional and abandoned. Structure is abandoned. LMA will need to coordinate with landowner to determine if pipe is still needed as drainage structure. Dense vegetation covers the WS outlet and only LS headwall is visible at LS toe. If structure is no longer needed then structure will need to be abandoned properly or removed according to Title 23. DWR DMP internal inspection shows pipe has been filled with grout starting at about 47 feet from WS flap gate. No permit has been identified authorizing pipe. DMP internal video inspection has not found pipe integrity issues. LOF of crossing is less or equal to 4. Recommend next video inspection in 5 years. (O. Magana - DWR UCIP, A. Freitag - DWR Sutter Yard)05/30/2017 LS pipe end is buried and location unknown. WS flap gate bolted shut. Pipe has been selected to be internally cleaned and inspected as part of the DMP project. (A. Freitag - DWR Sutter Yard)11/17/2016 Unable to locate LS pipe end. WS flap gate bolted shut. (A. Freitag - DWR Sutter Yard)04/26/2016 Appears to be an abandoned crossing. LS pipe end was still buried and WS flap gate was bolted shut. (A. Freitag - DWR Sutter Yard)06/30/2015 LS headwall still buried somewhere. WS looked to be in good condition. (A. Freitag - DWR Sutter Yard)05/28/2014 Same as last inspection. (A. Freitag - DWR Sutter Yard)12/04/2013 Same as last inspection. (A. Freitag - DWR Sutter Yard)07/08/2013 Same as last inspection. (A. Freitag - DWR Sutter Yard)04/24/2012 LS headwall buried. Limited inspection on WS and LS slopes due to dense vegetation. Need photos of cleared WS and LS slopes during next inspection. Need to determine the status of LS headwall. This crossing was listed in the USACE Periodic Inspection report as Corp's inspect ID# USACE_CESPK_M13E_2011_p_0022 -- unknown issue. (O. Magana - DWR UCIP)

FIELD_STRUCT_DESC: 24-inch corrugated metal drainage pipe through the levee, 9 feet below the crown. Flap gate located on the waterside (WS) end. Concrete "U" headwalls on both WS and landside (LS). WS gate bolted shut and LS crossing is non-operable (inlet not found). Additional Reference(s): DWR Levee Log, 1993 (HLM 15.87). USACE Sacramento O&M Manual, Unit 519, June 1962, Revised 3 Feb 2011, (HLM 15.87), As-built DWG No. 50-4-3511, Sheet No. 3511/8.3, STA 392+42E, page 8 of 31 electronic file, listed as 24-inch CMP; As-built DWG No 50-4-3037 referenced not available]
FS Date: 8/29/2019 7:33:00 AM

Overview of crossing looking downstream of the left bank of Cherokee

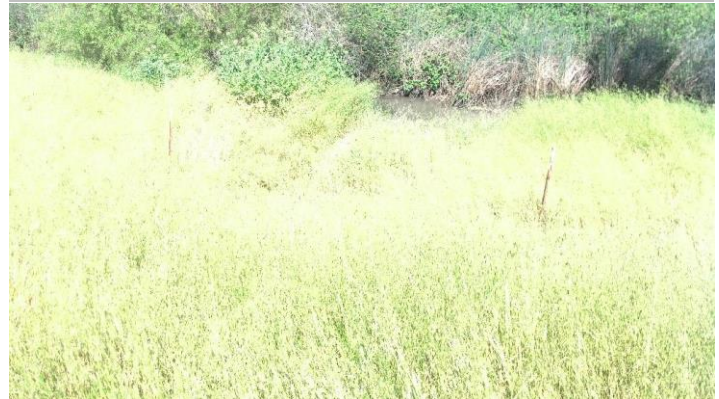
Photo 2 of 3 : UCIP_SP_2023_58553_67351.jpg

LM Start	15.68	Rating **	M	Issue No.	31 (cont)
LM End	15.68	Issue Type +	Ma	Location *	
Category	Supplemental		GPS Latitude/Longitude		
			Start	End	
Item	DWR UCIP LMA Responsibility		39.417043 °	39.417043 °	
			-121.777240 °	-121.777240 °	
DWR ID	16382

View of WS slope. Limited inspection due to the dense vegetation.

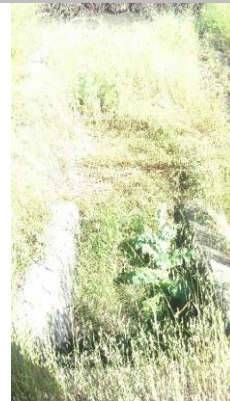
Photo 3 of 3 : UCIP_SP_2023_58553_67350.jpg

View of WS headwall.

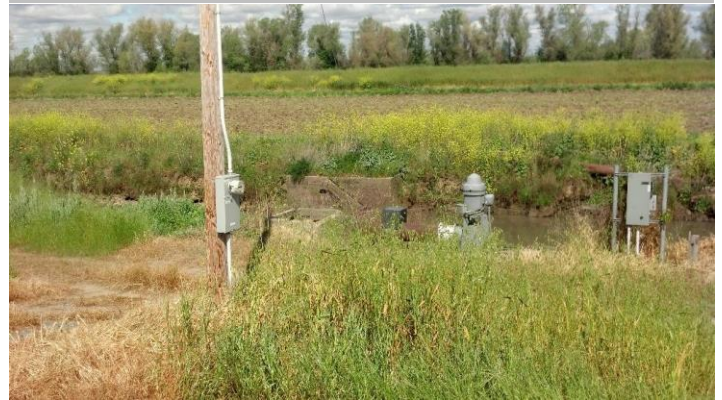
Photo 2 of 3 : UCIP_SP_2023_58554_67359.jpg

Appurtenances on WS.

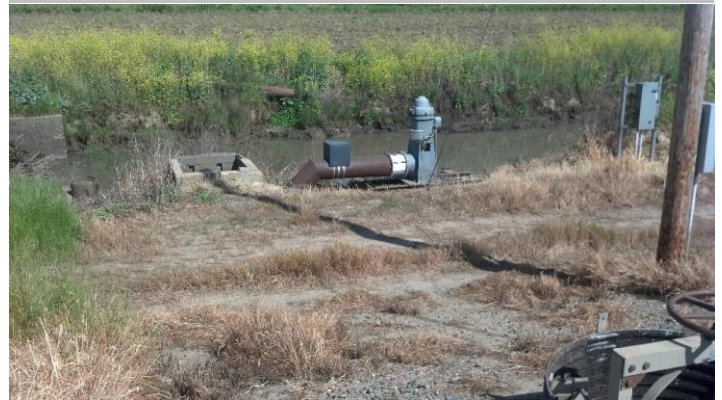
Photo 3 of 3 : UCIP_SP_2023_58554_67355.jpg

WS view of crossing.

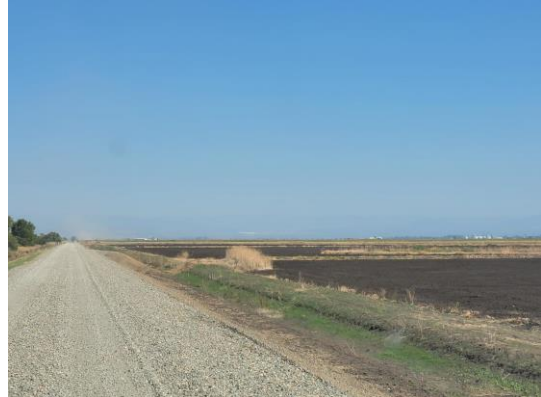
Photo 1 of 1 : SP_2023_MA0013_301_20_20230417_00005.jpg

LM Start	16.89	Rating **	M	Issue No.	20
LM End	18.72	Issue Type +	En	Location *	LS
Category	Earthen Levee			GPS Latitude/Longitude	
				Start	End
Item	Encroachments			39.406217°	39.389187°
				-121.794945°	-121.821233°
DWR ID	DWR_MA0013_02_s_2012_20				
Comment Code					
DT : Ditch					
Inspector Comment

View of the agricultural ditch along the landside toe. Fall 2022.

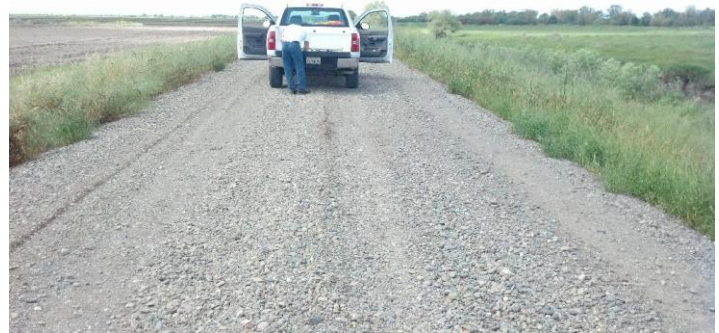
Photo 1 of 3 : UCIP_SP_2023_58557_67387.jpg

DS_ID:16379
FS_ID:58557
EP_NO: N/A
Repair Type: Non-Urgent
EVAL Issue:
Crossing Status: Found
UCIP Comments: 08/29/2019 Record has been updated from No Action Needed to Non-Urgent, no permit has been identified authorizing pipe. Pipe is under water. Pipe is scheduled to be lined. (O. Magana - DWR UCIP, A. Freitag - DWR Sutter Yard)05/30/2017 Crossing appears to be in good condition. Pipe has been selected to be internally cleaned and inspected as part of the DMP project. (A. Freitag - DWR Sutter Yard)11/17/2016 Crossing appears to be in good condition. (A. Freitag - DWR Sutter Yard)04/26/2016 Crossing appears to be in good condition. (A. Freitag - DWR Sutter Yard)06/30/2015 Vegetation still present on WS. LS side was underwater during inspection. (A. Freitag - DWR Sutter Yard)05/28/2014 Same as last inspection. (A. Freitag - DWR Sutter Yard)12/04/2013 Same as last inspection. (A. Freitag - DWR Sutter Yard)07/08/2013 LS slope cleared of vegetation and is in good condition. WS is still vegetated. LS pipe end under water and blocked off by plywood so unable to measure culvert size. (A. Freitag - DWR Sutter Yard)04/24/2012 Limited inspection on WS and LS slopes due to dense vegetation. Need photos of cleared WS and LS slopes. This crossing was listed in the USACE Periodic Inspection report as Corp's inspect ID# USACE_CESPK_M13E_2011_p_0134 for unknown culvert size on LS and no outlet visible on WS. (O. Magana - DWR UCIP) FIELD_STRUCT_DESC: 36-inch CIPP-lined corrugated metal drainage pipe through the levee, 13.2 feet below the crown. Flap gate on the waterside (WS) end. Concrete "U" headwalls on both ends. [Additional Reference(s): DWR Levee Log, 1993 (HLM 18.37). USACE Sacramento O&M Manual, Unit 519, June 1962, Revised 3 Feb 2011, (HLM 18.37), As-built DWG No. 50-4-3511, Sheet No. 3511/6. unable to read exact page, STA 261+67E, page 6 of 31 electronic file, listed as 36-inch CMP] FS Date: 8/29/2019 7:36:00 AM

Overview of crossing looking D/S at left bank of Cherokee Canal.

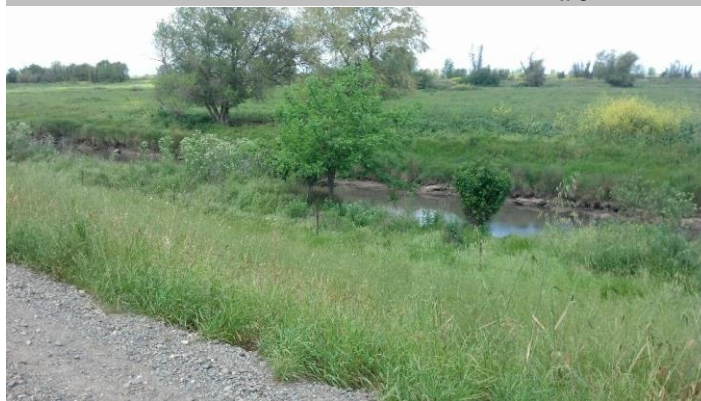
Photo 2 of 3 : UCIP_SP_2023_58557_67386.jpg

View of WS slope and berm.

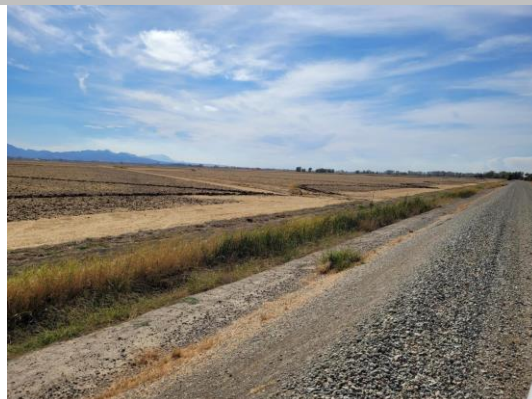
Photo 1 of 1 : SP_2023_MA0013_301_21_20230417_00006.jpg

LM Start	19.37	Rating **	M	Issue No.	21
LM End	19.92	Issue Type +	En	Location *	LS
Category	Earthen Levee			GPS Latitude/Longitude	
				Start	End
Item	Encroachments			39.383252°	39.378192°
				-121.830565°	-121.838543°
DWR ID	DWR_MA0013_02_s_2012_21				
Comment Code					
DT : Ditch					
Inspector Comment

View of the agricultural ditch along the landside toe. Fall 2021.

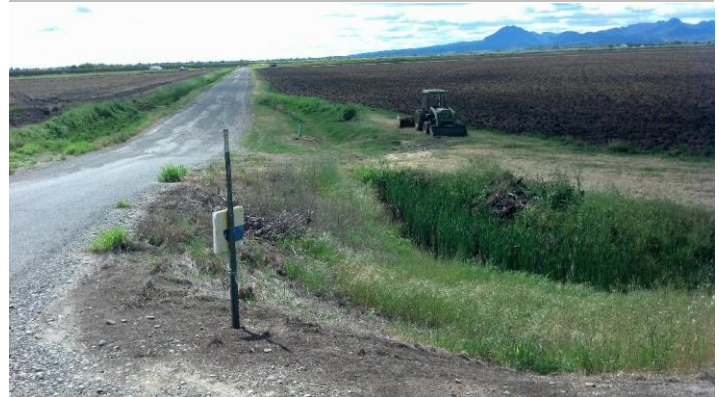
Photo 1 of 3 : UCIP_SP_2023_57681_67393.jpg

DS_ID:16381
FS_ID:57681
EP_NO: 10918
Repair Type: Non-Urgent
EVAL Issue: 11, Maintenance Compliance Issue
Crossing Status: Indicator Found
UCIP Comments: 08/29/2019 Record has been updated from No Action Needed to Non-Urgent, due to maintenance issue. Recommend contacting owner to determine if line is still in use. No marker visible. (O. Magana - DWR UCIP, A. Freitag - DWR Sutter Yard)05/30/2017 Crossing appears to be in good condition. (A. Freitag - DWR Sutter Yard)11/17/2016 Crossing appears to be in good condition. (A. Freitag - DWR Sutter Yard)04/26/2016 Crossing appears to be in good condition. (A. Freitag - DWR Sutter Yard)06/30/2015 Crossing is in good condition. (A. Freitag - DWR Sutter Yard)05/28/2014 Same as last inspection. (A. Freitag - DWR Sutter Yard)12/04/2013 Same as last inspection. (A. Freitag - DWR Sutter Yard)07/08/2013 Same as last inspection. (A. Freitag - DWR Sutter Yard)

Overview of landside where cable splice box (by front loader) is located approximately 60 feet from levee crown.

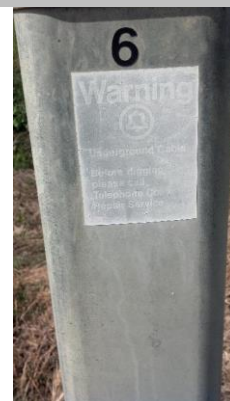
Photo 2 of 3 : UCIP_SP_2023_57681_67394.jpg

Splice box information located on LS approximately 60 feet from levee crown.

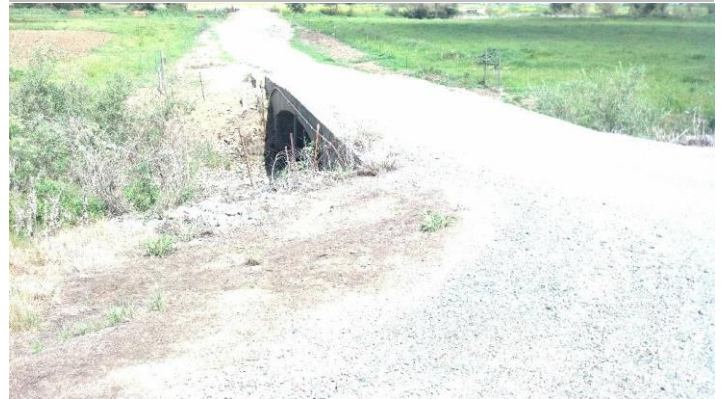
Photo 3 of 3 : UCIP_SP_2023_57681_67395.jpg

View of WS where cable line is attached to culvert crossing.

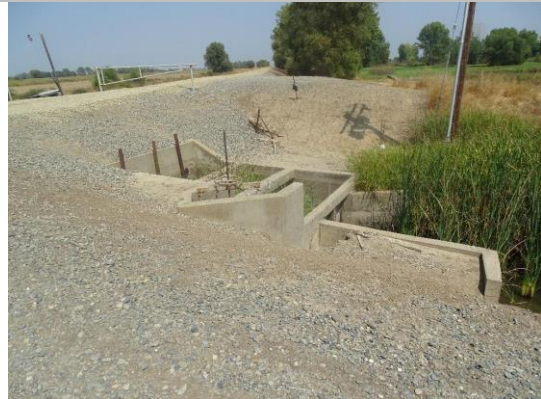
Photo 1 of 3 : UCIP_SP_2023_58559_77951.jpg

DS_ID:16383
FS_ID:58559
EP_NO: N/A
Repair Type: Urgent
EVAL Issue: 1, Pipe Integrity
Crossing Status: Found
UCIP Comments: 08/29/2019 Record remains Urgent due to pipe and levee integrity concerns. Also no permit has been identified authorizing pump station. Pump station is still active. Crossing shows sloughing on the WS with visible holes in pipe on the LS. This crossing is under investigation under CVFPB enforcement case (ENF ID) 723. (O. Magana - DWR UCIP, A. Freitag - DWR Sutter Yard)08/23/2018 The CVFPB has filed an enforcement for this crossing, Enforcement Case: 2018-723. There is still massive erosion around the WS headwall and corrosion and degradation of the LS outlet pipes, so the crossing remains Urgent. (D. Sanoski - DWR UCIP)05/30/2017 No repairs have been made here yet. WS still has depressions above the pipe alignment. LS pipe end still showing heavy signs of rusting and deterioration. Sediment build up inside of concrete distribution box on the LS. (A. Freitag - DWR Sutter Yard)11/17/2016 Crossing has not been repaired yet. pipe ends still showing heavy signs of rust and corrosion. (A. Freitag - DWR Sutter Yard)04/26/2016 No repairs have been made at this crossing yet. (A. Freitag - DWR Sutter Yard)06/30/2015 Crossing has not been repaired yet. pipe ends still showing heavy signs of rust and corrosion. (A. Freitag - DWR Sutter Yard)05/28/2014 Same as last inspection. (A. Freitag - DWR Sutter Yard)12/04/2013 Same as last inspection. (A. Freitag - DWR Sutter Yard)07/08/2013 Same as last inspection. (A. Freitag - DWR Sutter Yard)04/19/2012 LS pipe collars severely damaged--section missing at flap gate. Buried section of pipe could be in the same condition. Crossing needs to be repaired; will need to coordinate with applicant. WS slide gate handle missing. (O. Magana - DWR UCIP)

LS view: levee slope and headwall.

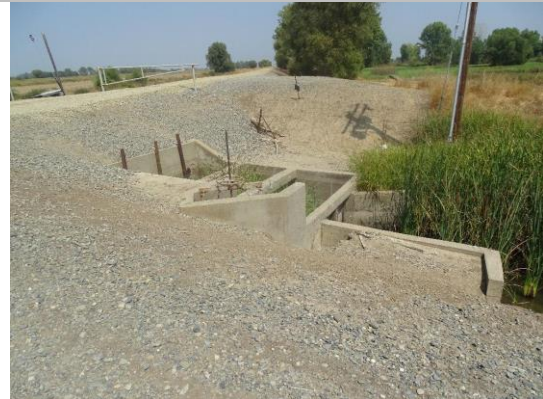
Photo 1 of 3 : UCIP_SP_2023_58560_77955.jpg

DS_ID:17014
FS_ID:58560
EP_NO: N/A
Repair Type: Urgent
EVAL Issue: 1, Pipe Integrity
Crossing Status: Found
UCIP Comments: 08/29/2019 Record remains Urgent due to pipe and levee integrity concerns. Also no permit has been identified authorizing pump station. Pump station is still active. Crossing shows sloughing on the WS with visible holes in pipe on the LS. This crossing is under investigation under CVFPB enforcement case (ENF ID) 723. (O. Magana - DWR UCIP, A. Freitag - DWR Sutter Yard)08/23/2018 The CVFPB has filed an enforcement for this crossing, Enforcement Case: 2018-723. There is still massive erosion around the WS headwall and corrosion and degradation of the LS outlet pipes, so the crossing remains Urgent. (D. Sanoski - DWR UCIP)05/30/2017 No repairs have been made here yet. WS still has depressions above the pipe alignment. LS pipe end still showing heavy signs of rusting and deterioration. Sediment build up inside of concrete distribution box on the LS. (A. Freitag - DWR Sutter Yard)11/17/2016 Crossing has not been repaired yet. pipe ends still showing heavy signs of rust and corrosion. (A. Freitag - DWR Sutter Yard)04/26/2016 No repairs have been made at this crossing yet. (A. Freitag - DWR Sutter Yard)06/30/2015 Crossing has not been repaired yet. pipe ends still showing heavy signs of rust and corrosion. (A. Freitag - DWR Sutter Yard)05/28/2014 Same as last inspection. (A. Freitag - DWR Sutter Yard)12/04/2013 Same as last inspection. (A. Freitag - DWR Sutter Yard)07/08/2013 Same as last inspection. (A. Freitag - DWR Sutter Yard)04/24/2012 LS pipe collars severely damaged--section missing at flap gate. Crossing needs repair. Will need to coordinate with owner. (O. Magana - DWR UCIP)

LS view: levee slope and headwall.

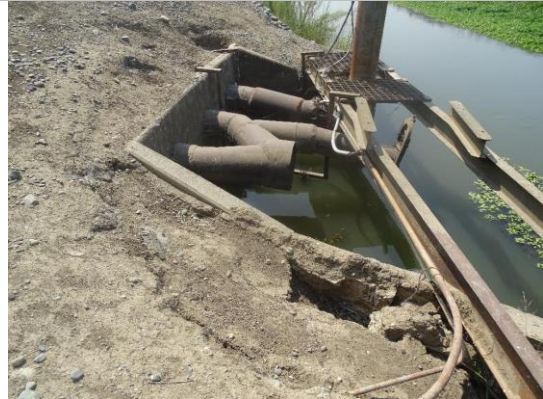
Photo 3 of 3 : UCIP_SP_2023_58560_77957.jpg

WS view: massive erosion around headwall.

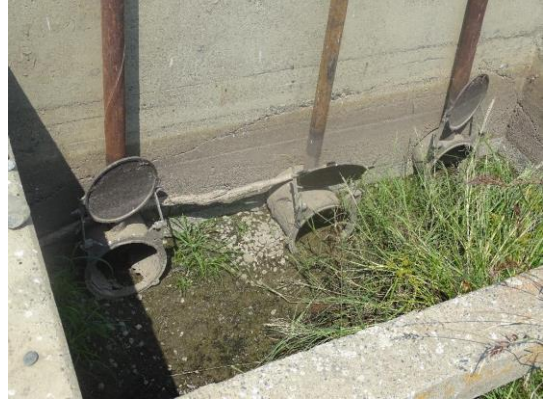
Photo 2 of 3 : UCIP_SP_2023_58561_77959.jpg

DS_ID:17185
FS_ID:58561
EP_NO: N/A
Repair Type: Urgent
EVAL Issue: 1, Pipe Integrity
Crossing Status: Found
UCIP Comments: 08/29/2019 Record remains Urgent due to pipe and levee integrity concerns. Also no permit has been identified authorizing pump station. Pump station is still active. Crossing shows sloughing on the WS with visible holes in pipe on the LS. This crossing is under investigation under CVFPB enforcement case (ENF ID) 723. (O. Magana - DWR UCIP, A. Freitag - DWR Sutter Yard)08/23/2018 The CVFPB has filed an enforcement for this crossing, Enforcement Case: 2018-723. There is still massive erosion around the WS headwall and corrosion and degradation of the LS outlet pipes, so the crossing remains Urgent. (D. Sanoski - DWR UCIP)05/30/2017 No repairs have been made here yet. WS still has depressions above the pipe alignment. LS pipe end still showing heavy signs of rusting and deterioration. Sediment build up inside of concrete distribution box on the LS. (A. Freitag - DWR Sutter Yard)11/17/2016 Crossing has not been repaired yet. pipe ends still showing heavy signs of rust and corrosion. (A. Freitag - DWR Sutter Yard)04/26/2016 No repairs have been made at this crossing yet. (A. Freitag - DWR Sutter Yard)06/30/2015 Crossing has not been repaired yet. pipe ends still showing heavy signs of rust and corrosion. (A. Freitag - DWR Sutter Yard)05/28/2014 Same as last inspection. (A. Freitag - DWR Sutter Yard)12/04/2013 Same as last inspection. (A. Freitag - DWR Sutter Yard)07/08/2013 Same as last inspection. (A. Freitag - DWR Sutter Yard)04/24/2012 Sink hole present on WS. LS pipe collars severely damaged--section missing at flap gate. Crossing needs repair. Need to coordinate with owner. (O. Magana - DWR UCIP)

LS view: corroded outlet pipes.

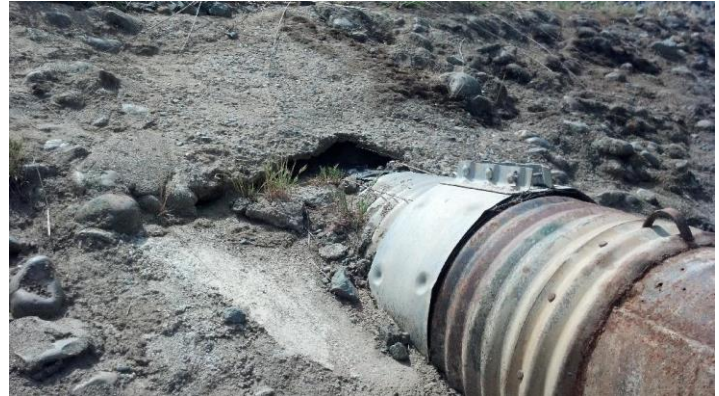
Photo 2 of 3 : UCIP_SP_2023_58562_67451.jpg

View of WS daylight. Hole present at pipe daylight.

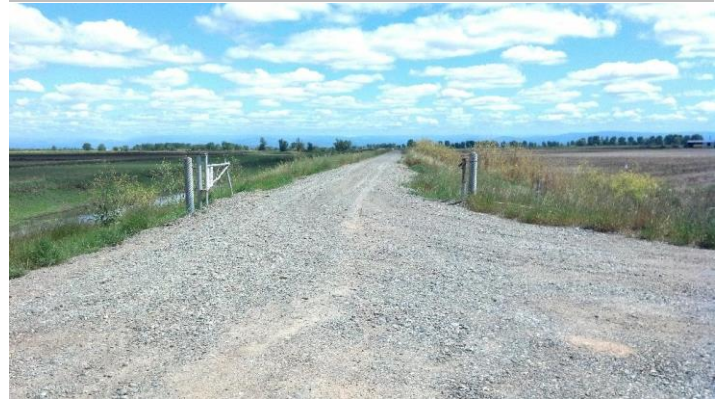
Photo 1 of 3 : UCIP_SP_2023_58575_67462.jpg

Comment Code					
Inspector Comment					
DS_ID:16394 FS_ID:58575 EP_NO: N/A Repair Type: Non-Urgent EVAL Issue: Crossing Status: Found UCIP Comments: 08/29/2019 Record remains Non-Urgent, no permit has been identified authorizing pipe. Pipe has been lined and a new flap gate has been installed on the WS. (O. Magana - DWR UCIP, A. Freitag - DWR Sutter Yard)05/30/2017 WS flap gate showing signs of rusting and deterioration but still appears to be able to function properly. Pipe has been selected to be internally cleaned and inspected as part of the DMP project. (A. Freitag - DWR Sutter Yard)11/17/2016 WS flap gate is really rusted and deteriorated but it appears to still function properly. (A. Freitag - DWR Sutter Yard)04/26/2016 WS flap gate is really rusted and deteriorated. May need to be replaced. The rest of the crossing appeared in good condition. (A. Freitag - DWR Sutter Yard)06/30/2015 Crossing is in good condition. No noticeable issues to be reported. (A. Freitag - DWR Sutter Yard)05/28/2014 Same as last inspection. (A. Freitag - DWR Sutter Yard)12/04/2013 WS and LS slopes are in good condition. (A. Freitag - DWR Sutter Yard)07/08/2013 Same as last inspection. (A. Freitag - DWR Sutter Yard)04/24/2012 Limited inspection on WS and LS slopes due to dense vegetation. Need photos of cleared WS and LS slopes. This crossing was listed in the USACE Periodic Inspection report as Corp's inspect ID# USACE_CESPK_M13E_2011_p_0251 for no outlet visible on WS. (O. Magana - DWR UCIP) FIELD_STRUCT_DESC: 24-inch CIPP-lined corrugated metal drainage pipe through the levee, 11.6 feet below the crown. Flap gate on the waterside (WS) end. Concrete "U" headwalls on both WS and landside (LS). Rusted gate located on the WS (gate stuck). [Additional Reference(s): DWR Levee Log, 1993 (HLM 22.08). USACE Sacramento O&M Manual, Unit 519, June 1962, Revised 3 Feb 2011, (HLM 22.08), As-built DWG No. 50-4-3511, Sheet No. 3511/2.2 and 31.2, STA 67+70E, page 2, 31 of 31 electronic file, listed as 24-inch CMP section through the levee] FS Date: 8/29/2019 7:40:00 AM

Overview of crossing looking upstream at the left bank of Cherokee Canal.

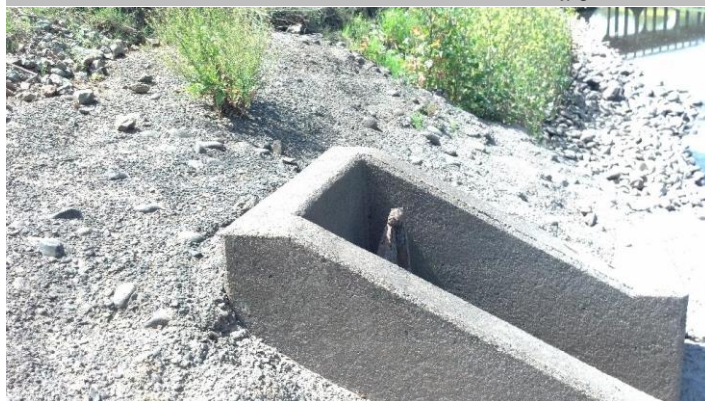
Photo 2 of 3 : UCIP_SP_2023_58575_67460.jpg

View of WS headwall.

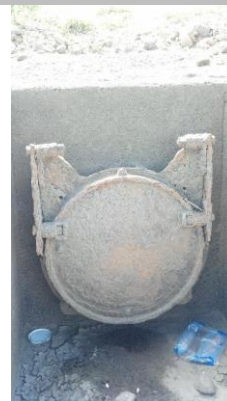
Photo 3 of 3 : UCIP_SP_2023_58575_67461.jpg

Flap gate located on WS.

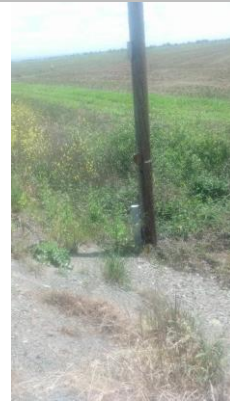
Photo 1 of 1 : UCIP_SP_2023_58569_67480.jpg

Comment Code					
Inspector Comment					
DS_ID:16374 FS_ID:58569 EP_NO: N/A Repair Type: Non-Urgent EVAL Issue: 10, Unauthorized Modification or Non-Compliant Permit Crossing Status: Indicator Found UCIP Comments: 08/29/2019 Record remains Non-Urgent, no permit has been identified authorizing pipe. Also modification have been made without prior notification to the CVFPB. Multiple splice boxes can be found along the LS toe. Need to review CVFPB enforcement case to determine if issue has been resolved. Need updated photos for this crossing. (O. Magana - DWR UCIP, A. Freitag - DWR Sutter Yard)05/30/2017 Splice box still present at LS toe. (A. Freitag - DWR Sutter Yard)11/17/2016 Splice box still present at LS toe. (A. Freitag - DWR Sutter Yard)04/26/2016 Communication Splice box was still present. Not sure what was done to ever resolve the encroachment issue. (A. Freitag - DWR Sutter Yard)06/30/2015 Same as last inspection. (A. Freitag - DWR Sutter Yard)05/28/2014 Same as last inspection. (A. Freitag - DWR Sutter Yard)12/04/2013 Same as last inspection. (A. Freitag - DWR Sutter Yard)07/08/2013 Same as last inspection. (A. Freitag - DWR Sutter Yard)04/24/2012 Unauthorized Encroachment. This crossing is listed multiple times in the USACE Periodic Inspection report as USACE_CESPK_M13E_2011_p_0307, 0315, 0317, 0318 for slope failure on LS hinge. DWR-Flood Maintenance Office records shows that CVFPB has requested AT&T to remove conduit in June 2, 2009 letter. LMA working with CVFPB to resolve. (O. Magana - DWR UCIP) FIELD_STRUCT_DESC: Underground telephone cable through the levee. Depth unknown. (AT&T) START latitude 39.36210336, longitude -121.8678207 END latitude 39.35458541, longitude -121.8823409. Line extends from Gridley Colusa Highway to the south end of project levee along landside (LS) shoulder and levee crown hinge point. Levee sloughs along cable trench after heavy rains. [Additional Reference(s): DWR Levee Log, 1993 (HLM 22.11). USACE Sacramento O&M Manual, Unit 519, June 1962, Revised 3 Feb 2011, listed in As-built DWG No. 50-4-3511 only and not manual, Sheet No. 3511/31.2, STA 66+00E, page 31 of 31 electronic file, listed as underground telephone and electric line through the levee] FS Date: 8/29/2019 7:42:00 AM

View of utility line located on LS toe.

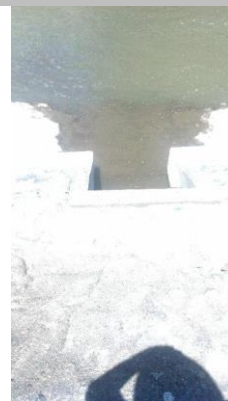
Photo 2 of 3 : UCIP_SP_2023_58572_67496.jpg

LM Start	22.15	Rating **	M	Issue No.	45 (cont)
LM End	22.15	Issue Type +	Ma	Location *	
Category	Supplemental		GPS Latitude/Longitude		
			Start	End	
Item	DWR UCIP LMA Responsibility		39.359827°	39.359827°	
			-121.872300°	-121.872300°	
DWR ID	16391

View of WS slope looking from WS headwall to levee crown.

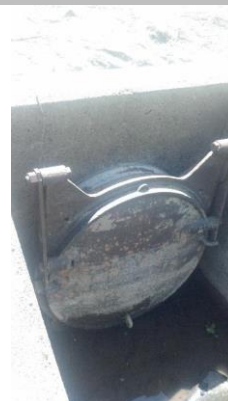
Photo 3 of 3 : UCIP_SP_2023_58572_67497.jpg

LM Start	22.15	Rating **	M	Issue No.	45 (cont)
LM End	22.15	Issue Type +	Ma	Location *

View of flap gate on WS.

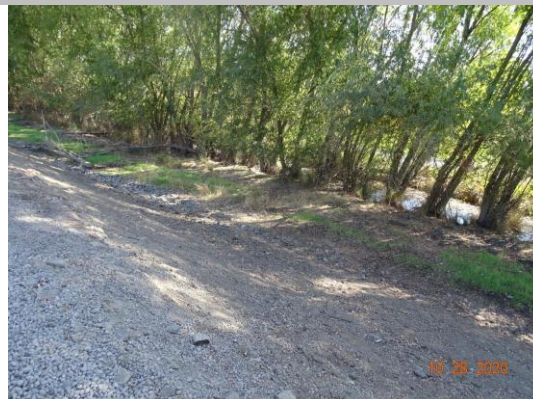
Photo 1 of 1 : SP_2023_MA0013_301_62_20230417_00010.jpg

LM Start	22.33	Rating **	A/W	Issue No.	62
LM End	22.33	Issue Type +	Ma	Location *	LS
Category	Earthen Levee			GPS Latitude/Longitude	
				Start	End
Item	Slope Stability			39.358419°	39.358419°
				-121.875088°	-121.875088°
DWR ID	DWR_MA0013_02_s_2016_62				
Comment Code					
S1 : Repair slope instability.					
Inspector Comment

View of the slope instability along the landside slope. Fall 2020.

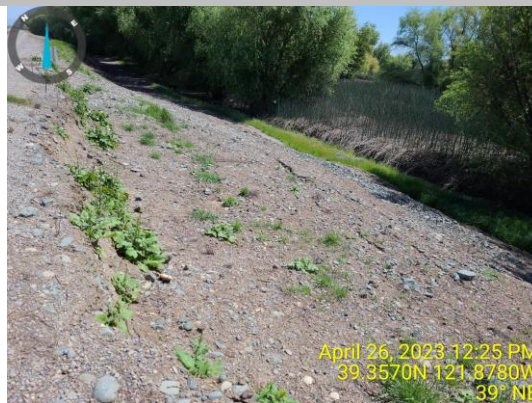
Photo 1 of 1 : SP_2023_MA0013_301_58_20230427_00128.jpg

LM Start	22.50	Rating **	U	Issue No.	58
LM End	22.51	Issue Type +	Ma	Location *	LS
Category	Earthen Levee			GPS Latitude/Longitude	
				Start	End
Item	Slope Stability			39.357085°	39.357033°
				-121.877812°	-121.877901°
DWR ID	DWR_MA0013_02_f_2019_58				
Comment Code					
S1 : Repair slope instability.					
Inspector Comment

View of the sloughing along the landside slope. Spring 2023.
