Flood Control Project Maintenance  
Levee Inspections  
LMA District Cover Sheet

Sutter Maintenance Yard Maintenance Area 0013

**Flood Control Project Maintenance  
Levee Inspections  
Unit Cover Sheet**

Waterway			Bank	Unit Miles
Unit No. 01 Cherokee Canal			Right	18.19
	Spring (March - May)	Summer (June - August)	(September - November) Fall	Winter (December - February)
Unit Maintenance Rating (Fall Only)				
Date of Inspection	4/17/2024 - 4/17/2024			
DWR Inspector	Makar Sokol			
Accompanied By	Shawn Freitag DWR Sutter Yard

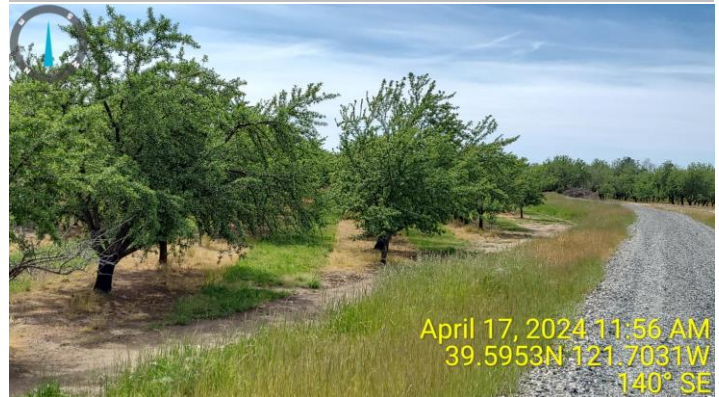
Photo 1 of 1 : SP\_2024\_MA0013\_300\_57\_20240422\_00127.jpg

LM Start	0.11	Rating **	M	Issue No.	57
LM End	3.70	Issue Type +	Ma	Location *	WS
Category	Earthen Levee			GPS Latitude/Longitude	
				Start	End
Item	Vegetation			39.595311°	39.546940°
				-121.703168°	-121.707634°
DWR ID	DWR_MA0013_01_s_2024_57				
Comment Code					
V1 : Control annual grass and weeds on the levee slopes and easements.					
Inspector Comment

View of the vegetation along the waterside slope. Spring 2024.

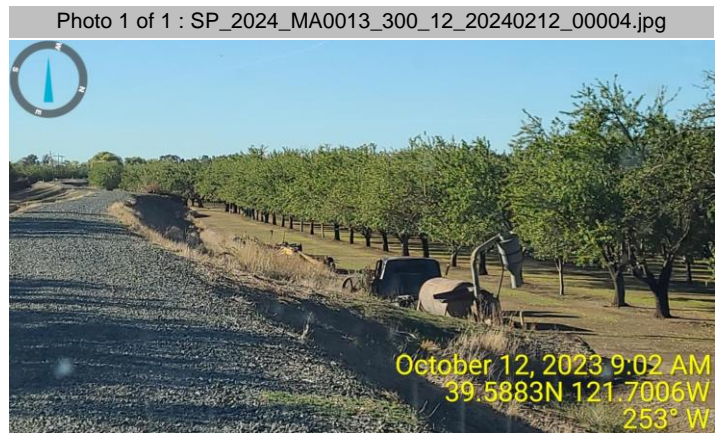
LM Start	0.73	Rating **	M	Issue No.	12
LM End	0.76	Issue Type +	En	Location *	LS
Category	Earthen Levee			GPS Latitude/Longitude	
				Start	End
Item	Encroachments			39.587905°	39.587505°
				-121.700822°	-121.700880°
DWR ID	DWR_MA0013_01_s_2012_12				
Comment Code					
EQ : Equipment					
Inspector Comment					
Remove the equipment from the landside toe.

View of the equipment along the landside toe. Fall 2023.

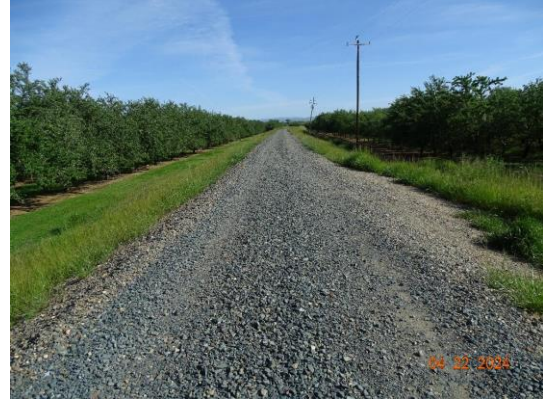
Photo 1 of 3 : UCIP\_SP\_2024\_83167\_121410.jpg

Comment Code					
Inspector Comment					
DS_ID:16343 FS_ID:83167 EP_NO: N/A Repair Type: No Action Needed EVAL Issue: Crossing Status: Found UCIP Comments: 04/22/2024 Record updated from Non-Urgent to No Action Needed. Pipe was CIPP lined on 07/17/2019. DMP internal video inspection has found none or minor pipe defects. No issues observed during inspection. (M. Thao - DWR UCIP) 09/25/2023 DMP internal video inspection has found none or minor pipe defects. Recommend next video inspection in 5 years. (J. Taylor - DWR UCIP) 08/06/2019 Record has been updated from No Action Needed to Non-Urgent, due to unauthorized encroachment. Pipe has been lined. (O. Magana - DWR UCIP, A. Freitag - DWR Sutter Yard) 06/14/2017 Crossing appears to be in good condition. Pipe has been selected to be internally cleaned and inspected as part of the DMP project. (A. Freitag - DWR Sutter Yard) 11/16/2016 Crossing appears to be in good condition. (A. Freitag - DWR Sutter Yard) 04/28/2016 Crossing appears to be in good condition. (A. Freitag - DWR Sutter Yard) 07/14/2015 Crossing appears in good condition. No noticeable issues to report. (A. Freitag - DWR Sutter Yard) 05/21/2014 Same as last inspection. (A. Freitag - DWR Sutter Yard) 12/02/2013 Same as last inspection. (A. Freitag - DWR Sutter Yard) 07/10/2013 Same as last inspection. (A. Freitag - DWR Sutter Yard) 04/17/2012 Drain is still in use. 4 inch pipe in channel near WS headwall (see photo). The pipe does not appear to impact the crossing. (O. Magana - DWR UCIP) FIELD_STRUCT_DESC: 24-inch CIPP-lined corrugated metal drainage pipe through the levee, 8.6 feet below the crown. Concrete "U" headwalls on both the waterside (WS) and landside (LS). Flap gate on the WS end. [Additional Reference(s): DWR Levee Log, 1993 (HLM 1.15). USACE Sacramento O&M Manual, Unit 519, June 1962, Revised 3 Feb 2011, (HLM 1.15), As-built DWG No. 50-4-3608, Sheet No. 3608/19.1, STA 1072+20E, page 20 of 28 electronic file, listed as 24-inch CMP; As-built DWG No 50-4-3037 referenced not available] FS Date: 4/22/2024 12:00:47 PM

Levee crown looking upstream.

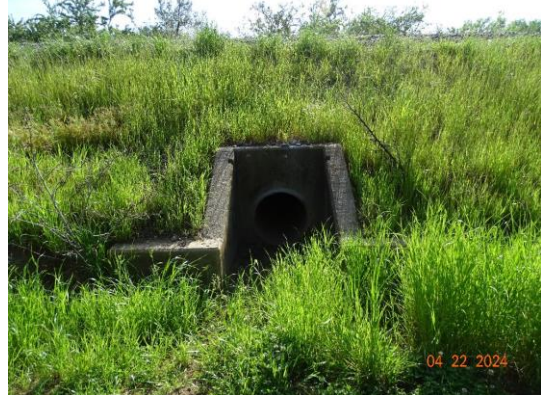
Photo 2 of 3 : UCIP\_SP\_2024\_83167\_121411.jpg

LS view: Concrete headwall at toe; looking toward levee.

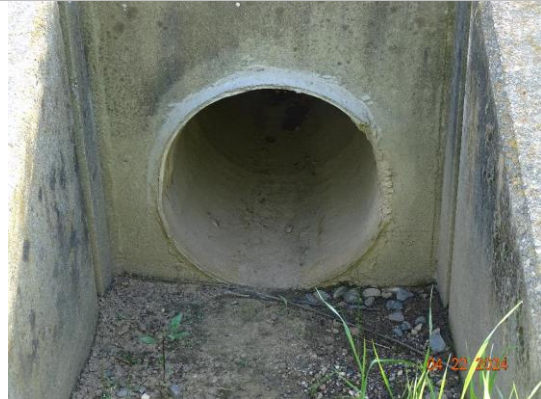
Photo 3 of 3 : UCIP\_SP\_2024\_83167\_121412.jpg

LS view: Close-up view of pipe inlet at toe.

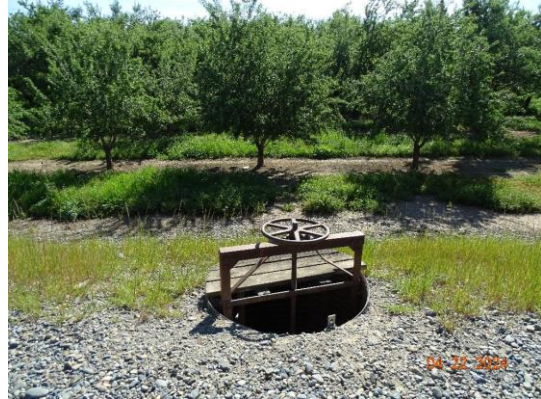
Photo 1 of 1 : UCIP\_SP\_2024\_83164\_121399.jpg

DS\_ID:16831  
FS\_ID:83164  
EP\_NO: N/A  
Repair Type: Non-Urgent  
EVAL Issue: 4b, Safety Issue  
Crossing Status: Found  
UCIP Comments: 04/22/2024 Record remains Non-Urgent. Only half the cover was present on CMP riser causing a safety hazard; recommend repairing the cover. DMP internal video inspection has found none or minor pipe defects. Pipe appears to have features of an irrigation pipe; UCIP will need to verify structure type during the detailed QAP process. (M. Thao - DWR UCIP)  
08/06/2019 Record remains Non-Urgent, need to clarify owner for this crossing. This pipe has been identified as an LMA responsible drainage pipe. However, adjacent property owner has modified the WS outlet by burying the concrete headwall. No permit has been found authorizing the modification to the WS. LMA and adjacent property owner will need to coordinate with the CVFPB to comply with Title 23. DMP internal video inspection has not found pipe integrity issues. LOF of crossing is less or equal to 4. Recommend next video inspection in 5 years. (O. Magana - DWR UCIP, A. Freitag - DWR Sutter Yard)

WS view: CMP riser on the slope with half the cover missing.

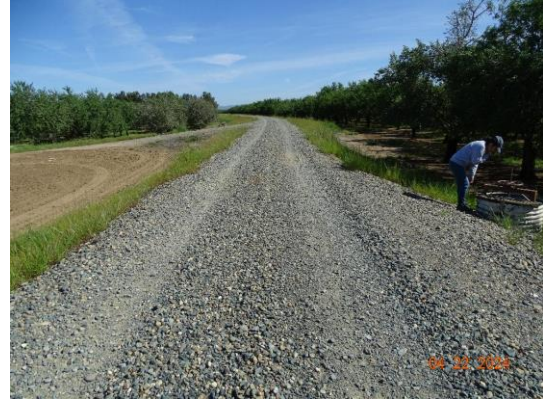
Photo 1 of 3 : UCIP\_SP\_2024\_83161\_121367.jpg

Comment Code						
Inspector Comment						
DS_ID:16345 FS_ID:83161 EP_NO: N/A Repair Type: Non-Urgent EVAL Issue: 4b, Safety Issue Crossing Status: Found UCIP Comments: 04/22/2024 Record remains Non-Urgent. No cover was present on CMP riser causing a safety hazard; recommend adding a cover. Wooden riser cover debris present within CMP riser located on the WS slope. Pipe outlet on LS is approximately 90% blocked by sediment; crossing appears to no longer be in use. Recommend owner to contact CVFPB to abandon or remove pipe from levee. No permit has been identified authorizing pipe. (M. Thao - DWR UCIP) 08/06/2019 Record remains Non-Urgent, pipe has been abandoned. Crossing needs to be abandoned properly per Title 23. No owner has been identified for this crossing. Recommend adding cover to riser as a safety measure. (O. Magana - DWR UCIP, A. Freitag - DWR Sutter Yard) 06/14/2017 PVC pipe still present blocking screw gate. LS inlet of the 24" cmp pipe is about 75% blocked by sediment. (A. Freitag - DWR Sutter Yard) 11/16/2016 PVC pipe still present blocking the screw gate. (A. Freitag - DWR Sutter Yard) 04/28/2016 Pvc pipe is still present through the crossing. Slide gate cannot shut fully. (A. Freitag - DWR Sutter Yard) 07/14/2015 4-inch pipe still present and blocking the screw gate. (A. Freitag - DWR Sutter Yard) 05/21/2014 Same as last inspection. (A. Freitag - DWR Sutter Yard) 12/02/2013 Same as last inspection. (A. Freitag - DWR Sutter Yard) 07/15/2013 Same as last inspection. (A. Freitag - DWR Sutter Yard) 04/17/2012 Crossing has 4-inch pipe inside blocking positive closure/notify landowner to remove prior to flood season. LS crossing is blocked about 50% by sediment build up. Burrow activity present on LS near crossing. (O. Magana - DWR UCIP) FIELD_STRUCT_DESC: 24-inch corrugated metal irrigation pipe through the levee, 7.6 feet below the crown. Slide gate in corrugated metal pipe (CMP) riser on the waterside (WS) slope. Concrete headwall on the landside (LS). 36-inch concrete standpipe in the channel with 2 piles to deflect debris (39.576614, -121.7009). [Additional Reference(s): DWR Levee Log, 1993 (HLM 1.68). USACE Sacramento O&M Manual, Unit 519, June 1962, Revised 3 Feb 2011, (HLM 1.69), listed as 24-inch pipe, no as-built referenced found] FS Date: 4/22/2024 11:20:06 AM

Levee crown looking upstream.

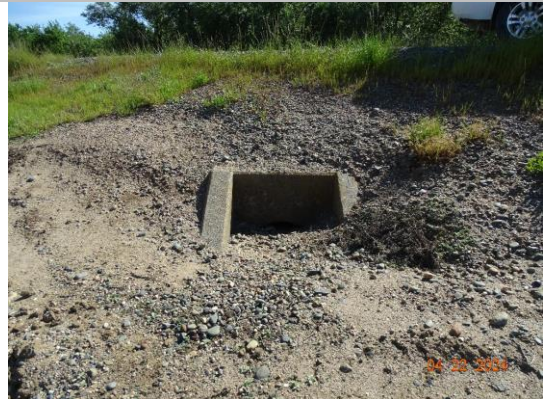
Photo 2 of 3 : UCIP\_SP\_2024\_83161\_121370.jpg

LS view: Concrete headwall at toe covered with sediment.

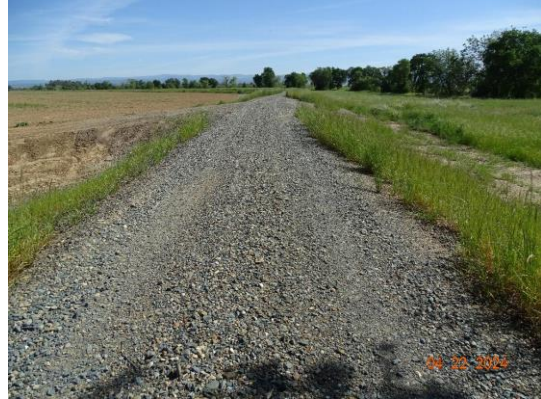
Photo 1 of 3 : UCIP\_SP\_2024\_83154\_121354.jpg

DS\_ID:16347  
FS\_ID:83154  
EP\_NO: N/A  
Repair Type: No Action Needed  
EVAL Issue:  
Crossing Status: Found  
UCIP Comments: 04/22/2024 Record updated from Non-Urgent to No Action Needed. Pipe was CIPP lined on 08/28/2019. DMP internal video inspection has found none or minor pipe defects. LS end was altered to include a CMP pipe, but is not connected and does not appear to impact the intent of the pipe crossing. No other issues observed during inspection. (M. Thao - DWR UCIP)  
09/25/2023 DMP internal video inspection has found none or minor pipe defects. Recommend next video inspection in 5 years. (J. Taylor - DWR UCIP)  
08/06/2019 Record has been updated from No Action Needed to Non-Urgent, no permit identified. Crossing is scheduled to be lined. (O. Magana - DWR UCIP, A. Freitag - DWR Sutter Yard)  
06/14/2017 Crossing appears to be in good condition. (A. Freitag - DWR Sutter Yard)  
11/16/2016 Crossing appears to be in good condition. (A. Freitag - DWR Sutter Yard)

Levee crown looking upstream.

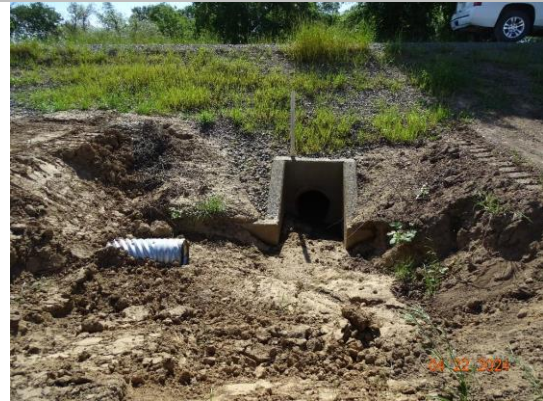
Photo 2 of 3 : UCIP\_SP\_2024\_83154\_121356.jpg

LS view: Concrete headwall with flap gate at toe.

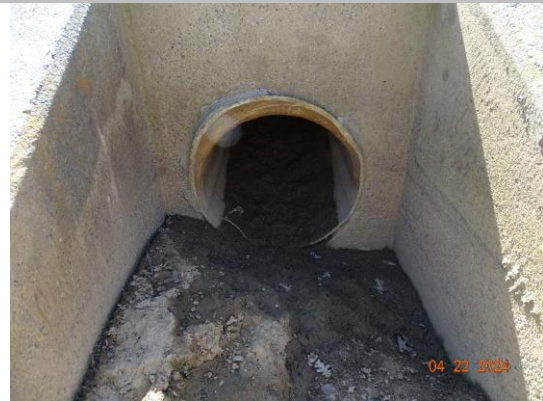
Photo 3 of 3 : UCIP\_SP\_2024\_83154\_121357.jpg

LS view: Close-up view of pipe inlet at toe.

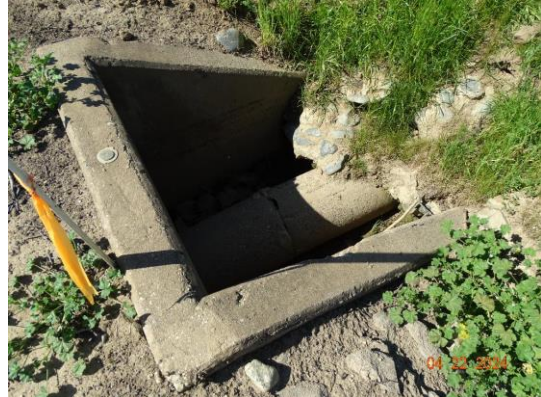
Photo 1 of 2 : UCIP\_SP\_2024\_83133\_121332.jpg

DS\_ID:17372  
FS\_ID:83133  
EP\_NO: N/A  
Repair Type: Non-Urgent  
EVAL Issue: 10, Unauthorized Modification or Non-Compliant Permit  
Crossing Status: Found  
UCIP Comments: 04/22/2024 Record remains Non-Urgent. 18-inch concrete pipe inserted partially into 36-inch CMP pipe at LS. Unable to find a permit for modification. DMP internal video inspection has found none or minor pipe defects. (M. Thao - DWR UCIP)  
08/06/2019 Record remains Non-Urgent, no permit identified authorizing pipe. Pipe has been internally cleaned and cleared of any obstructions on the WS and LS. DMP internal inspection pending. (O. Magana - DWR UCIP, A. Freitag - DWR Sutter Yard)  
06/14/2017 WS flap gate is completely buried by sediment - needs to be dug out. Pipe is about 50% full of sediment inside. Pipe has been selected to be internally cleaned and inspected as part of the DMP project. (A. Freitag - DWR Sutter Yard)

LS view: Concrete headwall with 18-inch concrete pipe inserted partially into 36-inch CMP pipe at the toe.

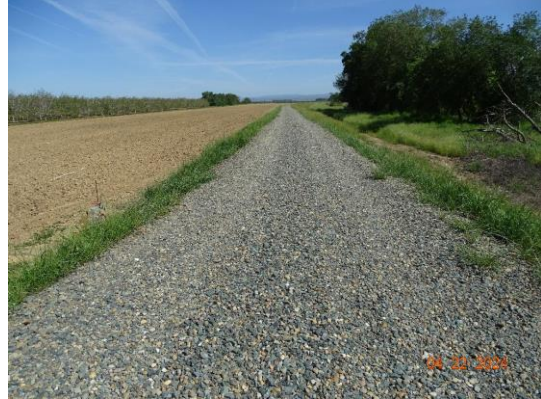
Photo 1 of 3 : UCIP\_SP\_2024\_83131\_121329.jpg

DS\_ID:16349  
FS\_ID:83131  
EP\_NO: N/A  
Repair Type: No Action Needed  
EVAL Issue:  
Crossing Status: Found  
UCIP Comments: 04/22/2024 Record updated from Non-Urgent to No Action Needed. Pipe was CIPP lined on 07/17/2019. DMP internal video inspection has found none or minor pipe defects. No issues observed during inspection. (M. Thao - DWR UCIP)  
09/25/2023 DMP internal video inspection has found none or minor pipe defects. Recommend next video inspection in 5 years. (J. Taylor - DWR UCIP)  
08/06/2019 Record remains Non-Urgent, no permit found authorizing pipe. Pipe has been lined. (O. Magana - DWR UCIP, A. Freitag - DWR Sutter Yard)  
06/14/2017 Both pipe ends and gates are mostly buried- need to be dug out. Pipe has been selected to be internally cleaned and inspected as part of the DMP project. (A. Freitag - DWR Sutter Yard)  
11/16/2016 Both gates closed but partially buried and unable to open. (A. Freitag - DWR Sutter Yard)

Levee crown looking upstream.

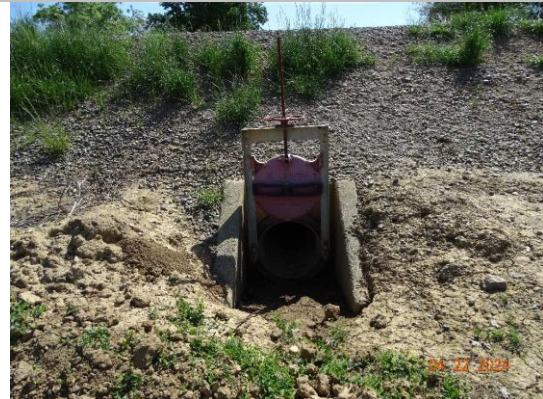
Photo 2 of 3 : UCIP\_SP\_2024\_83131\_121331.jpg

LS view: Concrete headwall with slide gate at toe.

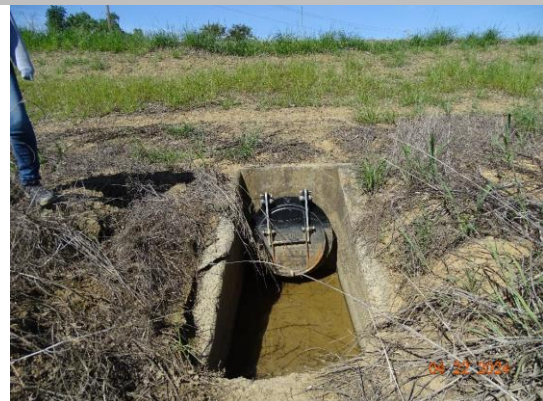
Photo 3 of 3 : UCIP\_SP\_2024\_83131\_121330.jpg

WS view: Concrete headwall with flap gate at toe.

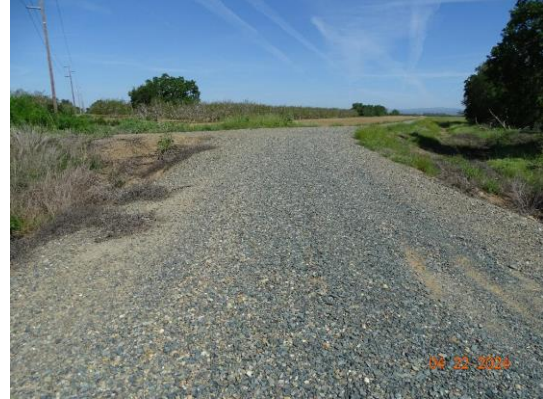
Photo 1 of 3 : UCIP\_SP\_2024\_83130\_121324.jpg

Comment Code					
Inspector Comment					
DS_ID:16350 FS_ID:83130 EP_NO: N/A Repair Type: No Action Needed EVAL Issue: Crossing Status: Found UCIP Comments: 04/22/2024 Record updated from Non-Urgent to No Action Needed. Pipe was CIPP lined on 07/15/2019. DMP internal video inspection has found none or minor pipe defects. No issues observed during inspection. (M. Thao - DWR UCIP) 09/25/2023 DMP internal video inspection has found none or minor pipe defects. Recommend next video inspection in 5 years. (J. Taylor - DWR UCIP) 08/06/2019 Record has been updated from No Action Needed to Non-Urgent, no permit has been found authorizing pipe. Pipe has been lined. (O. Magana - DWR UCIP, A. Freitag - DWR Sutter Yard) 06/14/2017 WS flap gate is buried by sediment- needs to be dug out. Pipe has been selected to be internally cleaned and inspected as part of the DMP project. (A. Freitag - DWR Sutter Yard) 11/16/2016 Crossing appears to be in good condition. (A. Freitag - DWR Sutter Yard) 04/28/2016 Crossing appears to be in good condition. (A. Freitag - DWR Sutter Yard) 07/14/2015 Crossing appears in good condition. No noticeable issues to report. (A. Freitag - DWR Sutter Yard) 05/21/2014 Same as last inspection. (A. Freitag - DWR Sutter Yard) 12/02/2013 Same as last inspection. (A. Freitag - DWR Sutter Yard) 07/15/2013 Same as last inspection. (A. Freitag - DWR Sutter Yard) 04/17/2012 WS headwall has been cleared of debris and sedimentation. (O. Magana - DWR UCIP) FIELD_STRUCT_DESC: 24-inch CIPP-lined corrugated metal drainage pipe through the levee, 8.4 feet below the crown. Concrete "U" headwalls on both the waterside (WS) and landside (LS) ends. Flap gate on the WS end. [Additional Reference(s): DWR Levee Log, 1993 (HLM 3.31). USACE Sacramento O&M Manual, Unit 519, June 1962, Revised 3 Feb 2011, (HLM 3.31), listed as 24-inch pipe, no as-built referenced found] FS Date: 4/22/2024 8:37:13 AM

Levee crown looking upstream.

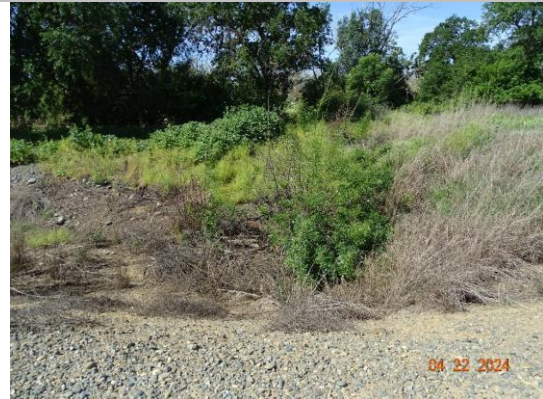
Photo 2 of 3 : UCIP\_SP\_2024\_83130\_121327.jpg

LS view: General overview looking from crown.

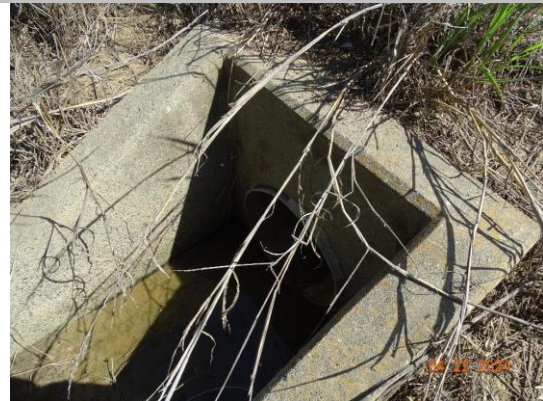
Photo 3 of 3 : UCIP\_SP\_2024\_83130\_121328.jpg

LS view: Concrete headwall and pipe inlet at toe.

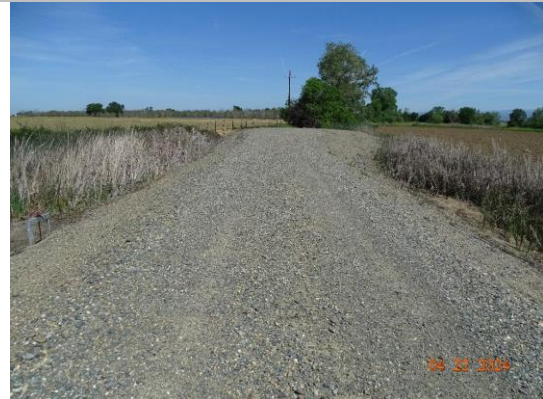
Photo 1 of 3 : UCIP\_SP\_2024\_83129\_121320.jpg

Comment Code						
Inspector Comment						
DS_ID:16351 FS_ID:83129 EP_NO: N/A Repair Type: No Action Needed EVAL Issue: Crossing Status: Found UCIP Comments: 04/22/2024 Record updated from Non-Urgent to No Action Needed. Pipe was CIPP lined on 10/17/2019. DMP internal video inspection has found none or minor pipe defects. No issues observed during inspection. (M. Thao - DWR UCIP) 09/25/2023 DMP internal video inspection has found none or minor pipe defects. Recommend next video inspection in 5 years. (J. Taylor - DWR UCIP) 08/26/2019 Record has been updated from No Action Needed to Non-Urgent, no permit has been identified for this crossing. Crossing is scheduled to be lined. (O. Magana - DWR UCIP, A. Freitag - DWR Sutter Yard) 06/14/2017 Both pipe ends were underwater during site visit. Pipe has been selected to be internally cleaned and inspected as part of the DMP project. (A. Freitag - DWR Sutter Yard) 11/16/2016 Crossing appears to be in good condition. (A. Freitag - DWR Sutter Yard) 04/28/2016 Both sides of the crossing were underwater during time of inspection. (A. Freitag - DWR Sutter Yard) 07/14/2015 Crossing appears in good condition. No noticeable issues to report. (A. Freitag - DWR Sutter Yard) 05/21/2014 Same as last inspection. (A. Freitag - DWR Sutter Yard) 12/02/2013 Same as last inspection. (A. Freitag - DWR Sutter Yard) 07/15/2013 Slopes have been cleared of vegetation and are in good condition. (A. Freitag - DWR Sutter Yard) 04/18/2012 Limited inspection on WS and LS slope due to dense vegetation. Need photos of cleared slopes. (O. Magana - DWR UCIP) FIELD_STRUCT_DESC: 24-inch CIPP-lined corrugate metal drainage pipe through the levee, 8.1 feet below the crown. Flap gate on the waterside (WS) end. Slide gate located on the landside (LS) end. Concrete "U" headwalls on both ends. [Additional Reference(s): DWR Levee Log, 1993 (HLM 3.80). USACE Sacramento O&M Manual, Unit 519, June 1962, Revised 3 Feb 2011, (HLM 3.80), listed as 24-inch pipe, no as-built referenced found] FS Date: 4/22/2024 8:27:12 AM

Levee crown looking upstream.

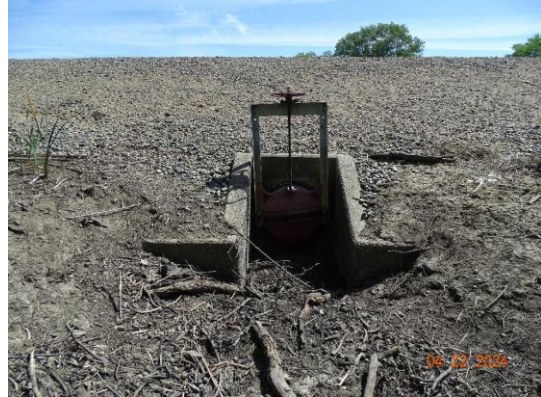
Photo 2 of 3 : UCIP\_SP\_2024\_83129\_121323.jpg

LS view: Concrete headwall with slide gate at toe.

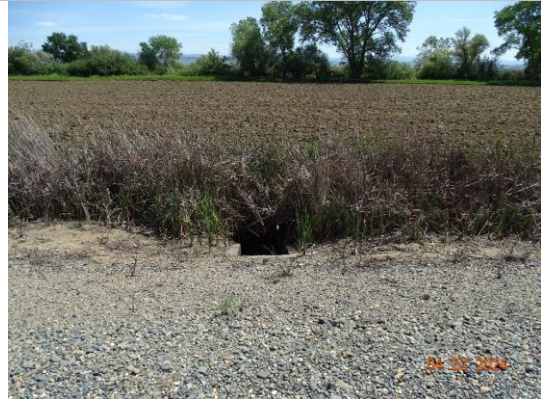
Photo 3 of 3 : UCIP\_SP\_2024\_83129\_121321.jpg

WS view: General overview looking from crown.

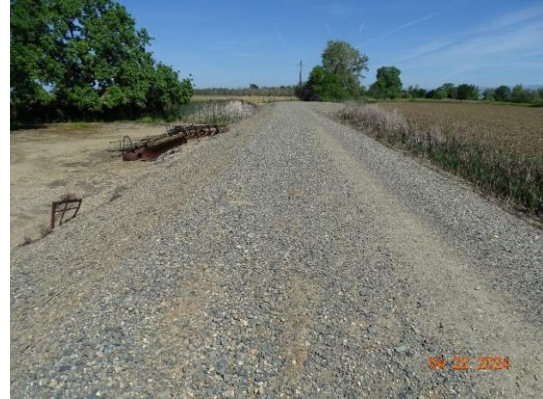
Photo 1 of 3 : UCIP\_SP\_2024\_83128\_121316.jpg

DS\_ID:16365  
FS\_ID:83128  
EP\_NO: N/A  
Repair Type: Non-Urgent  
EVAL Issue:  
Crossing Status: Found  
UCIP Comments: 04/22/2024 Record remains Non-Urgent. Concrete headwall and pipe inlet at LS toe buried with sediment; slide gate guides are damaged. Concrete headwall at toe filled with vegetation preventing flap gate from operating properly. Crossing appears to no longer be in use. Unable to locate a permit and confirm proper pipe abandonment. (M. Thao - DWR UCIP)  
08/26/2019 Record remains Non-Urgent, pipe has been abandoned. No permit has been identified for this crossing. DMP internal inspection has not been completed. (O. Magana - DWR UCIP, A. Freitag - DWR Sutter Yard)  
06/14/2017 Appears abandoned- needs to be done properly. WS gate was buried/submerged and the LS slide gate is still damaged and buried. Pipe has been selected to be internally cleaned and inspected as part of the DMP project. (A. Freitag - DWR Sutter Yard)

Levee crown looking upstream.

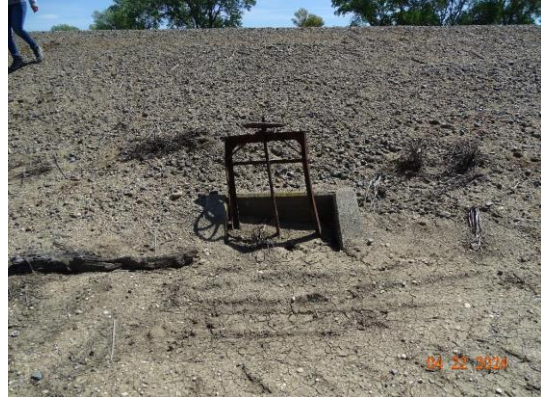
Photo 2 of 3 : UCIP\_SP\_2024\_83128\_121317.jpg

LS view: Concrete headwall and pipe inlet at toe buried with sediment; slide gate guides are damaged.

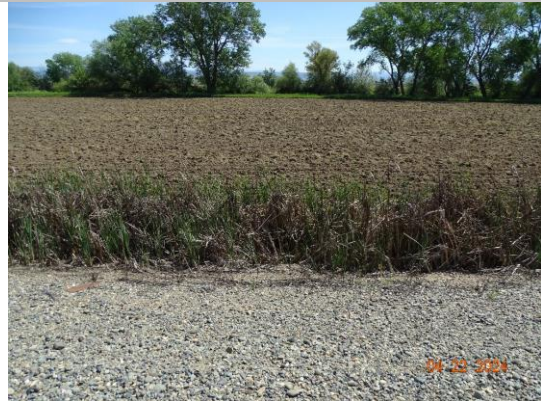
Photo 3 of 3 : UCIP\_SP\_2024\_83128\_121318.jpg

WS view: General overview looking from crown.

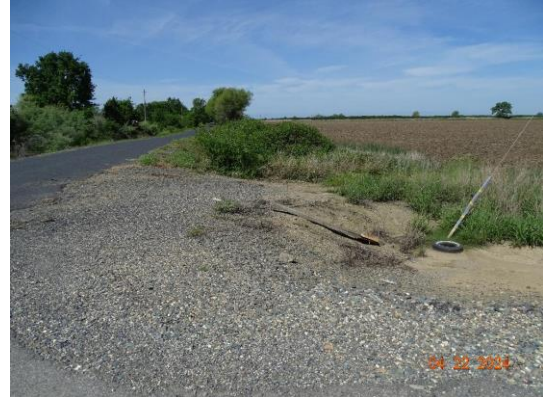
Photo 1 of 2 : UCIP\_SP\_2024\_83127\_121313.jpg

Comment Code						
Inspector Comment						
DS_ID:16353 FS_ID:83127 EP_NO: 6084 Repair Type: Non-Urgent EVAL Issue: 11, Maintenance Compliance Issue Crossing Status: Indicator Found UCIP Comments: 04/22/2024 Record remains Non-Urgent. Underground telephone cable sign is down on LS; recommend owner install a new indicator. (M. Thao - DWR UCIP) 08/26/2019 Record has been updated from No Action Needed to Non-Urgent, maintenance required. Sign is down on LS. (O. Magana - DWR UCIP, A. Freitag - DWR Sutter Yard) 06/14/2017 Crossing appears to be in good condition. (A. Freitag - DWR Sutter Yard) 11/16/2016 Crossing appears to be in good condition. (A. Freitag - DWR Sutter Yard) 04/28/2016 Crossing appears to be in good condition. (A. Freitag - DWR Sutter Yard) 07/14/2015 Crossing appears in good condition. (A. Freitag - DWR Sutter Yard) 05/21/2014 Same as last inspection. (A. Freitag - DWR Sutter Yard) 12/02/2013 Same as last inspection. (A. Freitag - DWR Sutter Yard) 07/15/2013 Same as last inspection. (A. Freitag - DWR Sutter Yard) 04/18/2012 Visible marker on LS. (O. Magana - DWR UCIP) FIELD_STRUCT_DESC: Underground telephone cable, 1.5-inch through the levee at approximately 2 feet below the crown. (buried cable authorized to go through Cherokee Canal and across Cottonwood Creek under Permit No. 6084, 1968 - Pacific Telephone and Telegraph Company [PT&T]) Contact No. listed in case of emergencies is 1-800-642-2444. [Additional Reference(s): DWR Levee Log, 1993 (HLM 4.41)] FS Date: 4/22/2024 7:59:31 AM

LS view: Down underground telephone cable post with sign near the toe.

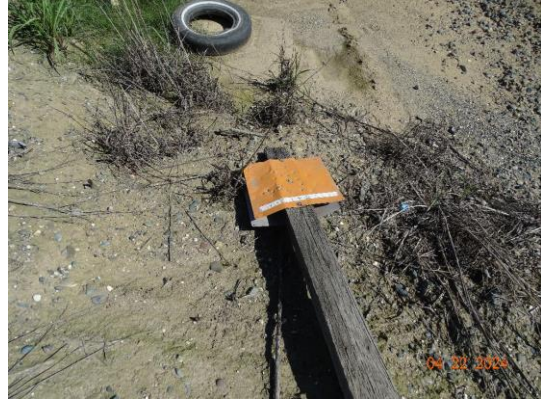
Photo 2 of 2 : UCIP\_SP\_2024\_83127\_121314.jpg

LS view: Close-up view of the down underground telephone cable post with sign near the toe.

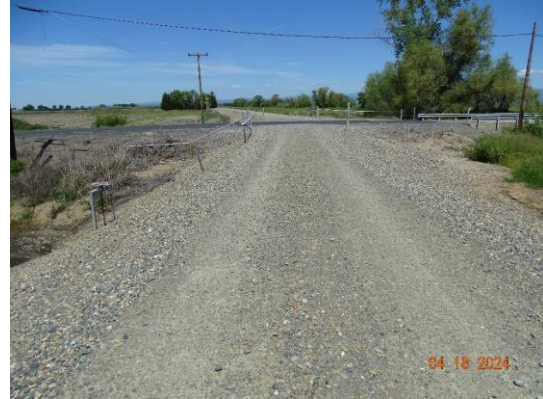
Photo 1 of 3 : UCIP\_SP\_2024\_83079\_121116.jpg

DS\_ID:16341  
FS\_ID:83079  
EP\_NO: N/A  
Repair Type: No Action Needed  
EVAL Issue:  
Crossing Status: Found  
UCIP Comments: 04/18/2024 Record updated from Non-Urgent to No Action Needed. Pipe was CIPP lined on 03/18/2020. DMP internal video inspection has found none or minor pipe defects. No issues observed during inspection. (M. Thao - DWR UCIP)  
09/25/2023 DMP internal video inspection has found none or minor pipe defects. Recommend next video inspection in 5 years. (J. Taylor - DWR UCIP)  
08/26/2019 Record has been updated from No Action Needed to Non-Urgent, no permit has been found authorizing pipe. Pipe is scheduled to be lined. (O. Magana - DWR UCIP, A. Freitag - DWR Sutter Yard)  
06/14/2017 WS flap gate is shut but blocked by sediment- needs to be dug out. LS slide gate has some minor sediment built up against it. Pipe has been selected to be internally cleaned and inspected as part of the DMP project. (A. Freitag - DWR Sutter Yard)

Levee crown looking upstream.

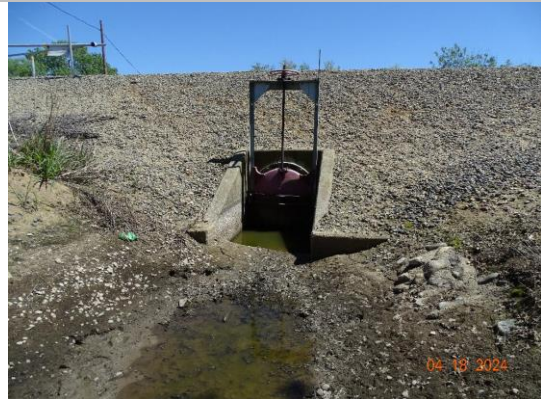
Photo 2 of 3 : UCIP\_SP\_2024\_83079\_121117.jpg

LS view: Concrete headwall and slide gate at toe.

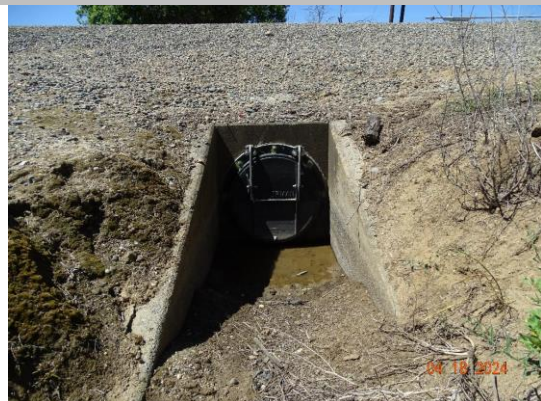
Photo 3 of 3 : UCIP\_SP\_2024\_83079\_121118.jpg

WS view: Concrete headwall and flap gate at toe.

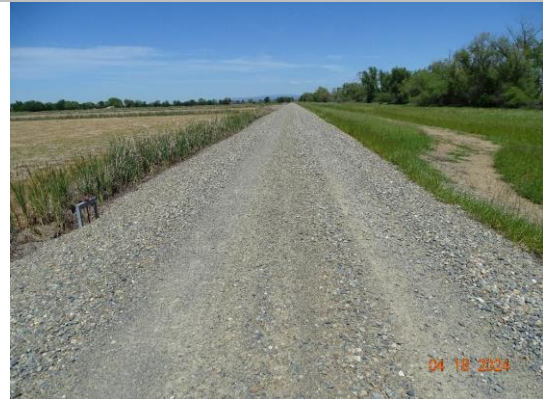
Photo 1 of 3 : UCIP\_SP\_2024\_83078\_121113.jpg

Comment Code						
Inspector Comment						
DS_ID:16355 FS_ID:83078 EP_NO: N/A Repair Type: No Action Needed EVAL Issue: Crossing Status: Found UCIP Comments: 04/18/2024 Record updated from Non-Urgent to No Action Needed. Pipe was CIPP lined on 10/16/2019. DMP internal video inspection has found none or minor pipe defects. No issues observed during inspection. (M. Thao - DWR UCIP) 09/25/2023 DMP internal video inspection has found none or minor pipe defects. Recommend next video inspection in 5 years. (J. Taylor - DWR UCIP) 08/26/2019 Record has been updated from No Action Needed to Non-Urgent, no permit has been identified for this pipe. Pipe is scheduled to be lined. (O. Magana - DWR UCIP, A. Freitag - DWR Sutter Yard) 06/14/2017 WS flap gate is submerged and appears to be half buried by sediment. LS slide gate is fully submerged on the edge of the rice field. Pipe has been selected to be internally cleaned and inspected as part of the DMP project. (A. Freitag - DWR Sutter Yard) 11/16/2016 Crossing appears to be in good condition. (A. Freitag - DWR Sutter Yard) 04/28/2016 Crossing appears to be in good condition. (A. Freitag - DWR Sutter Yard) 07/13/2015 LS screw gate was completely submerged but crossing appears to be in good condition. (A. Freitag - DWR Sutter Yard) 05/21/2014 Same as last inspection. (A. Freitag - DWR Sutter Yard) 12/02/2013 Same as last inspection. (A. Freitag - DWR Sutter Yard) 07/15/2013 No signs of burrowing activity on this inspection. (A. Freitag - DWR Sutter Yard) 04/18/2012 Burrow activity near crossing, burrow holes present on WS slope. (O. Magana - DWR UCIP) FIELD_STRUCT_DESC: 24-inch CIPP-lined corrugated metal drainage pipe through the levee 7.7 feet below the crown. Flap gate on the waterside (WS) end. Slide gate located on the landside (LS) end. Concrete "U" headwalls on both ends. [Additional Reference(s): DWR Levee Log, 1993 (HLM 4.94). USACE Sacramento O&M Manual, Unit 519, June 1962, Revised 3 Feb 2011, (HLM 4.94), As-built DWG No. 50-4-3608, Sheet No. 3608/18, STA 865+00E, page 19 of 28 electronic file, listed as 24-inch CMP; As-built DWG No 50-4-3037 referenced not available] FS Date: 4/18/2024 9:07:31 PM

Levee crown looking upstream.

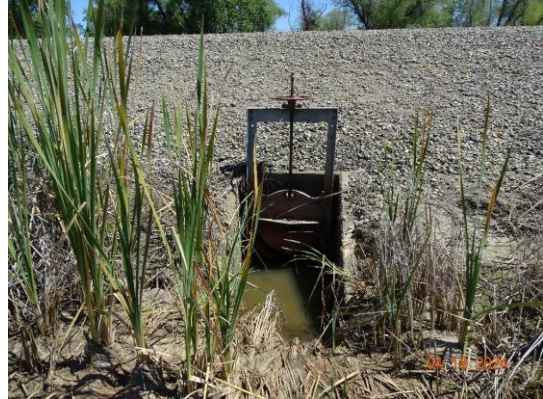
Photo 2 of 3 : UCIP\_SP\_2024\_83078\_121114.jpg

LS view: Concrete headwall and slide gate; looking toward levee.

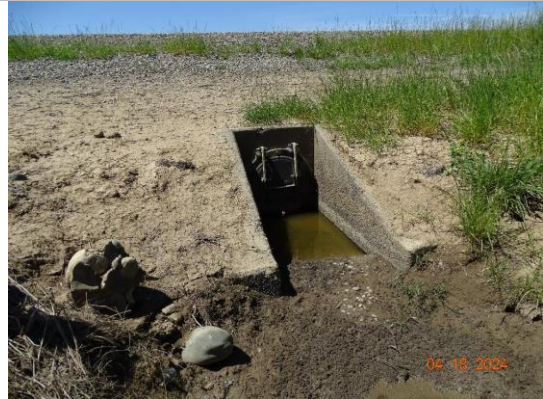
Photo 3 of 3 : UCIP\_SP\_2024\_83078\_121115.jpg

WS view: Concrete headwall and flap gate; looking toward levee.

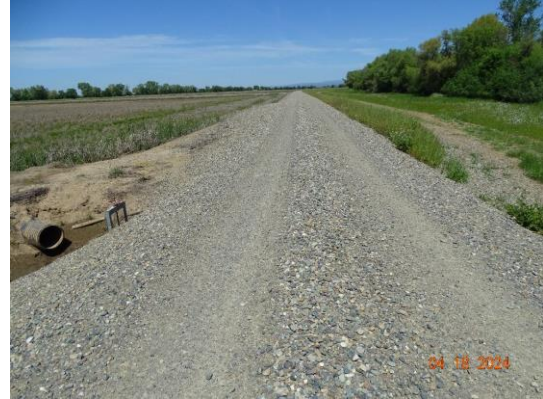
Photo 1 of 3 : UCIP\_SP\_2024\_83077\_121110.jpg

DS\_ID:16356  
FS\_ID:83077  
EP\_NO: N/A  
Repair Type: No Action Needed  
EVAL Issue:  
Crossing Status: Found  
UCIP Comments: 04/18/2024 Record updated from Non-Urgent to No Action Needed. Pipe was CIPP lined on 10/17/2019. DMP internal video inspection has found none or minor pipe defects. No issues observed during inspection. (M. Thao - DWR UCIP)  
09/25/2023 DMP internal video inspection has found none or minor pipe defects. Recommend next video inspection in 5 years. (J. Taylor - DWR UCIP)  
08/26/2019 Record has been updated from No Action Needed to Non-Urgent, no permit has been identified authorizing this pipe. Pipe is scheduled to be lined. Minor sloughing observed on LS just immediately d/s of concrete headwall (see photo). (O. Magana - DWR UCIP, A. Freitag - DWR Sutter Yard)  
06/14/2017 Crossing appears to be in good condition. Pipe has been selected to be internally cleaned and inspected as part of the DMP project. (A. Freitag - DWR Sutter Yard)

Levee crown looking upstream.

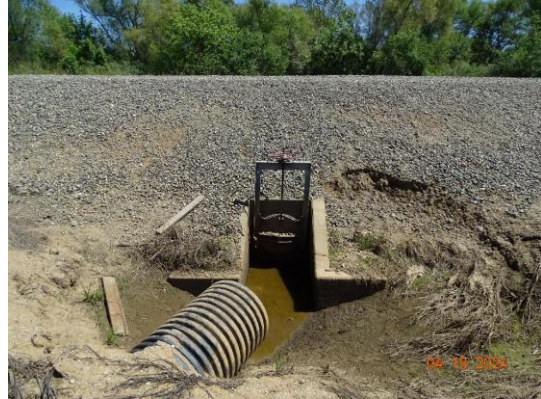
Photo 2 of 3 : UCIP\_SP\_2024\_83077\_121111.jpg

LS view: Concrete headwall and slide gate at toe.

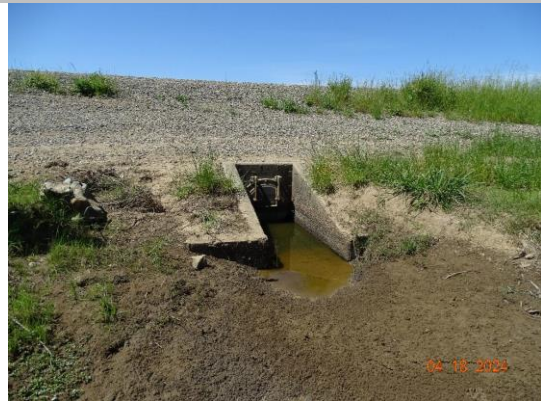
Photo 3 of 3 : UCIP\_SP\_2024\_83077\_121112.jpg

WS view: Concrete headwall and flap gate at toe.

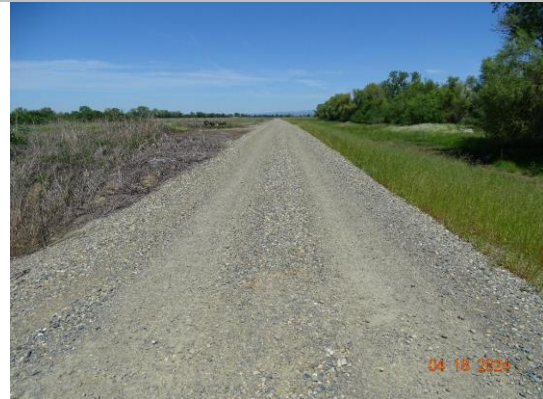
Photo 1 of 3 : UCIP\_SP\_2024\_83076\_121107.jpg

Comment Code						
Inspector Comment						
DS_ID:16357 FS_ID:83076 EP_NO: N/A Repair Type: No Action Needed EVAL Issue: Crossing Status: Found UCIP Comments: 04/18/2024 Record updated from Non-Urgent to No Action Needed. Pipe was CIPP lined on 07/18/2019. DMP internal video inspection has found none or minor pipe defects. No issues observed during inspection. (M. Thao - DWR UCIP) 09/25/2023 DMP internal video inspection has found none or minor pipe defects. Recommend next video inspection in 5 years. (J. Taylor - DWR UCIP) 08/26/2019 Record remains Non-Urgent, no permit has been identified authorizing this pipe. Pipe has been lined. (O. Magana - DWR UCIP, A. Freitag - DWR Sutter Yard) 06/14/2017 WS flap gate is partially buried by sediment- needs to be dug out. LS appears to be in good condition. Pipe has been selected to be internally cleaned and inspected as part of the DMP project. (A. Freitag - DWR Sutter Yard) 11/16/2016 WS flap gate closed but blocked from opening by sediment. (A. Freitag - DWR Sutter Yard) 04/28/2016 WS flap gate blocked from opening by sediment. (A. Freitag - DWR Sutter Yard) 07/13/2015 WS flap gate is blocked from opening by sediment. Needs to be dug out. (A. Freitag - DWR Sutter Yard) 05/21/2014 Same as last inspection. (A. Freitag - DWR Sutter Yard) 12/02/2013 Same as last inspection. (A. Freitag - DWR Sutter Yard) 07/15/2013 Slopes have been cleared of vegetation and are in good condition. (A. Freitag - DWR Sutter Yard) 04/18/2012 Limited inspection on WS and LS slopes due to dense vegetation. Need photos of cleared slopes. (O. Magana - DWR UCIP) FIELD_STRUCT_DESC: 24-inch CIPP-lined corrugated metal drainage pipe through the levee, 8.6 feet below the crown. Flap gate on the waterside (WS) end. Concrete "U" headwalls an both ends. [Additional Reference(s): DWR Levee Log, 1993 (HLM 5.48). USACE Sacramento O&M Manual, Unit 519, June 1962, Revised 3 Feb 2011, (HLM 5.48), listed as 24-inch pipe, no as-built referenced found] FS Date: 4/18/2024 8:47:51 PM

Levee crown looking upstream.

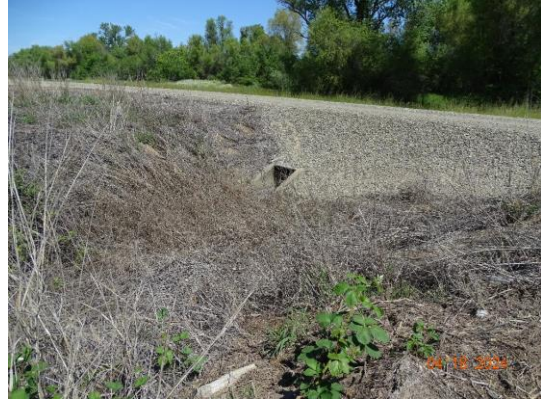
Photo 2 of 3 : UCIP\_SP\_2024\_83076\_121106.jpg

LS view: Concrete headwall at toe; looking toward levee.

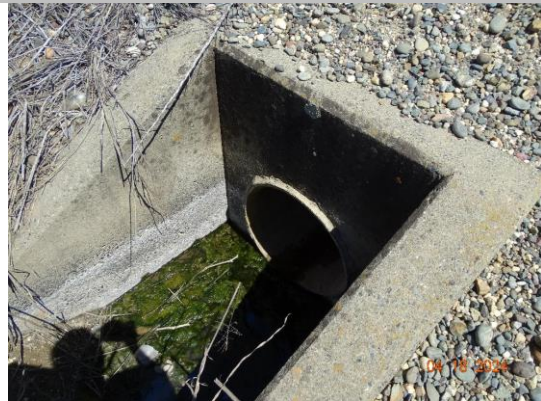
Photo 3 of 3 : UCIP\_SP\_2024\_83076\_121108.jpg

LS view: Close-up view of concrete headwall and pipe inlet.

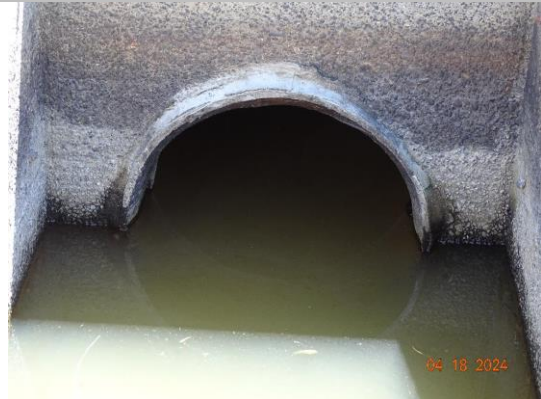
Photo 1 of 3 : UCIP\_SP\_2024\_83072\_121090.jpg

DS\_ID:16359  
FS\_ID:83072  
EP\_NO: N/A  
Repair Type: Non-Urgent  
EVAL Issue: 11, Maintenance Compliance Issue  
Crossing Status: Found  
UCIP Comments: 04/18/2024 Record remains Non-Urgent. Flap gate is completely buried with sediment; recommend removing sediment. Pipe inlet on LS is filled approximately 40% with water most likely due to the blocked flap gate. Pipe was CIPP lined on 08/28/2019. DMP internal video inspection has found none or minor pipe defects. (M. Thao - DWR UCIP)  
09/25/2023 DMP internal video inspection has found none or minor pipe defects. Recommend next video inspection in 5 years. (J. Taylor - DWR UCIP)  
08/26/2019 Record remains Non-Urgent, no permit has been identified authorizing pipe. Pipe is scheduled to be lined. (O. Magana - DWR UCIP, A. Freitag - DWR Sutter Yard)  
06/14/2017 WS Flap gate is completely buried- needs to be dug out. LS is blocked off by flashboards that are partially buried. Pipe has been selected to be internally cleaned and inspected as part of the DMP project. (A. Freitag - DWR Sutter Yard)

LS view: Close-up view of pipe inlet; pipe is filled approximately 40% with water.

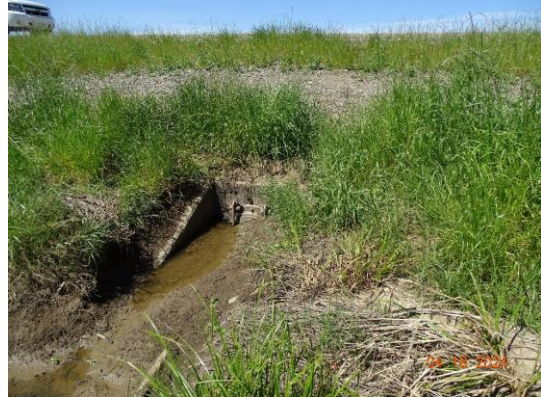
Photo 2 of 3 : UCIP\_SP\_2024\_83072\_121086.jpg

WS view: Concrete headwall with flap gate completely blocked by sediment.

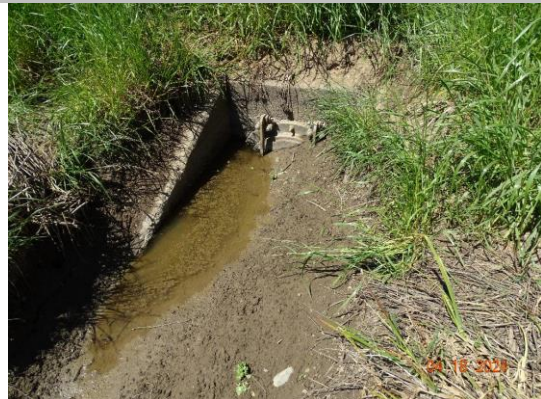
Photo 3 of 3 : UCIP\_SP\_2024\_83072\_121087.jpg

WS view: Close-up view of flap gate completely blocked by sediment.

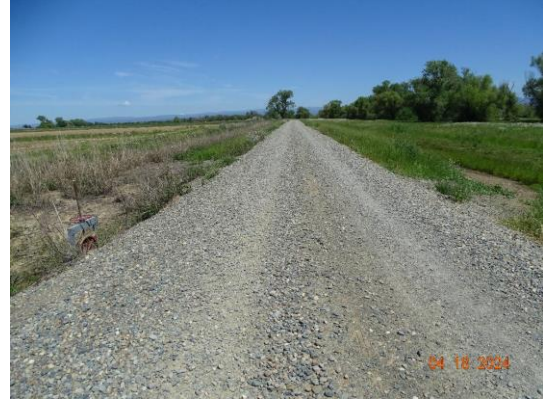
Photo 1 of 3 : UCIP\_SP\_2024\_83071\_121082.jpg

DS\_ID:16360  
FS\_ID:83071  
EP\_NO: N/A  
Repair Type: No Action Needed  
EVAL Issue:  
Crossing Status: Found  
UCIP Comments: 04/18/2024 Record updated from Non-Urgent to No Action Needed. DMP internal video inspection has found none or minor pipe defects. No issues observed during inspection. (M. Thao - DWR UCIP)  
09/25/2023 DMP internal video inspection has found none or minor pipe defects. Recommend next video inspection in 5 years. (J. Taylor - DWR UCIP)  
08/26/2019 Record has been updated from No Action Needed to Non-Urgent, no permit has been identified authorizing pipe. Pipe is scheduled to be lined. (O. Magana - DWR UCIP, A. Freitag - DWR Sutter Yard)  
06/14/2017 Crossing appears to be in good condition. LS is completely submerged in an irrigation ditch. Pipe has been selected to be internally cleaned and inspected as part of the DMP project. (A. Freitag - DWR Sutter Yard)  
11/16/2016 Crossing appears to be in good condition. (A. Freitag - DWR Sutter Yard)

Levee crown looking upstream.

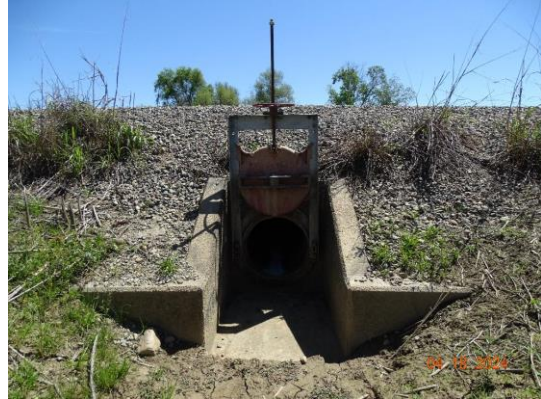
Photo 2 of 3 : UCIP\_SP\_2024\_83071\_121083.jpg

LS view: Concrete headwall with slide gate at toe.

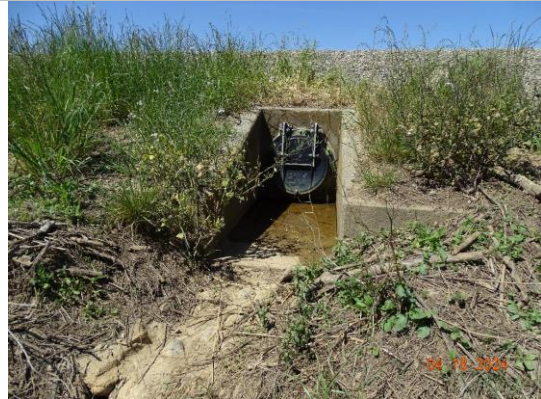
Photo 3 of 3 : UCIP\_SP\_2024\_83071\_121084.jpg

WS view: Concrete headwall with flap gate at toe.

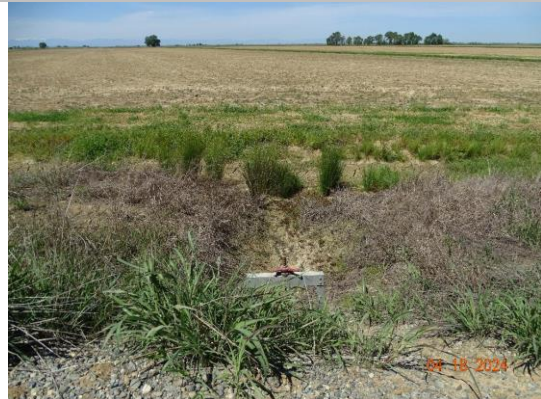
Photo 1 of 2 : UCIP\_SP\_2024\_83070\_121079.jpg

Comment Code						
Inspector Comment						
DS_ID:16361 FS_ID:83070 EP_NO: N/A Repair Type: Non-Urgent EVAL Issue: 11, Maintenance Compliance Issue Crossing Status: Found UCIP Comments: 04/18/2024 Record remains Non-Urgent. Pipe was CIPP lined on 04/01/2020. DMP internal video inspection has found none or minor pipe defects. Slide gate wheel is broken; recommend installing a new gate wheel. Additionally, the slide guides on the LS is slightly bent; recommend fixing the guides if gate does not function properly. (M. Thao - DWR UCIP) 09/25/2023 DMP internal video inspection has found none or minor pipe defects. Recommend next video inspection in 5 years. (J. Taylor - DWR UCIP) 08/26/2019 Record remains Non-Urgent, no permit has been identified authorizing pipe. Pipe is scheduled to be lined. (O. Magana - DWR UCIP, A. Freitag - DWR Sutter Yard) 06/14/2017 WS appears to be in good condition. LS slide gate is buried and submerged. Pipe has been selected to be internally cleaned and inspected as part of the DMP project. (A. Freitag - DWR Sutter Yard) 11/16/2016 LS screw gate is buried and non-operational. (A. Freitag - DWR Sutter Yard) 04/28/2016 LS screw gate is still completely buried. (A. Freitag - DWR Sutter Yard) 07/13/2015 LS screw gate is completely buried. (A. Freitag - DWR Sutter Yard) 05/21/2014 Same as last inspection. (A. Freitag - DWR Sutter Yard) 07/15/2013 WS slope has been cleared of vegetation and is in good condition. LS screw gate is still buried. (A. Freitag - DWR Sutter Yard) 12/02/2013 Same as last inspection. (A. Freitag - DWR Sutter Yard) 04/18/2012 LS slide gate is buried. Pipe is not visible on LS toe. Limited inspection on WS slope due to dense vegetation. (O. Magana - DWR UCIP) FIELD_STRUCT_DESC: 24-inch CIPP-lined corrugated metal drainage pipe through the levee, 7.4 feet below the crown. Flap gate on the waterside (WS) end. Slide gate on the landside (LS) end. Concrete "U" headwalls on both ends. [Additional Reference(s): DWR Levee Log, 1993 (HLM 6.32). USACE Sacramento O&M Manual, Unit 519, June 1962, Revised 3 Feb 2011, (HLM 6.34), As-built DWG No. 50-4-3608, Sheet No. 3608/18, STA 789+00E, page 19 of 28 electronic file, listed as 24-inch CMP; As-built DWG No 50-4-3037 referenced not available] FS Date: 4/18/2024 7:16:50 PM

LS view: General overview looking from crown; broken slide gate wheel attached to slide gate guide.

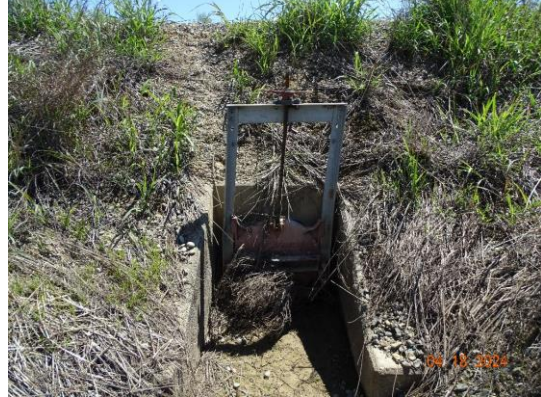
Photo 2 of 2 : UCIP\_SP\_2024\_83070\_121080.jpg

LS view: Concrete headwall with slide gate at toe; slide gate wheel is broken and slide guides slightly bent.

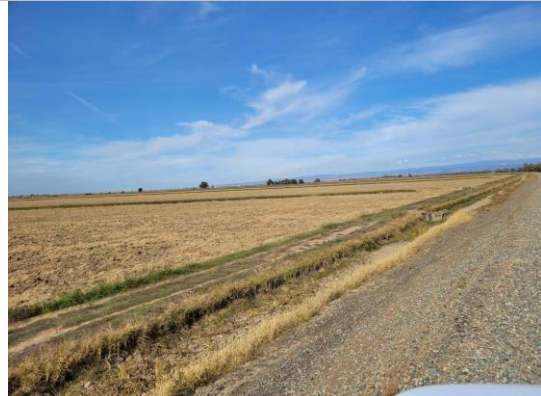
Photo 1 of 1 : SP\_2024\_MA0013\_300\_3\_20240212\_00001.jpg

LM Start	6.41	Rating **	M	Issue No.	3
LM End	6.99	Issue Type +	En	Location *	LS
Category	Earthen Levee			GPS Latitude/Longitude	
				Start	End
Item	Encroachments			39.508928°	39.501438°
				-121.714842°	-121.719715°
DWR ID	DWR_MA0013_01_s_2012_3				
Comment Code					
DT : Ditch					
Inspector Comment

View of the agricultural ditch along the toe. Fall 2021.

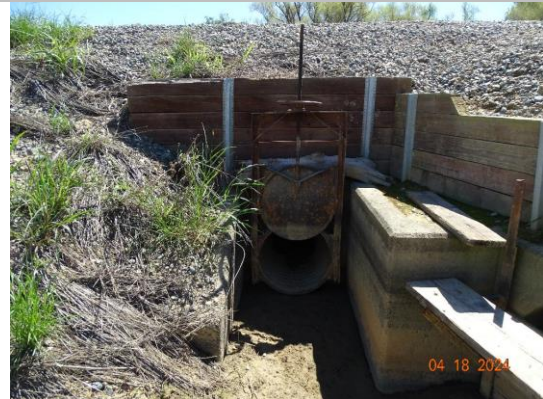
Photo 1 of 2 : UCIP\_SP\_2024\_83069\_121076.jpg

FIELD\_STRUCT\_DESC: 24-inch corrugated metal drainage pipe through the levee, 7.8 feet below the crown. Flap gate on the waterside (WS) end. Slide gate on the landside (LS) end. Concrete headwall on both ends (Permit No. 5200B - 1965, Richvale Irrigation District) (Additional Related Permit(s): Permit No. 5200 and 5200A) [Additional Reference(s): DWR Levee Log, 1993 (HLM 6.56). USACE Sacramento O&M Manual, Unit 519, June 1962, Revised 3 Feb 2011, (HLM 6.56),

LS view: Concrete headwall with slide gate at toe.

LM Start	<b>6.45</b>	Rating **	U	Issue No.	<b>97 (cont)</b>
LM End	<b>6.45</b>	Issue Type +	En	Location *

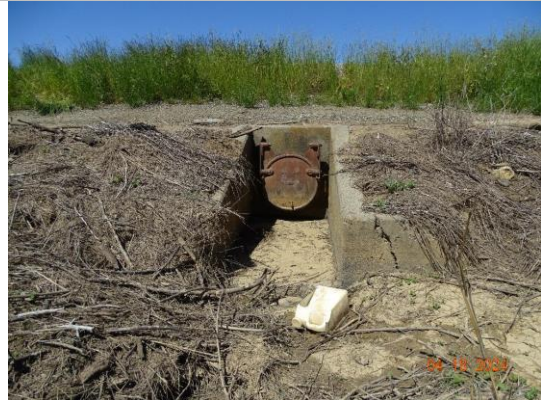
Photo 2 of 2 : UCIP\_SP\_2024\_83069\_121077.jpg

WS view: Concrete headwall with flap gate at toe.

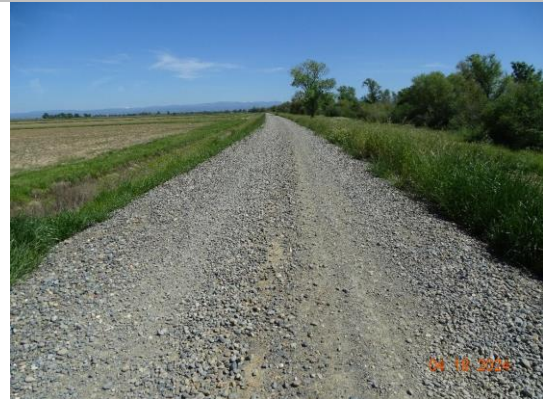
Photo 1 of 3 : UCIP\_SP\_2024\_83068\_121070.jpg

DS\_ID:16329  
FS\_ID:83068  
EP\_NO: N/A  
Repair Type: No Action Needed  
EVAL Issue:  
Crossing Status: Found  
UCIP Comments: 04/18/2024 Record updated from Non-Urgent to No Action Needed. Pipe was CIPP lined on 08/27/2019. DMP internal video inspection has found none or minor pipe defects. No issues observed during inspection. (M. Thao - DWR UCIP)  
09/25/2023 DMP internal video inspection has found none or minor pipe defects. Recommend next video inspection in 5 years. (J. Taylor - DWR UCIP)  
08/26/2019 Record remains Non-Urgent, due to no permit found authorizing pipe and maintenance issue. Pipe is scheduled to be lined. Slide gate detached and sitting on the side of concrete wingwall. Slide gate will need to be re-attached. (O. Magana - DWR UCIP, A. Freitag - DWR Sutter Yard)  
06/14/2017 LS slide gate is still damaged and needing to be replaced. WS appeared to be in good condition. Pipe has been selected to be internally cleaned and inspected as part of the DMP project. (A. Freitag - DWR Sutter Yard)

Levee crown looking upstream.

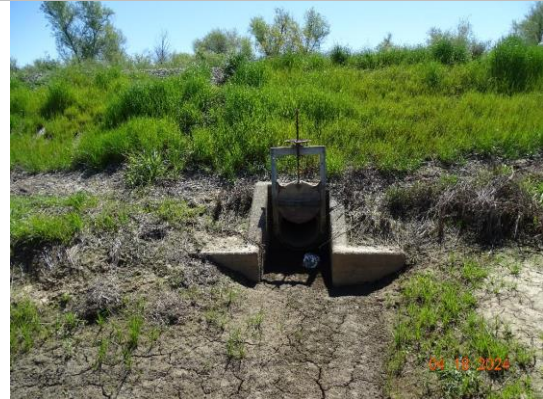
Photo 2 of 3 : UCIP\_SP\_2024\_83068\_121071.jpg

LS view: Concrete headwall with slide gate at toe.

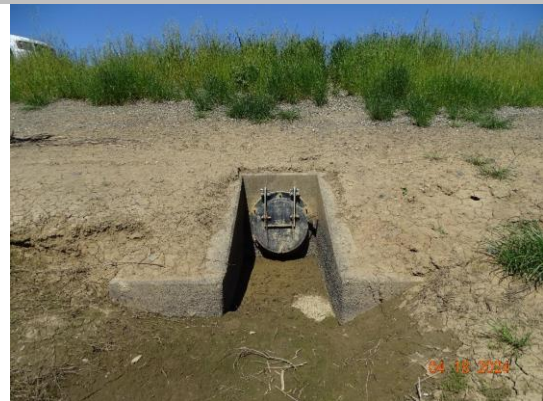
Photo 3 of 3 : UCIP\_SP\_2024\_83068\_121072.jpg

WS view: Concrete headwall with flap gate at toe.

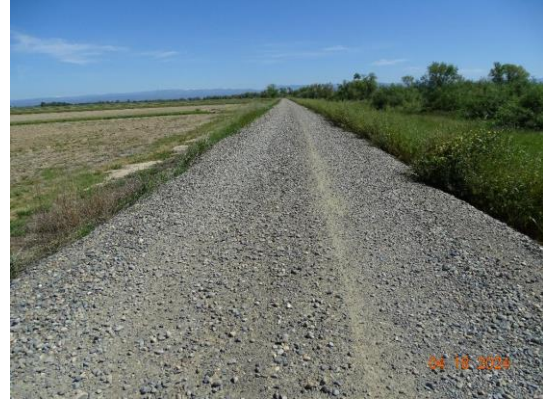
Photo 1 of 3 : UCIP\_SP\_2024\_83067\_121065.jpg

DS\_ID:16354  
FS\_ID:83067  
EP\_NO: N/A  
Repair Type: No Action Needed  
EVAL Issue:  
Crossing Status: Found  
UCIP Comments: 04/18/2024 Record updated from Non-Urgent to No Action Needed. Pipe was CIPP lined on 03/05/2020. DMP internal video inspection has found none or minor pipe defects. No issues observed during inspection. (M. Thao - DWR UCIP)  
09/25/2023 DMP internal video inspection has found none or minor pipe defects. Recommend next video inspection in 5 years. (J. Taylor - DWR UCIP)  
08/26/2019 Record remains Non-Urgent, no permit has been identified authorizing pipe. Pipe is scheduled to be lined. (O. Magana - DWR UCIP, A. Freitag - DWR Sutter Yard)  
06/14/2017 LS slide gate stem still bent. WS appeared to be in good condition. Pipe has been selected to be internally cleaned and inspected as part of the DMP project. (A. Freitag - DWR Sutter Yard)  
11/16/2016 Screw gate stem bent but gate is still operational. (A. Freitag - DWR Sutter Yard)

Levee crown looking upstream.

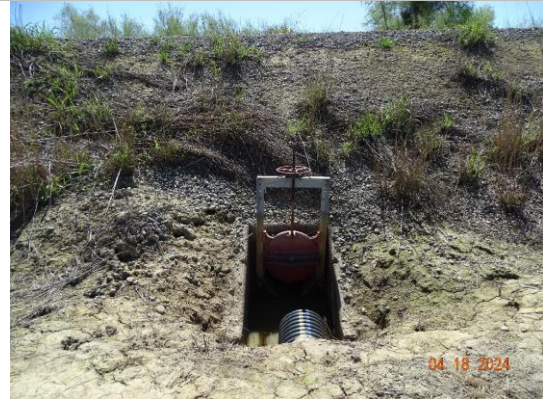
Photo 2 of 3 : UCIP\_SP\_2024\_83067\_121066.jpg

LS view: Concrete headwall with slide gate at toe.

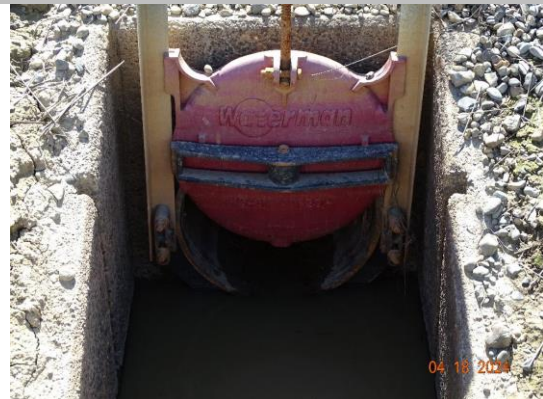
Photo 3 of 3 : UCIP\_SP\_2024\_83067\_121067.jpg

04/28/2016 Tested positive closure device the bent stem on the slide gate did not seem to affect its functions. Gate operable. (A. Freitag - DWR Sutter Yard)  
07/13/2015 LS screw gate stem is still bent. Gate should still be able to close fully. The rest of the crossing seems to be in good condition. (A. Freitag - DWR Sutter Yard)  
05/21/2014 Same as last inspection. (A. Freitag - DWR Sutter Yard)  
12/02/2013 Same as last inspection. (A. Freitag - DWR Sutter Yard)  
07/15/2013 Slopes have been cleared of vegetation and are in good condition. LS screw gate stem is still bent. (A. Freitag - DWR Sutter Yard)  
04/18/2012 LS slide gate stem is bent and needs to be replaced. Limited inspection on WS and LS slope due to dense vegetation. Need photos of cleared slopes during next inspection. Confirmed flap gate on WS. This crossing was listed in the USACE Periodic Inspection report as Corp's inspect ID#USACE\_CESPK\_M13D\_2011\_p\_0244 for submerged WS gate. (O. Magana - DWR UCIP)

LS view: Close-up view of slide gate.
