Flood Control Project Maintenance  
Levee Inspections  
LMA District Cover Sheet

Sutter Maintenance Yard Maintenance Area 0013

**Flood Control Project Maintenance  
Levee Inspections  
Unit Cover Sheet**

Waterway			Bank	Unit Miles
Unit No. 01 Cherokee Canal			Right	18.19
	Spring (March - May)	Summer (June - August)	(September - November) Fall	Winter (December - February)
Unit Maintenance Rating (Fall Only)				
Date of Inspection	4/17/2024 - 4/17/2024			
DWR Inspector	Makar Sokol			
Accompanied By	Shawn Freitag DWR Sutter Yard

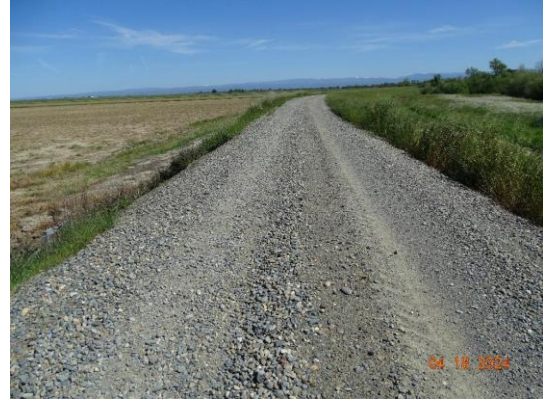
Photo 1 of 3 : UCIP\_SP\_2024\_83066\_121060.jpg

DS\_ID:16352  
FS\_ID:83066  
EP\_NO: N/A  
Repair Type: No Action Needed  
EVAL Issue:  
Crossing Status: Found  
UCIP Comments: 04/18/2024 Record updated from Non-Urgent to No Action Needed. Pipe was CIPP lined on 03/03/2020. DMP internal video inspection has found none or minor pipe defects. No issues observed during inspection. (M. Thao - DWR UCIP)  
09/25/2023 DMP internal video inspection has found none or minor pipe defects. Recommend next video inspection in 5 years. (J. Taylor - DWR UCIP)  
08/26/2019 Record has been updated from No Action Needed to Non-Urgent, no permit has been identified authorizing pipe. Pipe is scheduled to be lined. (O. Magana - DWR UCIP, A. Freitag - DWR Sutter Yard)  
06/14/2017 Crossing appears to be in good condition. Pipe has been selected to be internally cleaned and inspected as part of the DMP project. (A. Freitag - DWR Sutter Yard)  
11/16/2016 Crossing appears to be in good condition. (A. Freitag - DWR Sutter Yard)

Levee crown looking upstream.

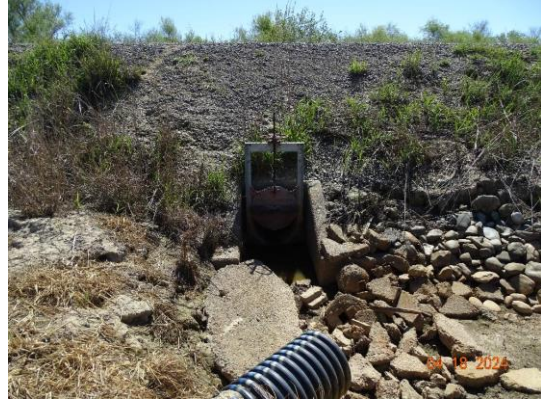
Photo 2 of 3 : UCIP\_SP\_2024\_83066\_121061.jpg

LS view: Concrete headwall with slide gate at toe; looking toward levee.

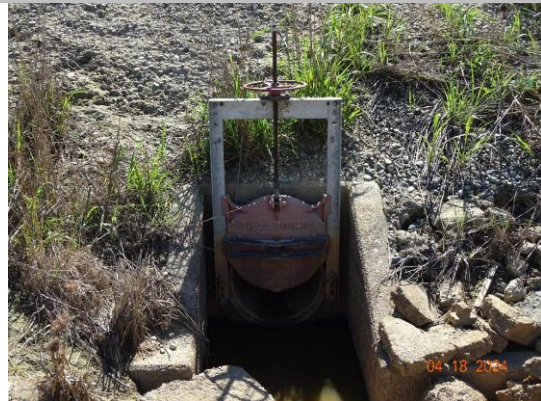
Photo 3 of 3 : UCIP\_SP\_2024\_83066\_121062.jpg

LS view: Close-up view of concrete headwall with slide gate at toe; looking toward levee.

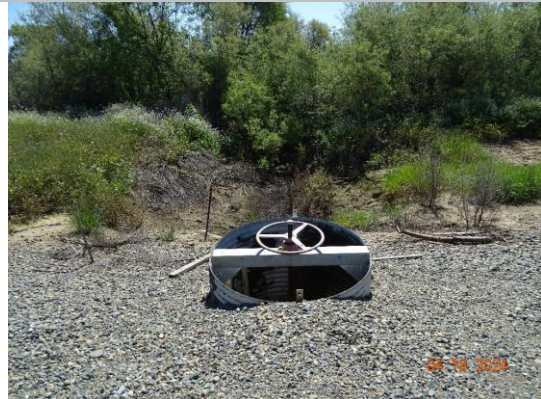
Photo 1 of 1 : UCIP\_SP\_2024\_83063\_121049.jpg

DS\_ID:16320  
FS\_ID:83063  
EP\_NO: N/A  
Repair Type: Non-Urgent  
EVAL Issue: 4b, Safety Issue  
Crossing Status: Found  
UCIP Comments: 04/18/2024 Record remains Non-Urgent. No cover was present on CMP riser causing a safety hazard; recommend adding a cover. Pipe was CIPP lined on 04/08/2021. DMP internal video inspection has found none or minor pipe defects. (M. Thao - DWR UCIP)  
08/26/2019 Record has been updated from No Action Needed to Non-Urgent, no permit has been identified authorizing pipe. Pipe is scheduled to be lined. DMP internal video inspection has not found pipe integrity issues. LOF of crossing is less or equal to 4. Recommend next video inspection in 5 years. The following maintenance issues should be addressed: clear vegetation from LS inlet and repair CMP riser lid (safety measure). (O. Magana - DWR UCIP, A. Freitag - DWR Sutter Yard)  
06/14/2017 Debris down inside of WS riser. The rest of the crossing appears to be in good condition. Pipe has been selected to be internally cleaned and inspected as part of the DMP project. (A. Freitag - DWR Sutter Yard)

WS view: CMP riser with no cover on slope; looking from crown.

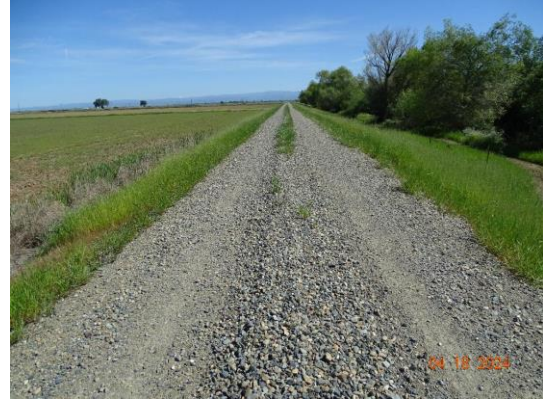
Photo 1 of 3 : UCIP\_SP\_2024\_83062\_121042.jpg

DS\_ID:16321  
FS\_ID:83062  
EP\_NO: N/A  
Repair Type: No Action Needed  
EVAL Issue:  
Crossing Status: Found  
UCIP Comments: 04/18/2024 Record updated from Non-Urgent to No Action Needed. Pipe was CIPP lined on 03/12/2020. DMP internal video inspection has found none or minor pipe defects. No issues observed during inspection. (M. Thao - DWR UCIP)  
09/25/2023 DMP internal video inspection has found none or minor pipe defects. Recommend next video inspection in 5 years. (J. Taylor - DWR UCIP)  
08/27/2019 Record has been updated from No Action Needed to Non-Urgent, no permit has been identified authorizing pipe. Pipe is scheduled to be lined. (O. Magana - DWR UCIP, A. Freitag - DWR Sutter Yard)  
06/14/2017 Crossing appears to be in good condition. Pipe has been selected to be internally cleaned and inspected as part of the DMP project. (A. Freitag - DWR Sutter Yard)  
11/16/2016 Crossing appears to be in good condition. (A. Freitag - DWR Sutter Yard)

Levee crown looking upstream.

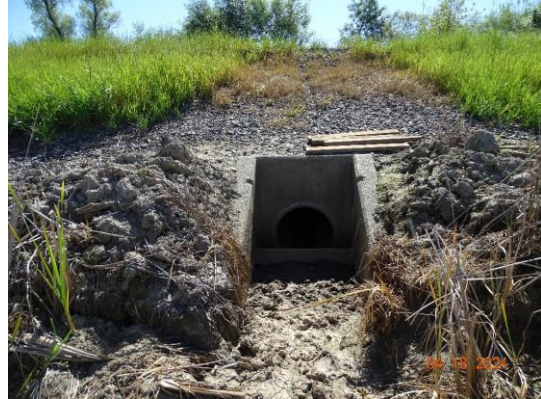
Photo 2 of 3 : UCIP\_SP\_2024\_83062\_121043.jpg

LS view: Concrete headwall at toe; looking toward levee.

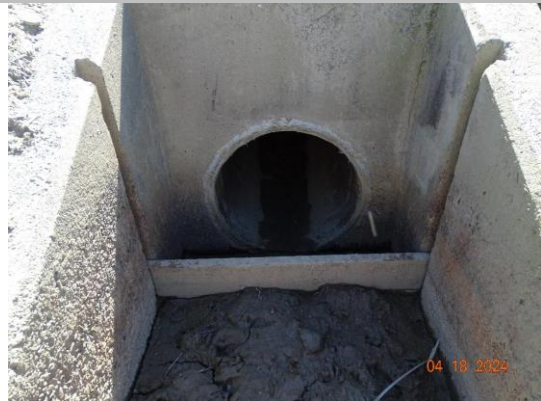
Photo 3 of 3 : UCIP\_SP\_2024\_83062\_121044.jpg

LS view: Close-up view of pipe inlet at toe.

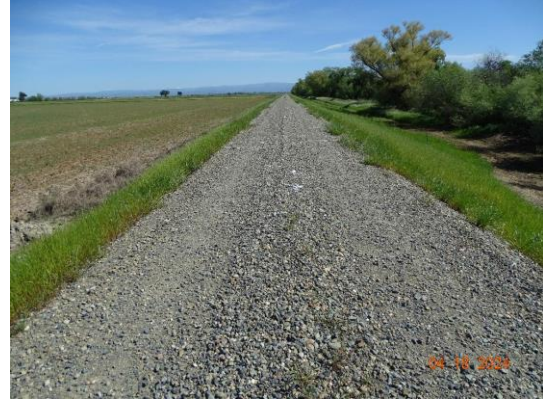
Photo 1 of 3 : UCIP\_SP\_2024\_83061\_121037.jpg

DS\_ID:16322  
FS\_ID:83061  
EP\_NO: N/A  
Repair Type: No Action Needed  
EVAL Issue:  
Crossing Status: Found  
UCIP Comments: 04/18/2024 Record updated from Non-Urgent to No Action Needed. Pipe was CIPP lined on 03/31/2020. DMP internal video inspection has found none or minor pipe defects. No issues observed during inspection. (M. Thao - DWR UCIP)  
09/25/2023 DMP internal video inspection has found none or minor pipe defects. Recommend next video inspection in 5 years. (J. Taylor - DWR UCIP)  
08/27/2019 Record remains Non-Urgent, no permit has been identified authorizing pipe. Vegetation needs to be cleared from inlet/outlet. Pipe is scheduled to be lined. (O. Magana - DWR UCIP, A. Freitag - DWR Sutter Yard)  
06/14/2017 Both sides of the crossing were buried with sediment-needs to be cleared away. Pipe has been selected to be internally cleaned and inspected as part of the DMP project. (A. Freitag - DWR Sutter Yard)

Levee crown looking upstream.

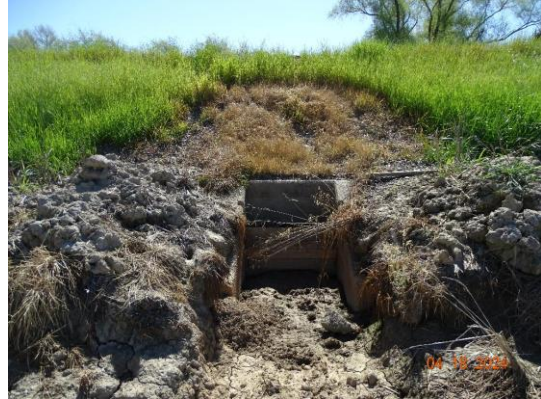
Photo 2 of 3 : UCIP\_SP\_2024\_83061\_121038.jpg

LS view: Concrete headwall at toe; looking toward levee.

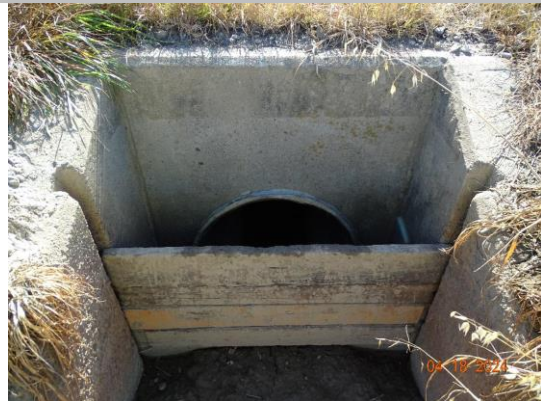
Photo 3 of 3 : UCIP\_SP\_2024\_83061\_121039.jpg

11/16/2016 WS flap gate is closed but is blocked from opening by sediment. (A. Freitag - DWR Sutter Yard)  
04/28/2016 Crossing appears to be in good condition. (A. Freitag - DWR Sutter Yard)  
07/13/2015 Minor sediment build up blocking flap gate from opening on WS. Needs to be dug out. (A. Freitag - DWR Sutter Yard)  
05/21/2014 Same as last inspection. (A. Freitag - DWR Sutter Yard)  
12/03/2013 Same as last inspection. (A. Freitag - DWR Sutter Yard)  
07/15/2013 Slopes are cleared of vegetation and are in good condition. WS flap gate is blocked from opening fully by sediment. (A. Freitag - DWR Sutter Yard)  
04/18/2012 Sediment build up on LS. Debris (broken panels) scattered near LS headwall. Limited inspection on WS and LS slope due to dense vegetation. Need photos of cleared WS and LS slopes. (O. Magana - DWR UCIP)  
FIELD\_STRUCT\_DESC: 24-inch CIPP-lined corrugated metal drainage pipe through the levee, 9.3 feet below the crown. Flap gate on the waterside (WS) end. Concrete "U" headwalls on both ends. Flashboards should be present on the landside (LS). [Additional Reference(s): DWR Levee Log, 1993 (HLM 8.40). USACE Sacramento O&M Manual, Unit 519, June 1962, Revised 3 Feb 2011, (HLM 8.40), As-built DWG No. 50-4-3608, Sheet No. 3608/18, STA 681+30E, page 19 of 28 electronic file, listed as 24-inch CMP; As-built DWG No 50-4-3037 referenced not available]

LS view: Close-up view of pipe inlet with flashboards in place.

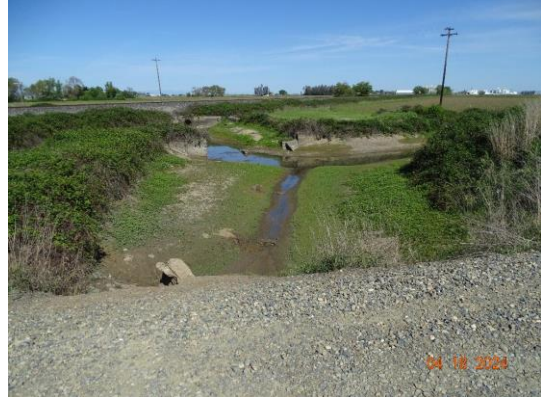
Photo 1 of 3 : UCIP\_SP\_2024\_83060\_121034.jpg

DS\_ID:16323  
FS\_ID:83060  
EP\_NO: N/A  
Repair Type: Urgent  
EVAL Issue: 2b, Levee Integrity  
Crossing Status: Found  
UCIP Comments: 04/18/2024 Record remains Urgent. Erosion of more than 1/2-foot displacement is present around the concrete headwall on the LS. No permit has been identified authorizing pipe. (M. Thao - DWR UCIP)  
08/27/2019 Same as last inspection; crossing remains Urgent due to LS toe erosion. No permit has been identified authorizing irrigation structure. (O. Magana - DWR UCIP, A. Freitag - DWR Sutter Yard)  
08/23/2018 Same as last inspection; crossing remains Urgent because LS erosion is still present and poses a levee integrity risk. (D. Sanoski - DWR UCIP)  
06/14/2017 LS underwater but levee erosion is still present- needs to be repaired. Pipe has been selected to be internally cleaned and inspected as part of the DMP project. (A. Freitag - DWR Sutter Yard)  
11/16/2016 LS erosion is still a major problem here. (A. Freitag - DWR Sutter Yard)

04/28/2016 Erosion still present at the LS headwall. (A. Freitag - DWR Sutter Yard)  
07/13/2015 Erosion still present behind the LS headwall. It looks to be getting worse and is starting to affect the levee slope. (A. Freitag - DWR Sutter Yard)  
05/21/2014 Same as last inspection. (A. Freitag - DWR Sutter Yard)  
12/03/2013 Same as last inspection. (A. Freitag - DWR Sutter Yard)  
07/15/2013 Same as last inspection. (A. Freitag - DWR Sutter Yard)  
04/18/2012 Concrete headwall is cracked, erosion behind headwall is also present. LS headwall needs to be repaired/replaced. Remove wooden debris from levee shoulder. (O. Magana - DWR UCIP)  
FIELD\_STRUCT\_DESC: [Richvale Irrigation Canal Siphon] 60-inch by 84-inch (5-foot by 7 foot) concrete irrigation conduit through the levee, 18.4 feet below the crown. Distribution box and walkway are located on the waterside (WS). Concrete headwall on the landside (LS). 28-foot reinforced concrete protective slab on top of the conduit in the center of the levee. [Additional Reference(s): DWR Levee Log, 1993 (HLM 8.95). USACE Sacramento O&M Manual, Unit 519, June 1962, Revised 3 Feb 2011, (HLM 8.95), listed as 5-foot by 7-foot concrete conduit, As-built DWG No. 50-4-3608, Sheet No. 3608/20, STA 651+66E, page 21 of 28 electronic file, listed as 6-foot diameter concrete pipe (siphon)]

LS view: General overview looking from crown; erosion at concrete headwall.

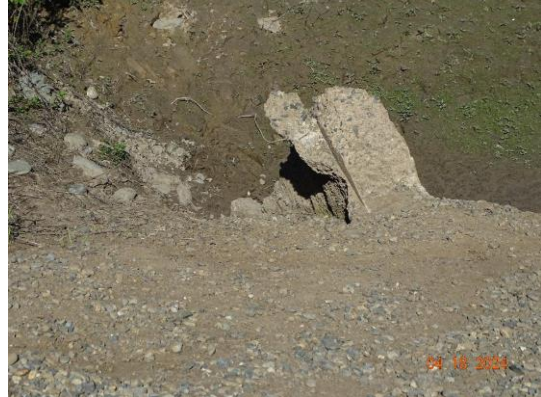
Photo 2 of 3 : UCIP\_SP\_2024\_83060\_121035.jpg

LS view: Erosion of more than 1/2-foot displacement at concrete headwall.

LM Start	<b>8.82</b>	Rating **	U	Issue No.	<b>104 (cont)</b>
LM End	<b>8.82</b>	Issue Type +	En	Location *

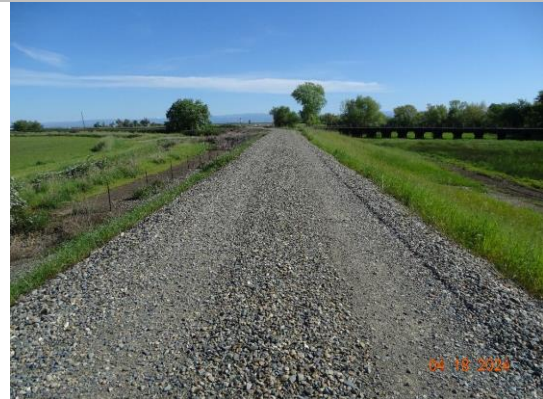
Photo 1 of 3 : UCIP\_SP\_2024\_83051\_120997.jpg

DS\_ID:16317  
FS\_ID:83051  
EP\_NO: N/A  
Repair Type: No Action Needed  
EVAL Issue:  
Crossing Status: Found  
UCIP Comments: 04/18/2024 Record updated from Non-Urgent to No Action Needed. Pipe was CIPP lined on 02/04/2020. DMP internal video inspection has found none or minor pipe defects. No issues observed during inspection. (M. Thao - DWR UCIP)  
09/25/2023 DMP internal video inspection has found none or minor pipe defects. Recommend next video inspection in 5 years. (J. Taylor - DWR UCIP)  
08/27/2019 Record has been updated from No Action Needed to Non-Urgent, no permit has been identified authorizing pipe. Pipe is scheduled to be lined. (O. Magana - DWR UCIP, A. Freitag - DWR Sutter Yard)  
06/14/2017 Crossing appears to be in good condition. Pipe has been selected to be internally cleaned and inspected as part of the DMP project. (A. Freitag - DWR Sutter Yard)  
11/16/2016 Crossing appears to be in good condition. (A. Freitag - DWR Sutter Yard)

Levee crown looking upstream.

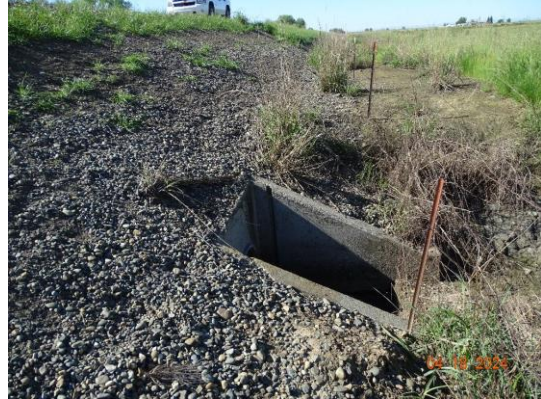
Photo 2 of 3 : UCIP\_SP\_2024\_83051\_121000.jpg

LS view: Concrete headwall at toe.

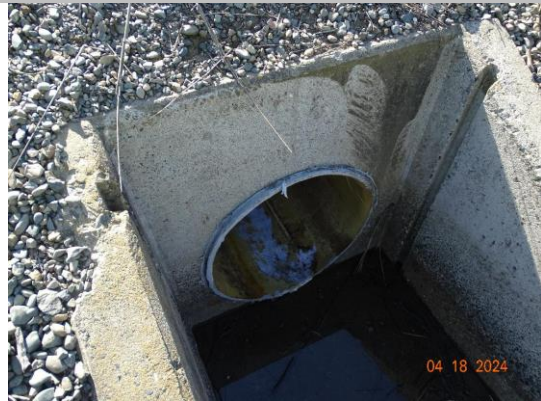
Photo 3 of 3 : UCIP\_SP\_2024\_83051\_120999.jpg

LS view: Pipe inlet and concrete headwall at toe.

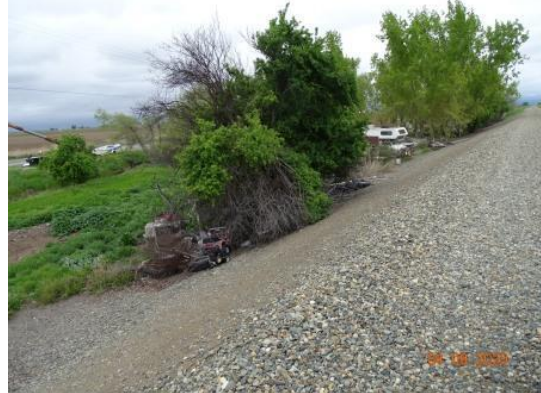
Photo 1 of 1 : SP\_2024\_MA0013\_300\_10\_20240212\_00003.jpg

LM Start	9.73	Rating **	M	Issue No.	10
LM End	9.75	Issue Type +	En	Location *	LS
Category	Earthen Levee			GPS Latitude/Longitude	
				Start	End
Item	Encroachments			39.466732°	39.466478°
				-121.744180°	-121.744338°
DWR ID	DWR_MA0013_01_f_2013_10				
Comment Code					
MA : Material					
Inspector Comment					
Move the trailer and materials outside the 10 foot easement.

View of trailer and material along the landside toe. Spring 2020.

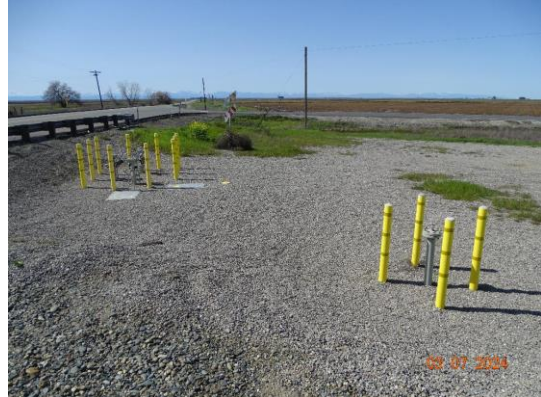
Photo 1 of 1 : UCIP\_SP\_2024\_82522\_119622.jpg

Comment Code						
Inspector Comment						
DS_ID:16331 FS_ID:82522 EP_NO: 1238 Repair Type: Non-Urgent EVAL Issue: 10, Unauthorized Modification or Non-Compliant Permit Crossing Status: Indicator Found UCIP Comments: 03/07/2024 Record remains Non-Urgent. LS appurtenances appear to have been modified; unable to find a permit for modification. No inspection records were available to determine status of line through the levee. No permit has been identified authorizing pipe. (M. Thao - DWR UCIP) 08/27/2019 Record has been updated from No Action Needed to Non-Urgent, no maintenance records were made available to determine condition of line through levee. Need to contact owner to request maintenance records to confirm integrity of line. (O. Magana - DWR UCIP, A. Freitag - DWR Sutter Yard) 06/14/2017 Crossing appears to be in good condition. (A. Freitag - DWR Sutter Yard) 11/16/2016 Crossing appears to be in good condition. (A. Freitag - DWR Sutter Yard) 04/28/2016 Crossing appears to be in good condition. (A. Freitag - DWR Sutter Yard) 07/13/2015 Crossing appears in good condition. No noticeable issues to report. (A. Freitag - DWR Sutter Yard) 05/21/2014 Same as last inspection. (A. Freitag - DWR Sutter Yard) 12/03/2013 Same as last inspection. (A. Freitag - DWR Sutter Yard) 07/15/2013 New structure with shutoff valve installed about 5ft. from LS toe. (A. Freitag - DWR Sutter Yard) FIELD_STRUCT_DESC: 8-inch high pressure gas line through the levee, 13.3 feet below the crown. Substation with wire enclosure at the landside (LS) toe. (6.625-inch gas line authorized under Permit No. 1238, 1947 - Pacific Gas and Electric Company [PG&E]) [Additional Reference(s): DWR Levee Log, 1993 (HLM 10.03). USACE Sacramento O&M Manual 519, June 1962 (HLM 10.03), listed as 8-inch gas line] FS Date: 3/7/2024 11:08:38 AM

LS view: Shut-off valves with bollards near toe; looking from levee.

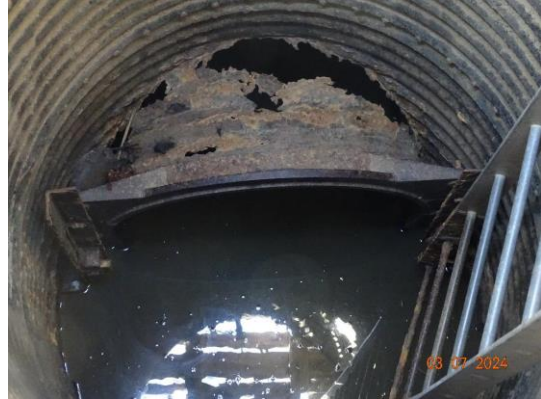
Photo 1 of 2 : UCIP\_SP\_2024\_82516\_119601.jpg

WS view: Slide gate missing in CMP riser; pipe through levee within riser has holes.

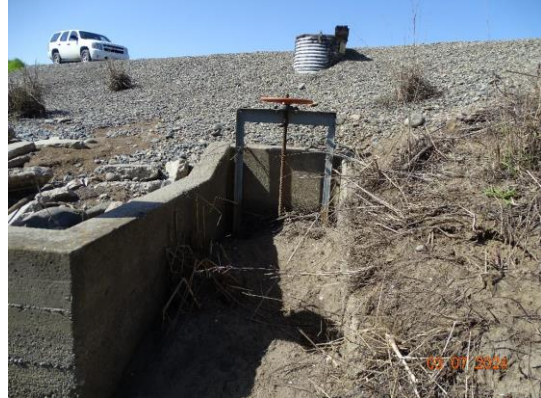
Photo 2 of 2 : UCIP\_SP\_2024\_82516\_119595.jpg

LM Start	<b>12.74</b>	Rating **	U	Issue No.	<b>108 (cont)</b>
LM End	<b>12.74</b>	Issue Type +	En	Location *

WS view: Concrete headwall with slide gate at toe; sediment blocking gate. CMP riser on slope (background).

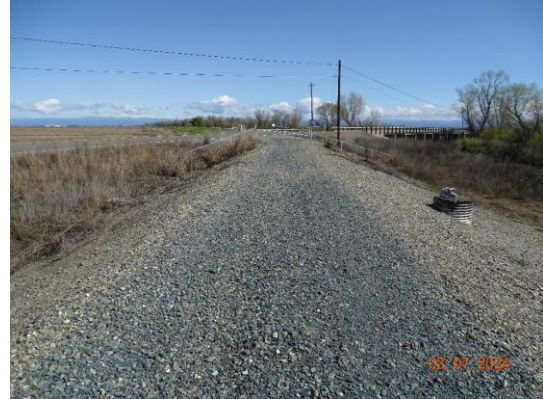
Photo 1 of 3 : UCIP\_SP\_2024\_82509\_119586.jpg

DS\_ID:16337  
FS\_ID:82509  
EP\_NO: N/A  
Repair Type: Non-Urgent  
EVAL Issue: 5, Pipe Damage  
Crossing Status: Found  
UCIP Comments: 03/07/2024 Record remains Non-Urgent. DMP internal video inspection has found moderate pipe defects. Crossing will be monitored until funding becomes available for rehabilitation. No permit has been identified authorizing pipe. (M. Thao - DWR UCIP)  
08/27/2019 Record has been updated from No Action Needed to Non-Urgent, no permit has been identified authorizing the dual purpose of this crossing. This crossing is not maintained or operated by LMA-Sutter Yard. (O. Magana - DWR UCIP, A. Freitag - DWR Sutter Yard)  
06/15/2017 Crossing appears to be in good condition. Pipe has been selected to be internally cleaned and inspected as part of the DMP project. (A. Freitag - DWR Sutter Yard)  
11/17/2016 WS pipe end was submerged but crossing appears to be in good condition. (A. Freitag - DWR Sutter Yard)

Levee crown looking upstream.

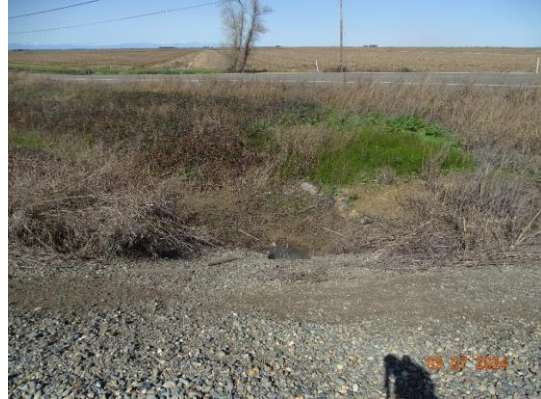
Photo 2 of 3 : UCIP\_SP\_2024\_82509\_119588.jpg

LM Start	13.33	Rating **	M	Issue No.	109 (cont)
LM End	13.33	Issue Type +	En	Location *	
Category	Supplemental			GPS Latitude/Longitude	
				Start	End
Item	DWR UCIP Field Study			39.420667°	39.420667°
				-121.775700°	-121.775700°
DWR ID	16337

LS view: General overview looking from crown.

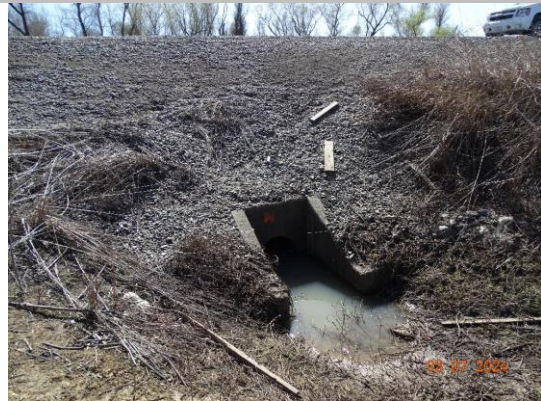
Photo 3 of 3 : UCIP\_SP\_2024\_82509\_119589.jpg

LM Start	<b>13.33</b>	Rating **	M	Issue No.	<b>109 (cont)</b>
LM End	<b>13.33</b>	Issue Type +	En	Location *

LS view: Concrete headwall at toe.

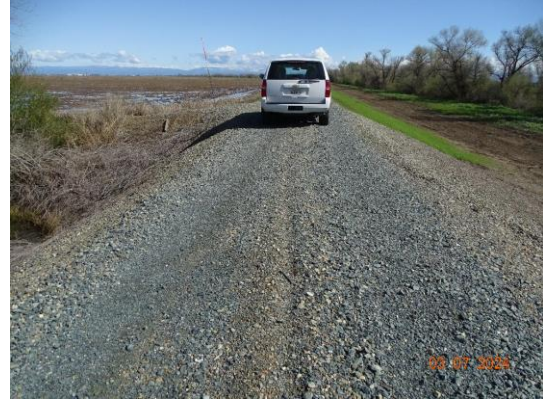
Photo 1 of 3 : UCIP\_SP\_2024\_82508\_119584.jpg

DS\_ID:16338  
FS\_ID:82508  
EP\_NO: N/A  
Repair Type: Non-Urgent  
EVAL Issue:  
Crossing Status: Found  
UCIP Comments: 03/07/2024 Record remains Non-Urgent. Both the LS and WS were submerged limiting inspection of the concrete headwalls and pipe inlet and outlet. DMP internal video inspection has found none or minor pipe defects. (M. Thao - DWR UCIP)  
09/25/2023 DMP internal video inspection has found none or minor pipe defects. Recommend next video inspection in 5 years. (J. Taylor - DWR UCIP)  
08/27/2019 Record remains Non-Urgent, no permit has been identified authorizing pipe. Pipe is scheduled to be lined. (O. Magana - DWR UCIP, A. Freitag - DWR Sutter Yard)  
08/23/2018 WS flap gate has been replaced. LS outlet still has a lot of vegetation, but overall levee integrity looks good at time of this inspection. Downgrading to Non-Urgent from Urgent due to fixed flap gate and current levee condition. (D. Sanoski - DWR UCIP)

Levee crown looking upstream.

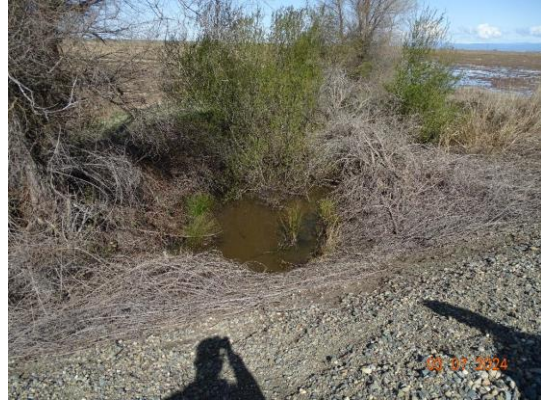
Photo 2 of 3 : UCIP\_SP\_2024\_82508\_119583.jpg

LM Start	<b>13.76</b>	Rating **	M	Issue No.	<b>110 (cont)</b>
LM End	<b>13.76</b>	Issue Type +	Ma	Location *

LS view: General overview looking from crown; concrete headwall submerged.

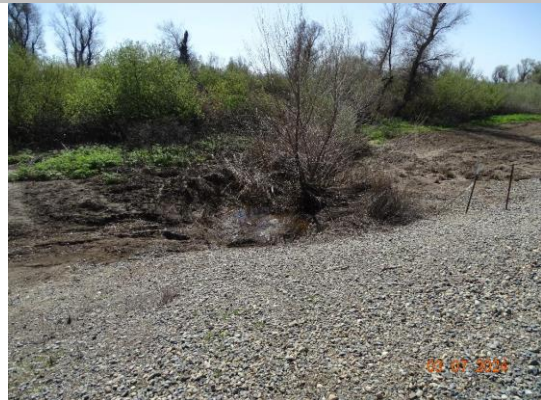
Photo 3 of 3 : UCIP\_SP\_2024\_82508\_119585.jpg

LM Start	<b>13.76</b>	Rating **	M	Issue No.	<b>110 (cont)</b>
LM End	<b>13.76</b>	Issue Type +	Ma	Location *

WS view: General overview looking from crown.

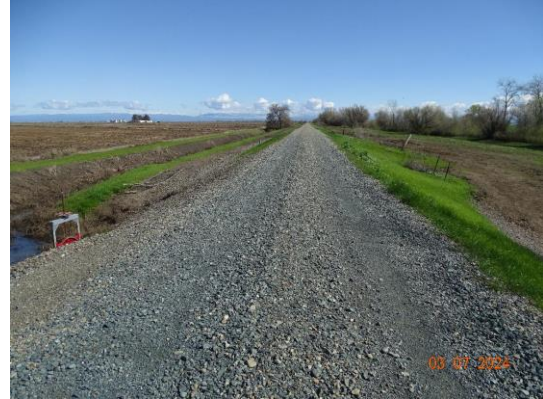
Photo 1 of 3 : UCIP\_SP\_2024\_82462\_119450.jpg

DS\_ID:16368  
FS\_ID:82462  
EP\_NO: N/A  
Repair Type: No Action Needed  
EVAL Issue:  
Crossing Status: Found  
UCIP Comments: 03/07/2024 Record updated from Non-Urgent to No Action Needed. DMP internal video inspection has found none or minor pipe defects. No issues observed during inspection. (M. Thao - DWR UCIP)  
09/25/2023 DMP internal video inspection has found none or minor pipe defects. Recommend next video inspection in 5 years. (J. Taylor - DWR UCIP)  
02/11/2020 Record updated from Urgent to Non-Urgent. Pipe has been CIPP-lined. Levee integrity issue recorded previously needs to be confirmed during next field inspection and updated if not present. (O. Yakimov - DWR UCIP)  
08/27/2019 Record remains Urgent due to pipe integrity and levee integrity issues. Previously noted holes on the pipe collar located at WS have been sealed using splash zone epoxy. Two holes (possible sink holes) were observed behind WS concrete headwall. Recommend internal inspection of pipe through levee to determine if sink holes are attributed to holes in pipe. (O. Magana - DWR UCIP, A. Freitag - DWR Sutter Yard)

Levee crown looking upstream.

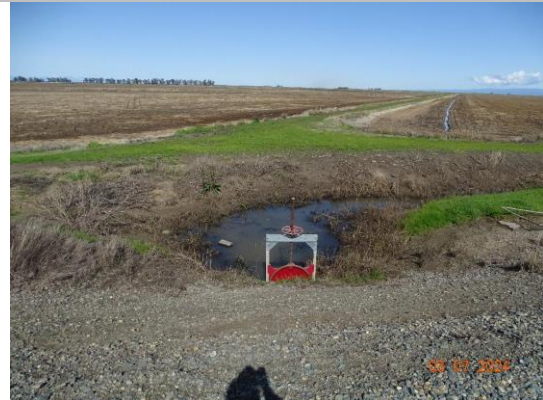
Photo 2 of 3 : UCIP\_SP\_2024\_82462\_119451.jpg

LM Start	<b>14.58</b>	Rating **	A	Issue No.	<b>111 (cont)</b>
LM End	<b>14.58</b>	Issue Type +	Ma	Location *

LS view: Back of slide gate and guide at toe; looking from crown.

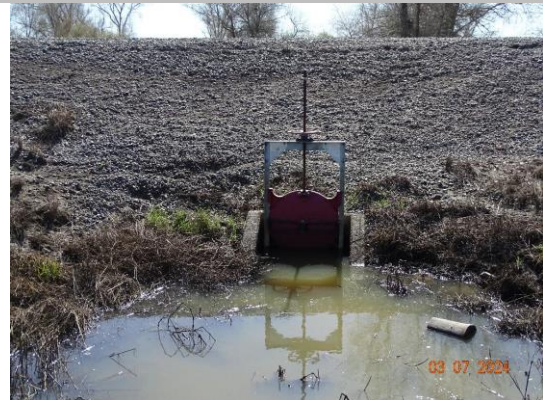
Photo 3 of 3 : UCIP\_SP\_2024\_82462\_119449.jpg

LM Start	<b>14.58</b>	Rating **	A	Issue No.	<b>111 (cont)</b>
LM End	<b>14.58</b>	Issue Type +	Ma	Location *

LS view: Concrete headwall and slide gate at toe.

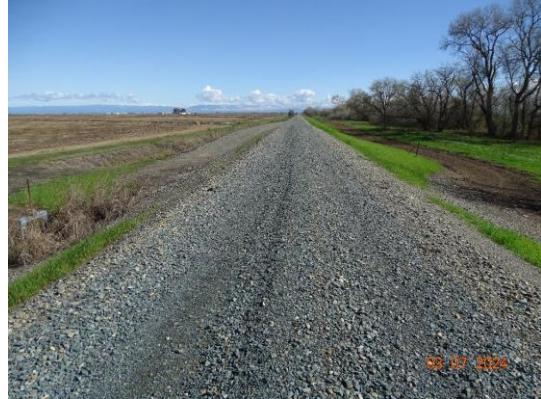
Photo 1 of 3 : UCIP\_SP\_2024\_82461\_119443.jpg

Comment Code						
Inspector Comment						
DS_ID:16367						
FS_ID:82461						
EP_NO: N/A						
Repair Type: No Action Needed						
EVAL Issue:						
Crossing Status: Found						
UCIP Comments: 03/07/2024 Record updated from Non-Urgent to No Action Needed. DMP internal video inspection has found none or minor pipe defects. No issues observed during inspection. (M. Thao - DWR UCIP)						
09/25/2023 DMP internal video inspection has found none or minor pipe defects. Recommend next video inspection in 5 years. (J. Taylor - DWR UCIP)						
08/27/2019 Record has been updated from No Action Needed to Non-Urgent, no permit has been identified authorizing pipe. Pipe is scheduled to be lined. (O. Magana - DWR UCIP, A. Freitag - DWR Sutter Yard)						
06/15/2017 Crossing appears to be in good condition. Pipe has been selected to be internally cleaned and inspected as part of the DMP project. (A. Freitag - DWR Sutter Yard)

Levee crown looking upstream.

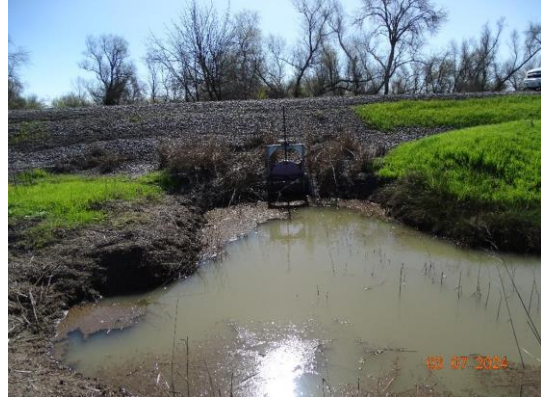
Photo 2 of 3 : UCIP\_SP\_2024\_82461\_119444.jpg

LM Start	14.91	Rating **	A	Issue No.	112 (cont)
LM End	14.91	Issue Type +	Ma	Location *	
Category	Supplemental			GPS Latitude/Longitude	
				Start	End
Item	DWR UCIP LMA Responsibility			39.406570°	39.406570°
				-121.798770°	-121.798770°
DWR ID	16367

LS view: Concrete headwall and slide gate at toe; looking toward levee.

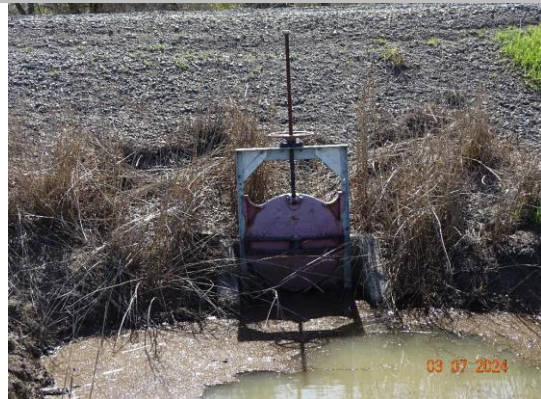
Photo 3 of 3 : UCIP\_SP\_2024\_82461\_119445.jpg

LM Start	<b>14.91</b>	Rating **	A	Issue No.	<b>112 (cont)</b>
LM End	<b>14.91</b>	Issue Type +	Ma	Location *

LS view: Close-up view of concrete headwall and slide gate at toe.

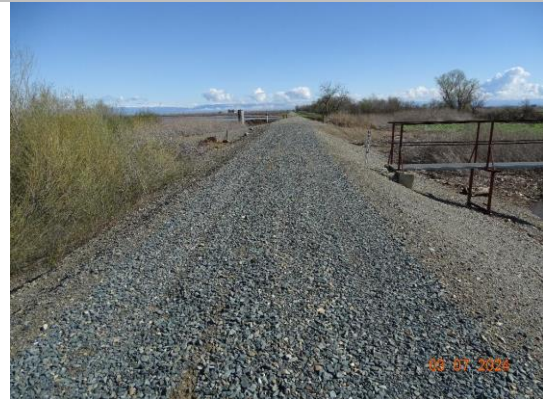
Photo 1 of 3 : UCIP\_SP\_2024\_82459\_119436.jpg

DS\_ID:16373  
FS\_ID:82459  
EP\_NO: 11805B  
Repair Type: Non-Urgent  
EVAL Issue: 6, Levee Damage or Threat for Levee Damage  
Crossing Status: Found  
UCIP Comments: 03/07/2024 Record remains Non-Urgent. Minor erosion of less than 1/2-foot of displacement at LS toe. Both LS and WS were submerged limiting inspection of pipe inlet and outlet. (M. Thao - DWR UCIP)  
08/27/2019 Record remains Non-Urgent, sloughing/erosion observed on the LS toe during inspection. Recommend monitoring to determine progression of sloughing/erosion. (O. Magana - DWR UCIP, A. Freitag - DWR Sutter Yard)  
06/15/2017 Both pipe ends submerged during site visit. LS ditch near pipe end is heavily vegetated and covering the pipe end. There is some erosion happening at the LS levee toe but this is more of a ditch problem and not a problem with the pipe. (A. Freitag - DWR Sutter Yard)  
11/17/2016 Both pipe ends underwater at time of inspection. (A. Freitag - DWR Sutter Yard)

Levee crown looking upstream.

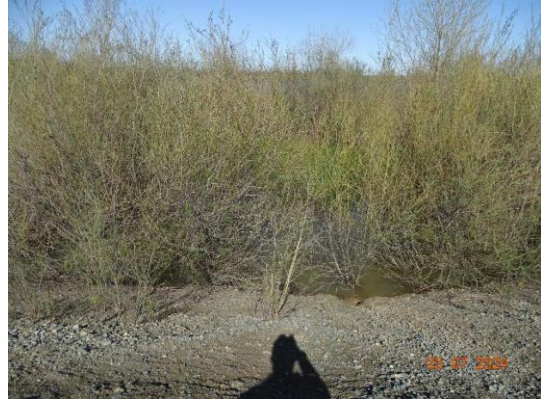
Photo 2 of 3 : UCIP\_SP\_2024\_82459\_119439.jpg

LM Start	15.77	Rating **	M	Issue No.	113 (cont)
LM End	15.77	Issue Type +	En	Location *	
Category	Supplemental			GPS Latitude/Longitude	
				Start	End
Item	DWR UCIP Field Study			39.398615°	39.398615°
				-121.811250°	-121.811250°
DWR ID	16373

LS view: General overview looking from crown; pipe outlet submerged.

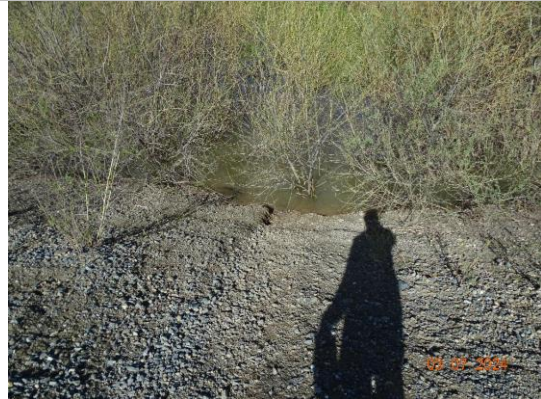
Photo 3 of 3 : UCIP\_SP\_2024\_82459\_119435.jpg

LM Start	15.77	Rating **	M	Issue No.	113 (cont)
LM End	15.77	Issue Type +	En	Location *

LS view: Minor erosion of less than 1/2-foot displacement at toe.

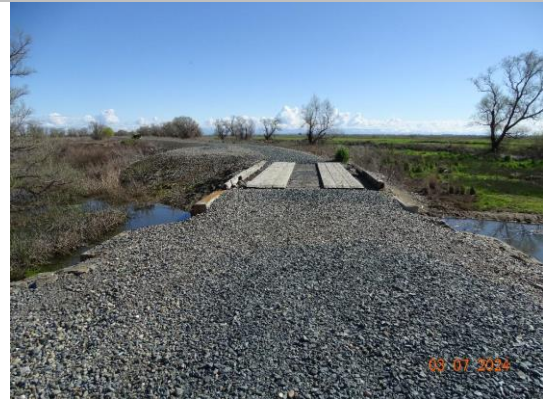
Photo 1 of 3 : UCIP\_SP\_2024\_82458\_119434.jpg

DS\_ID:16372  
FS\_ID:82458  
EP\_NO: N/A  
Repair Type: Non-Urgent  
EVAL Issue:  
Crossing Status: Found  
UCIP Comments: 03/07/2024 Record updated from Non-Urgent to No Action Needed. No issues observed during inspection. (M. Thao - DWR UCIP)  
08/27/2019 Structure is referenced in Permit Number 11805. Need to pull permit to review details. Need to update structure description to reference correct permit. (O. Magana - DWR UCIP, A. Freitag - DWR Sutter Yard)  
06/15/2017 Crossing appears to be in good condition. Pipe has been selected to be internally cleaned and inspected as part of the DMP project. (A. Freitag - DWR Sutter Yard)  
11/17/2016 Crossing appears to be in good condition. (A. Freitag - DWR Sutter Yard)  
05/03/2016 Crossing appears to be in good condition. (A. Freitag - DWR Sutter Yard)  
07/13/2015 Crossing appears in good condition. No noticeable issues to report. (A. Freitag - DWR Sutter Yard)

Levee crown looking upstream.

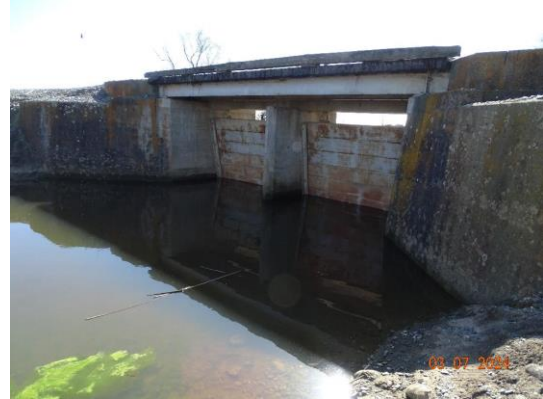
Photo 2 of 3 : UCIP\_SP\_2024\_82458\_119433.jpg

LM Start	<b>16.19</b>	Rating **	M	Issue No.	<b>114 (cont)</b>
LM End	<b>16.19</b>	Issue Type +	Ma	Location *	
Category	Supplemental		GPS Latitude/Longitude		
			Start	End	
Item	DWR UCIP LMA Responsibility		39.394748°	39.394748°	
			-121.817360°	-121.817360°	
DWR ID	16372

LS view: View of structure and metal stop logs.

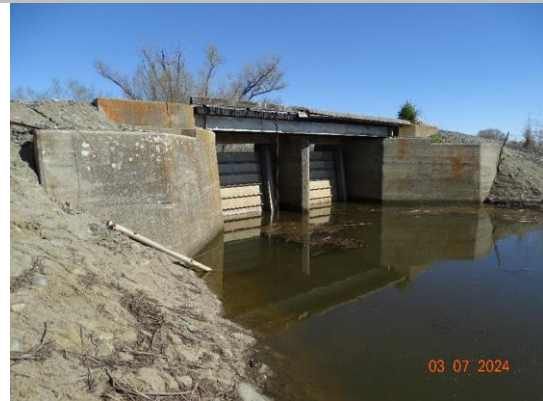
Photo 3 of 3 : UCIP\_SP\_2024\_82458\_119432.jpg

LM Start	<b>16.19</b>	Rating **	M	Issue No.	<b>114 (cont)</b>
LM End	<b>16.19</b>	Issue Type +	Ma	Location *

WS view: View of structure and metal stop logs.

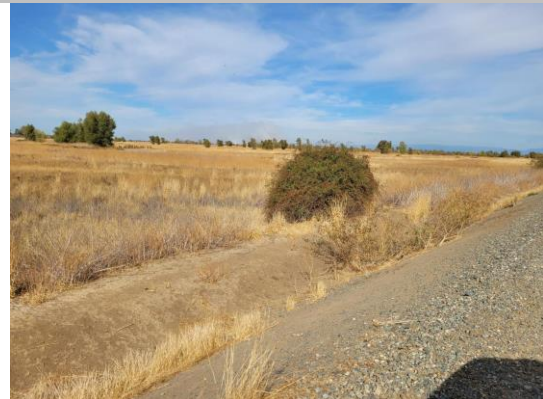
Photo 1 of 1 : SP\_2024\_MA0013\_300\_7\_20240212\_00002.jpg

LM Start	16.22	Rating **	M	Issue No.	7
LM End	17.17	Issue Type +	En	Location *	LS
Category	Earthen Levee			GPS Latitude/Longitude	
				Start	End
Item	Encroachments			39.394523°	39.385580°
				-121.817630°	-121.831282°
DWR ID	DWR_MA0013_01_s_2012_7				
Comment Code					
DT : Ditch					
Inspector Comment

View of the ditch along the landside toe. Fall 2021.

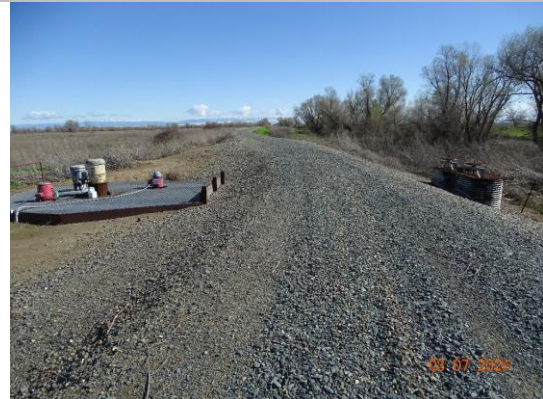
Photo 1 of 3 : UCIP\_SP\_2024\_82524\_119635.jpg

Comment Code						
Inspector Comment						
DS_ID:16370						
FS_ID:82524						
EP_NO: N/A						
Repair Type: Non-Urgent						
EVAL Issue: 6, Levee Damage or Threat for Levee Damage						
Crossing Status: Found						
UCIP Comments: 03/07/2024 Record remains Non-Urgent. Minor erosion present at LS toe along sump structure. Erosion present approximately 20 feet from LS toe along both upstream and downstream wingwalls. Previous comment mentions that the structure is referenced in Permit No. 11805; UCIP will review permit during QAP process. (M. Thao - DWR UCIP)						
08/27/2019 Record has been updated from No Action Needed to Non-Urgent due to maintenance issue. Minor scour is present at the concrete wingwalls located on LS. Need to contact owner to address maintenance issue (minor scour). No permit has been identified authorizing pipe. Structure is referenced in permit number 11805. Need to pull permit to review details and update structure description to reference correct permit. (O. Magana - DWR UCIP, A. Freitag - DWR Sutter Yard)

Levee crown looking upstream.

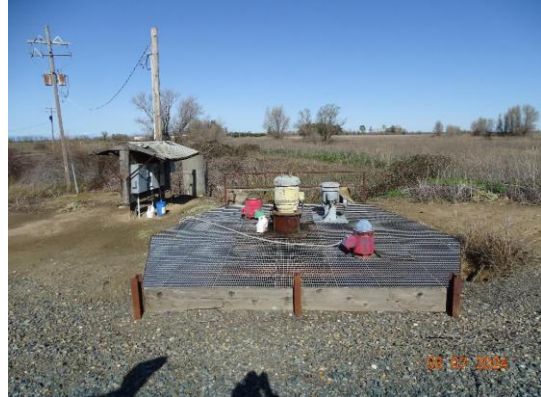
Photo 2 of 3 : UCIP\_SP\_2024\_82524\_119634.jpg

LM Start	17.19	Rating **	M	Issue No.	115 (cont)
LM End	17.19	Issue Type +	En	Location *	
Category	Supplemental			GPS Latitude/Longitude	
				Start	End
Item	DWR UCIP Field Study			39.385415°	39.385415°
				-121.831480°	-121.831480°
DWR ID	16370

LS view: Concrete sump structure with pumps at toe; looking from crown.

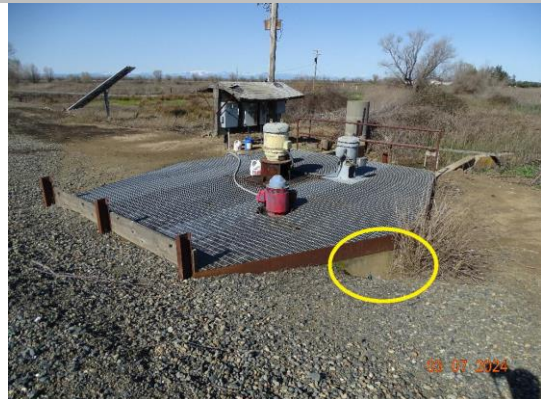
Photo 3 of 3 : UCIP\_SP\_2024\_82524\_119636.jpg

LM Start	17.19	Rating **	M	Issue No.	115 (cont)
LM End	17.19	Issue Type +	En	Location *

LS view: Minor erosion (yellow circle) at toe along sump structure.

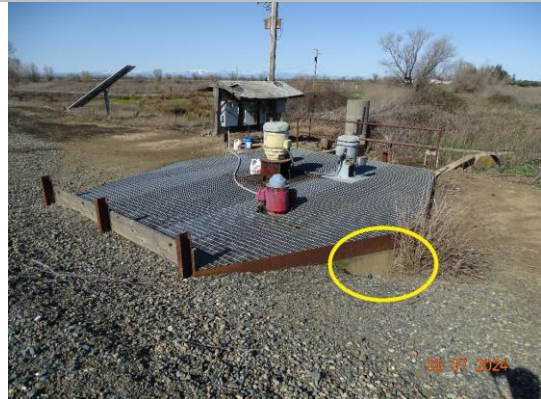
Photo 1 of 3 : UCIP\_SP\_2024\_82523\_119627.jpg

DS\_ID:17133  
FS\_ID:82523  
EP\_NO: N/A  
Repair Type: Non-Urgent  
EVAL Issue: 6, Levee Damage or Threat for Levee Damage  
Crossing Status: Found  
UCIP Comments: 03/07/2024 Record remains Non-Urgent. Minor erosion present at LS toe along sump structure. Erosion present approximately 20 feet from LS toe along both upstream and downstream wingwalls. Previous comment mentions that the structure is referenced in Permit No. 11805; UCIP will review permit during QAP process. (M. Thao - DWR UCIP)  
08/27/2019 Record has been updated from No Action Needed to Non-Urgent due to maintenance issue. Minor scour is present at the concrete wingwalls located on LS. Need to contact owner to address maintenance issue (minor scour). No permit has been identified authorizing pipe. Structure is referenced in permit number 11805. Need to pull permit to review details and update structure description to reference correct permit. (O. Magana - DWR UCIP, A. Freitag - DWR Sutter Yard)

LS view: Minor erosion (yellow circle) at toe along sump structure.

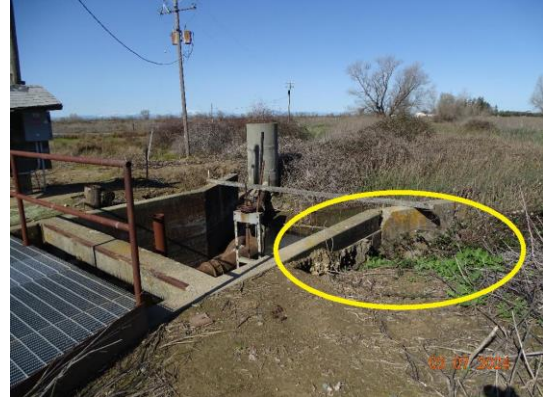
Photo 2 of 3 : UCIP\_SP\_2024\_82523\_119624.jpg

LM Start	17.19	Rating **	M	Issue No.	116 (cont)
LM End	17.19	Issue Type +	En	Location *	
Category	Supplemental		GPS Latitude/Longitude		
			Start	End	
Item	DWR UCIP Field Study		39.385415°	39.385415°	
			-121.831480°	-121.831480°	
DWR ID	17133

LS view: Erosion on upstream wingwall; looking away from levee.  
Erosion is located approximately 20 feet off toe.

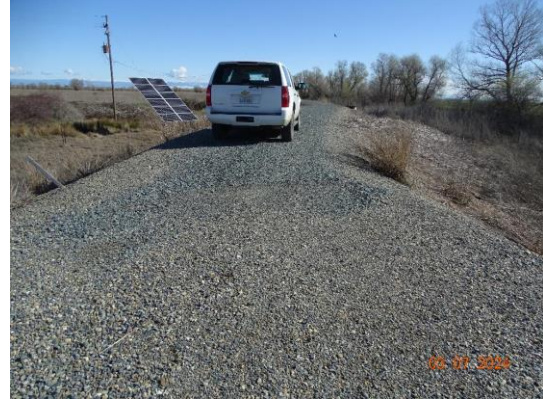
Photo 1 of 3 : UCIP\_SP\_2024\_82455\_119425.jpg

DS\_ID:16369  
FS\_ID:82455  
EP\_NO: N/A  
Repair Type: No Action Needed  
EVAL Issue:  
Crossing Status: Found  
UCIP Comments: 03/07/2024 Record updated from Non-Urgent to No Action Needed. DMP internal video inspection has found none or minor pipe defects. No issues observed during inspection. (M. Thao - DWR UCIP)  
09/25/2023 DMP internal video inspection has found none or minor pipe defects. Recommend next video inspection in 5 years. (J. Taylor - DWR UCIP)  
08/27/2019 Record remains Non-Urgent, no permit has been identified authorizing pipe. Pipe has been lined. (O. Magana - DWR UCIP, A. Freitag - DWR Sutter Yard)  
06/15/2017 Flap gate bolted shut. Hinges seem very stiff to operate as gate will not fully close and has about a 1/2" gap near the top. Land owner claims the gate leaks during high water times. Pipe has been selected to be internally cleaned and inspected as part of the DMP project. (A. Freitag - DWR Sutter Yard)

Levee crown looking upstream.

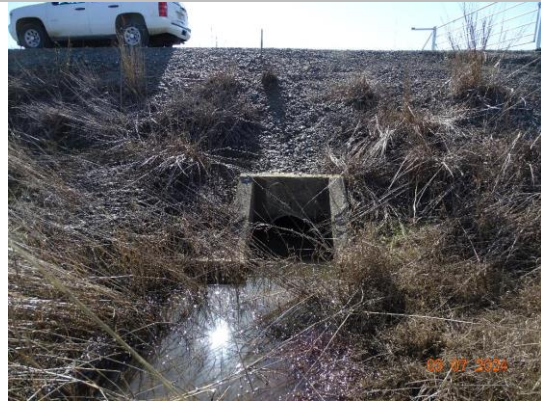
Photo 2 of 3 : UCIP\_SP\_2024\_82455\_119427.jpg

LM Start	17.23	Rating **	A	Issue No.	117 (cont)
LM End	17.23	Issue Type +	Ma	Location *	
Category	Supplemental		GPS Latitude/Longitude		
			Start	End	
Item	DWR UCIP LMA Responsibility		39.385172°	39.385172°	
			-121.832060°	-121.832060°	
DWR ID	16369

LS view: Concrete headwall at toe; looking toward levee.

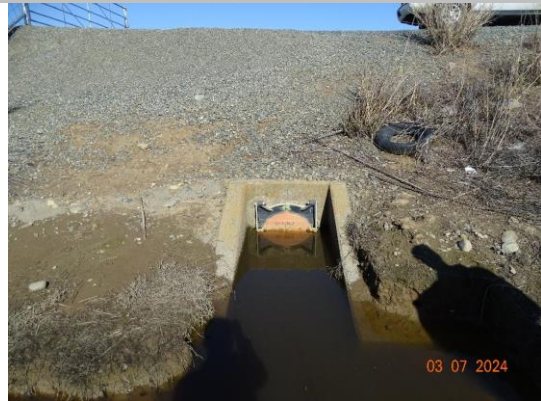
Photo 3 of 3 : UCIP\_SP\_2024\_82455\_119426.jpg

LM Start	17.23	Rating **	A	Issue No.	117 (cont)
LM End	17.23	Issue Type +	Ma	Location *

WS view: Concrete headwall and flap gate at toe; looking toward levee.

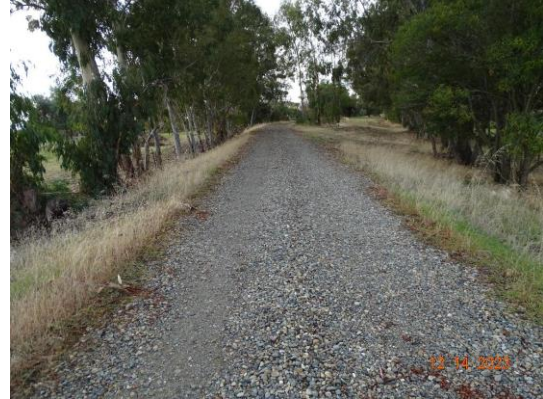
Photo 1 of 3 : UCIP\_SP\_2024\_82153\_118955.jpg

DS\_ID:16397  
FS\_ID:82153  
EP\_NO: N/A  
Repair Type: No Action Needed  
EVAL Issue:  
Crossing Status: Found  
UCIP Comments: 12/14/2023 Record updated from Non-Urgent to No Action Needed. DMP internal video inspection has found none or minor pipe defects. No issues observed during inspection. (M. Thao - DWR UCIP)  
09/25/2023 DMP internal video inspection has found none or minor pipe defects. Recommend next video inspection in 5 years. (J. Taylor - DWR UCIP)  
08/28/2019 Record remains Non-Urgent, no permit has been identified authorizing pipe. Pipe has been lined. (O. Magana - DWR UCIP, A. Freitag - DWR Sutter Yard)  
06/05/2017 Crossing appears to be in good condition. (A. Freitag - DWR Sutter Yard)  
11/18/2016 Crossing appears to be in good condition. 4-inch pipe still present on LS but it does not affect the function of the crossing. (A. Freitag - DWR Sutter Yard)  
09/27/2016 Crossing has been downgraded from Urgent to Non-Urgent--sleeved pipe does not prevent flap gate from closing on WS. Still need to coordinate with owner to remove sleeved pipe through existing crossing per Title 23. (O. Magana - DWR UCIP)

Levee crown looking downstream.

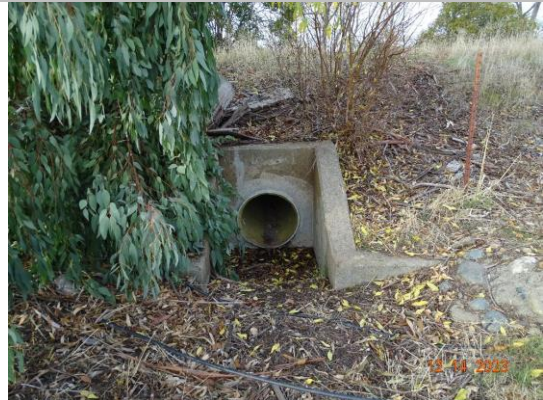
Photo 2 of 3 : UCIP\_SP\_2024\_82153\_118956.jpg

LS view: Concrete headwall at toe; looking towards levee.

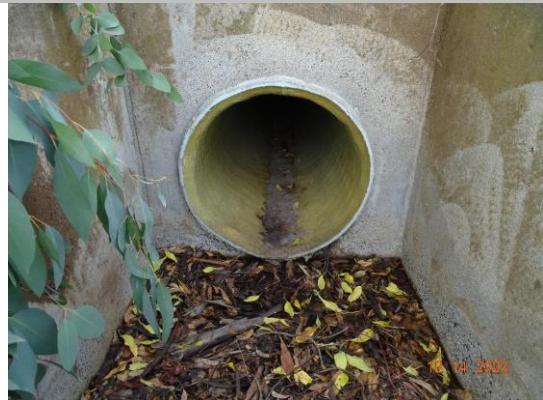
Photo 3 of 3 : UCIP\_SP\_2024\_82153\_118957.jpg

LS view: Close-up view of pipe inlet; pipe has been lined.

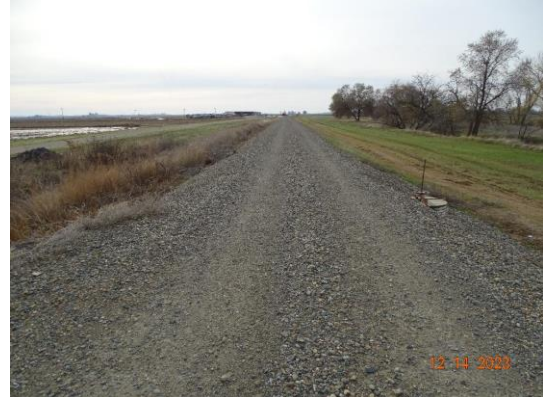
Photo 1 of 3 : UCIP\_SP\_2024\_82156\_118958.jpg

DS\_ID:16398  
FS\_ID:82156  
EP\_NO: N/A  
Repair Type: Non-Urgent  
EVAL Issue: 10, Unauthorized Modification or Non-Compliant Permit  
Crossing Status: Found  
UCIP Comments: 12/14/2023 Record remains Non-Urgent. Pipe is being used as an irrigation pipe according to the 08/28/2019 comment; unable to find a permit for modification. DMP internal video inspection has found none or minor pipe defects. (M. Thao - DWR UCIP)  
08/28/2019 Record remains Non-Urgent, no permit has been identified authorizing pipe and modifications. Structure type has been changed from drainage to irrigation. Mr. Sohnrey property owner mentioned that this pipe is being used as irrigation line. DMP internal video inspection has not found pipe integrity issues. LOF of crossing is less or equal to 4. Recommend next video inspection in 5 years. (O. Magana - DWR UCIP, A. Freitag - DWR Sutter Yard)  
06/05/2017 LS ditch at outlet is getting over grown with vegetation. WS near concrete standpipe is overgrown with vegetation. Pipe has been selected to be internally cleaned and inspected as part of the DMP project. (A. Freitag - DWR Sutter Yard)

11/18/2016 Between the screw gate on the WS shoulder and the LS pipe end the pipe is about 50% full of soil. Crossing is still actively used by landowner for irrigation purposes. (A. Freitag - DWR Sutter Yard)  
04/27/2016 Pipe gets used by the landowner to irrigate his rice fields. It appeared to be in good condition. (A. Freitag - DWR Sutter Yard)  
07/01/2015 LS pipe end is still about 50% full of sediment. (A. Freitag - DWR Sutter Yard)  
05/29/2014 Same as last inspection. (A. Freitag - DWR Sutter Yard)  
12/09/2013 Same as last inspection. (A. Freitag - DWR Sutter Yard)  
07/10/2013 LS and WS slopes have been cleared of vegetation and are in good condition. LS pipe end is half full of sediment. Sediment inside of WS standpipe may hinder slide gate from fully closing. Standpipe cover is still broken. (A. Freitag - DWR Sutter Yard)  
04/19/2012 Need to fix the top of slide gate cover. The wooden cap on standpipe is broken. Limited evaluation of crossing due to dense vegetation on LS slope. Need photos of cleared slopes during fall inspection. (O. Magana - DWR UCIP)

Levee crown looking downstream.

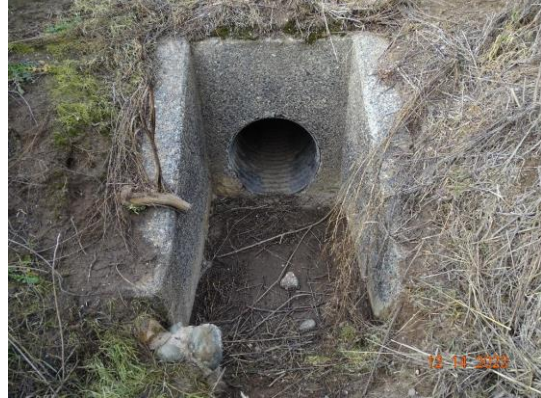
Photo 2 of 3 : UCIP\_SP\_2024\_82156\_118959.jpg

LS view: Concrete headwall at toe; looking towards levee.

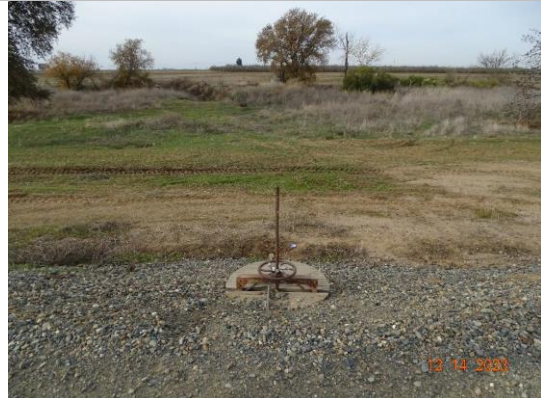
Photo 3 of 3 : UCIP\_SP\_2024\_82156\_118960.jpg

WS view: General overview looking from crown; slide gate in CMP riser (foreground) and 36-inch concrete standpipe in the background.

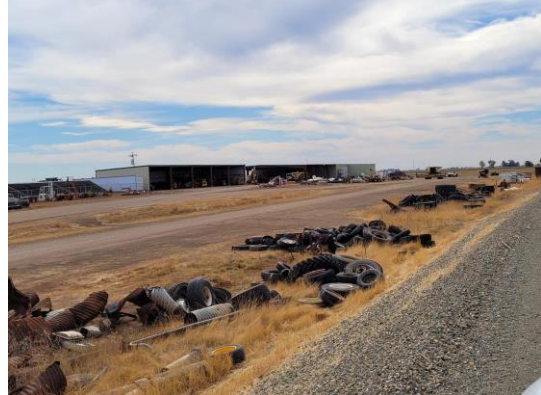
Photo 1 of 1 : SP\_2024\_MA0013\_301\_91\_20240212\_00012.jpg

LM Start	0.77	Rating **	M	Issue No.	91
LM End	0.85	Issue Type +	En	Location *	LS
Category	Earthen Levee			GPS Latitude/Longitude	
				Start	End
Item	Encroachments			39.563684°	39.562508°
				-121.702413°	-121.702535°
DWR ID	DWR_MA0013_02_f_2021_91				
Comment Code					
EQ : Equipment					
Inspector Comment

View of the equipment along the landside toe. Fall 2021.

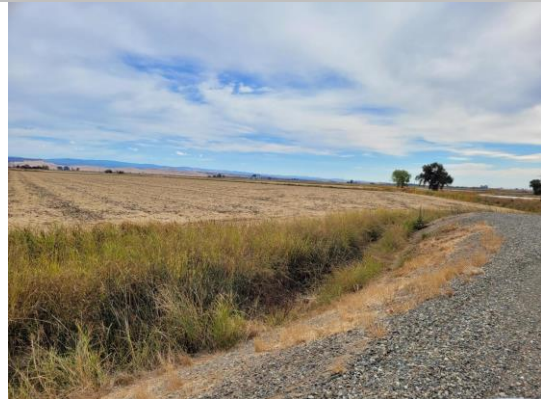
Photo 1 of 1 : SP\_2024\_MA0013\_301\_56\_20240212\_00008.jpg

LM Start	1.60	Rating **	U	Issue No.	56
LM End	1.63	Issue Type +	En	Location *	LS
Category	Earthen Levee			GPS Latitude/Longitude	
				Start	End
Item	Encroachments			39.552195°	39.551731°
				-121.704786°	-121.704721°
DWR ID	DWR_MA0013_02_s_2016_56				
Comment Code					
DT : Ditch					
Inspector Comment

View of the agricultural ditch along the landside toe. Fall 2021.

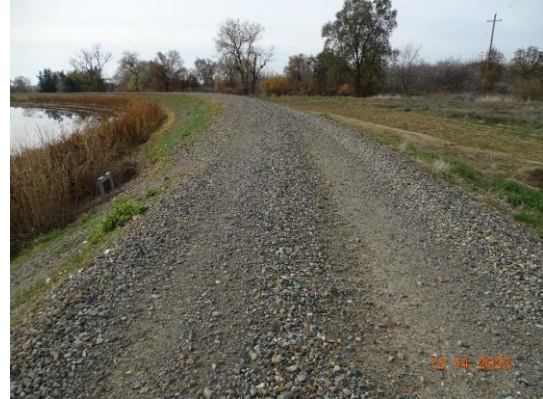
Photo 1 of 3 : UCIP\_SP\_2024\_82159\_118971.jpg

Levee crown looking downstream.

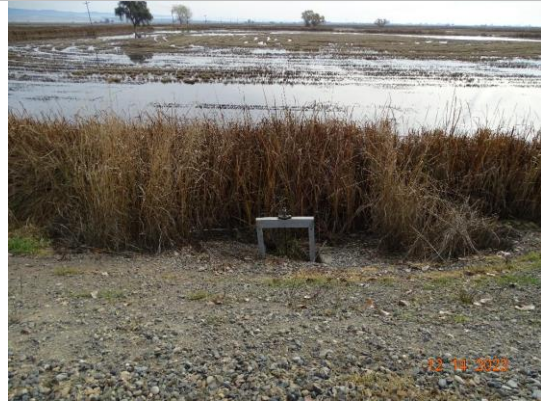
Photo 2 of 3 : UCIP\_SP\_2024\_82159\_118972.jpg

LS view: Concrete headwall with slide gate guide located at the toe; looking from crown.

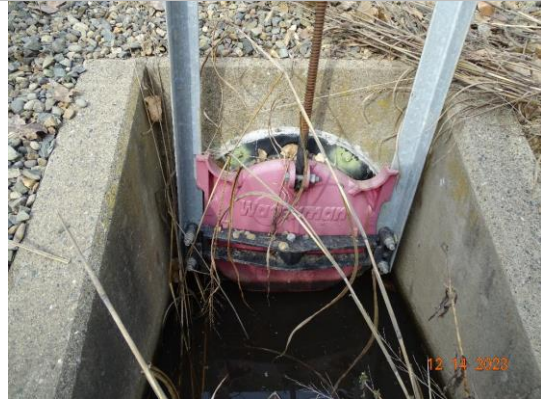
Photo 3 of 3 : UCIP\_SP\_2024\_82159\_118973.jpg

11/18/2016 LS screw gate still bent and in-operable. (A. Freitag - DWR Sutter Yard)  
04/27/2016 LS screw gate is still bent. Rest of crossing appeared in good condition. (A. Freitag - DWR Sutter Yard)  
07/01/2015 LS screw gate frame is still twisted and hindering the gate from opening. (A. Freitag - DWR Sutter Yard)  
05/29/2014 Same as last inspection. (A. Freitag - DWR Sutter Yard)  
12/09/2013 Same as last inspection. (A. Freitag - DWR Sutter Yard)  
07/10/2013 WS slope is cleared of vegetation and is in good condition. LS screw gate frame is twisted and is preventing the gate from opening. (A. Freitag - DWR Sutter Yard)  
04/19/2012 Limited inspection dense vegetation on WS. Need photos of clear WS slope & toe. Ditch present in channel? This crossing was listed in the USACE Periodic Inspection report as Corp's Inspect ID# USACE\_CESPK\_M13G\_2011\_p\_0108 for WS flap gate filled with soil and LS gate not functioning because of overgrown vegetation. (O. Magana - DWR UCIP)

LS view: Close-up view of slide gate.
