Flood Control Project Maintenance  
Levee Inspections  
LMA District Cover Sheet

Sutter Maintenance Yard Maintenance Area 0013

**Flood Control Project Maintenance  
Levee Inspections  
Unit Cover Sheet**

Waterway			Bank	Unit Miles
Unit No. 01 Cherokee Canal			Right	18.19
	Spring (March - May)	Summer (June - August)	(September - November) Fall	Winter (December - February)
Unit Maintenance Rating (Fall Only)				
Date of Inspection	4/17/2024 - 4/17/2024			
DWR Inspector	Makar Sokol			
Accompanied By	Shawn Freitag DWR Sutter Yard

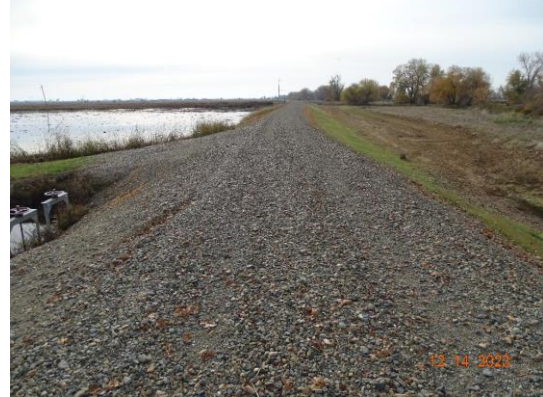
Photo 1 of 3 : UCIP\_SP\_2024\_82175\_118996.jpg

DS\_ID:16400  
FS\_ID:82175  
EP\_NO: N/A  
Repair Type: Non-Urgent  
EVAL Issue:  
Crossing Status: Found  
UCIP Comments: 12/14/2023 Record remains Non-Urgent. Water on LS limited inspection of the slide gate and concrete headwall at this crossing. DMP internal video inspection has found none or minor pipe defects. (M. Thao - DWR UCIP)  
09/25/2023 DMP internal video inspection has found none or minor pipe defects. Recommend next video inspection in 5 years. (J. Taylor - DWR UCIP)  
08/28/2019 Record has been updated from No Action Needed to Non-Urgent, no permit has been identified authorizing pipe. Pipe is scheduled to be lined. (O. Magana - DWR UCIP, A. Freitag - DWR Sutter Yard)  
06/05/2017 LS inlet was underwater. WS flap gate blocked shut by sediment. Pipe has been selected to be internally cleaned and inspected as part of the DMP project. (A. Freitag - DWR Sutter Yard)  
11/18/2016 Sediment dug out from in front of flap gate. Gate can now function properly. (A. Freitag - DWR Sutter Yard)

04/27/2016 WS flap gate still blocked from opening by sediment buildup. (A. Freitag - DWR Sutter Yard)  
07/01/2015 New screw gate installed on the LS. WS flap gate is still blocked from opening by sediment. (A. Freitag - DWR Sutter Yard)  
05/29/2014 Same as last inspection. (A. Freitag - DWR Sutter Yard)  
12/09/2013 Same as last inspection. (A. Freitag - DWR Sutter Yard)  
07/10/2013 Sediment is built up against WS flap gate not allowing it to open. Handle for LS slide gate is still missing. (A. Freitag - DWR Sutter Yard)  
04/19/2012 Handle missing on slide gate. (O. Magana - DWR UCIP)  
FIELD\_STRUCT\_DESC: 1 of 2: 36-inch CIPP-lined corrugated metal drainage pipe through the levee, 9.7 feet below the crown. Concrete "U" headwalls located on the waterside (WS) and landside (LS) ends. Flap gate on the WS end. Slide gate on the LS end. [Additional Reference(s): DWR Levee Log, 1993 (HLM 2.53). USACE Sacramento O&M Manual, Unit 519, June 1962, Revised 3 Feb 2011, (HLM 2.54), As-built DWG No. 50-4-3608, Sheet No. 3608/19.1, STA 899+10E LT BK, page 20 of 28 electronic file, listed as two 36-inch CMP; As-built DWG No 50-4-3037 referenced not available]

Levee crown looking downstream.

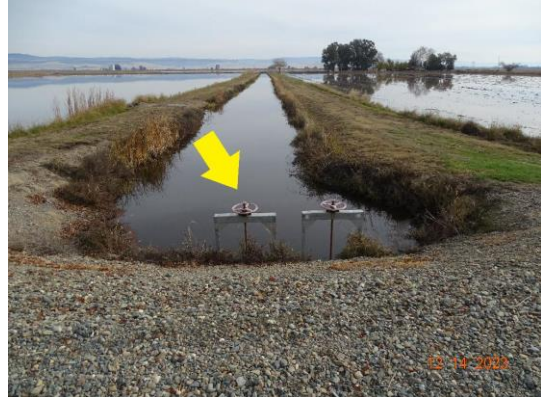
Photo 2 of 3 : UCIP\_SP\_2024\_82175\_118997.jpg

LS view: Slide gate guide at toe (yellow arrow pointing to this record); looking from crown.

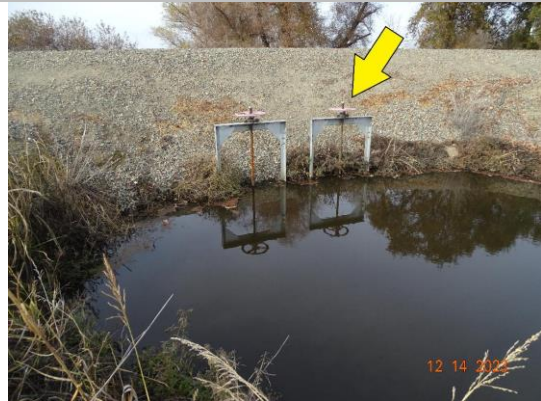
Photo 3 of 3 : UCIP\_SP\_2024\_82175\_118995.jpg

LS view: Concrete headwall and slide gate at toe (yellow arrow pointing to this record).

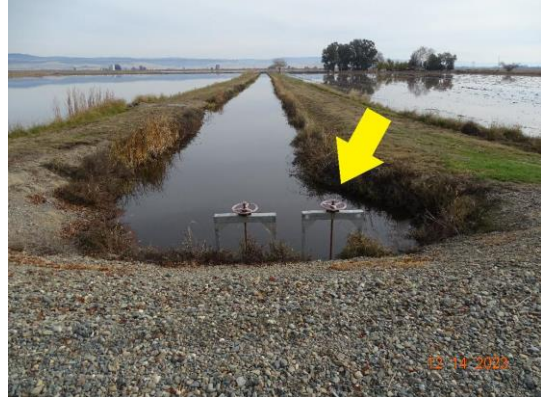
Photo 2 of 3 : UCIP\_SP\_2024\_82176\_119001.jpg

Comment Code						
Inspector Comment						
DS_ID:17169 FS_ID:82176 EP_NO: N/A Repair Type: Non-Urgent EVAL Issue: Crossing Status: Found UCIP Comments: 12/14/2023 Record remains Non-Urgent. Water on LS limited inspection of the slide gate and concrete headwall at this crossing. DMP internal video inspection has found none or minor pipe defects. (M. Thao - DWR UCIP) 09/25/2023 DMP internal video inspection has found none or minor pipe defects. Recommend next video inspection in 5 years. (J. Taylor - DWR UCIP) 08/28/2019 Record has been updated from No Action Needed to Non-Urgent, no permit has been identified authorizing pipe. Pipe is scheduled to be lined. (O. Magana - DWR UCIP, A. Freitag - DWR Sutter Yard) 06/05/2017 LS inlet was underwater. WS appears to be in good condition. Pipe has been selected to be internally cleaned and inspected as part of the DMP project. (A. Freitag - DWR Sutter Yard) 11/18/2016 Crossing appears to be in good condition. (A. Freitag - DWR Sutter Yard) 04/27/2016 Crossing appears to be in good condition. (A. Freitag - DWR Sutter Yard) 07/01/2015 New screw gate installed on the LS. WS appears to be in good condition. (A. Freitag - DWR Sutter Yard) 05/29/2014 Same as last inspection. (A. Freitag - DWR Sutter Yard) 12/09/2013 Same as last inspection. (A. Freitag - DWR Sutter Yard) 07/10/2013 Same as last inspection. (A. Freitag - DWR Sutter Yard) FIELD_STRUCT_DESC: 2 of 2: 36-inch CIPP-lined corrugated metal drainage pipe through the levee, 9.7 feet below the crown. Concrete "U" headwalls on both the waterside (WS) and landside (LS) ends. Flap gate on the waterside (WS) end. Slide gate on the landside (LS) end. [Additional Reference(s): DWR Levee Log, 1993 (HLM 2.53). USACE Sacramento O&M Manual, Unit 519, June 1962, Revised 3 Feb 2011, (HLM 2.54), As-built DWG No. 50-4-3608, Sheet No. 3608/19.1, STA 899+10E LT BK, page 20 of 28 electronic file, listed as two 36-inch CMP; As-built DWG No 50-4-3037 referenced not available] FS Date: 12/14/2023 9:31:03 AM

LS view: Slide gate guide at toe (yellow arrow pointing to this record); looking from crown.

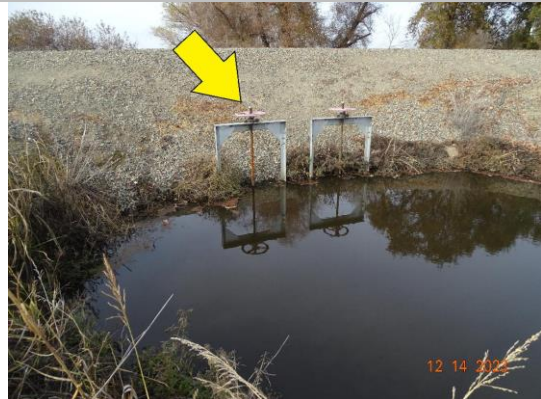
Photo 3 of 3 : UCIP\_SP\_2024\_82176\_118999.jpg

LS view: Concrete headwall and slide gate at toe (yellow arrow pointing to this record).

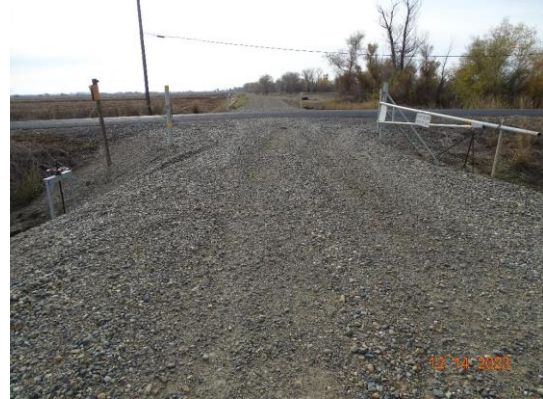
Photo 1 of 3 : UCIP\_SP\_2024\_82167\_119007.jpg

DS\_ID:16402  
FS\_ID:82167  
EP\_NO: N/A  
Repair Type: No Action Needed  
EVAL Issue:  
Crossing Status: Found  
UCIP Comments: 12/14/2023 Record updated from Non-Urgent to No Action Needed. DMP internal video inspection has found none or minor pipe defects. No issues observed during inspection. (M. Thao - DWR UCIP)  
09/25/2023 DMP internal video inspection has found none or minor pipe defects. Recommend next video inspection in 5 years. (J. Taylor - DWR UCIP)  
08/28/2019 Record remains Non-Urgent, no permit has been identified authorizing pipe. Pipe is scheduled to be lined (O. Magana - DWR UCIP, A. Freitag - DWR Sutter Yard)  
06/05/2017 Sediment blocking LS slide gate from closing fully. Pipe has been selected to be internally cleaned and inspected as part of the DMP project. (A. Freitag - DWR Sutter Yard)  
11/18/2016 Sediment still blocking screw gate from fully closing. (A. Freitag - DWR Sutter Yard)

04/27/2016 LS slide gate is full of sediment and needs to be dug out so gate can close fully. (A. Freitag - DWR Sutter Yard)  
07/01/2015 LS screw gate is still silted in and unable to be screwed down all the way. Needs to be cleaned out. (A. Freitag - DWR Sutter Yard)  
05/29/2014 Same as last inspection. (A. Freitag - DWR Sutter Yard)  
12/09/2013 WS flap gate was closed but LS slide gate is heavily vegetated and blocked from closing by sediment. (A. Freitag - DWR Sutter Yard)  
07/10/2013 Same as last inspection. (A. Freitag - DWR Sutter Yard)  
04/19/2012 Minor sediment built up on LS, remove sediment. Need photo of LS slide gate without sediment build up. This crossing was listed in the USACE Periodic Inspection report as Corp's inspect ID# USACE\_CESPK\_M13G\_2011\_p\_0148 for LS gate obstructed by vegetation and WS flap gate is not functioning (propped open). (O. Magana - DWR UCIP)  
FIELD\_STRUCT\_DESC: 36-inch CIPP-lined corrugated metal drainage pipe through the levee, 8.8 feet below the crown. Concrete "U" headwalls located on both the waterside (WS) and landside (LS) ends. Flap gate on the WS end. Slide gate on the LS end. Structure used to drain water from Nelson Shippe Road. [Additional Reference(s): DWR Levee Log, 1993 (HLM 2.63). USACE Sacramento O&M Manual, Unit 519, June 1962, Revised 3 Feb 2011, (HLM 2.63), As-built DWG No. 50-4-3608, Sheet No. 3608/19.1, STA 895+65E LT BK, page 20 of 28 electronic file, listed as 36-inch CMP; As-built DWG No 50-4-3037 referenced not available]

Levee crown looking downstream.

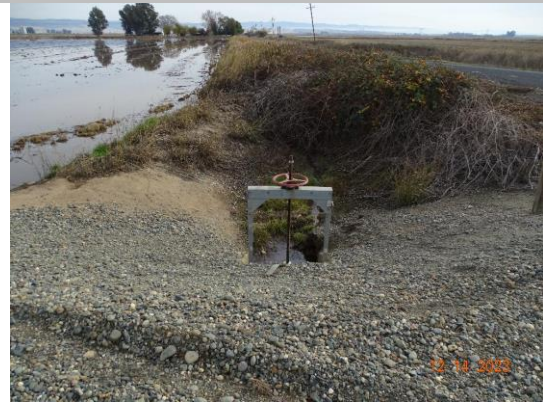
Photo 2 of 3 : UCIP\_SP\_2024\_82167\_119003.jpg

LS view: Concrete headwall with slide gate guide; looking from crown.

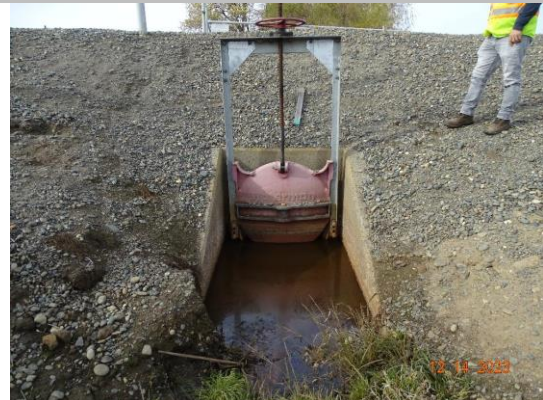
Photo 3 of 3 : UCIP\_SP\_2024\_82167\_119004.jpg

LS view: Concrete headwall with slide gate at toe.

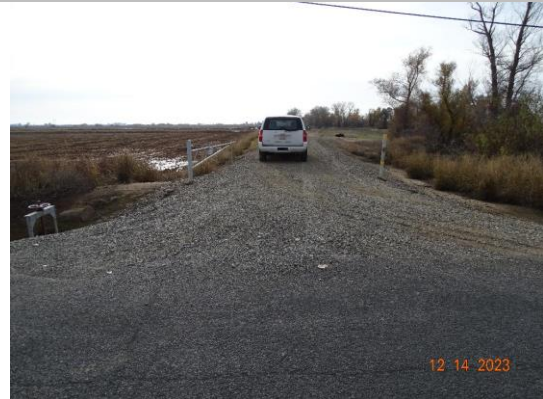
Photo 1 of 3 : UCIP\_SP\_2024\_82169\_119012.jpg

DS\_ID:16403  
FS\_ID:82169  
EP\_NO: N/A  
Repair Type: No Action Needed  
EVAL Issue:  
Crossing Status: Found  
UCIP Comments: 12/14/2023 Record updated from Non-Urgent to No Action Needed. DMP internal video inspection has found none or minor pipe defects. (M. Thao - DWR UCIP)  
09/25/2023 DMP internal video inspection has found none or minor pipe defects. Recommend next video inspection in 5 years. (J. Taylor - DWR UCIP)  
08/28/2019 Record remains Non-Urgent, no permit has been identified authorizing pipe. Pipe is scheduled to be lined. (O. Magana - DWR UCIP, A. Freitag - DWR Sutter Yard)  
06/05/2017 Crossing appears to be in good condition. Pipe has been selected to be internally cleaned and inspected as part of the DMP project. (A. Freitag - DWR Sutter Yard)  
11/18/2016 Crossing appears to be in good condition. (A. Freitag - DWR Sutter Yard)  
04/27/2016 Crossing appears to be in good condition. (A. Freitag - DWR Sutter Yard)

07/01/2015 WS flap gate is partially blocked by sediment and needs to be cleaned. (A. Freitag - DWR Sutter Yard)  
05/29/2014 Same as last inspection. (A. Freitag - DWR Sutter Yard)  
12/09/2013 Same as last inspection. (A. Freitag - DWR Sutter Yard)  
07/10/2013 LS and WS slopes have been cleared of vegetation and are in good condition. (A. Freitag - DWR Sutter Yard)  
04/19/2012 Burrowing holes located above WS headwall. Limited inspection on WS and LS slopes due to dense vegetation. Need photos of cleared WS & LS slopes. (O. Magana - DWR UCIP)  
FIELD\_STRUCT\_DESC: 36-inch CIPP-lined corrugated metal drainage pipe through the levee, 8.7 feet below the crown. Concrete "U" headwalls located on the waterside (WS) and landside (LS) ends. Flap gate on the WS end. Slide gate on the LS end. [Additional Reference(s): DWR Levee Log, 1993 (HLM 2.64). USACE Sacramento O&M Manual, Unit 519, June 1962, Revised 3 Feb 2011, (HLM 2.65), As-built DWG No. 50-4-3608, Sheet No. 3608/19.1, STA 892+57E LT BK, page 20 of 28 electronic file, listed as 36-inch CMP; As-built DWG No 50-4-3037 referenced not available]

Levee crown looking downstream.

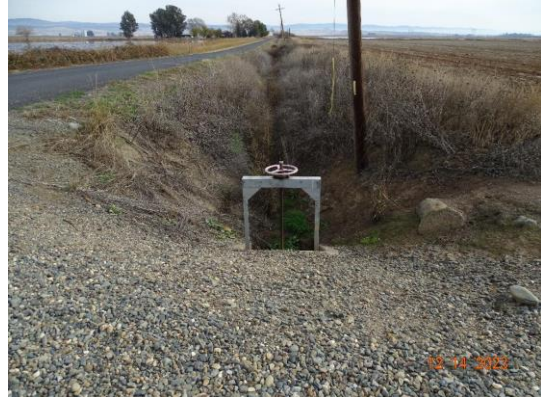
Photo 2 of 3 : UCIP\_SP\_2024\_82169\_119013.jpg

LS view: Concrete headwall and slide gate guide at toe; looking from crown.

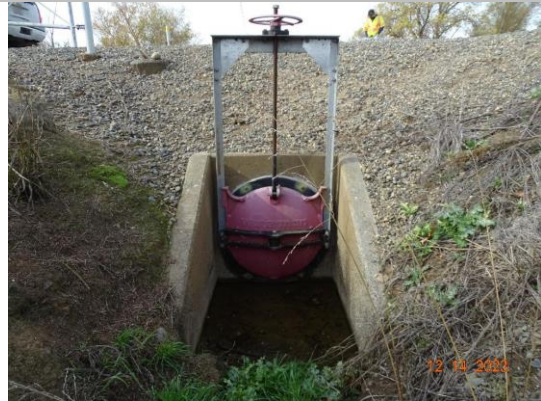
Photo 3 of 3 : UCIP\_SP\_2024\_82169\_119014.jpg

LS view: Concrete headwall and slide gate located at the toe.

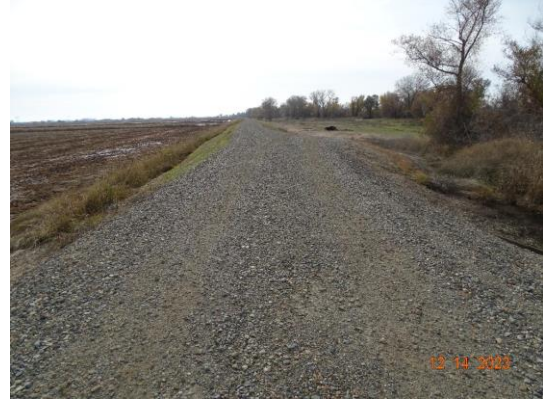
Photo 1 of 3 : UCIP\_SP\_2024\_82177\_119021.jpg

Comment Code						
Inspector Comment						
DS_ID:16415 FS_ID:82177 EP_NO: N/A Repair Type: Non-Urgent EVAL Issue: Crossing Status: Found UCIP Comments: 12/14/2023 Record remains Non-Urgent. DMP internal video inspection has found none or minor pipe defects. Water on both LS and WS limited inspection of levee at this crossing. (M. Thao - DWR UCIP) 09/25/2023 DMP internal video inspection has found none or minor pipe defects. Recommend next video inspection in 5 years. (J. Taylor - DWR UCIP) 08/28/2019 Record remains Non-Urgent, no permit has been identified authorizing pipe. Both inlet/outlet were underwater during inspection. Pipe is scheduled to be lined. (O. Magana - DWR UCIP, A. Freitag - DWR Sutter Yard) 06/05/2017 Both gates partially submerged during site visit. Appears to be in good condition. Pipe has been selected to be internally cleaned and inspected as part of the DMP project. (A. Freitag - DWR Sutter Yard) 11/18/2016 LS screw gate closed but partially buried. WS flap gate was half submerged for inspection. (A. Freitag - DWR Sutter Yard) 04/27/2016 Both gates were underwater for inspection. (A. Freitag - DWR Sutter Yard) 07/01/2015 WS flap gate is partially held open by sediment and needs to be dug out to allow it to fully close. (A. Freitag - DWR Sutter Yard) 05/29/2014 Same as last inspection. (A. Freitag - DWR Sutter Yard) 12/09/2013 Both gates were out of water and in good condition. (A. Freitag - DWR Sutter Yard) 07/10/2013 LS and WS slopes are in good condition. Both LS and WS gates were fully submerged in water and unable to be inspected. (A. Freitag - DWR Sutter Yard) FIELD_STRUCT_DESC: 36-inch CIPP-lined corrugated metal drainage pipe through the levee, 9 feet below the crown. Concrete "U" headwall on both waterside (WS) and landside (LS) ends. Flap gate on the WS end. Slide gate on the LS. [Additional Reference(s): DWR Levee Log, 1993 (HLM 2.65). USACE Sacramento O&M Manual, Unit 519, June 1962, Revised 3 Feb 2011, (HLM 2.66), As-built DWG No. 50-4-3608, Sheet No. 3608/19.1, STA 891+80E LT BK, page 20 of 28 electronic file, listed as 36-inch CMP; As-built DWG No 50-4-3037 referenced not available] FS Date: 12/14/2023 1:13:55 PM

Levee crown looking downstream.

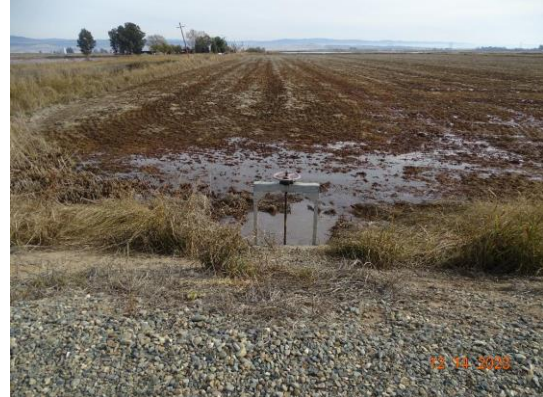
Photo 2 of 3 : UCIP\_SP\_2024\_82177\_119022.jpg

LS view: Concrete headwall and slide gate guide at toe; looking from crown.

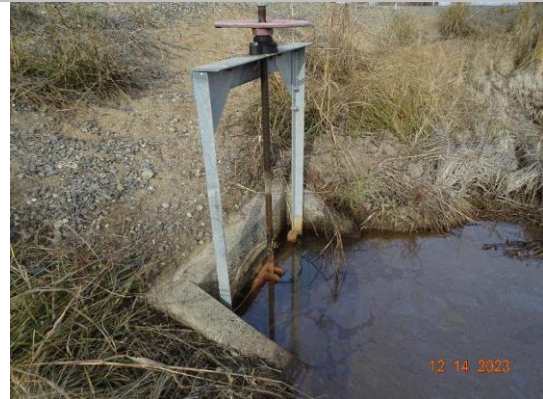
Photo 3 of 3 : UCIP\_SP\_2024\_82177\_119023.jpg

LS view: Concrete headwall and slide gate at toe.

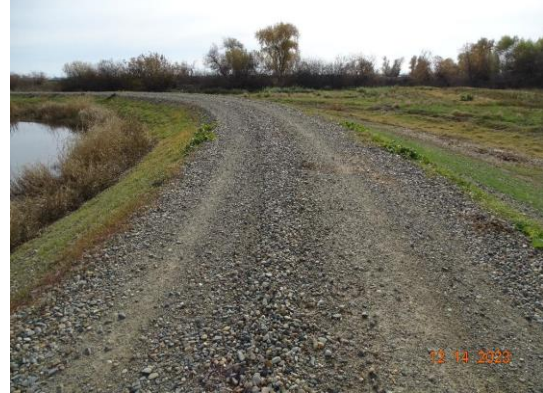
Photo 1 of 3 : UCIP\_SP\_2024\_82173\_119026.jpg

DS\_ID:16405  
FS\_ID:82173  
EP\_NO: N/A  
Repair Type: Non-Urgent  
EVAL Issue:  
Crossing Status: Found  
UCIP Comments: 12/14/2023 Record remains Non-Urgent. Water limits inspection of crossing on LS. No concrete headwall was found during inspection; it may be buried making the crossing non-functional. Unable to locate a permit and confirm proper pipe abandonment. Recommend owner to contact CVFPB to abandon or remove pipe from levee. (M. Thao - DWR UCIP)  
08/28/2019 Record remains Non-Urgent, no permit has been identified authorizing pipe. Structure is buried and non-functional. (O. Magana - DWR UCIP, A. Freitag - DWR Sutter Yard)  
06/05/2017 Abandoned- LS slide gate completely buried in rice field and WS flap gate almost fully buried. (A. Freitag - DWR Sutter Yard)  
11/18/2016 Appears abandoned. Both gates completely buried. (A. Freitag - DWR Sutter Yard)  
04/27/2016 Crossing appears abandoned. LS screw gate still buried and WS flap gate was 95% buried. (A. Freitag - DWR Sutter Yard)

07/01/2015 Still a non functioning crossing. LS screw gate is completely buried by sediment with only part of its frame and stem visible. WS flap gate is blocked from opening by sediment and debris. (A. Freitag - DWR Sutter Yard)  
05/29/2014 Same as last inspection. (A. Freitag - DWR Sutter Yard)  
12/09/2013 LS slide gate is completely buried by soil and WS flap gate is blocked from opening by sediment. Crossing appears abandoned and non-function. (A. Freitag - DWR Sutter Yard)  
07/10/2013 LS and WS slopes have been cleared by vegetation and are in good condition. WS flap gate is out of water but is blocked from opening by sediment build up. LS gate is fully submerged and not able to be inspected. (A. Freitag - DWR Sutter Yard)  
04/19/2012 Non-functioning crossing. Farmer uses pipe located at LM 3.682 to drain field & not this one. Dense vegetation-need photos of cleared WS & LS slopes. This crossing was listed in the USACE Periodic Inspection report as Corp's inspect ID#

USACE\_CESPK\_M13G\_2011\_p\_0172 for no access to WS gate due to high water & dense vegetation. (O. Magana - DWR UCIP)  
FIELD\_STRUCT\_DESC: 36-inch corrugated metal drainage pipe through the levee, 11.5 feet below the crown. Concrete "U" headwalls located on both the waterside (WS) and landside (LS) ends. Flap gate on the WS end. Slide gate on the LS end. [Additional Reference(s): DWR Levee Log, 1993 (HLM 3.61). USACE Sacramento O&M Manual, Unit 519, June 1962, Revised 3 Feb 2011, (HLM 3.61), As-built DWG No. 50-4-3608, Sheet No. 3608/5.2, 19.1, STA 4+50C RT. BK. (Cottonwood), page 5, 20 of 28 electronic file, listed as 36-inch pipe]

Levee crown looking downstream.

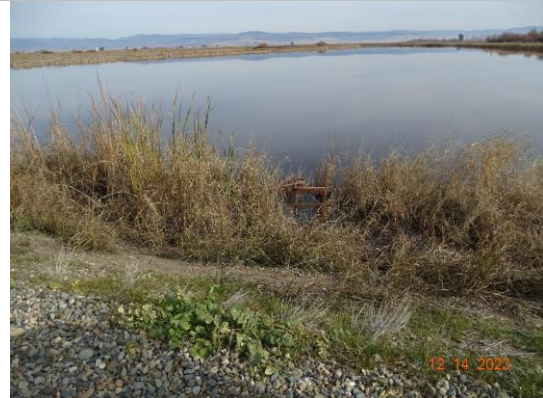
Photo 2 of 3 : UCIP\_SP\_2024\_82173\_119027.jpg

LS view: Concrete headwall and slide gate guide at toe; looking from crown.

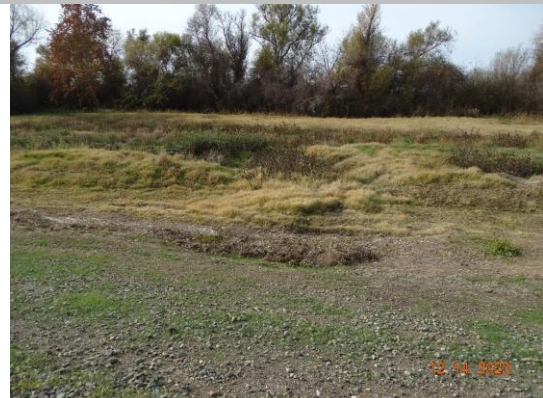
Photo 3 of 3 : UCIP\_SP\_2024\_82173\_119028.jpg

WS view: General overview looking from crown; no concrete headwall visible.

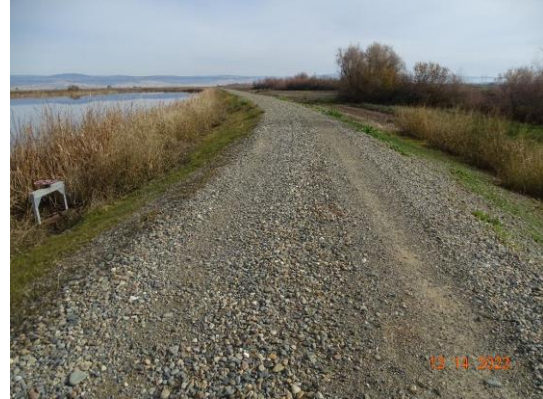
Photo 1 of 3 : UCIP\_SP\_2024\_82174\_119034.jpg

Levee crown looking upstream.

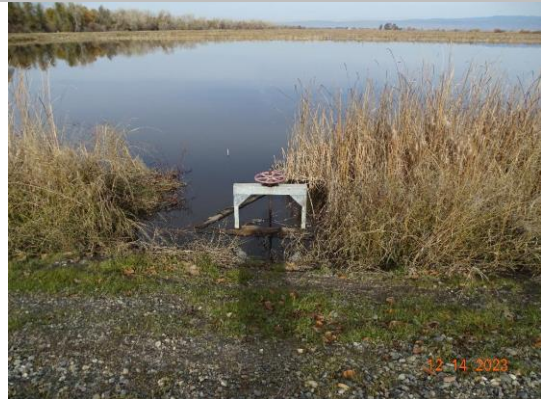
Photo 2 of 3 : UCIP\_SP\_2024\_82174\_119035.jpg

LS view: Concrete headwall and slide gate guide at toe.

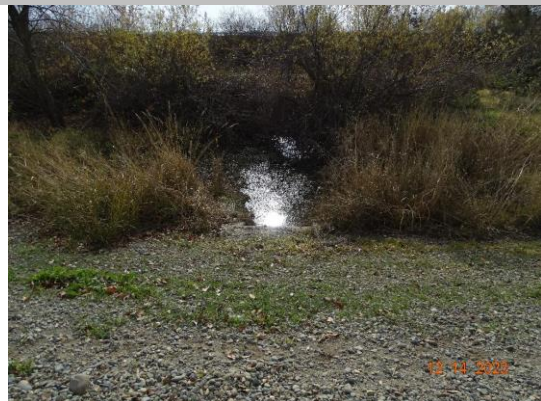
Photo 3 of 3 : UCIP\_SP\_2024\_82174\_119036.jpg

WS view: Concrete headwall at toe; looking from crown.

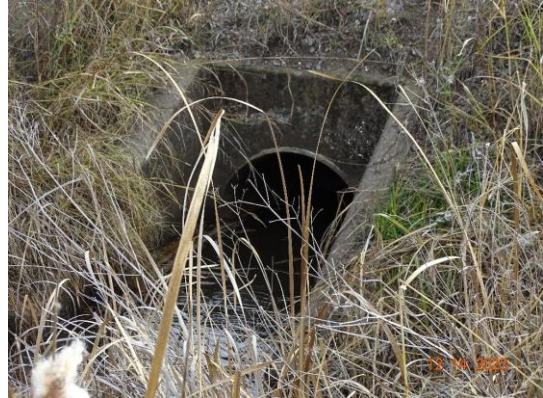
Photo 2 of 2 : UCIP\_SP\_2024\_82179\_119041.jpg

DS\_ID:16847  
FS\_ID:82179  
EP\_NO: N/A  
Repair Type: Non-Urgent  
EVAL Issue: 11, Maintenance Compliance Issue  
Crossing Status: Found  
UCIP Comments: 12/14/2023 Record remains Non-Urgent. Slide gate on LS end is missing; recommend owner install a new gate if there is supposed to be one. Water on both LS and WS limits inspection of the pipe inlet and outlet. DMP internal video inspection has found none or minor pipe defects. (M. Thao - DWR UCIP)  
09/25/2023 DMP internal video inspection has found none or minor pipe defects. Recommend next video inspection in 5 years. (J. Taylor - DWR UCIP)  
08/28/2019 Record remains Non-Urgent, no permit has been identified authorizing pipe. Pending internal inspection under DMP Phase 1 both inlet and outlet underwater. (O. Magana - DWR UCIP, A. Freitag - DWR Sutter Yard)  
06/05/2017 Both ends submerged but crossing appears to be in good condition. (A. Freitag - DWR Sutter Yard)

LS view: Close-up view of concrete headwall with missing slide gate.

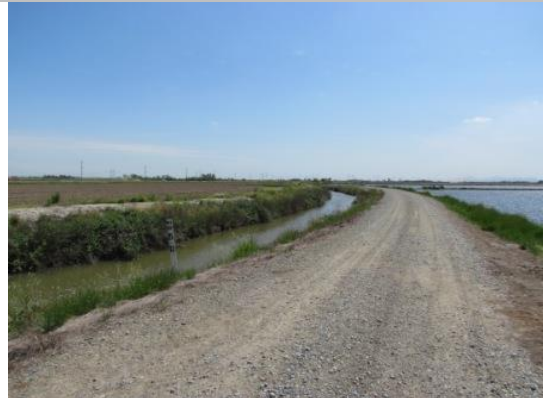
Photo 1 of 1 : SP\_2024\_MA0013\_301\_911\_20240212\_00013.jpg

LM Start	4.04	Rating **	M	Issue No.	911
LM End	4.78	Issue Type +	En	Location *	WS
Category	Earthen Levee			GPS Latitude/Longitude	
				Start	End
Item	Encroachments			39.526653°	39.534091°
				-121.699675°	-121.690404°
DWR ID	DWR_MA0013_02_s_2012_911				
Comment Code					
DT : Ditch					
Inspector Comment

View of agricultural ditch along the toe.

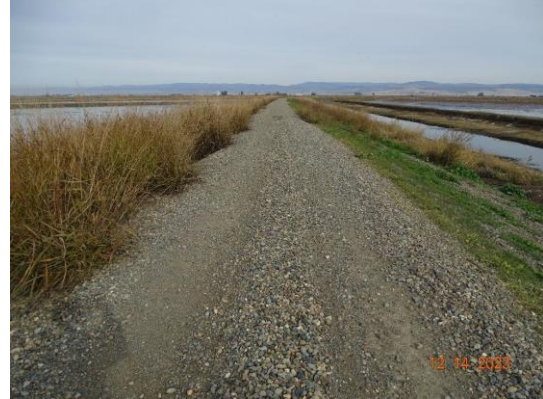
Photo 1 of 3 : UCIP\_SP\_2024\_82185\_119056.jpg

Levee crown looking upstream.

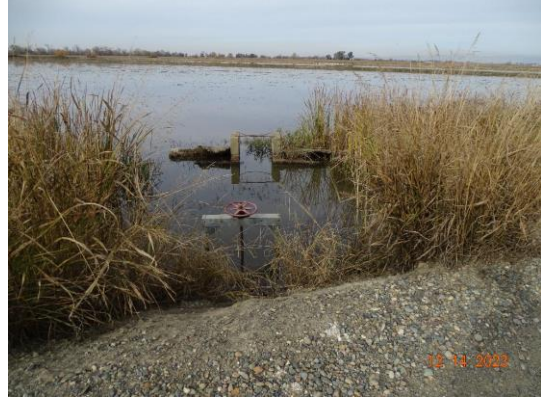
Photo 2 of 3 : UCIP\_SP\_2024\_82185\_119055.jpg

DS\_ID:16846  
FS\_ID:82185  
EP\_NO: N/A  
Repair Type: Non-Urgent  
EVAL Issue:  
Crossing Status: Found  
UCIP Comments: 12/14/2023 Record remains Non-Urgent. Water on both LS and WS limits inspection of the pipe inlet and outlet. DMP internal video inspection has found none or minor pipe defects. (M. Thao - DWR UCIP)  
09/25/2023 DMP internal video inspection has found none or minor pipe defects. Recommend next video inspection in 5 years. (J. Taylor - DWR UCIP)  
08/28/2019 Record remains Non-Urgent due to potential levee threat. Minor scour was visible on both WS and LS toe. No permit has been identified authorizing pipe. Pending internal inspection under DMP Phase 1 both inlet and outlet underwater. (O. Magana - DWR UCIP, A. Freitag - DWR Sutter Yard)  
06/05/2017 Both ends submerged during site visit. Pipe has been selected to be internally cleaned and inspected as part of the DMP project. (A. Freitag - DWR Sutter Yard)

LS view: Submerged concrete sump and slide gate at toe.

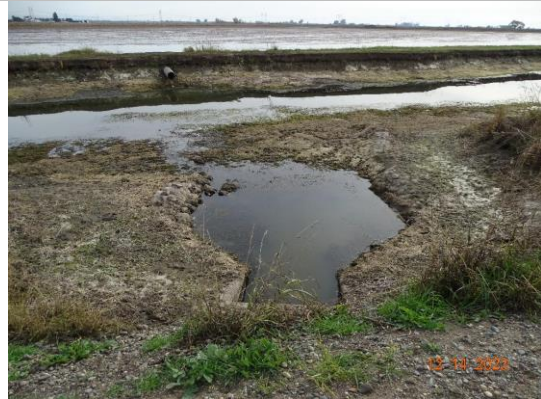
Photo 3 of 3 : UCIP\_SP\_2024\_82185\_119053.jpg

WS view: Concrete headwall at toe; looking from crown.

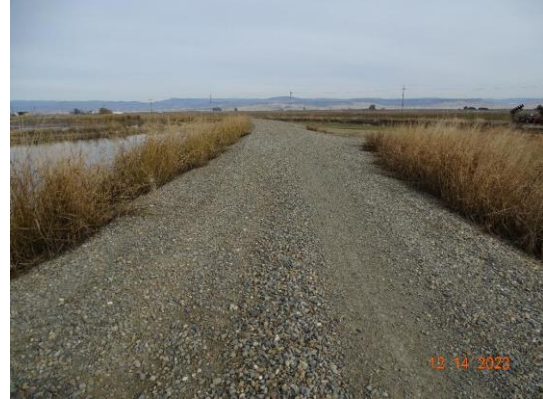
Photo 1 of 3 : UCIP\_SP\_2024\_82186\_119058.jpg

Levee crown looking upstream.

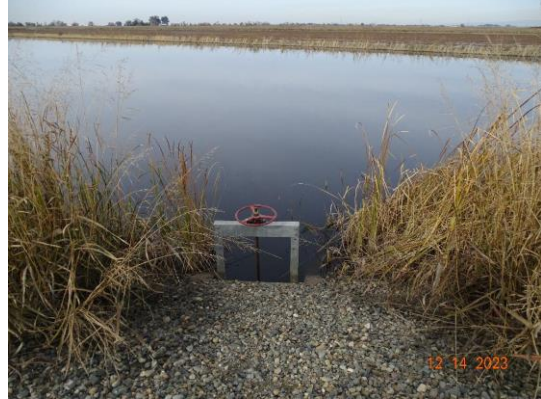
Photo 2 of 3 : UCIP\_SP\_2024\_82186\_119059.jpg

LS view: Submerge concrete headwall and slide gate at toe.

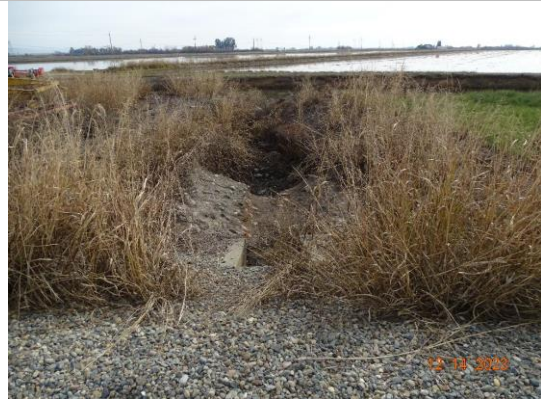
Photo 3 of 3 : UCIP\_SP\_2024\_82186\_119060.jpg

WS view: Concrete headwall at toe; looking from crown.

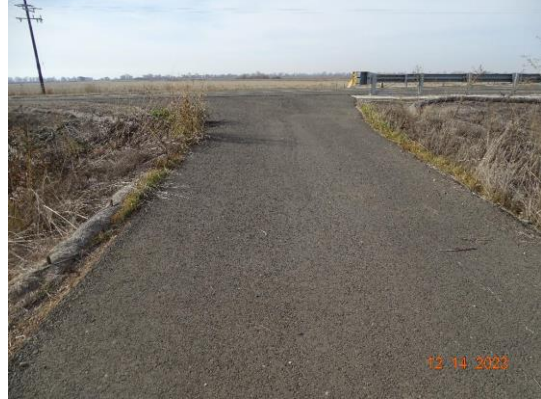
Photo 1 of 3 : UCIP\_SP\_2024\_82190\_119064.jpg

Levee crown looking downstream.

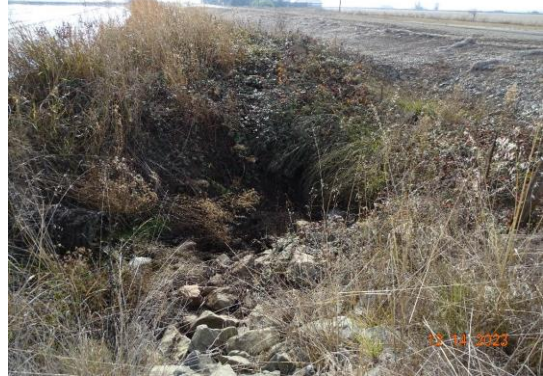
Photo 2 of 3 : UCIP\_SP\_2024\_82190\_119065.jpg

LS view: General overview looking from crown.

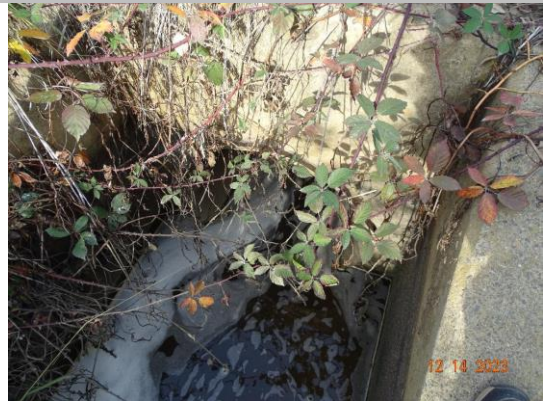
Photo 3 of 3 : UCIP\_SP\_2024\_82190\_119066.jpg

LS view: Concrete headwall and pipe inlet at toe.

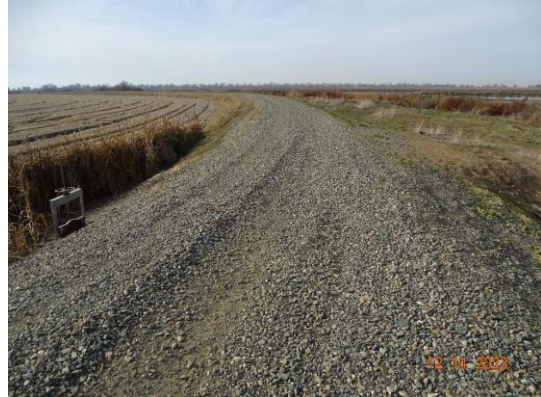
Photo 1 of 3 : UCIP\_SP\_2024\_82198\_119085.jpg

Levee crown looking downstream.

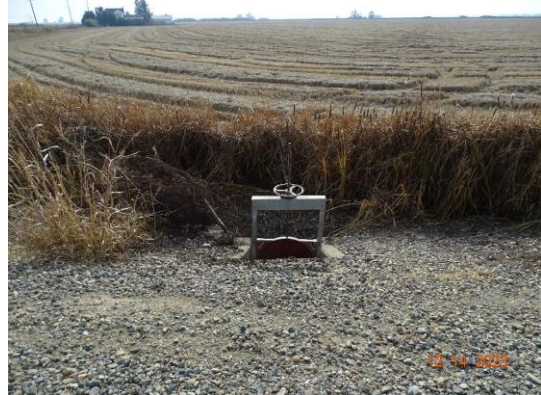
Photo 2 of 3 : UCIP\_SP\_2024\_82198\_119086.jpg

LS view: Concrete headwall and slide gate guide at toe; looking from crown.

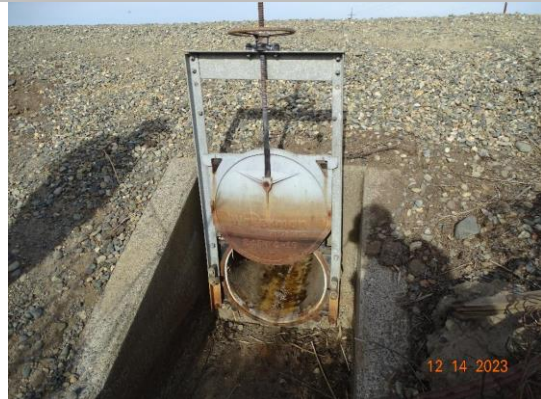
Photo 3 of 3 : UCIP\_SP\_2024\_82198\_119087.jpg

LS view: Concrete headwall and slide gate at toe.

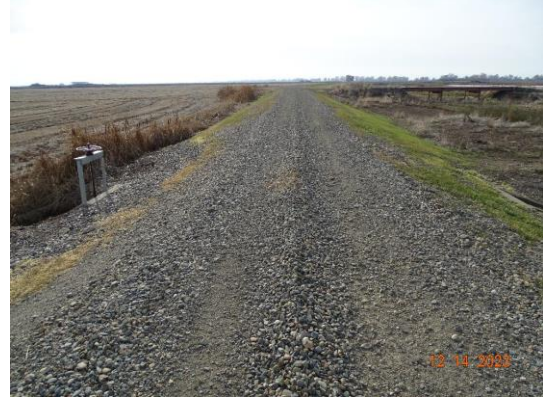
Photo 1 of 3 : UCIP\_SP\_2024\_82199\_119090.jpg

Levee crown looking downstream.

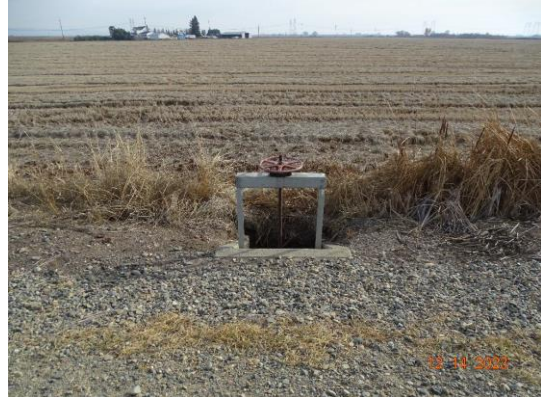
Photo 2 of 3 : UCIP\_SP\_2024\_82199\_119091.jpg

LS view: Concrete headwall and slide gate guide at toe; looking from crown.

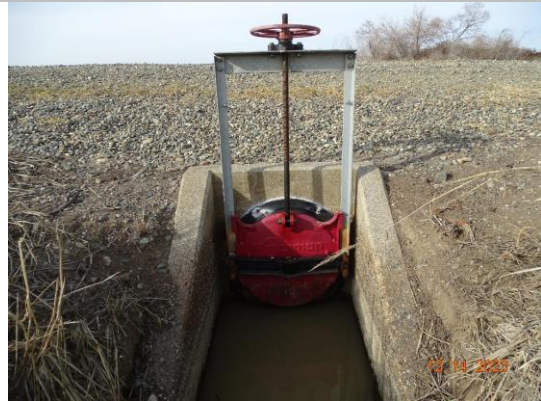
Photo 3 of 3 : UCIP\_SP\_2024\_82199\_119092.jpg

LS view: Concrete headwall and slide gate at toe.

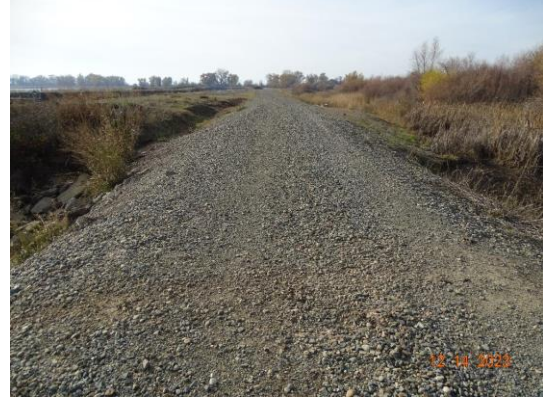
Photo 1 of 3 : UCIP\_SP\_2024\_82297\_119149.jpg

Levee crown looking downstream.

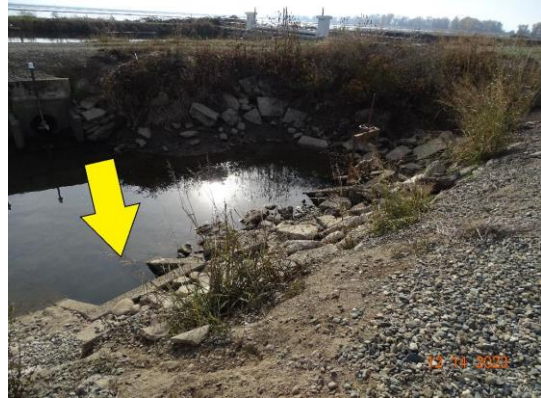
Photo 2 of 3 : UCIP\_SP\_2024\_82297\_119150.jpg

LS view: Concrete headwall at toe; looking from crown.

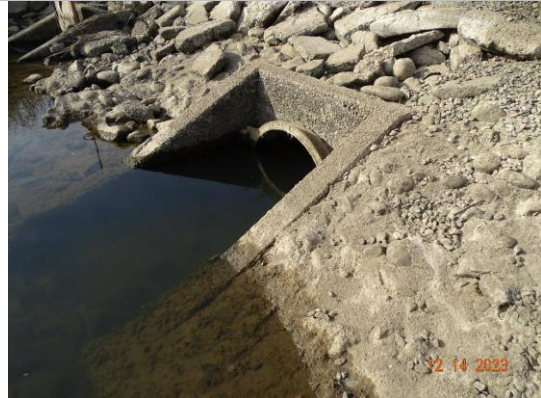
Photo 3 of 3 : UCIP\_SP\_2024\_82297\_119151.jpg

DS\_ID:16411  
FS\_ID:82297  
EP\_NO: N/A  
Repair Type: Non-Urgent  
EVAL Issue: 11, Maintenance Compliance Issue  
Crossing Status: Found  
UCIP Comments: 12/14/2023 Record remains Non-Urgent. Slide gate appears to be missing at concrete headwall on LS. DMP internal video inspection has found none or minor pipe defects. (M. Thao - DWR UCIP)  
08/28/2019 Record remains Non-Urgent, unable to determine if crossing is in use. Need to audit record to determine if Permit No. 13170 is associated with 36-inch. Slide gate that is supposed to be located on the WS is still missing. Need to check permit 13170 to see if this pipe crossing is also part of permit. (O. Magana - DWR UCIP, A. Freitag - DWR Sutter Yard)  
06/05/2017 Both ends were underwater but it appears that the LS slide gate is still missing. (A. Freitag - DWR Sutter Yard)  
11/18/2016 LS slide gate still missing. Both pipe ends were submerged during inspection. (A. Freitag - DWR Sutter Yard)

LS view: Concrete headwall at toe with missing slide gate.

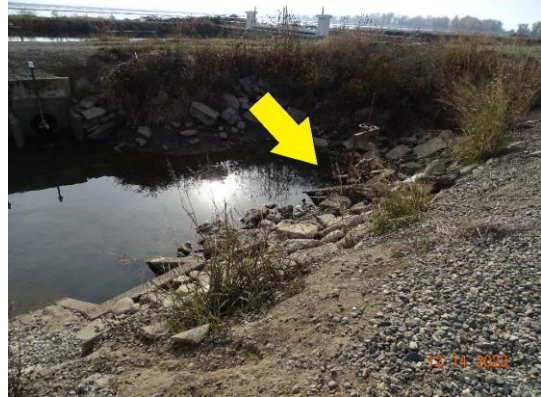
Photo 2 of 3 : UCIP\_SP\_2024\_82299\_119155.jpg

DS\_ID:16466  
FS\_ID:82299  
EP\_NO: 13170  
Repair Type: Non-Urgent  
EVAL Issue: 5, Pipe Damage  
Crossing Status: Found  
UCIP Comments: 12/14/2023 Record remains Non-Urgent. DMP internal video inspection has found moderate pipe defects. Crossing will be monitored until funding becomes available for rehabilitation. Need to check if Permit No. 13170 is for this record during QAP process. (M. Thao - DWR UCIP)  
08/28/2019 Record has been updated from No Action Needed to Non-Urgent, pipe appears to be part of a larger system and could have been modified. Flow meter labelled 30-58 located on the canal berm lines up with pipe crossing. Both inlet and outlet were underwater during inspection. Need to contact owner to determine purpose of pipe crossing. No other issues were recorded. (O. Magana - DWR UCIP, A. Freitag - DWR Sutter Yard)  
06/05/2017 Both pipe ends fully submerged during site visit but crossing appears to be in good condition. Pipe has been selected to be internally cleaned and inspected as part of the DMP project. (A. Freitag - DWR Sutter Yard)

LS view: Concrete headwall with slide gate at toe; looking from crown.

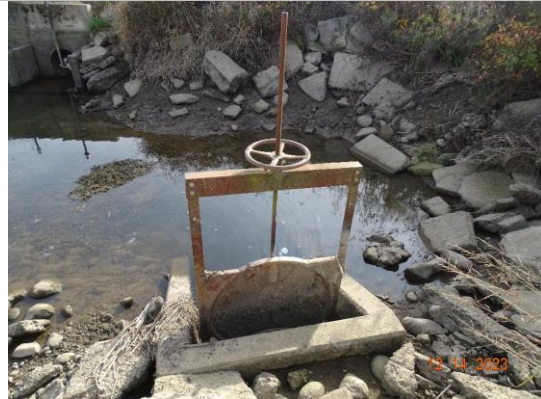
Photo 3 of 3 : UCIP\_SP\_2024\_82299\_119157.jpg

LS view: Backside of concrete headwall with slide gate at toe.

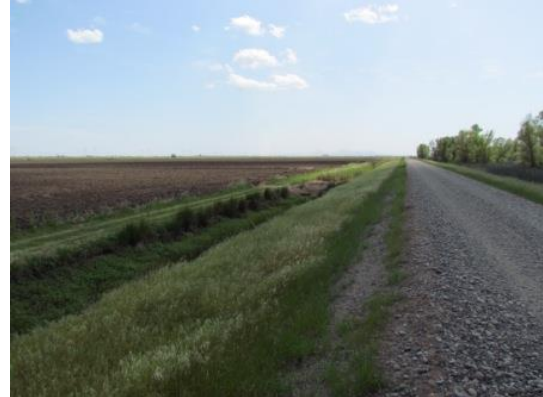
Photo 1 of 1 : SP\_2024\_MA0013\_301\_12\_20240212\_00001.jpg

LM Start	6.16	Rating **	M	Issue No.	12
LM End	7.54	Issue Type +	En	Location *	LS
Category	Earthen Levee			GPS Latitude/Longitude	
				Start	End
Item	Encroachments			39.521089°	39.502958°
				-121.706303°	-121.716953°
DWR ID	DWR_MA0013_02_s_2012_12				
Comment Code					
DT : Ditch					
Inspector Comment

View of the agricultural ditch along the toe.

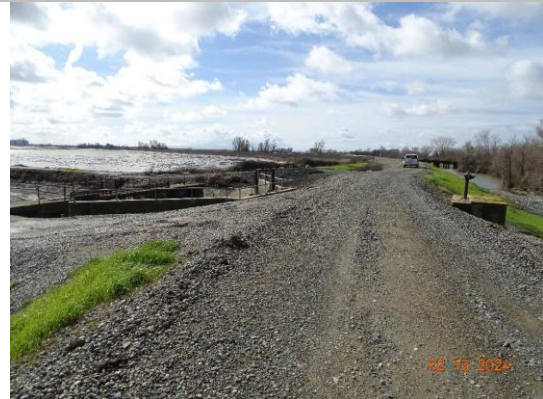
Photo 1 of 3 : UCIP\_SP\_2024\_82315\_119219.jpg

Comment Code					
Inspector Comment					
DS_ID:16838 FS_ID:82315 EP_NO: N/A Repair Type: Non-Urgent EVAL Issue: Crossing Status: Found UCIP Comments: 02/15/2024 Record remains Non-Urgent. No permit has been identified authorizing pipe. Flap gate was under water which limits inspection of the crossing on WS. (M. Thao - DWR UCIP) 08/28/2019 Record has been updated from No Action Needed to Non-Urgent, no permit has been identified authorizing structure. (O. Magana - DWR UCIP, A. Freitag - DWR Sutter Yard) 06/05/2017 Crossing appears to be in good condition. (A. Freitag - DWR Sutter Yard) 11/18/2016 Crossing appears to be in good condition. (A. Freitag - DWR Sutter Yard) 04/27/2016 Crossing appears to be in good condition. (A. Freitag - DWR Sutter Yard) 06/30/2015 Path to access the WS flap gate was getting overgrown with vegetation but other than that everything with the crossing looked in good condition. (A. Freitag - DWR Sutter Yard) 05/28/2014 Same as last inspection. (A. Freitag - DWR Sutter Yard) 12/04/2013 Same as last inspection. (A. Freitag - DWR Sutter Yard) 07/09/2013 Same as last inspection. (A. Freitag - DWR Sutter Yard) 04/24/2012 This crossing was listed in the USACE Periodic Inspection report as Corp's inspect ID# USACE_CESPK_M13F_2011_p_0080 for limited visibility of LS slide gate and WS flap gate. (O. Magana - DWR UCIP) FIELD_STRUCT_DESC: 36-inch corrugated metal drainage pipe through the levee, 11.2 feet below the crown. Crossing drains into Cherokee Canal and is part of the Richvale Irrigation District siphon structure. Slide gate is located on the landside (LS). Flap gate is located on the waterside (WS). Crossing angles to the southwest to a flap gate and headwall located about 60 feet from WS toe. [Additional Reference(s): USACE Sacramento O&M Manual, Unit 519, June 1962, Revised 3 Feb 2011, (HLM 9.66), listed as 36-inch pipe drain into Cherokee Canal, As-built DWG No. 50-4-3608, Sheet No. 3608/20, ~ STA 649+85E, page 21 of 28 electronic file] FS Date: 2/15/2024 10:31:48 AM

Levee crown looking downstream.

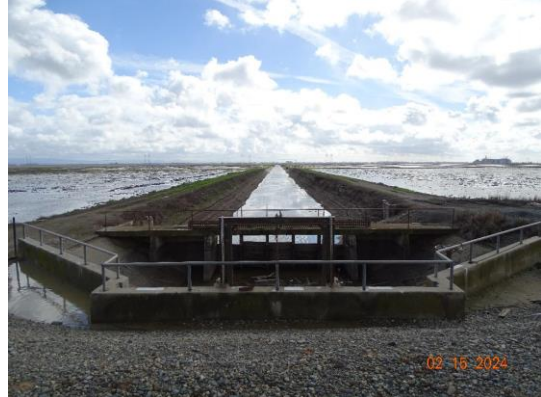
Photo 2 of 3 : UCIP\_SP\_2024\_82315\_119224.jpg

LS view: General overview looking from crown; backside of Richvale Irrigation District Siphon structure.

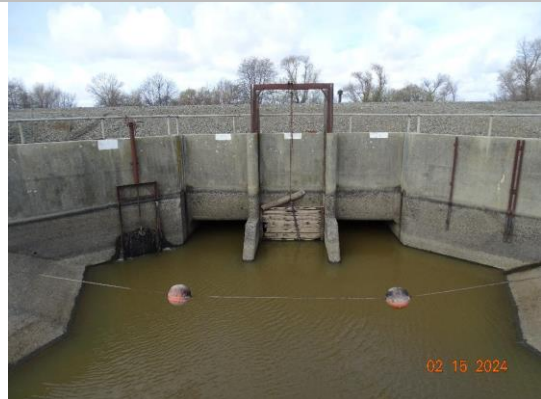
Photo 3 of 3 : UCIP\_SP\_2024\_82315\_119220.jpg

LS view: Concrete headwall with culvert; looking toward levee.

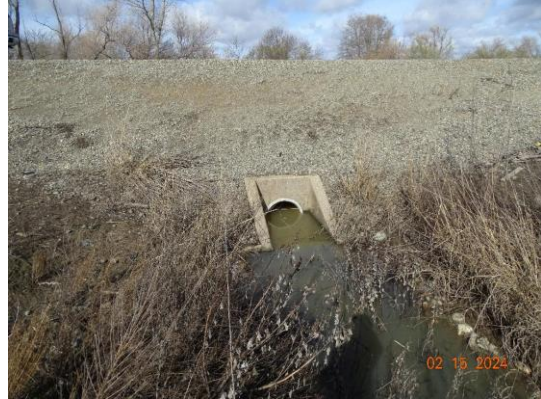
Photo 1 of 2 : UCIP\_SP\_2024\_82316\_119226.jpg

DS\_ID:16839  
FS\_ID:82316  
EP\_NO: N/A  
Repair Type: Non-Urgent  
EVAL Issue: 11, Maintenance Compliance Issue  
Crossing Status: Found  
UCIP Comments: 02/15/2024 Record remains Non-Urgent. Ground elevation near the headwall is higher than the pipe invert preventing proper drainage; recommend owner regrade WS end to allow for proper drainage. DMP internal video inspection has found none or minor pipe defects. (M. Thao - DWR UCIP)  
09/25/2023 DMP internal video inspection has found none or minor pipe defects. Recommend next video inspection in 5 years. (J. Taylor - DWR UCIP)  
08/28/2019 Record has been updated from No Action Needed to Non-Urgent, no permit has been identified authorizing structure. (O. Magana - DWR UCIP, A. Freitag - DWR Sutter Yard)  
06/05/2017 Crossing appears to be in good condition. (A. Freitag - DWR Sutter Yard)  
11/18/2016 Crossing appears to be in good condition. (A. Freitag - DWR Sutter Yard)

LS view: Concrete headwall at toe; looking towards levee. Water pooled up at headwall and pipe inlet.

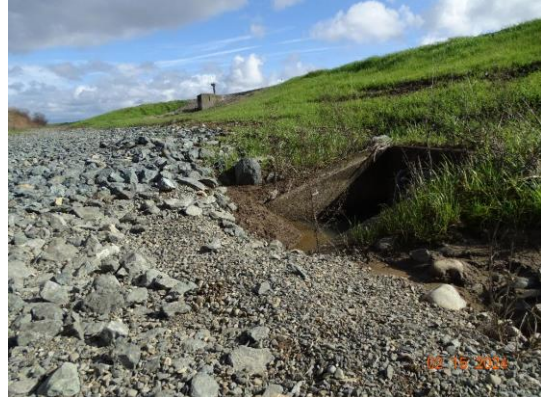
Photo 2 of 2 : UCIP\_SP\_2024\_82316\_119229.jpg

WS view: Ground elevation near the headwall is higher than the pipe invert preventing proper drainage.

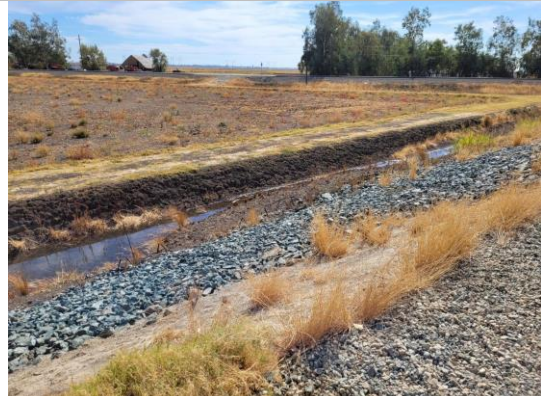
Photo 1 of 1 : SP\_2024\_MA0013\_301\_13\_20240212\_00002.jpg

LM Start	10.03	Rating **	M	Issue No.	13
LM End	10.52	Issue Type +	En	Location *	LS
Category	Earthen Levee			GPS Latitude/Longitude	
				Start	End
Item	Encroachments			39.471517°	39.465113°
				-121.739433°	-121.743592°
DWR ID	DWR_MA0013_02_s_2012_13				
Comment Code					
DT : Ditch					
Inspector Comment

View of the agricultural ditch along the toe. Fall 2021.

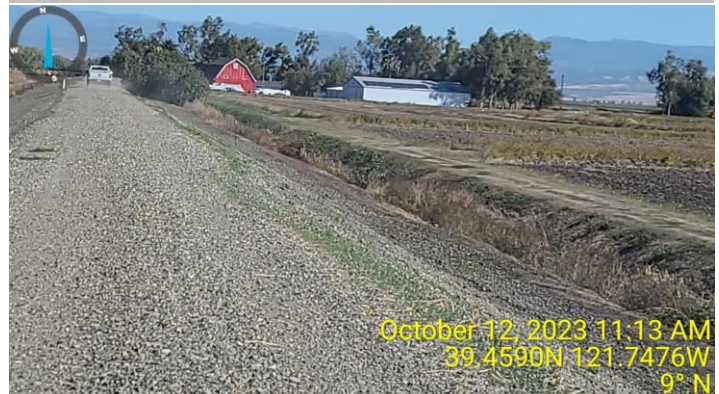
Photo 1 of 1 : SP\_2024\_MA0013\_301\_18\_20240212\_00003.jpg

LM Start	10.59	Rating **	M	Issue No.	18
LM End	11.66	Issue Type +	En	Location *	LS
Category	Earthen Levee			GPS Latitude/Longitude	
				Start	End
Item	Encroachments			39.464305°	39.450333°
				-121.744172°	-121.753157°
DWR ID	DWR_MA0013_02_s_2012_18				
Comment Code					
DT : Ditch					
Inspector Comment

View of the agricultural ditch along the landside toe. Fall 2023.

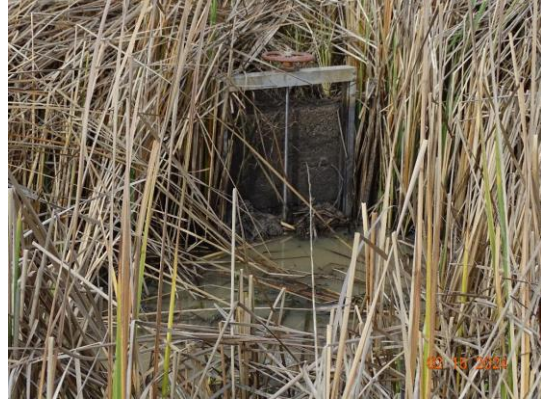
Photo 1 of 2 : UCIP\_SP\_2024\_82327\_119264.jpg

DS\_ID:16385  
FS\_ID:82327  
EP\_NO: N/A  
Repair Type: Urgent  
EVAL Issue: 1, Pipe Integrity  
Crossing Status: Found  
UCIP Comments: 02/15/2024 Record remains Urgent. DMP internal video inspection has found severe pipe defects. Crossing will be monitored until funding becomes available to address the issues. No permit has been identified authorizing pipe. (M. Thao - DWR UCIP)  
12/14/2022 Record updated from Non-Urgent to Urgent. DMP internal video inspection has found pipe integrity issues. LOF of crossing is between 5 and 6. Crossing will be monitored until funding becomes available to address the issues. (O.Yakimov - DWR UCIP)  
08/29/2019 Record remains Non-Urgent, no permit has been identified authorizing pipe. This crossing is associated with DSID 16334 in Unit 1. LS slide gate was under water during inspection. This structure is not maintained or operated by LMA-DWR Sutter Yard. (O. Magana - DWR UCIP, A. Freitag - DWR Sutter Yard)

LS view: Close-up view of concrete headwall with slide gate at toe.

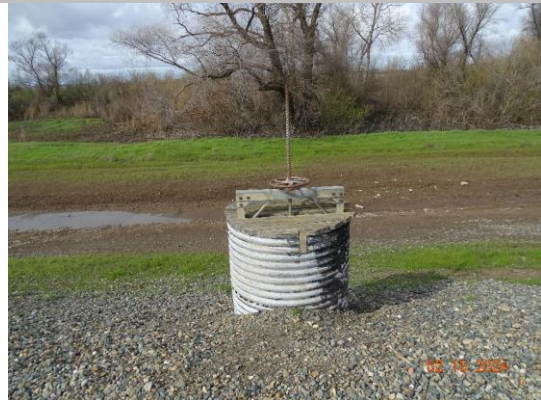
Photo 2 of 2 : UCIP\_SP\_2024\_82327\_119261.jpg

WS view: CMP riser located on slope; general overview looking from crown.

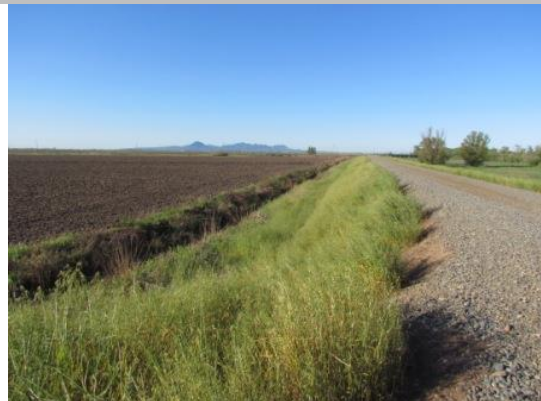
Photo 1 of 1 : SP\_2024\_MA0013\_301\_19\_20240212\_00004.jpg

LM Start	13.40	Rating **	M	Issue No.	19
LM End	16.00	Issue Type +	En	Location *	LS
Category	Earthen Levee			GPS Latitude/Longitude	
				Start	End
Item	Encroachments			39.428192°	39.414202°
				-121.768443°	-121.781863°
DWR ID	DWR_MA0013_02_s_2012_19				
Comment Code					
DT : Ditch					
Inspector Comment

View of the agricultural ditch along the toe.

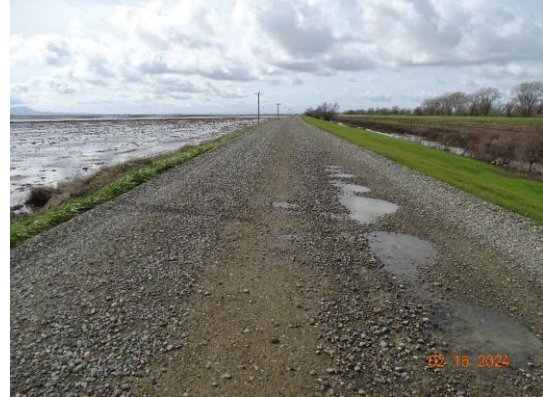
Photo 1 of 3 : UCIP\_SP\_2024\_82329\_119268.jpg

DS\_ID:16376  
FS\_ID:82329  
EP\_NO: N/A  
Repair Type: Non-Urgent  
EVAL Issue:  
Crossing Status: Found  
UCIP Comments: 02/15/2024 Record remains Non-Urgent. Pipe inlet on LS is dammed up. Crossing may not serve its intended function of drainage due to the topography being altered. DMP internal video inspection has found none or minor pipe defects. (M. Thao - DWR UCIP)  
08/29/2019 Record remains Non-Urgent, no permit has been identified authorizing pipe. Crossing appears abandoned. LMA will need to coordinate with landowner to determine is drainage structure is still needed. DMP internal inspection shows that 90% of the pipe is filled with soil at a length of about 42 feet from WS flap gate. If crossing is not in use anymore, crossing will need to be abandoned properly or removed. DMP internal video inspection has not found pipe integrity issues. LOF of crossing is less or equal to 4. Recommend next video inspection in 5 years. (O. Magana - DWR UCIP, A. Freitag - DWR Sutter Yard)

Levee crown looking downstream.

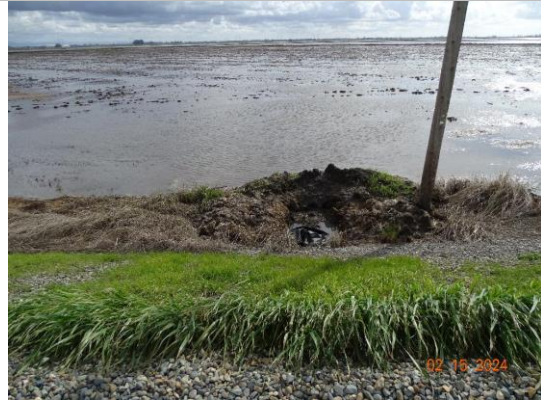
Photo 2 of 3 : UCIP\_SP\_2024\_82329\_119269.jpg

LS view: Top of concrete headwall at toe; pipe inlet is dammed up.

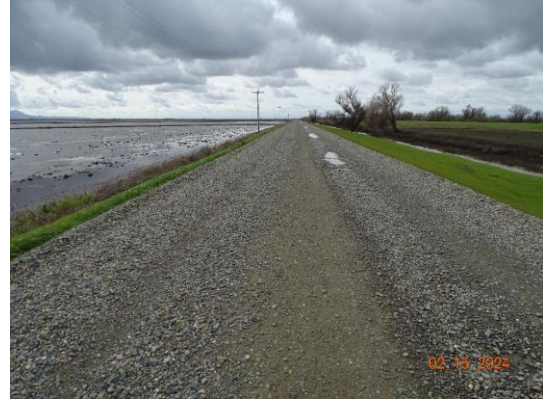
Photo 1 of 3 : UCIP\_SP\_2024\_82330\_119273.jpg

DS\_ID:16382  
FS\_ID:82330  
EP\_NO: N/A  
Repair Type: Non-Urgent  
EVAL Issue:  
Crossing Status: Found  
UCIP Comments: 02/15/2024 Record remains Non-Urgent. LS is pooled up with water at the pipe inlet and not draining properly, while the flap gate on the WS end is shut and not flowing. Crossing may not serve its intended function of drainage due to the topography being altered. DMP internal video inspection has found none or minor pipe defects. (M. Thao - DWR UCIP)  
08/29/2019 Record remains Non-Urgent, structure is non-functional and abandoned. Structure is abandoned. LMA will need to coordinate with landowner to determine if pipe is still needed as drainage structure. Dense vegetation covers the WS outlet and only LS headwall is visible at LS toe. If structure is no longer needed then structure will need to be abandoned properly or removed according to Title 23. DWR DMP internal inspection shows pipe has been filled with grout starting at about 47 feet from WS flap gate. No permit has been identified authorizing pipe. DMP internal video inspection has not found pipe integrity issues. LOF of crossing is less or equal to 4. Recommend next video inspection in 5 years. (O. Magana - DWR UCIP, A. Freitag - DWR Sutter Yard)

Levee crown looking downstream.

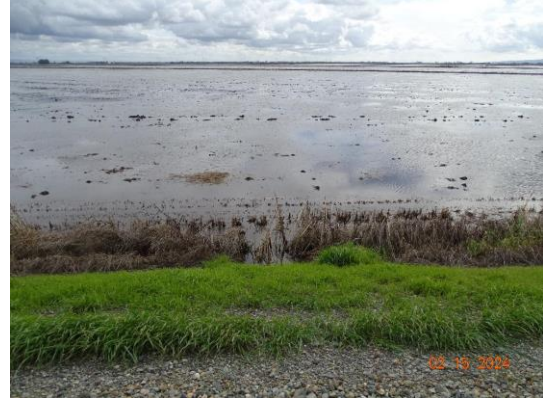
Photo 2 of 3 : UCIP\_SP\_2024\_82330\_119274.jpg

LS view: General overview looking from crown.

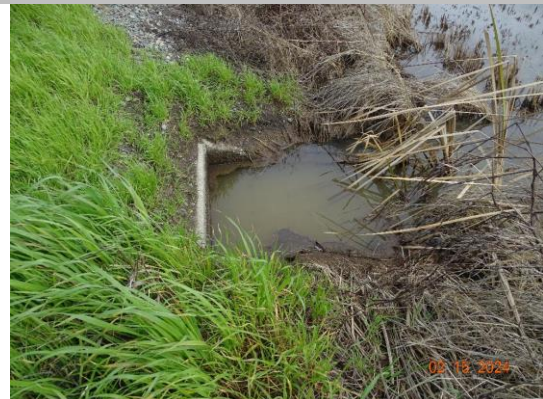
Photo 3 of 3 : UCIP\_SP\_2024\_82330\_119275.jpg

LS view: Concrete headwall at toe; water pooled up and not draining properly.

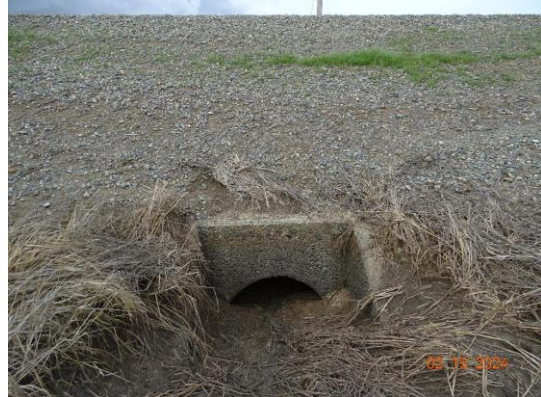
Photo 1 of 2 : UCIP\_SP\_2024\_82332\_119280.jpg

DS\_ID:16377  
FS\_ID:82332  
EP\_NO: N/A  
Repair Type: Non-Urgent  
EVAL Issue: 4b, Safety Issue  
Crossing Status: Found  
UCIP Comments: 02/15/2024 Record remains Non-Urgent. No cover was present on CMP riser causing a safety hazard; recommend adding a cover. Pipe outlet on LS is filled approximately 60% with debris; recommend clearing debris. No permit has been identified authorizing pipe. (M. Thao - DWR UCIP)  
08/29/2019 Record remains Non-Urgent due to maintenance issues. Unable to determine status of crossing. Steel pipe is deteriorated on the WS between concrete boxes. 36-inch pipe not visible inside concrete boxes. Recommend internal inspection to determine pipe condition through the levee. Riser lid missing on WS (considered a safety issue). LS inlet shows about 75% blockage. No permit has been identified authorizing pipe. (O. Magana - DWR UCIP, A. Freitag - DWR Sutter Yard)  
05/30/2017 LS headwall was mostly buried and pipe end over 50% full of sediment. WS distribution box appears to have not been repaired yet but it does not seem to affect the integrity of the levee. (A. Freitag - DWR Sutter Yard)

LS view: Concrete headwall with debris blocking approximately 60% of pipe inlet.
