Flood Control Project Maintenance  
Levee Inspections  
LMA District Cover Sheet

Sutter Maintenance Yard Maintenance Area 0013

**Flood Control Project Maintenance  
Levee Inspections  
Unit Cover Sheet**

Waterway			Bank	Unit Miles
Unit No. 01 Cherokee Canal			Right	18.19
	Spring (March - May)	Summer (June - August)	(September - November) Fall	Winter (December - February)
Unit Maintenance Rating (Fall Only)				
Date of Inspection	4/17/2024 - 4/17/2024			
DWR Inspector	Makar Sokol			
Accompanied By	Shawn Freitag DWR Sutter Yard

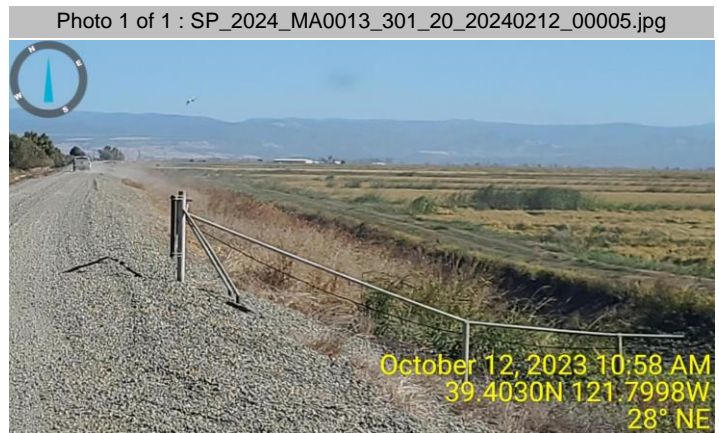
LM Start	16.89	Rating **	M	Issue No.	20
LM End	18.72	Issue Type +	En	Location *	LS
Category	Earthen Levee			GPS Latitude/Longitude	
				Start	End
Item	Encroachments			39.406217°	39.389187°
				-121.794945°	-121.821233°
DWR ID	DWR_MA0013_02_s_2012_20				
Comment Code					
DT : Ditch					
Inspector Comment

View of the agricultural ditch along the landside toe. Fall 2023.

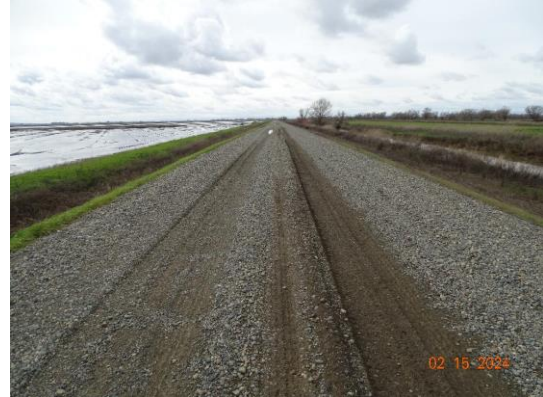
Photo 1 of 3 : UCIP\_SP\_2024\_82342\_119292.jpg

DS\_ID:16379  
FS\_ID:82342  
EP\_NO: N/A  
Repair Type: No Action Needed  
EVAL Issue:  
Crossing Status: Found  
UCIP Comments: 02/15/2024 Record updated from Non-Urgent to No Action Needed. DMP internal video inspection has found none or minor pipe defects. No issues observed during inspection. (M. Thao - DWR UCIP)  
09/25/2023 DMP internal video inspection has found none or minor pipe defects. Recommend next video inspection in 5 years. (J. Taylor - DWR UCIP)  
08/29/2019 Record has been updated from No Action Needed to Non-Urgent, no permit has been identified authorizing pipe. Pipe is under water. Pipe is scheduled to be lined. (O. Magana - DWR UCIP, A. Freitag - DWR Sutter Yard)  
05/30/2017 Crossing appears to be in good condition. Pipe has been selected to be internally cleaned and inspected as part of the DMP project. (A. Freitag - DWR Sutter Yard)  
11/17/2016 Crossing appears to be in good condition. (A. Freitag - DWR Sutter Yard)

Levee crown looking downstream.

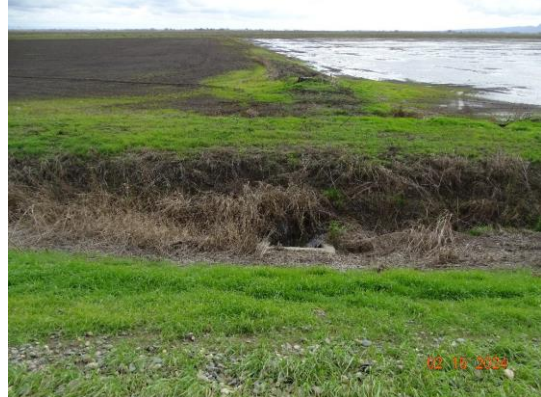
Photo 2 of 3 : UCIP\_SP\_2024\_82342\_119293.jpg

LS view: General overview looking from crown; top of concrete headwall at toe.

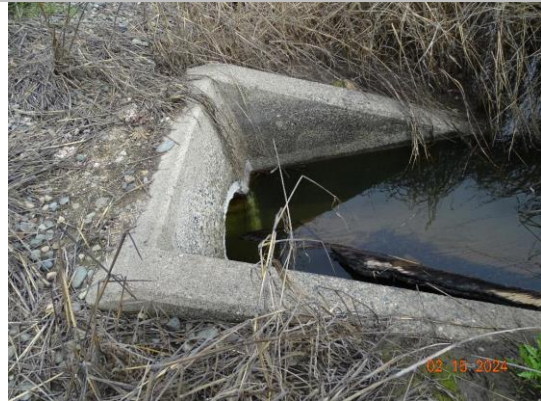
Photo 3 of 3 : UCIP\_SP\_2024\_82342\_119294.jpg

LS view: Concrete headwall located at toe.

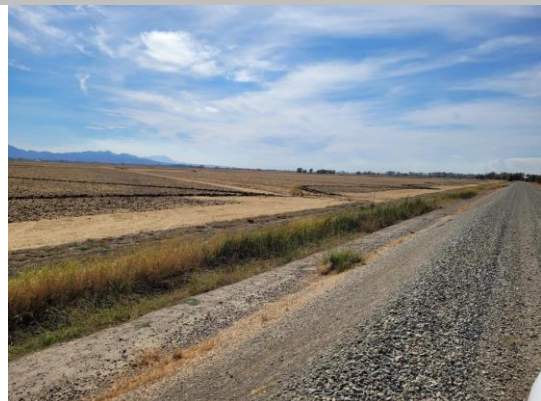
Photo 1 of 1 : SP\_2024\_MA0013\_301\_21\_20240212\_00006.jpg

LM Start	19.37	Rating **	M	Issue No.	21
LM End	19.92	Issue Type +	En	Location *	LS
Category	Earthen Levee			GPS Latitude/Longitude	
				Start	End
Item	Encroachments			39.383252°	39.378192°
				-121.830565°	-121.838543°
DWR ID	DWR_MA0013_02_s_2012_21				
Comment Code					
DT : Ditch					
Inspector Comment

View of the agricultural ditch along the landside toe. Fall 2021.

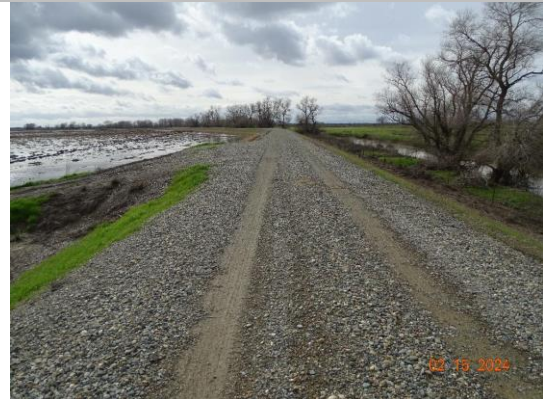
Photo 1 of 3 : UCIP\_SP\_2024\_82346\_119310.jpg

Comment Code					
Inspector Comment					
DS_ID:16375					
FS_ID:82346					
EP_NO: N/A					
Repair Type: No Action Needed					
EVAL Issue:					
Crossing Status: Found					
UCIP Comments: 02/22/2024 Record updated from Non-Urgent to No Action Needed. DMP internal video inspection has found none or minor pipe defects. No issues observed during inspection. (M. Thao - DWR UCIP)					
09/25/2023 DMP internal video inspection has found none or minor pipe defects. Recommend next video inspection in 5 years. (J. Taylor - DWR UCIP)					
08/29/2019 Record remains Non-Urgent, no permit has been identified authorizing pipe. Pipe is scheduled to be lined. (O. Magana - DWR UCIP, A. Freitag - DWR Sutter Yard)					
05/30/2017 Erosion still present at WS headwall. Pipe has been selected to be internally cleaned and inspected as part of the DMP project. (A. Freitag - DWR Sutter Yard)					
11/17/2016 Erosion still present at WS headwall. (A. Freitag - DWR Sutter Yard)

Levee crown looking downstream.

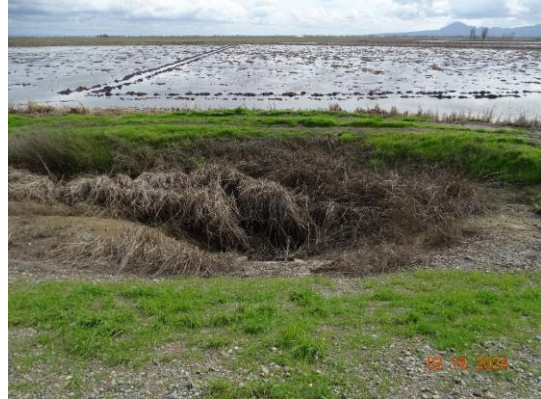
Photo 2 of 3 : UCIP\_SP\_2024\_82346\_119311.jpg

LS view: General overview looking from crown.

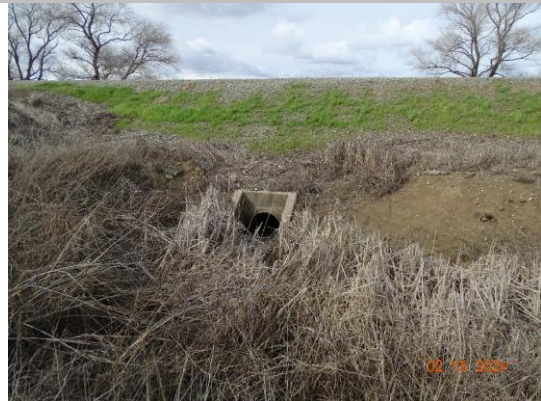
Photo 3 of 3 : UCIP\_SP\_2024\_82346\_119312.jpg

LS view: Concrete headwall located at toe; looking toward levee.

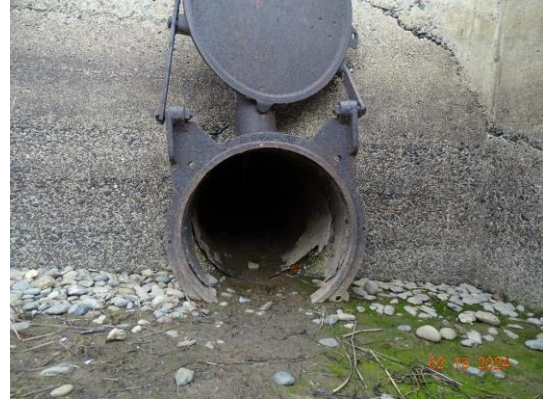
Photo 1 of 3 : UCIP\_SP\_2024\_82355\_119359.jpg

DS\_ID:16383  
FS\_ID:82355  
EP\_NO: N/A  
Repair Type: Urgent  
EVAL Issue: 1, Pipe Integrity  
Crossing Status: Found  
UCIP Comments: 02/15/2024 Record remains Urgent. DMP internal video inspection has found severe pipe defects. Crossing will be monitored until funding becomes available to address the issues. LS pipe wall is missing with heavy rust, corrosion, and deterioration. Depression is present on WS slope along the pipe alignment. Massive erosion is present along the WS concrete headwall. No permit has been identified authorizing pipe. This crossing is still under investigation under CVFPB enforcement case (ENF ID) 723. (M. Thao - DWR UCIP)  
08/29/2019 Record remains Urgent due to pipe and levee integrity concerns. Also no permit has been identified authorizing pump station. Pump station is still active. Crossing shows sloughing on the WS with visible holes in pipe on the LS. This crossing is under investigation under CVFPB enforcement case (ENF ID) 723. (O. Magana - DWR UCIP, A. Freitag - DWR Sutter Yard)

08/23/2018 The CVFPB has filed an enforcement for this crossing, Enforcement Case: 2018-723. There is still massive erosion around the WS headwall and corrosion and degradation of the LS outlet pipes, so the crossing remains Urgent. (D. Sanoski - DWR UCIP)  
05/30/2017 No repairs have been made here yet. WS still has depressions above the pipe alignment. LS pipe end still showing heavy signs of rusting and deterioration. Sediment build up inside of concrete distribution box on the LS. (A. Freitag - DWR Sutter Yard)  
11/17/2016 Crossing has not been repaired yet. pipe ends still showing heavy signs of rust and corrosion. (A. Freitag - DWR Sutter Yard)  
04/26/2016 No repairs have been made at this crossing yet. (A. Freitag - DWR Sutter Yard)  
06/30/2015 Crossing has not been repaired yet. pipe ends still showing heavy signs of rust and corrosion. (A. Freitag - DWR Sutter Yard)  
05/28/2014 Same as last inspection. (A. Freitag - DWR Sutter Yard)

12/04/2013 Same as last inspection. (A. Freitag - DWR Sutter Yard)  
07/08/2013 Same as last inspection. (A. Freitag - DWR Sutter Yard)  
04/19/2012 LS pipe collars severely damaged--section missing at flap gate. Buried section of pipe could be in the same condition. Crossing needs to be repaired; will need to coordinate with applicant. WS slide gate handle missing. (O. Magana - DWR UCIP)  
FIELD\_STRUCT\_DESC: 1 of 3: 16-inch steel irrigation pipe encased in reinforced concrete through the levee, 9.7 feet below the crown. Concrete "U" headwall on both ends. Slide gates on corrugated metal pipe risers on the waterside (WS) slope. Pump structure on the WS end. [Additional Reference(s): DWR Levee Log, 1993 (HLM 21.00). USACE Sacramento O&M Manual, Unit 519, June 1962, Revised 3 Feb

LS view: Close-up view of pipe and flap gate; pipe wall missing with rust, corrosion, and deterioration.

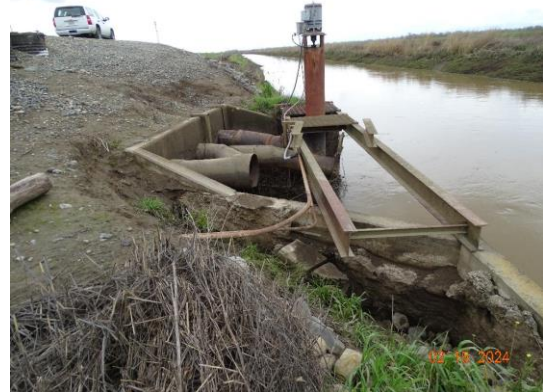
Photo 2 of 3 : UCIP\_SP\_2024\_82355\_119357.jpg

WS view: Massive erosion along concrete headwall with depression on the slope along the pipe alignment.

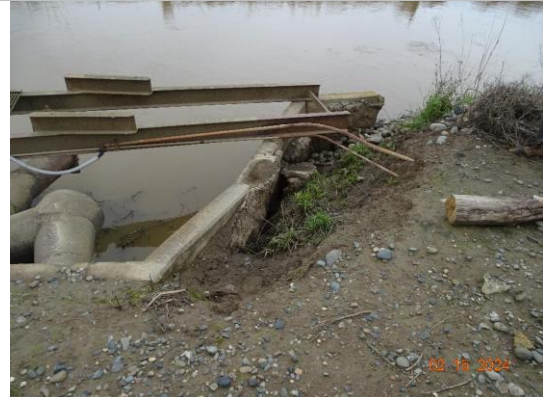
Photo 3 of 3 : UCIP\_SP\_2024\_82355\_119358.jpg

WS view: Another view of the massive erosion along concrete headwall.

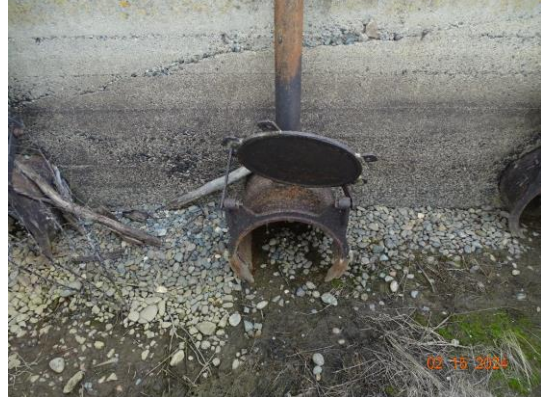
Photo 1 of 3 : UCIP\_SP\_2024\_82356\_119364.jpg

DS\_ID:17014  
FS\_ID:82356  
EP\_NO: N/A  
Repair Type: Urgent  
EVAL Issue: 1, Pipe Integrity  
Crossing Status: Found  
UCIP Comments: 02/15/2024 Record remains Urgent. DMP internal video inspection has found severe pipe defects. Crossing will be monitored until funding becomes available to address the issues. LS pipe wall is missing with heavy rust, corrosion, and deterioration. Depression is present on WS slope along the pipe alignment. Massive erosion is present along the WS concrete headwall. No permit has been identified authorizing pipe. This crossing is still under investigation under CVFPB enforcement case (ENF ID) 723. (M. Thao - DWR UCIP)  
08/29/2019 Record remains Urgent due to pipe and levee integrity concerns. Also no permit has been identified authorizing pump station. Pump station is still active. Crossing shows sloughing on the WS with visible holes in pipe on the LS. This crossing is under investigation under CVFPB enforcement case (ENF ID) 723. (O. Magana - DWR UCIP, A. Freitag - DWR Sutter Yard)

08/23/2018 The CVFPB has filed an enforcement for this crossing, Enforcement Case: 2018-723. There is still massive erosion around the WS headwall and corrosion and degradation of the LS outlet pipes, so the crossing remains Urgent. (D. Sanoski - DWR UCIP)  
05/30/2017 No repairs have been made here yet. WS still has depressions above the pipe alignment. LS pipe end still showing heavy signs of rusting and deterioration. Sediment build up inside of concrete distribution box on the LS. (A. Freitag - DWR Sutter Yard)  
11/17/2016 Crossing has not been repaired yet. pipe ends still showing heavy signs of rust and corrosion. (A. Freitag - DWR Sutter Yard)  
04/26/2016 No repairs have been made at this crossing yet. (A. Freitag - DWR Sutter Yard)  
06/30/2015 Crossing has not been repaired yet. pipe ends still showing heavy signs of rust and corrosion. (A. Freitag - DWR Sutter Yard)  
05/28/2014 Same as last inspection. (A. Freitag - DWR Sutter Yard)

12/04/2013 Same as last inspection. (A. Freitag - DWR Sutter Yard)  
07/08/2013 Same as last inspection. (A. Freitag - DWR Sutter Yard)  
04/24/2012 LS pipe collars severely damaged--section missing at flap gate. Crossing needs repair. Will need to coordinate with owner. (O. Magana - DWR UCIP)  
FIELD\_STRUCT\_DESC: 2 of 3: 16-inch steel irrigation pipe encased in reinforced concrete through the levee, 9.7 feet below the crown. Concrete "U" headwall on both ends. Slide gates on corrugated metal pipe risers on the waterside (WS) slope. Pump structure on the WS end. [Additional Reference(s): DWR Levee Log, 1993 (HLM 21.00). USACE Sacramento O&M Manual, Unit 519, June 1962, Revised 3 Feb 2011, (HLM 21.00), As-built DWG No. 50-4-3511, Sheet No. 3511/23.3,

LS view: Close-up view of pipe and flap gate; pipe wall missing with rust, corrosion, and deterioration.

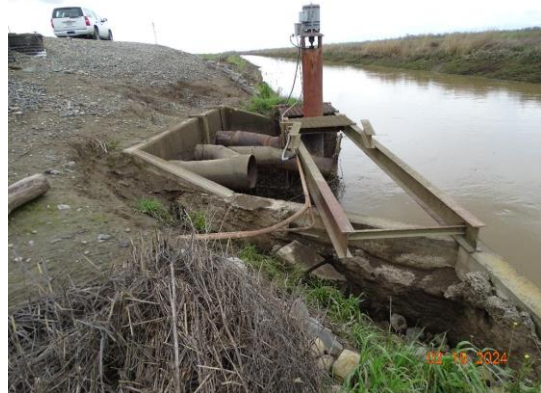
Photo 2 of 3 : UCIP\_SP\_2024\_82356\_119362.jpg

WS view: Massive erosion along concrete headwall with depression on the slope along the pipe alignment.

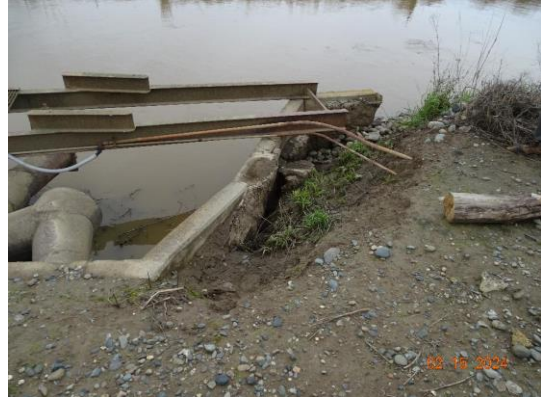
Photo 3 of 3 : UCIP\_SP\_2024\_82356\_119363.jpg

WS view: Another view of the massive erosion along concrete headwall.

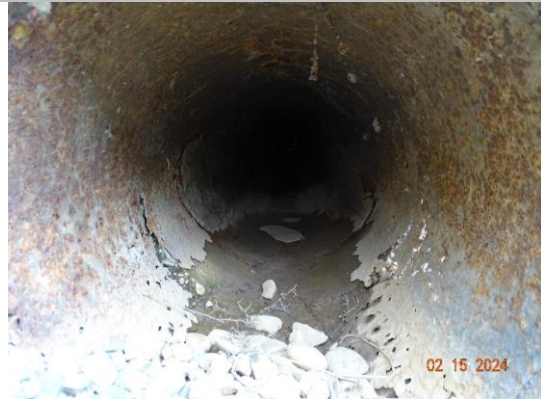
Photo 1 of 3 : UCIP\_SP\_2024\_82358\_119373.jpg

DS\_ID:17185  
FS\_ID:82358  
EP\_NO: N/A  
Repair Type: Urgent  
EVAL Issue: 1, Pipe Integrity  
Crossing Status: Found  
UCIP Comments: 02/15/2024 Record remains Urgent. DMP internal video inspection has found severe pipe defects. Crossing will be monitored until funding becomes available to address the issues. LS pipe wall is missing with heavy rust, corrosion, and deterioration. Depression is present on WS slope along the pipe alignment. Massive erosion is present along the WS concrete headwall. No permit has been identified authorizing pipe. This crossing is still under investigation under CVFPB enforcement case (ENF ID) 723. (M. Thao - DWR UCIP)  
08/29/2019 Record remains Urgent due to pipe and levee integrity concerns. Also no permit has been identified authorizing pump station. Pump station is still active. Crossing shows sloughing on the WS with visible holes in pipe on the LS. This crossing is under investigation under CVFPB enforcement case (ENF ID) 723. (O. Magana - DWR UCIP, A. Freitag - DWR Sutter Yard)

08/23/2018 The CVFPB has filed an enforcement for this crossing, Enforcement Case: 2018-723. There is still massive erosion around the WS headwall and corrosion and degradation of the LS outlet pipes, so the crossing remains Urgent. (D. Sanoski - DWR UCIP)  
05/30/2017 No repairs have been made here yet. WS still has depressions above the pipe alignment. LS pipe end still showing heavy signs of rusting and deterioration. Sediment build up inside of concrete distribution box on the LS. (A. Freitag - DWR Sutter Yard)  
11/17/2016 Crossing has not been repaired yet. pipe ends still showing heavy signs of rust and corrosion. (A. Freitag - DWR Sutter Yard)  
04/26/2016 No repairs have been made at this crossing yet. (A. Freitag - DWR Sutter Yard)  
06/30/2015 Crossing has not been repaired yet. pipe ends still showing heavy signs of rust and corrosion. (A. Freitag - DWR Sutter Yard)  
05/28/2014 Same as last inspection. (A. Freitag - DWR Sutter Yard)

12/04/2013 Same as last inspection. (A. Freitag - DWR Sutter Yard)  
07/08/2013 Same as last inspection. (A. Freitag - DWR Sutter Yard)  
04/24/2012 Sink hole present on WS. LS pipe collars severely damaged--section missing at flap gate. Crossing needs repair. Need to coordinate with owner. (O. Magana - DWR UCIP)  
FIELD\_STRUCT\_DESC: 3 of 3: 16-inch steel irrigation pipe encased in reinforced concrete through the levee, 9.7 feet below the crown. Concrete "U" headwall on both ends. Slide gates in corrugated metal pipe risers on the waterside (WS) slope. Pump structure located on the WS end. [Additional Reference(s): DWR Levee Log, 1993 (HLM 21.00). USACE Sacramento O&M Manual, Unit 519, June 1962, Revised 3 Feb 2011, (HLM 21.00), As-built DWG No. 50-4-3511, Sheet No. 3511/23.3,

LS view: Looking into the rusted, corroded, and deteriorated pipe with missing wall.

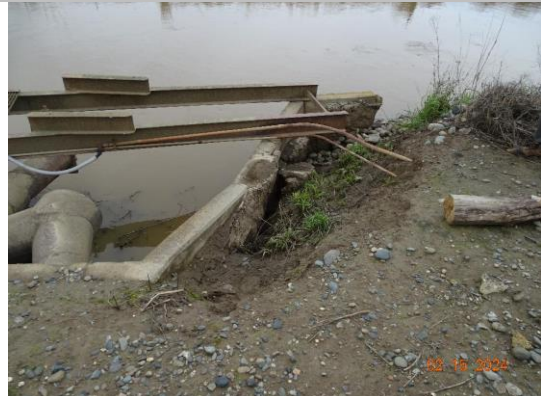
Photo 3 of 3 : UCIP\_SP\_2024\_82358\_119371.jpg

WS view: Another view of the massive erosion along concrete headwall.

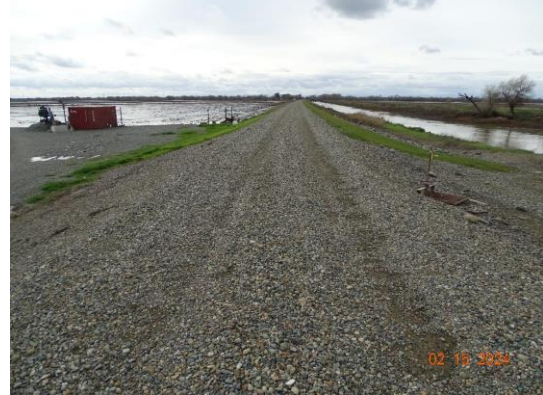
Photo 1 of 3 : UCIP\_SP\_2024\_82347\_119323.jpg

DS\_ID:16384  
FS\_ID:82347  
EP\_NO: N/A  
Repair Type: Non-Urgent  
EVAL Issue: 10, Unauthorized Modification or Non-Compliant Permit  
Crossing Status: Found  
UCIP Comments: 02/22/2024 Record remains Non-Urgent. Crossing appears to be modified since the last inspection conducted in 2019. The WS pipe extending across the canal is no longer present and the pipe on the LS now connects to a distribution box; a groundwater pump system also discharges into the distribution box. Unable to find a permit for modification. (M. Thao - DWR UCIP)  
08/29/2019 Record remains Non-Urgent due to unauthorized encroachment with recent modifications. Structure type needs to be corrected from Drainage to Irrigation. During inspection water was flowing from WS to LS to irrigate the rice fields. Structure has been modified since 2012, unable to determine extent of repair through levee. Need to contact owner to determine section replaced through levee. Structure is not maintained or operated by LMA-DWR Sutter Yard. (O. Magana - DWR UCIP, A. Freitag - DWR Sutter Yard)

05/30/2017 Crossing appears to be in good condition. Pipe has been selected to be internally cleaned and inspected as part of the DMP project. (A. Freitag - DWR Sutter Yard)  
11/17/2016 Pipe section that crosses through the levee appears to be in good condition. (A. Freitag - DWR Sutter Yard)  
04/26/2016 Pipe appears to have been repaired. Not sure on the extent of the repairs or if they were approved by the Central Valley Flood Control Board. (A. Freitag - DWR Sutter Yard)  
06/30/2015 Pipe is currently undergoing repairs. Not sure what all is planned to be fixed but will update the photos and inspection report with new details when its completed. (A. Freitag - DWR Sutter Yard)  
05/28/2014 Same as last inspection. (A. Freitag - DWR Sutter Yard)  
12/04/2013 Same as last inspection. (A. Freitag - DWR Sutter Yard)  
07/08/2013 Pipe appears to have been repaired. Need to talk to inspections and supervisor to find out more details on repair. (A. Freitag - DWR Sutter Yard)

04/24/2012 Needs repair. Internal piping, severe corrosion. Debris present--rusted pipe stockpiled on LS slope. Limited inspection on WS and LS slopes due to dense vegetation. Need photos of cleared WS & LS slopes. This crossing was listed in the USACE Periodic Inspection report as Corp's inspect ID# USACE\_CESPK\_M13E\_2011\_p\_0234 for no WS gate but sluice gate present. (O. Magana - DWR UCIP)  
FIELD\_STRUCT\_DESC: 24-inch corrugated metal irrigation pipe through the levee, 8.2 feet below the crown. Crossing penetrates levee at angle. Slide gate in corrugated metal pipe (CMP) riser on the waterside (WS) slope. Pipe crosses the channel. Corroded section of existing pipe, 9-foot and 8-inch of an 18-inch corrugated metal pipe

Levee crown looking downstream.

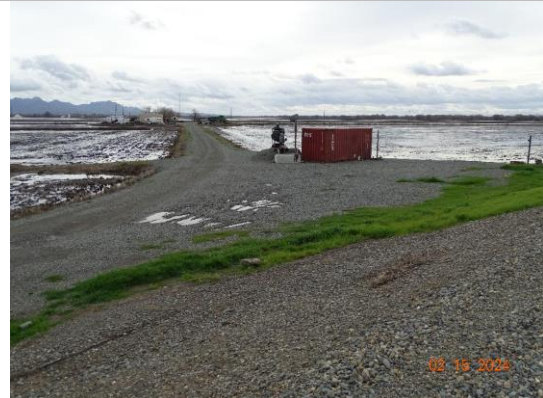
Photo 2 of 3 : UCIP\_SP\_2024\_82347\_119322.jpg

LS view: General overview looking from crown; groundwater pump and distribution box located approximately 50 feet from toe.

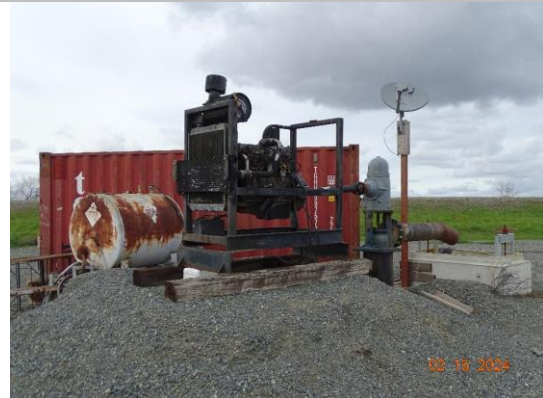
Photo 3 of 3 : UCIP\_SP\_2024\_82347\_119320.jpg

LS view: Groundwater pump and distribution box located approximately 50 feet from toe.

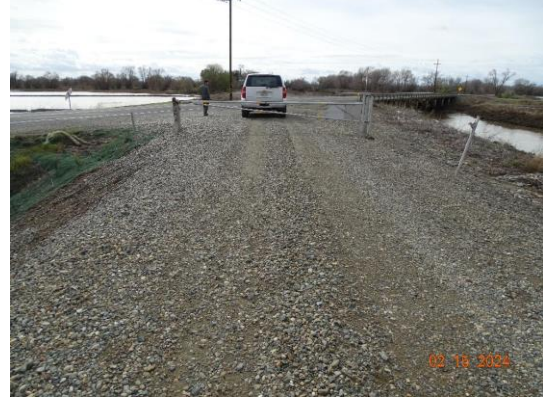
Photo 1 of 3 : UCIP\_SP\_2024\_82351\_119332.jpg

DS\_ID:16394  
FS\_ID:82351  
EP\_NO: N/A  
Repair Type: No Action Needed  
EVAL Issue:  
Crossing Status: Found  
UCIP Comments: 02/15/2024 Record updated from Non-Urgent to No Action Needed. DMP internal video inspection has found none or minor pipe defects. No issues observed during inspection. (M. Thao - DWR UCIP)  
09/25/2023 DMP internal video inspection has found none or minor pipe defects. Recommend next video inspection in 5 years. (J. Taylor - DWR UCIP)  
08/29/2019 Record remains Non-Urgent, no permit has been identified authorizing pipe. Pipe has been lined and a new flap gate has been installed on the WS. (O. Magana - DWR UCIP, A. Freitag - DWR Sutter Yard)  
05/30/2017 WS flap gate showing signs of rusting and deterioration but still appears to be able to function properly. Pipe has been selected to be internally cleaned and inspected as part of the DMP project. (A. Freitag - DWR Sutter Yard)

11/17/2016 WS flap gate is really rusted and deteriorated but it appears to still function properly. (A. Freitag - DWR Sutter Yard)  
04/26/2016 WS flap gate is really rusted and deteriorated. May need to be replaced. The rest of the crossing appeared in good condition. (A. Freitag - DWR Sutter Yard)  
06/30/2015 Crossing is in good condition. No noticeable issues to be reported. (A. Freitag - DWR Sutter Yard)  
05/28/2014 Same as last inspection. (A. Freitag - DWR Sutter Yard)  
12/04/2013 WS and LS slopes are in good condition. (A. Freitag - DWR Sutter Yard)  
07/08/2013 Same as last inspection. (A. Freitag - DWR Sutter Yard)  
04/24/2012 Limited inspection on WS and LS slopes due to dense vegetation. Need photos of cleared WS and LS slopes. This crossing was listed in the USACE Periodic Inspection report as Corp's inspect ID# USACE\_CESPK\_M13E\_2011\_p\_0251 for no outlet visible on WS. (O. Magana - DWR UCIP)

FIELD\_STRUCT\_DESC: 24-inch CIPP-lined corrugated metal drainage pipe through the levee, 11.6 feet below the crown. Flap gate on the waterside (WS) end. Concrete "U" headwalls on both WS and landside (LS). Rusted gate located on the WS (gate stuck). [Additional Reference(s): DWR Levee Log, 1993 (HLM 22.08). USACE Sacramento O&M Manual, Unit 519, June 1962, Revised 3 Feb 2011, (HLM 22.08), As-built DWG No. 50-4-3511, Sheet No. 3511/2.2 and 31.2, STA 67+70E, page 2, 31 of 31 electronic file, listed as 24-inch CMP section through the levee]  
FS Date: 2/15/2024 11:40:56 AM

Levee crown looking downstream.

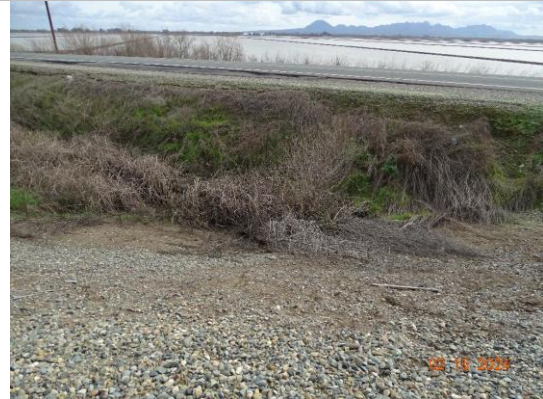
Photo 2 of 3 : UCIP\_SP\_2024\_82351\_119333.jpg

LS view: General overview looking from crown.

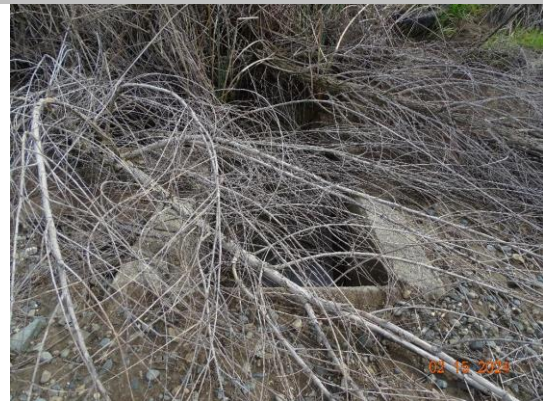
Photo 3 of 3 : UCIP\_SP\_2024\_82351\_119335.jpg

LS view: Concrete headwall located at toe; looking down from slope.

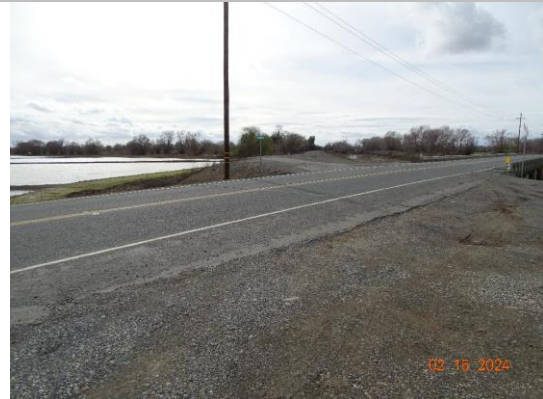
Photo 1 of 3 : UCIP\_SP\_2024\_82354\_119345.jpg

DS\_ID:16374  
FS\_ID:82354  
EP\_NO: N/A  
Repair Type: Non-Urgent  
EVAL Issue: 10, Unauthorized Modification or Non-Compliant Permit  
Crossing Status: Indicator Found  
UCIP Comments: 02/15/2024 Record remains Non-Urgent. Multiple splice boxes present along the LS toe. Unauthorized encroachment recorded in Levee Log. (M. Thao - DWR UCIP)  
08/29/2019 Record remains Non-Urgent, no permit has been identified authorizing pipe. Also modification have been made without prior notification to the CVFPB. Multiple splice boxes can be found along the LS toe. Need to review CVFPB enforcement case to determine if issue has been resolved. Need updated photos for this crossing. (O. Magana - DWR UCIP, A. Freitag - DWR Sutter Yard)  
05/30/2017 Splice box still present at LS toe. (A. Freitag - DWR Sutter Yard)  
11/17/2016 Splice box still present at LS toe. (A. Freitag - DWR Sutter Yard)  
04/26/2016 Communication Splice box was still present. Not sure what was done to ever resolve the encroachment issue. (A. Freitag - DWR Sutter Yard)

06/30/2015 Same as last inspection. (A. Freitag - DWR Sutter Yard)  
05/28/2014 Same as last inspection. (A. Freitag - DWR Sutter Yard)  
12/04/2013 Same as last inspection. (A. Freitag - DWR Sutter Yard)  
07/08/2013 Same as last inspection. (A. Freitag - DWR Sutter Yard)  
04/24/2012 Unauthorized Encroachment. This crossing is listed multiple times in the USACE Periodic Inspection report as USACE\_CESPK\_M13E\_2011\_p\_0307, 0315, 0317, 0318 for slope failure on LS hinge. DWR-Flood Maintenance Office records shows that CVFPB has requested AT&T to remove conduit in June 2, 2009 letter. LMA working with CVFPB to resolve. (O. Magana - DWR UCIP)  
FIELD\_STRUCT\_DESC: Underground telephone cable in the landside (LS) levee slope at an unknown depth. (AT&T) START latitude 39.36210336, longitude -121.8678207 END latitude 39.35458541, longitude -121.8823409. Line extends from Gridley Colusa Highway to the south end of project levee along landside (LS) shoulder and levee crown hinge point. Levee sloughs along cable trench after heavy rains. [Additional Reference(s): DWR Levee Log, 1993 (HLM 22.11). USACE Sacramento O&M Manual, Unit 519, June 1962, Revised 3 Feb 2011, listed in As-built DWG No. 50-4-3511 only and not manual, Sheet No. 3511/31.2, STA 66+00E, page 31 of 31 electronic file, listed as underground telephone and electric line through the levee]

Levee crown looking downstream.

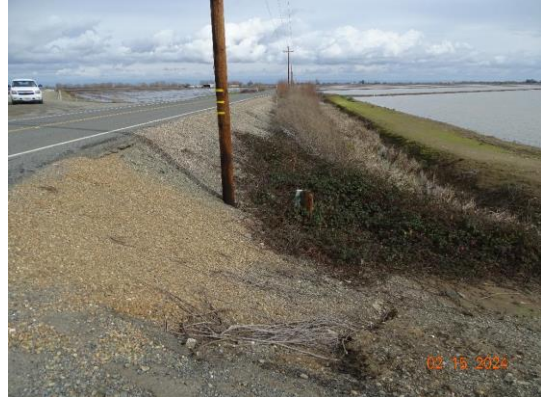
Photo 2 of 3 : UCIP\_SP\_2024\_82354\_119348.jpg

LS view: General overview looking from crown; splice box located at the toe (right of the power pole).

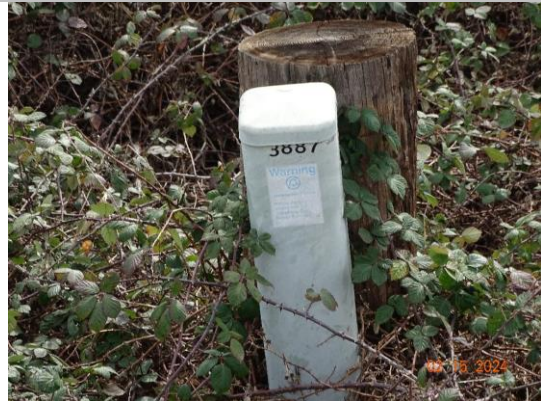
Photo 3 of 3 : UCIP\_SP\_2024\_82354\_119347.jpg

LS view: Close-up view of the splice box.

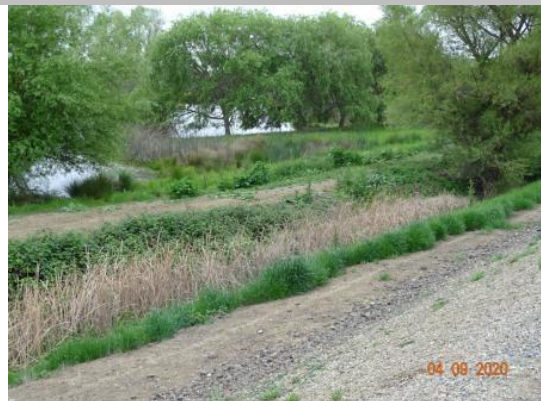
Photo 1 of 1 : SP\_2024\_MA0013\_301\_59\_20240212\_00010.jpg

LM Start	21.87	Rating **	U	Issue No.	59
LM End	22.09	Issue Type +	En	Location *	LS
Category	Earthen Levee			GPS Latitude/Longitude	
				Start	End
Item	Encroachments			39.362022°	39.360294°
				-121.867949°	-121.871339°
DWR ID	DWR_MA0013_02_s_2016_59				
Comment Code					
DT : Ditch					
Inspector Comment

View of the ditch along the landside toe. Spring 2020.

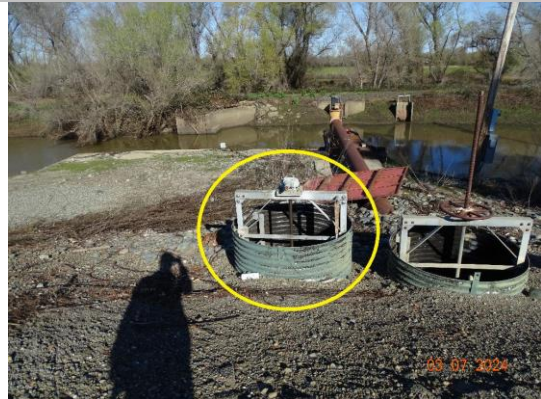
Photo 1 of 1 : UCIP\_SP\_2024\_82453\_119417.jpg

DS\_ID:16389  
FS\_ID:82453  
EP\_NO: N/A  
Repair Type: Non-Urgent  
EVAL Issue: 4b, Safety Issue  
Crossing Status: Found  
UCIP Comments: 03/07/2024 Record remains Non-Urgent. No permit has been identified authorizing pipe. No cover was present on CMP riser causing a safety hazard; recommend adding a cover. (M. Thao - DWR UCIP)  
08/29/2019 Record has been updated from No Action Needed to Non-Urgent, no permit has been identified authorizing pipe. Recommend CMP riser covers for this crossing for safety purposes. (O. Magana - DWR UCIP, A. Freitag - DWR Sutter Yard)  
05/30/2017 Crossing appears to be in good condition. (A. Freitag - DWR Sutter Yard)  
11/17/2016 Crossing appears to be in good condition. (A. Freitag - DWR Sutter Yard)  
04/26/2016 Crossing appears to be in good condition. (A. Freitag - DWR Sutter Yard)  
06/30/2015 Crossing is in good condition. No noticeable issues to report. (A. Freitag - DWR Sutter Yard)

05/28/2014 Same as last inspection. (A. Freitag - DWR Sutter Yard)  
12/04/2013 Top of screw gate has been replaced and gate is now fully functional. (A. Freitag - DWR Sutter Yard)  
07/08/2013 Top of slide gate frame and wheel missing making gate inoperable. Needs to be replaced before flood season. (A. Freitag - DWR Sutter Yard)  
FIELD\_STRUCT\_DESC: 42-inch corrugated metal irrigation pipe through the levee, 11.7 feet below the crown. Slide gate in corrugated metal pipe riser on the waterside (WS) slope. Concrete "U" headwall on the WS end. A concrete headwall trash gate is located on the WS inlet.  
[Additional Reference(s): DWR Levee Log, 1993 (HLM 22.40), listed as 42-inch pipe. USACE Sacramento O&M Manual, Unit 519, June 1962, Revised 3 Feb 2011, (HLM 22.40), listed as 36-inch pipe, As-built DWG No. 50-4-3511, Sheet No. 3511/21.2, STA 51+32E, page 21 of 31 electronic file, listed as combination of existing 36-inch CMP and new 42-inch CMP section through the levee (irrigation and drainage structures); As-built DWG No. 50-4-3037 referenced not available]

WS view: CMP riser unit on slope with no cover; looking from crown.

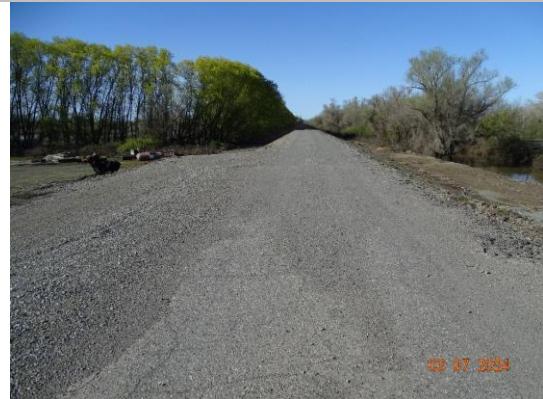
Photo 1 of 3 : UCIP\_SP\_2024\_82450\_119403.jpg

DS\_ID:16391  
FS\_ID:82450  
EP\_NO: N/A  
Repair Type: Non-Urgent  
EVAL Issue:  
Crossing Status: Found  
UCIP Comments: 03/07/2024 Record remains Non-Urgent. Geophysical results did not confirm presence of pipe through levee. Record will remain in UCIP's inspection records until future Levee Improvement Project can confirm no crossing was found through the levee. Crossing not found during current inspection. Concrete rubbles found at LS toe that appear it could be the headwalls. (M. Thao - DWR UCIP)  
08/29/2019 Record remains Non-Urgent, no permit has been identified authorizing pipe. WS outlet is blocked by dense vegetation. LS inlet is still unknown. DWR Geophysical Survey was unable to confirm alignment. Need to contact property owner to determine if crossing is still being used and confirm pipe alignment. (O. Magana - DWR UCIP, A. Freitag - DWR Sutter Yard)  
05/30/2017 Location of LS inlet still unknown. Need to trace with utility locator/GPR to find. Pipe has been selected to be internally cleaned and inspected as part of the DMP project. (A. Freitag - DWR Sutter Yard)

11/17/2016 Unable to locate LS pipe end. WS appears to be in good condition. (A. Freitag - DWR Sutter Yard)  
04/26/2016 Still unable to locate the LS headwall and end of pipe. Pipe is still being used. Pipe was draining to WS. (A. Freitag - DWR Sutter Yard)  
06/30/2015 Still unable to locate the LS headwall and pipe end. (A. Freitag - DWR Sutter Yard)  
05/28/2014 Same as last inspection. (A. Freitag - DWR Sutter Yard)  
12/04/2013 Same as last inspection. (A. Freitag - DWR Sutter Yard)  
07/08/2013 Same as last inspection. Unable to locate LS headwall. (A. Freitag - DWR Sutter Yard)  
04/24/2012 Unable to locate LS headwall. Need photo of LS headwall during next inspection. (O. Magana - DWR UCIP)  
FIELD\_STRUCT\_DESC: 30-inch corrugated metal drainage pipe through the levee, 15.3 feet below the crown. Concrete "U" headwalls on both waterside (WS) and landside (LS) ends. Flap gate on the WS end. This pipe runs on an angle through the levee, then underground along the LS slope to historic levee mile (HLM) 22.39 where it enters a ditch on the LS. [Additional Reference(s): DWR Levee Log, 1993 (HLM 22.41), listed as 30-inch pipe. USACE Sacramento O&M Manual, Unit 519, June 1962, Revised 3 Feb 2011, (HLM 22.41), listed as 24-inch pipe, As-built DWG No. 50-4-3511, Sheet No. 3511/21.2, STA 50+87E, page 21 of 31 electronic file, listed as 30-inch CMP section through the levee (irrigation and drainage structures); As-built DWG No. 50-4-3037 referenced not available]

Levee crown looking downstream.

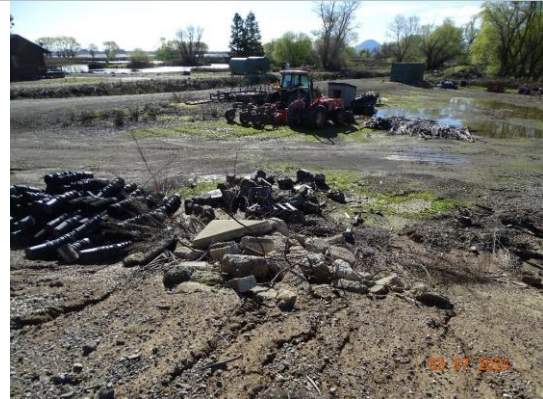
Photo 2 of 3 : UCIP\_SP\_2024\_82450\_119404.jpg

LS view: General overview looking from crown; concrete rubbles at toe.

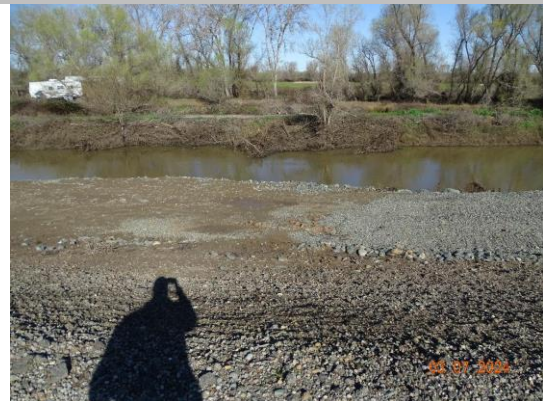
Photo 3 of 3 : UCIP\_SP\_2024\_82450\_119405.jpg

WS view: General overview looking from crown.

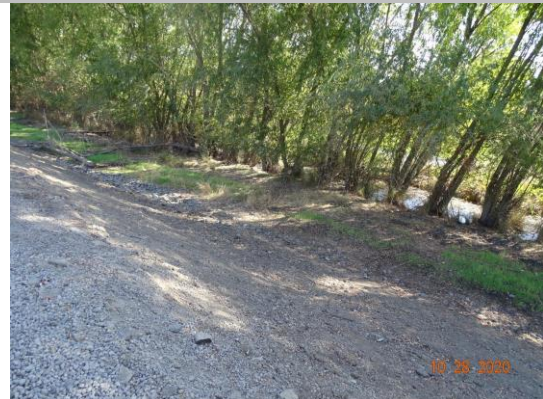
Photo 1 of 1 : SP\_2024\_MA0013\_301\_62\_20240212\_00011.jpg

LM Start	22.33	Rating **	A/W	Issue No.	62
LM End	22.33	Issue Type +	Ma	Location *	LS
Category	Earthen Levee			GPS Latitude/Longitude	
				Start	End
Item	Slope Stability			39.358419°	39.358419°
				-121.875088°	-121.875088°
DWR ID	DWR_MA0013_02_s_2016_62				
Comment Code					
S1 : Repair slope instability.					
Inspector Comment

View of the slope instability along the landside slope. Fall 2020.
