**Flood Control Project Maintenance  
Levee Inspections**

**Maintenance Issue Types Only, Levee Inspection Report By Mile - Spring 2016**

**Sutter Maintenance Yard Maintenance Area 0017**

Waterway	Bank	Unit Miles	Inspection Start/End	Inspector
Unit No. 01 Lake County Sutter Maintenance Yard - Middle Creek	Left	3.87	05/02/2016 05/02/2016	Keith Millard

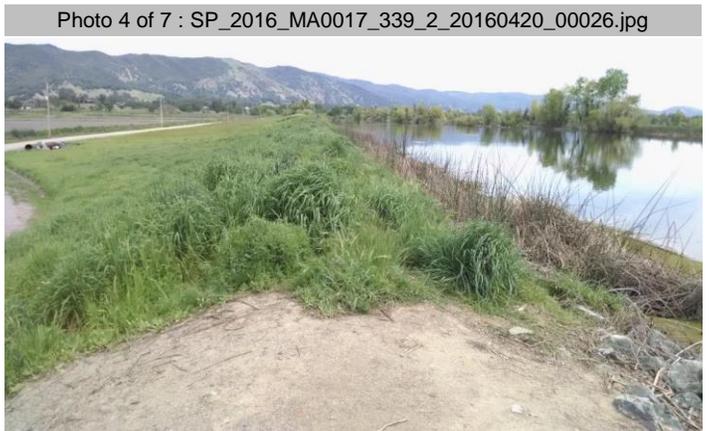
LM Start	<b>4.16</b>	Rating **	U	Issue No.	<b>2 (cont)</b>
LM End	<b>7.23</b>	Issue Type +	Ma	Location *	WS
Category	Earthen Levee			GPS Latitude/Longitude	
				Start	End
Item	Trim / Thin Trees			39.141894 °	39.118735 °
				-122.902201 °	-122.884892 °
DWR ID	DWR_MA0017_01_s_2012_2				
Comment Code					
T2 : Thin trees to allow visibility of the ground and room to flood fight.					
Inspector Comment					
Trees and limbs are completely obstructing visibility on crown and WS. Crown is too narrow to drive, and overgrown with weeds, brush and trees. Road follows LS toe.
